2-Methylnaphthalene Detections in CAMU Unit 1 Leak Detection Samples
2007 - 2017

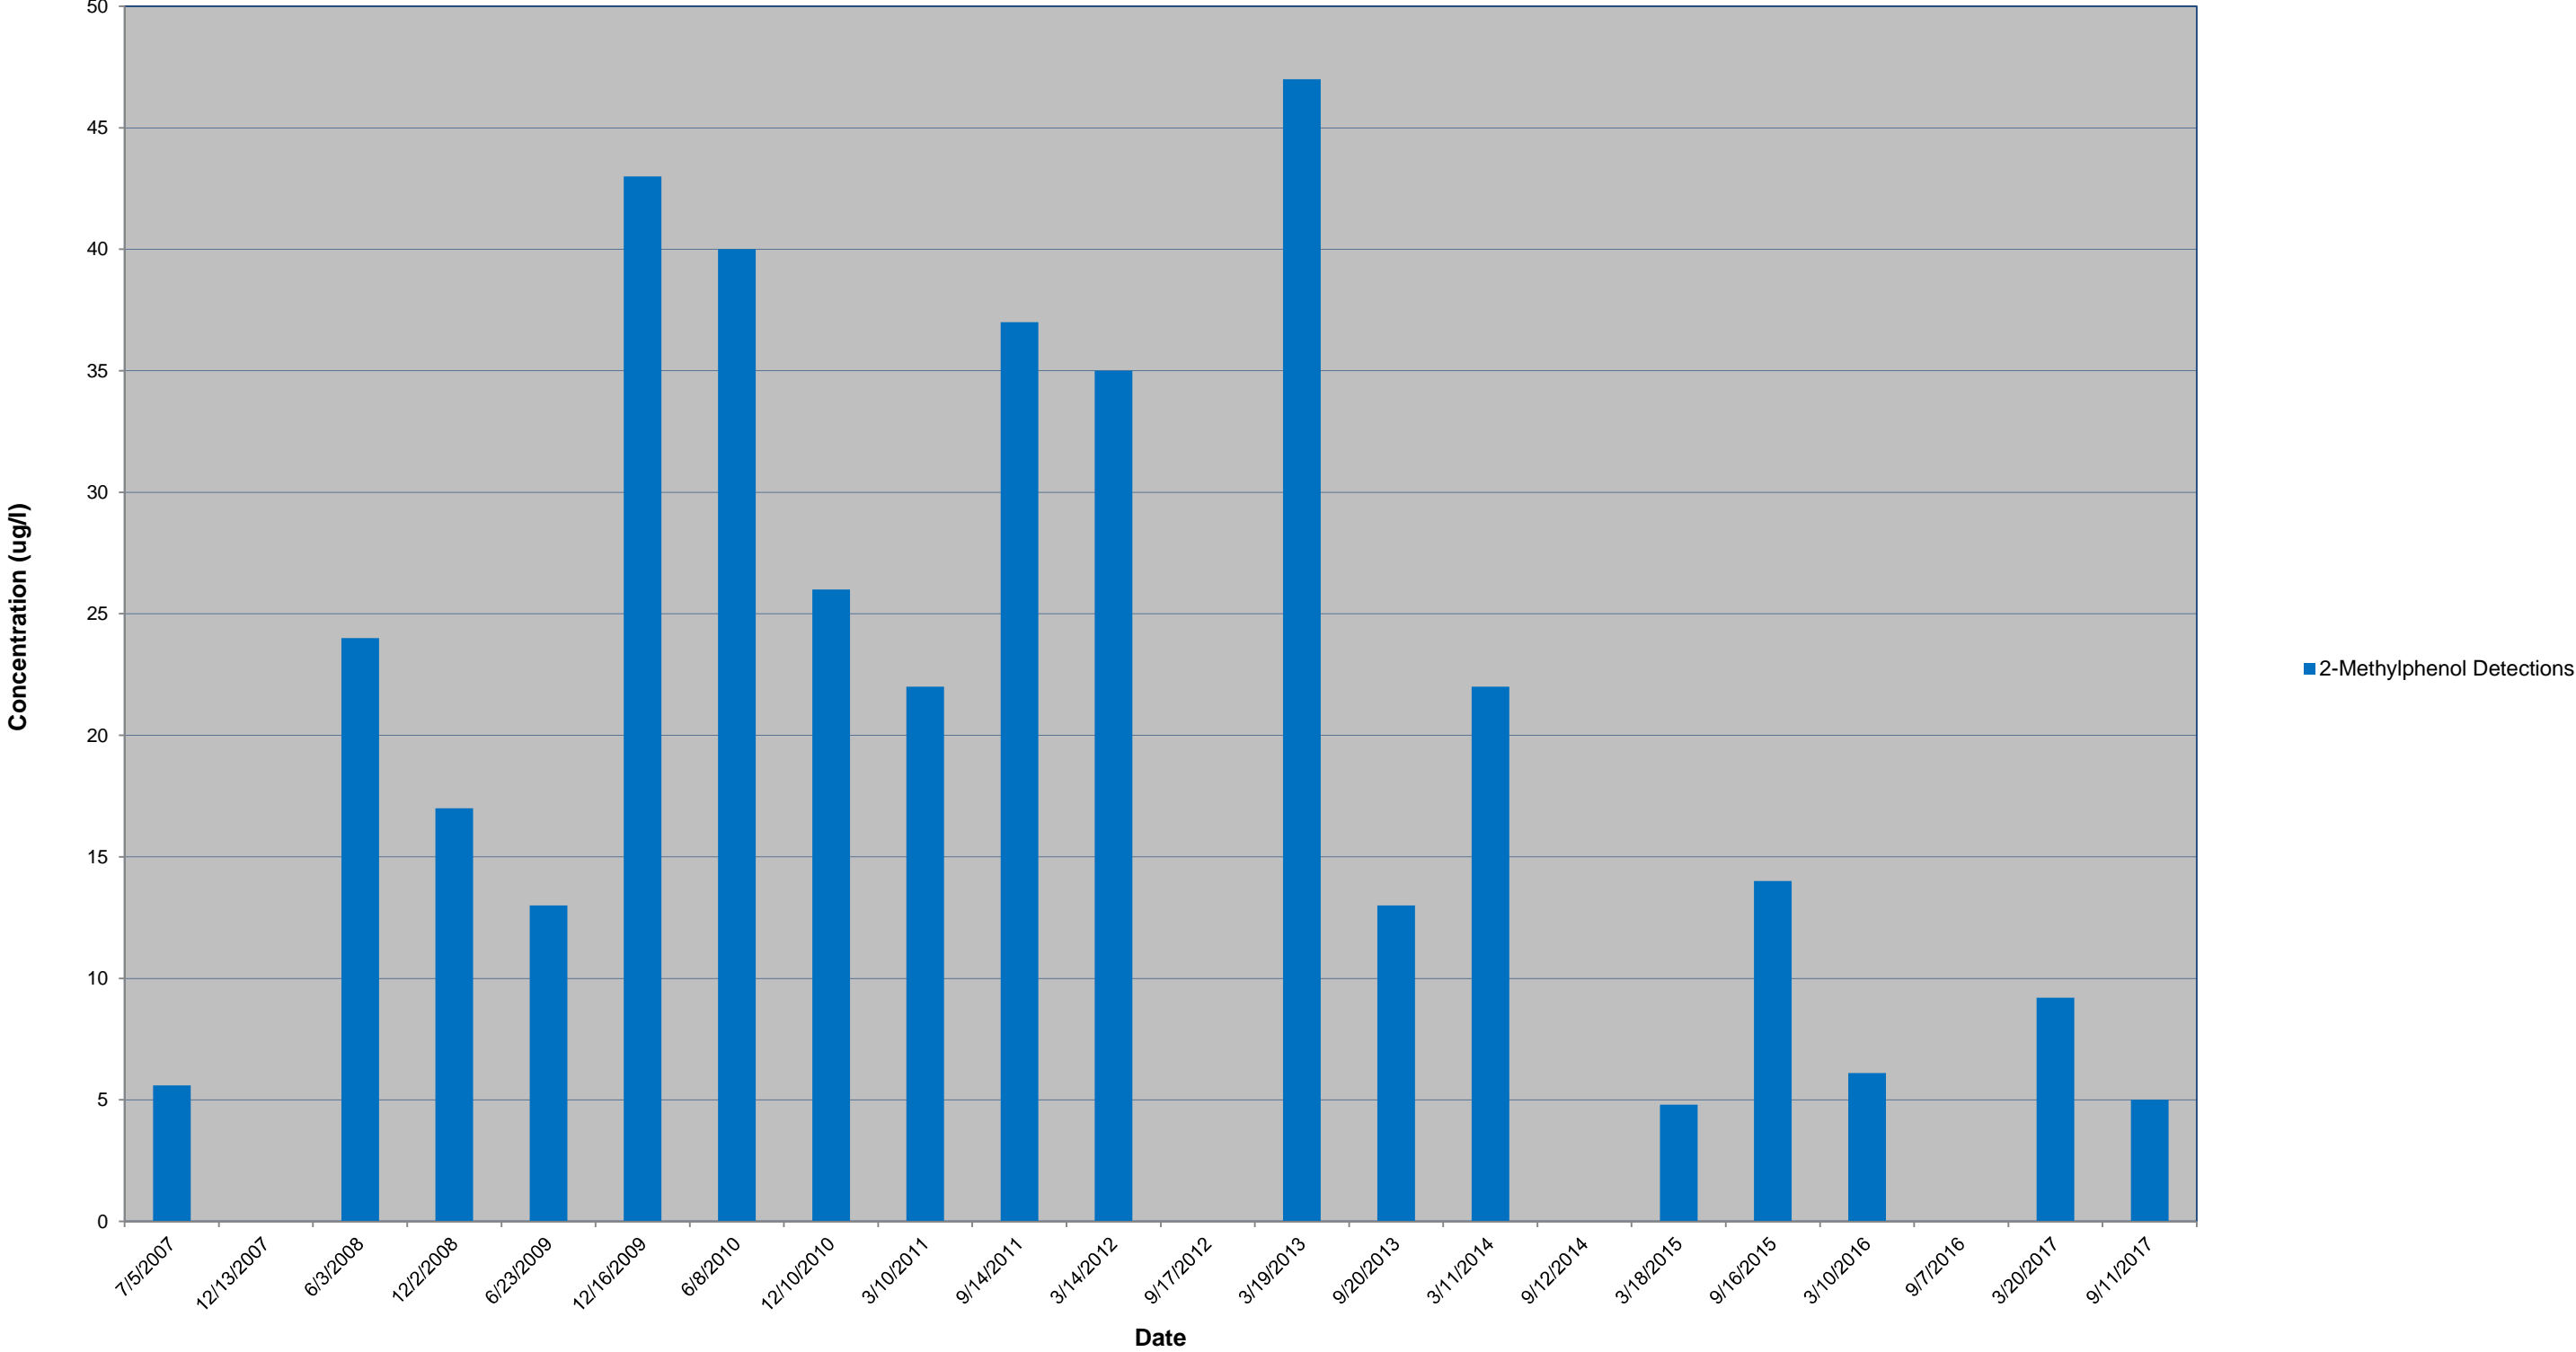
2-Methylphenol Detections in CAMU Unit 1 Leak Detection Samples
2007 - 2017

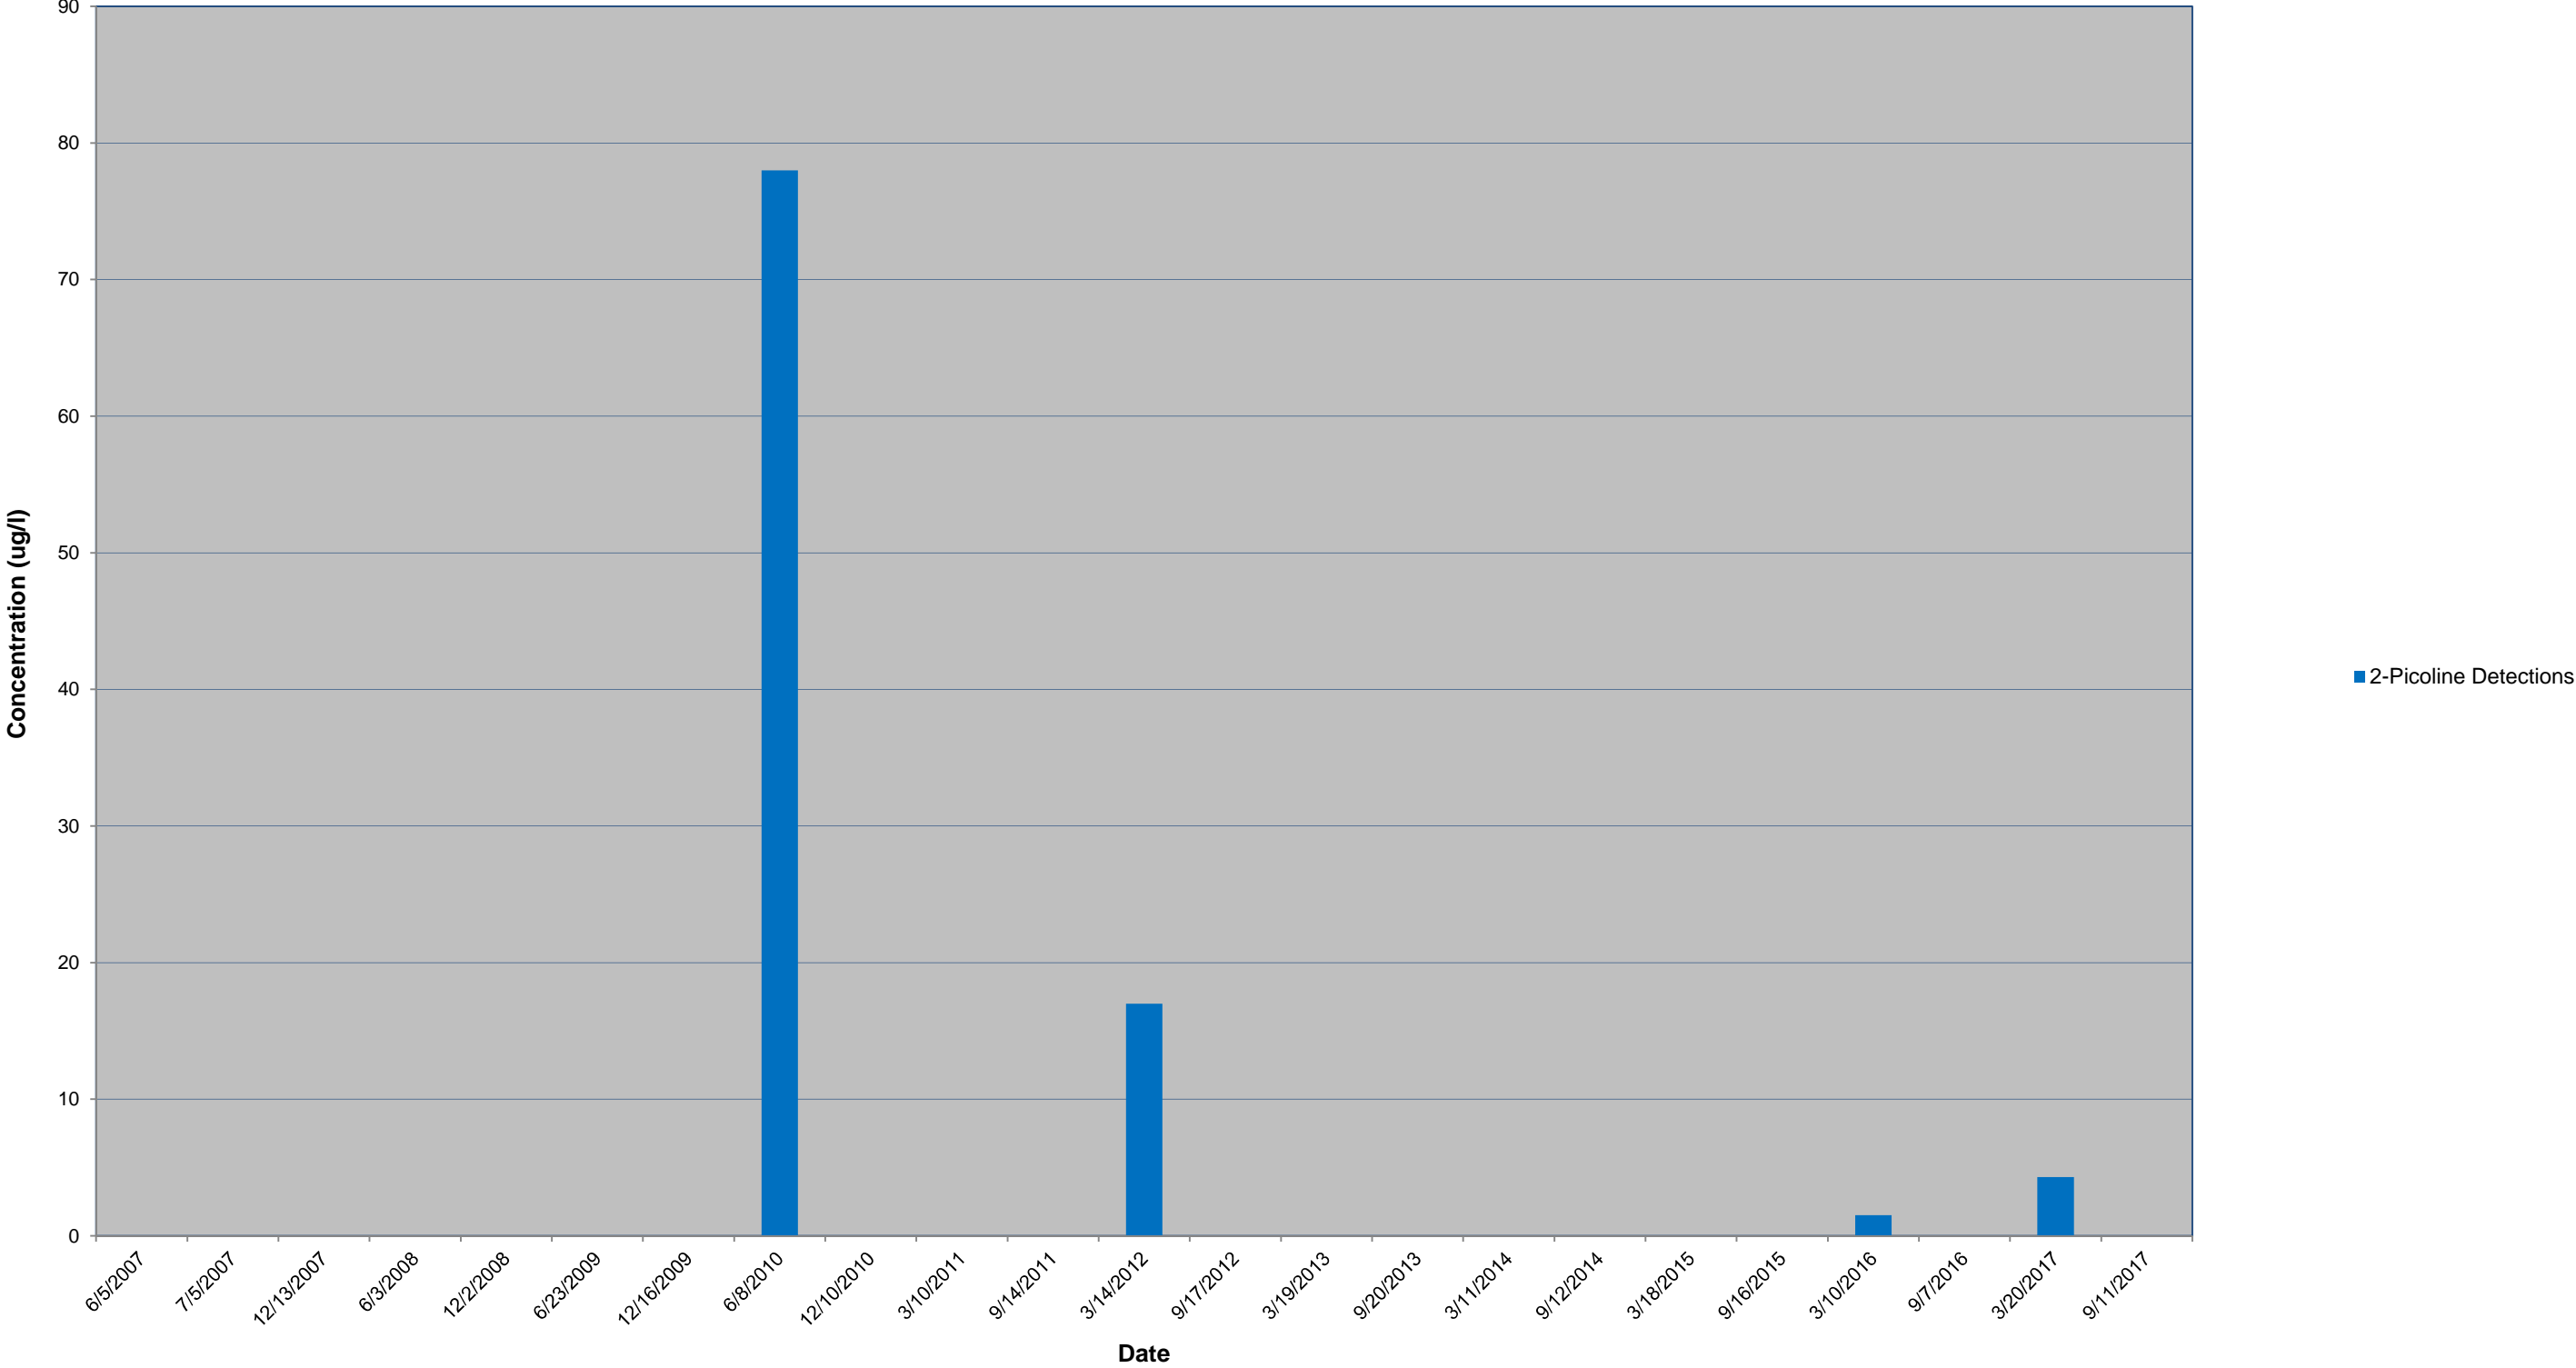
2-Picoline Detections in CAMU Unit 1 Leak Detection Samples
2007 - 2017

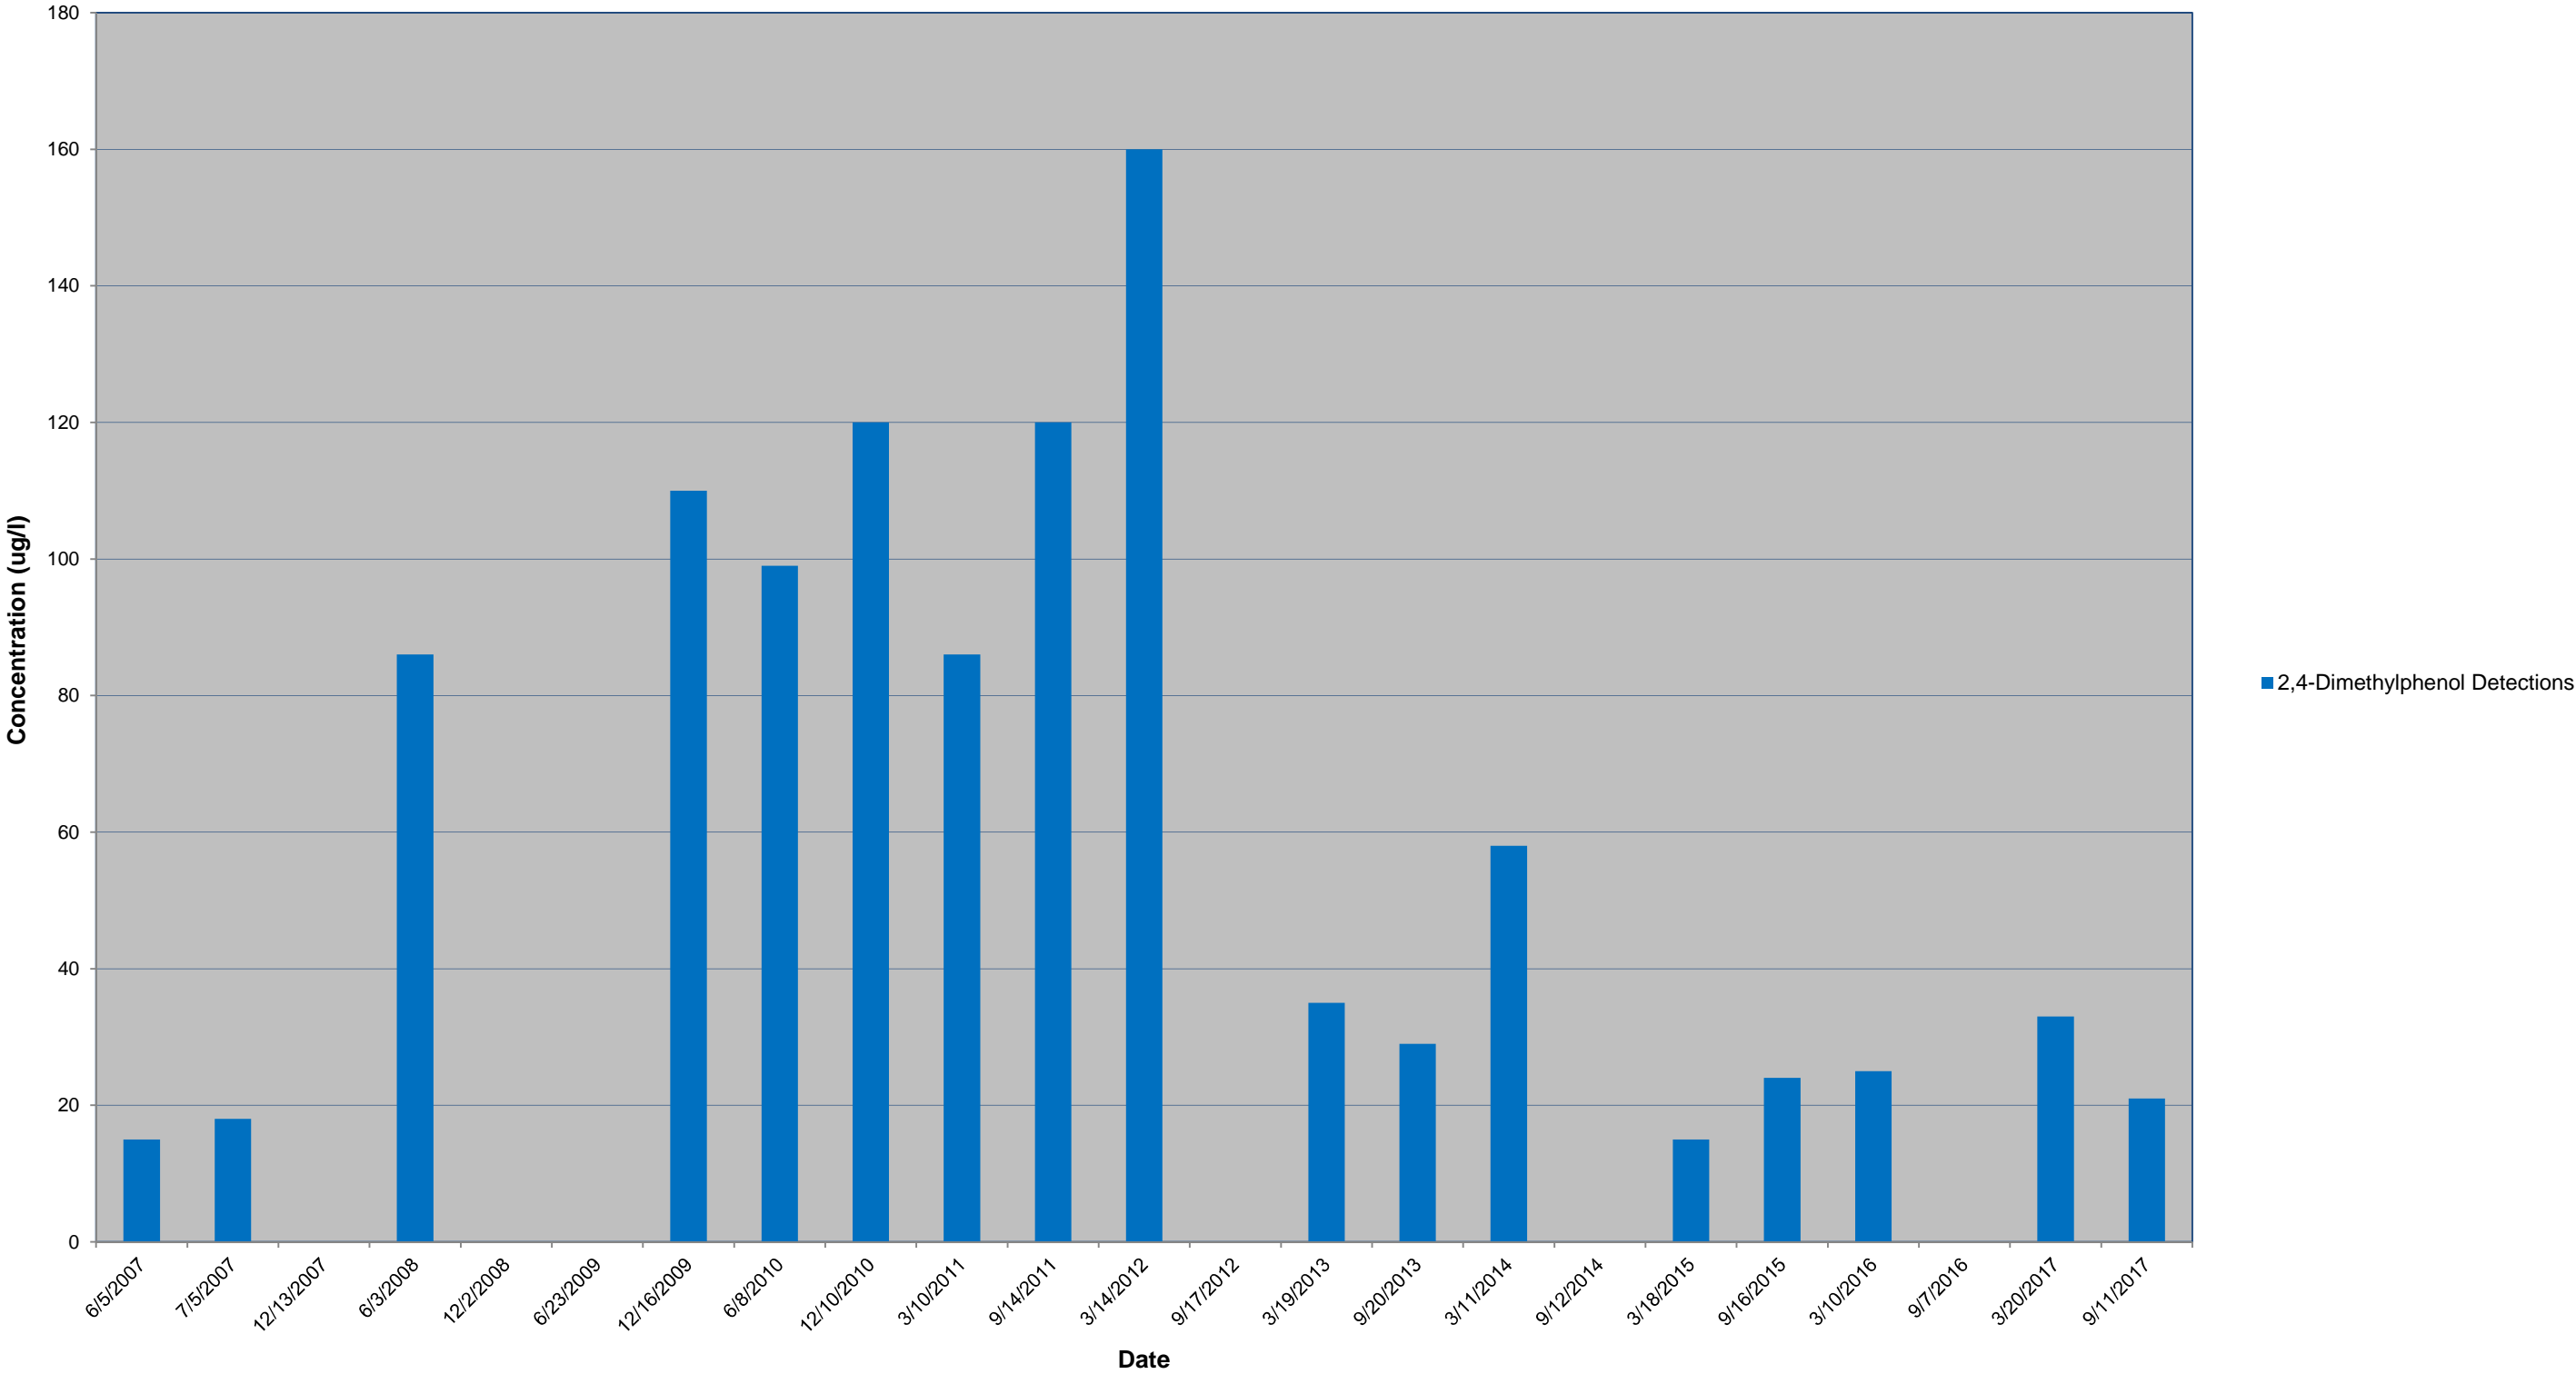
2,4-Dimethylphenol Detections in CAMU Unit 1 Leak Detection Samples
2007 - 2017

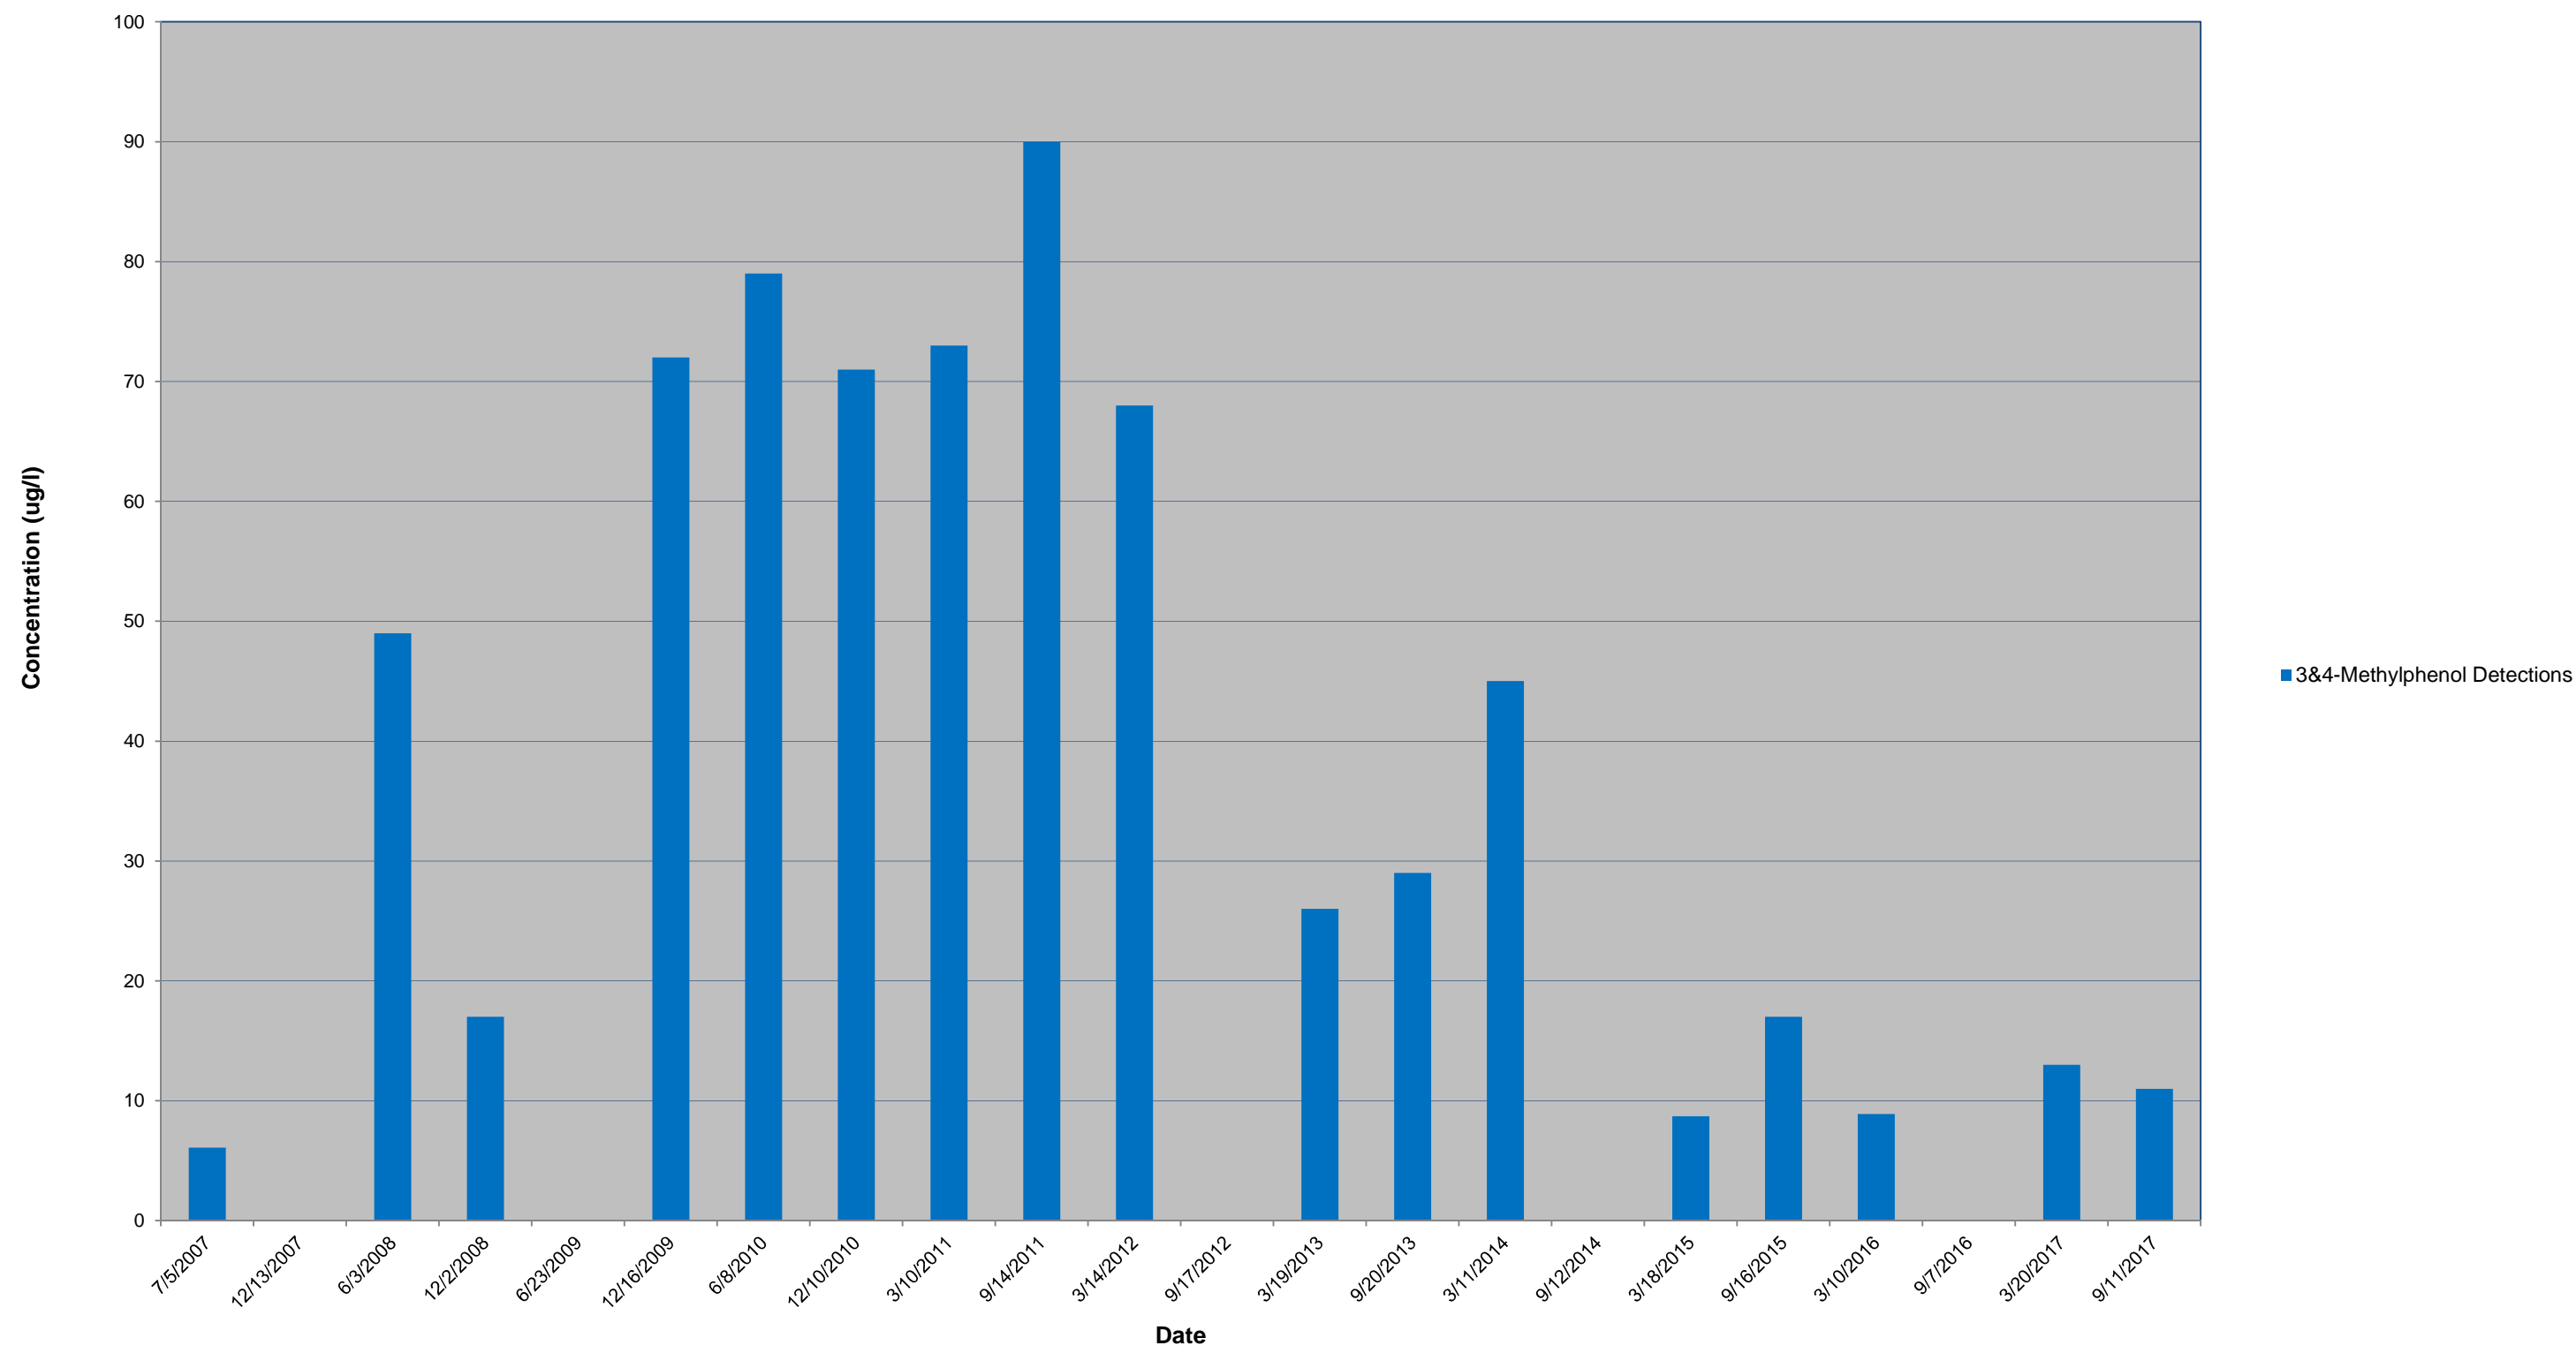
3&4-Methylphenol Detections in CAMU Unit 1 Leak Detection Samples
2007 - 2017

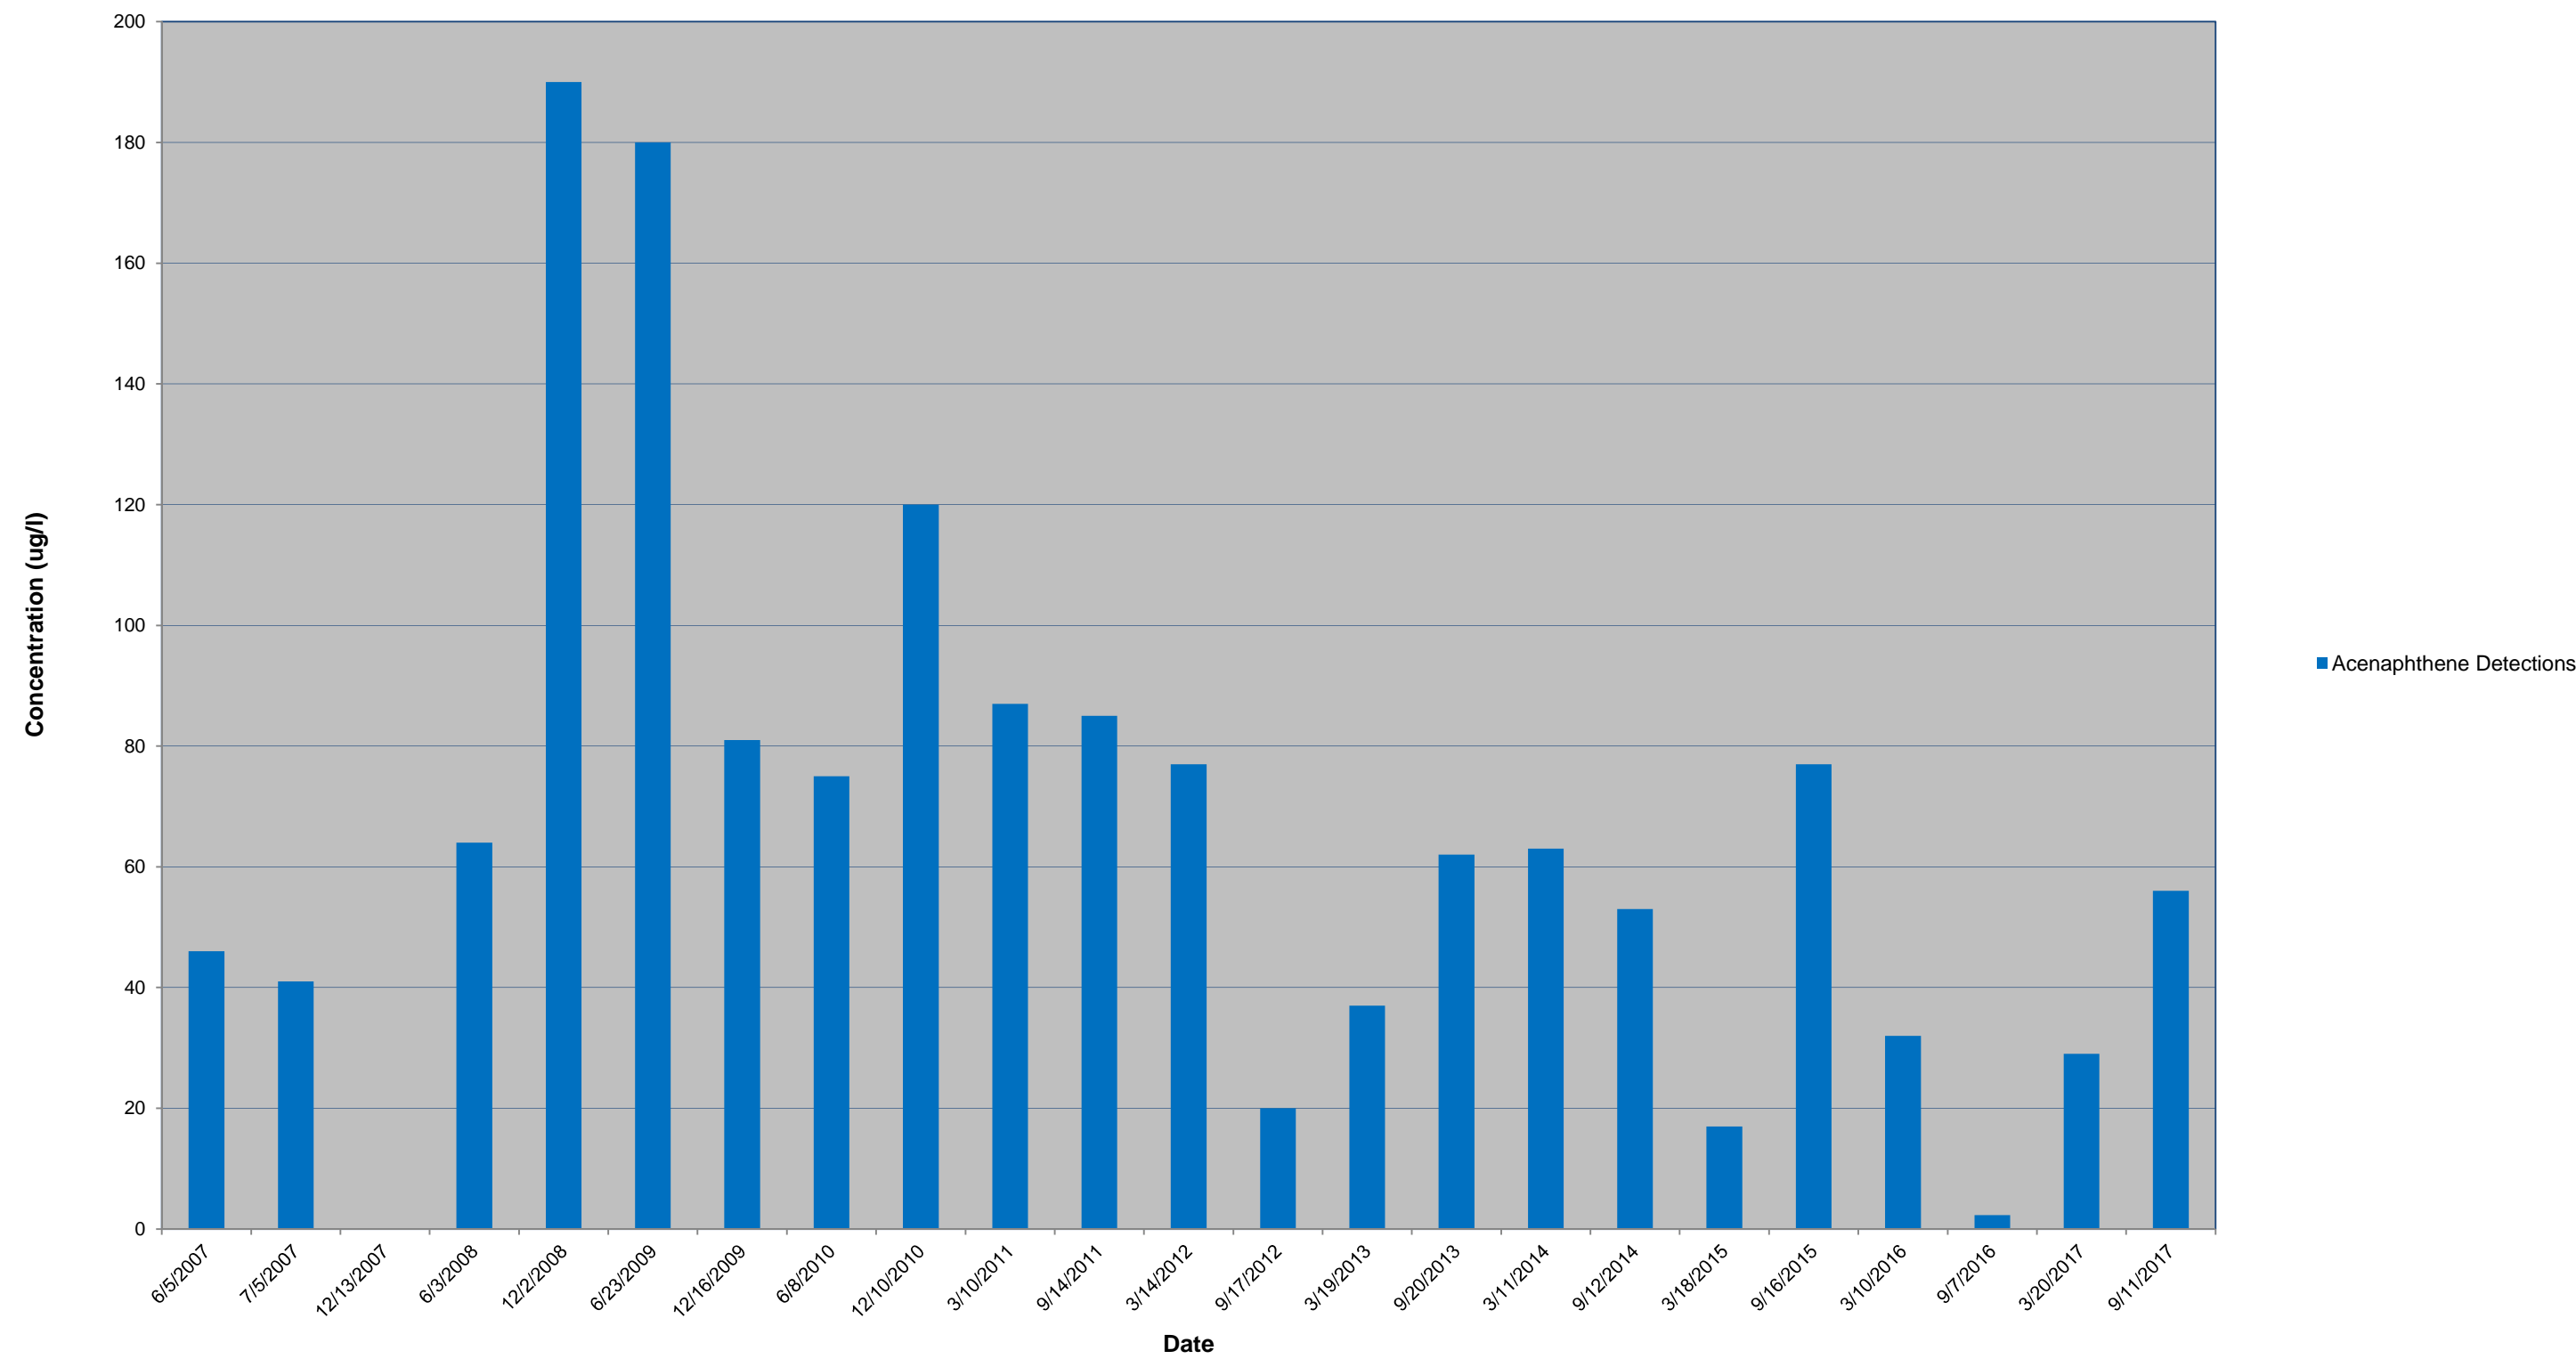
Acenaphthene Detections in CAMU Unit 1 Leak Detection Samples
2007 - 2017

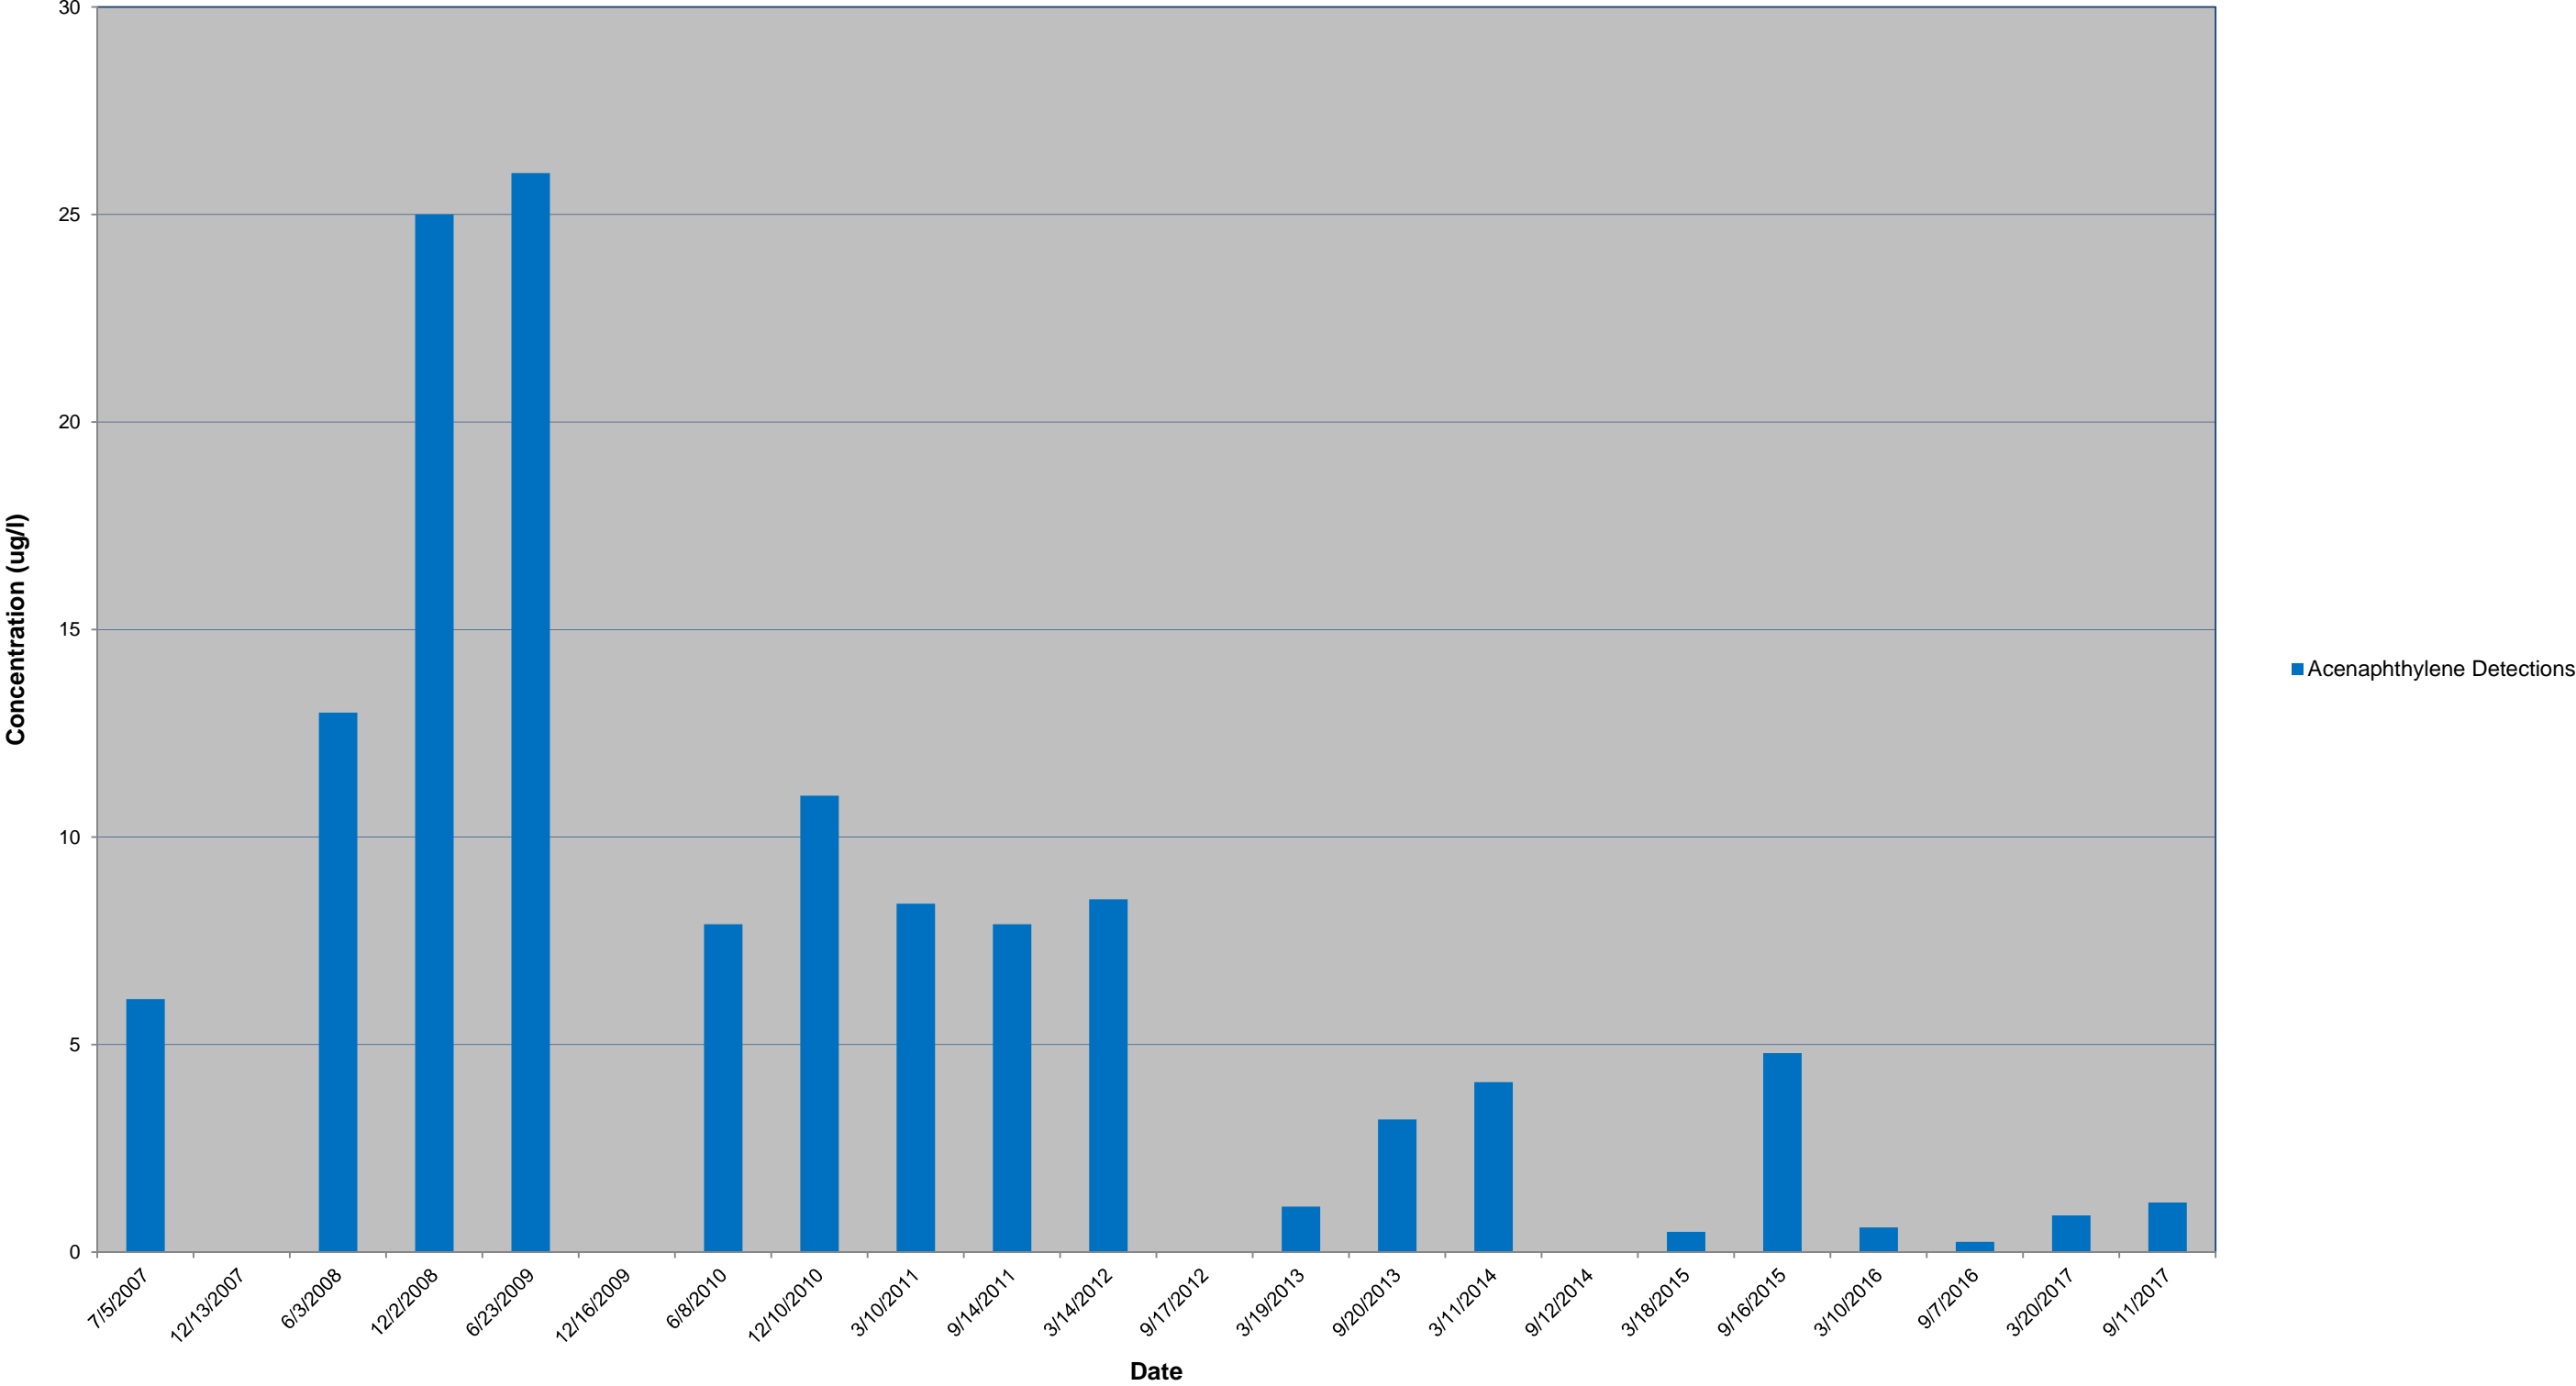
Acenaphthylene Detections in CAMU Unit 1 Leak Detection Samples
2007 - 2017
