2-Methylnaphthalene Detections in CAMU Unit 1 Leak Detection Samples
2007 - 2017

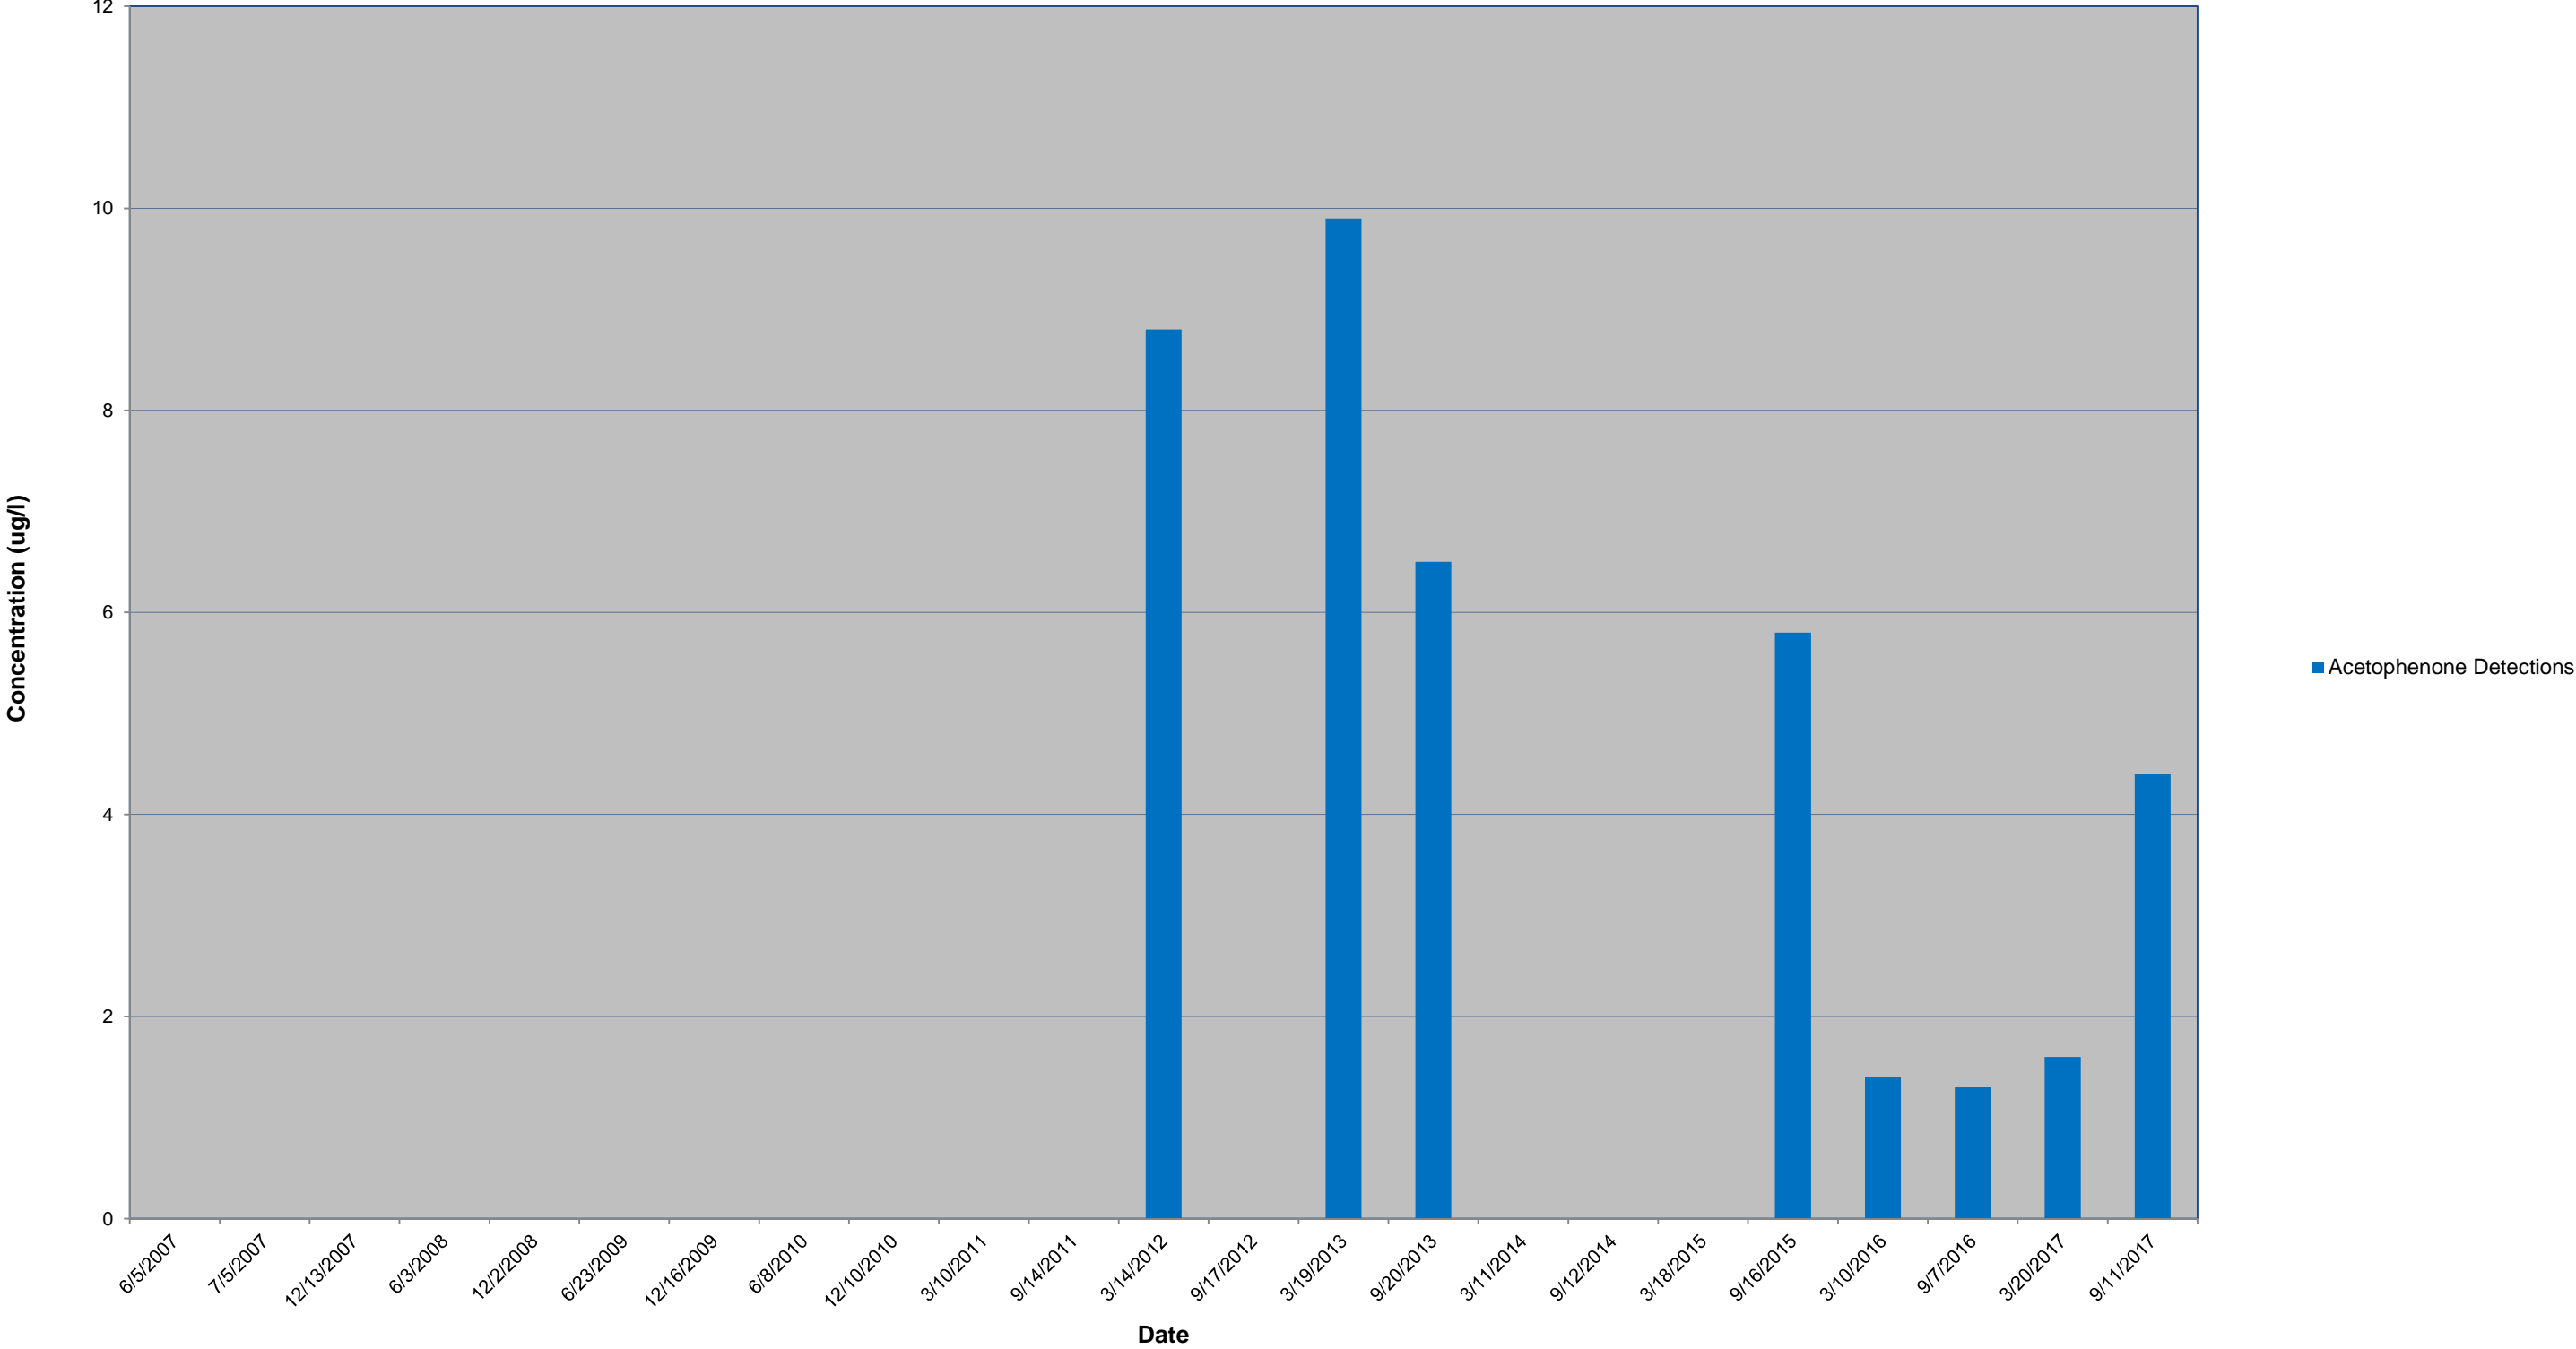
Acetophenone Detections in CAMU Unit 1 Leak Detection Samples
2007 - 2017

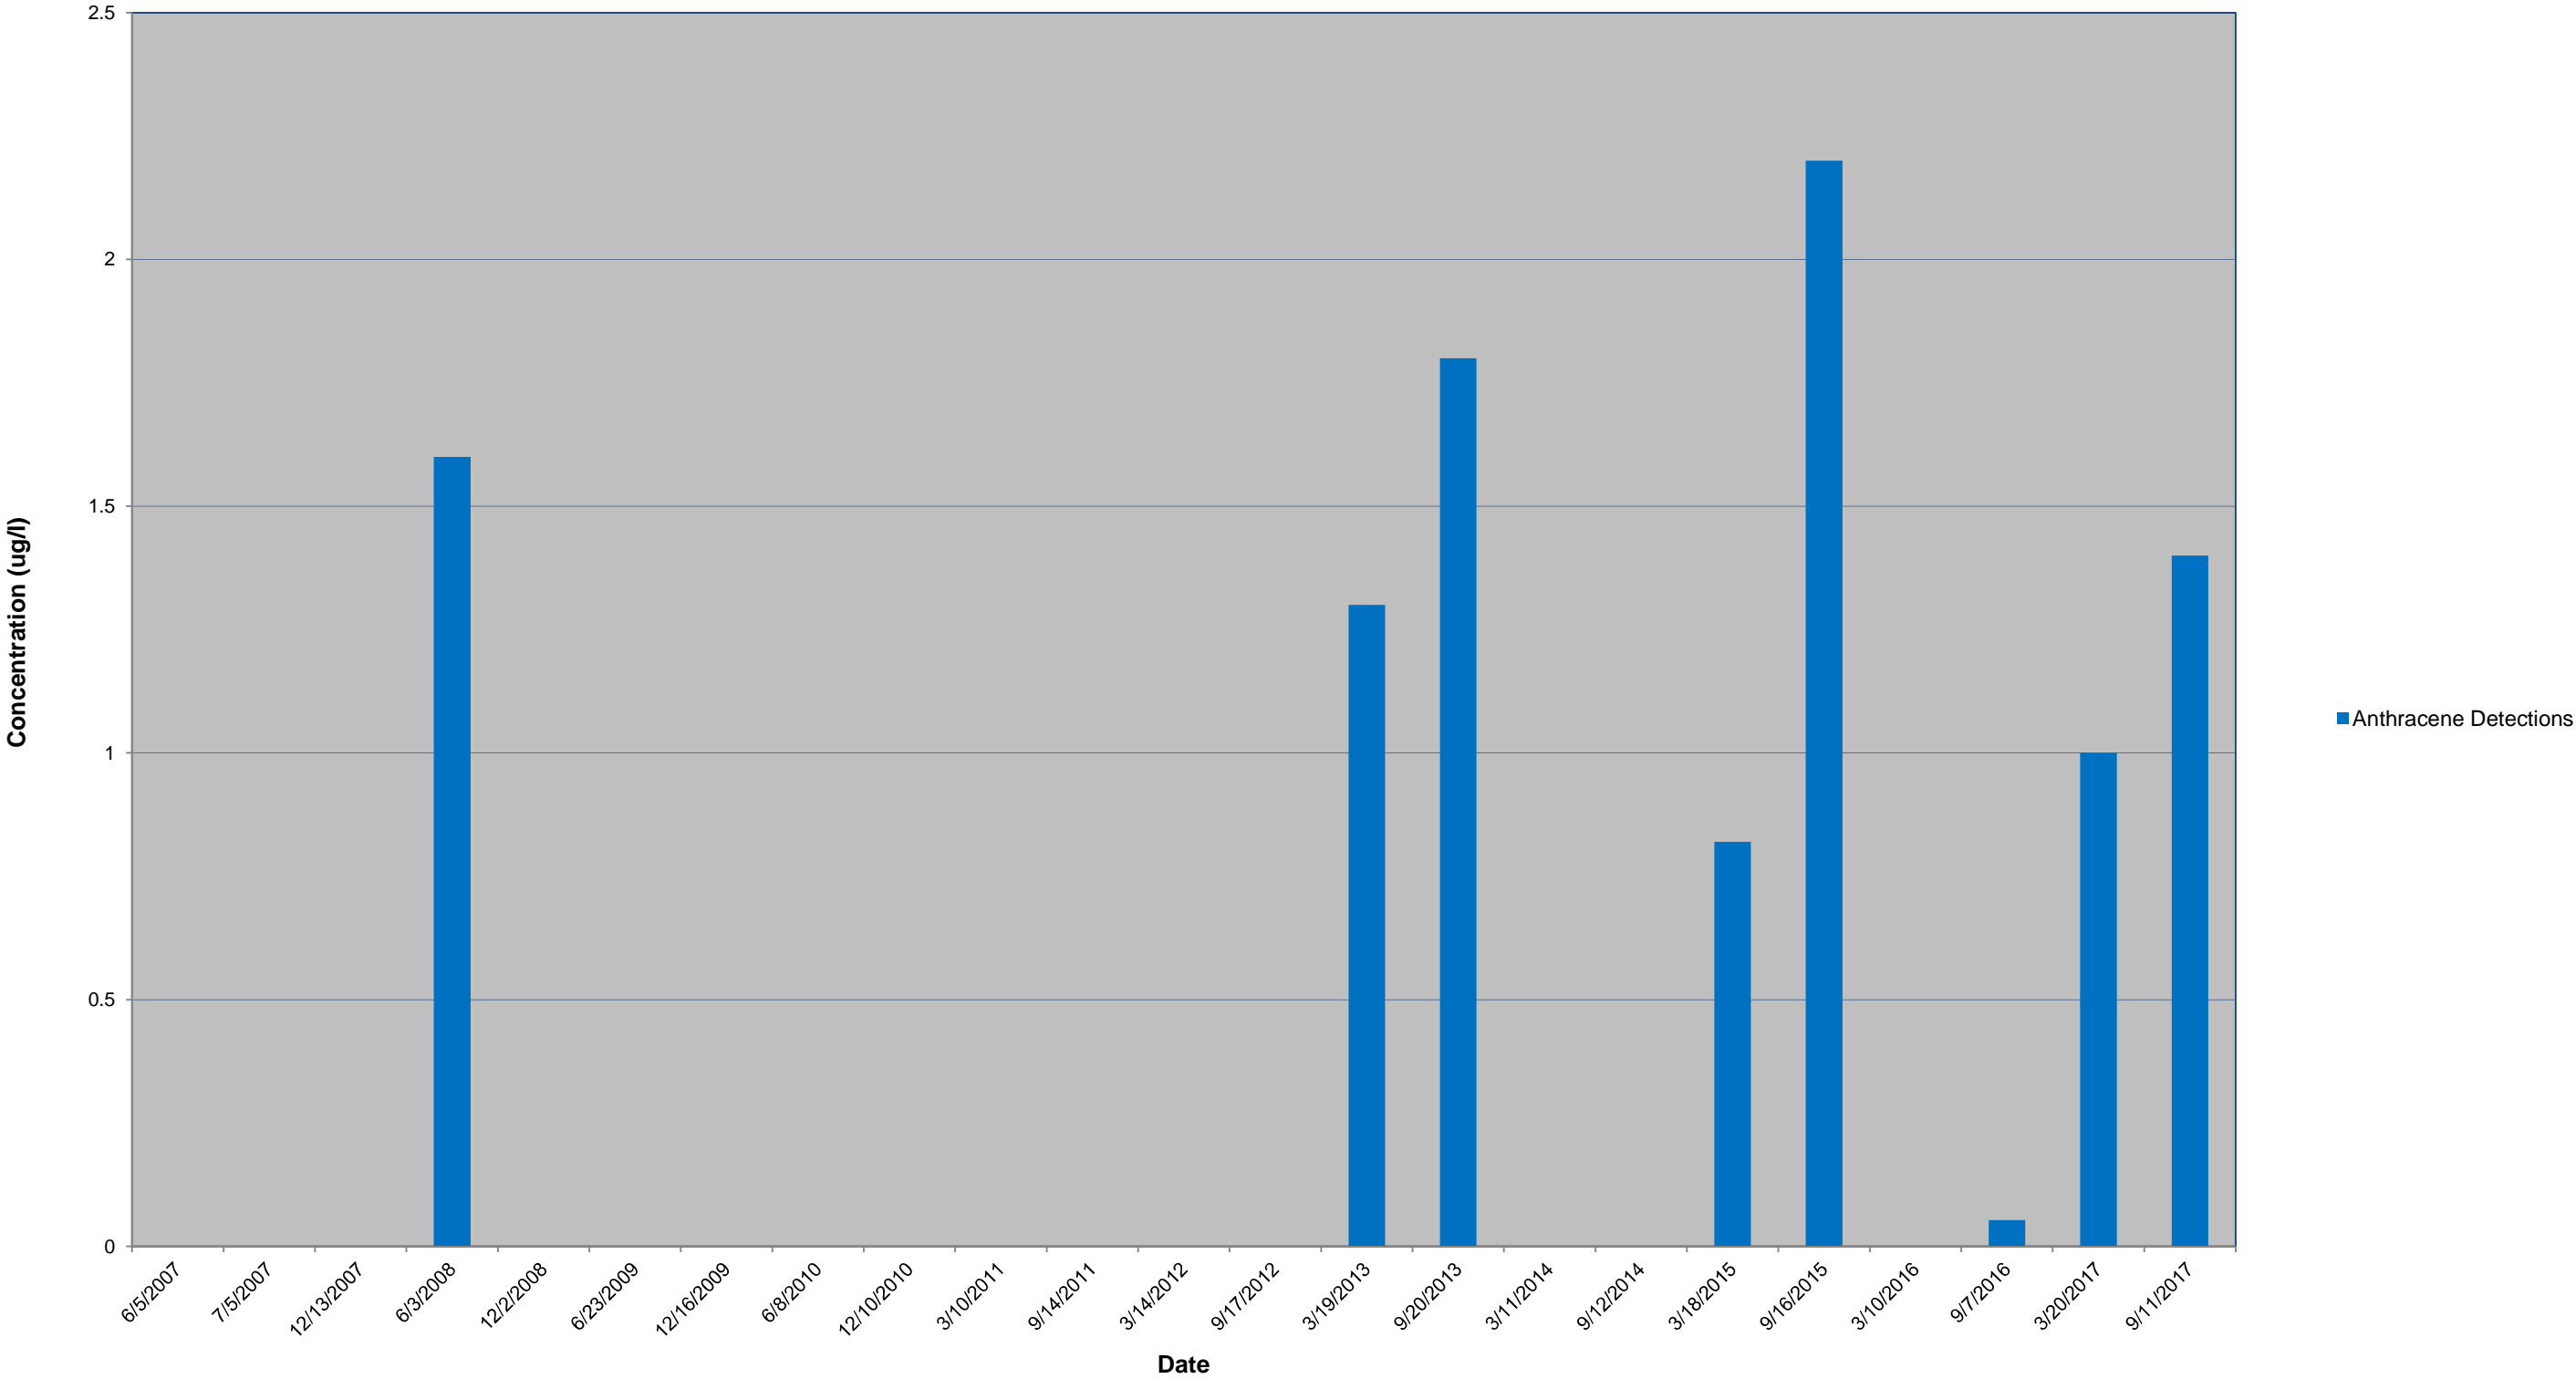
Anthracene Detections in CAMU Unit 1 Leak Detection Samples
2007 - 2017

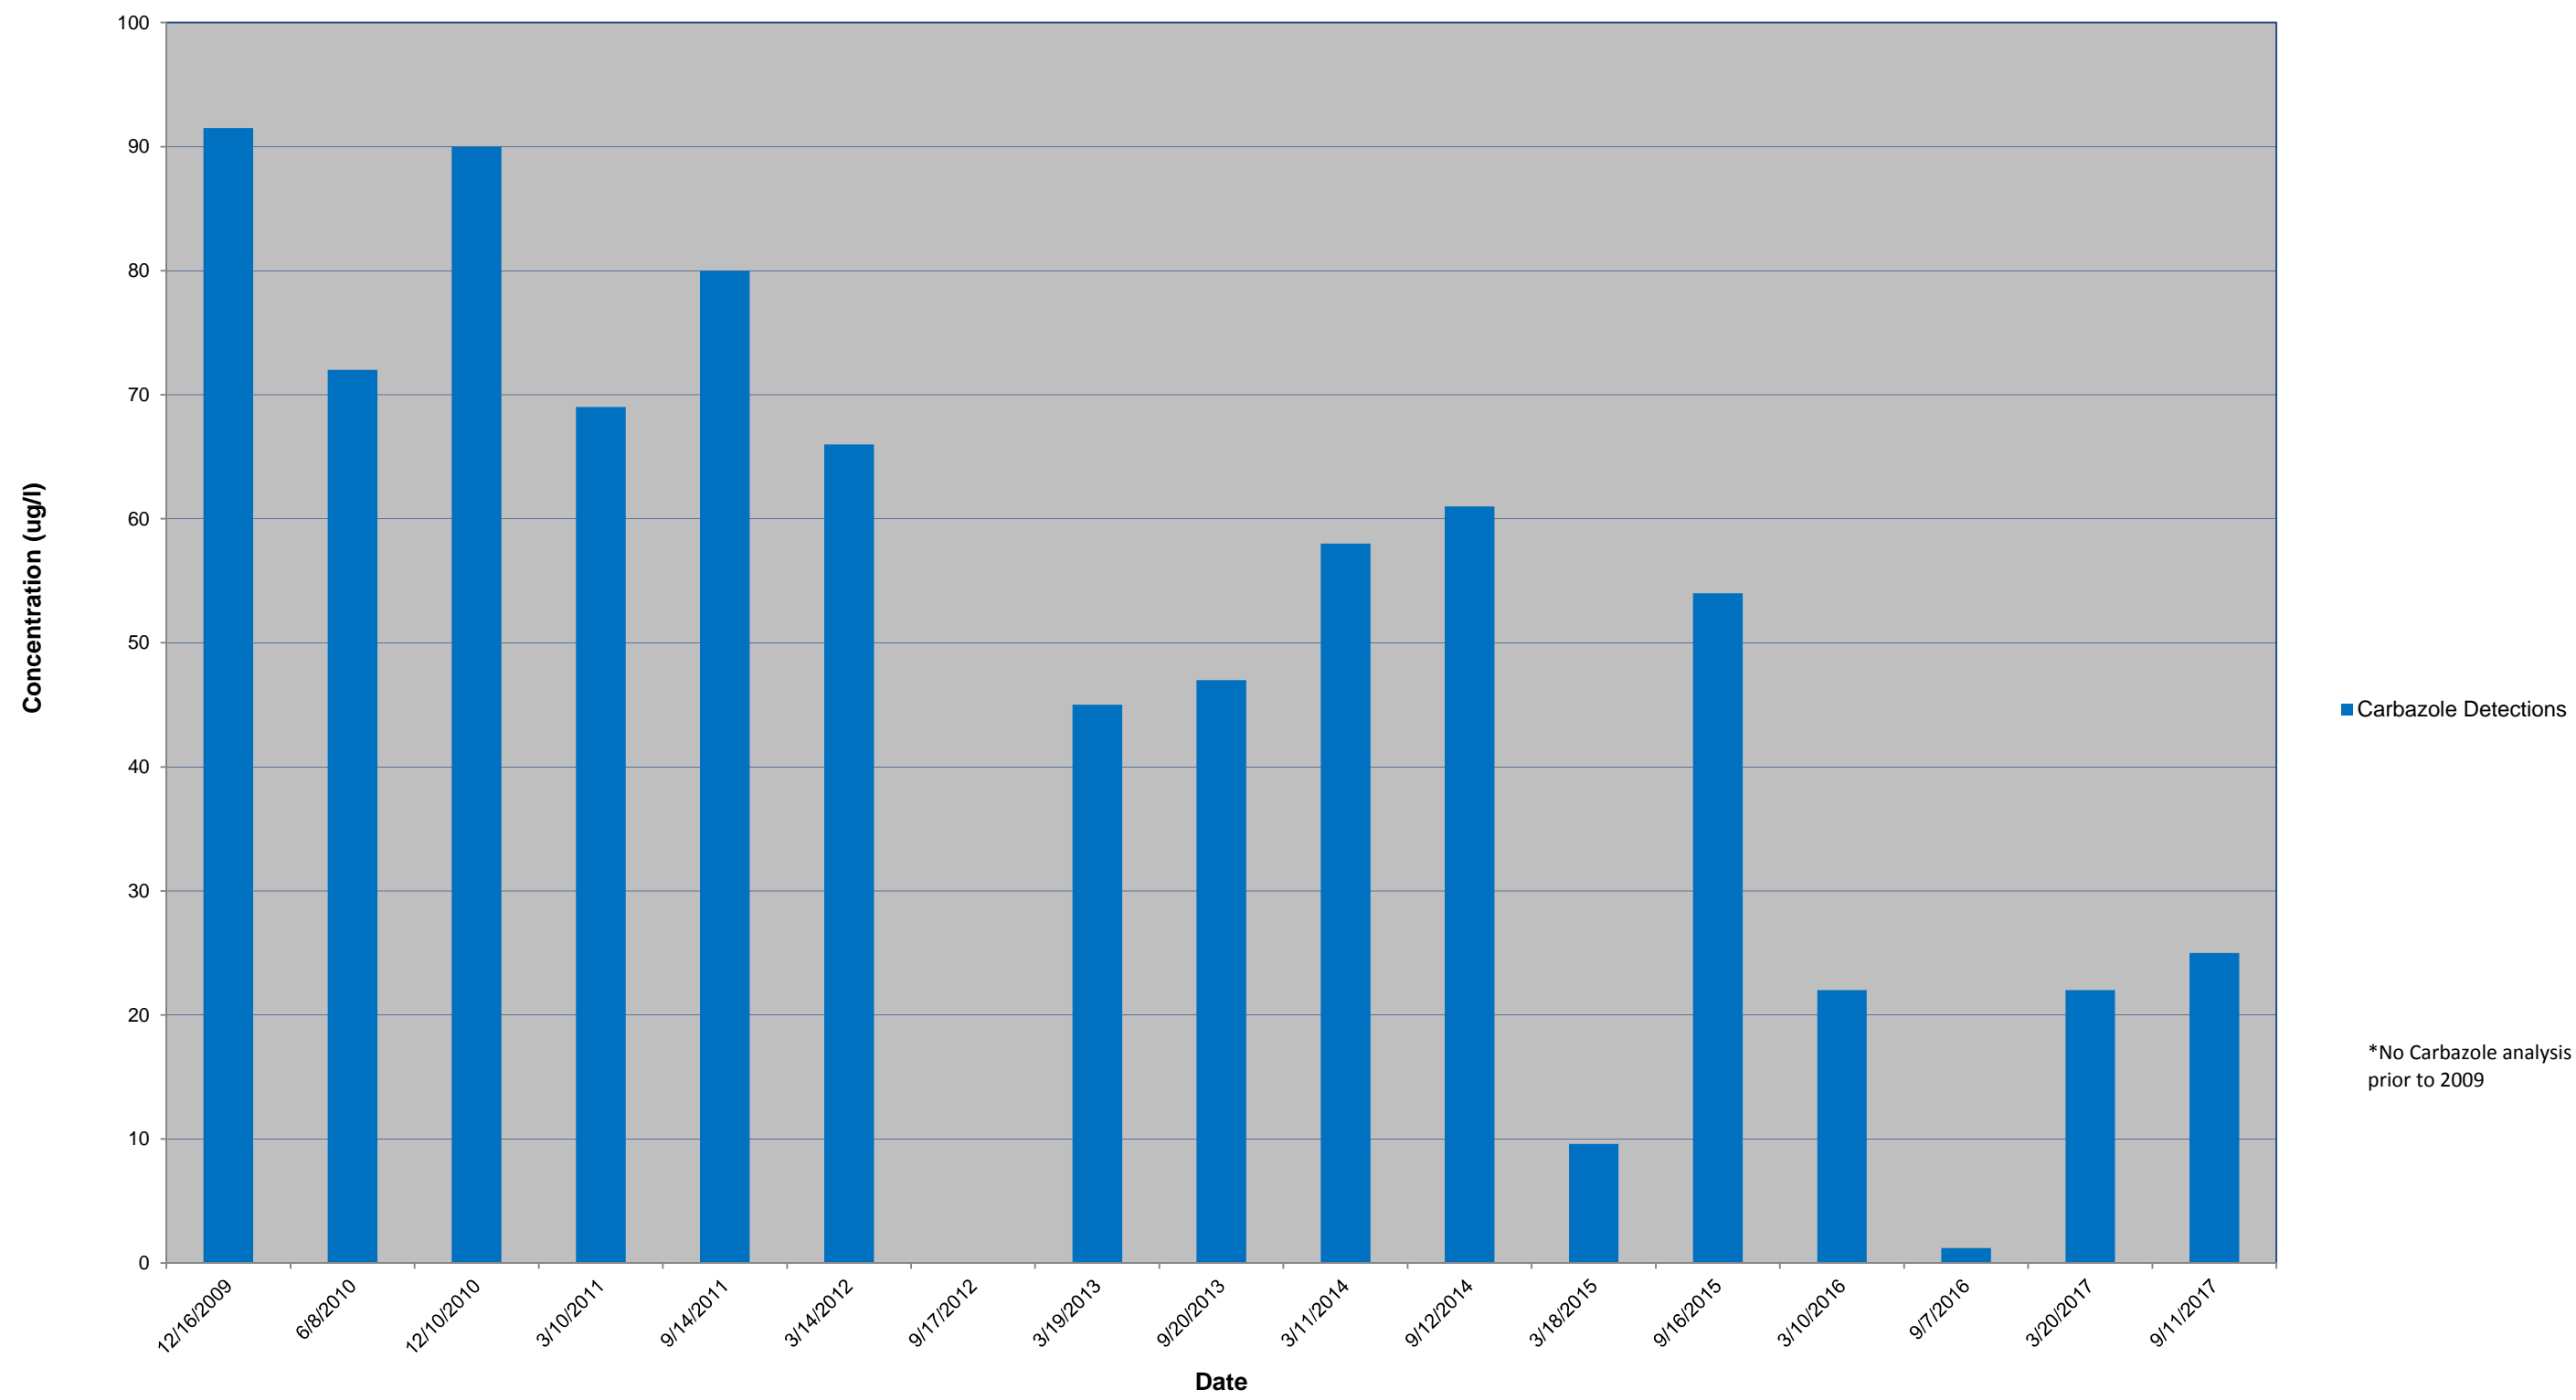
Carbazole Detections in CAMU Unit 1 Leak Detection Samples
2009-2017*

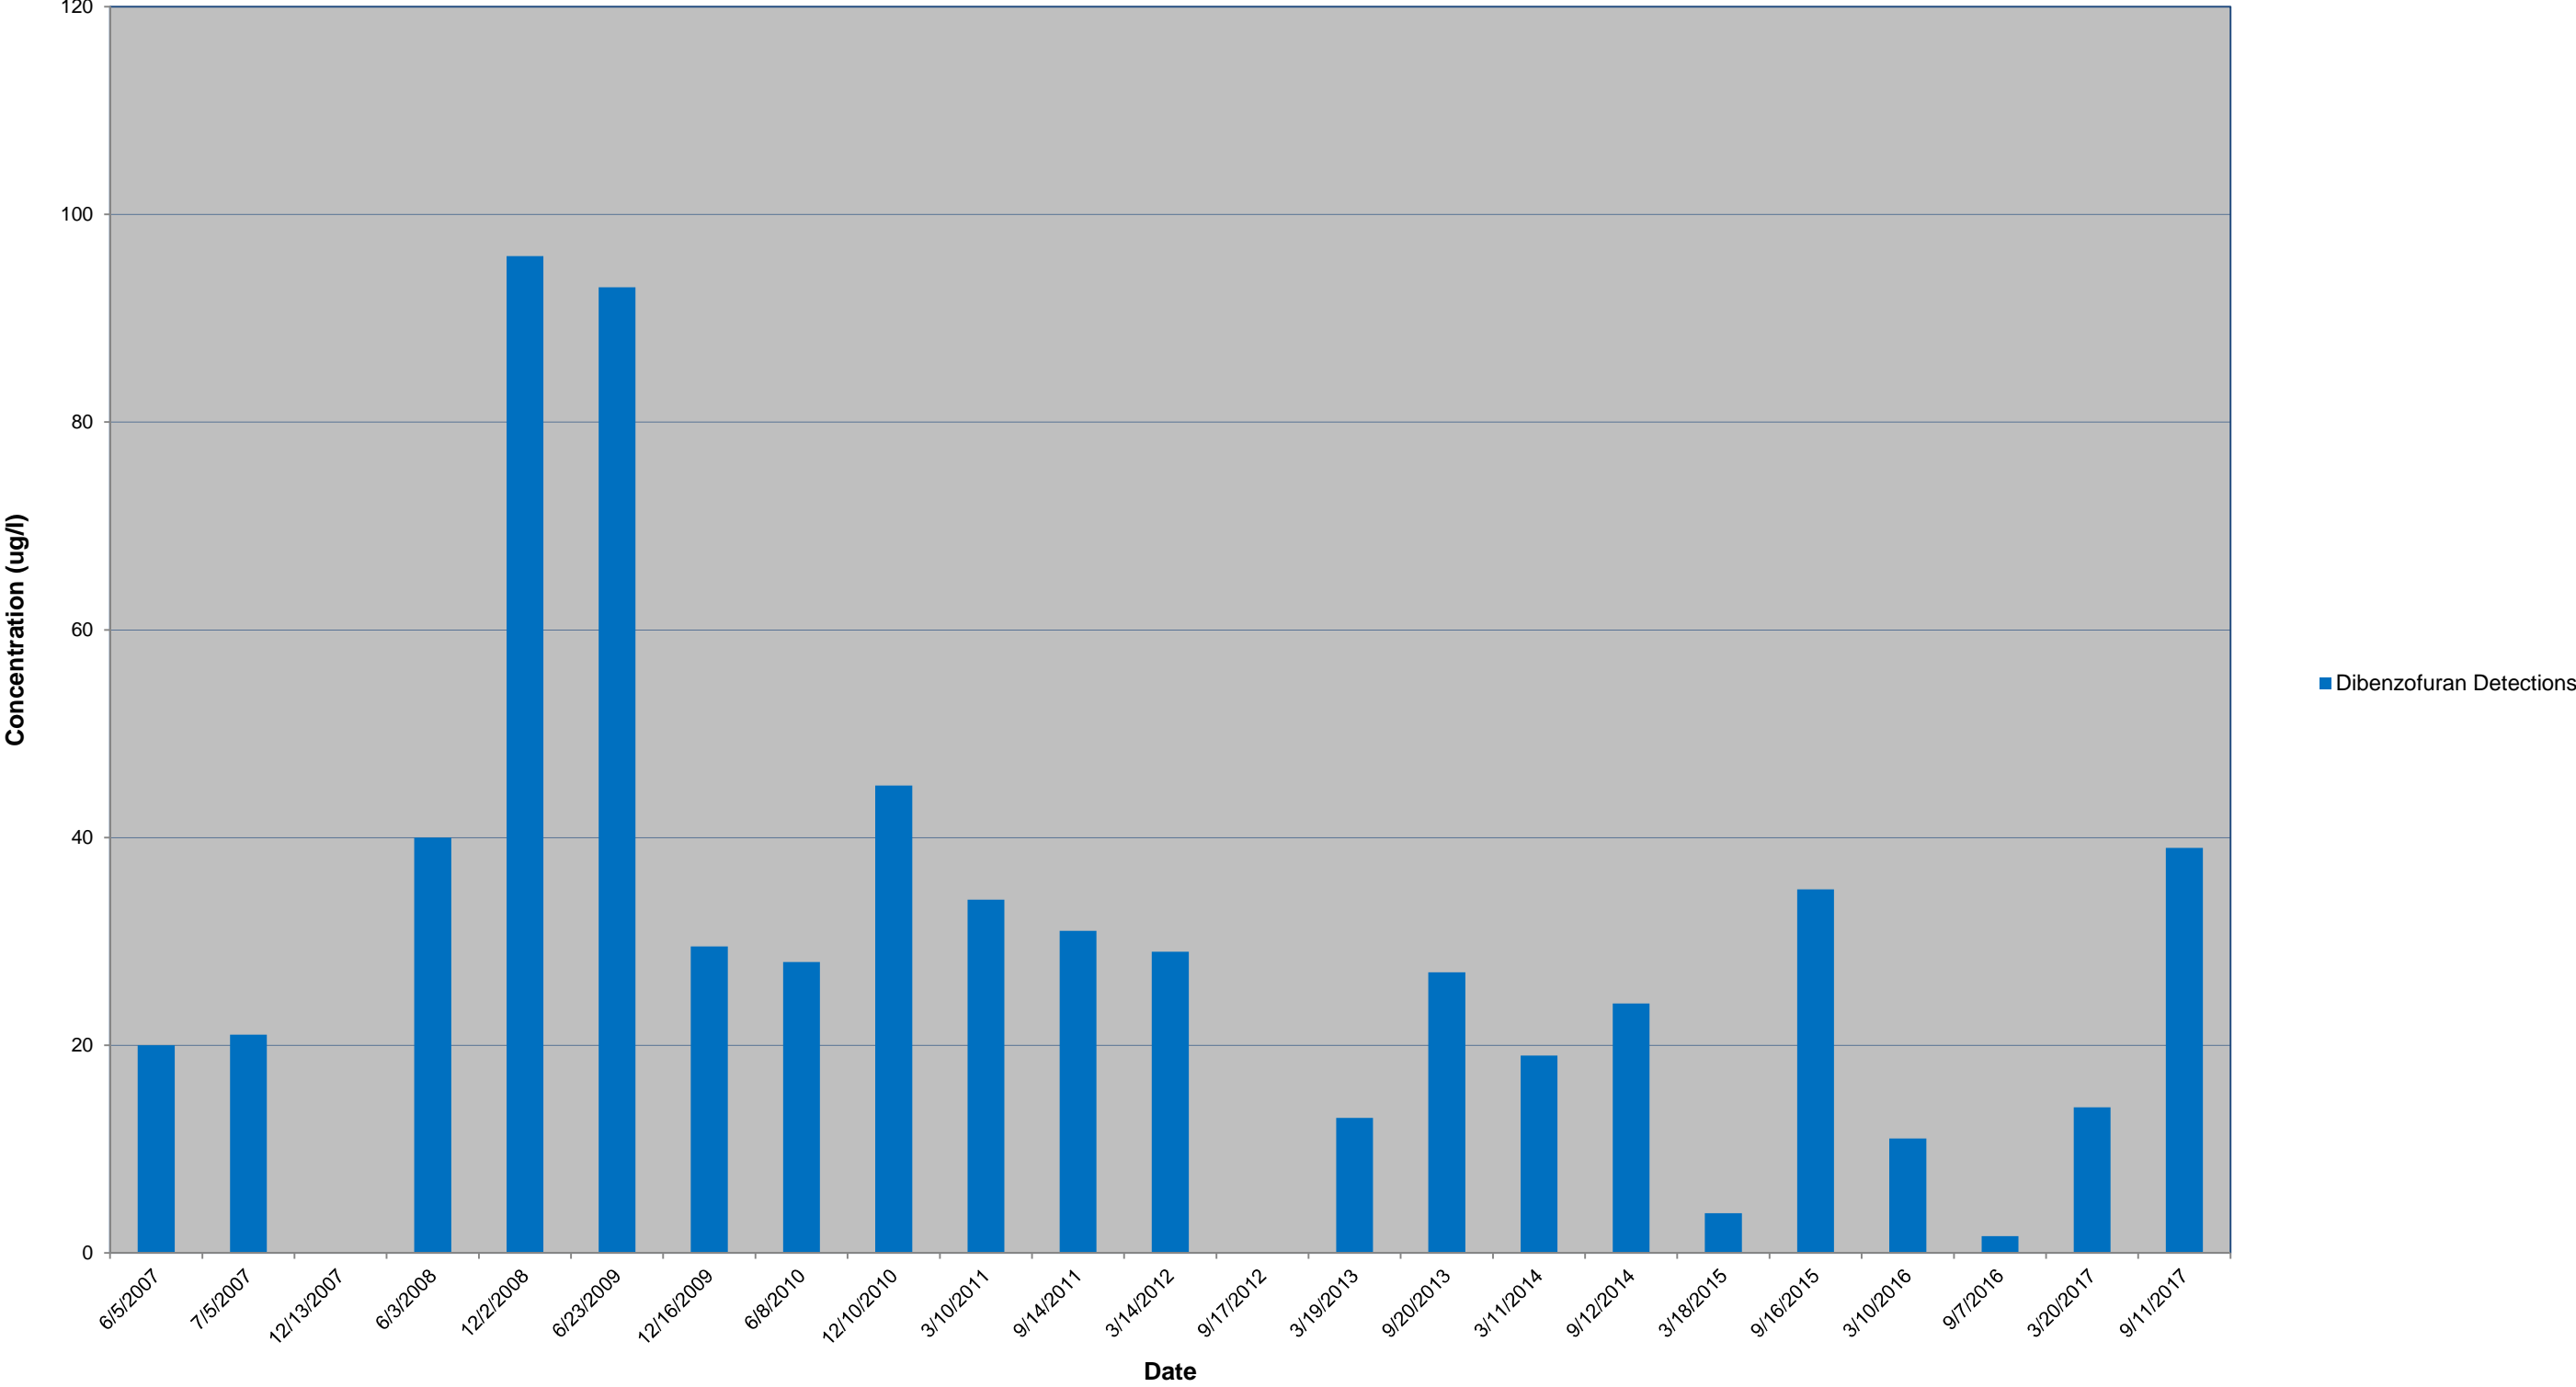
Dibenzofuran Detections in CAMU Unit 1 Leak Detection Samples
2007 - 2017

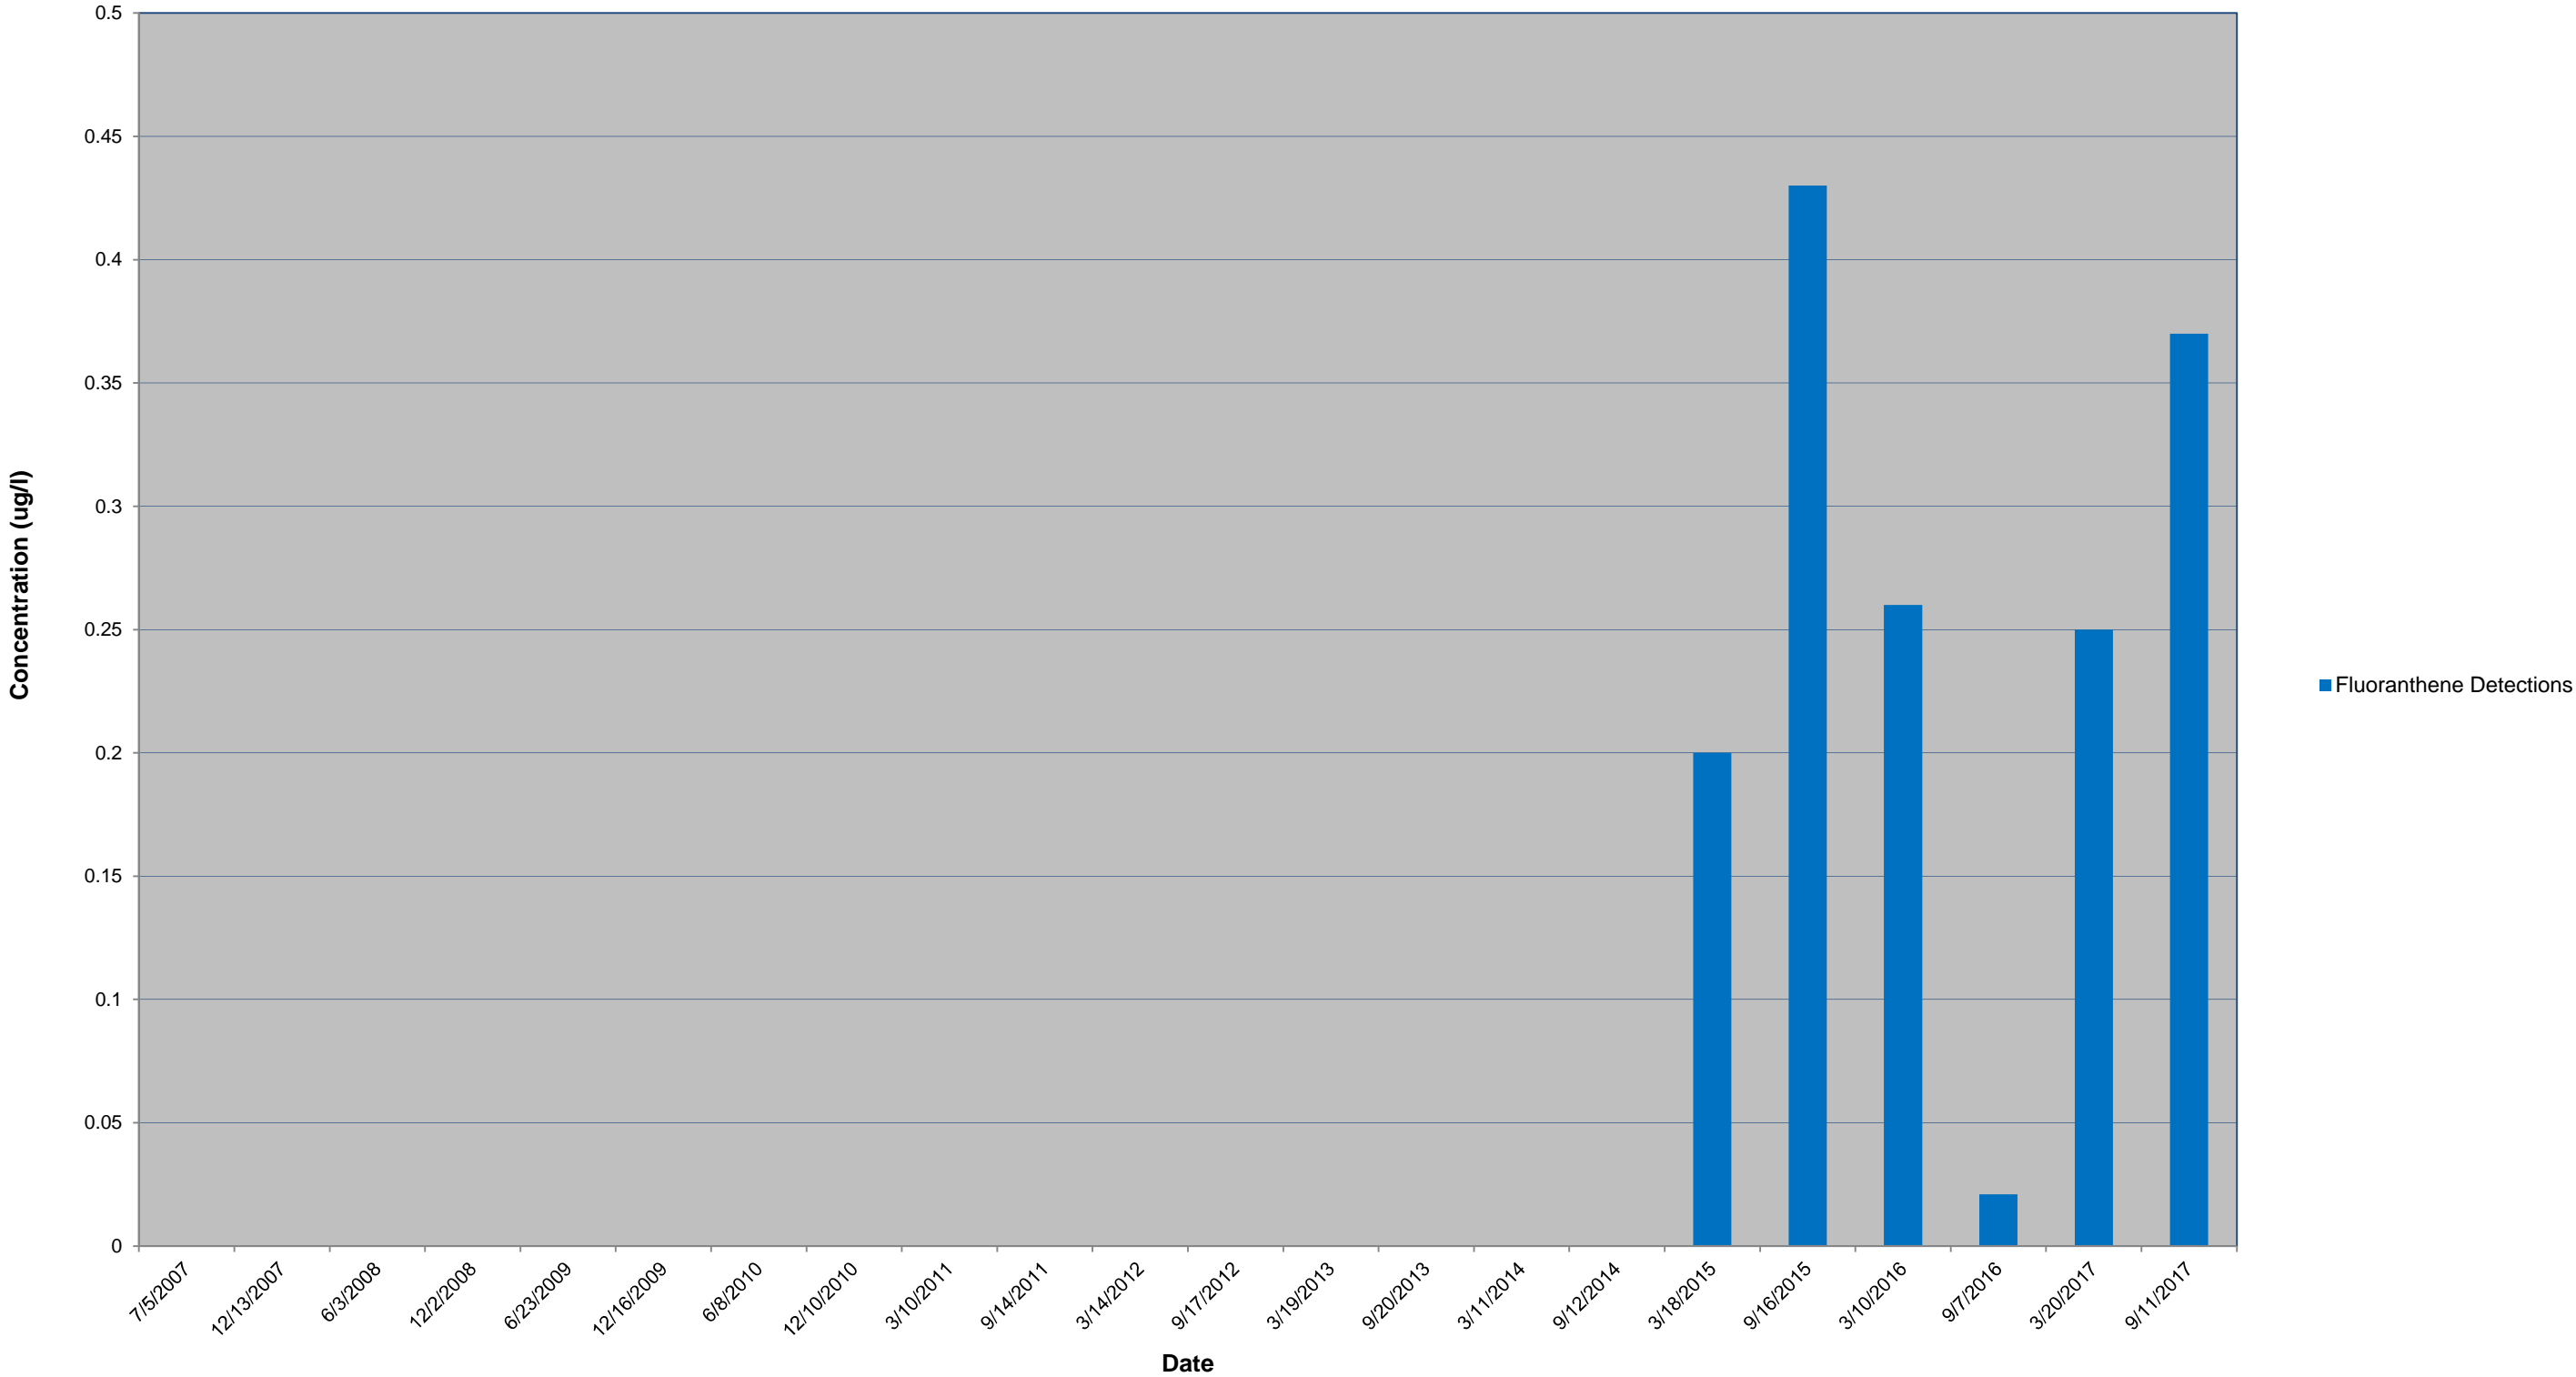
Fluoranthene Detections in CAMU Unit 1 Leak Detection Samples
2007 - 2017

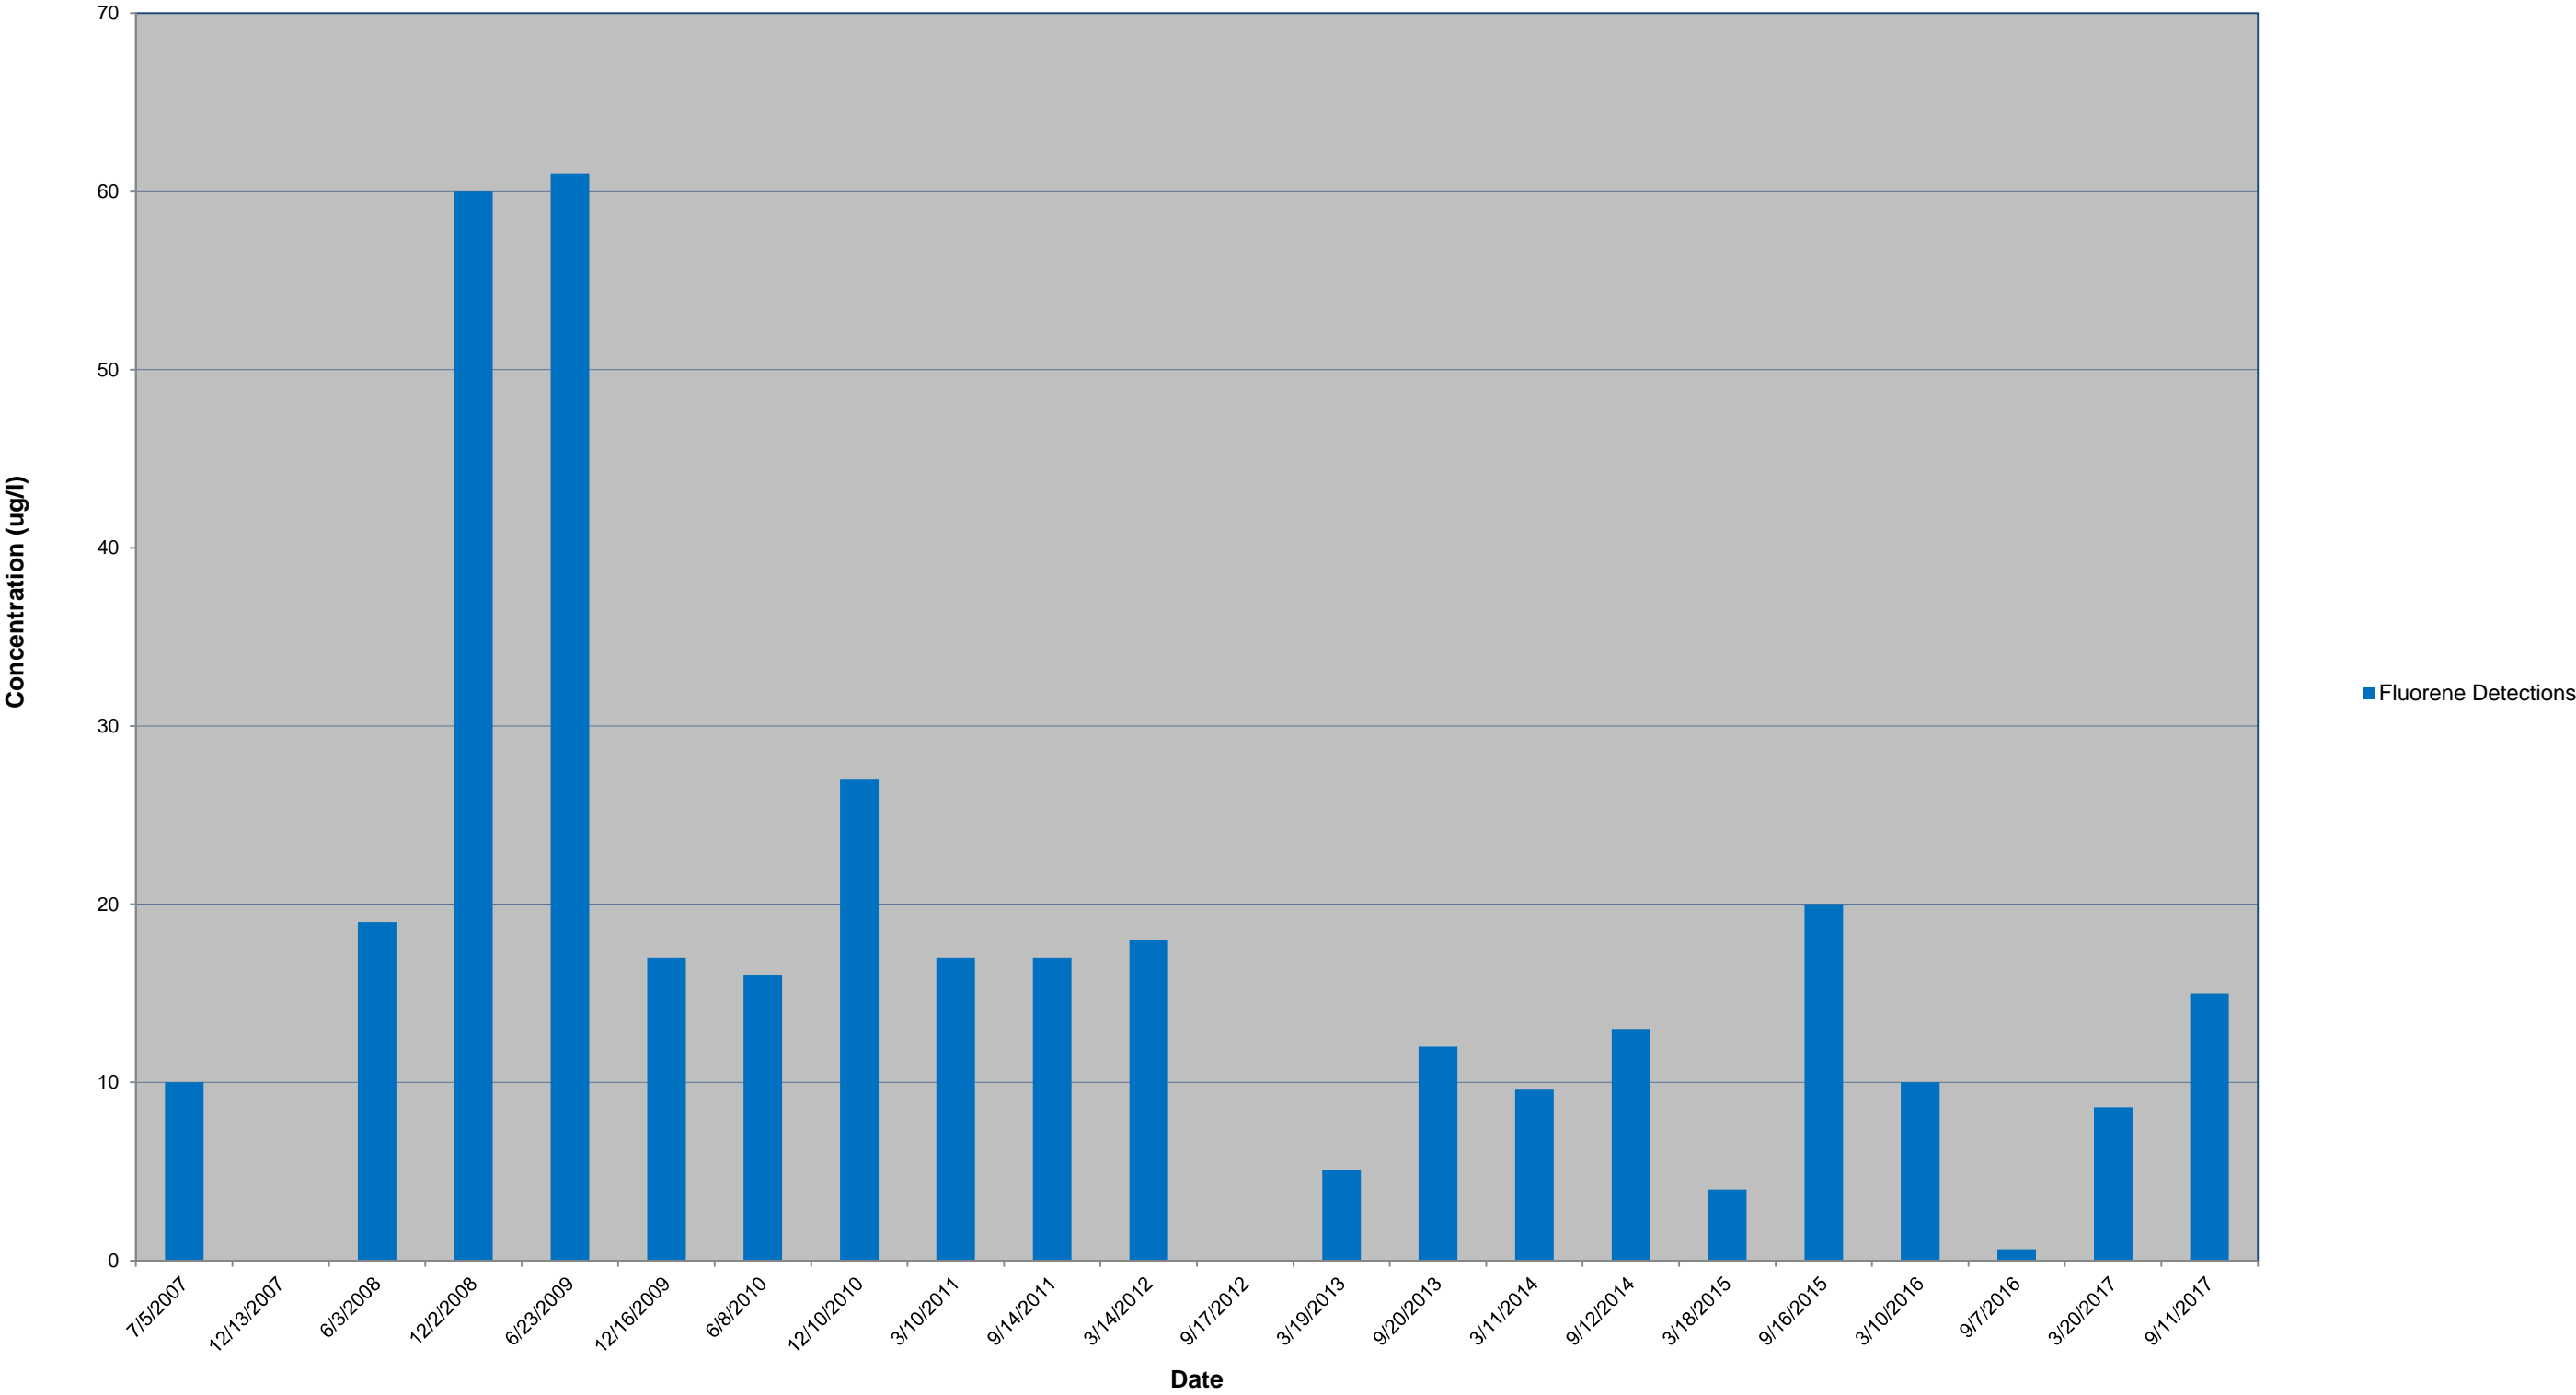
Fluorene Detections in CAMU Unit 1 Leak Detection Samples
2007 - 2017
