2-Methylnaphthalene Detections in CAMU Unit 1 Leak Detection Samples
2007 - 2017

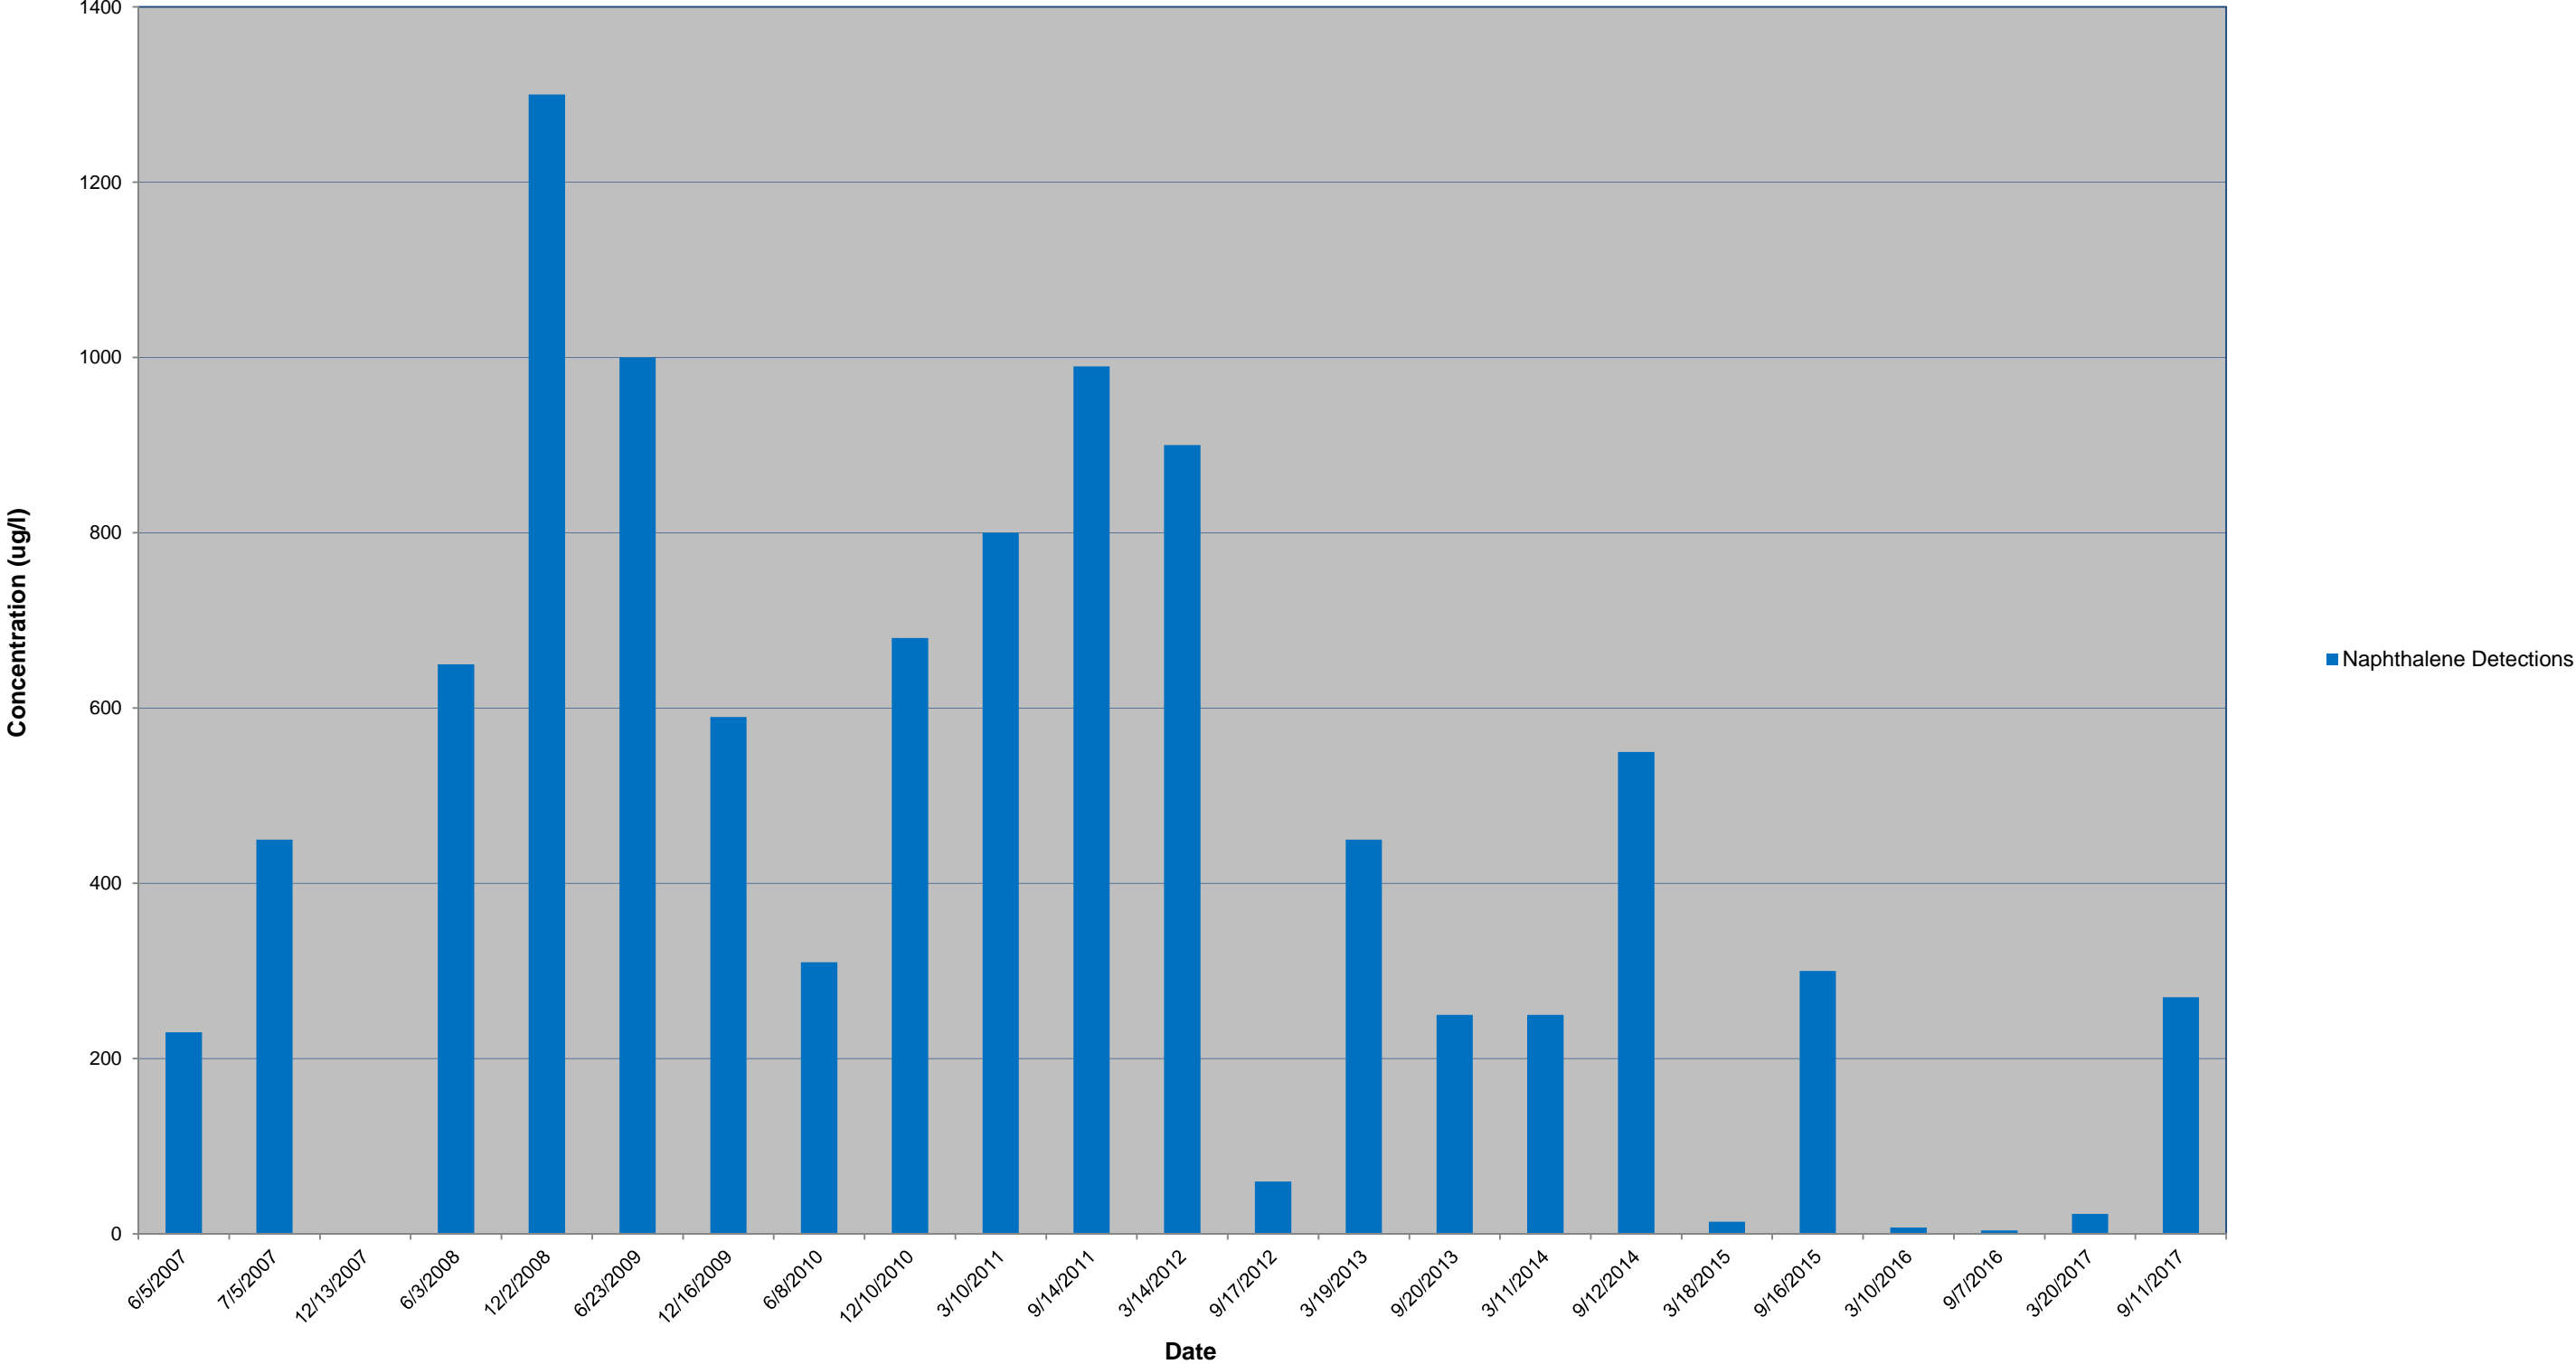
Naphthalene Detections in CAMU Unit 1 Leak Detection Samples
2007 - 2017

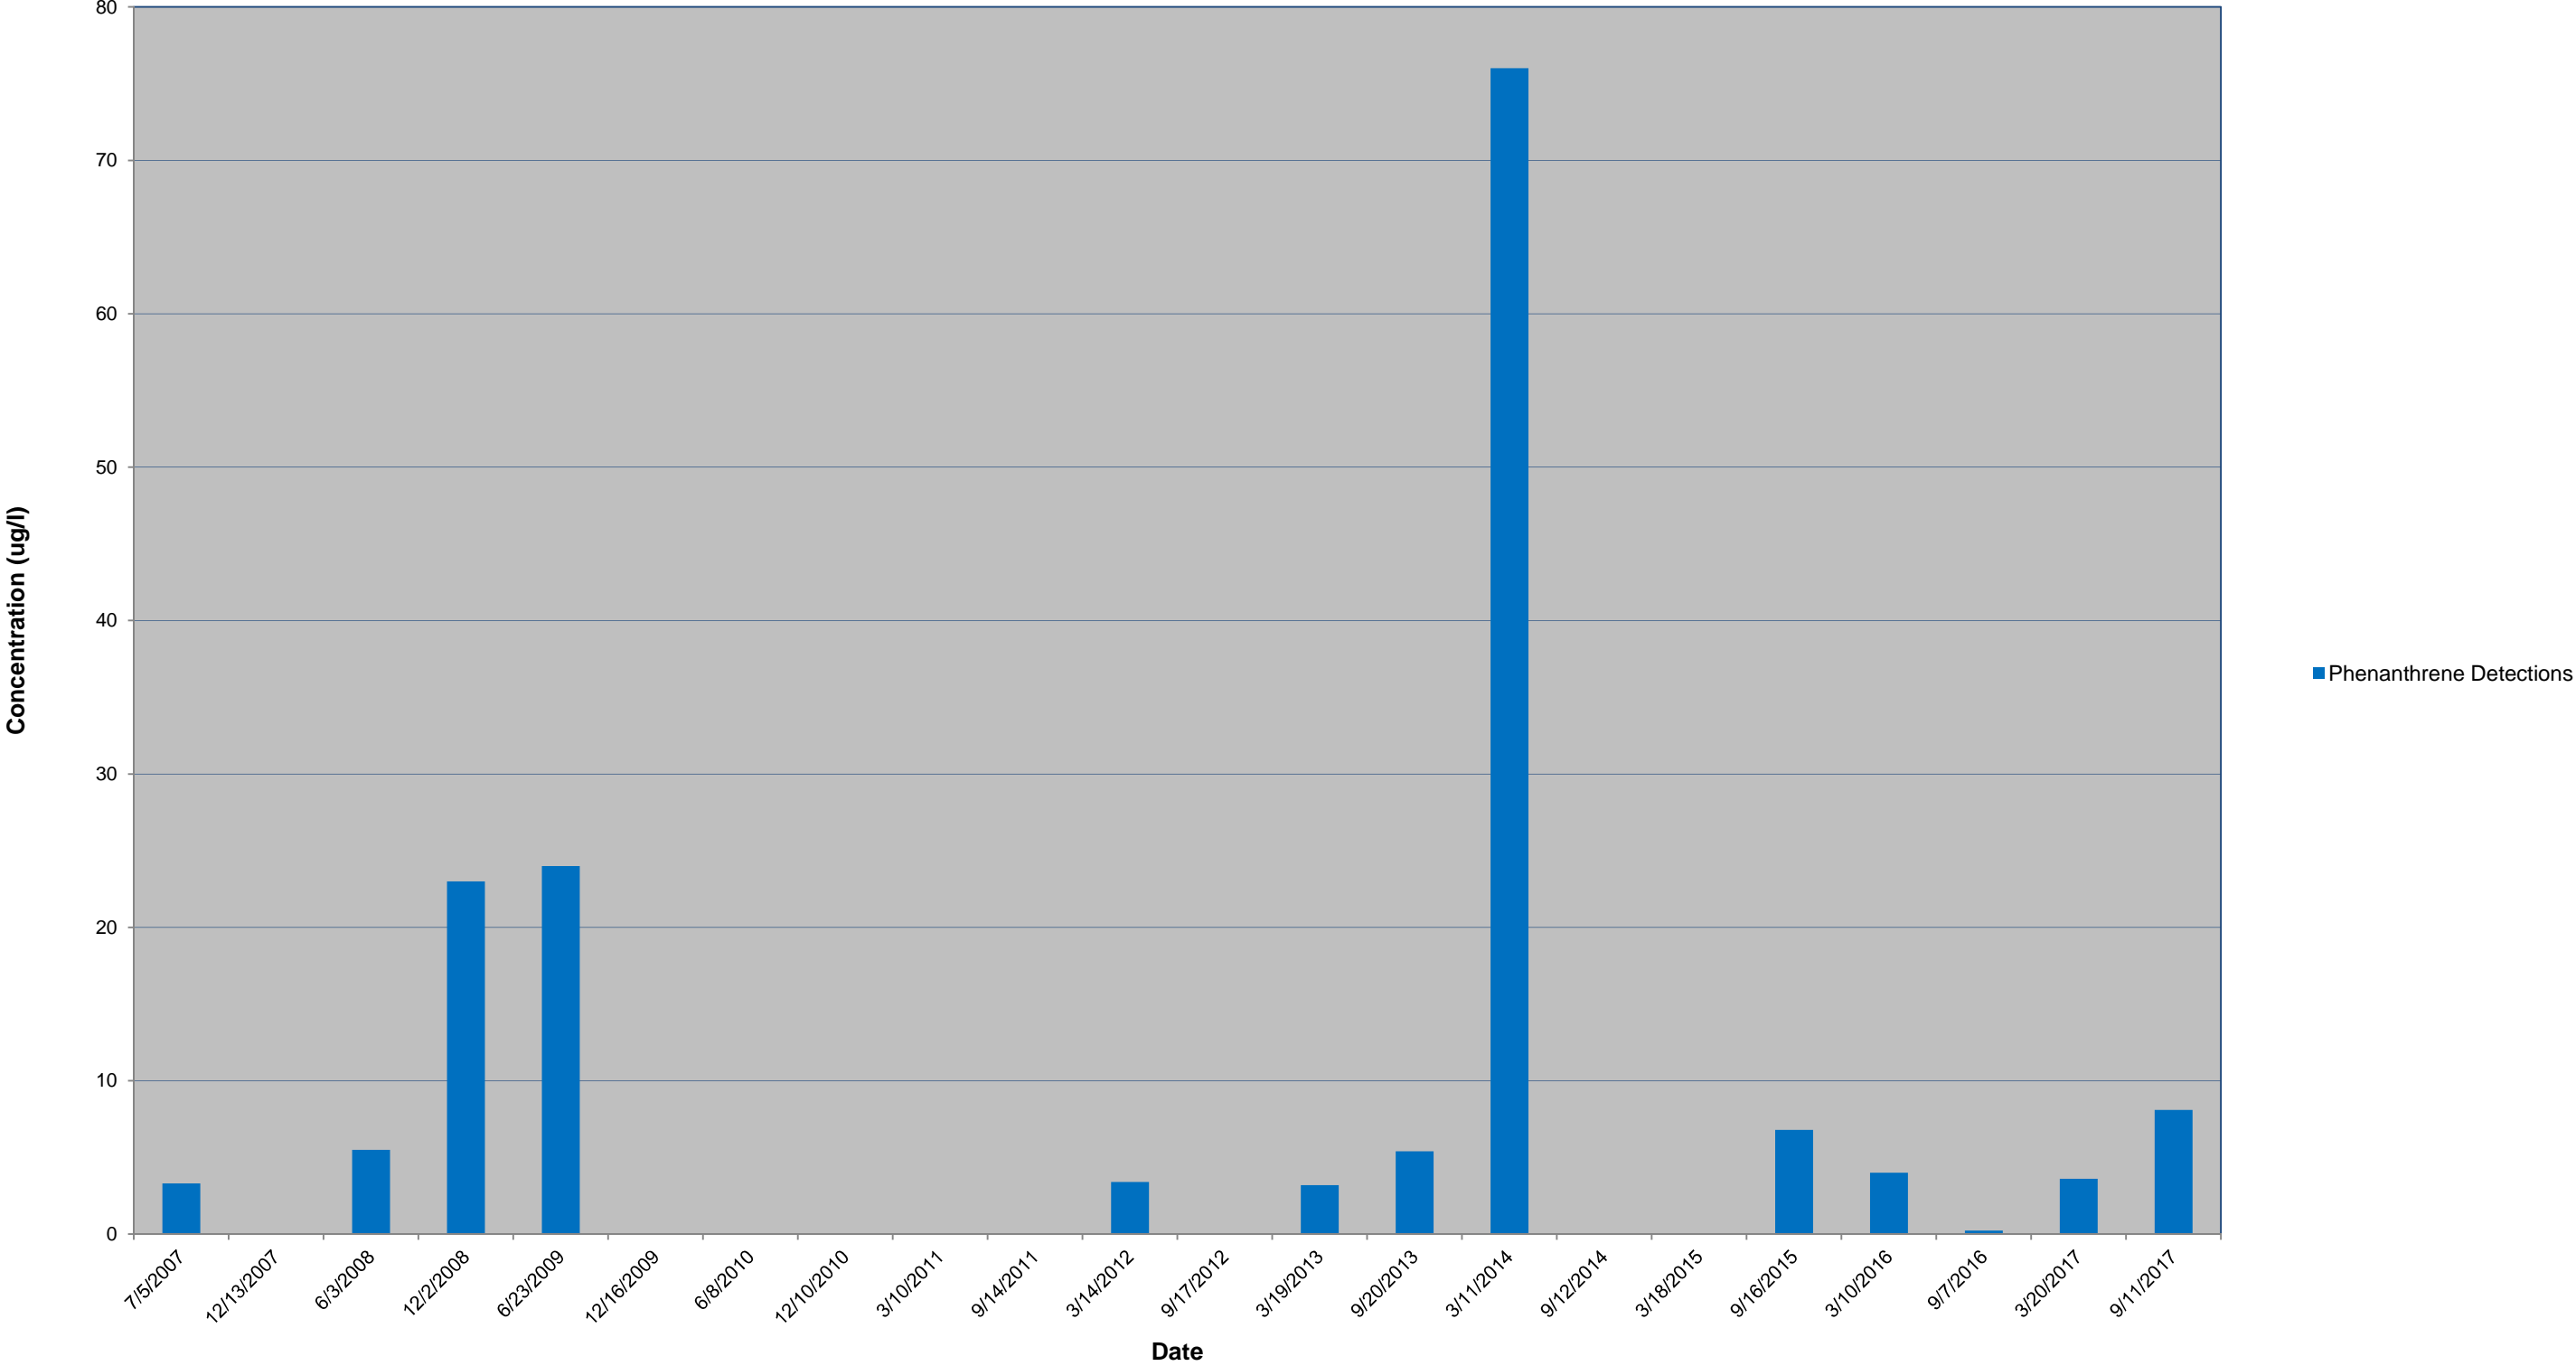
Phenanthrene Detections in CAMU Unit 1 Leak Detection Samples
2007 - 2017

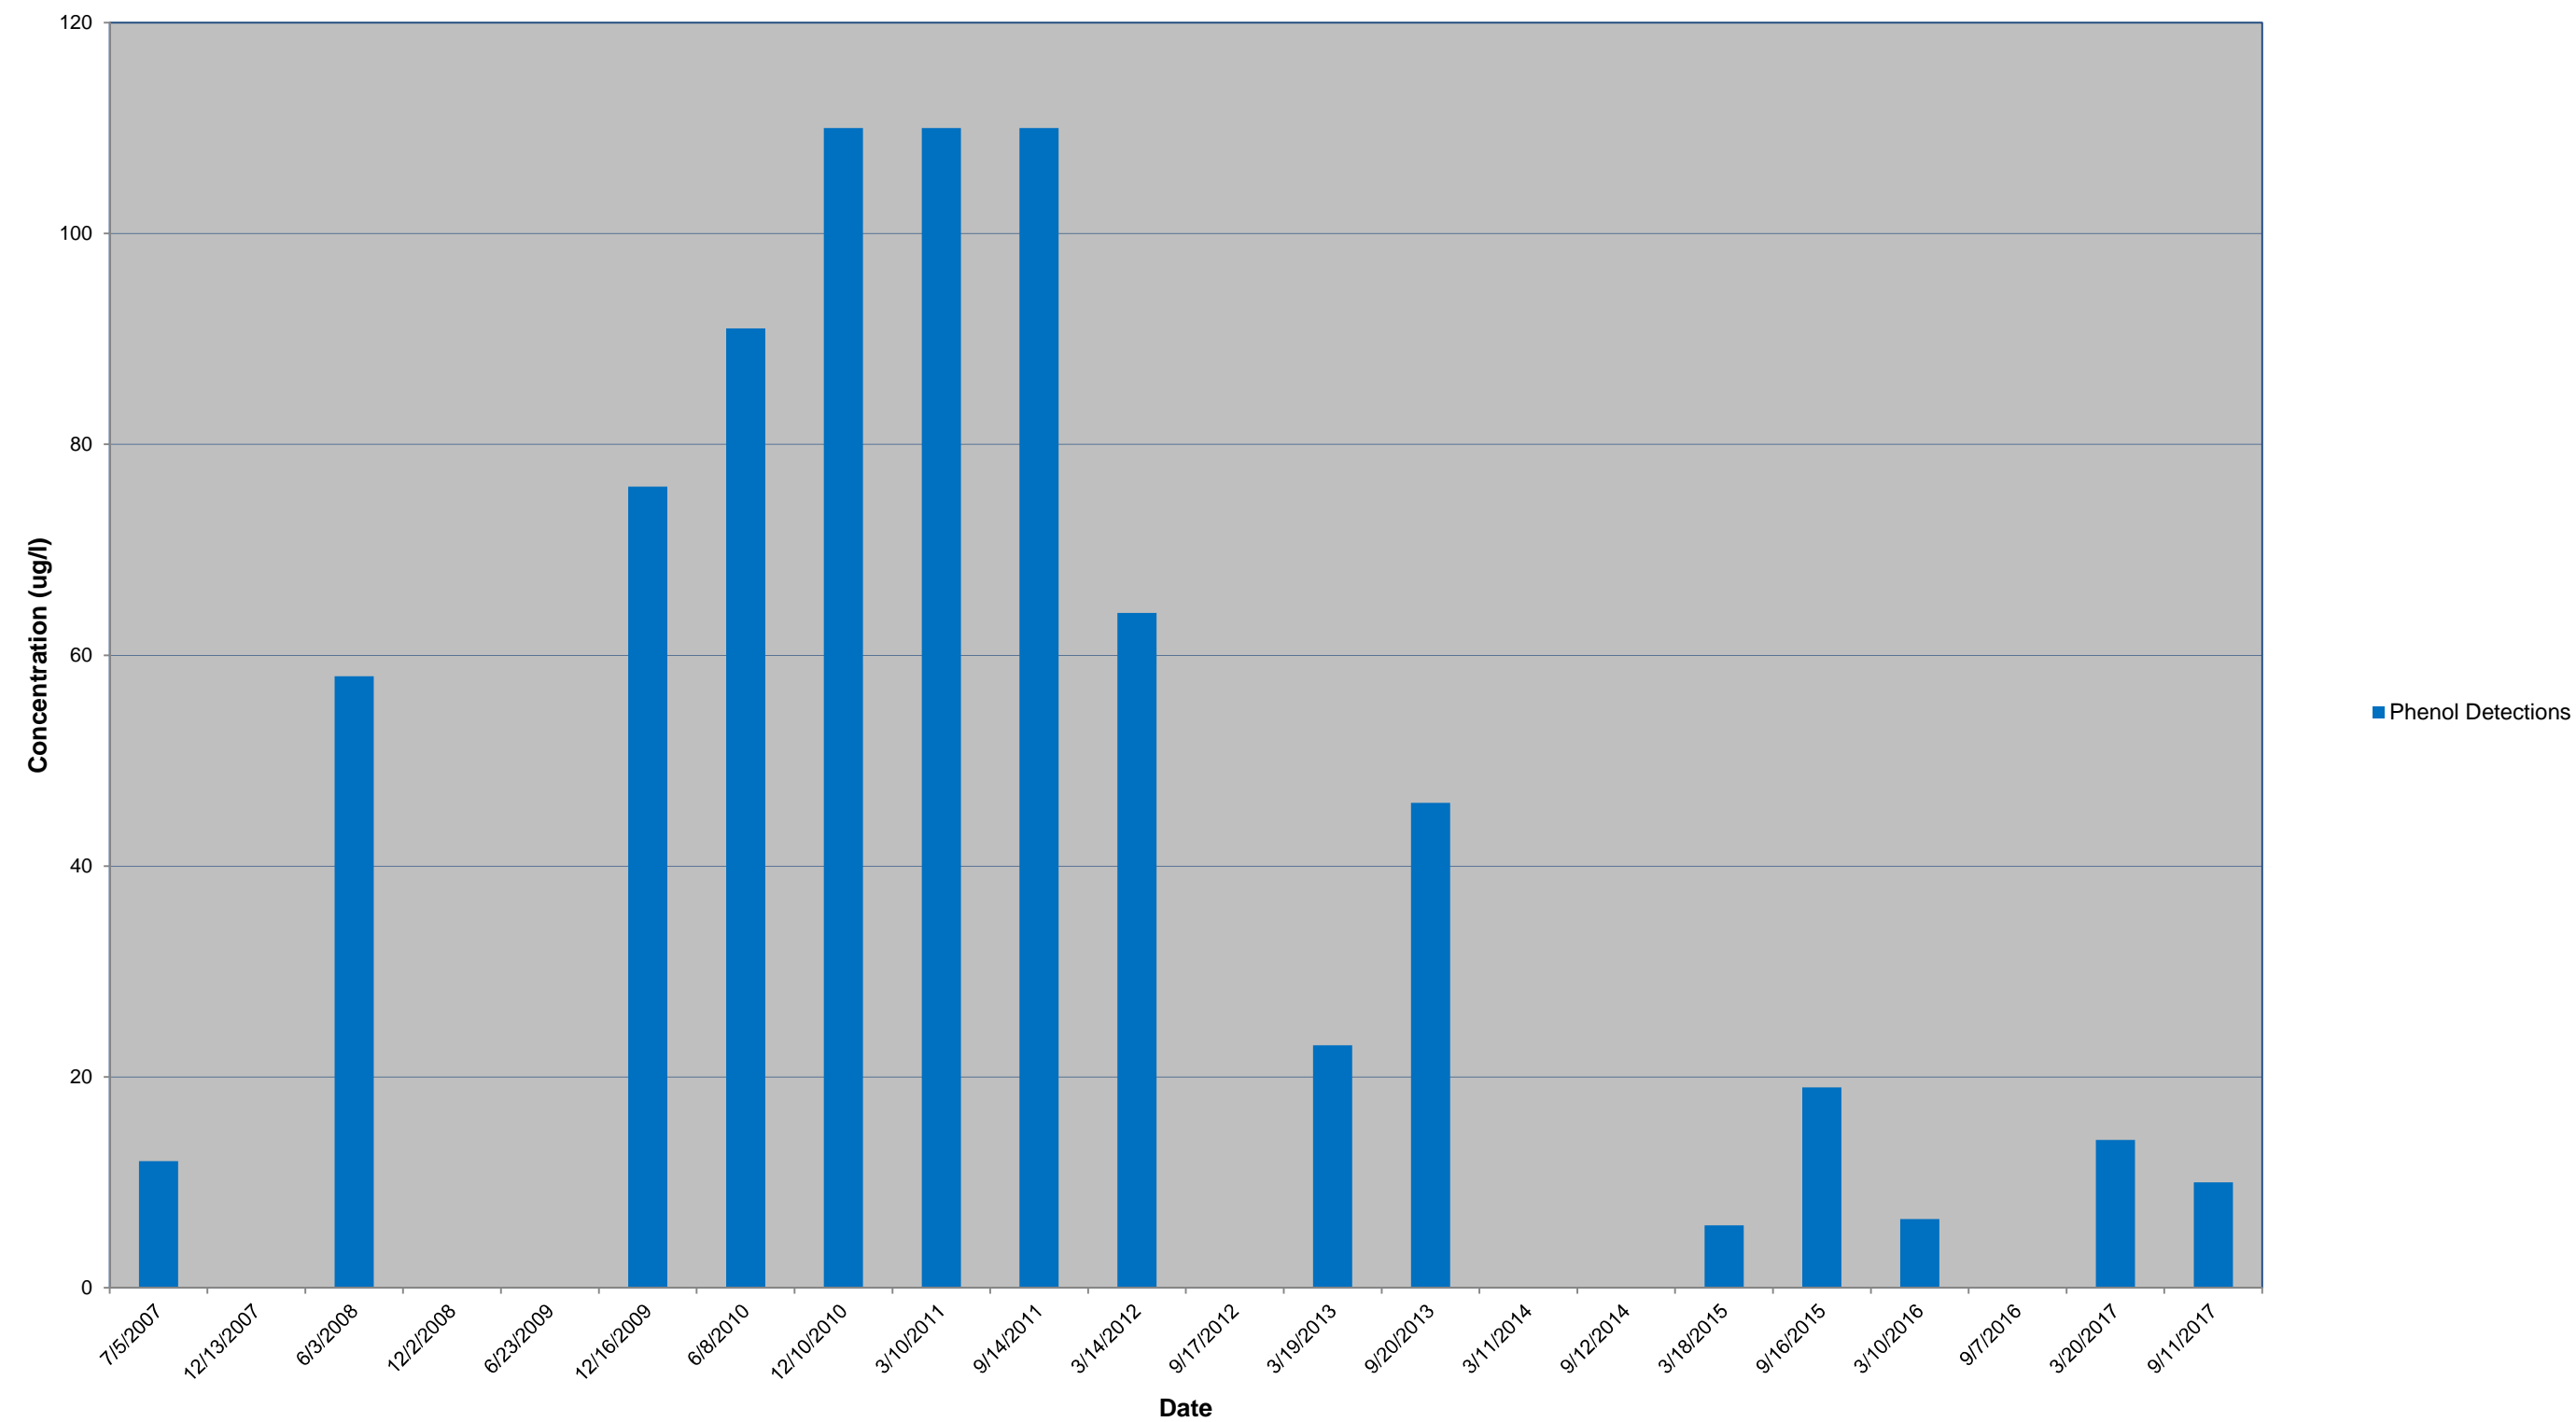
Phenol Detections in CAMU Unit 1 Leak Detection Samples
2007 - 2017

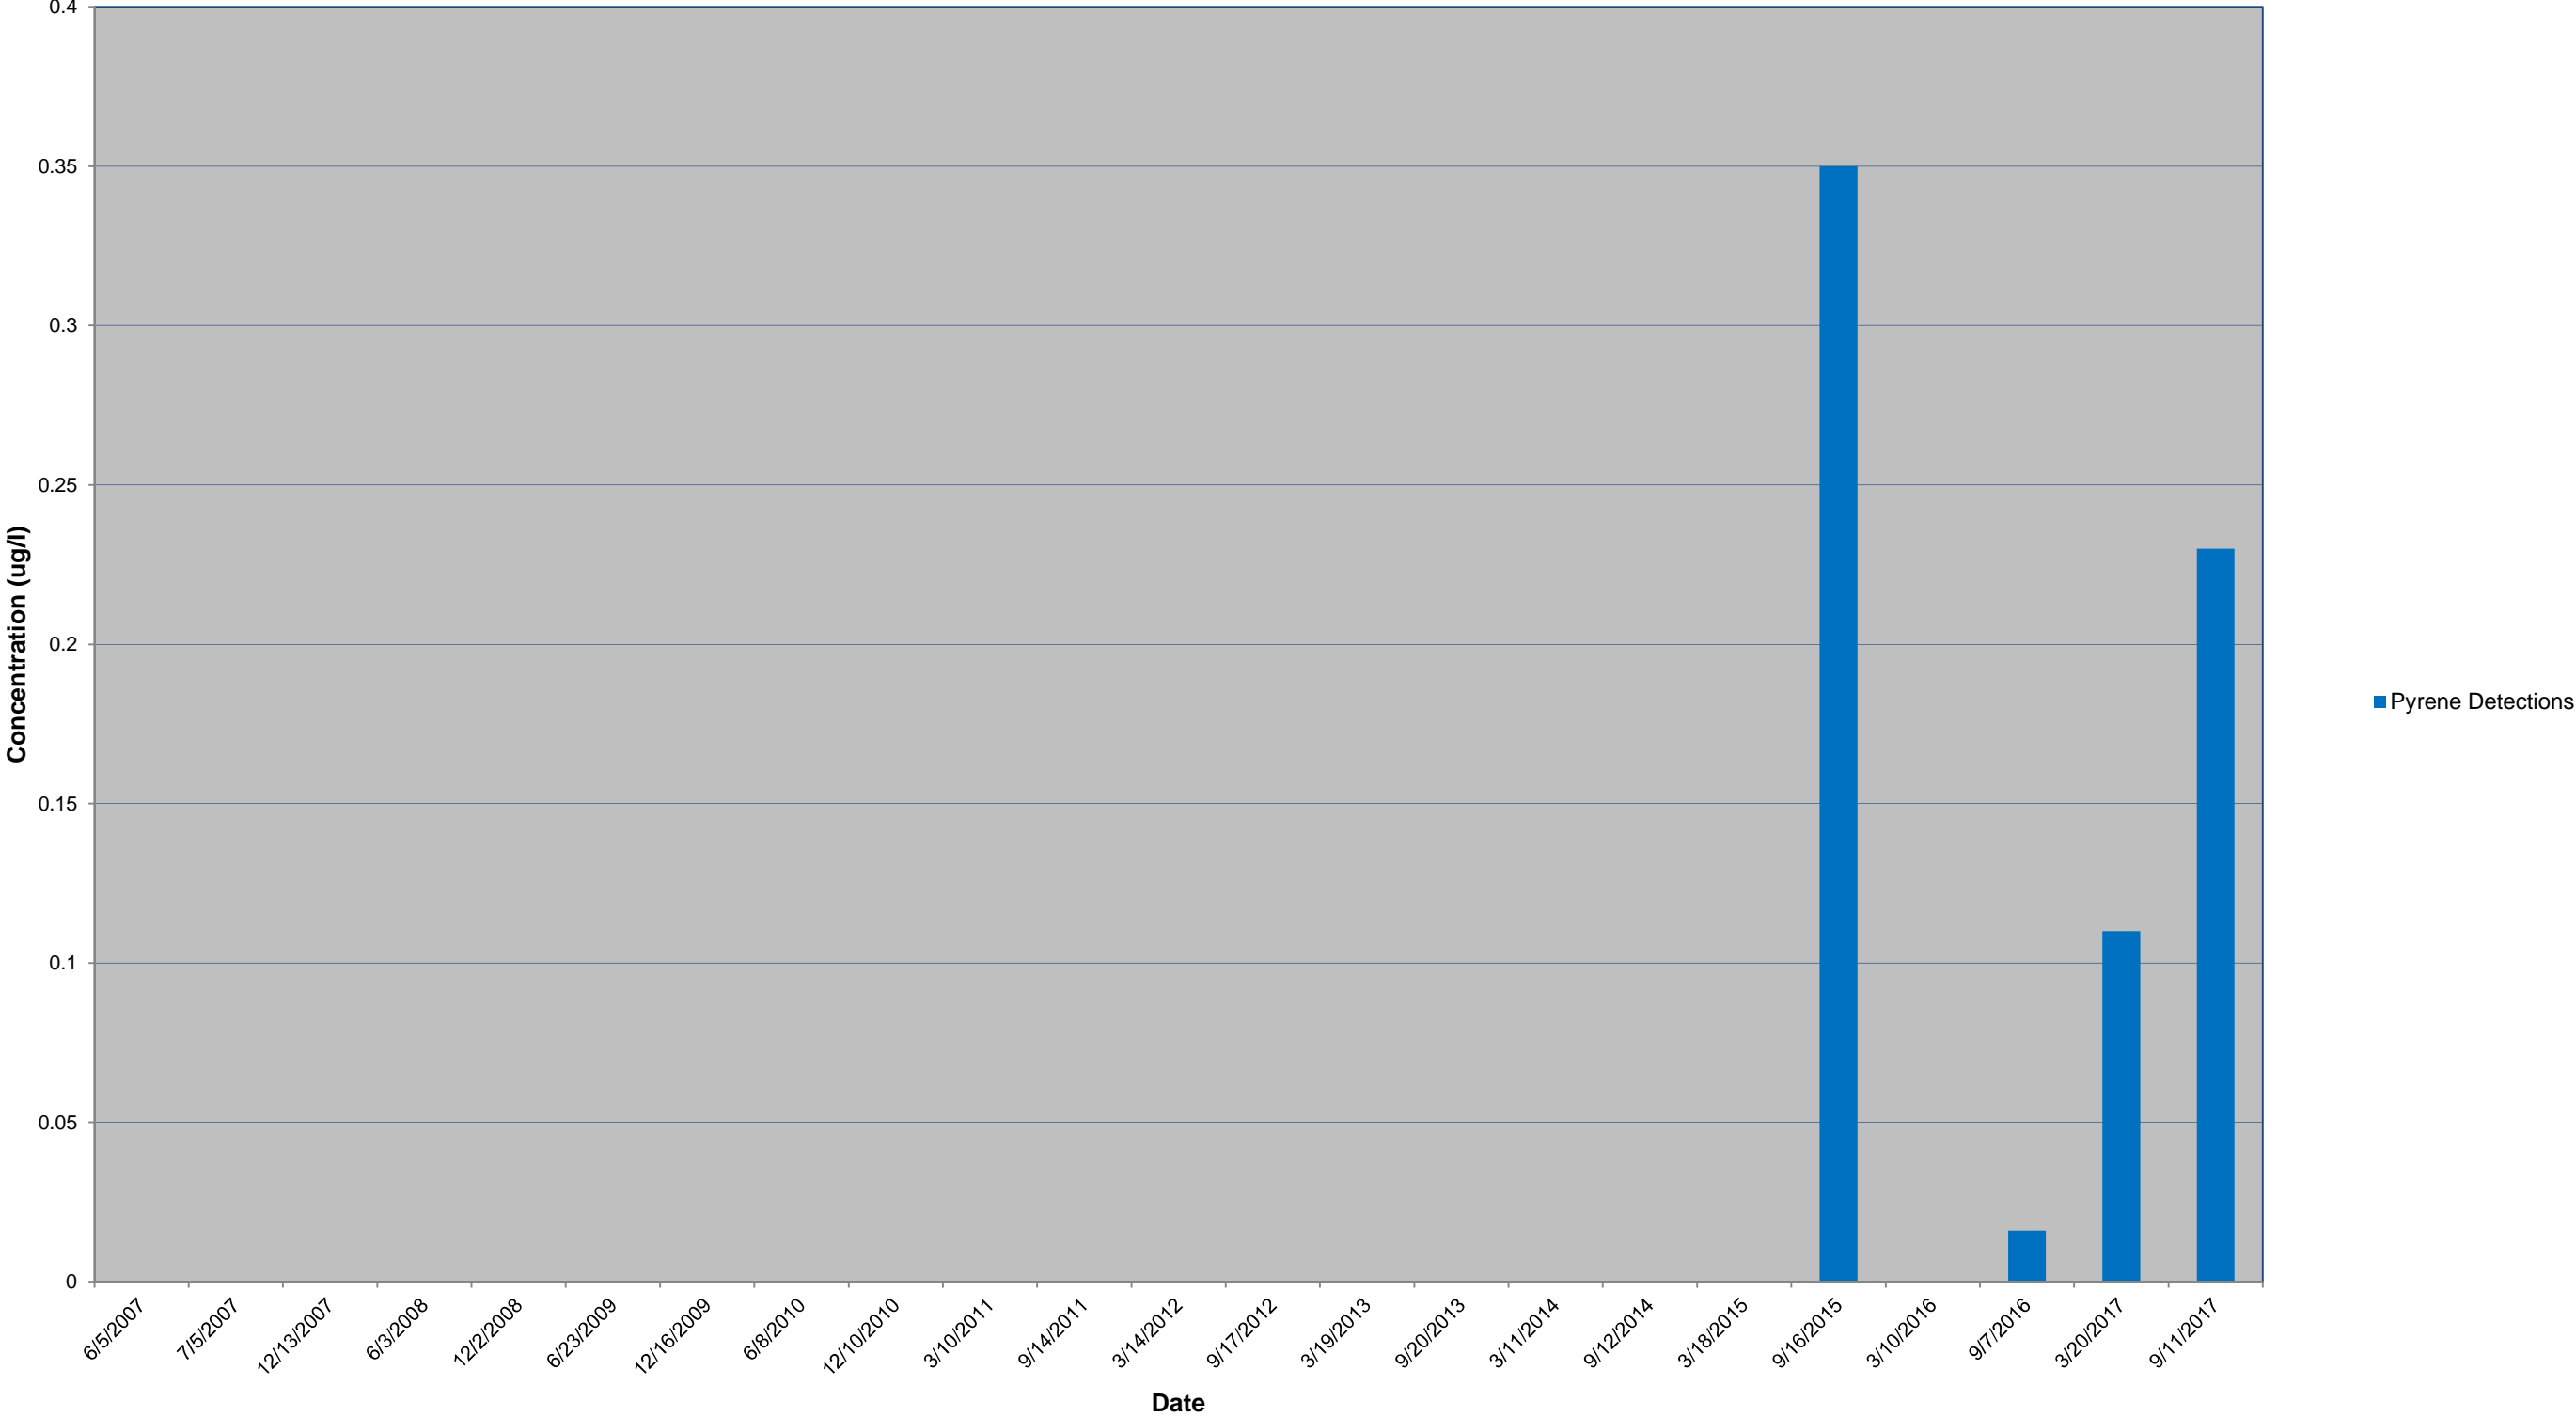
Pyrenel Detections in CAMU Unit 1 Leak Detection Samples
2007 - 2017
