2,4-Dimethylphenol Detections in CAMU Unit 2 Leachate
2008 - 2017*

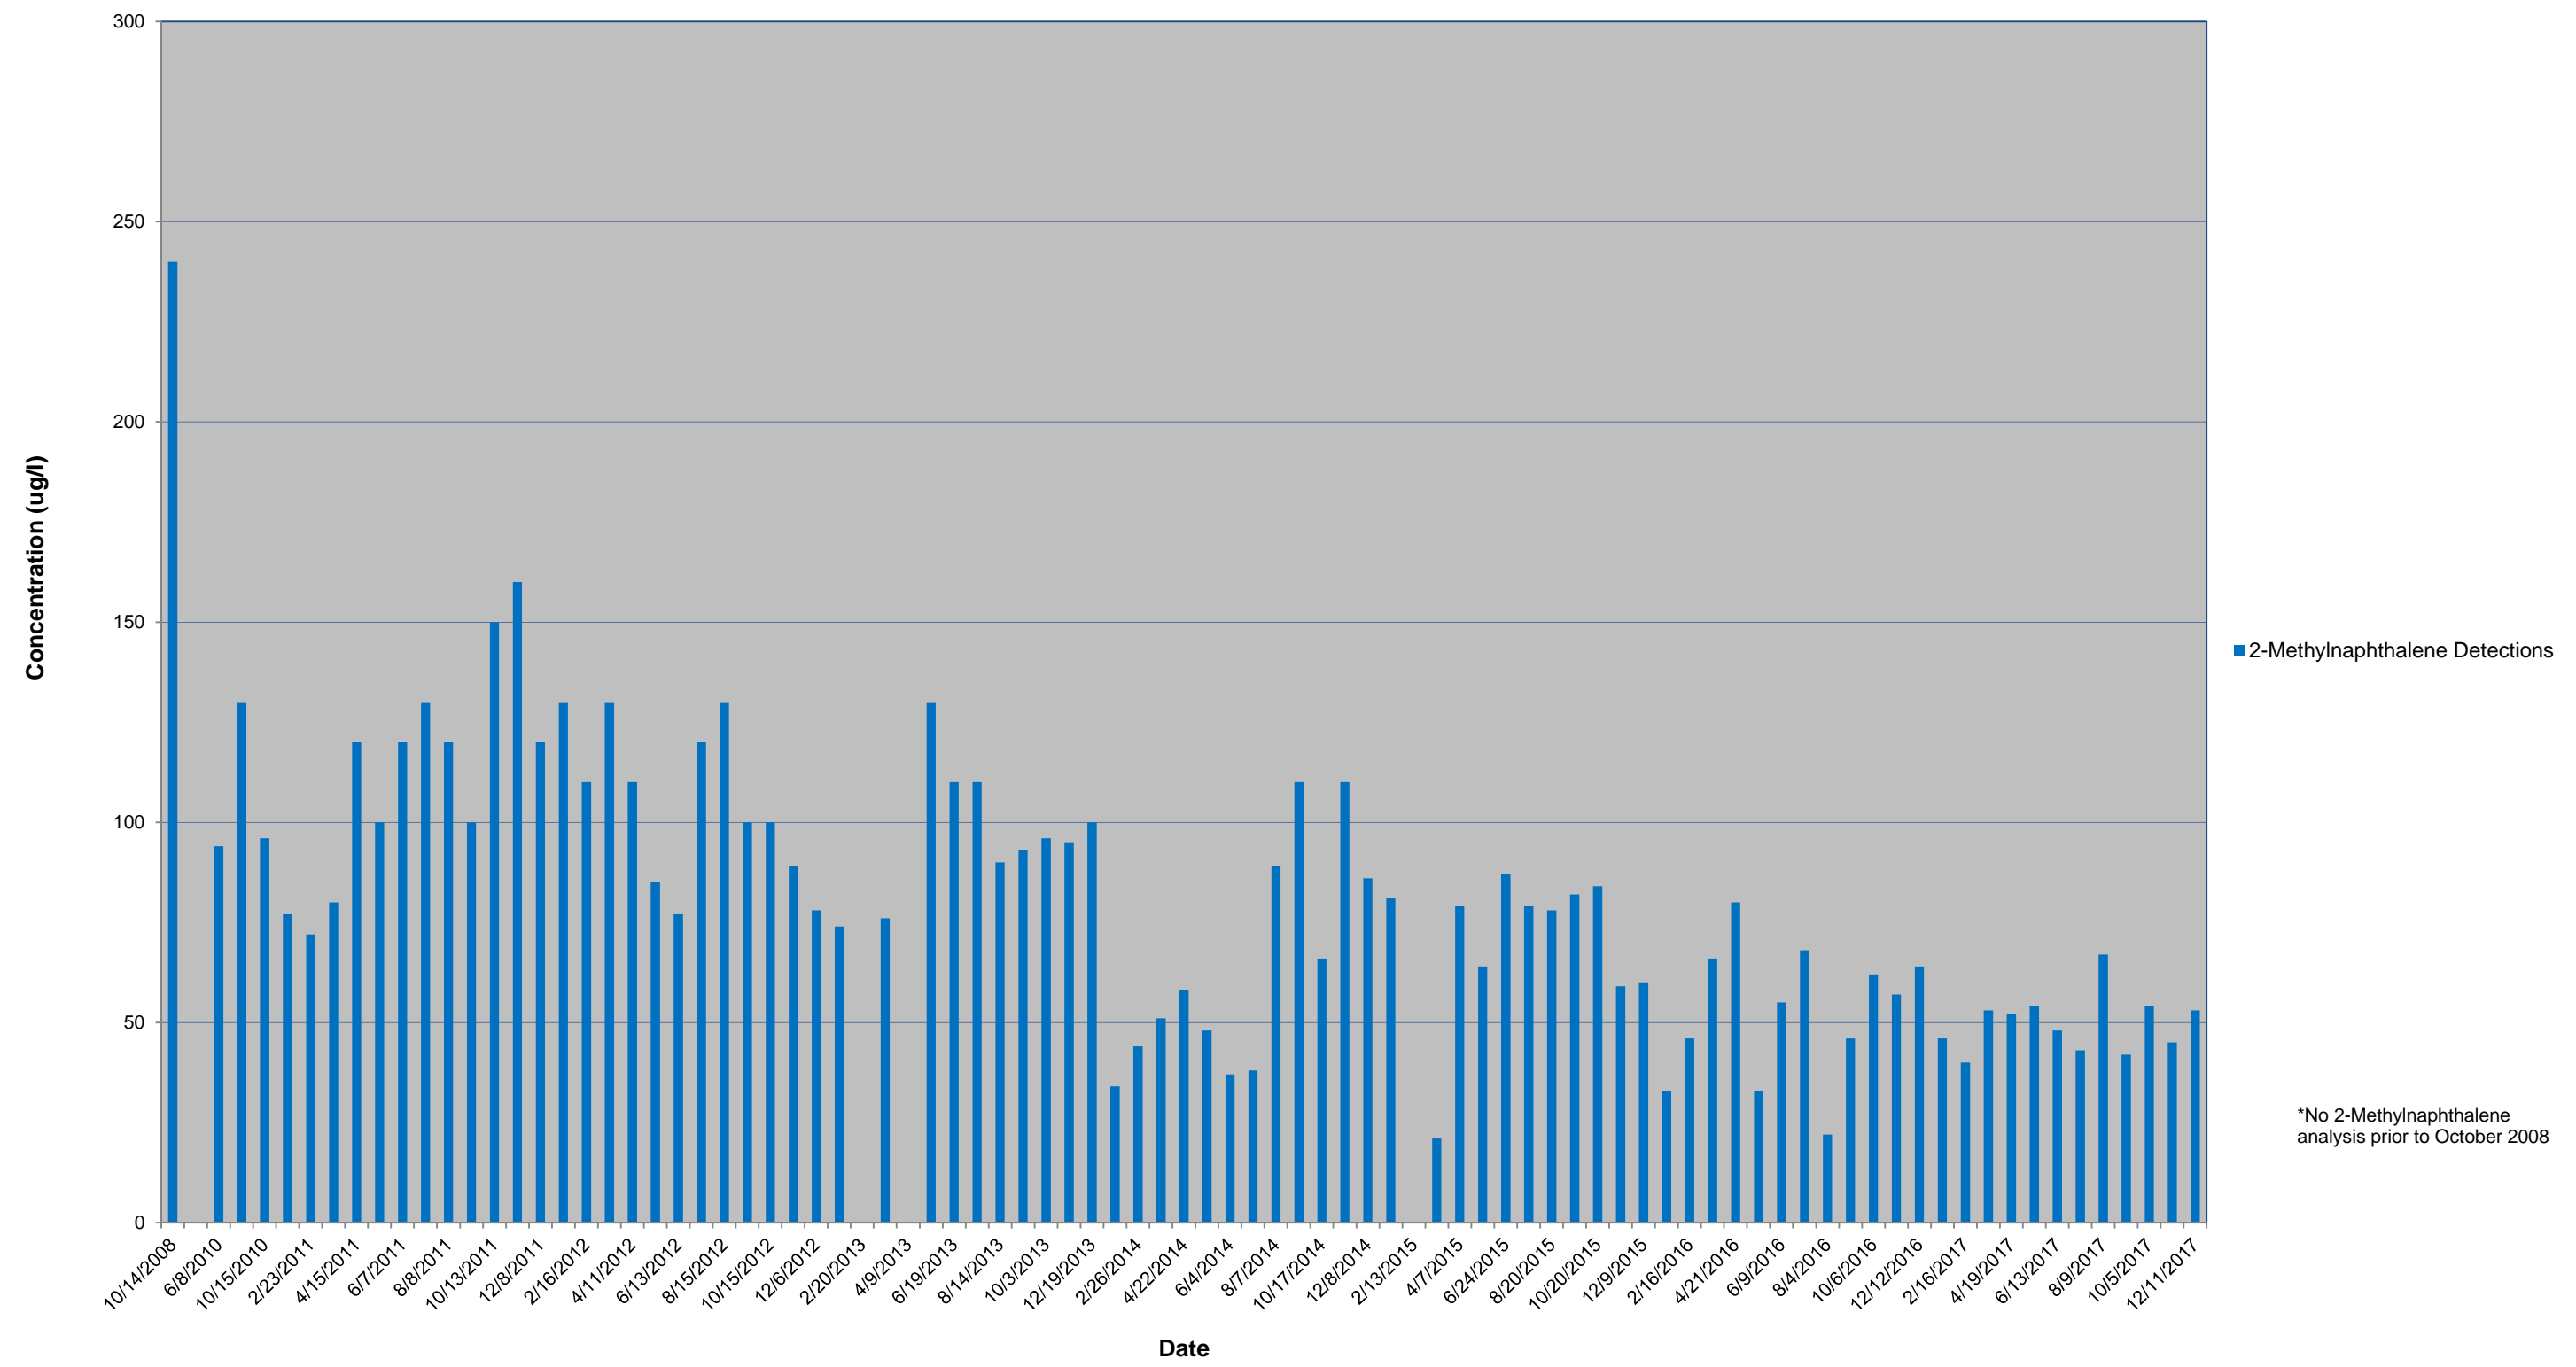
2-Methylnaphthalene Detections in CAMU Unit 2 Leachate Samples
2008 - 2017*

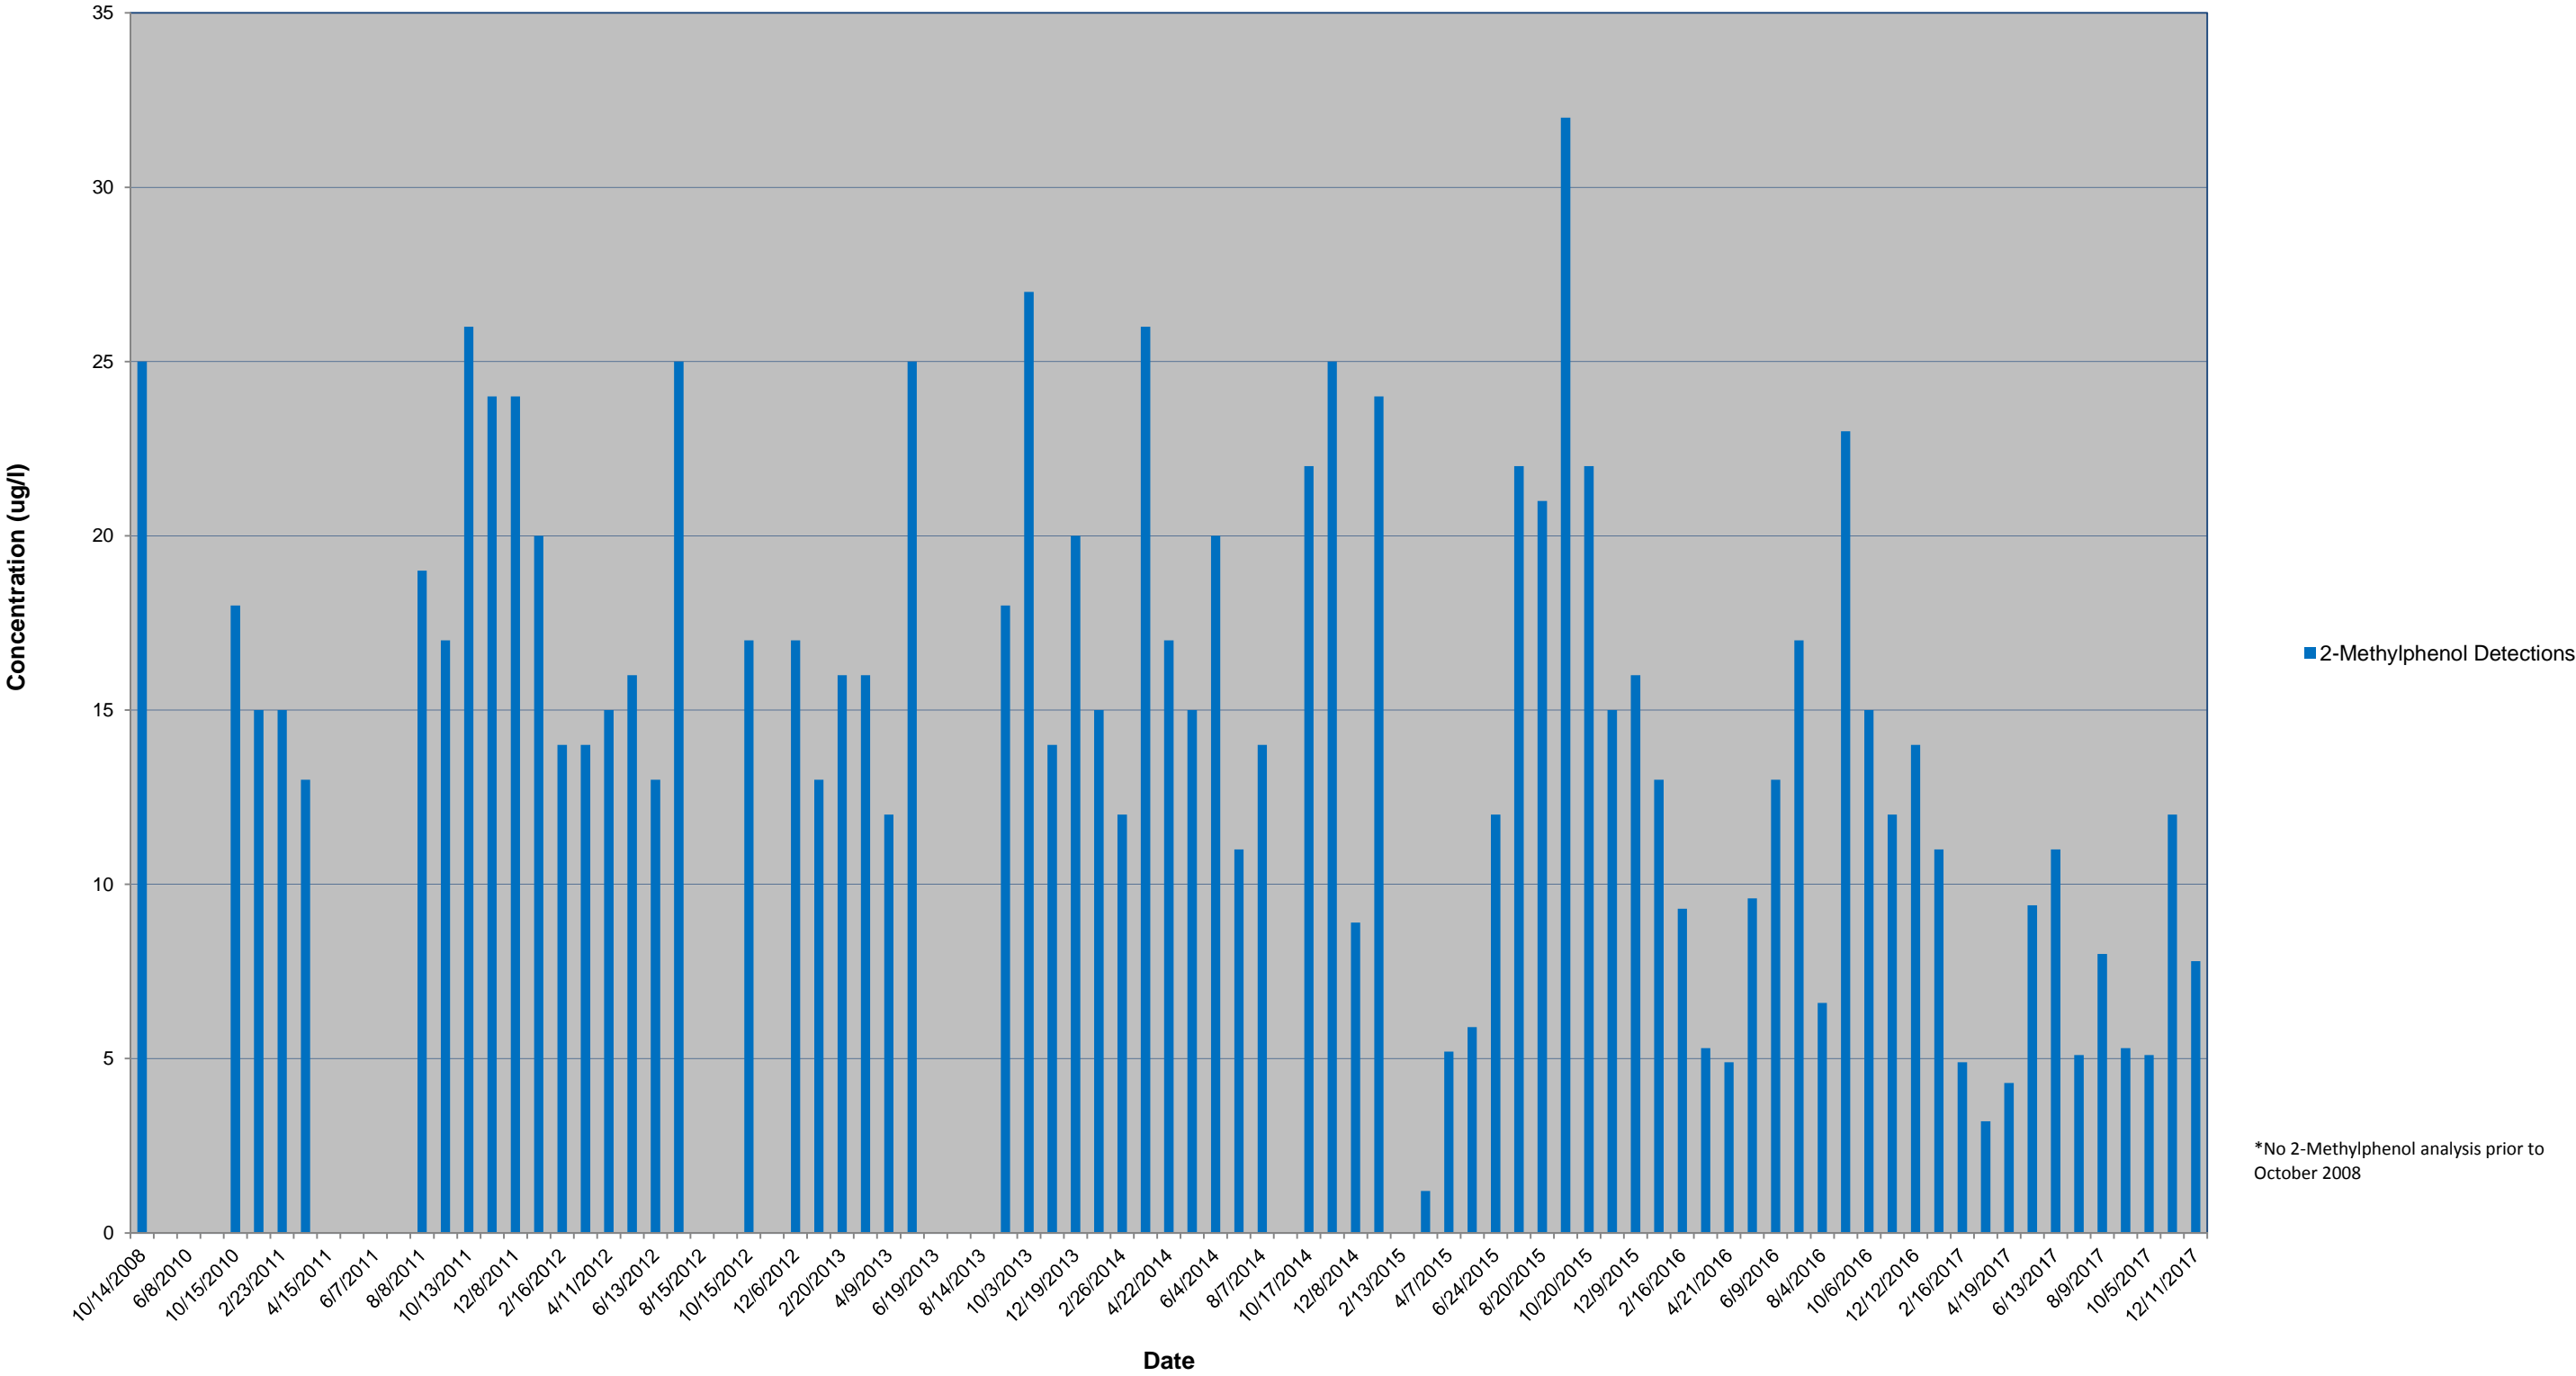
2-Methylphenol Detections in CAMU Unit 2 Leachate Samples
2008 - 2017*

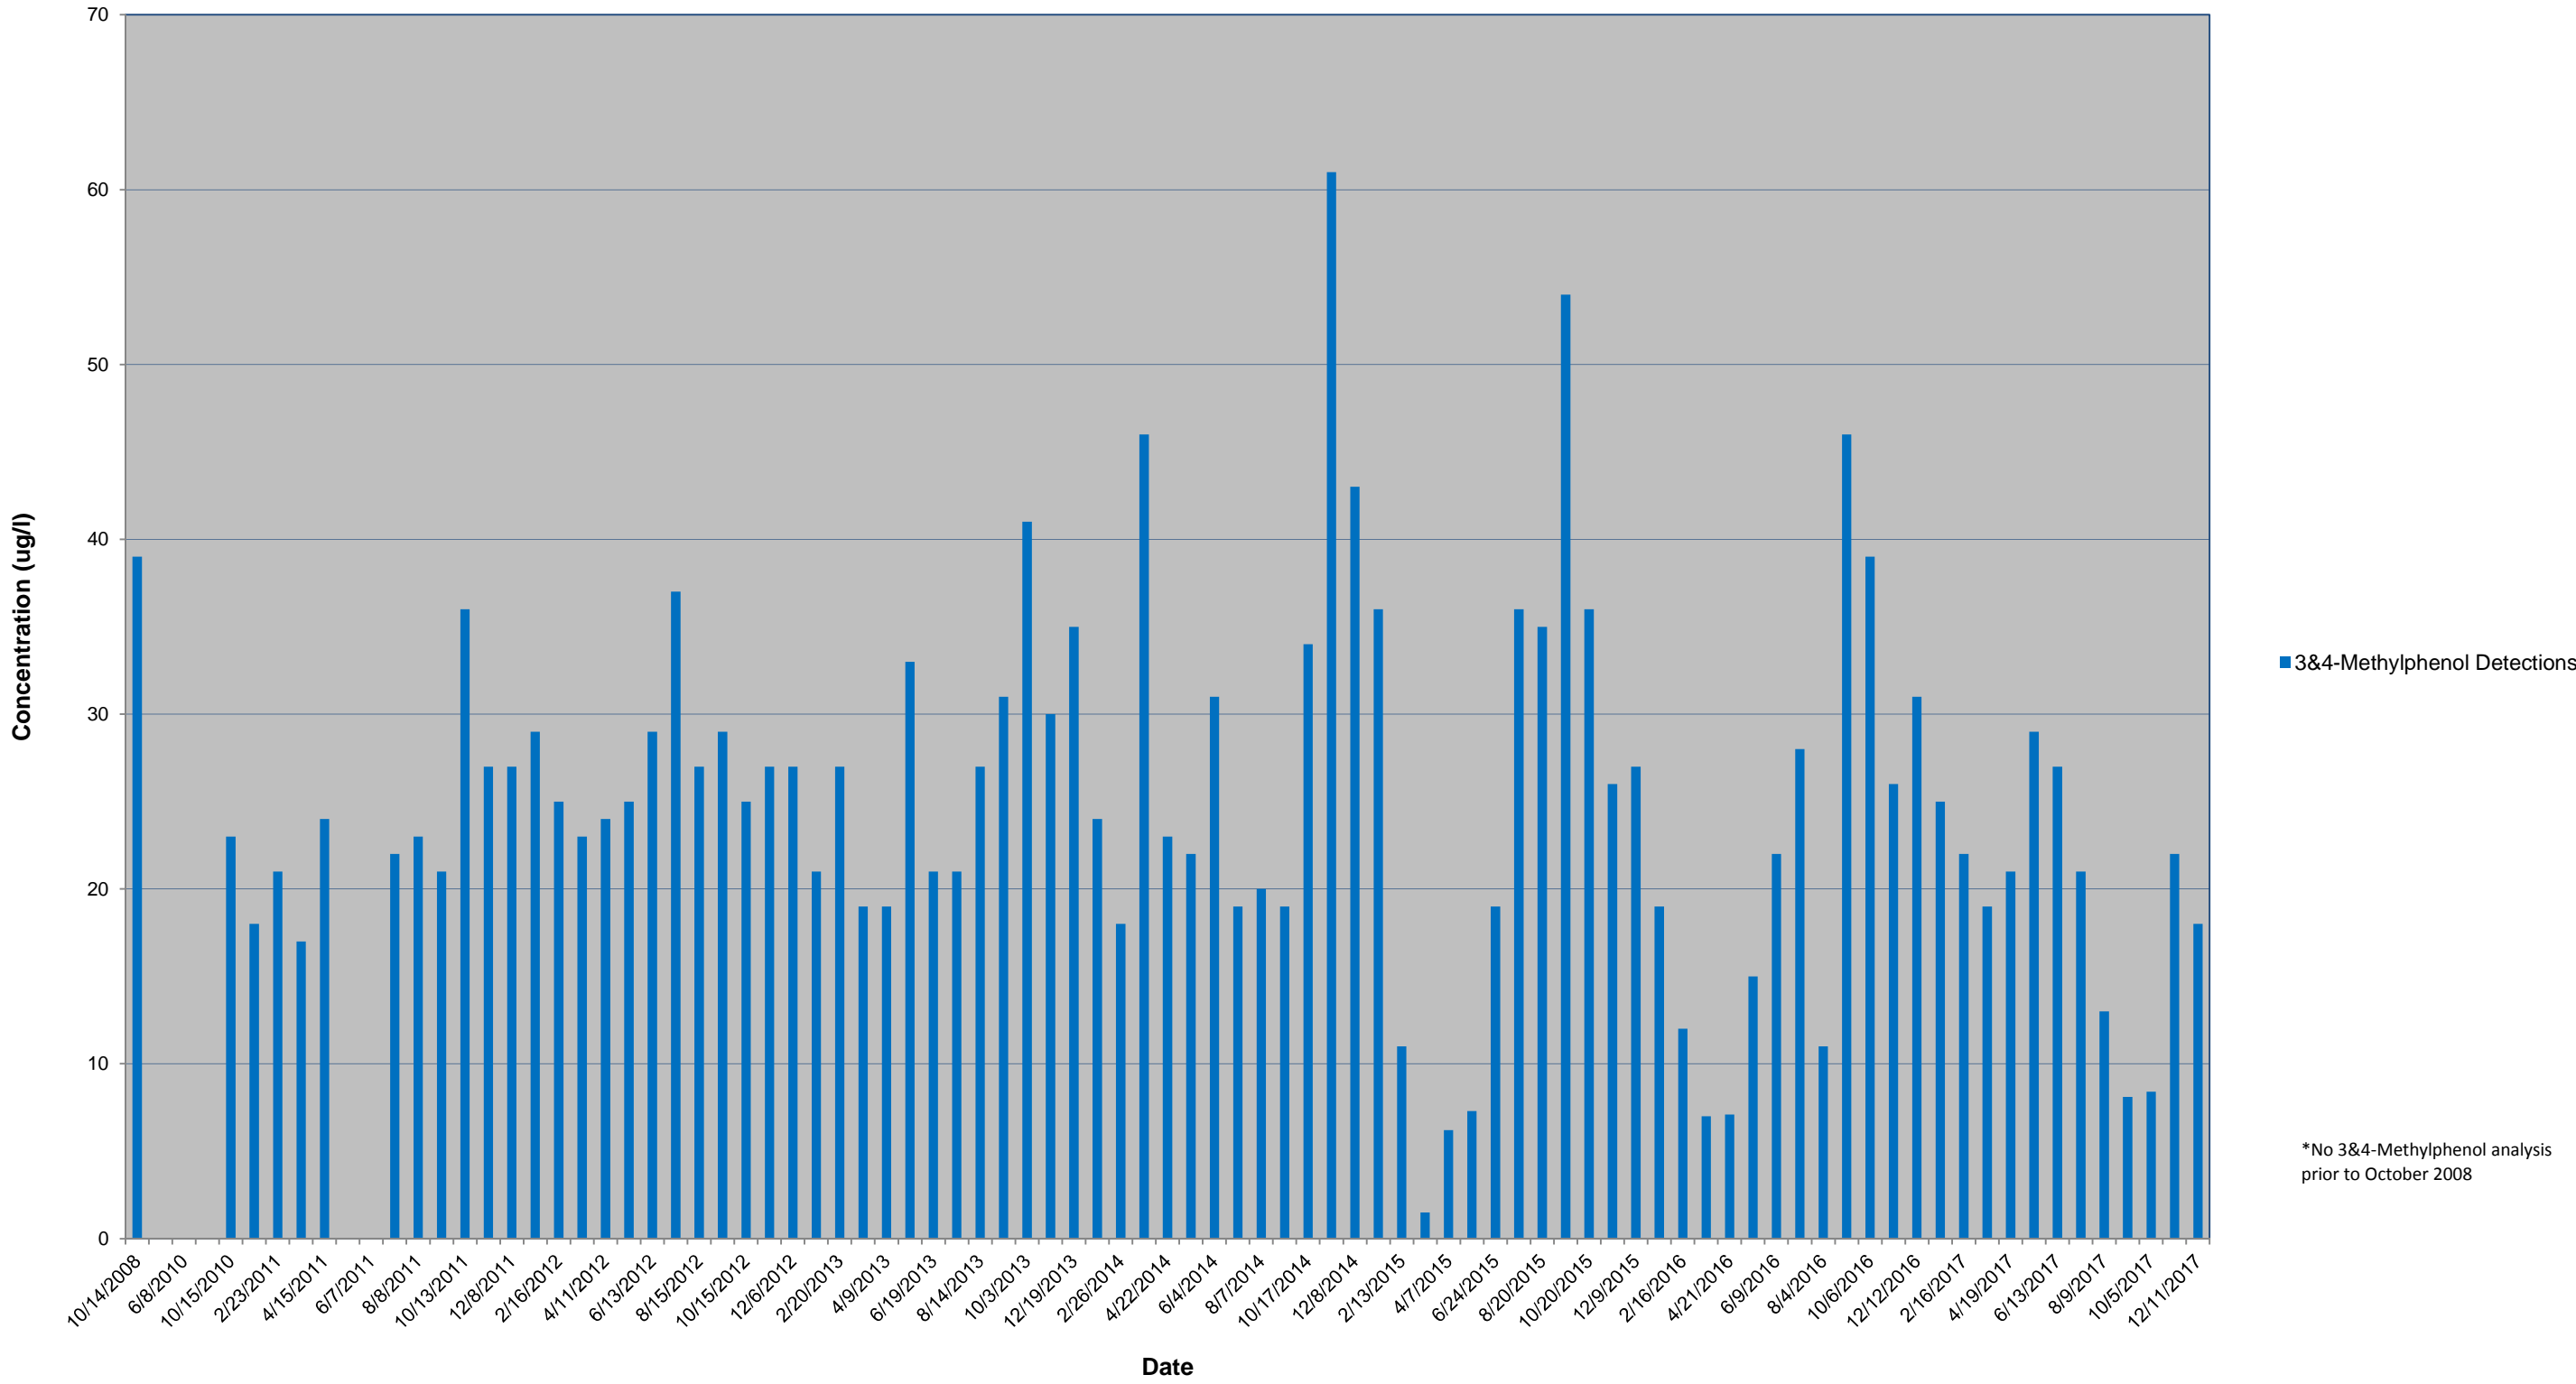
3&4-Methylphenol Detections in CAMU Unit 2 Leachate Samples
2008 - 2017*

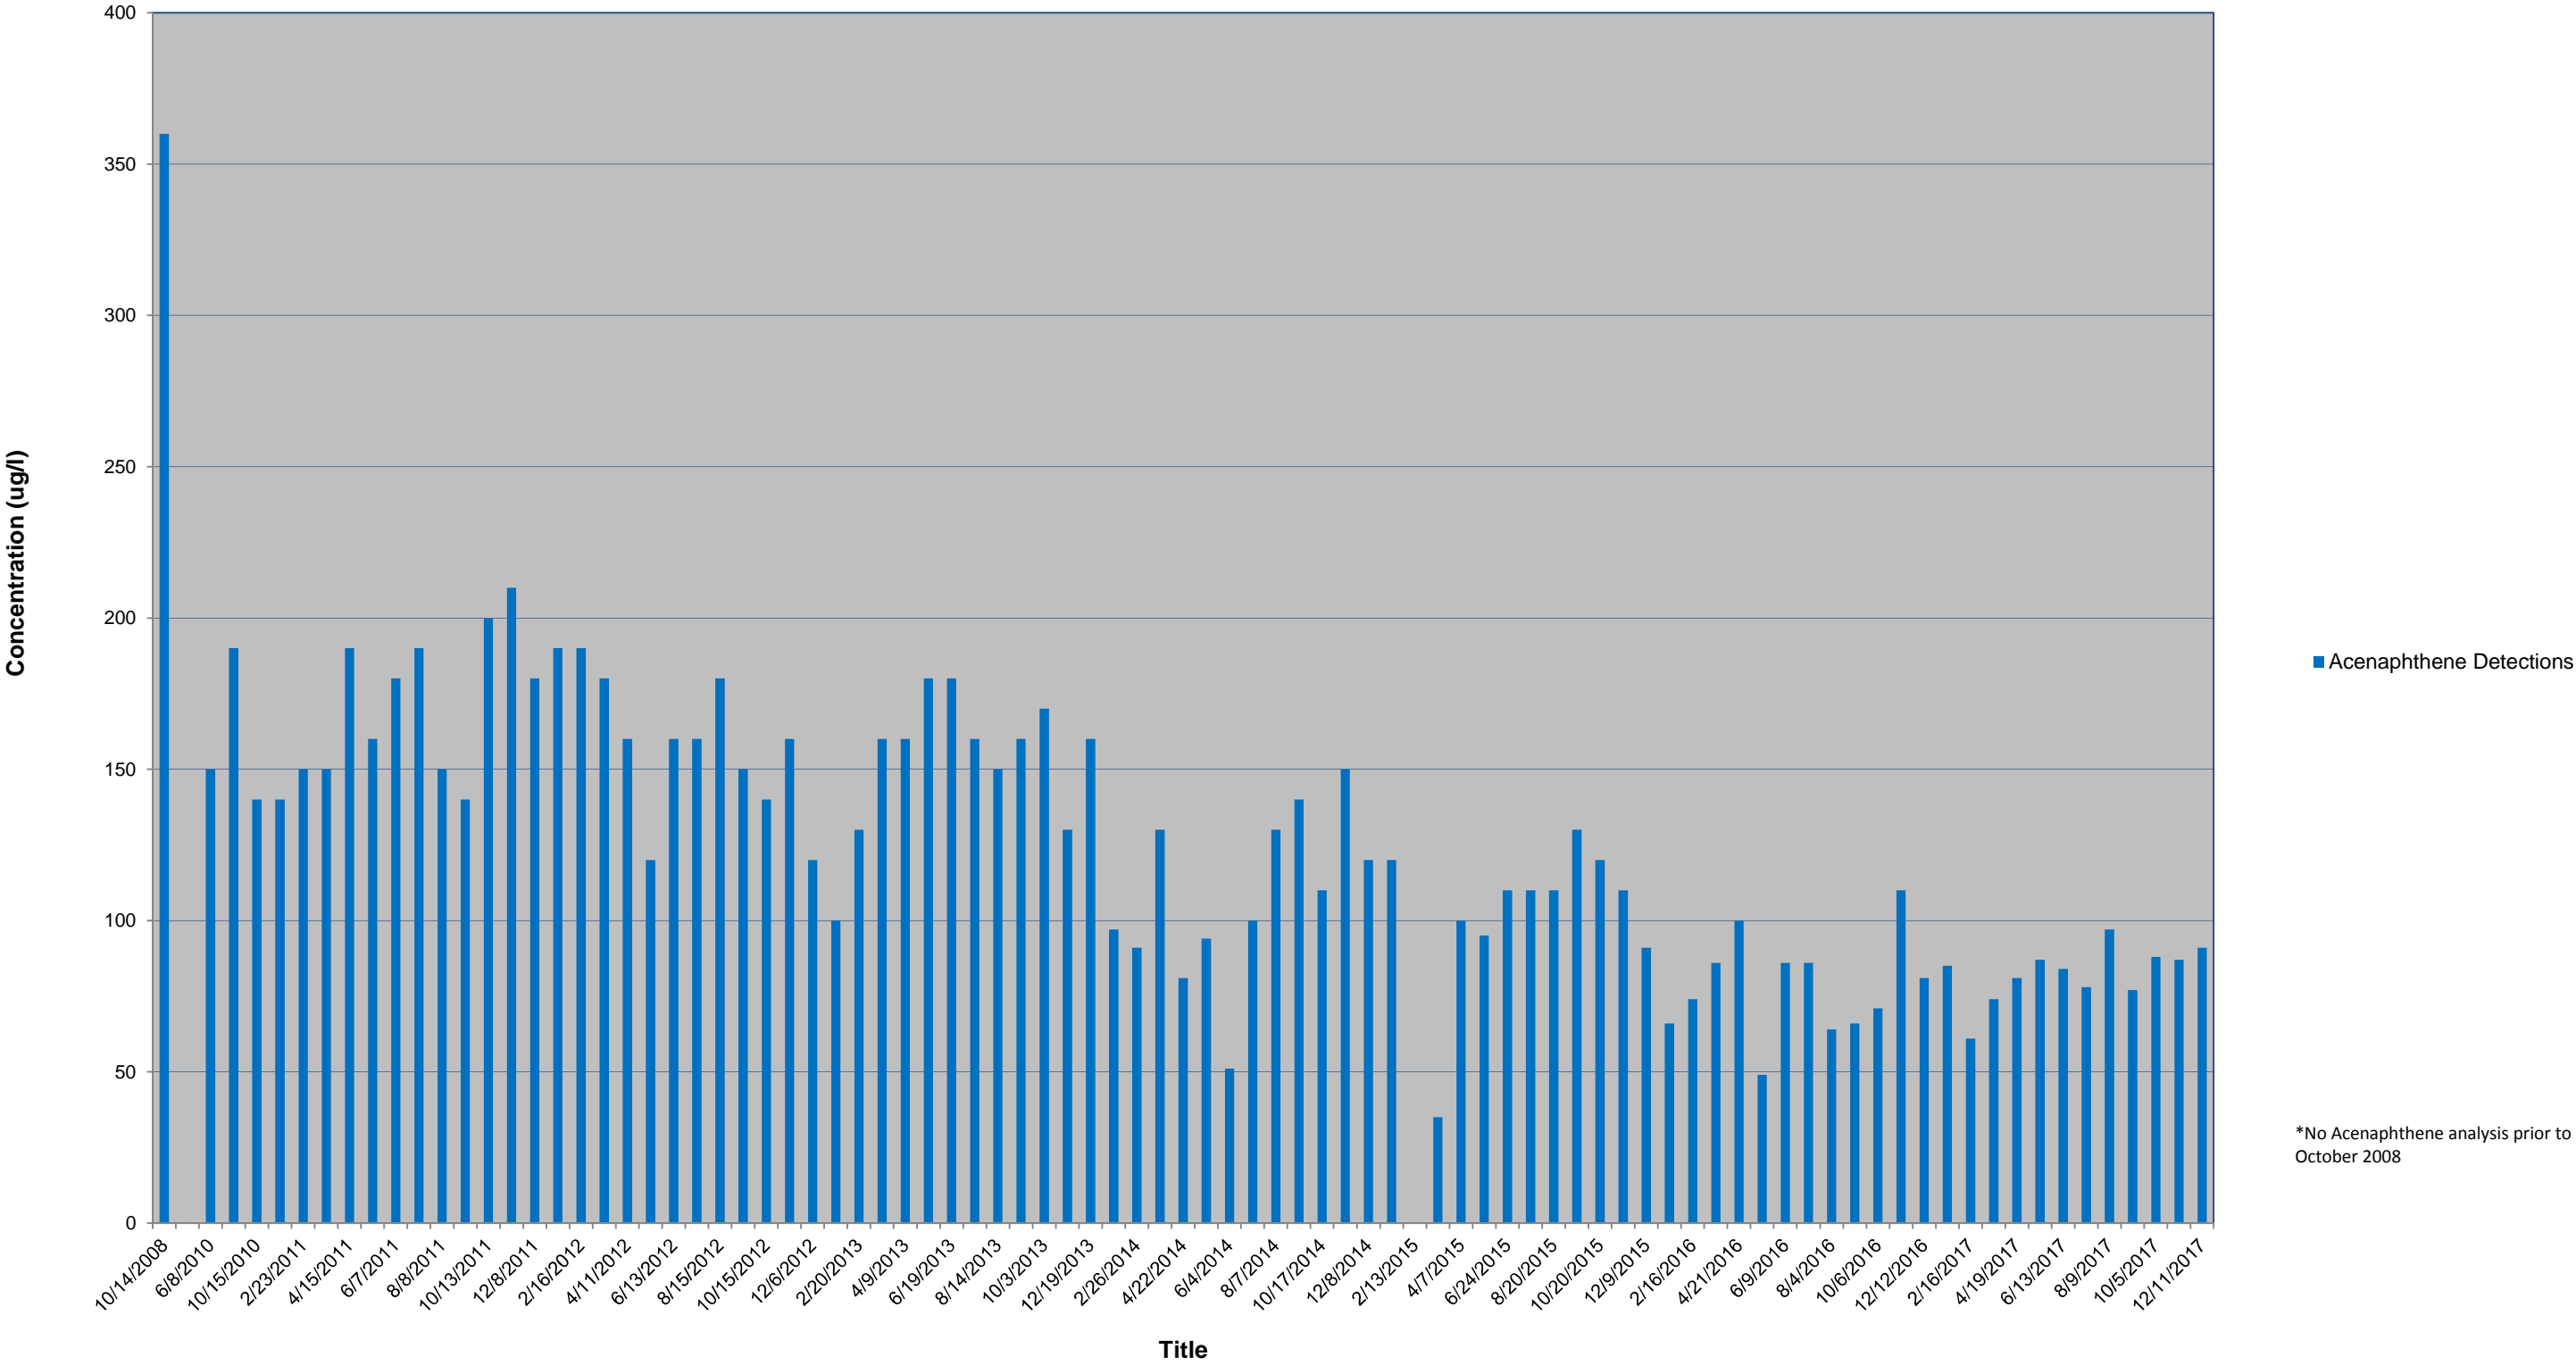
Acenaphthene Detections in CAMU Unit 2 Leachate Samples
2008 - 2017*

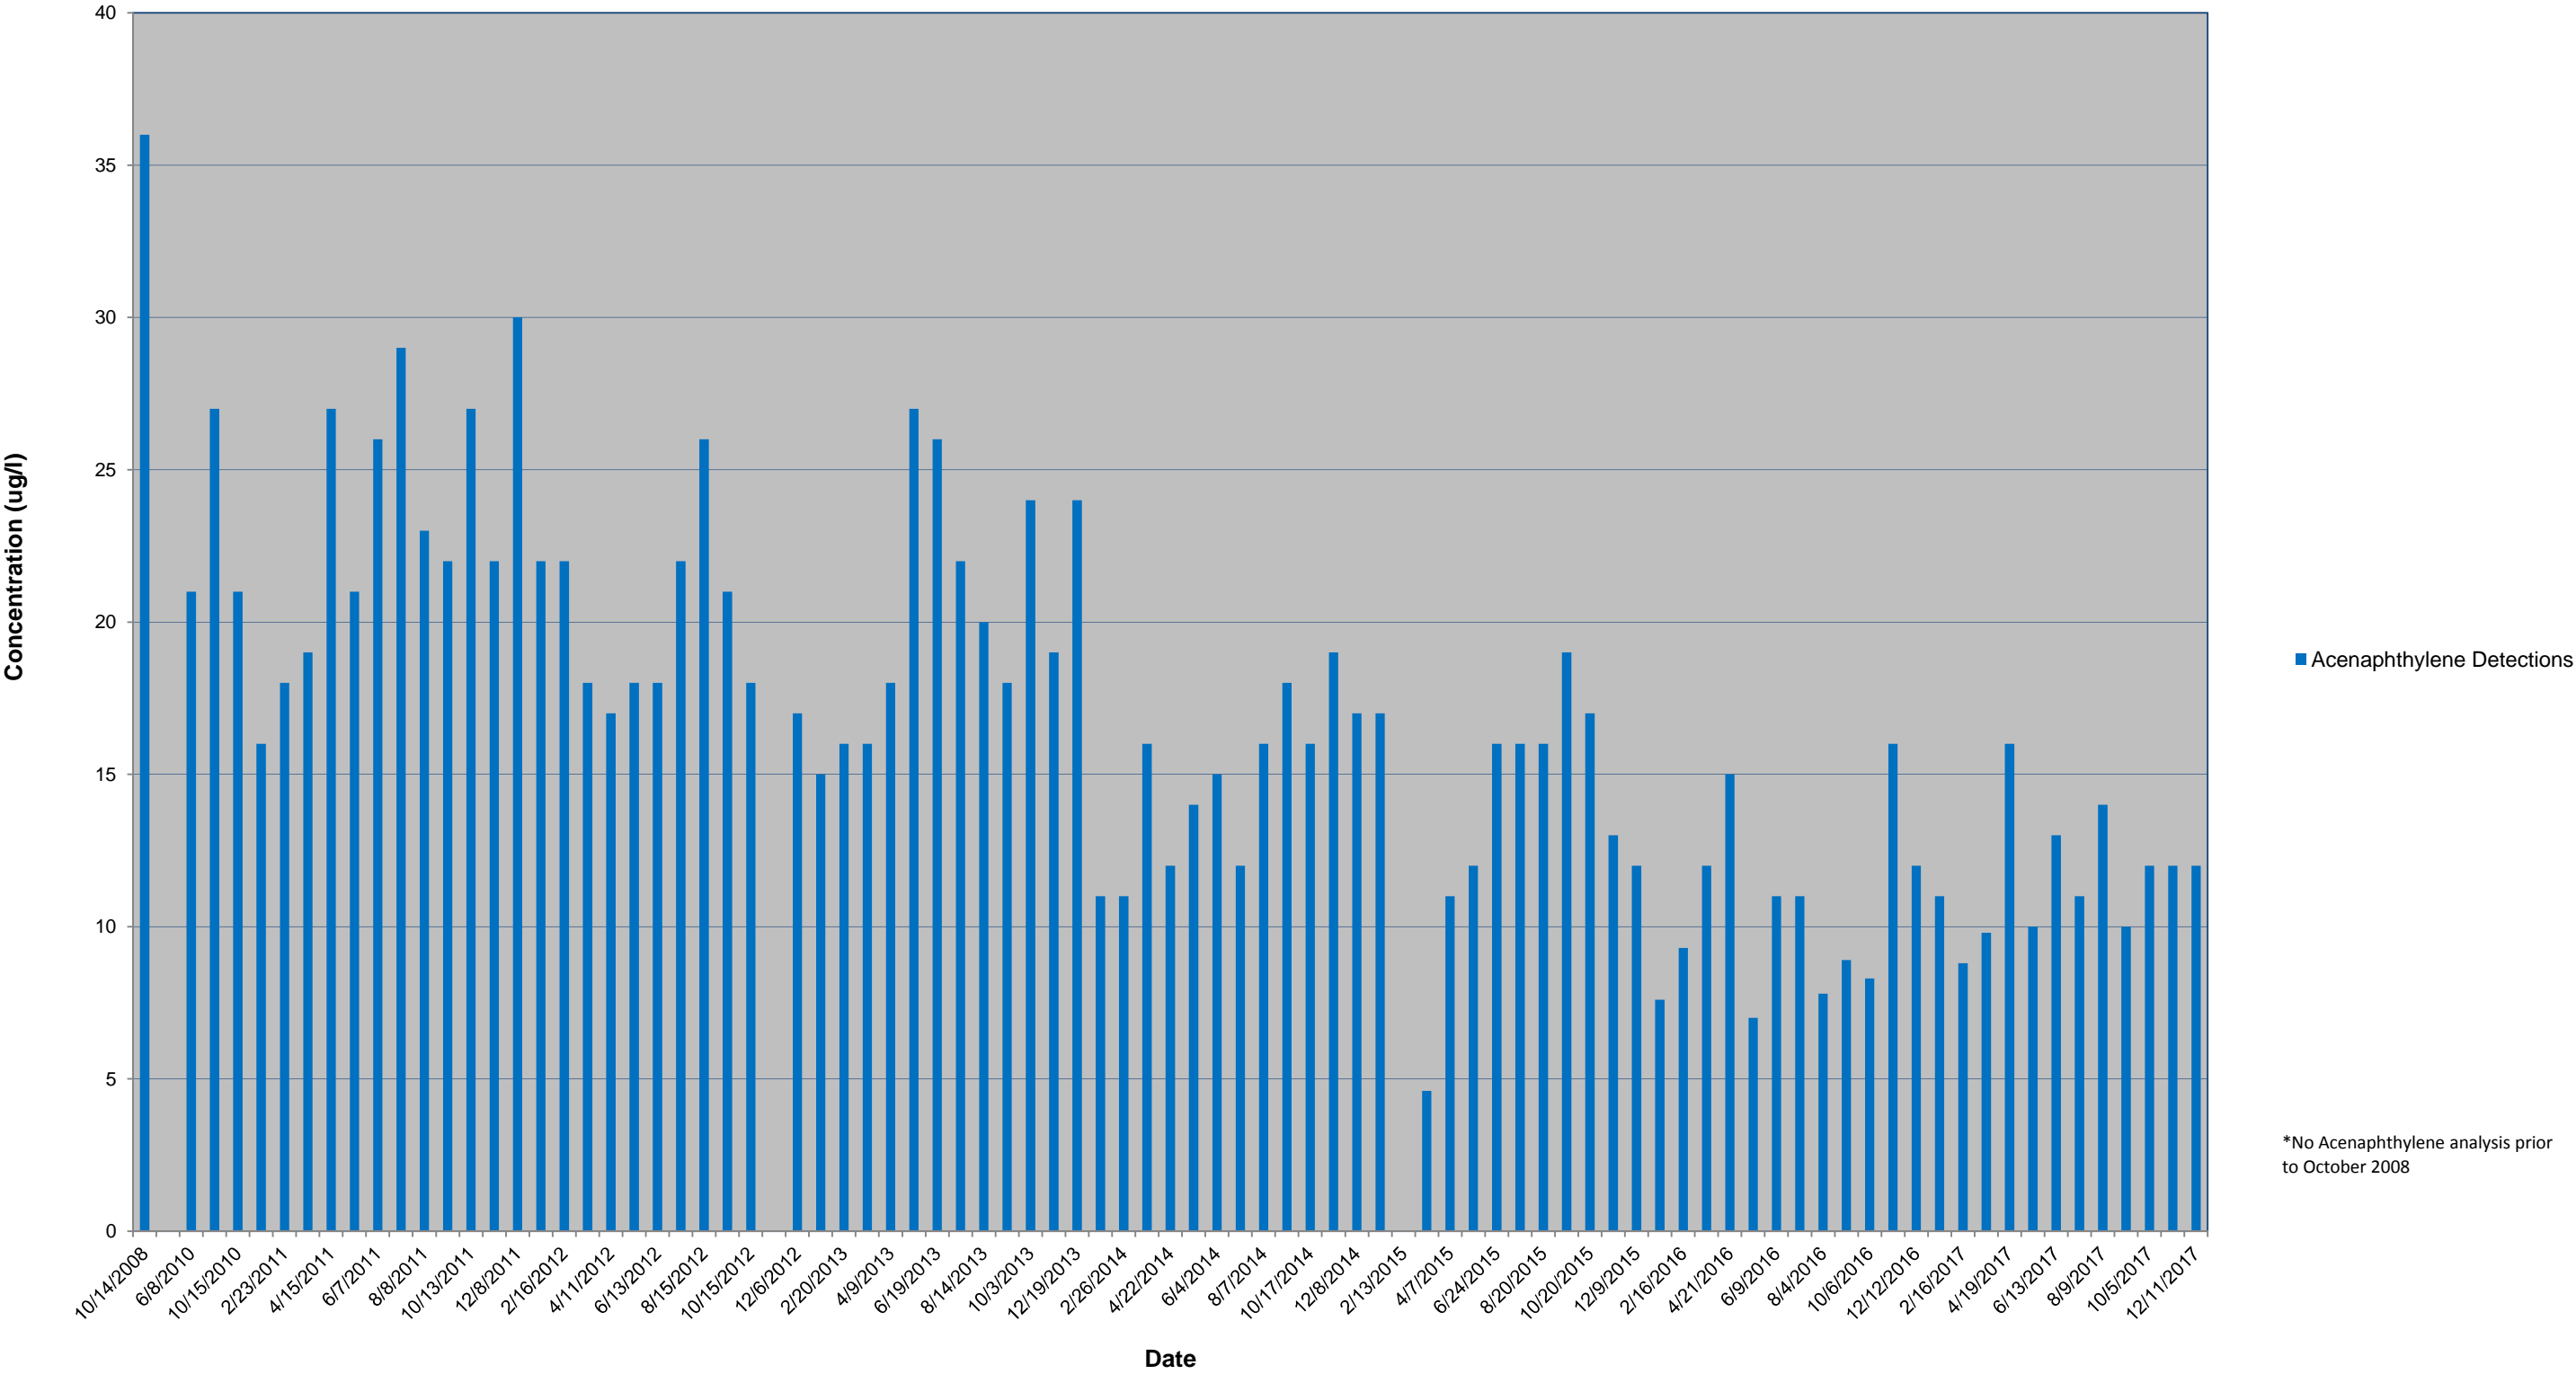
Acenaphthylene Detections in CAMU Unit 2 Leachate Samples
2008 - 2017*

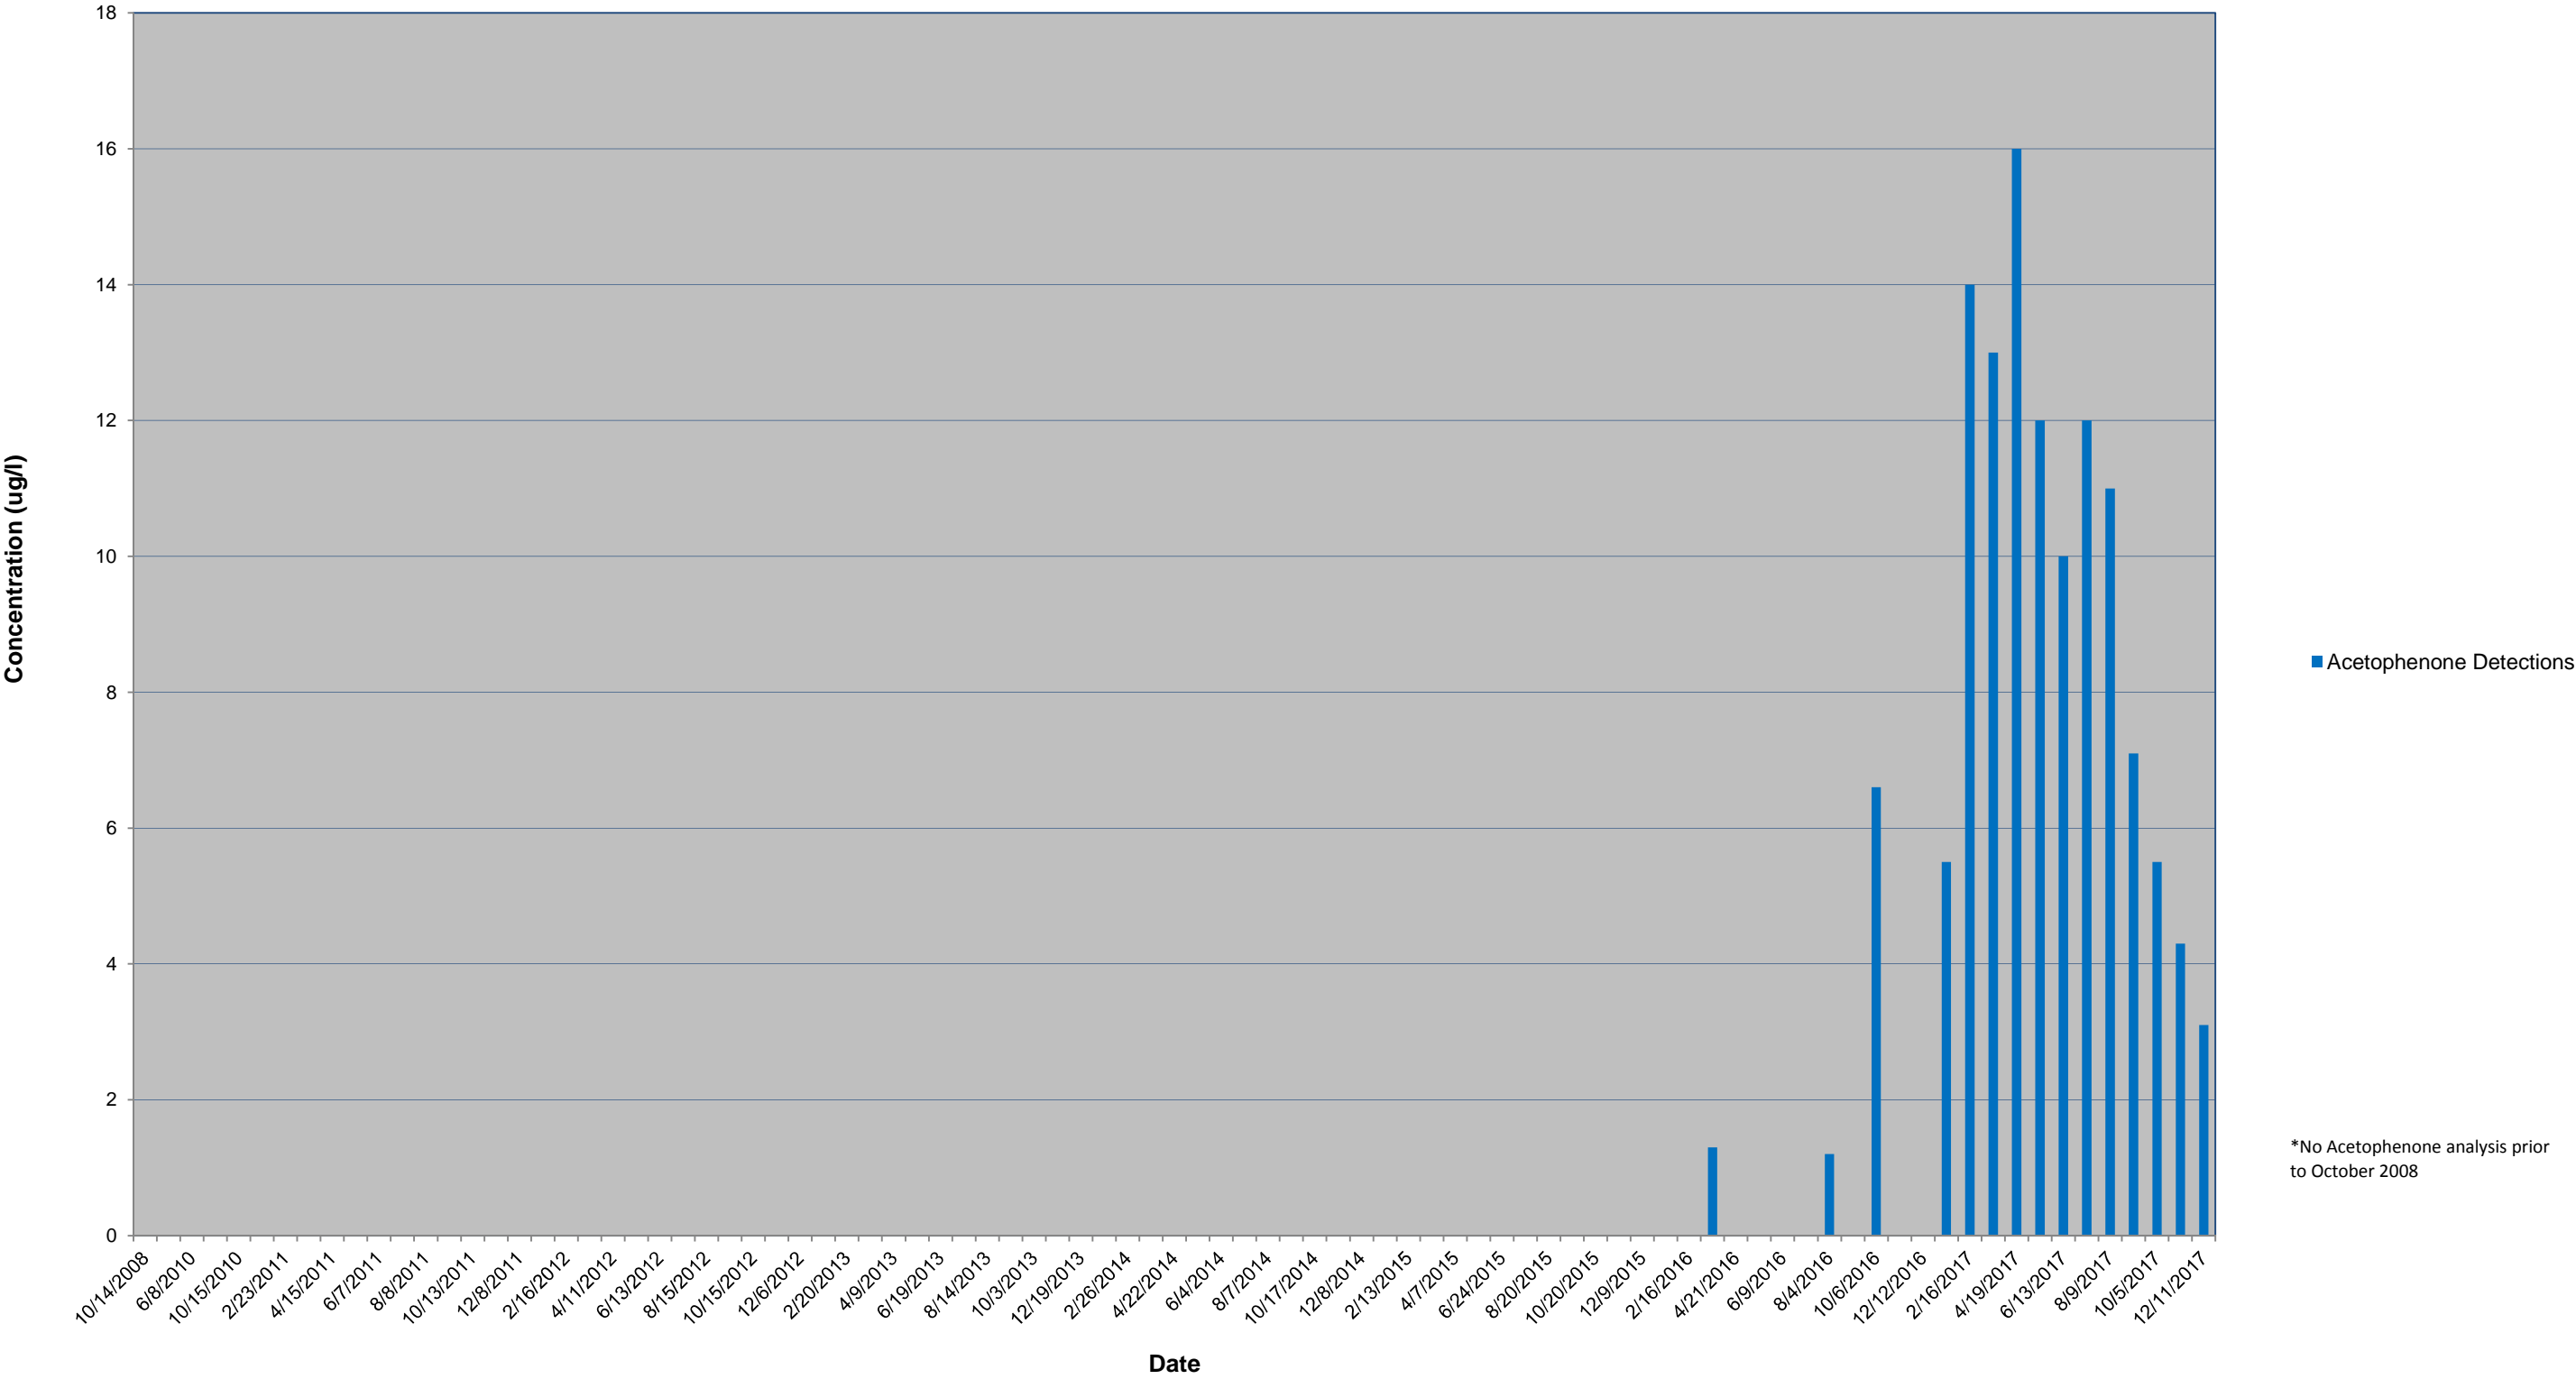
Acetophenone Detections in CAMU Unit 2 Leachate Samples
2008 - 2017*
