2,4-Dimethylphenol Detections in CAMU Unit 2 Leachate
2008 - 2017*

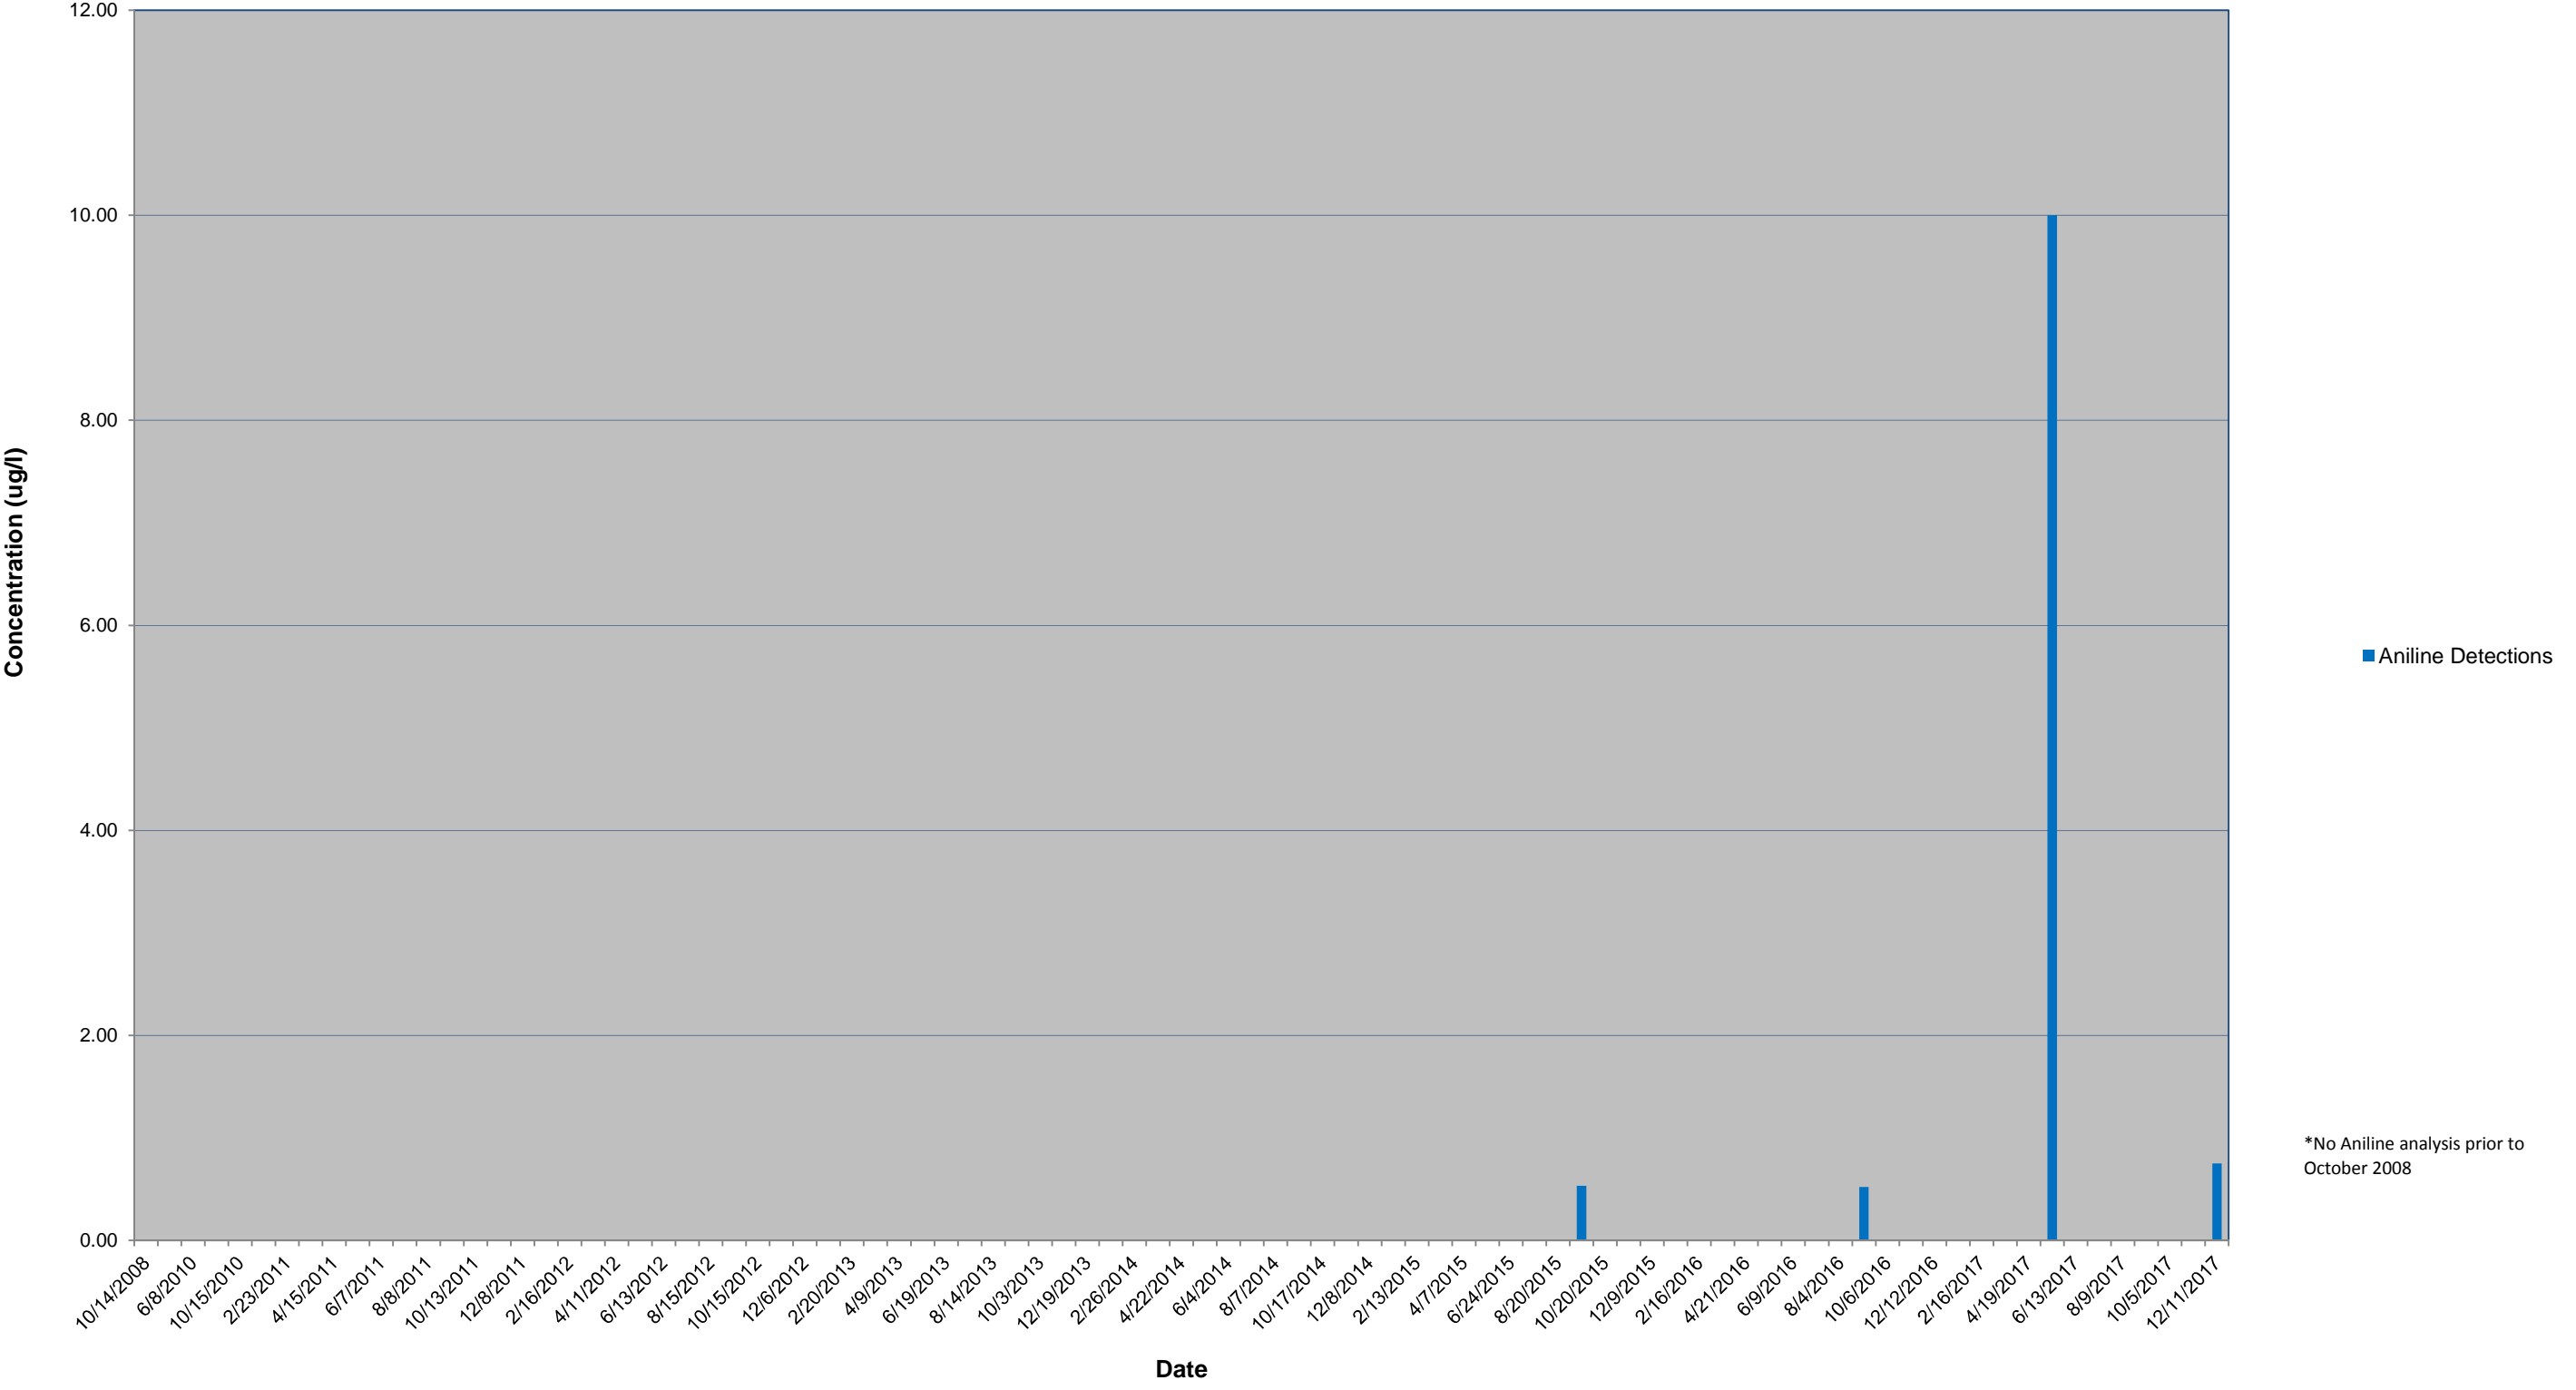
Aniline Detections in CAMU Unit 2 Leachate Samples
2008 - 2017*

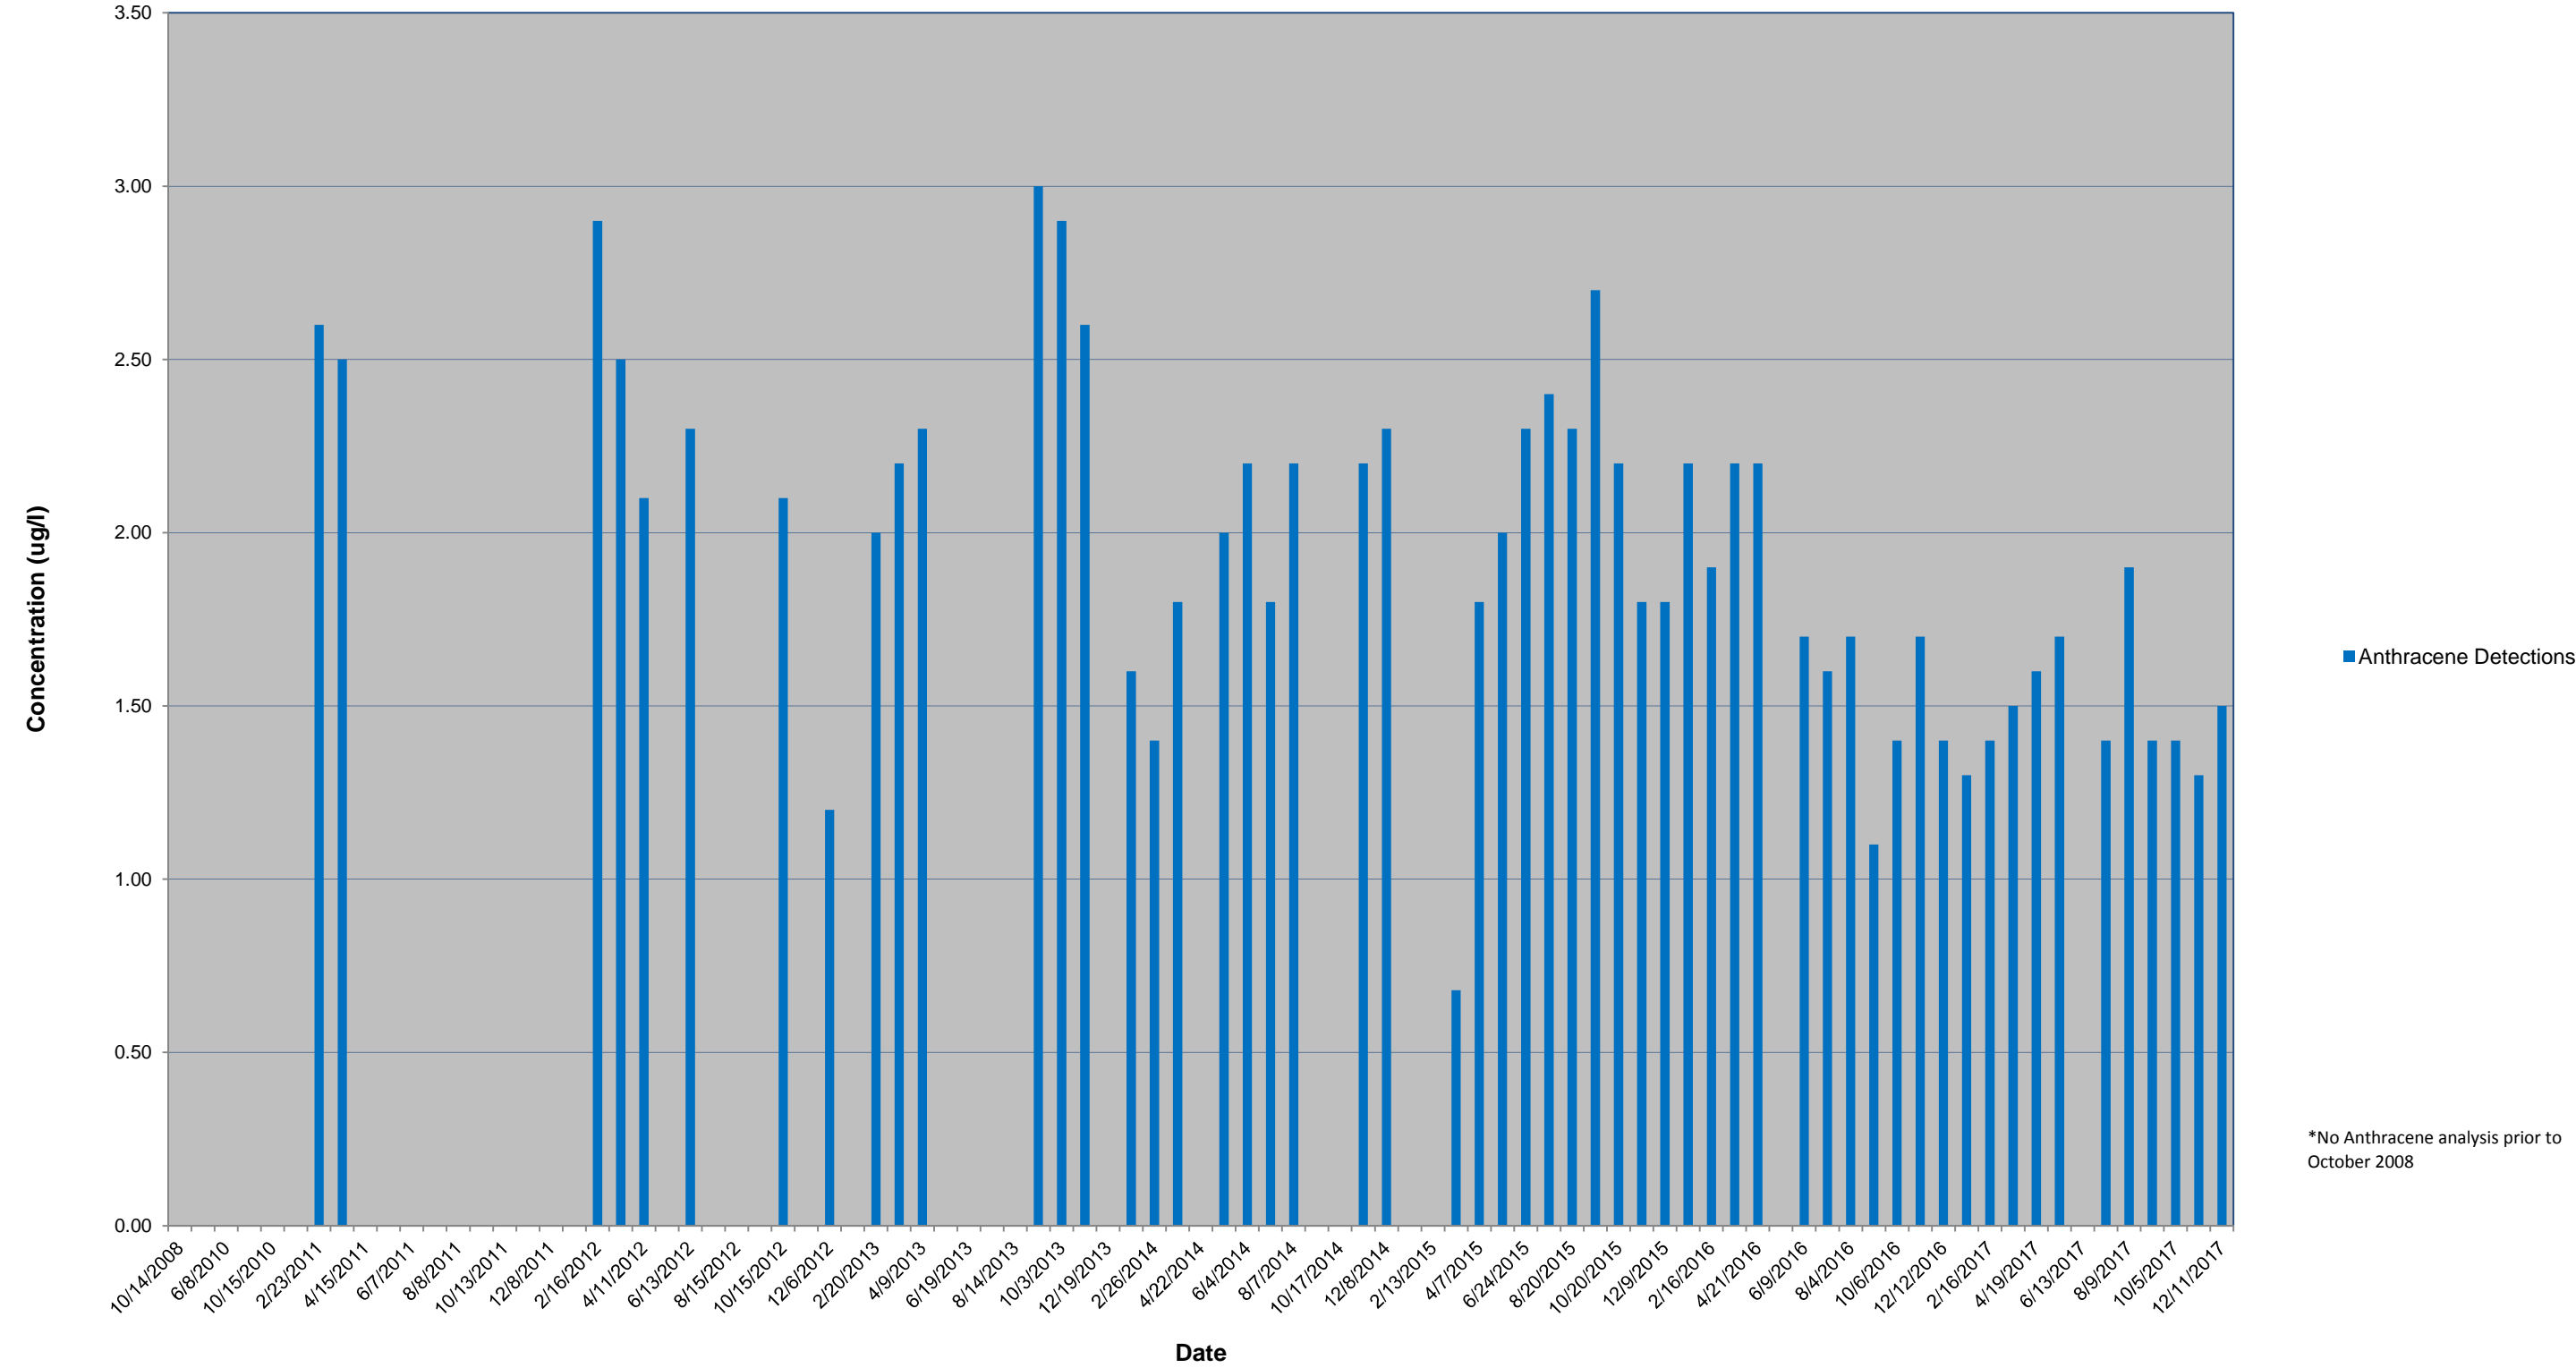
Anthracene Detections in CAMU Unit 2 Leachate Samples
2008 - 2017*

*No Anthracene analysis prior to October 2008

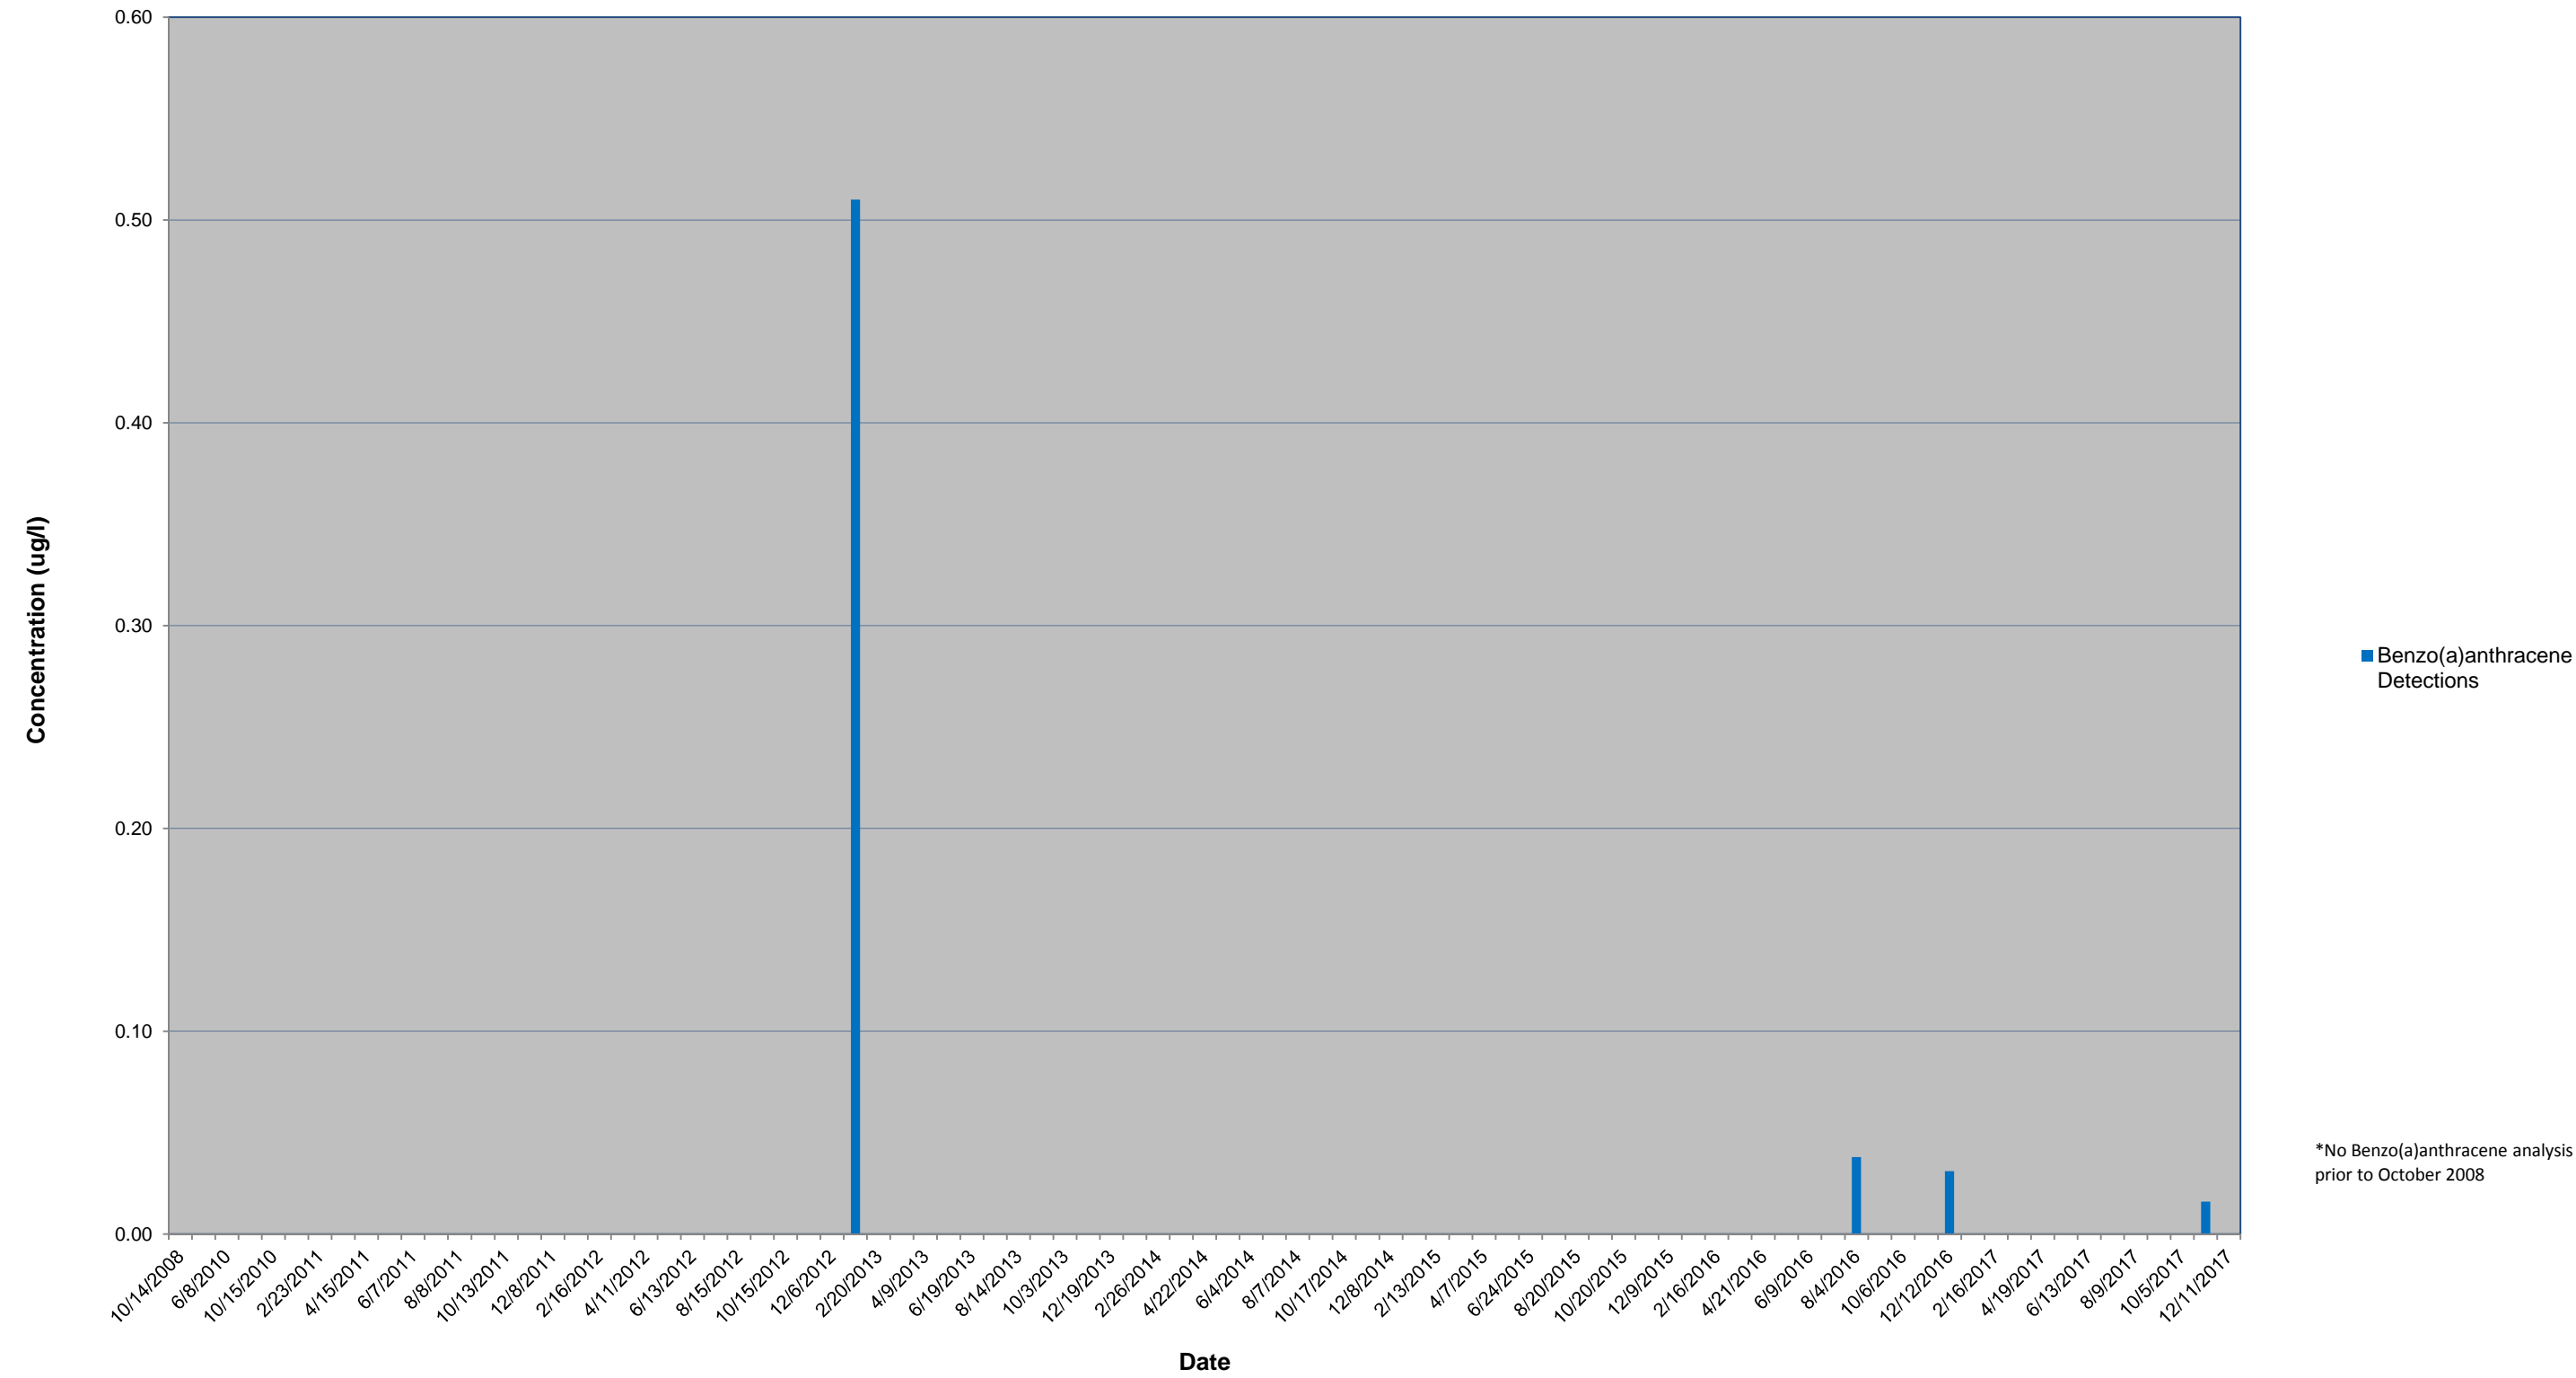
Benzo(a)anthracene Detections in CAMU Unit 2 Leachate Samples
2008 - 2017*

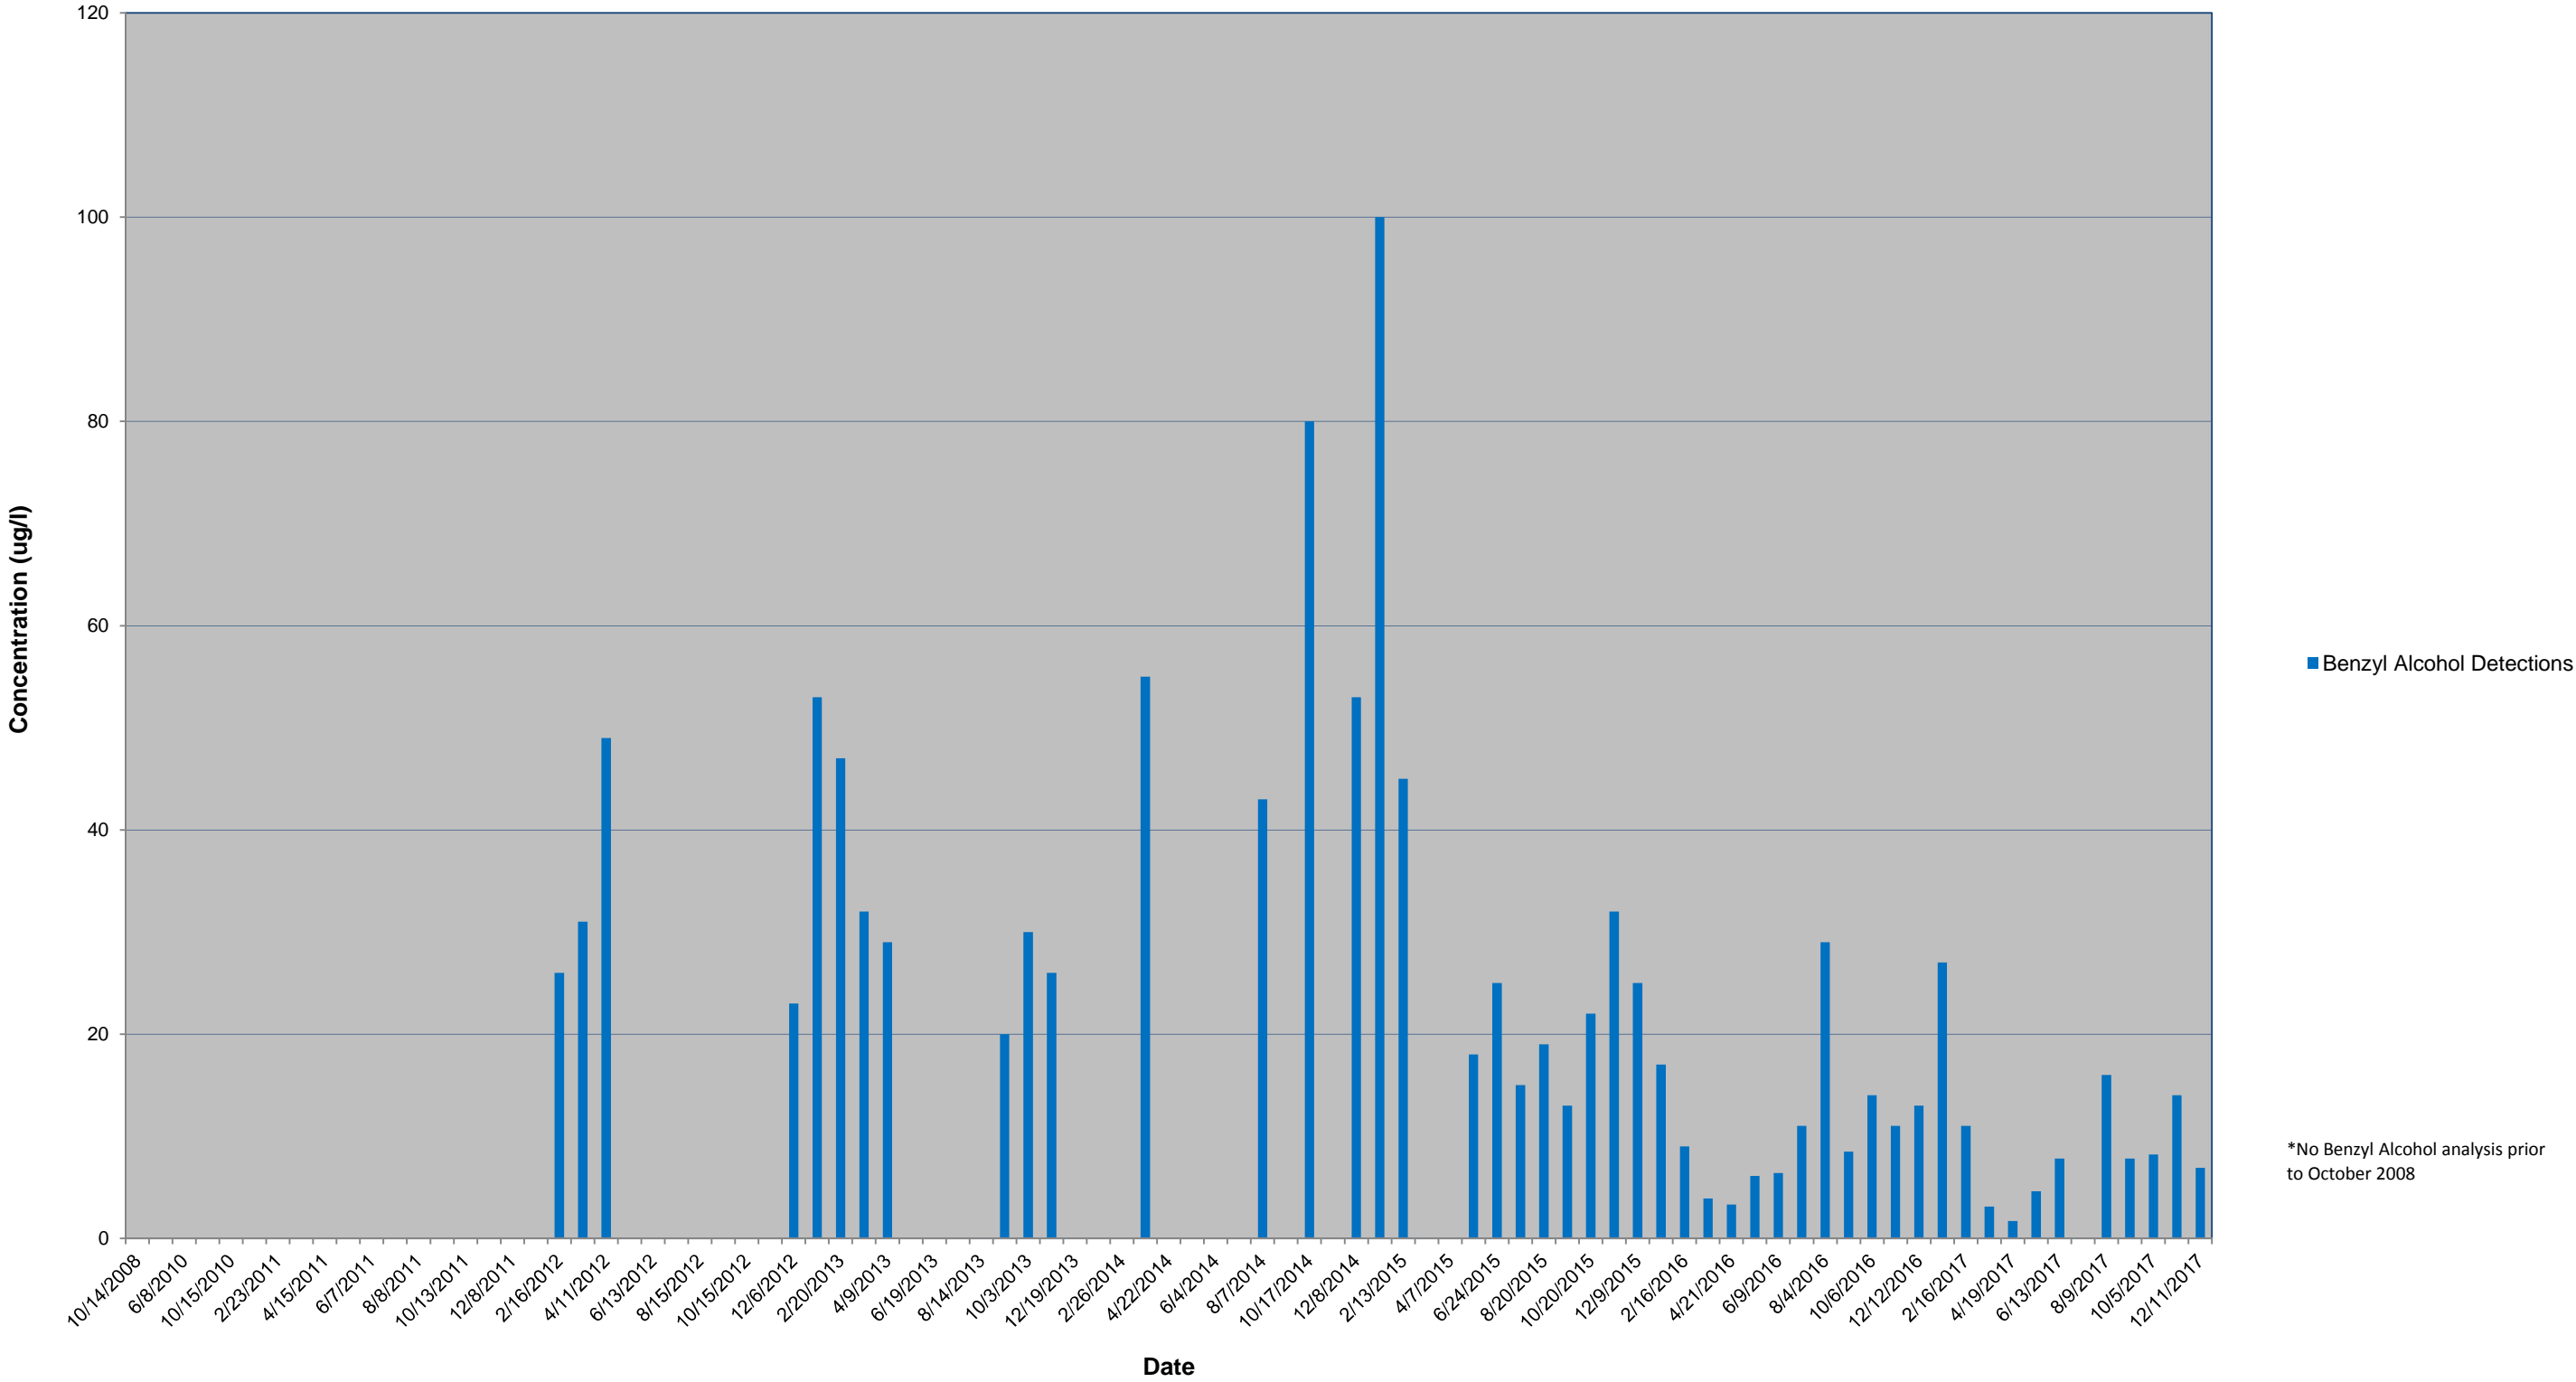
Benzyl Alcohol Detections in CAMU Unit 2 Leachate Samples
2008 - 2017*

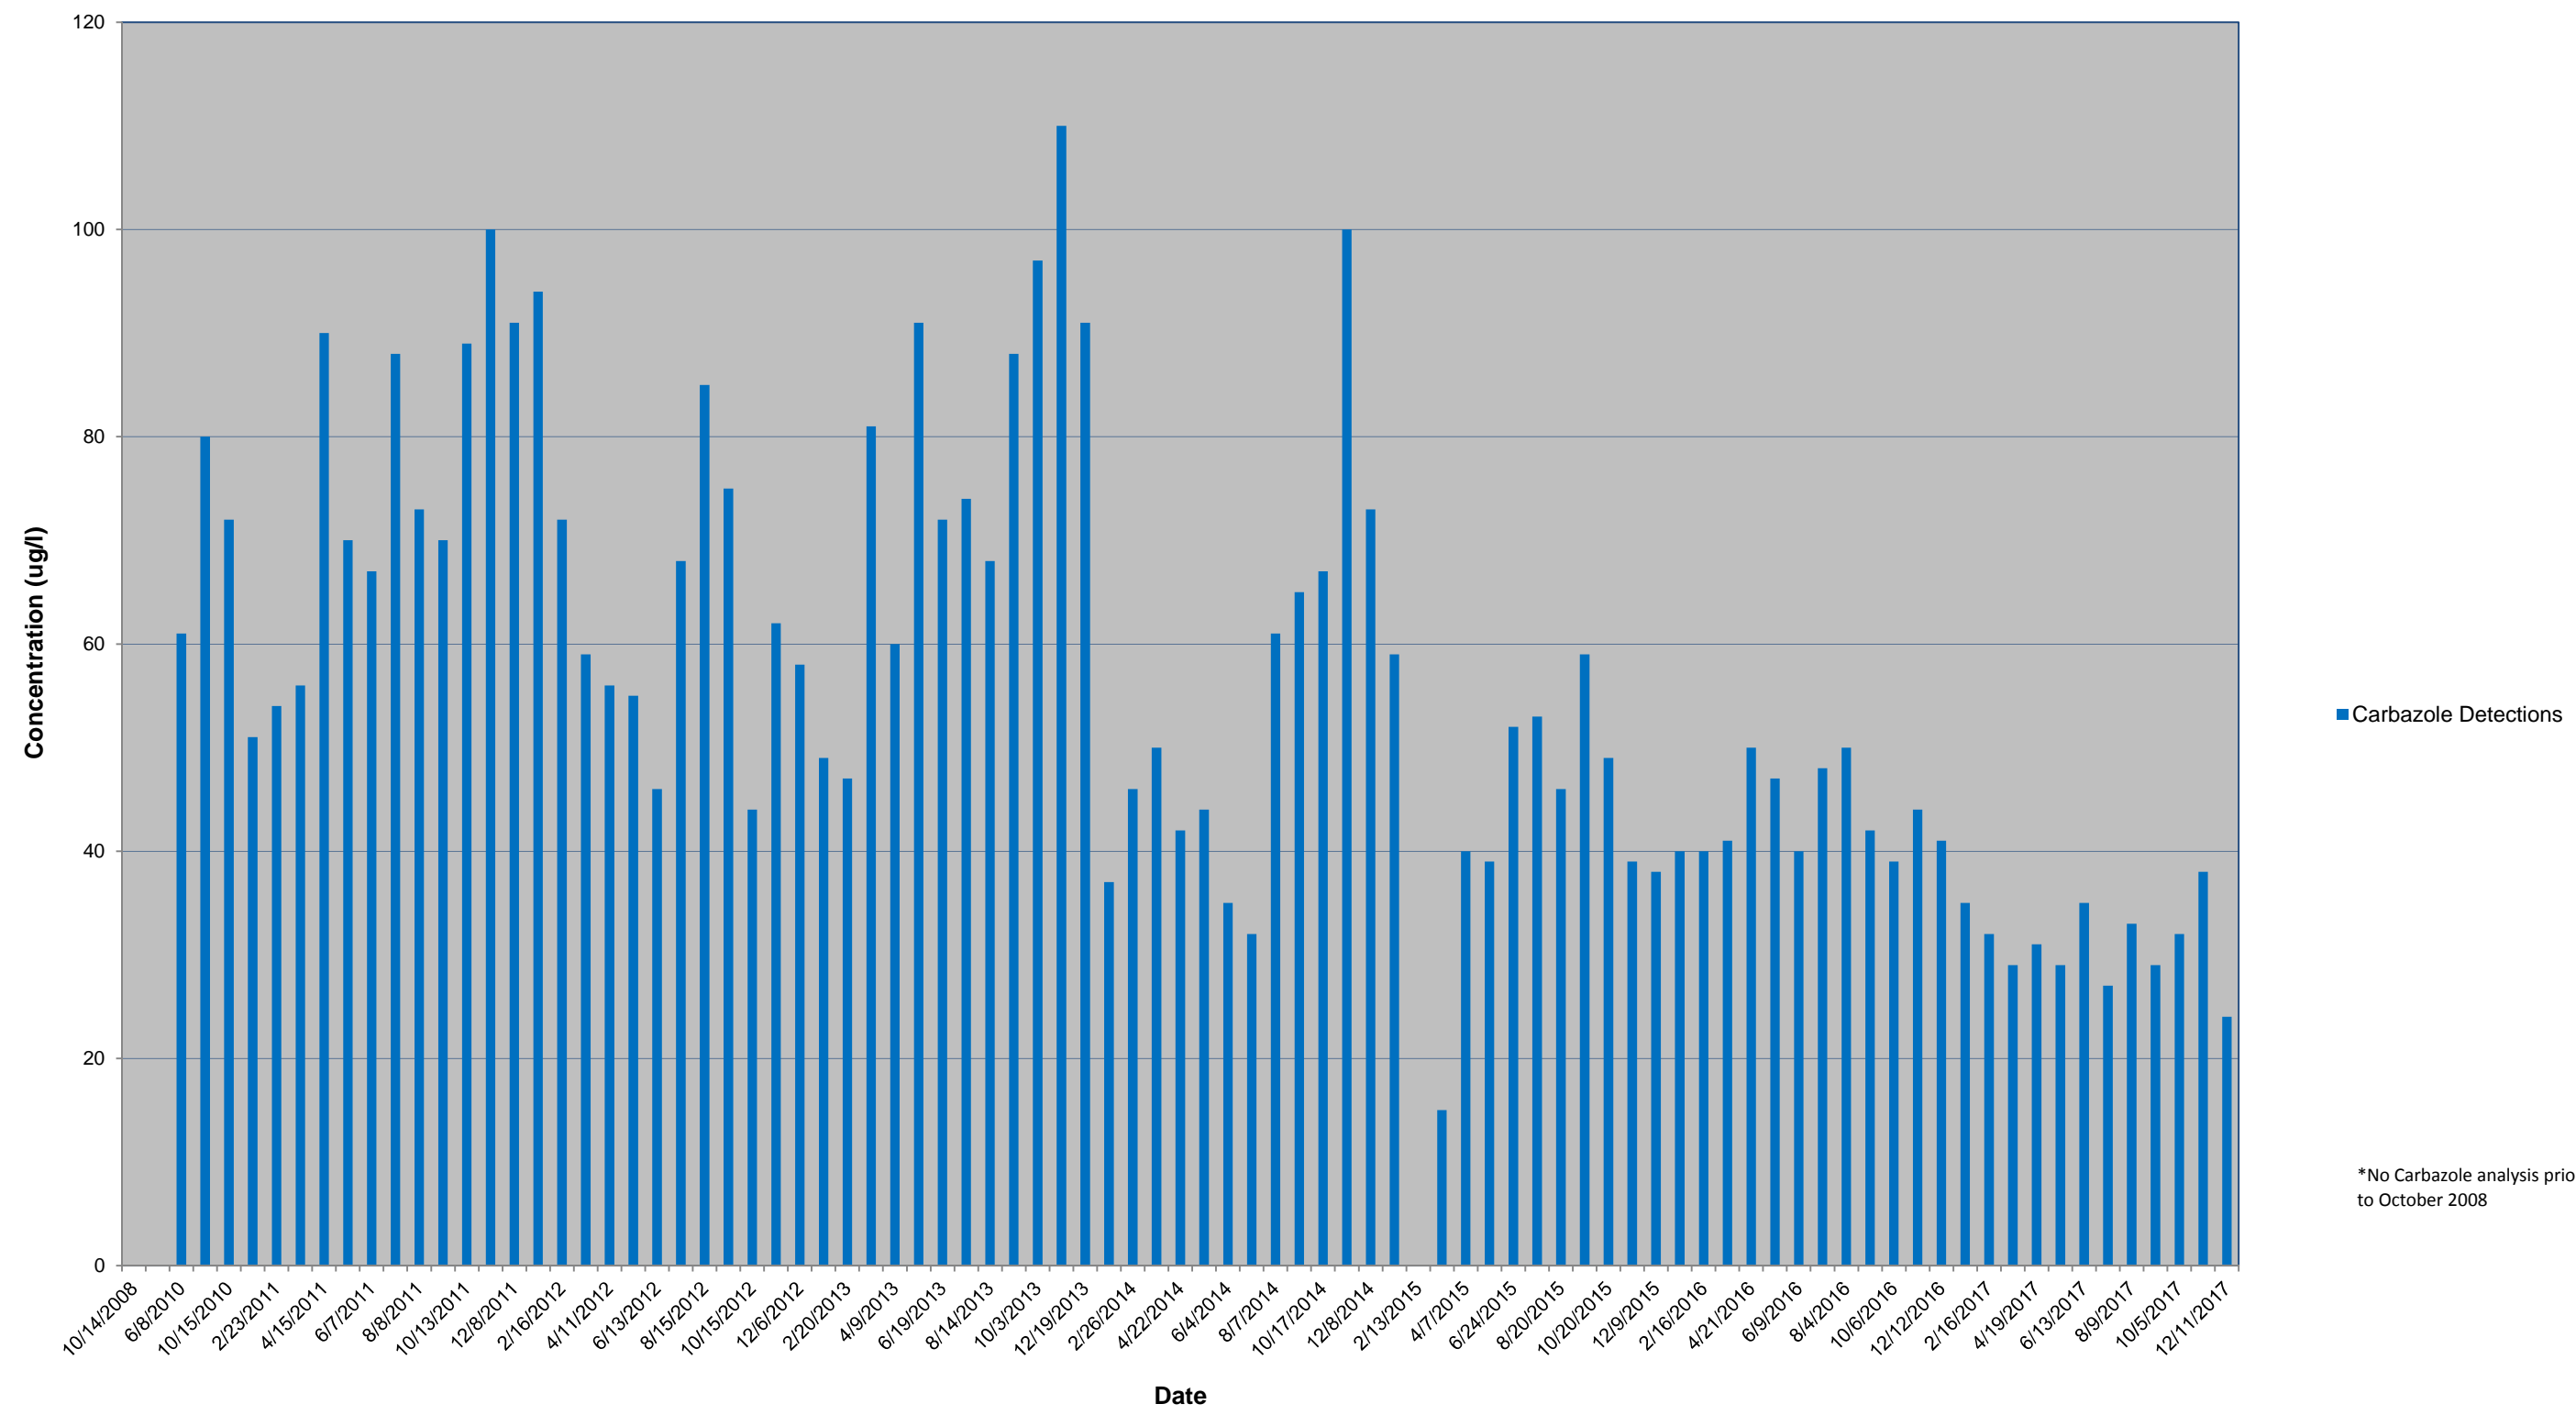
Carbazole Detections in CAMU Unit 2 Leachate Samples
2008 - 2017*

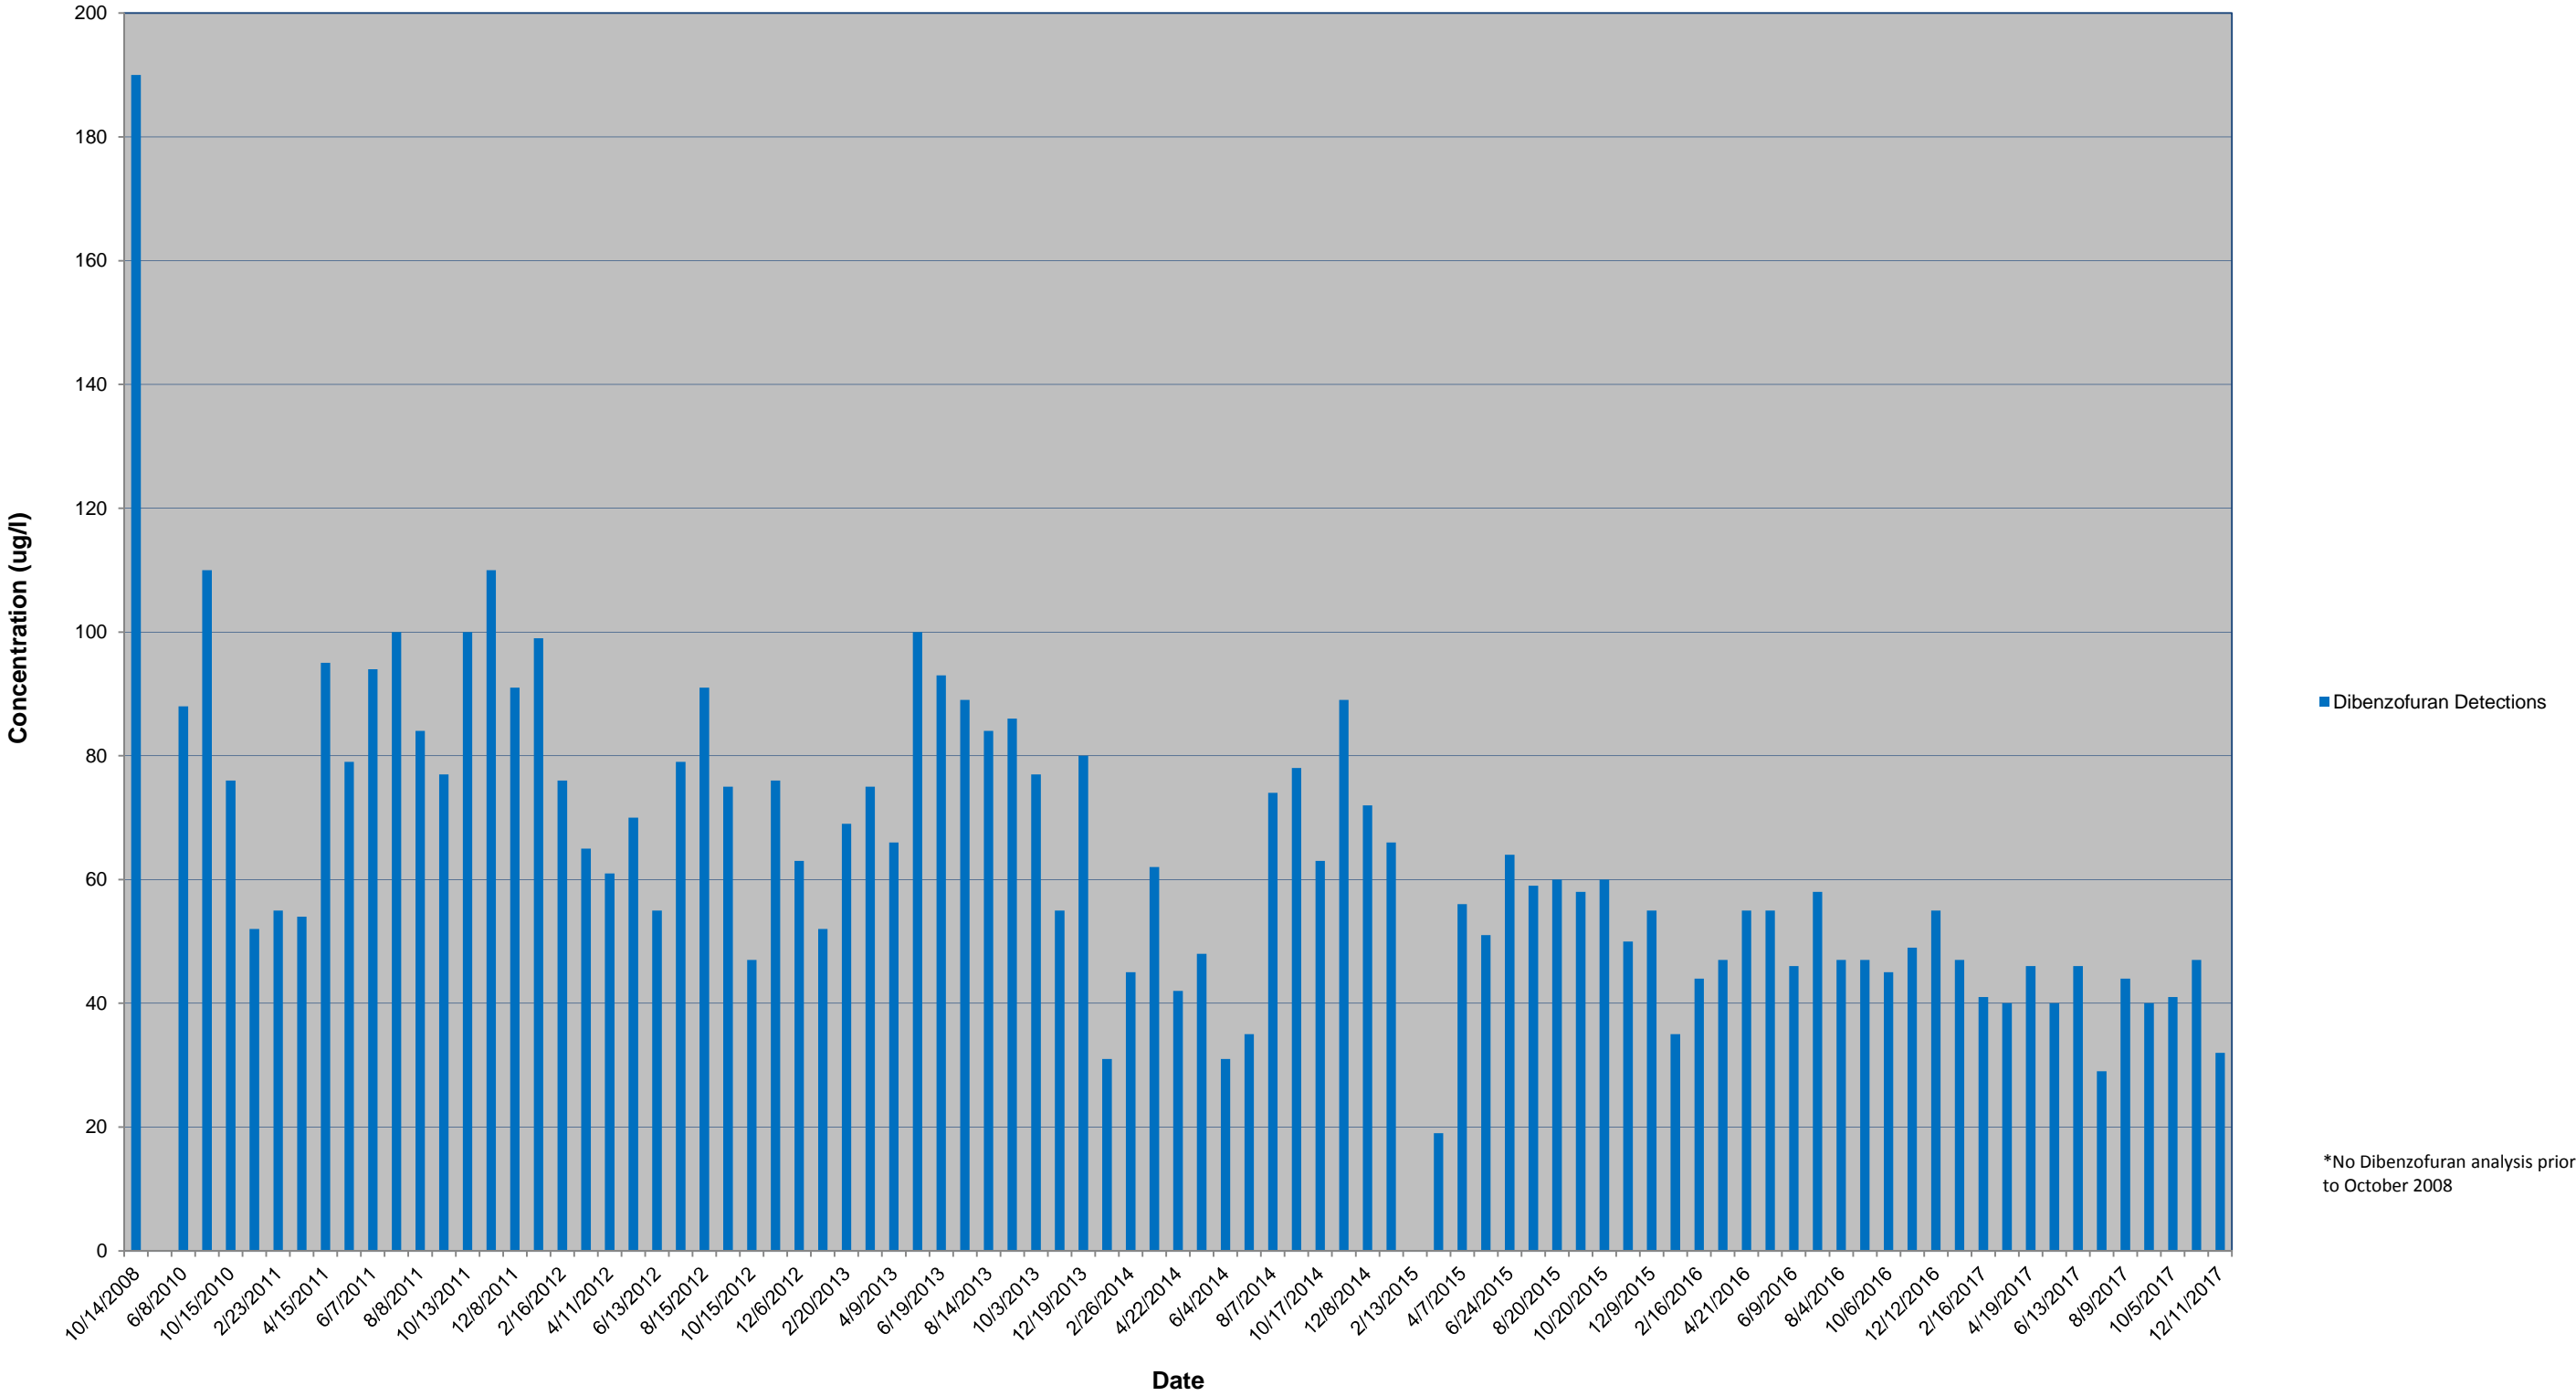
Dibenzofuran Detections in CAMU Unit 2 Leachate Samples
2008 - 2017*
