2,4-Dimethylphenol Detections in CAMU Unit 2 Leachate
2008 - 2017*

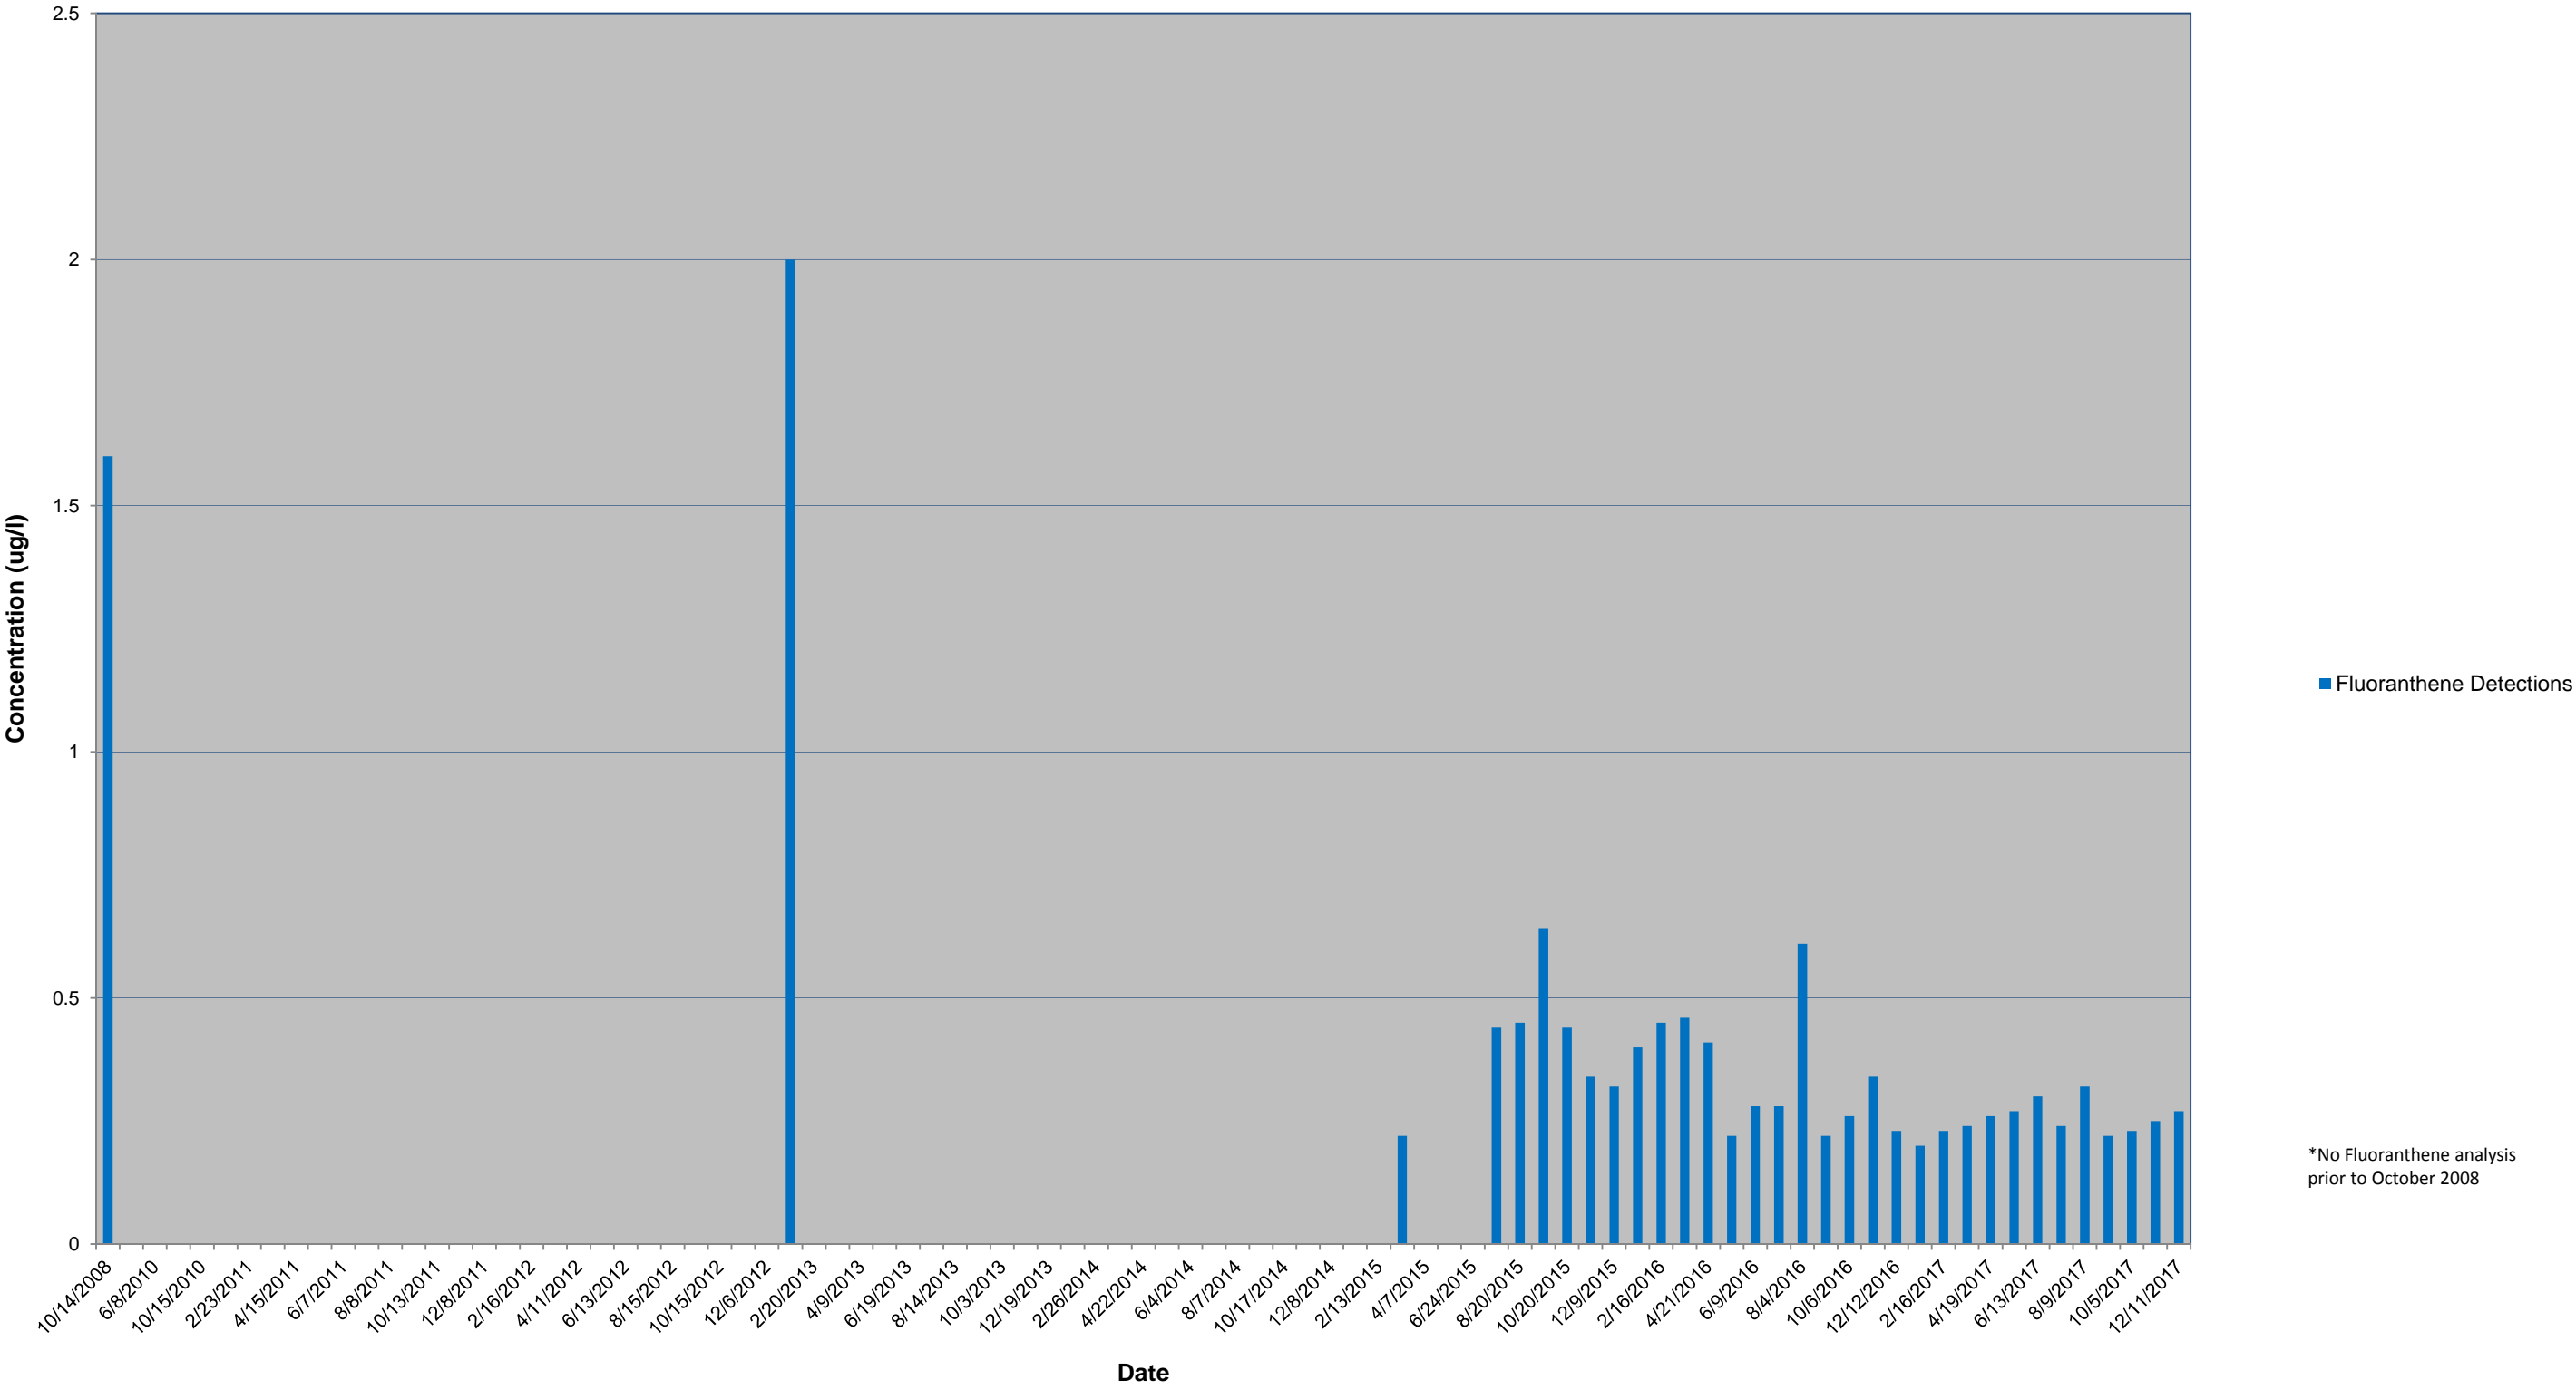
Fluoranthene Detections in CAMU Unit 2 Leachate Samples
2008 - 2017*

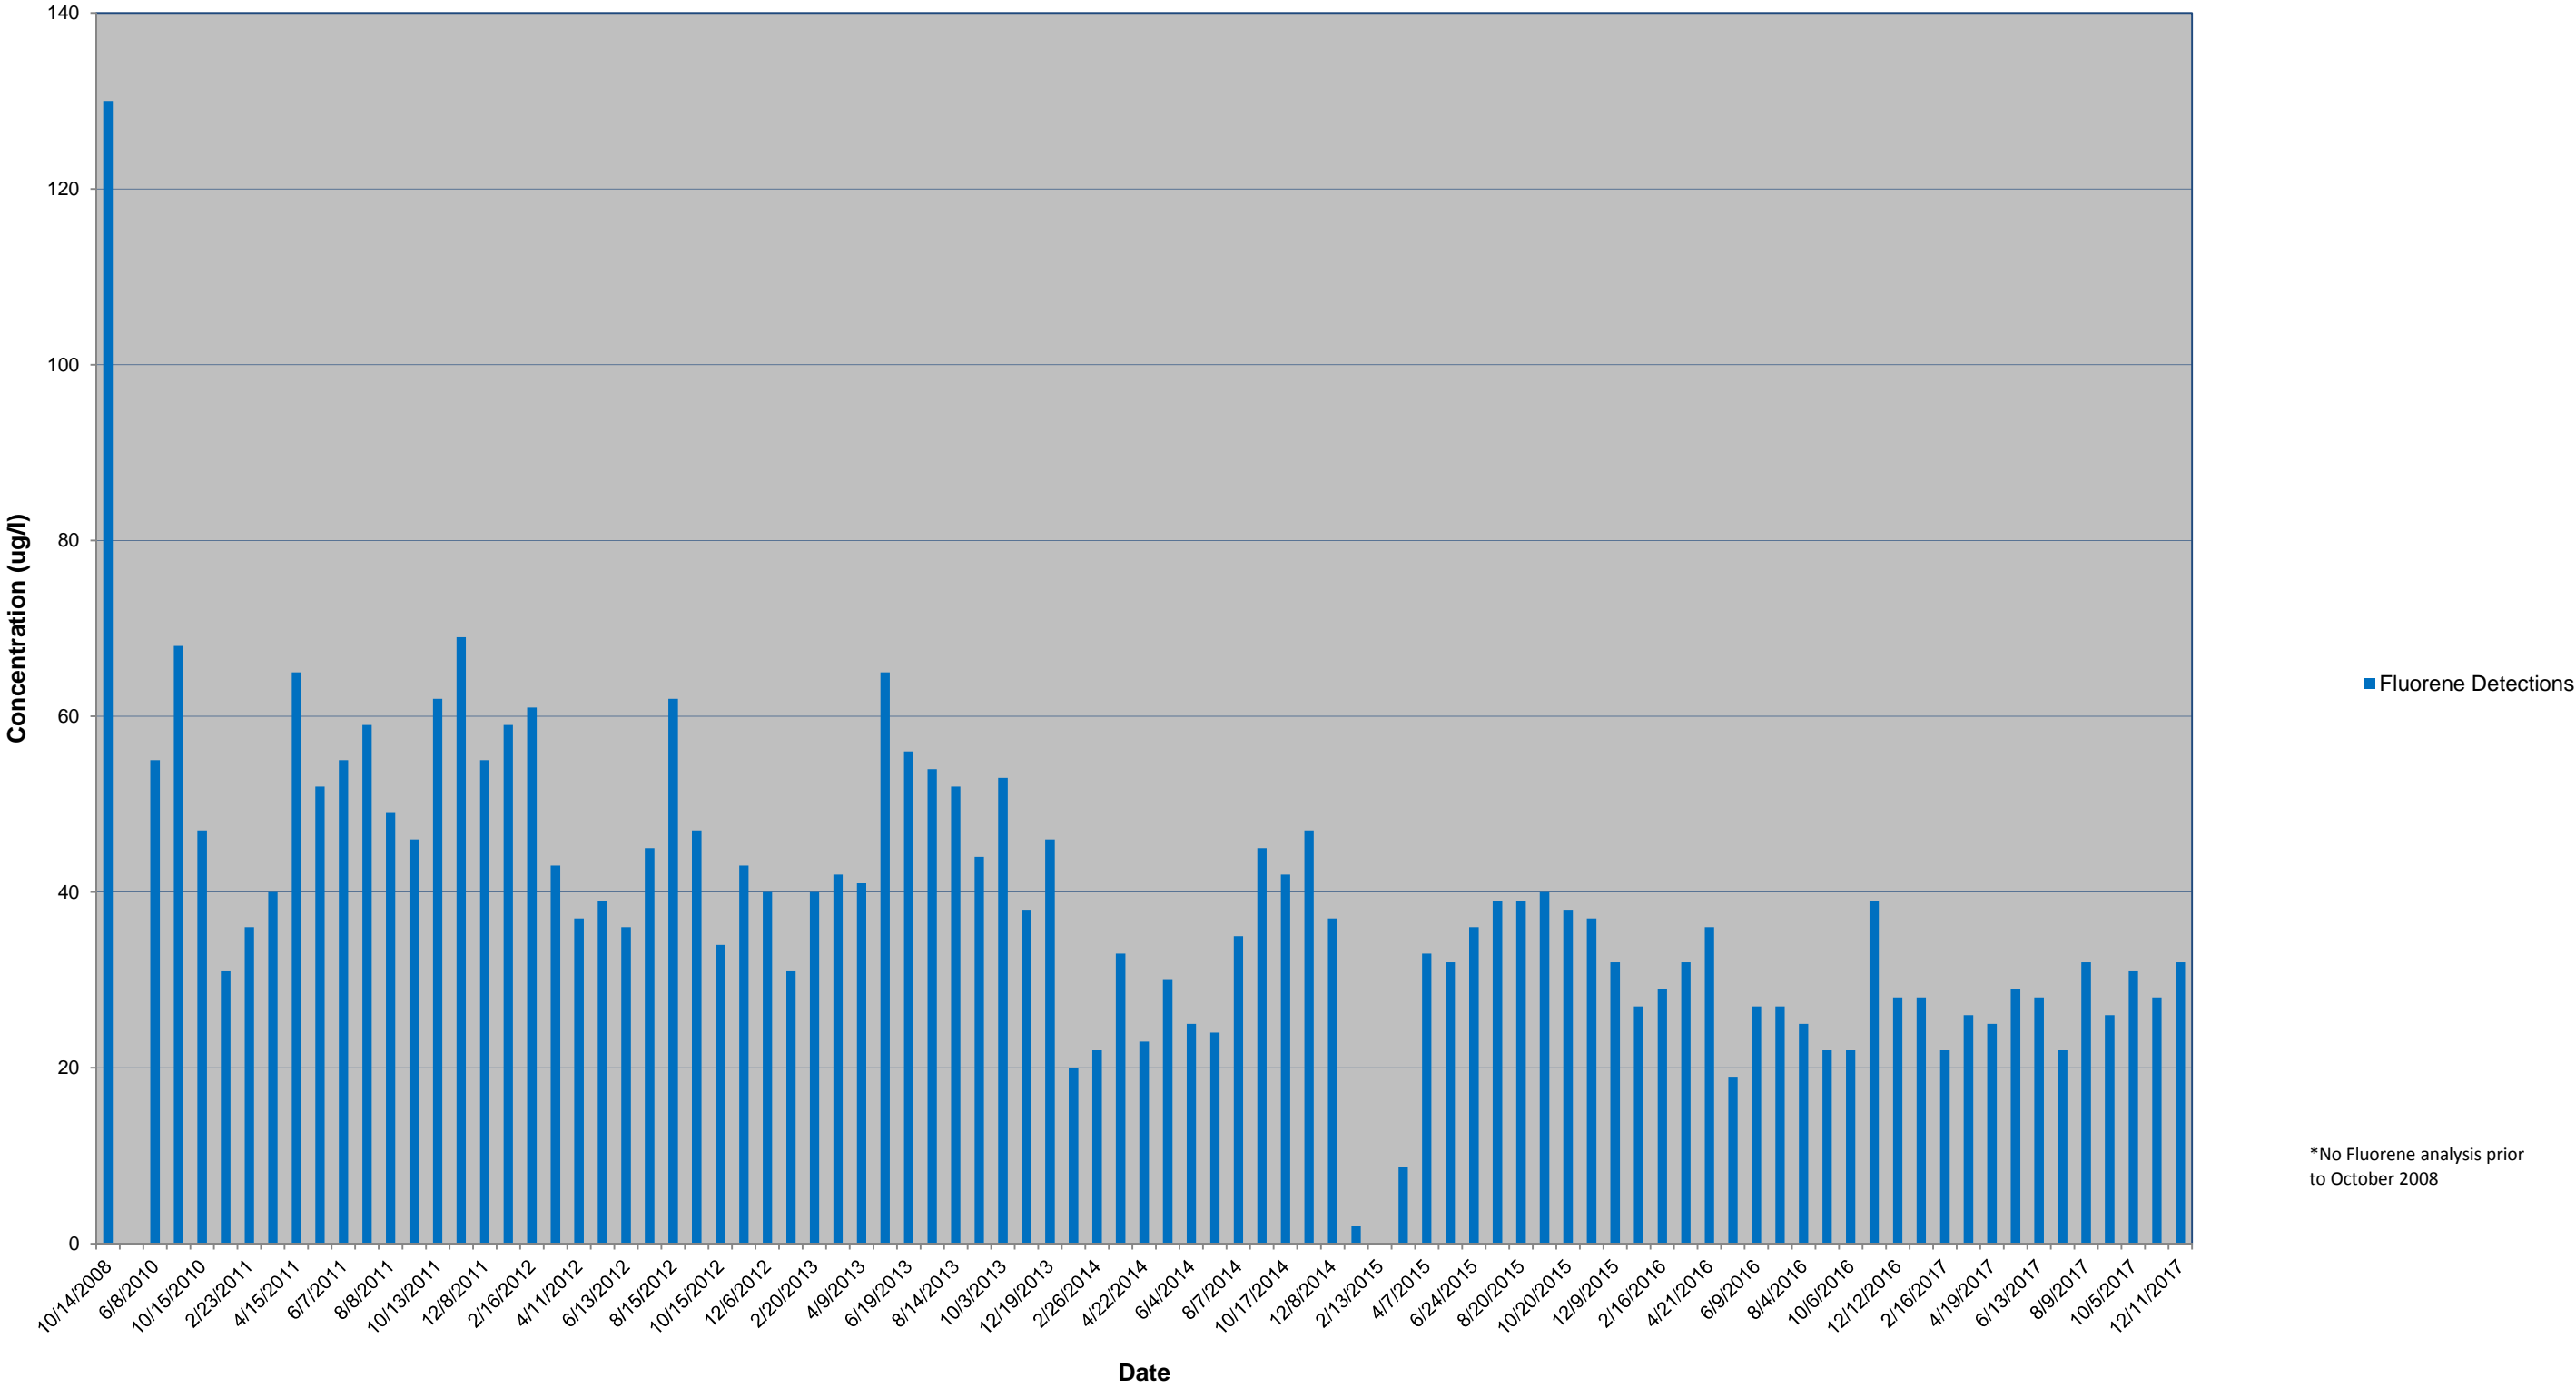
Fluorene Detections in CAMU Unit 2 Leachate Samples
2008 - 2017*

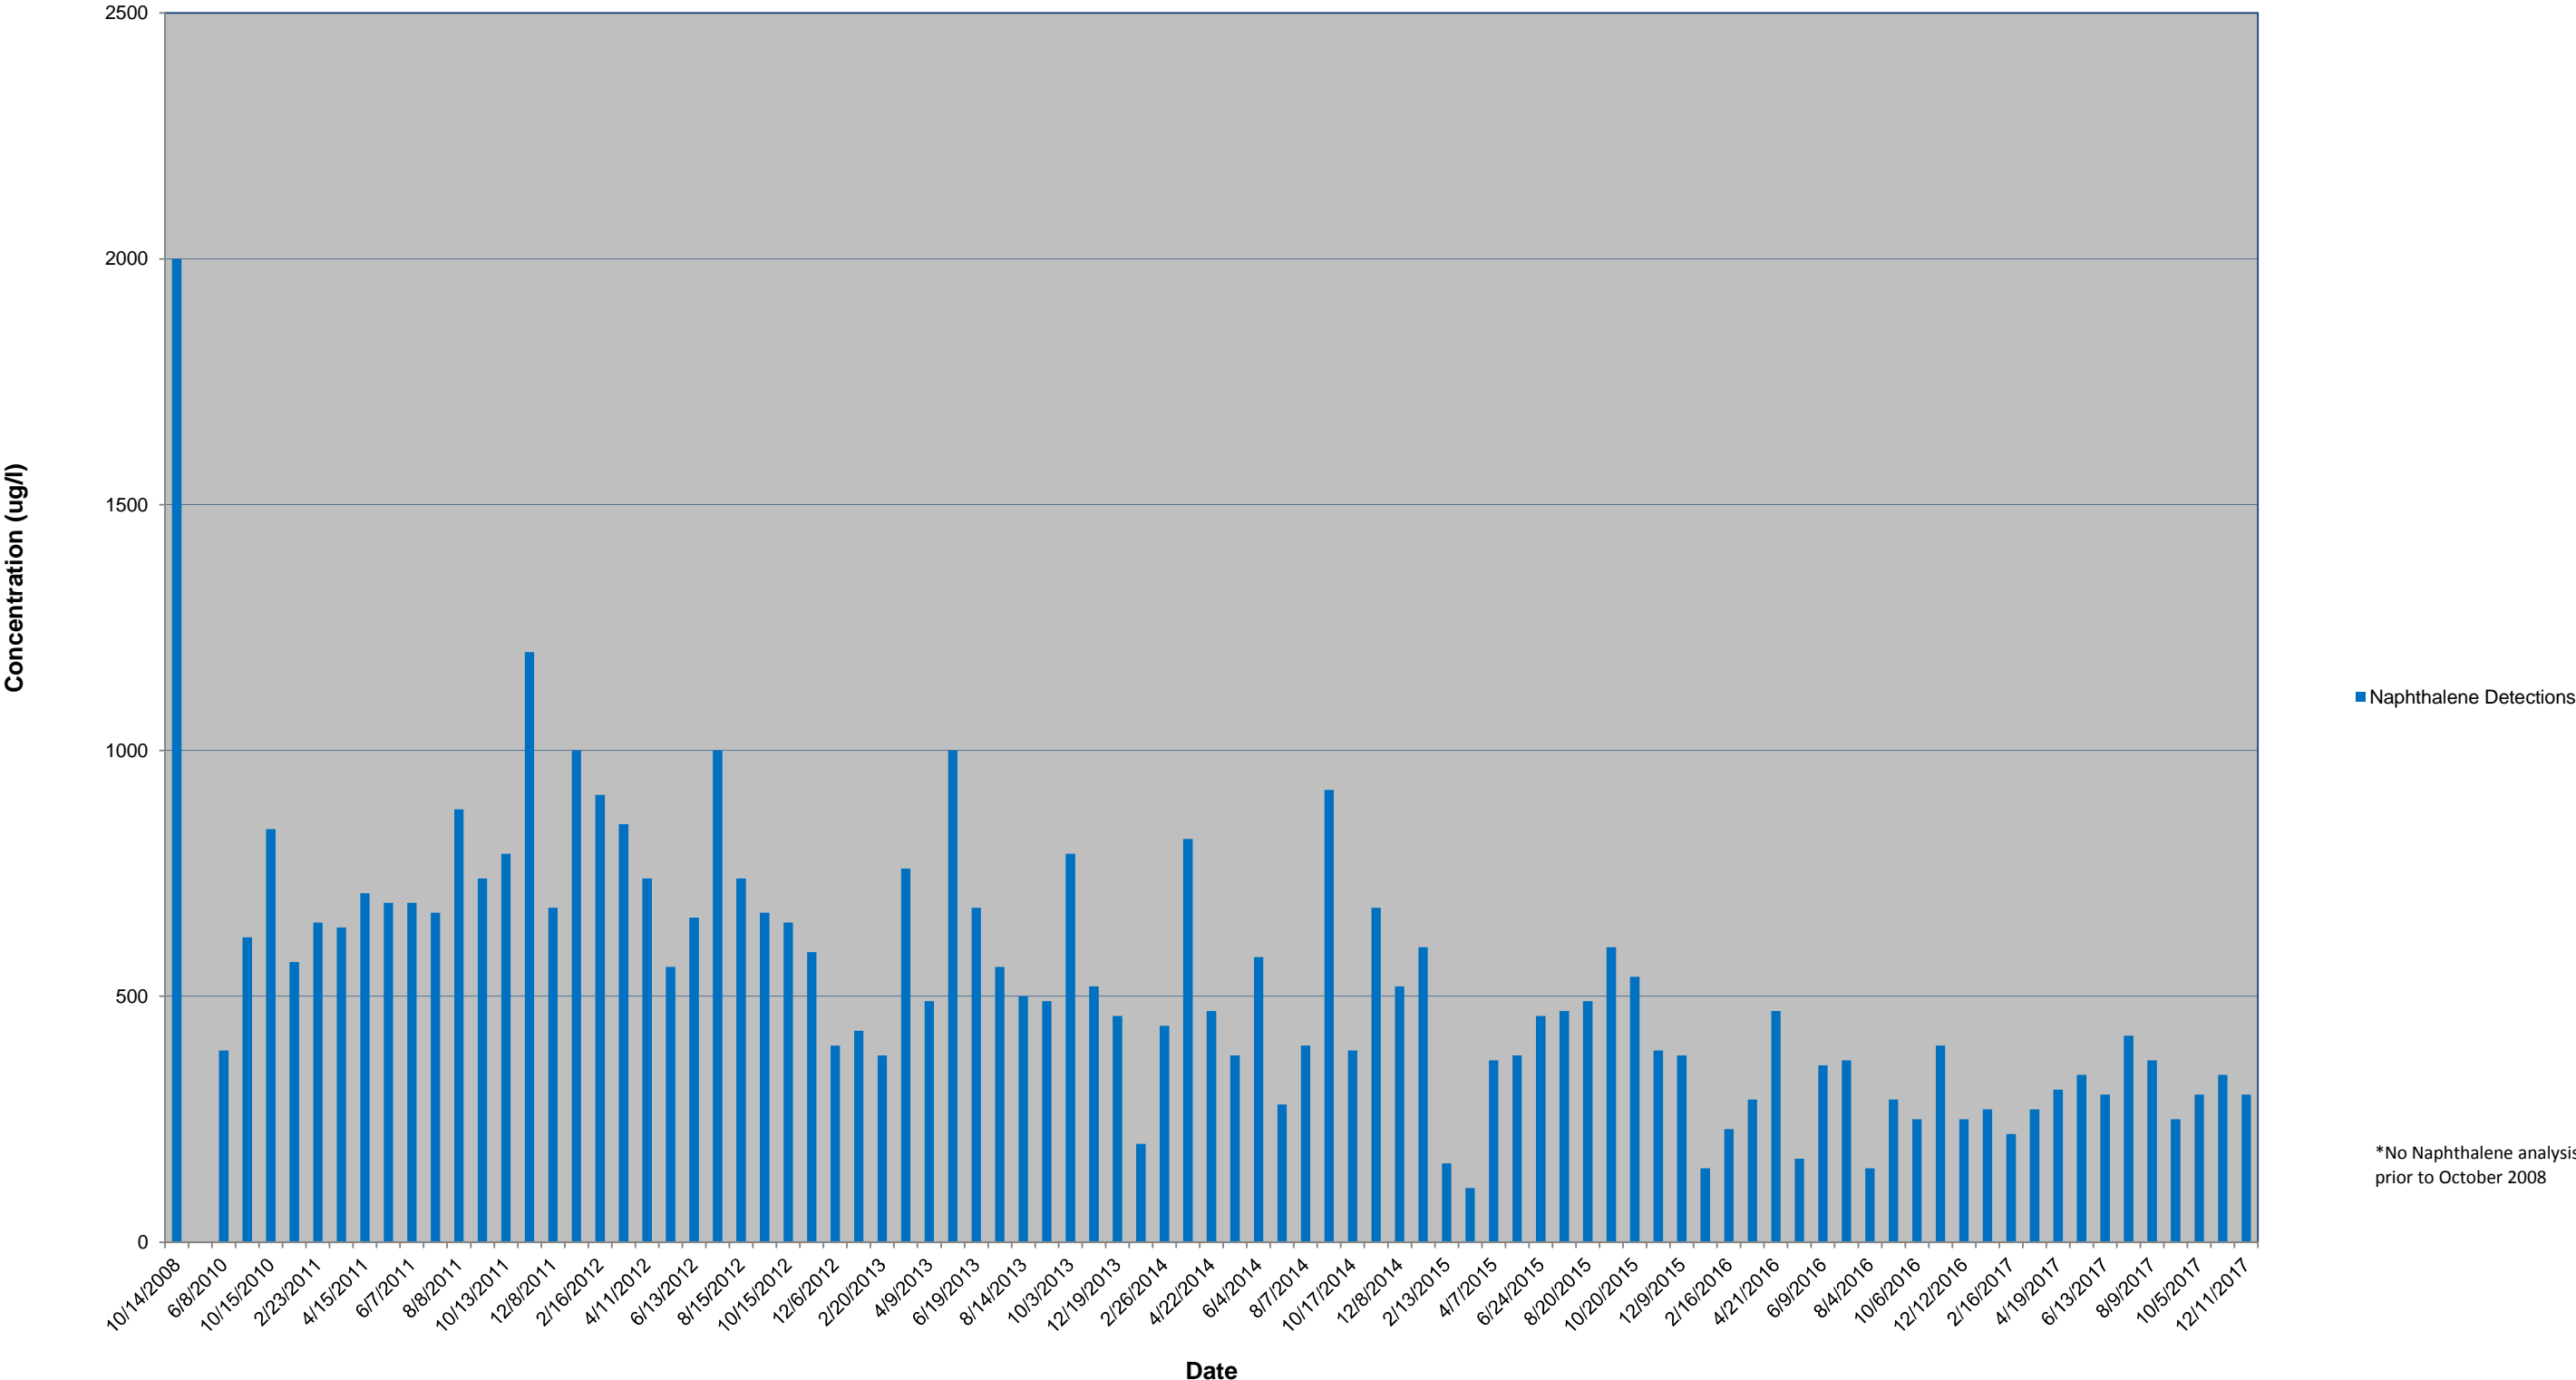
Naphthalene Detections in CAMU Unit 2 Leachate Samples
2008 - 2017*

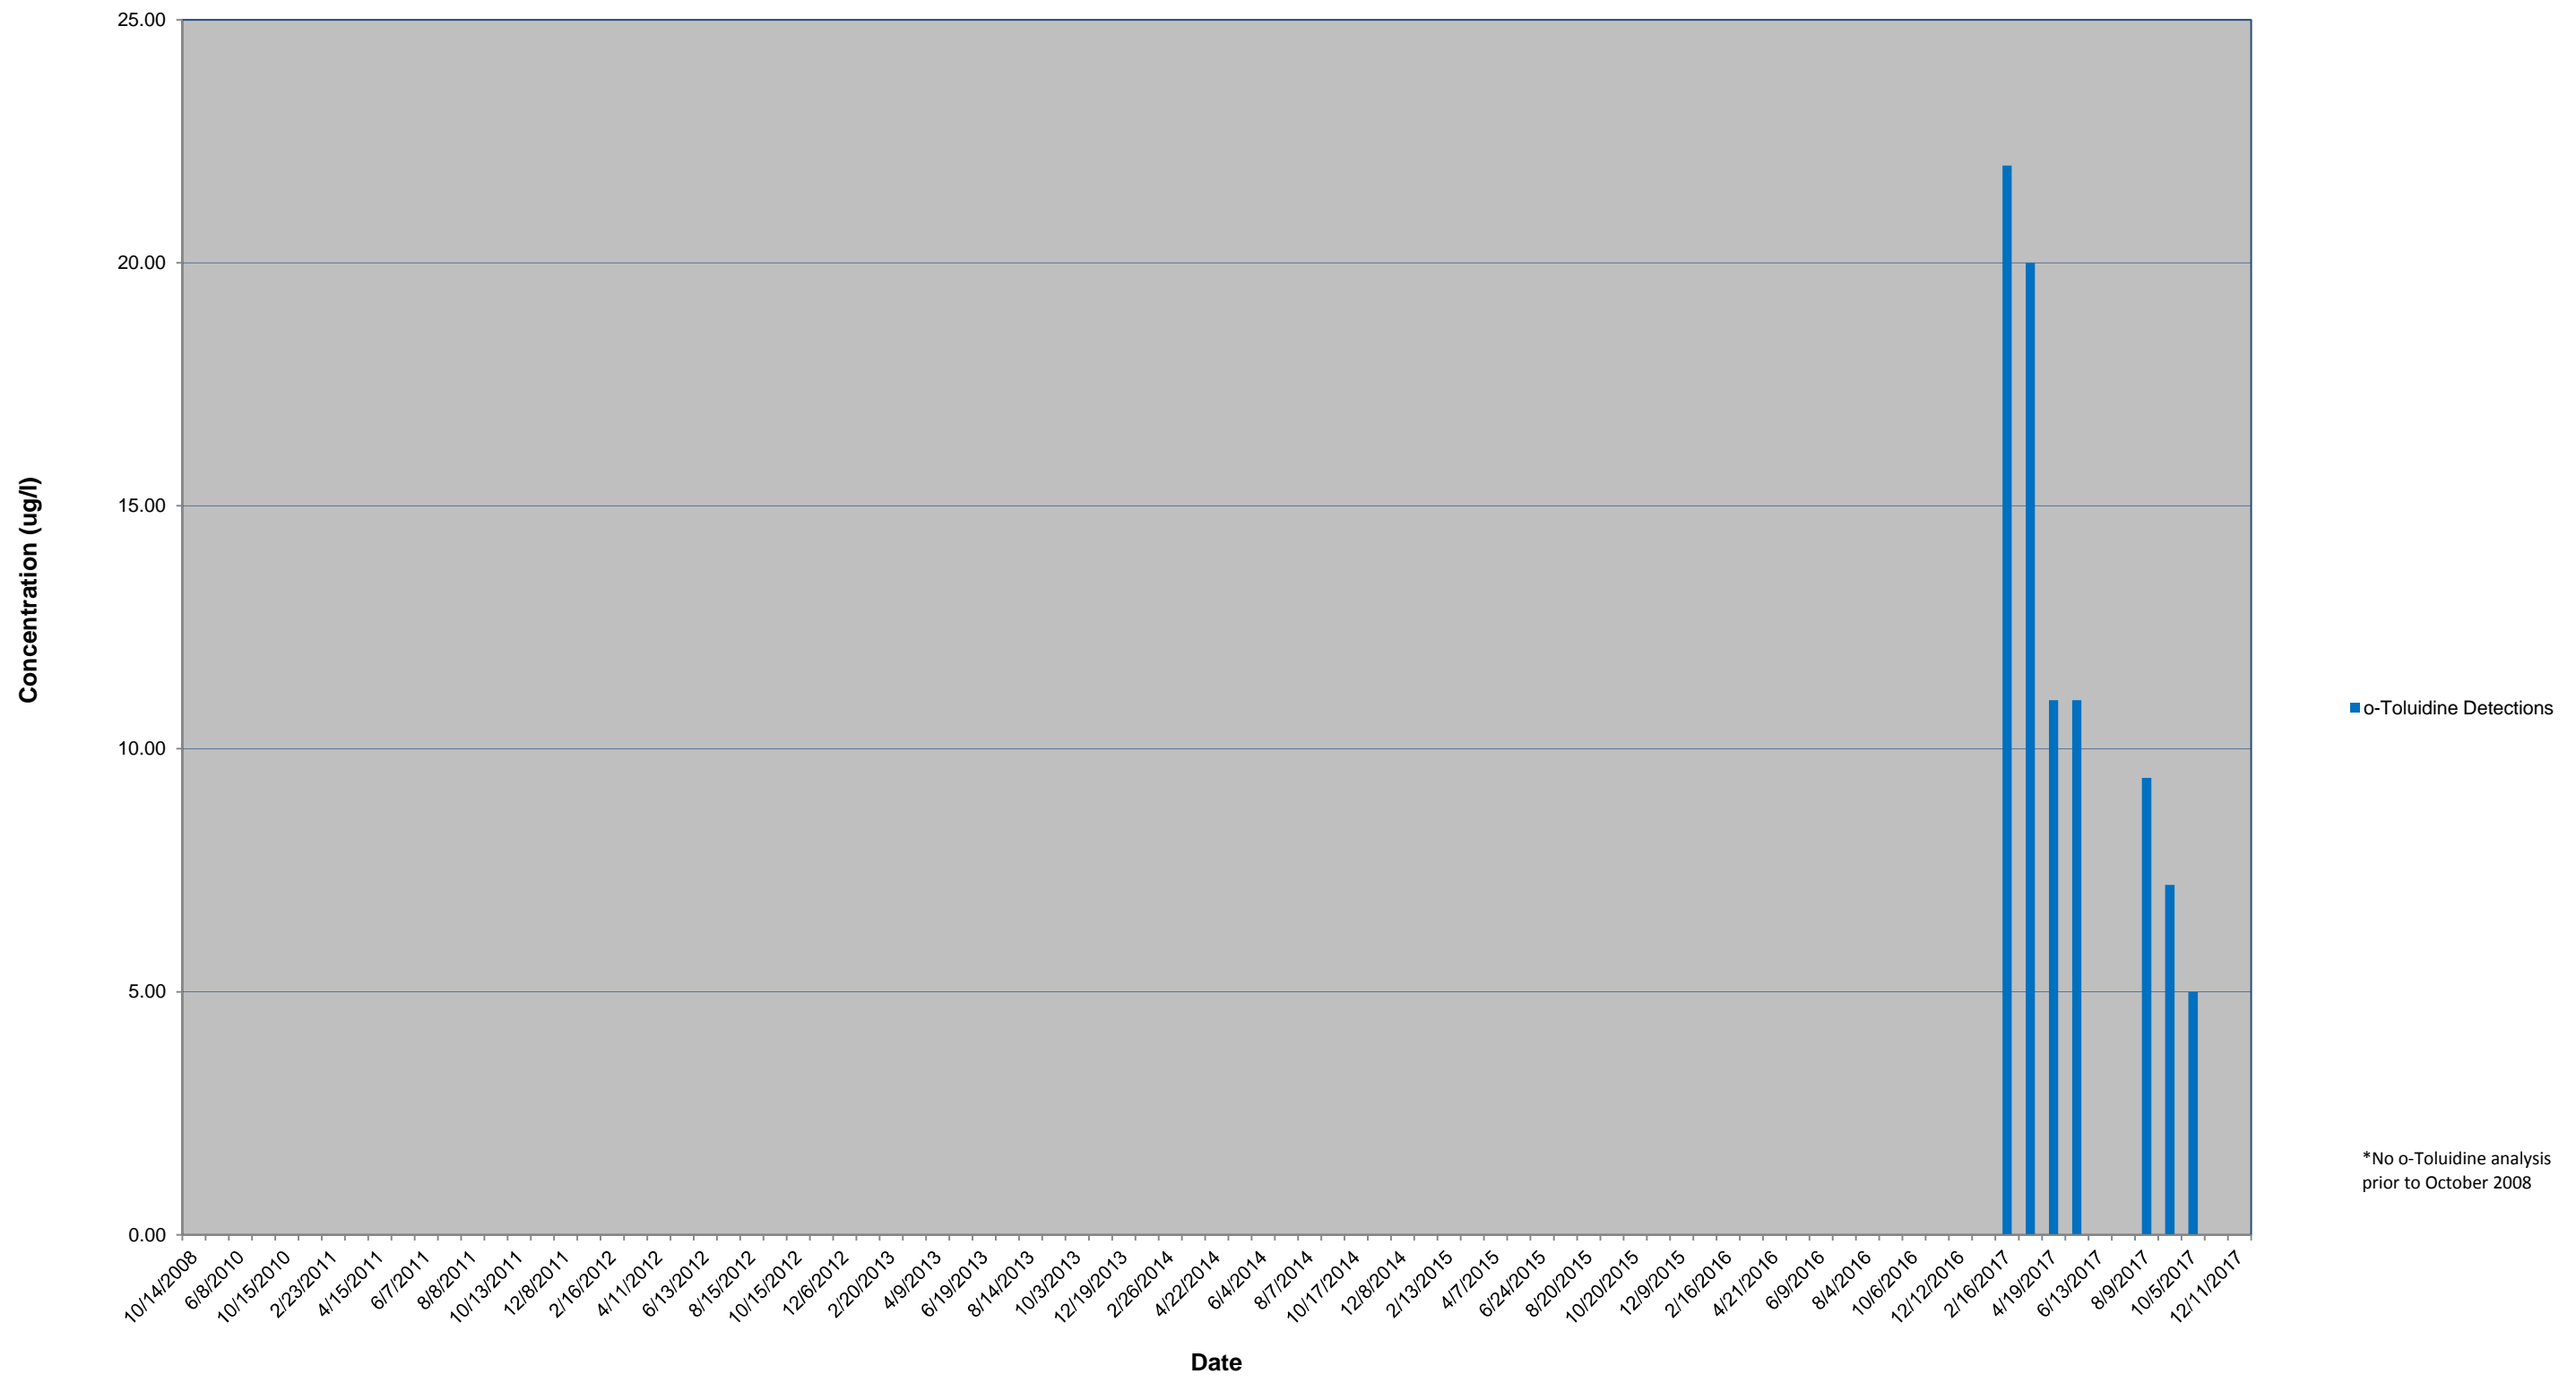
o-Toluidine Detections in CAMU Unit 2 Leachate Samples
2008 - 2017*

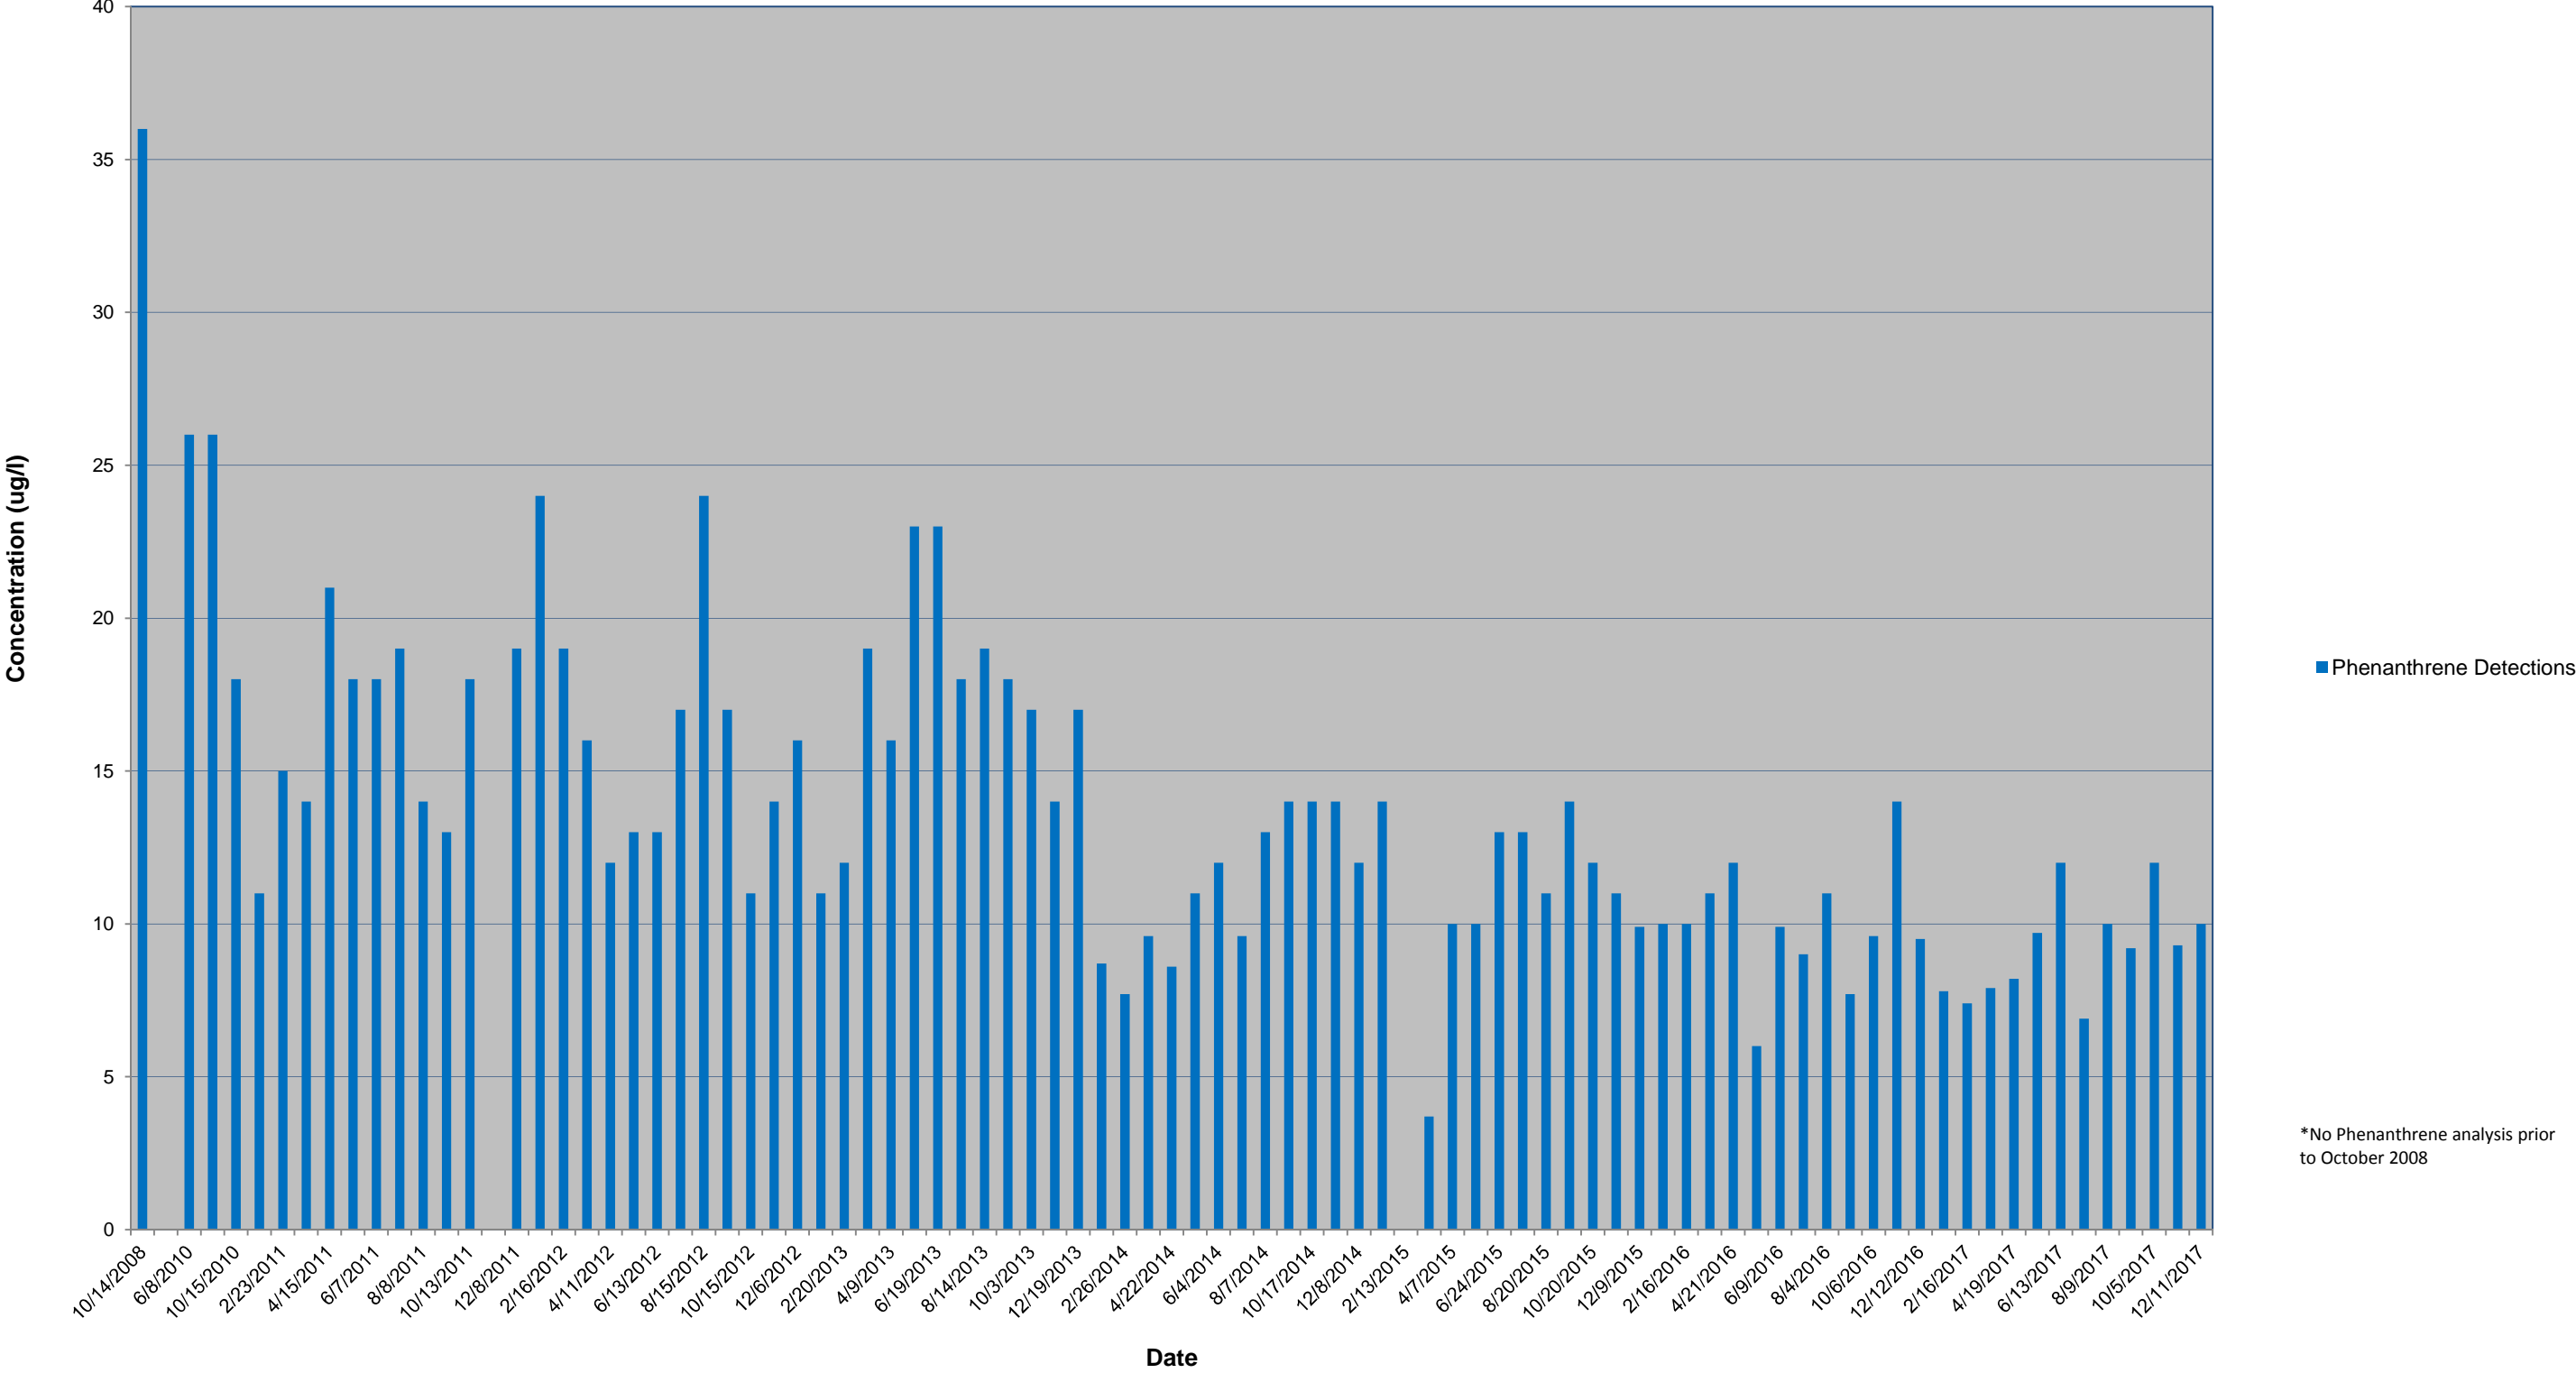
Phenanthrene Detections in CAMU Unit 2 Leachate Samples
2008 - 2017*

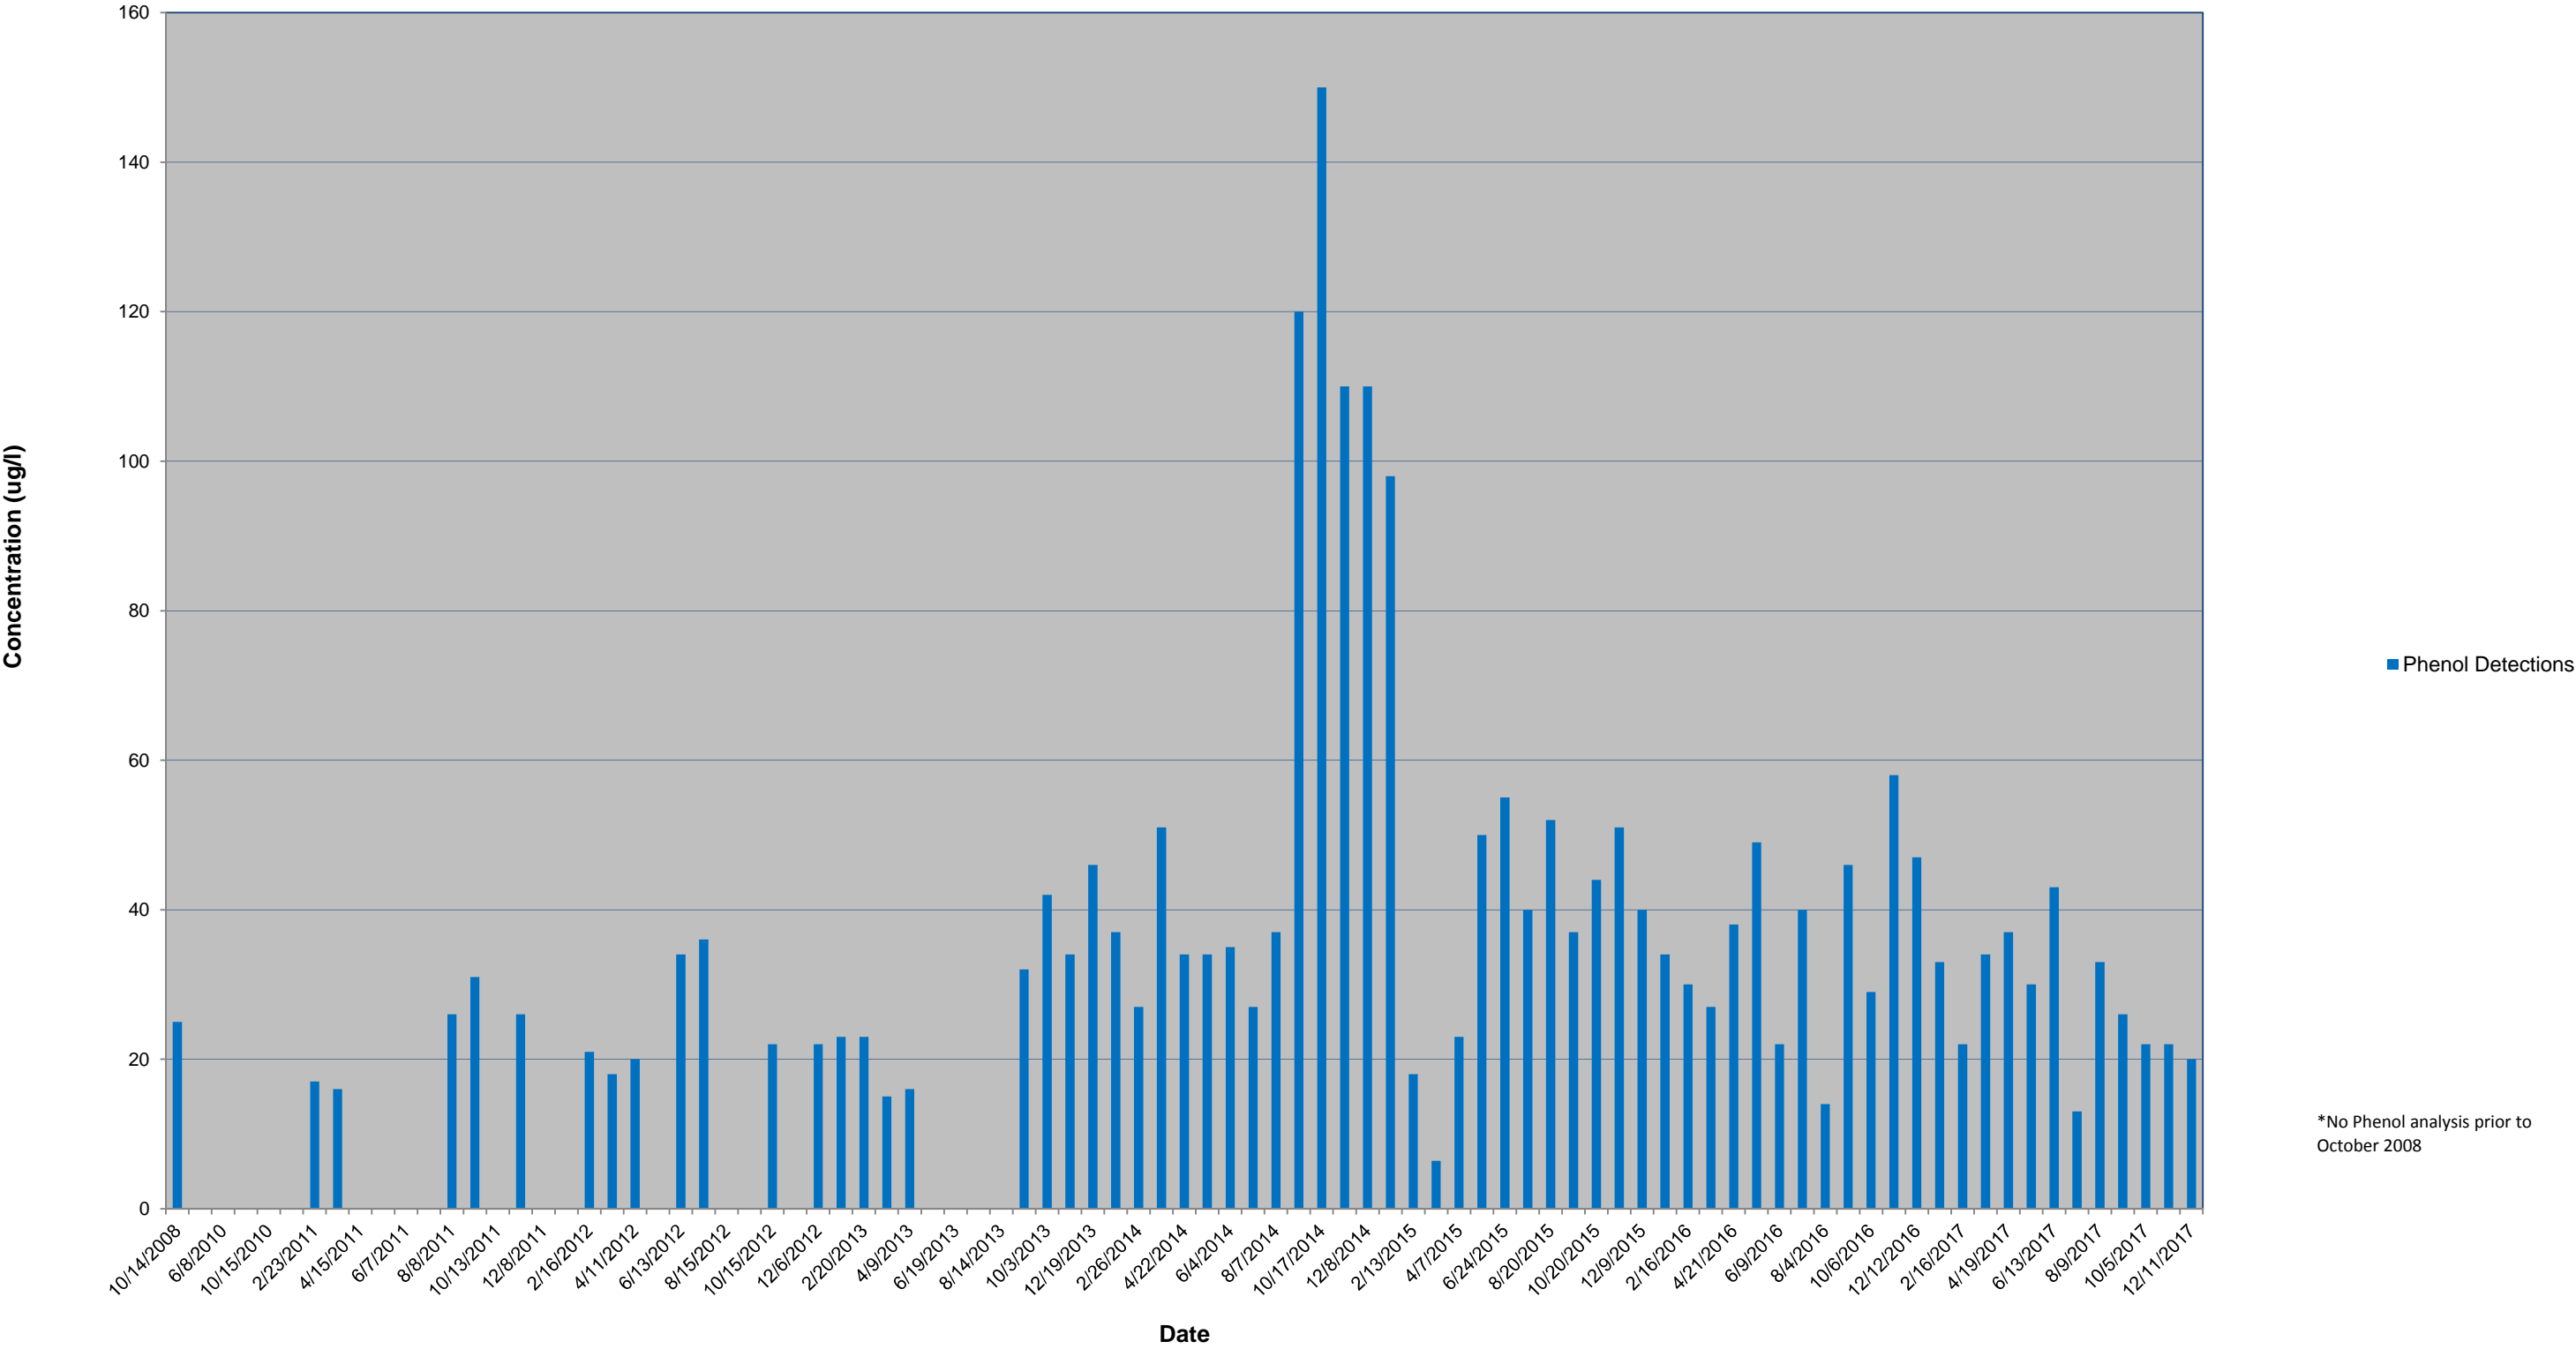
Phenol Detections in CAMU Unit 2 Leachate Samples
2008 - 2017*
