2-Butanone Detections in CAMU Unit 2 Leachate Samples
2008 - 2017*

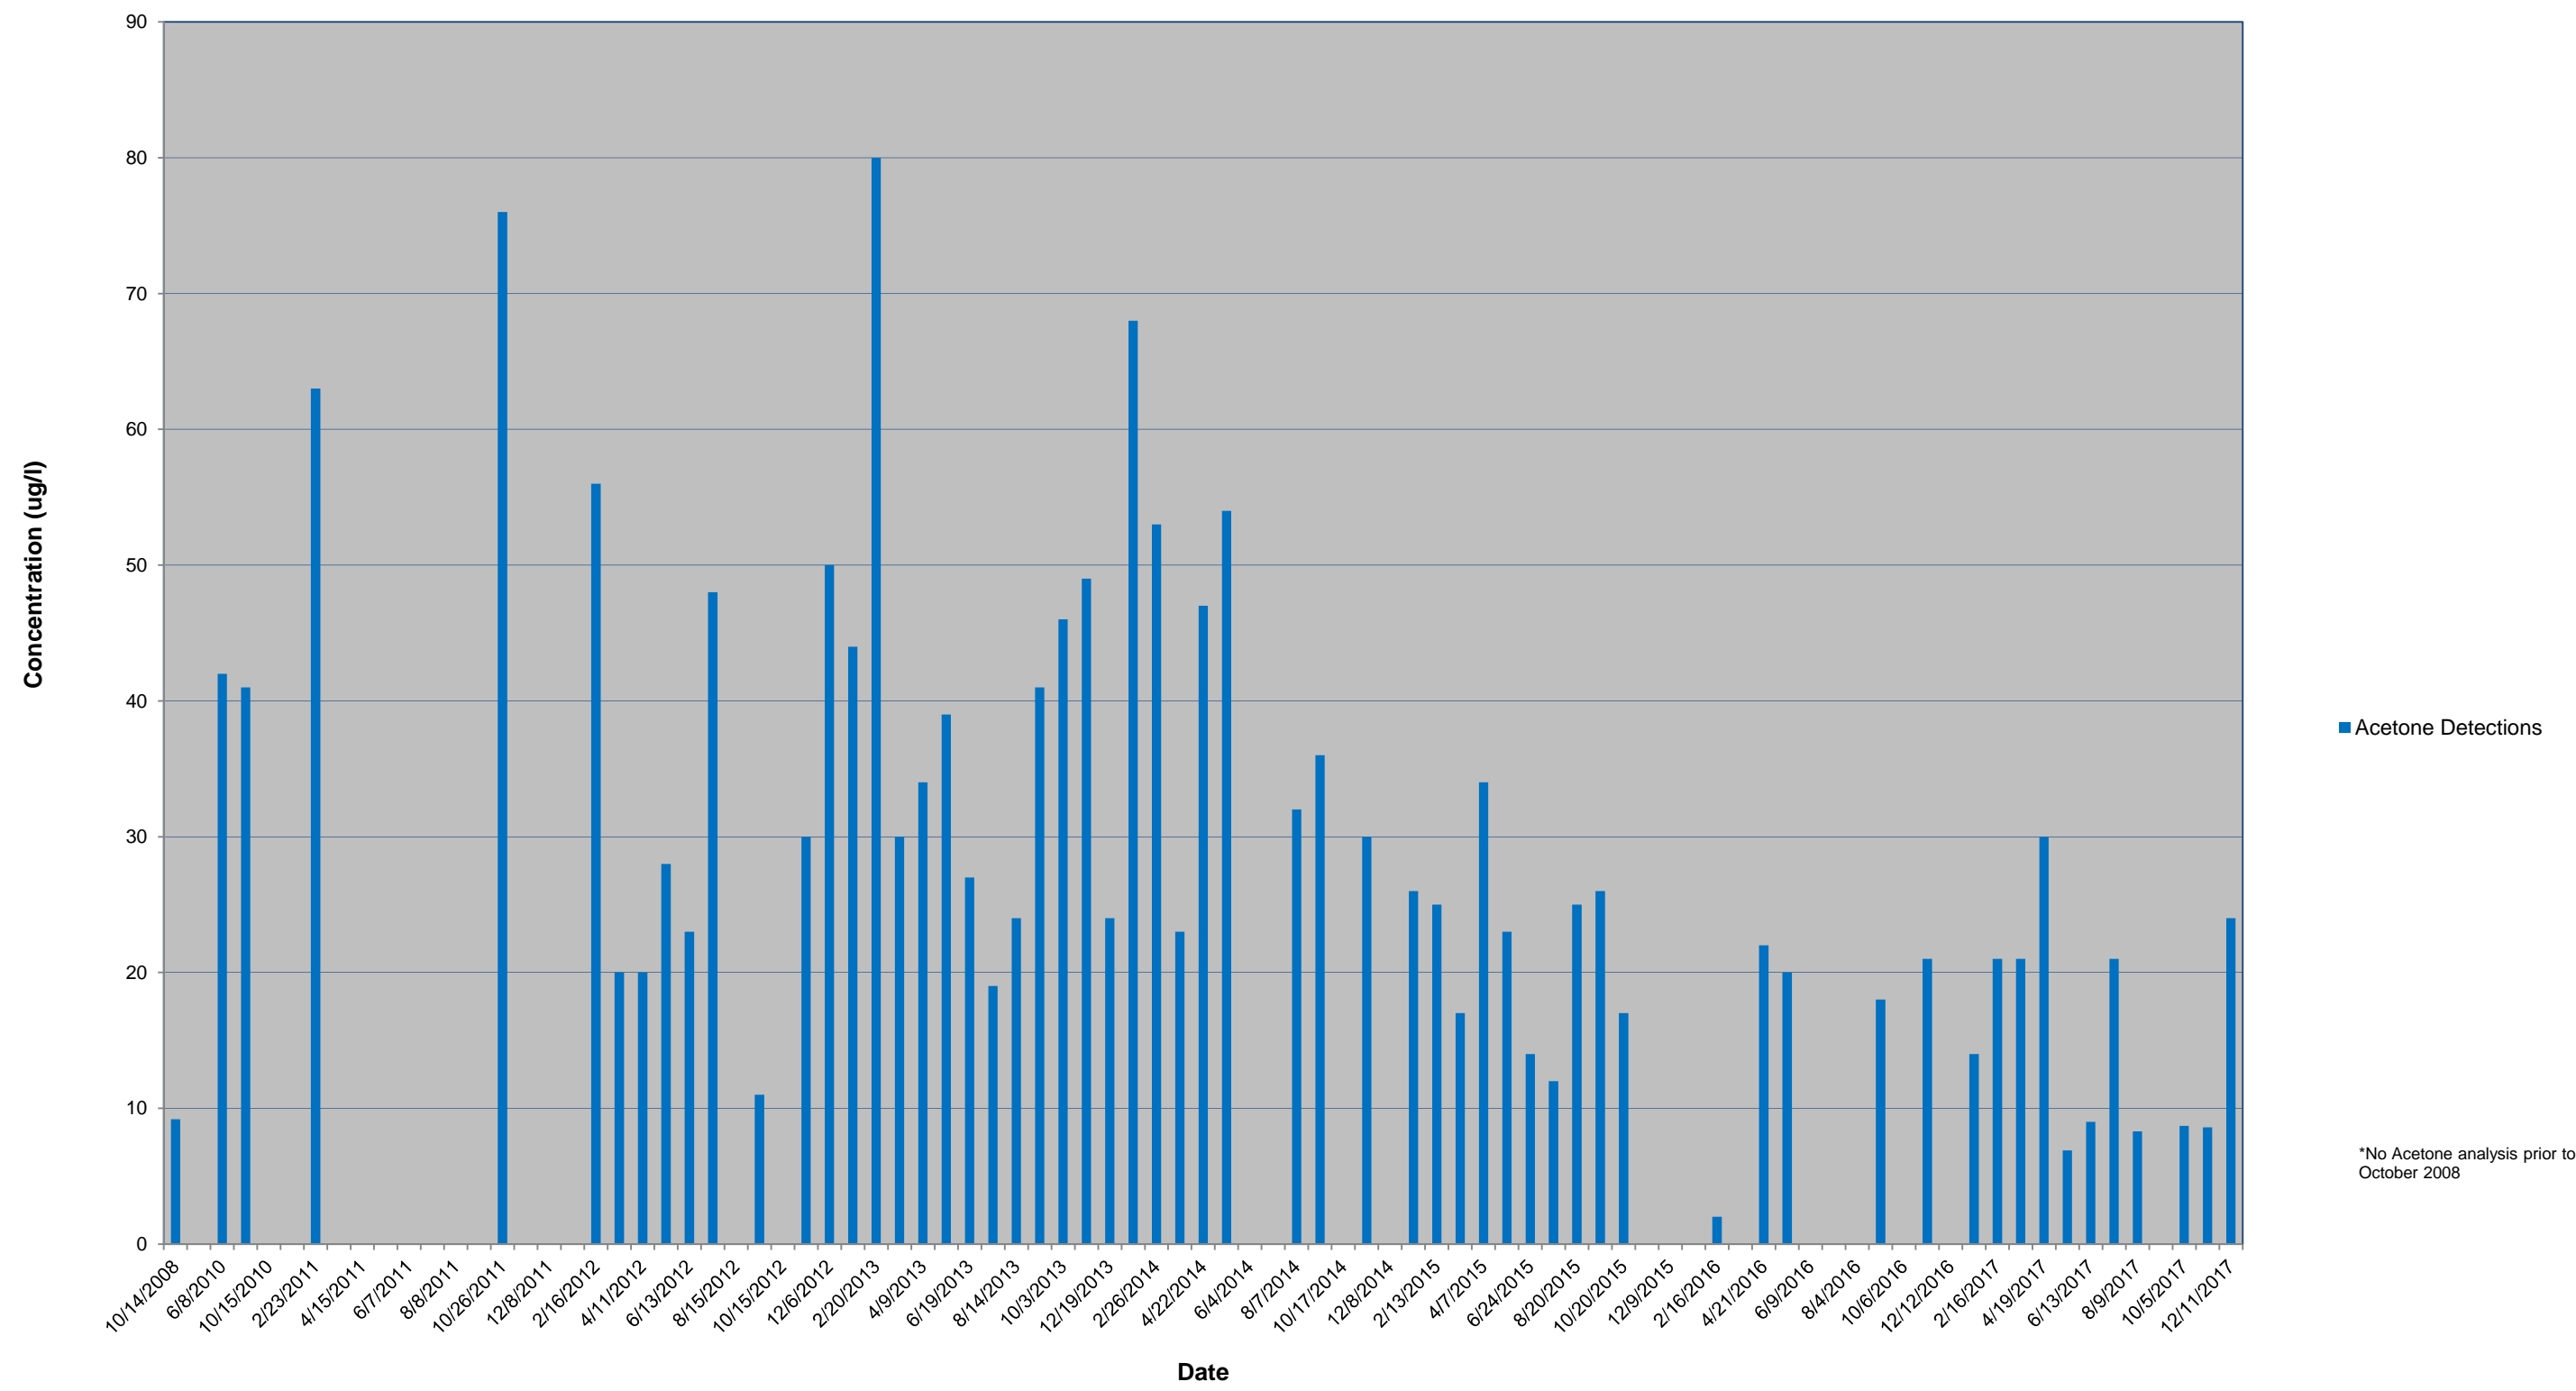
Acetone Detections in CAMU Unit 2 Leachate Samples
2008 - 2017*

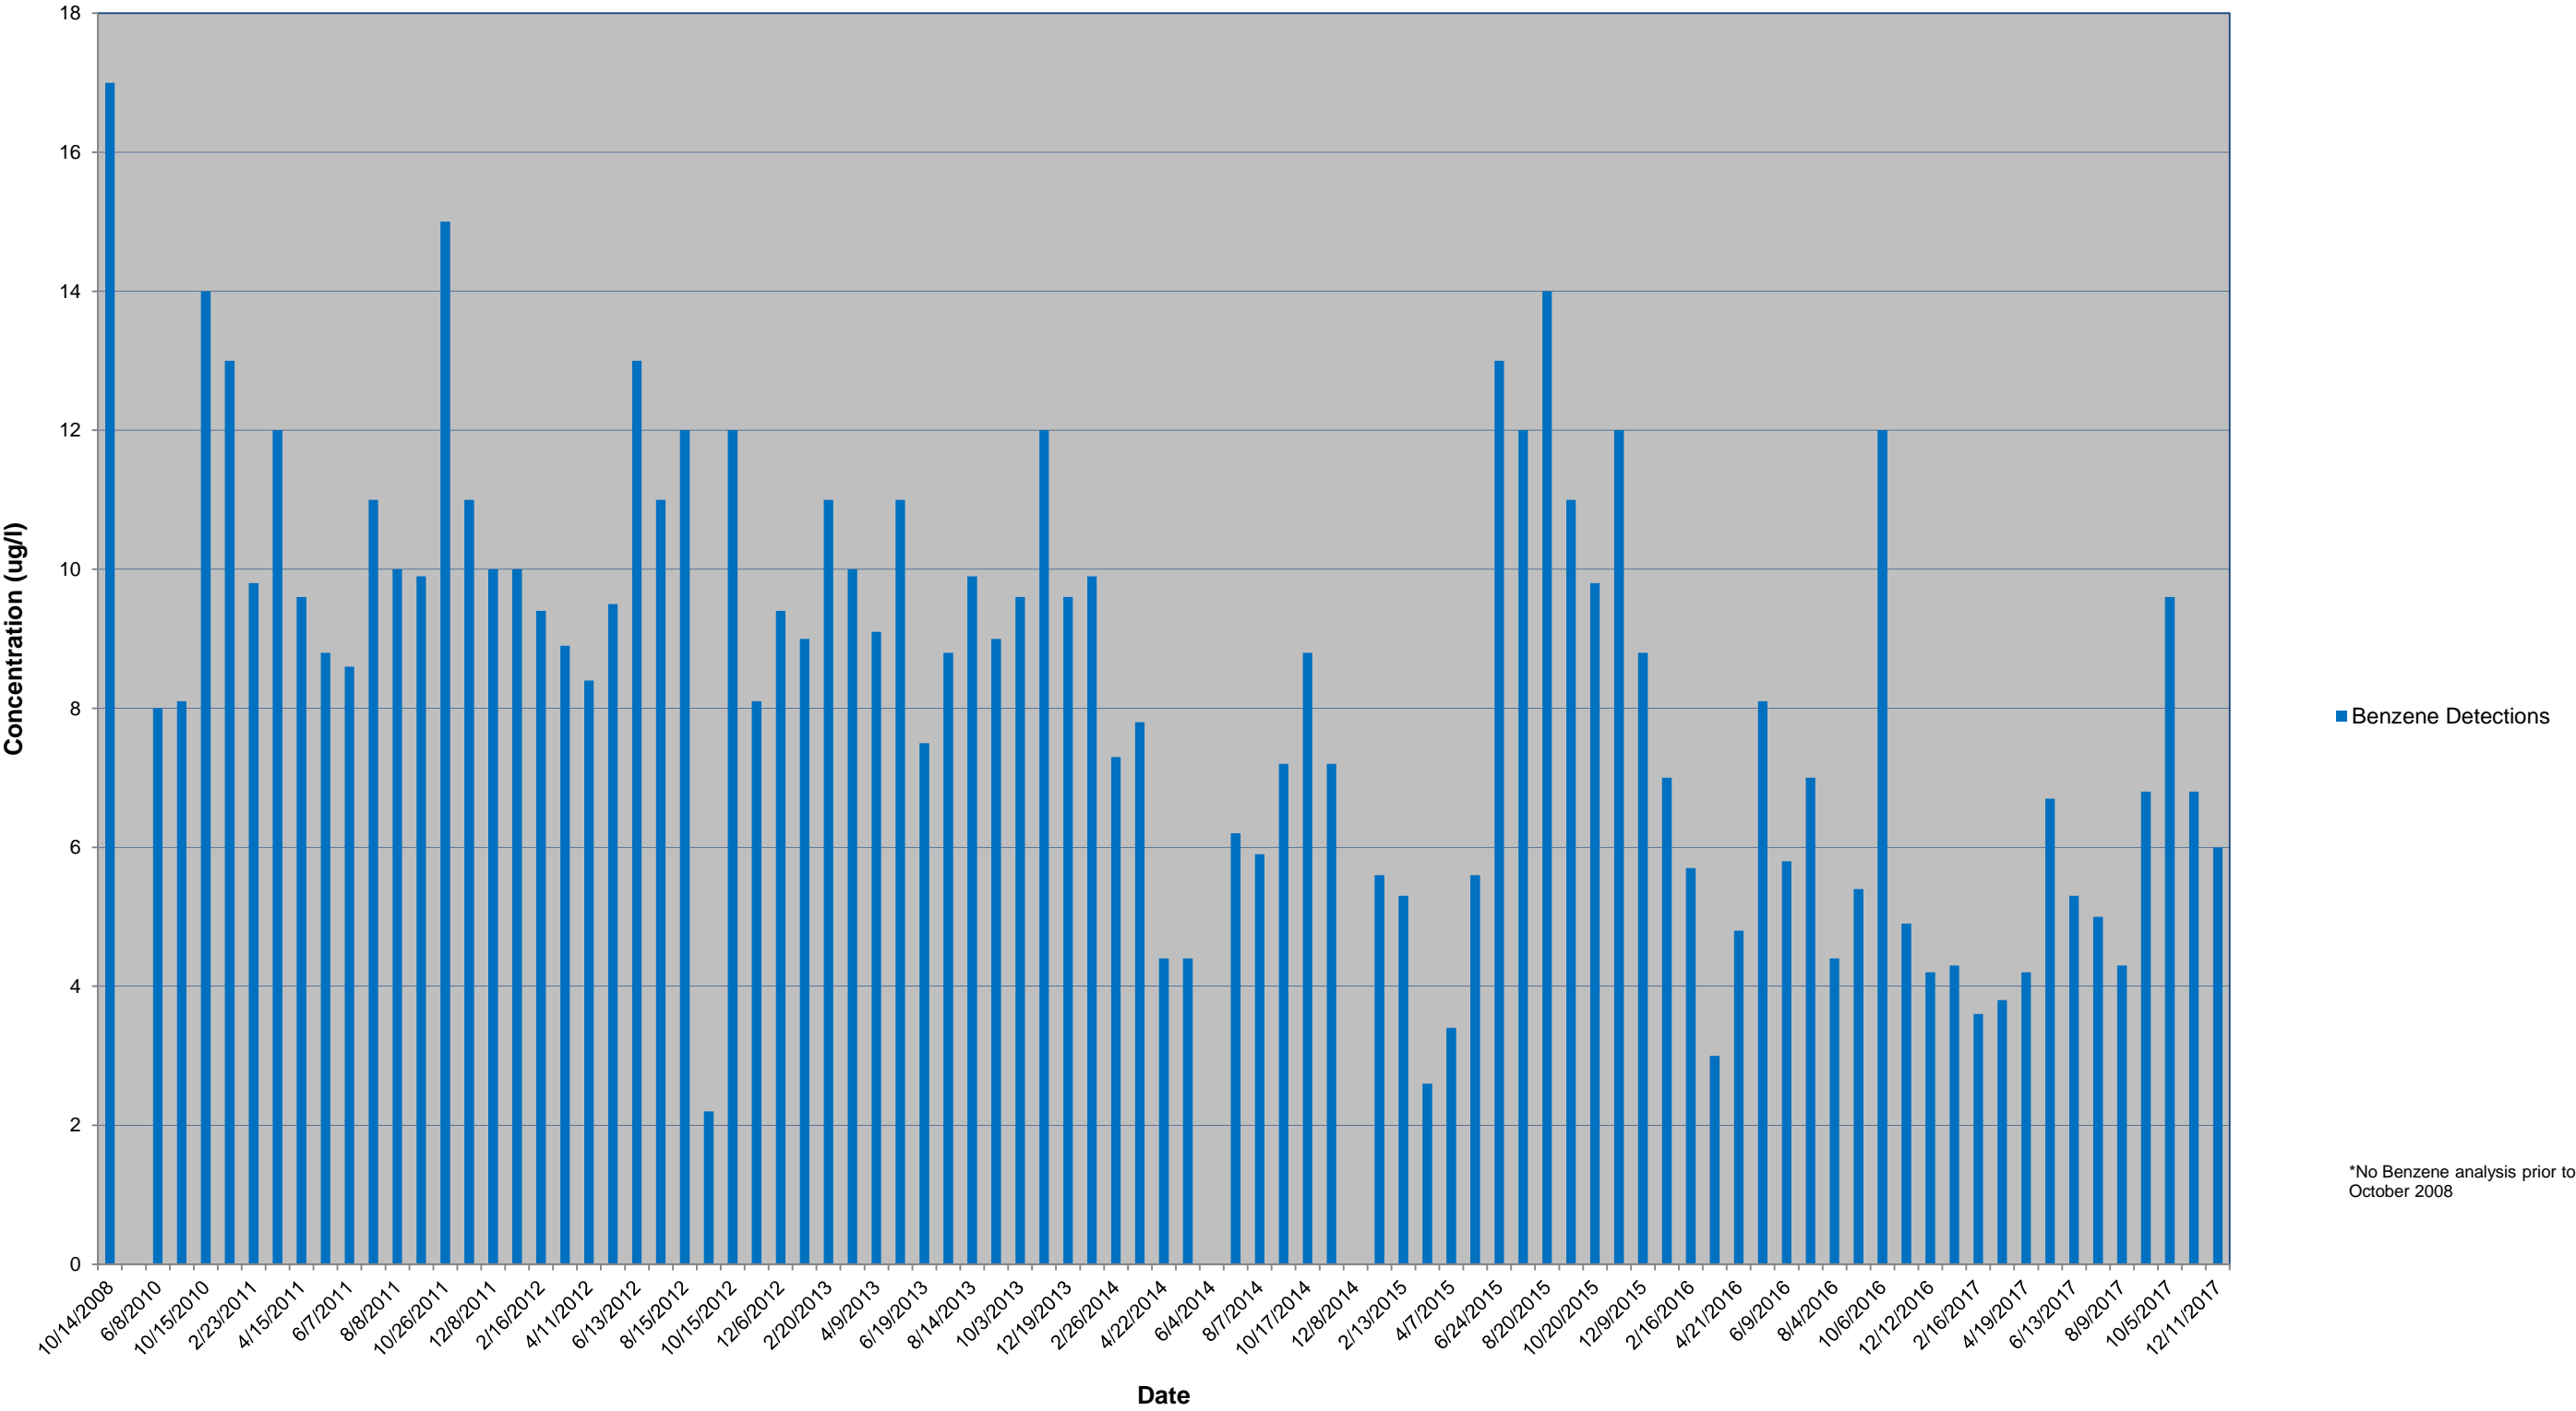
**Benzene Detections in CAMU Unit 2 Leachate Samples
2008 - 2017***

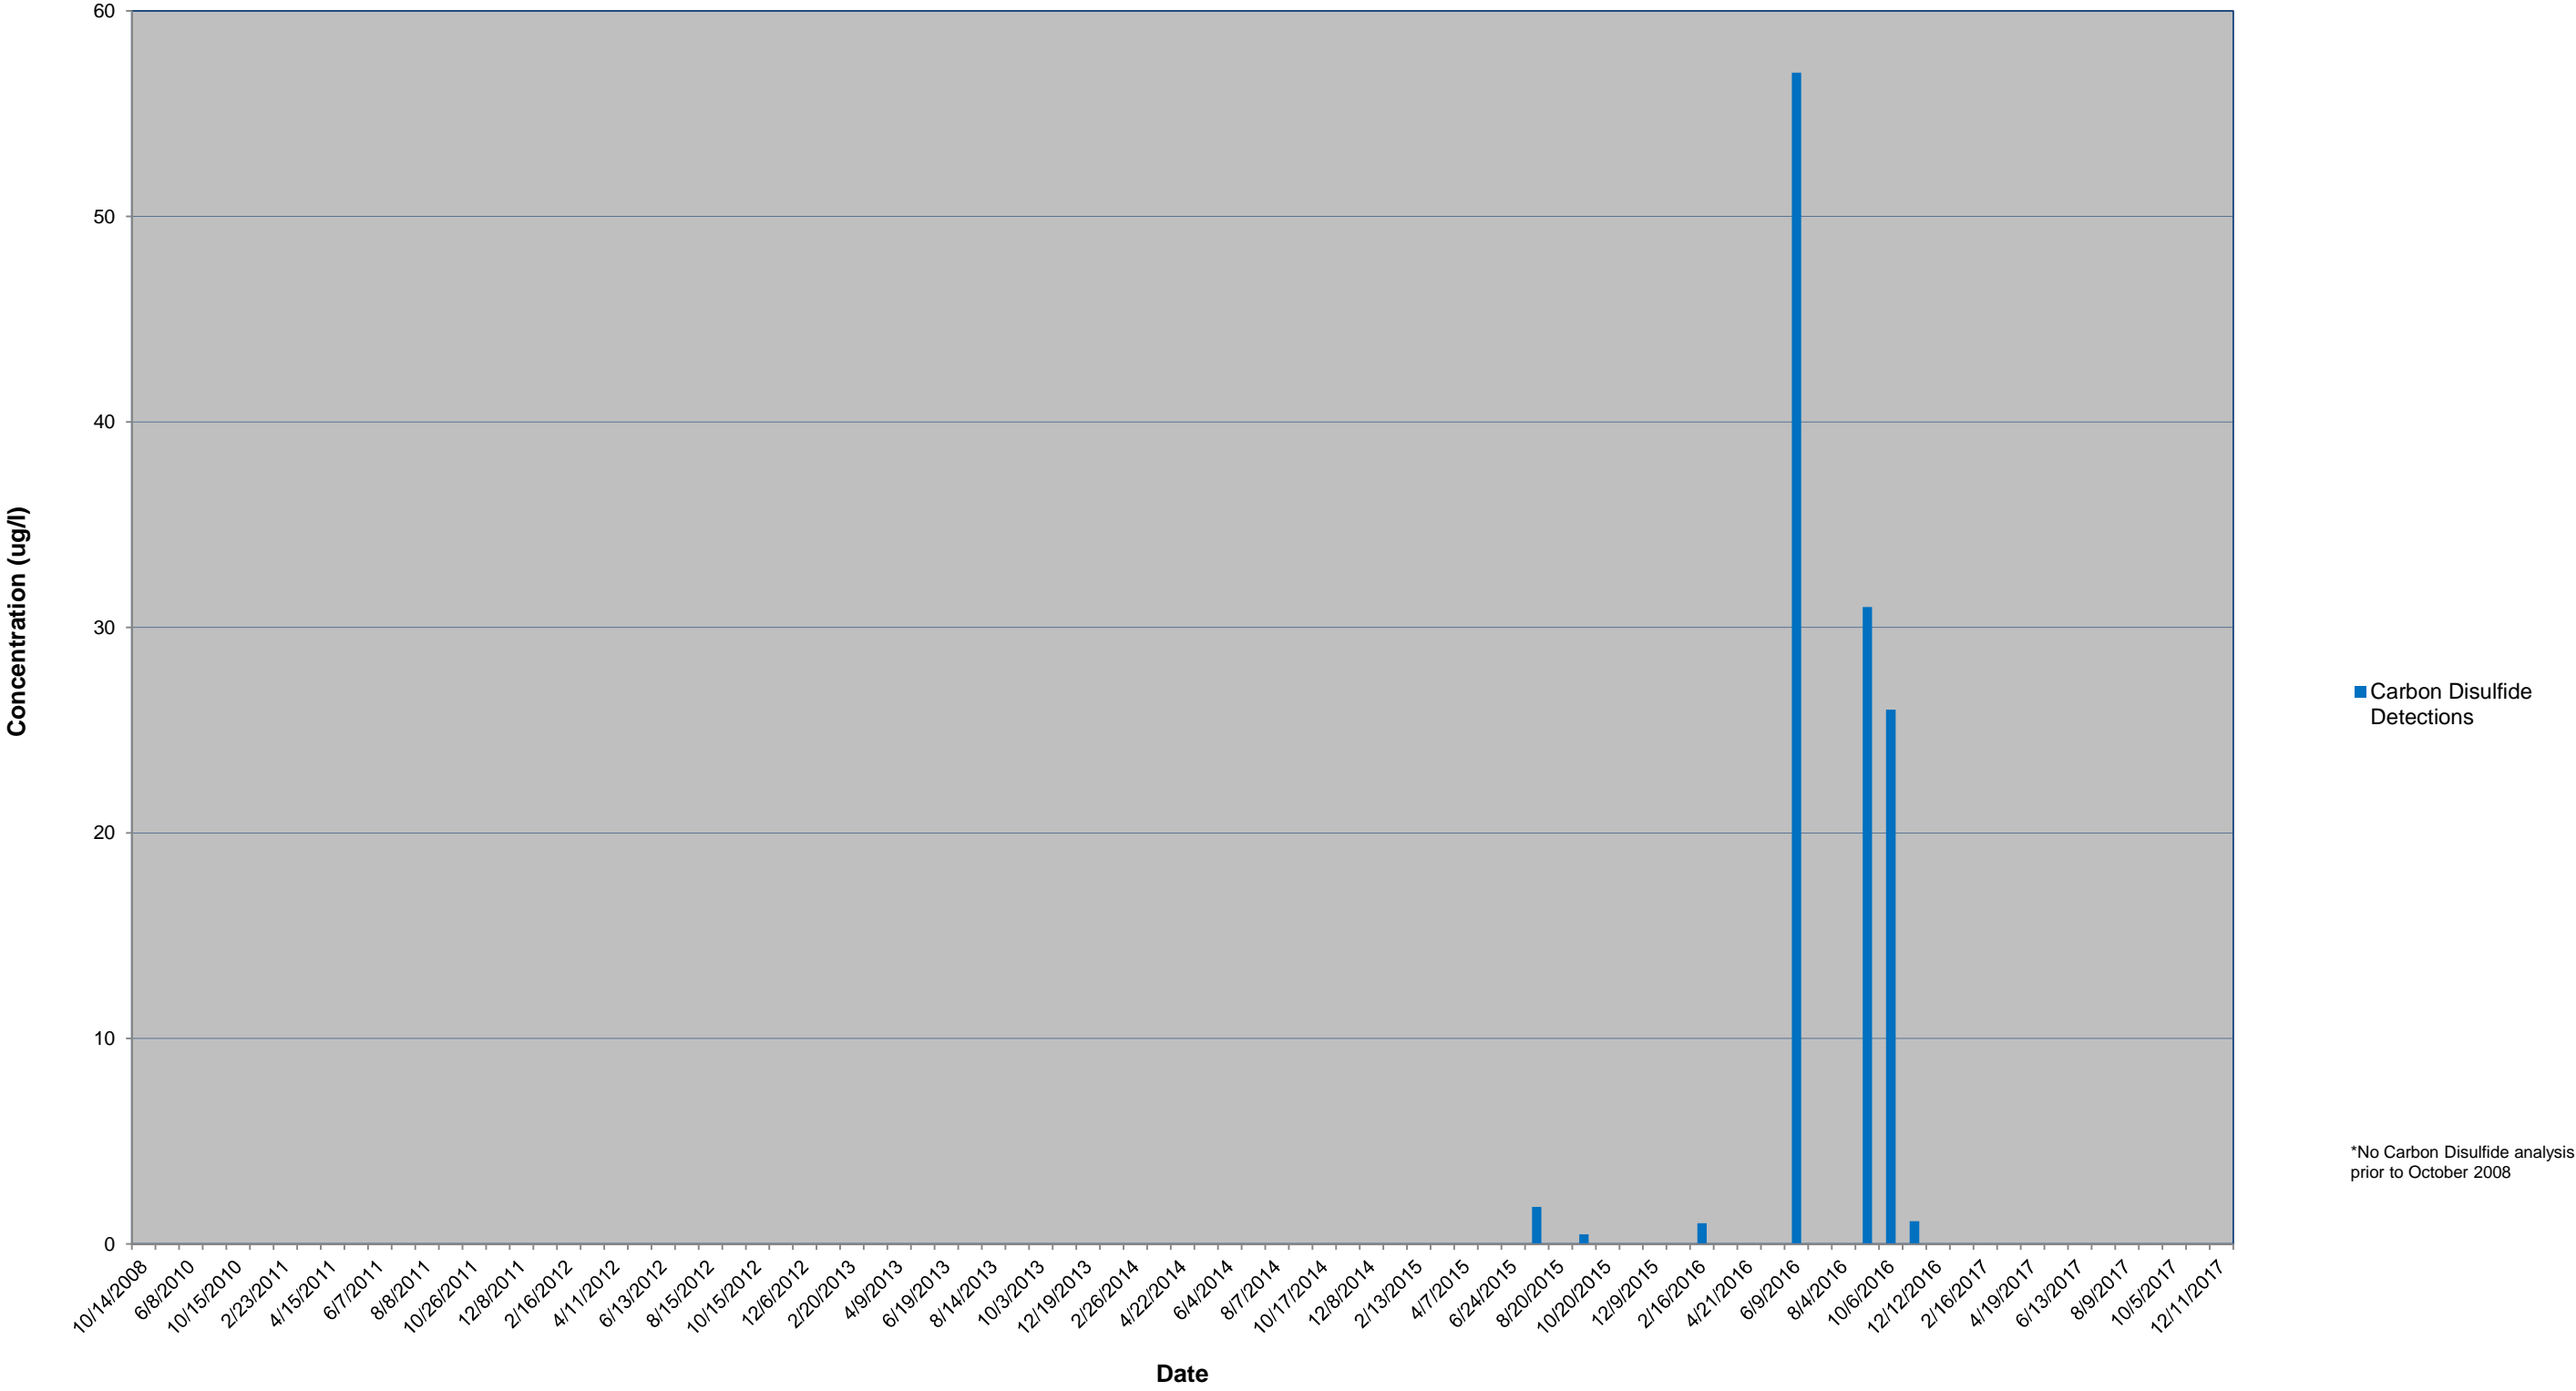
Carbon Disulfide Detections in CAMU Unit 2 Leachate Samples
2008 - 2017*

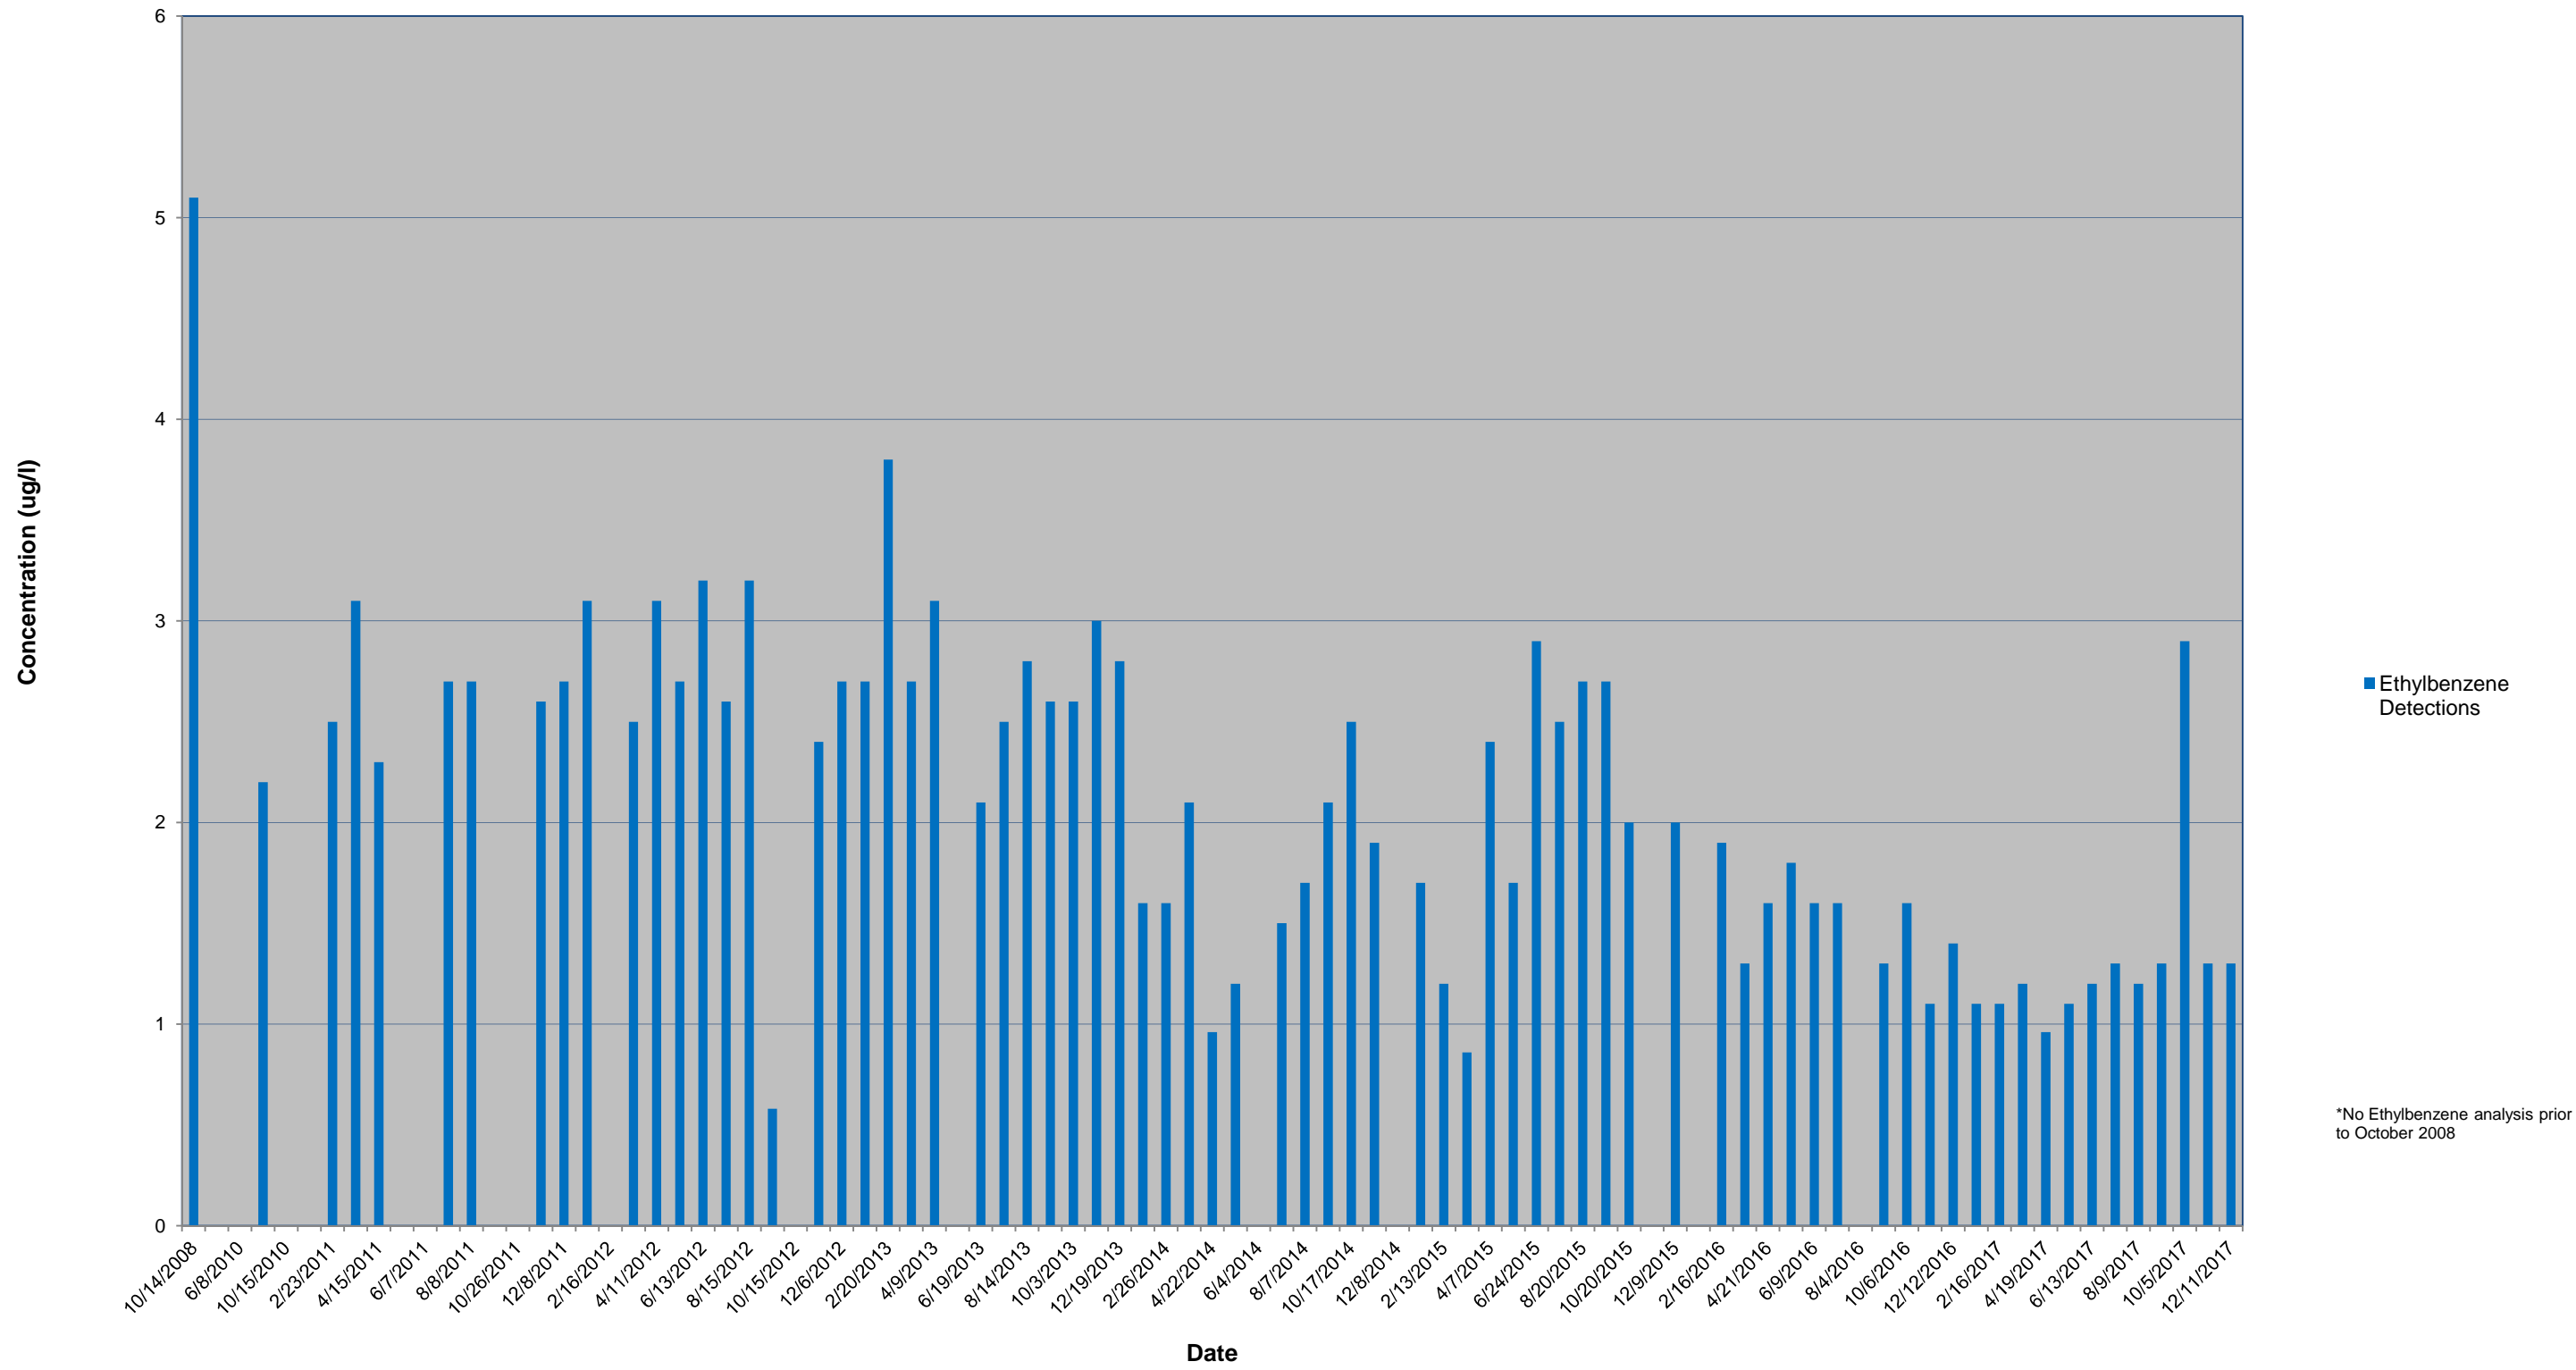
Ethylbenzene Detections in CAMU Unit 2 Leachate Samples
2008 - 2017*

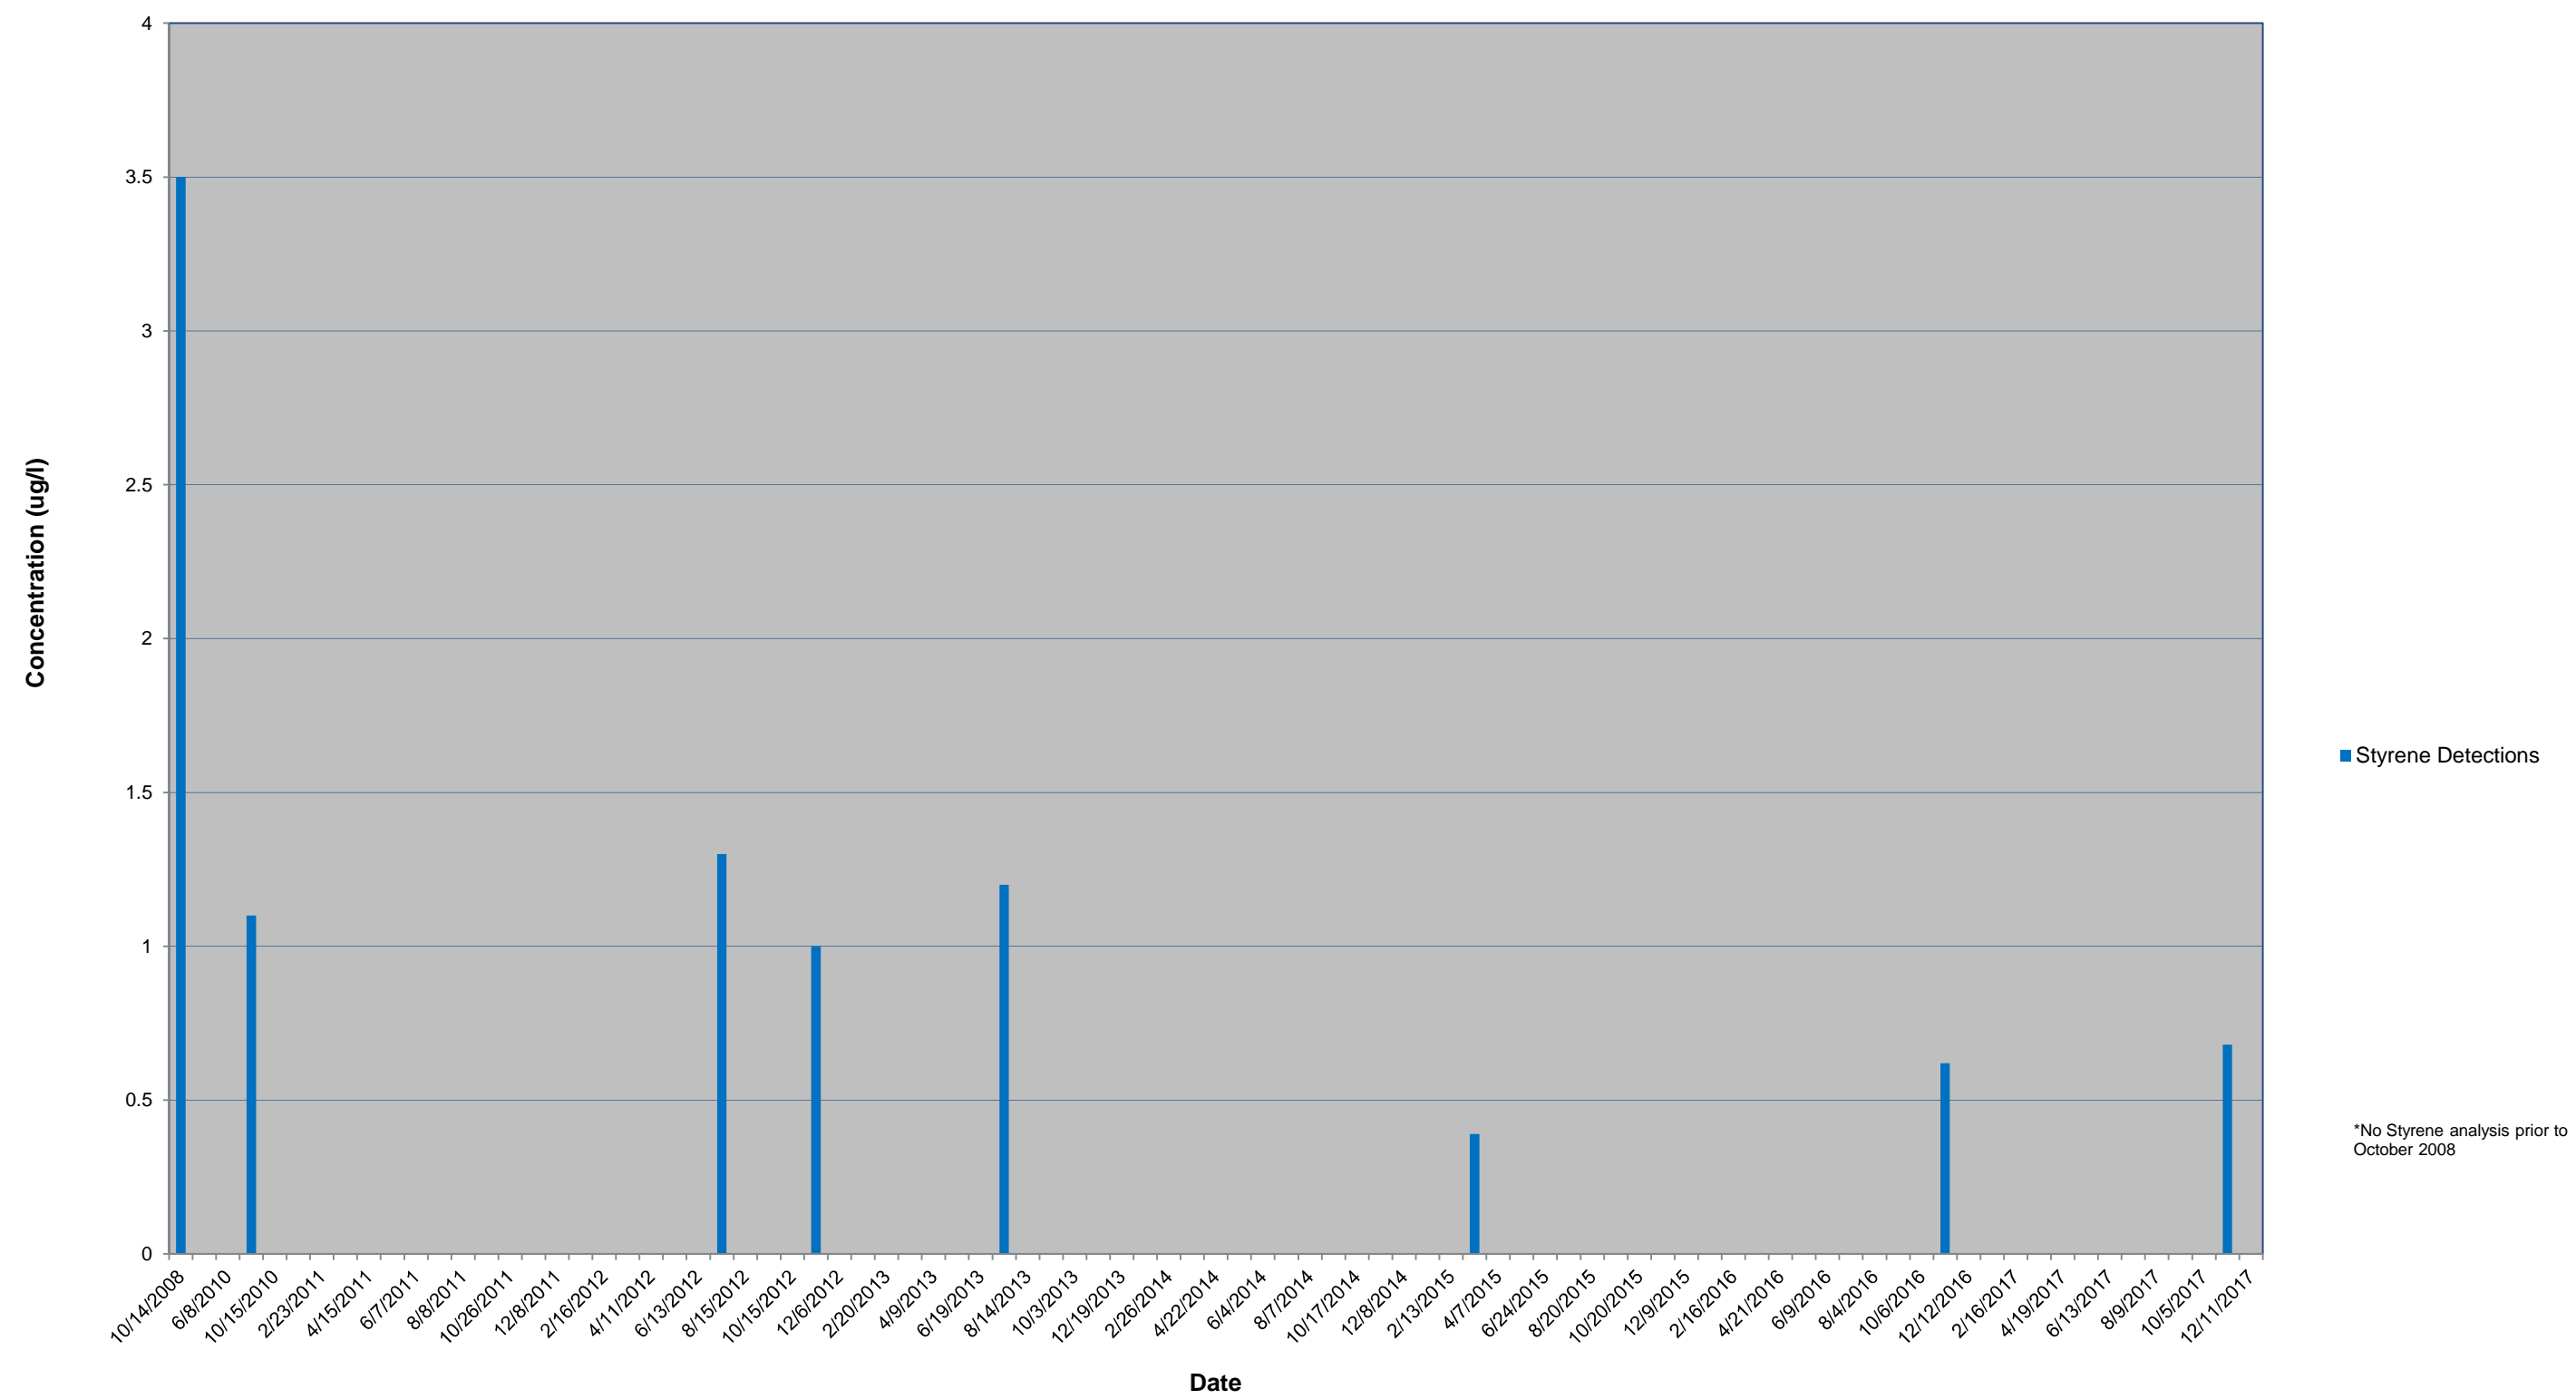
Styrene Detections in CAMU Unit 2 Leachate Samples
2008 - 2017*

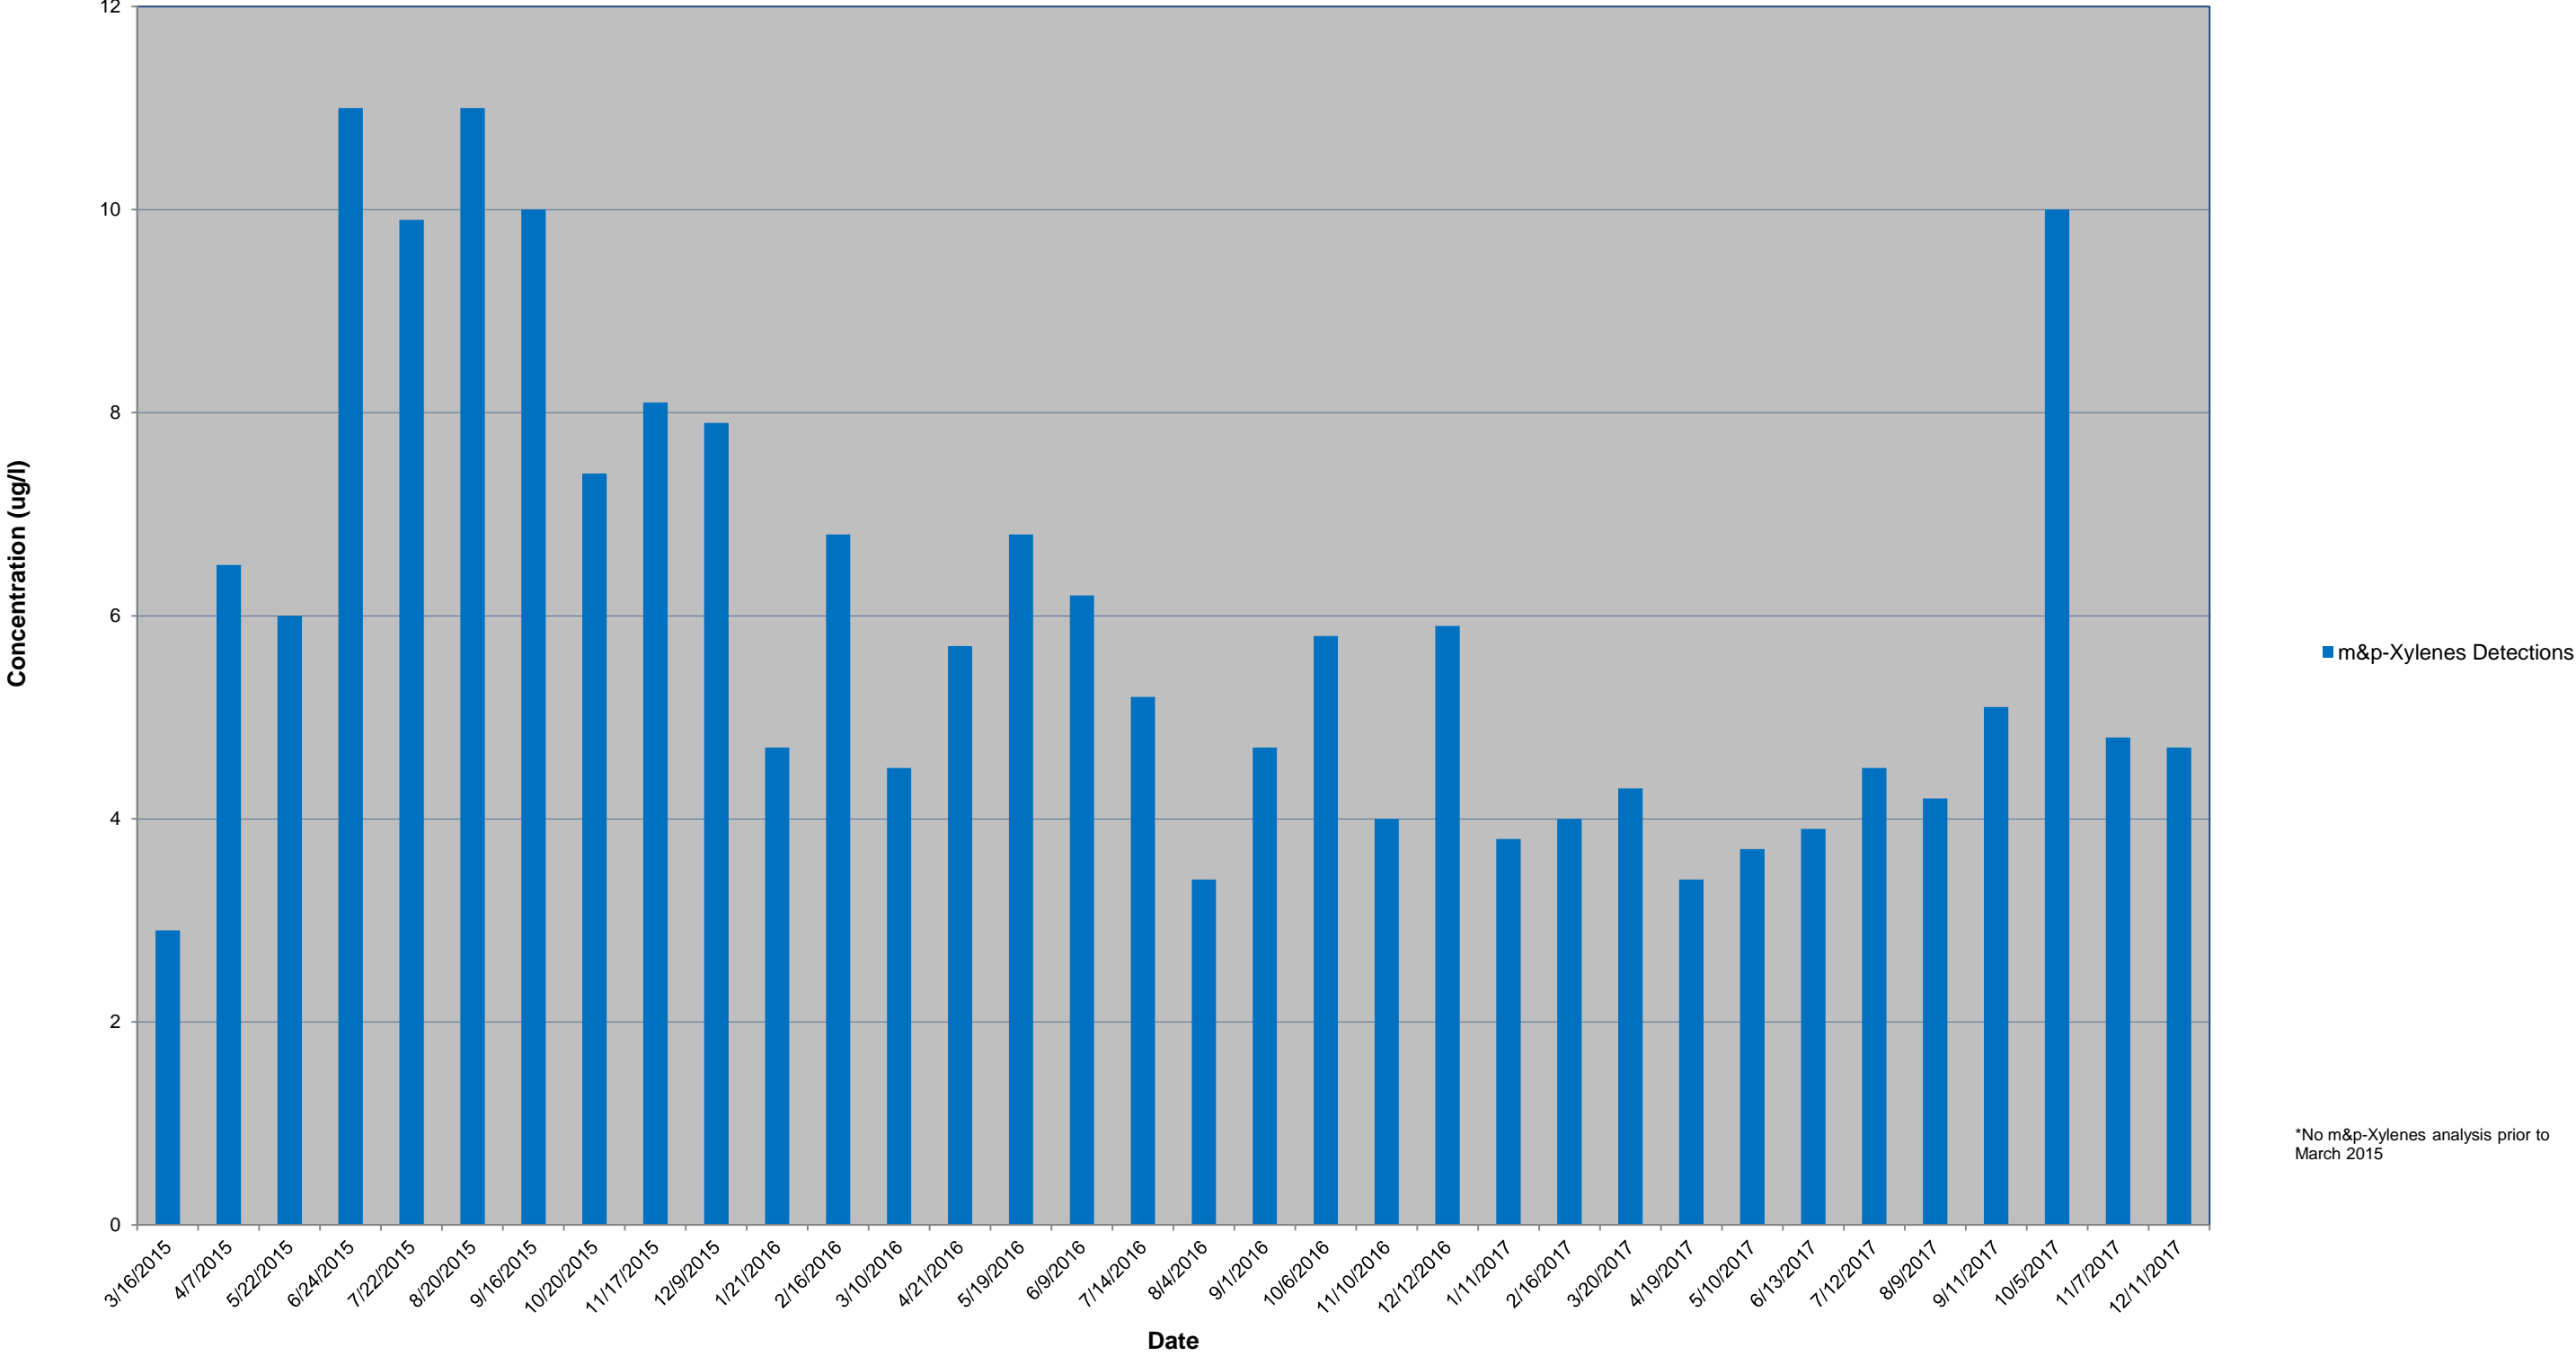
m&p-Xylenes in CAMU Unit 2 Leachate Samples
2015 - 2017*
