2-Butanone Detections in CAMU Unit 2 Leachate Samples
2008 - 2017*

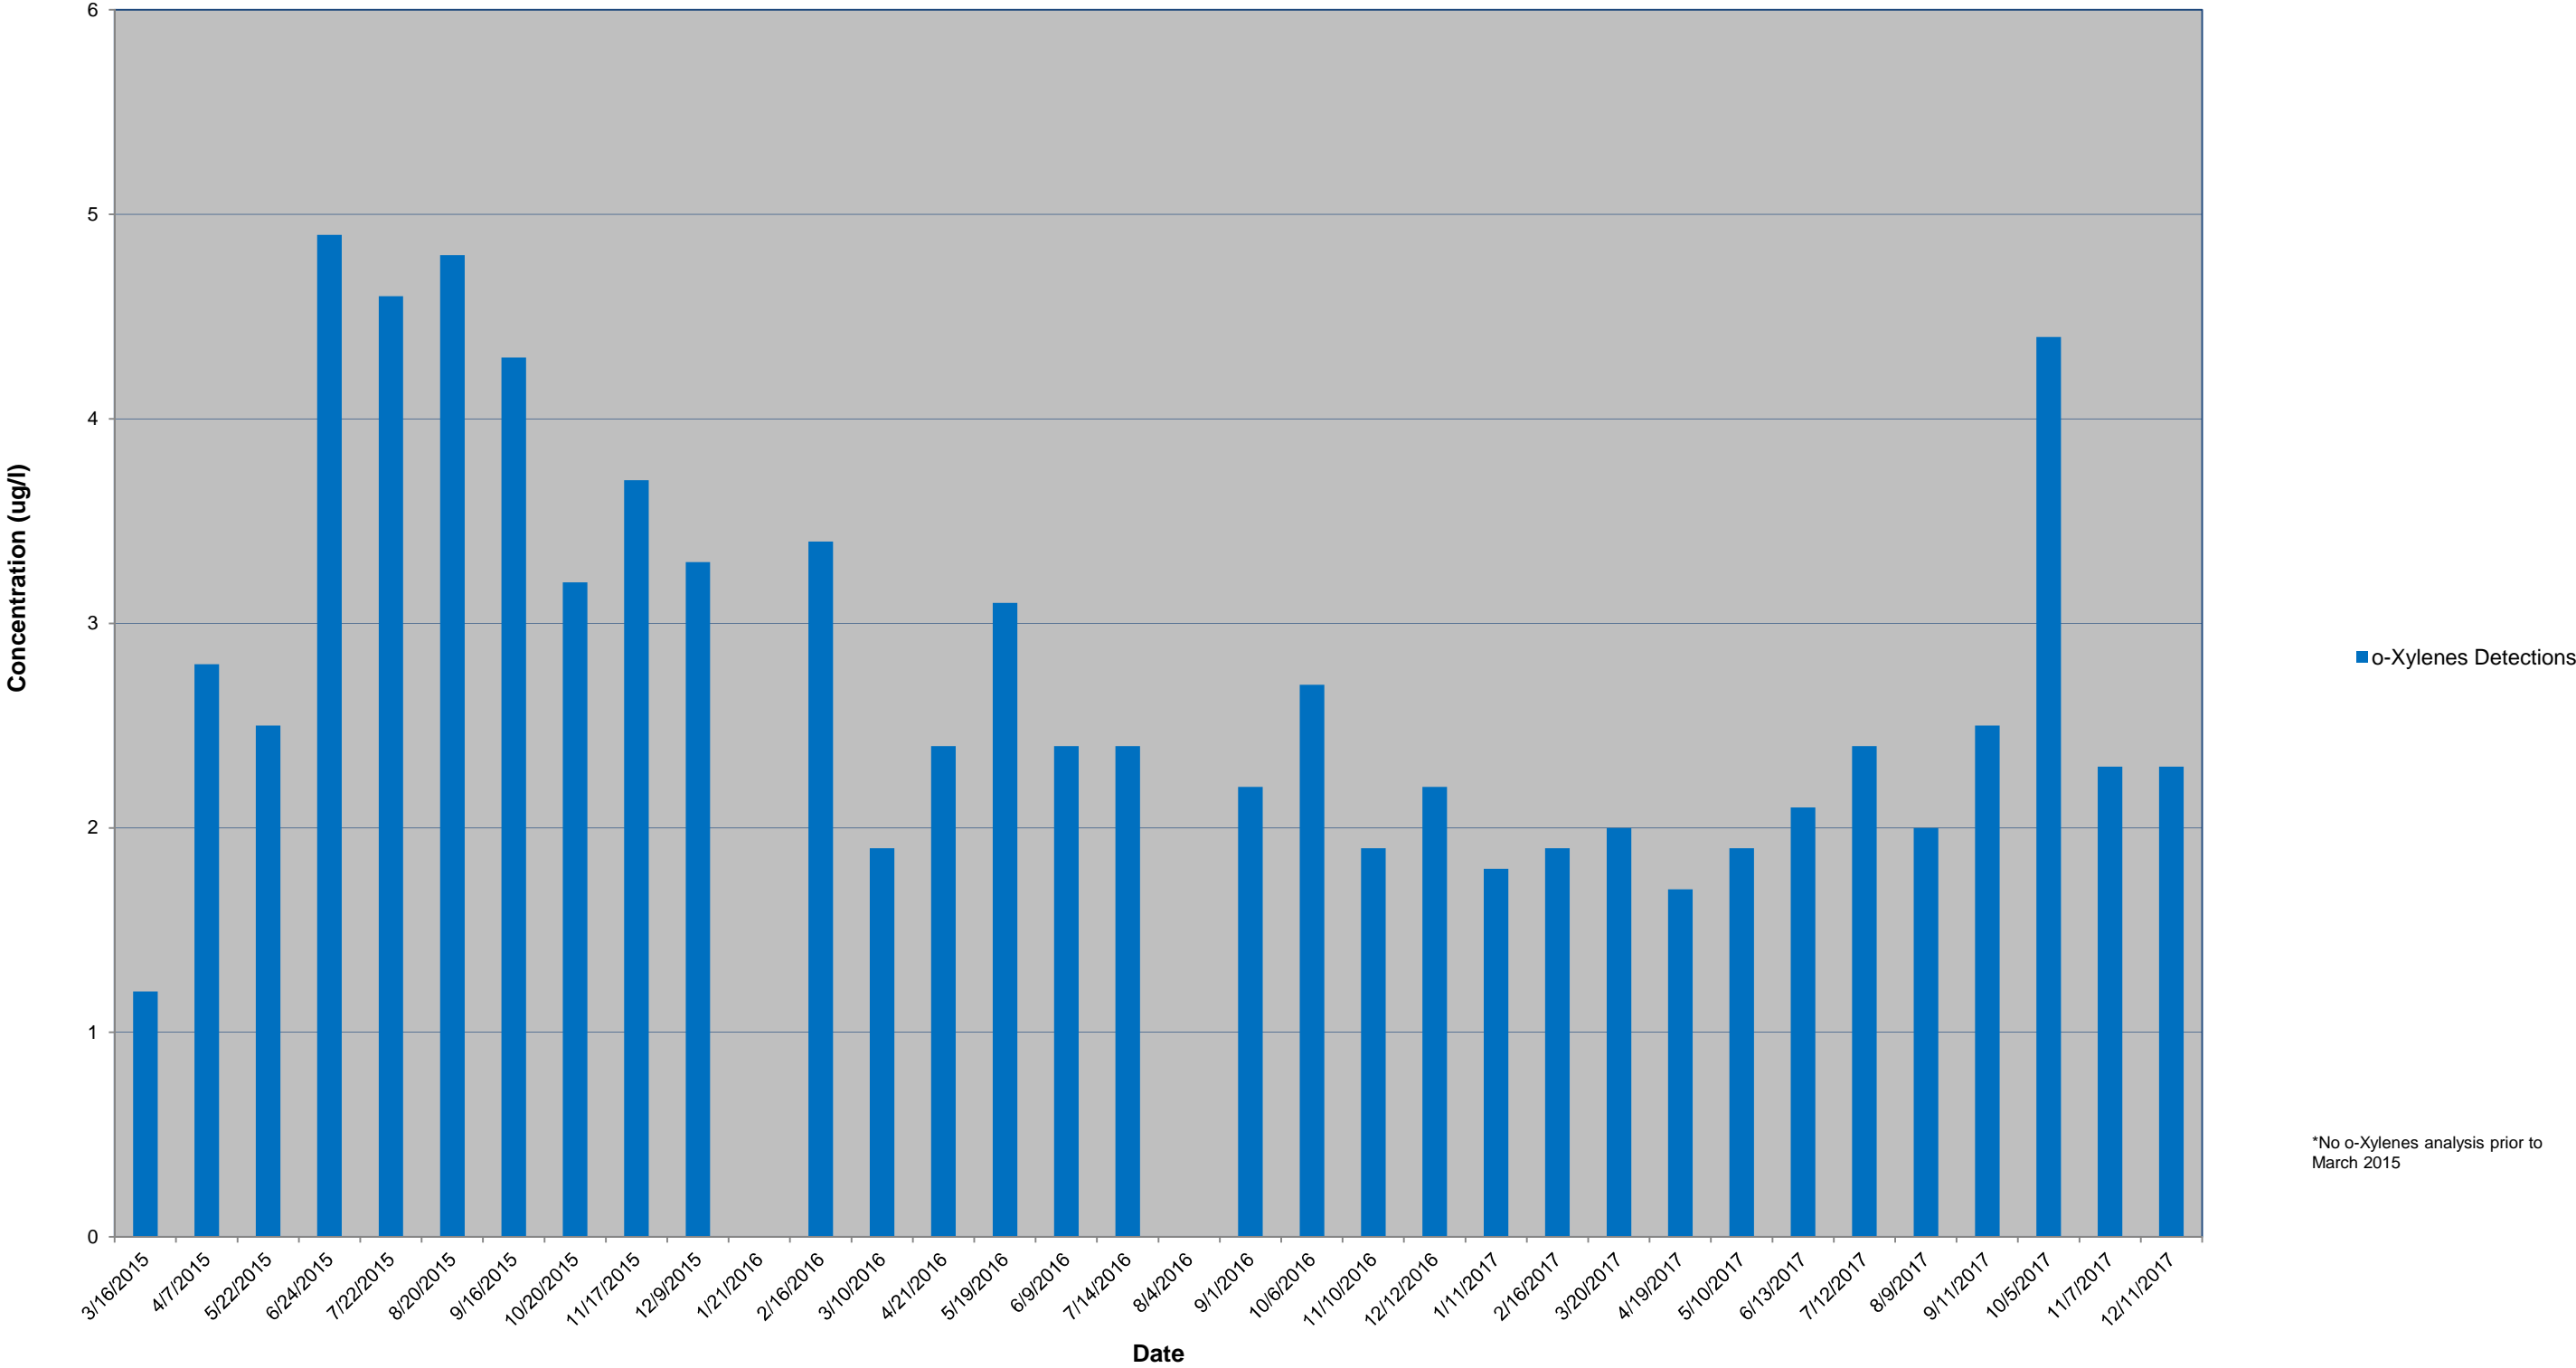
**o-Xylenes in CAMU Unit 2 Leachate Samples
2015 - 2017***

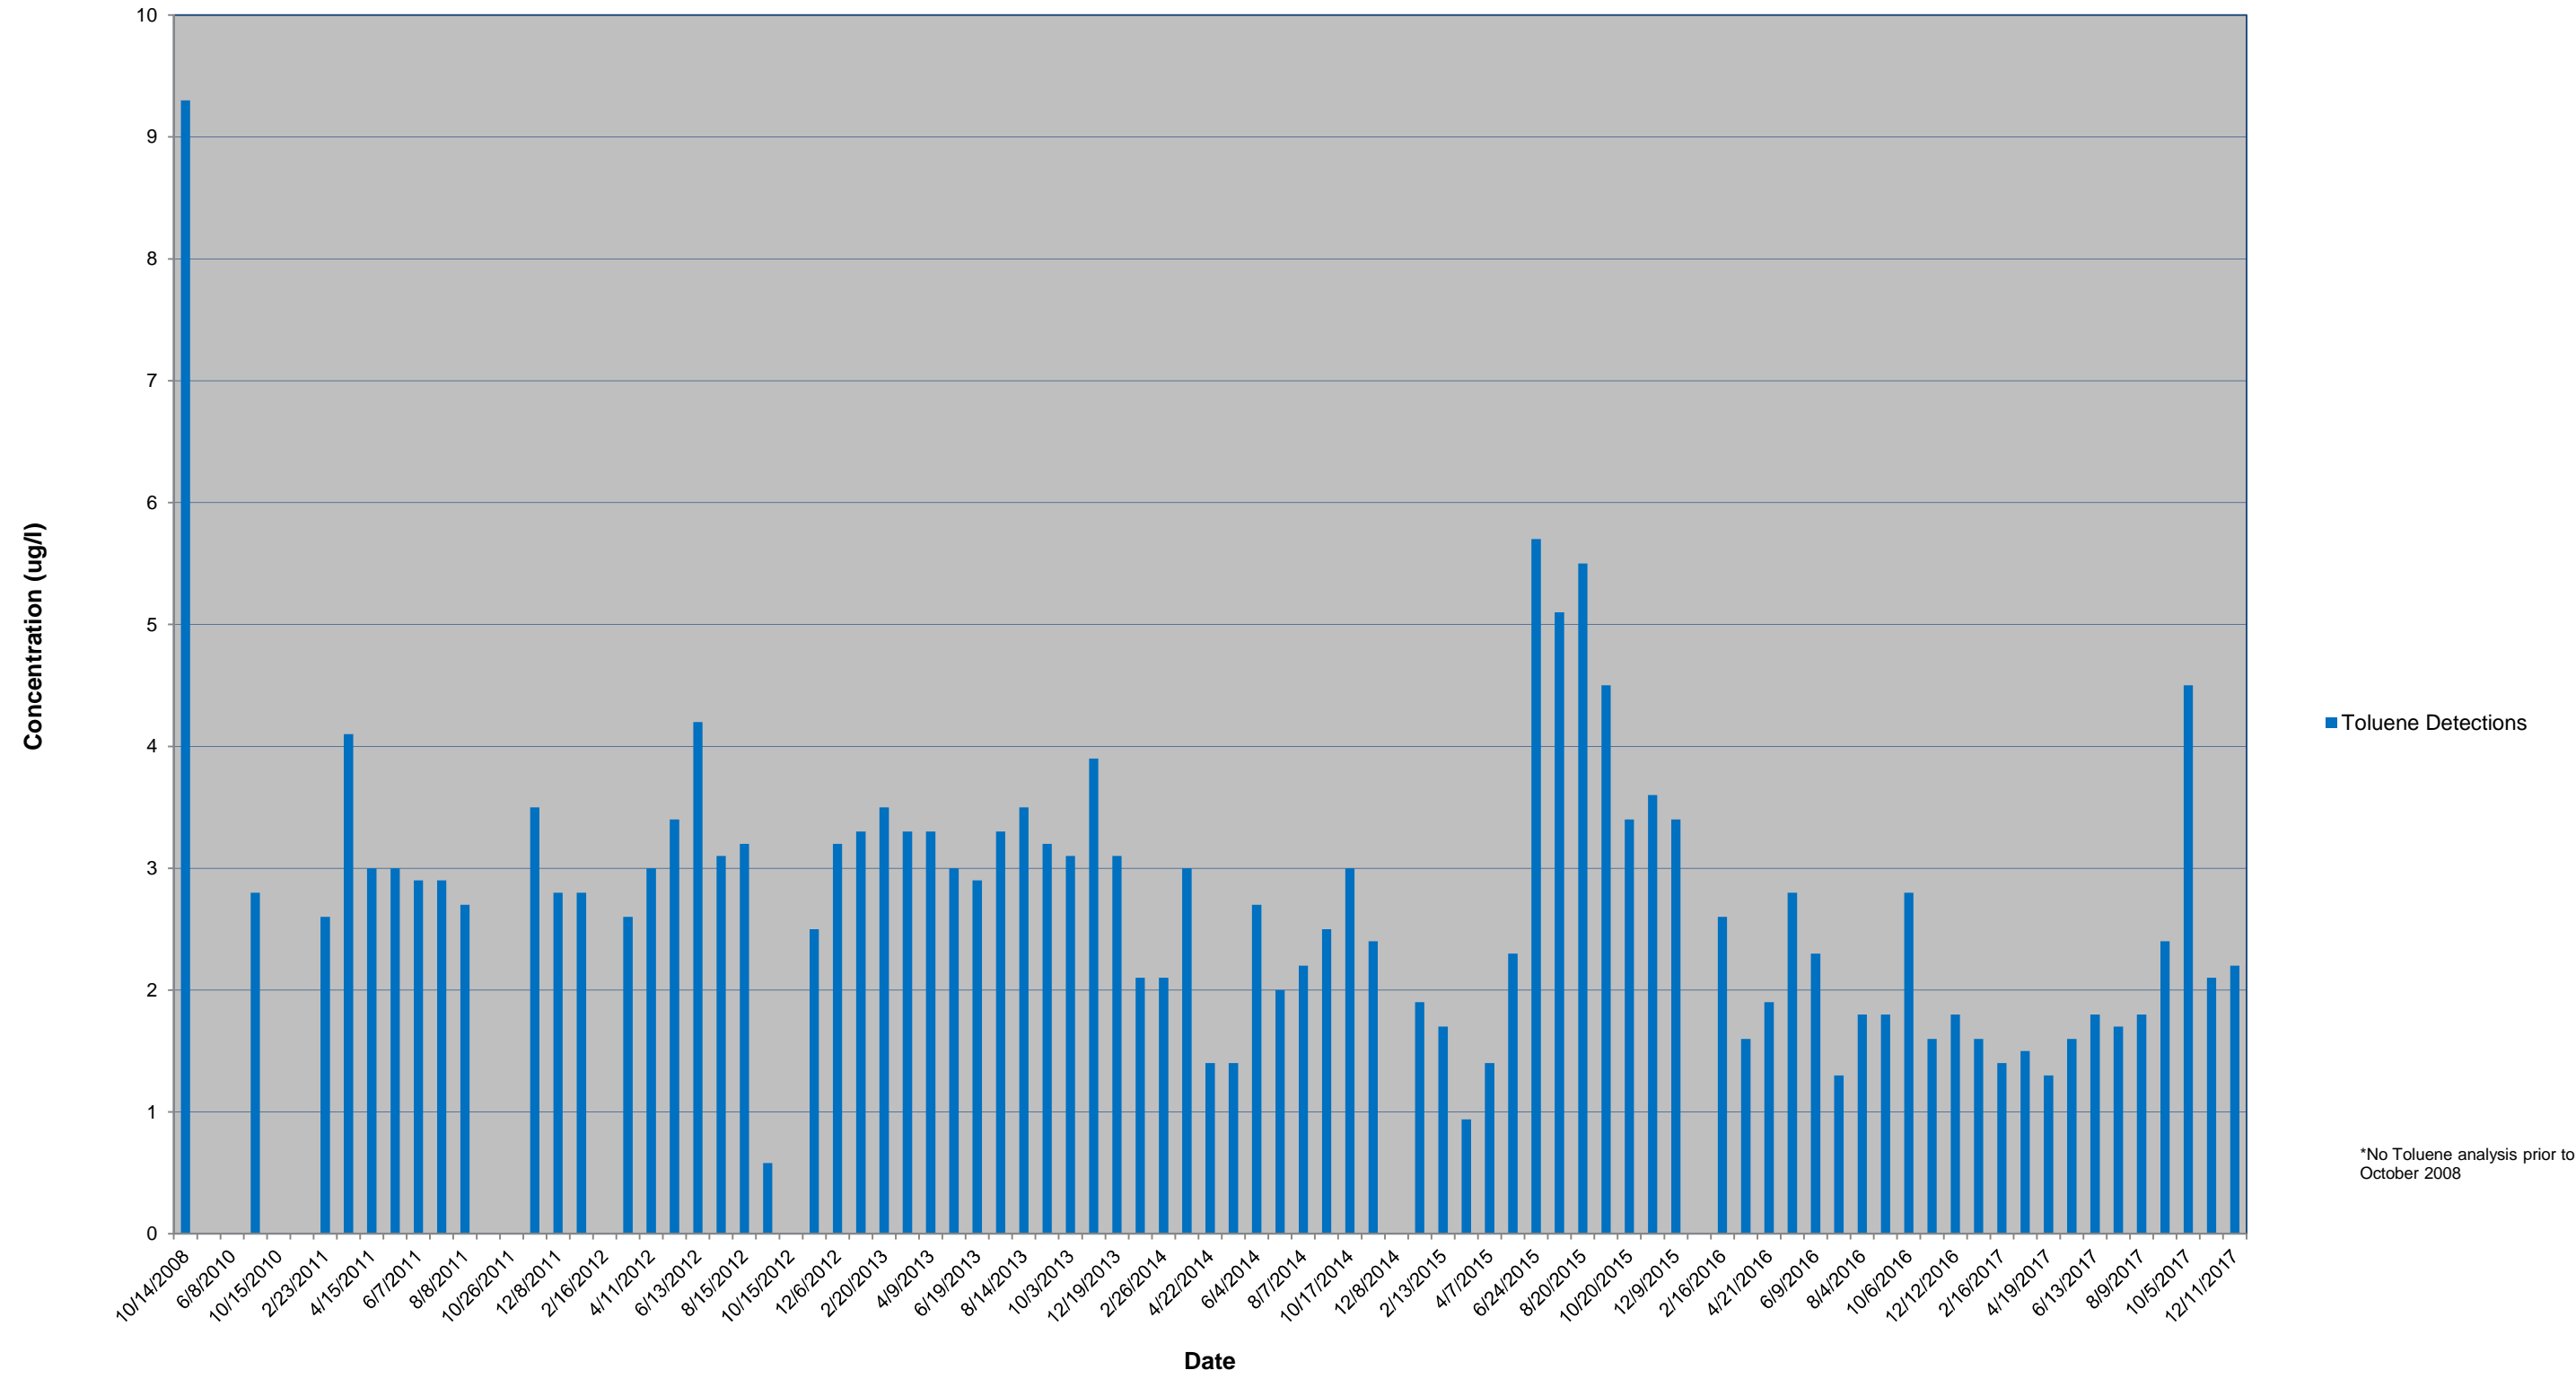
Toluene Detections in CAMU Unit 2 Leachate Samples
2008 - 2017*

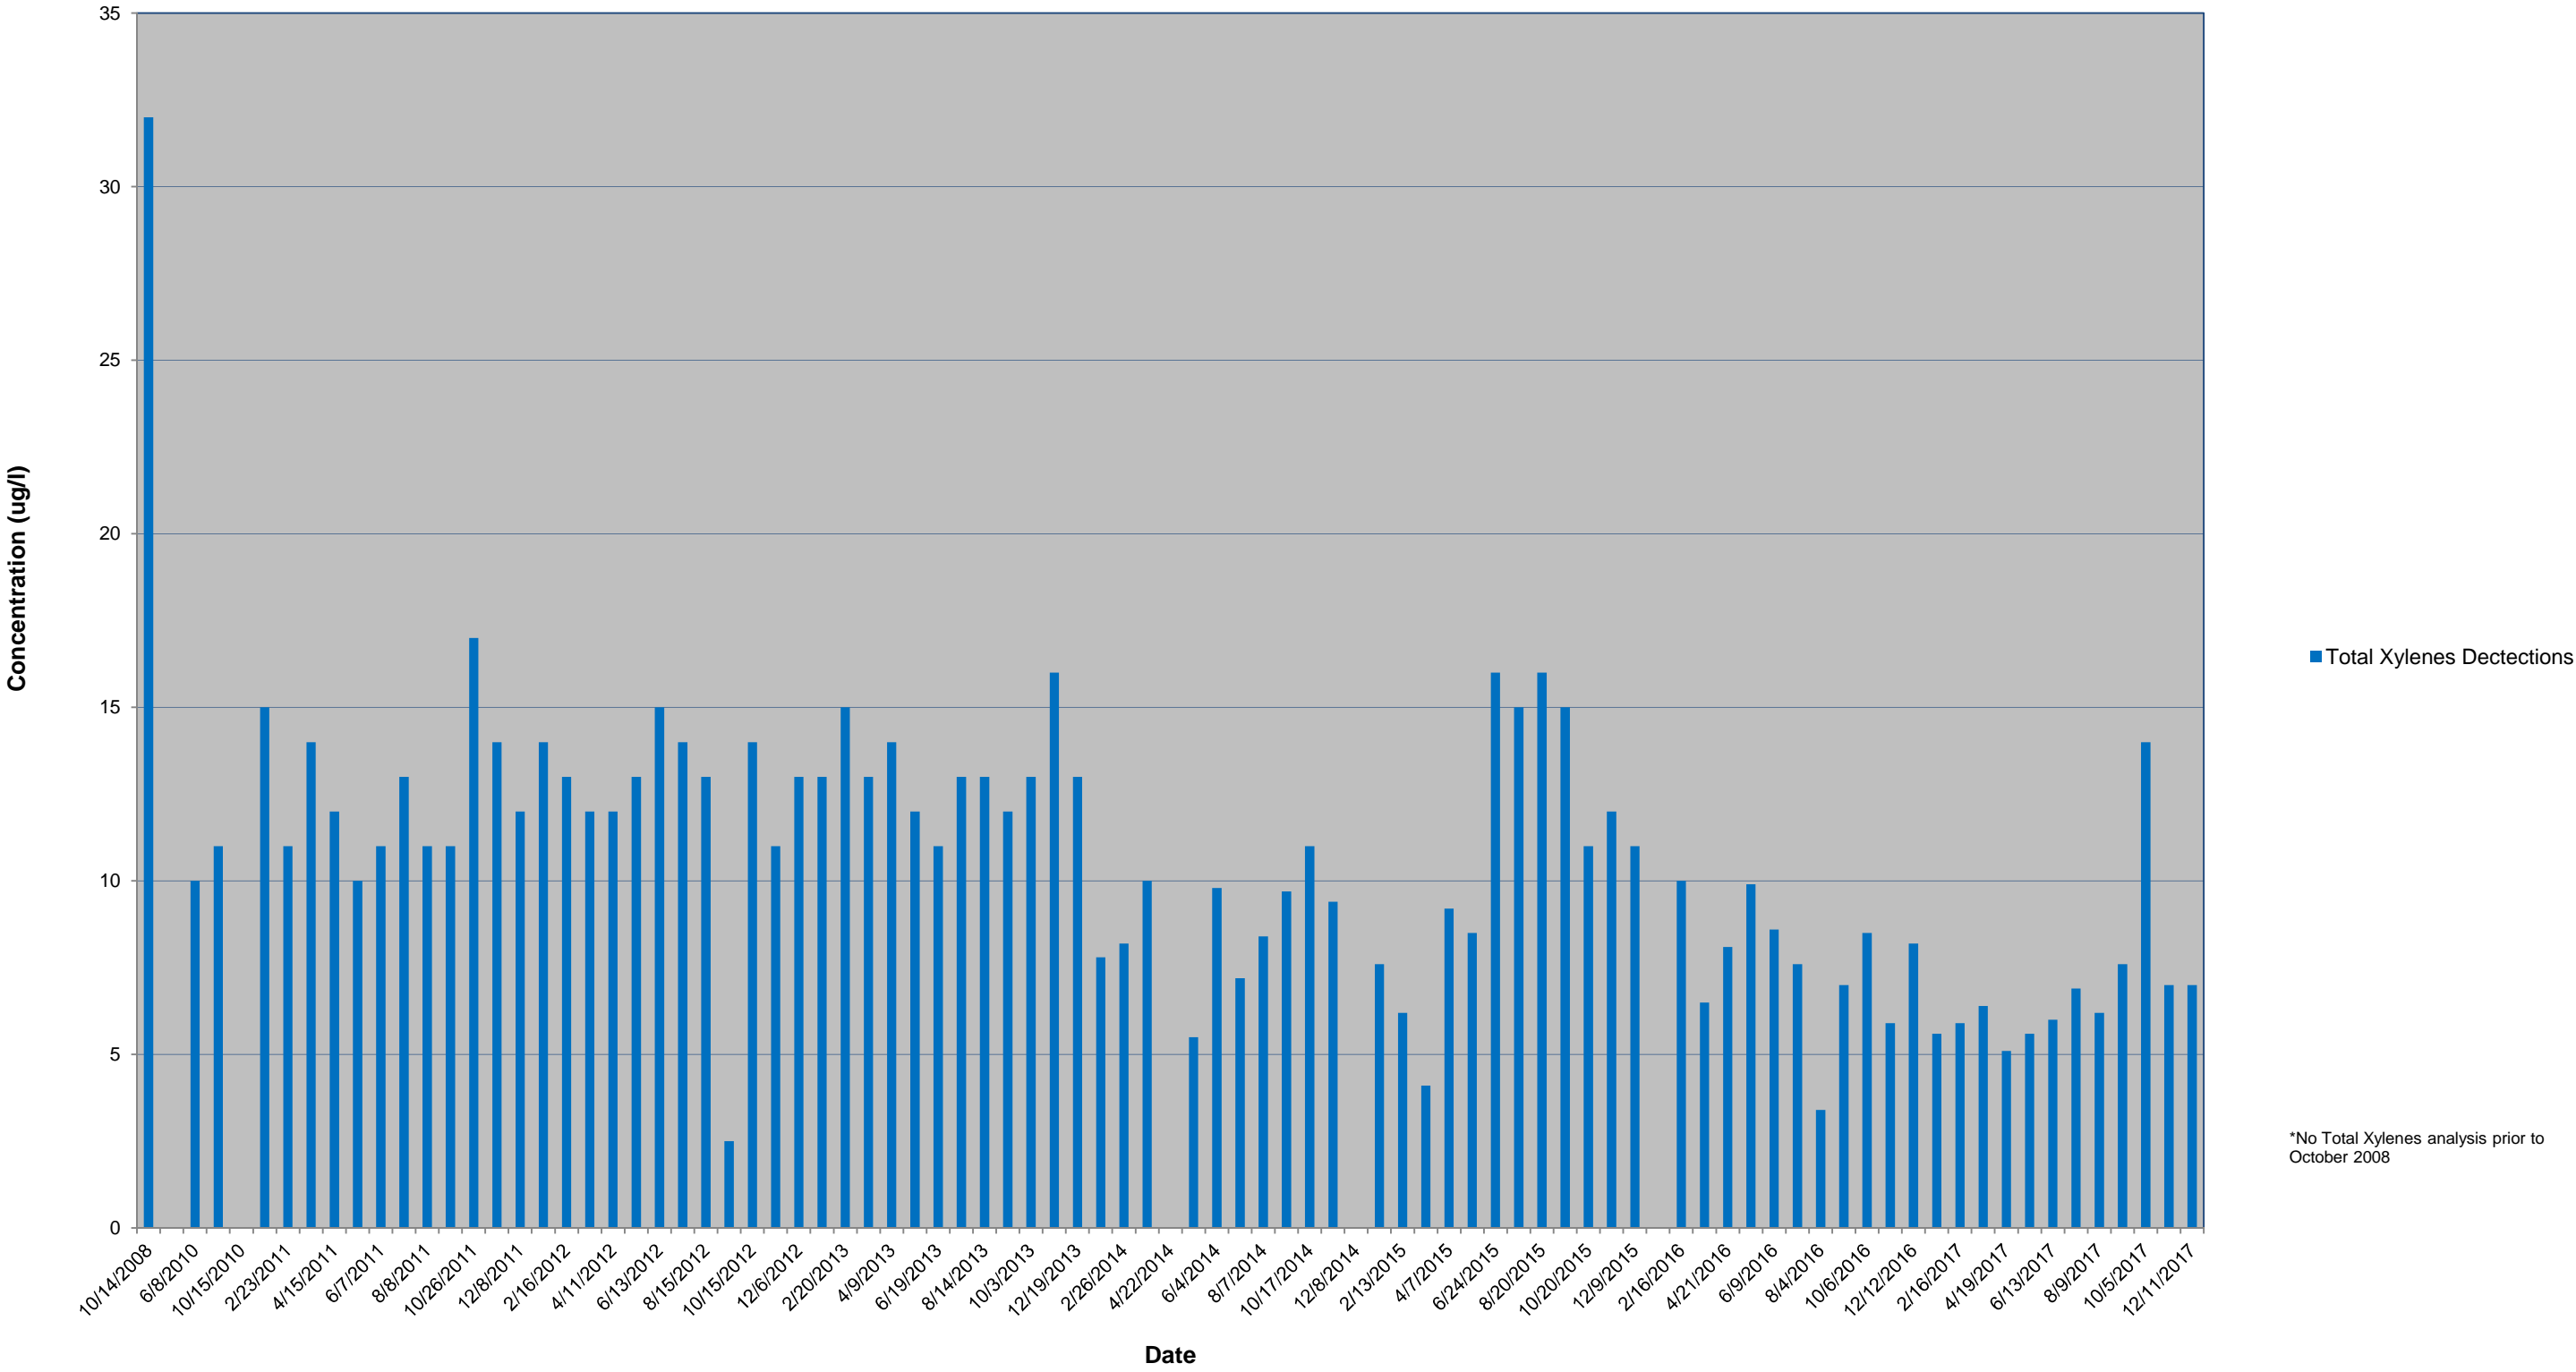
**Total Xylenes in CAMU Unit 2 Leachate Samples
2008 - 2017***
