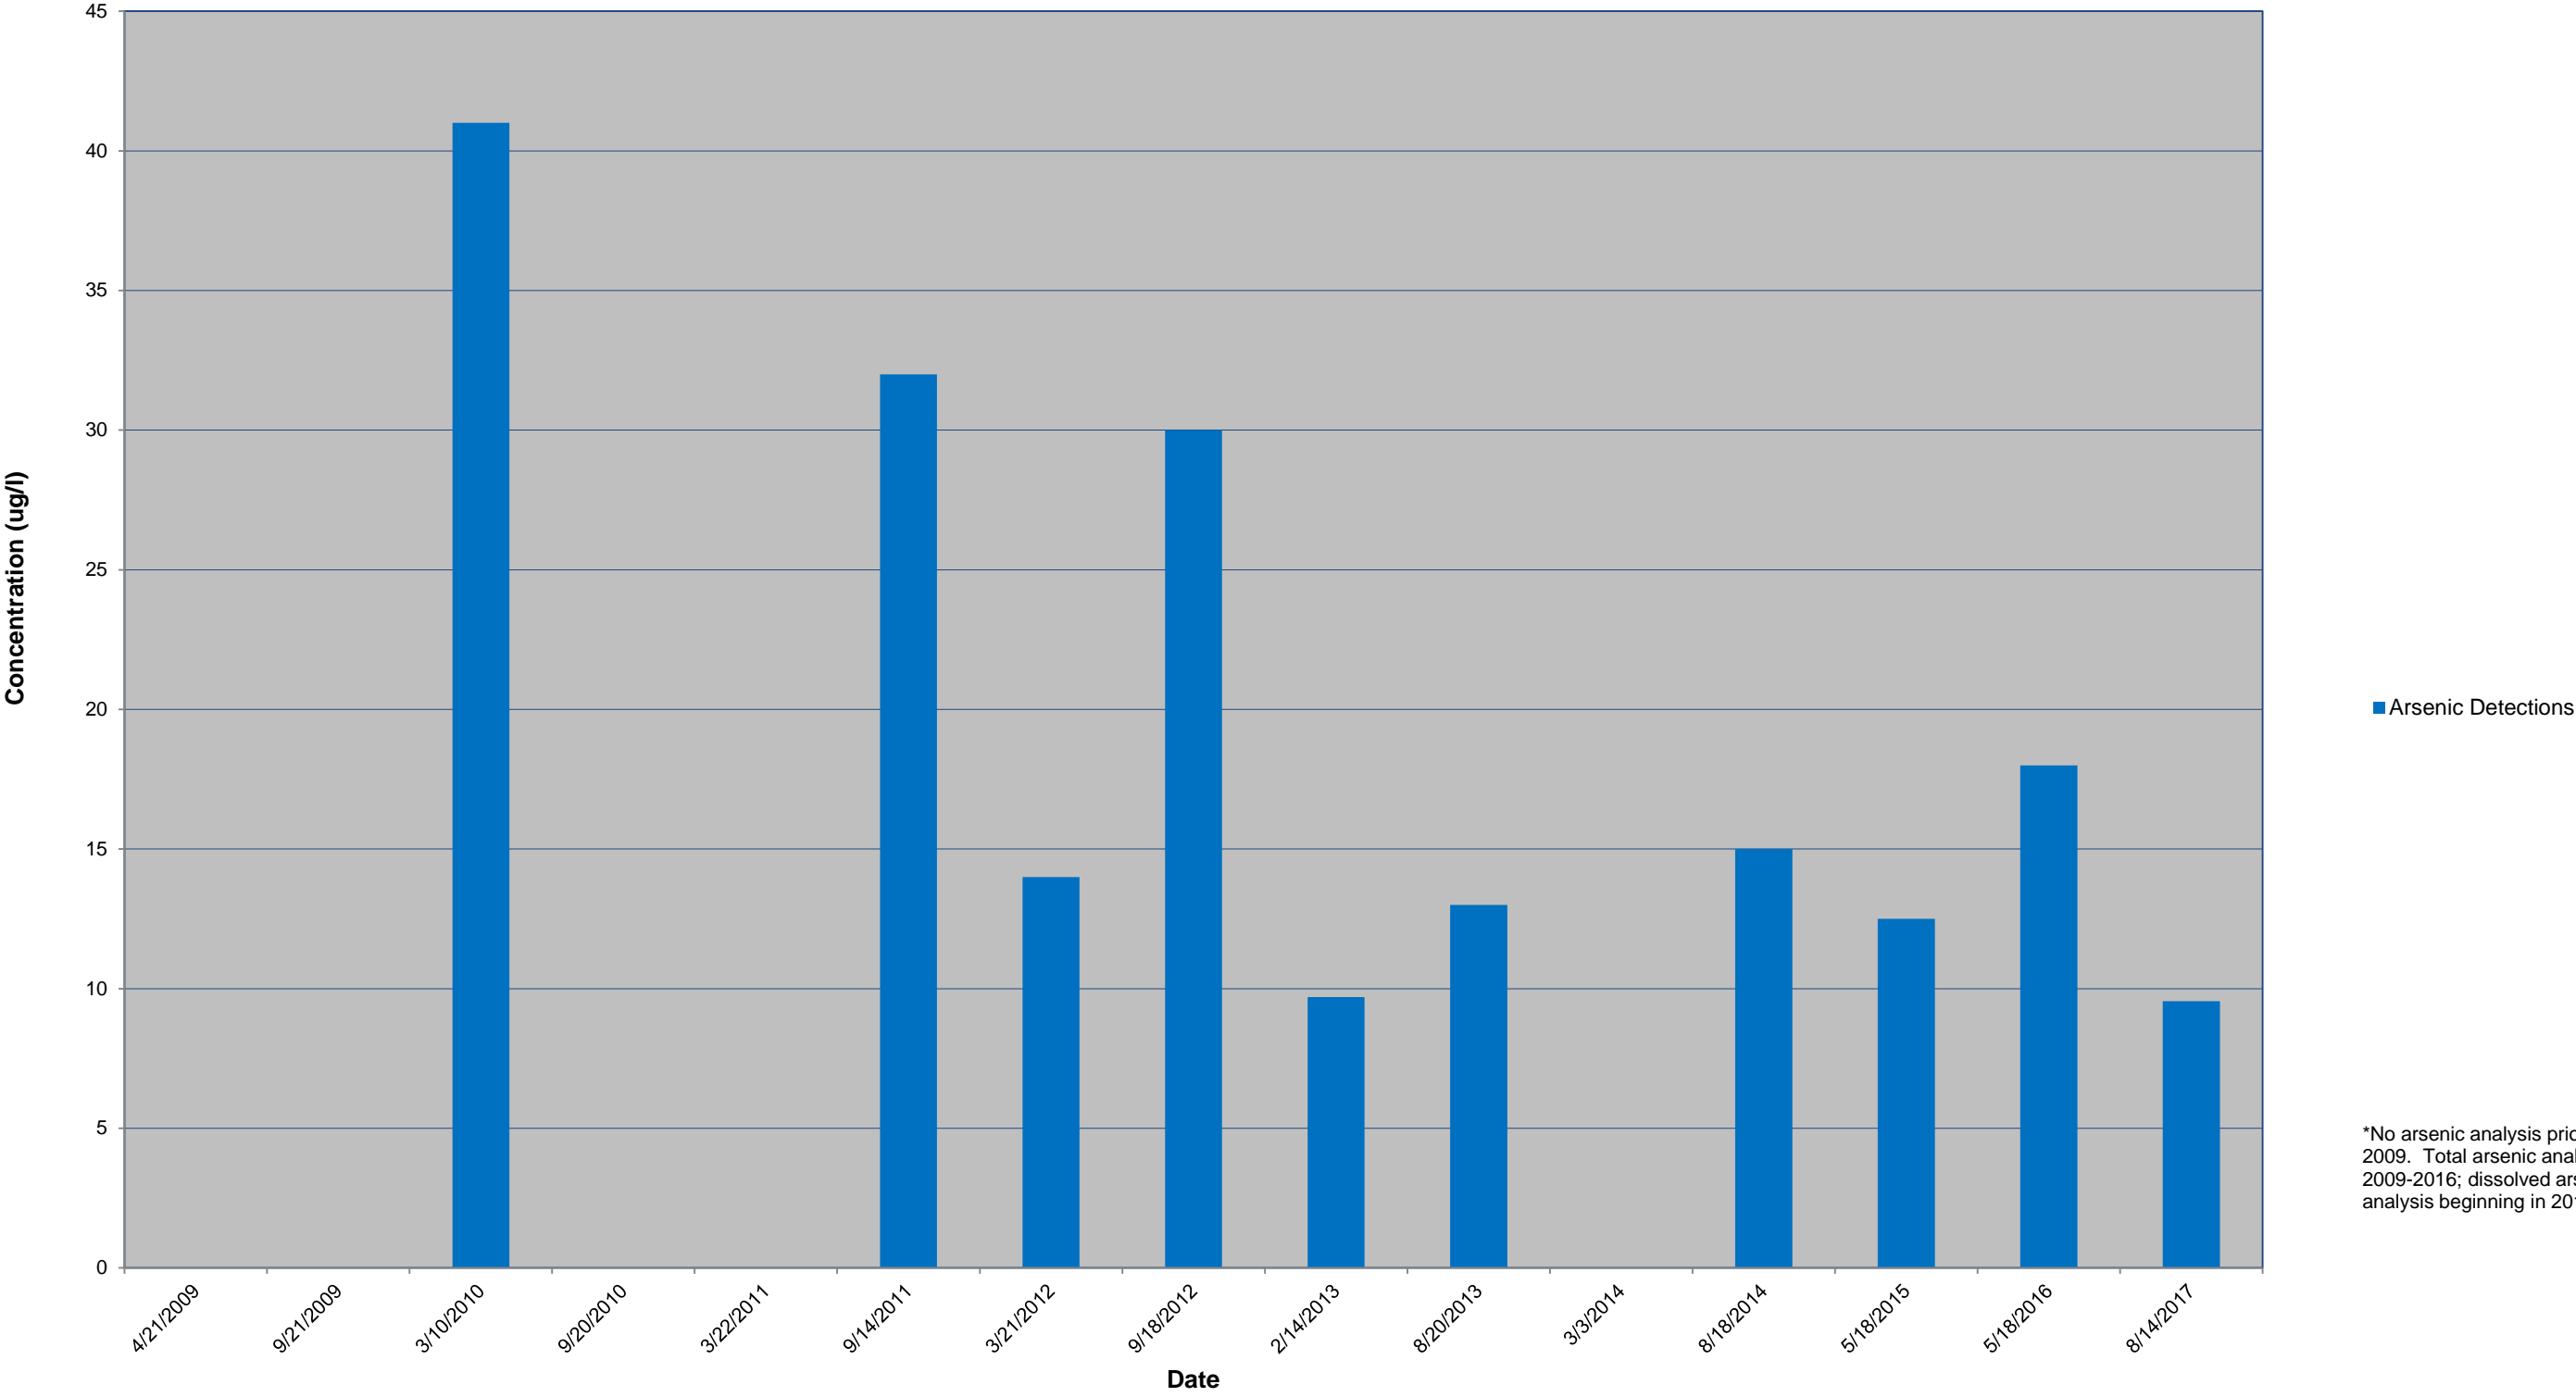
Arsenic Detections in CAMU MW01R Groundwater Samples  
2009 - 2017\*

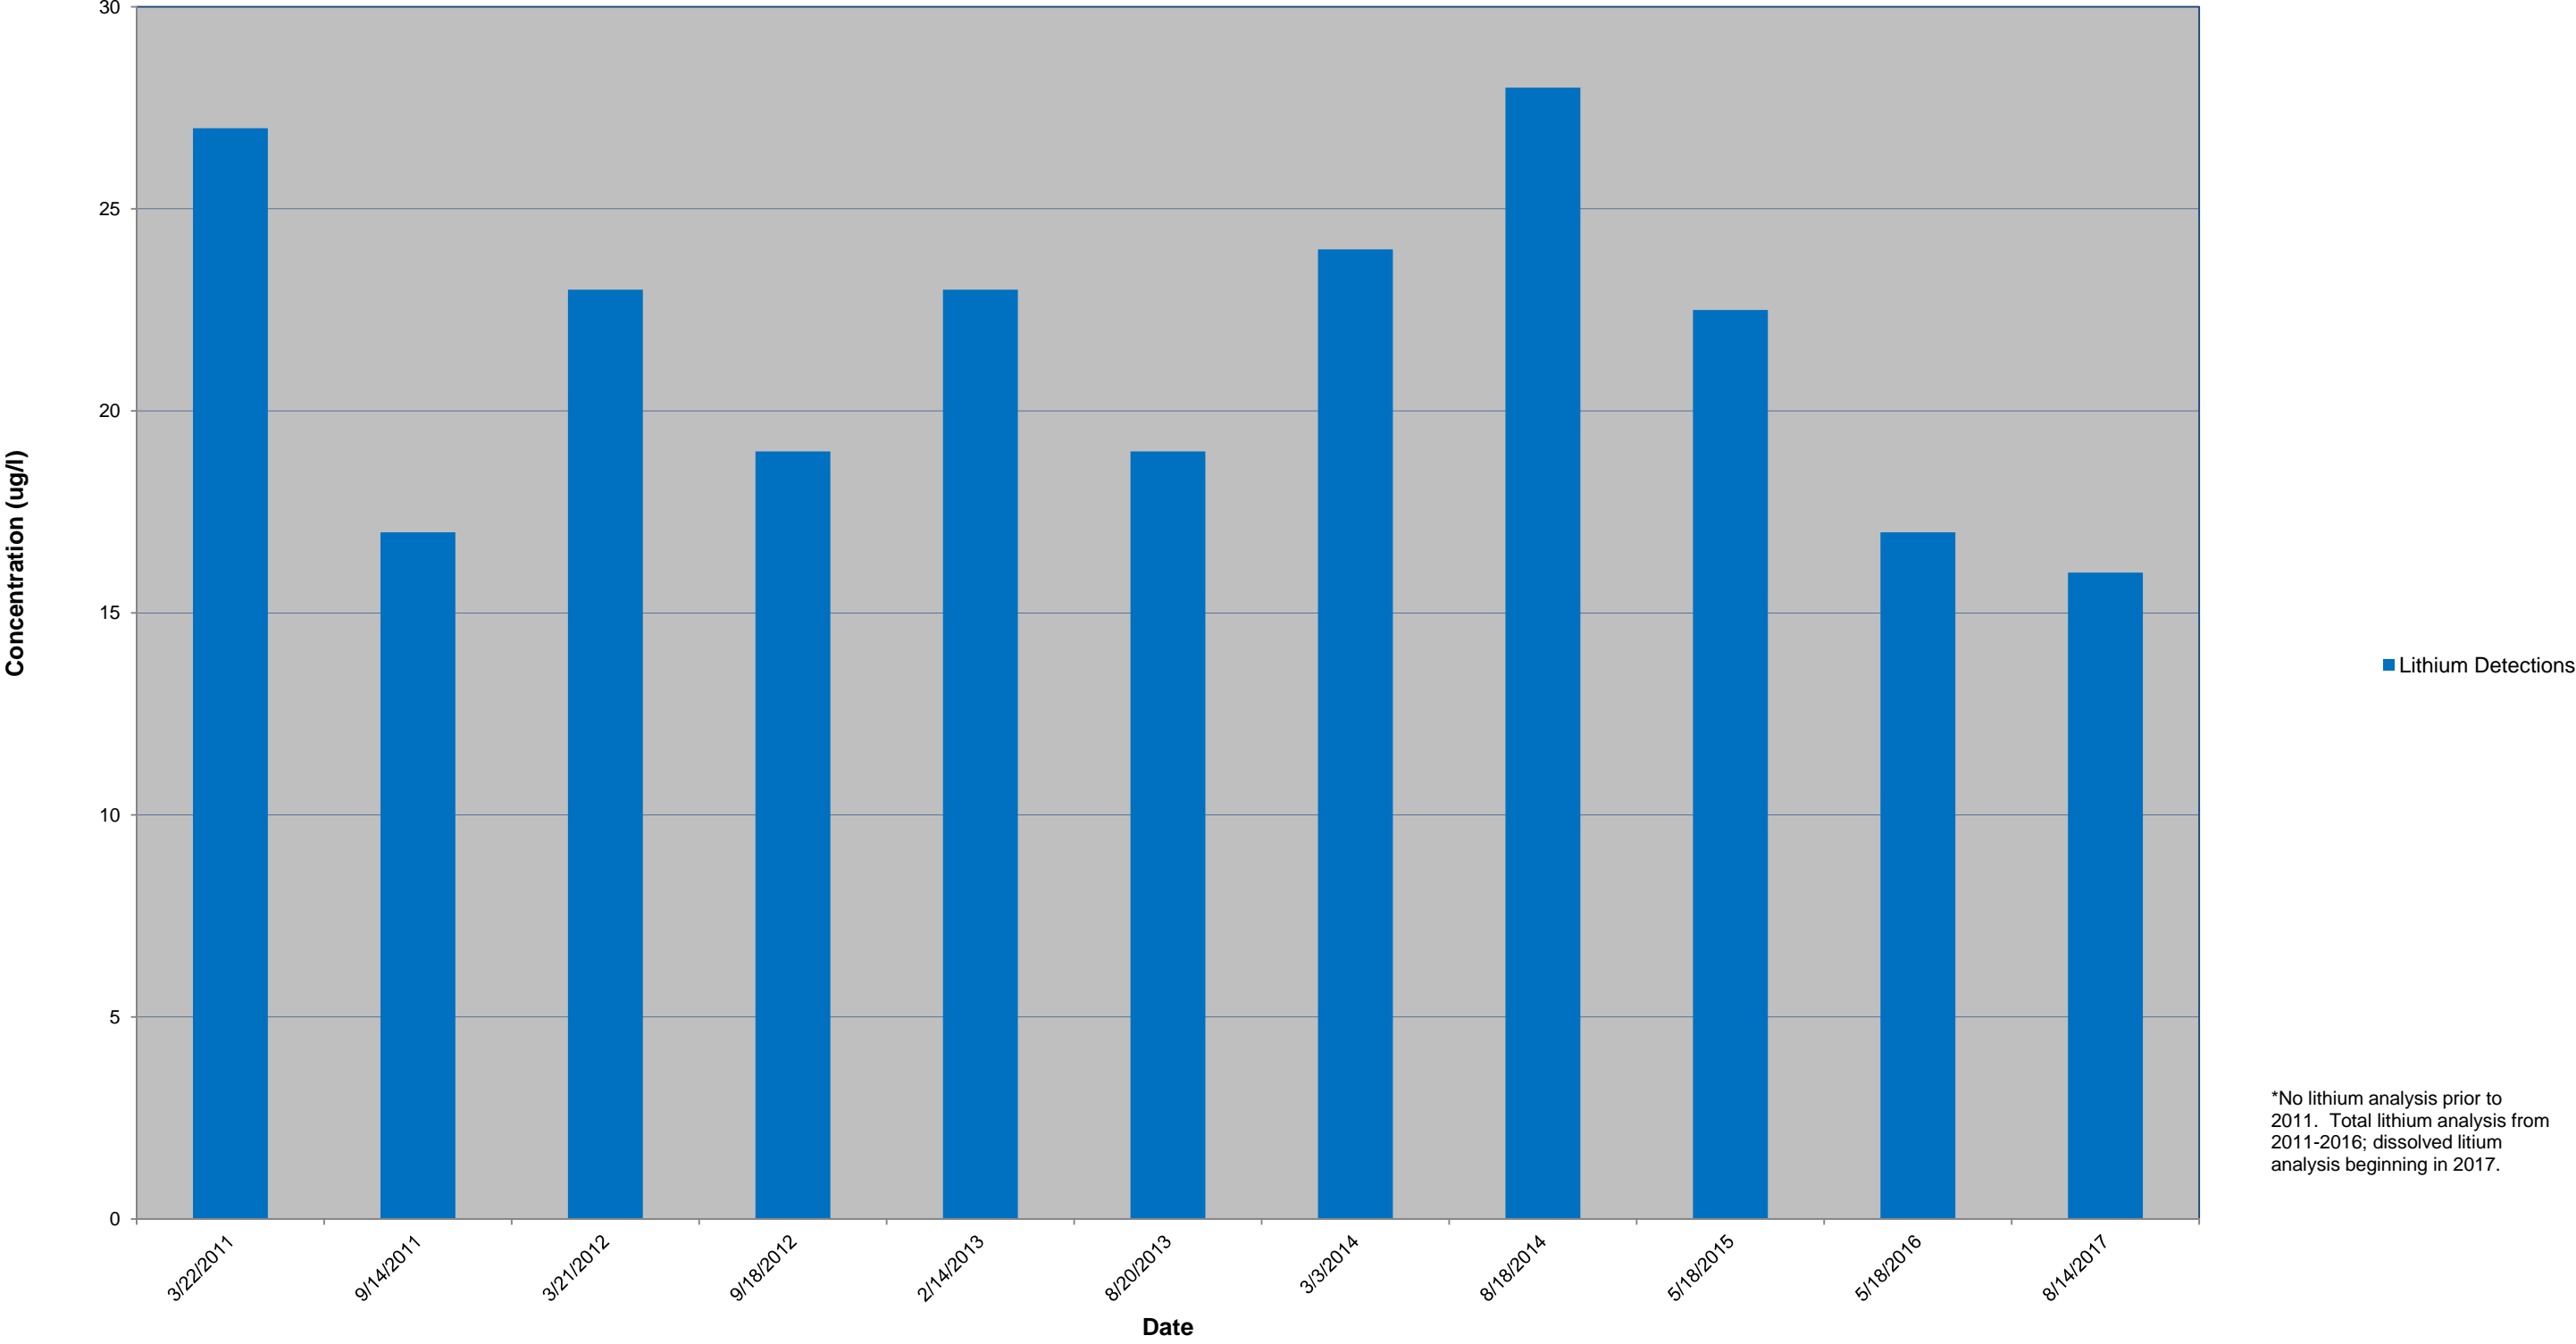
Lithium Detections in CAMU MW01R Groundwater Samples  
2011 - 2017\*

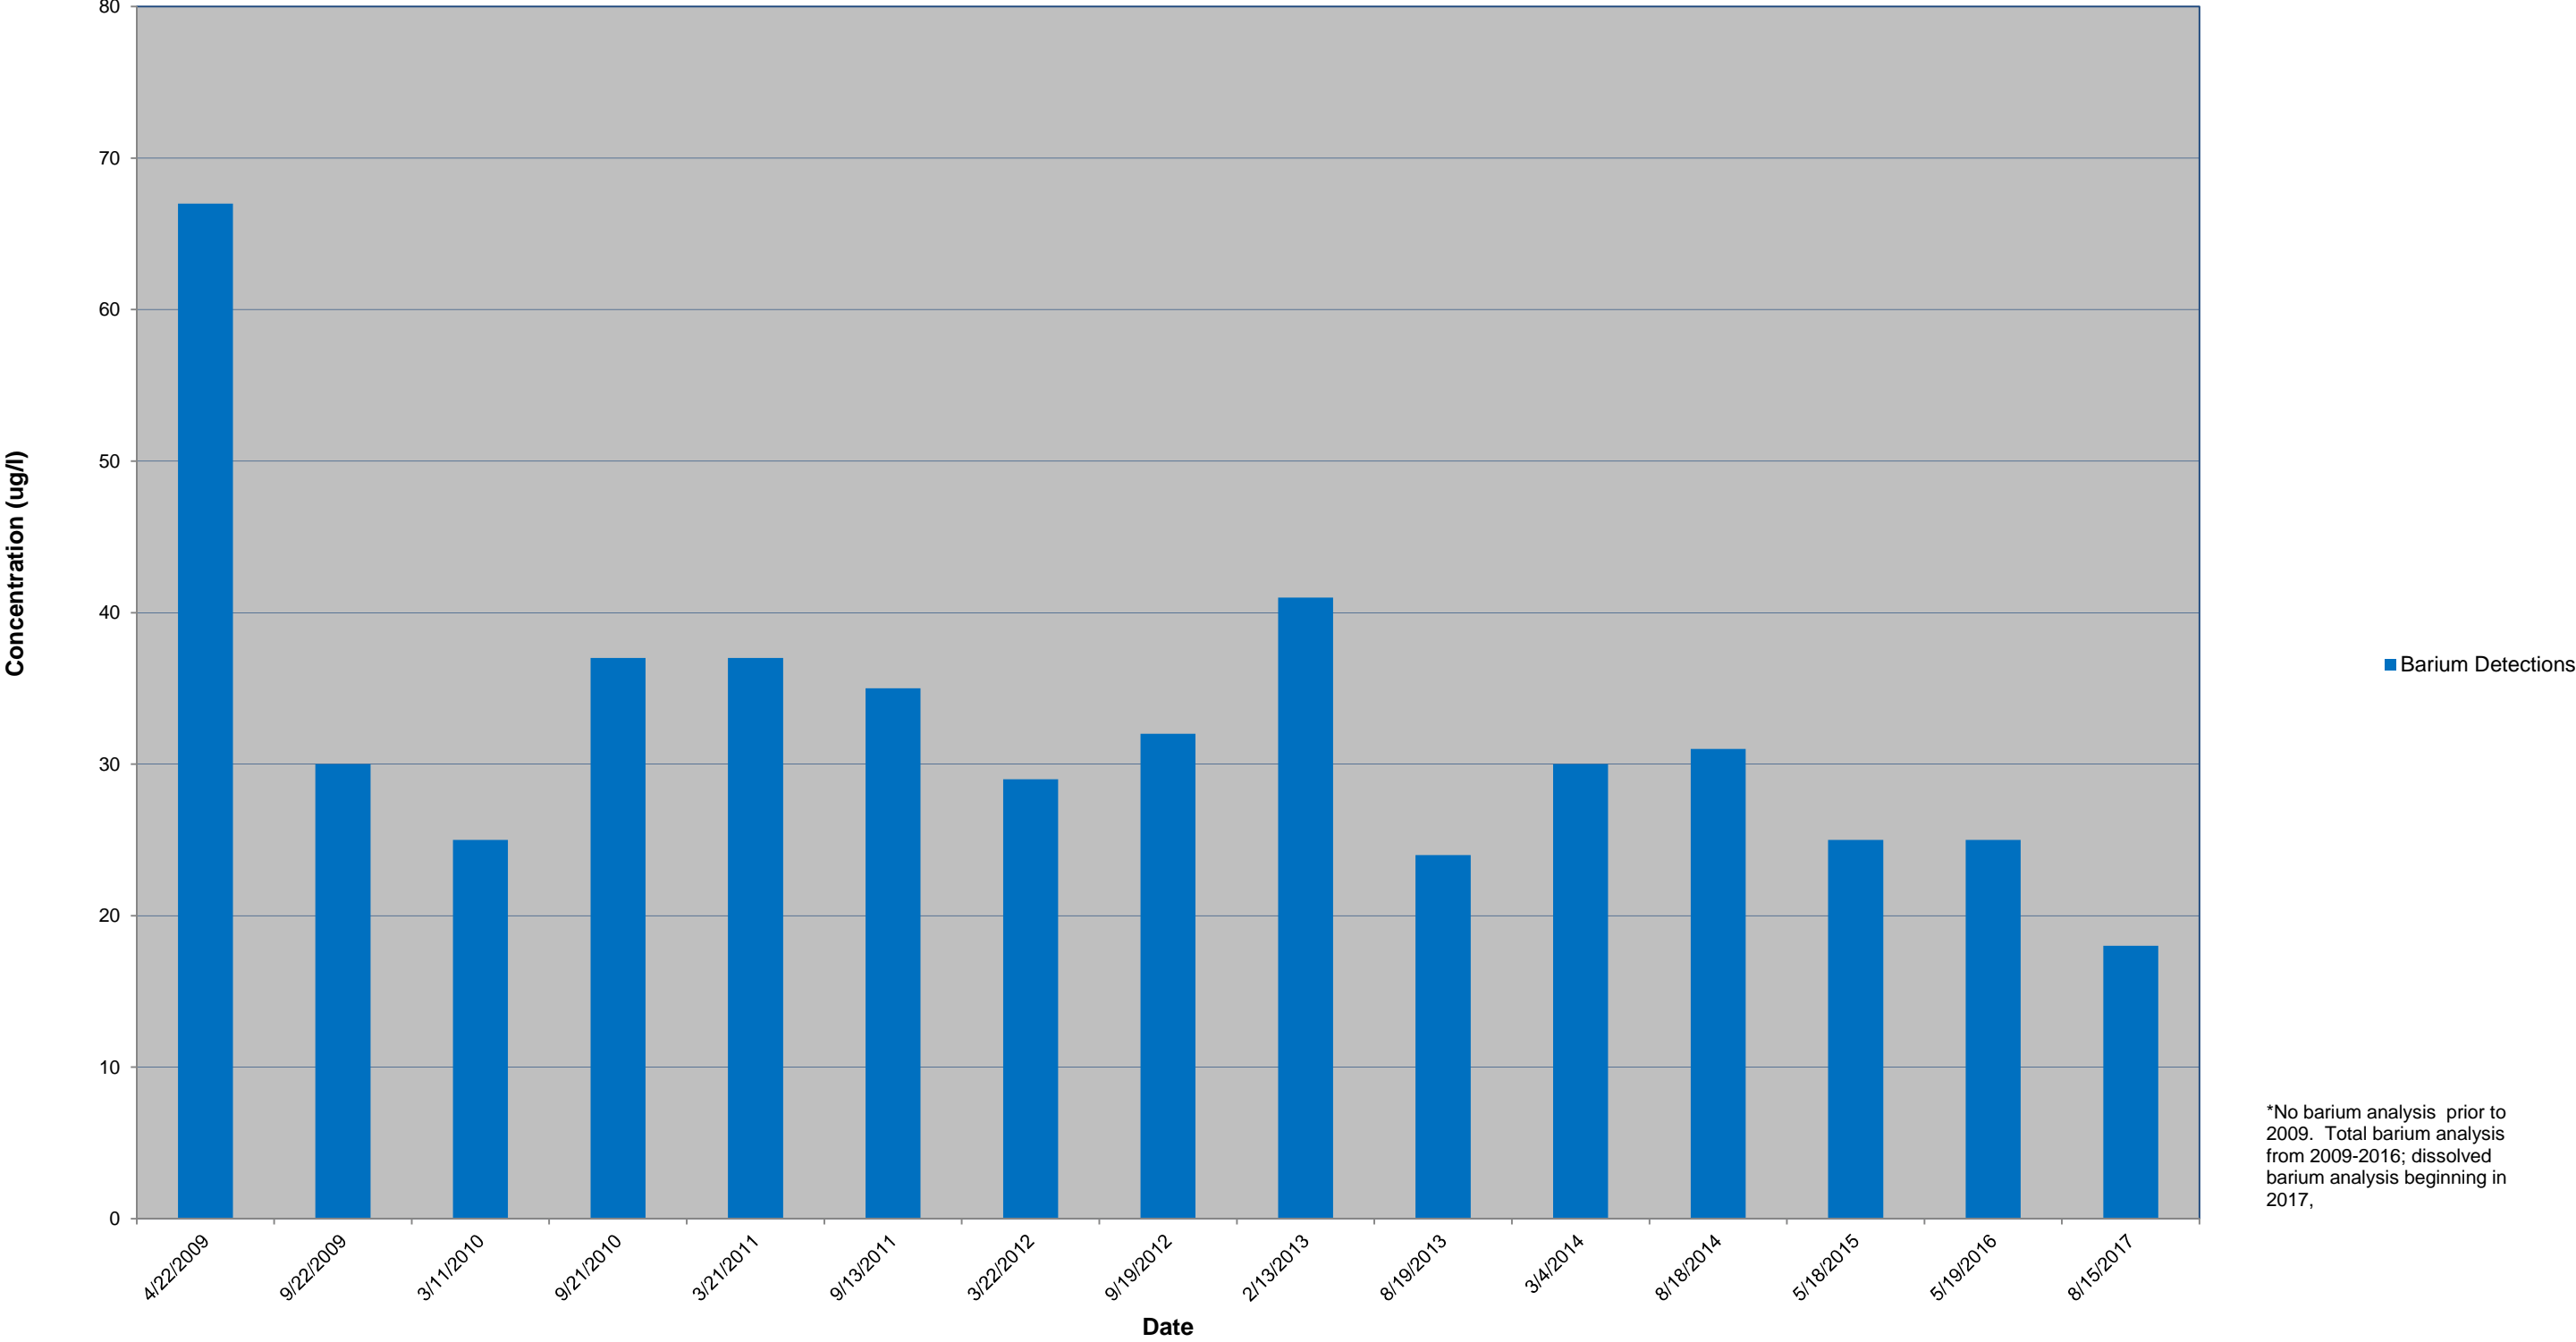
Barium Detections in CAMU MW02R Groundwater Samples  
2009 - 2017\*

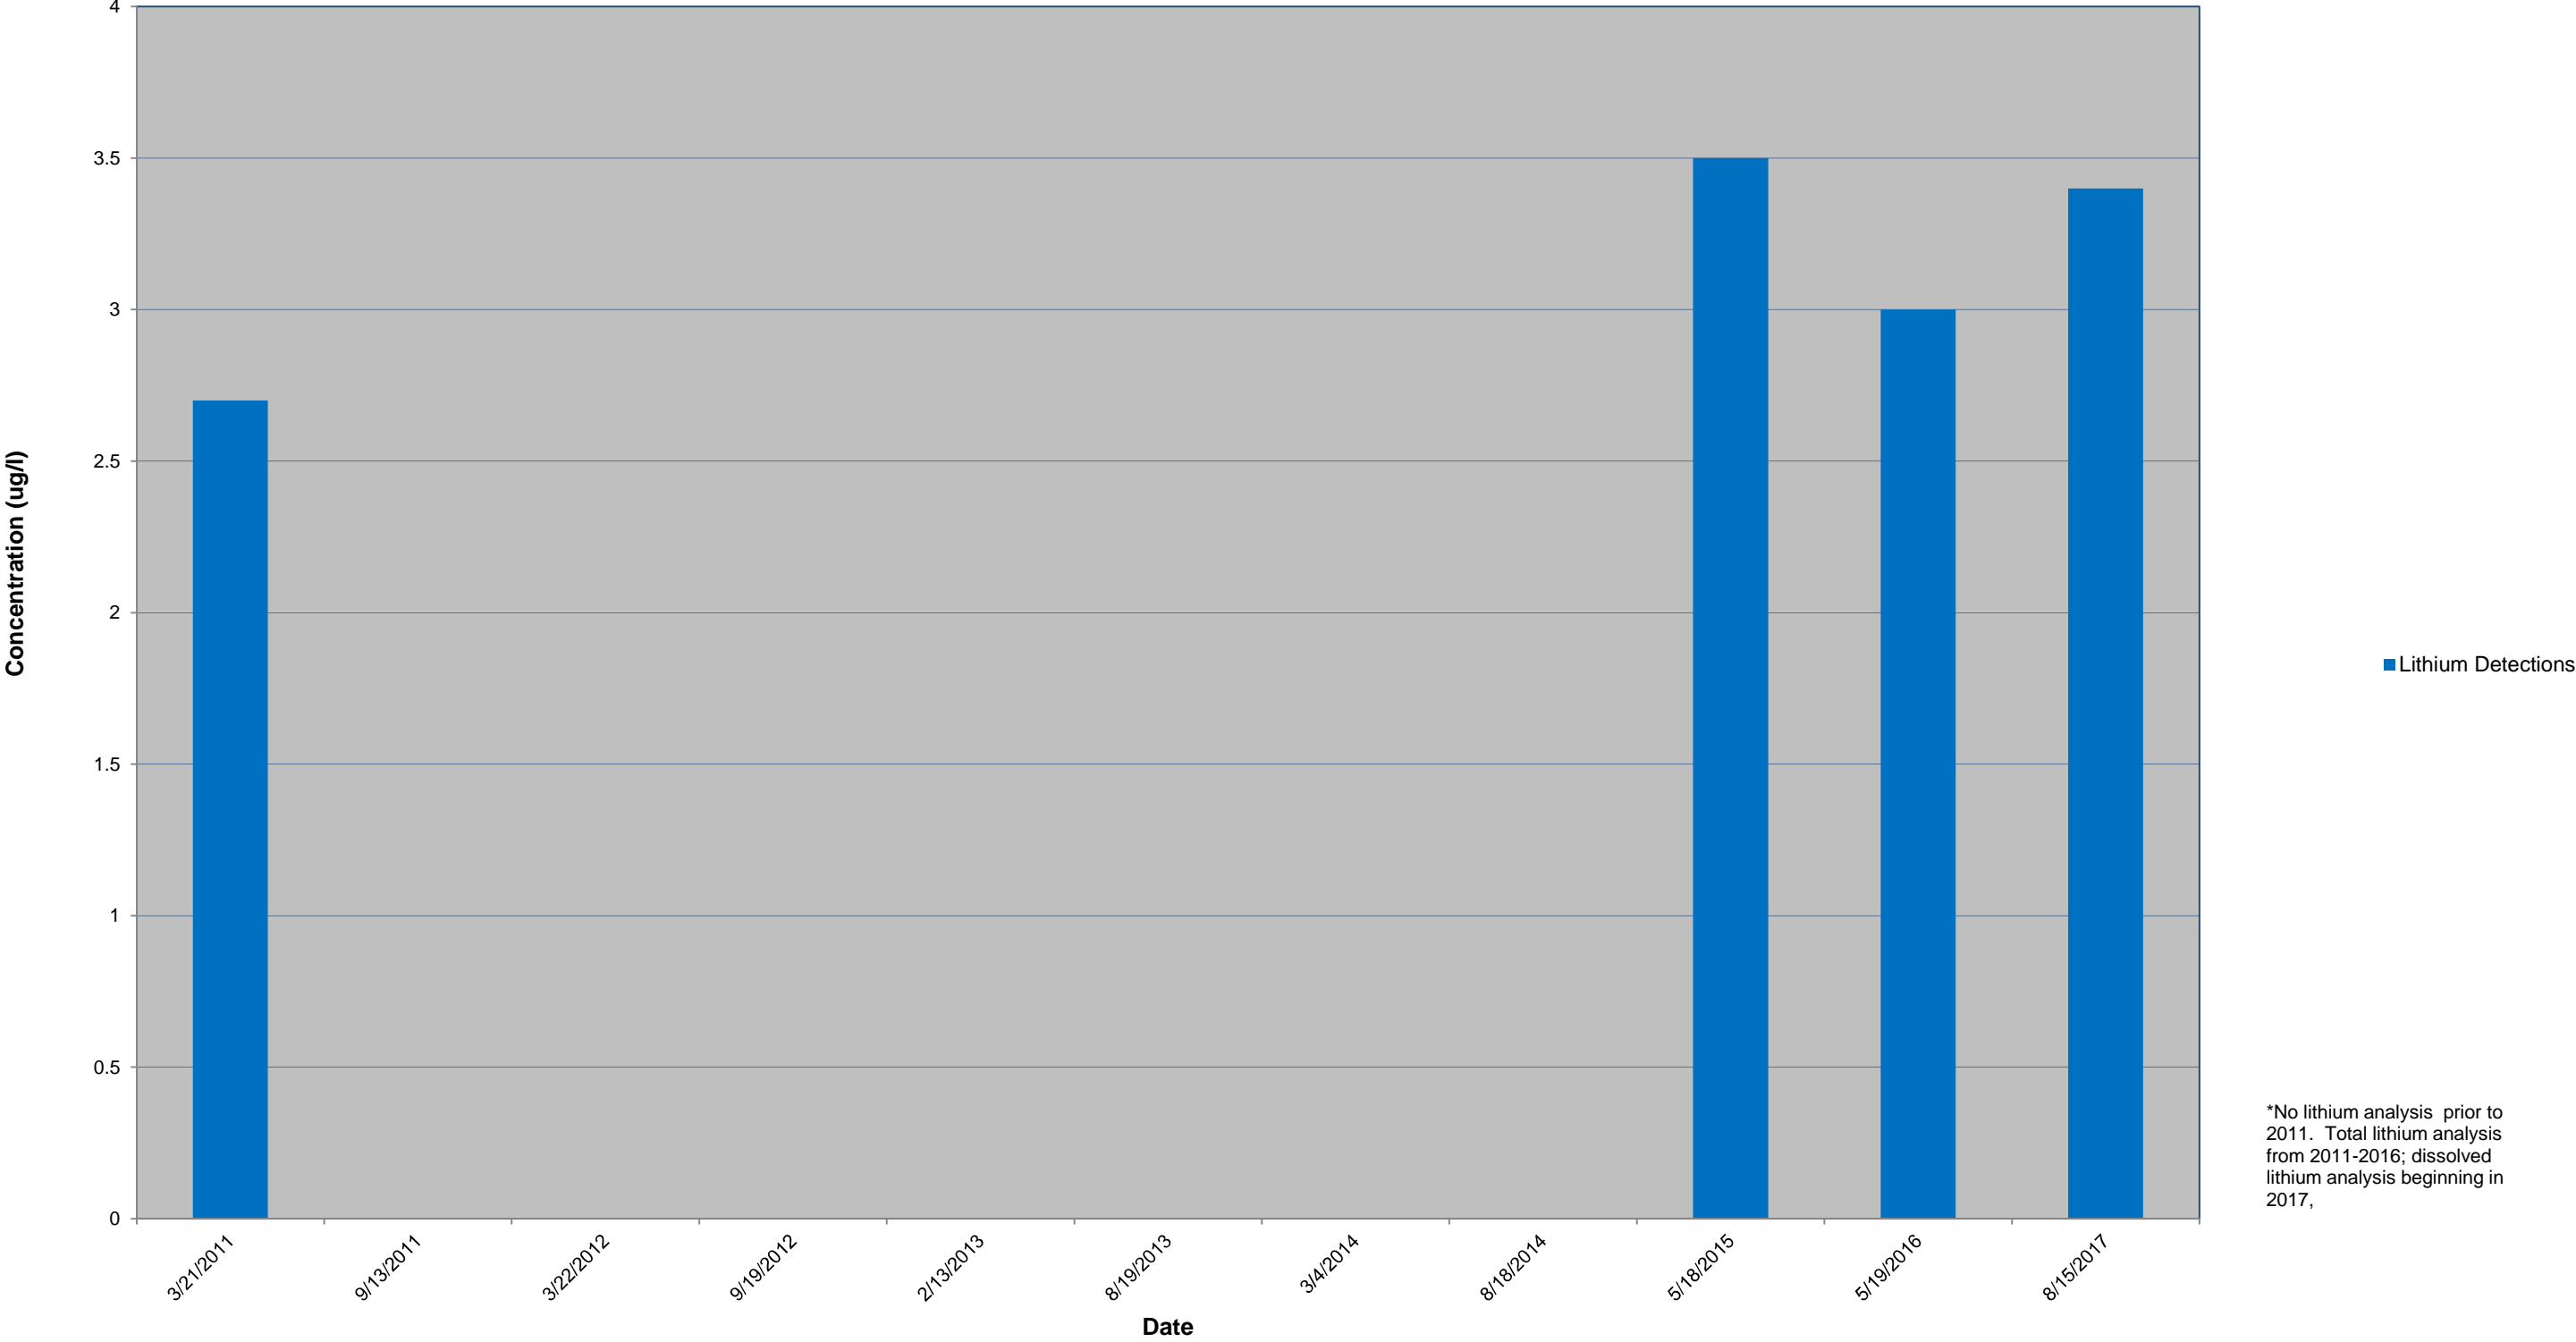
**Litium Detections in CAMU MW02R Groundwater Samples  
2011 - 2017\***

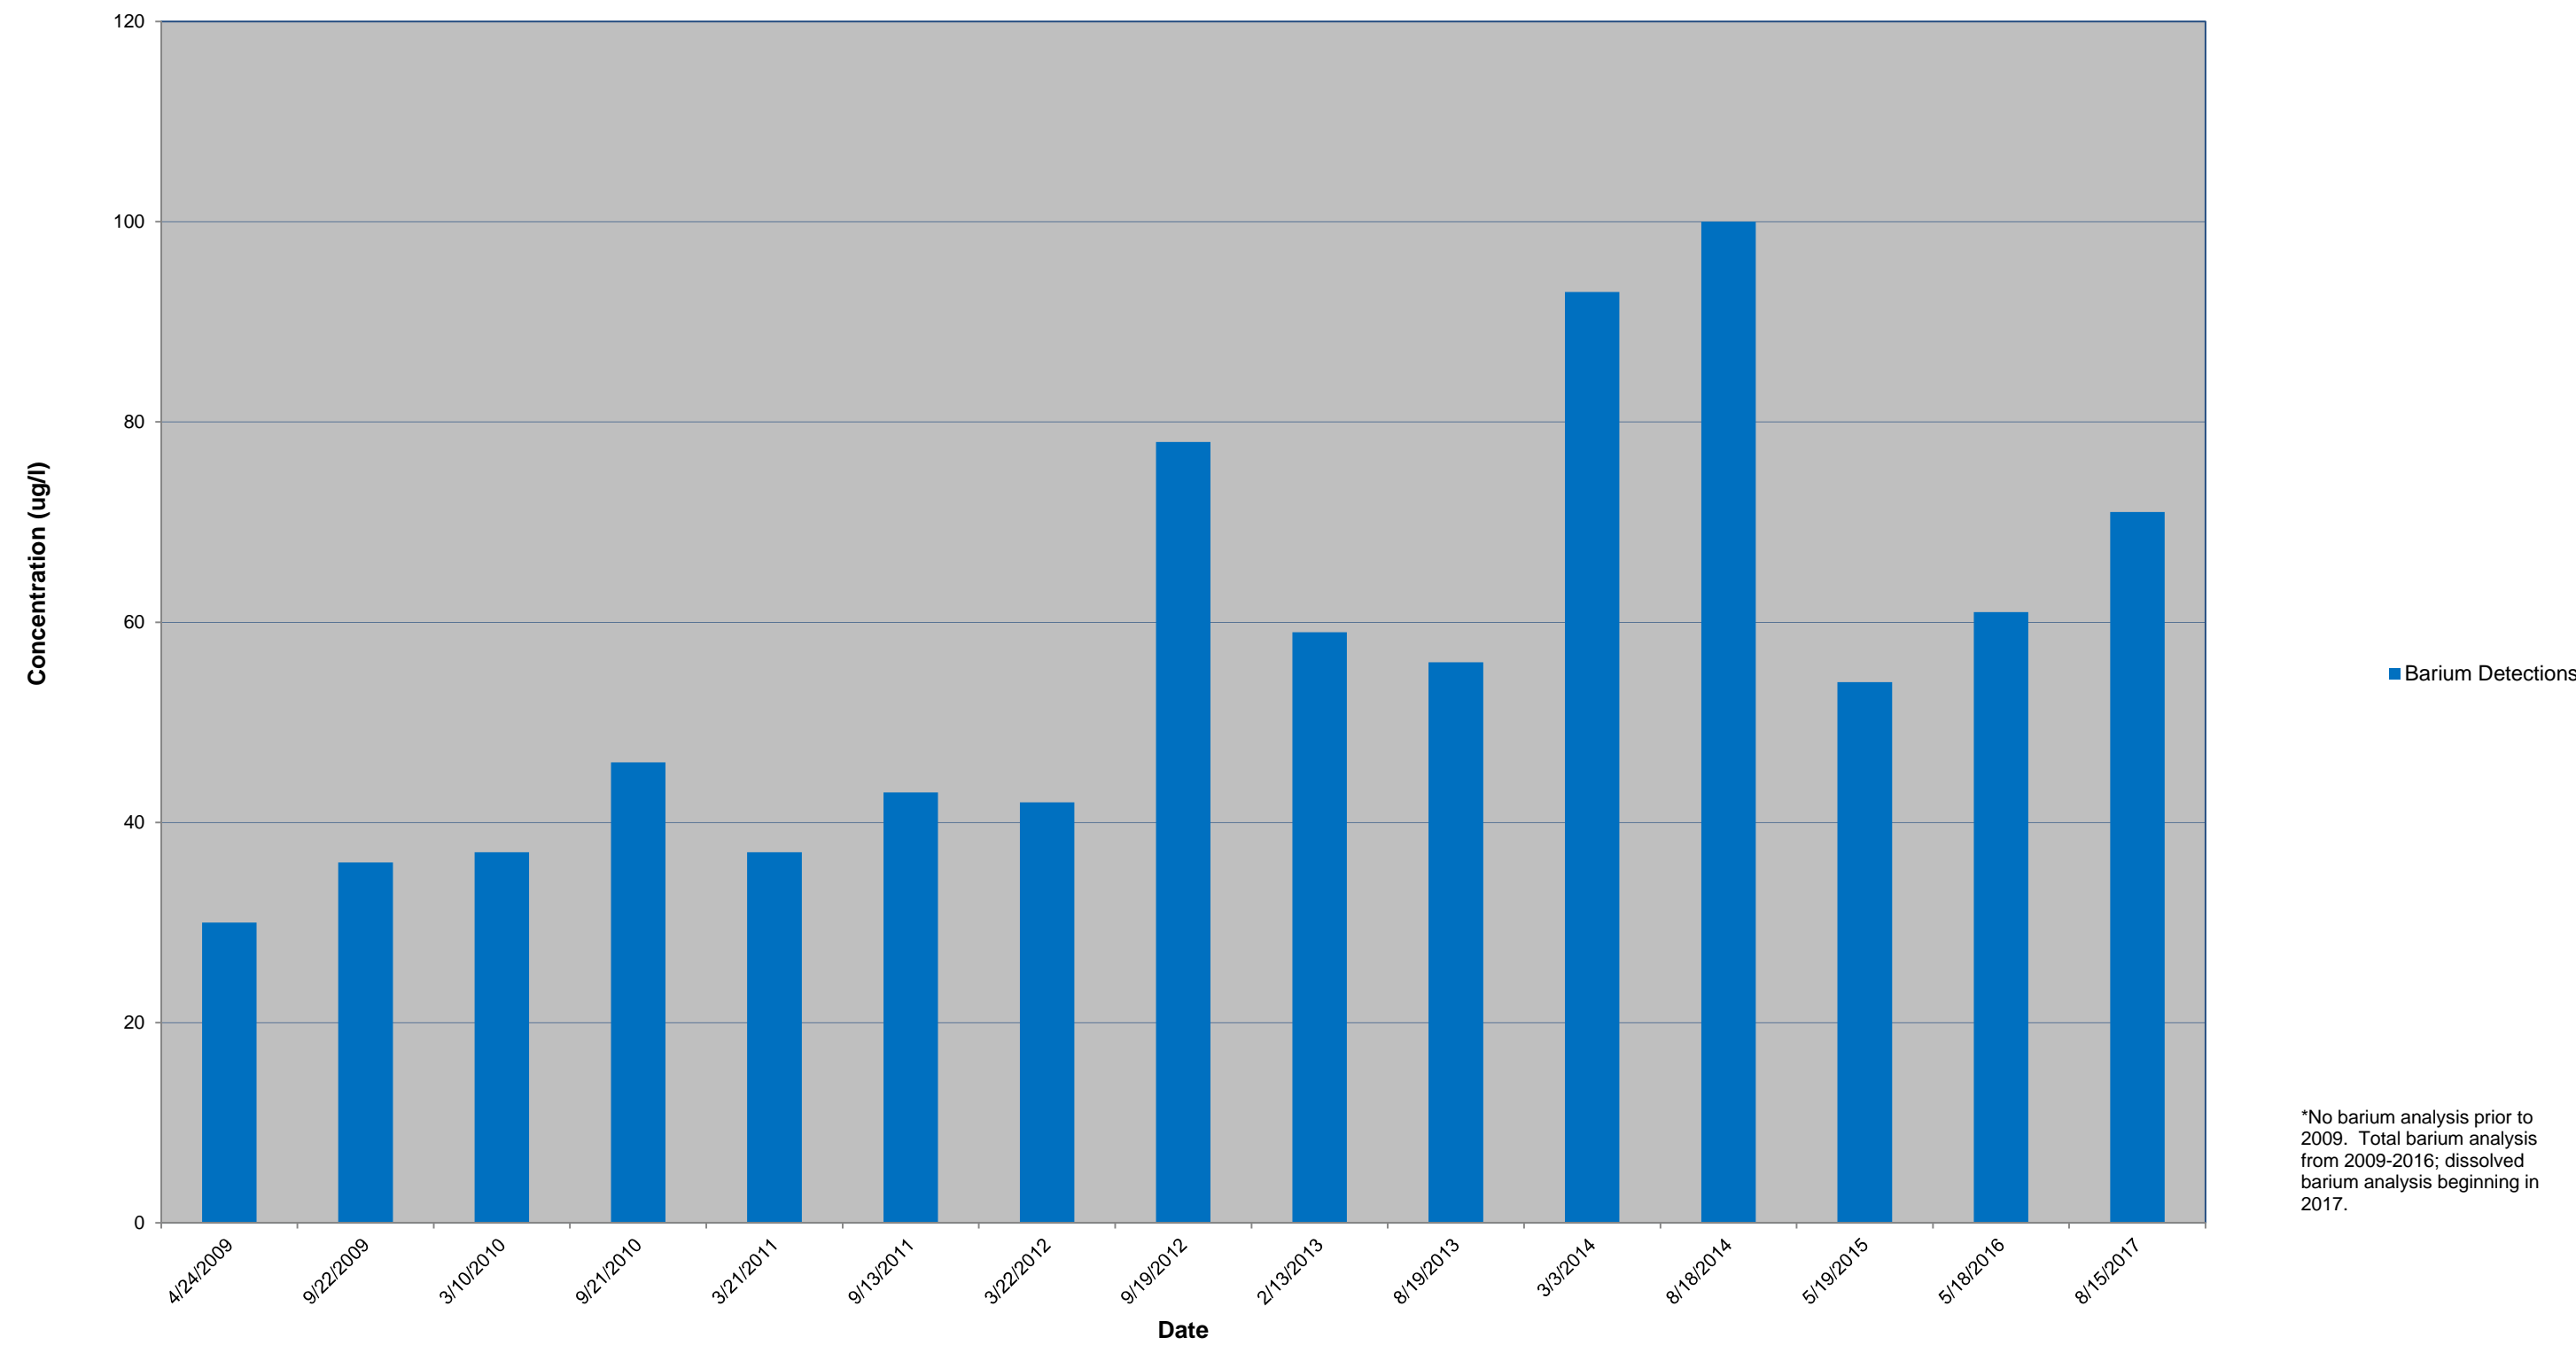
**Barium Detections in CAMU MW04 Groundwater Samples  
2009 - 2017\***

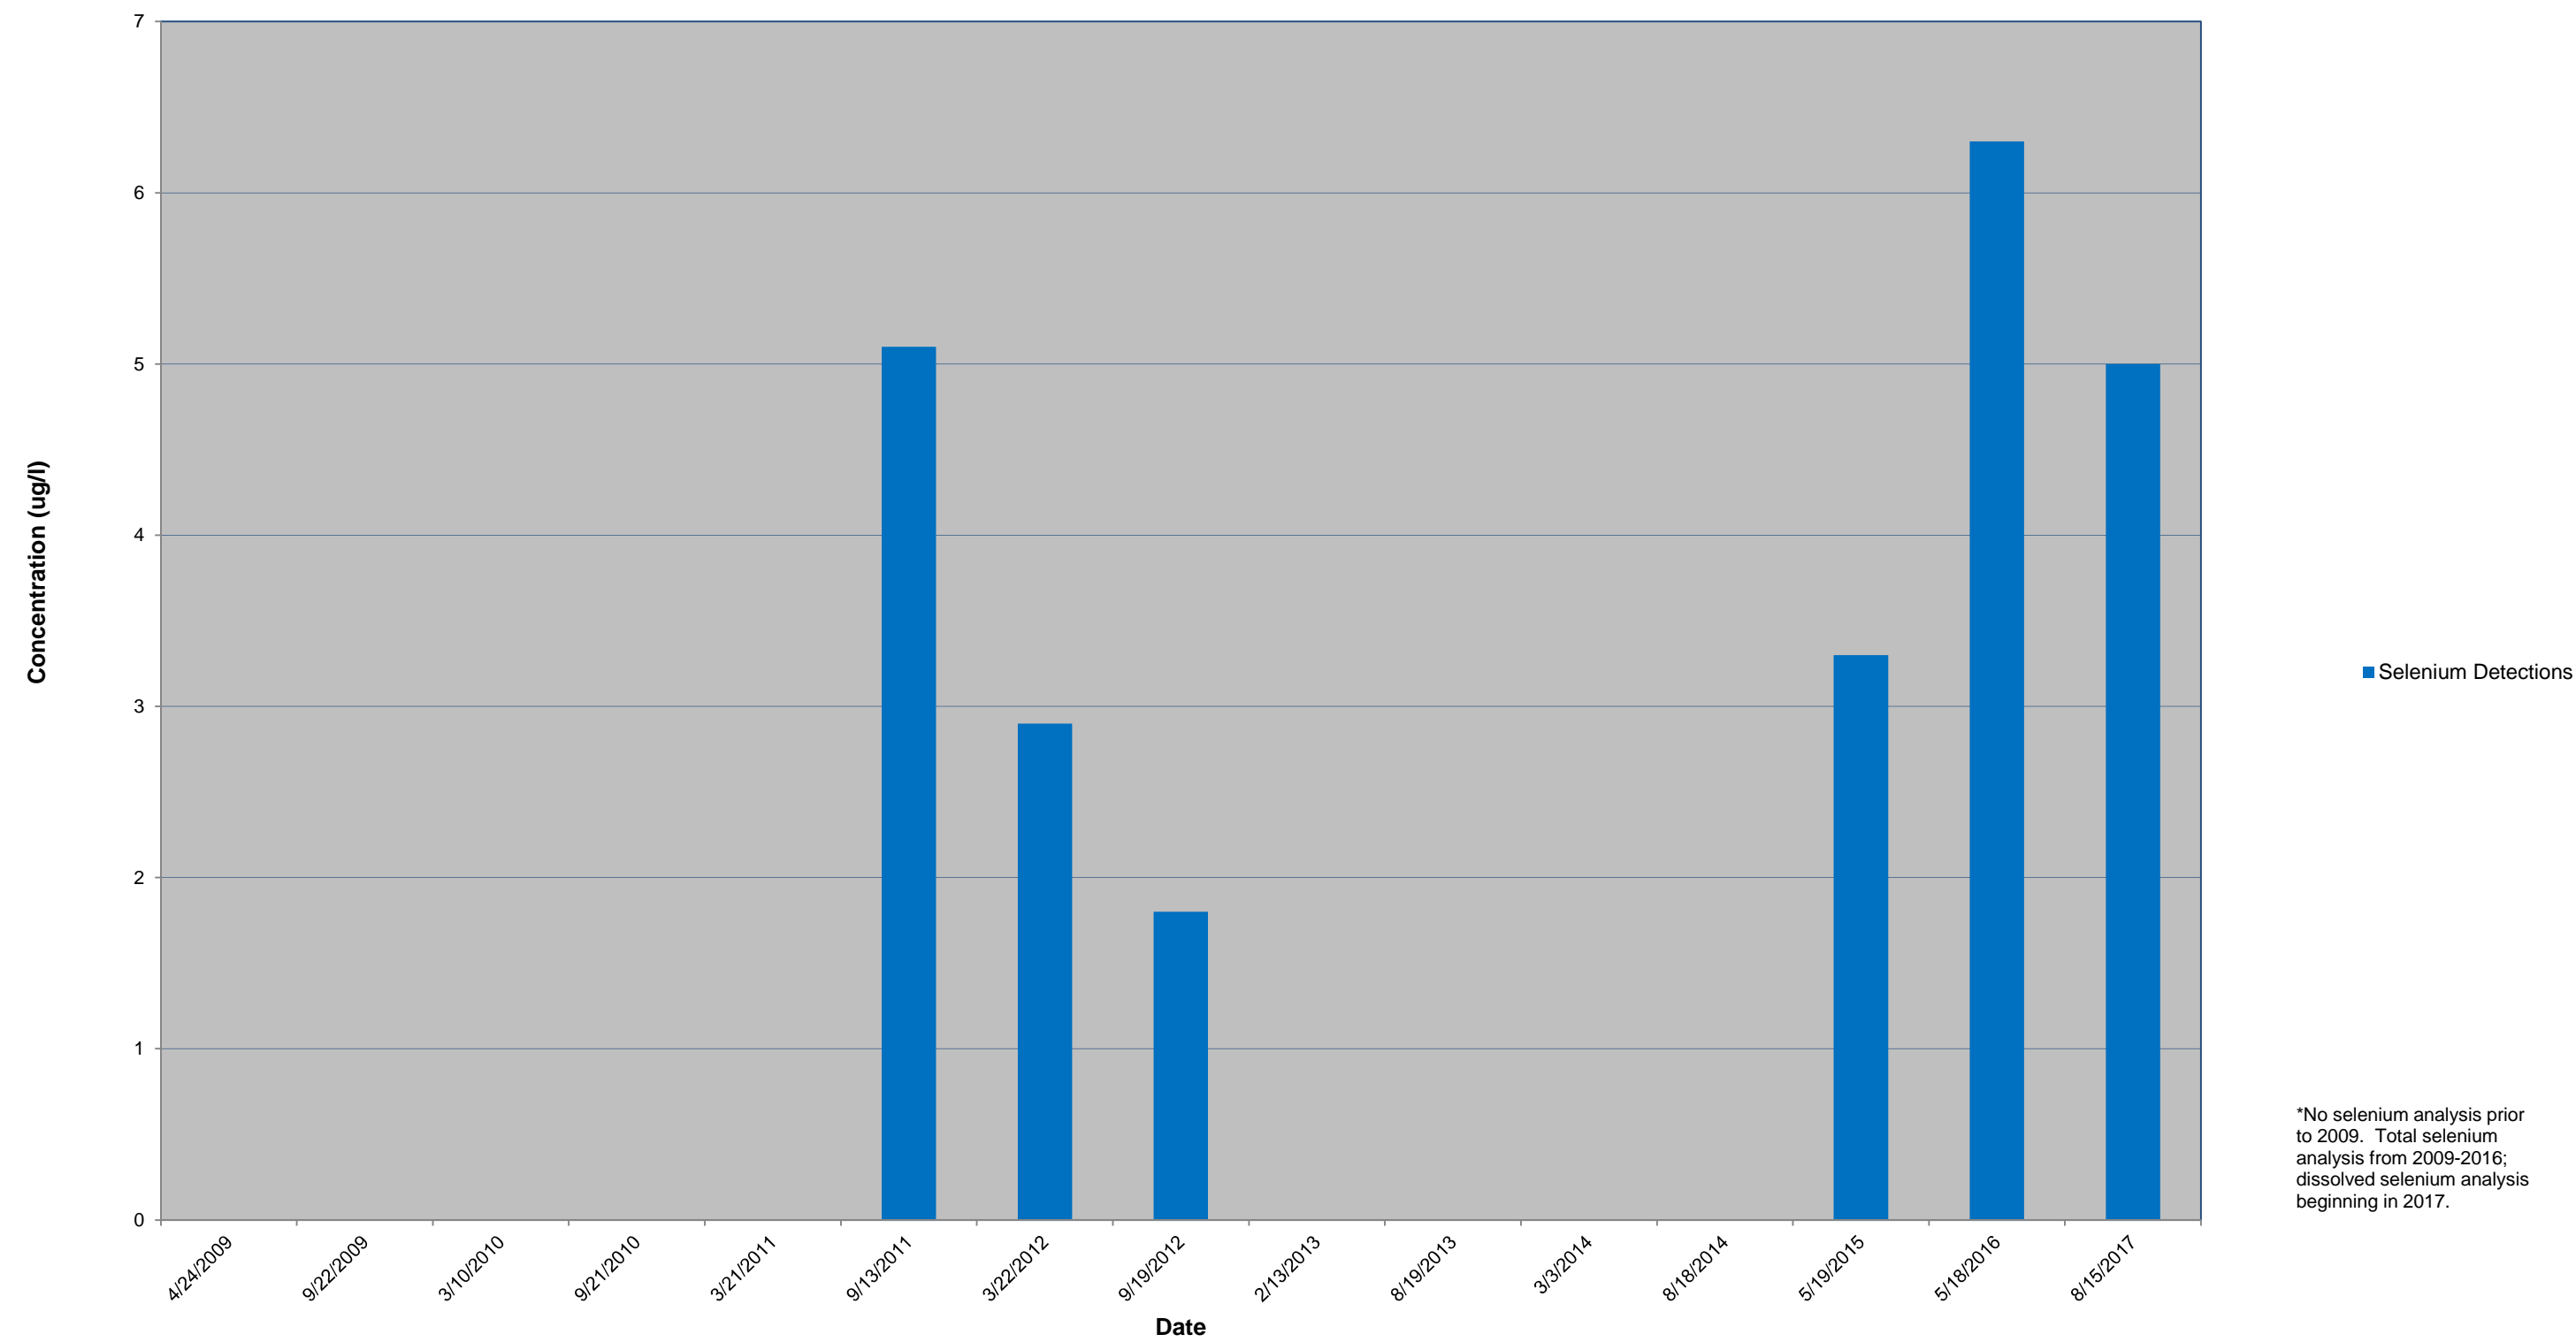
**Selenium Detections in CAMU MW04 Groundwater Samples  
2009 - 2017\***
