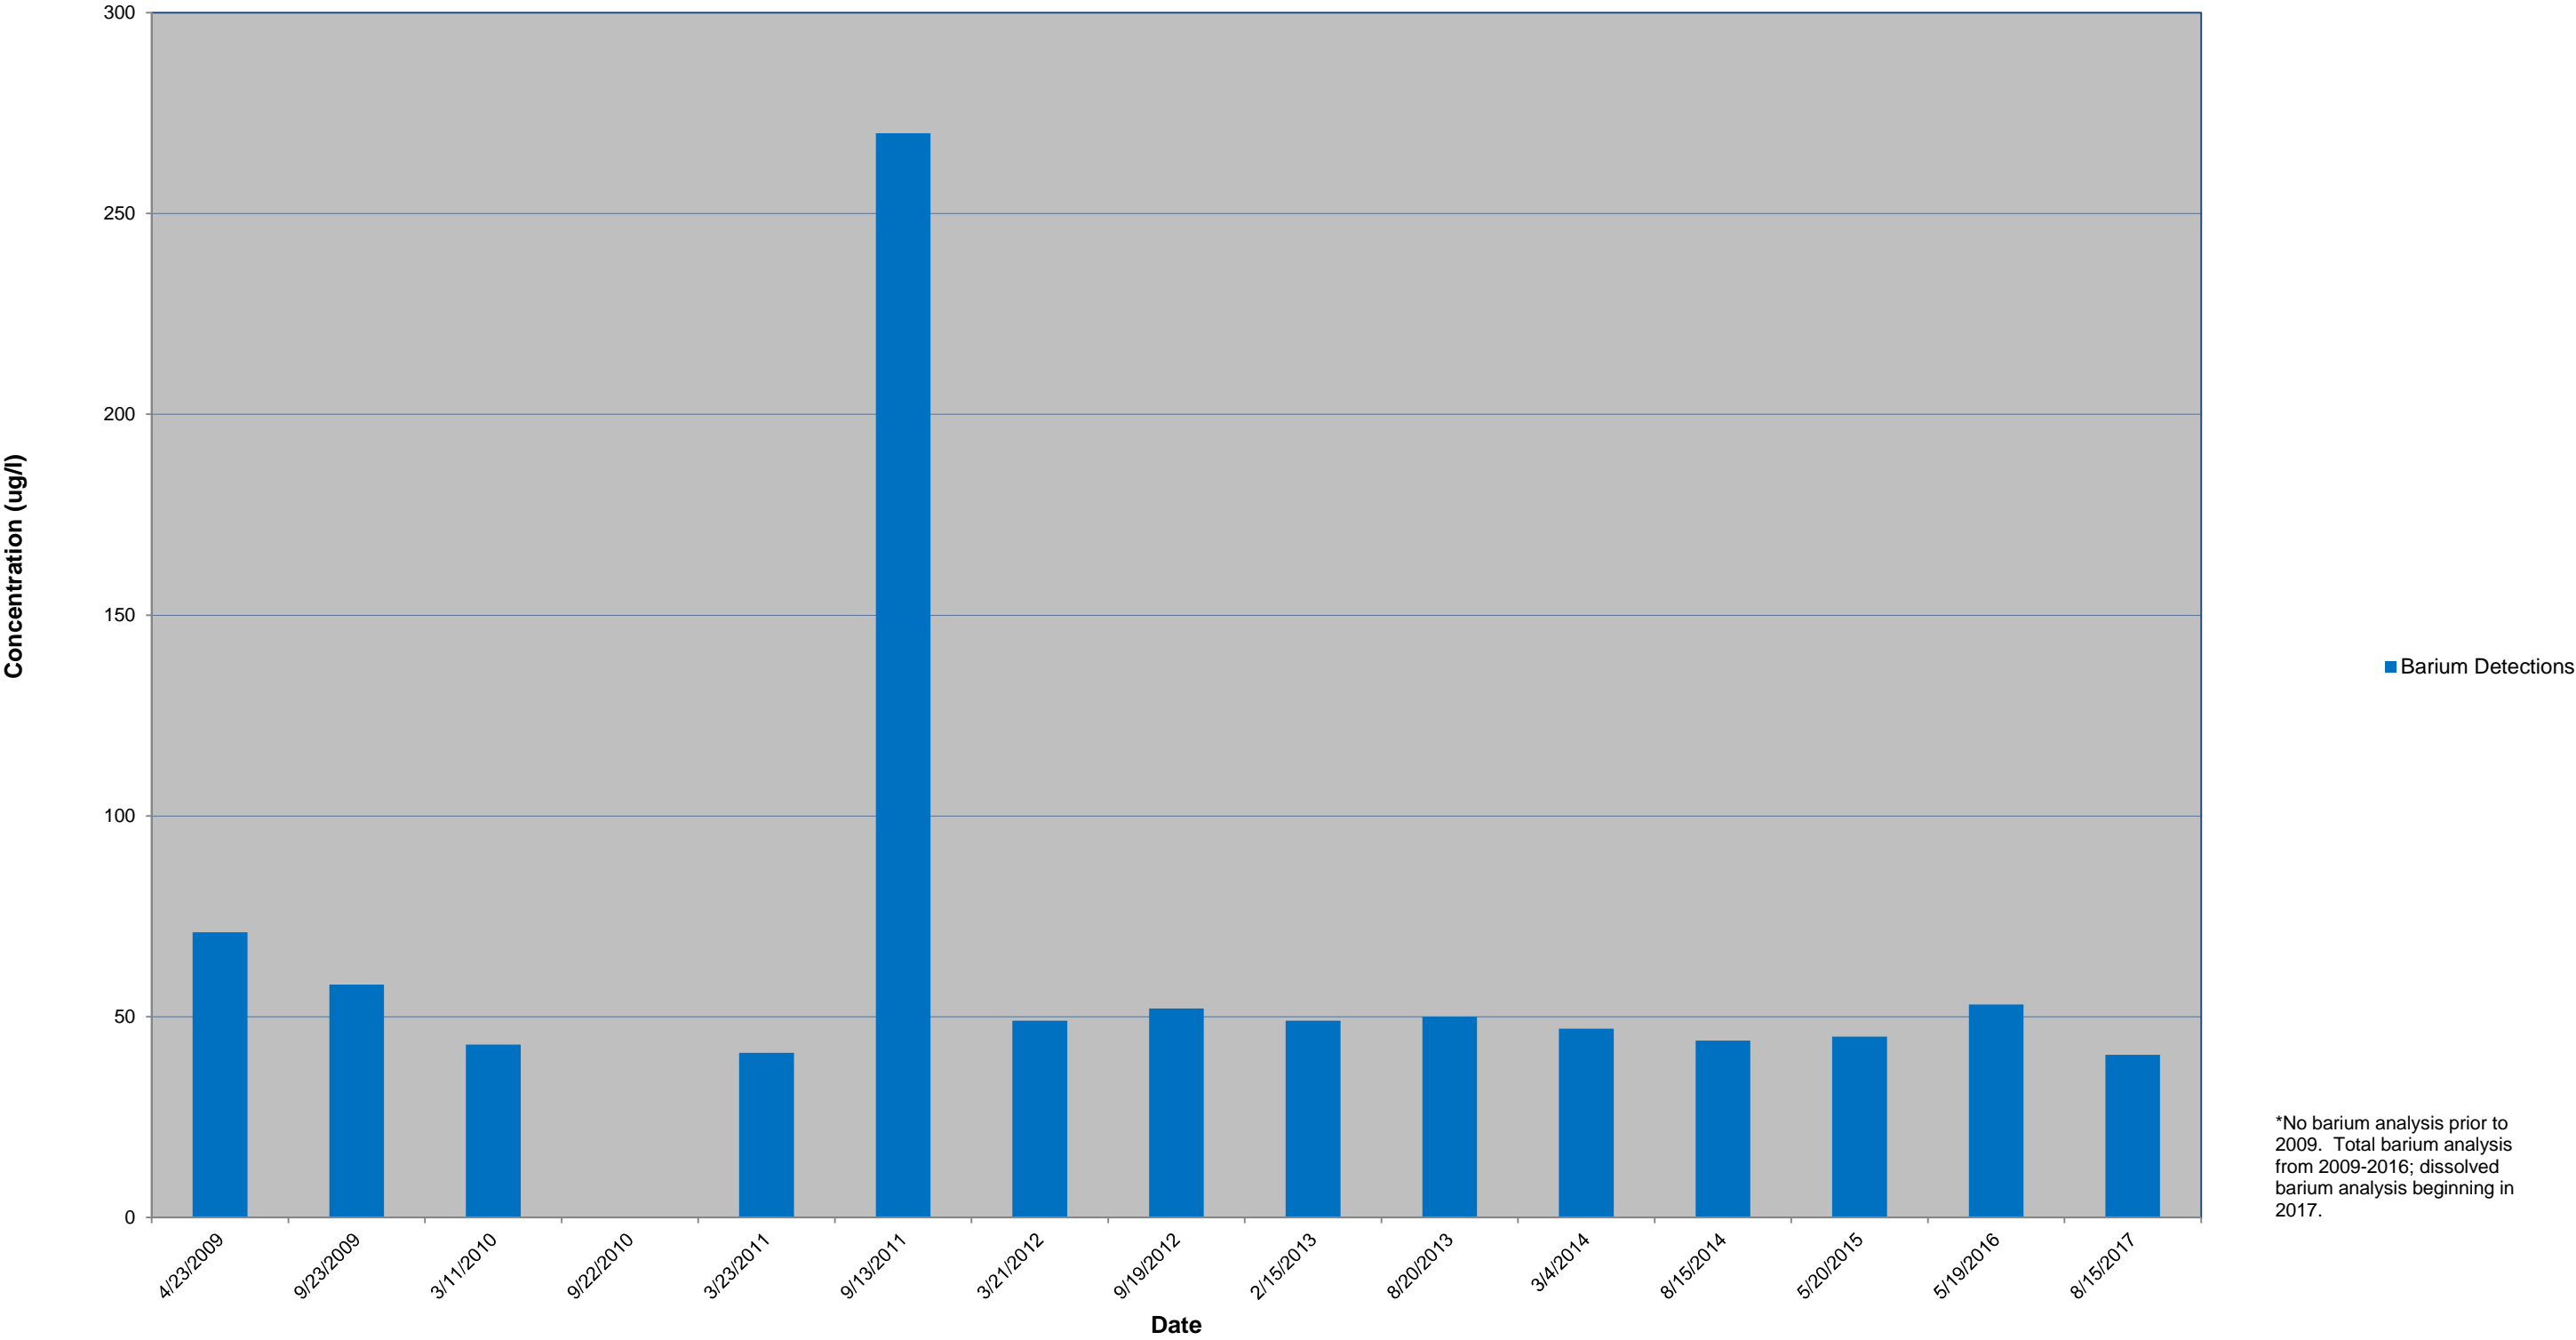
Barium Detections in CAMU MW05 Groundwater Samples  
2009 - 2017\*

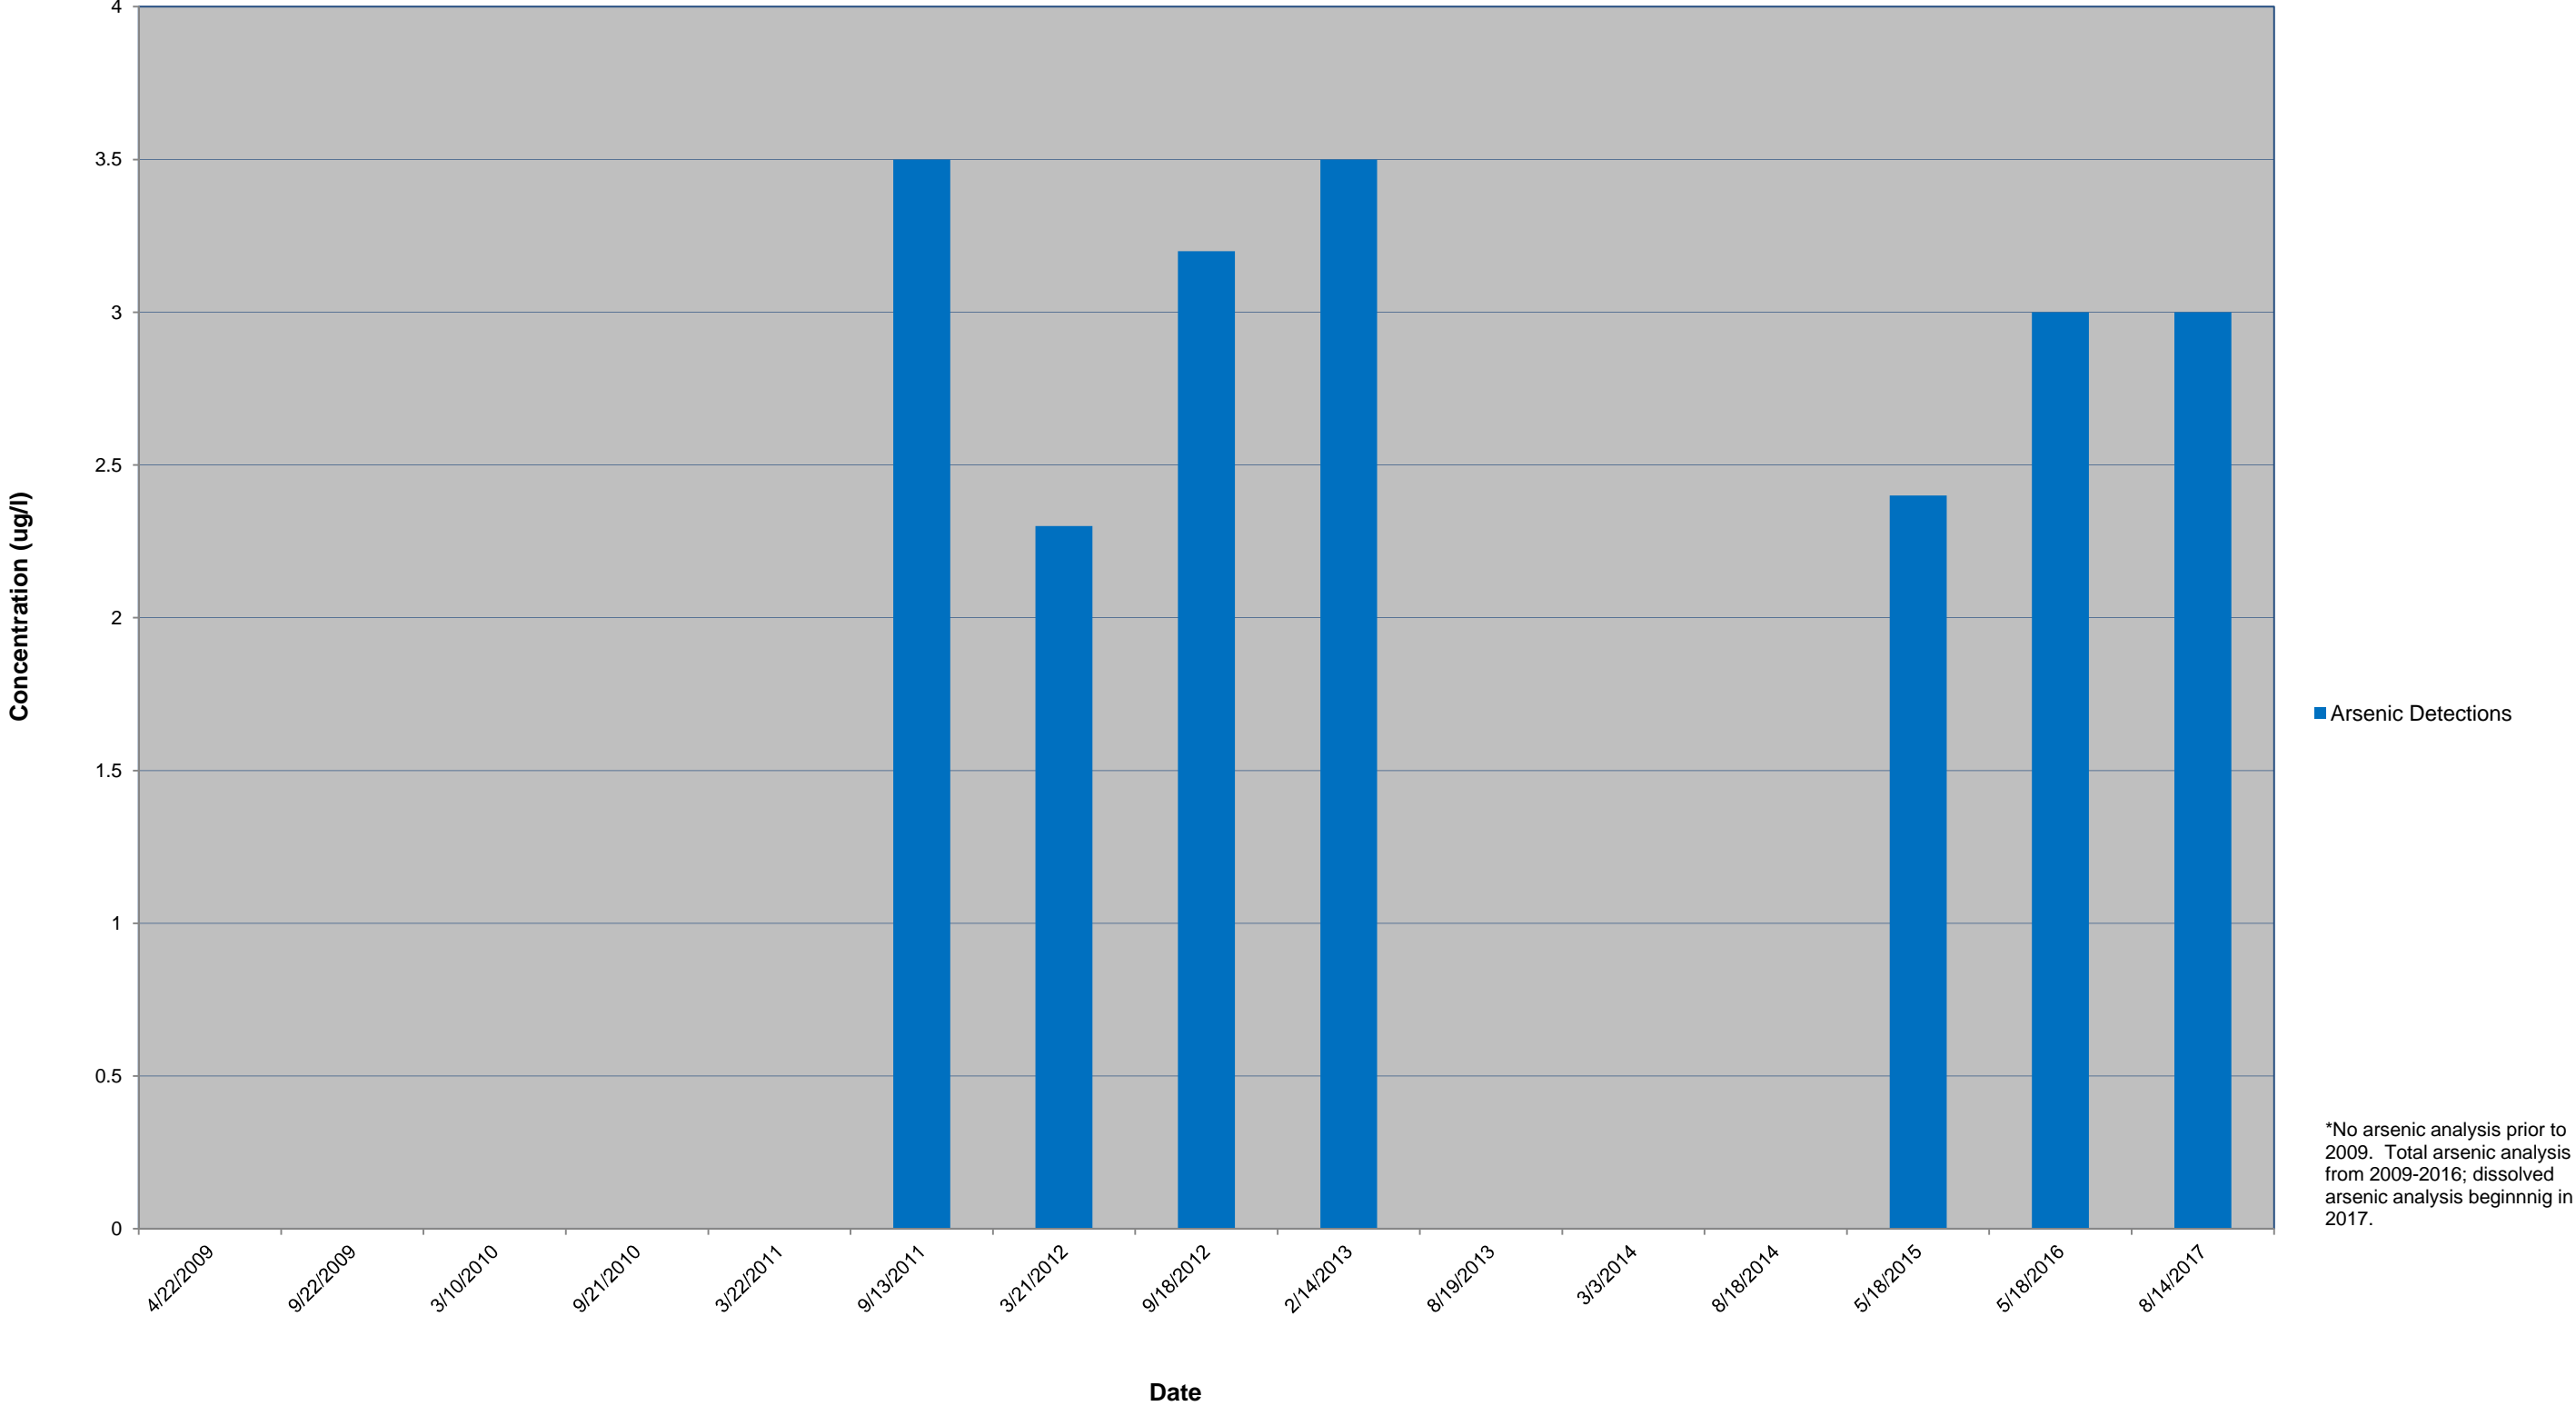
**Arsenic Detections in CAMU MW06R Groundwater Samples  
2009 - 2017\***

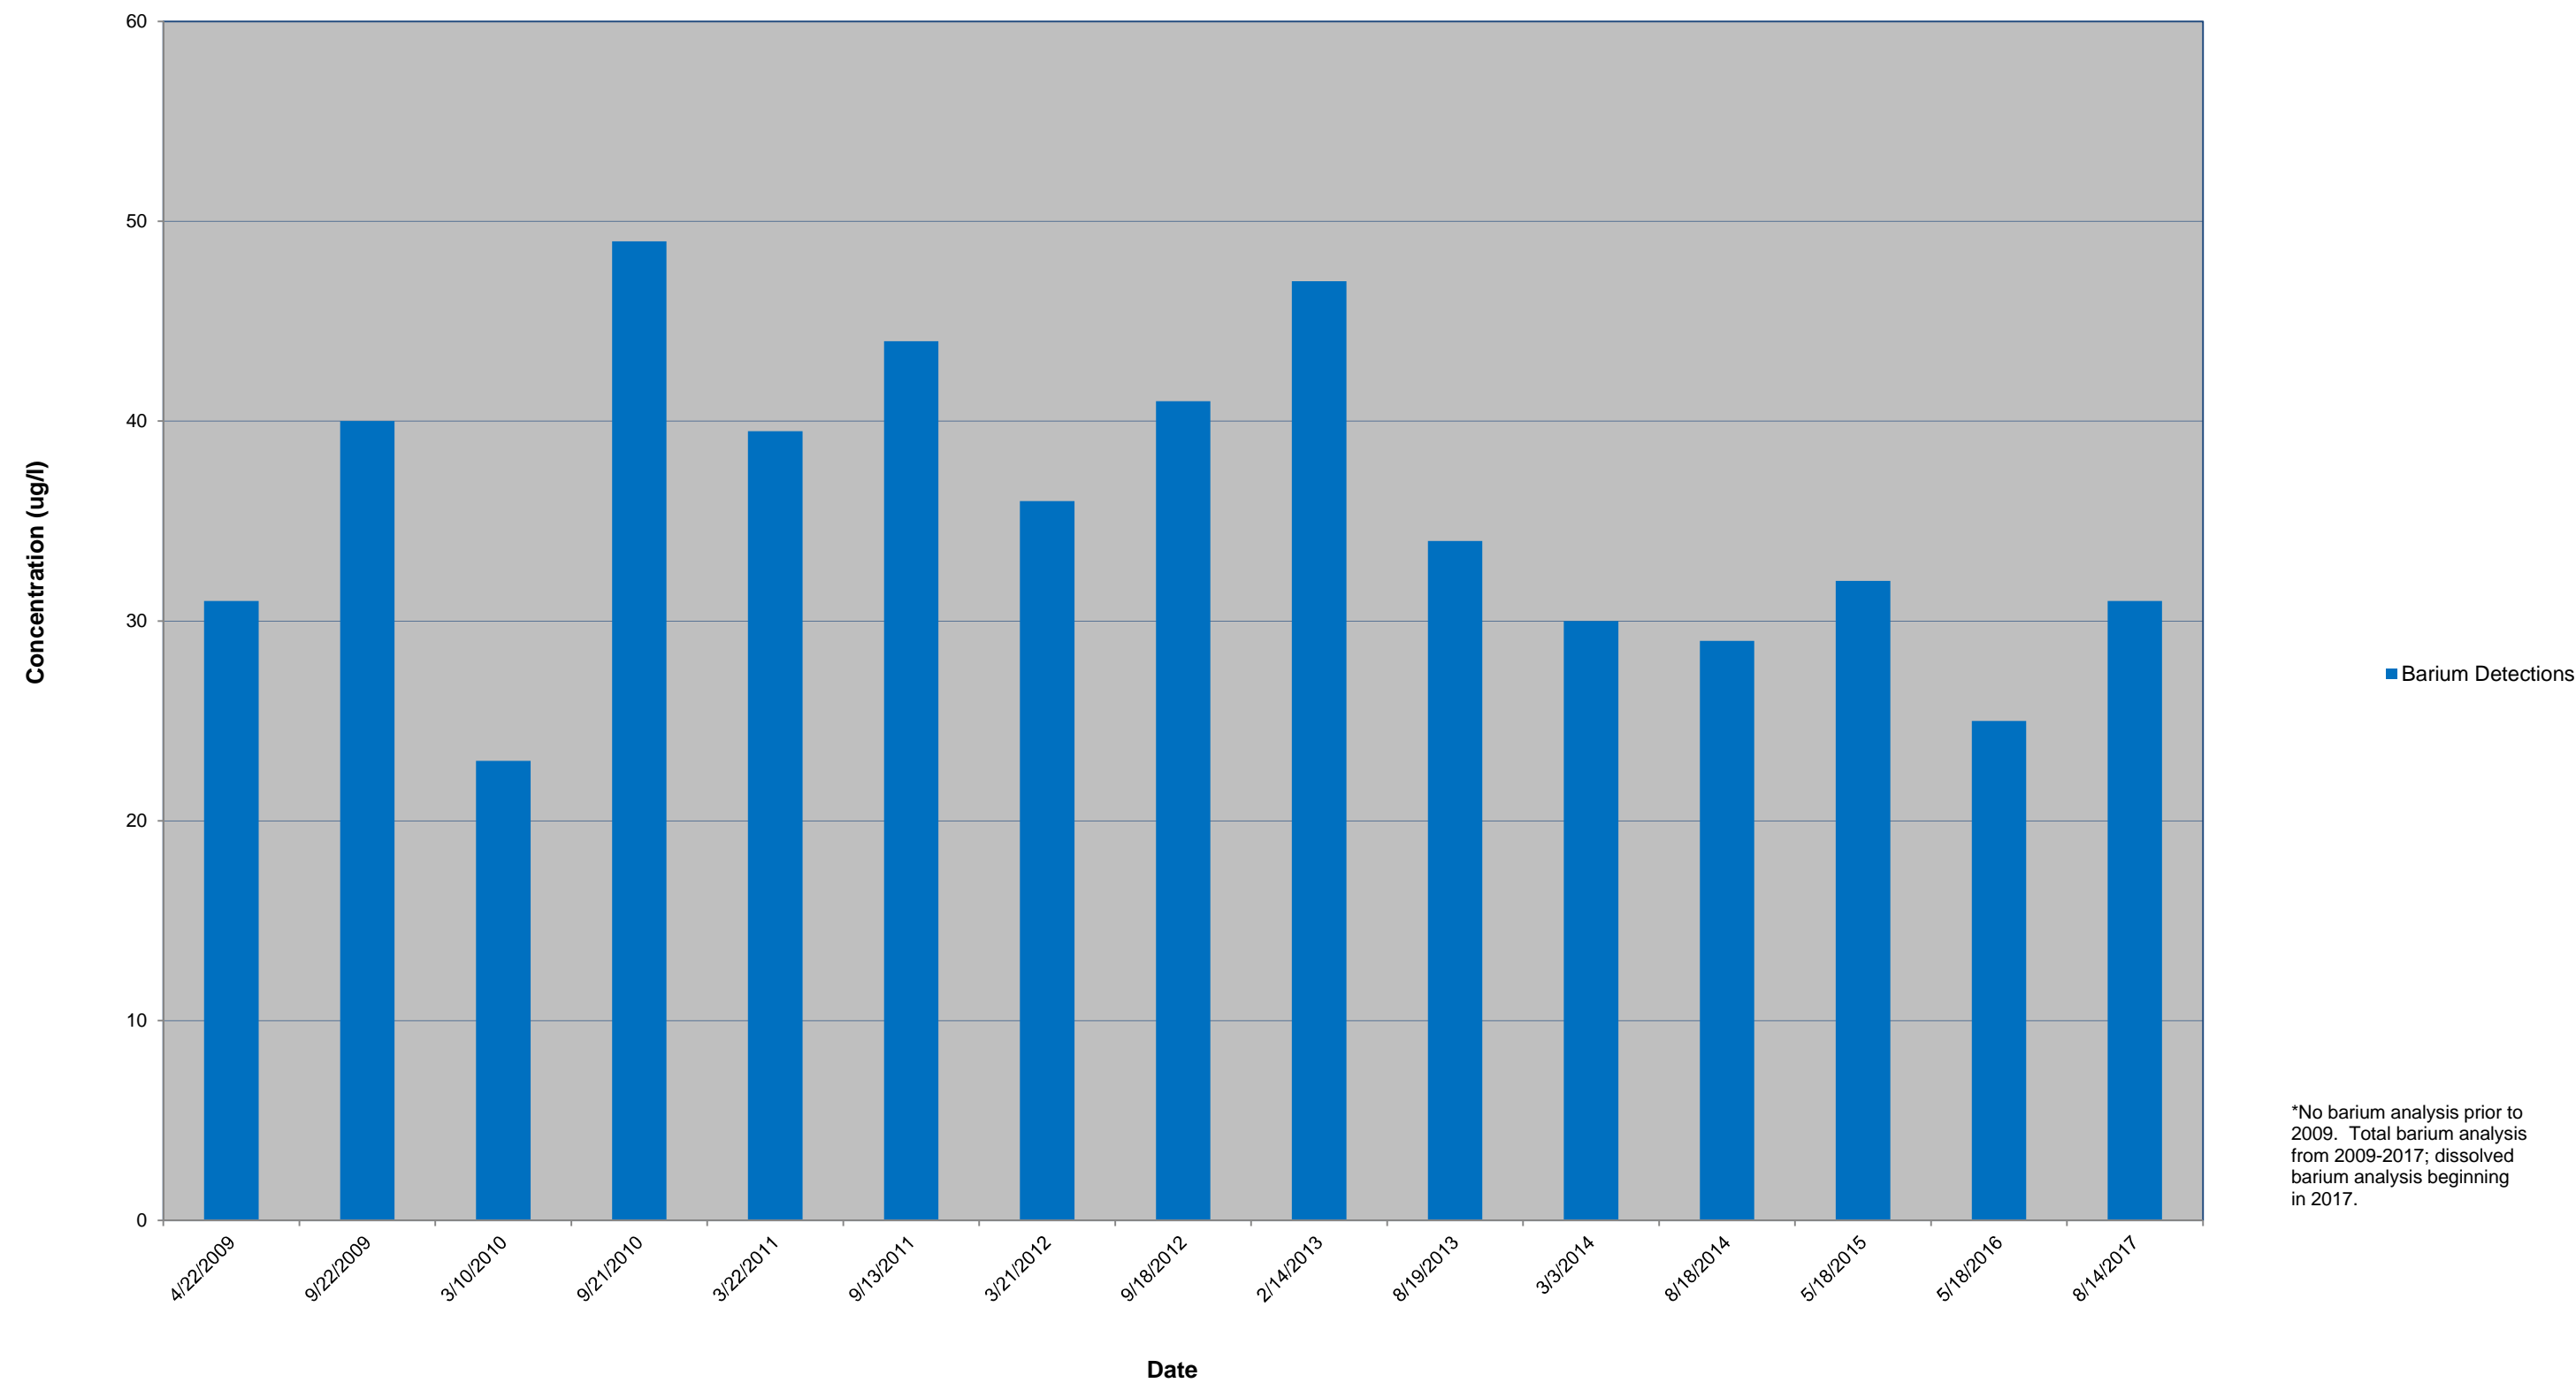
Barium Detections in CAMU MW06R Groundwater Samples  
2009 - 2017\*

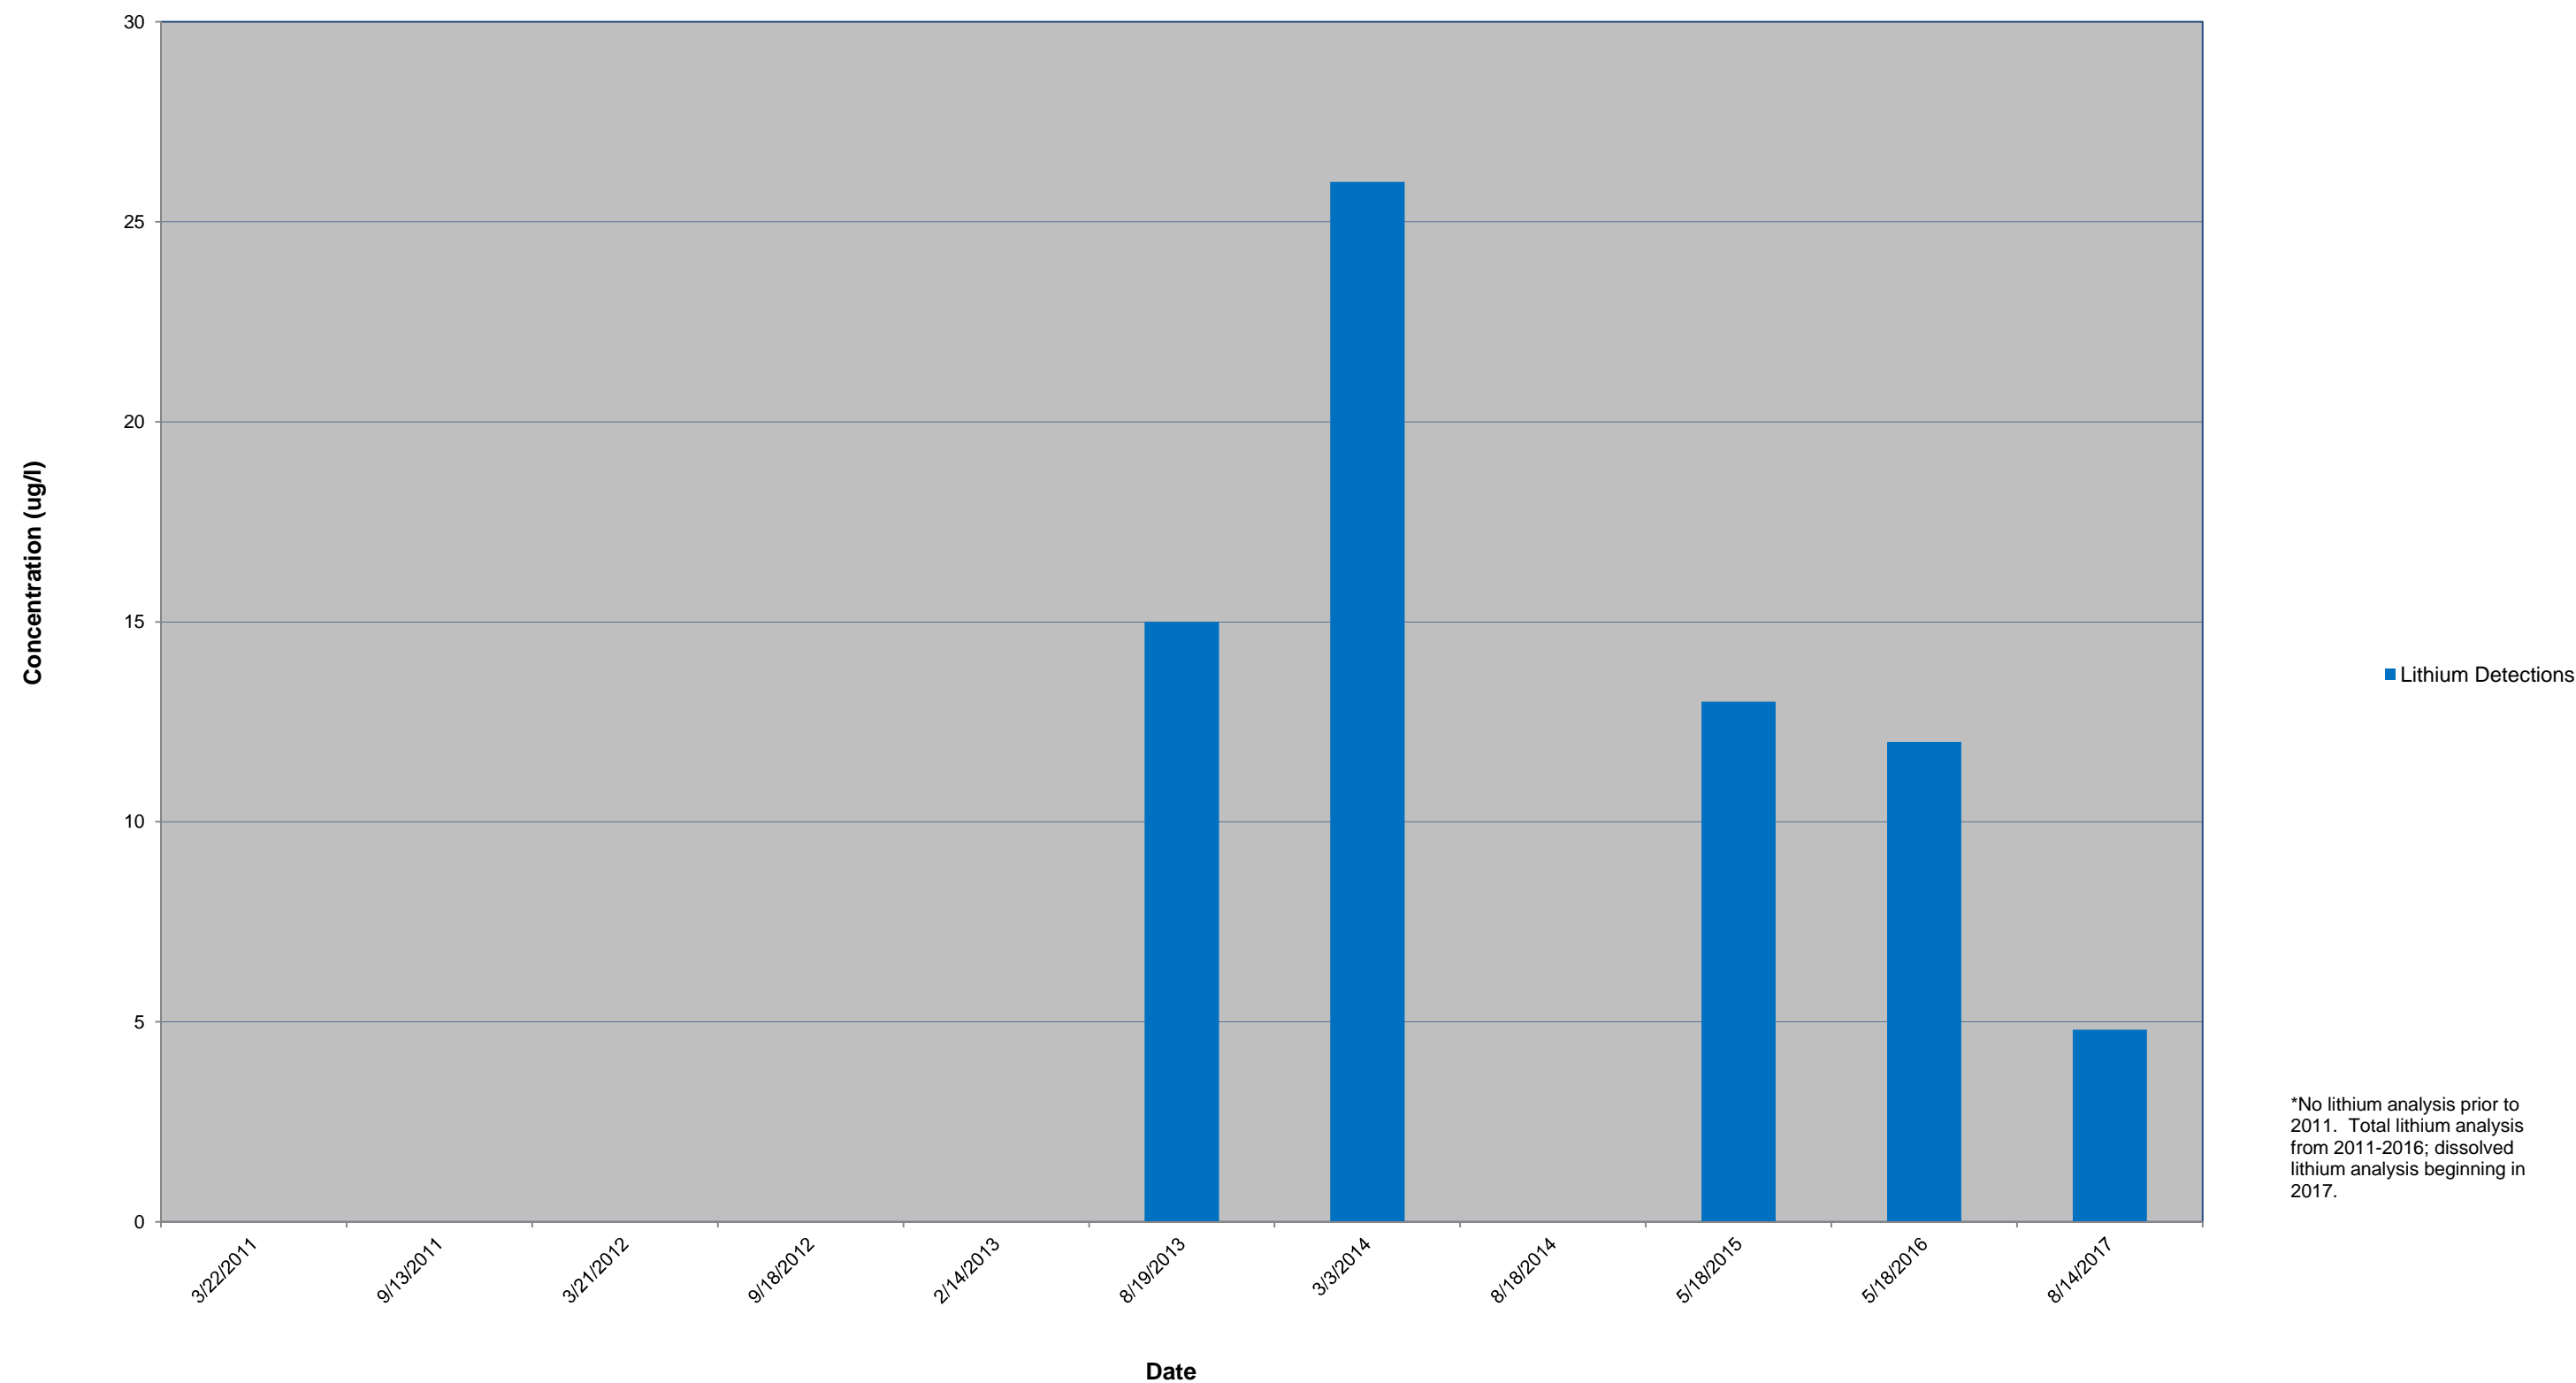
**Lithium Detections in CAMU MW06R Groundwater Samples  
2011 - 2017\***

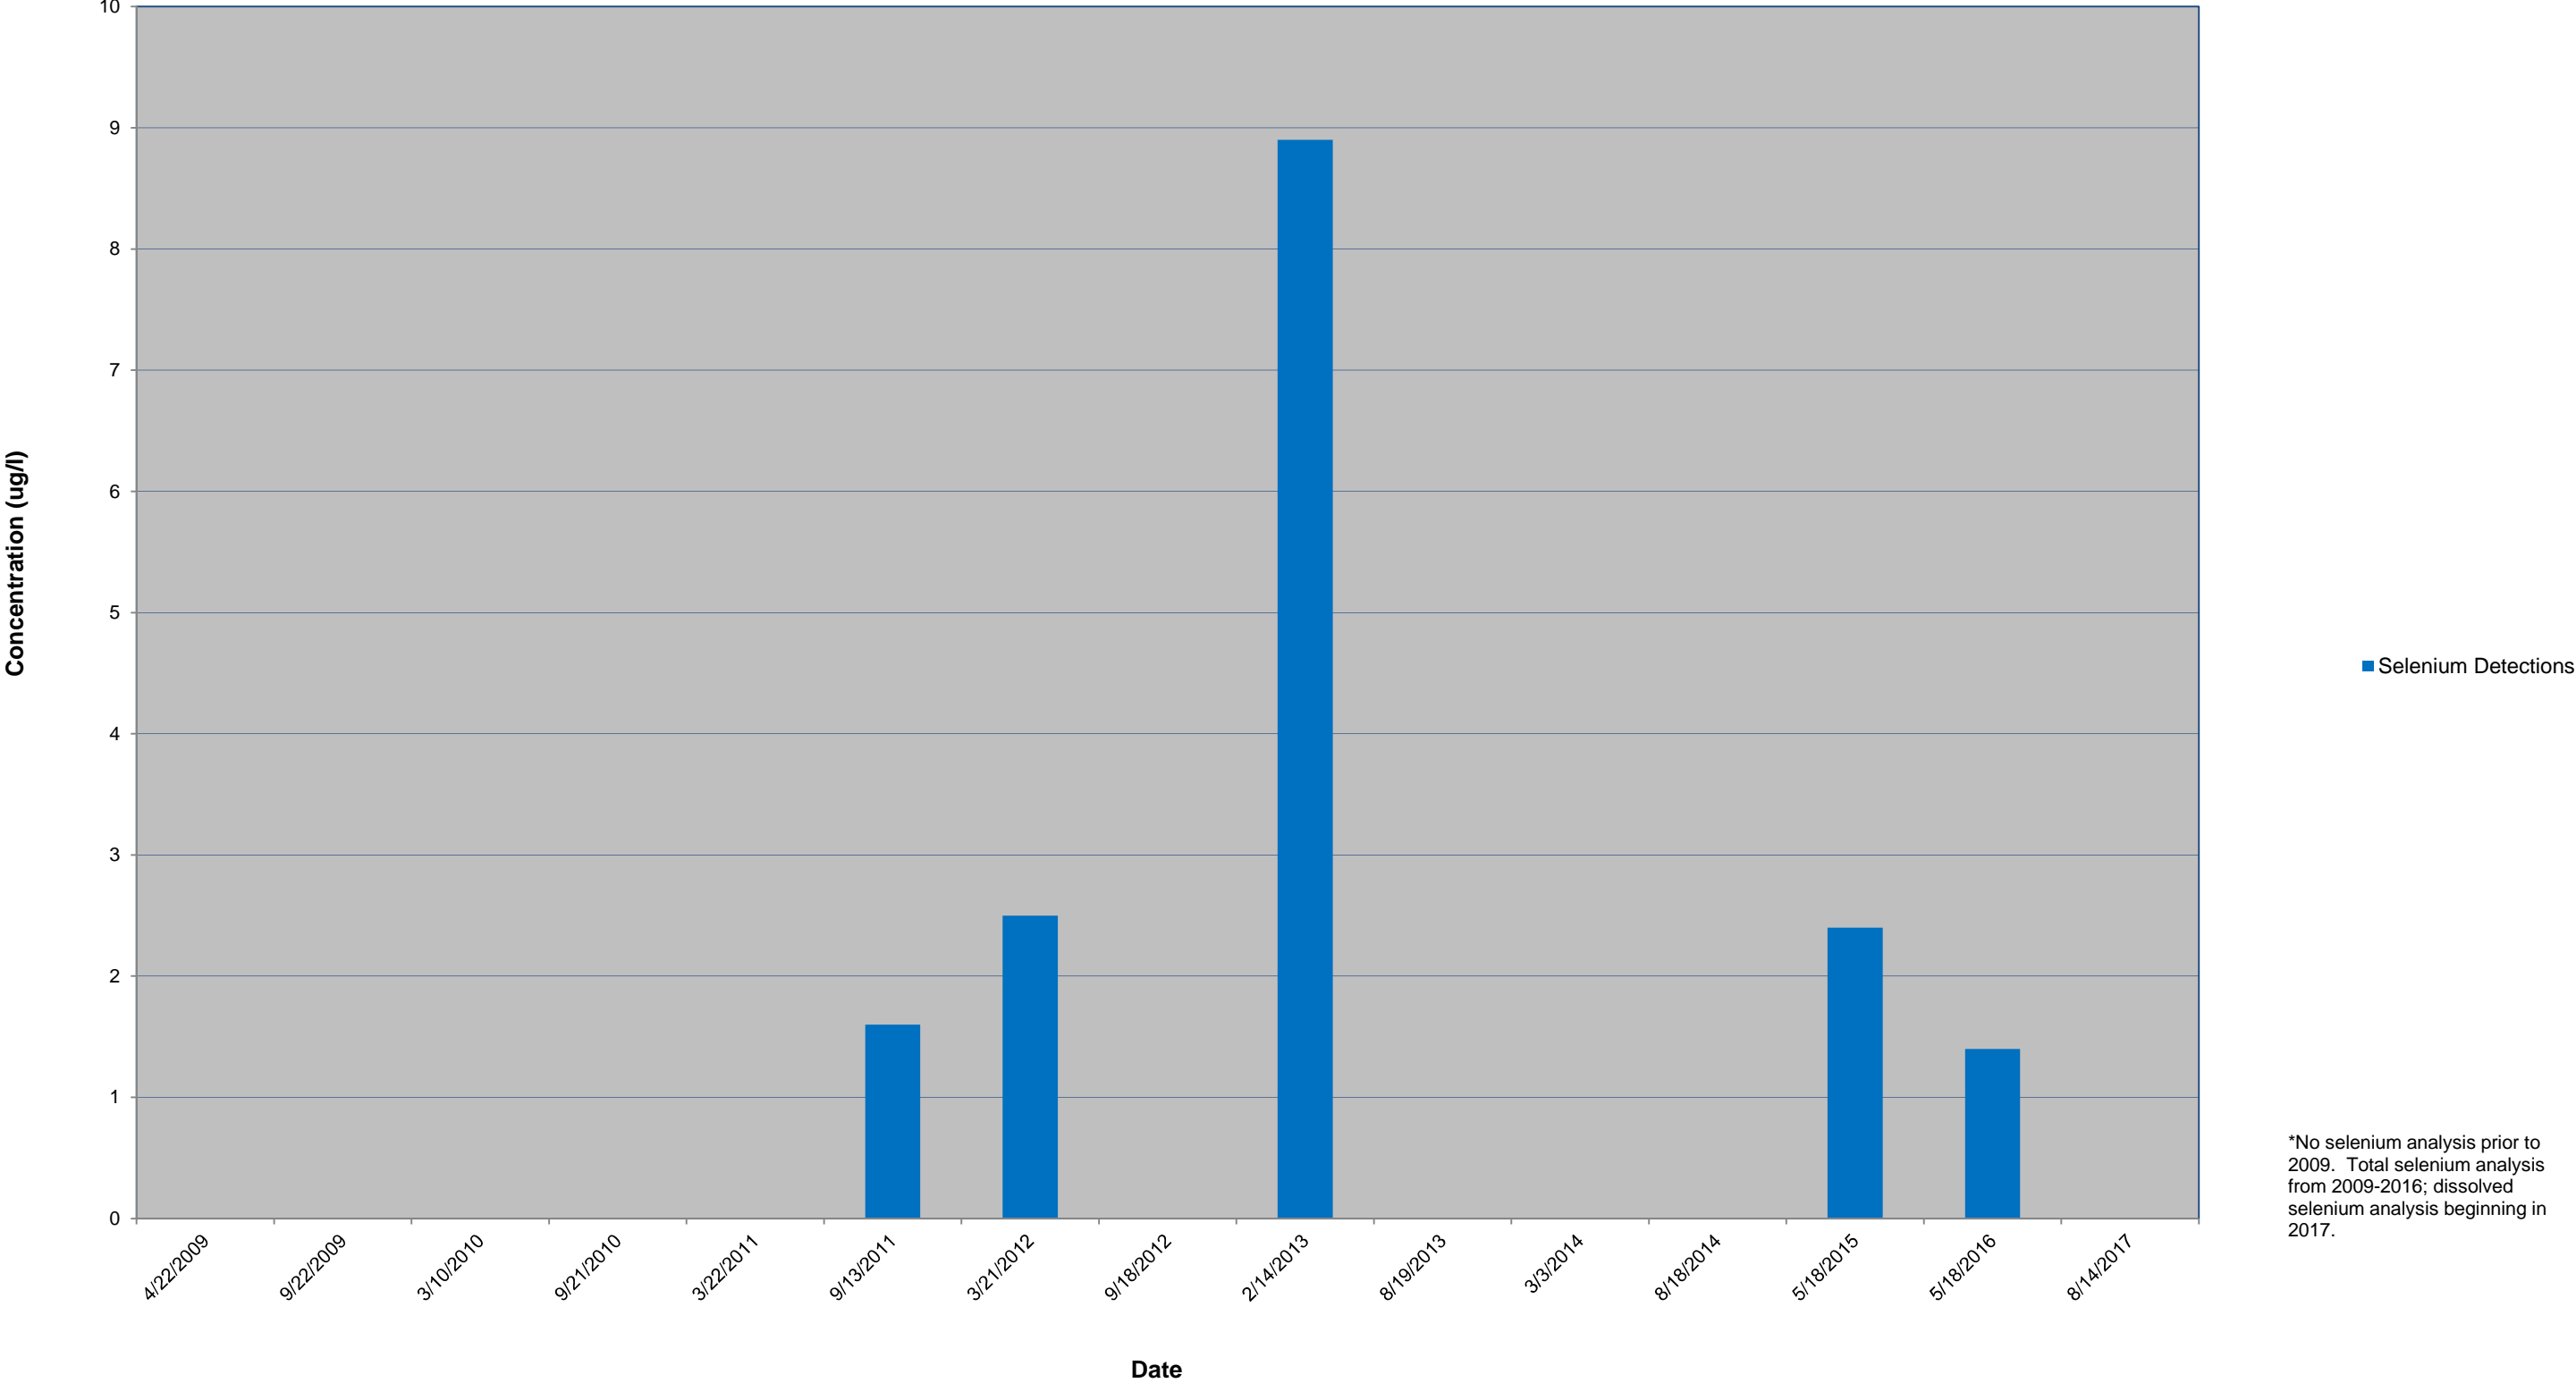
**Selenium Detections in CAMU MW06R Groundwater Samples  
2009 - 2017\***

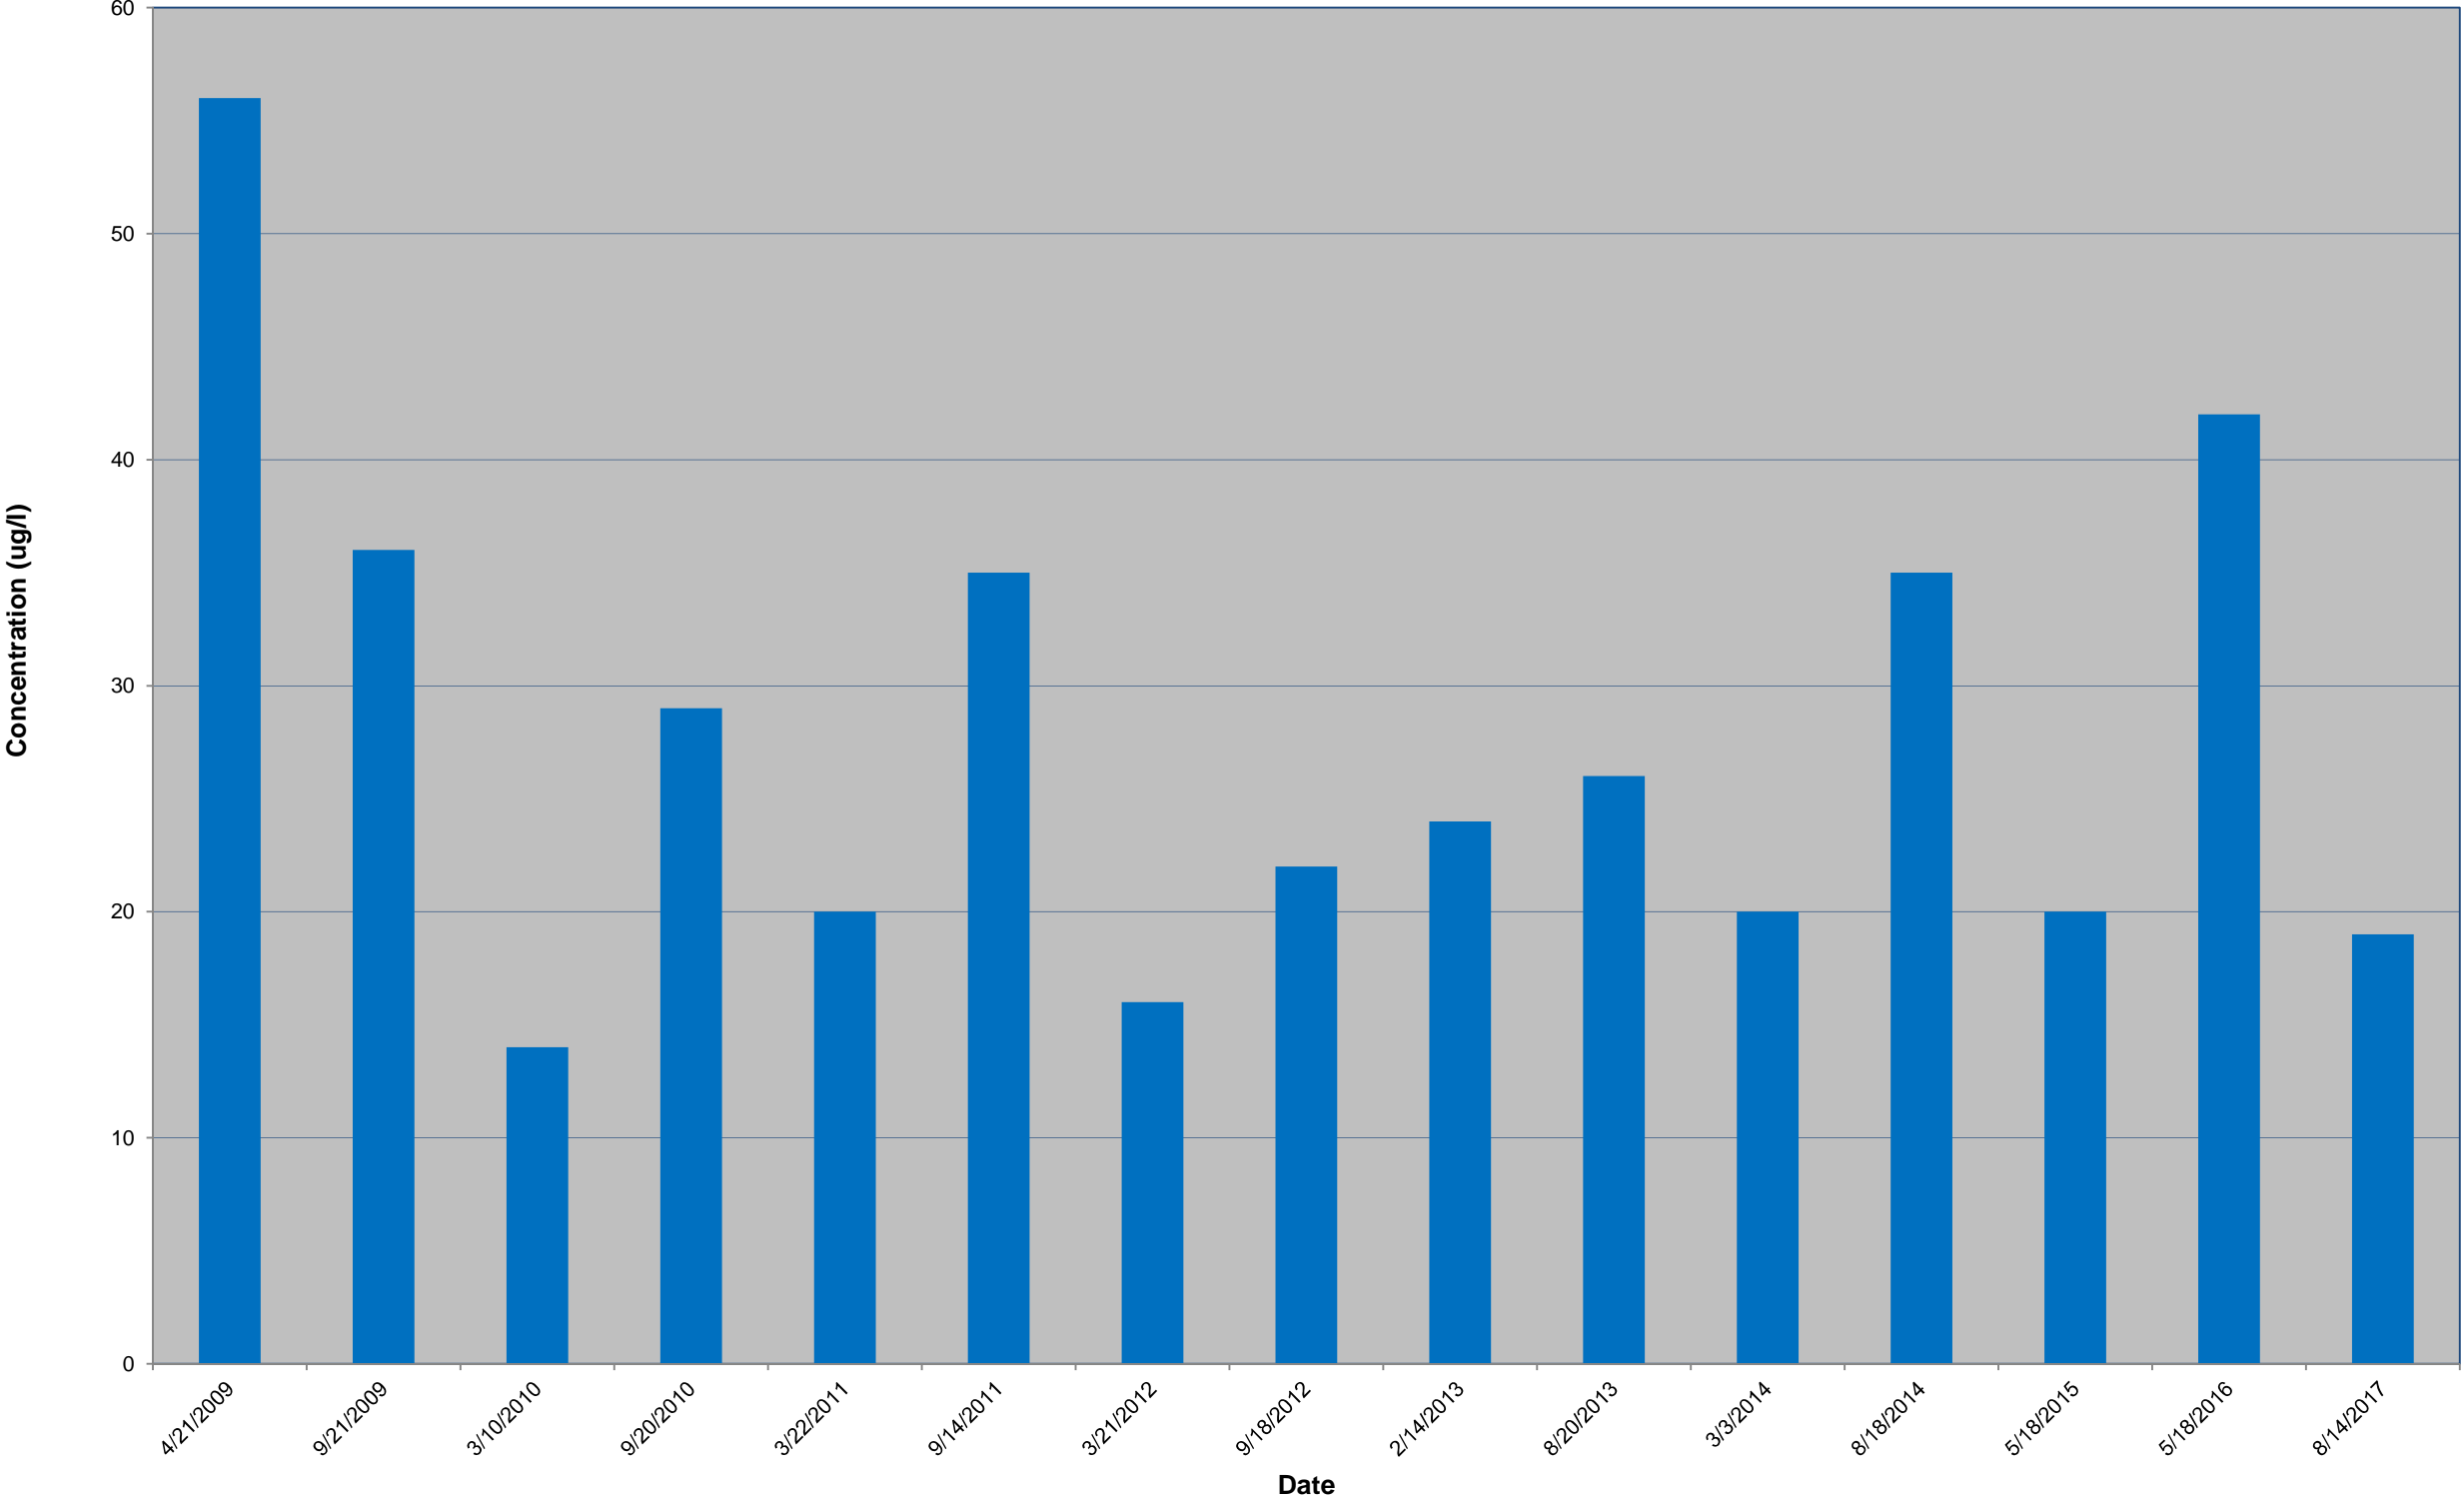
Barium Detections in CAMU MW07 Groundwater Samples  
2009 - 2017\*

\*No barium analysis prior to 2009. Total barium analysis from 2009-2016; dissolved barium analysis beginning in 2017.
