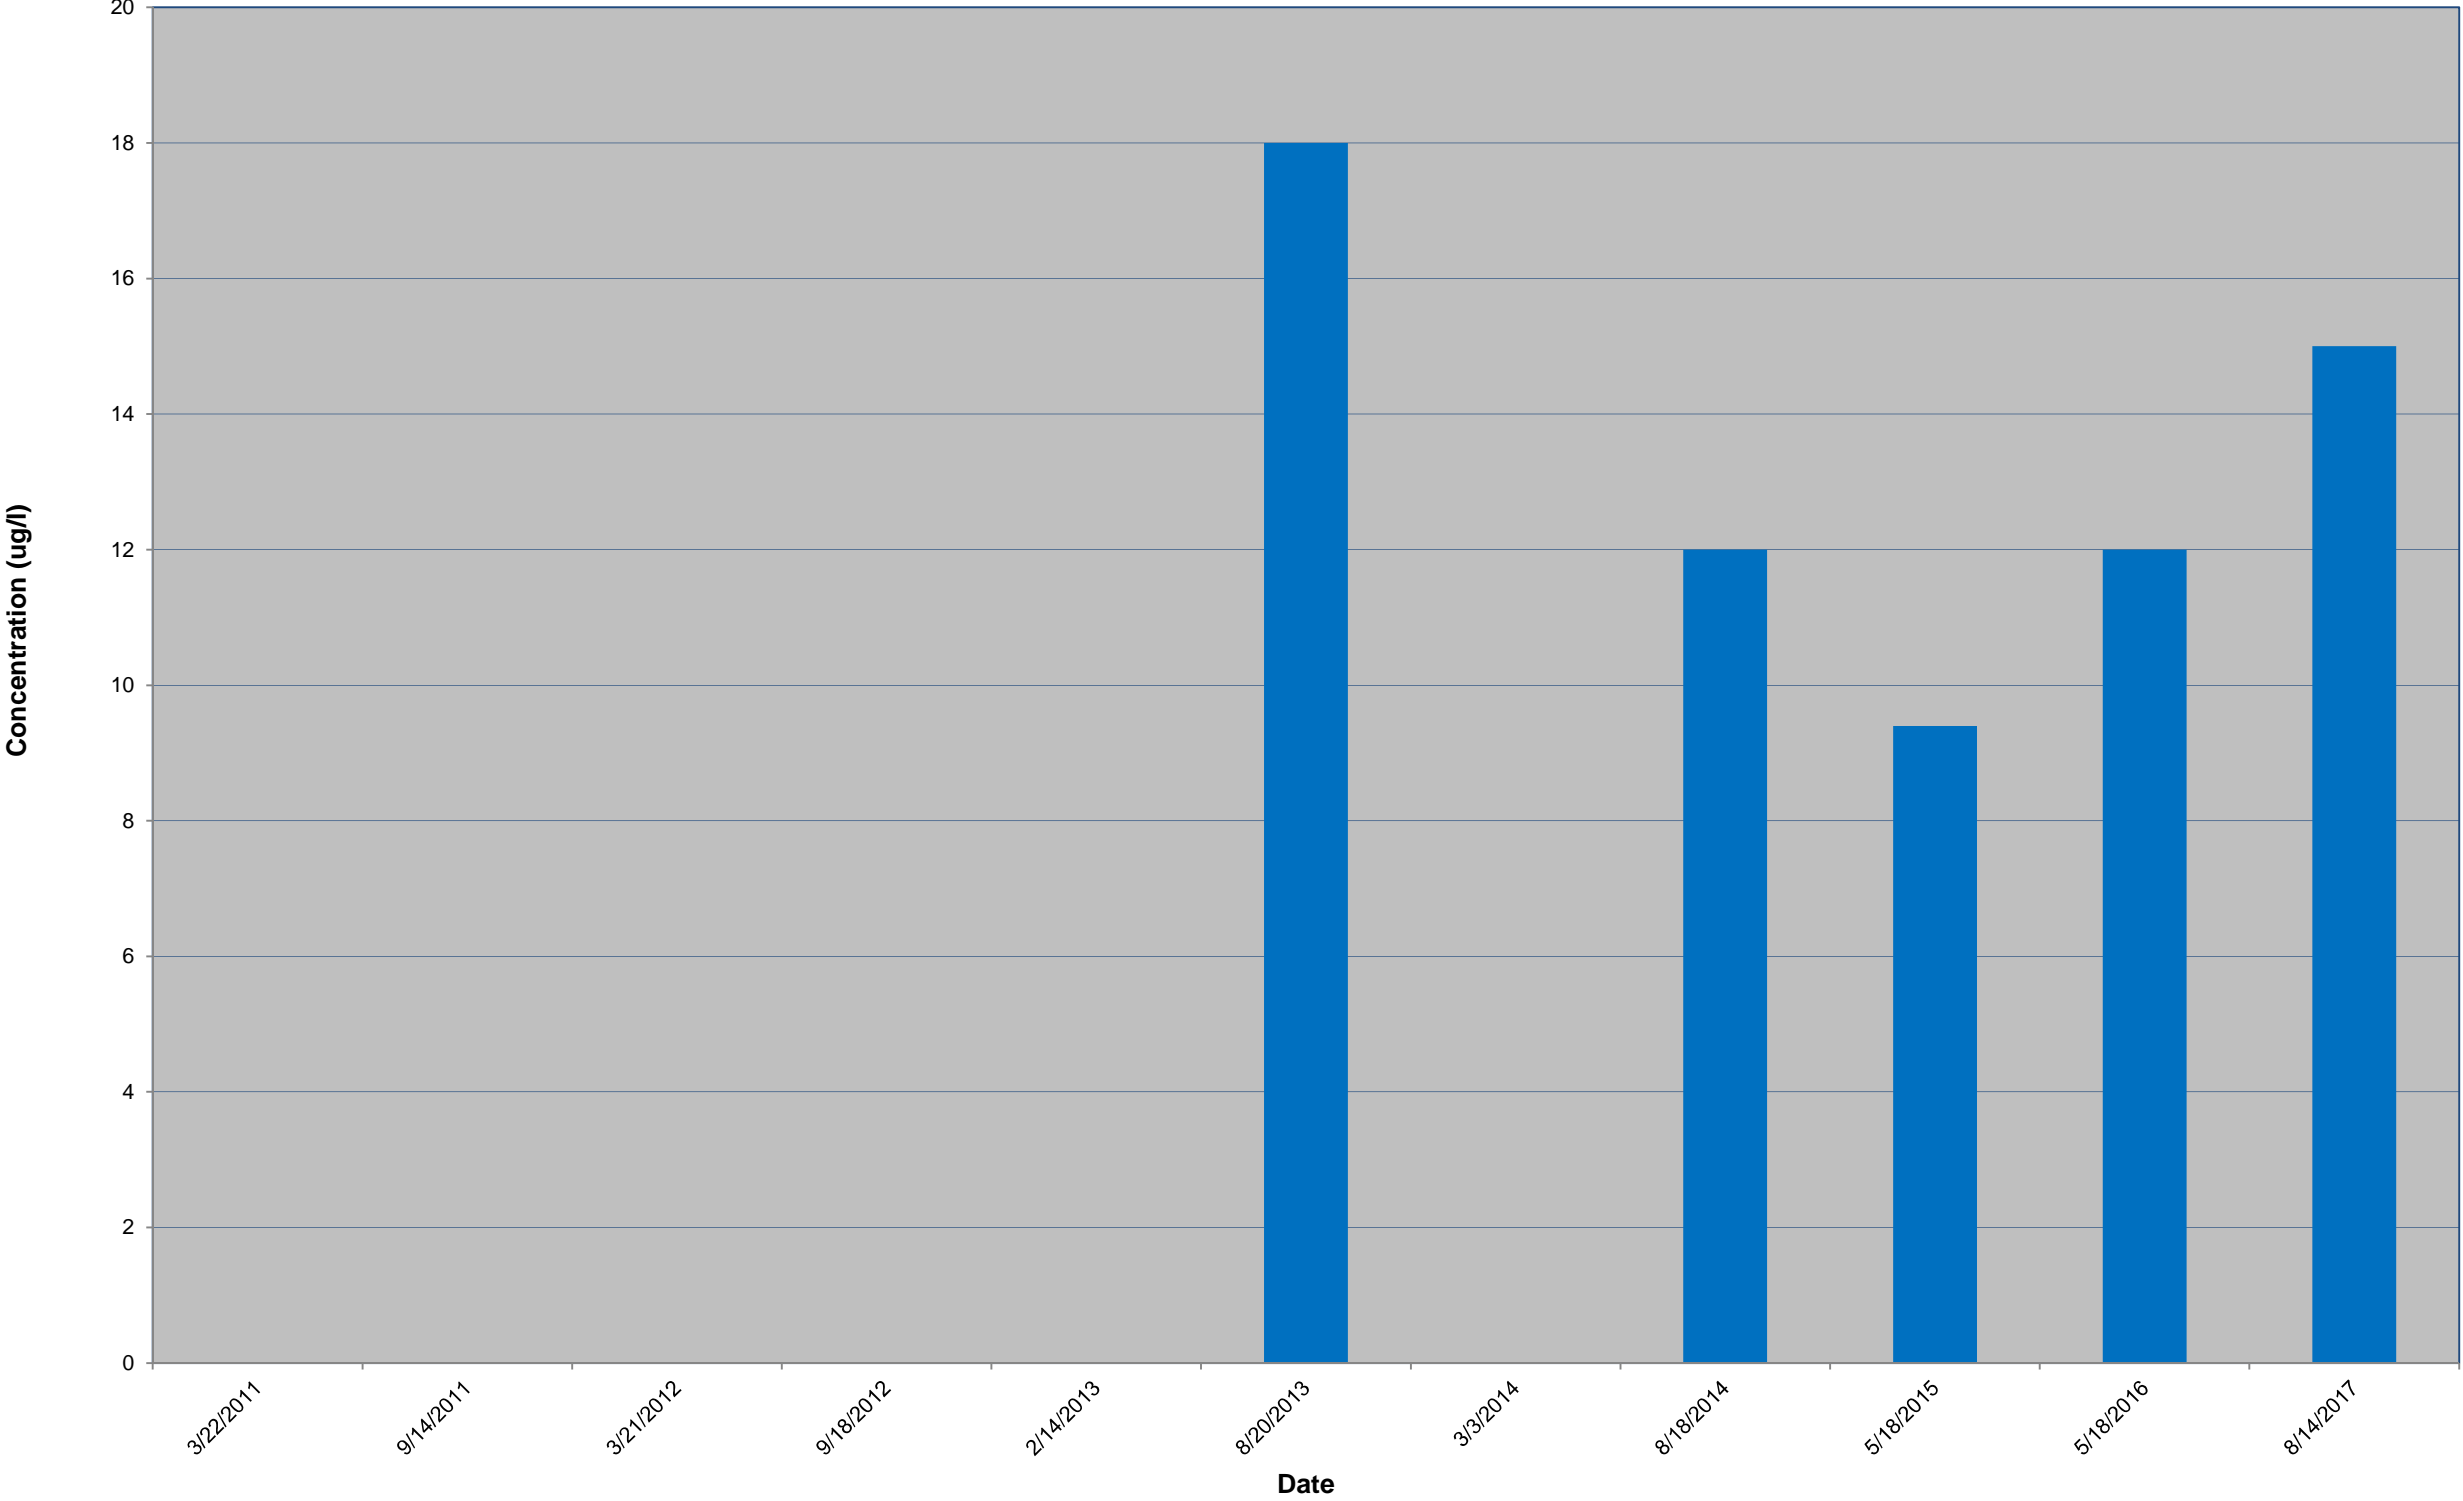
Lithium Detections in CAMU MW07 Groundwater Samples  
2011 - 2017\*

\*No lithium analysis prior to 2011. Total lithium analysis from 2011-2016; dissolved lithium analysis beginning in 2017.

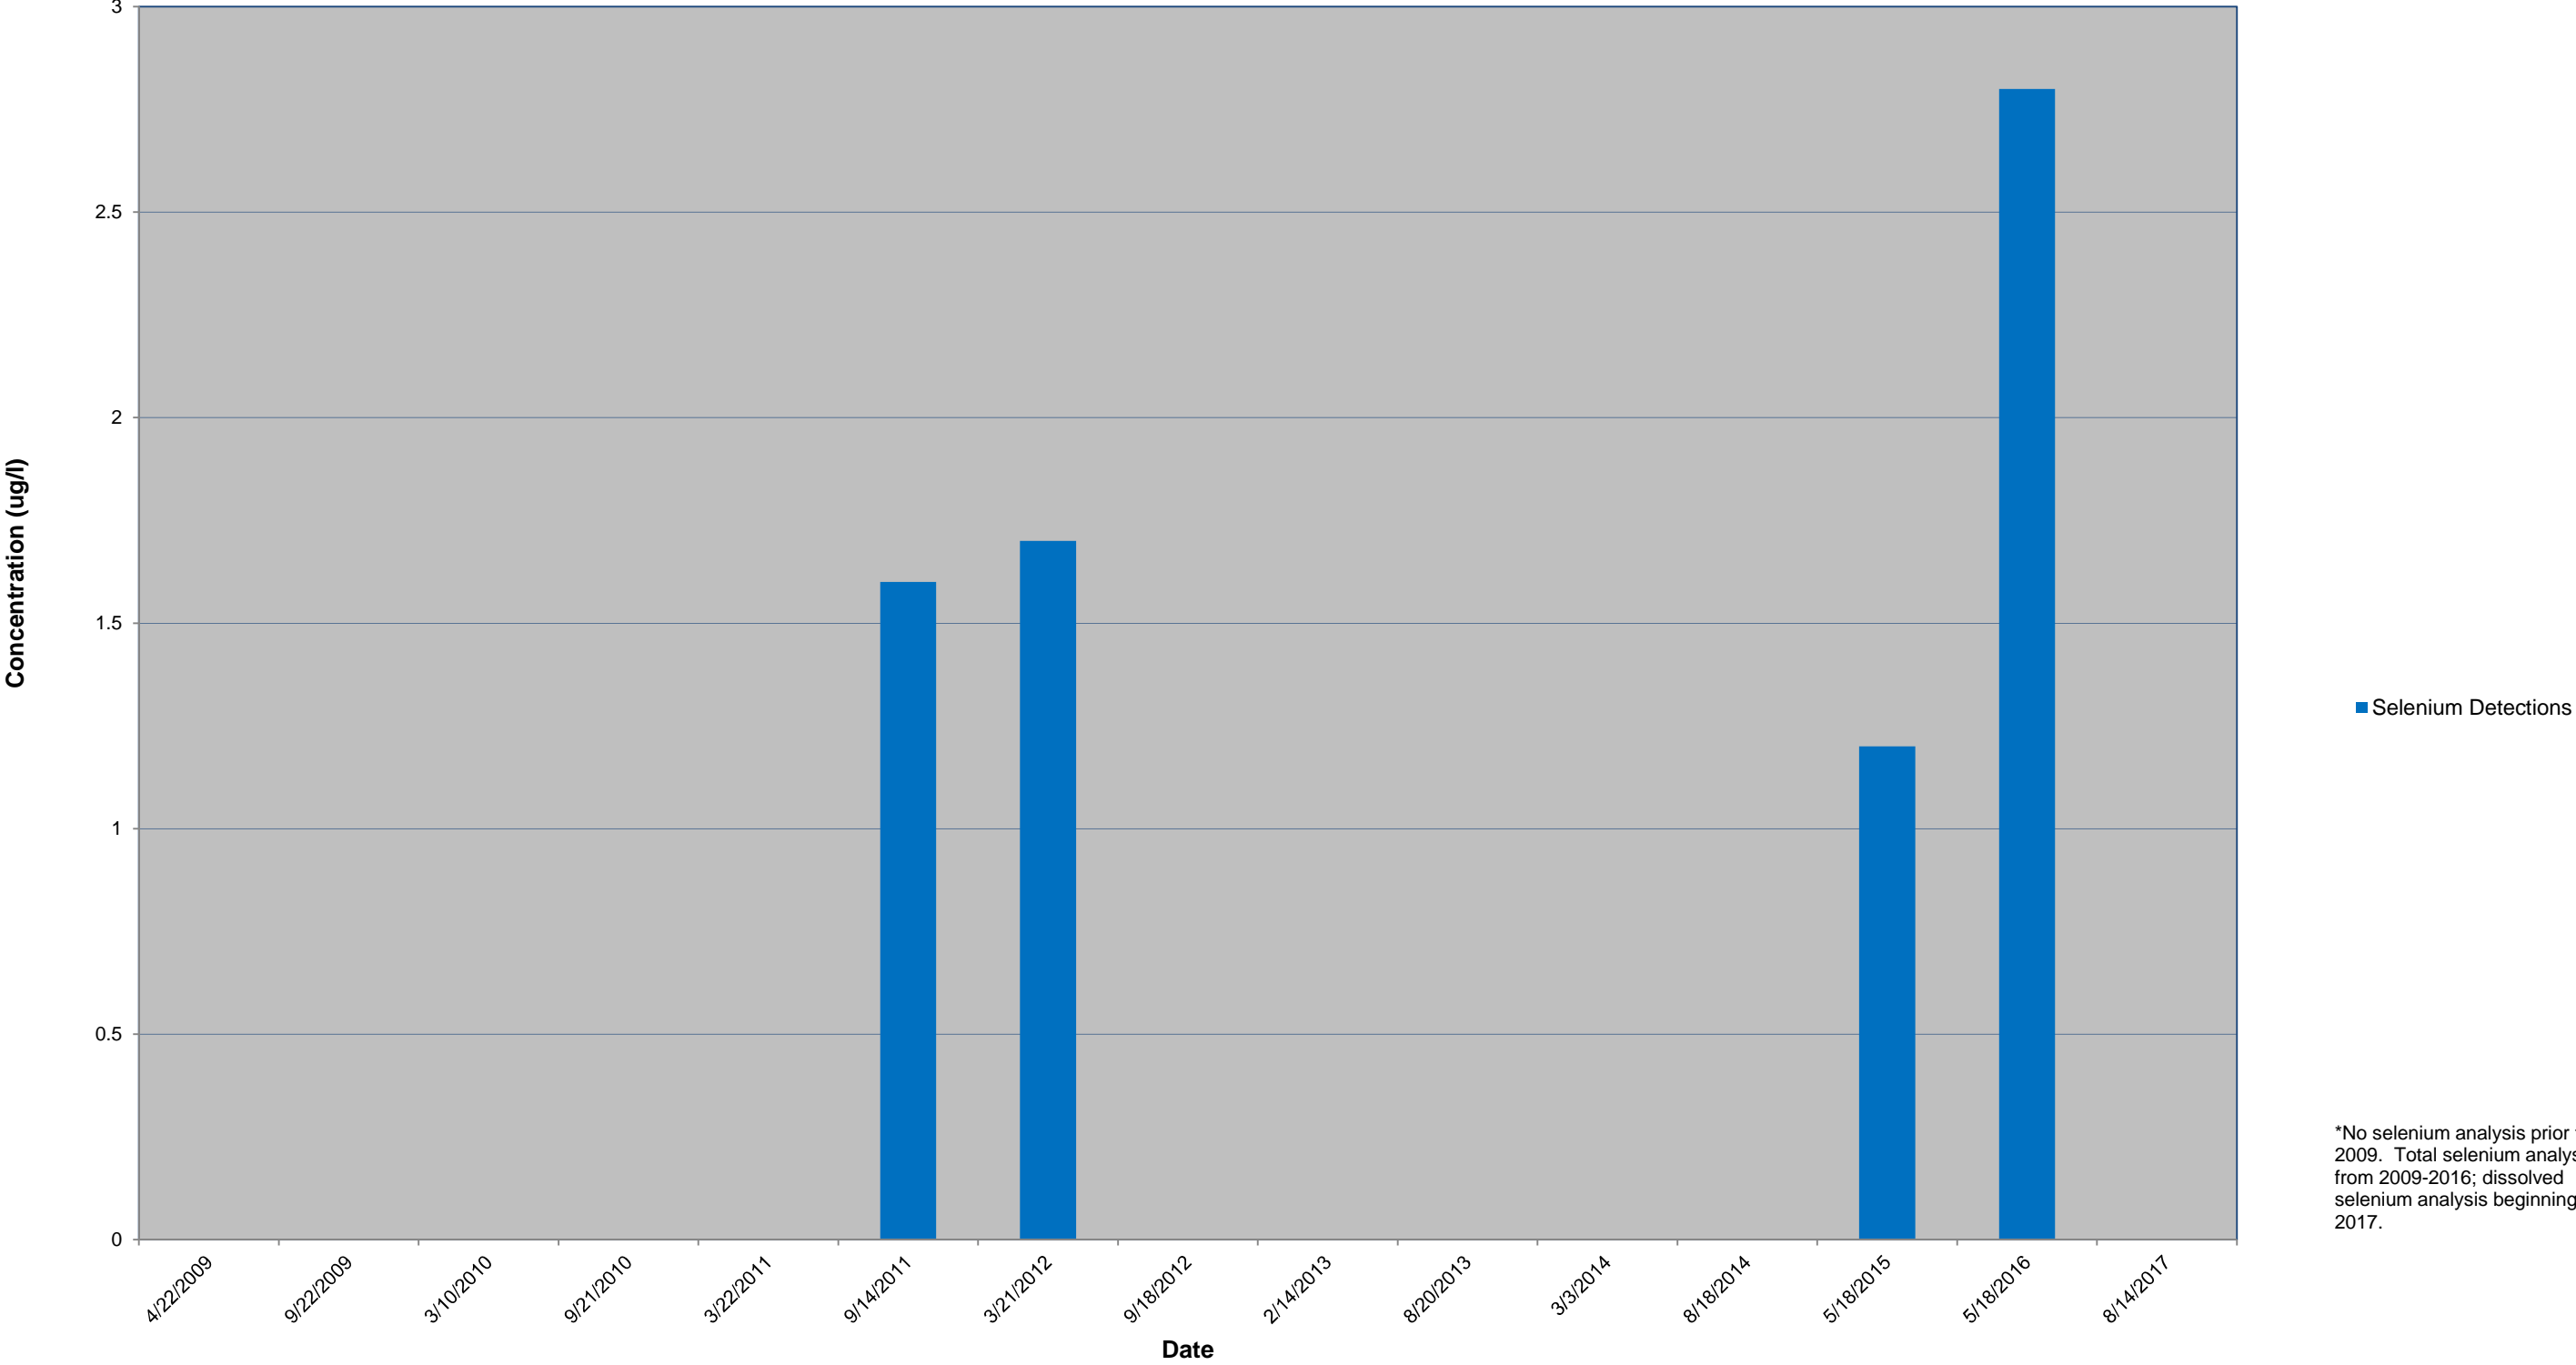
**Selenium Detections in CAMU MW07 Groundwater Samples  
2009 - 2017\***

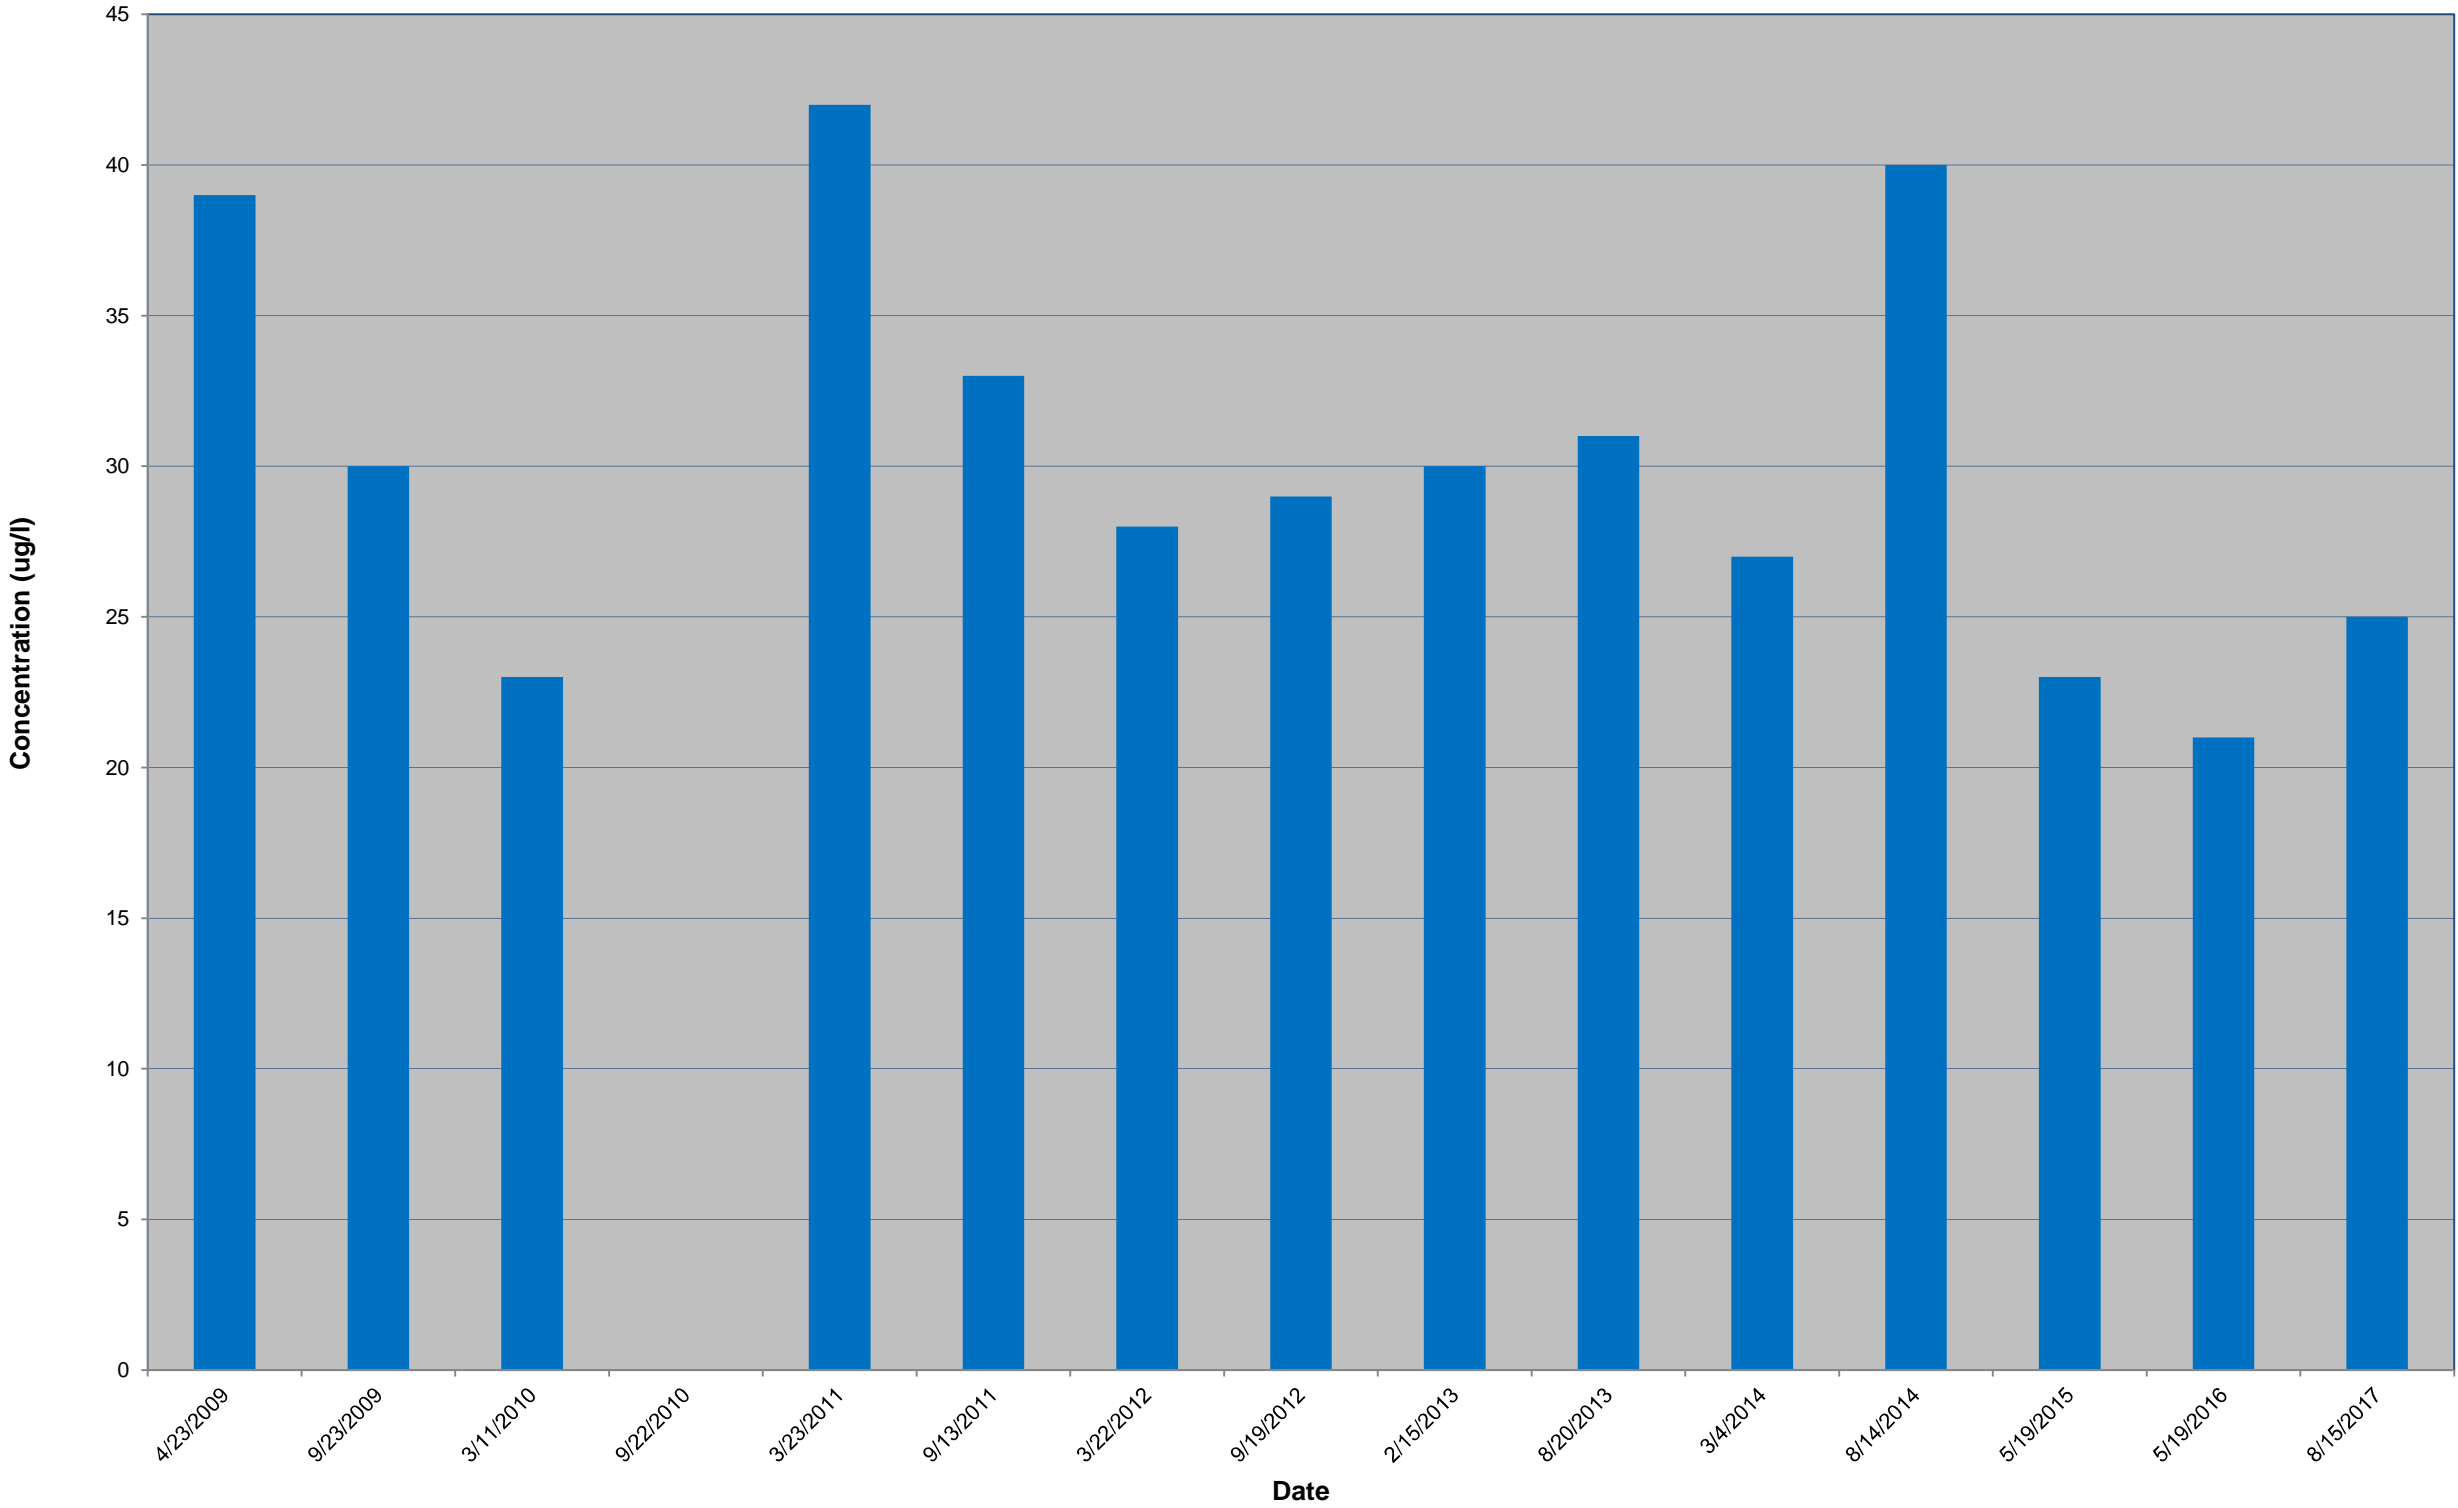
Barium Detections in CAMU MW08 Groundwater Samples  
2009 - 2017\*

\*No barium analysis prior to 2009. Total barium analysis from 2009-2016; dissolved barium analysis beginning in 2017.

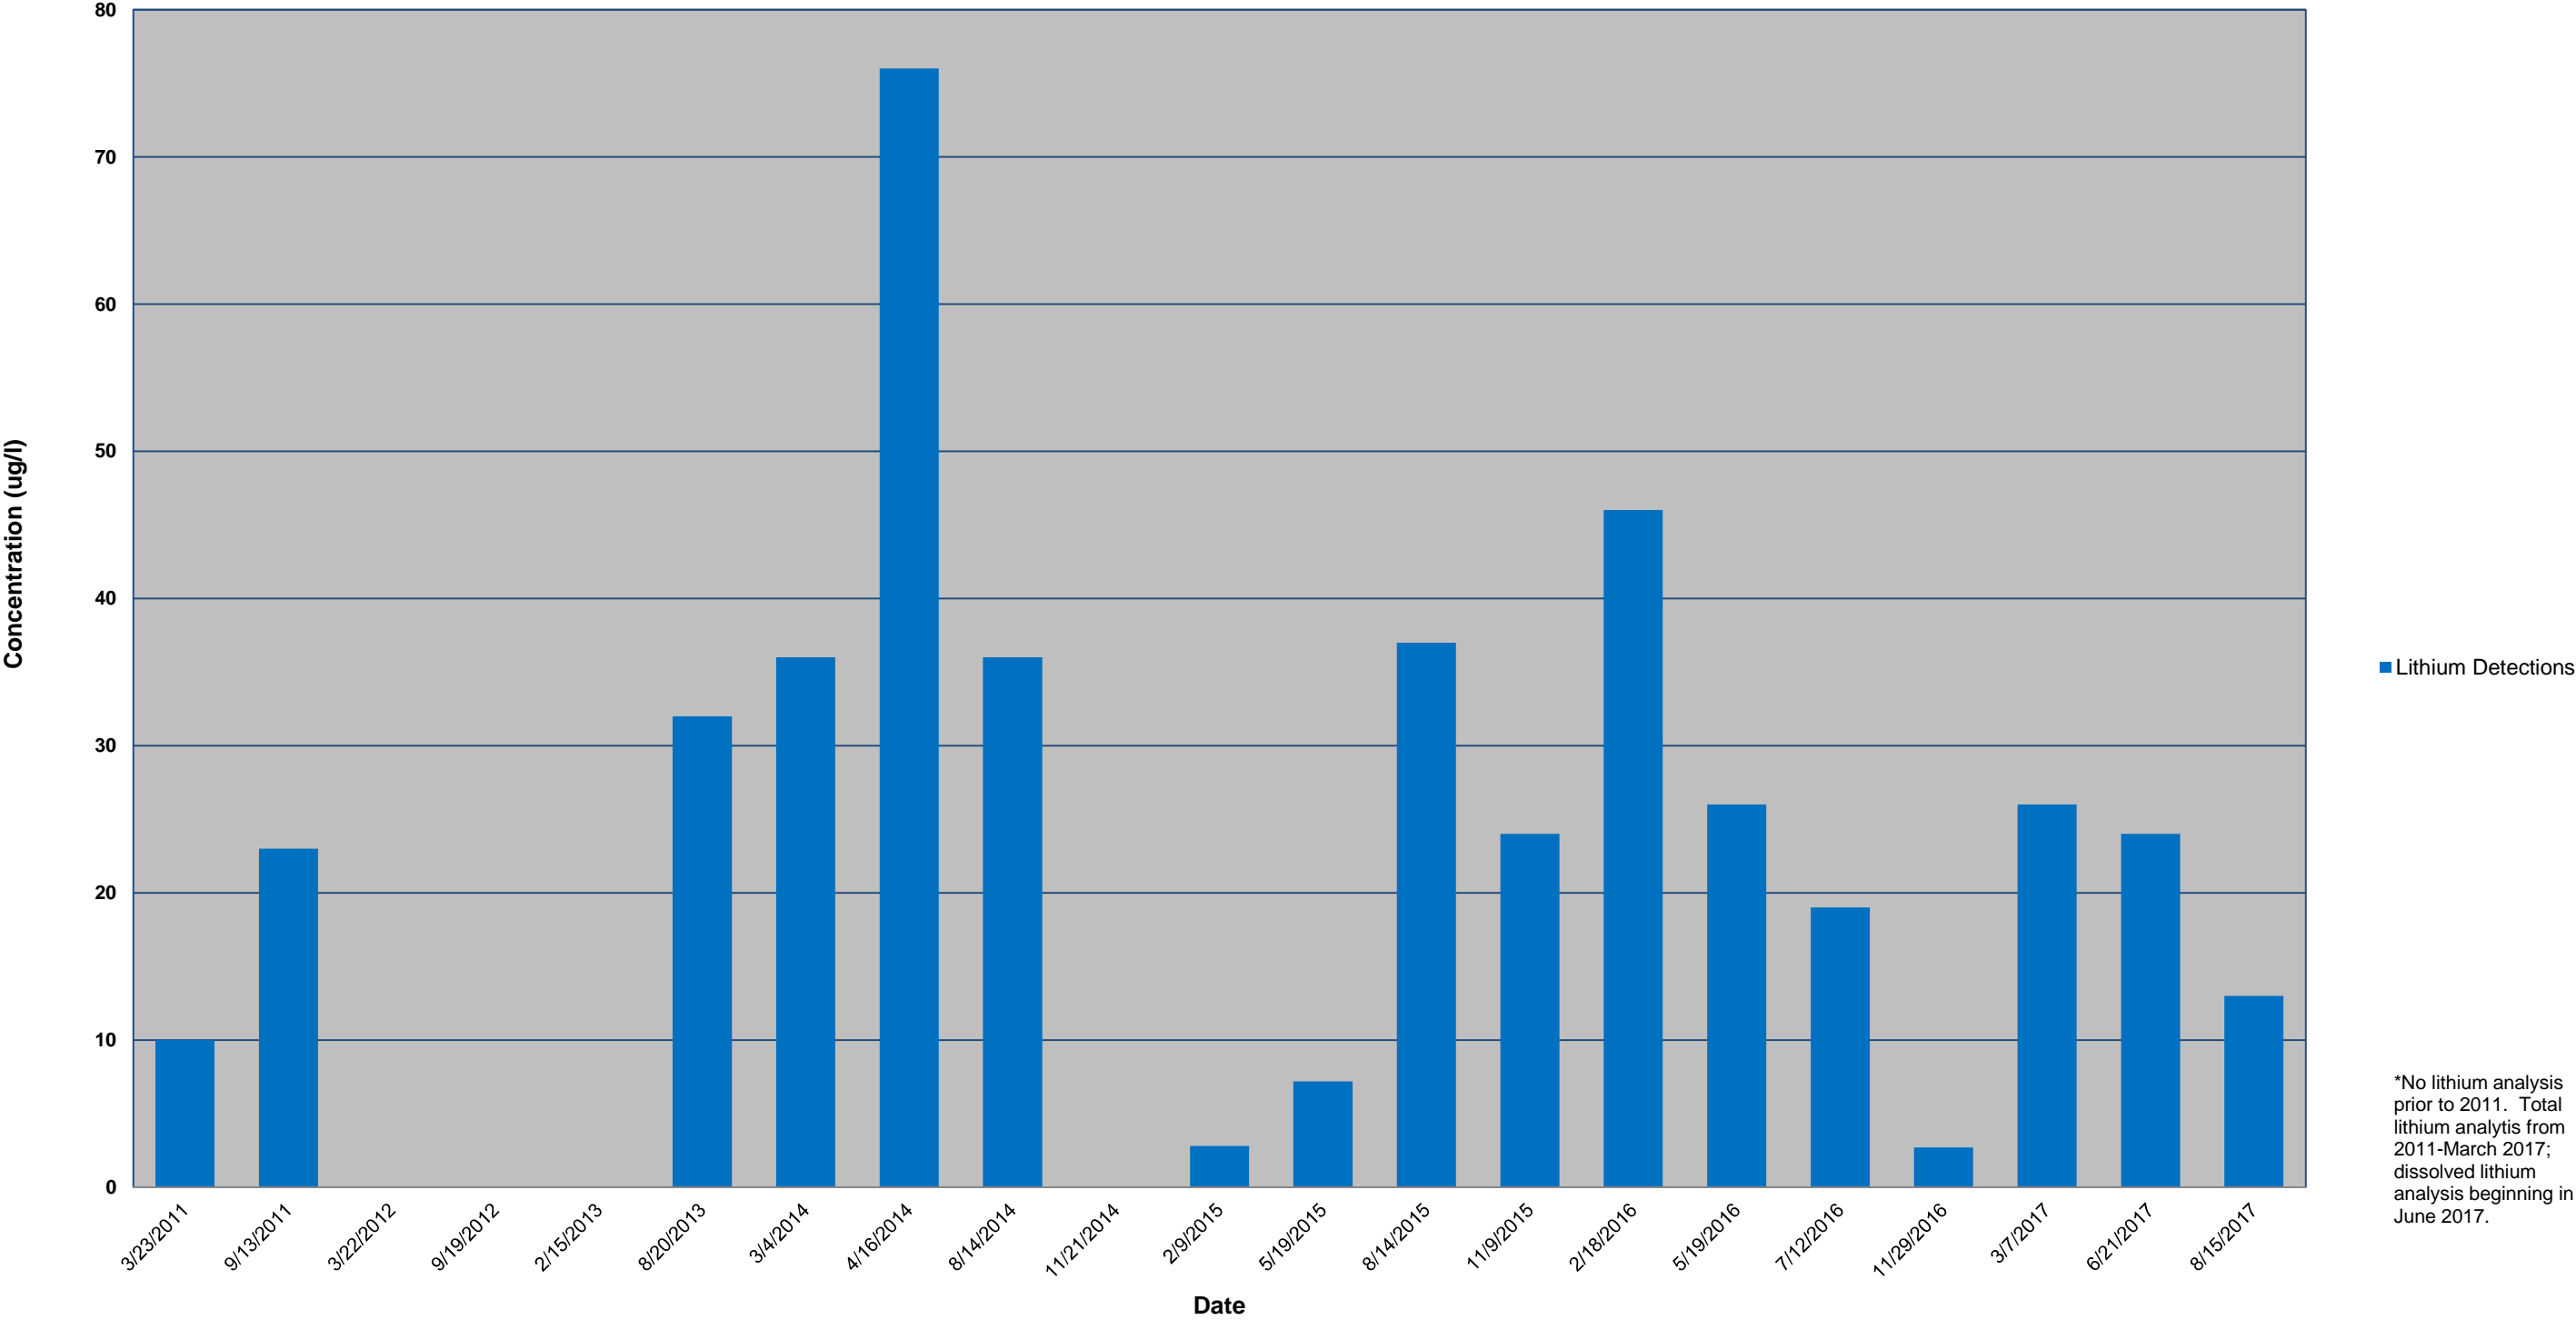
Lithium Detections in CAMU MW08 Groundwater Samples  
2011 - 2017\*

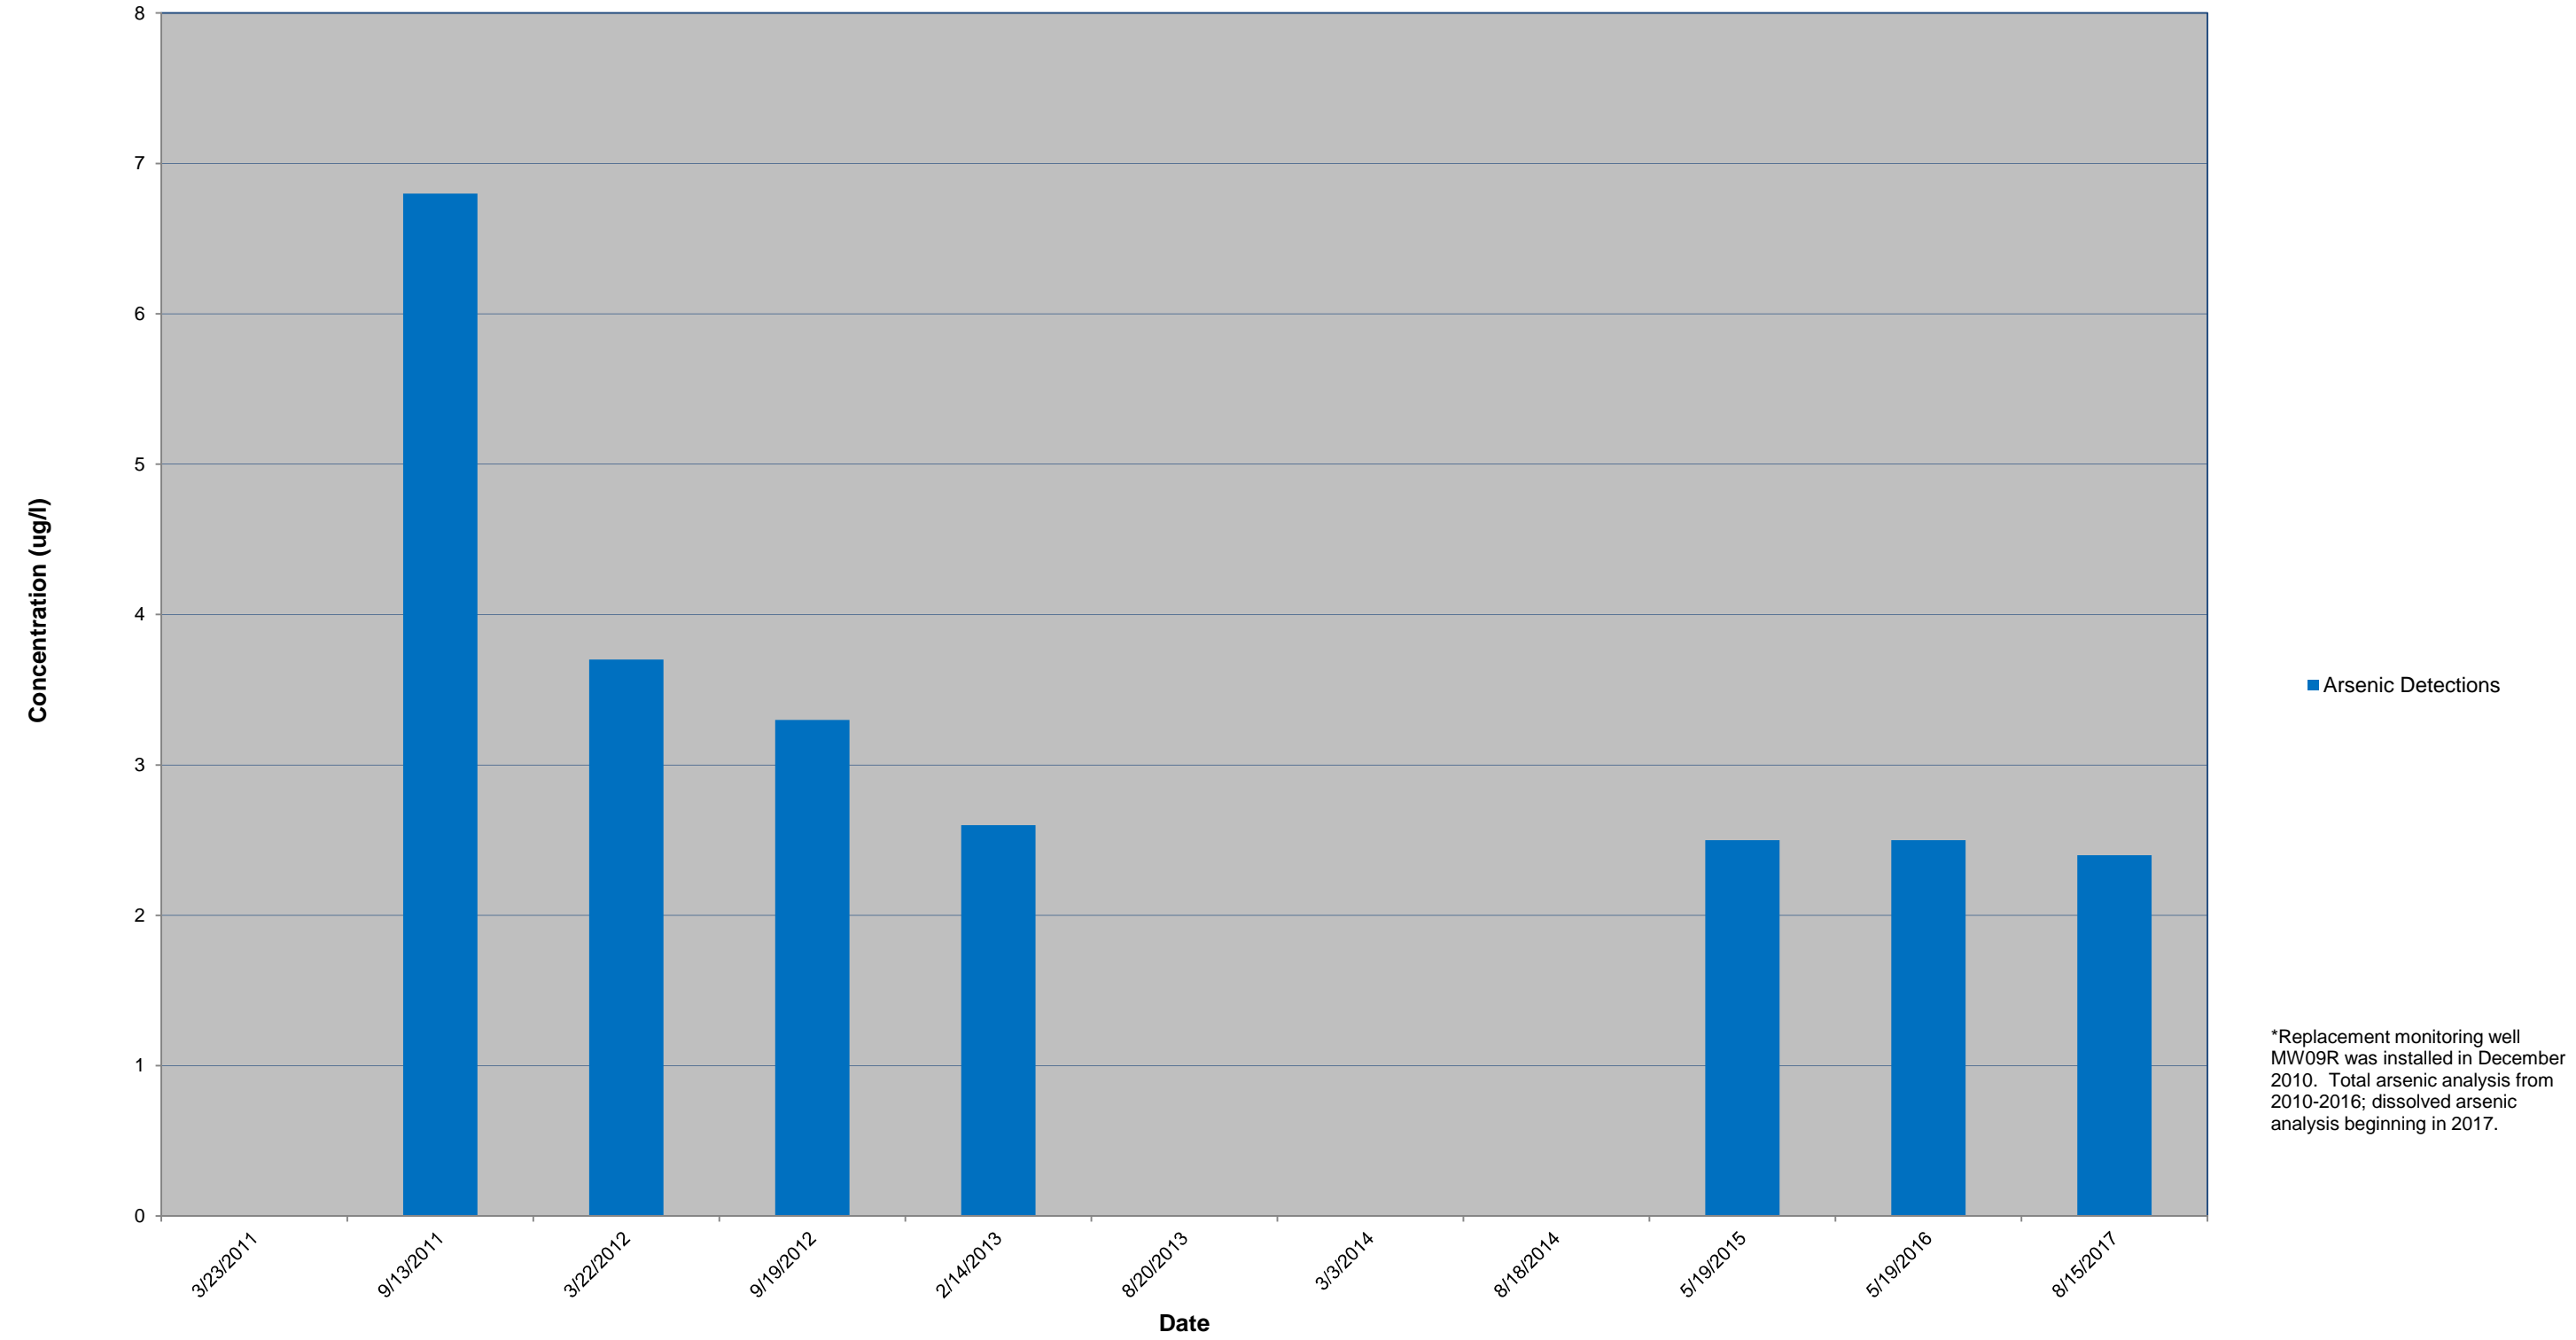
Arsenic Detections in CAMU MW09R Groundwater Samples  
2011 - 2017\*

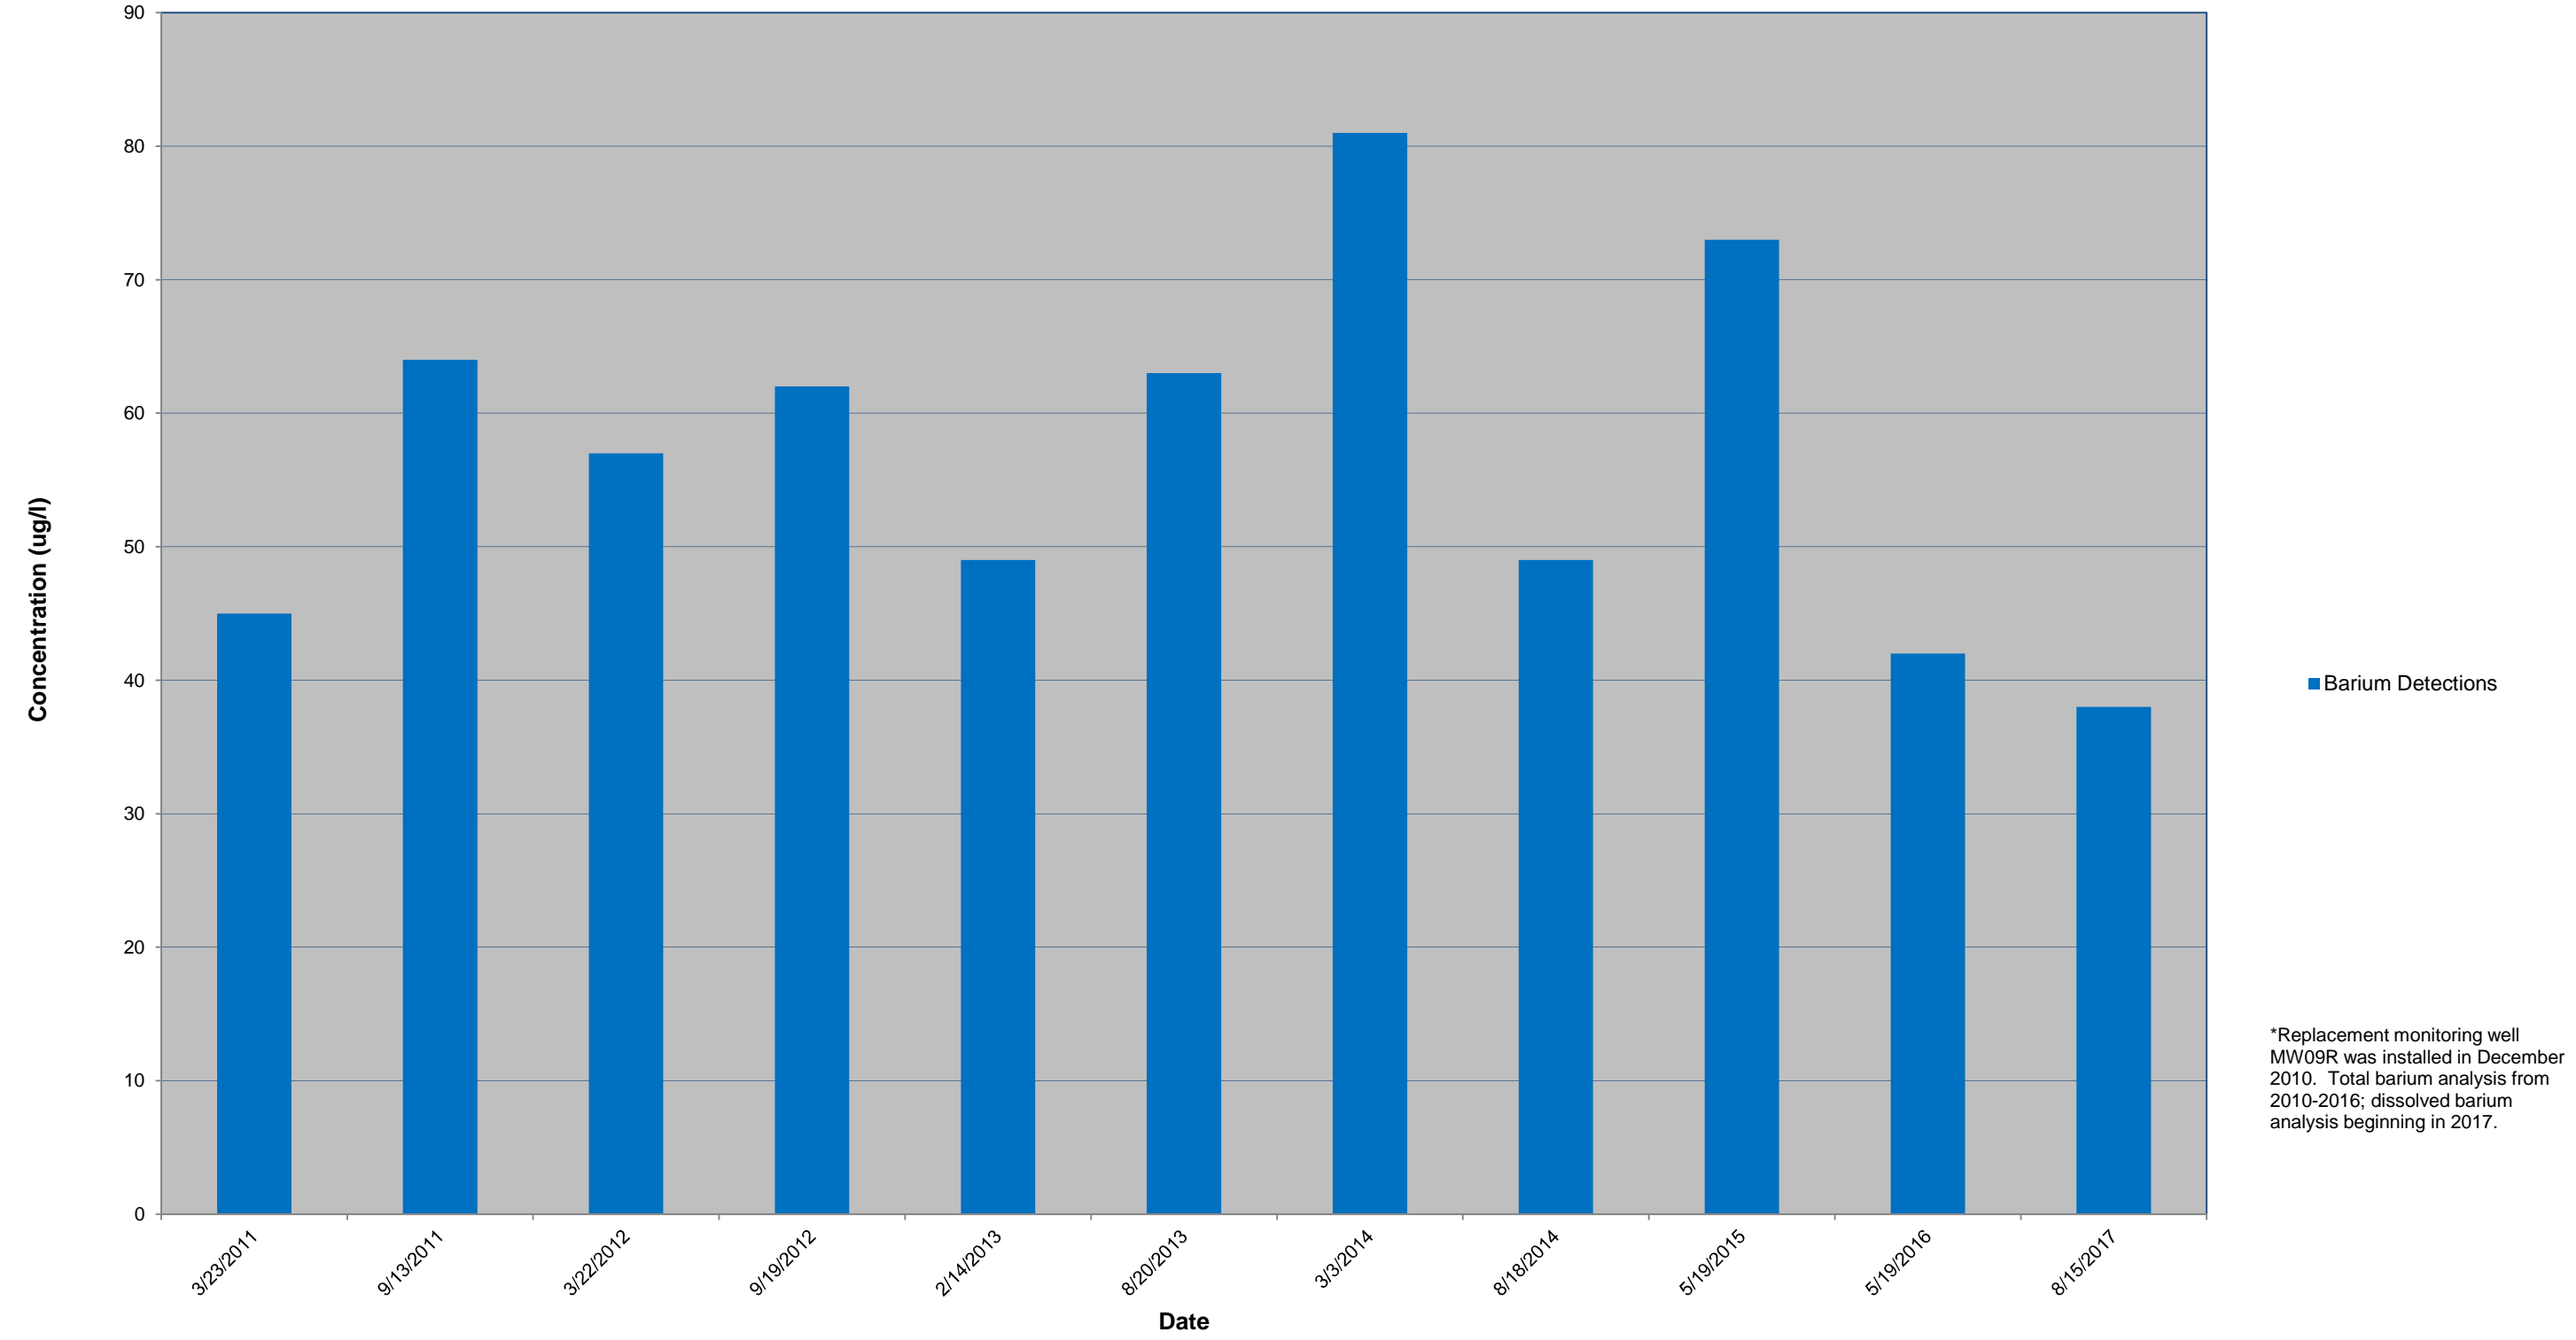
Barium Detections in CAMU MW09R Groundwater Samples  
2011 - 2017\*
