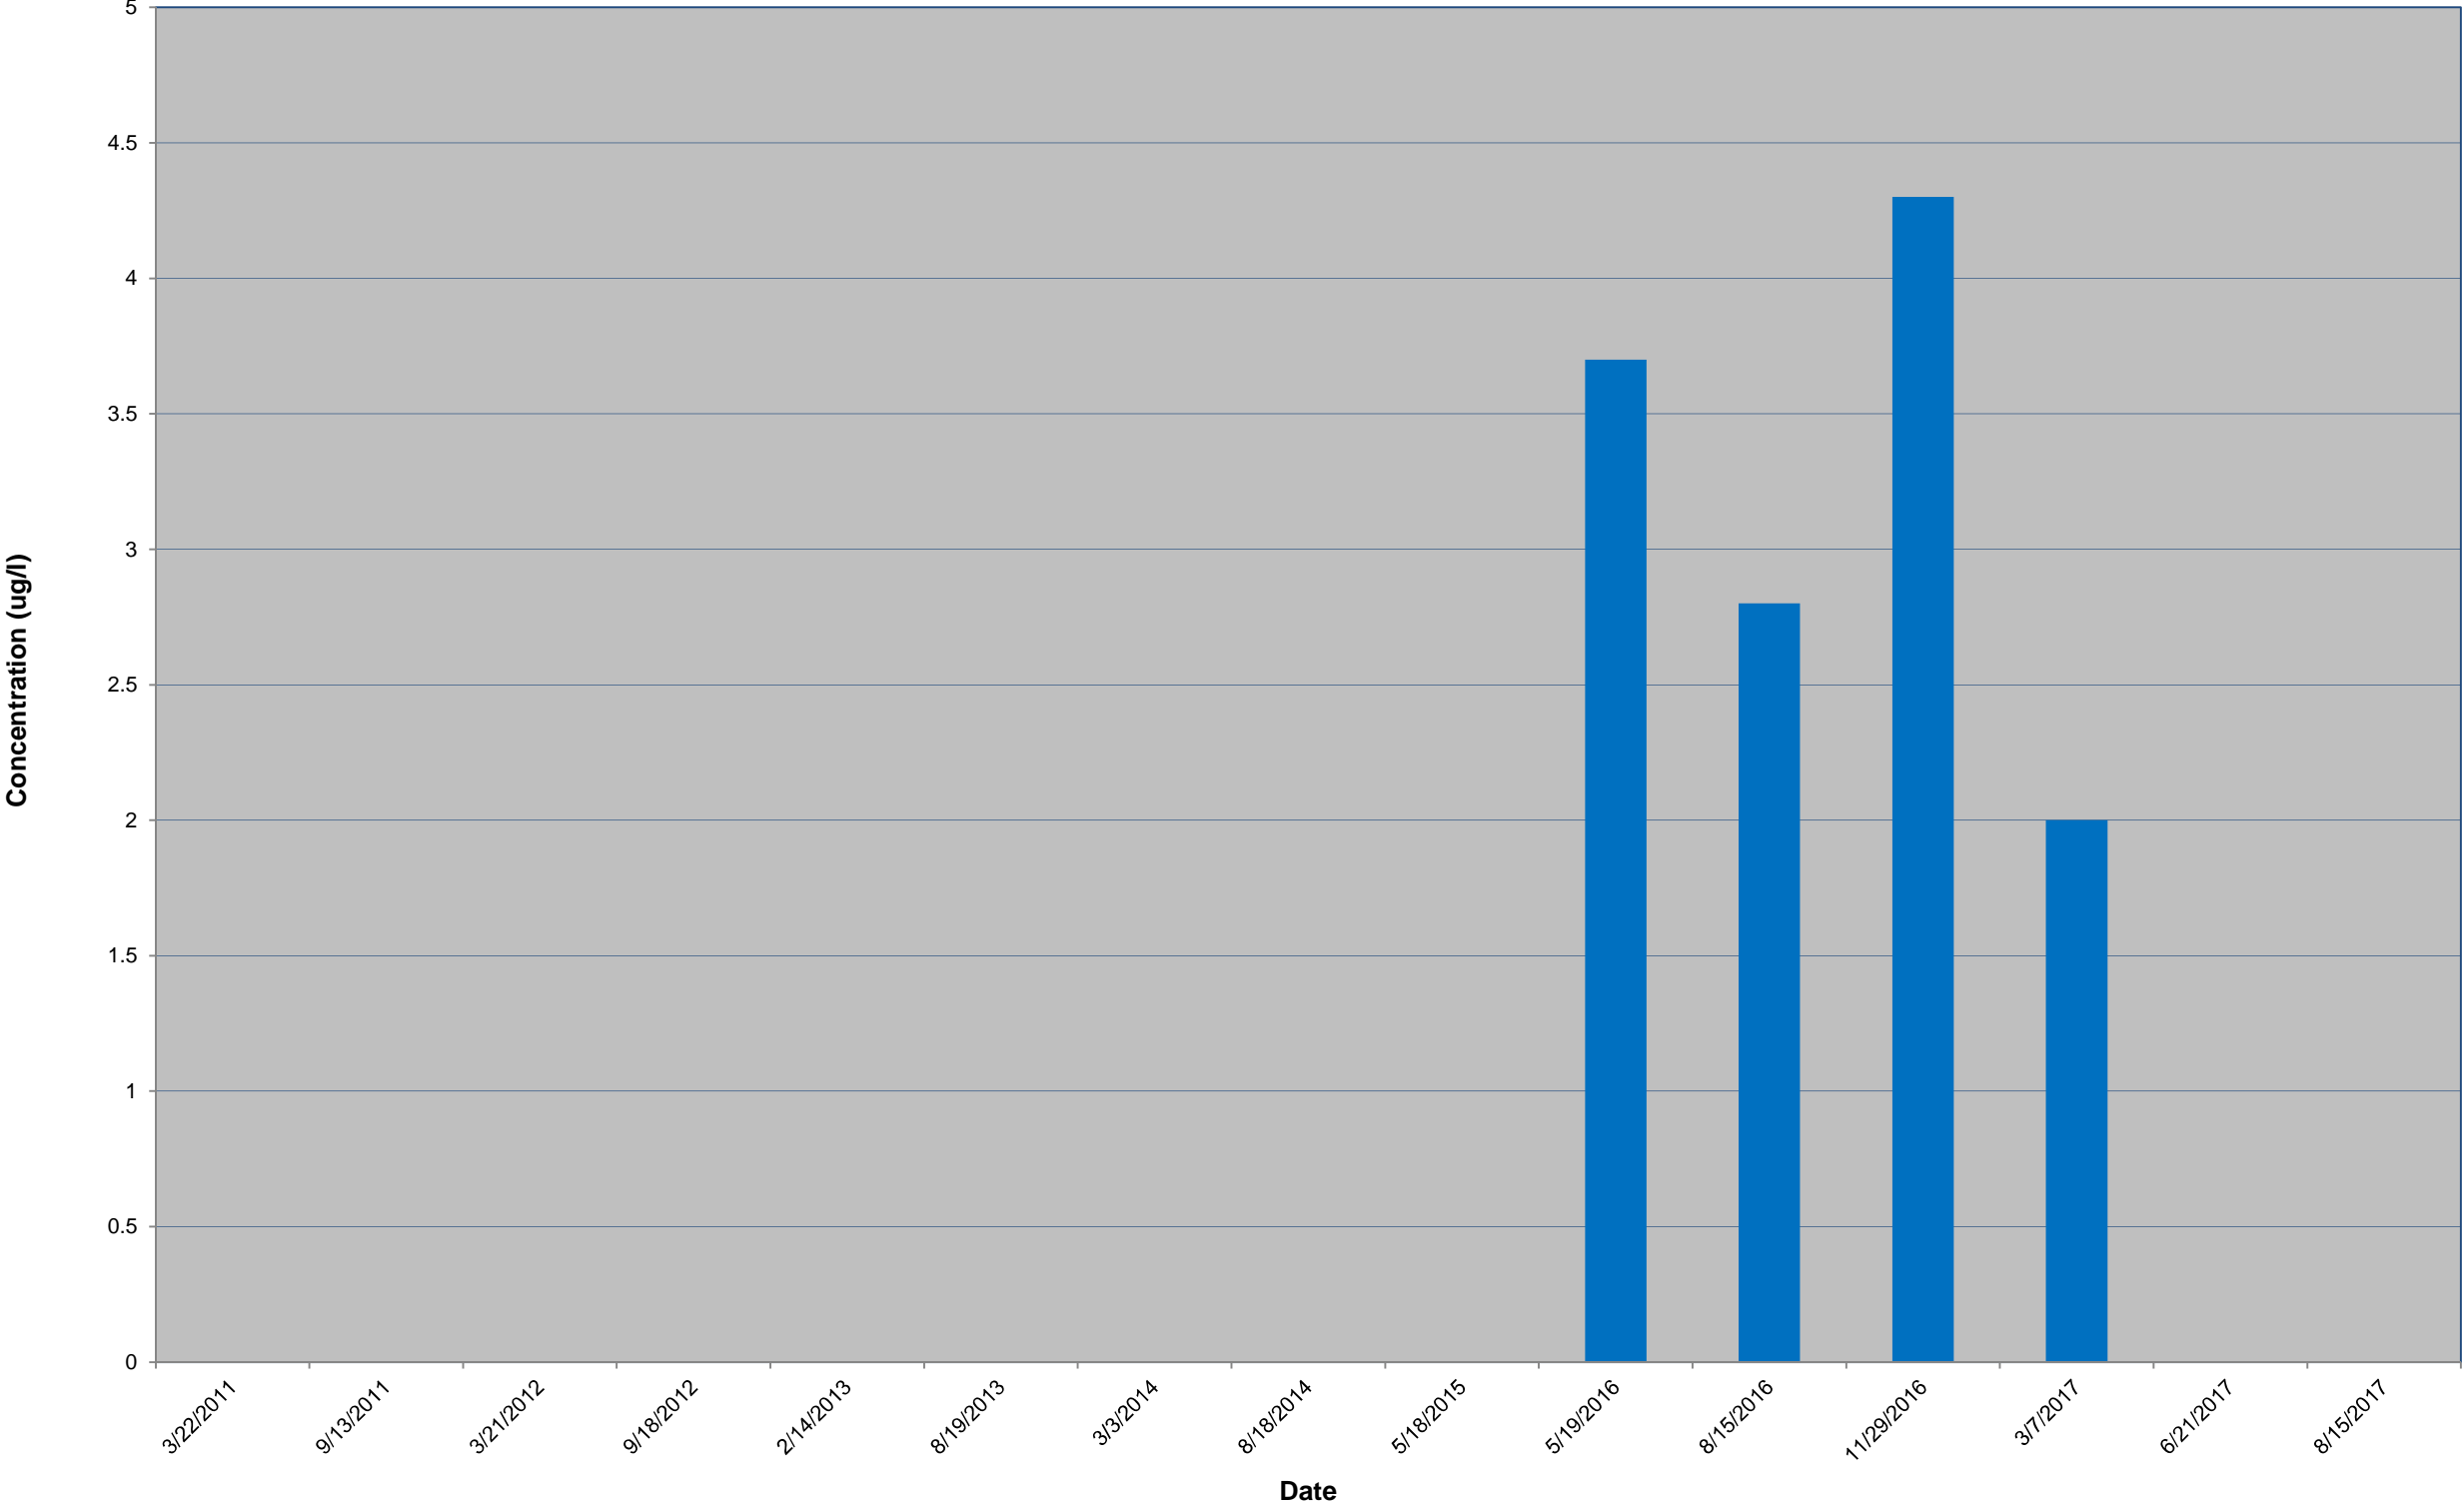
Hexavalent Chromium Detections in CAMU MW09R Groundwater Samples  
2011 - 2017\*

\*Replacement monitoring well  
MW09R was installed in  
December 2010. Total  
hexavalent chromium analysis  
performed from 2010-March  
2017; dissolved hexavalent  
chromium analysis beginning in  
June 2017.

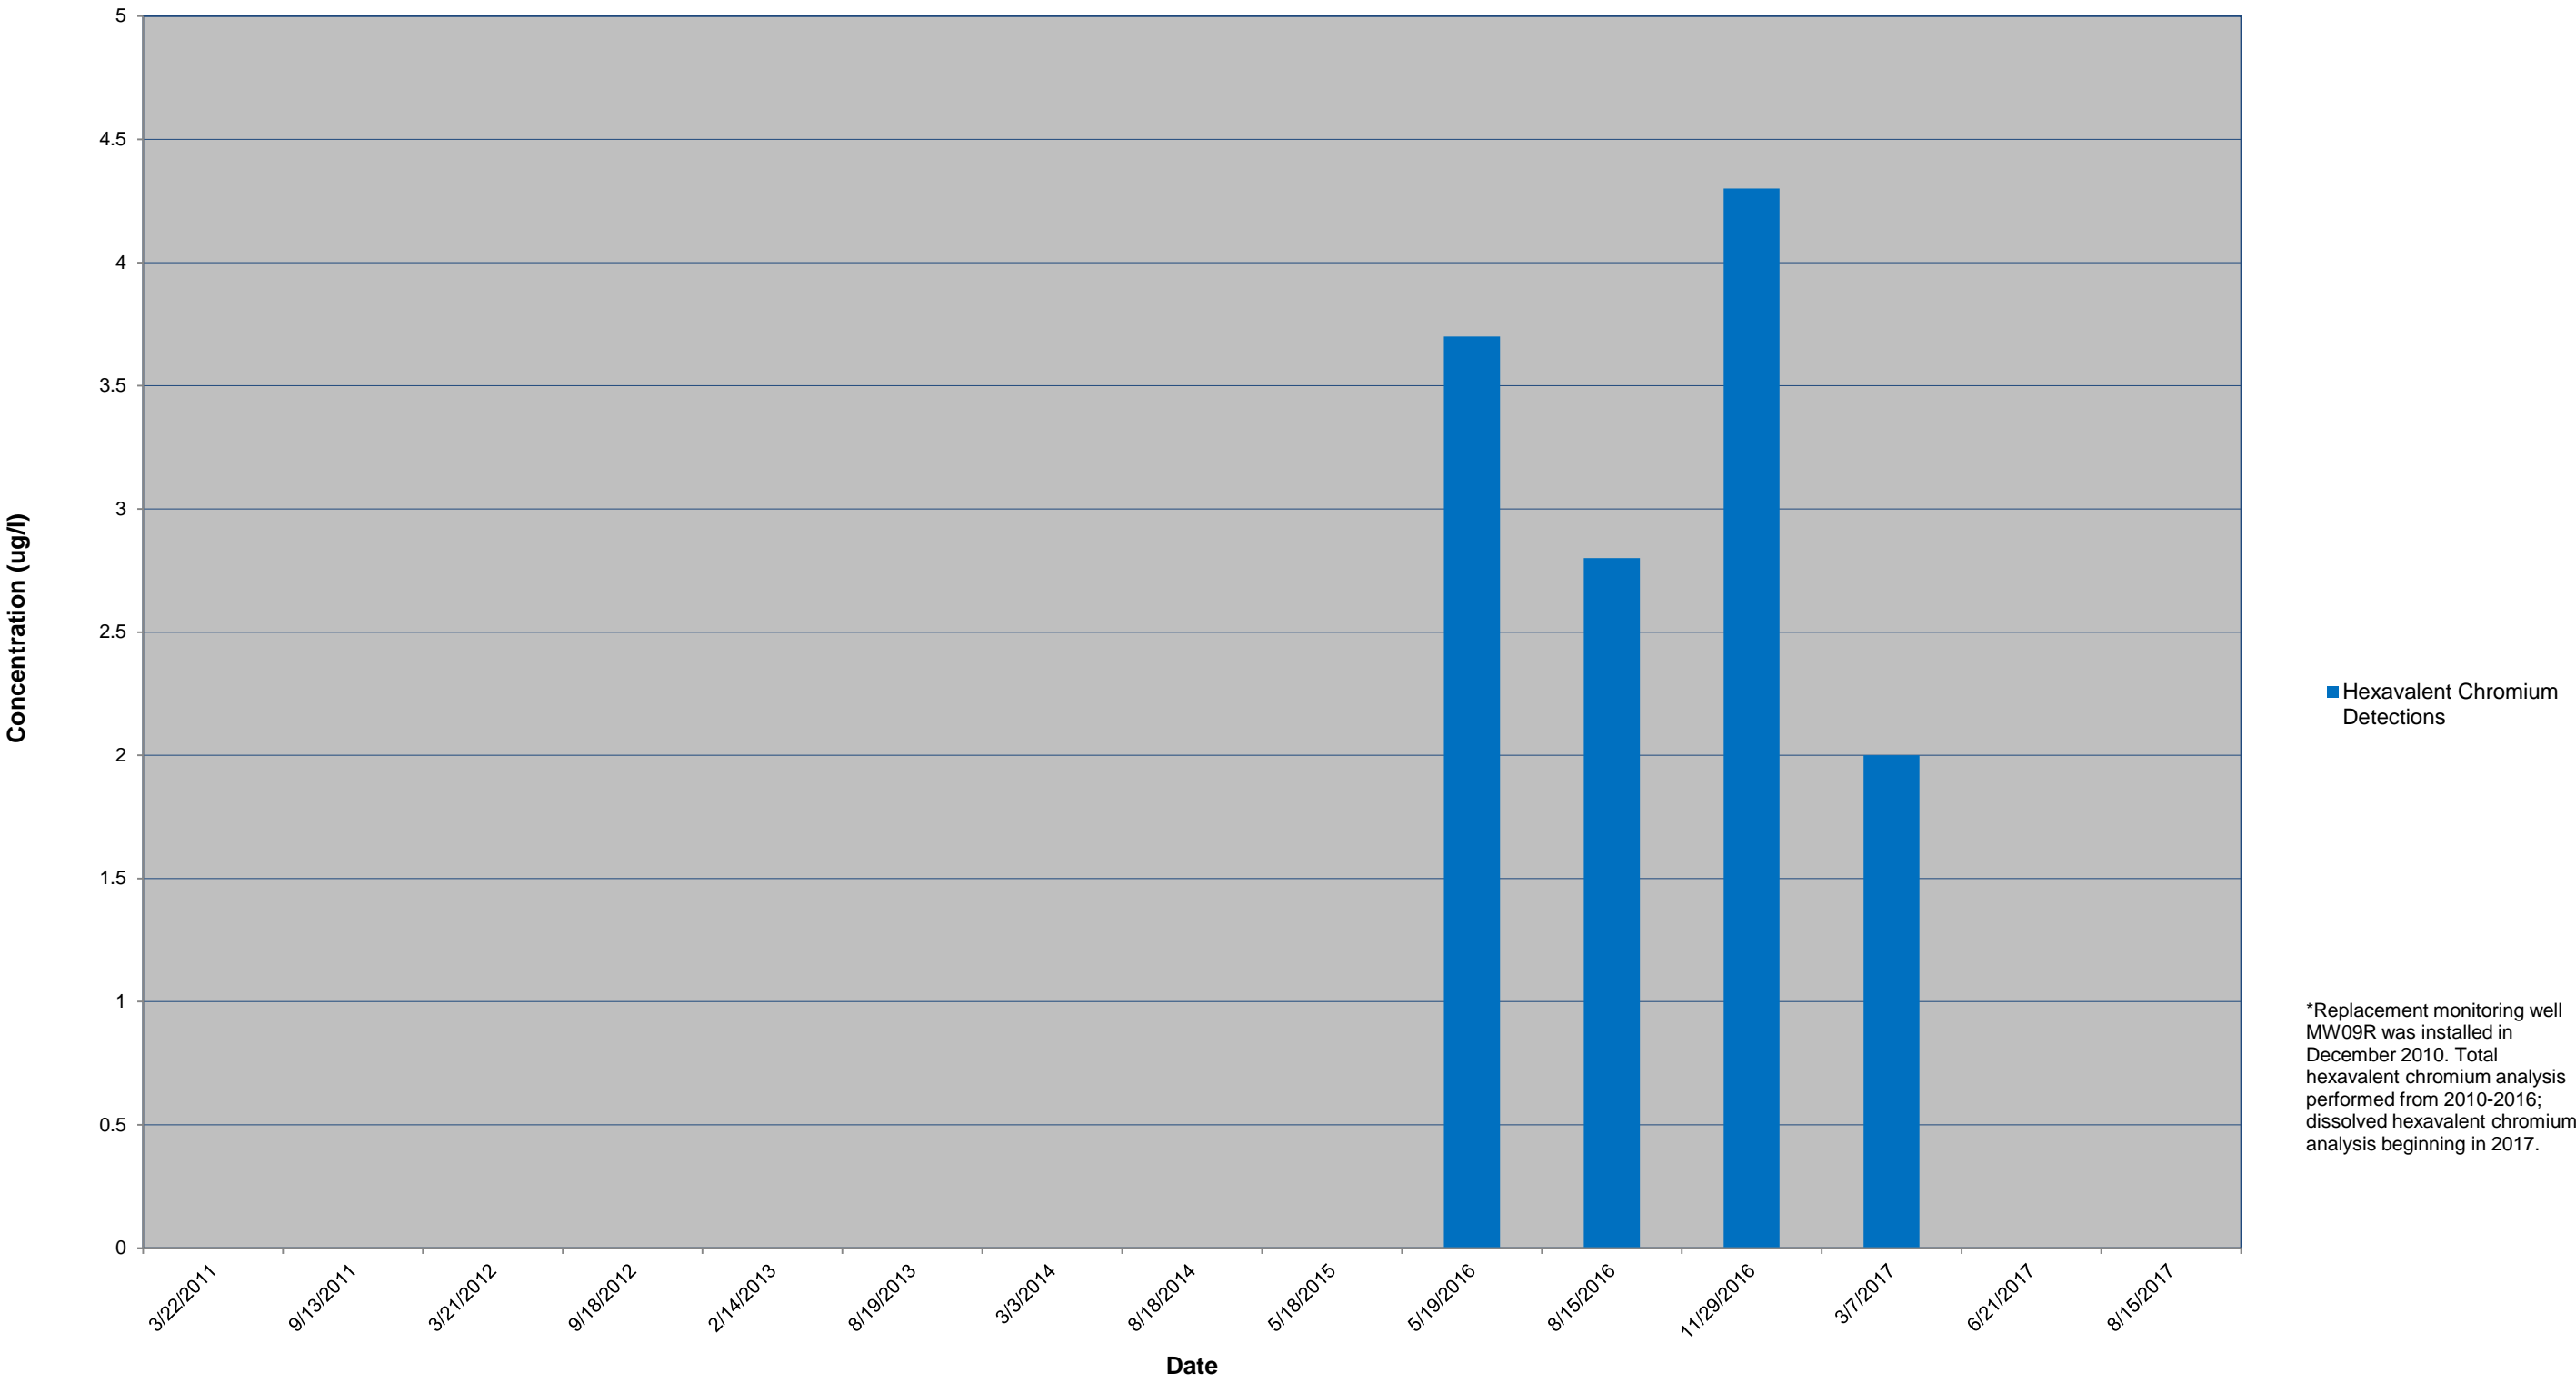
Hexavalent Chromium Detections in CAMU MW09R Groundwater Samples  
2011 - 2017\*

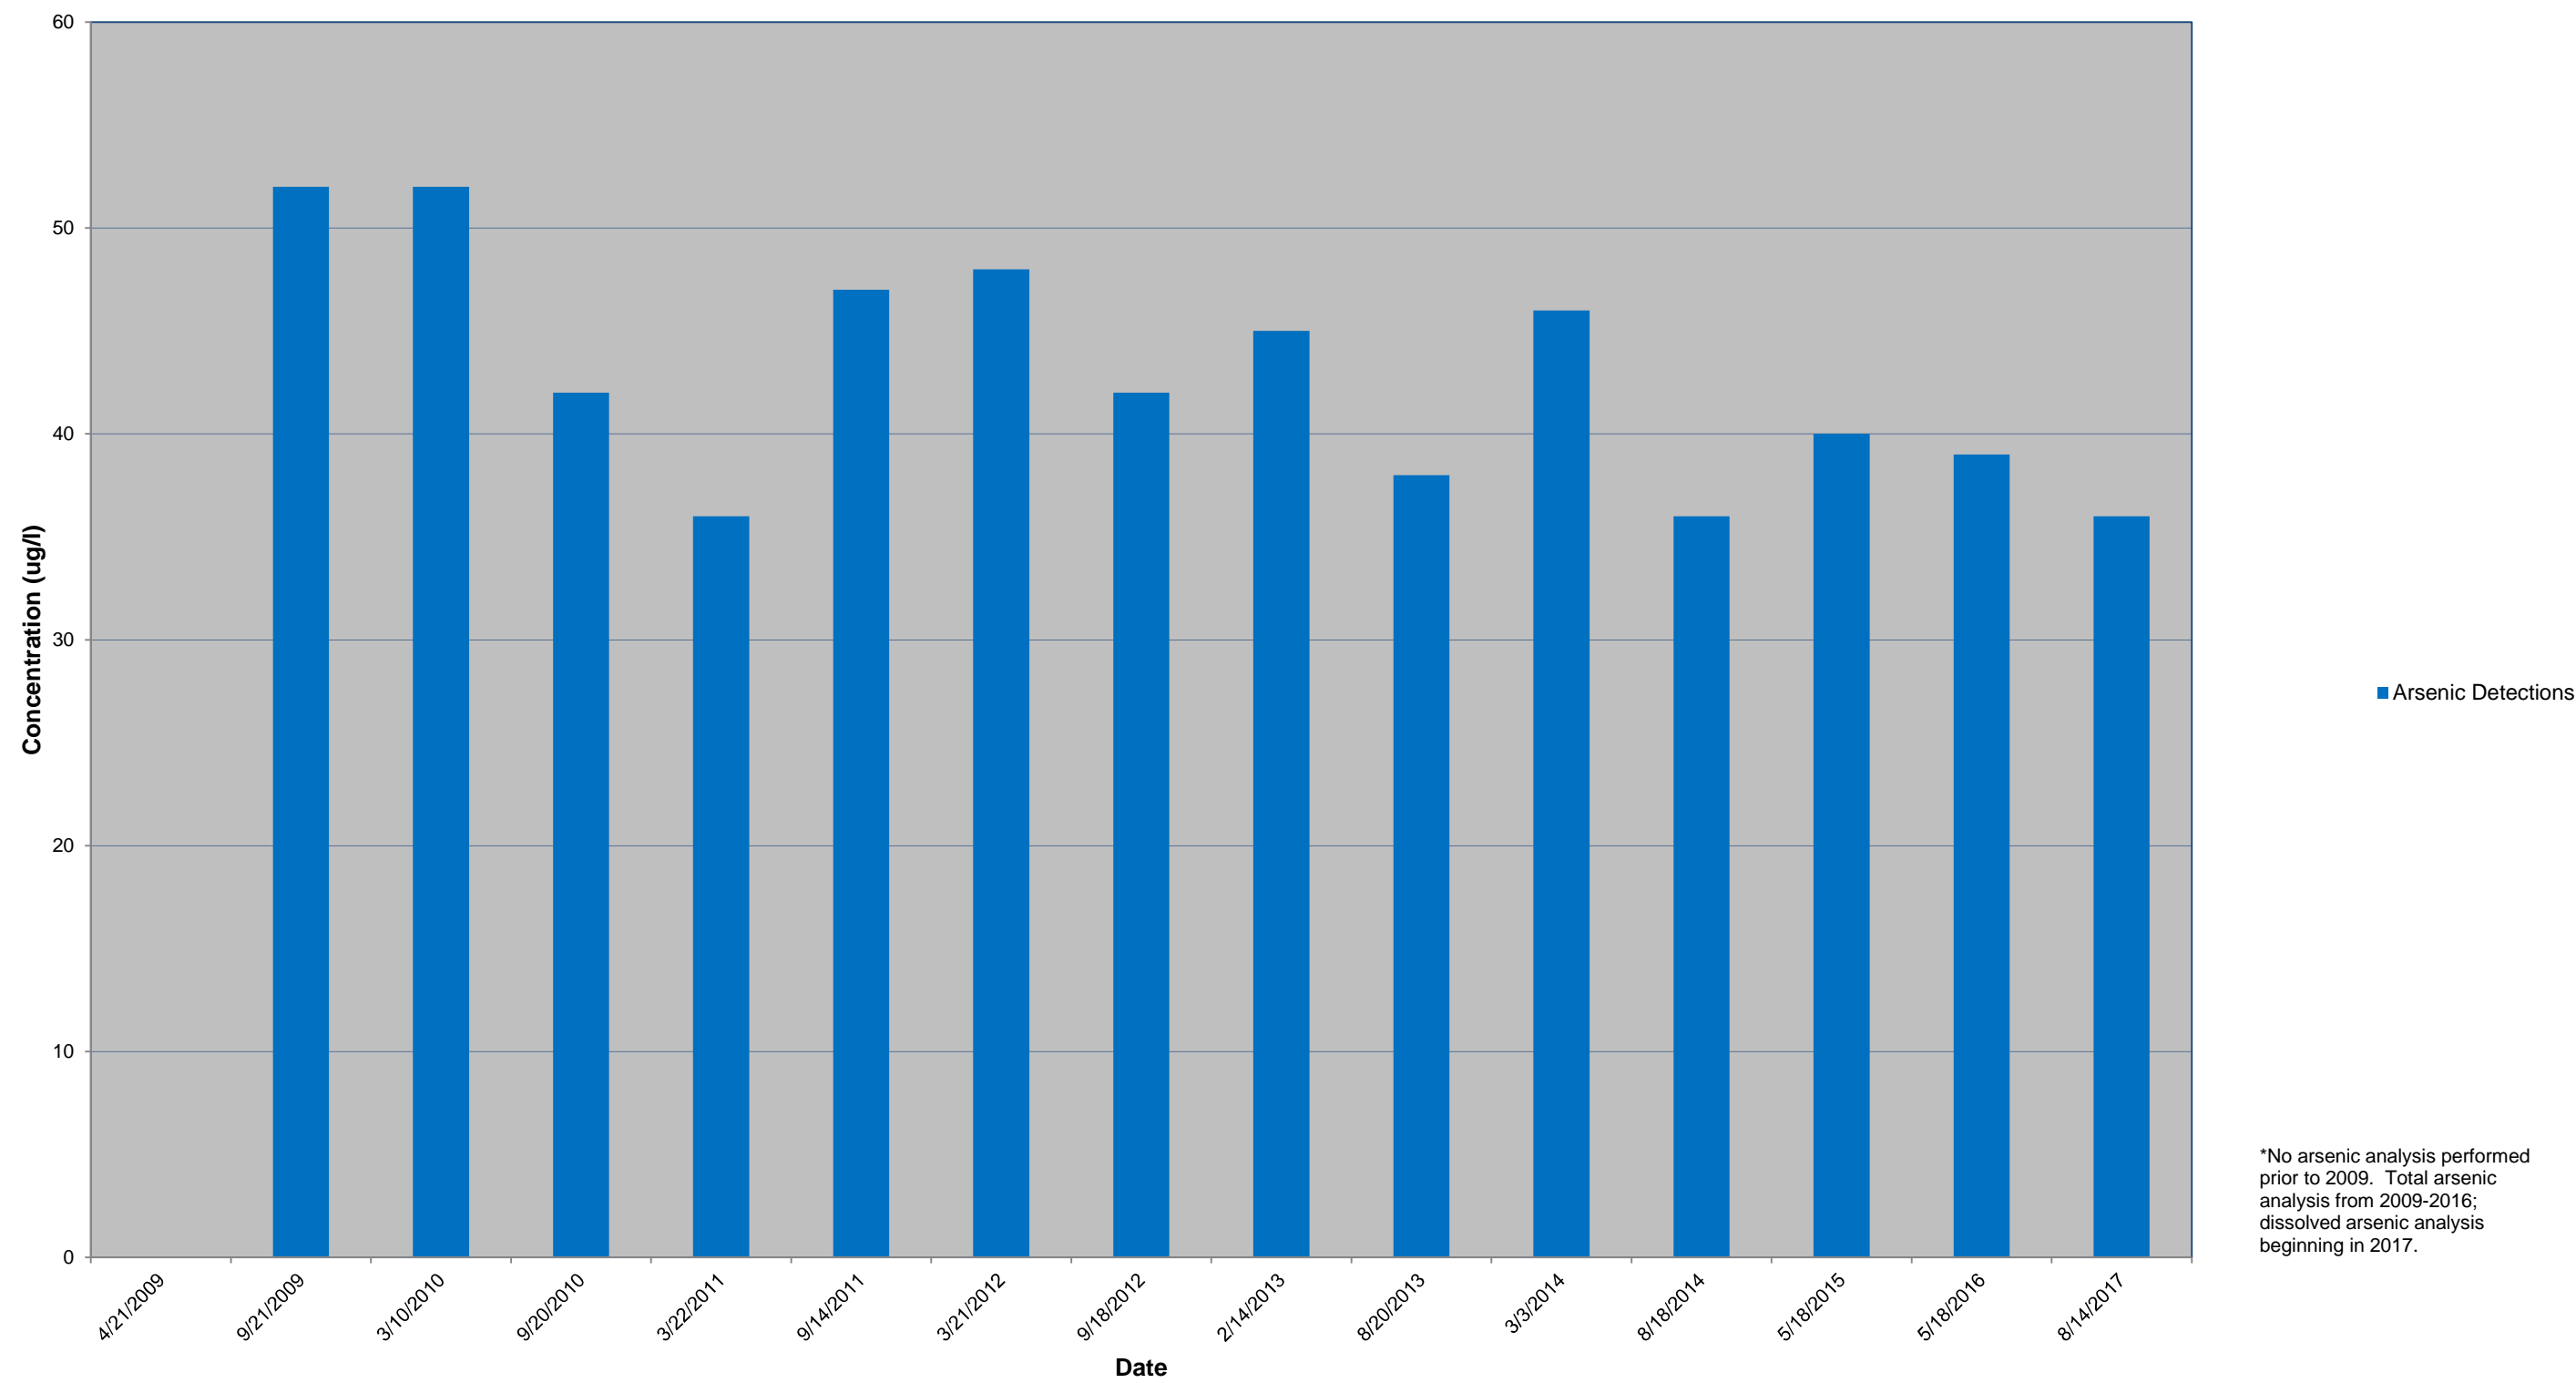
Arsenic Detections in CAMU P01R Groundwater Samples  
2009 - 2017\*

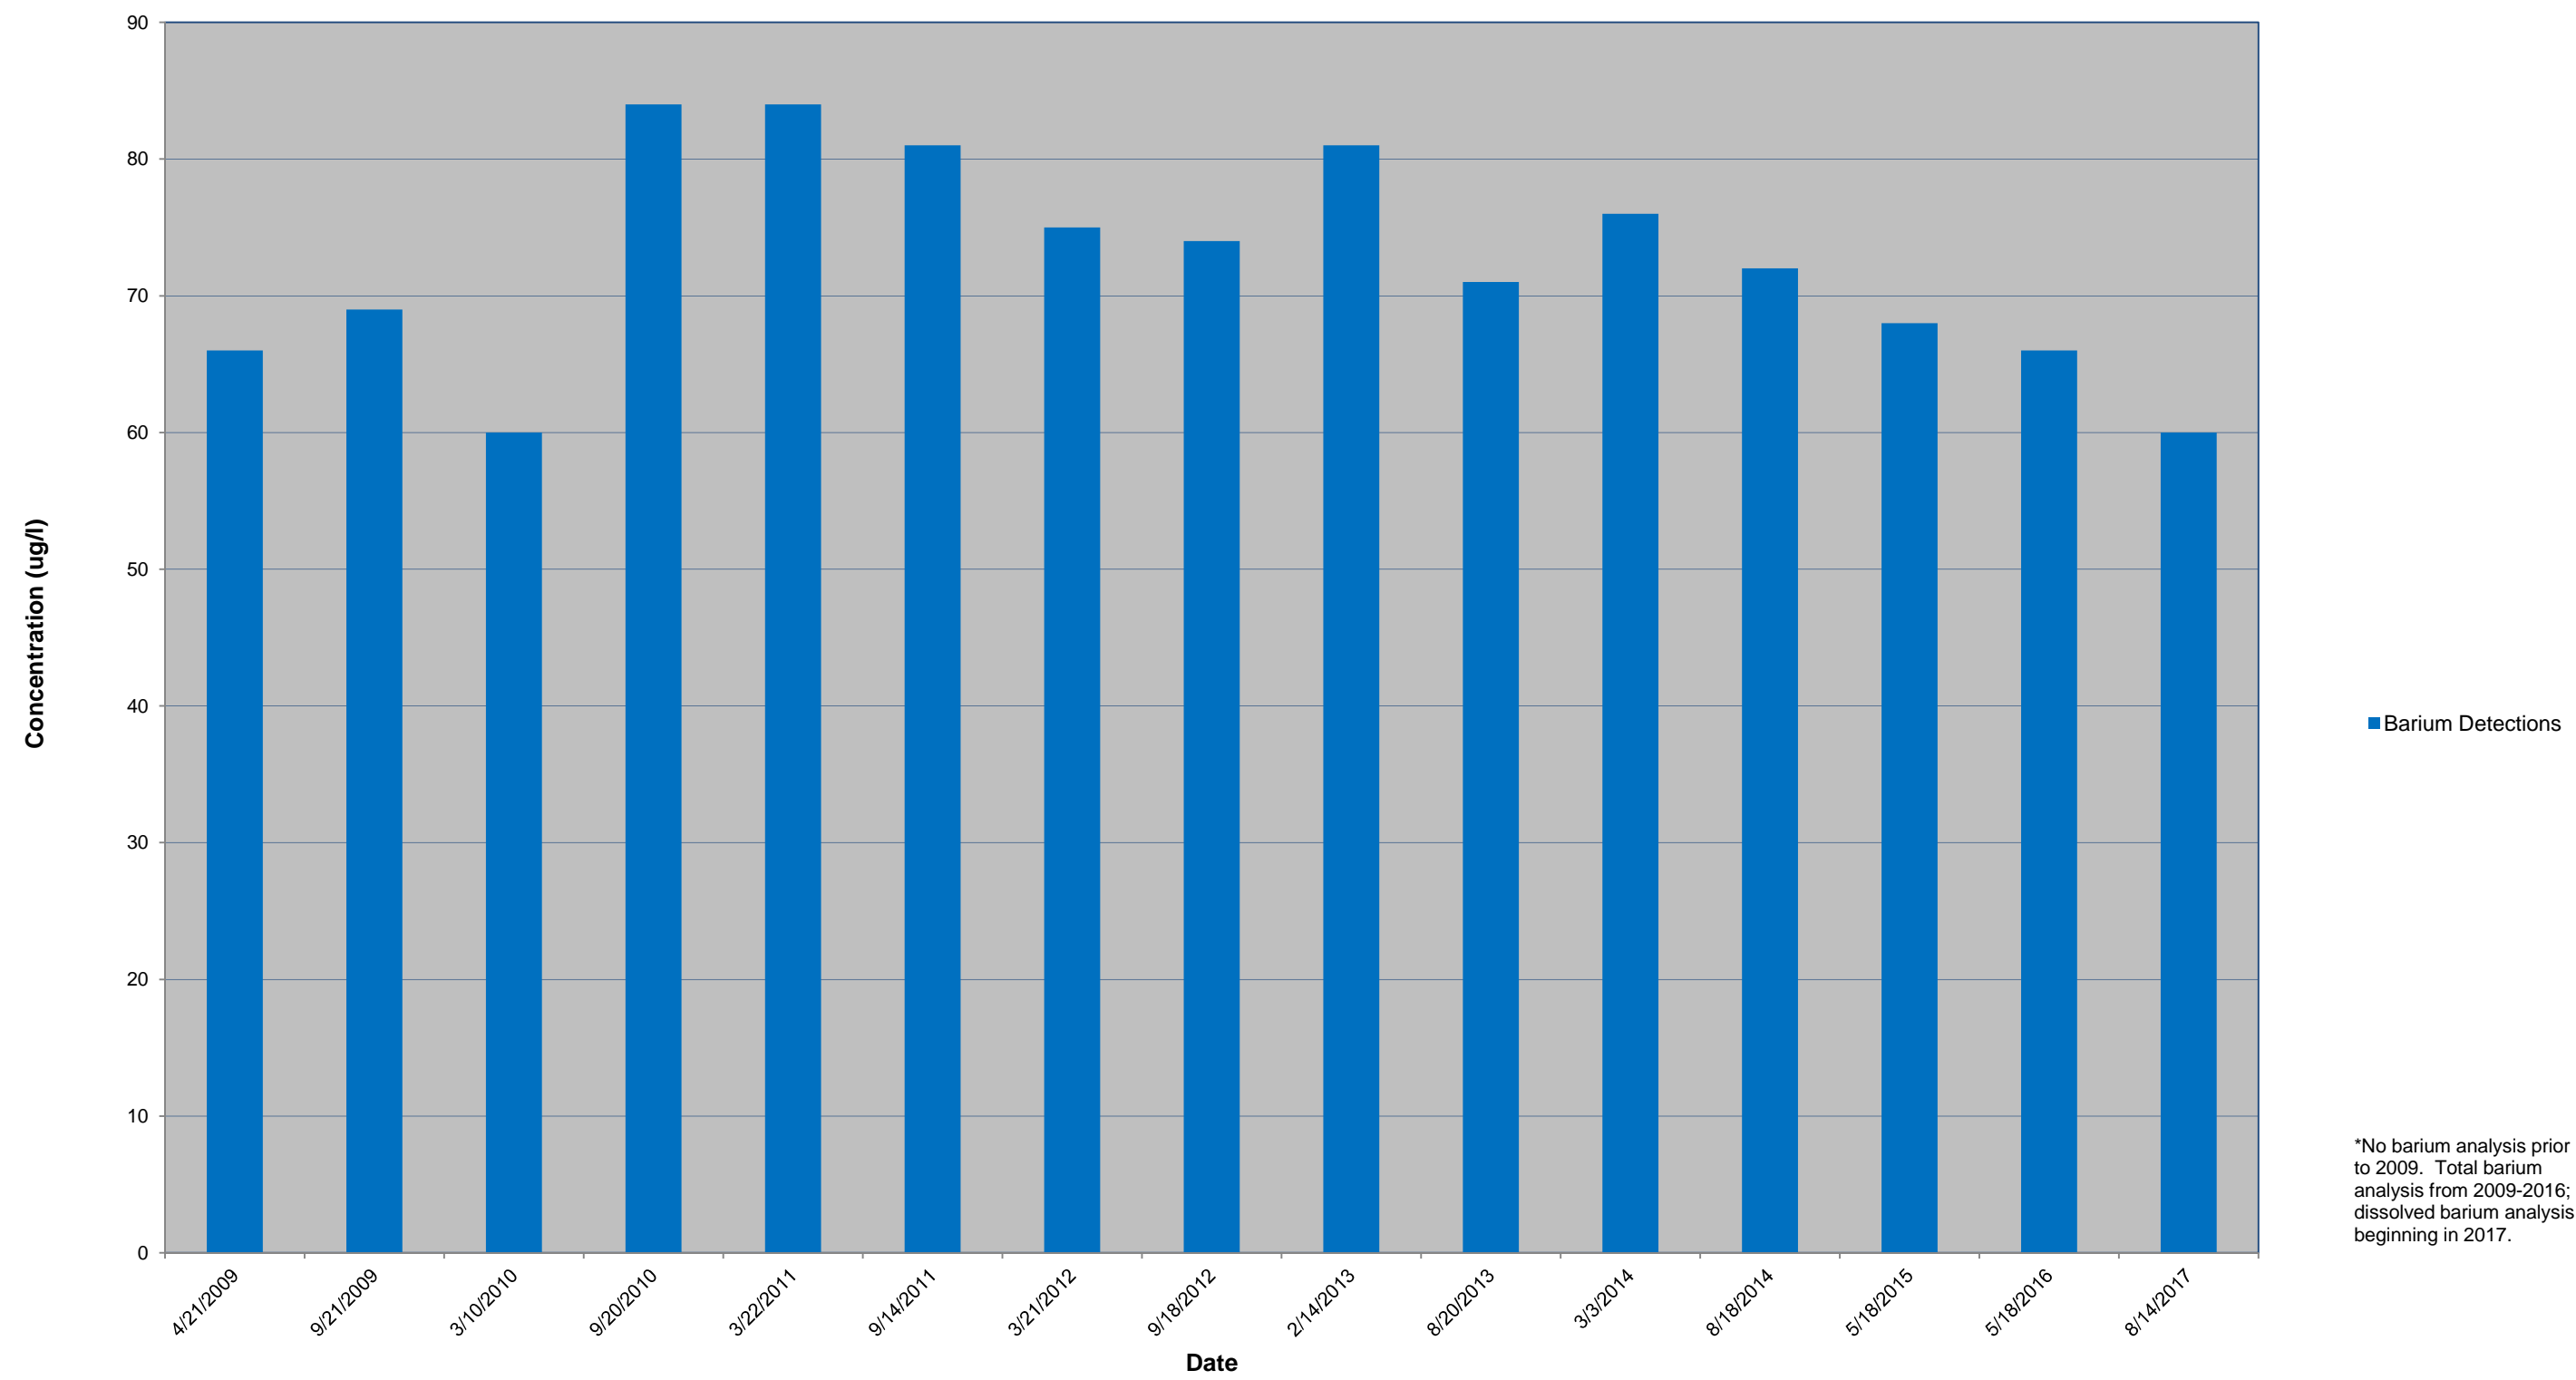
Barium Detections in CAMU P01R Groundwater Samples  
2009 - 2017\*

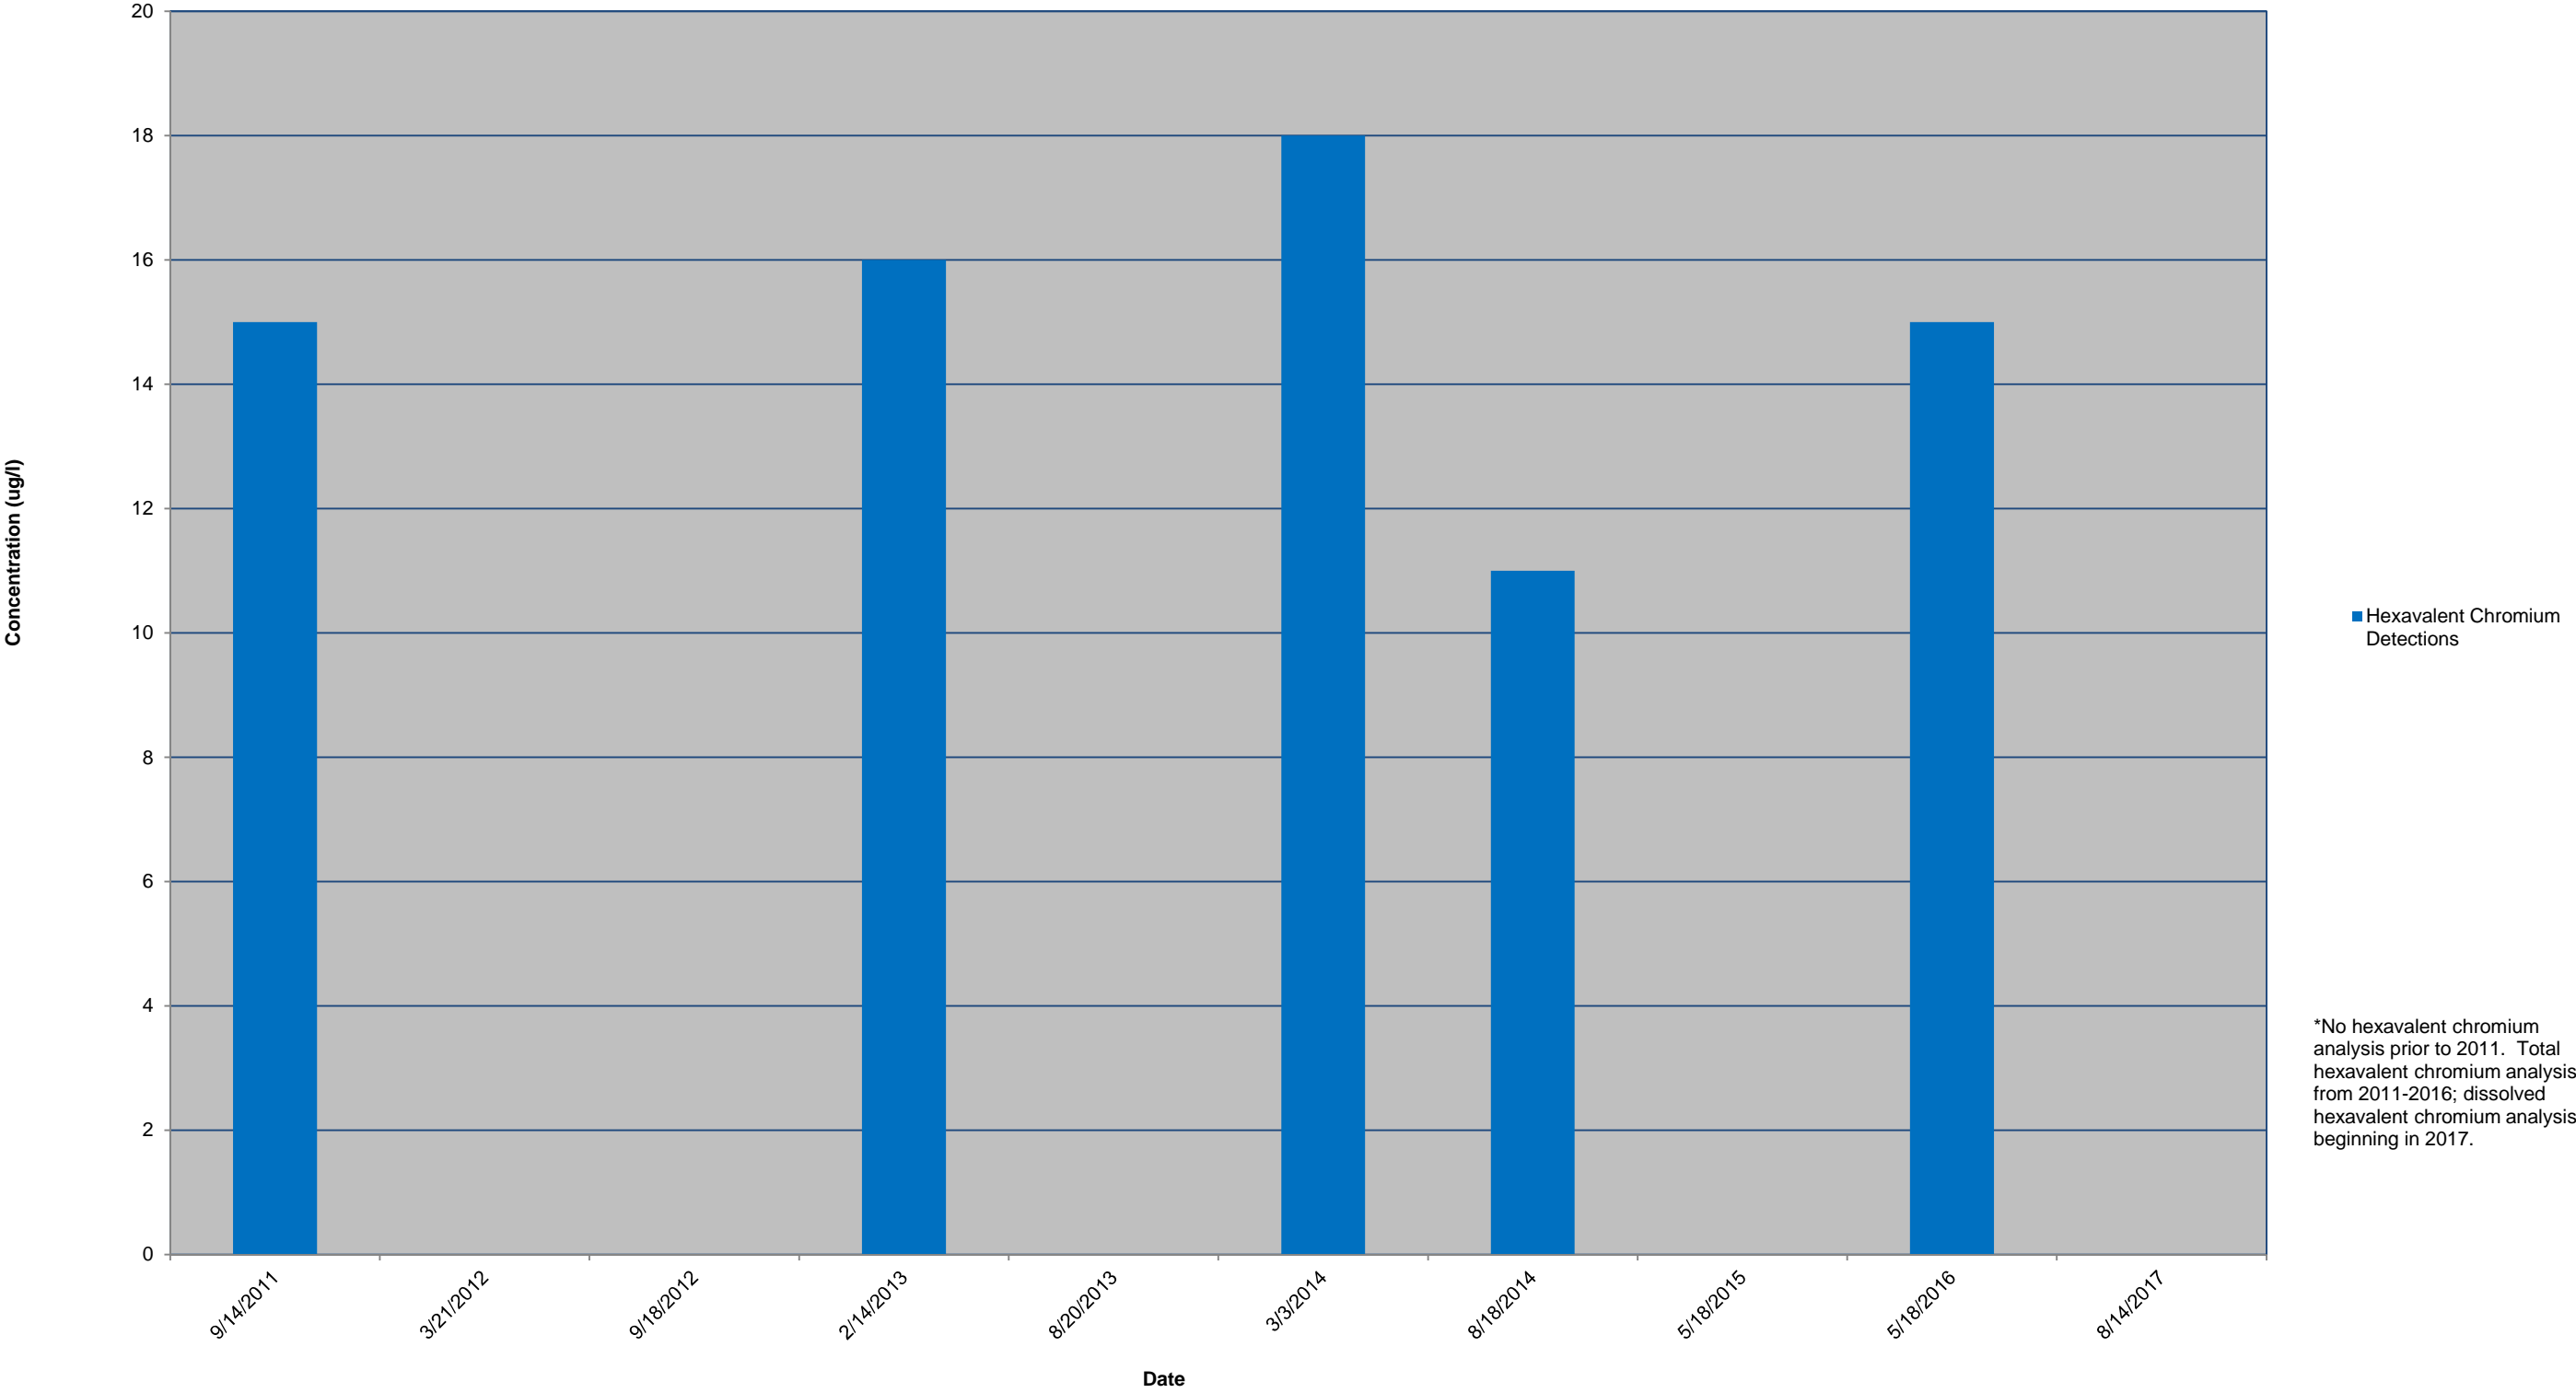
Hexavalent Chromium Detections in CAMU P01R Groundwater Samples  
2011 - 2017\*

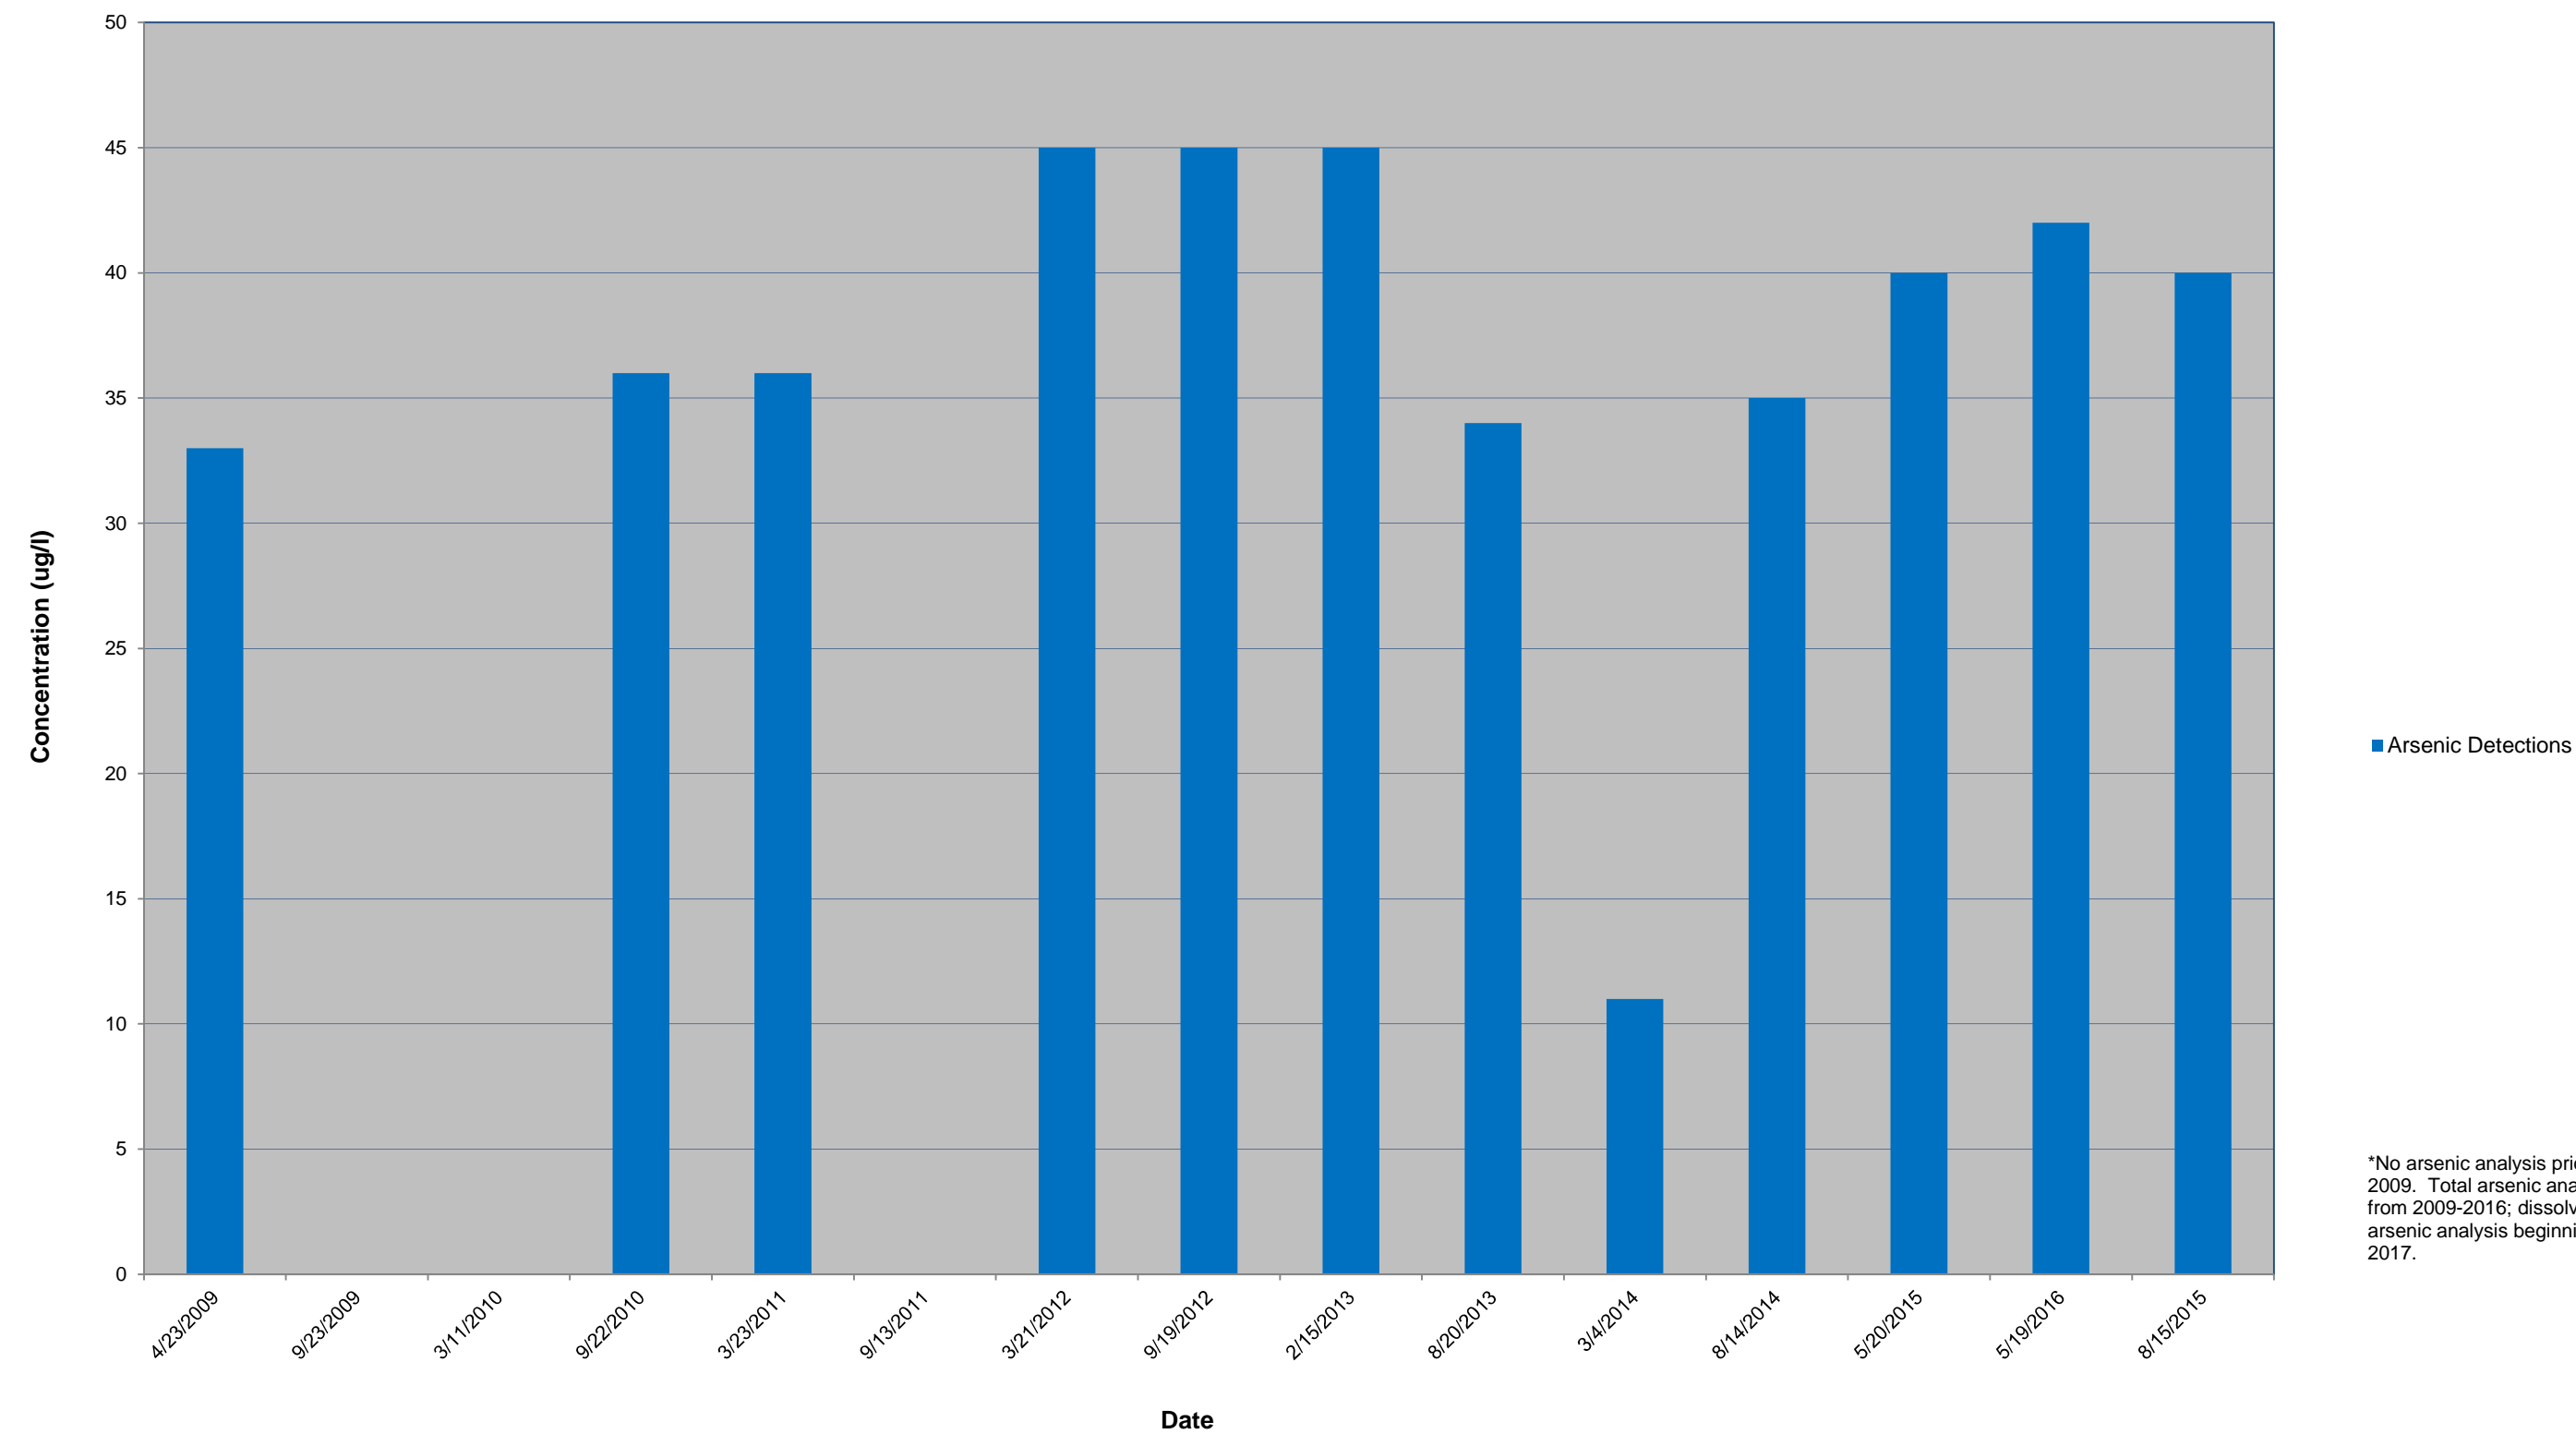
Arsenic Detections in CAMU P05 Groundwater Samples  
2009 - 2017\*
