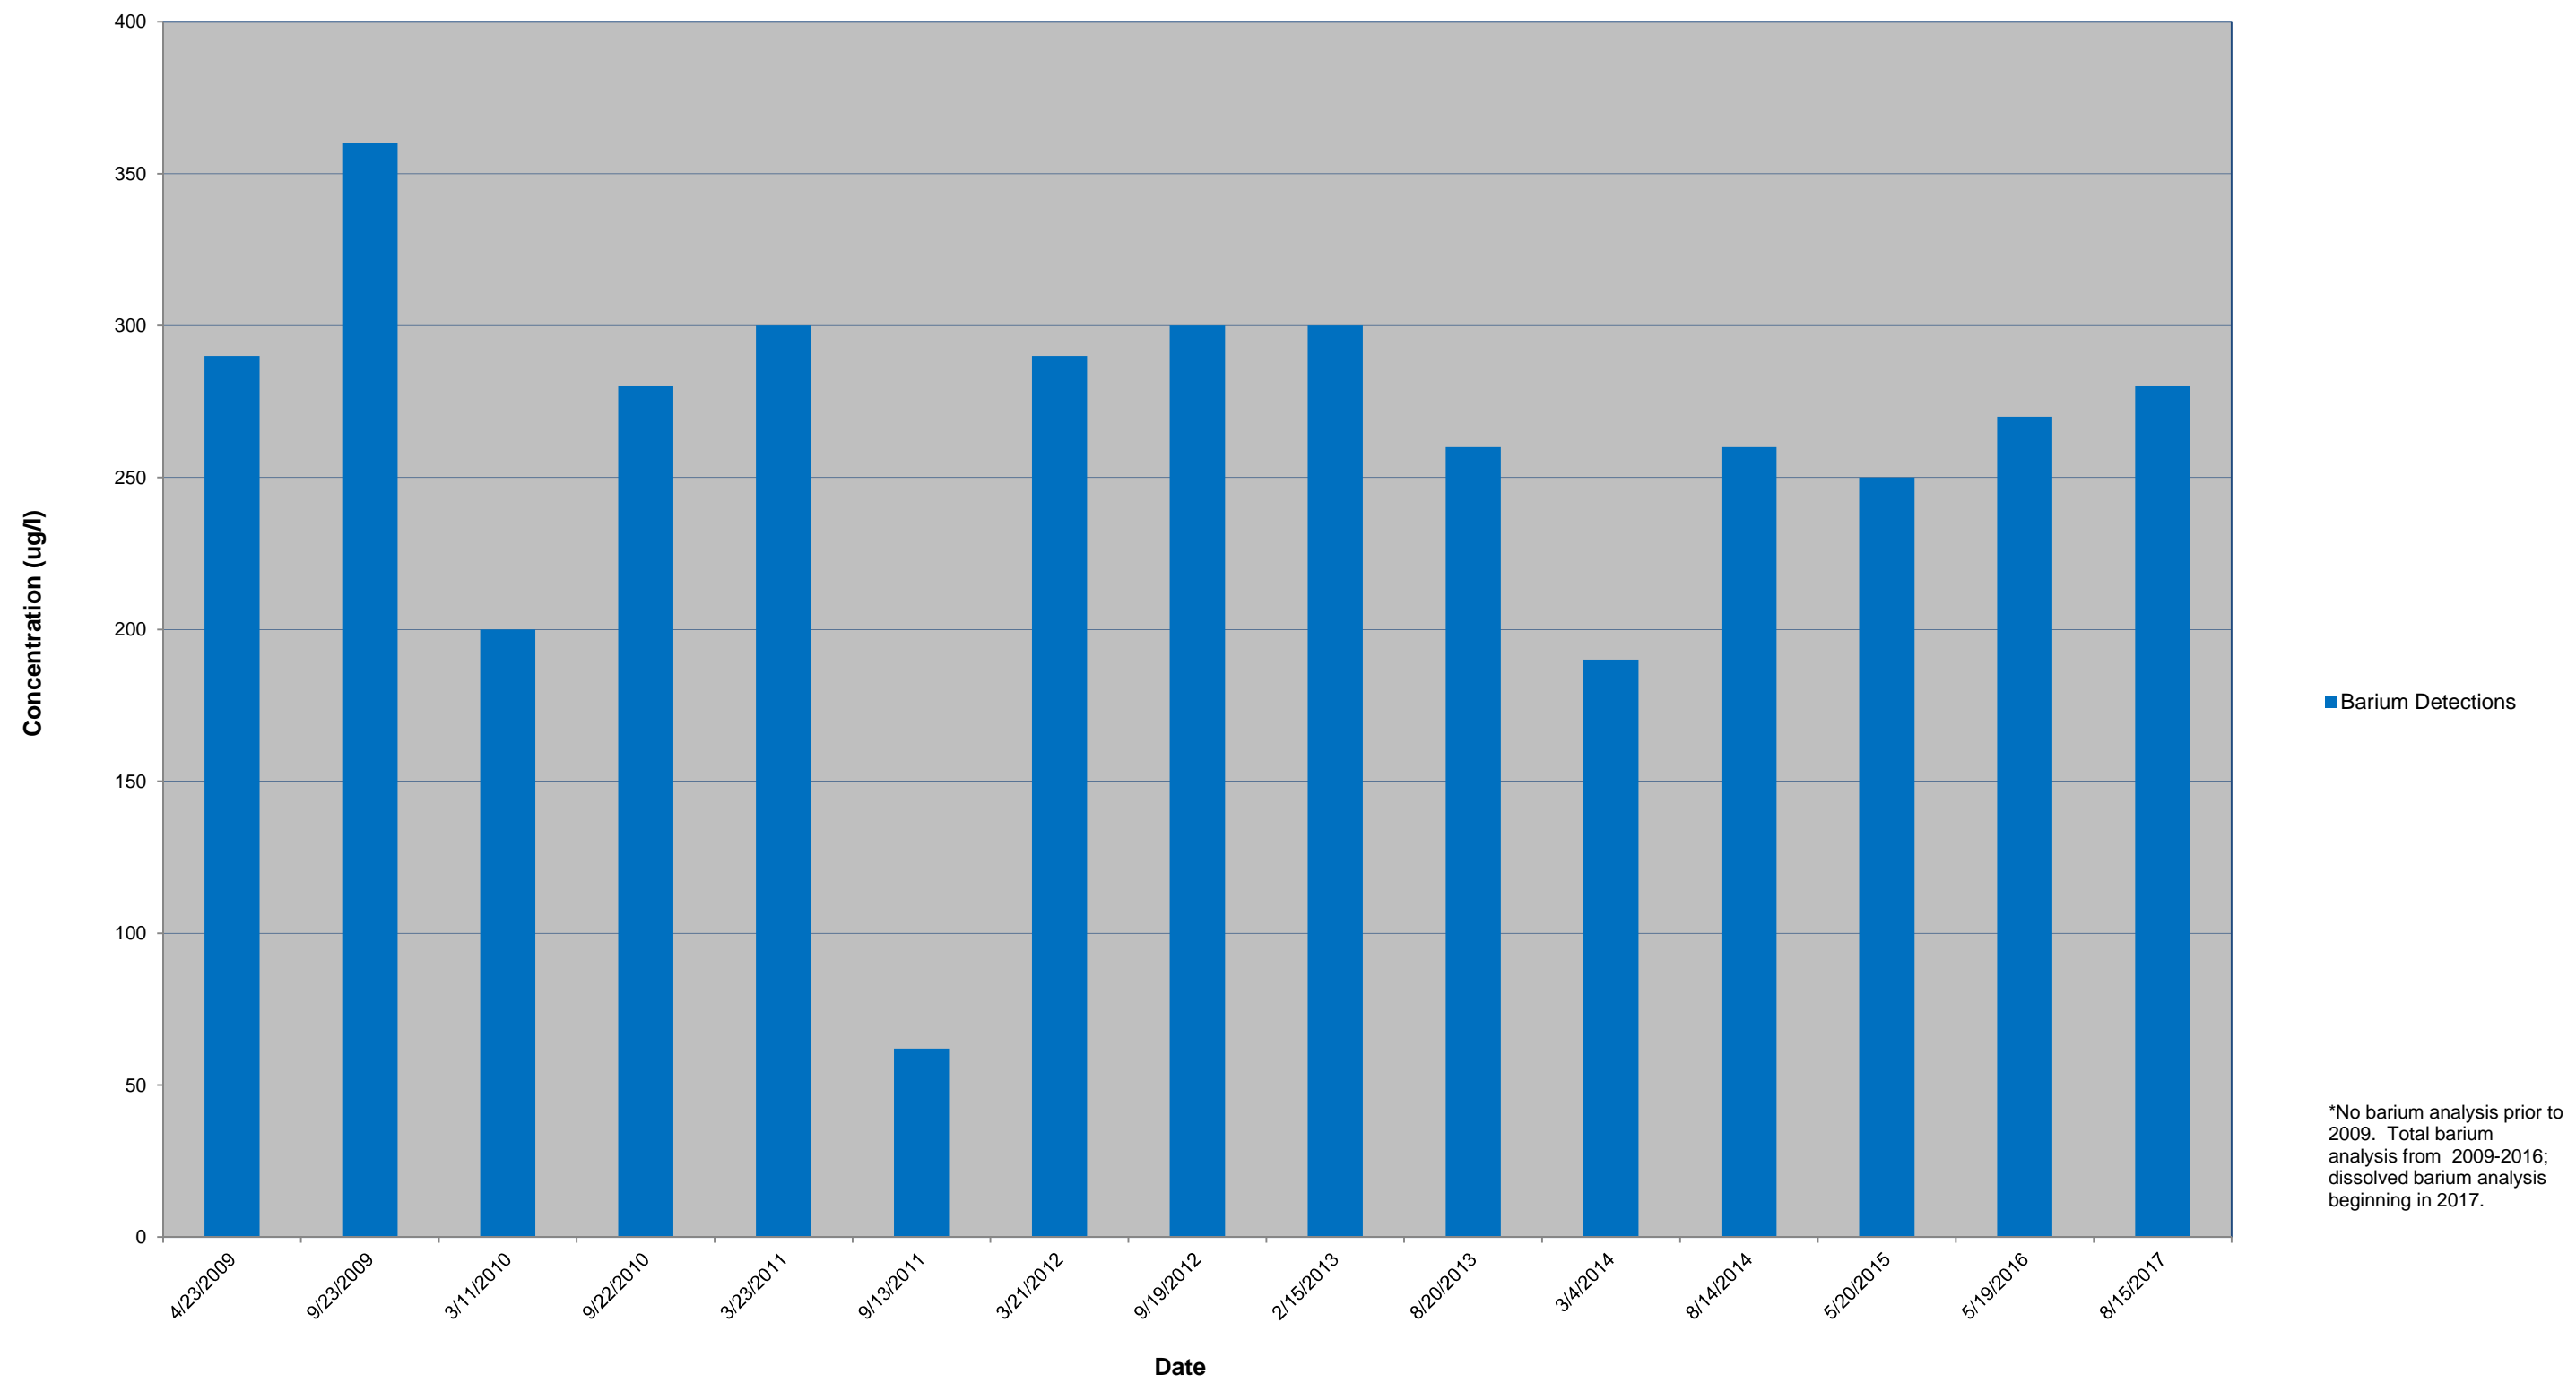
**Barium Detections in CAMU P05 Groundwater Samples  
2009 - 2017\***

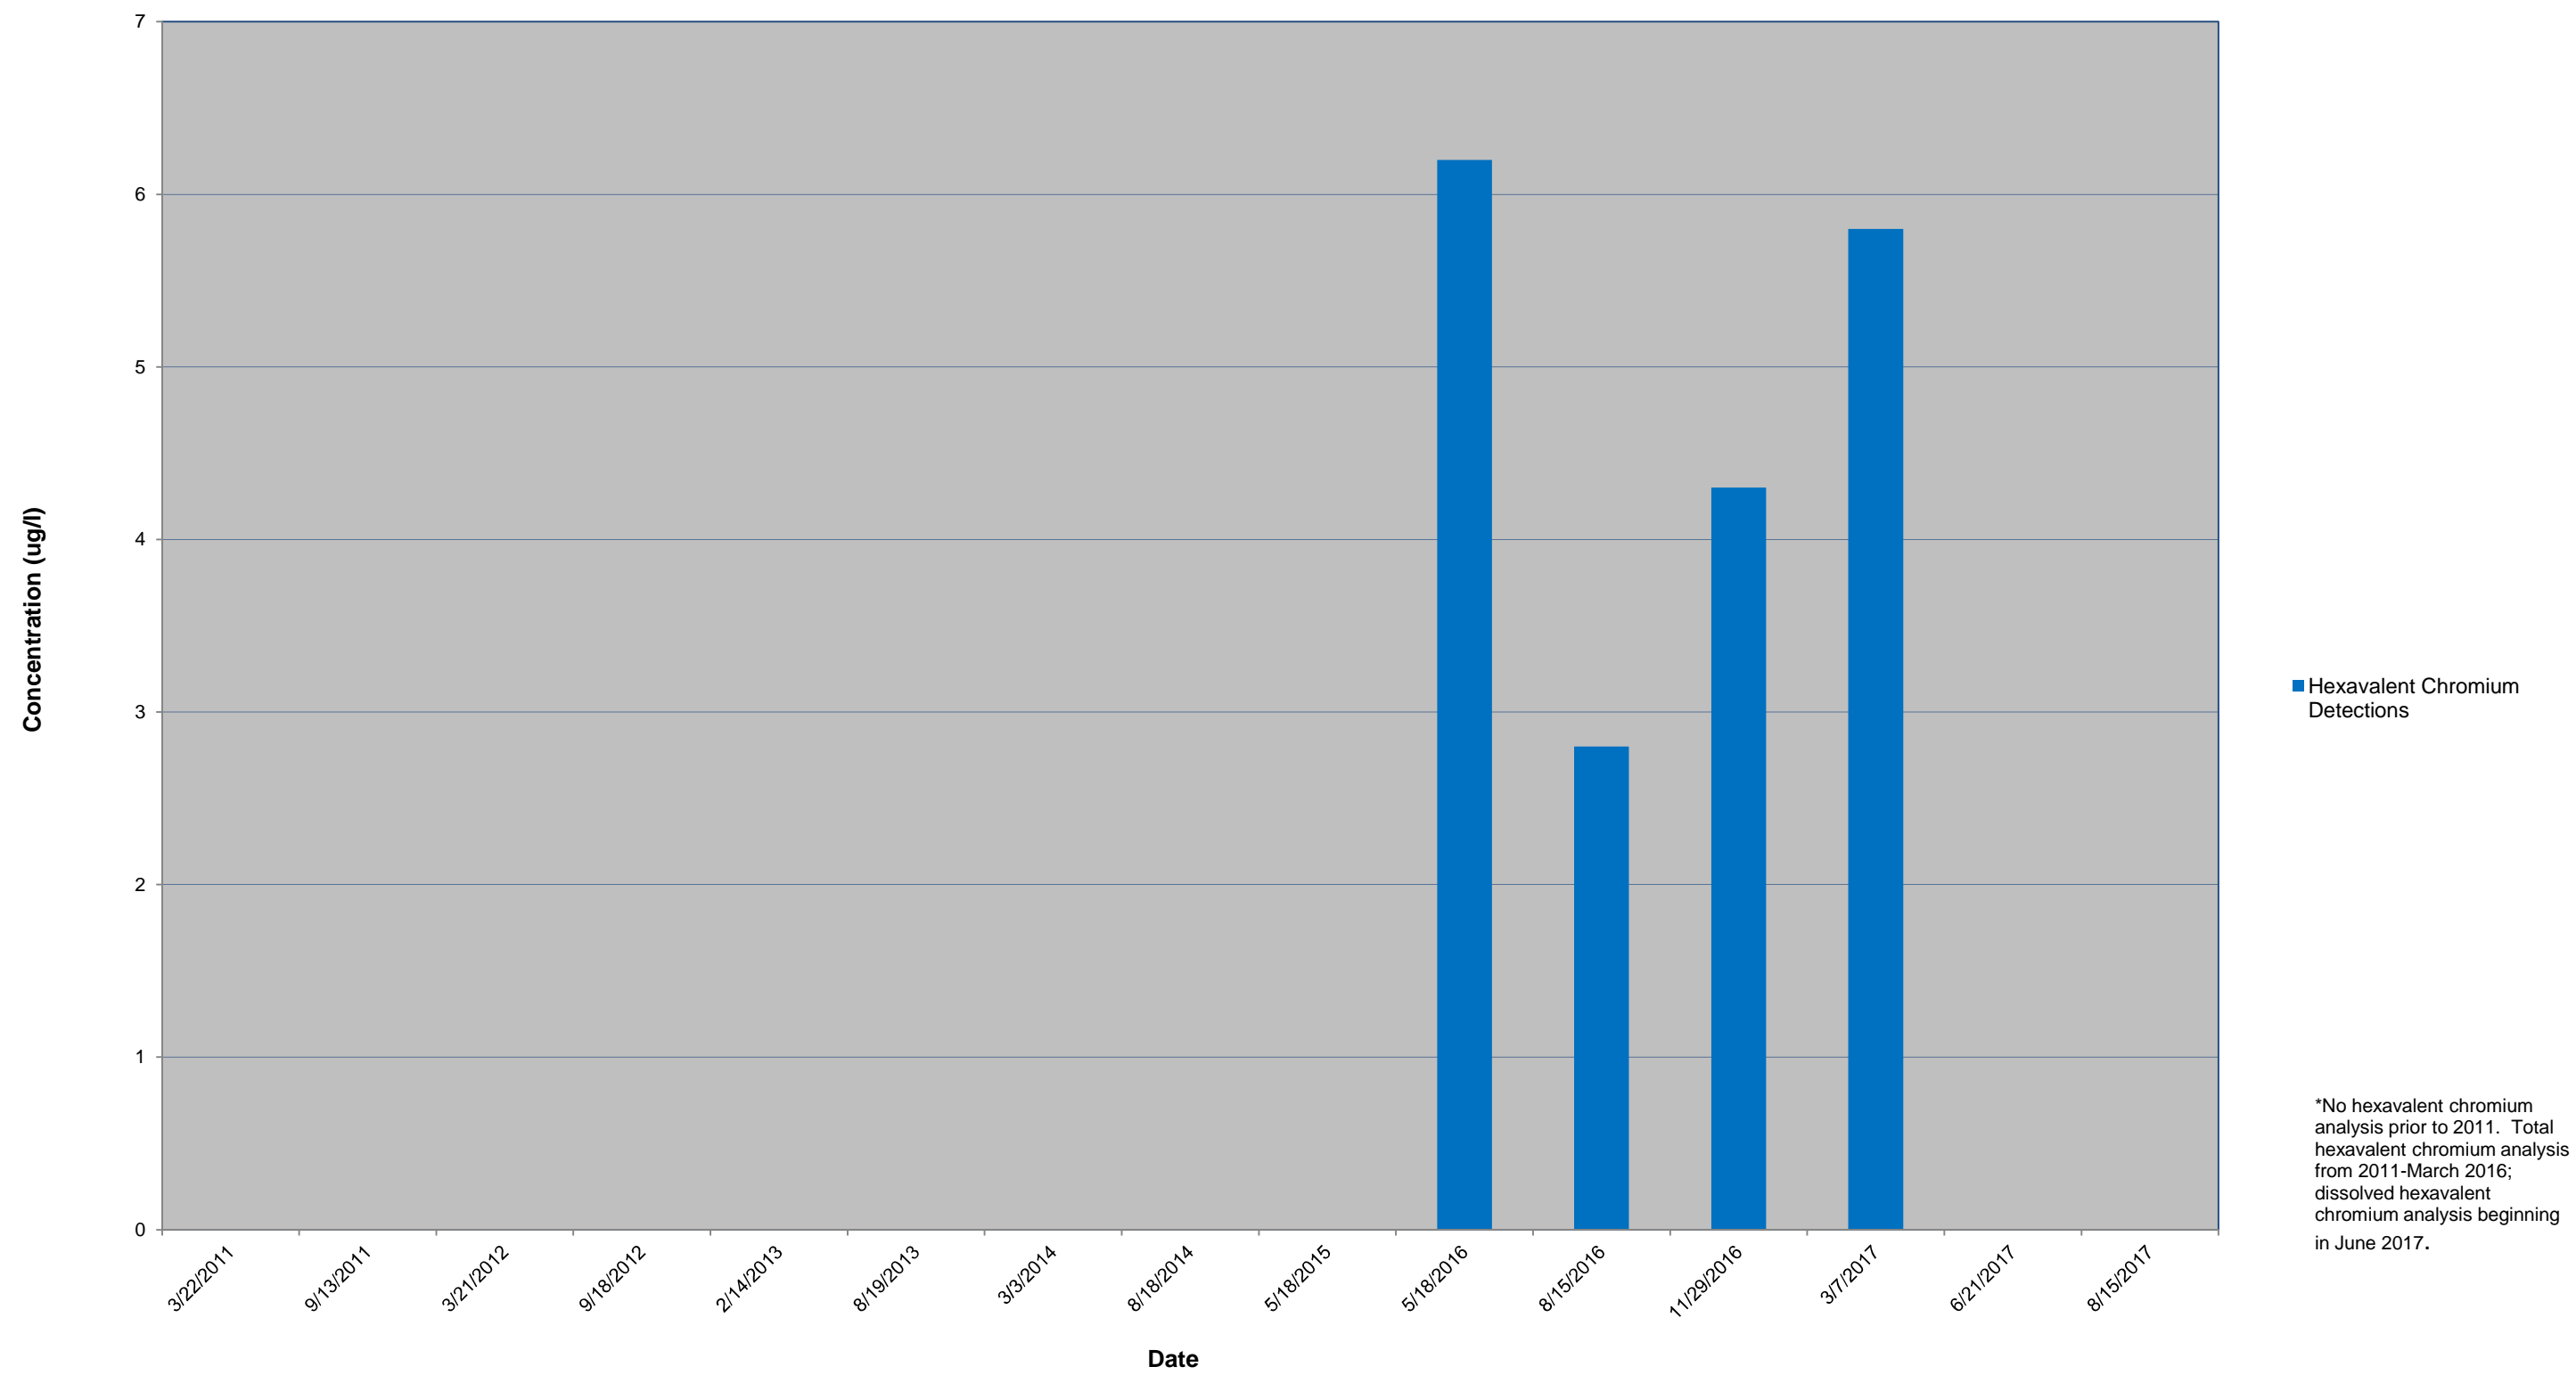
Hexavalent Chromium Detections in CAMU P05 Groundwater Samples  
2009 - 2017\*

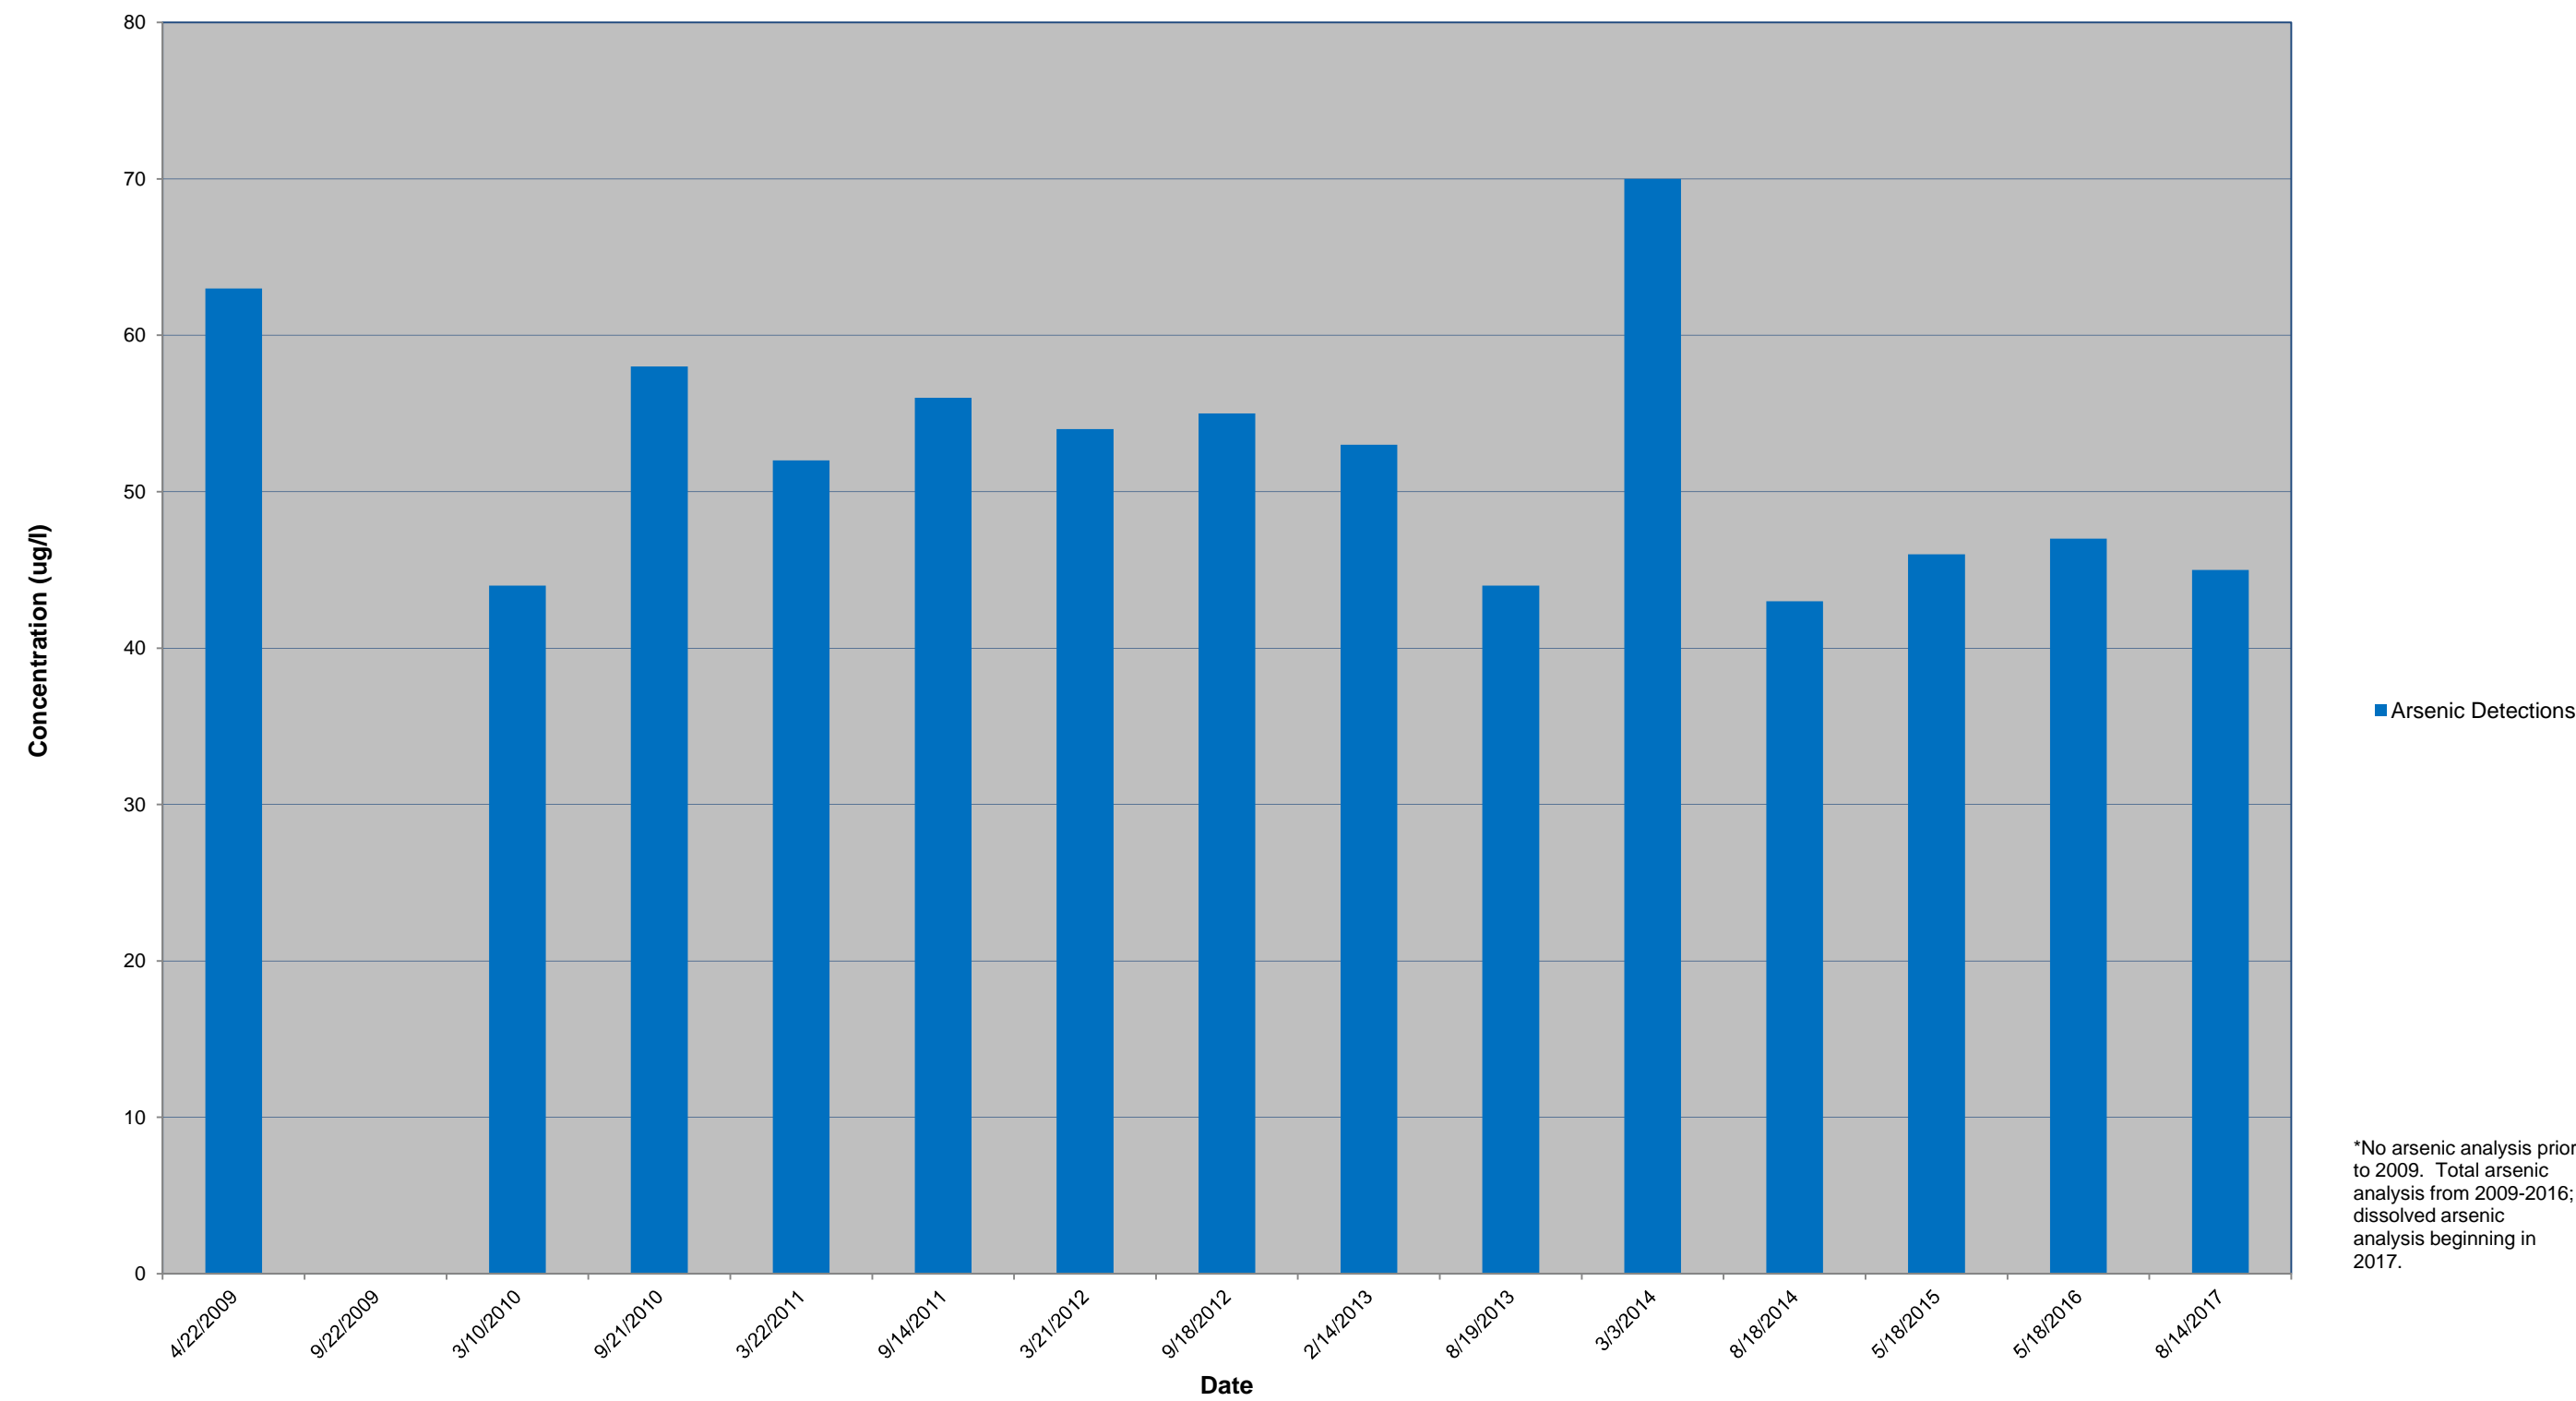
Arsenic Detections in CAMU P06R Groundwater Samples  
2009 - 2017\*

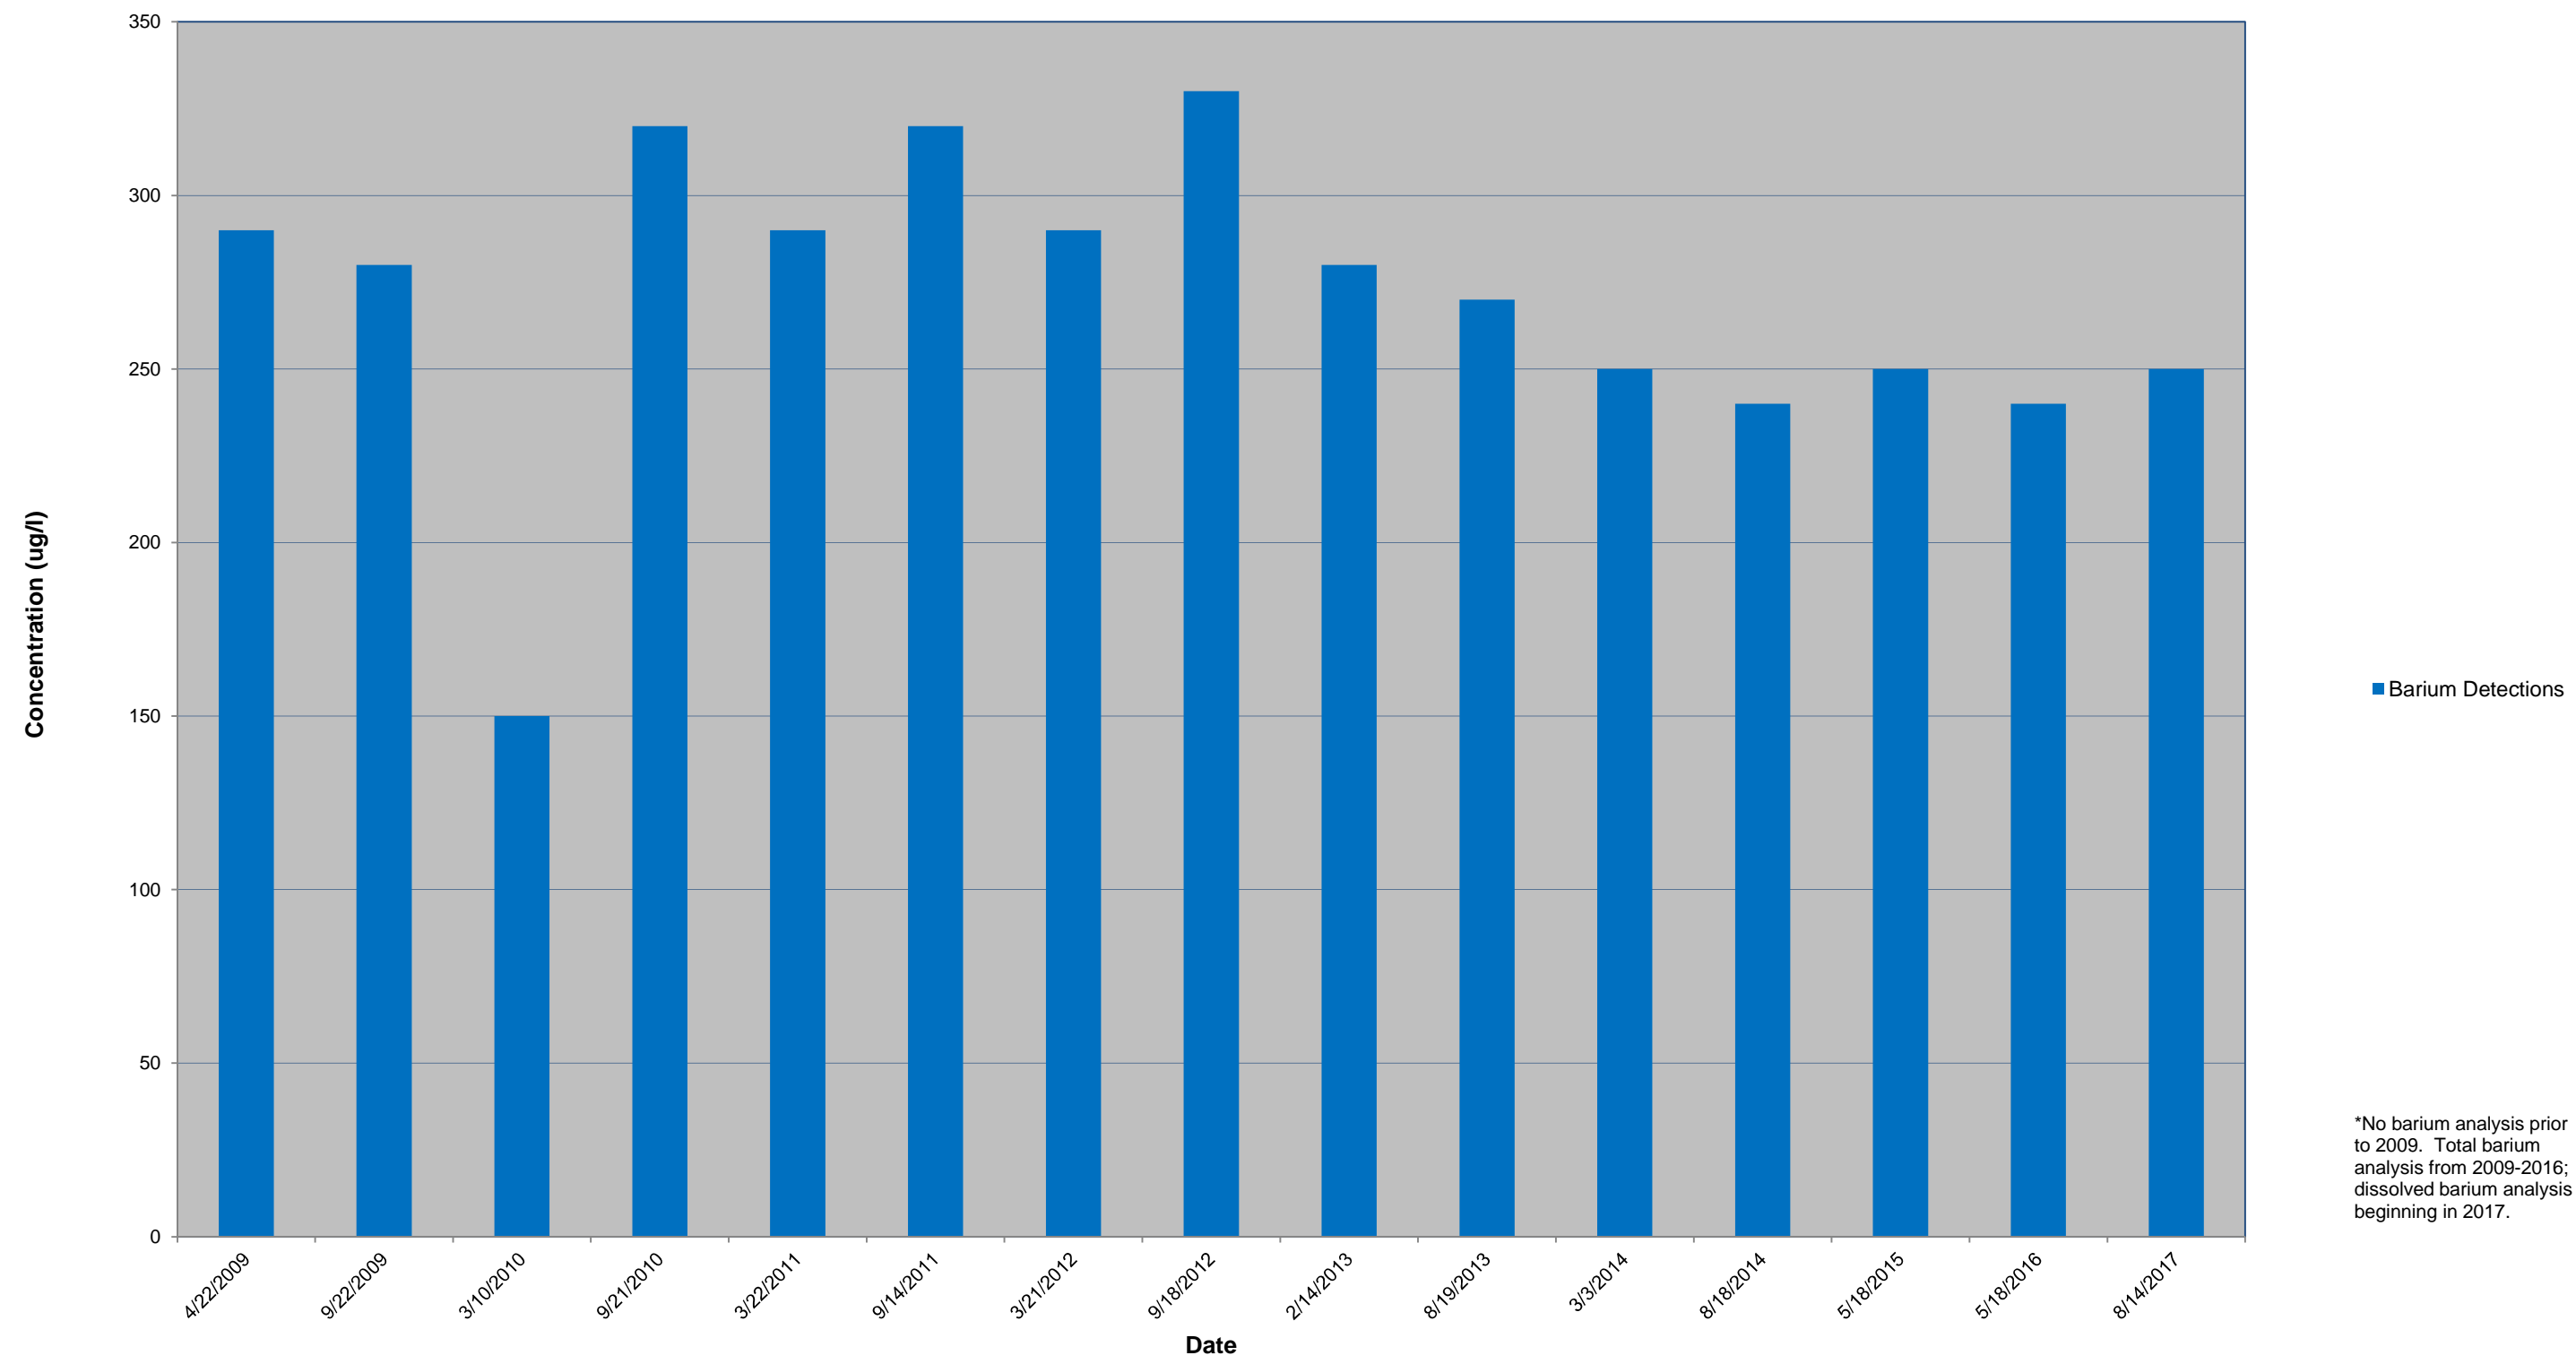
Barium Detections in CAMU P06R Groundwater Samples  
2009 - 2017\*

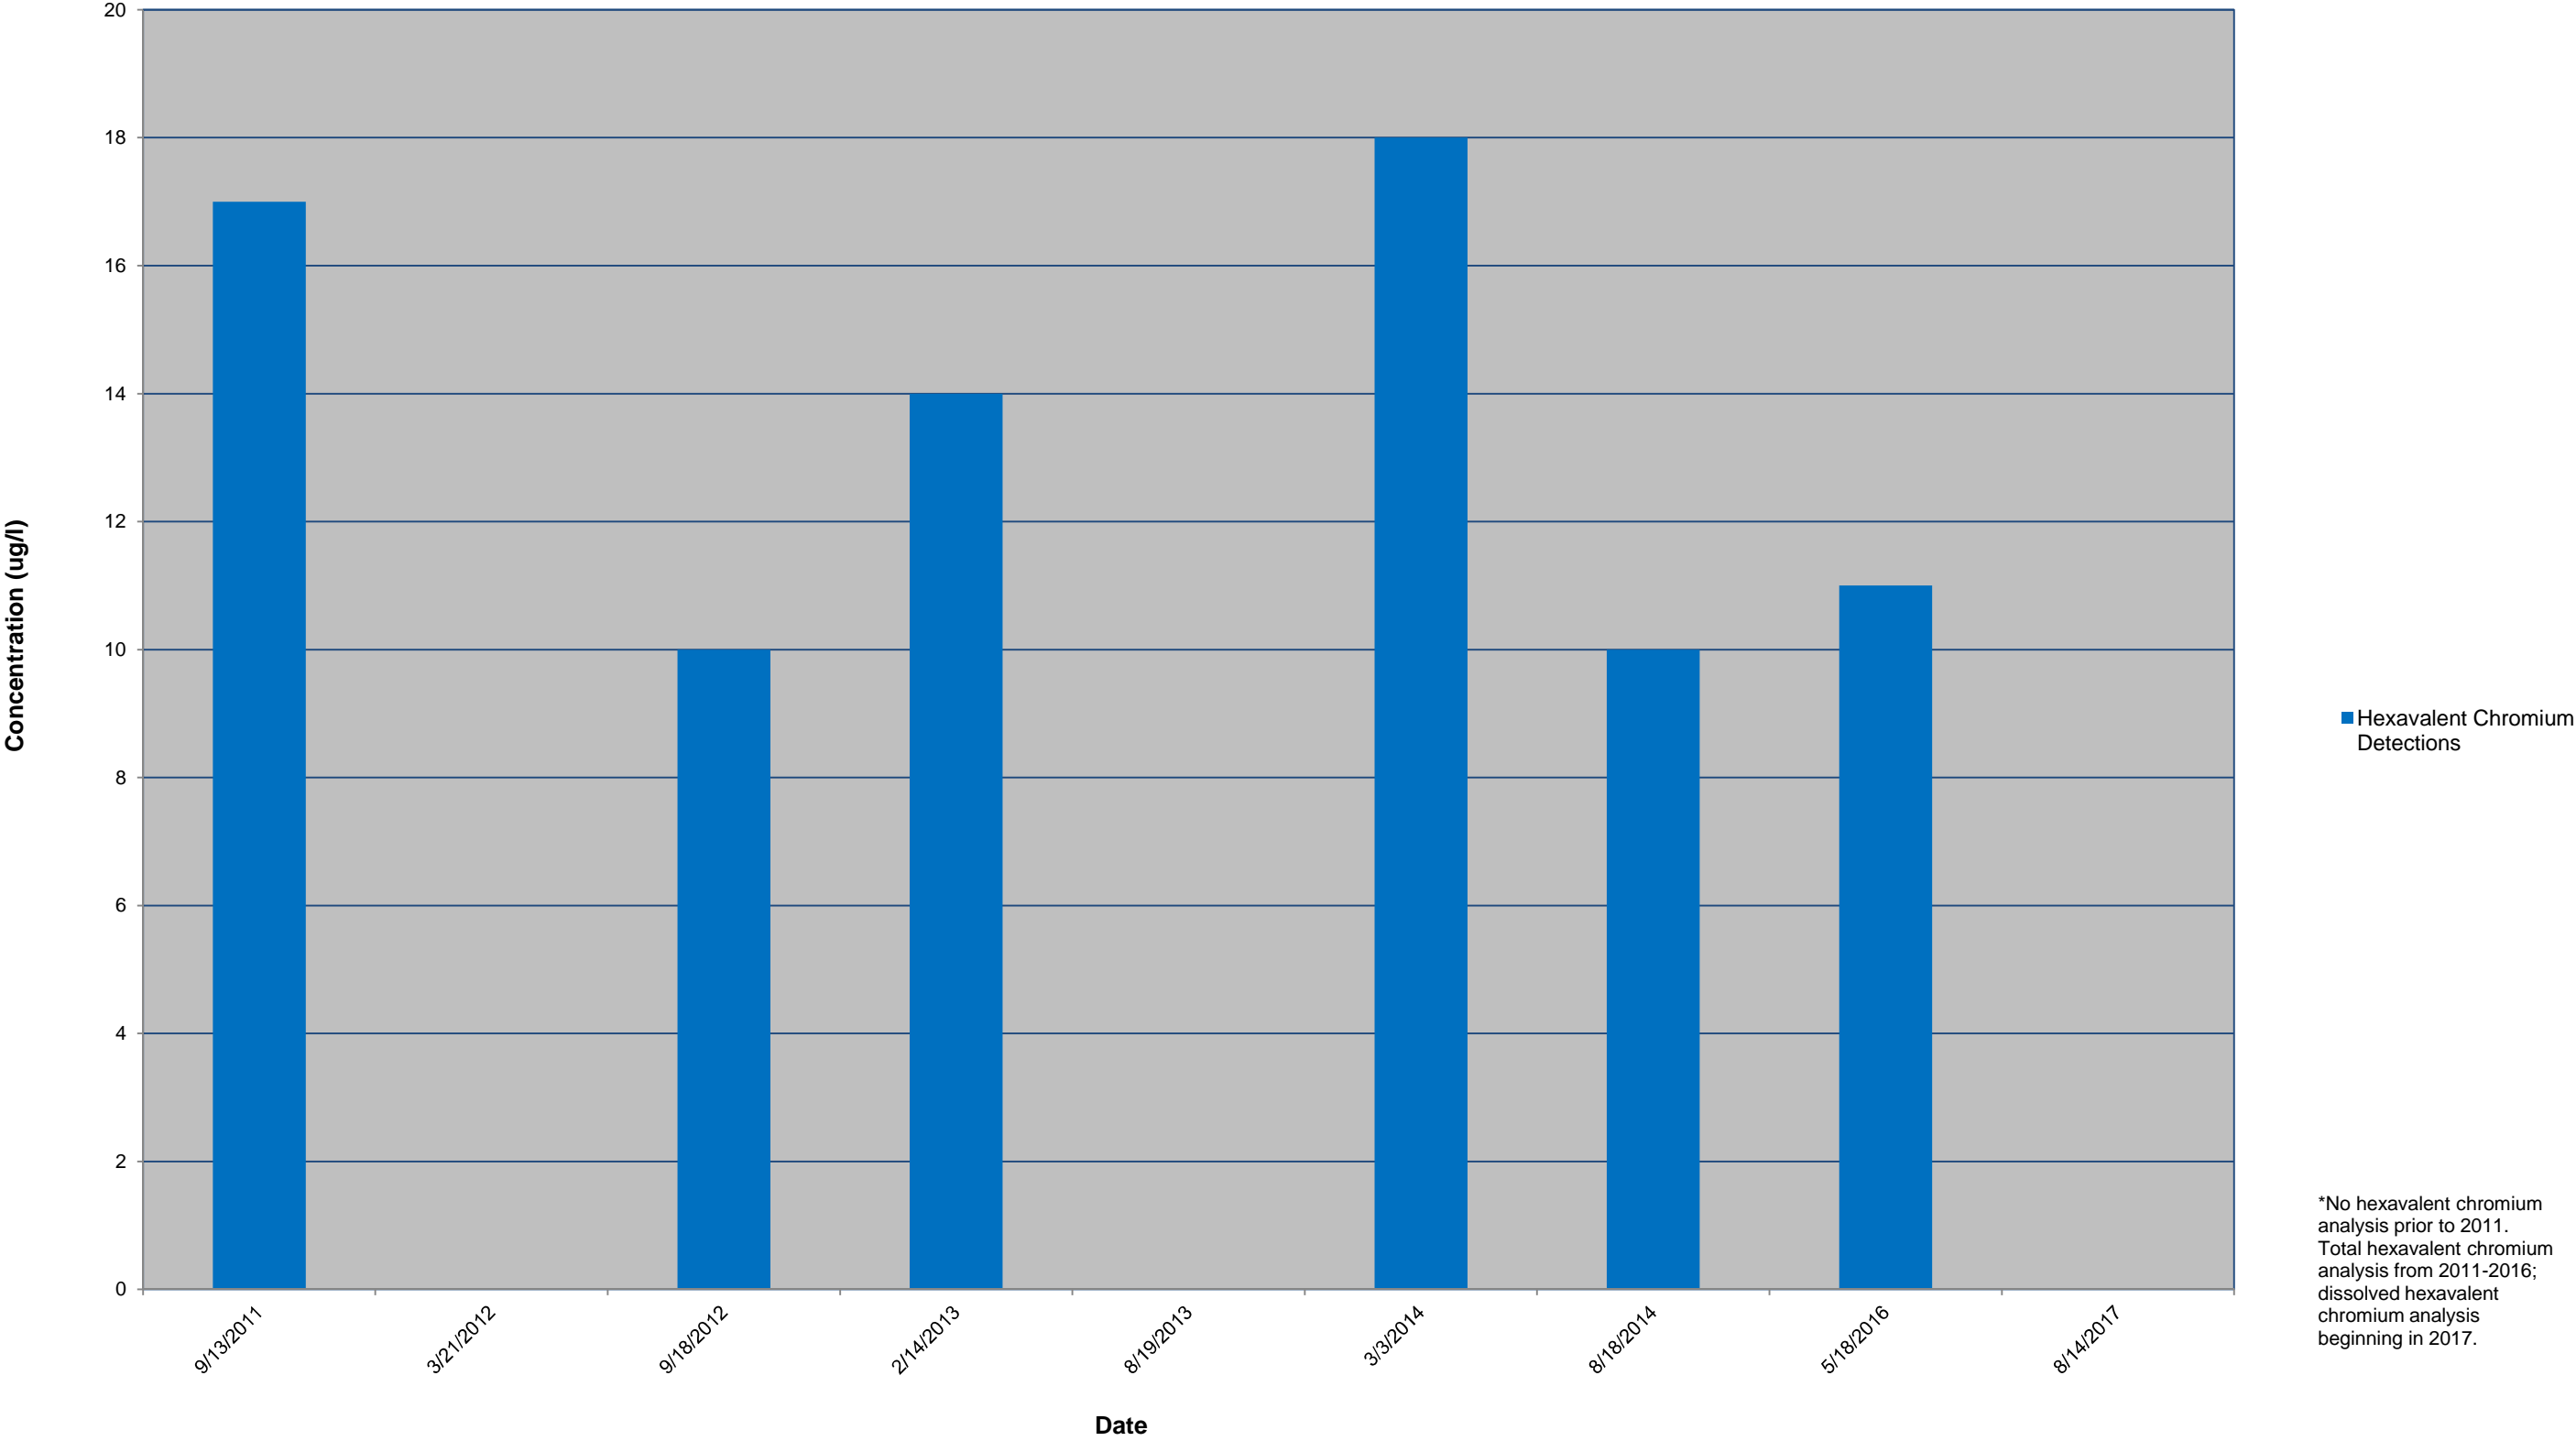
Hexavalent Chromium Detections in CAMU P06R Groundwater Samples  
2011 - 2017\*

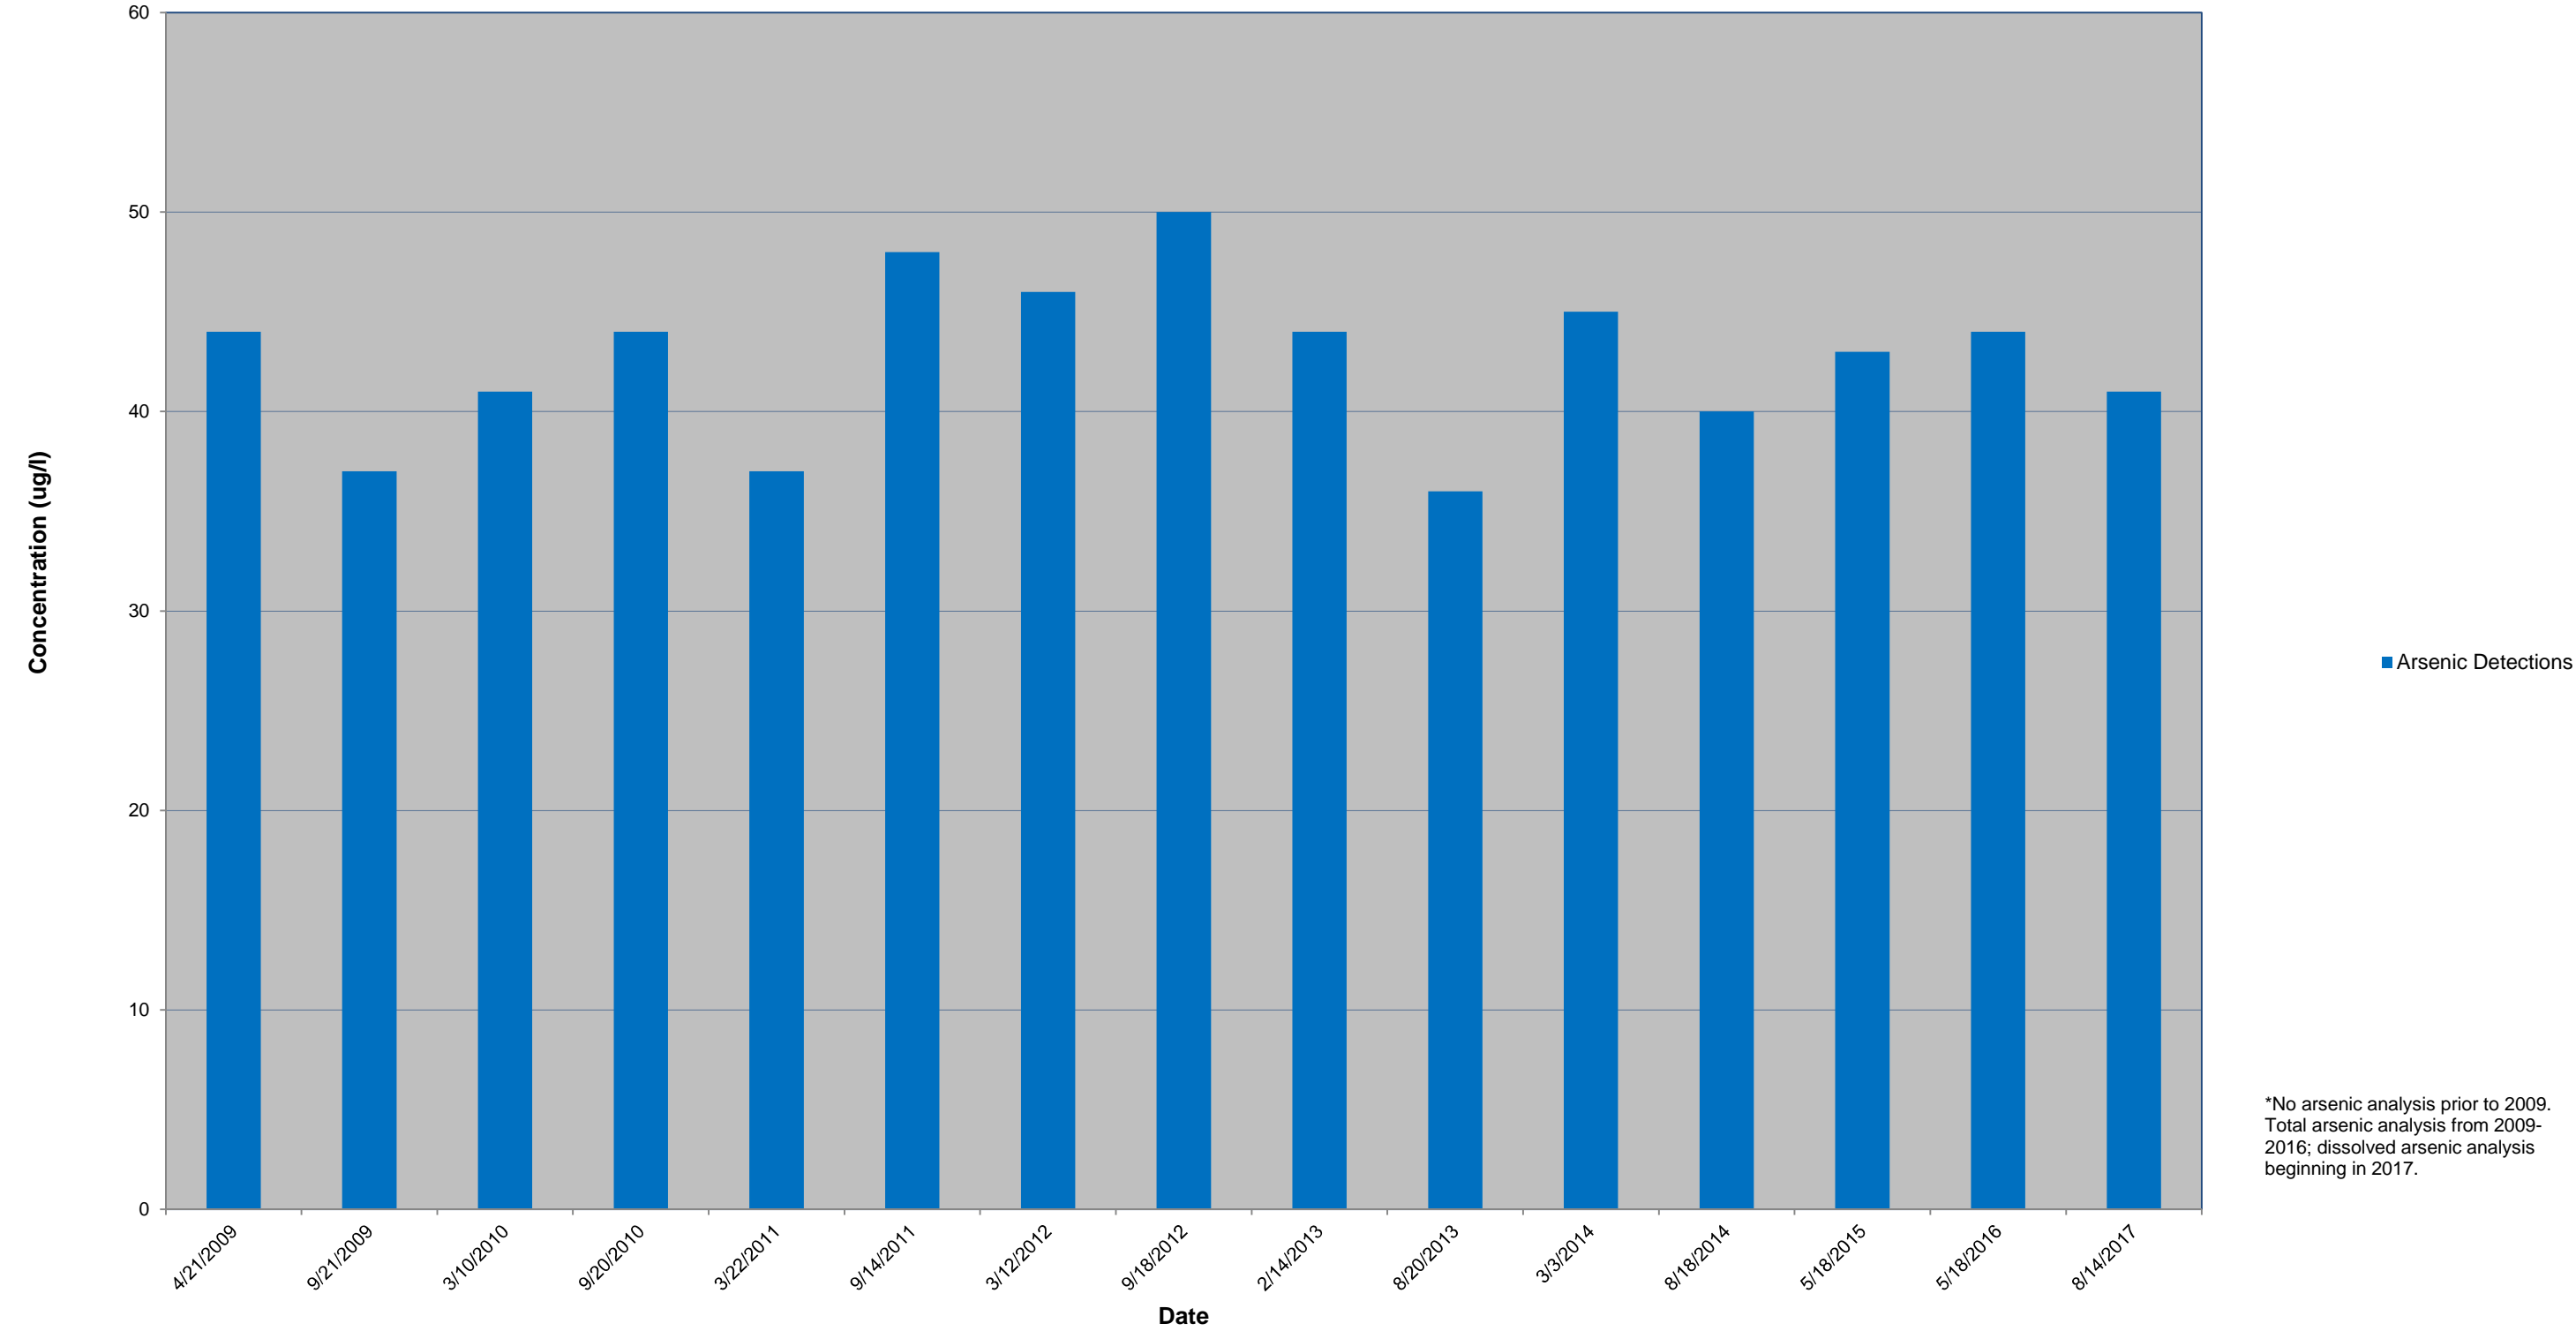
Arsenic Detections in CAMU P07 Groundwater Samples  
2009 - 2017\*
