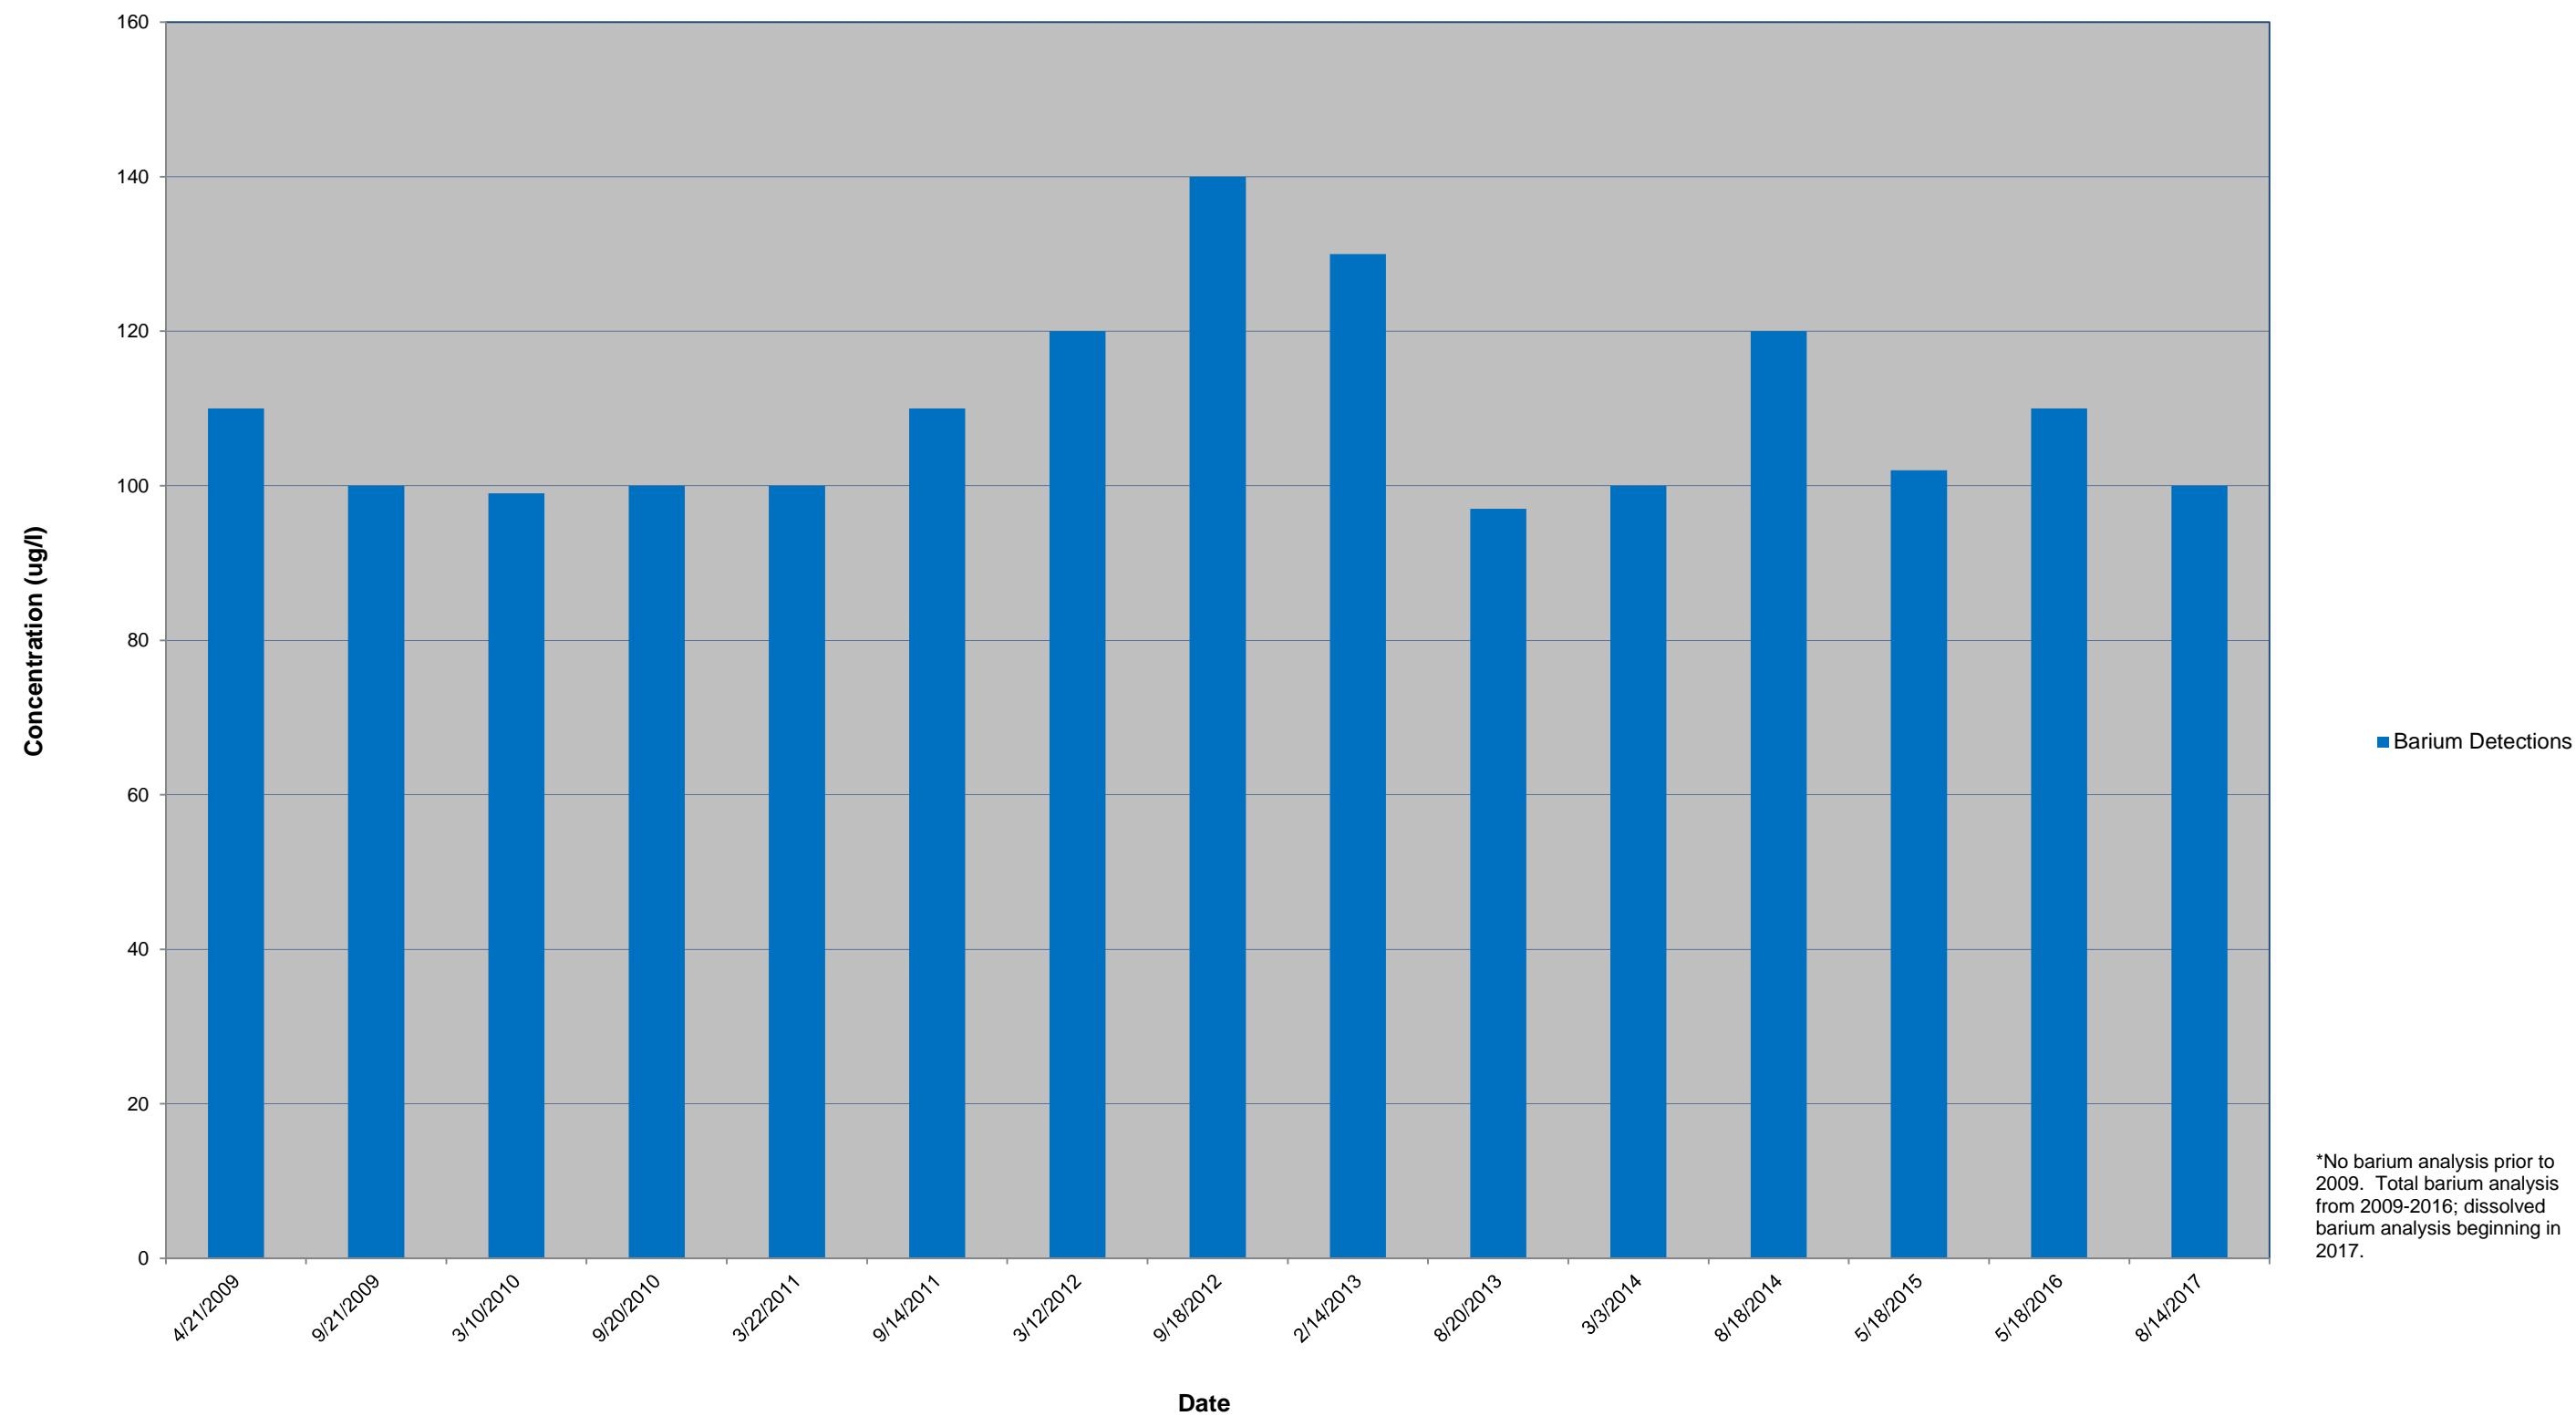
Barium Detections in CAMU P07 Groundwater Samples  
2009 - 2017\*

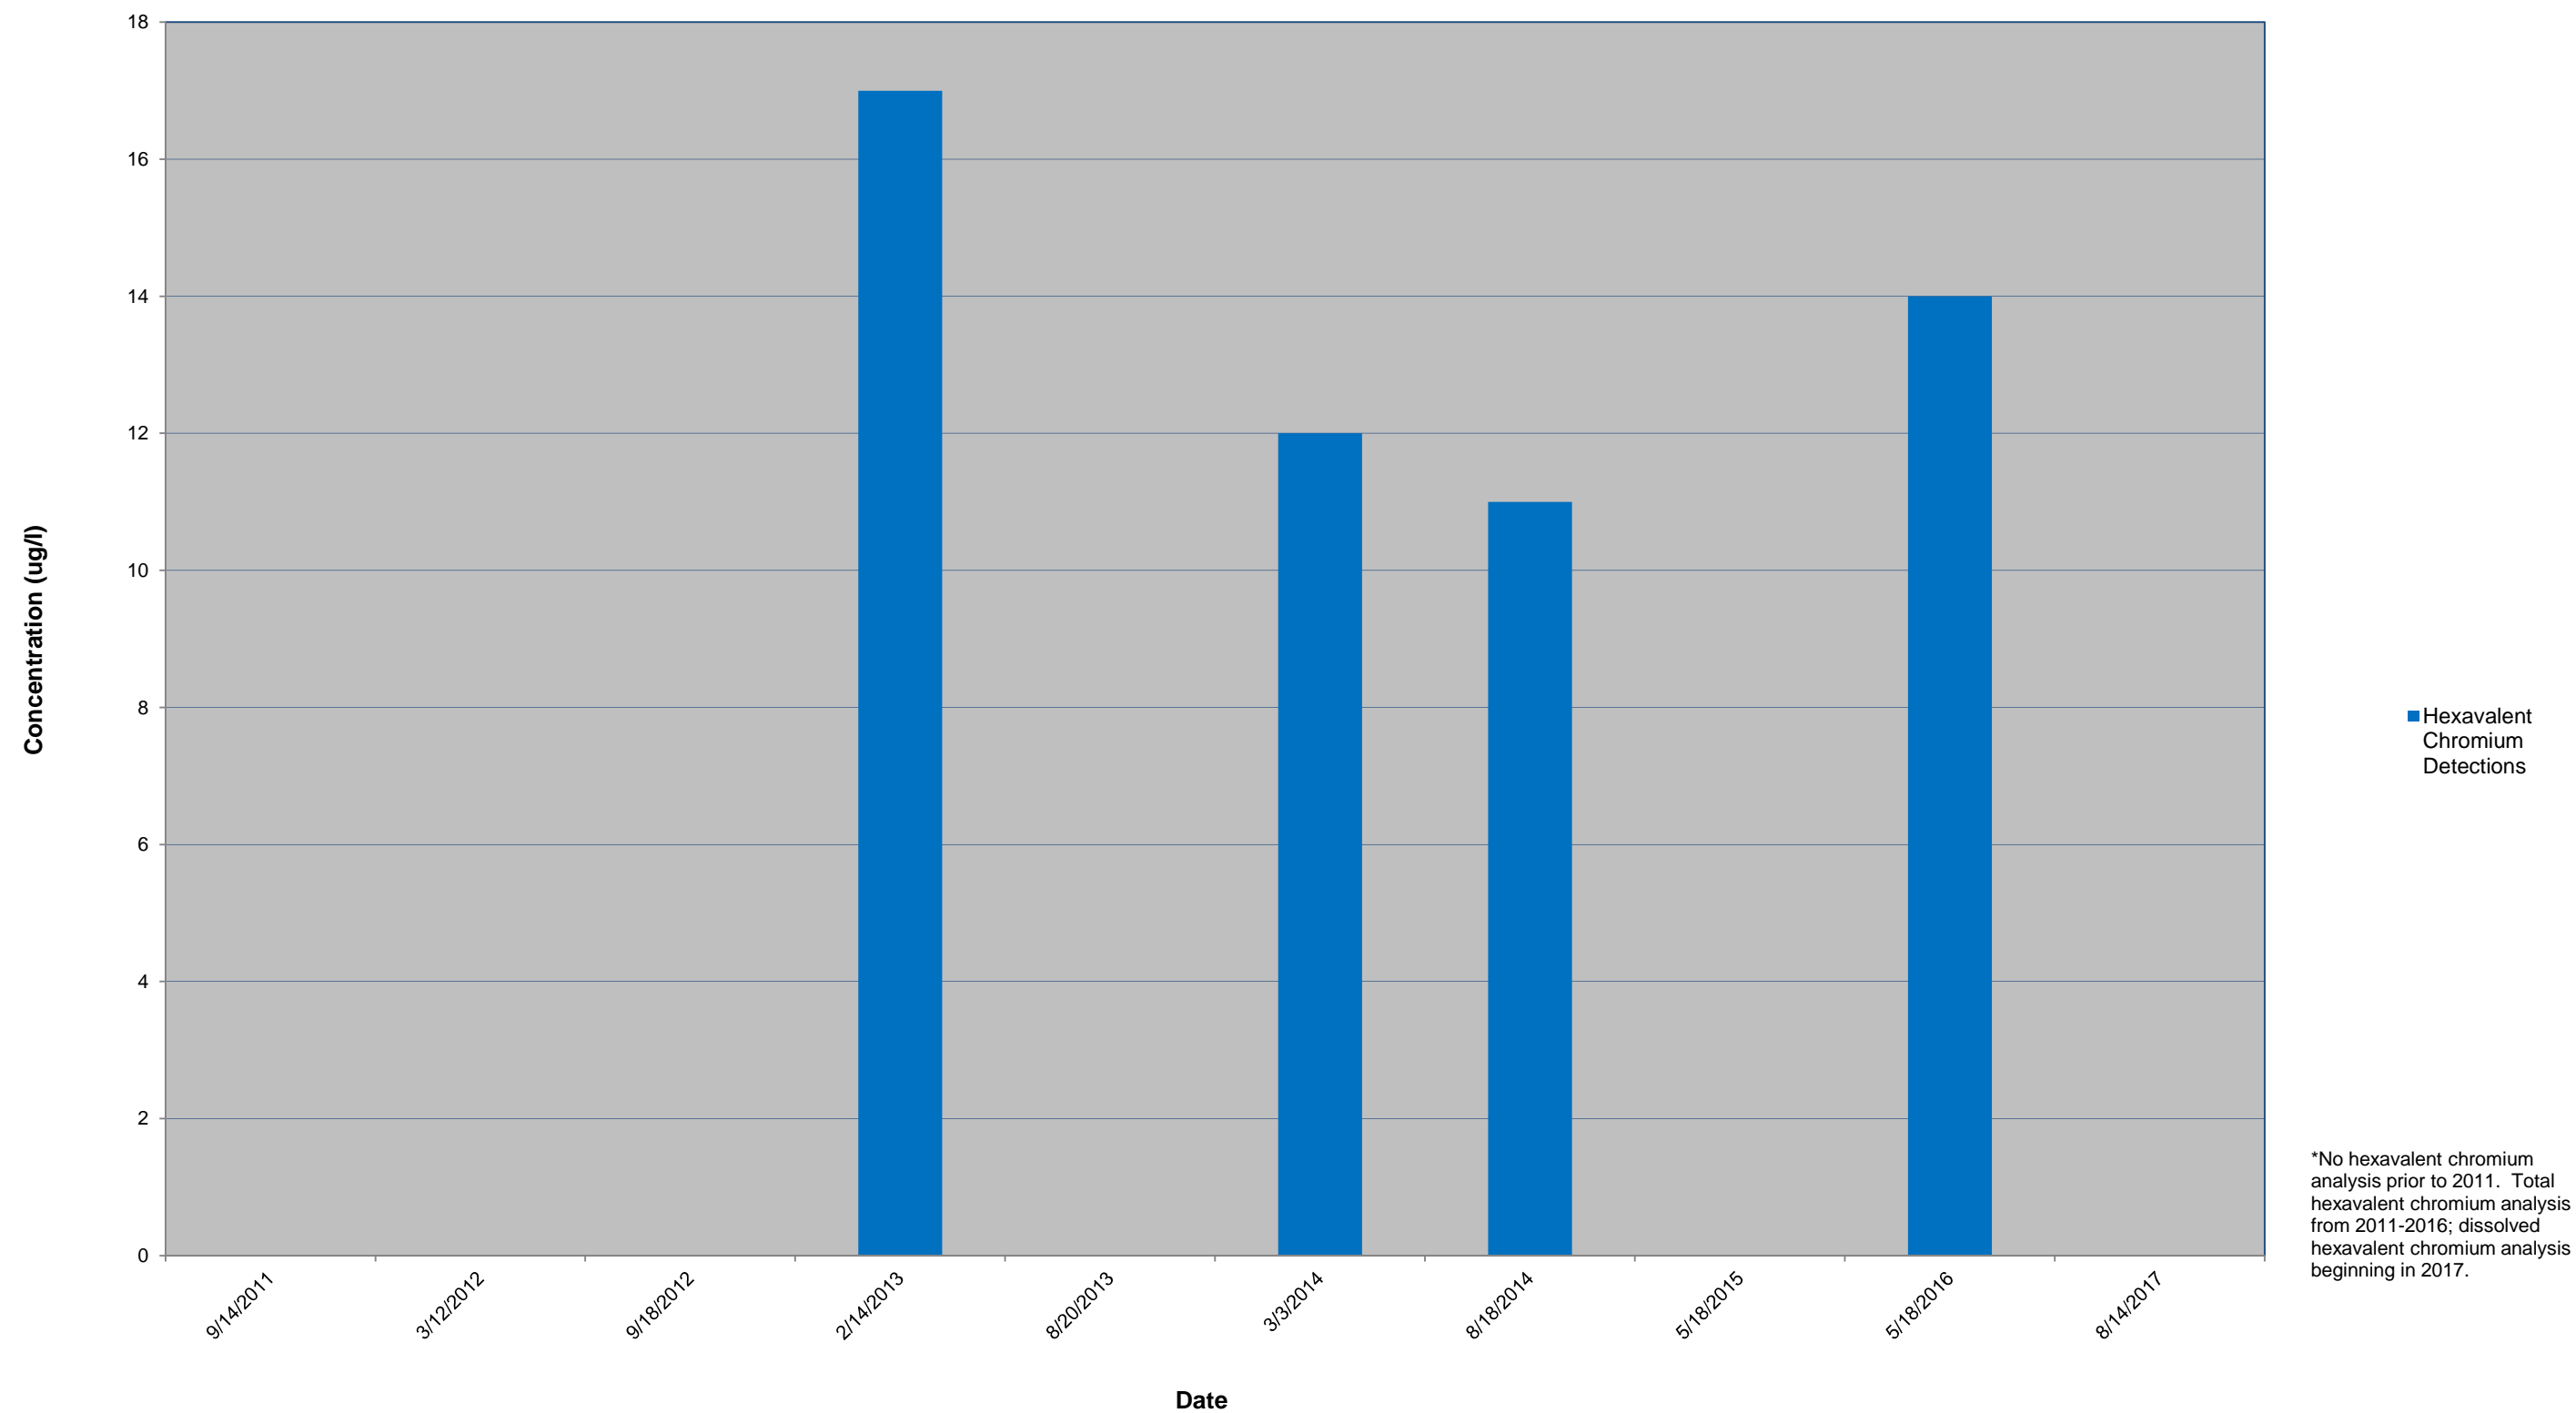
Hexavalent Chromium Detections in CAMU P07 Groundwater Samples  
2011 - 2017\*

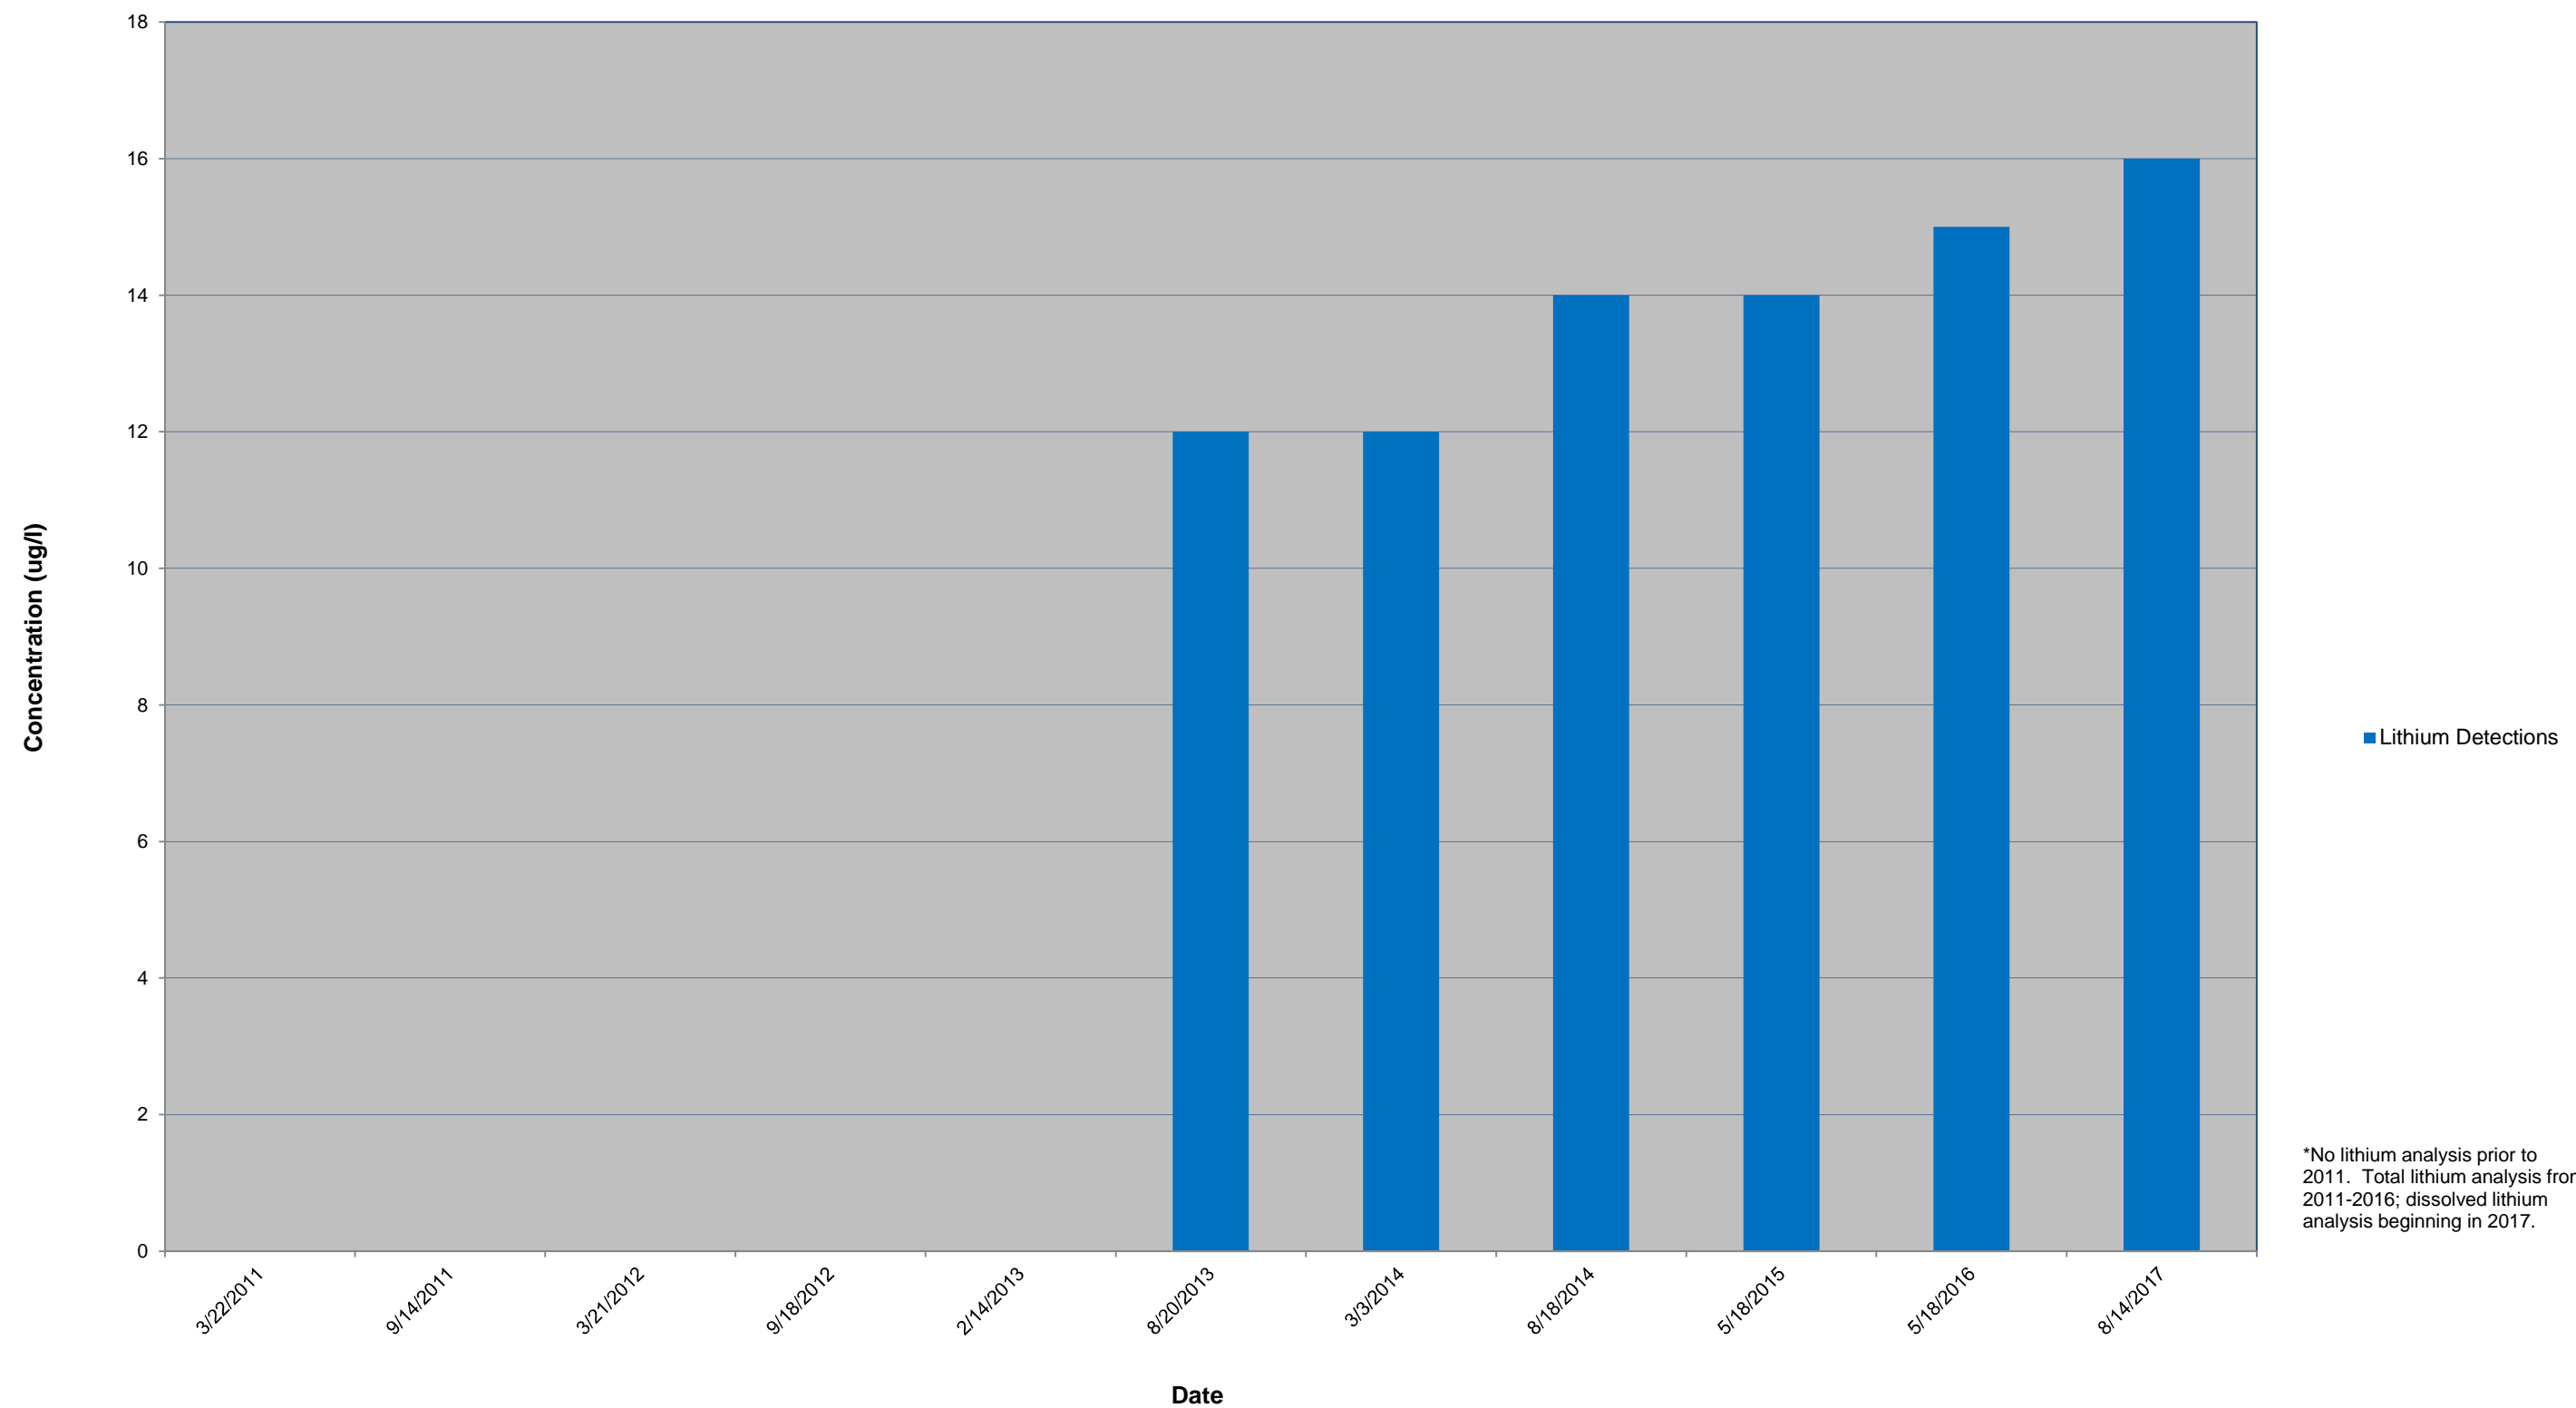
Lithium Detections in CAMU P07 Groundwater Samples  
2011 - 2017\*

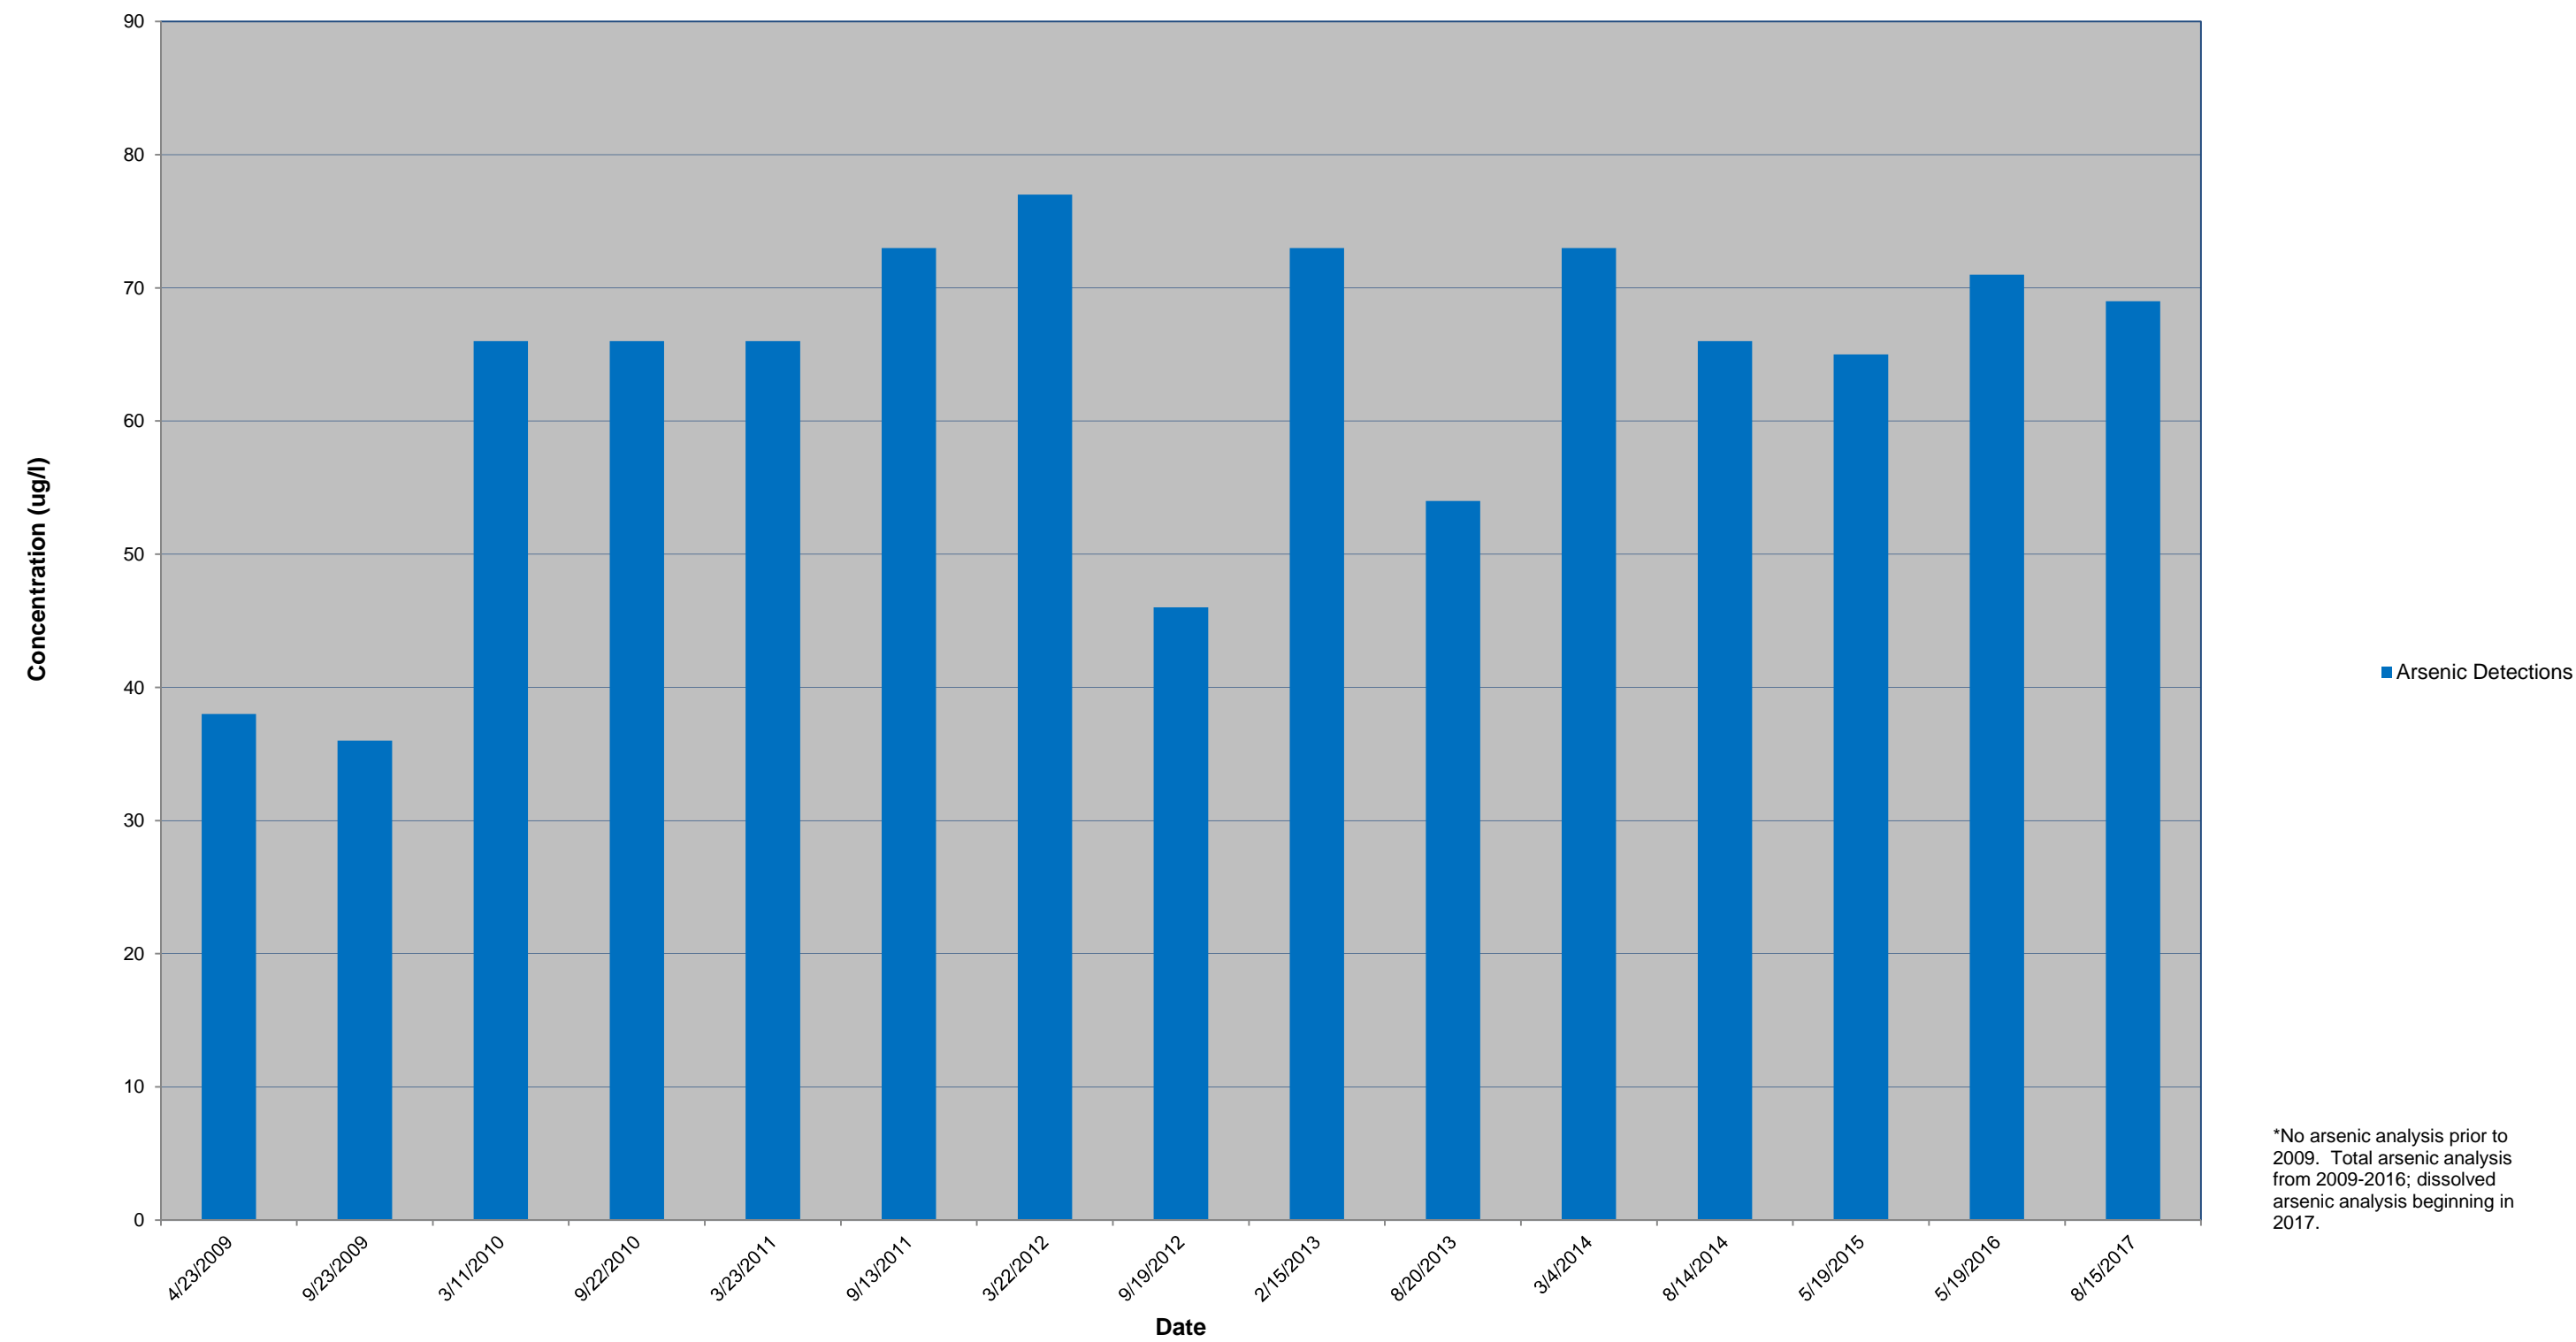
Arsenic Detections in CAMU P08 Groundwater Samples  
2009 - 2017\*

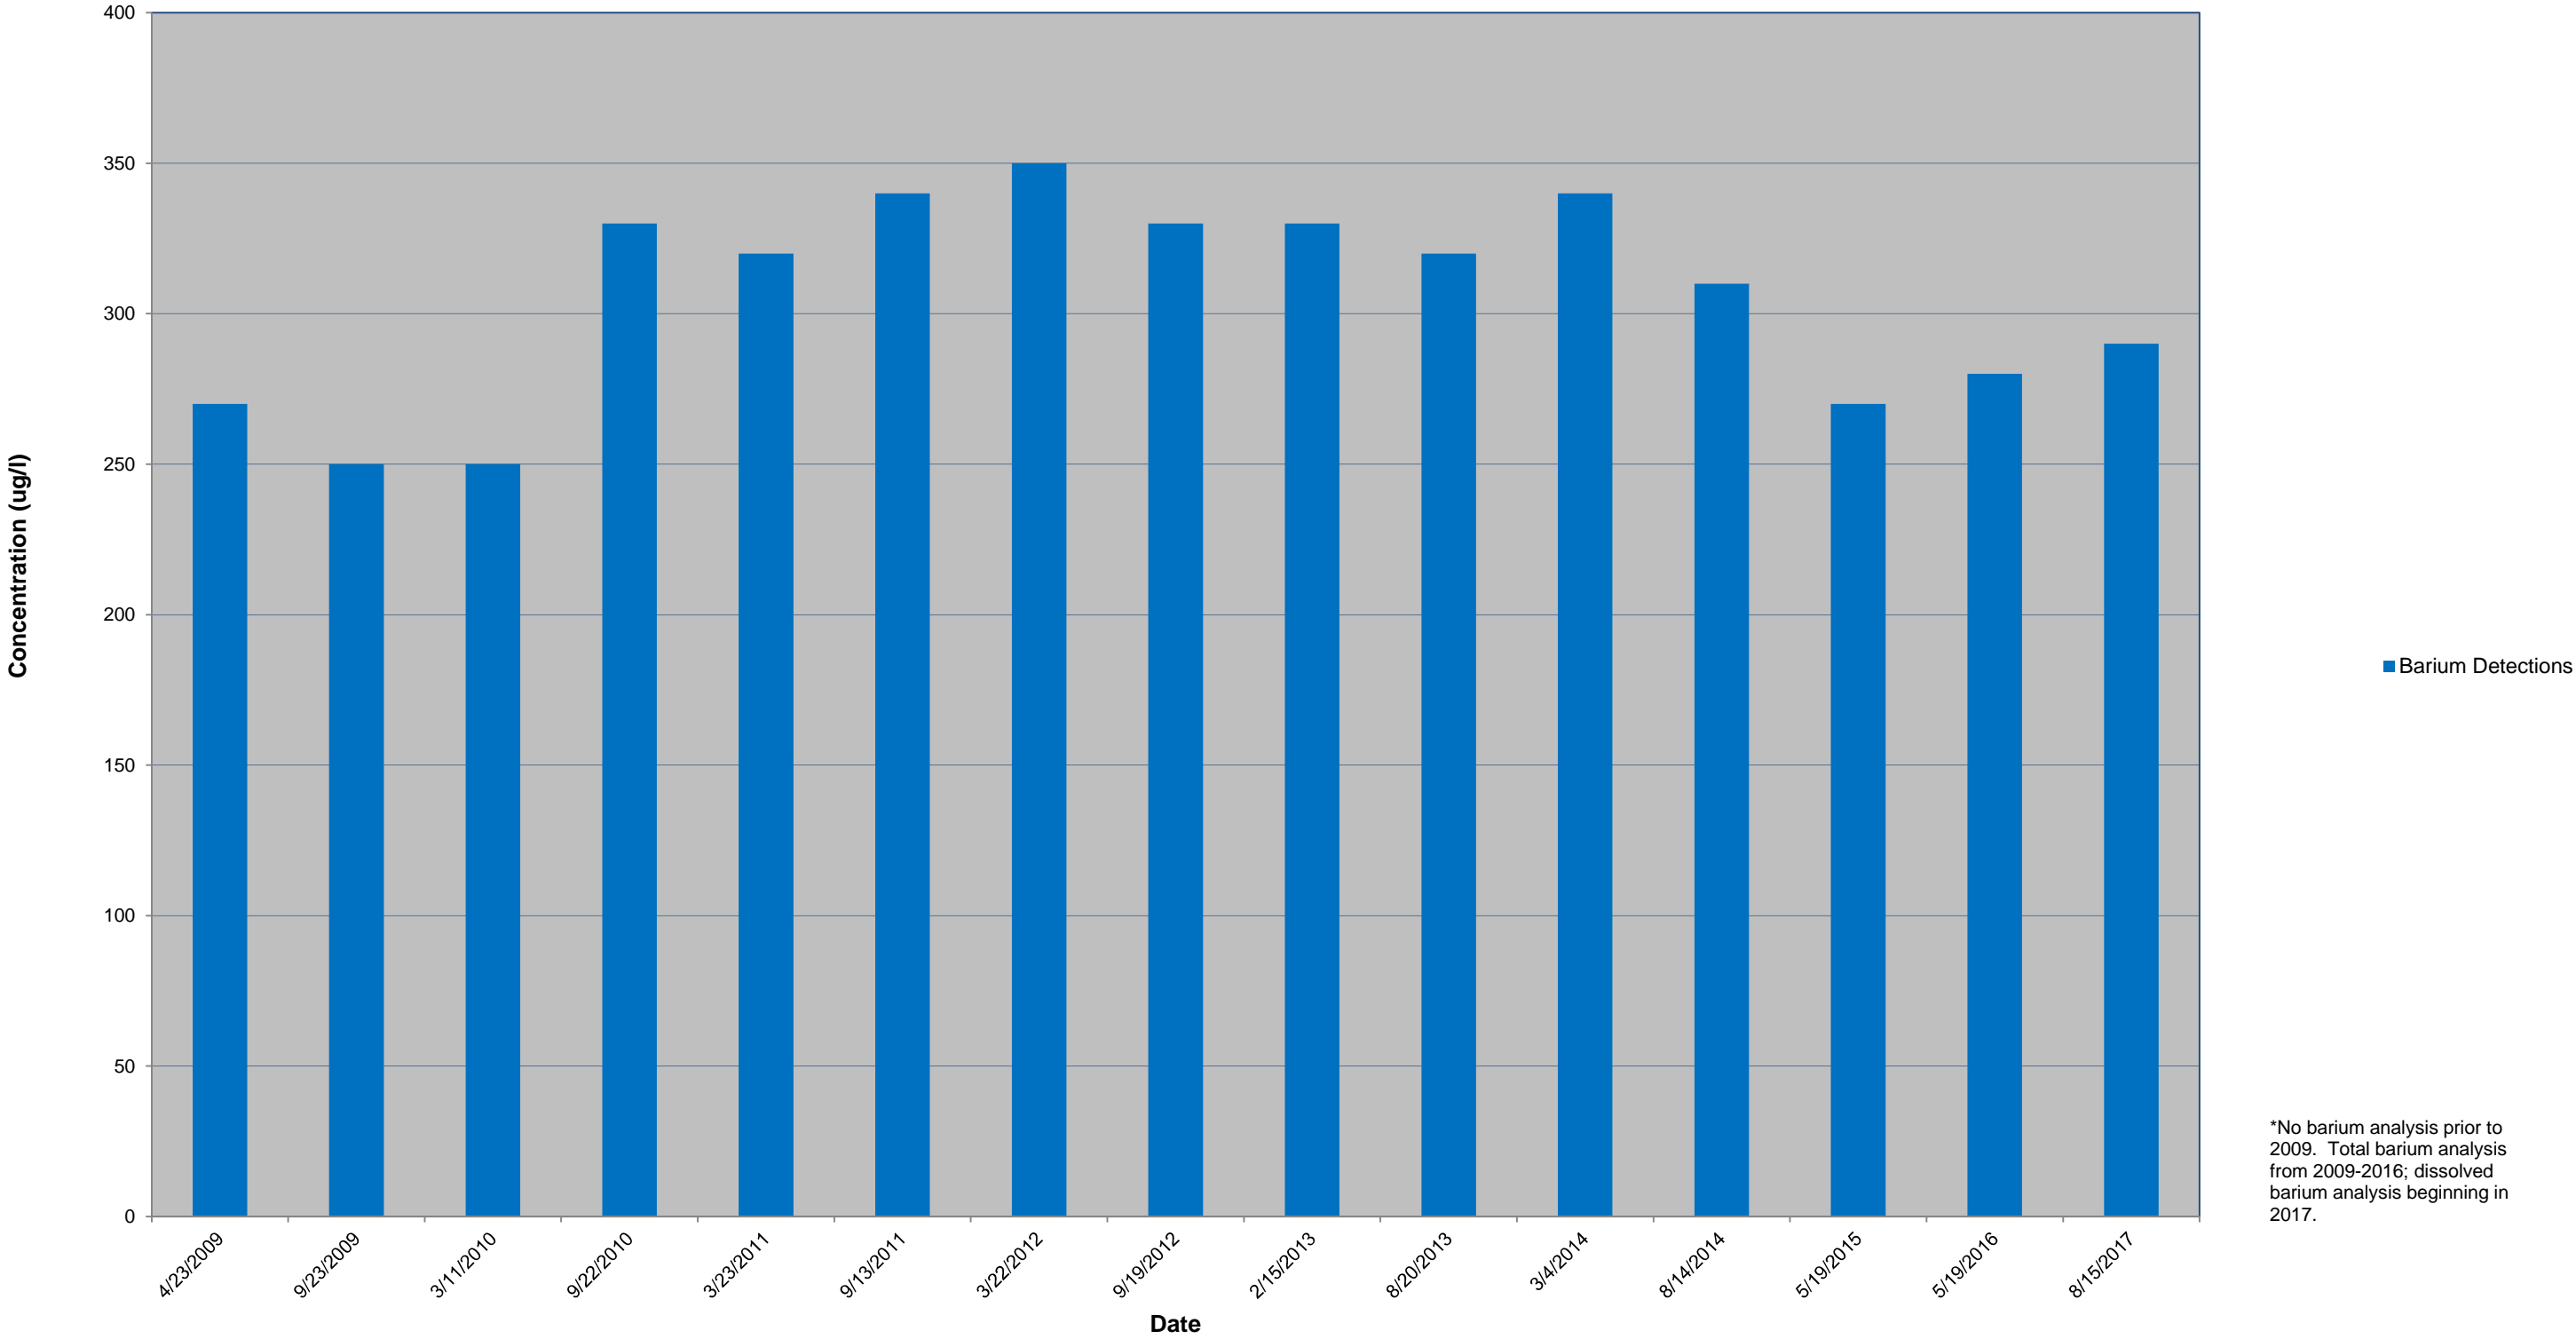
Barium Detections in CAMU P08 Groundwater Samples  
2009 - 2017\*

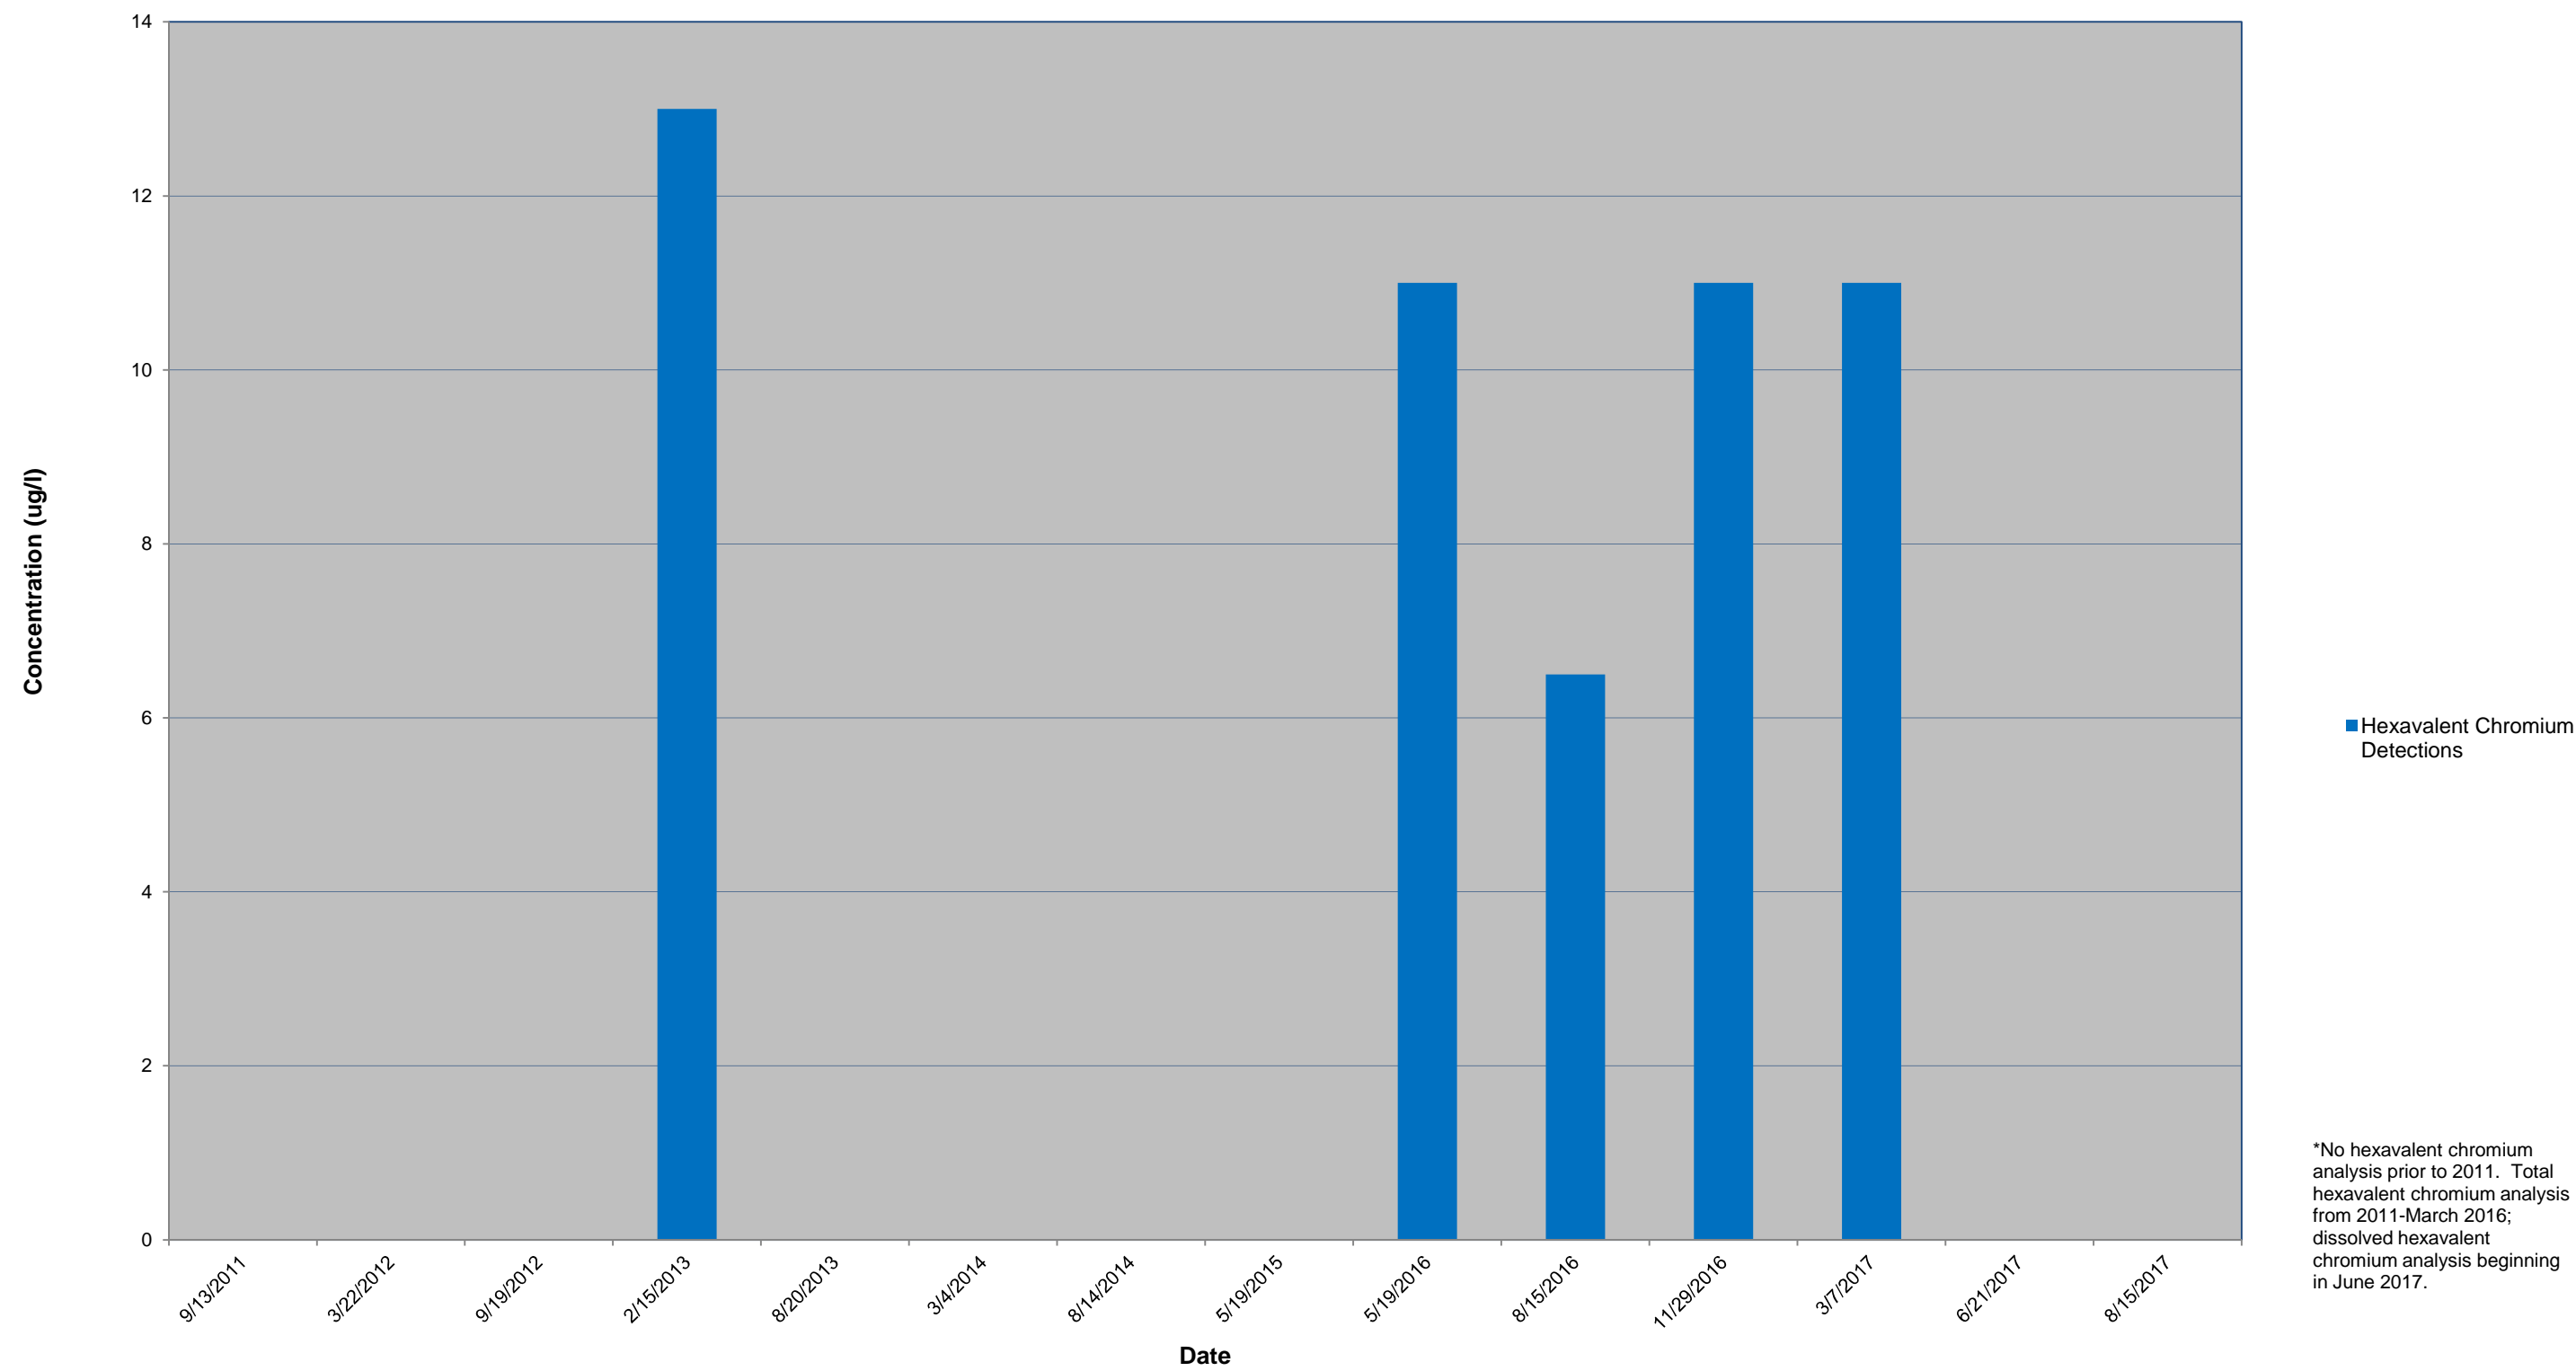
Hexavalent Chromium Detections in CAMU P08 Groundwater Samples  
2011 - 2017\*
