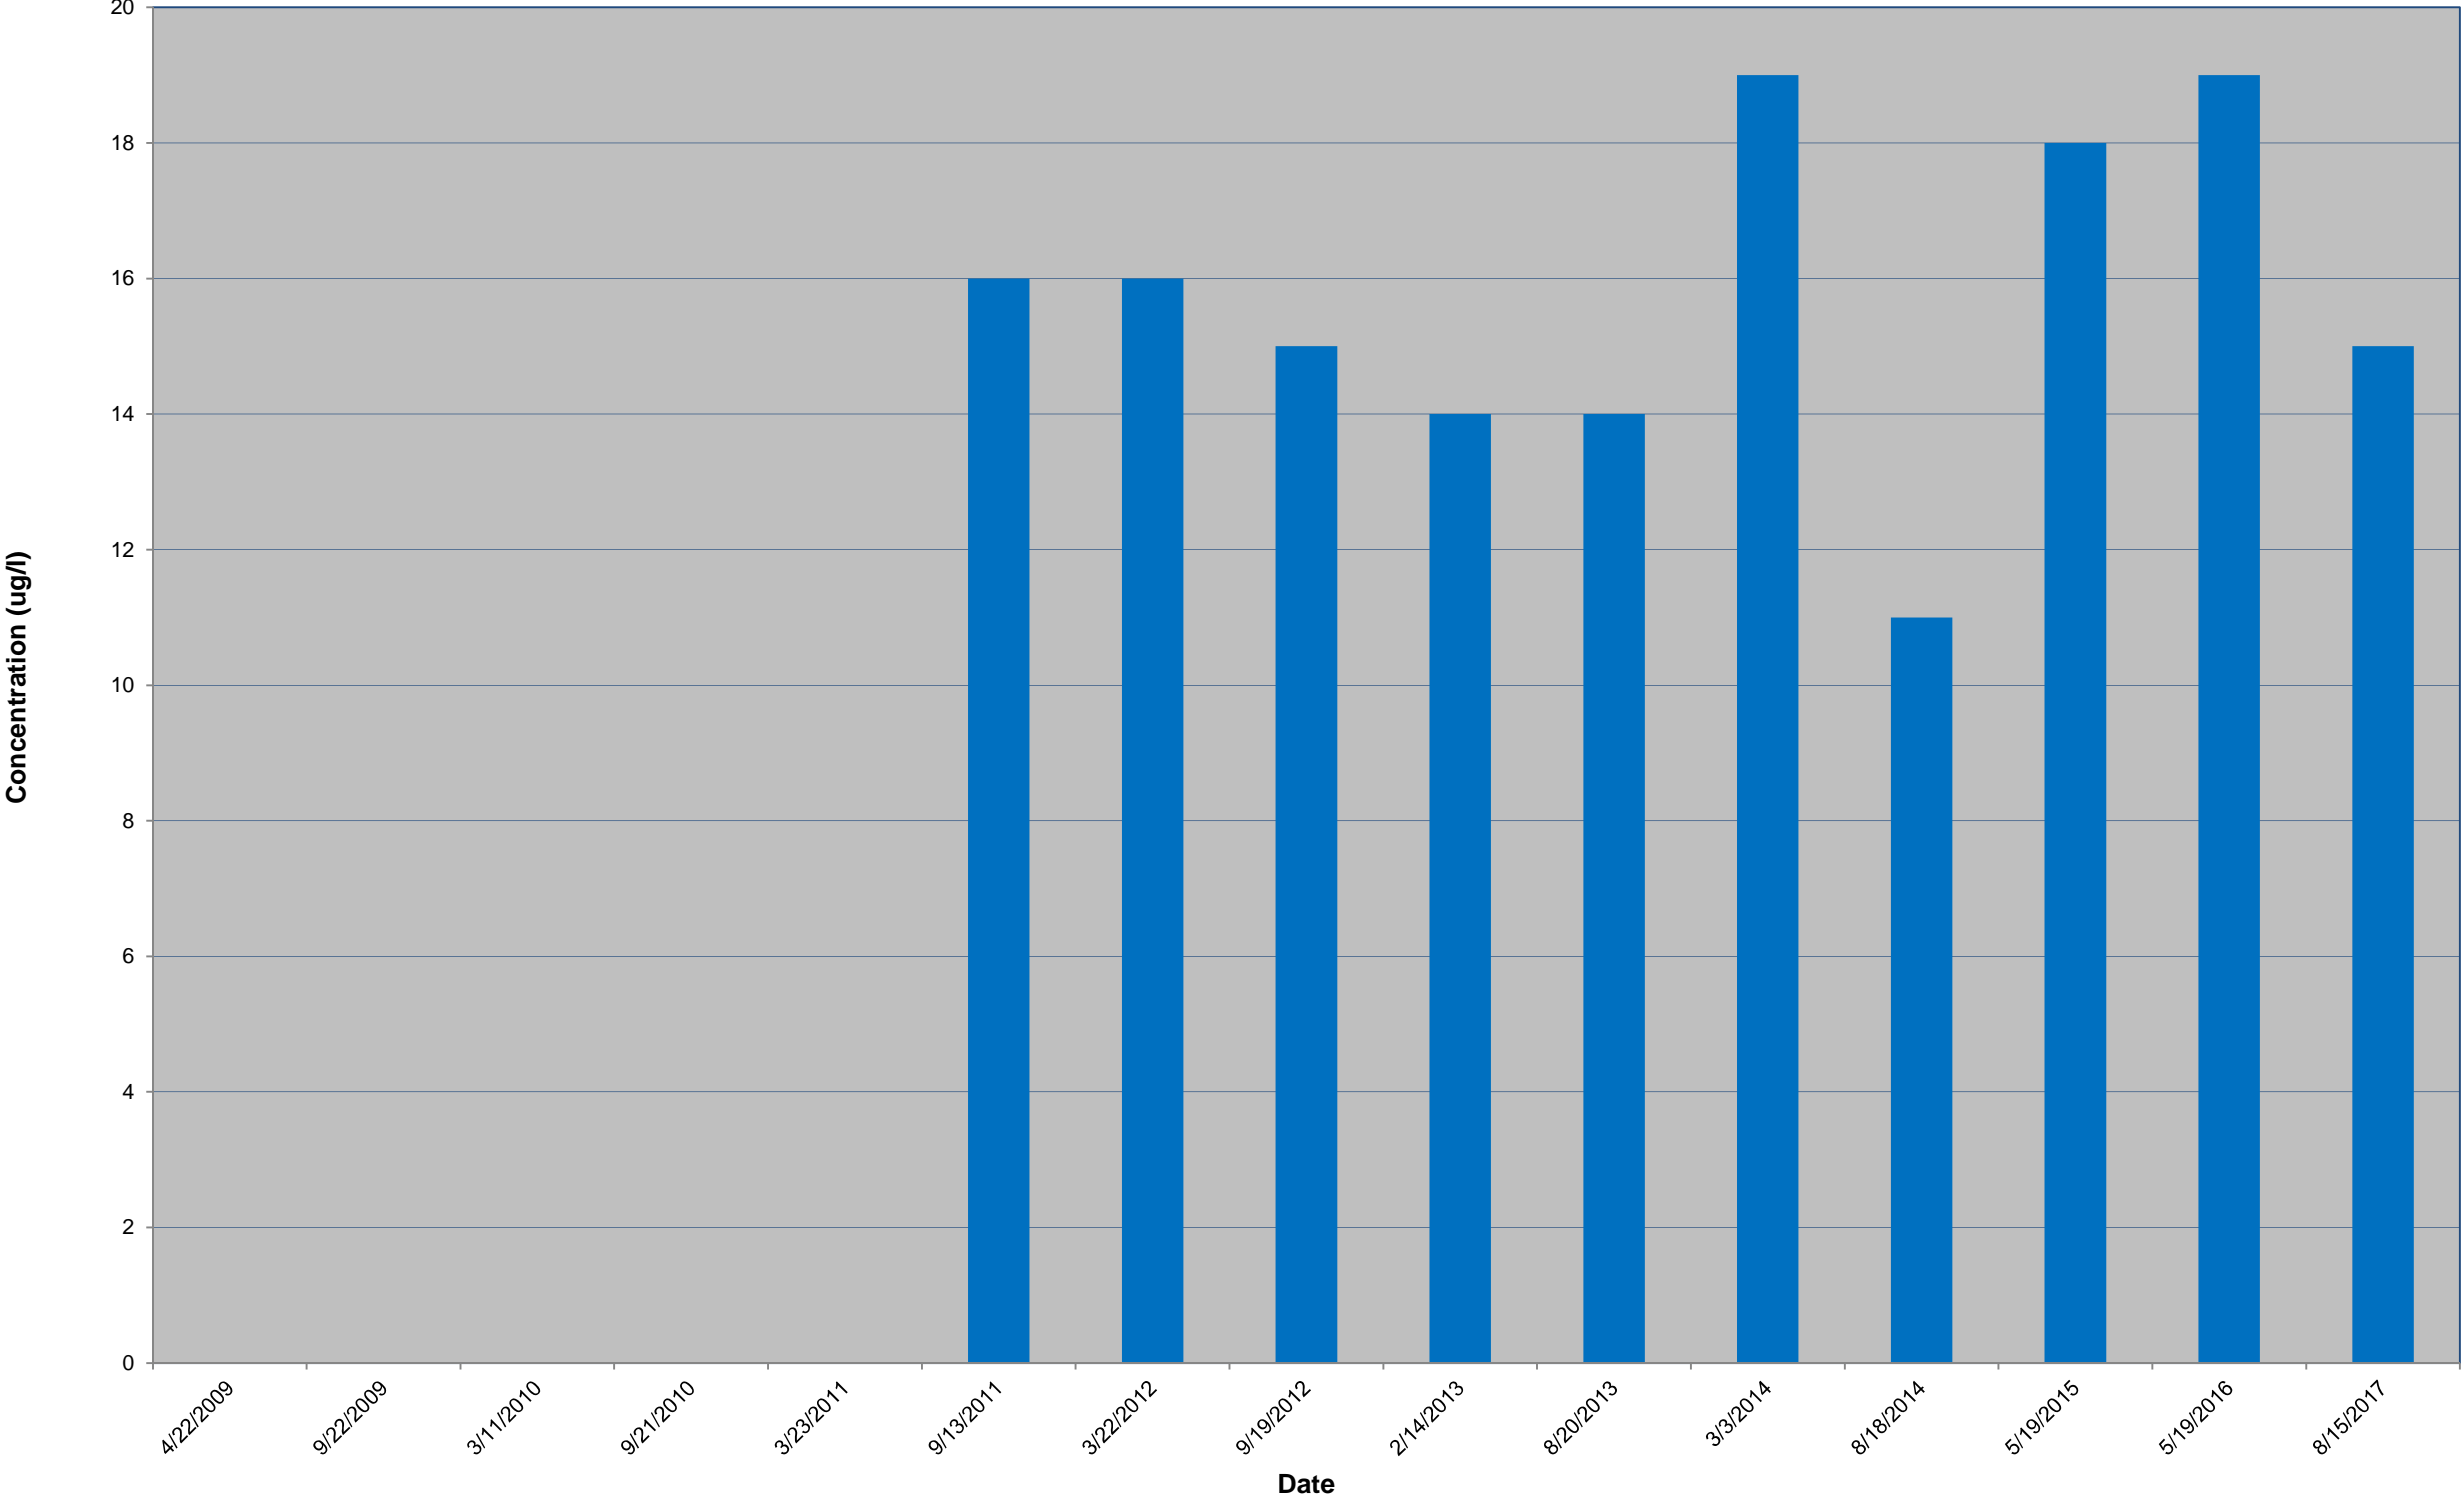
Arsenic Detections in CAMU P09 Groundwater Samples  
2009 - 2017\*

\*No arsenic analysis prior to 2009. Total arsenic analysis from 2009-2016; dissolved arsenic analysis beginning in 2017.

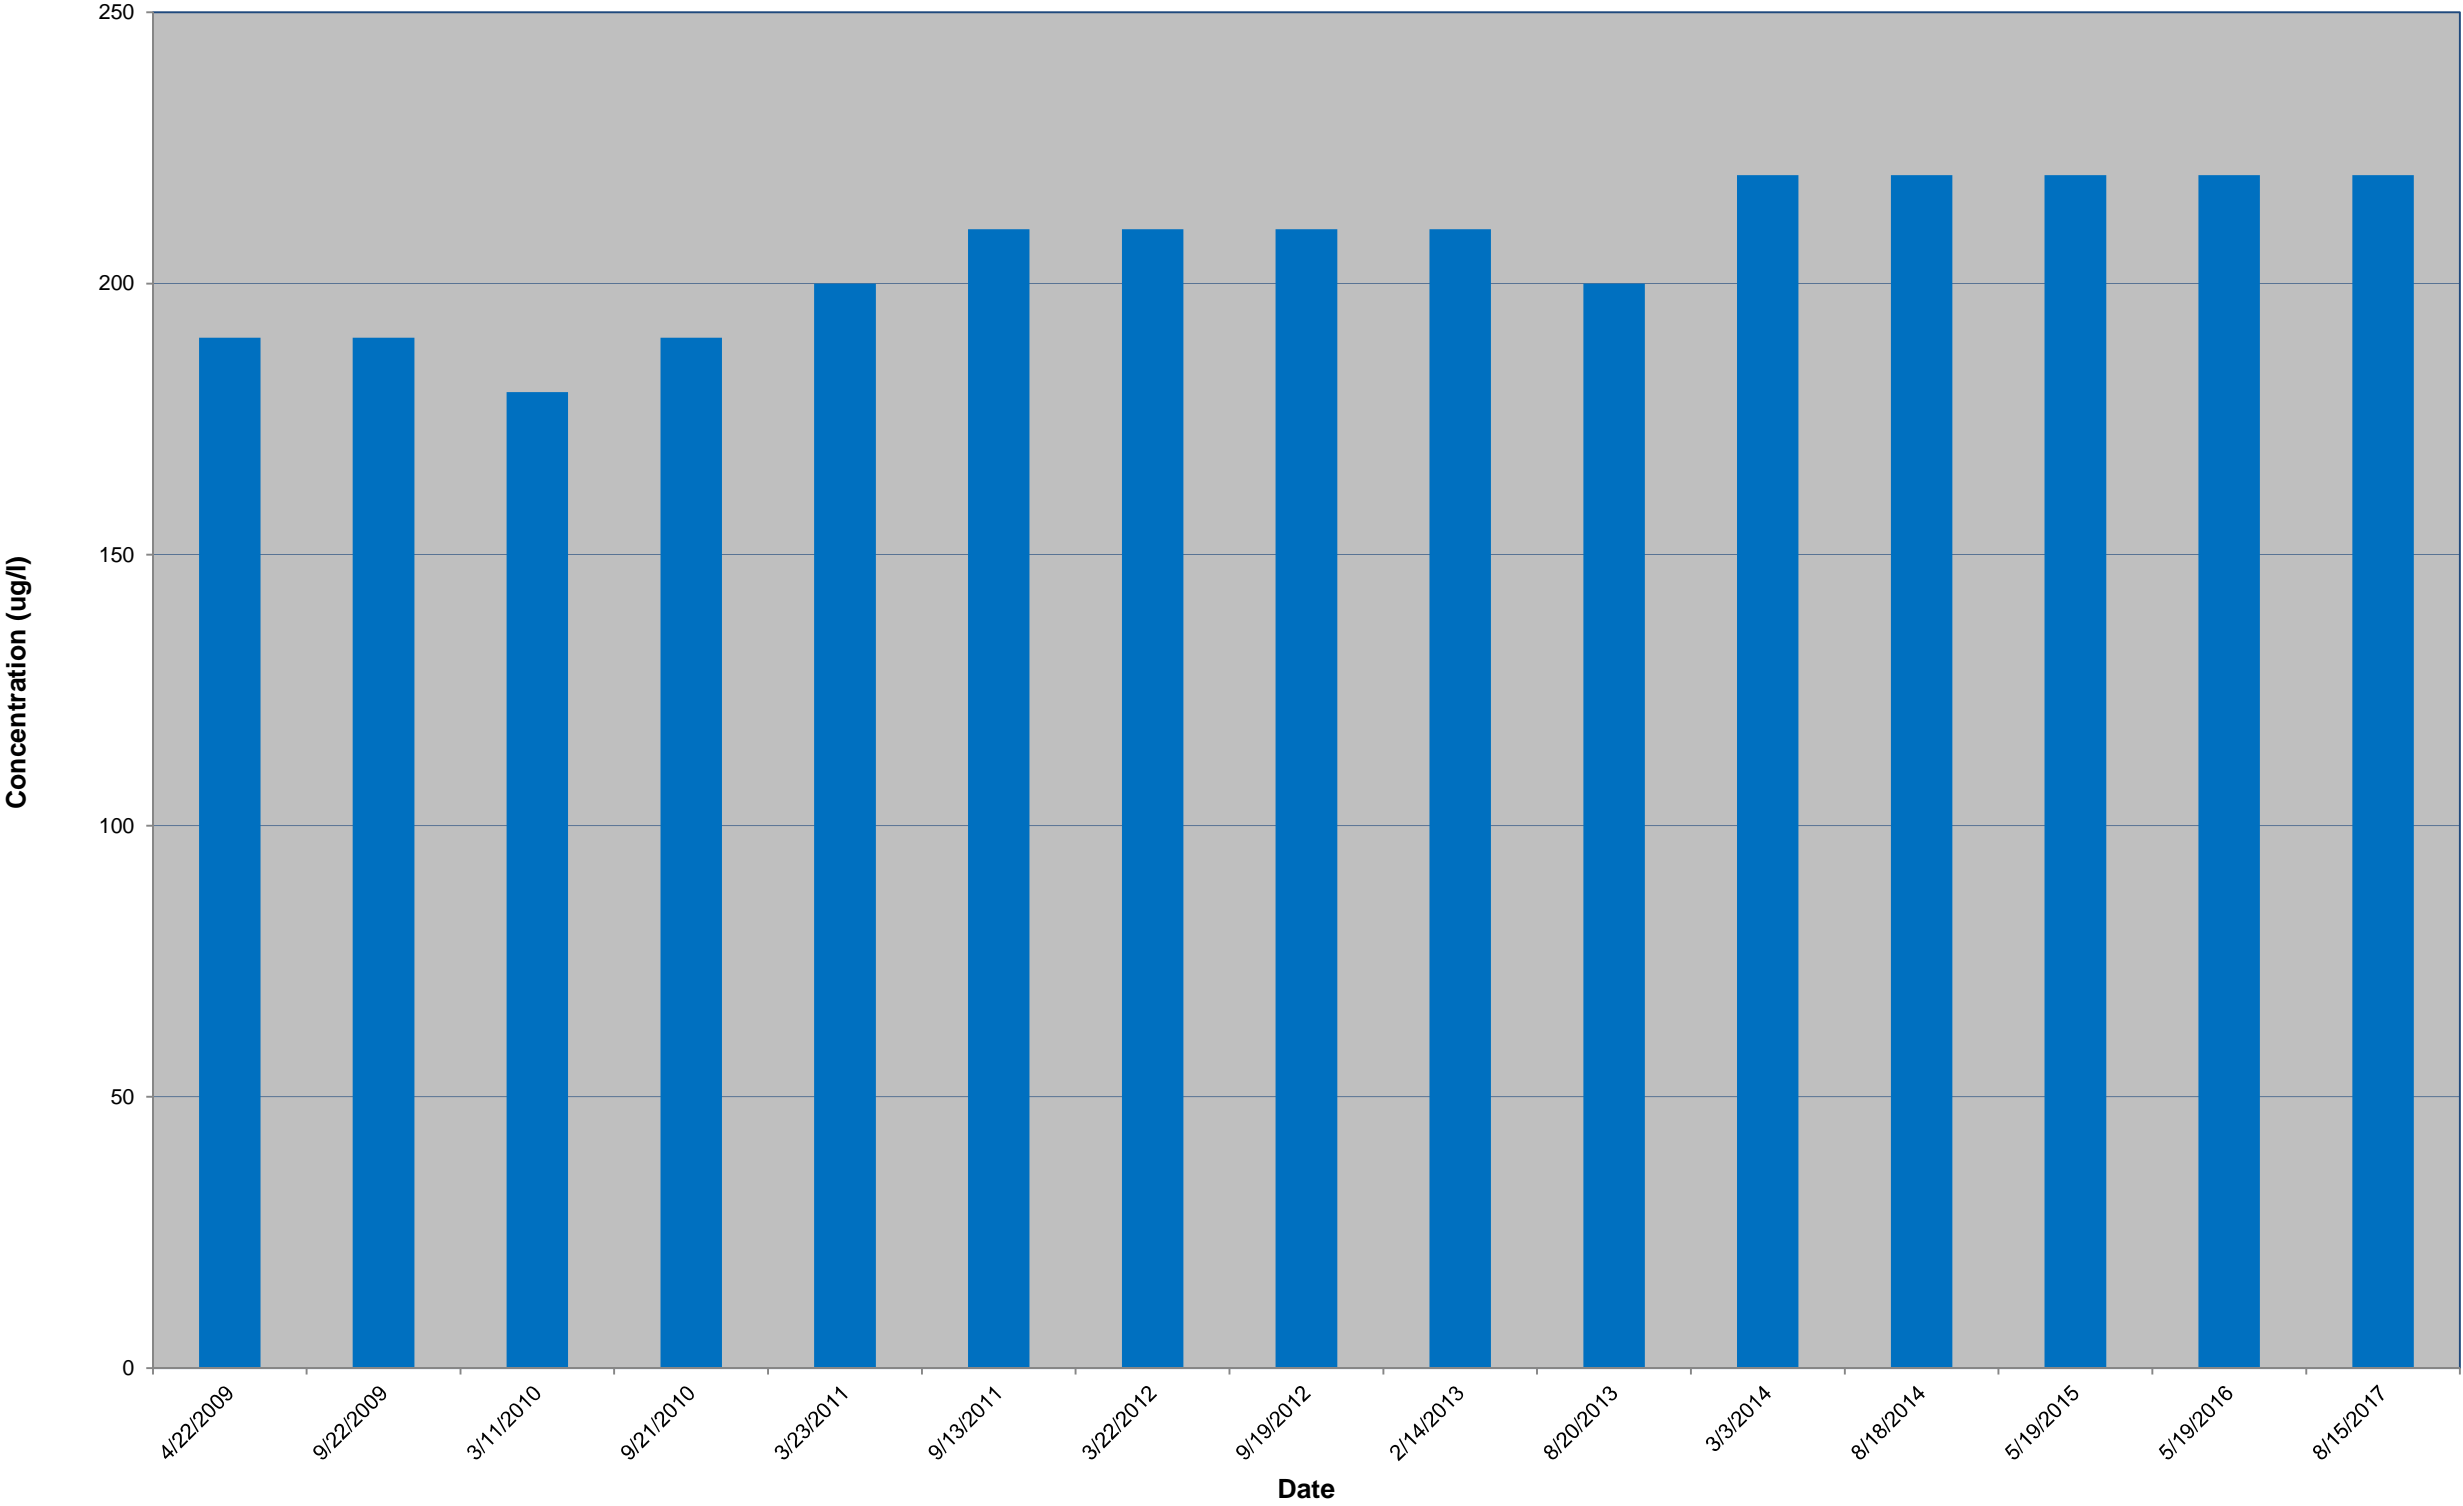
Barium Detections in CAMU P09 Groundwater Samples  
2009 - 2017\*

\*No barium analysis prior to 2009. Total barium analysis from 2009-2016; dissolved barium analysis beginning in 2017.

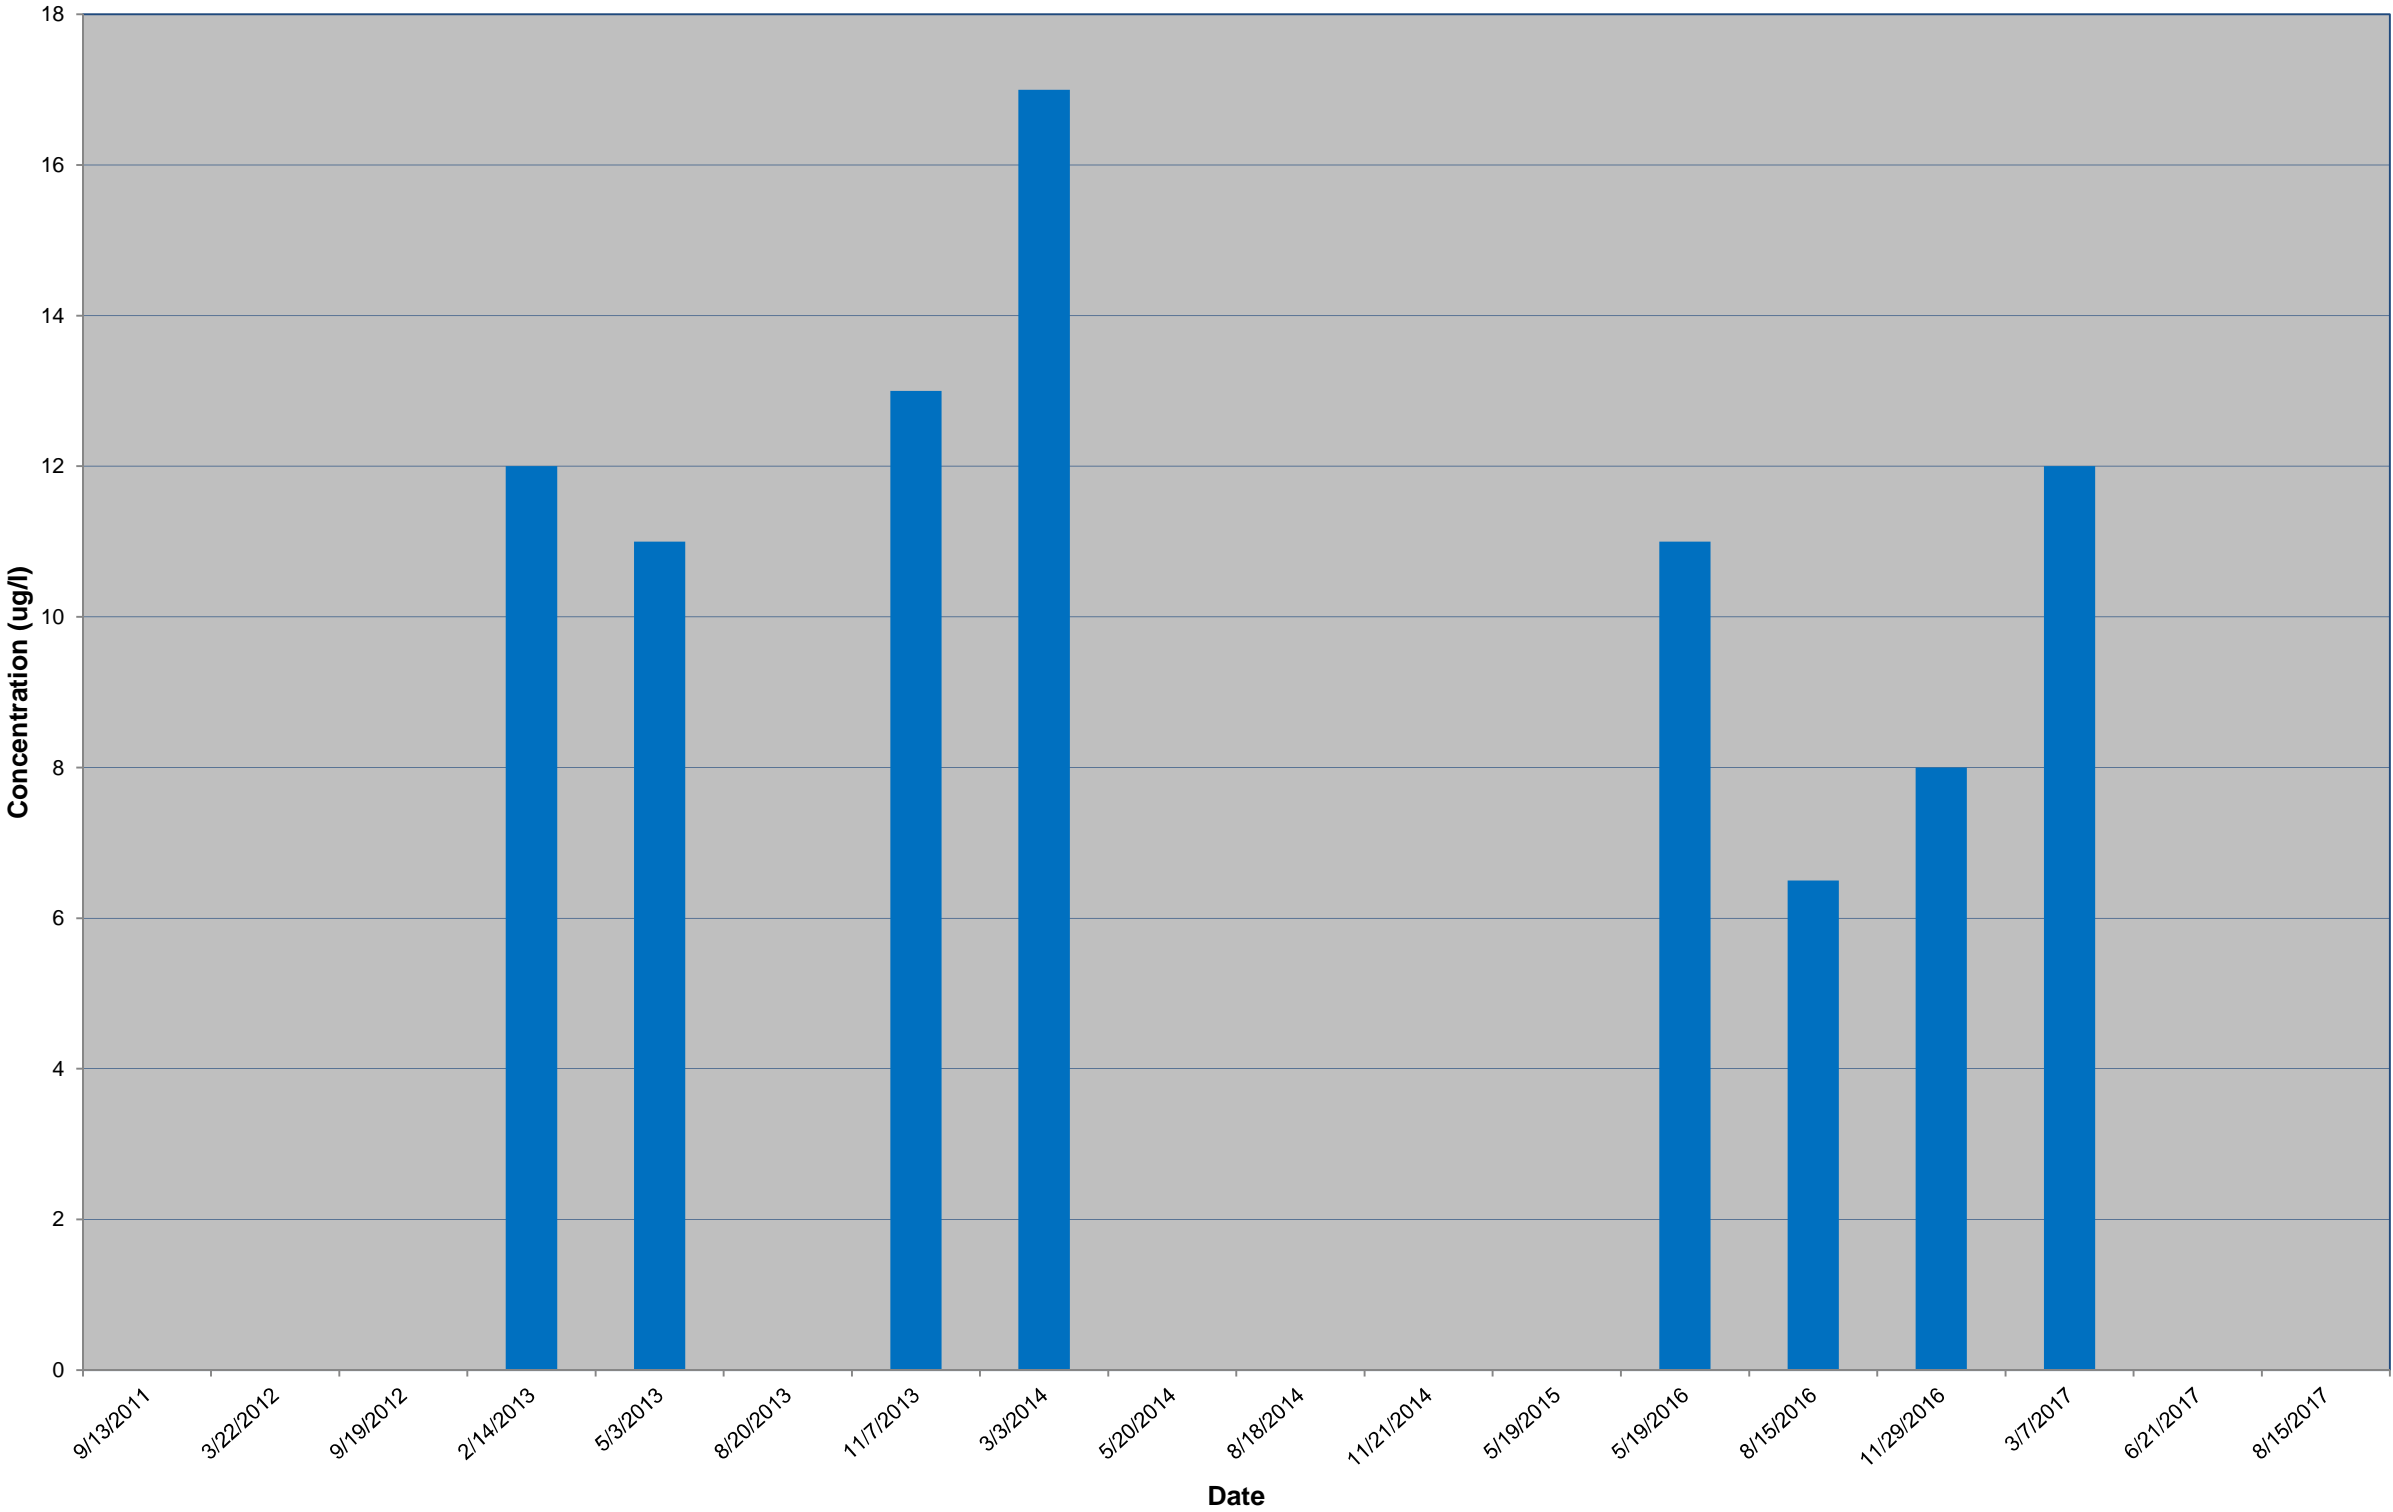
Hexavalent Chromium Detections in CAMU P09 Groundwater Samples  
2011 - 2017\*

\*No hexavalent chromium  
analysis prior to 2011.  
Total hexavalent chromium  
analysis from 2011-March  
2016; dissolved hexavalent  
chromium analysis  
beginning in June 2017.
