2-Methylnaphthalene Detections in CAMU Unit 2 Leak Detection Samples  
2007 - 2017

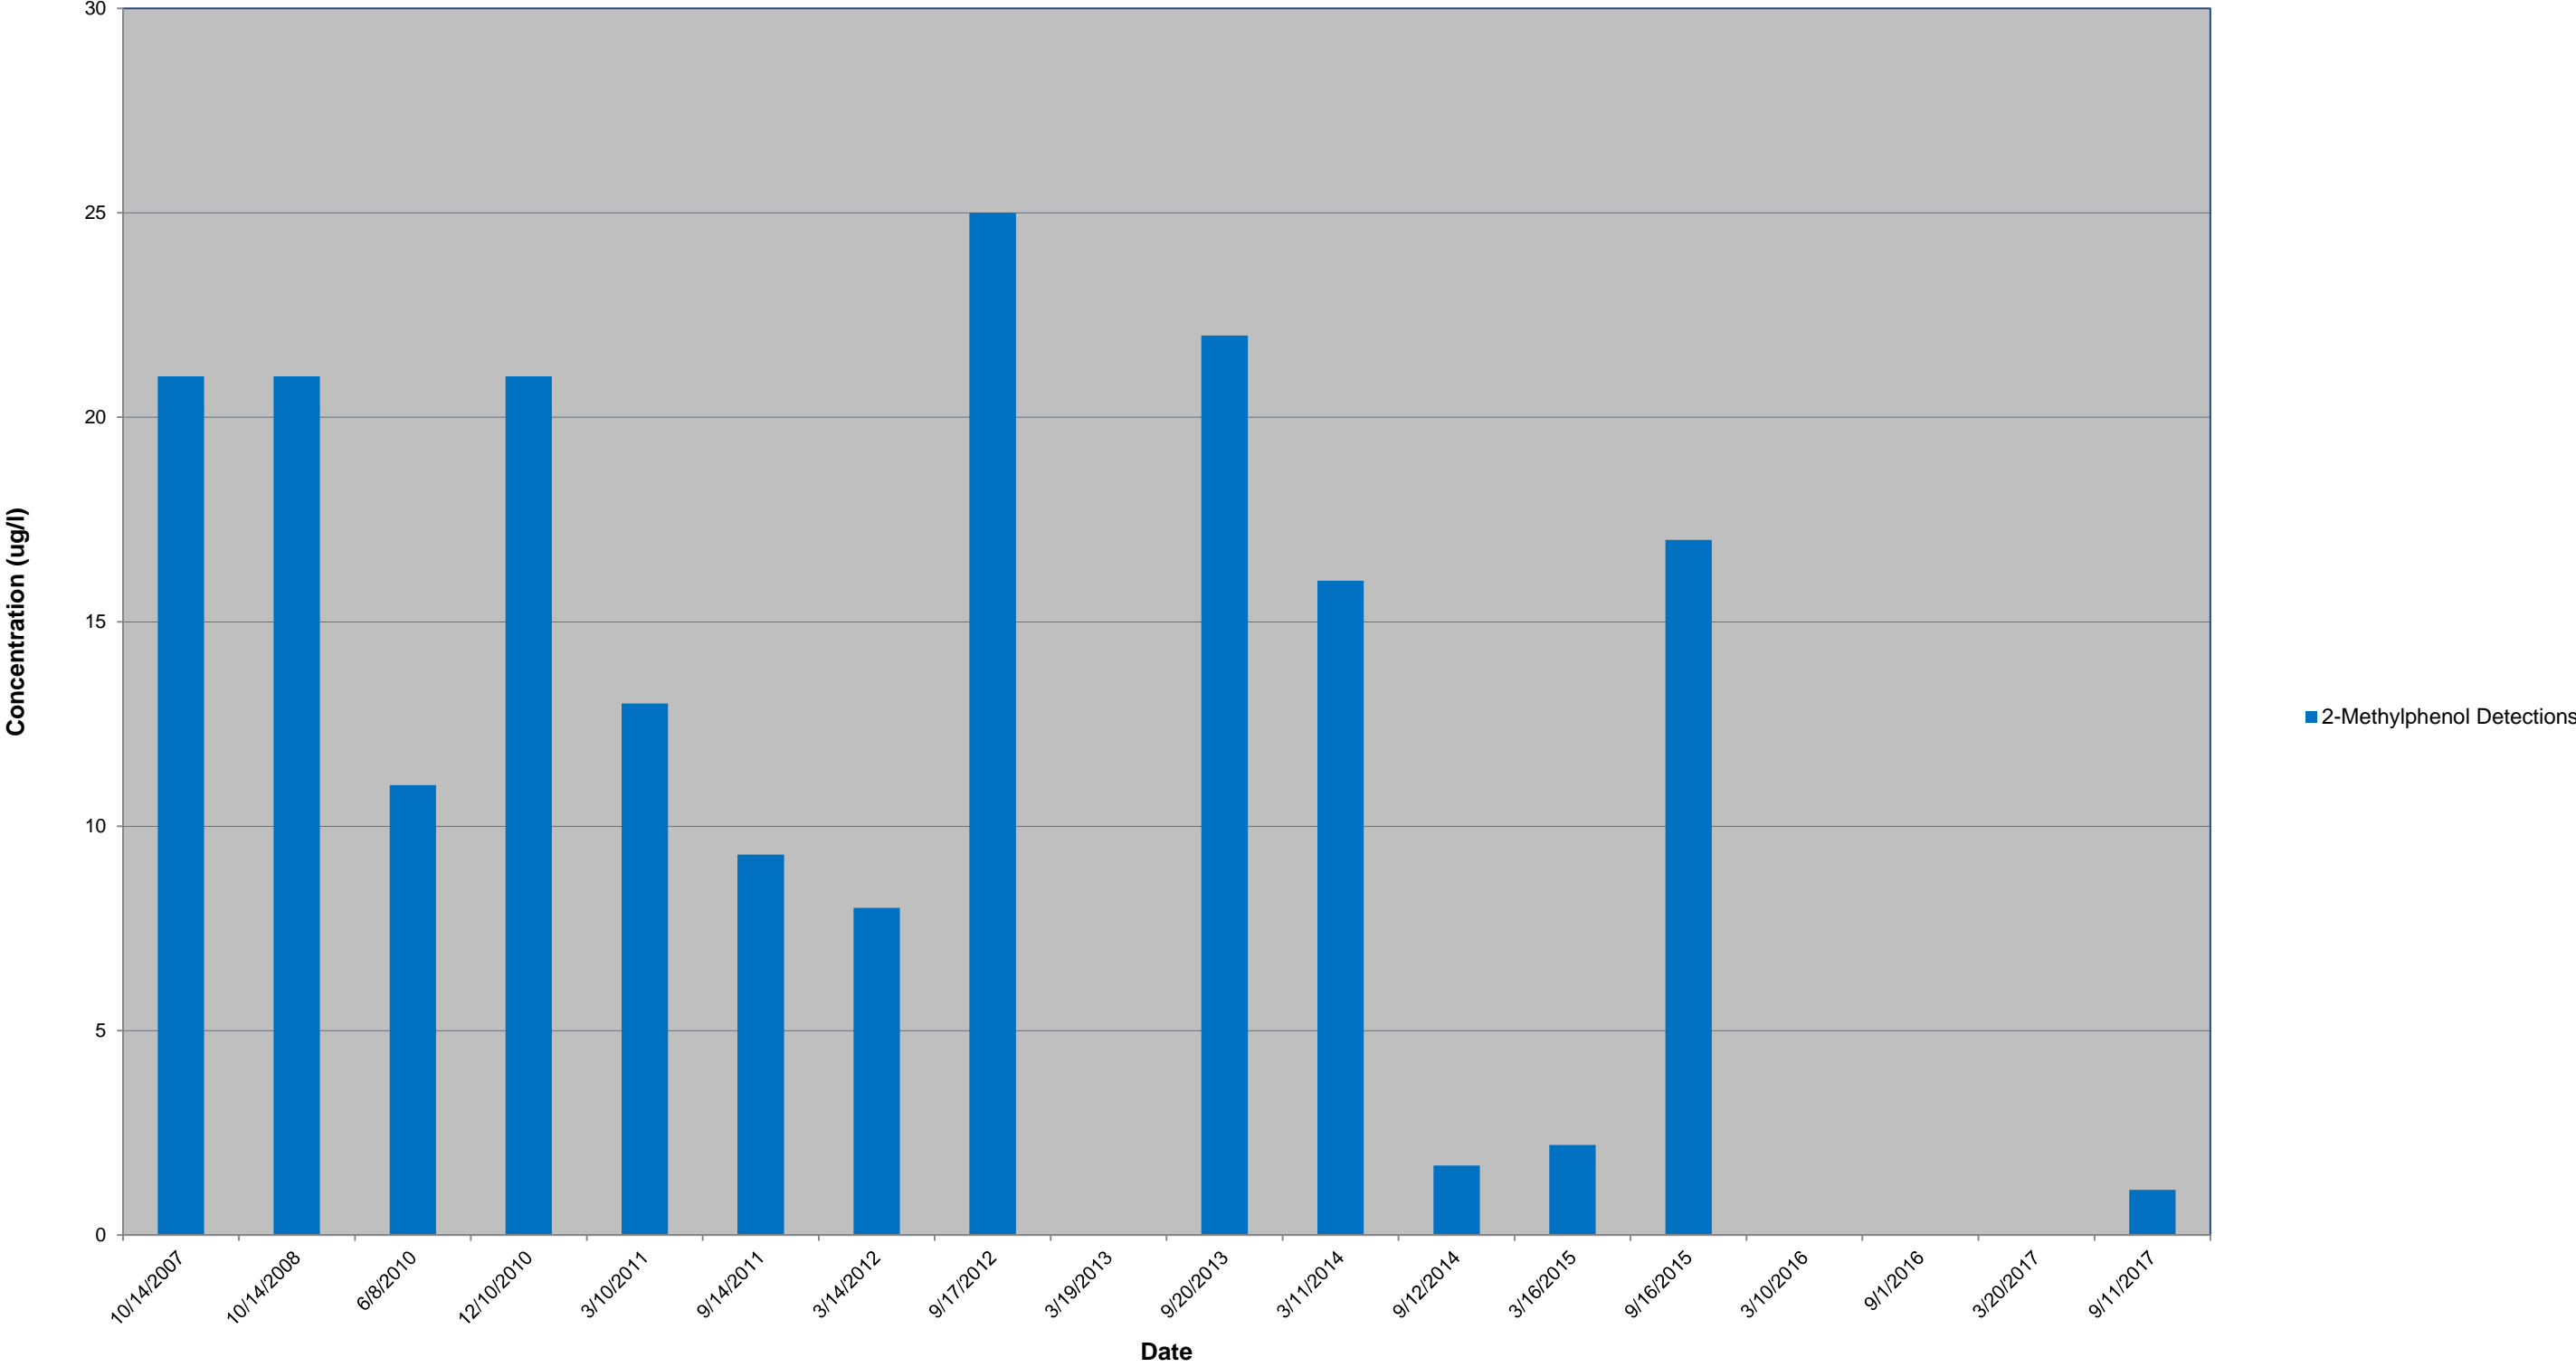
2-Methylphenol Detections in CAMU Unit 2 Leak Detection Samples  
2007 - 2017

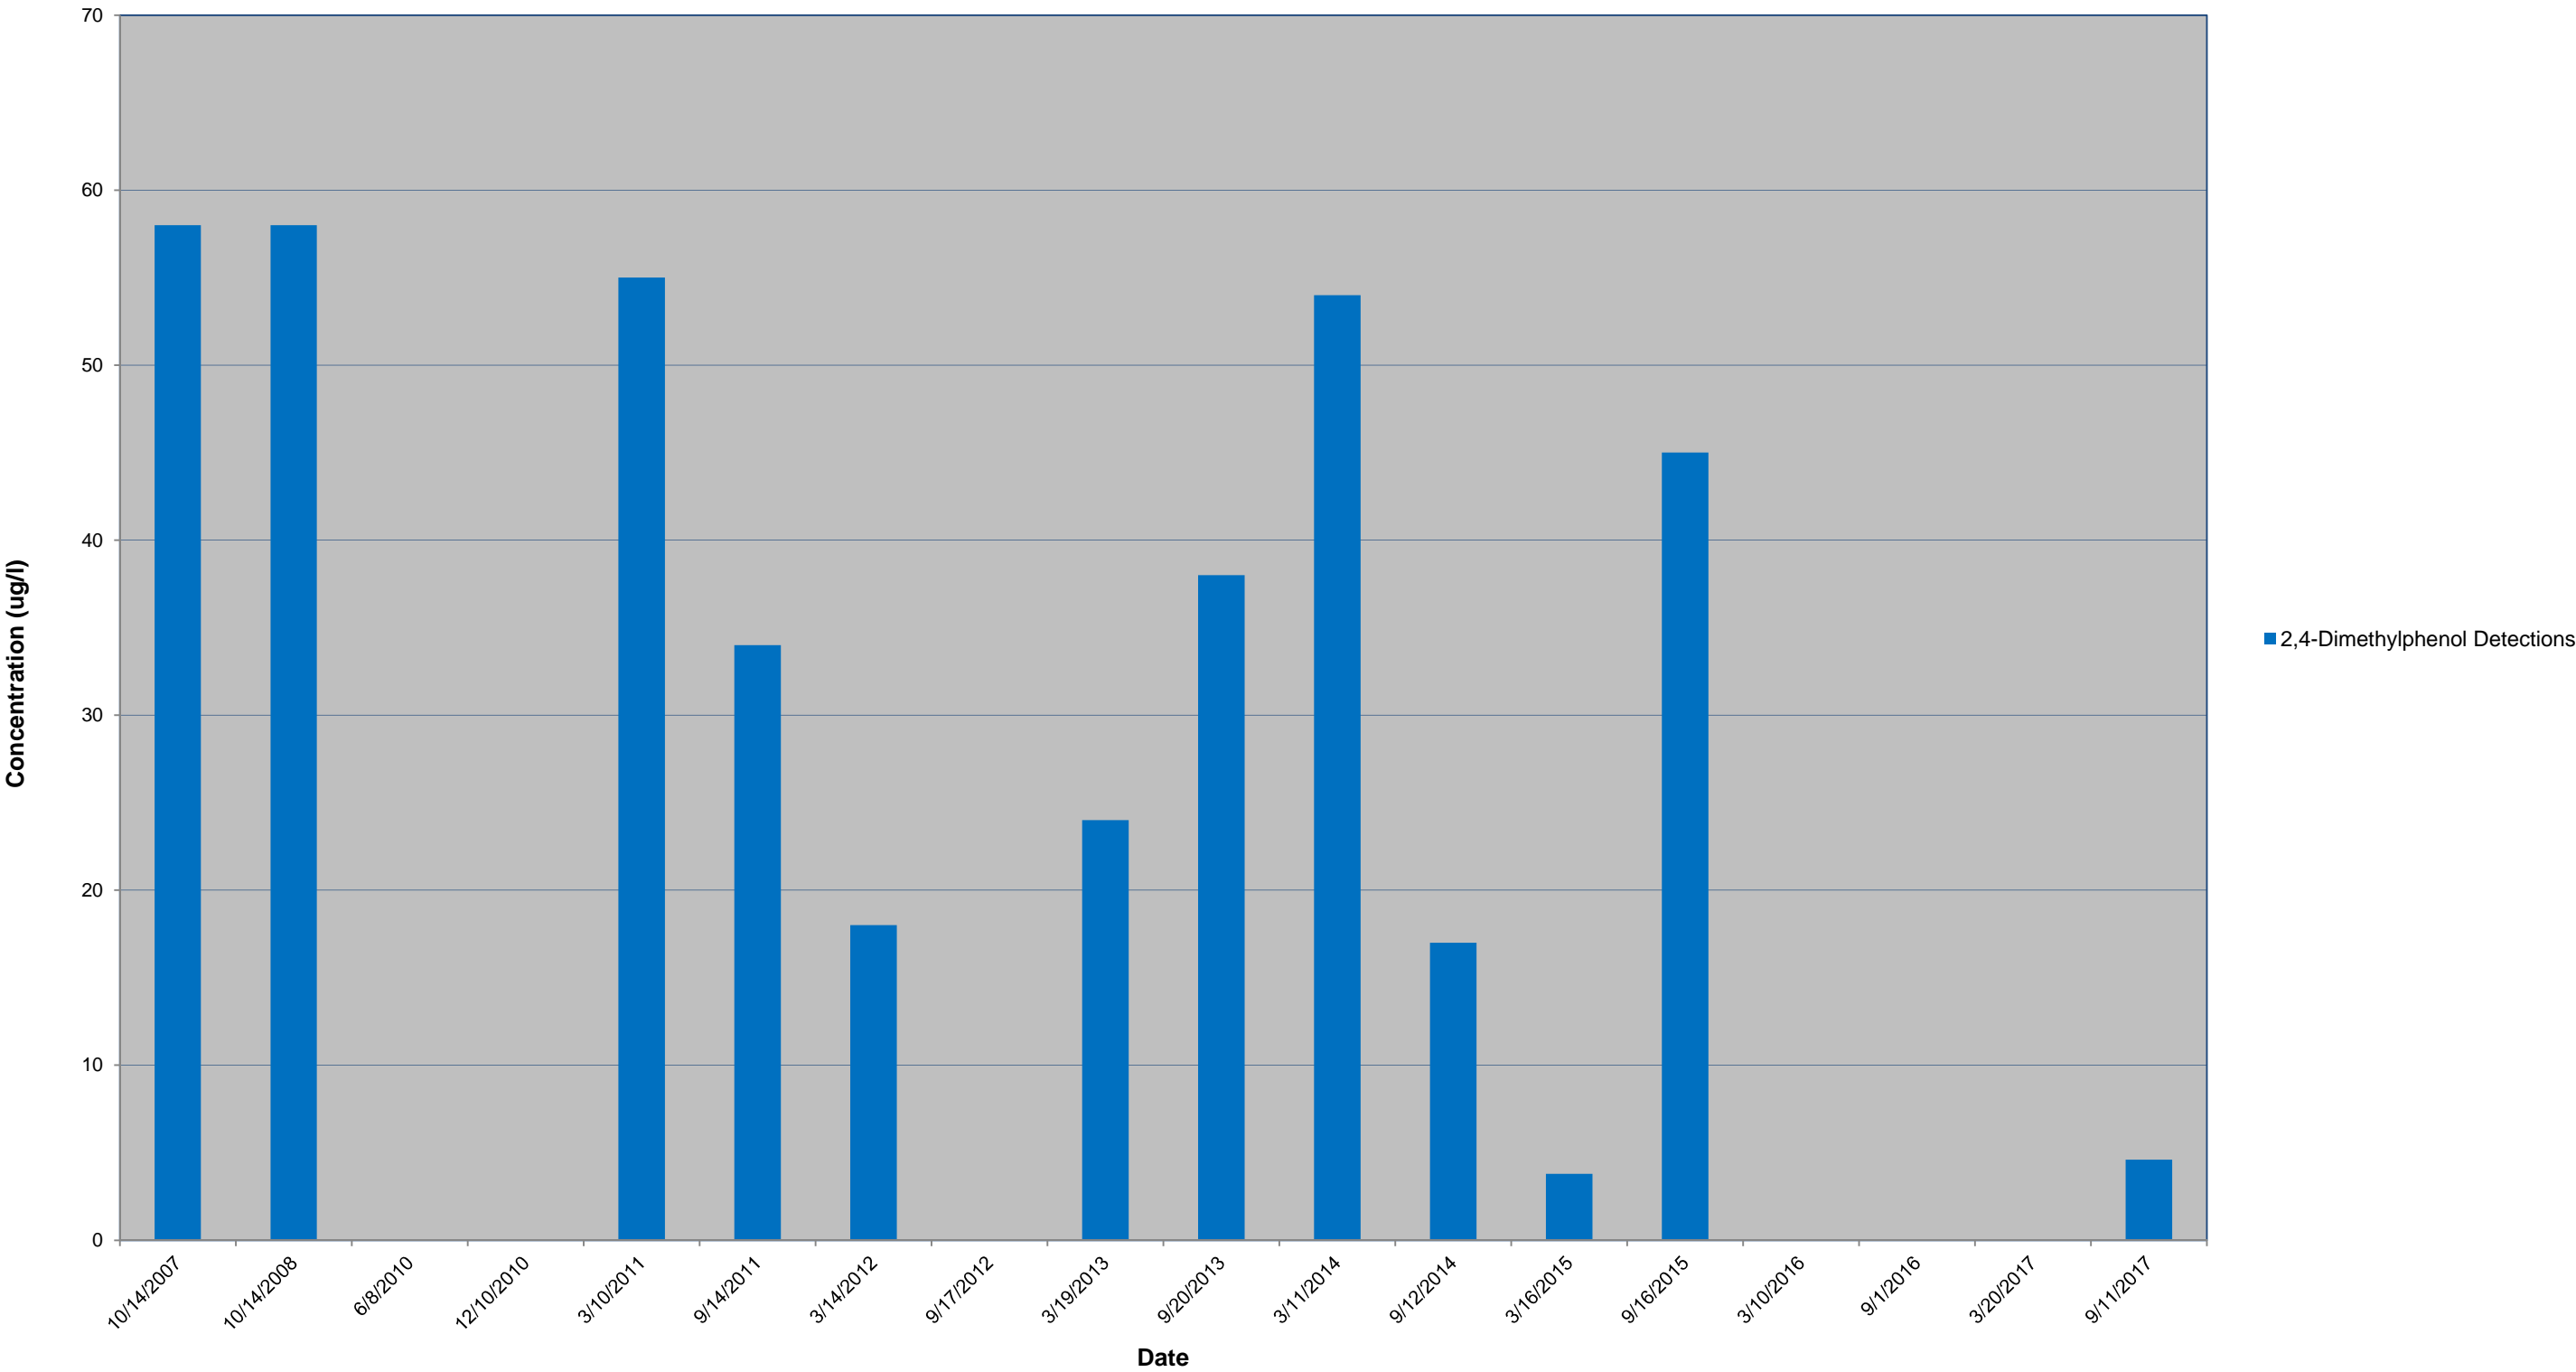
2,4-Dimethylphenol Detections in CAMU Unit 2 Leak Detection Samples  
2007 - 2017

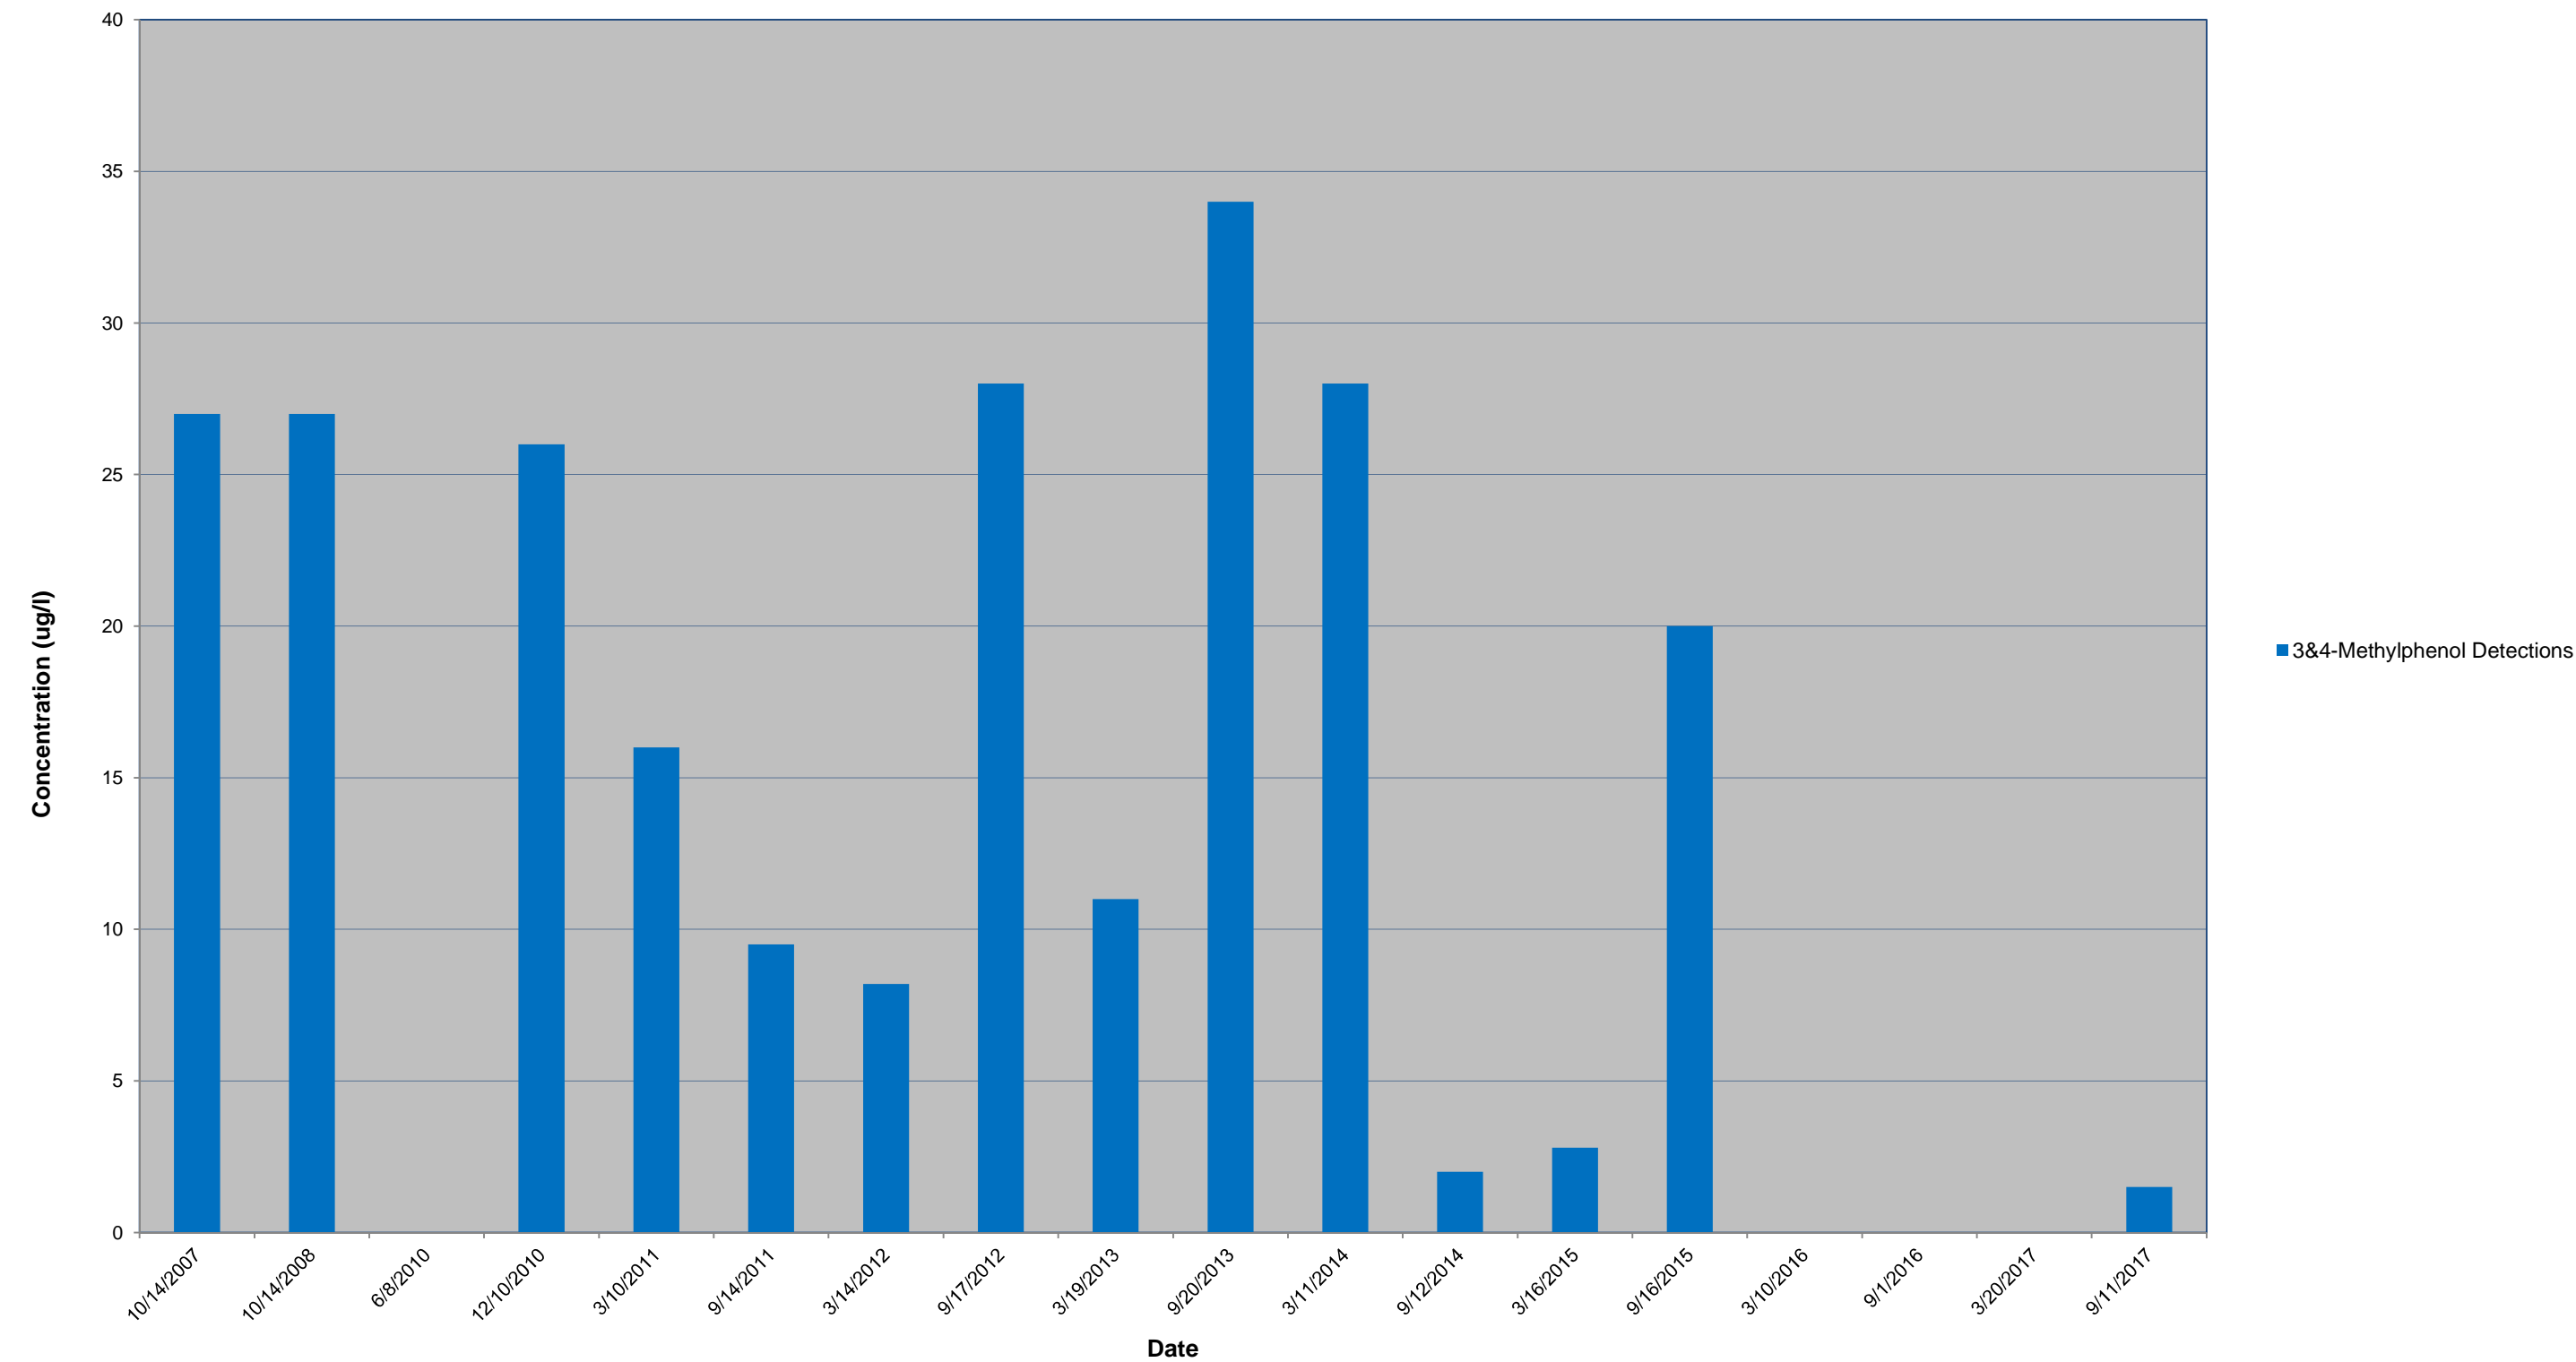
**3&4-Methylphenol Detections in CAMU Unit 2 Leak Detection Samples  
2007 - 2017**

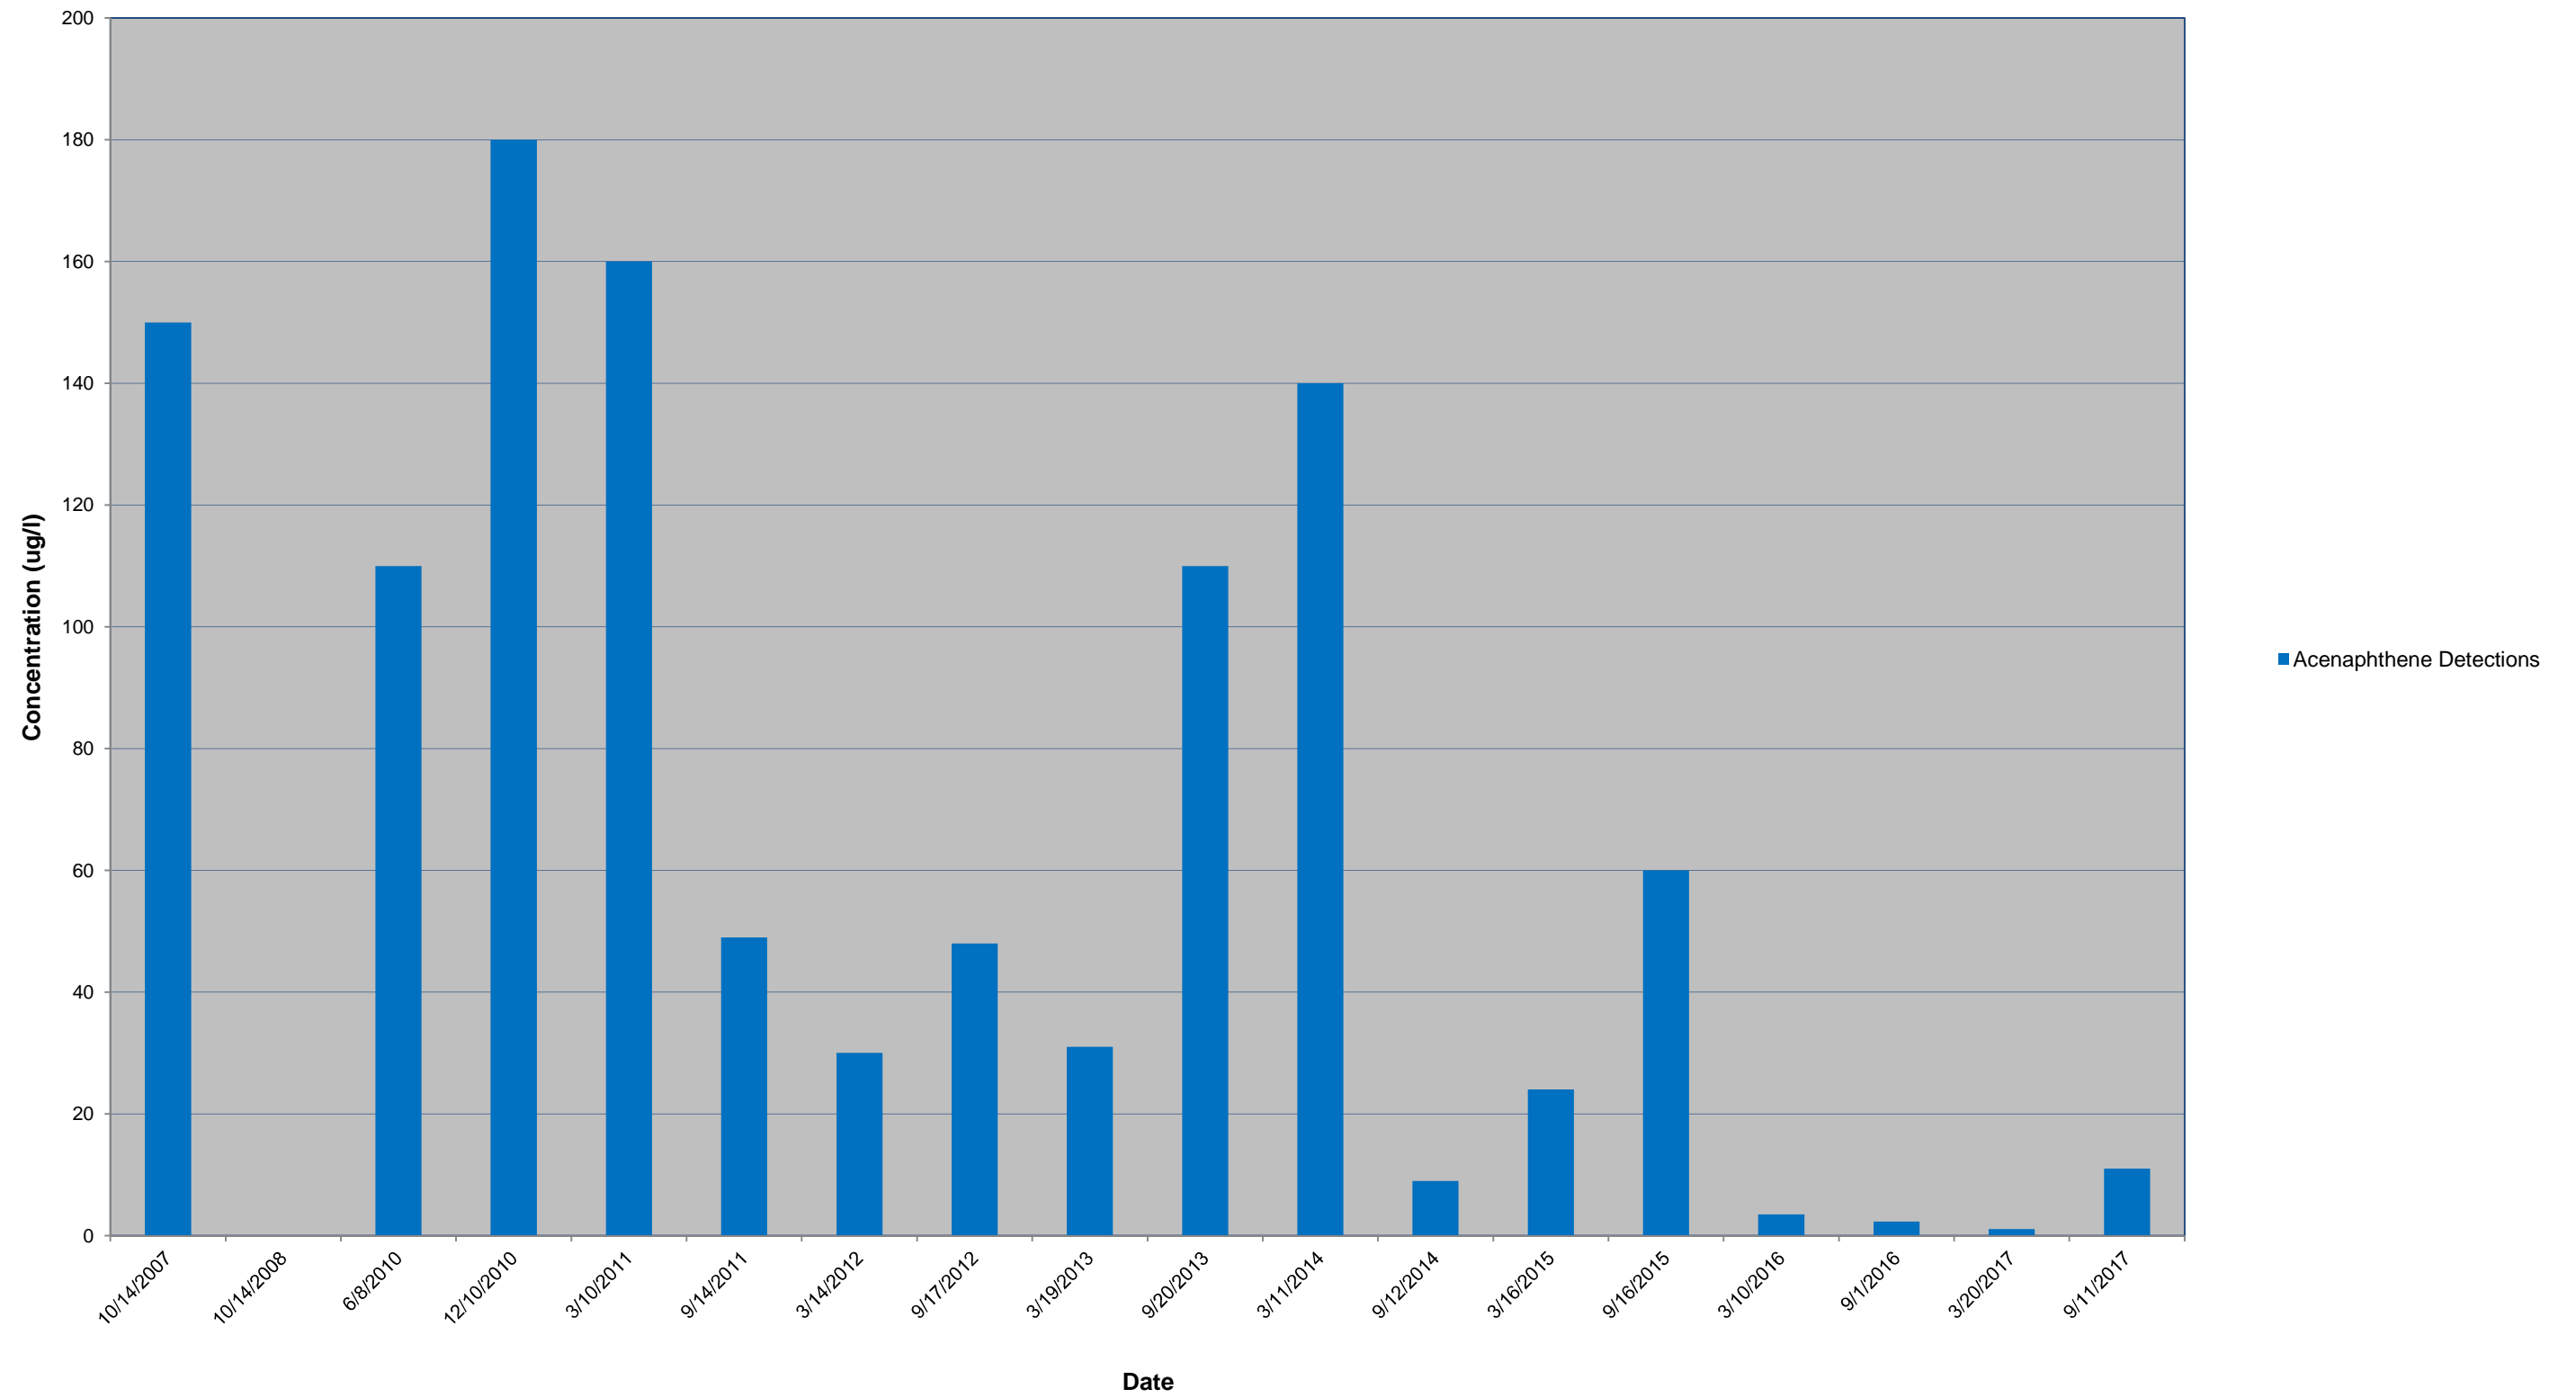
Acenaphthene Detections in CAMU Unit 2 Leak Detection Samples  
2007 - 2017

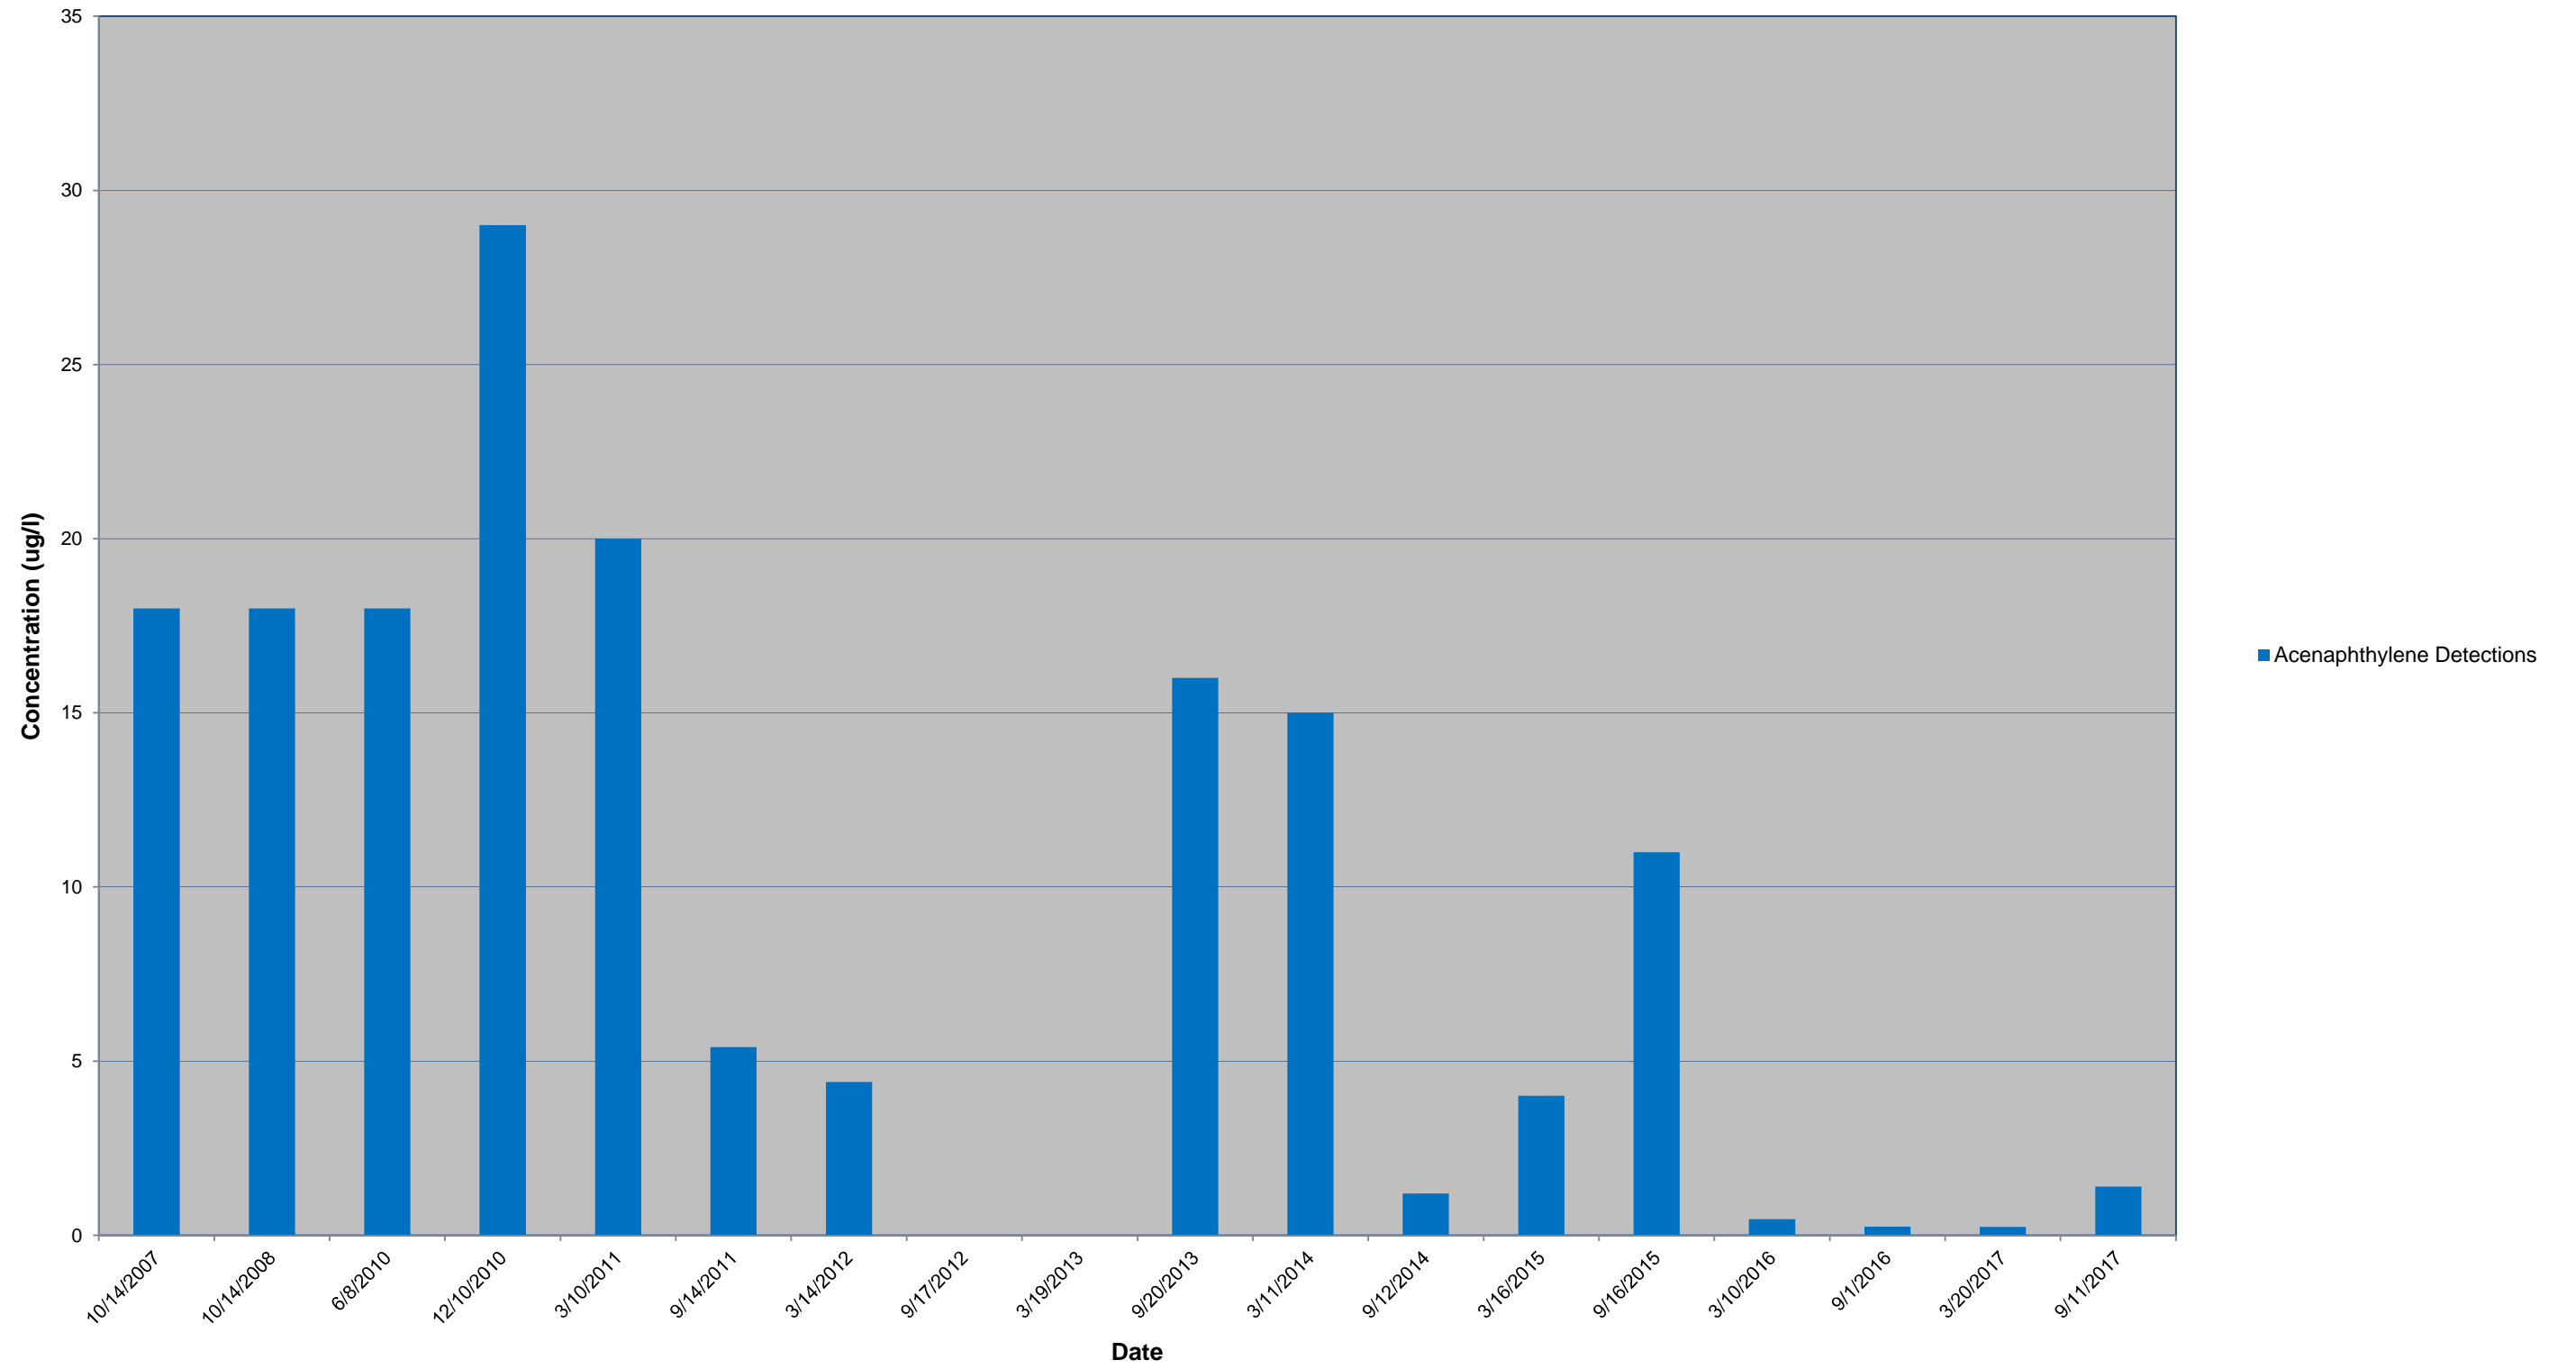
Acenaphthylene Detections in CAMU Unit 2 Leak Detection Samples  
2007 - 2017

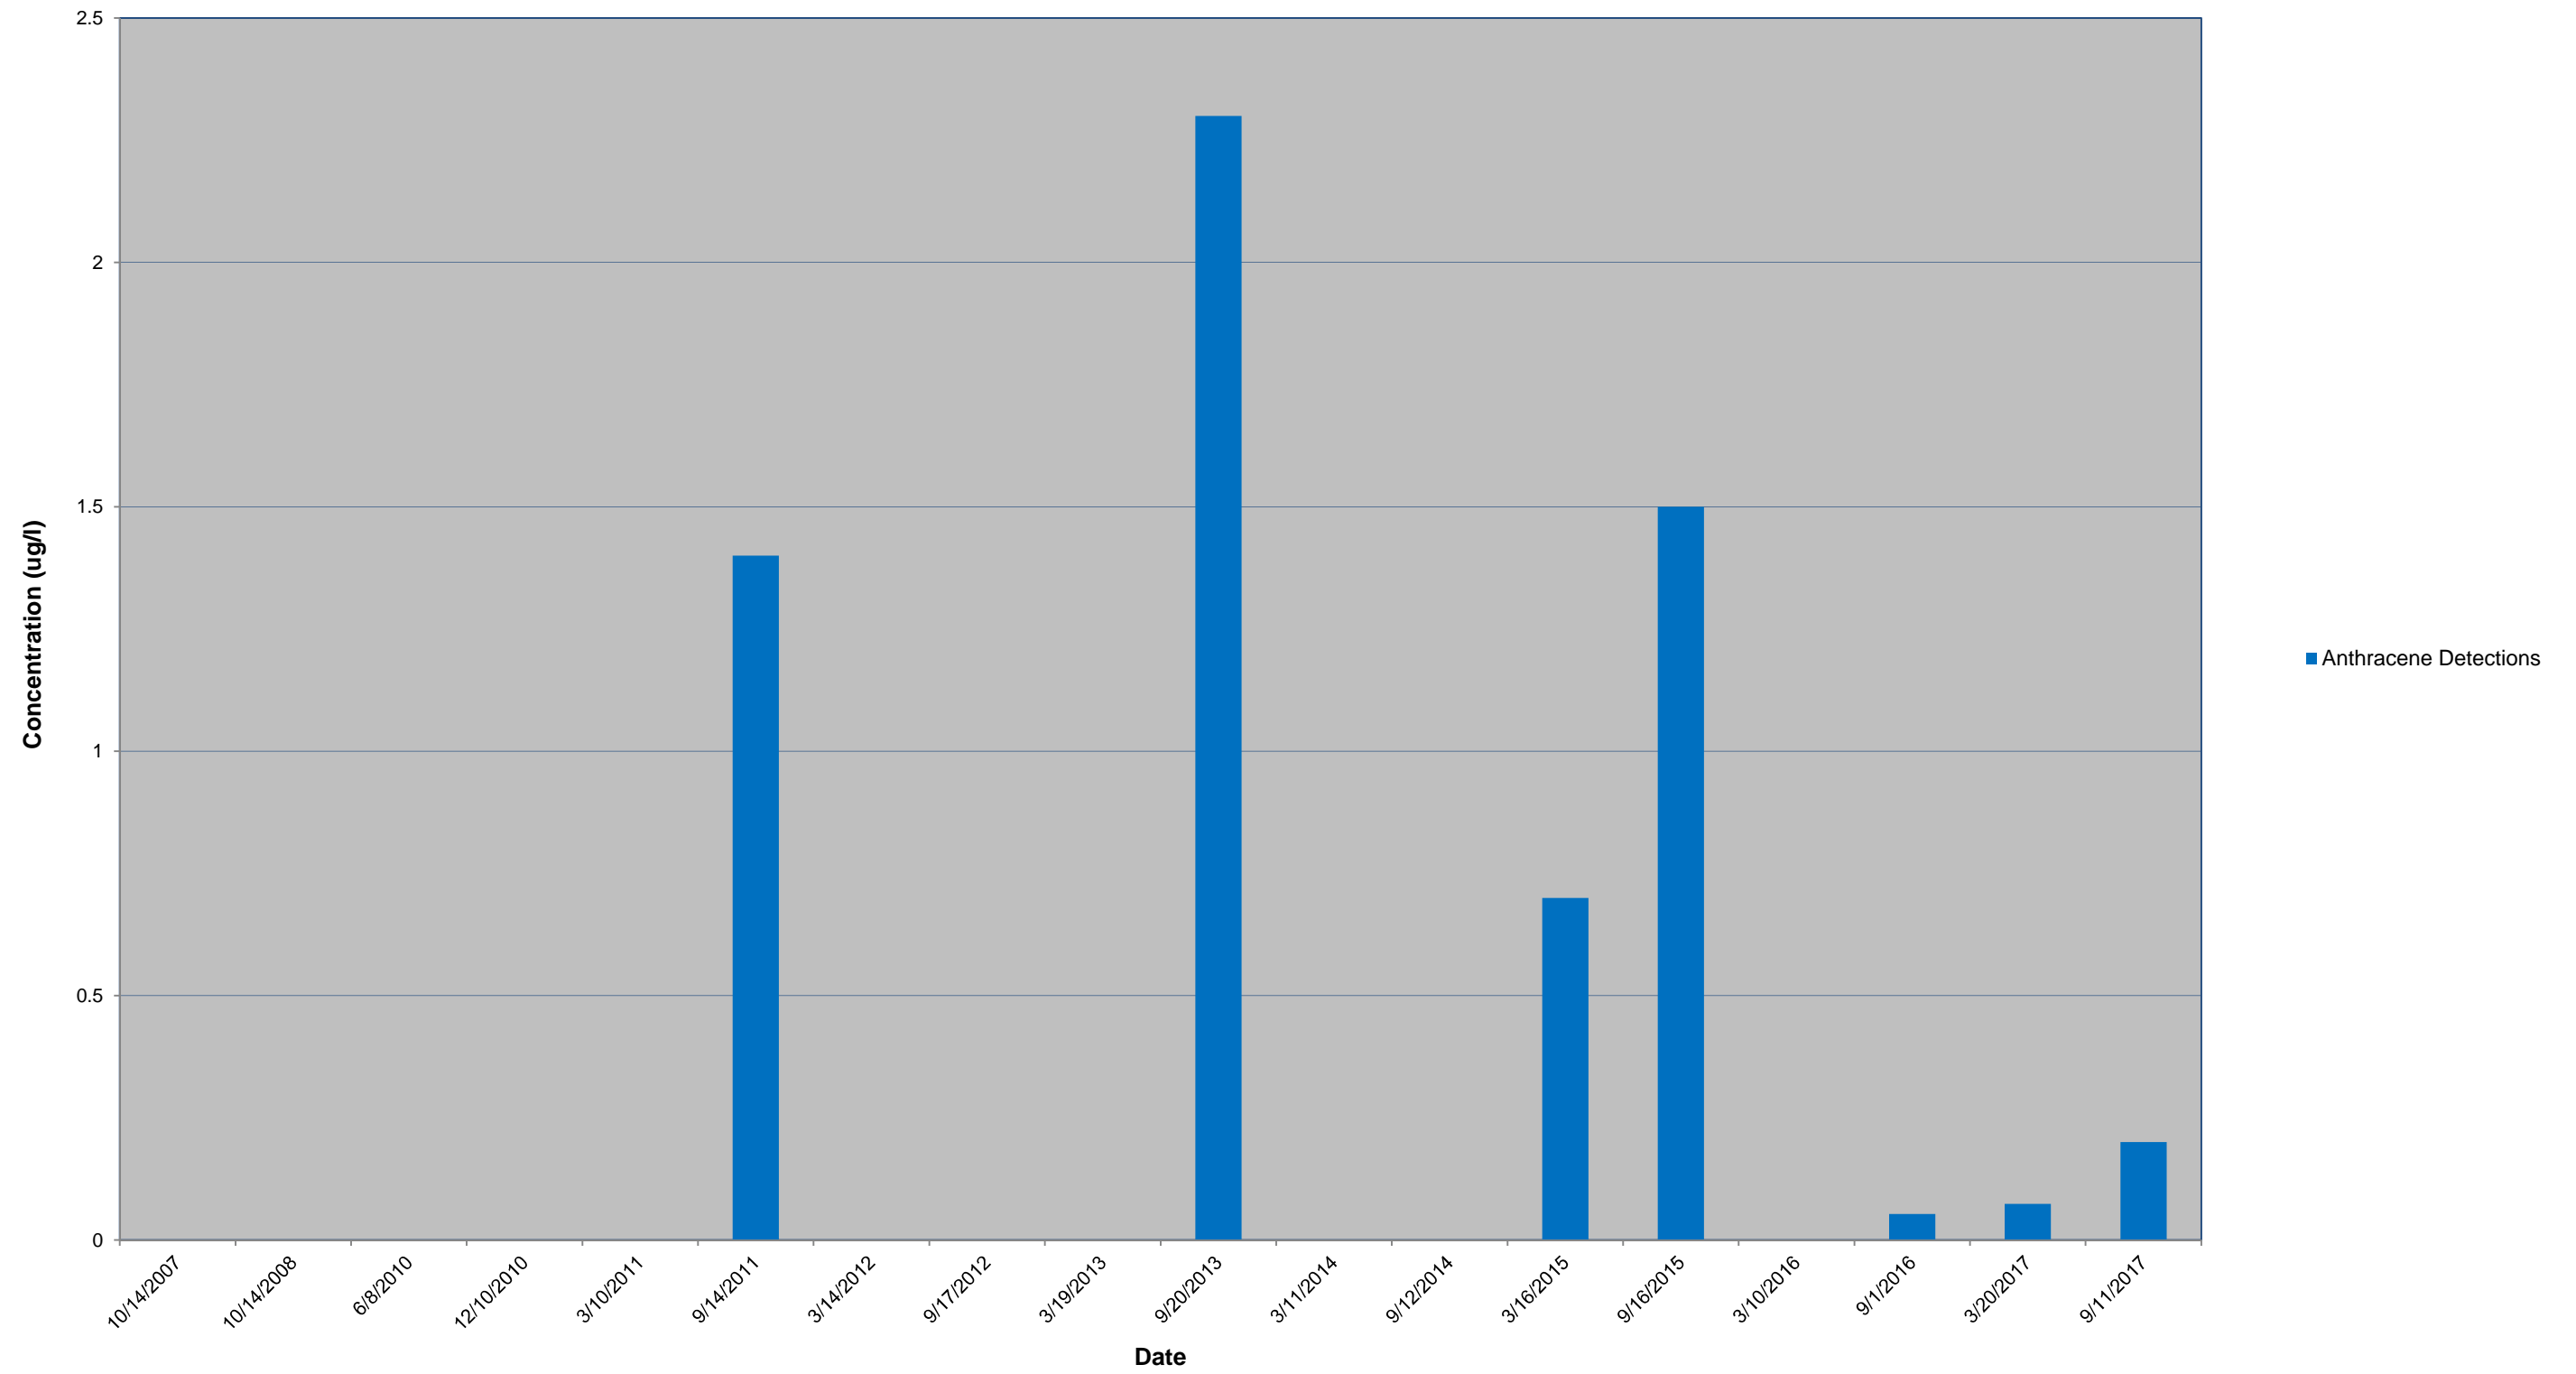
Anthracene Detections in CAMU Unit 2 Leak Detection Samples  
2007 - 2017
