2-Methylnaphthalene Detections in CAMU Unit 2 Leak Detection Samples  
2007 - 2017

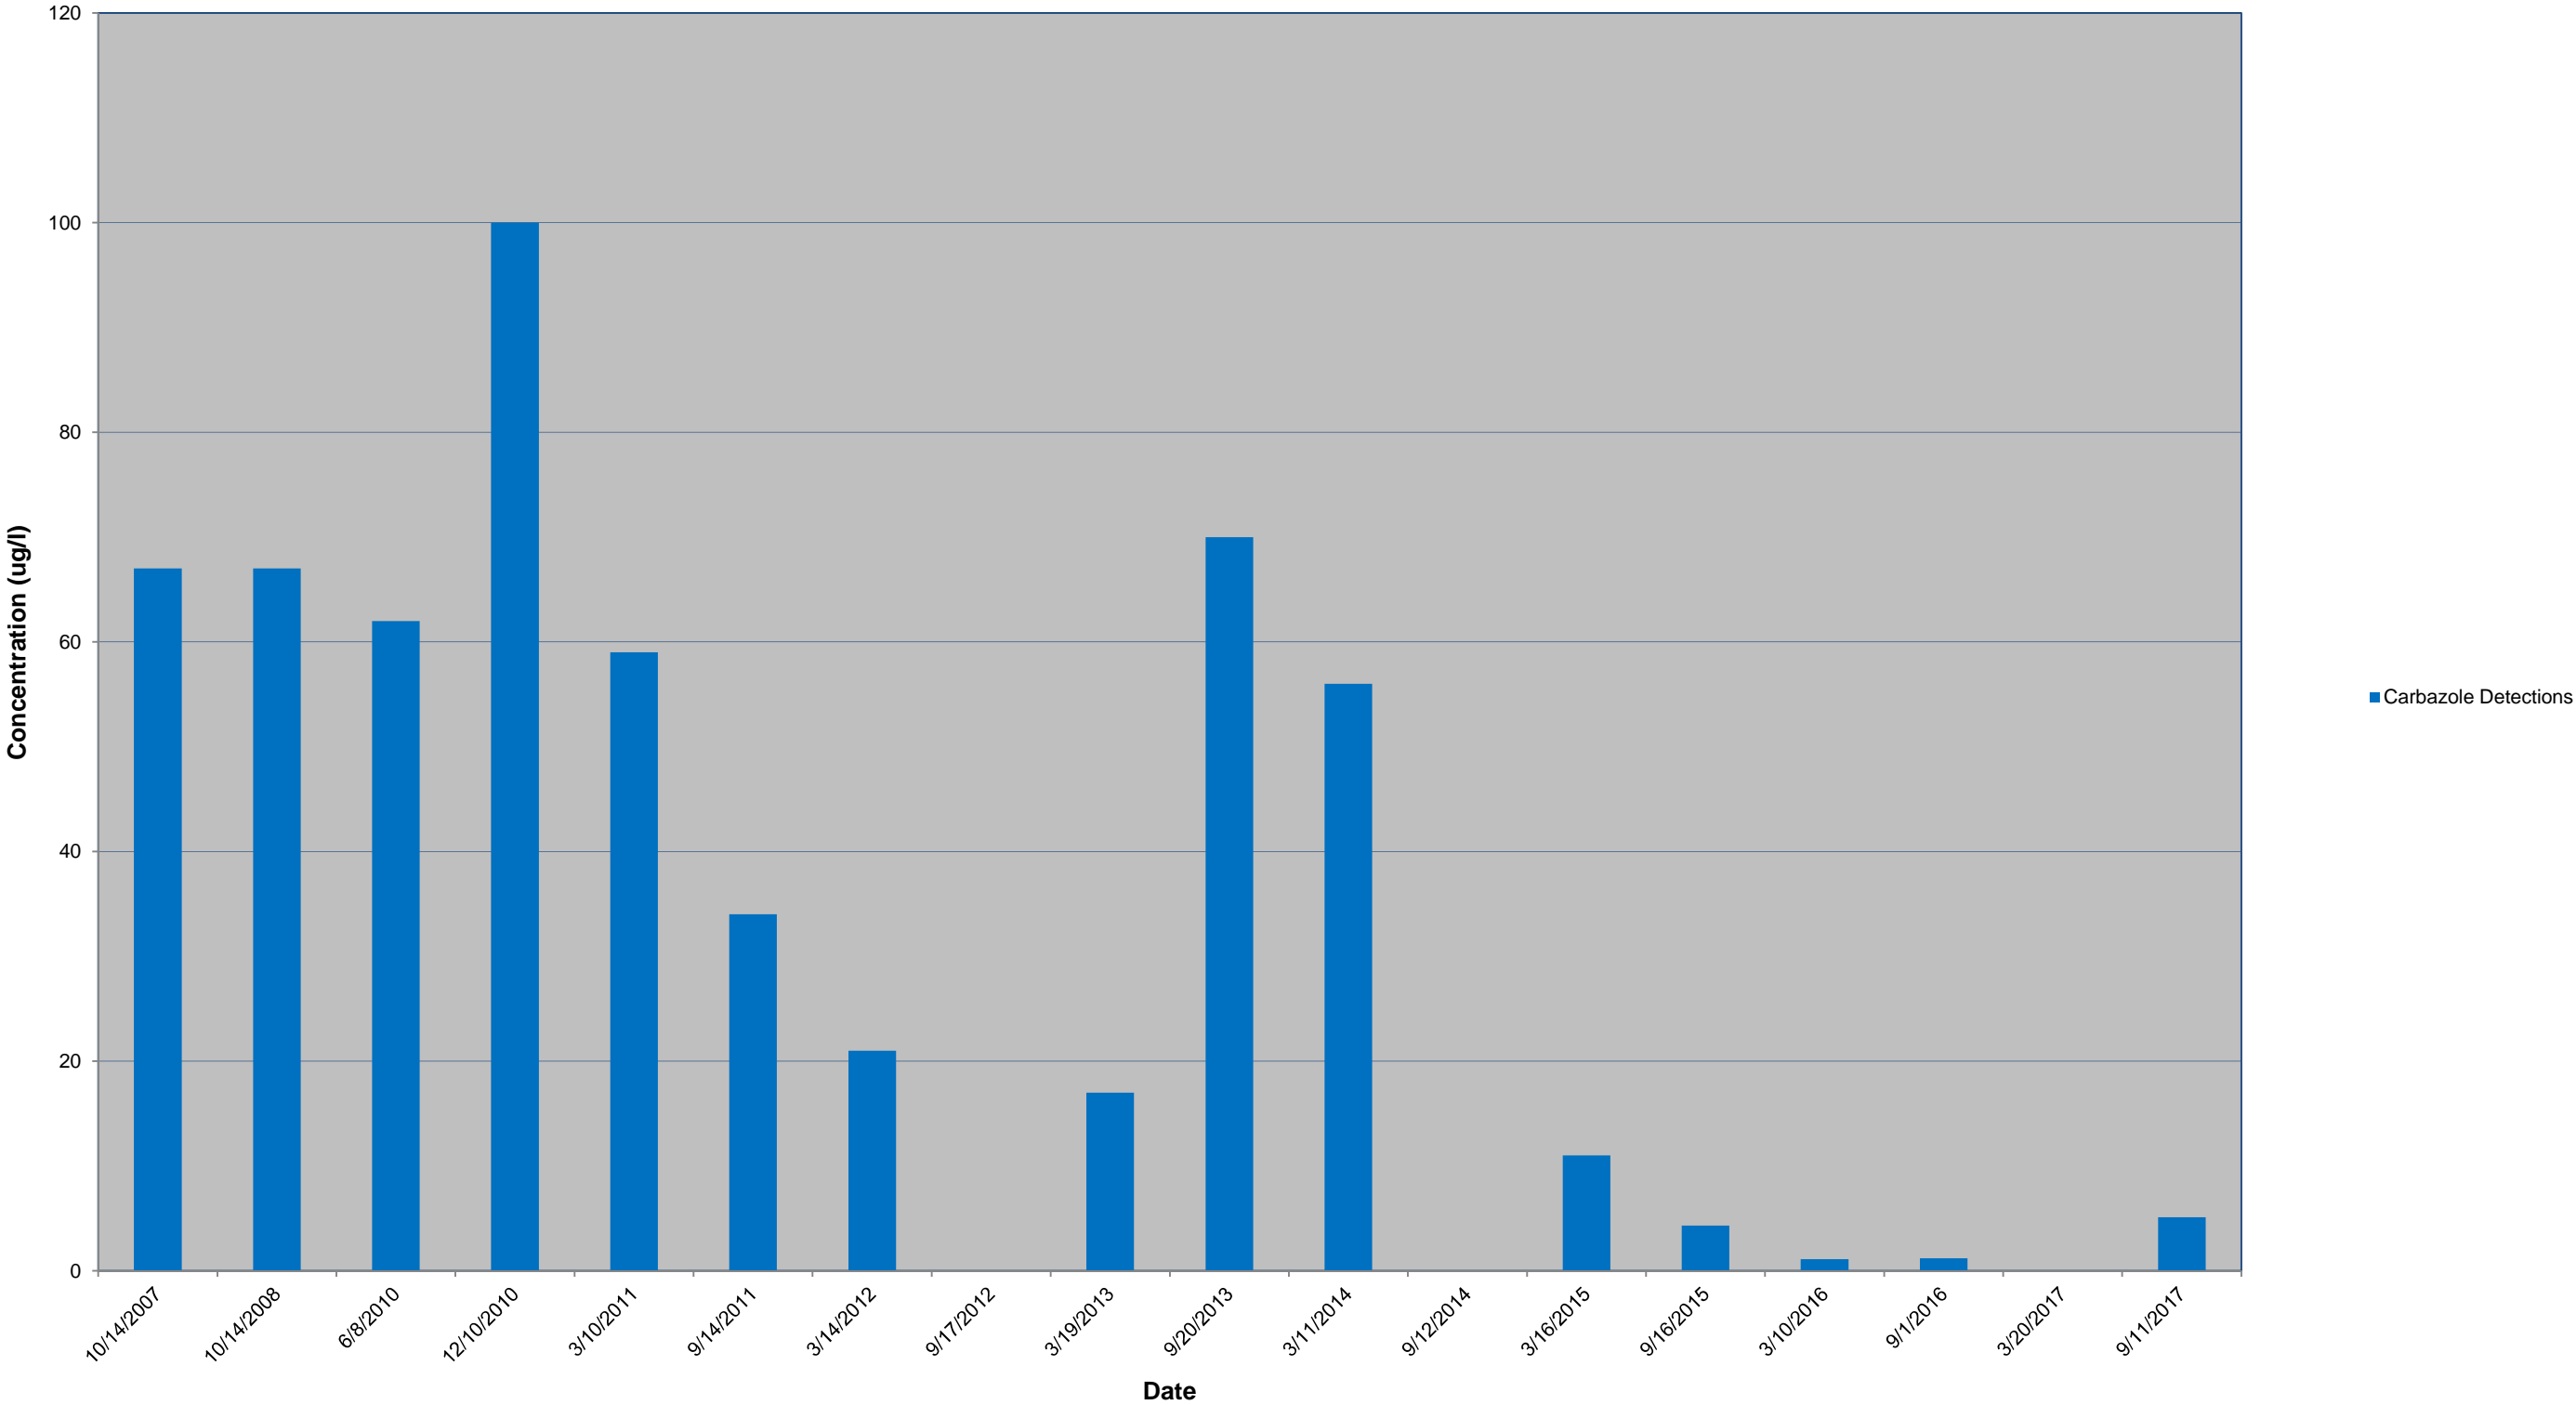
Carbazole Detections in CAMU Unit 2 Leak Detection Samples  
2007 - 2017

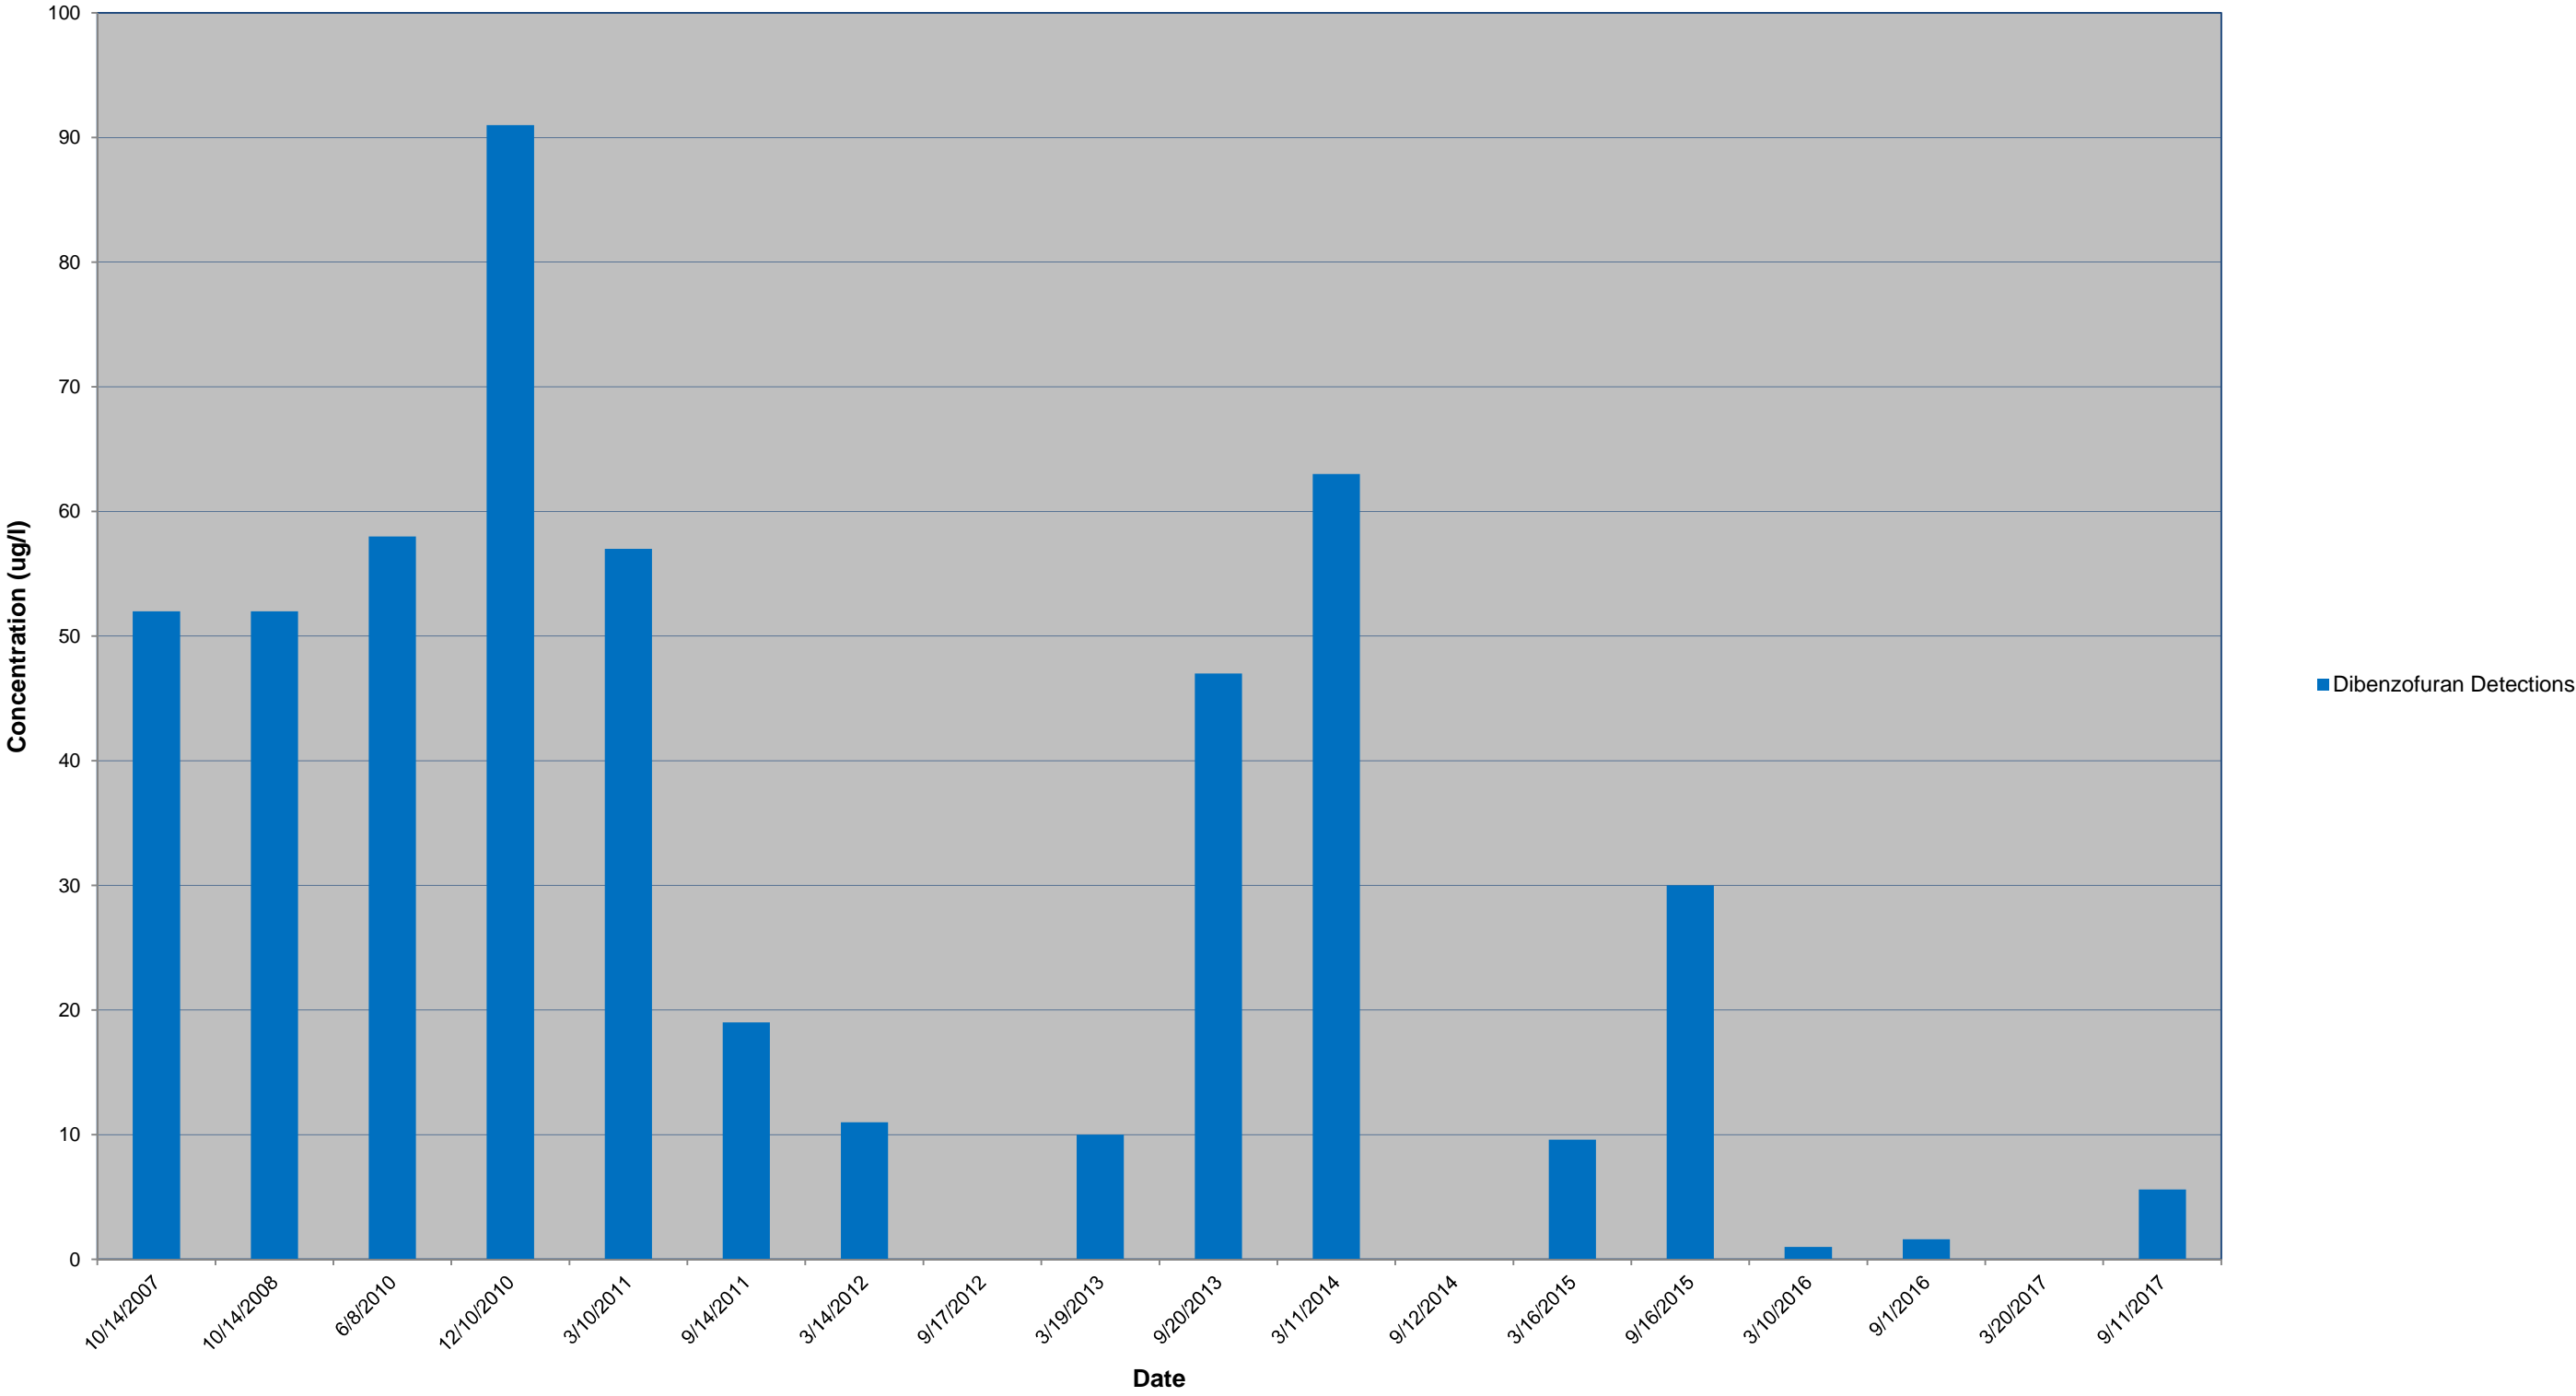
Dibenzofuran Detections in CAMU Unit 2 Leak Detection Samples  
2007 - 2017

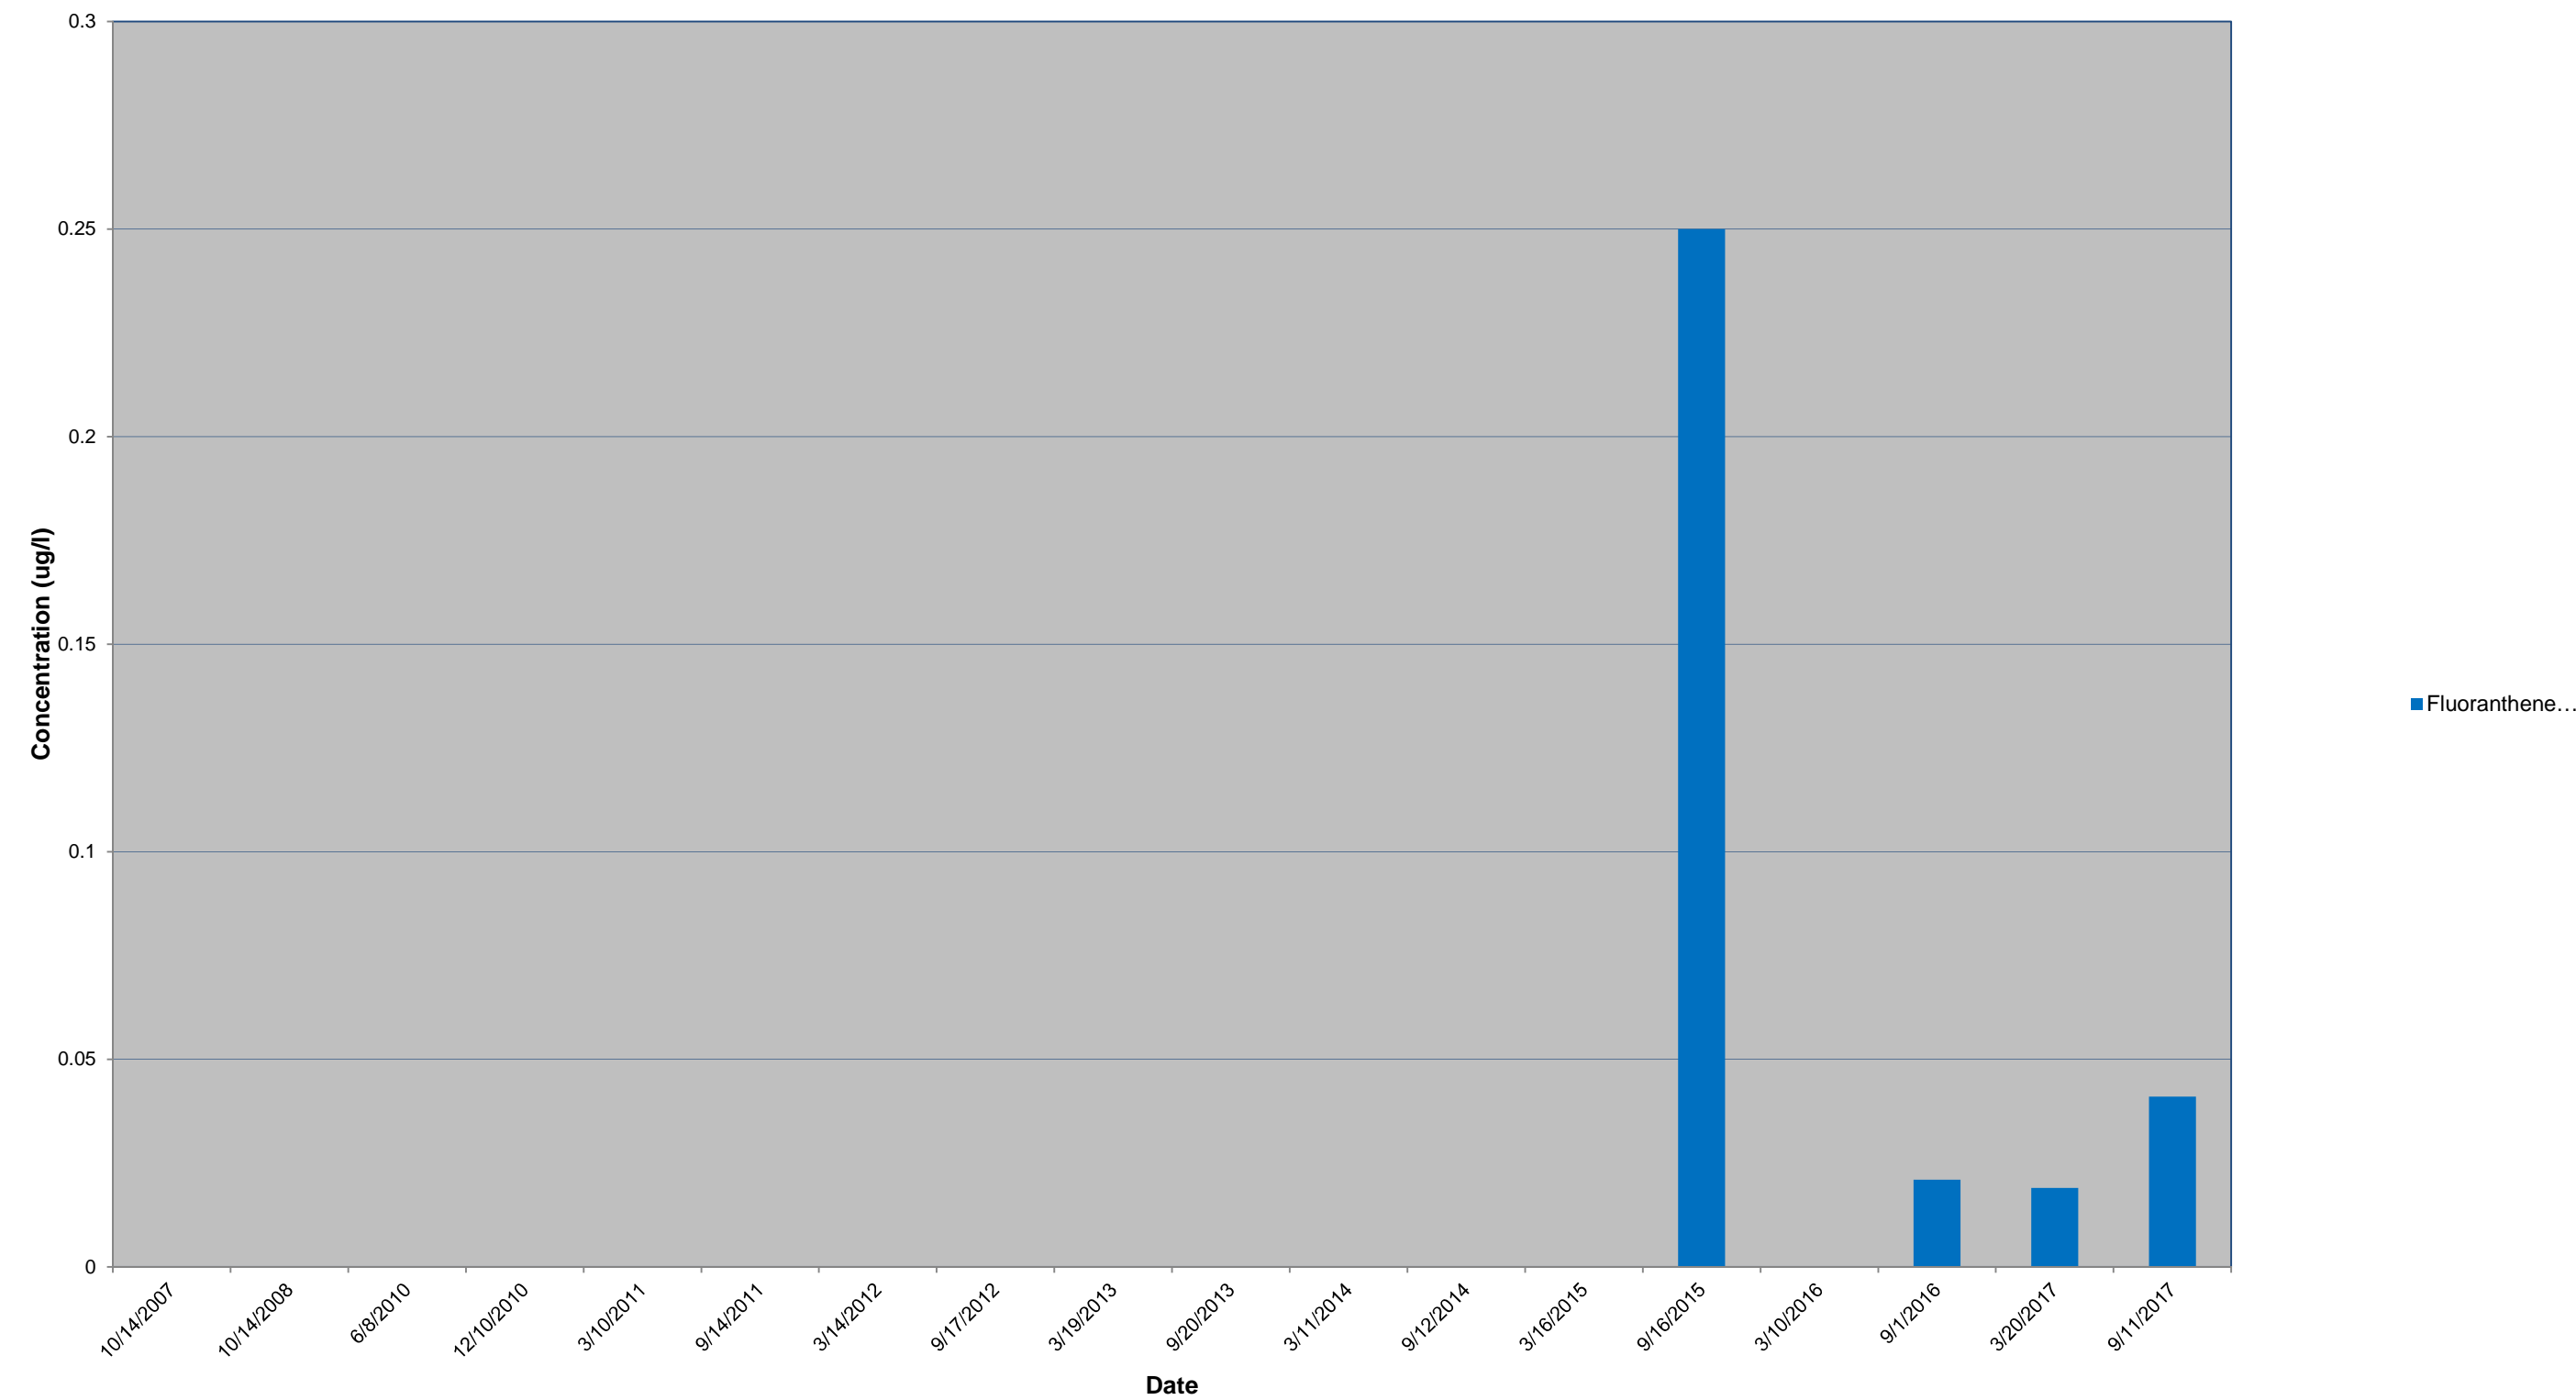
Fluoranthene Detections in CAMU Unit 2 Leak Detection Samples  
2007 - 2017

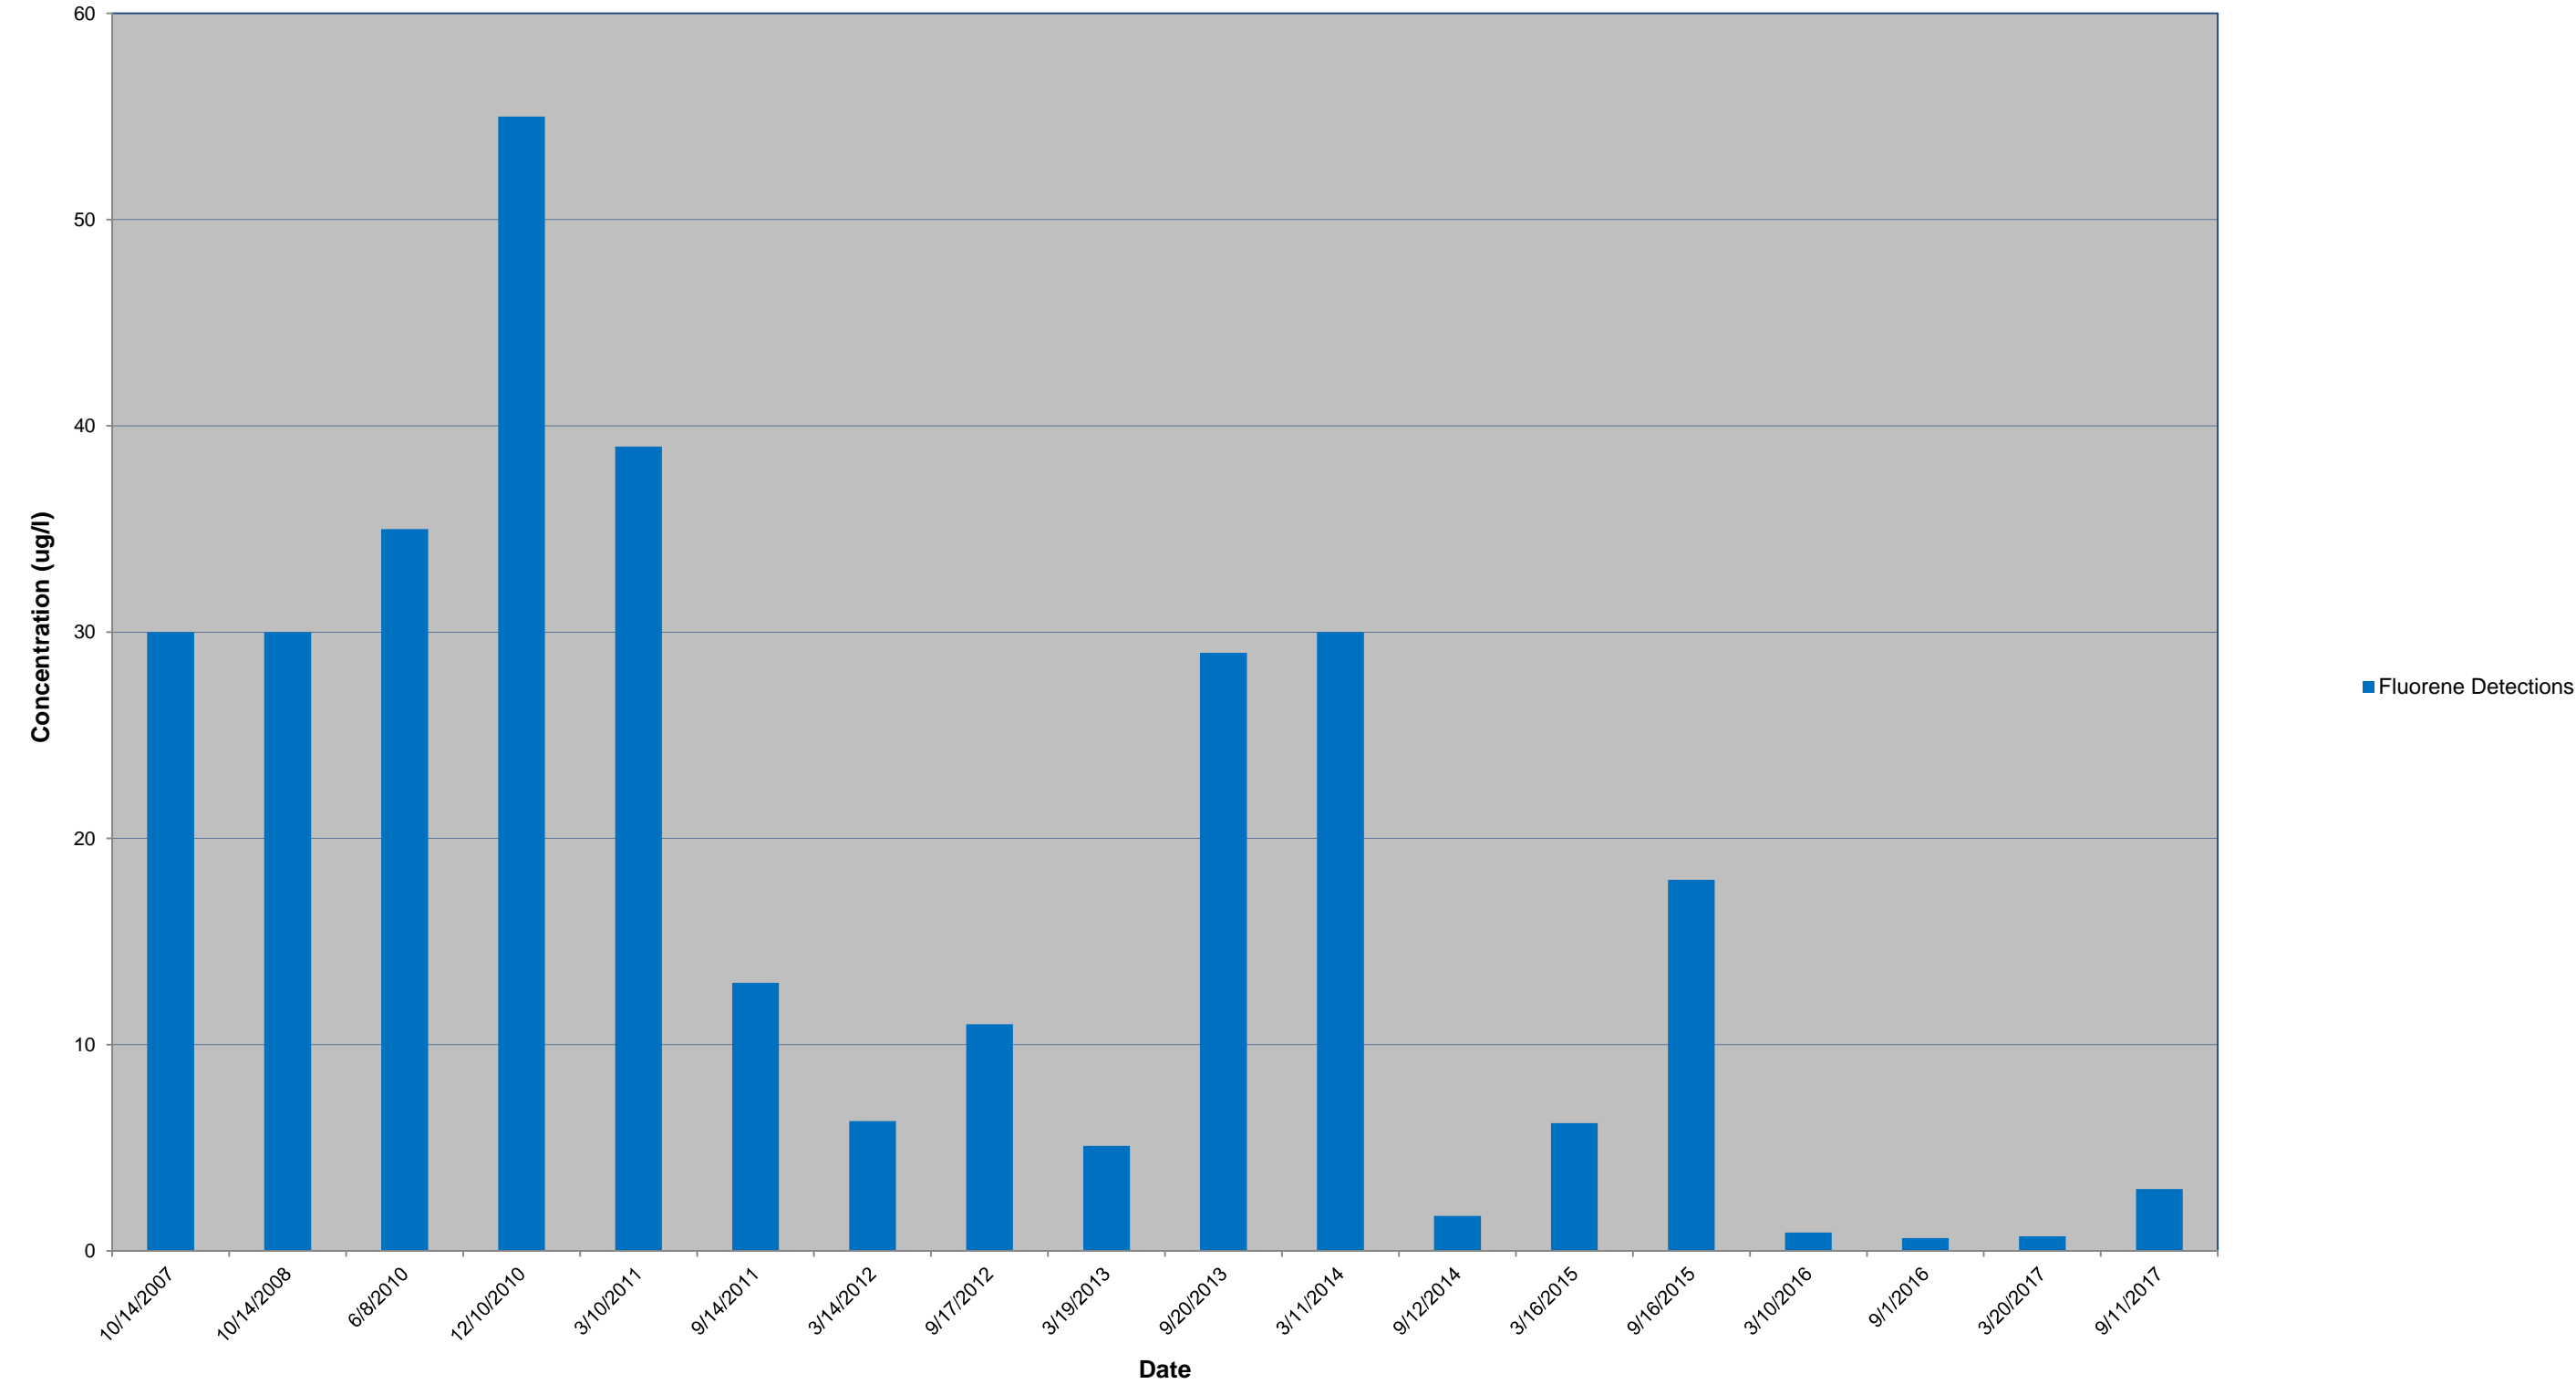
Fluorene Detections in CAMU Unit 2 Leak Detection Samples  
2007 - 2017

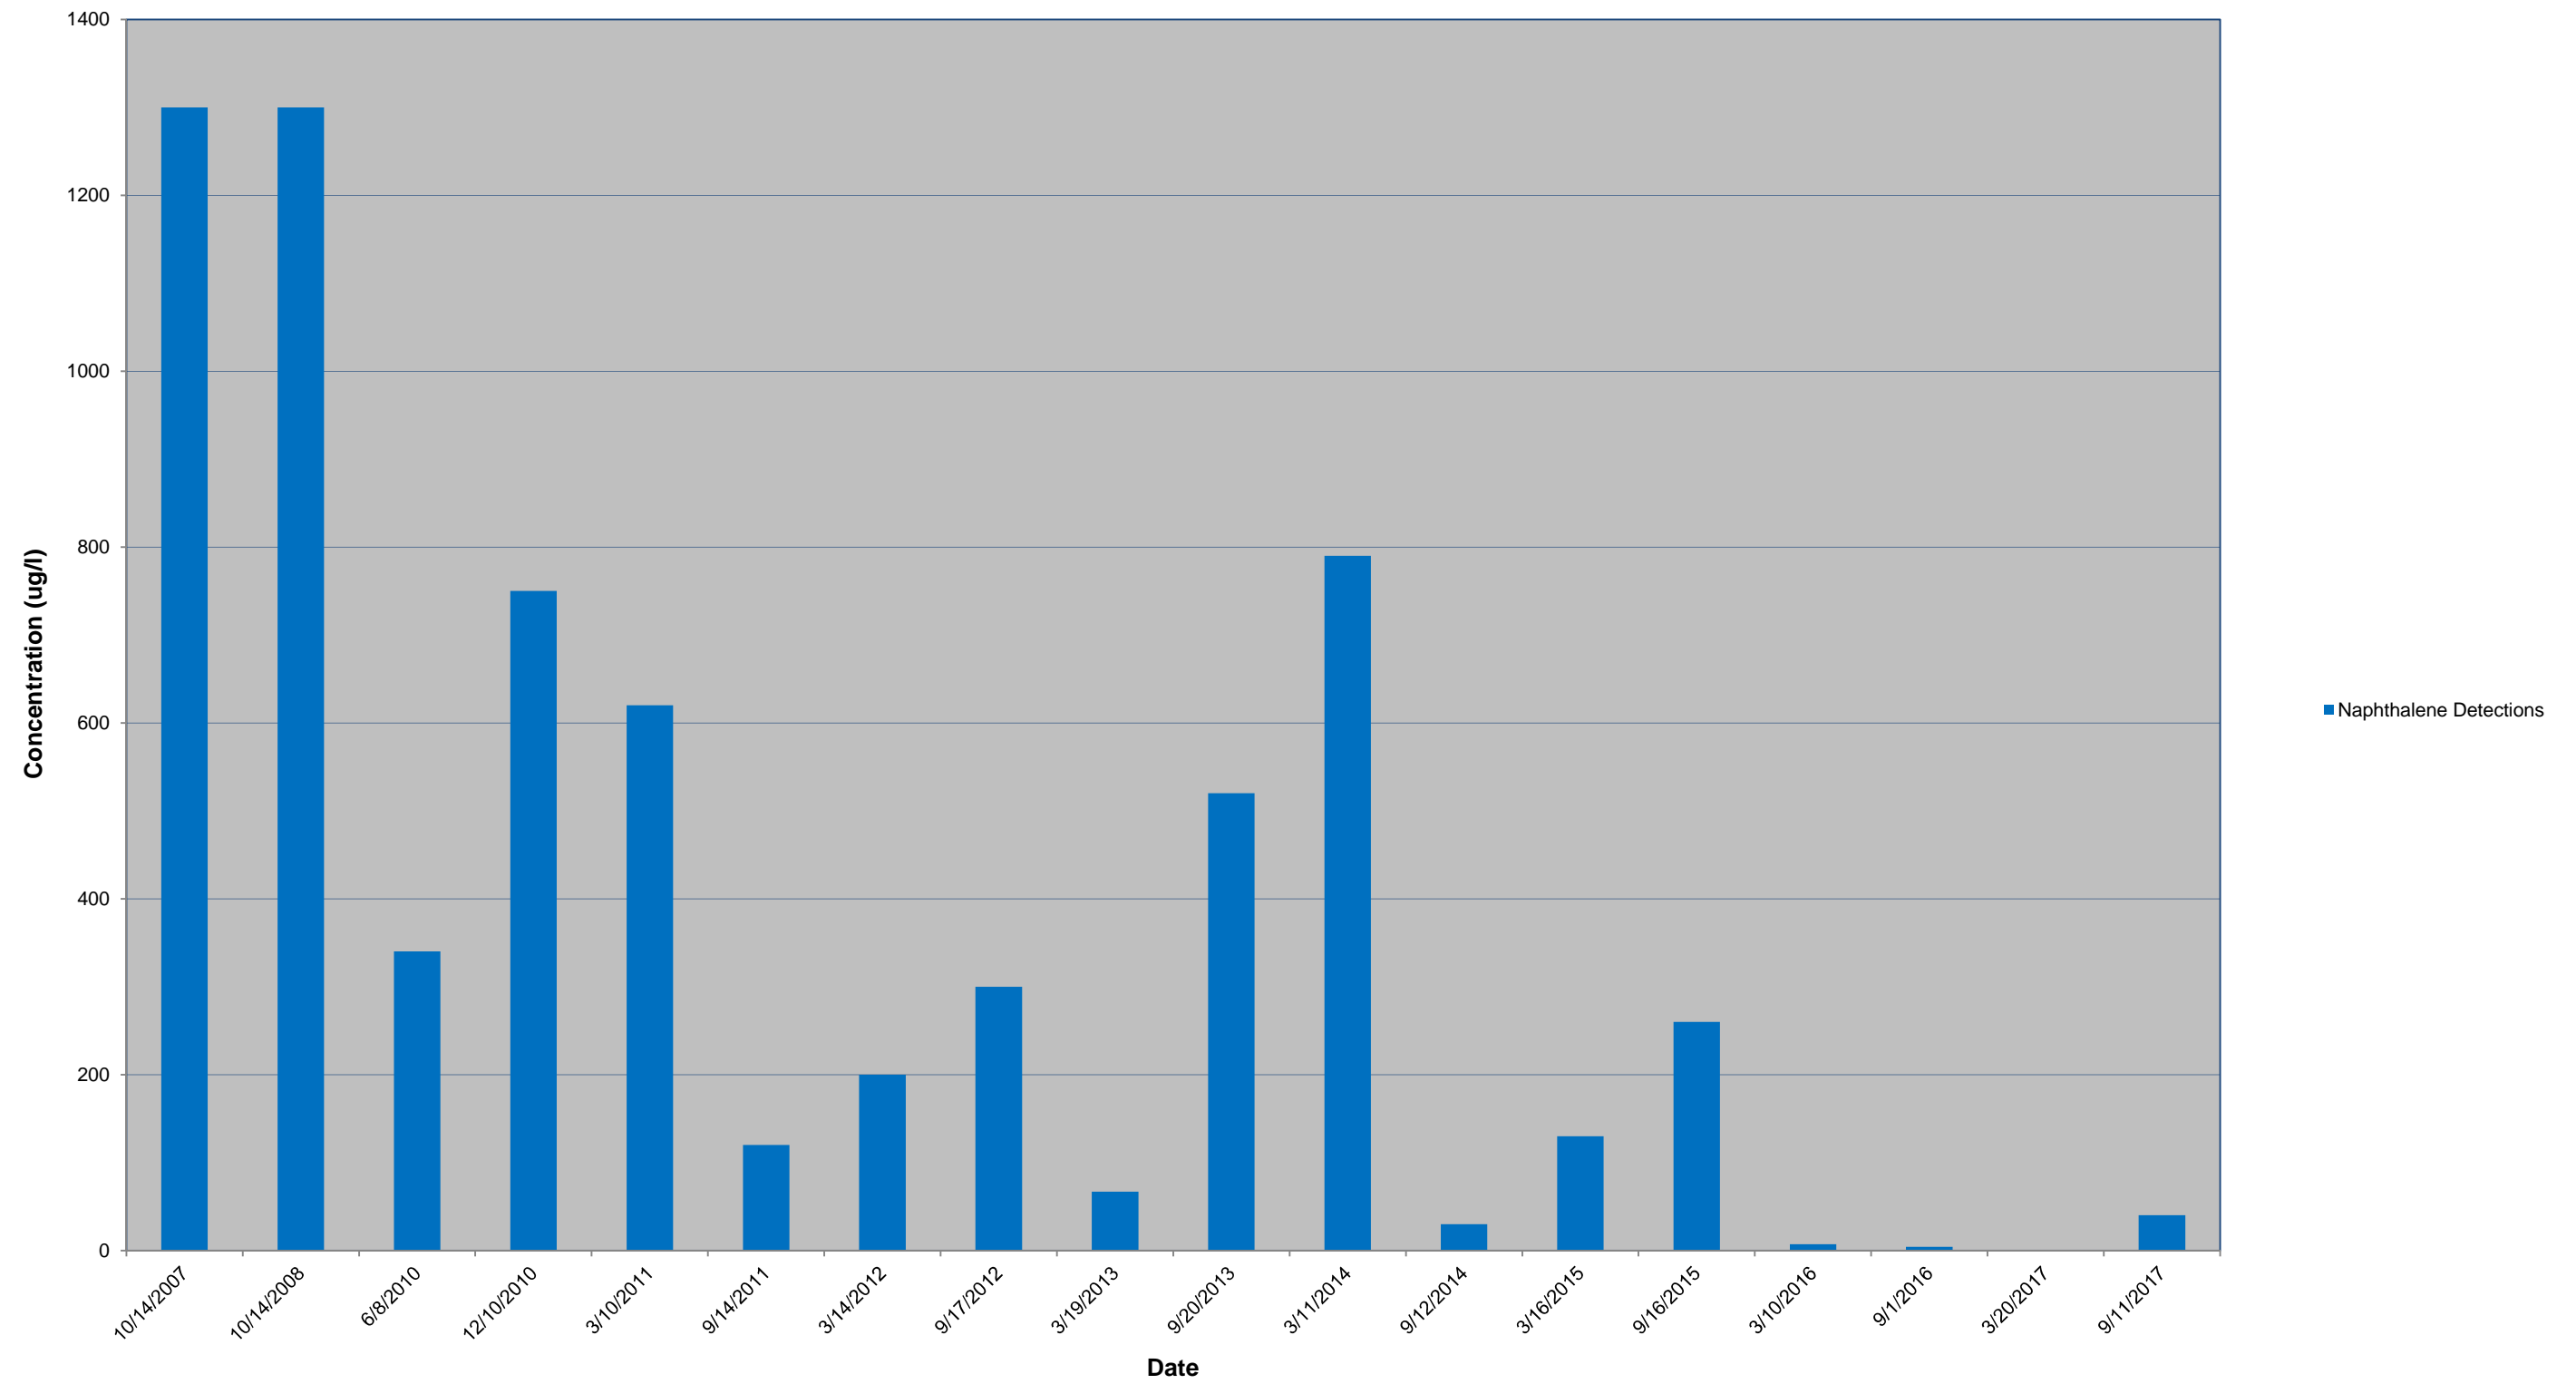
Naphthalene Detections in CAMU Unit 2 Leak Detection Samples  
2008 - 2017

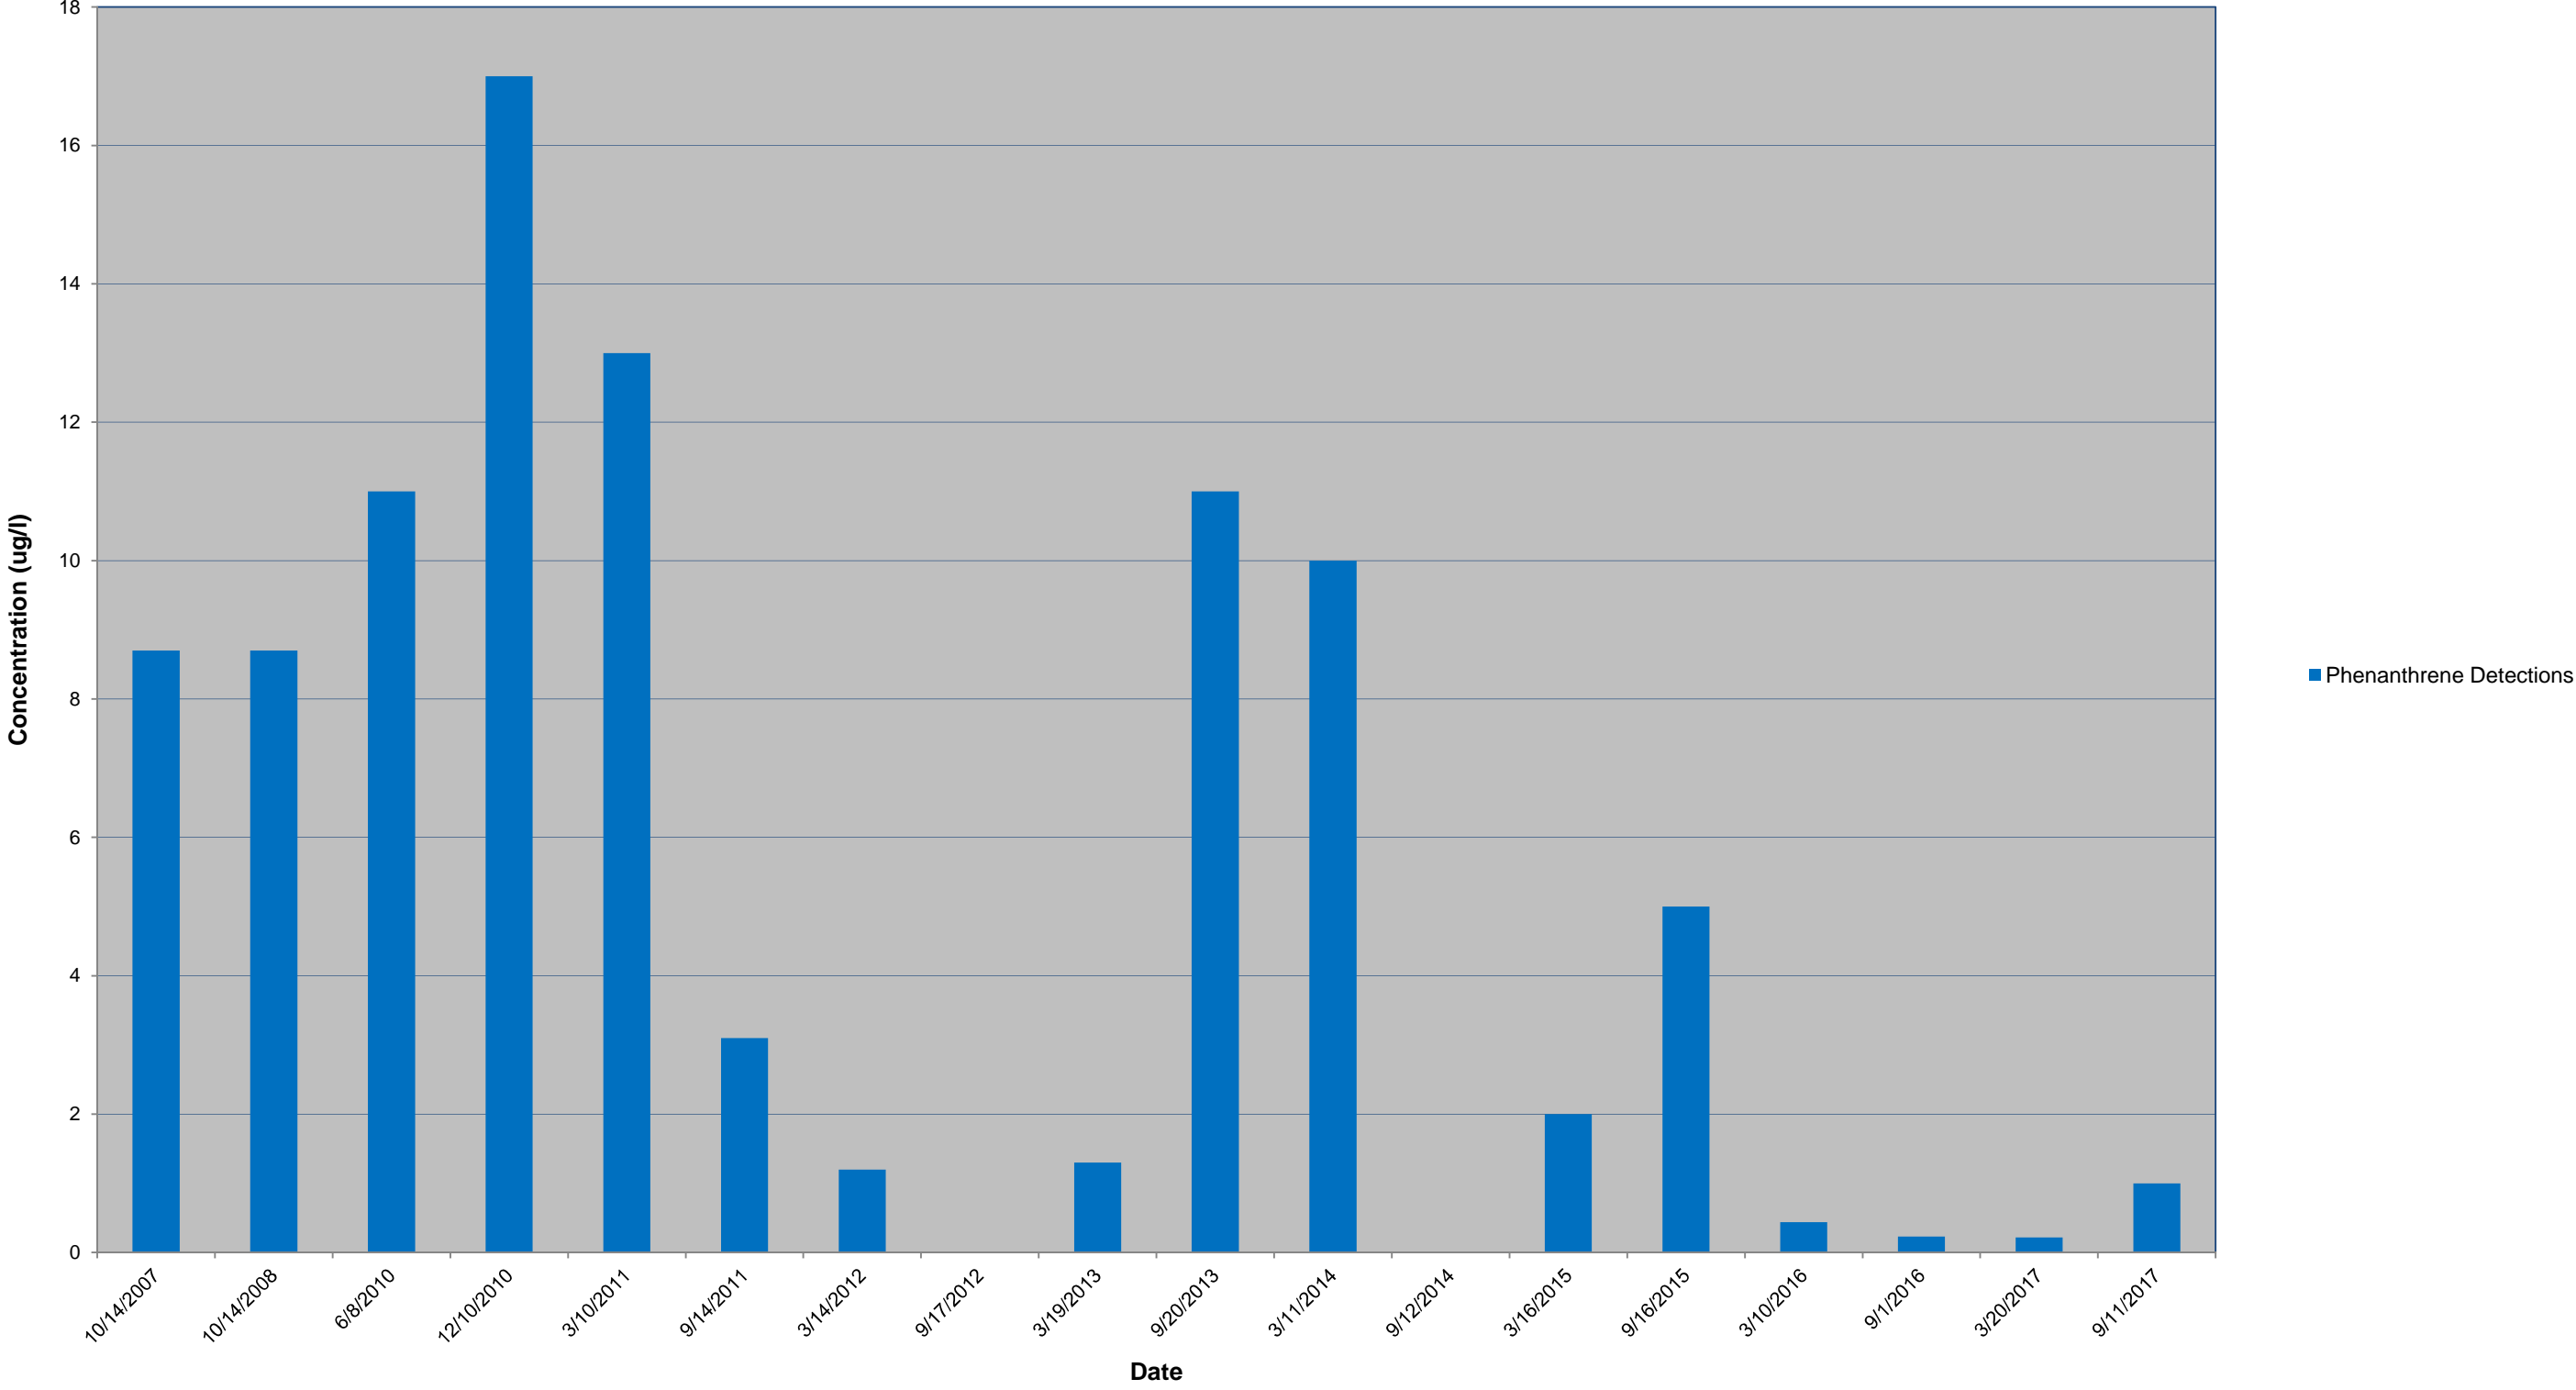
Phenanthrene Detections in CAMU Unit 2 Leak Detection Samples  
2007 - 2017
