2-Methylnaphthalene Detections in CAMU Unit 2 Leak Detection Samples  
2007 - 2017

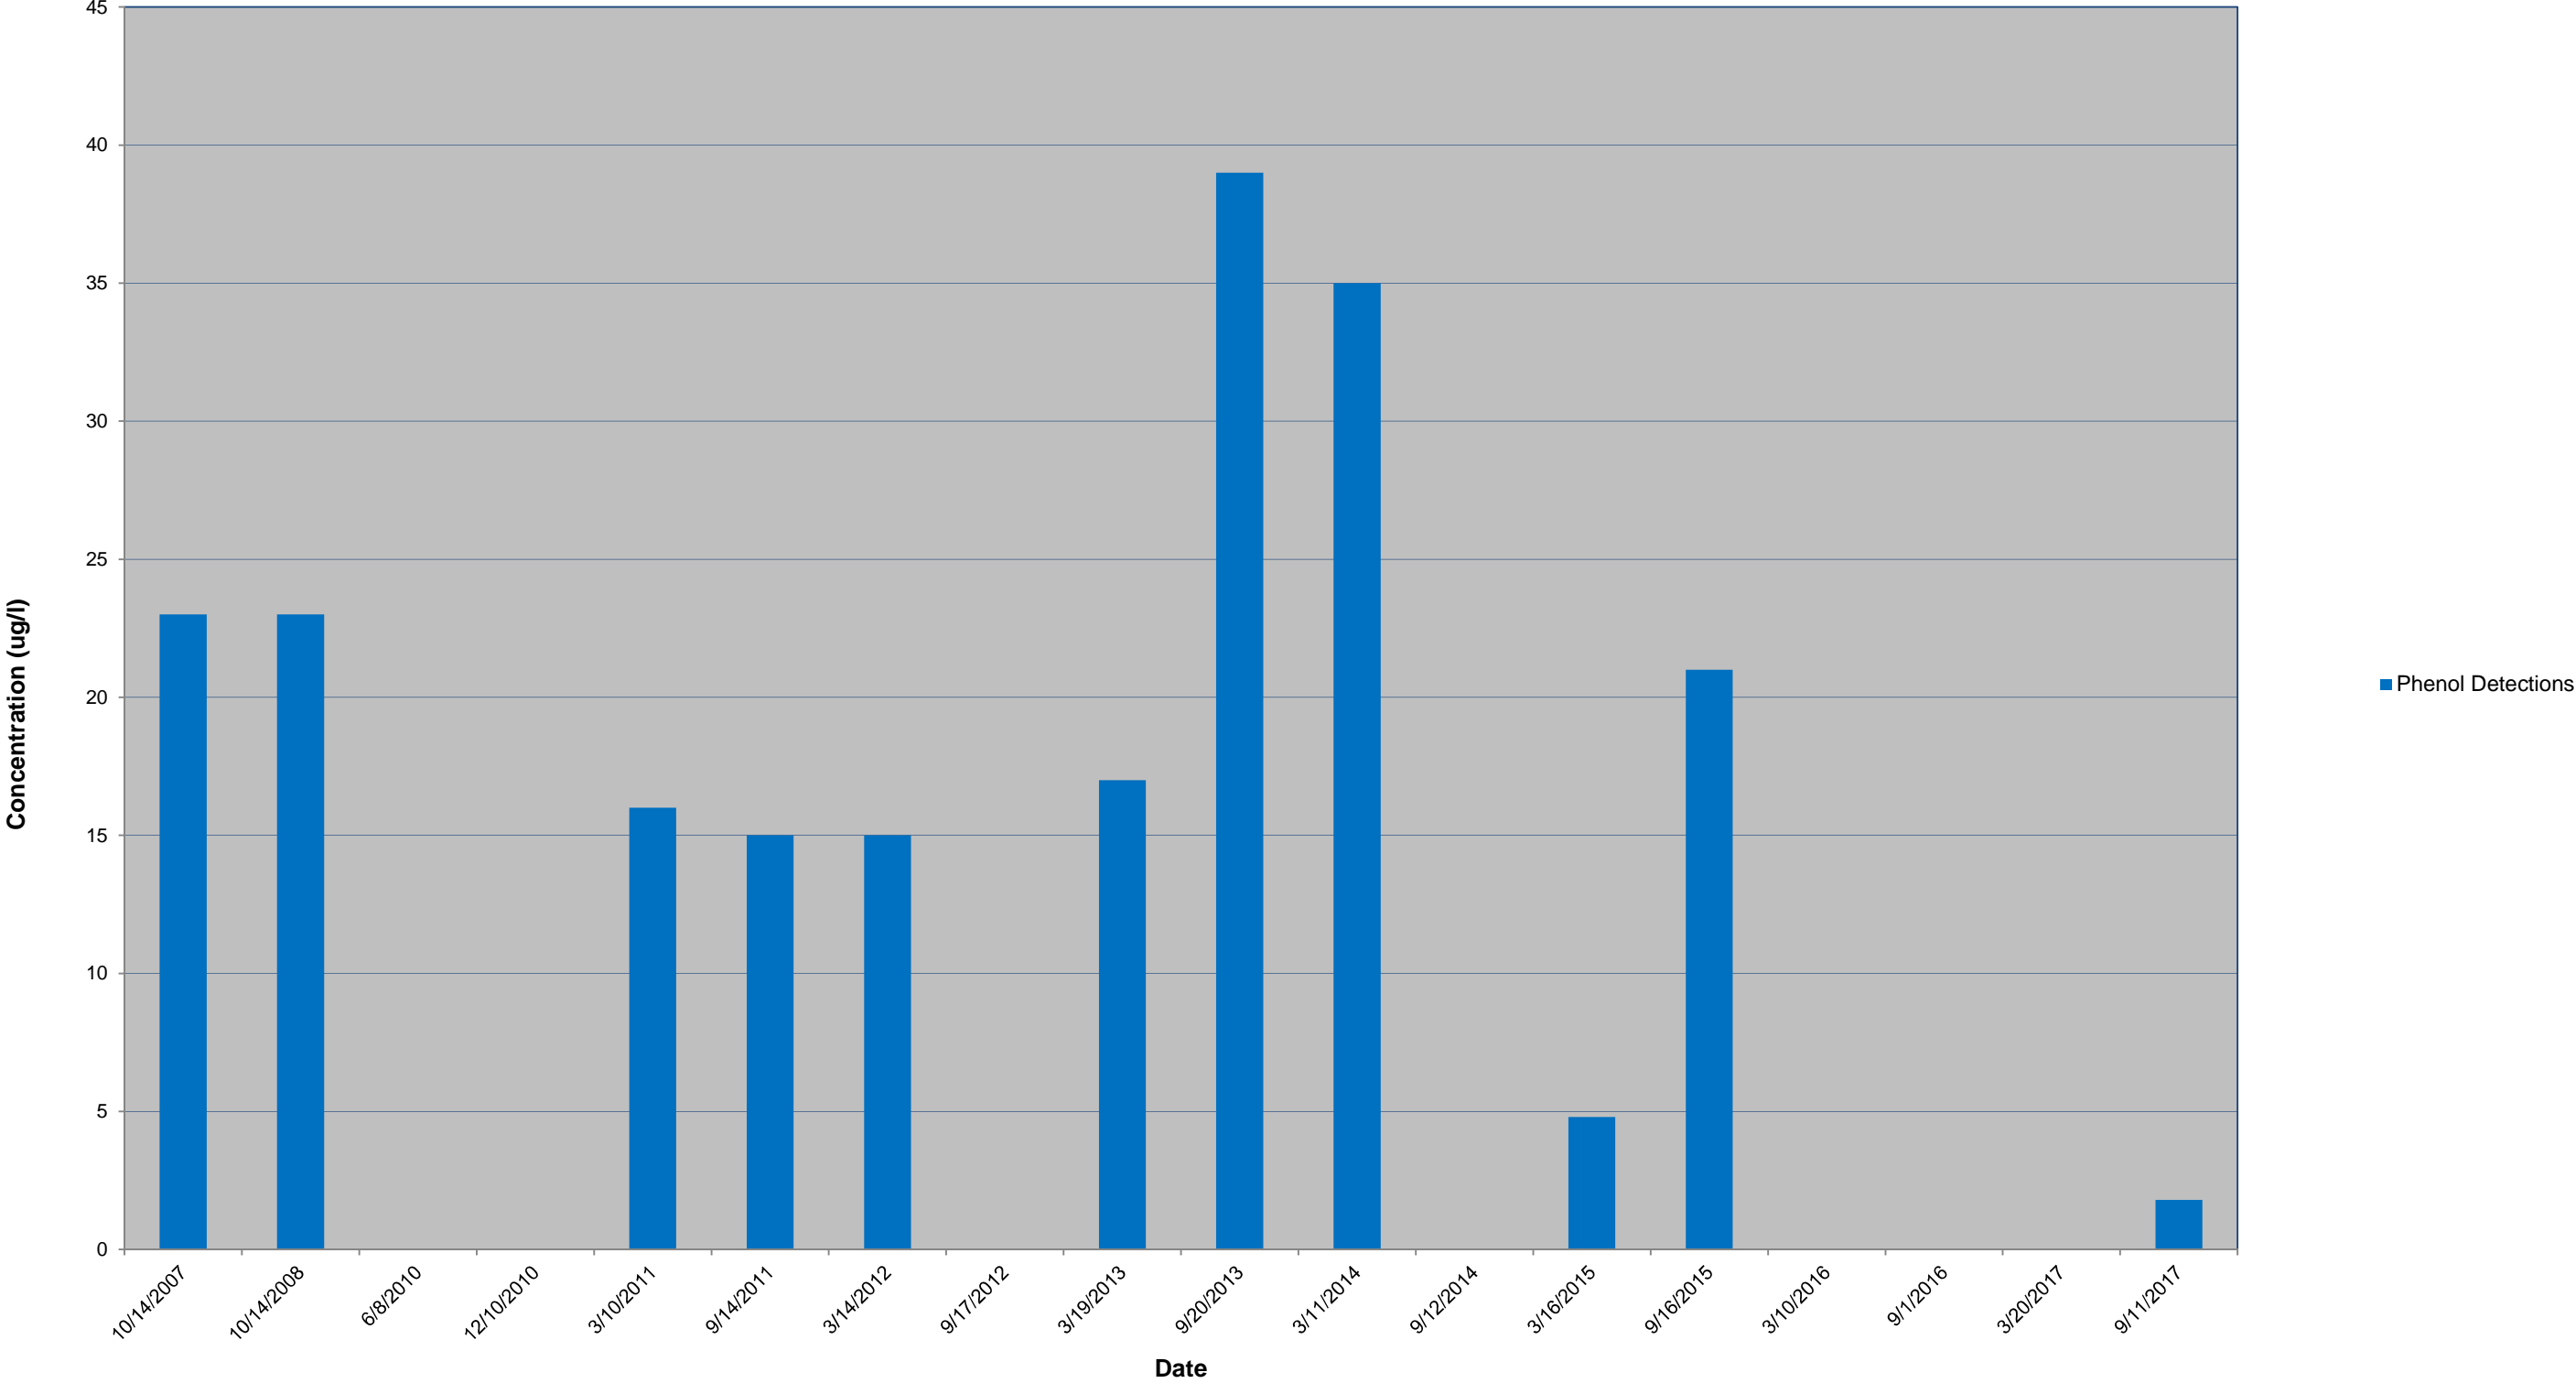
Phenol Detections in CAMU Unit 2 Leak Detection Samples  
2007 - 2017

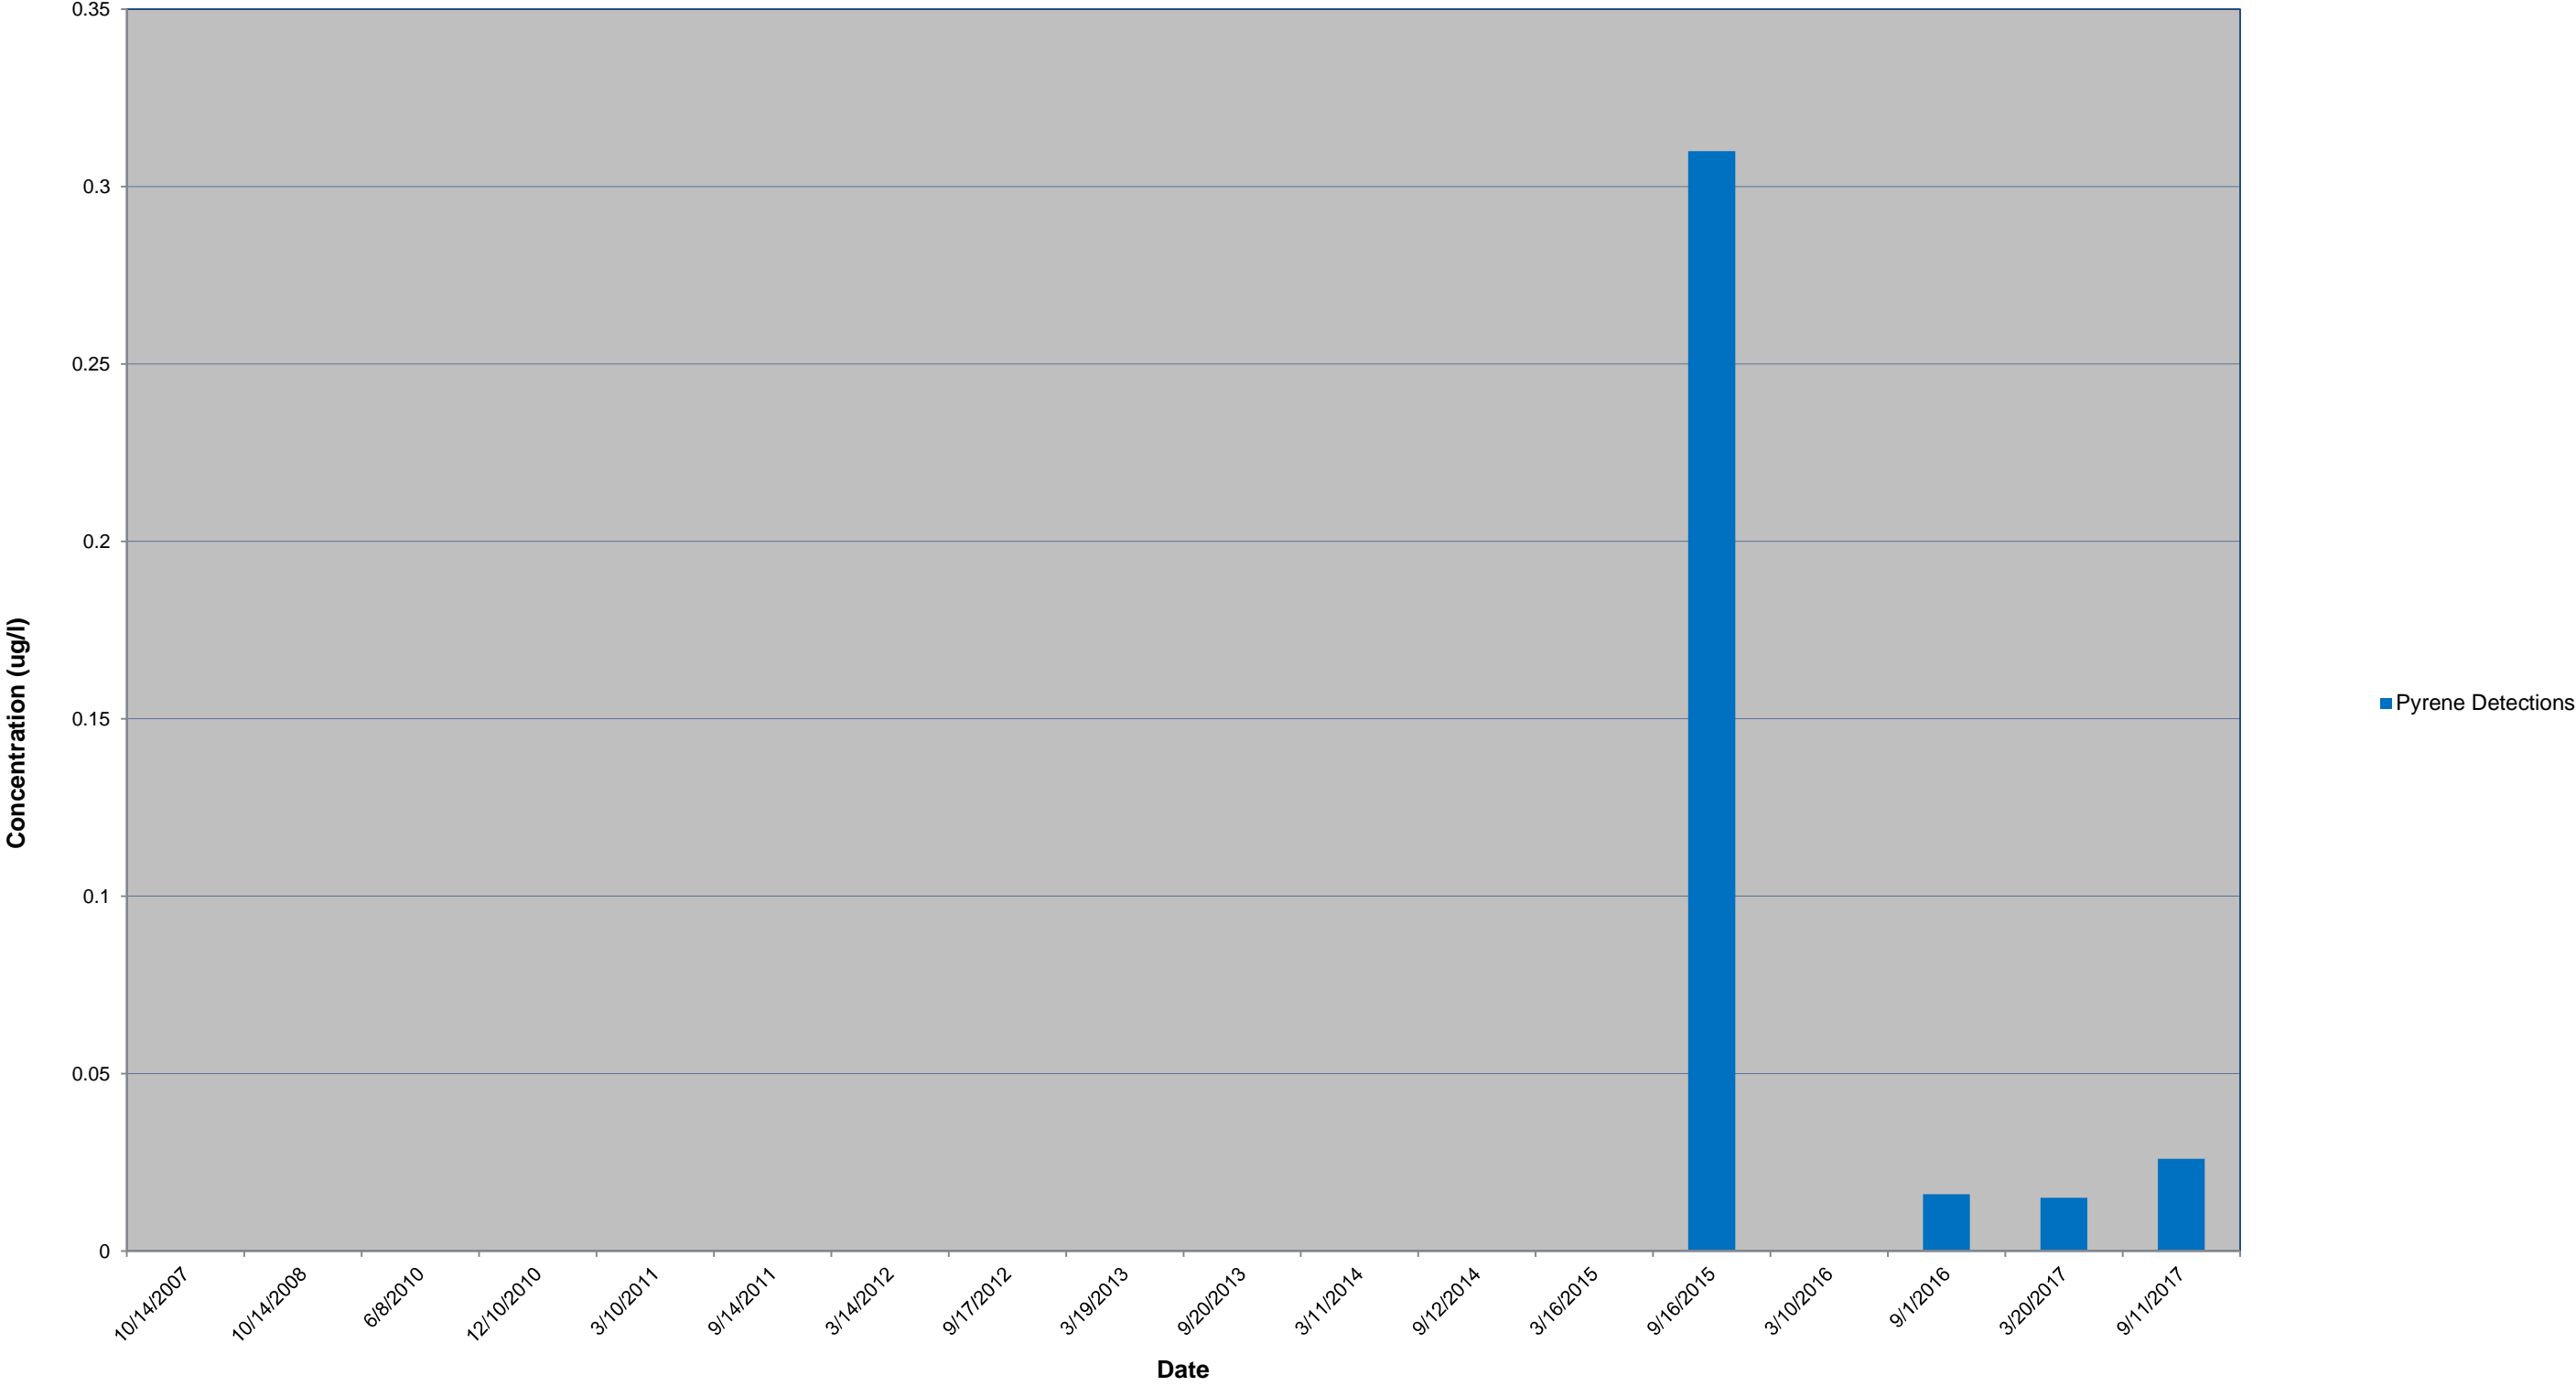
Pyrene Detections in CAMU Unit 2 Leak Detection Samples  
2007 - 2017
