Acetone Detections in CAMU Unit 1 Leachate Samples
2009 - 2017*

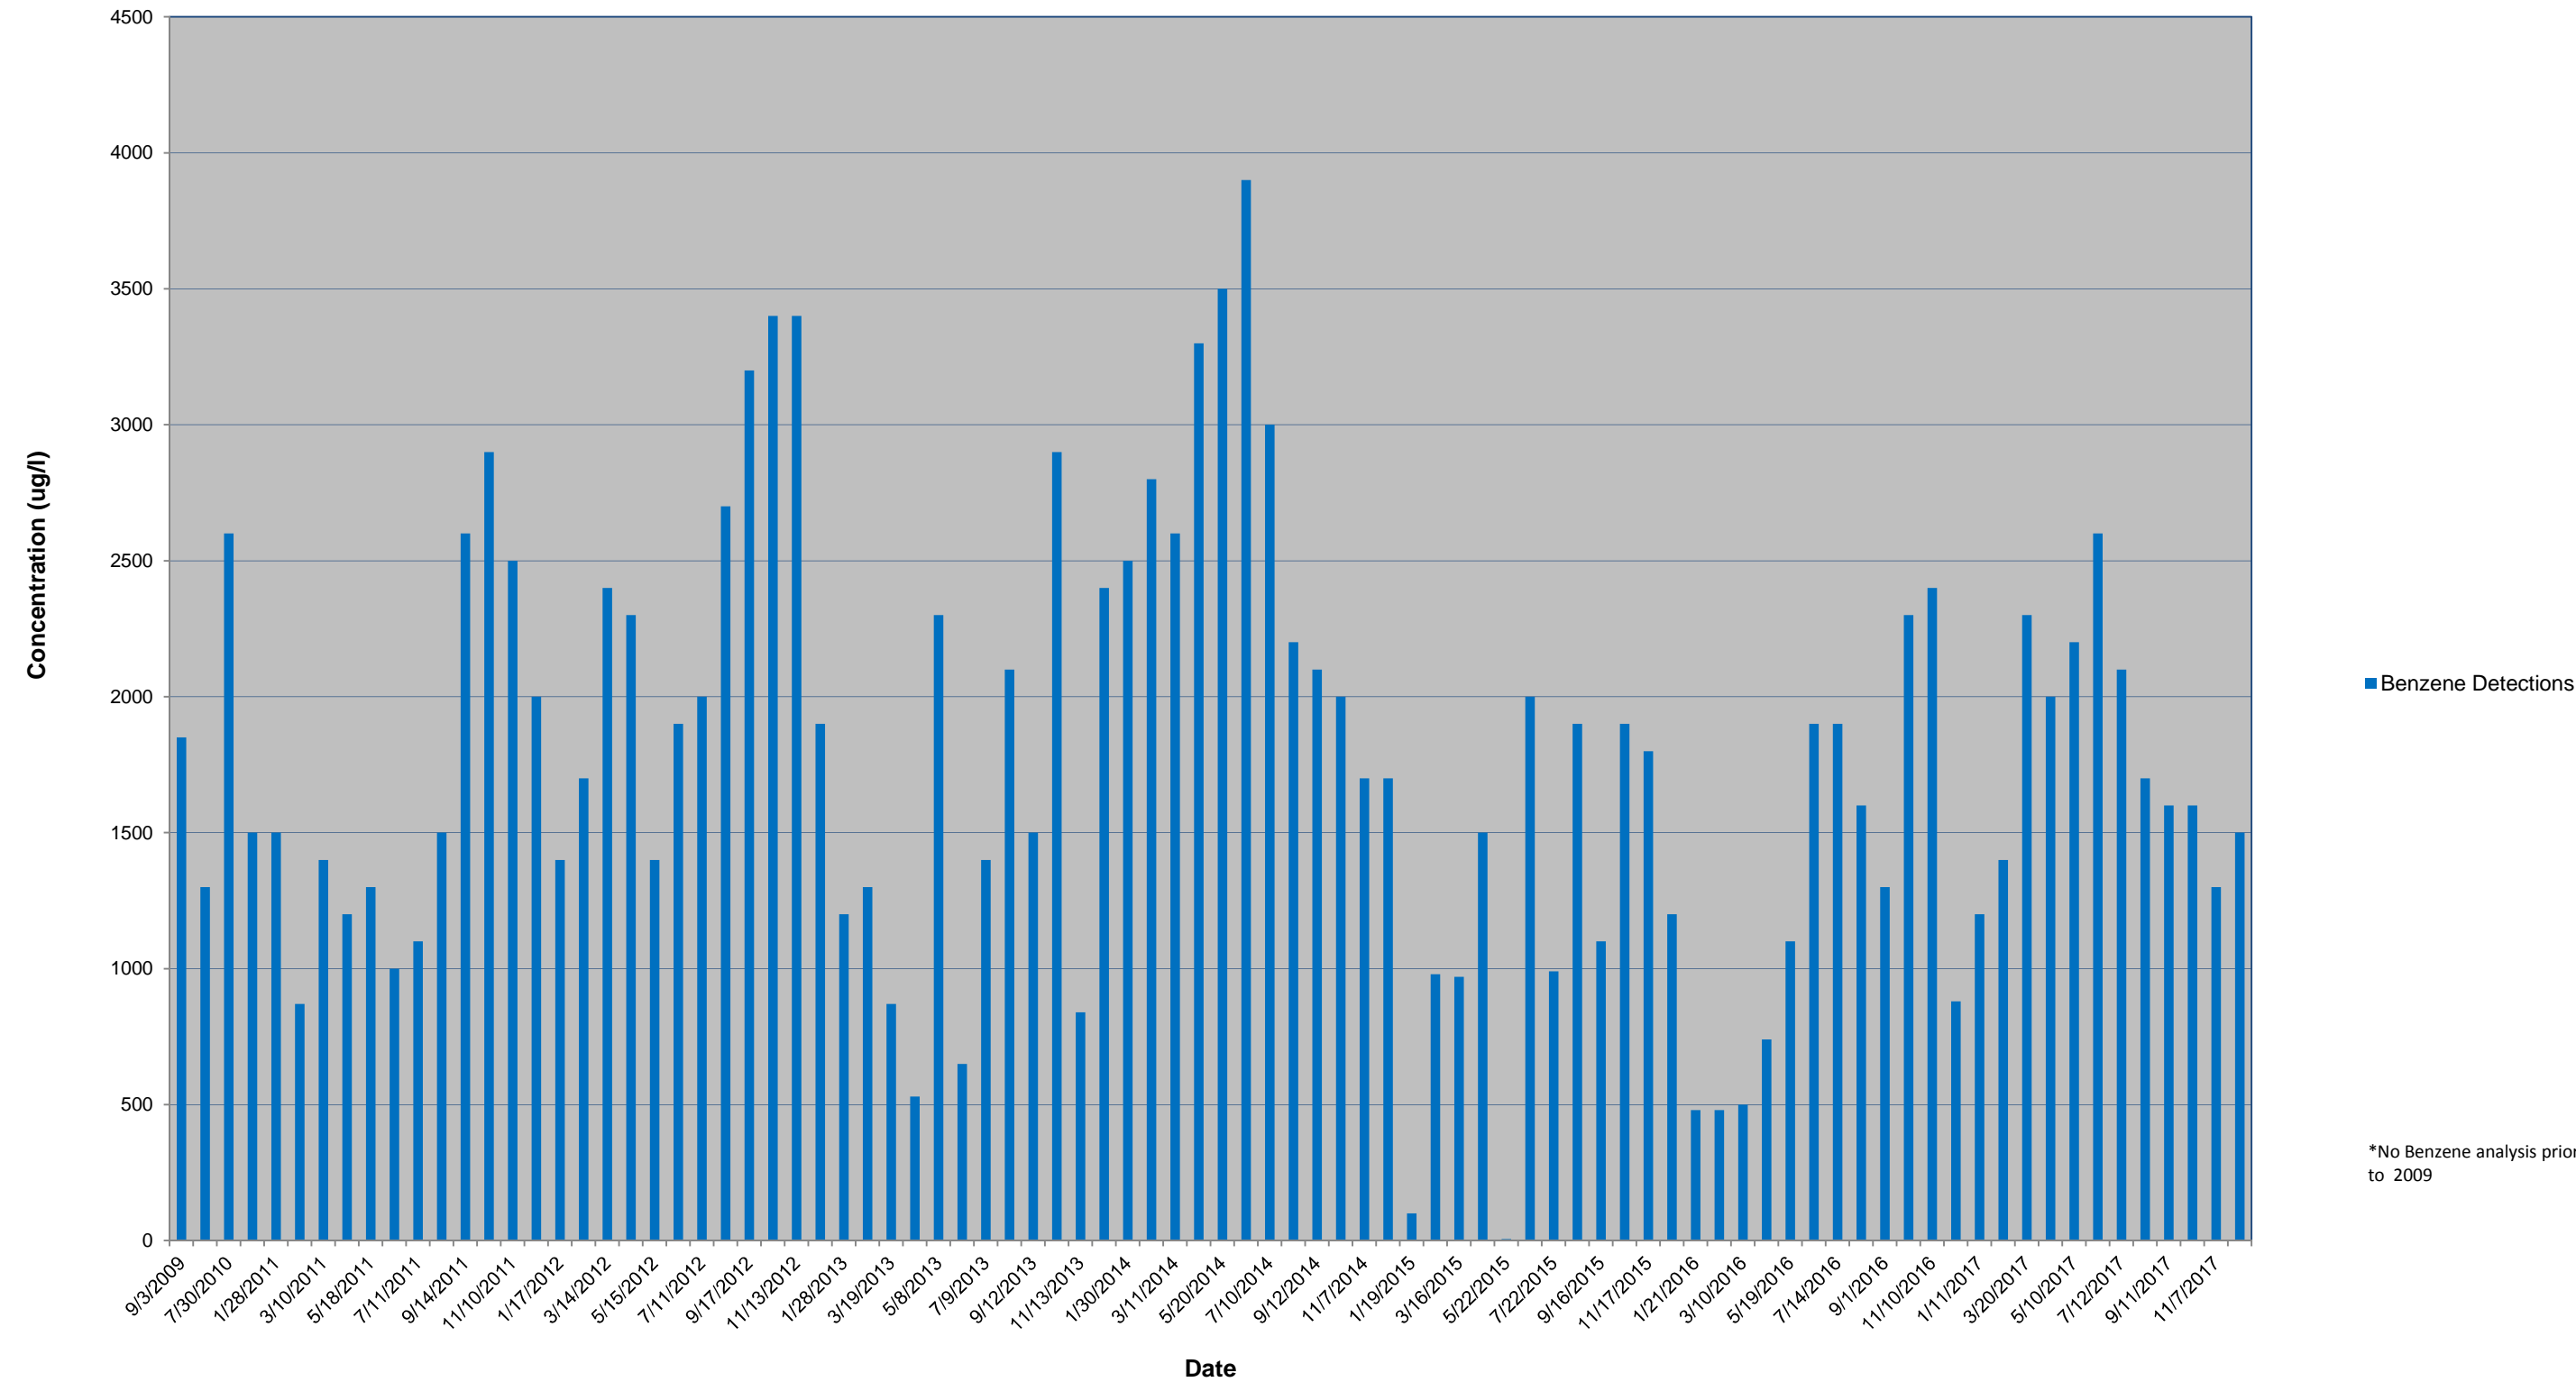
Benzene Detections in CAMU Unit 1 Leachate Samples
2009 - 2017*

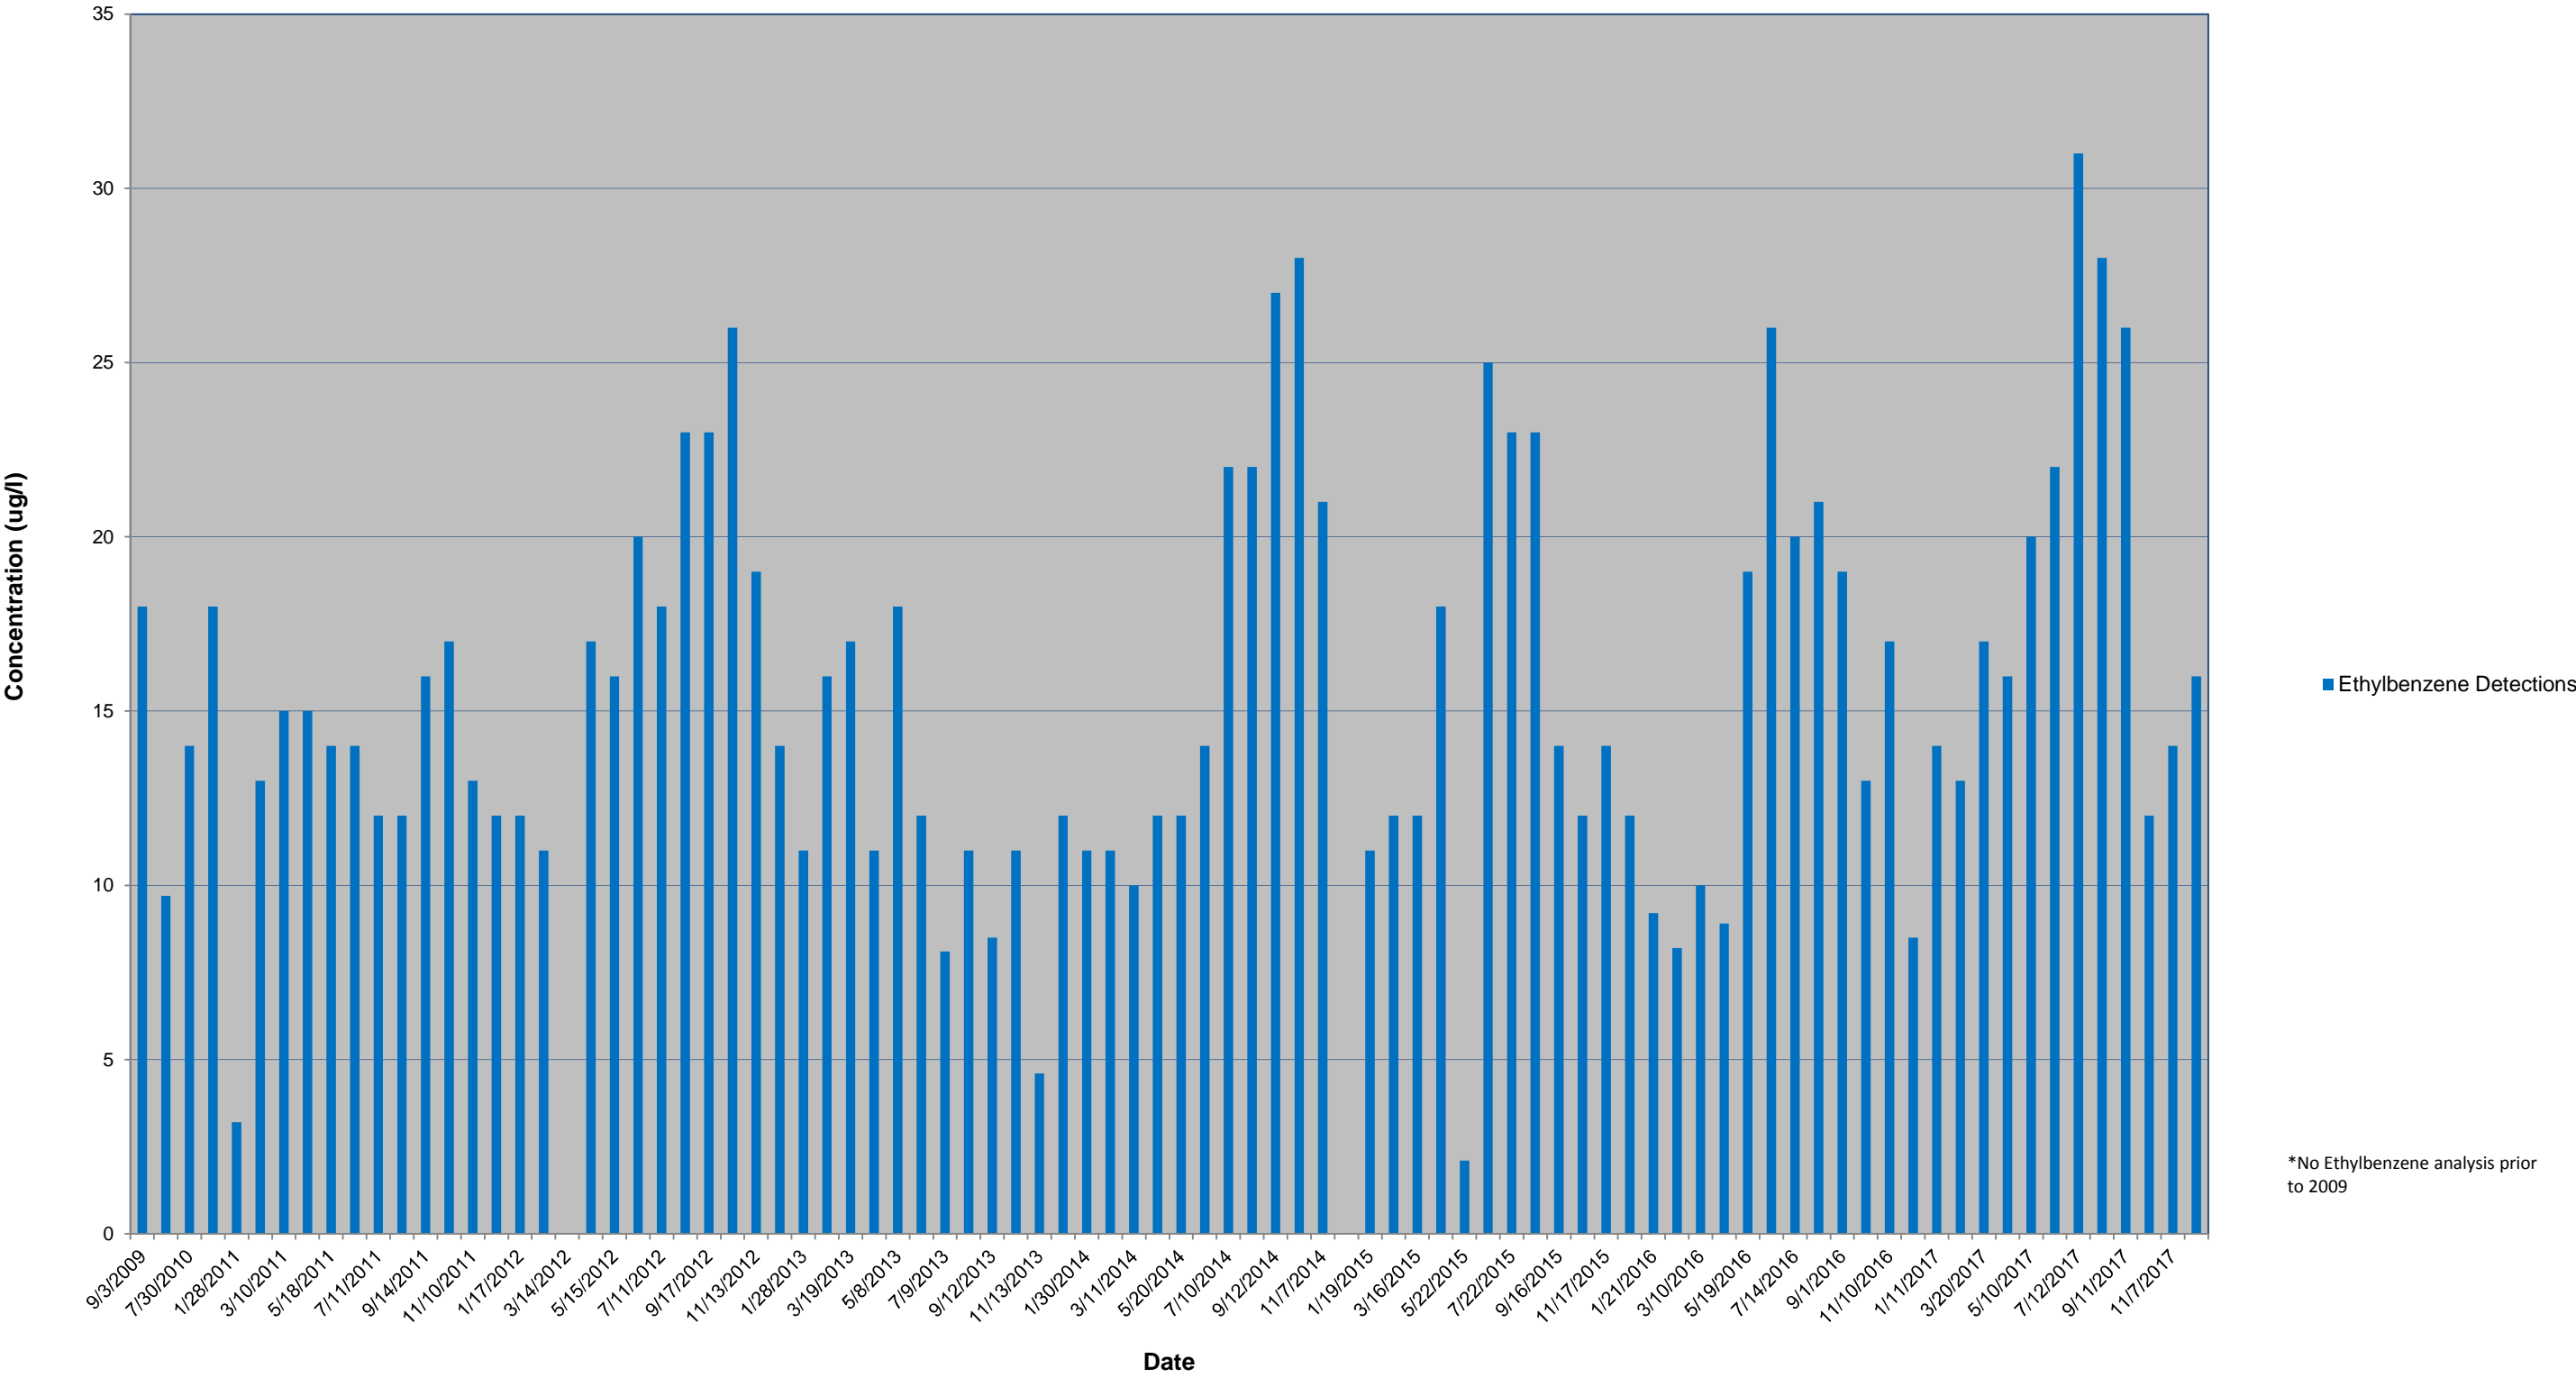
Ethylbenzene Detections in CAMU Unit 1 Leachate Samples
2009 - 2017*

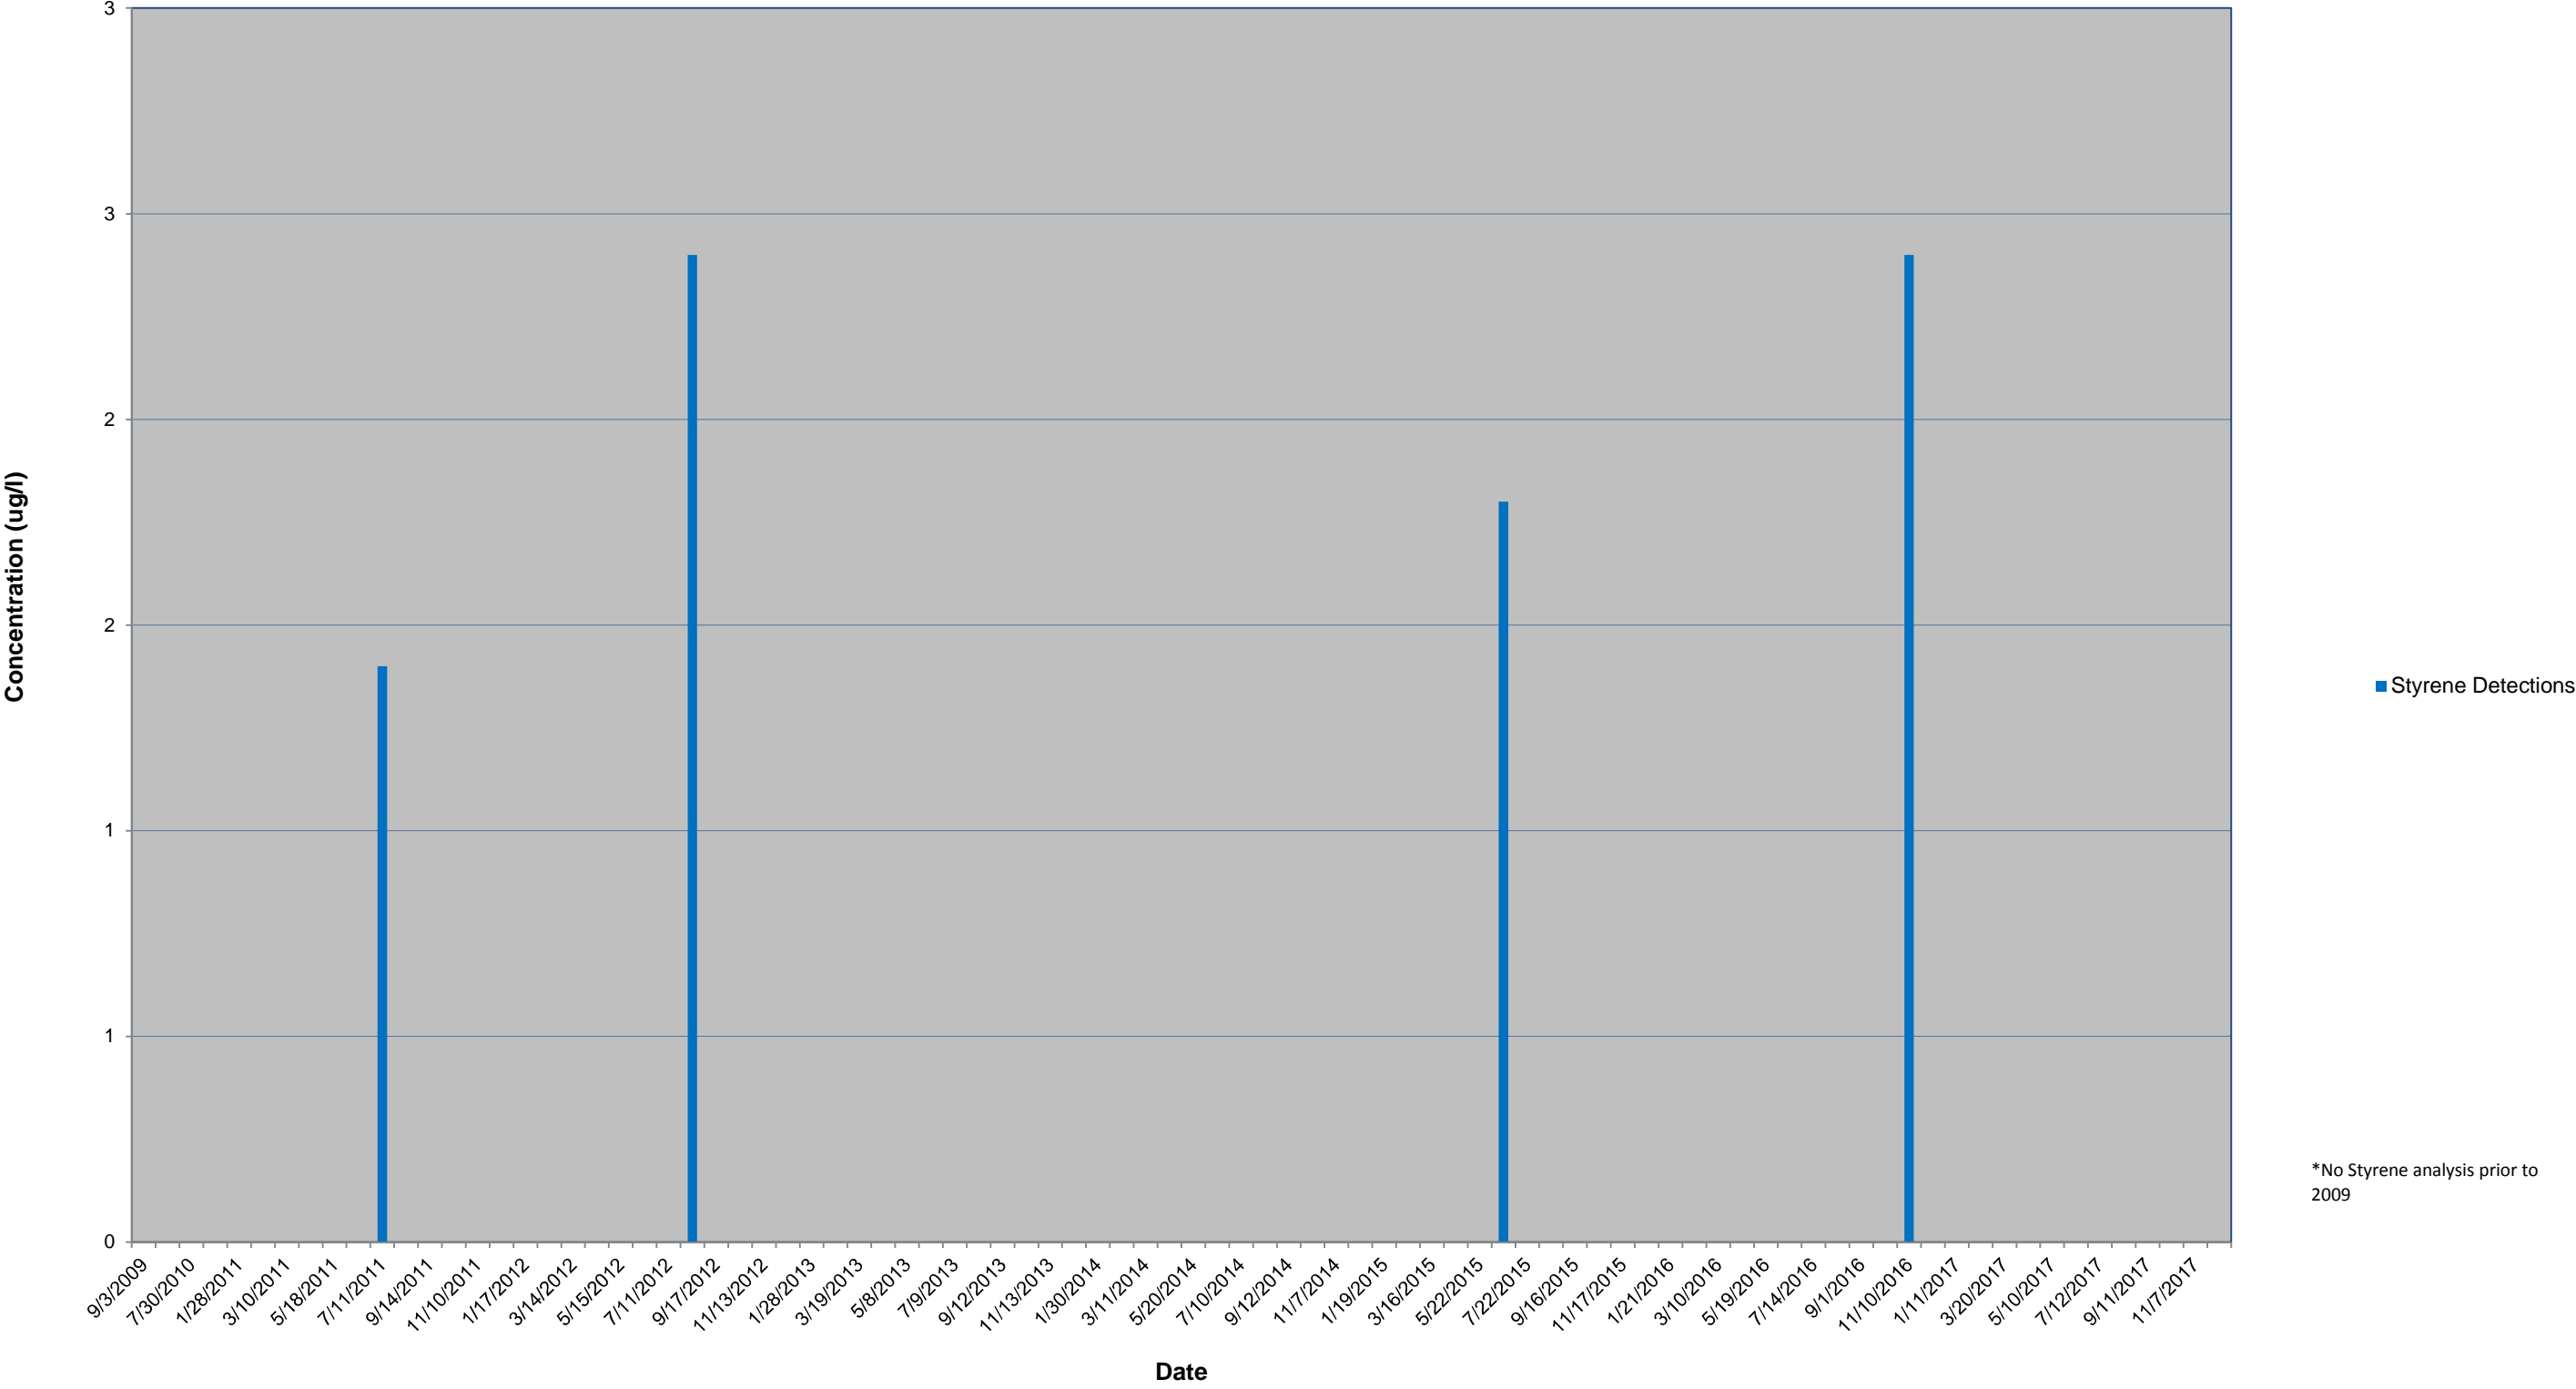
Styrene Detections in CAMU Unit 1 Leachate Samples
2009 - 2017*

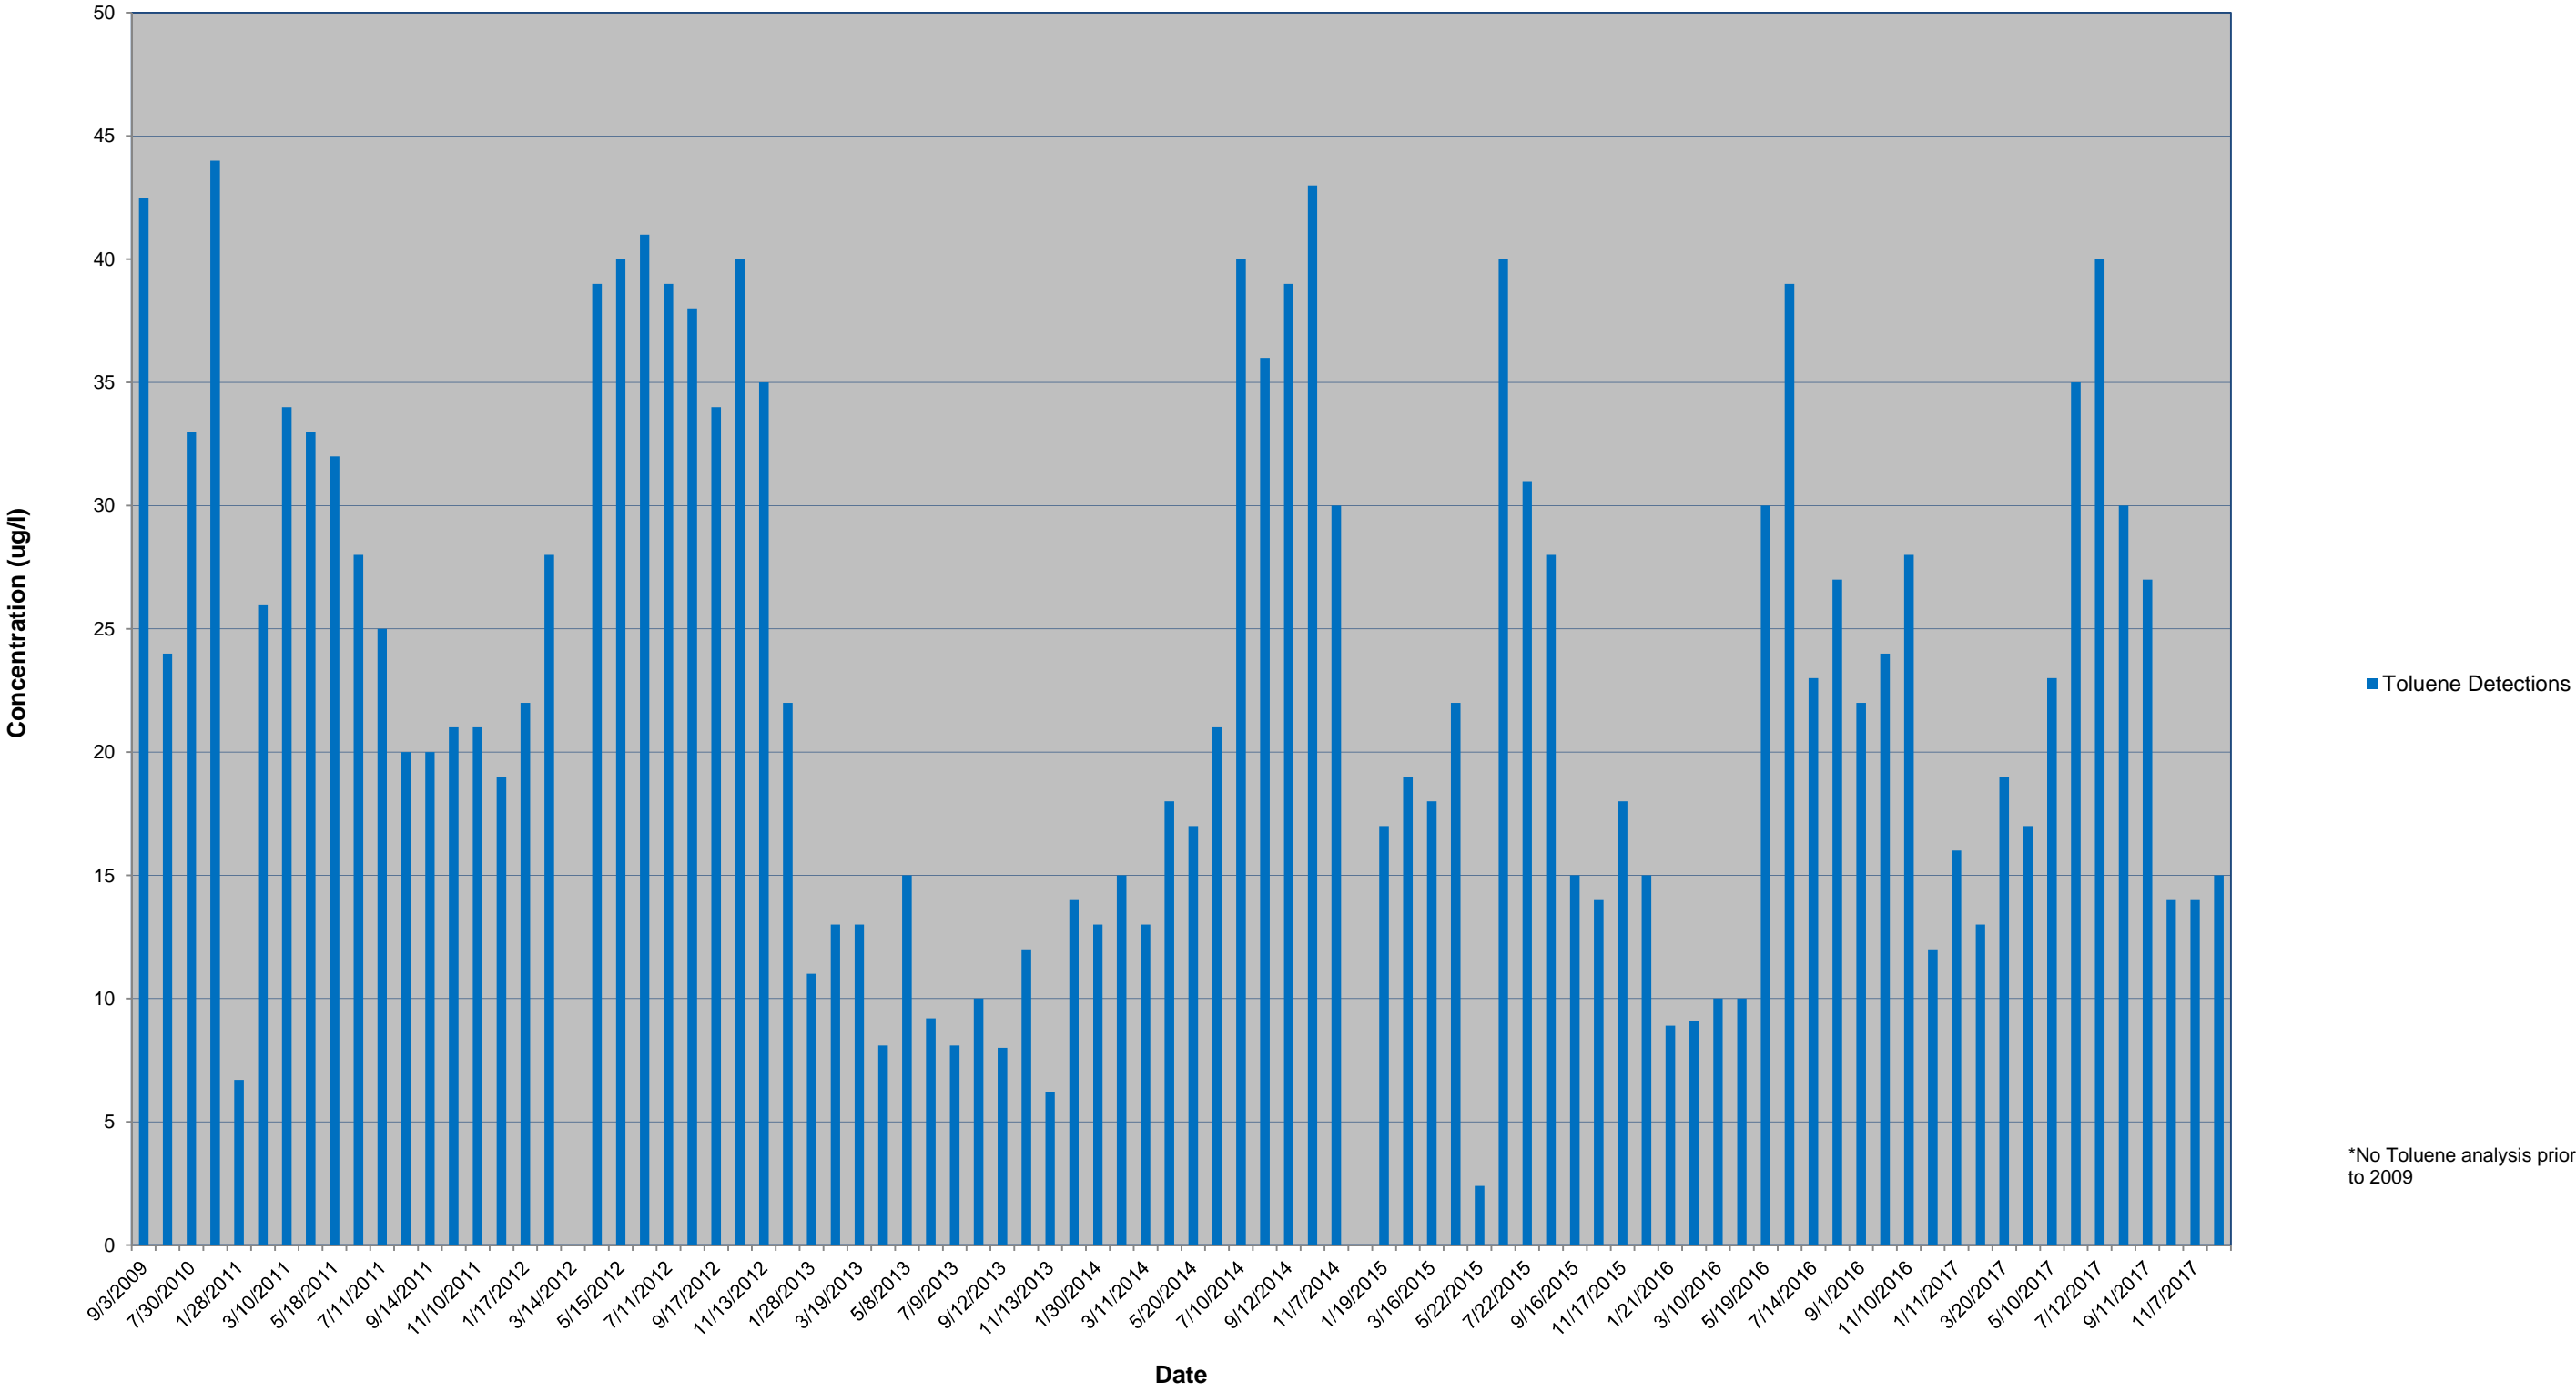
**Toluene Detections in CAMU Unit 1 Leachate Samples
2009 - 2017***

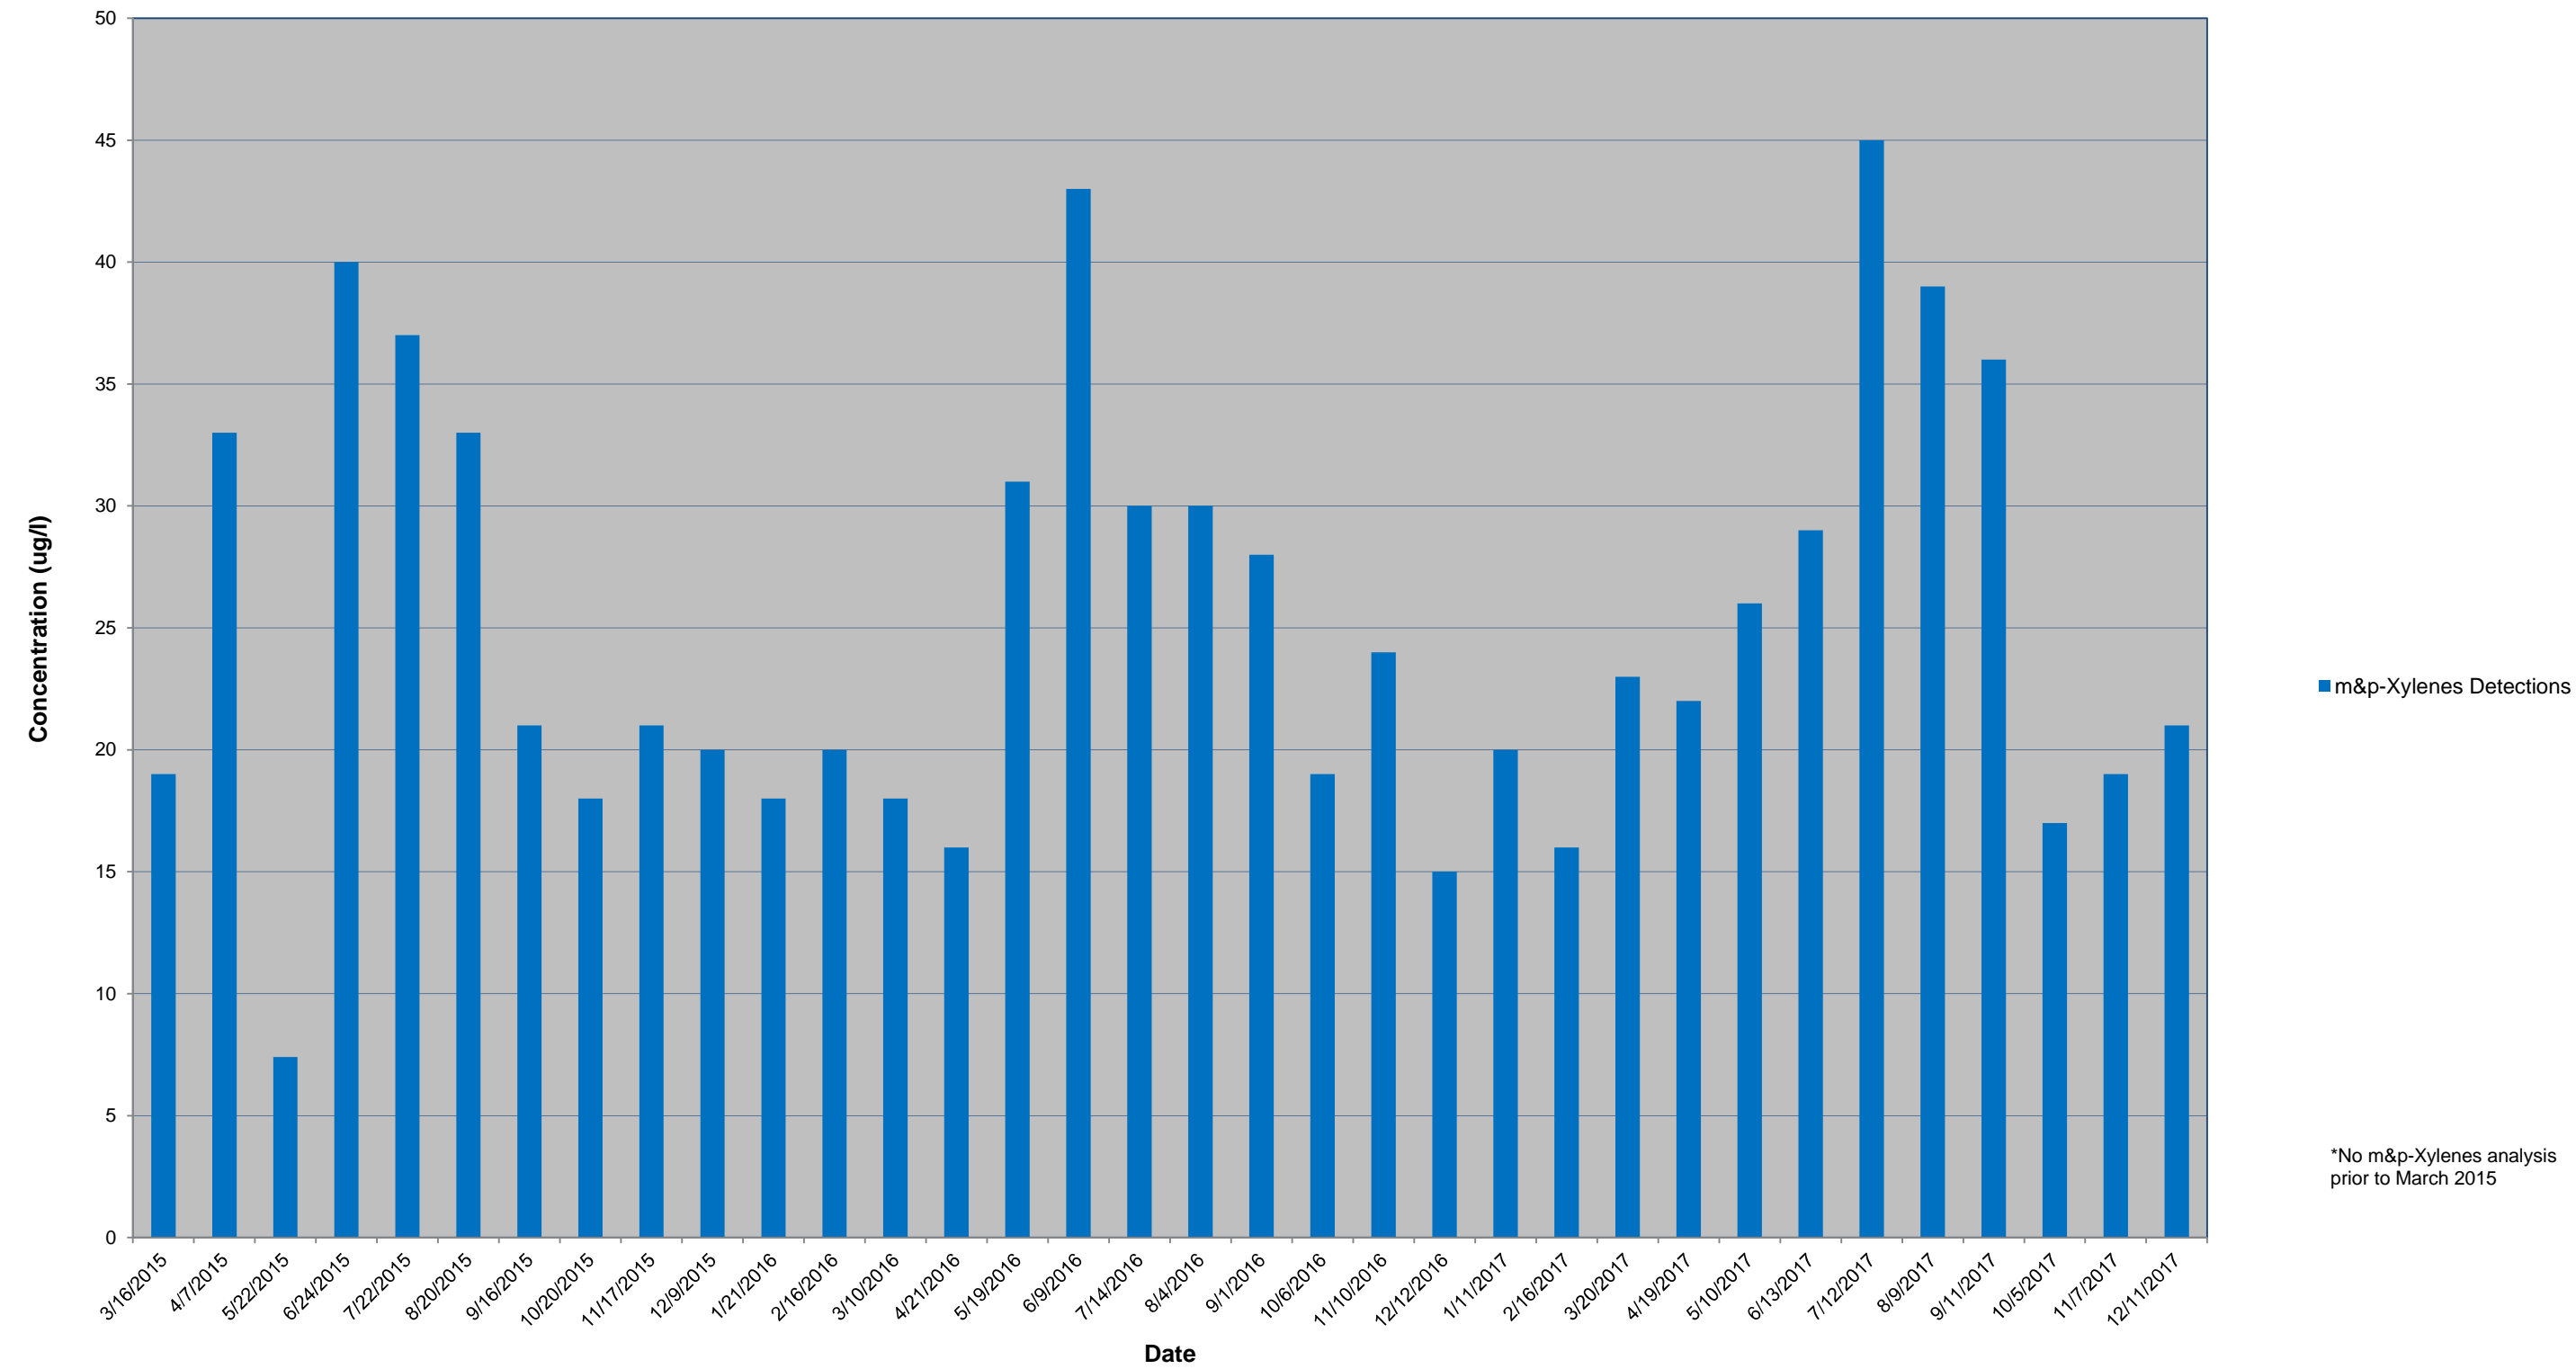
m&p-Xylenes Detections in CAMU Unit 1 Leachate Samples
2015 - 2017*

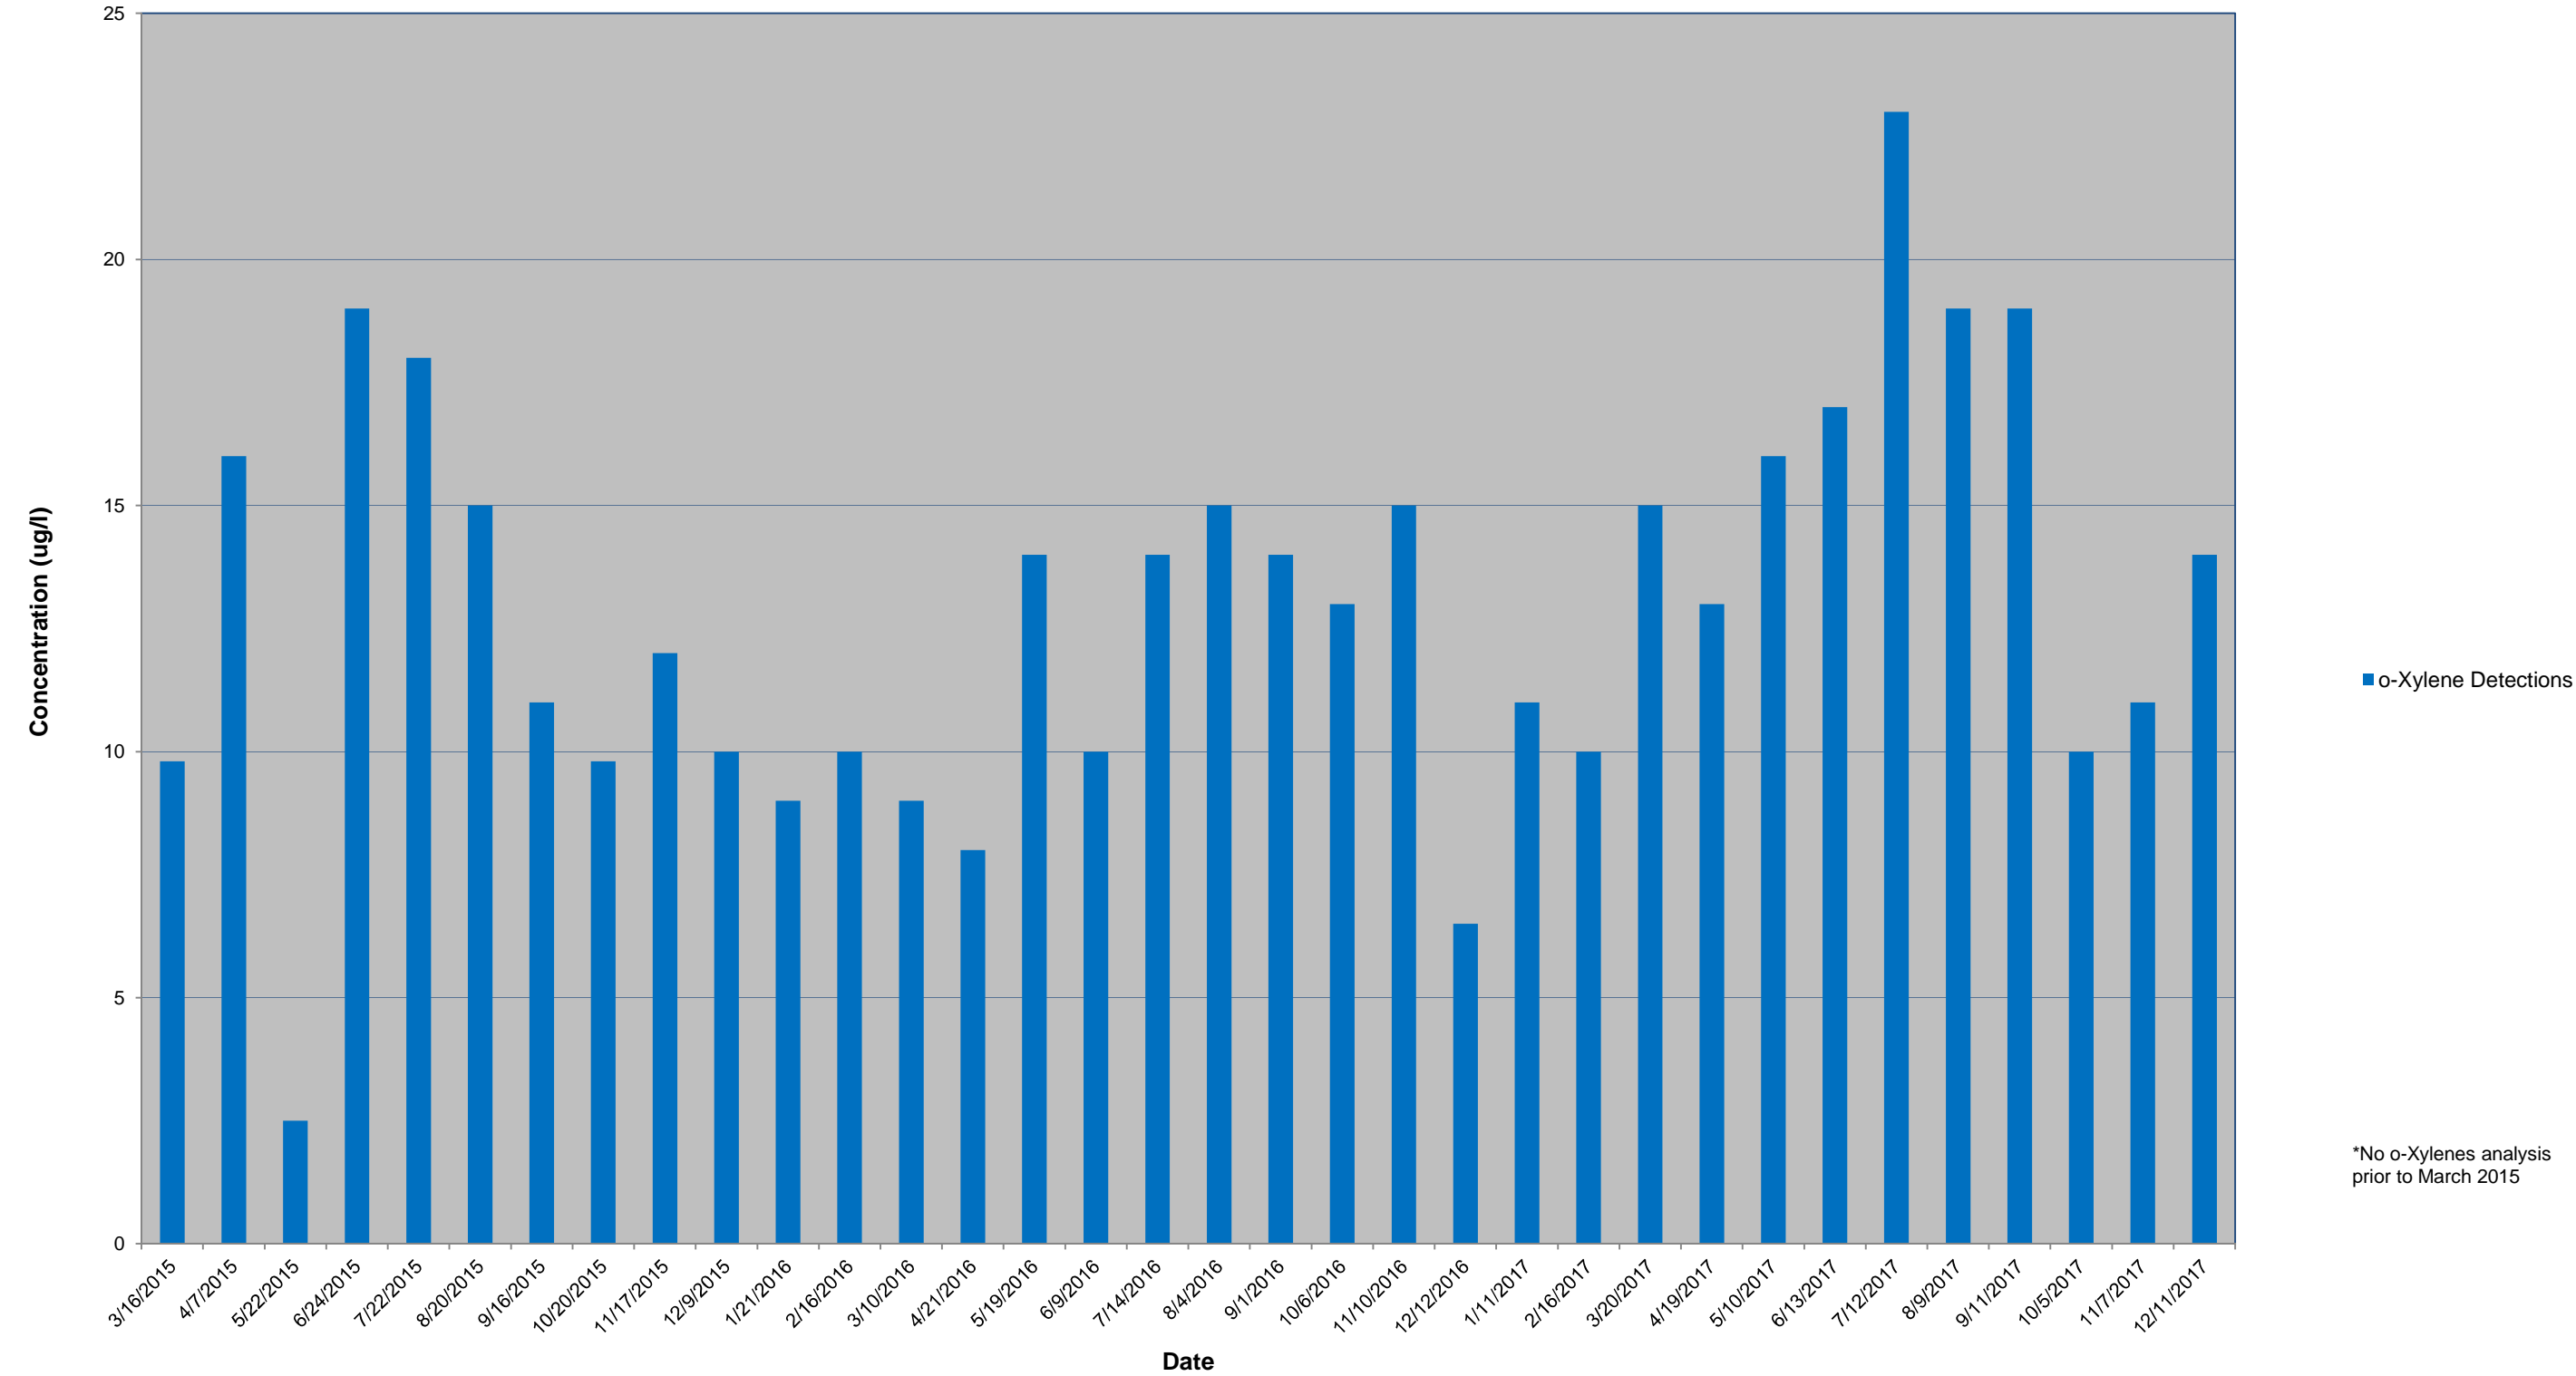
o-Xylenes Detections in CAMU Unit 1 Leachate Samples
2015 - 2017*
