Acetone Detections in CAMU Unit 1 Leachate Samples
2009 - 2017*

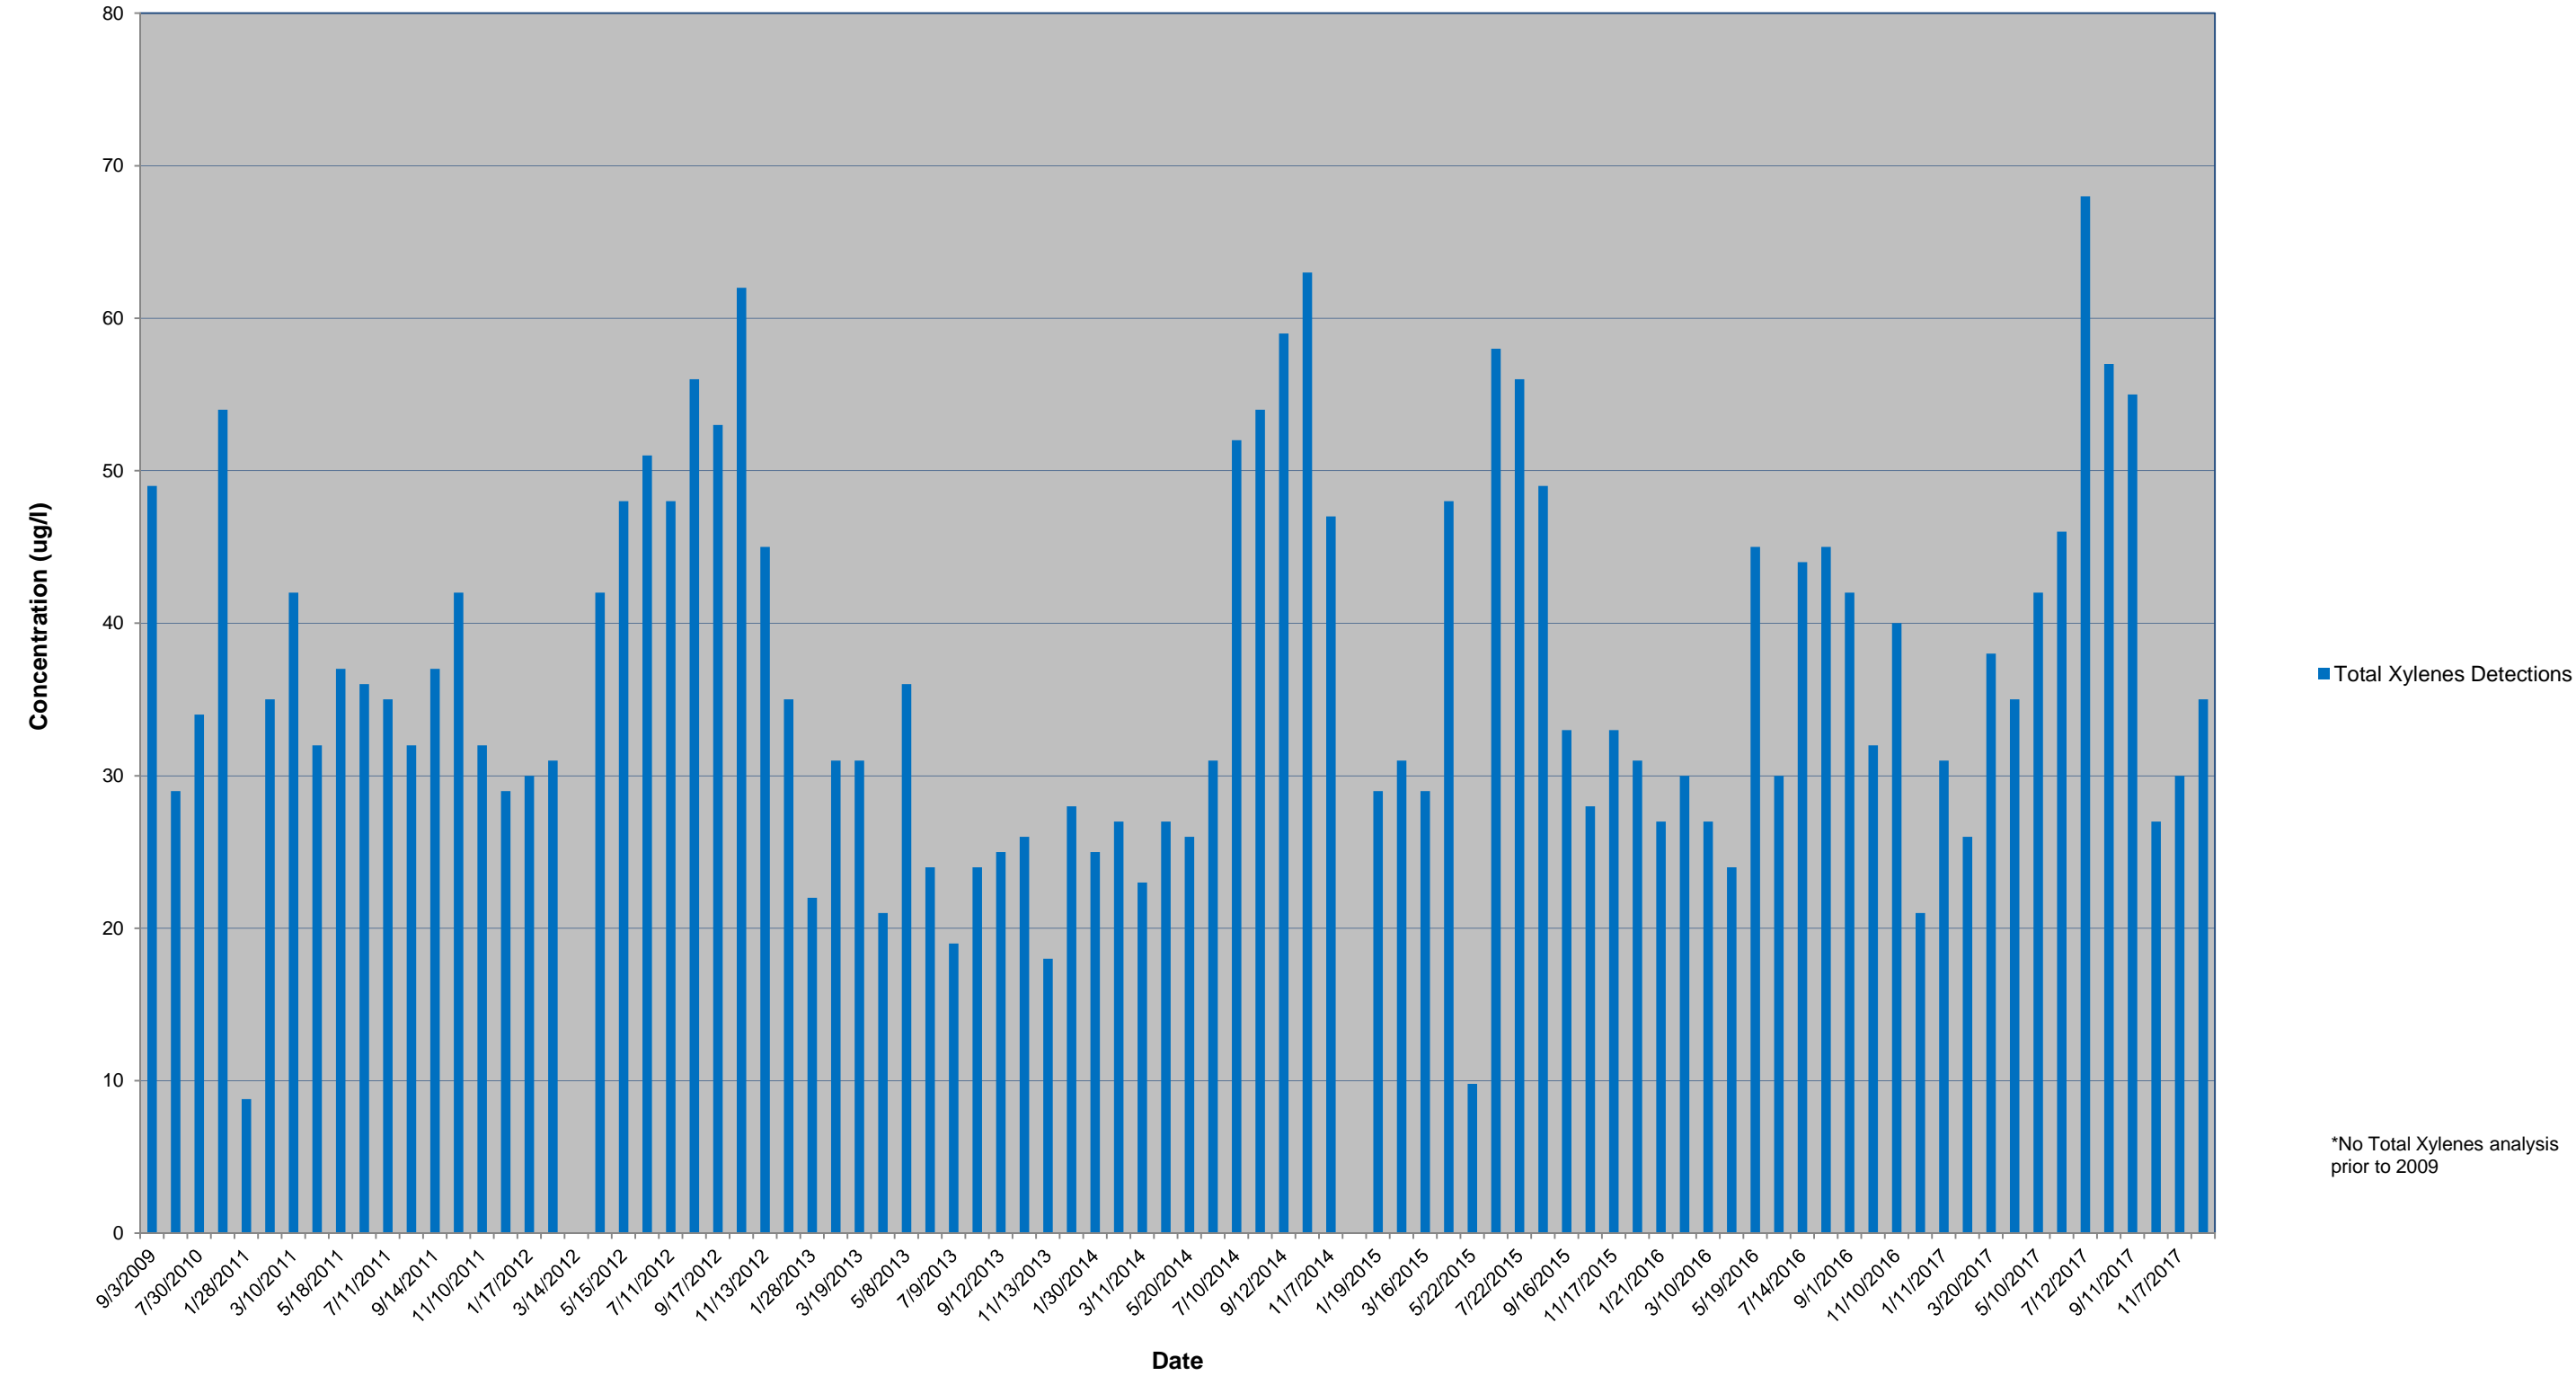
Total Xylenes Detections in CAMU Unit 1 Leachate Samples
2009 - 2017*
