**Third Five-Year Review Report for Silver
Bow Creek/Butte Area Site**

**Volume 2: Stream Side Tailings Operable
Unit**

June 2011

U.S. Environmental Protection Agency
Helena, Montana

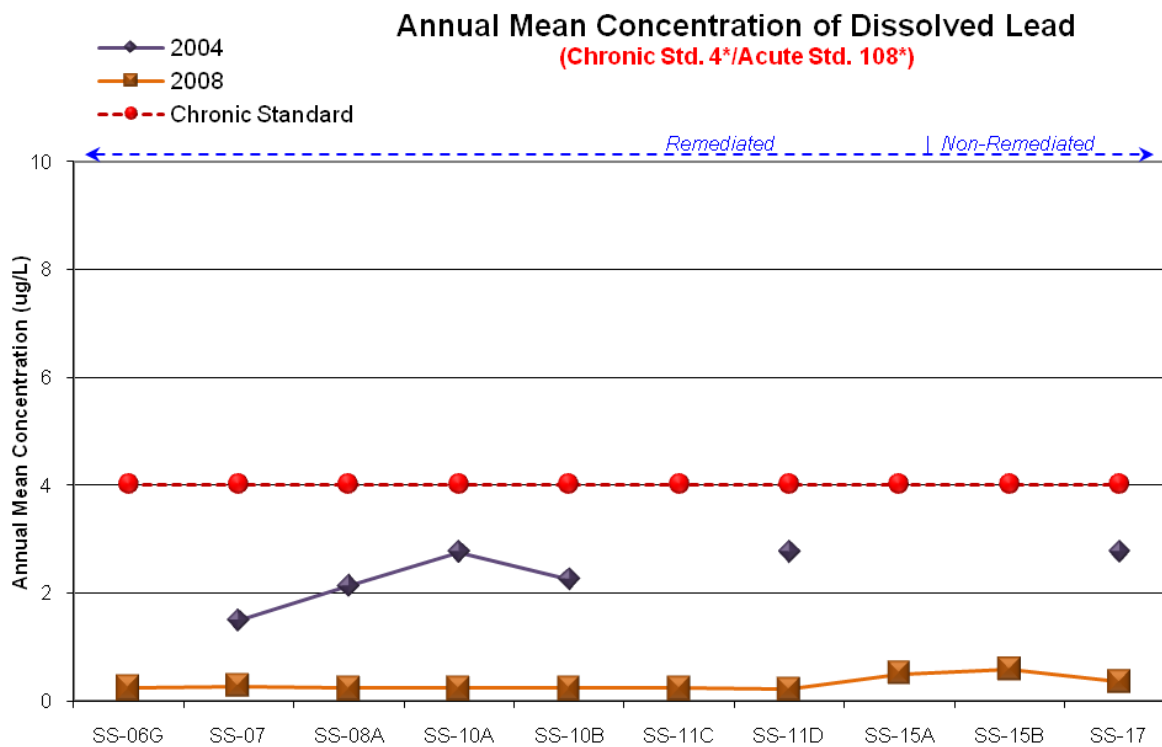
FIGURE 6-11

Annual Mean Concentration of Dissolved Lead

*Based on 125 mg/L hardness (typical Value for Silver Bow Creek in SSTOU)

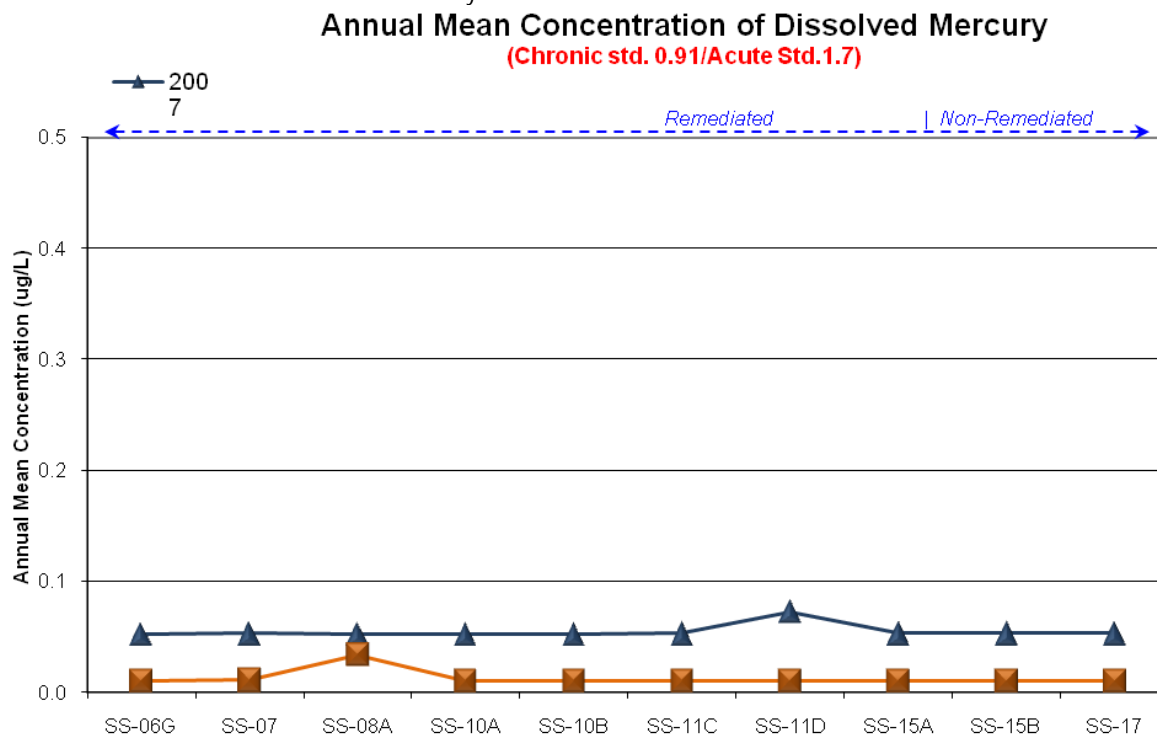
FIGURE 6-12

Annual Mean Concentration of Dissolved Mercury

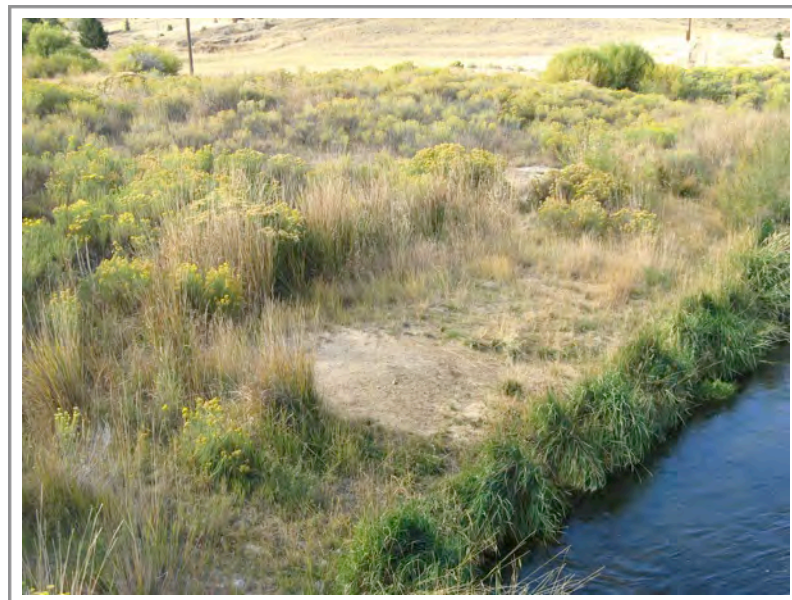
Photo 6: Upper section of Subarea 1—close-up of sparsely vegetated streambank

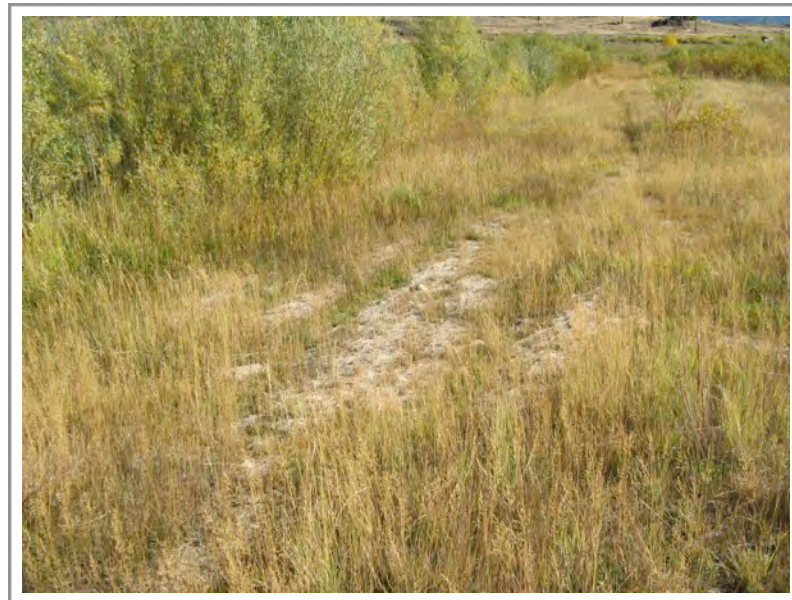
Photo 8: Upper section of Subarea 1—sparsely vegetated areas showing patches of salt

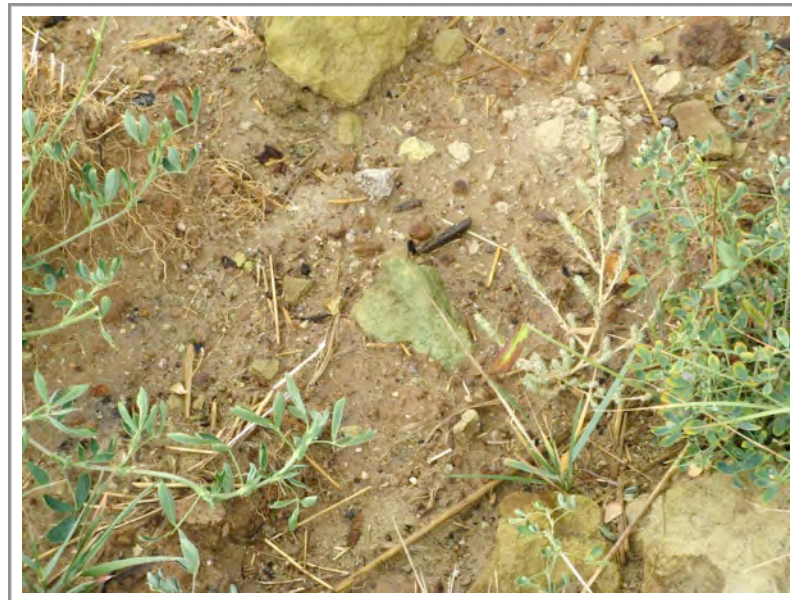
Photo 32: Middle section of Subarea 1—close-up of sparsely vegetated area along Greenway Trail upstream of South Rocker Road

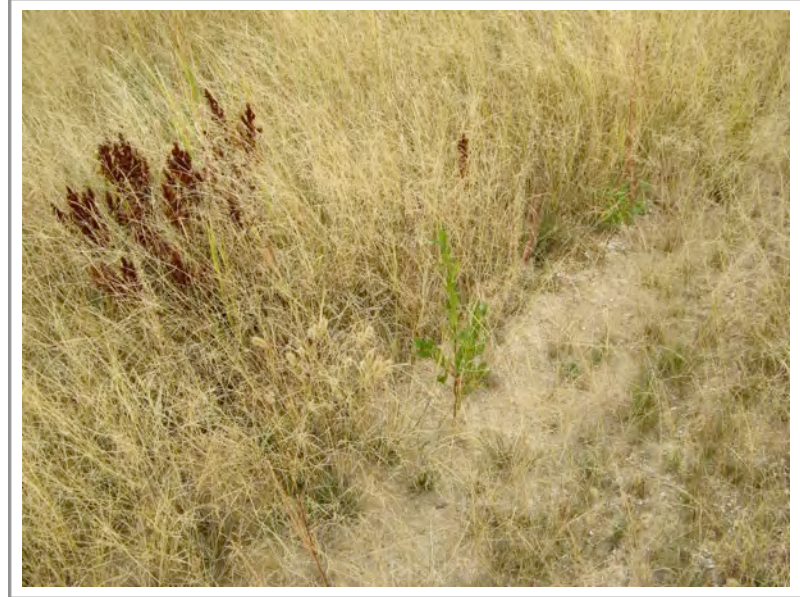
Photo 54: Lower section of Subarea 2—sparsely vegetated ground and willow seedling (probably *Salix boothii* [Booth willow])

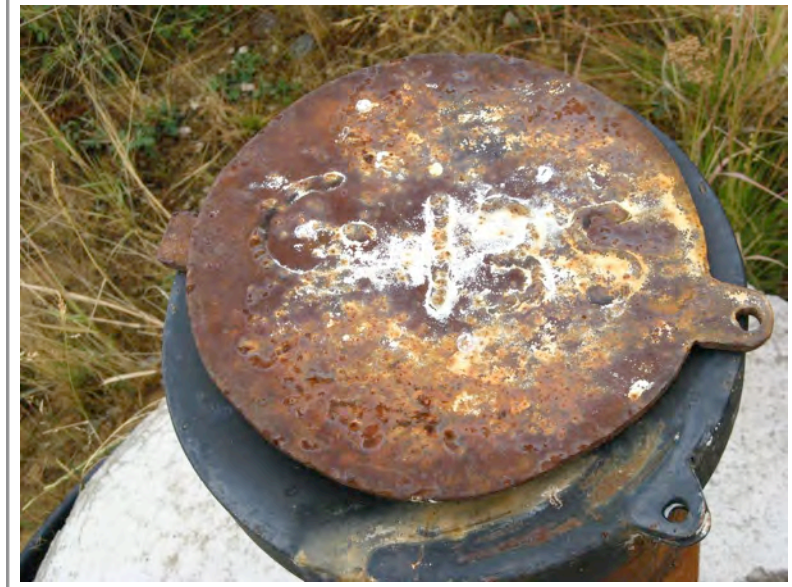
Photo 72: Ramsay Flats section of Subarea 2—unlocked well (G 135) with broken base at latitude 46.00032, longitude -112.68661 (WGS 84)

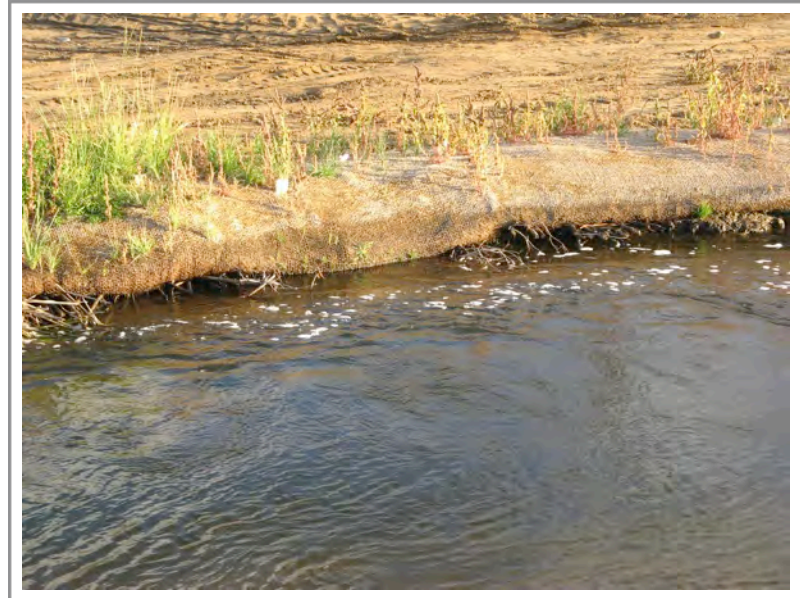
Photo 110: Upper section of Subarea 4—photo showing some gaps below a soil lift on a newly constructed streambanks

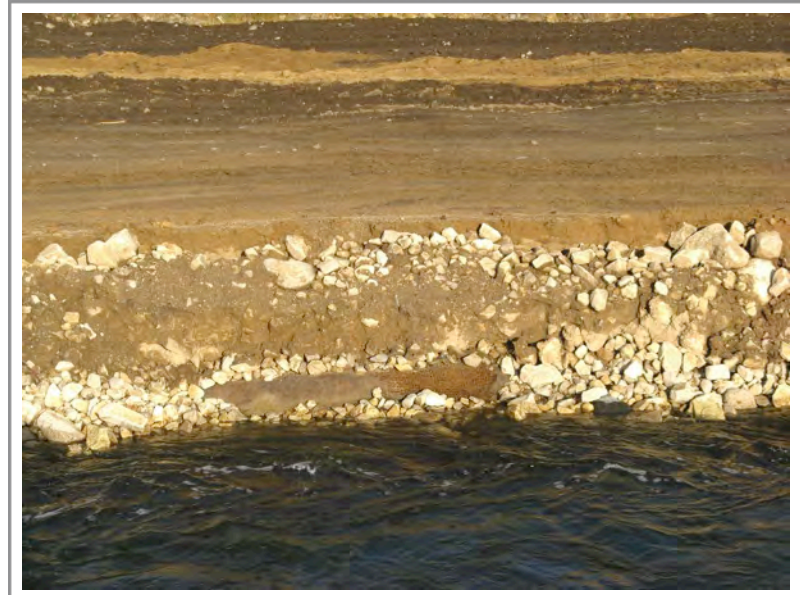
Photo 130: Upper section of Subarea 4—erosion of streambank downstream of pumping station

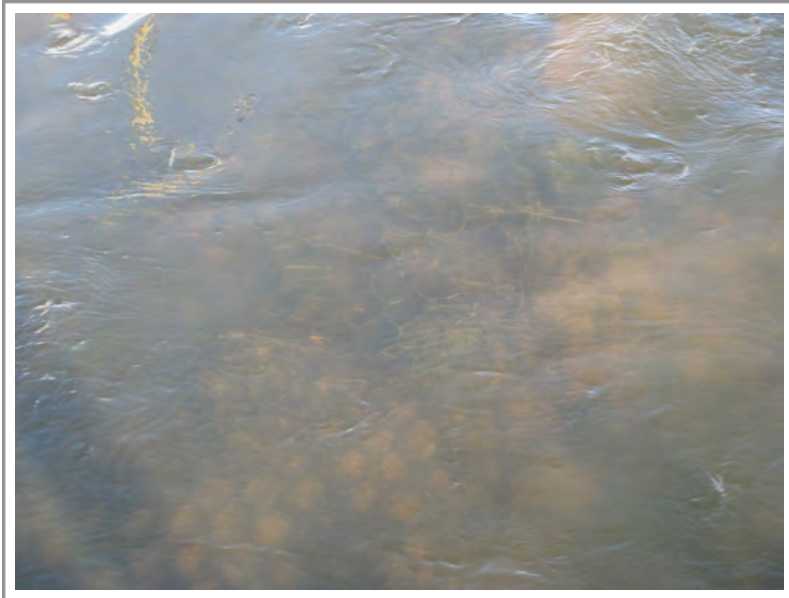
Photo 132: Upper section of Subarea 4—close-up of headcut downstream of pumping station (latitude 46.04443, longitude -112.79708 [WGS 84])

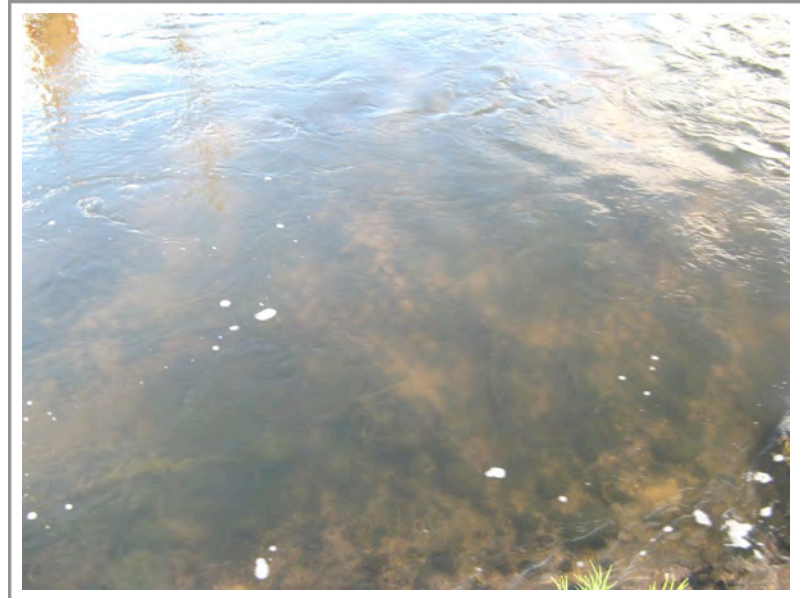
Photo 133: Upper section of Subarea 4—instream rock gabion (stainless steel cage) to control headcut just downstream of pumping station

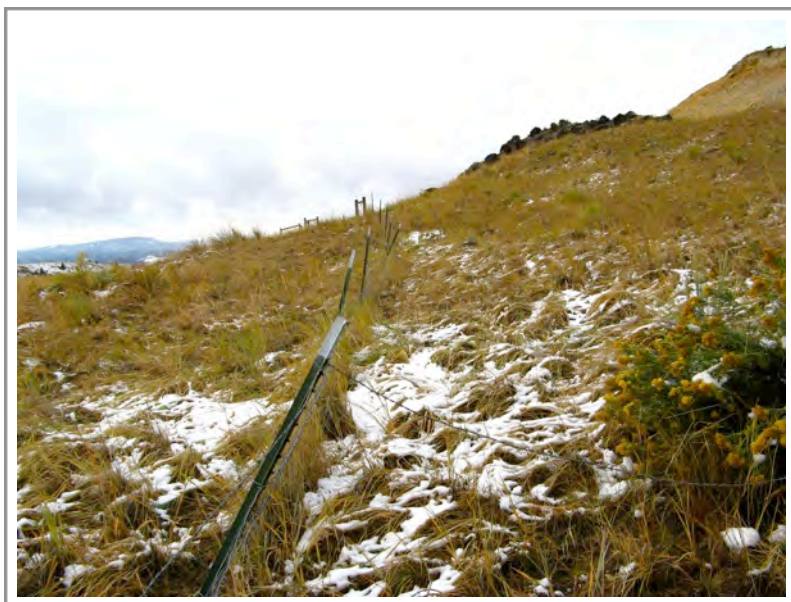
Photo 153: MWRR—fence along northeast portion of the repository. Sections of the fence are down in this area.

Photo 154: MWRR—downed fence along the northeast section of the repository
