Silver Bow Creek/Butte Area

Storm Water off the Butte Hill

Bulletin #20

March 2, 2014

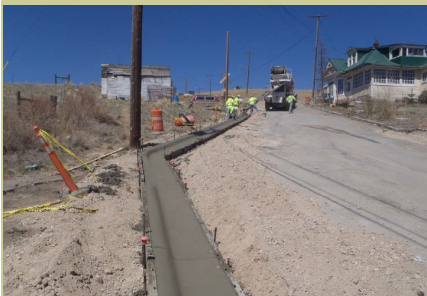
Wyoming Street
Steep Challenges for
Curb and Gutter
Storm Water Control

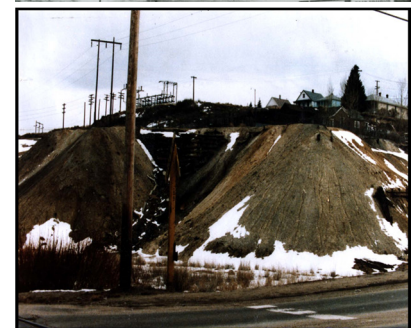
Or maybe you remember when the top of Buffalo Gulch looked like this at the Buffalo Dump?

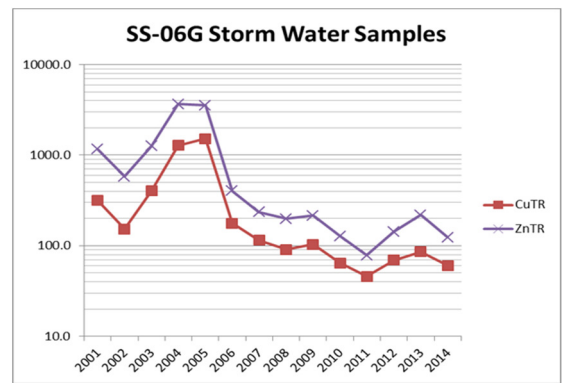
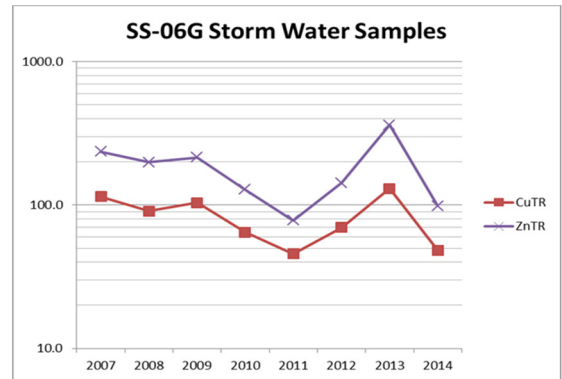
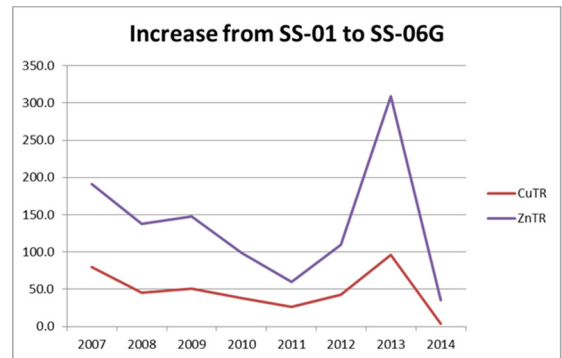
A Summary of what the Storm Water Data is telling us

Graphs to the right are measured in Parts Per Billion (ug/L) versus Time (years).

Using all available storm water data from 2001 to 2014, there has been an overall decrease in total recoverable (TR) copper and zinc concentrations at station SS-06G (located inside the western boundary of BPSOU). From 2005 to 2013, there has been a 96% decrease in copper and a 97% decrease in zinc TR concentrations.

Since 2007 the decreases in copper and zinc have been variable. There was a downward trend from 2007 to 2011. 2012 and 2013 showed increases and 2014 was lower again. The data show an overall improvement since 2007.

Of course, that's not the whole story. The upstream station, SS-01 (located outside the eastern boundary of BPSOU), also had increases in 2012 and 2013. The difference between SS-01 and SS-06G reflects contributions from BPSOU. Based on the differences, there has been improvement.

There are clear improvements since 2002, but improvements since 2007 are less obvious and subject to annual variations in conditions.
