**CLARIFIER WASTE TREATABILITY STUDY  
PHASE 3 REPORT  
PILOT PLANT OPERATION**

Rhodia, Inc.  
Silver Bow  
119130 German Gulch Road  
Butte, MT 59750

**February 2012**

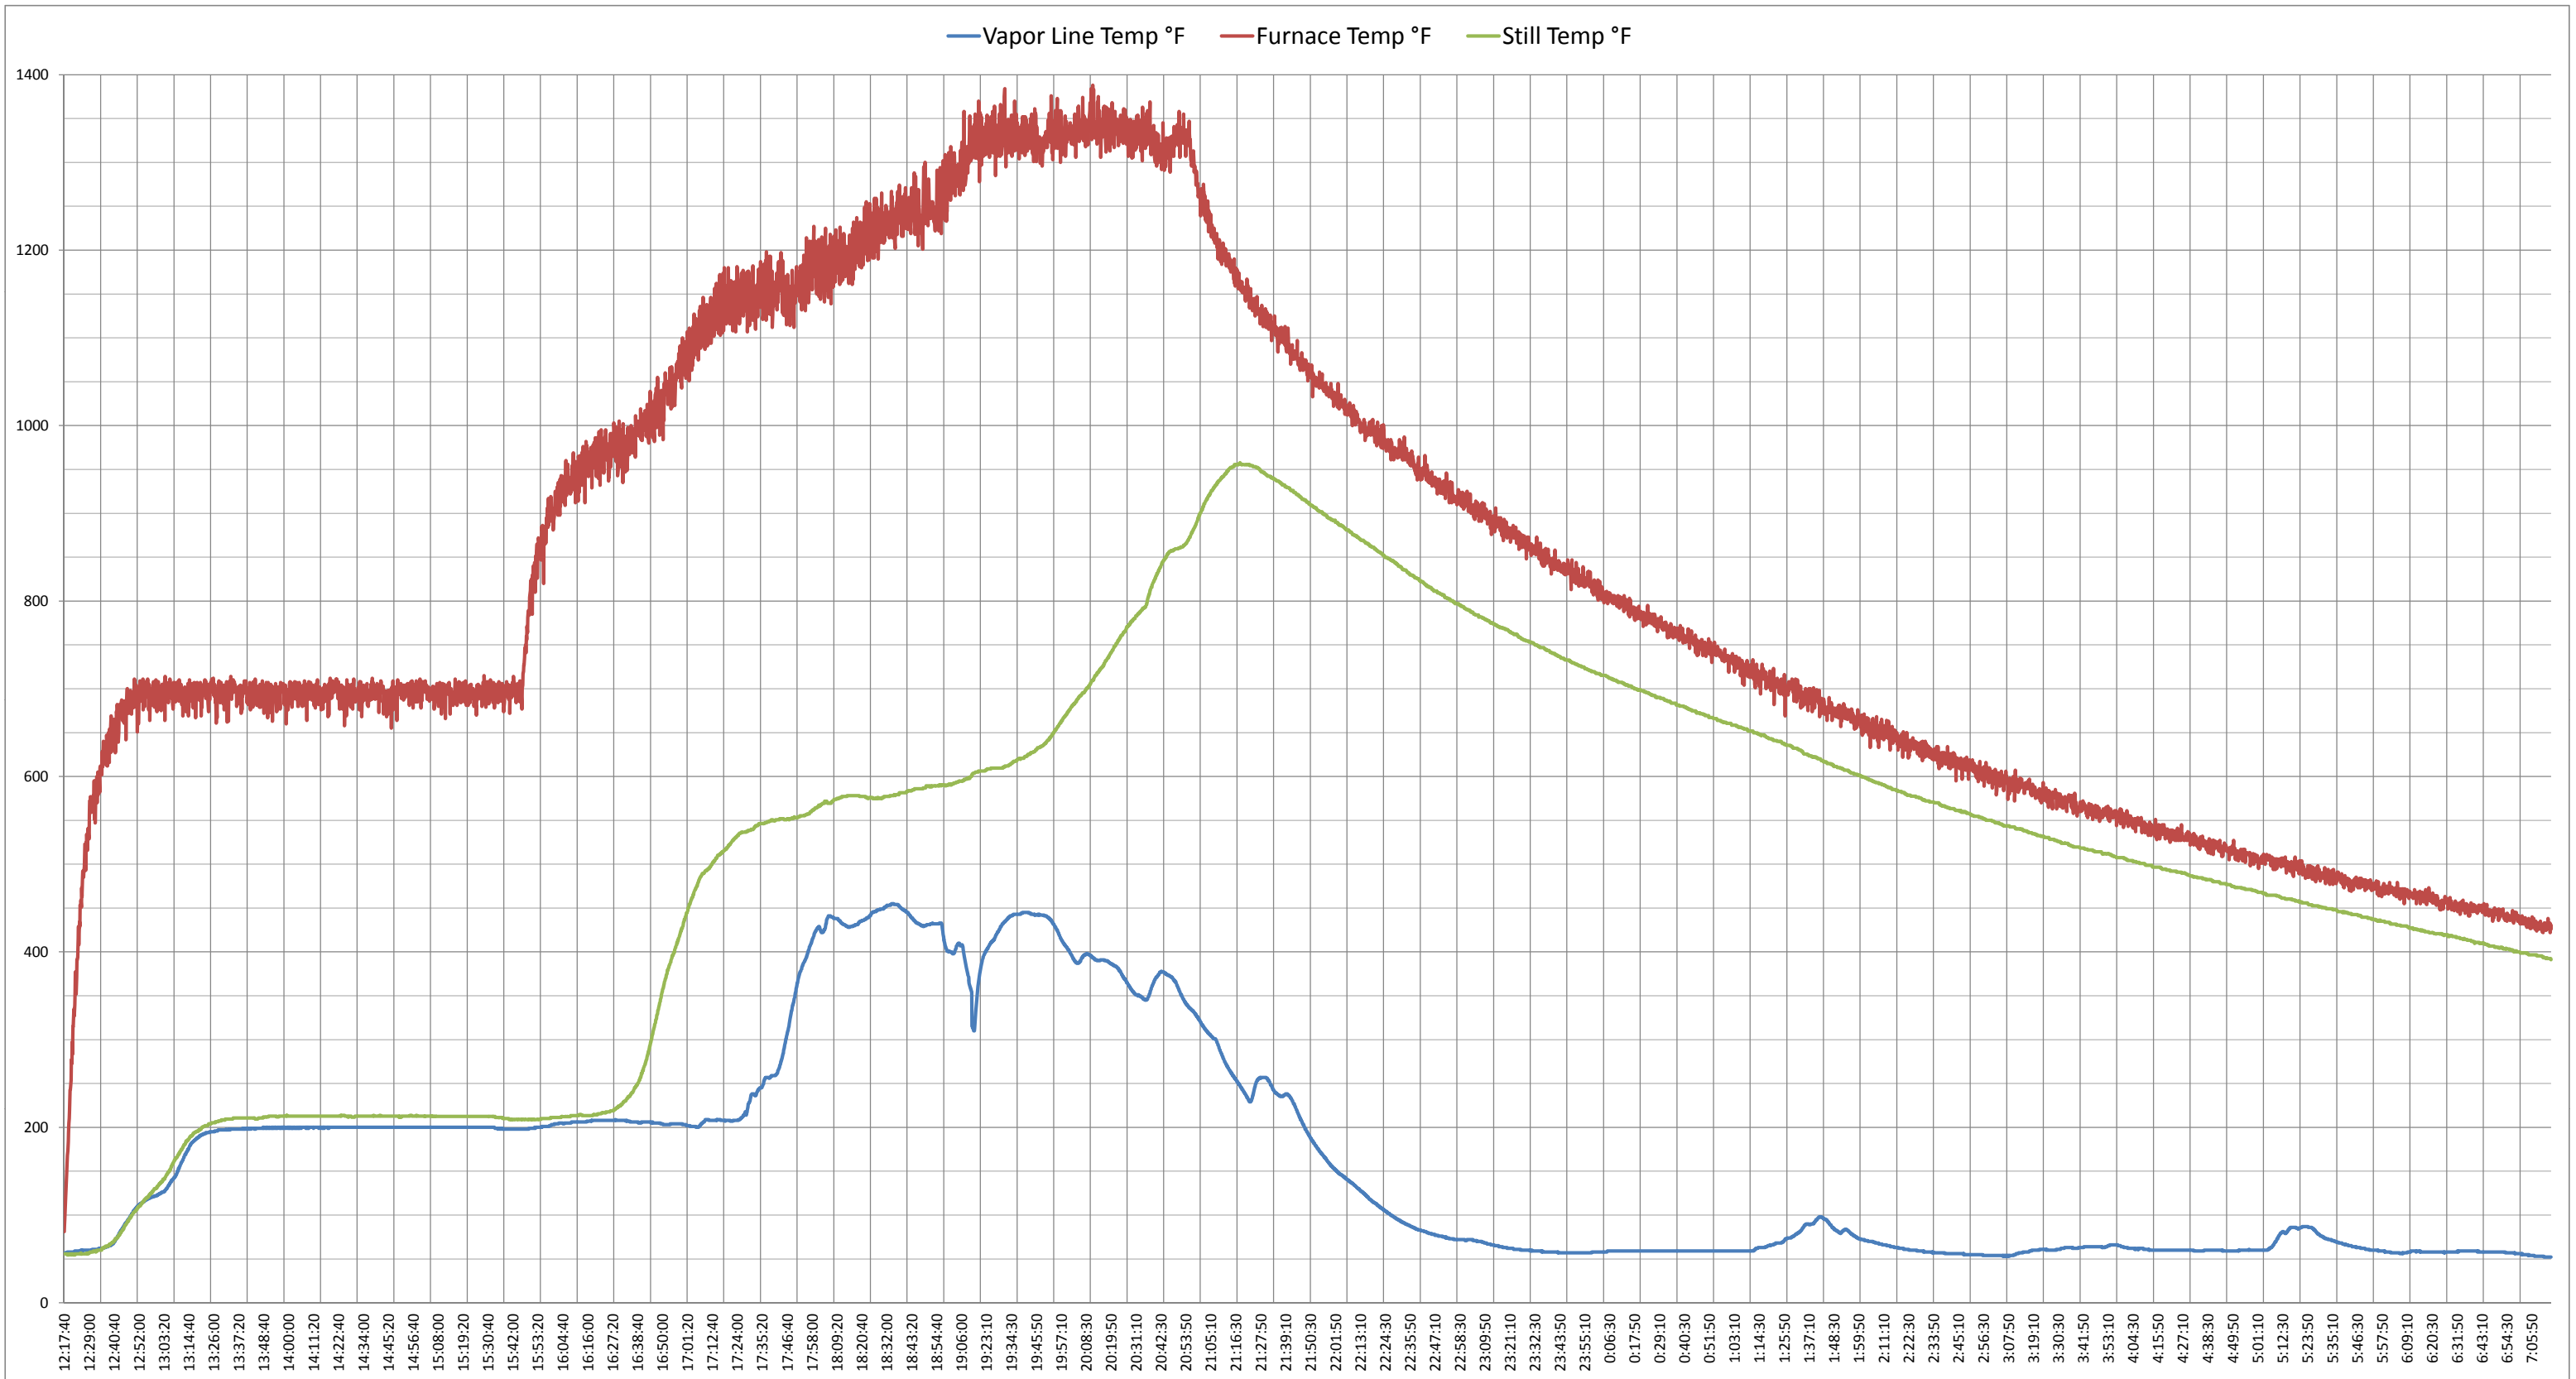
### Hi-Temperature Trend Chart

Vapor Line Temp °F    Furnace Temp °F    Still Temp °F

All of the data discussed in the data analysis section can be found in graphical chart form in Appendix 7.8 – “Graphs of Raw Data” or in Appendix 7.9 – “HMB Summary Sheets and Analysis Charts”. The vapor line temperature, furnace temperature, and still temperature are found in the Hi-Temperature Trend Chart. The condenser overflow temperature, condenser outlet temperature, and condenser spray temperature are found in the Lo-Temperature Trend Chart. The vapor line pressure and eductor inlet pressure are found in the Pressure Trend Chart. The cumulative kWh usage during the test run is found in the Cumulative Power Trend Chart.

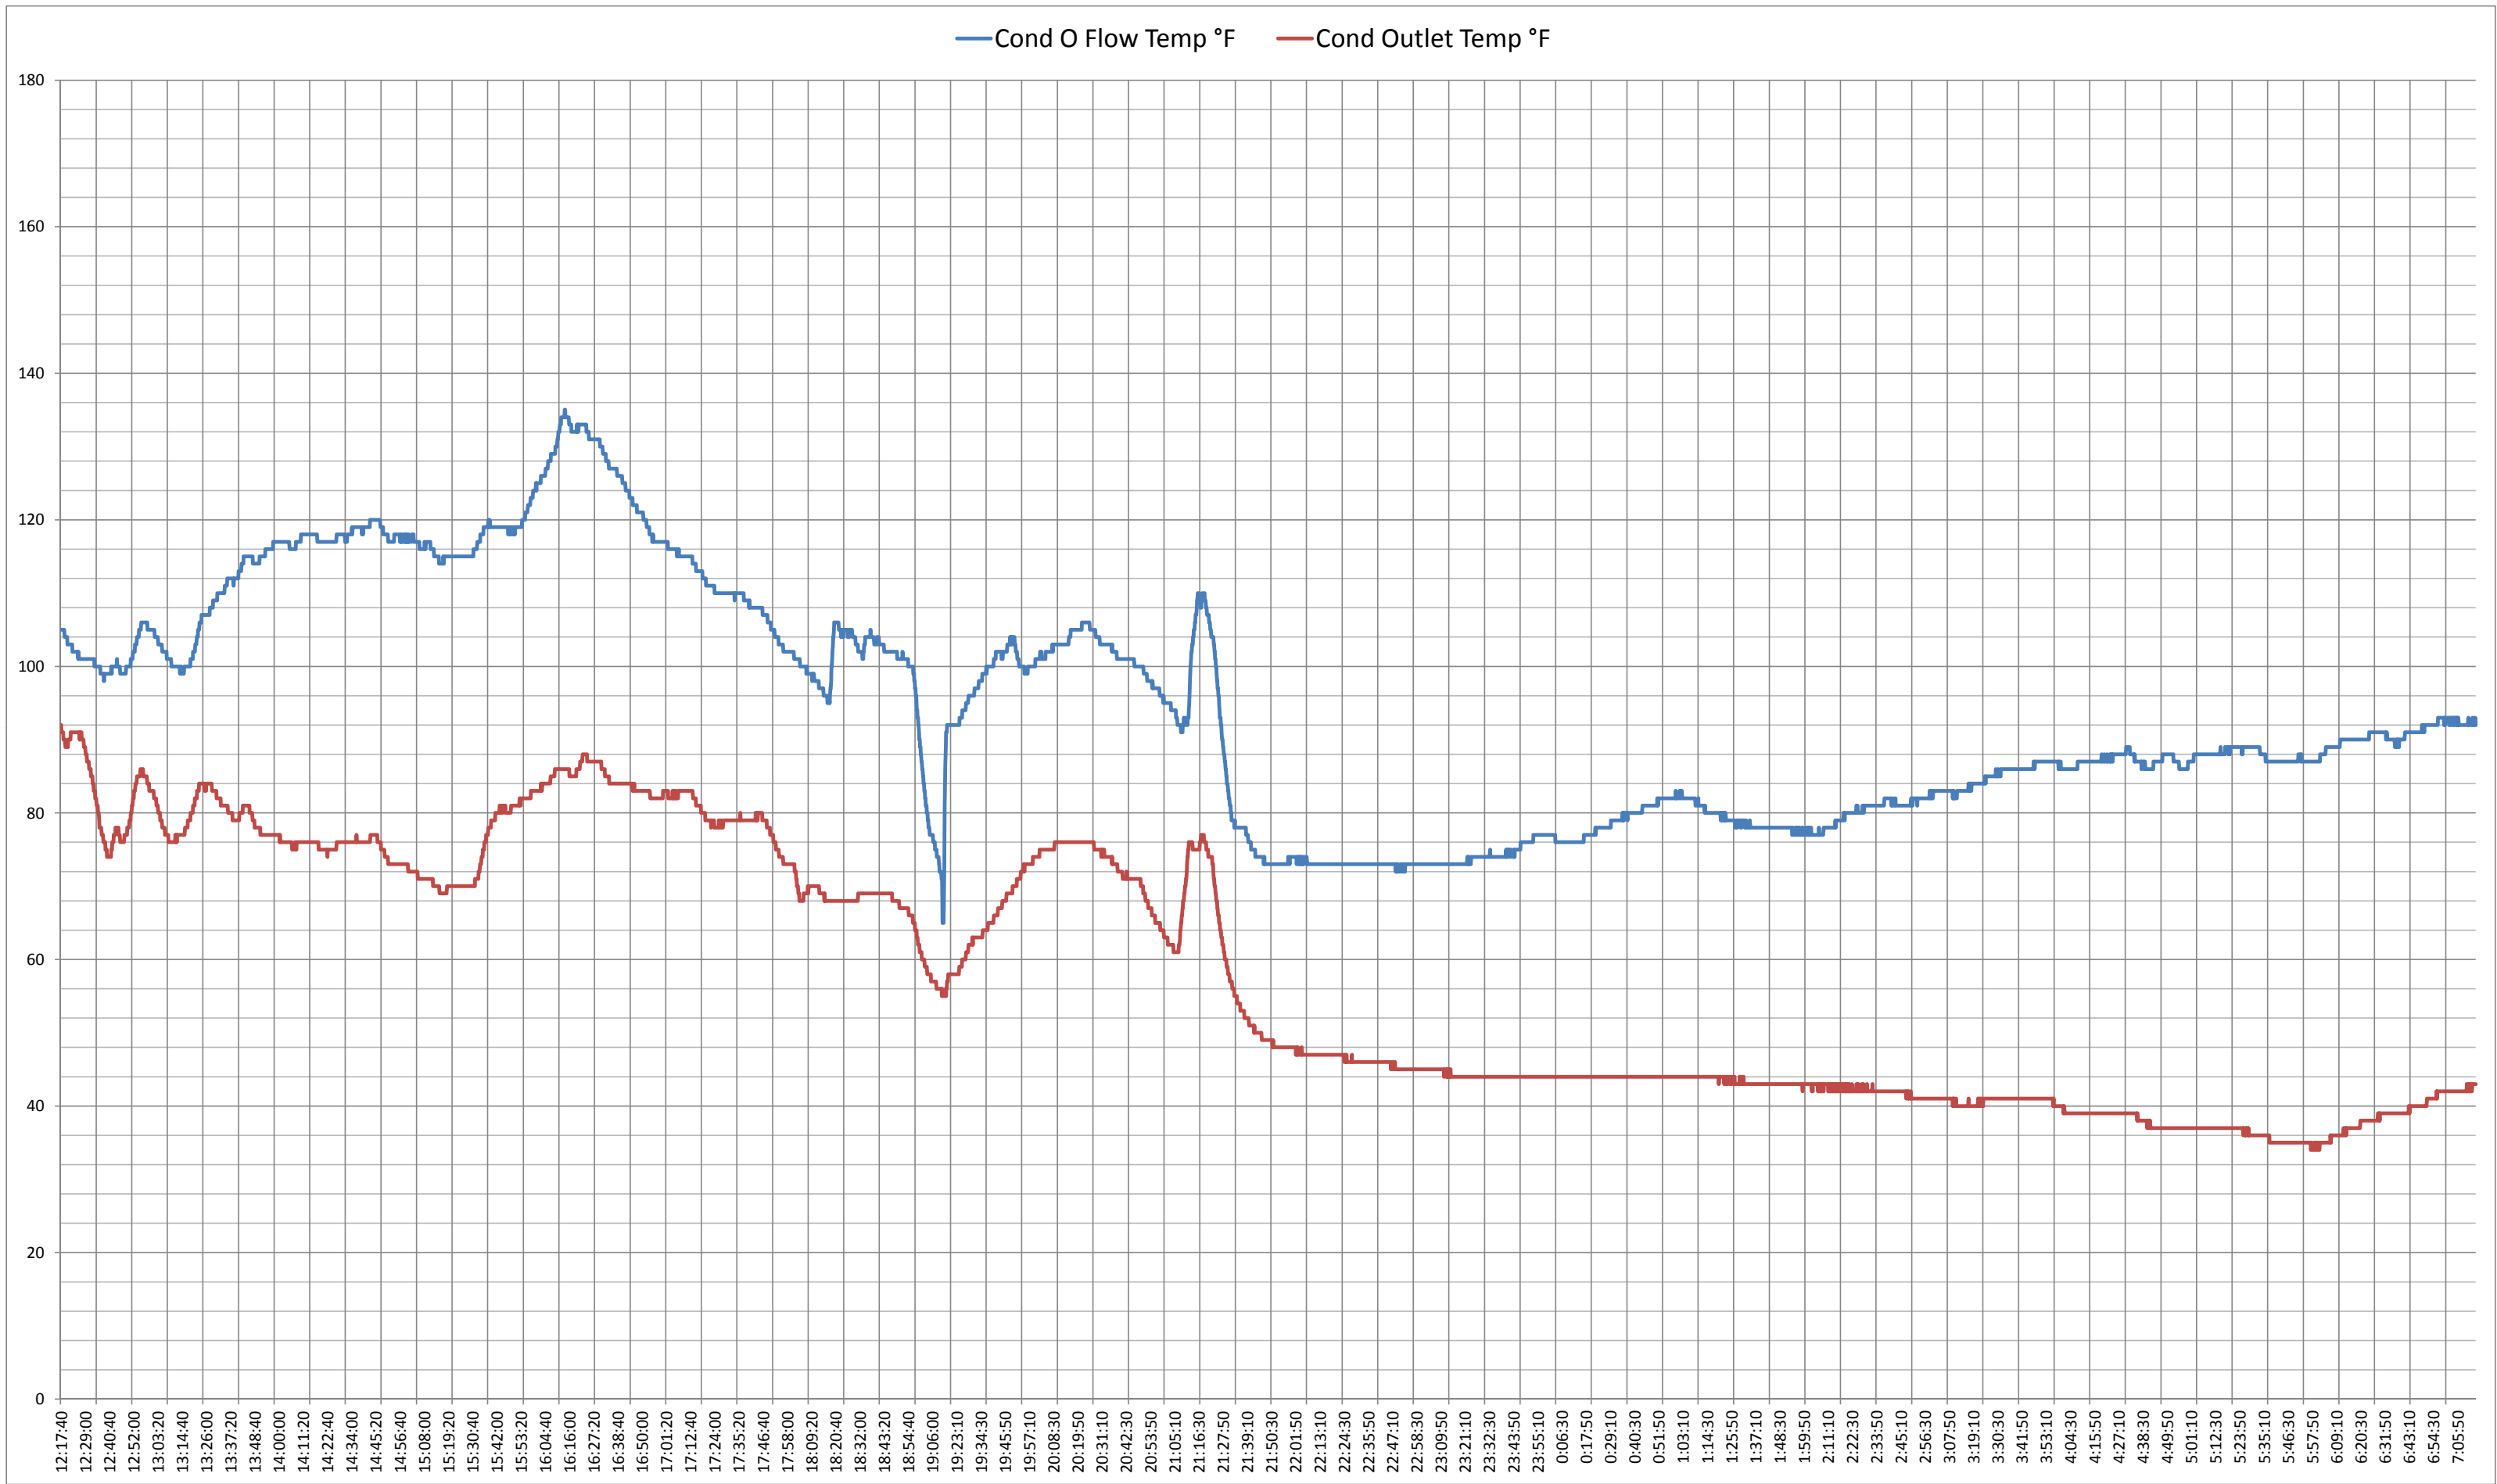
### Lo-Temperature Trend Chart

Cond O Flow Temp °F    Cond Outlet Temp °F

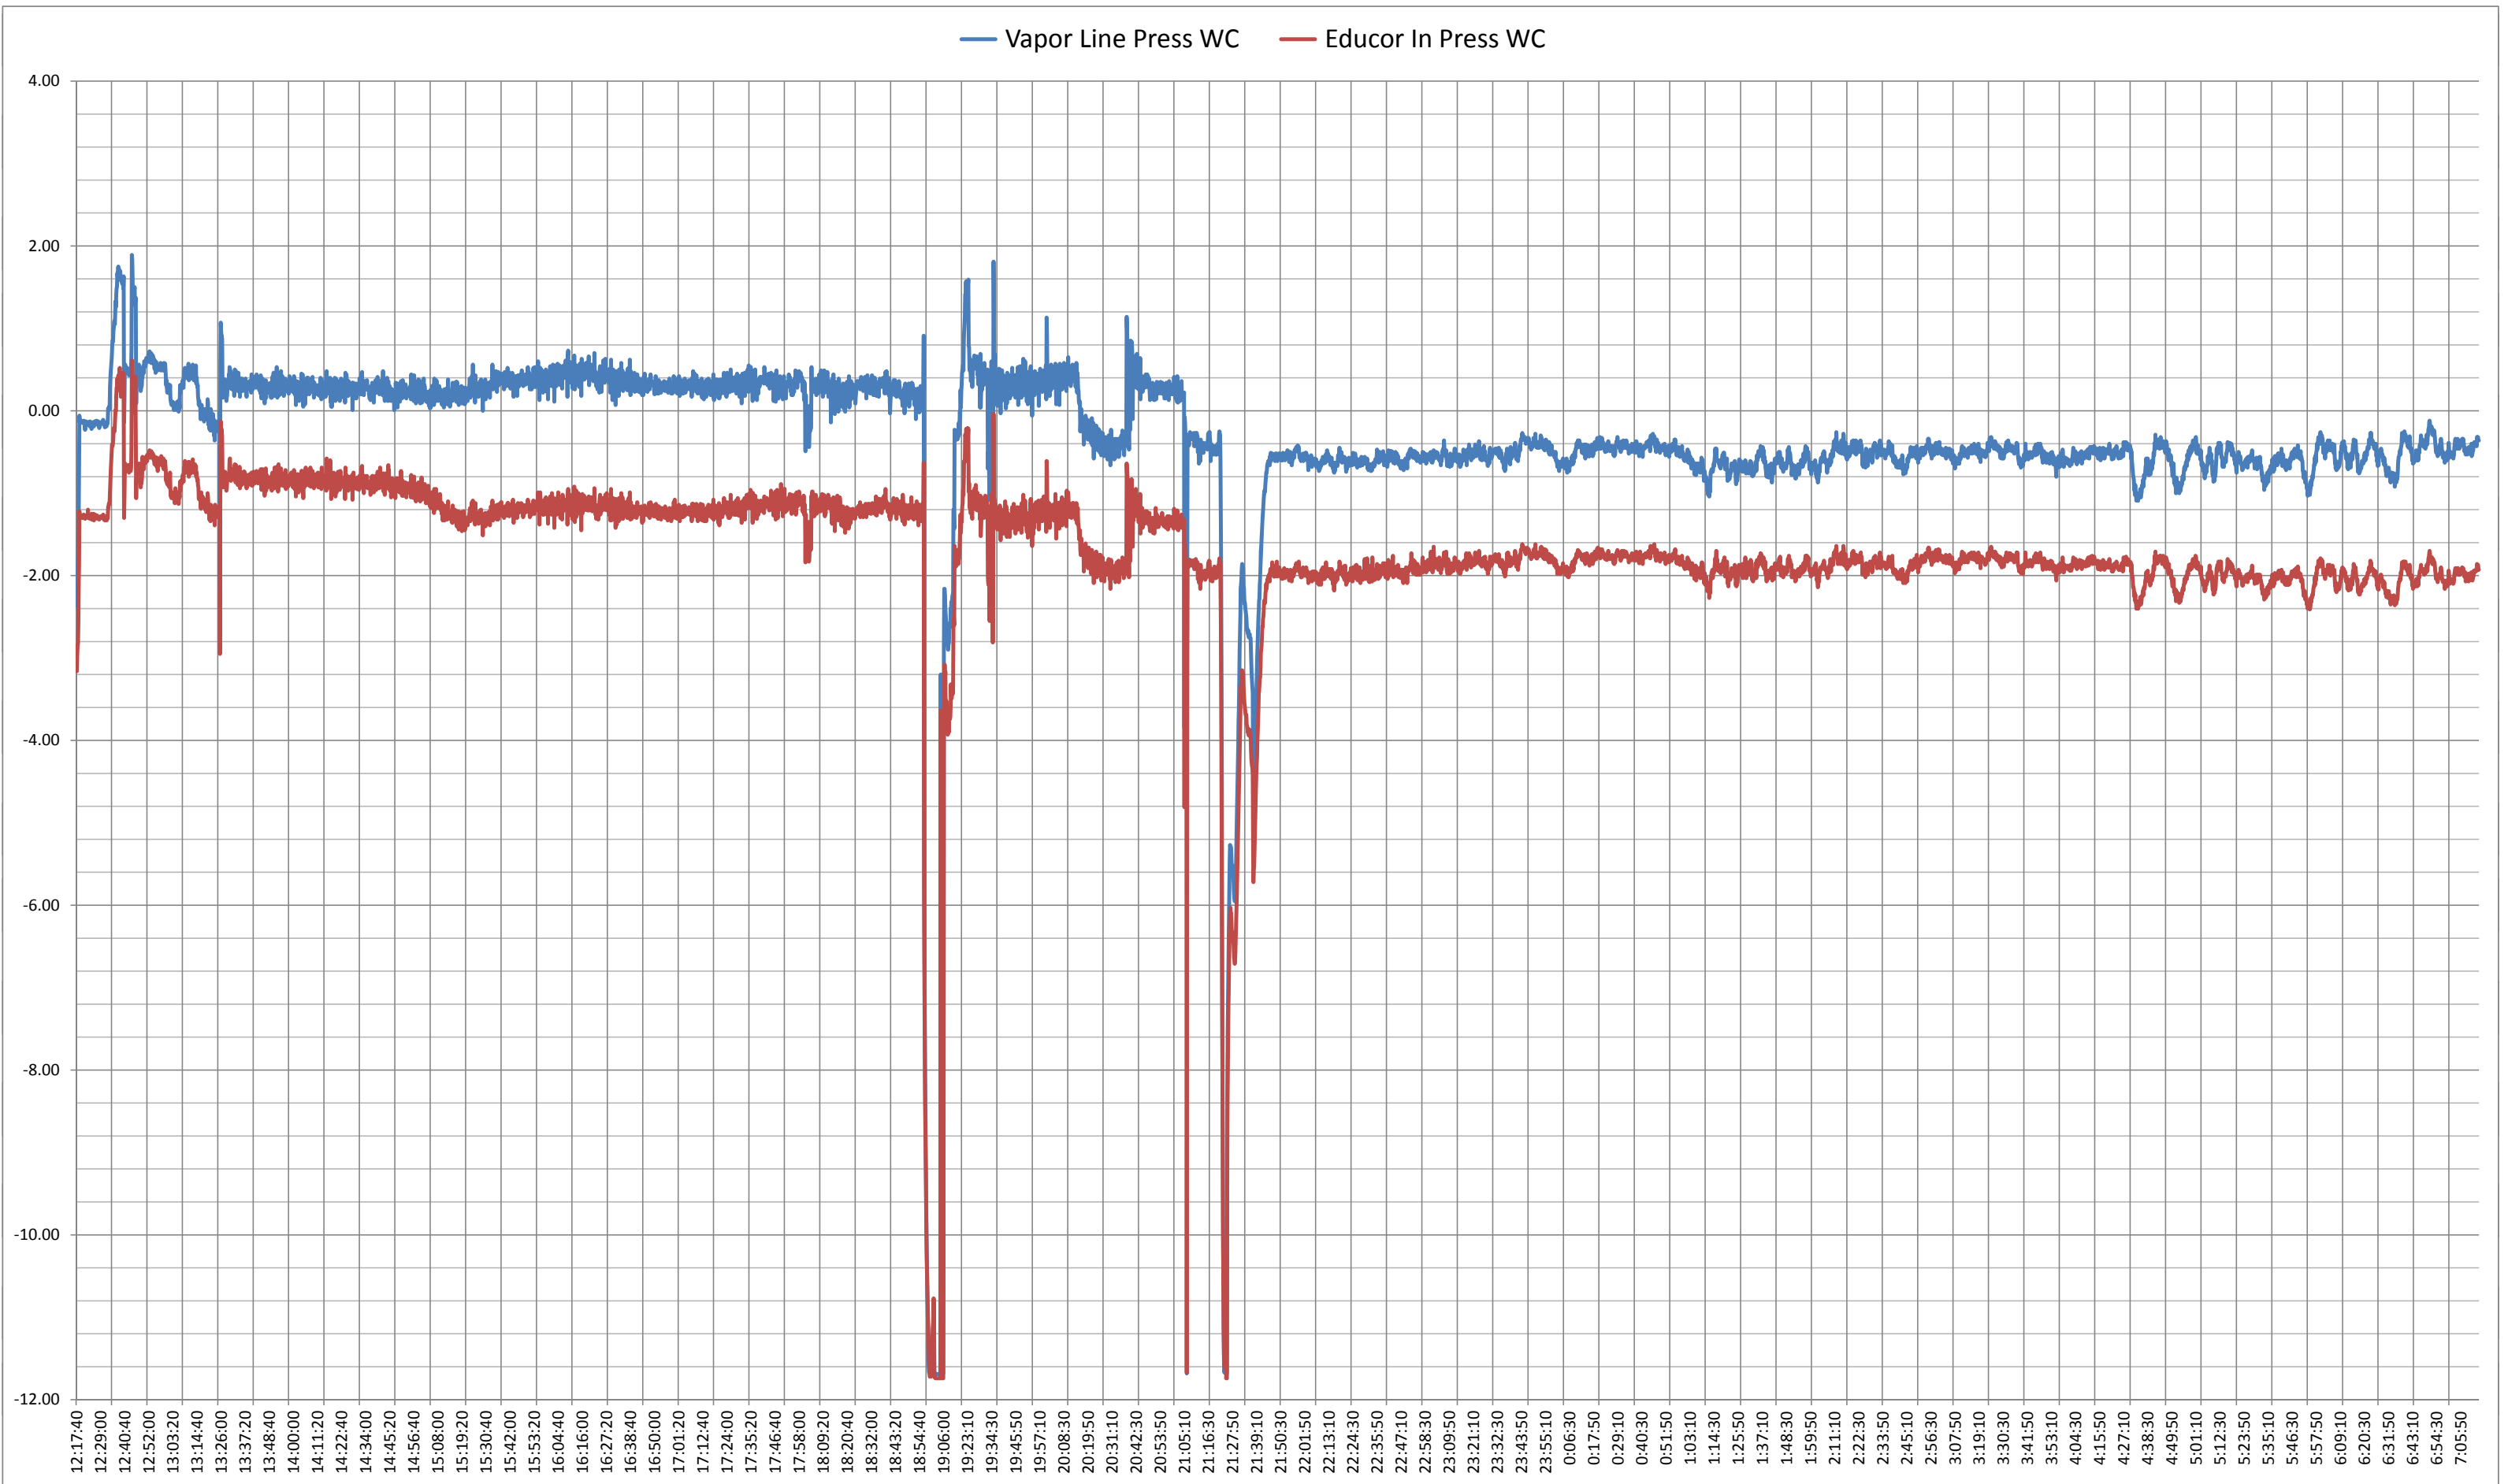
Pressure Trend Chart

Vapor Line Press WC Educor In Press WC

The pressure in the system is controlled by an educator/scrubber located on the top the condenser. Any issues with the flow of water to the educator, or with mechanical integrity of the educator will, cause a pressure excursion from the desired control point. The target for pressure was very slightly positive at the still (0 to 1” WC) and very slightly negative at the educator (0 to -1” WC). Runs 3, 9 and 12 were run with essentially no pressure excursions. The excursions that did occur during any of the runs were not expected to have had any adverse effects on the process or product quality. Controlling the process pressure is done to manage the risk of oxygen getting into the system or phosphorus getting out of the system.

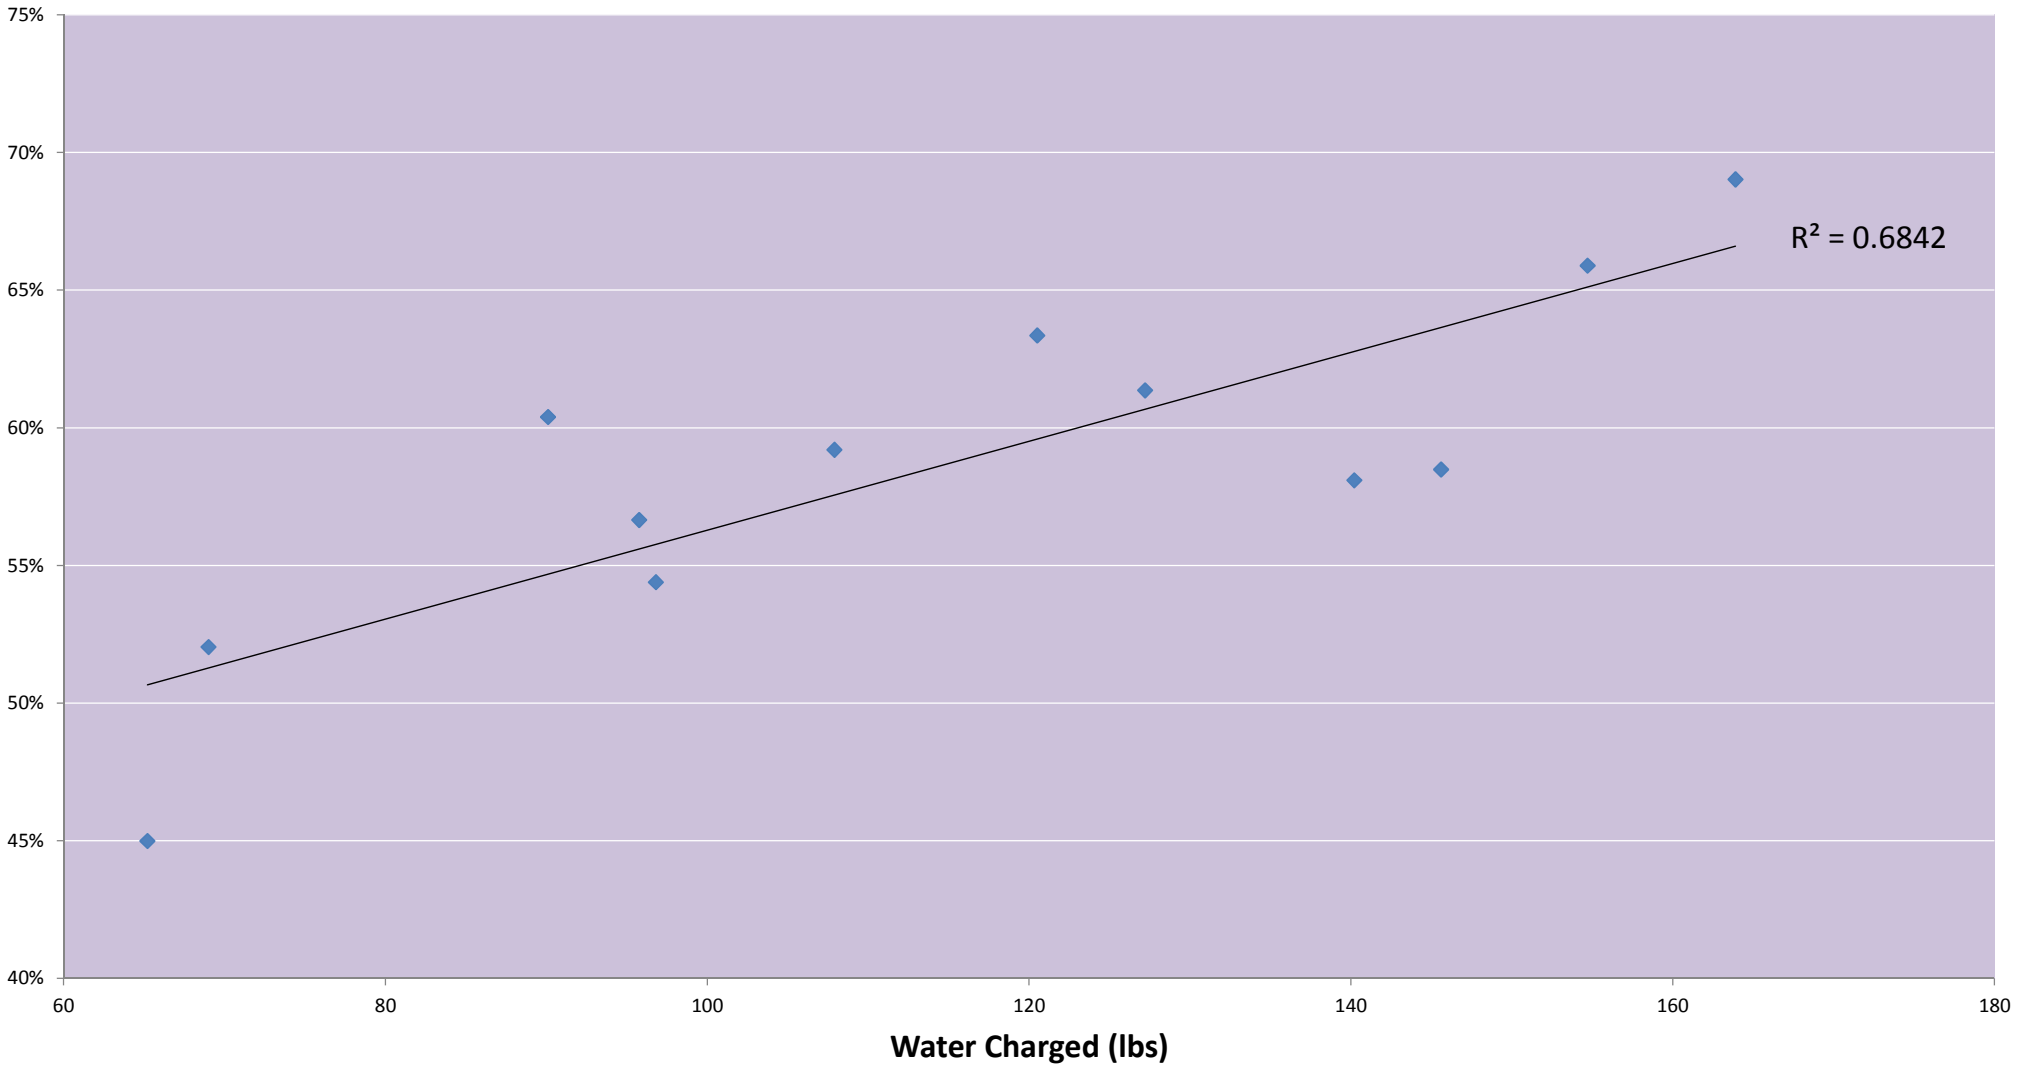
# PER CENT PROCESS ENERGY AS WATER vs. WATER CHARGED (lbs)

◆ % Process Energy as H2O

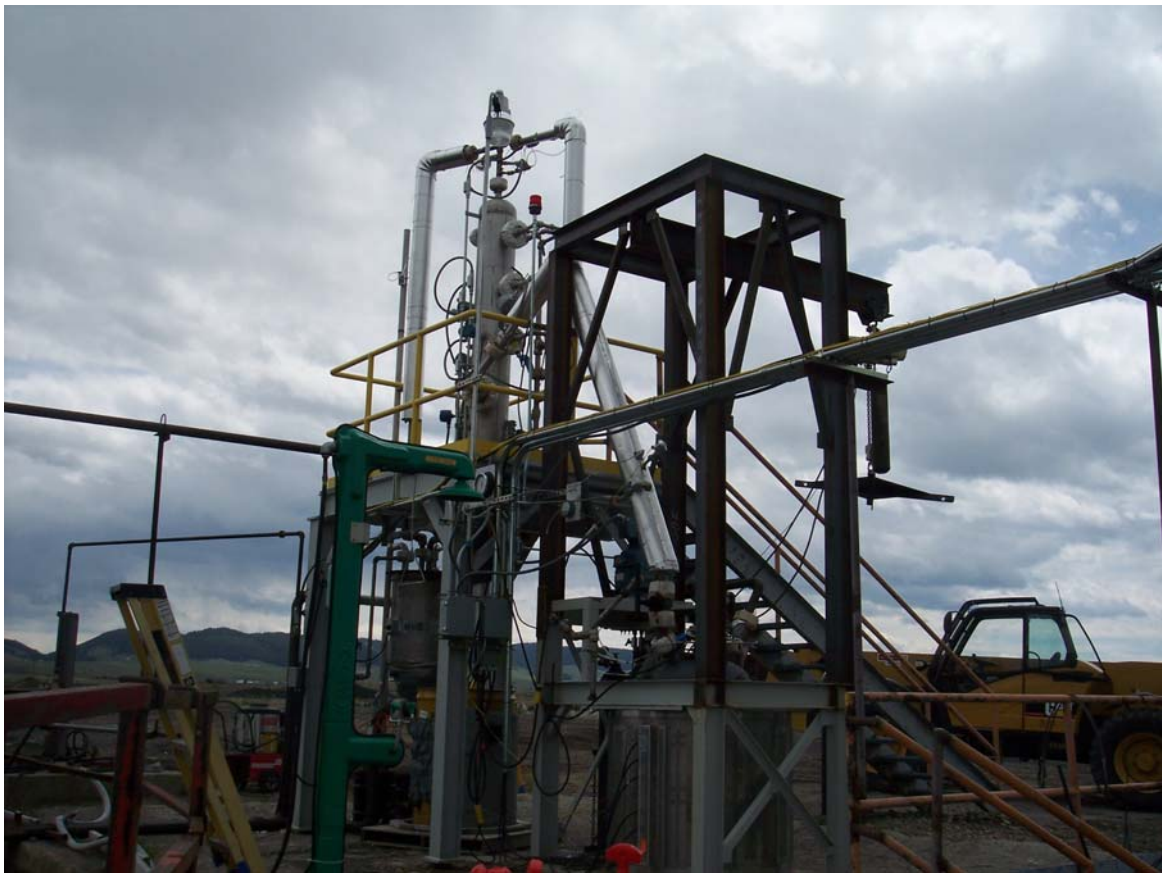
General Pilot Plant Arrangement

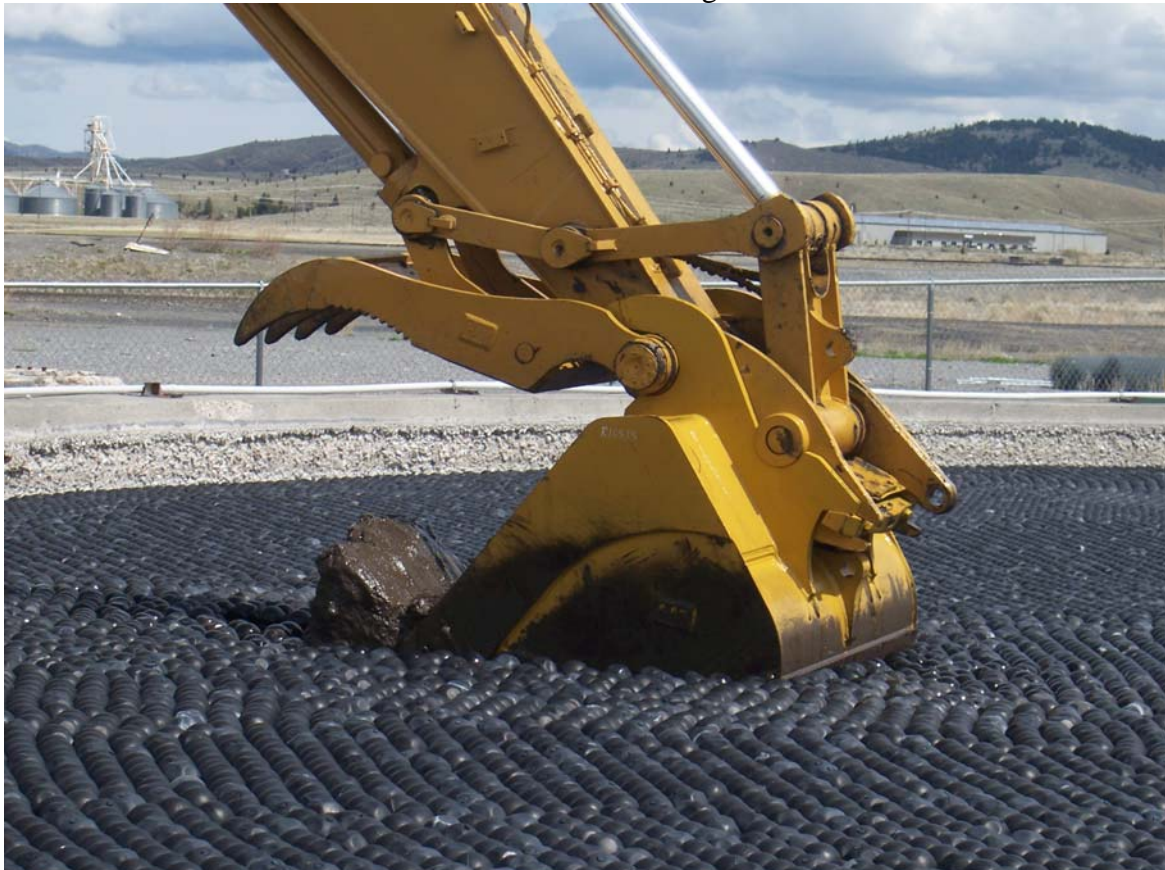
Trackhoe Sampling the Clarifier

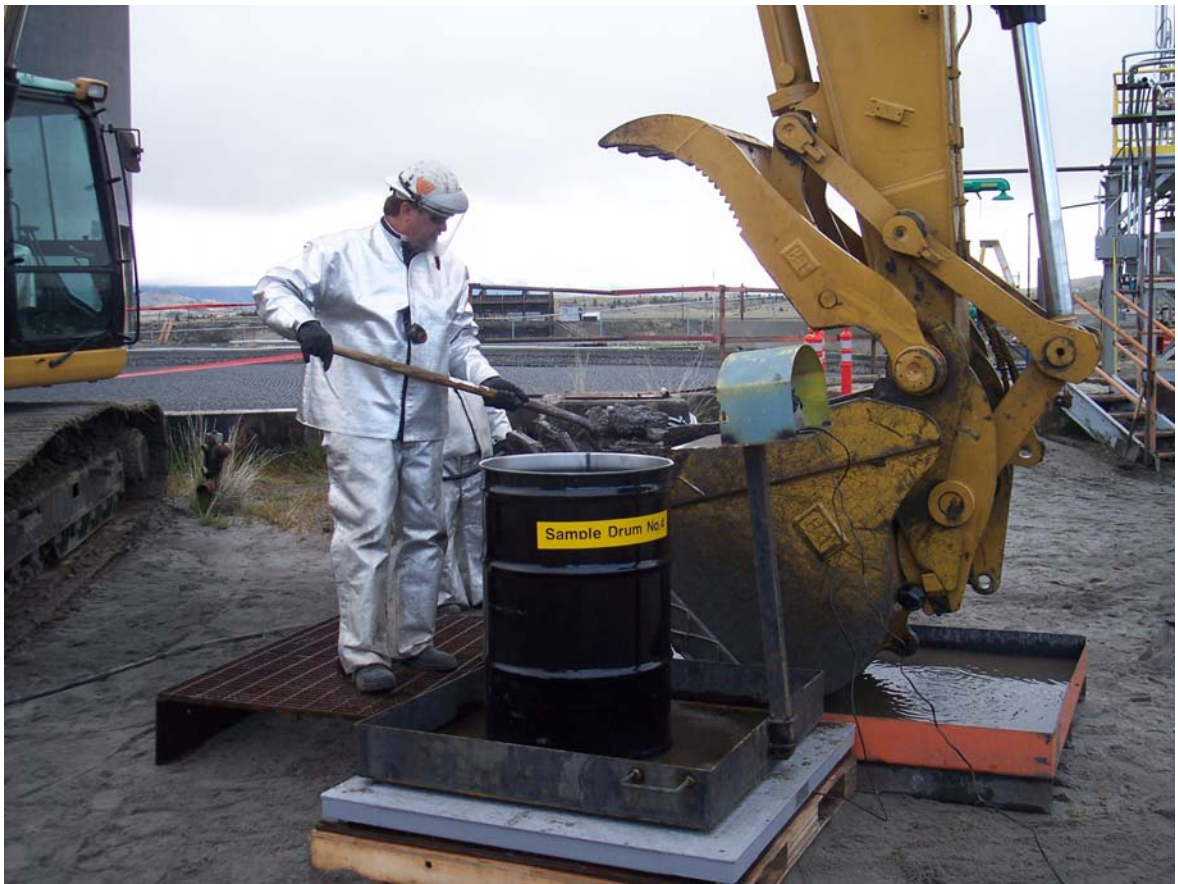
Loading the Sample Drum

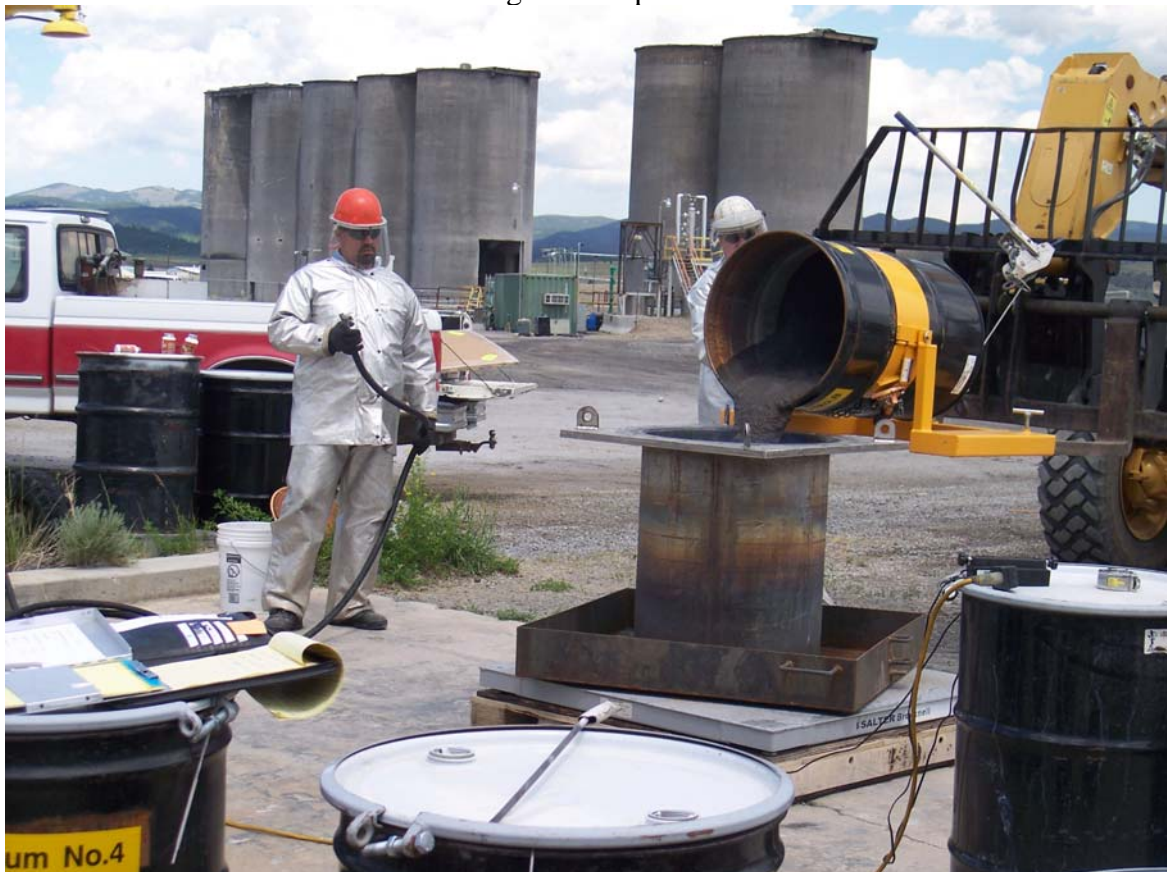
Loading the Still

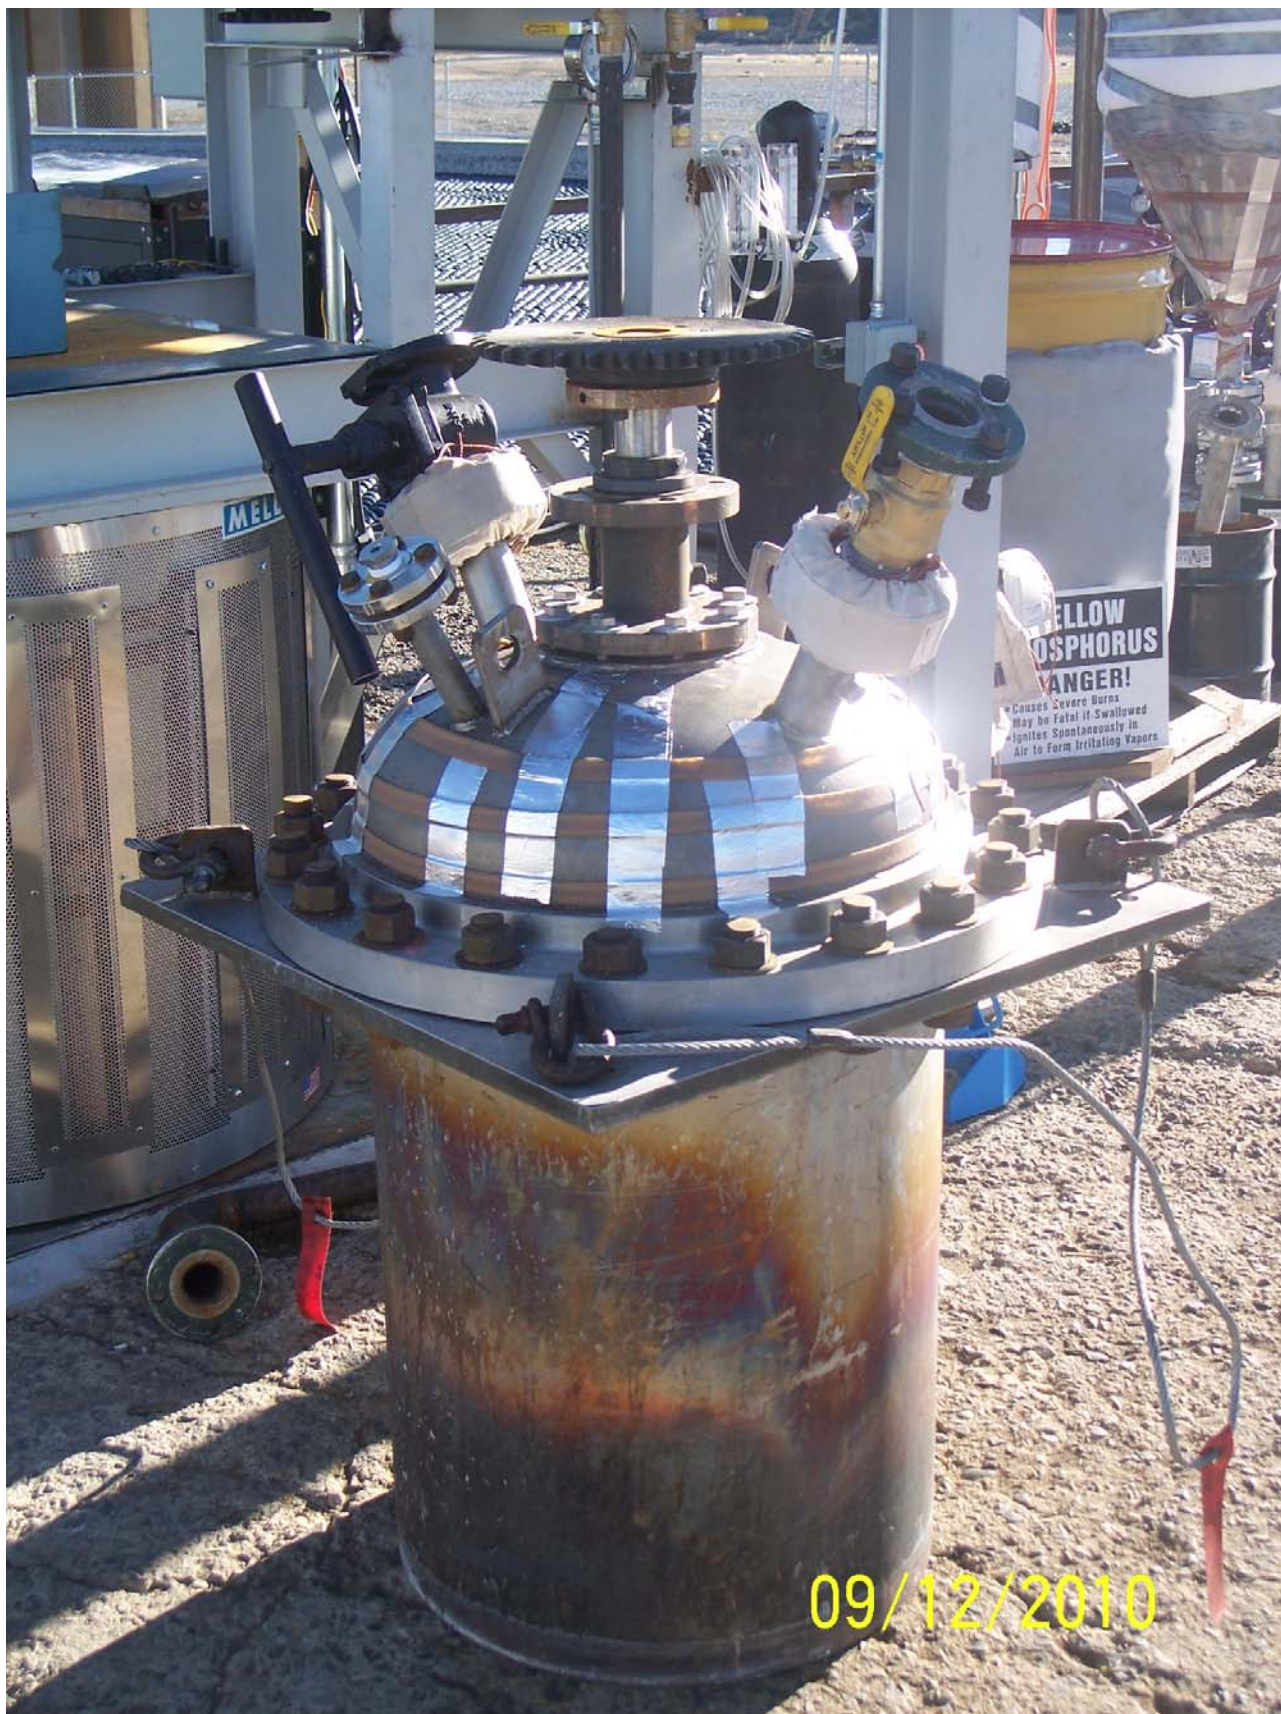
Loaded Still Ready to be Placed in Furnace

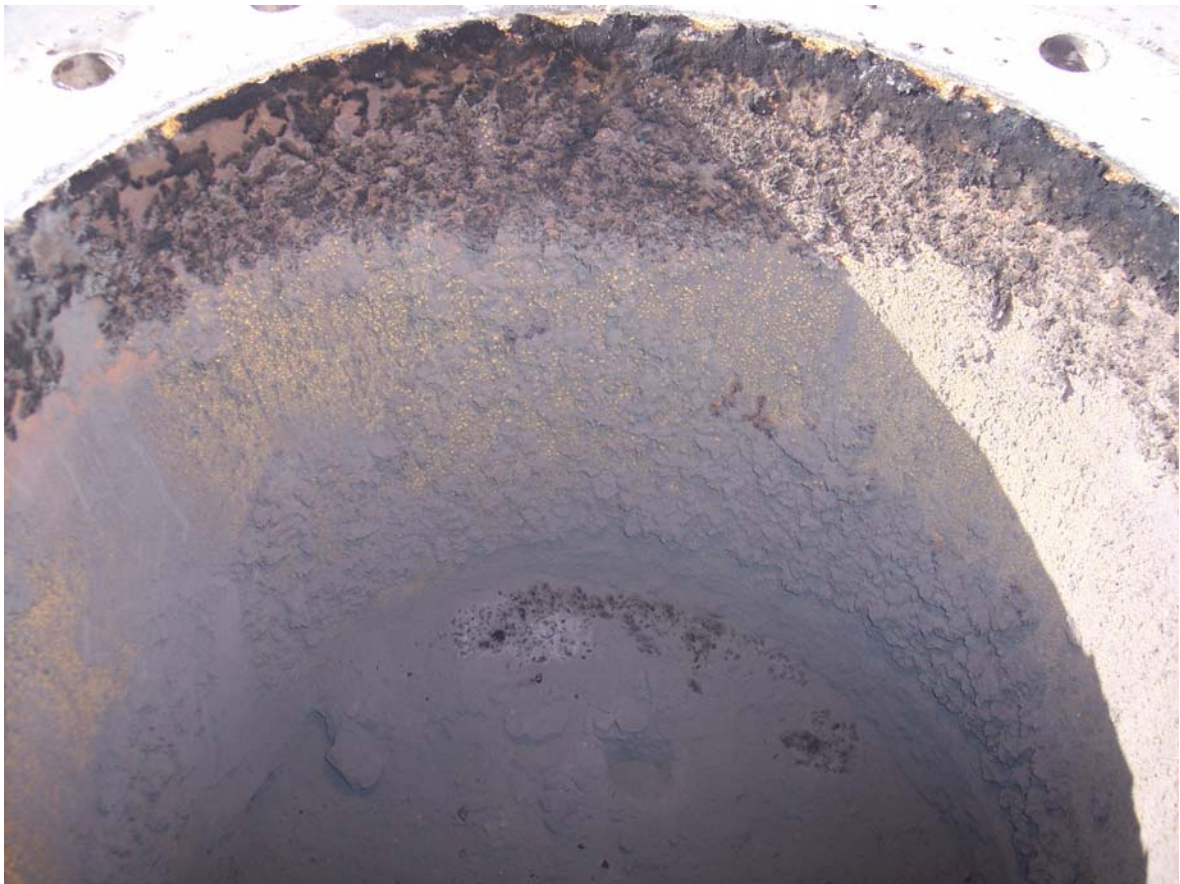
Residue in Still after Completed Batch

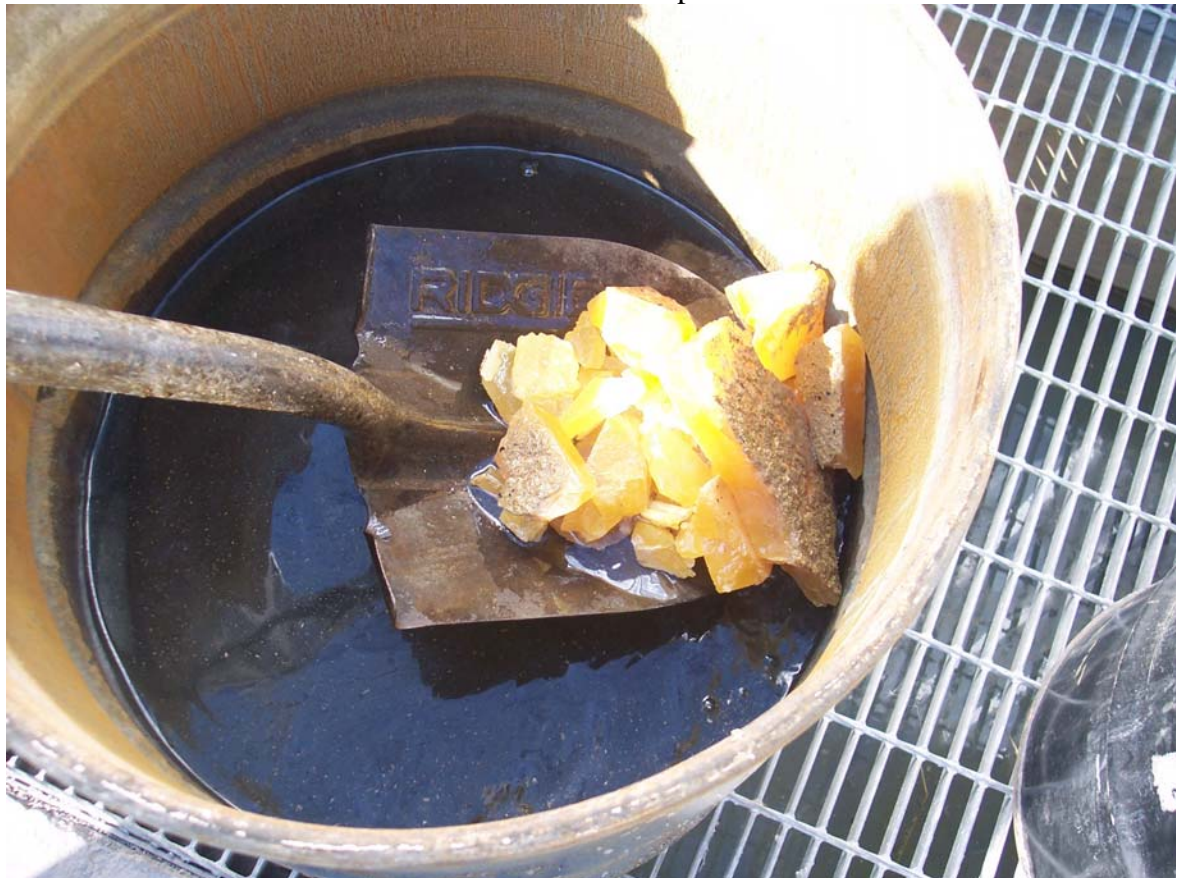
Recovered P4
