Evaluation of Remedy Resilience at Superfund NPL and SAA Sites

Remedy Resilience at Superfund NPL and SAA Sites: Analysis of 2017 Hurricane Season

Office of Land and Emergency Management
Final August 2018

Final Report

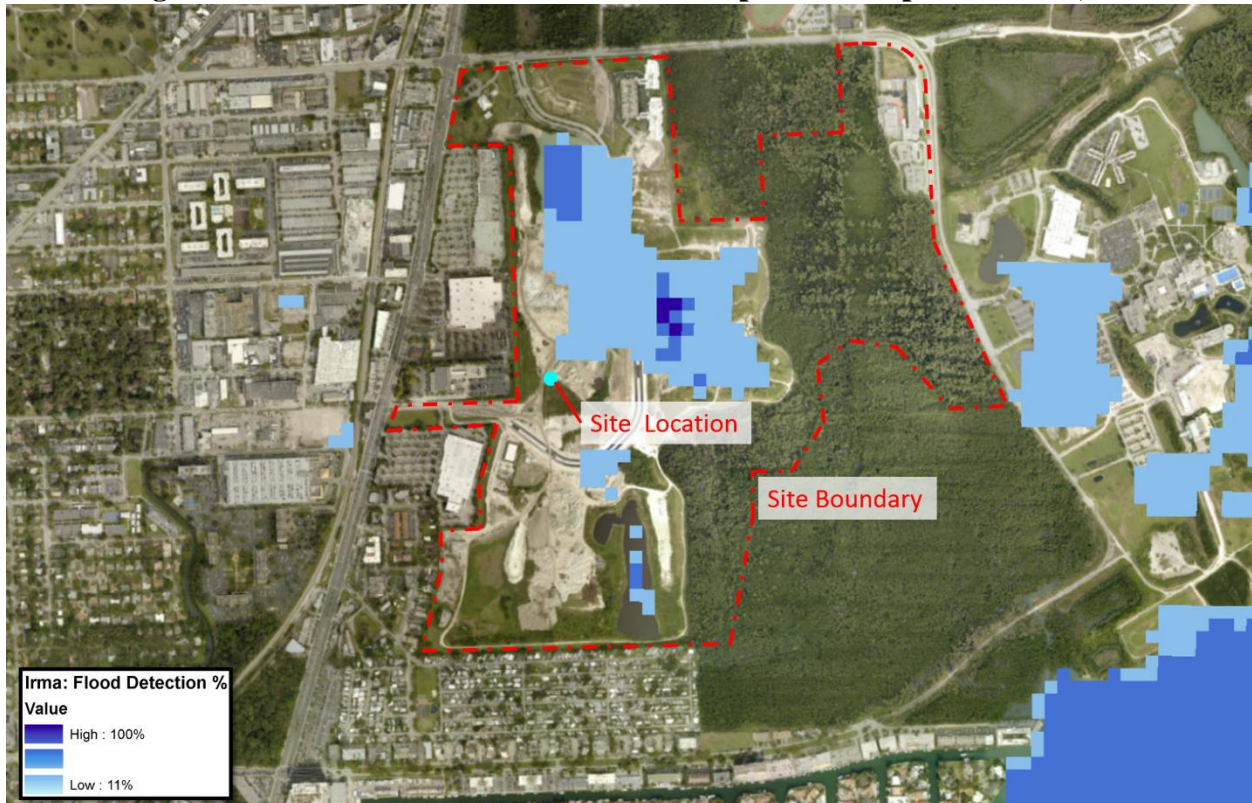
Figure 8. FEMA Flood Detection Percent Map for Munisport Landfill, FL

The FEMA Flood Detection Maps were added as layers onto the site location map. Because the site locations are single-point latitude and longitude coordinates, a distance of 0.2 miles from that point was used as the estimated site boundary. A site was categorized as flooded if any flooding was identified within the estimated site boundary. If the site type and imagery suggested a larger or smaller site boundary, the site boundary was modified accordingly. The site boundary provided in a site decision document was used in a small number of cases. In this way, the frequency of flooding and the extent of flooding was taken into account. In Figure 8, the single point for Munisport Landfill is not shown as flooded, but within the site boundary there are areas where flooding was observed. Therefore, this site was categorized as flooded.

- Location of single-point coordinate and site boundary for Munisport Landfill in relation to FEMA Flood Detection Percent.
