**US ARMY CORPS OF ENGINEERS**  
**NEW ENGLAND DISTRICT**  
Total Environmental Restoration Contract  
USACE Contract Number: DACW33-03-D-0006  
Task Order No. 0001

**AFTER-ACTION REPORT**  
**2004 NEW BEDFORD HARBOR**  
**REMEDIAL ACTION**  
New Bedford Harbor Superfund Site  
New Bedford, MA

November 2005

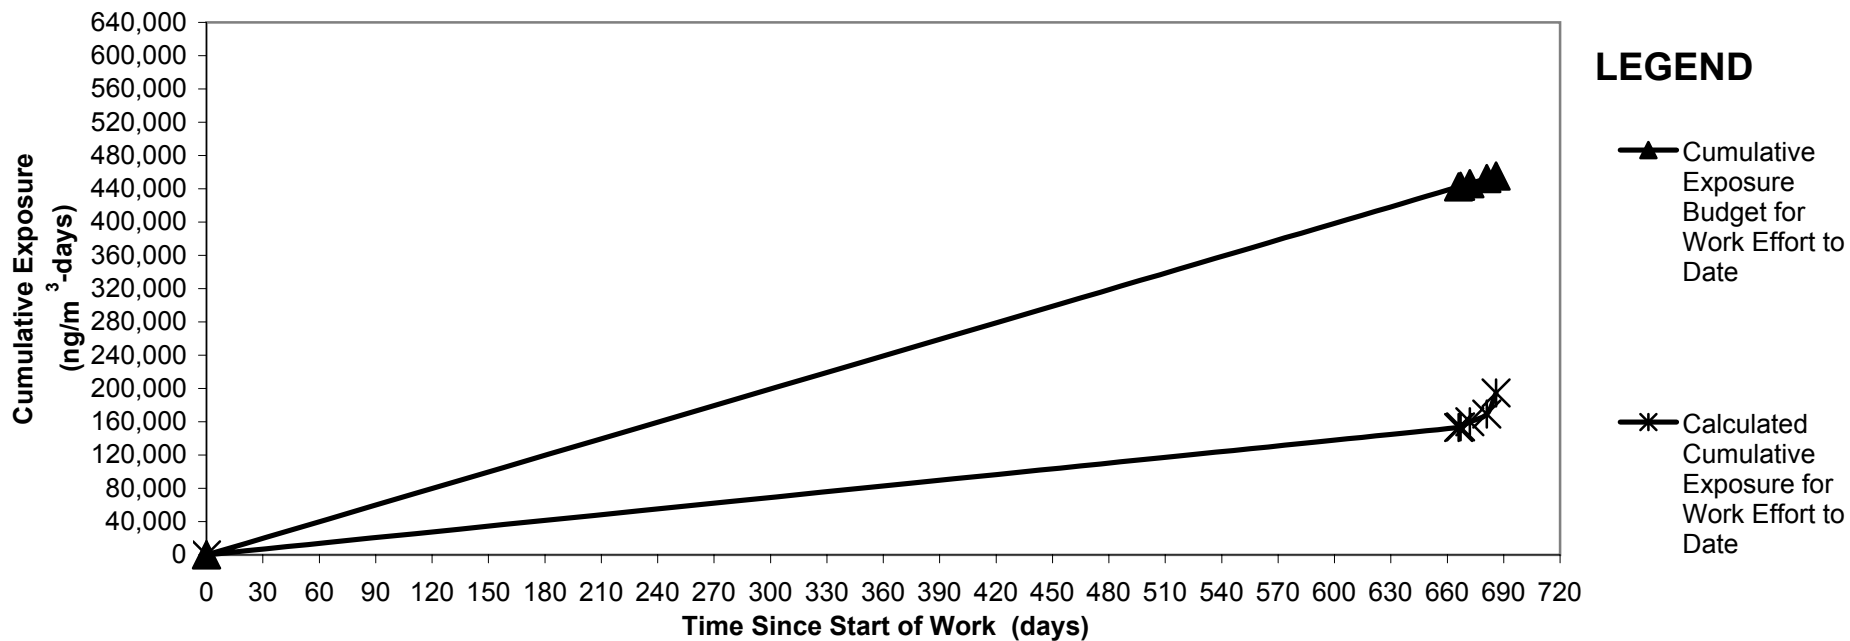
**Cumulative Exposure Tracking Comparison of Measured Values to the Health-Based Budget  
New Bedford Harbor DMU-2 Remediation Work Effort**

C5, C6, C5&C7, C1, C2, and C3 concentration triggers were identified during this sampling period. These triggering conditions indicate a low response level with the response being to evaluate the cause and significance of the triggering conditions. The higher total PCB concentration observed at the sampling station during this period was probably caused by a combination of the higher ambient temperature, calm winds directed toward the station and a relatively high background concentration. Additionally, negative low tides and large areas of floating oils probably contributed to the higher ambient concentrations. In response to this situation, additional measures to control surface oil were implemented by adding oil booms around the perimeter of the dredge and additional surface skimming by dragging oil boom by boat.

**Sample Station :** 24 Aerovox  
**Collection Date:** 9/28/2004  
**Measured PCB Concentration (ng/m<sup>3</sup>):** 9557  
**Exposure Budget Expended During This Period:** 763.9%  
**Cumulative Exposure Budget Expended to Date:** 42.7%  
**Response Level:** LOW  
**Response:** Evaluate the Cause and Significance of the Triggering Conditions

- Trigger C5: Measured Concentration Exceeds the Annual Average Background Concentration by more than 200%
- Trigger C6: Previous Two Measured Concentrations Exceed the Running Average Concentration
- Trigger C5 and Trigger C7: C5: Measured Concentration Exceeds the Annual Average Background Concentration by more than 200%; C7: Measured Concentration has Doubled Since the Last Monitoring Period
- Trigger C1: Measured Concentration Exceeds Maximum Occupational Limit
- Trigger C2: Measured Concentration Exceeds Minimum TEL/NTEL for a Worker in the Public
- Trigger C3: Measured Concentration Exceeds the Risk-Based Exposure Point Concentration Forming

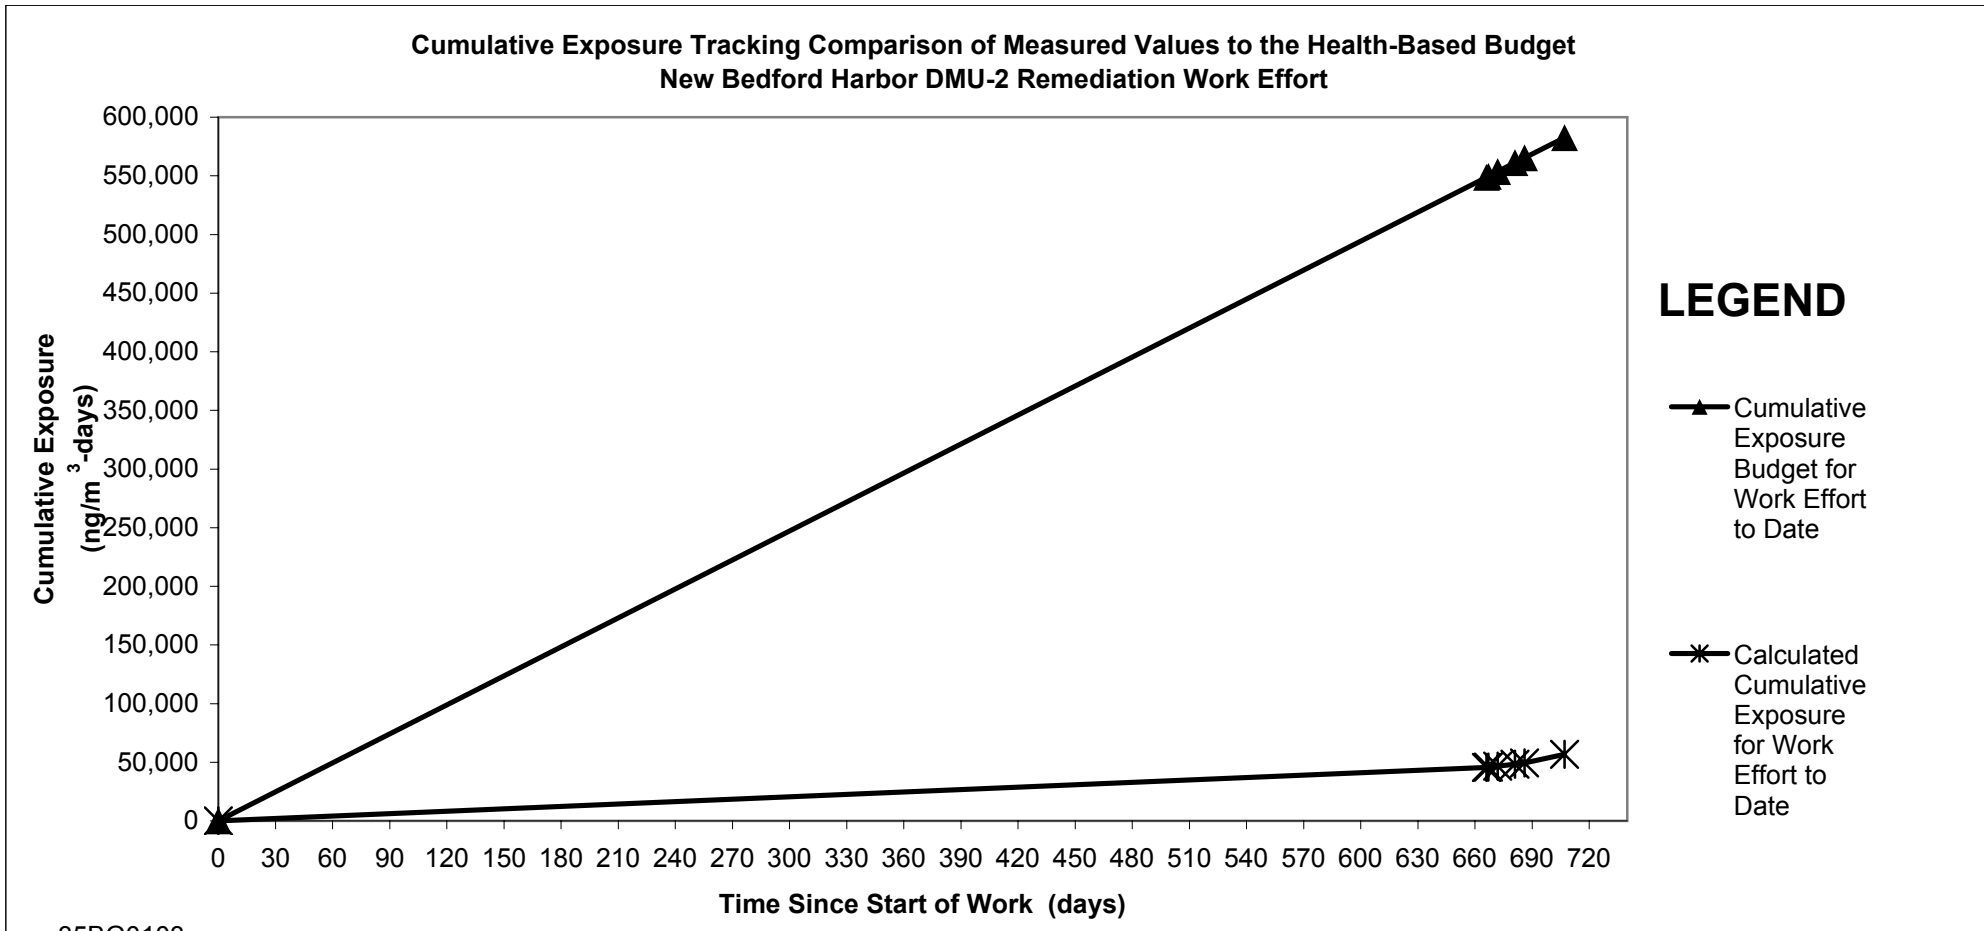
The C5 and C6 concentration triggers were identified during this sampling period. These triggering conditions indicate a low response level with the response being to evaluate the cause and significance of the triggering conditions. The higher total PCB concentration observed at the sampling station during this period was probably caused by a combination of the higher ambient temperature, calm winds directed toward the station and a relatively high background concentration. Since the expenditure of the cumulative exposure budget to date was still at a low level at this point in the project, no change in field procedures is warranted.

Sample Station : 25 Cliftex  
Collection Date: 10/19/2004  
Measured PCB Concentration (ng/m<sup>3</sup>): 256  
Exposure Budget Expended During This Period: 41.2%  
Cumulative Exposure Budget Expended to Date: 9.7%  
Response Level: LOW  
Response: Evaluate the Cause and Significance of the Triggering Conditions

Trigger C5: Measured Concentration Exceeds the Annual Average Background Concentration by more than 200%

Trigger C6: Previous Two Measured Concentrations Exceed the Running Average

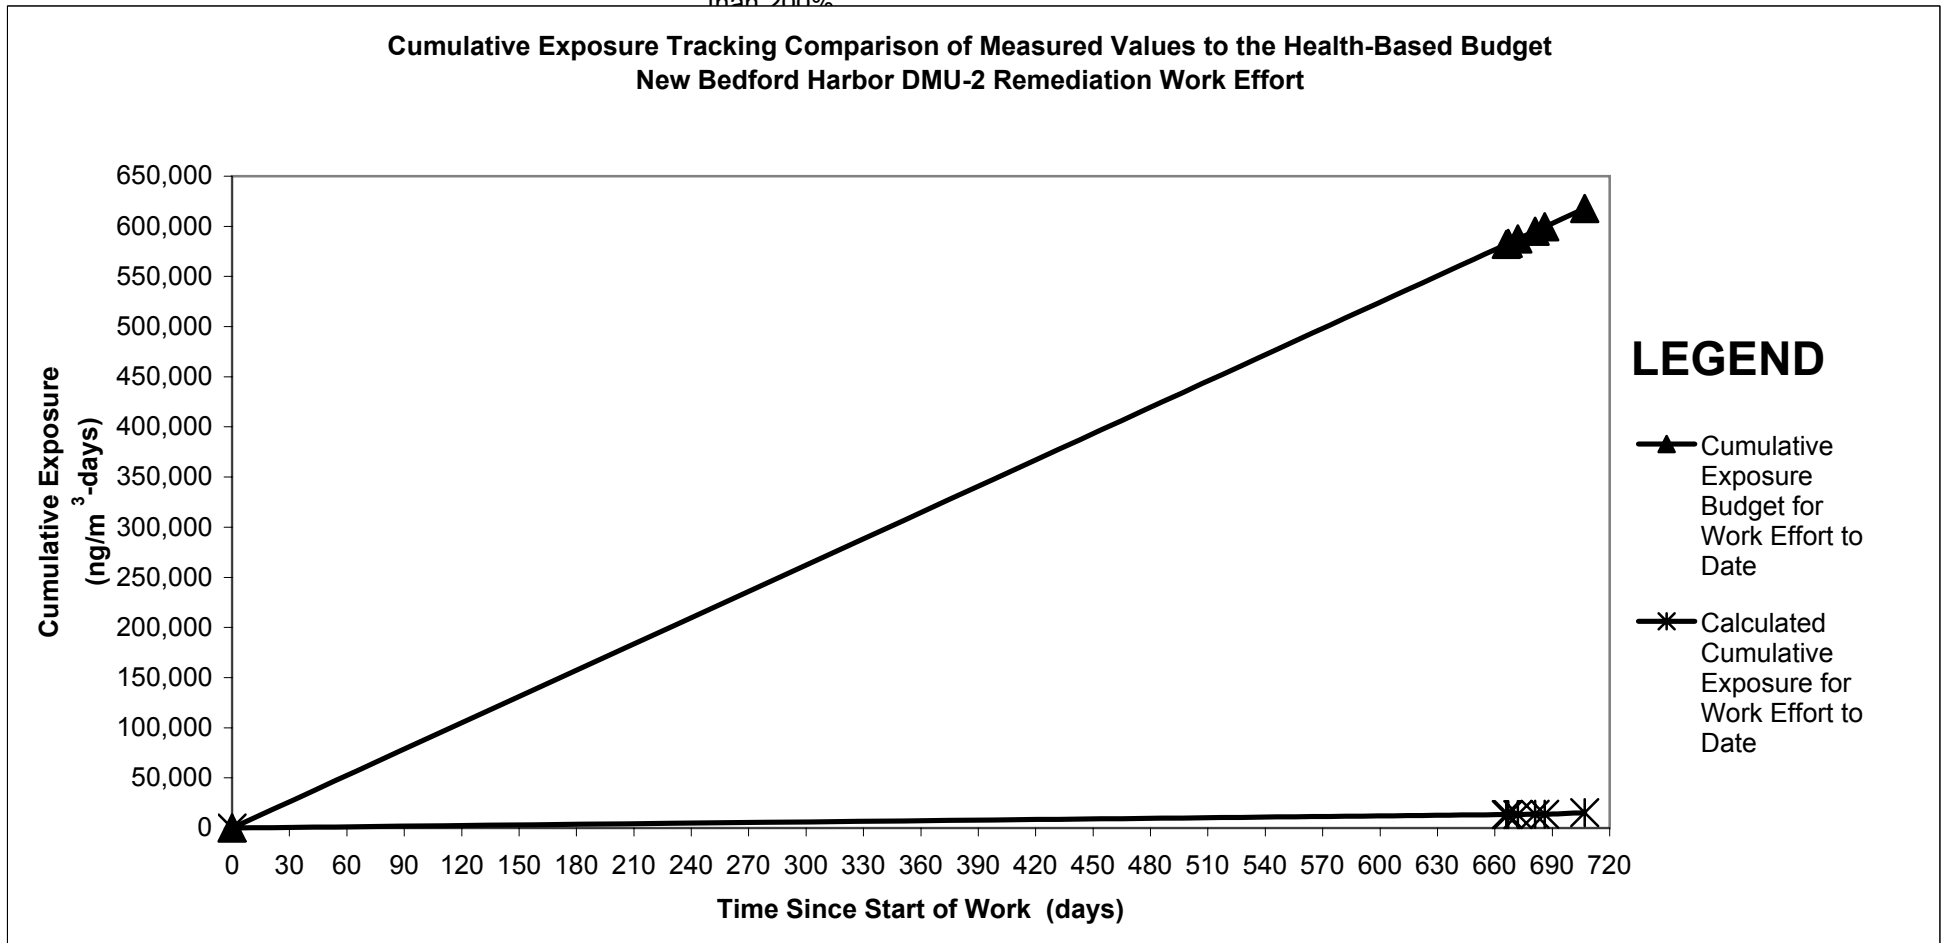
C5 and C6 concentration triggers were identified during this sampling period. These triggering conditions indicate a low response level with the response being to evaluate the cause and significance of the triggering conditions. The higher total PCB concentration observed at the sampling station during this period was probably caused by a combination of the higher ambient temperature, calm winds directed toward the station and a relatively high background concentration. Since the expenditure of the cumulative exposure budget to date was still at a low level at this point in the project, no change in field procedures is warranted.

**Sample Station :** 51 Area D Crosswind  
**Collection Date:** 10/19/2004  
**Measured PCB Concentration (ng/m<sup>3</sup>):** 74  
**Exposure Budget Expended During This Period:** 8.5%  
**Cumulative Exposure Budget Expended to Date:** 2.5%  
**Response Level:** LOW  
**Response:** Evaluate the Cause and Significance of the Triggering Conditions

Trigger C5: Measured Concentration Exceeds the Annual Average Background Concentration by more than 200%

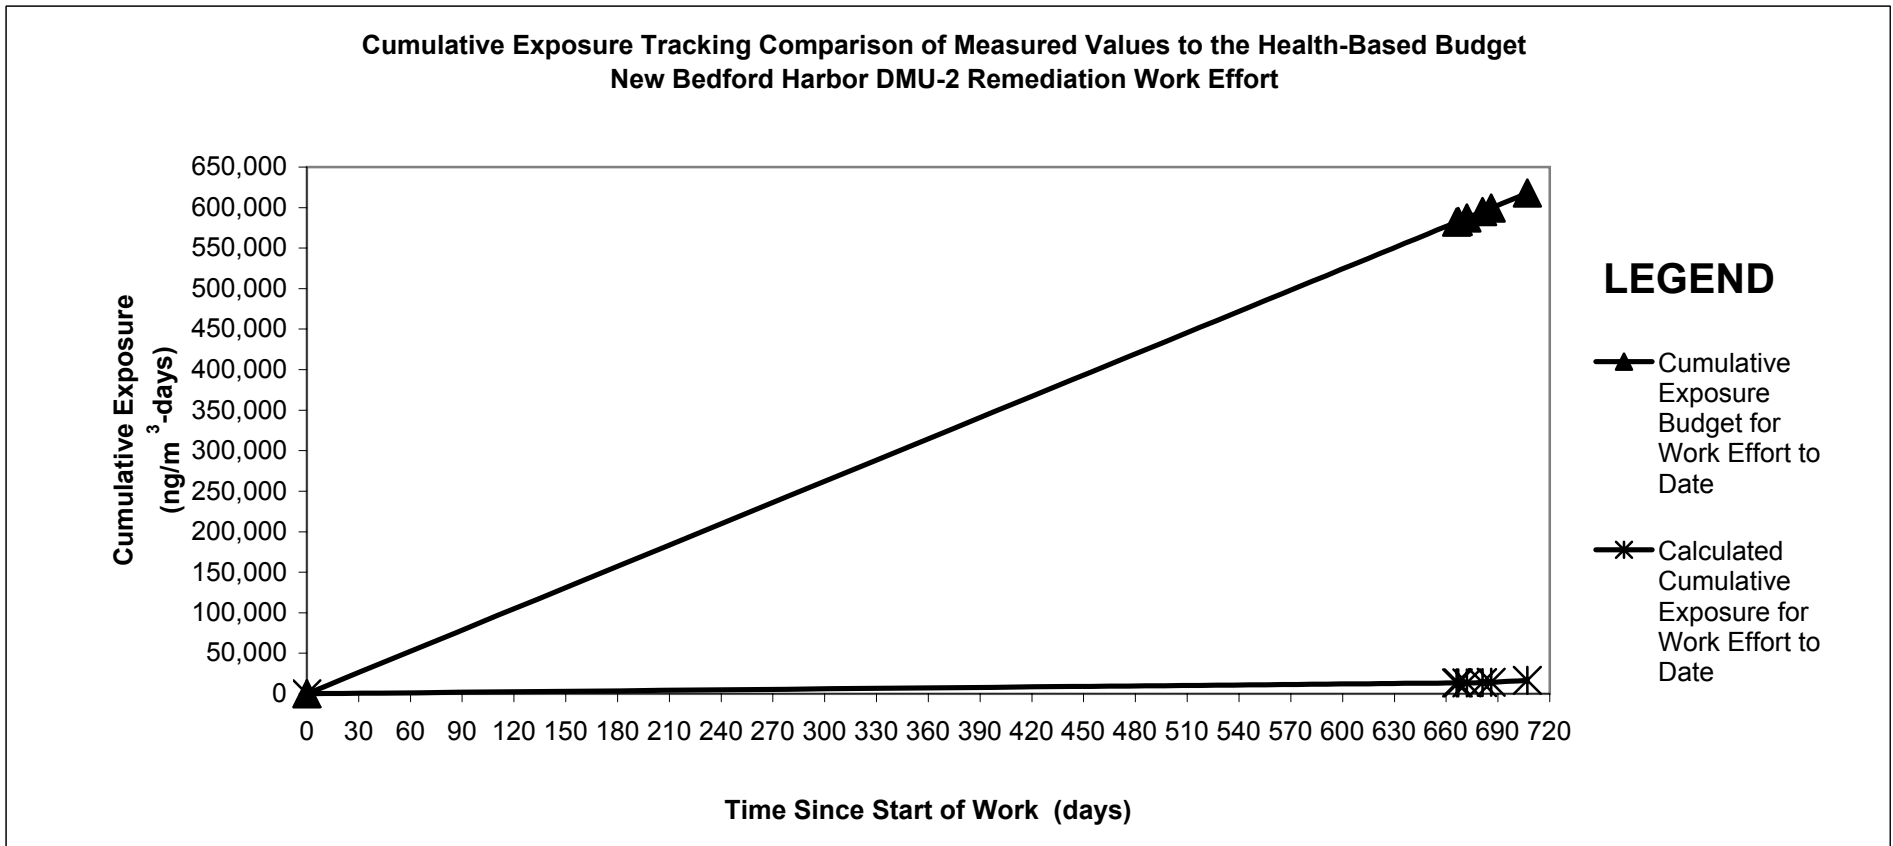
C5 and C6 concentration triggers were identified during this sampling period. These triggering conditions indicate a low response level with the response being to evaluate the cause and significance of the triggering conditions. The higher total PCB concentration observed at the sampling station during this period was probably caused by a combination of the higher ambient temperature, calm winds directed toward the station and a relatively high background concentration. Since the expenditure of the cumulative exposure budget to date was still at a low level at this point in the project, no change in field procedures is warranted.

**Sample Station :** 52 Area D Upwind  
**Collection Date:** 10/19/2004  
**Measured PCB Concentration (ng/m<sup>3</sup>):** 100  
**Exposure Budget Expended During This Period:** 12.3%  
**Cumulative Exposure Budget Expended to Date:** 2.7%  
**Response Level:** LOW  
**Response:** Evaluate the Cause and Significance of the Triggering Conditions

- Trigger C5: Measured Concentration Exceeds the Annual Average Background Concentration by more than 200%
- Trigger C6: Previous Two Measured Concentrations Exceed the Running Average Concentration

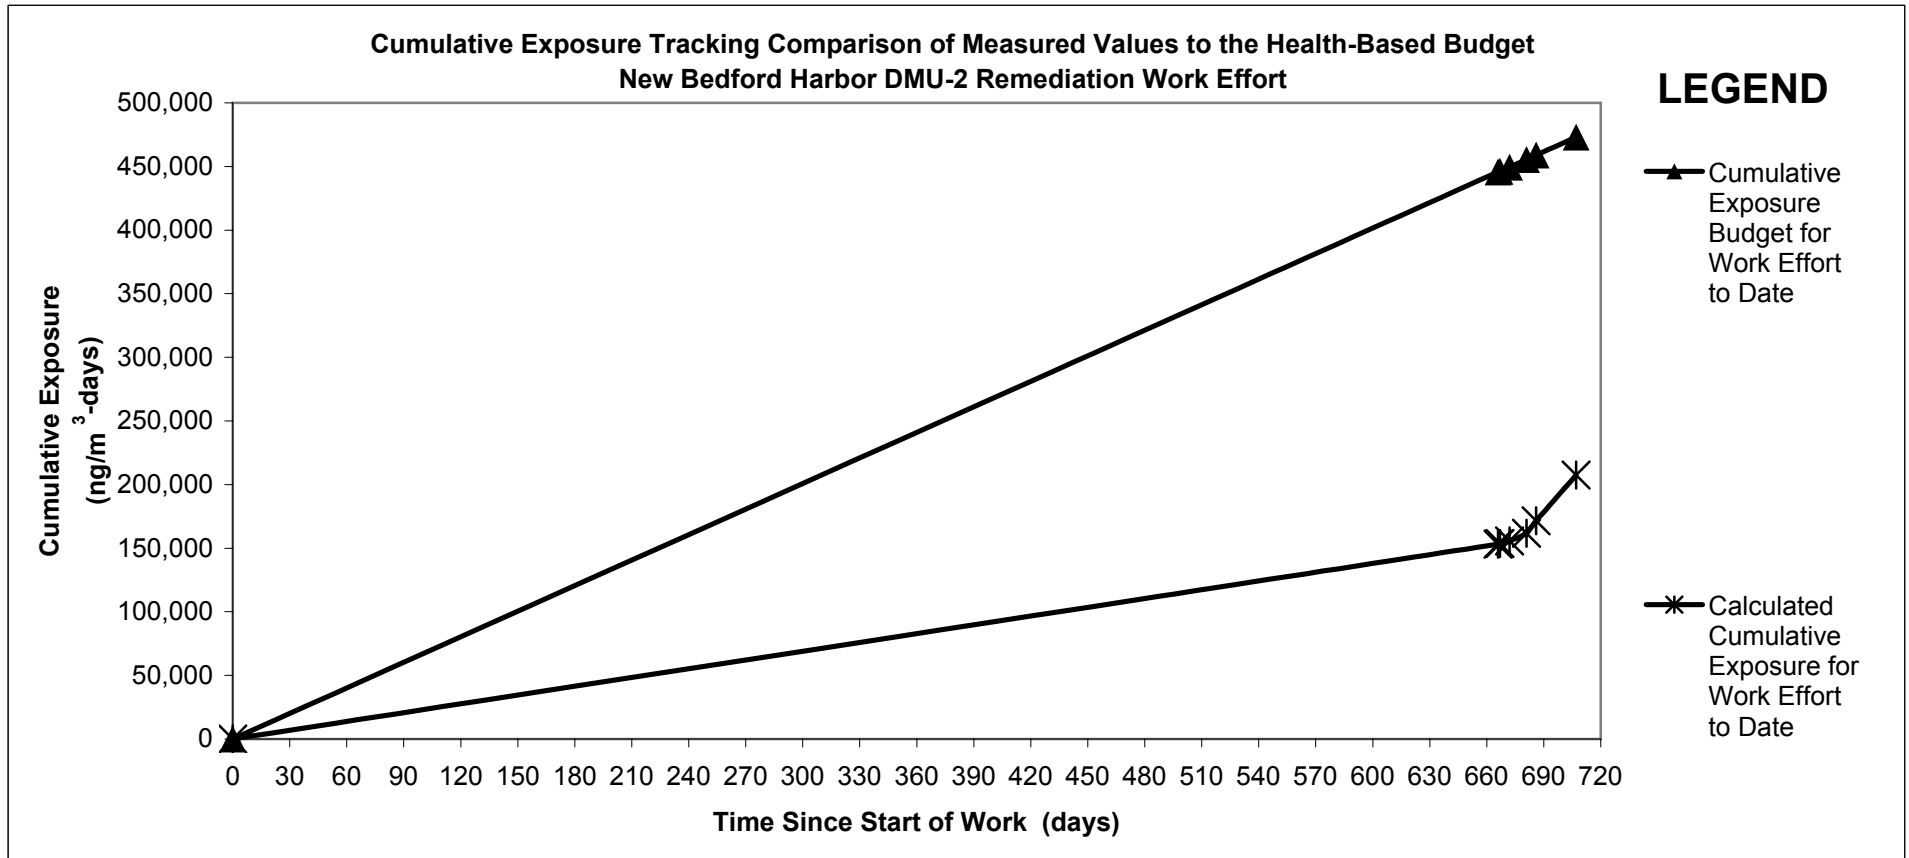
C5 and C6 concentration triggers were identified during this sampling period. These triggering conditions indicate a low response level with the response being to evaluate the cause and significance of the triggering conditions. The higher total PCB concentration observed at the sampling station during this period was probably caused by a combination of the higher ambient temperature, calm winds directed toward the station and a relatively high background concentration. Since the expenditure of the cumulative exposure budget to date was still at a low level at this point in the project, no change in field procedures is warranted.

**Sample Station :** 53 Dredge  
**Collection Date:** 10/19/2004  
**Measured PCB Concentration (ng/m<sup>3</sup>):** 704  
**Exposure Budget Expended During This Period:** 257.0%  
**Cumulative Exposure Budget Expended to Date:** 43.9%  
**Response Level:** LOW  
**Response:** Evaluate the Cause and Significance of the Triggering Conditions

Trigger C5: Measured Concentration Exceeds the Annual Average Background Concentration by more than 200%

Trigger C6: Previous Two Measured Concentrations Exceed the Running Average Concentration

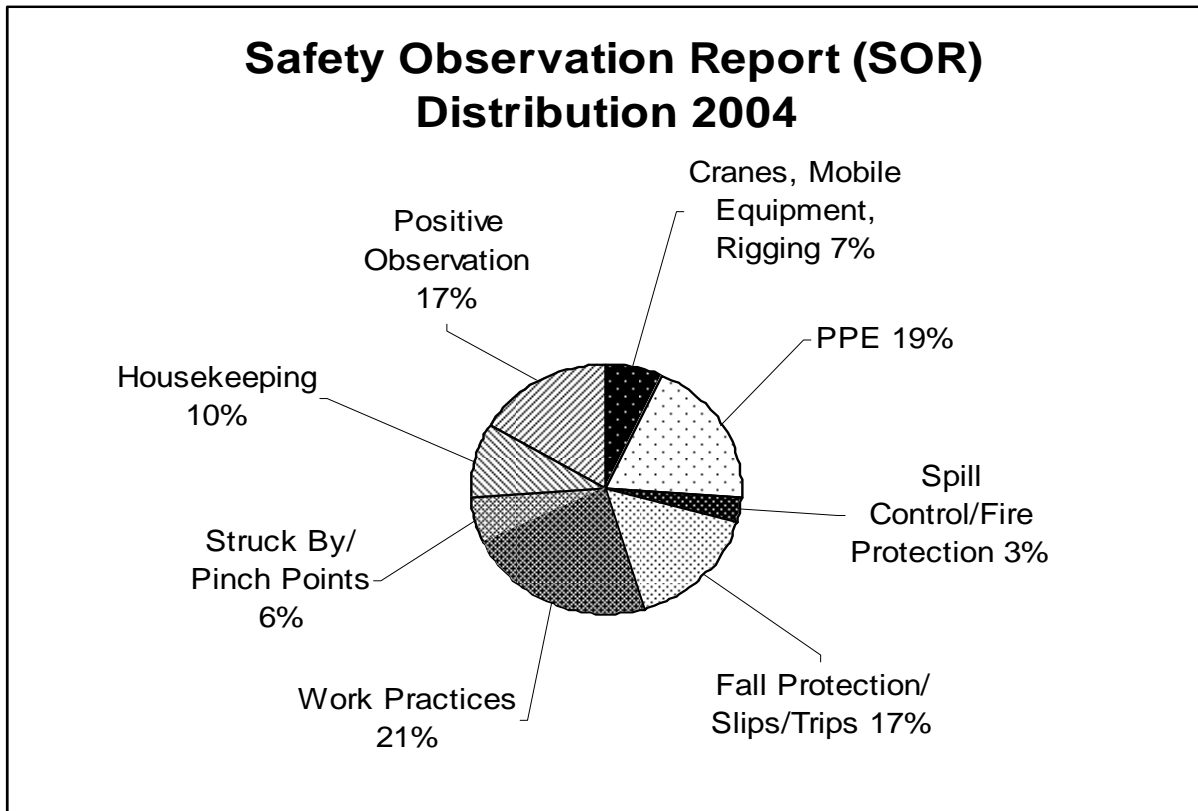
**Attachment K**  
**New Bedford Harbor Superfund Site 2004**  
**Health and Safety Statistics**

The Safety Observation Report (SOR) is a tool within the zero accident process that allows anyone on the Project to document identified unsafe conditions, unsafe acts or acknowledges good work practices. The second portion of the tool is to implement or recommend corrective measures as applicable. The chart below shows the distribution of SORs by observation for the 2004 season.
