Weekly Field Report
Week: 12-15-13 through 12-21-13
New Bedford Harbor Lower Harbor CAD Cell (LHCC)

This Weekly Field Report was prepared to serve as a summary of field activities conducted throughout the week for Phase I dredging of the New Bedford Harbor Lower Harbor CAD Cell (LHCC) in New Bedford, Massachusetts.

LOWER HARBOR CAD CELL PHASE I WATER QUALITY MONITORING

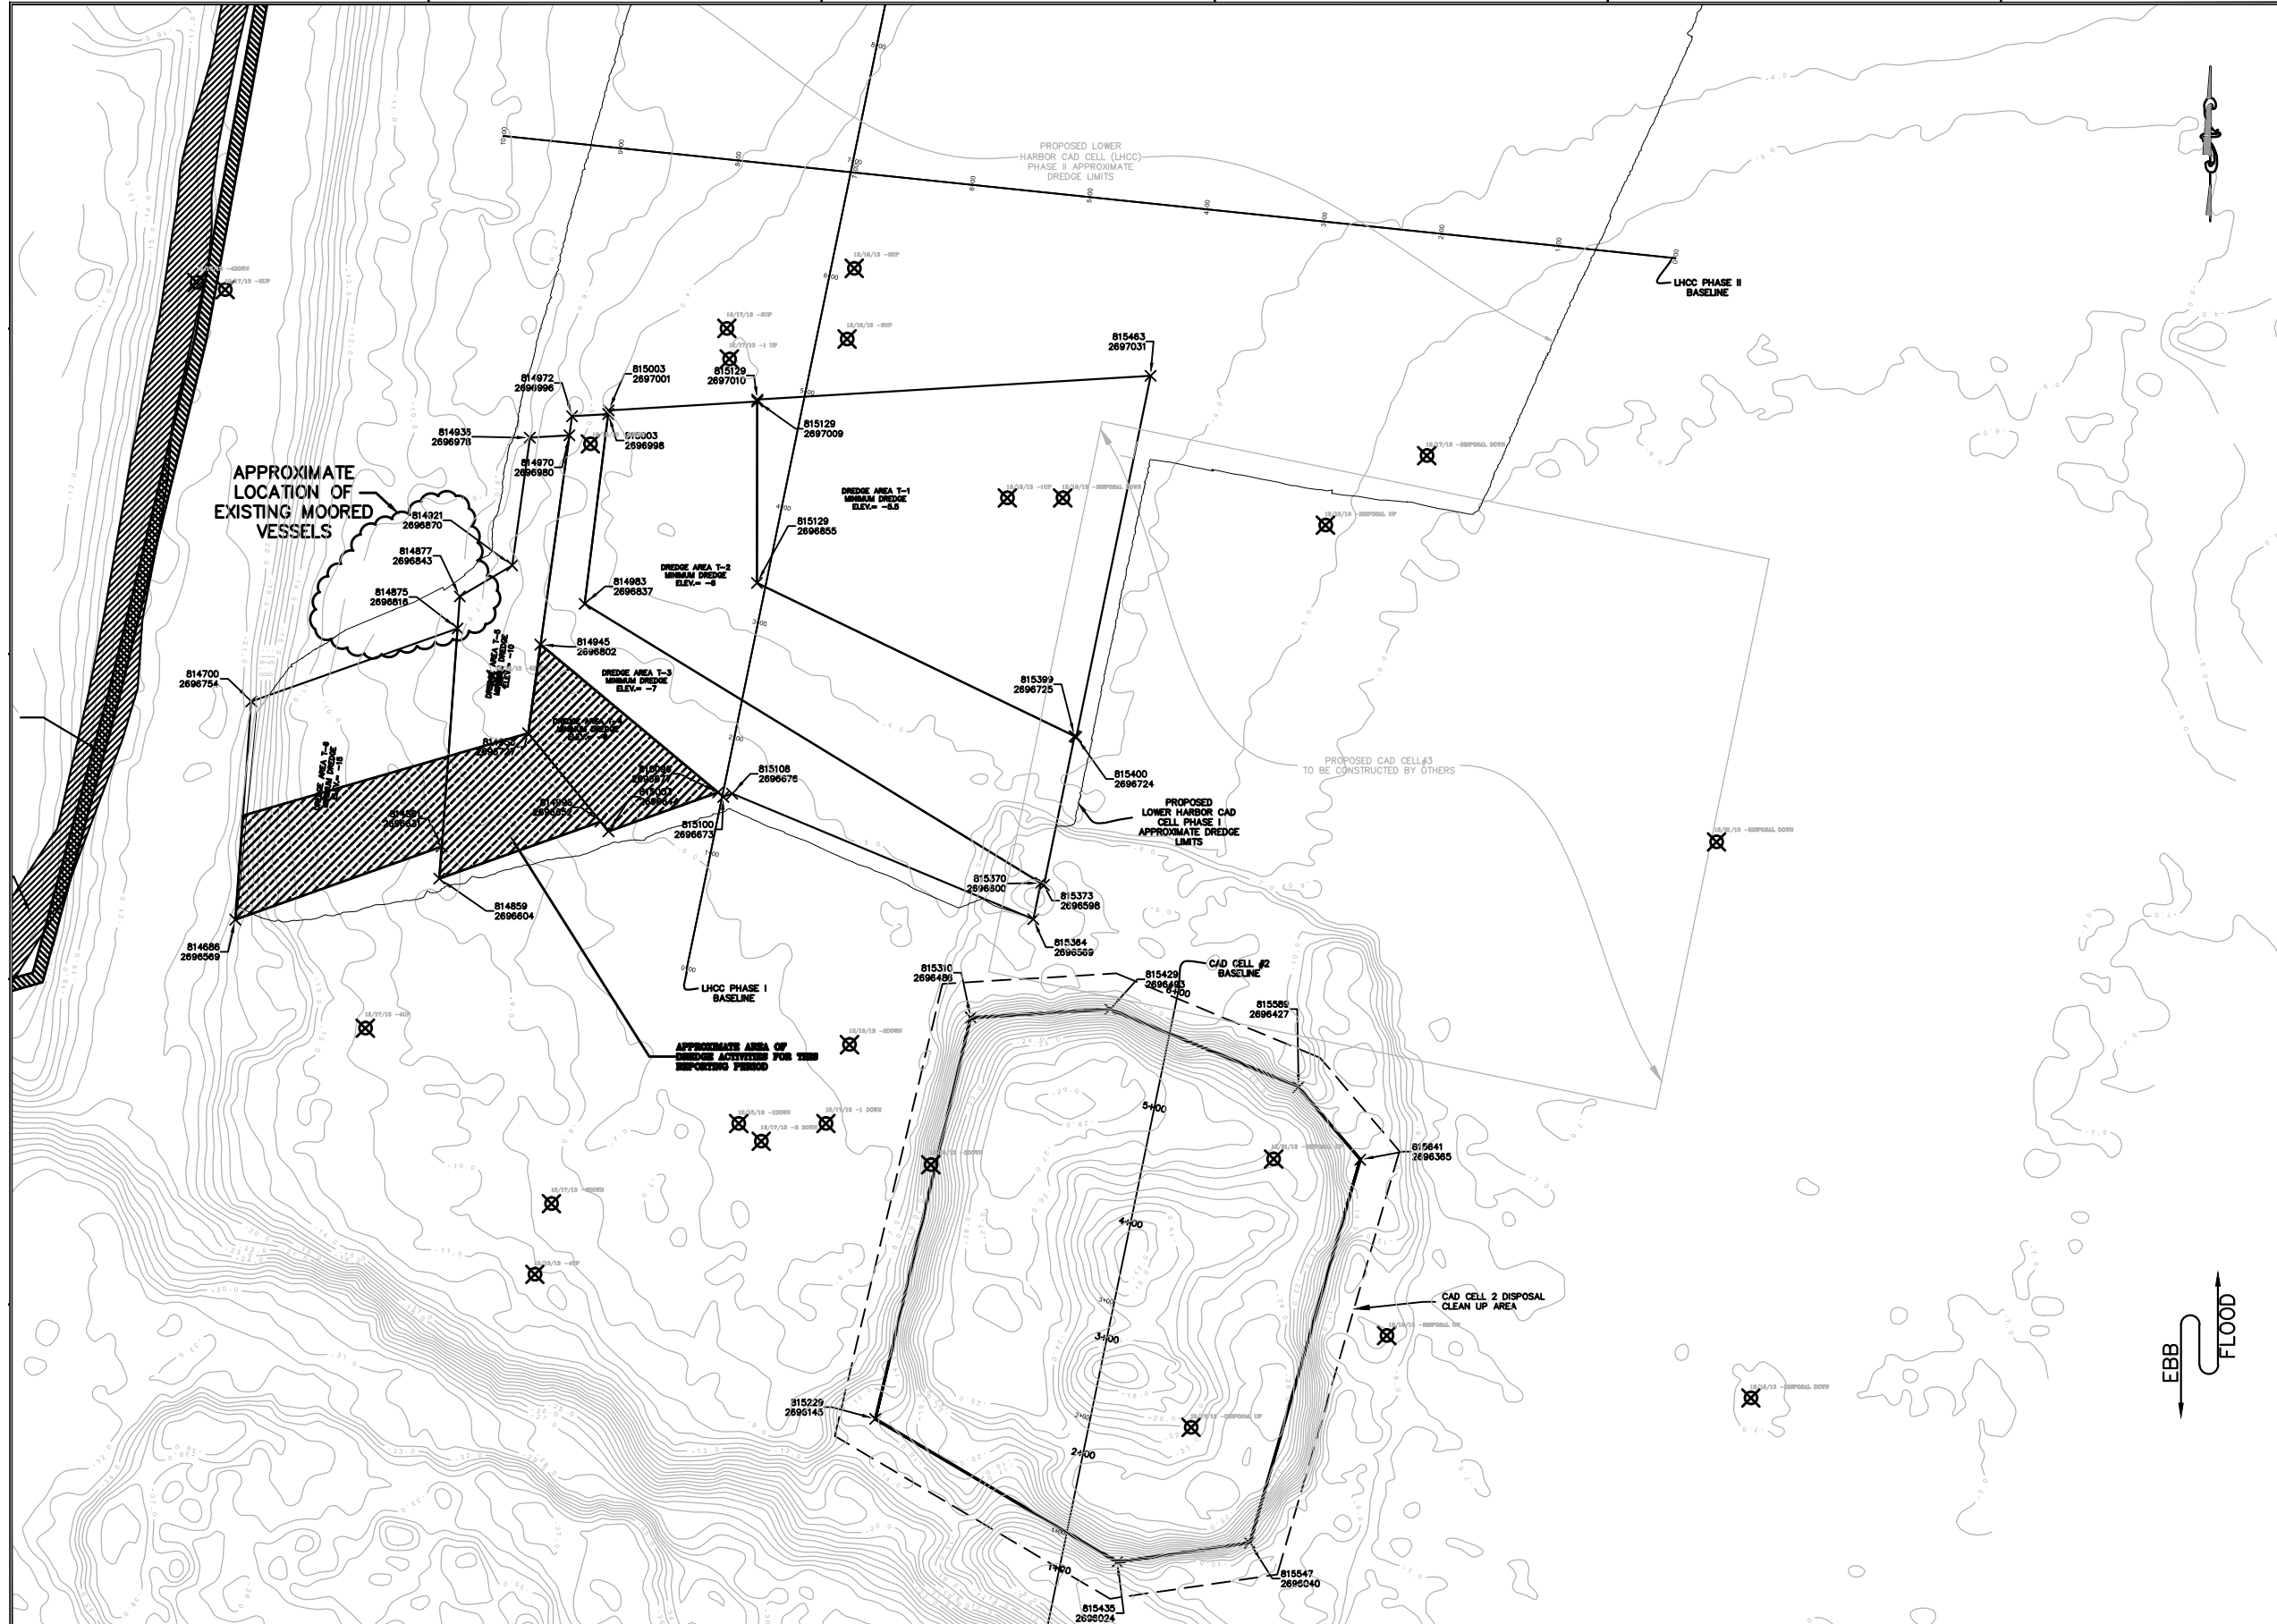
Figure 1
Lower Harbor CAD Cell Phase I – Water Quality Monitoring

- Water Quality Monitoring Forms completed for the week of December 15th through December 21st are attached (Attachment 2). Included with the attached forms is Figure 1 *Lower Harbor CAD Cell Phase I Water Quality Monitoring Plan*, which shows the locations of the water quality monitoring events conducted during this reporting period. Per the approved Water Quality Monitoring Plan and associated performance standards for the dredging efforts being conducted during this reporting period Apex has;
