FOURTH FIVE-YEAR REVIEW REPORT FOR **COAKLEY LANDFILL SUPERFUND SITE ROCKINGHAM COUNTY, NEW HAMPSHIRE**

U.S. Environmental Protection Agency Region 1 BOSTON, MASSACHUSETTS

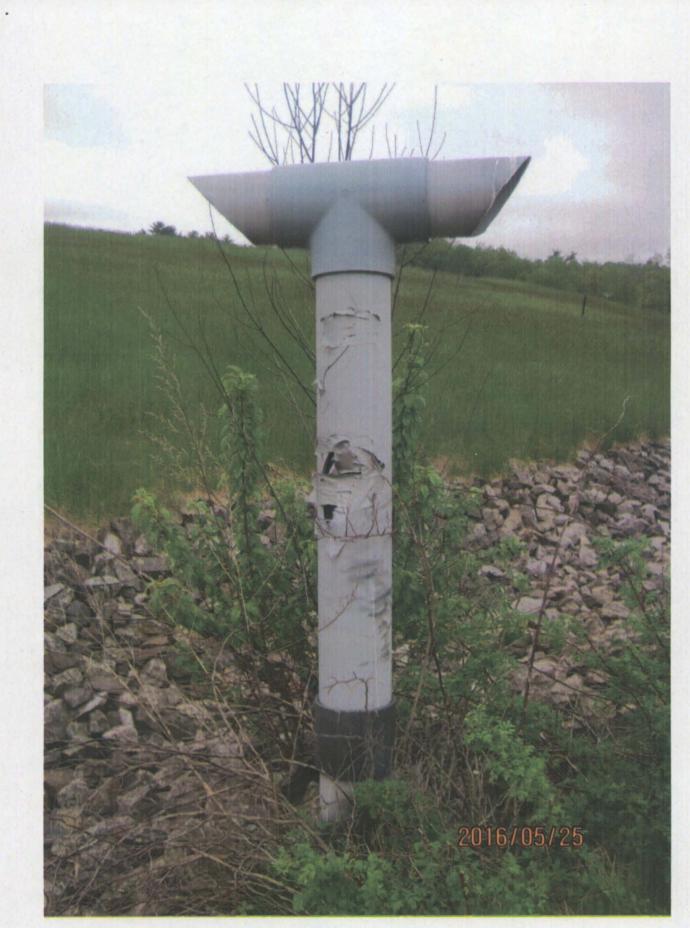
View of damaged gas vent (second vent left of the dirt road going east to west).

Photograph sent by the PRP in August 2016 documenting the repairs (new PVC couplings) to a broken gas vent.

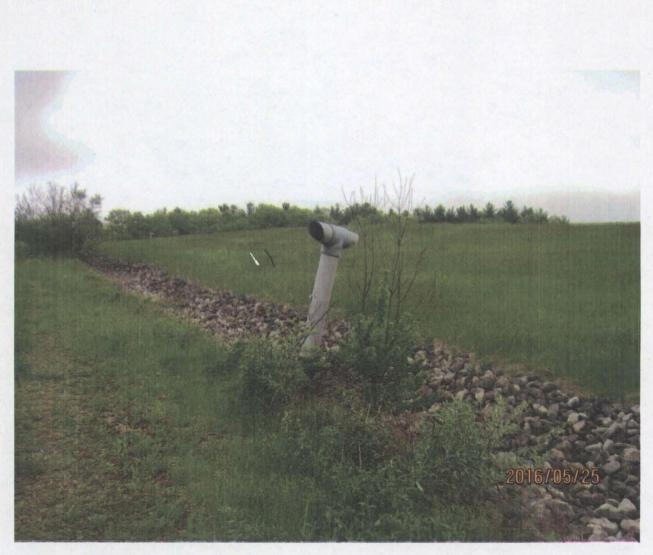
View of the damaged gas vent on previous figure looking south. Note that it is at an angle; also note overgrown vegetation within the rip-rap.

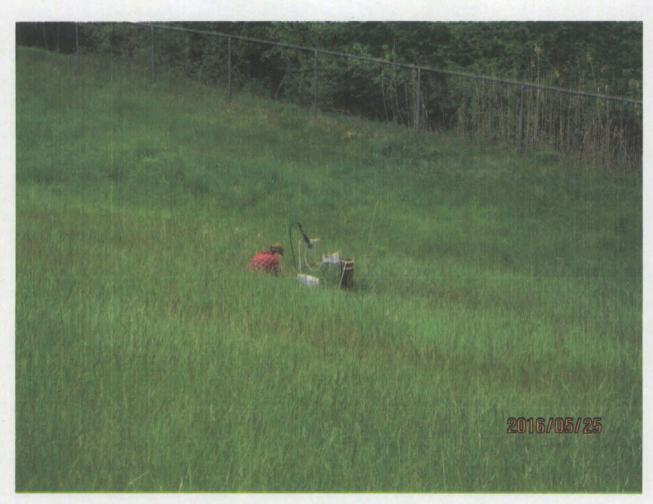
PFC sampling ongoing at one of the monitoring wells (MW-8) within OU-1.

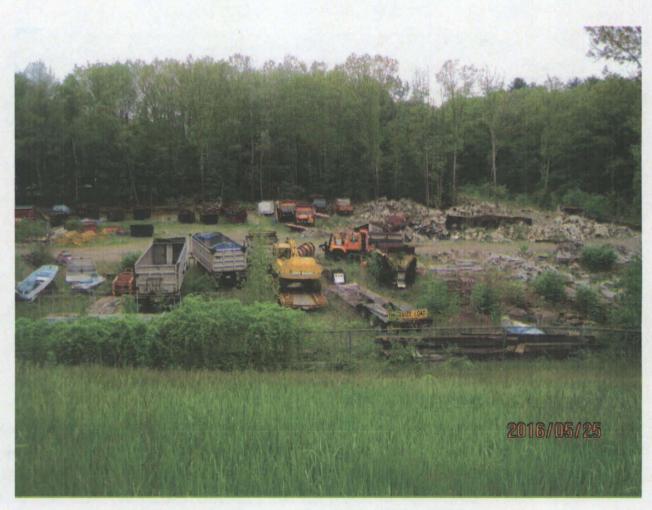
View of construction debris/landscaping operations abutting the southern section of the fence. Note the overgrown vegetation on top of the fence.

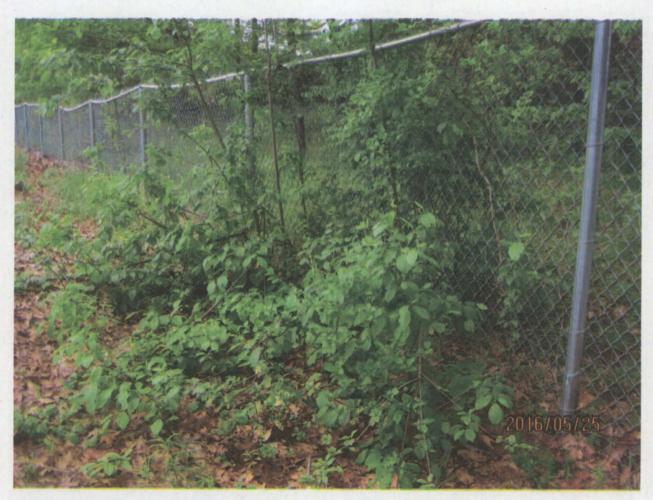
Example of vegetation growing right next to the eastern section of the fence.

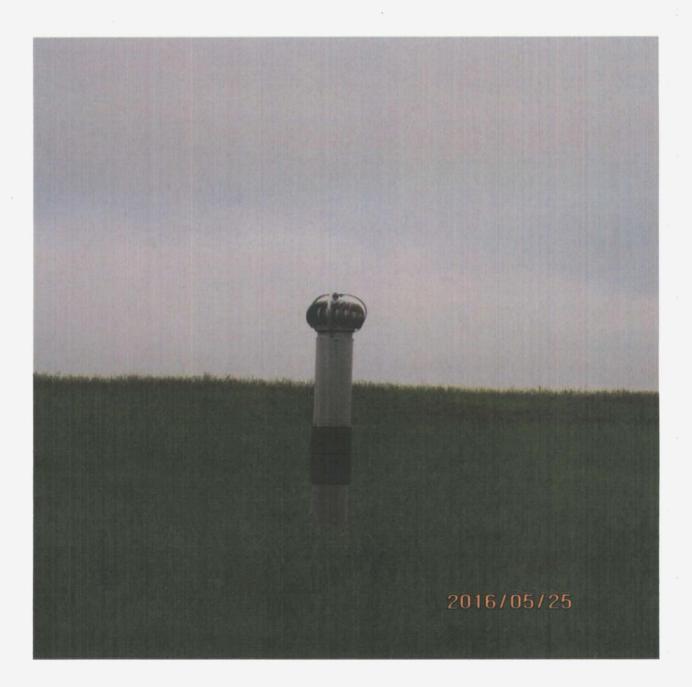
View of one of the gas vents with the whirly-wind cap not turning. Note the corrosion on the cap.

Photograph sent by the PRP in August 2016 documenting the repair (new whirly-wind cap) to a gas vent.

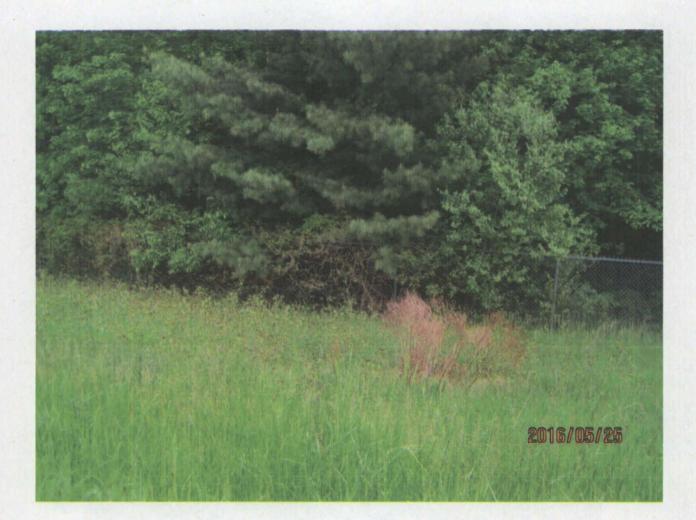
An example of vegetation that has grown too close and into the fence.
