**FIRST FIVE-YEAR REVIEW REPORT FOR THE
SHENANDOAH ROAD GROUNDWATER CONTAMINATION SUPERFUND SITE
DUTCHESS COUNTY, NEW YORK**

**U.S. Environmental Protection Agency
Region 2
New York, New York**

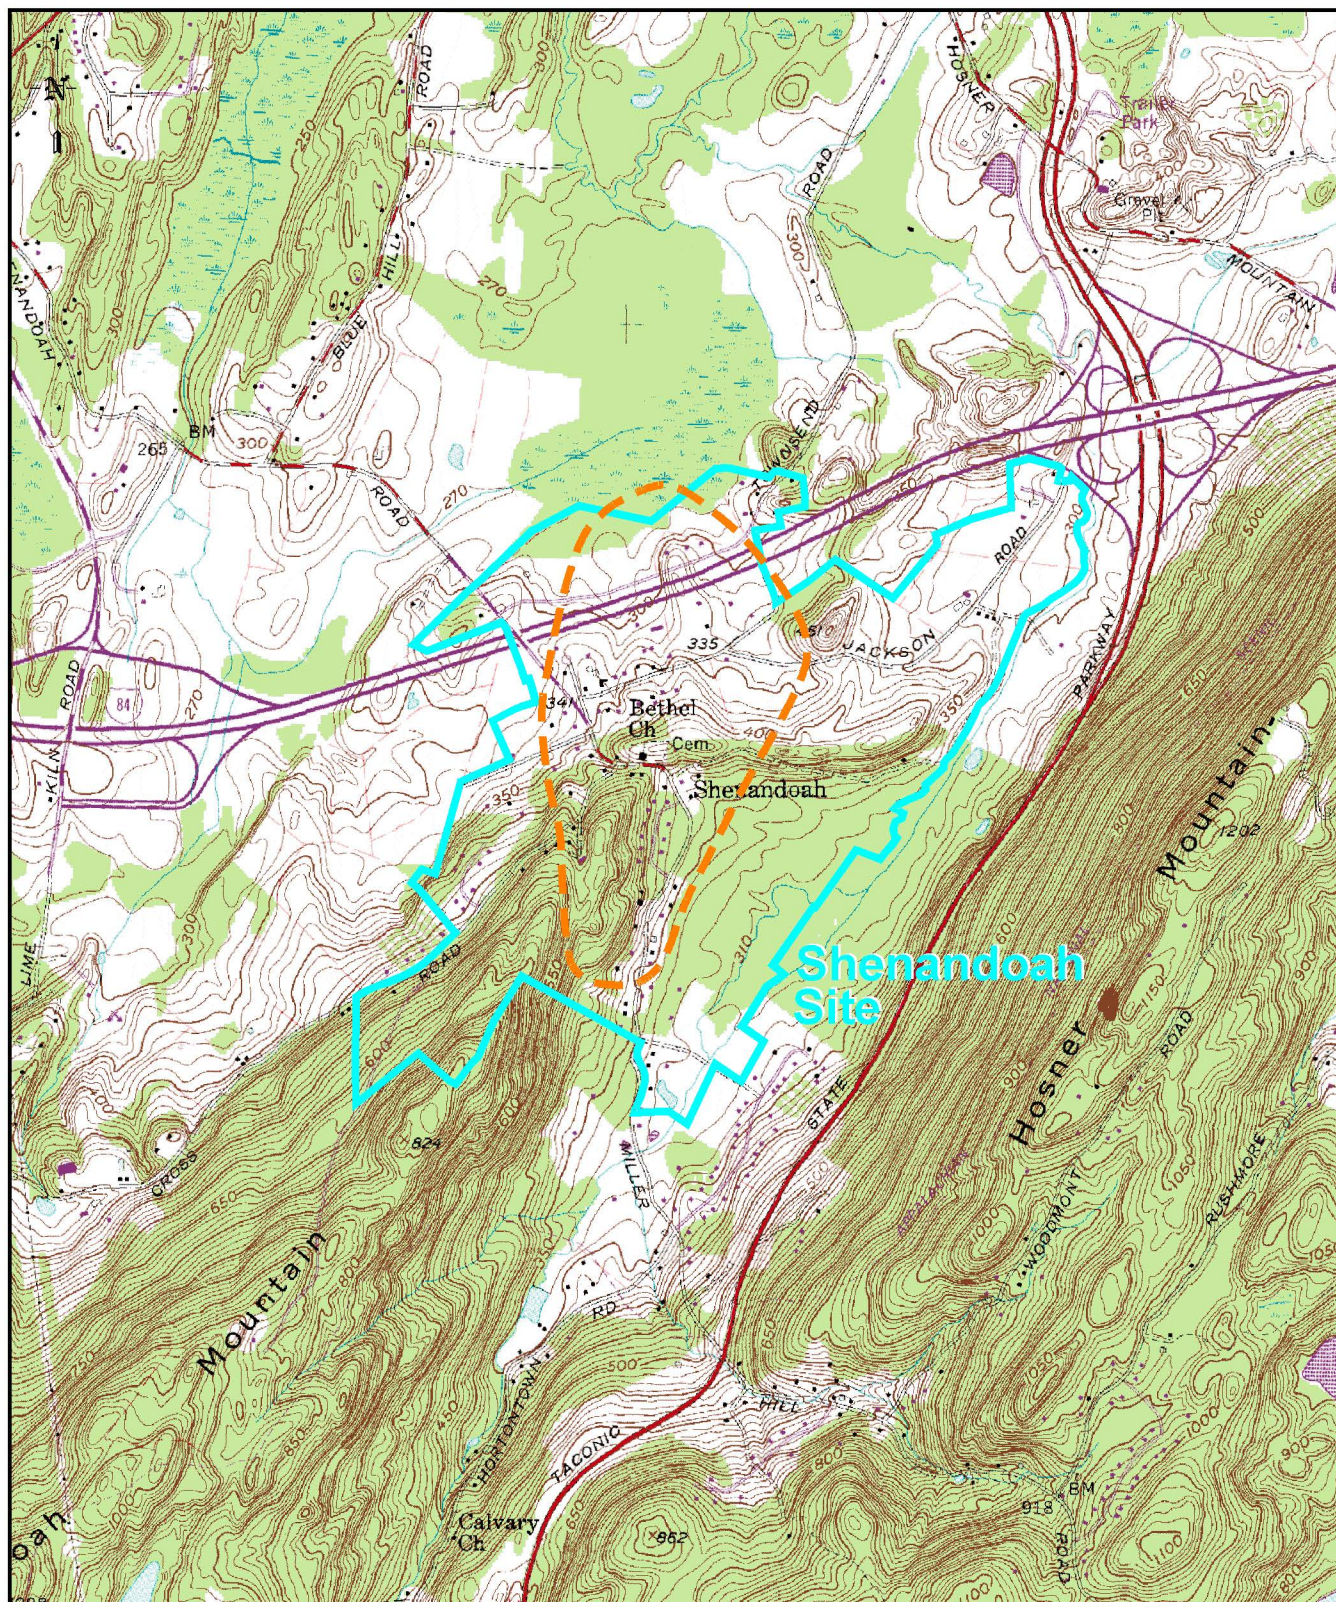
- - - Extent of Individual Site COPCs Detected
Above 5 µg/L in Groundwater

Shenandoah Road Groundwater Contamination Superfund Site Study Area Setting

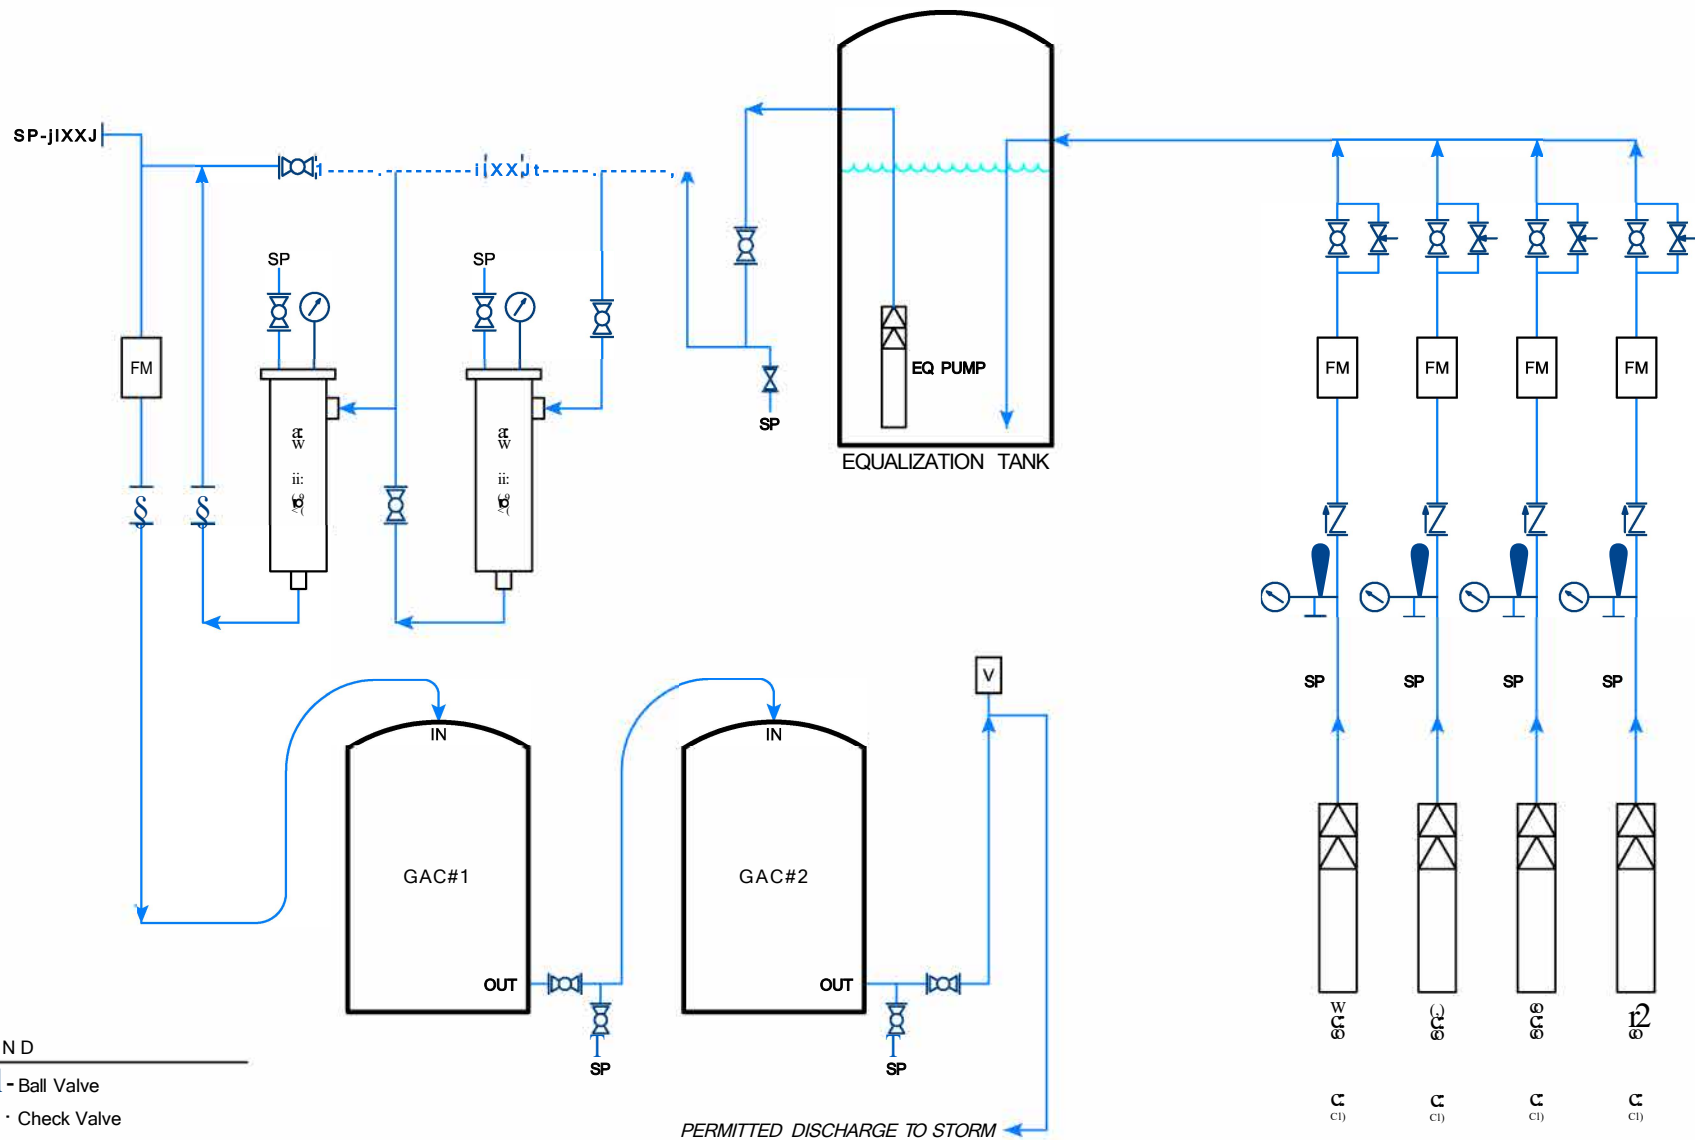
FIGURE 3

Shenandoah Road Groundwater Contamination Superfund Site Source Extraction and Treatment System Flow Diagram

In 2012, the NTCSRA was completed and the SETS was constructed and consists of the four groundwater extraction wells (SRMW-18RA, 18RB, 18RC and 18RE), previously installed in the source zone, and two granulated activated-carbon (GAC) adsorption vessels in series to treat the contaminated groundwater (**Figure 3**). The treated groundwater is then discharged to a designated storm water conveyance in compliance with NYS substantive permit requirements.

Currently, the source control SETS was installed under removal authority and continues to operate as designed. The groundwater SETS was constructed in 2012 and consists of four extraction wells, previously installed at the Facility in the source zone, to reduce DNAPL in the fractured bedrock and to control groundwater chemical flux from the source area to the groundwater plume. The capture zone of the extraction well network is approximately 16 acres surrounding the source area (see **Figure 4**). The treatment train for the contaminated groundwater consists of two GAC vessels. Treated groundwater is discharged to a designated storm sewer, in accordance with permit requirements.

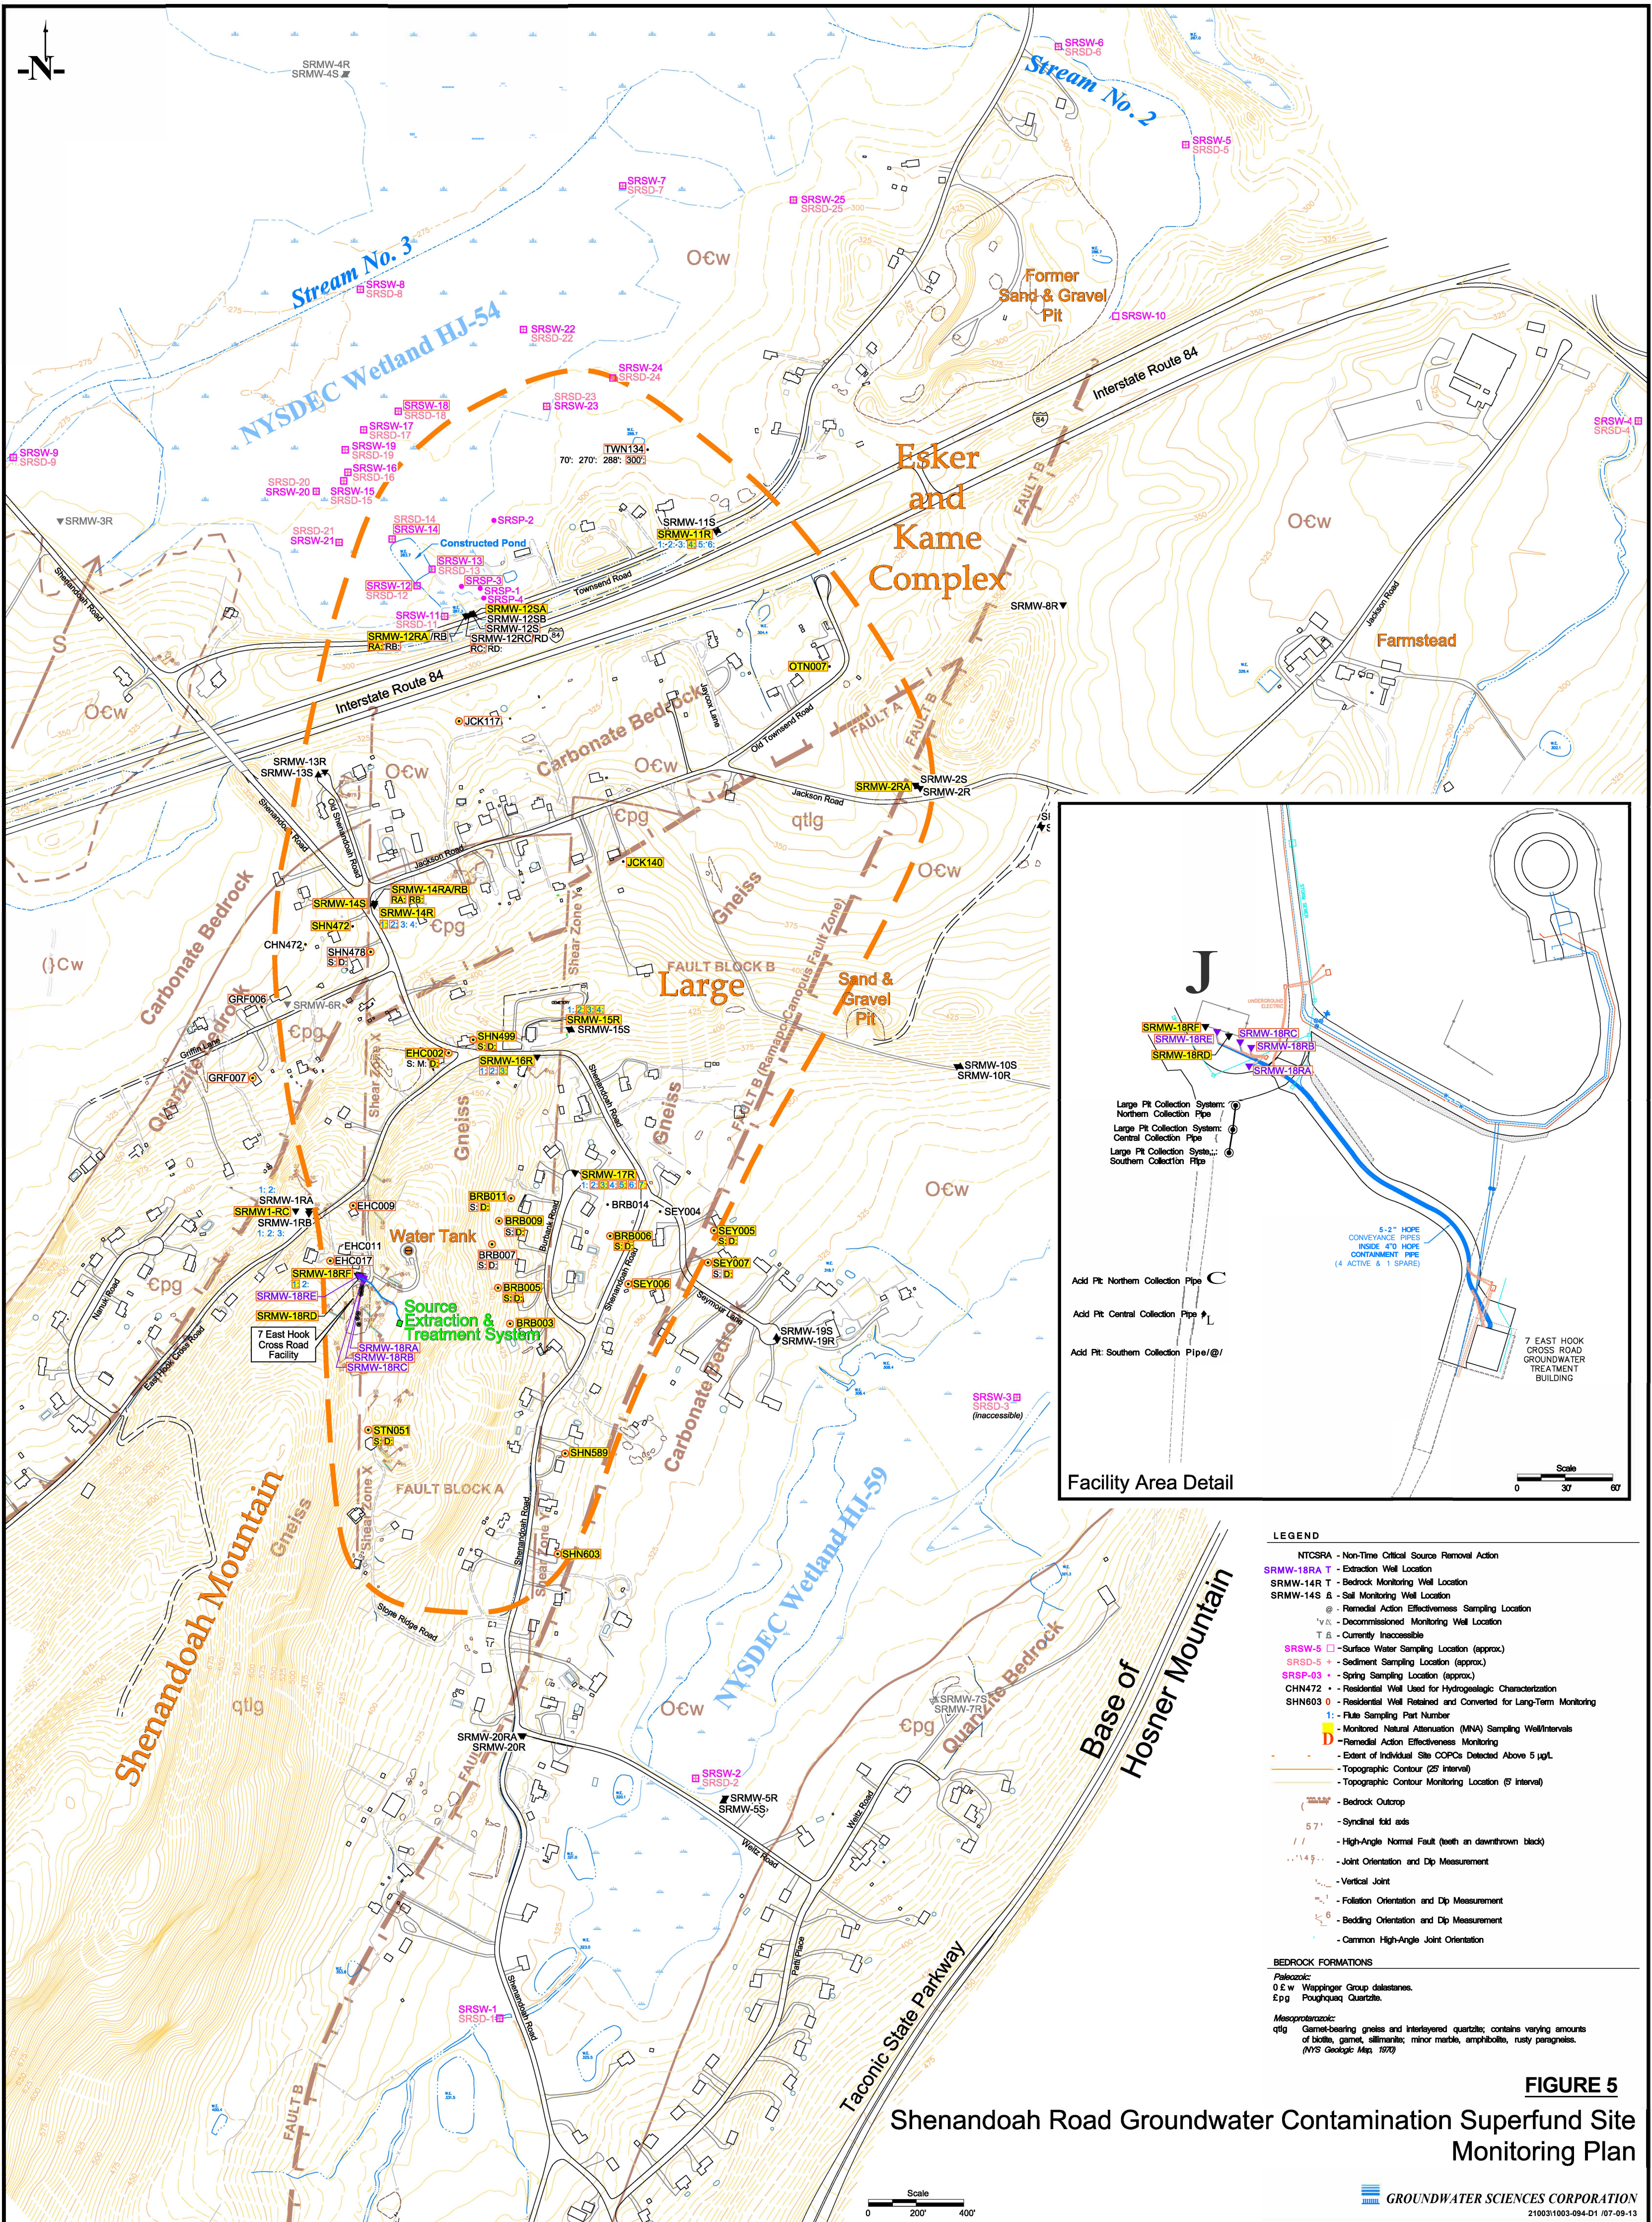
FIGURE 4

Bedrock Groundwater Elevation Contour Map
February 27, 2018
Shenandoah Road Groundwater Contamination Superfund Site

Laboratory results from groundwater monitoring wells and the effluent from the SETS indicate that site-related contaminants are being reduced and removed from the aquifer and treated to performance requirements. The SETS is continuing to remove mass from the groundwater in the source area via the extraction wells. The capture zone for the extraction wells system demonstrates that containment of the bedrock aquifer is being achieved. O&M data indicate that the system is running efficiently and does not affect protectiveness of the remedy. Cleanup levels are being achieved by the SETS which continues to remove mass from the groundwater in the source area extraction wells (see **Table 4** and **Table 5**). Analysis of the groundwater contours and the capture zone for the extraction wells demonstrates that containment of the bedrock aquifer is being achieved (see **Figure 4**).

The SETS is operating as designed and shows that the capture zone for the SETS demonstrates that containment of the bedrock aquifer is being achieved. O&M data indicate that the system is running efficiently and does not affect protectiveness of the remedy.

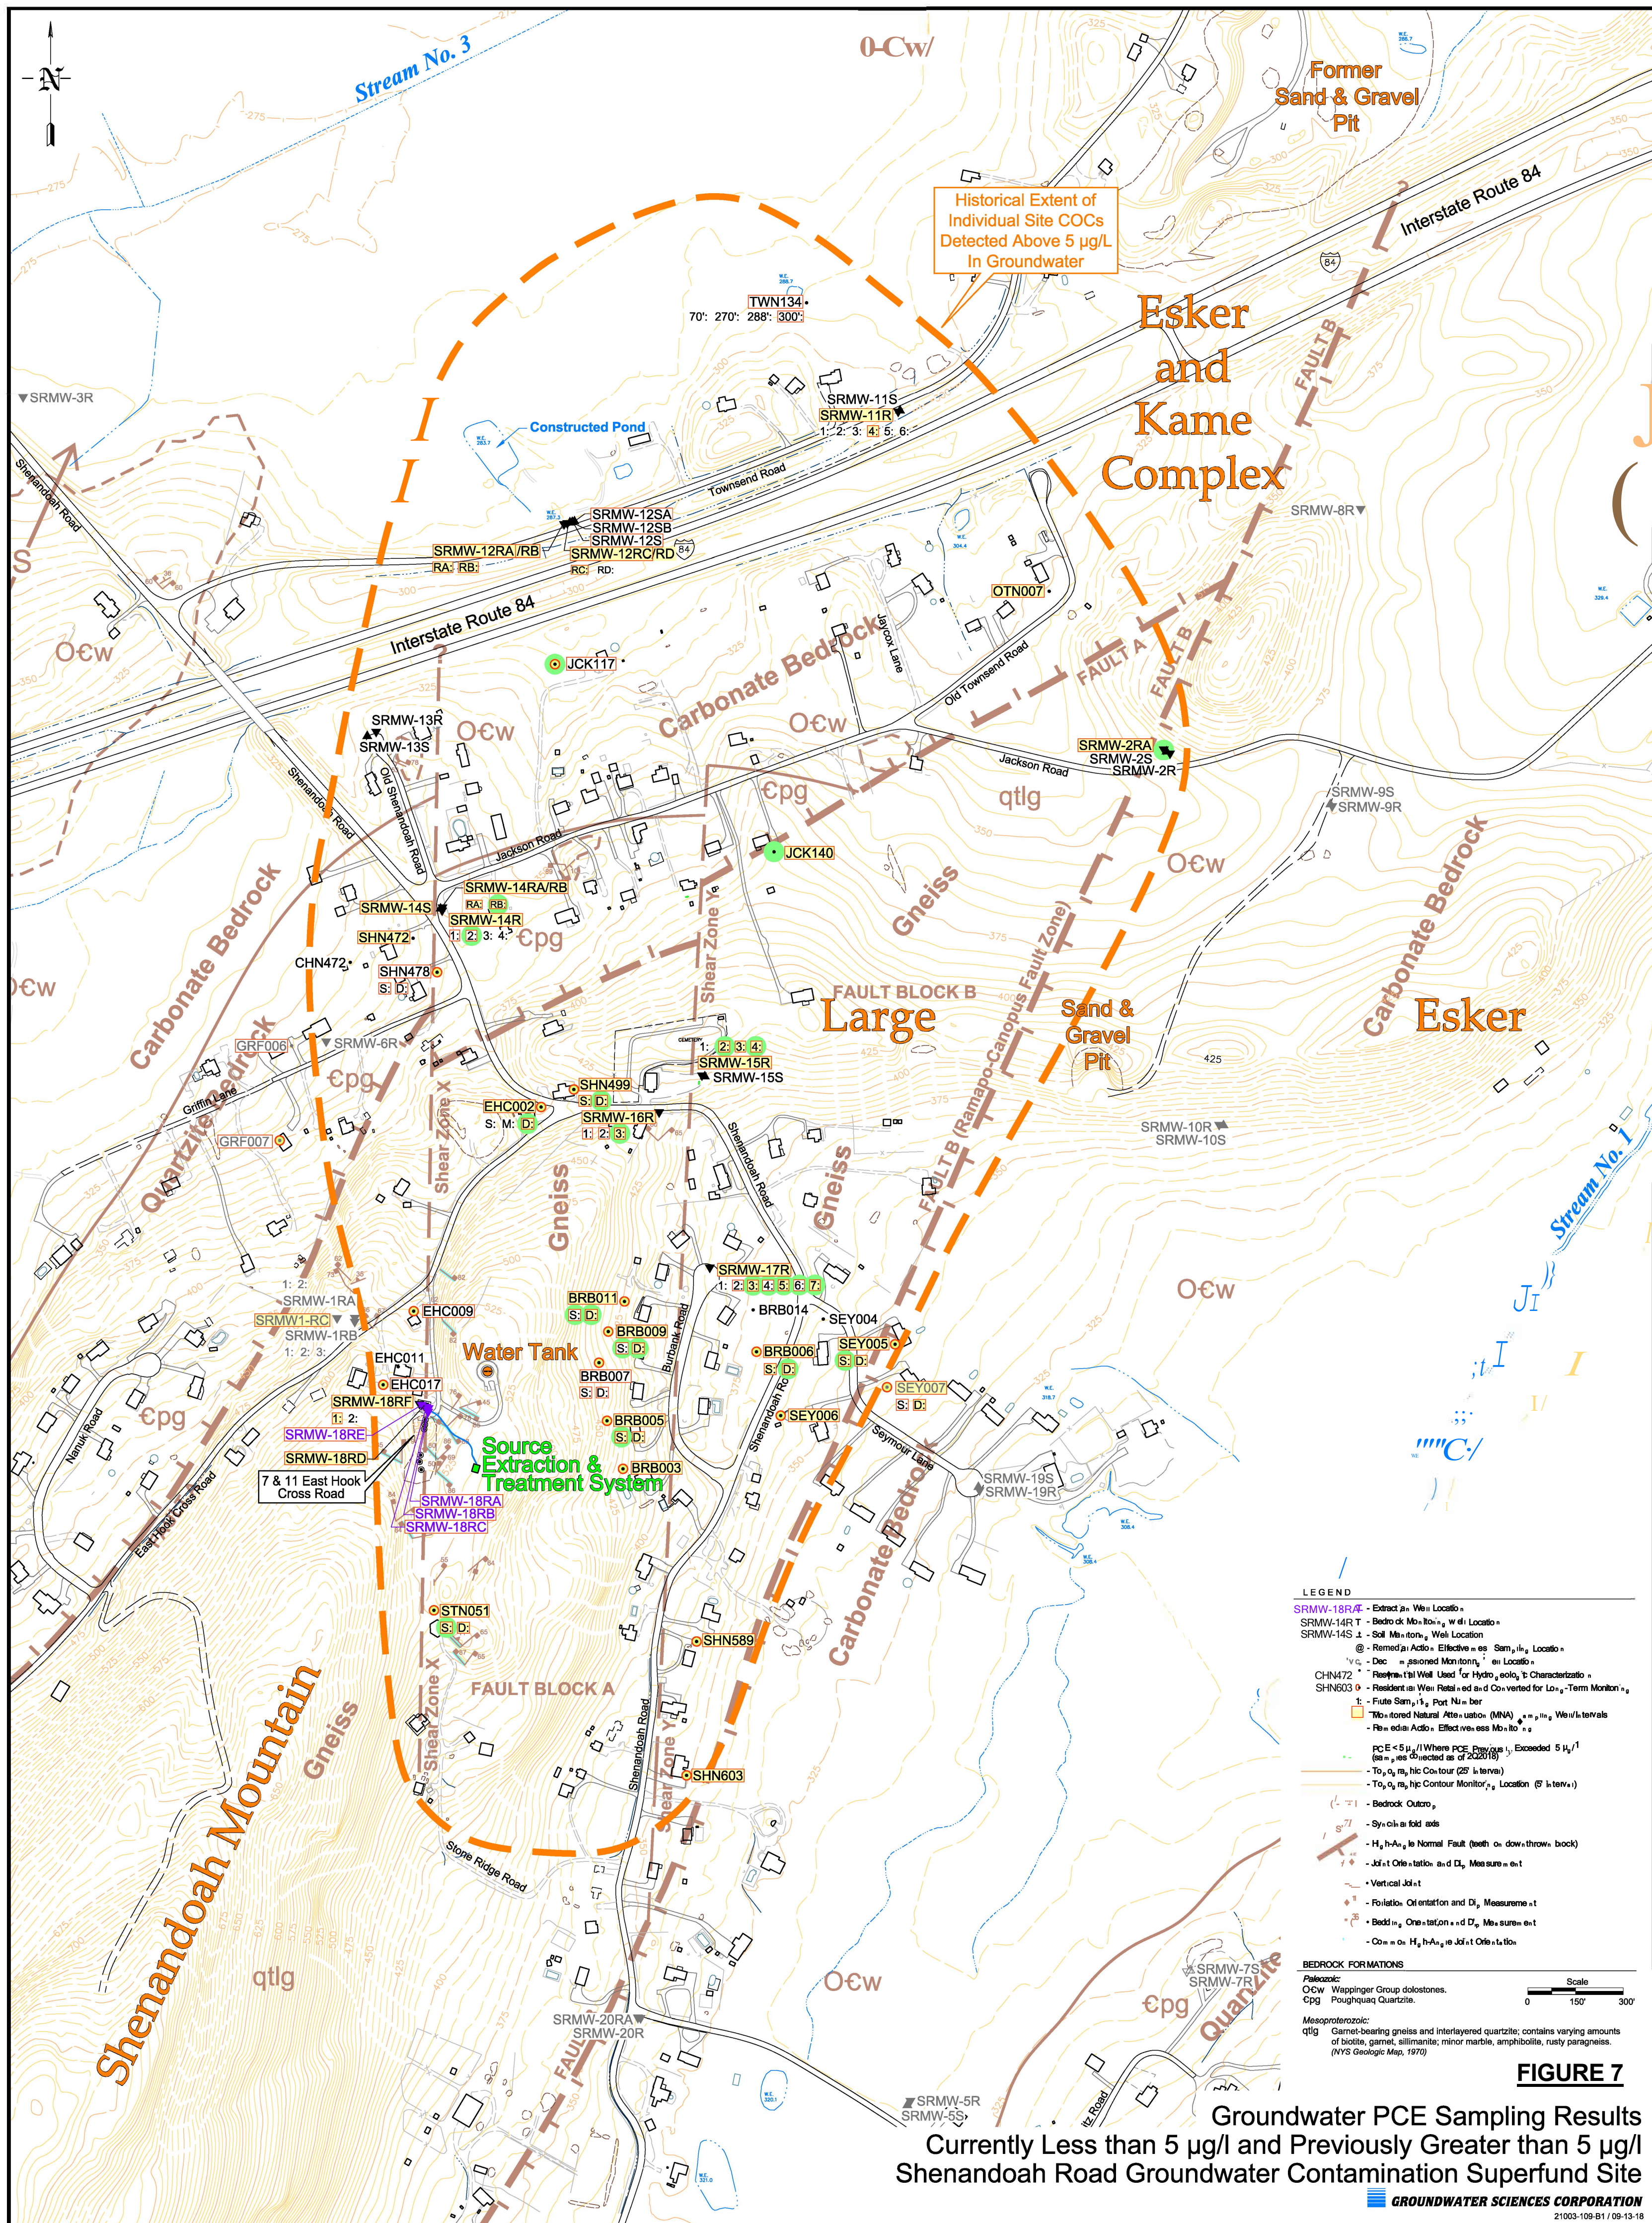
FIGURE 6

PCE and TCE Concentration Graphs
2008 - Present, Log Scale
Shenandoah Road Groundwater Contamination Superfund Site

Data from perimeter monitoring wells and monitoring wells within the groundwater plume show that concentrations of site-related contaminants are decreasing, thus demonstrating a stable and/or shrinking plume. The perimeter wells are also monitored for natural attenuation parameters. The geochemical data indicate that there is substantial evidence of reductions in COC concentrations throughout the plume, such as the creation of PCE degradation products, and consistent decreasing concentrations of PCE by orders of magnitude, as shown on **Figure 6** and **Figure 7**.
