**Second Five-Year Review Report  
for  
Macalloy Corporation**

**SCD003360476**

**Charleston  
Charleston County, South Carolina**

**August 2015**

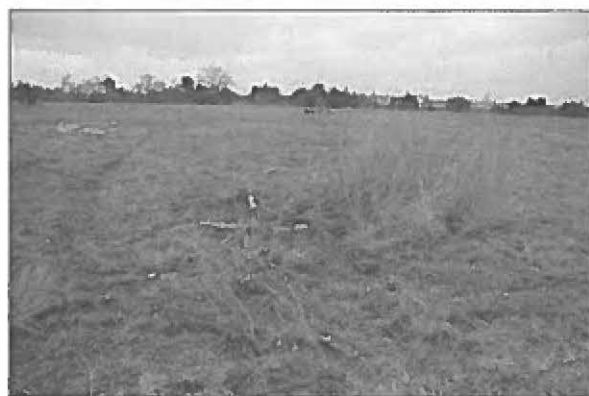
Photo 18 – MW061 destroyed

Although total chromium remained above the cleanup goal at MW041, MW043, and MW060, an overall decreasing trend was observed at MW041 and MW060 since monitoring began. Total chromium concentrations at MW043 have increased by more than three orders of magnitude since Event 1 to a historical high of 3,300 µg/L. MW061 was damaged prior to sampling in 2013 and has not been repaired or replaced. No groundwater samples could be collected. During the

last sampling event for MW061 in 2012, total chromium was above the cleanup goal with a concentration of 6,300  $\mu\text{g}/\text{L}$  and with an increasing historical trend.

Participants toured the Site and observed monitoring wells and adjacent properties. Monitoring wells were all secured and labeled, except for MW061 which was damaged. The Site is well maintained. The completed site inspection checklist is included in Appendix D. Photographs from the inspection are included in Appendix E.

<b>OU(s): 1</b>	<b>Issue Category: Monitoring</b>			
	<b>Issue:</b> MW061 has been damaged and is inaccessible.			
	<b>Recommendation:</b> Abandon and replace MW061			
<b>Affect Current Protectiveness</b>	<b>Affect Future Protectiveness</b>	<b>Implementing Party</b>	<b>Oversight Party</b>	<b>Milestone Date</b>
No	Yes	PRP	EPA/State	08/01/2017
<b>OU(s): 1</b>	<b>Issue Category: Monitoring</b>			
	<b>Issue:</b> Total chromium concentrations at MW041, MW043, MW060, (and previously at MW061) remain above the RAO of 100 µg/l.			
	<b>Recommendation:</b> Supplemental groundwater remediation similar to the in-situ chemical reduction completed in 2005 and 2008.			
<b>Affect Current Protectiveness</b>	<b>Affect Future Protectiveness</b>	<b>Implementing Party</b>	<b>Oversight Party</b>	<b>Milestone Date</b>
No	Yes	PRP	EPA/State	04/01/2019
<b>OU(s): 1</b>	<b>Issue Category: Monitoring</b>			
	<b>Issue:</b> Current groundwater data suggests that the horizontal extent of the contaminant plume boundary above the RAO to the north, east, and west of MW060 is unknown.
