## MEMORANDUM

**SUBJECT:** Request for Approval and Funding for a Time-Critical Removal Action at the Zizzo Properties Site, Kenosha, Kenosha County, Wisconsin (Site ID # C59U)

Site Location Map  
Zizzo Properties Site  
Kenosha, Wisconsin

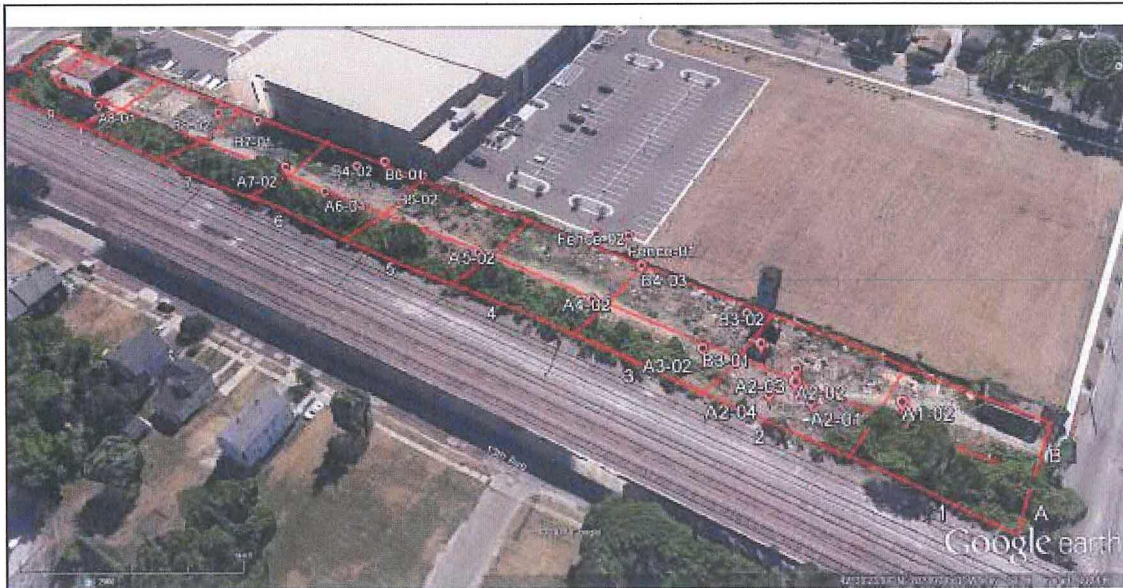
**FIGURE 2**

**SITE LAYOUT**  
**Zizzo Properties Site**  
**Kenosha, Wisconsin**

Grid A1 A

Sample Location ID

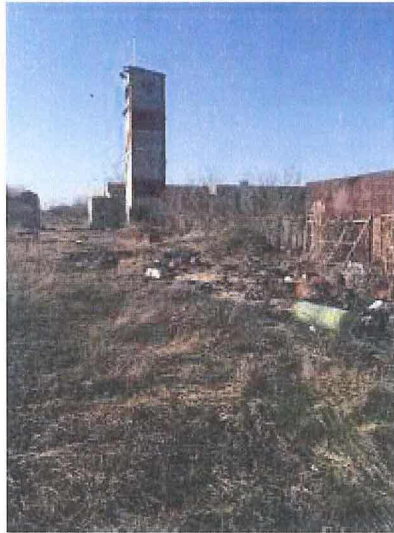
**Official Photograph No. 5:**  
Remnant Tower located in  
the middle of the Site  
property.

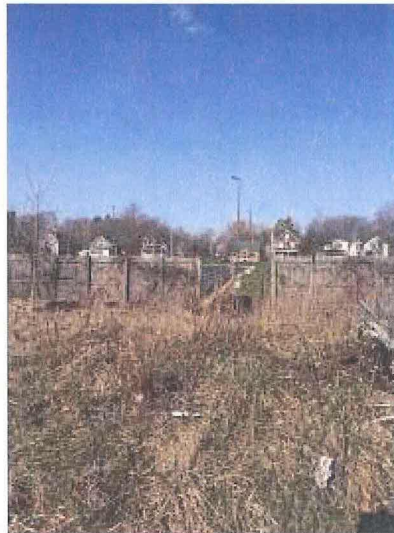
**Official Photograph No. 6:**  
First access point onto site,  
north of remnant tower, through  
west fence separating the Site  
from the Boys & Girls Club.

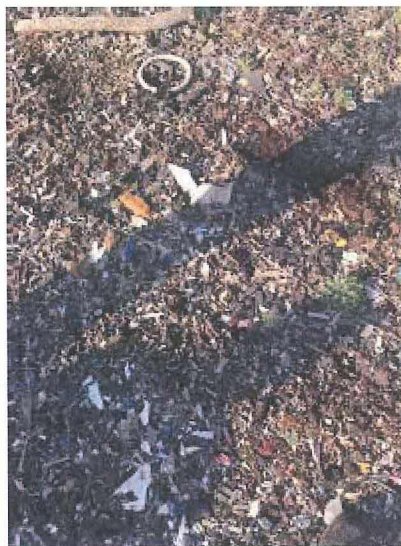
**Official Photograph No. 9:**  
Typical ground cover at Site,  
consists of an auto-shredder  
fluff and soil mix.

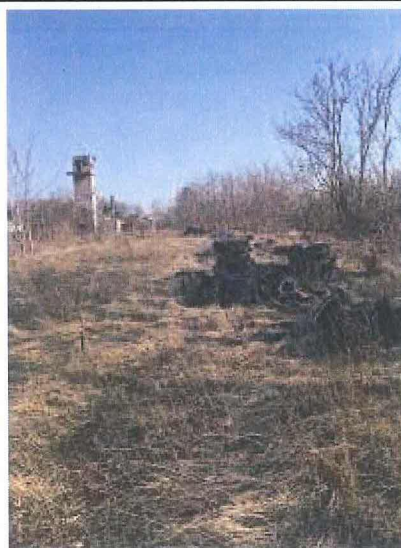
**Official Photograph No. 10:**  
Typical ground cover at Site  
includes tall grasses, brush, and  
debris.

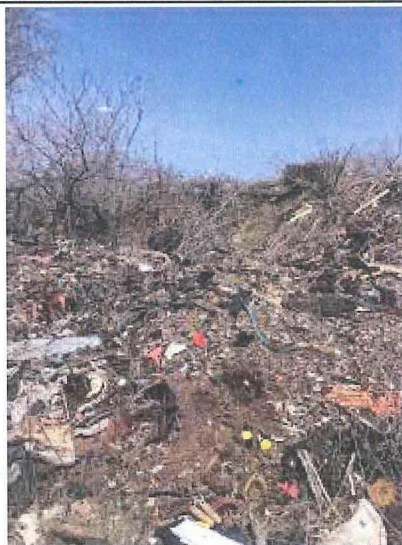
**Official Photograph No. 13:**  
A2 grid flagged and noted as  
having a higher than average  
concentration of auto-shredder  
fluff.

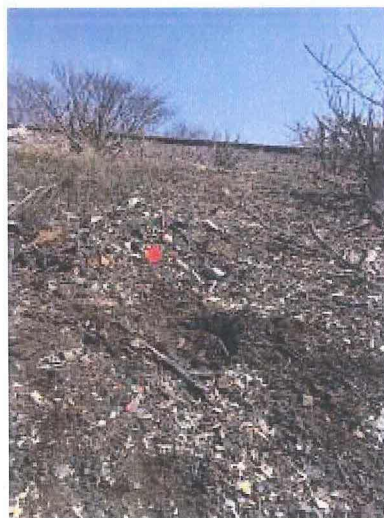
**Official Photograph No. 14:**  
A3 grid flagged and noted as  
having a higher than average  
concentration of auto-shredder  
fluff.

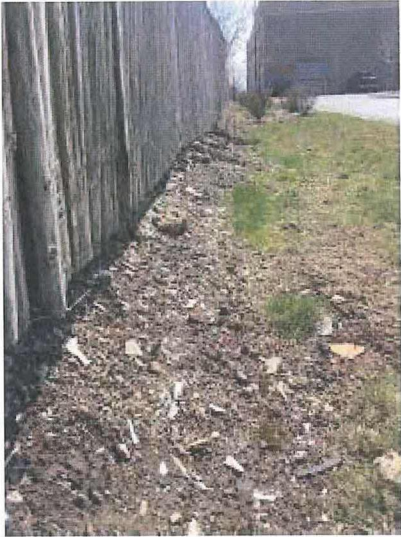
<p>Site: Zizzo Properties - RS Contract: EP-55-16-01 TDD: S05-0001-16-02-001 OSC: Brad Benning</p> <p>Date: April 14, 2016 Orientation: South Photographer: Katherine Cooper</p> <p>Official Photograph No. 18: Auto-shredder fluff and soil mix extending off-site beneath western fence; noted as having a higher than average concentration of auto-shredder fluff.</p>

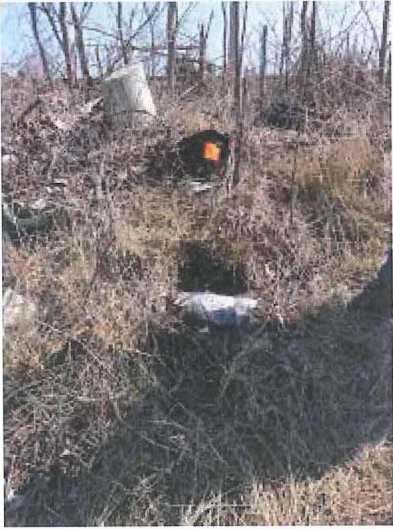
<p>Site: Zizzo Properties - RS Contract: EP-55-16-01 TDD: S05-0001-16-02-001 OSC: Brad Benning</p> <p>Date: April 14, 2016 Orientation: East Photographer: Katherine Cooper</p> <p>Official Photograph No. 19: Sample location A4 noted and flagged as a soil sample location.</p>
