Bonita Peak Mining District Update

June 2020

Site Updates

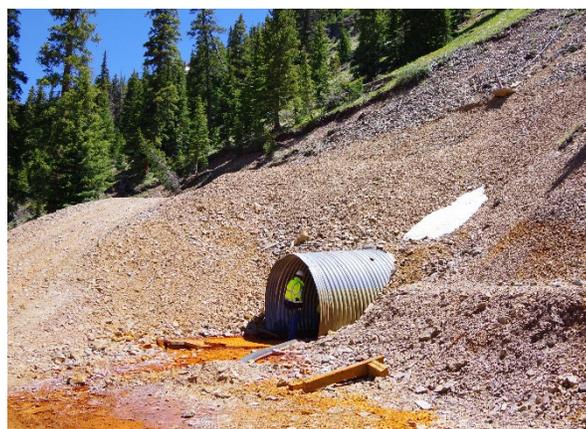
Red and Bonita Portal entrance

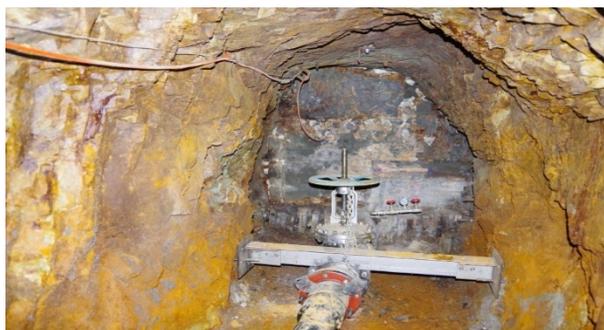
Beginning in mid-July 2020, EPA will start the Red and Bonita Mine bulkhead test. The Red and Bonita bulkhead was constructed in 2015 by Mining & Environmental Services to control the adit drainage from the mine workings behind the bulkhead. Running through the bulkhead is an 8-inch diameter pipe that has been kept open since the construction. This allows for controlled mine drainage discharge out of the mine portal and into Cement Creek.

Red and Bonita Bulkhead with flow-through pipe and valve

For the test, the pressure behind the Red and Bonita bulkhead will initially be raised to about 50 feet. Gradually, pressure behind the bulkhead will be increased to 100 feet, then 150 feet, and finally to 200 feet. It is estimated that it will take a month to reach 200. During this time, the bulkhead and surrounding structures will be monitored regularly.

At the end of the test, the water drawn down will be fully controlled at the bulkhead valve and be treated at the Interim Water Treatment Plan (IWTP) before being discharged into Cement Creek. In order to minimize the effects of draining and ensure no water quality impacts, the water level will be drawn down slowly. The draw-down activity will be coordinated with the IWTP operators so that they are ready to accommodate extra flow. Treatment of all Red and Bonita bulkhead water will continue until the mine pool has been drained. After the test is completed, the discharge from Red and Bonita mine will return
