# Final Remedial Investigation Report For Operable Unit 6 at the Libby Asbestos Site Libby, Montana

30 April 2014

Prepared for  
BNSF Railway Company  
800 North Last Chance Gulch, Suite 101  
Helena, Montana 59601

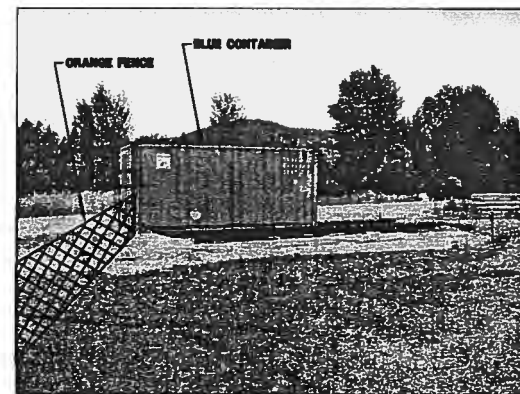
EXISTING DECONTAMINATION PAD

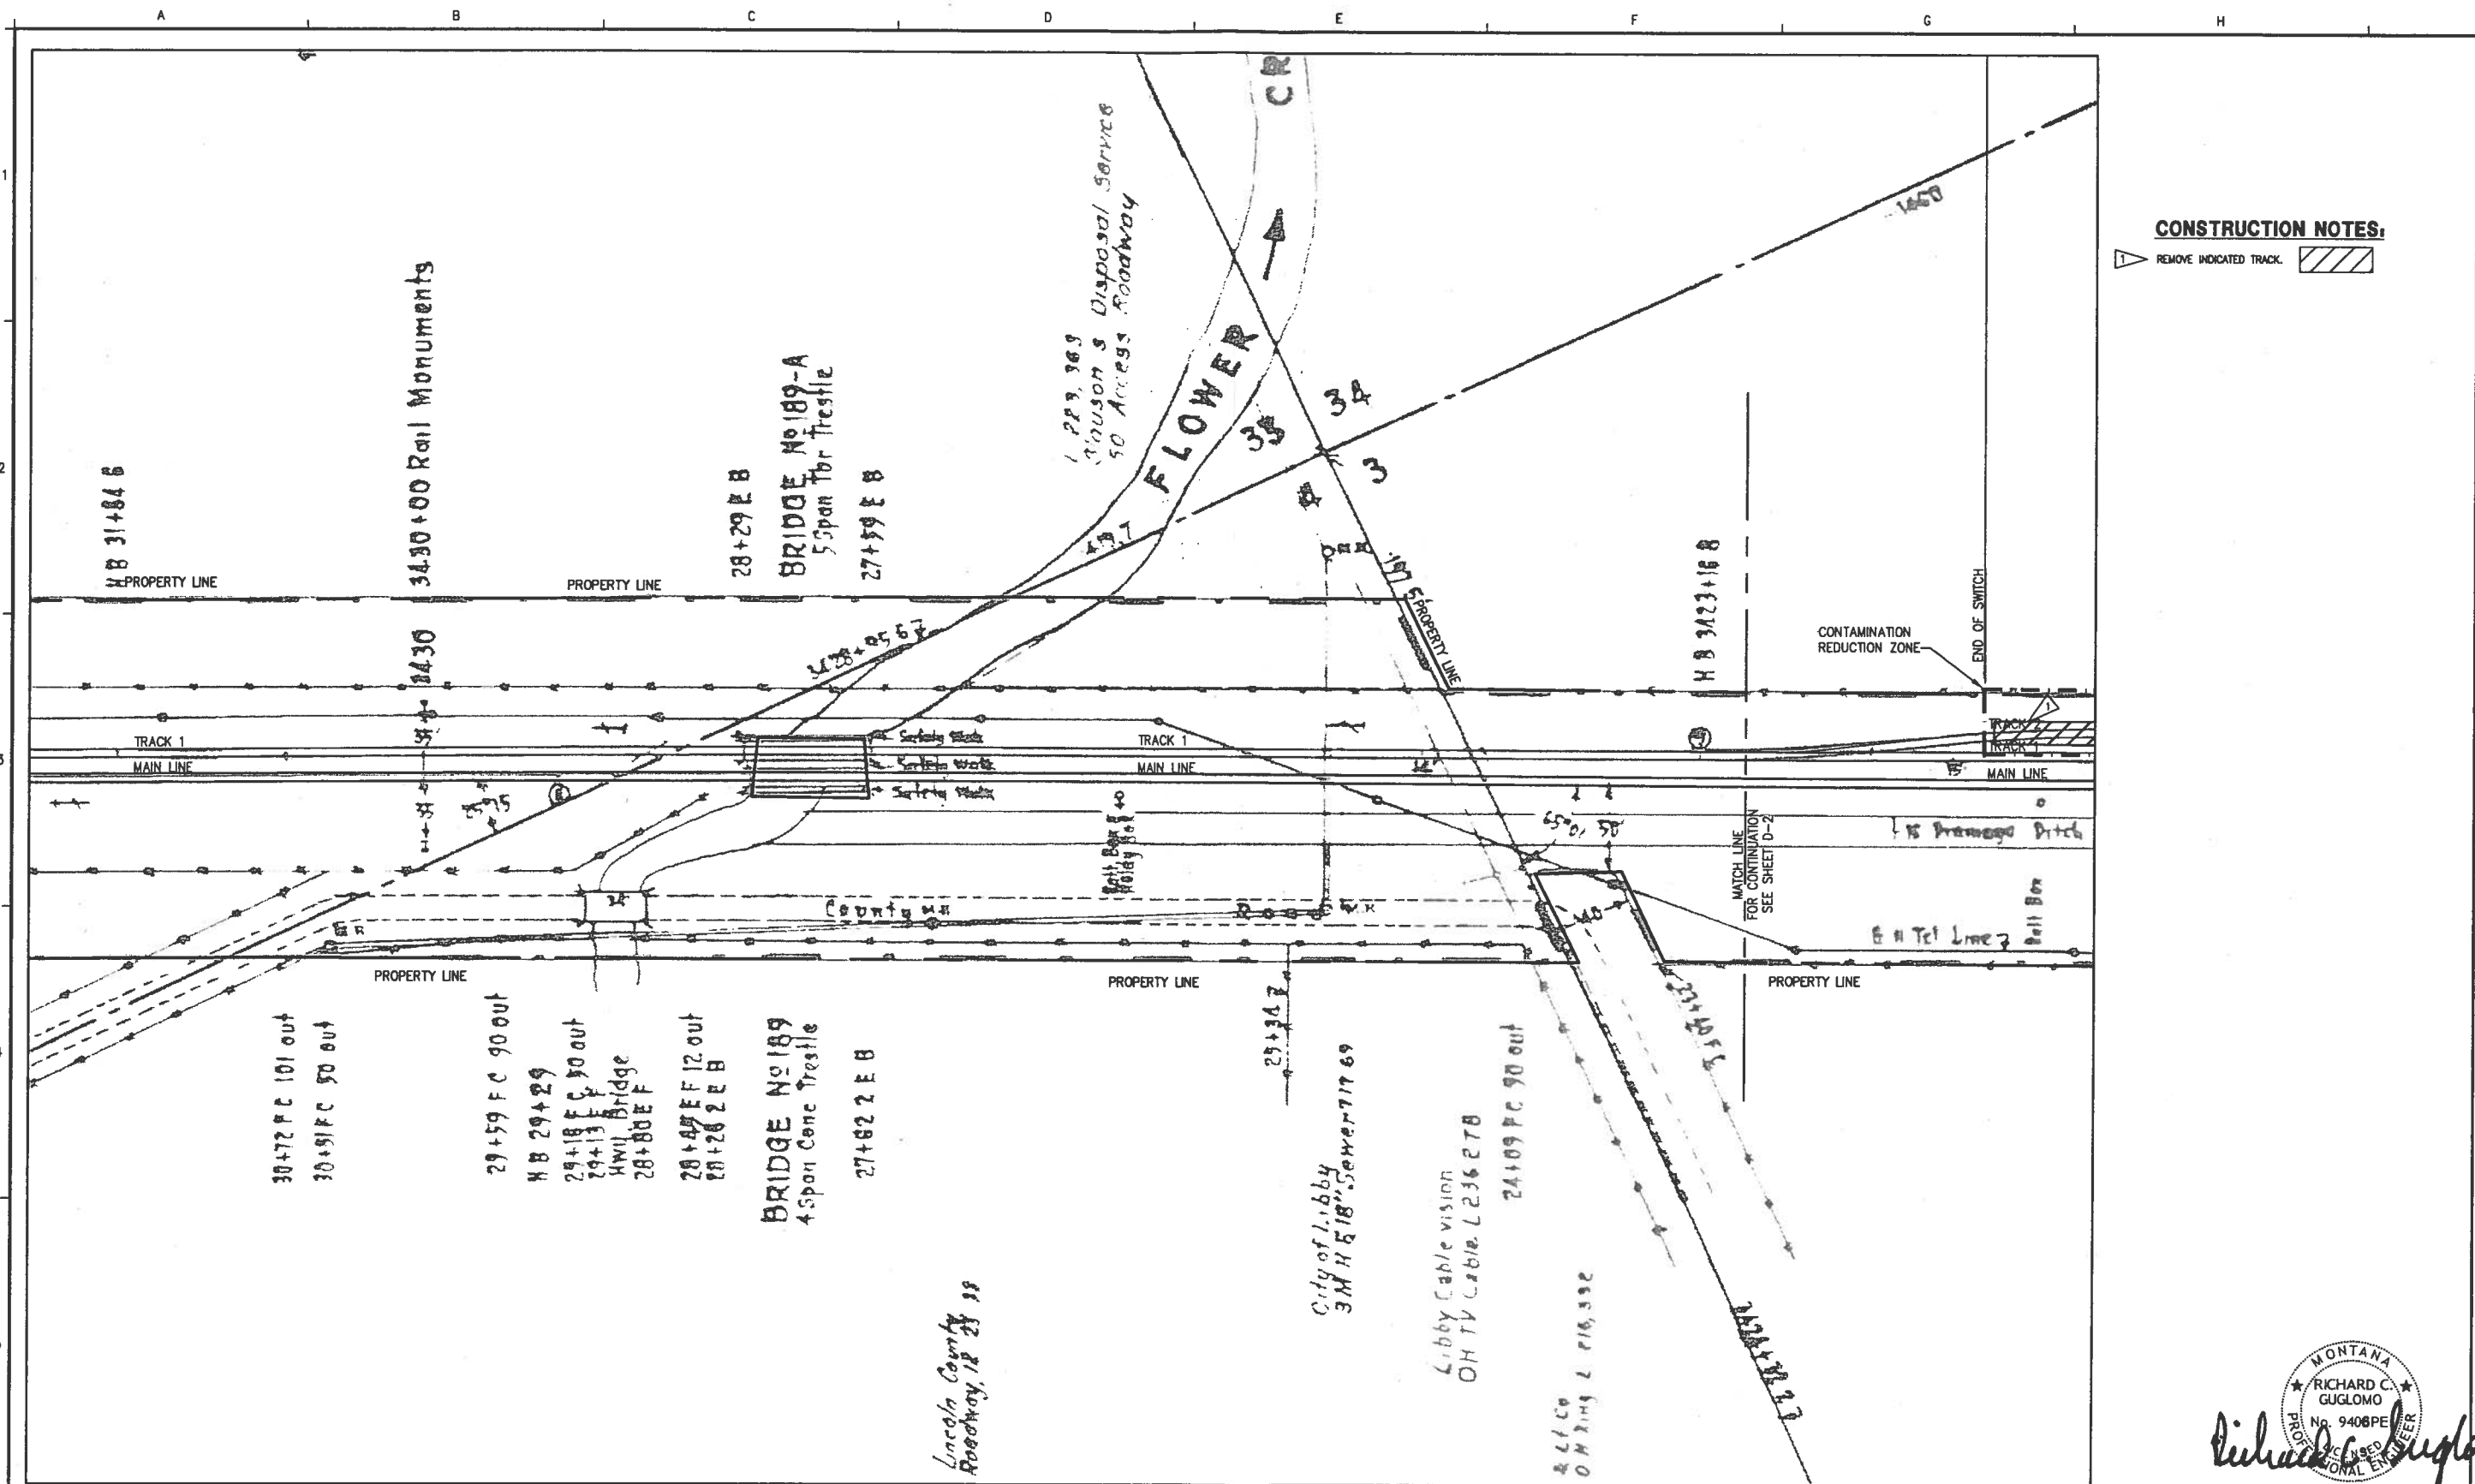
**CONSTRUCTION NOTES:**  
 REMOVE INDICATED TRACK.

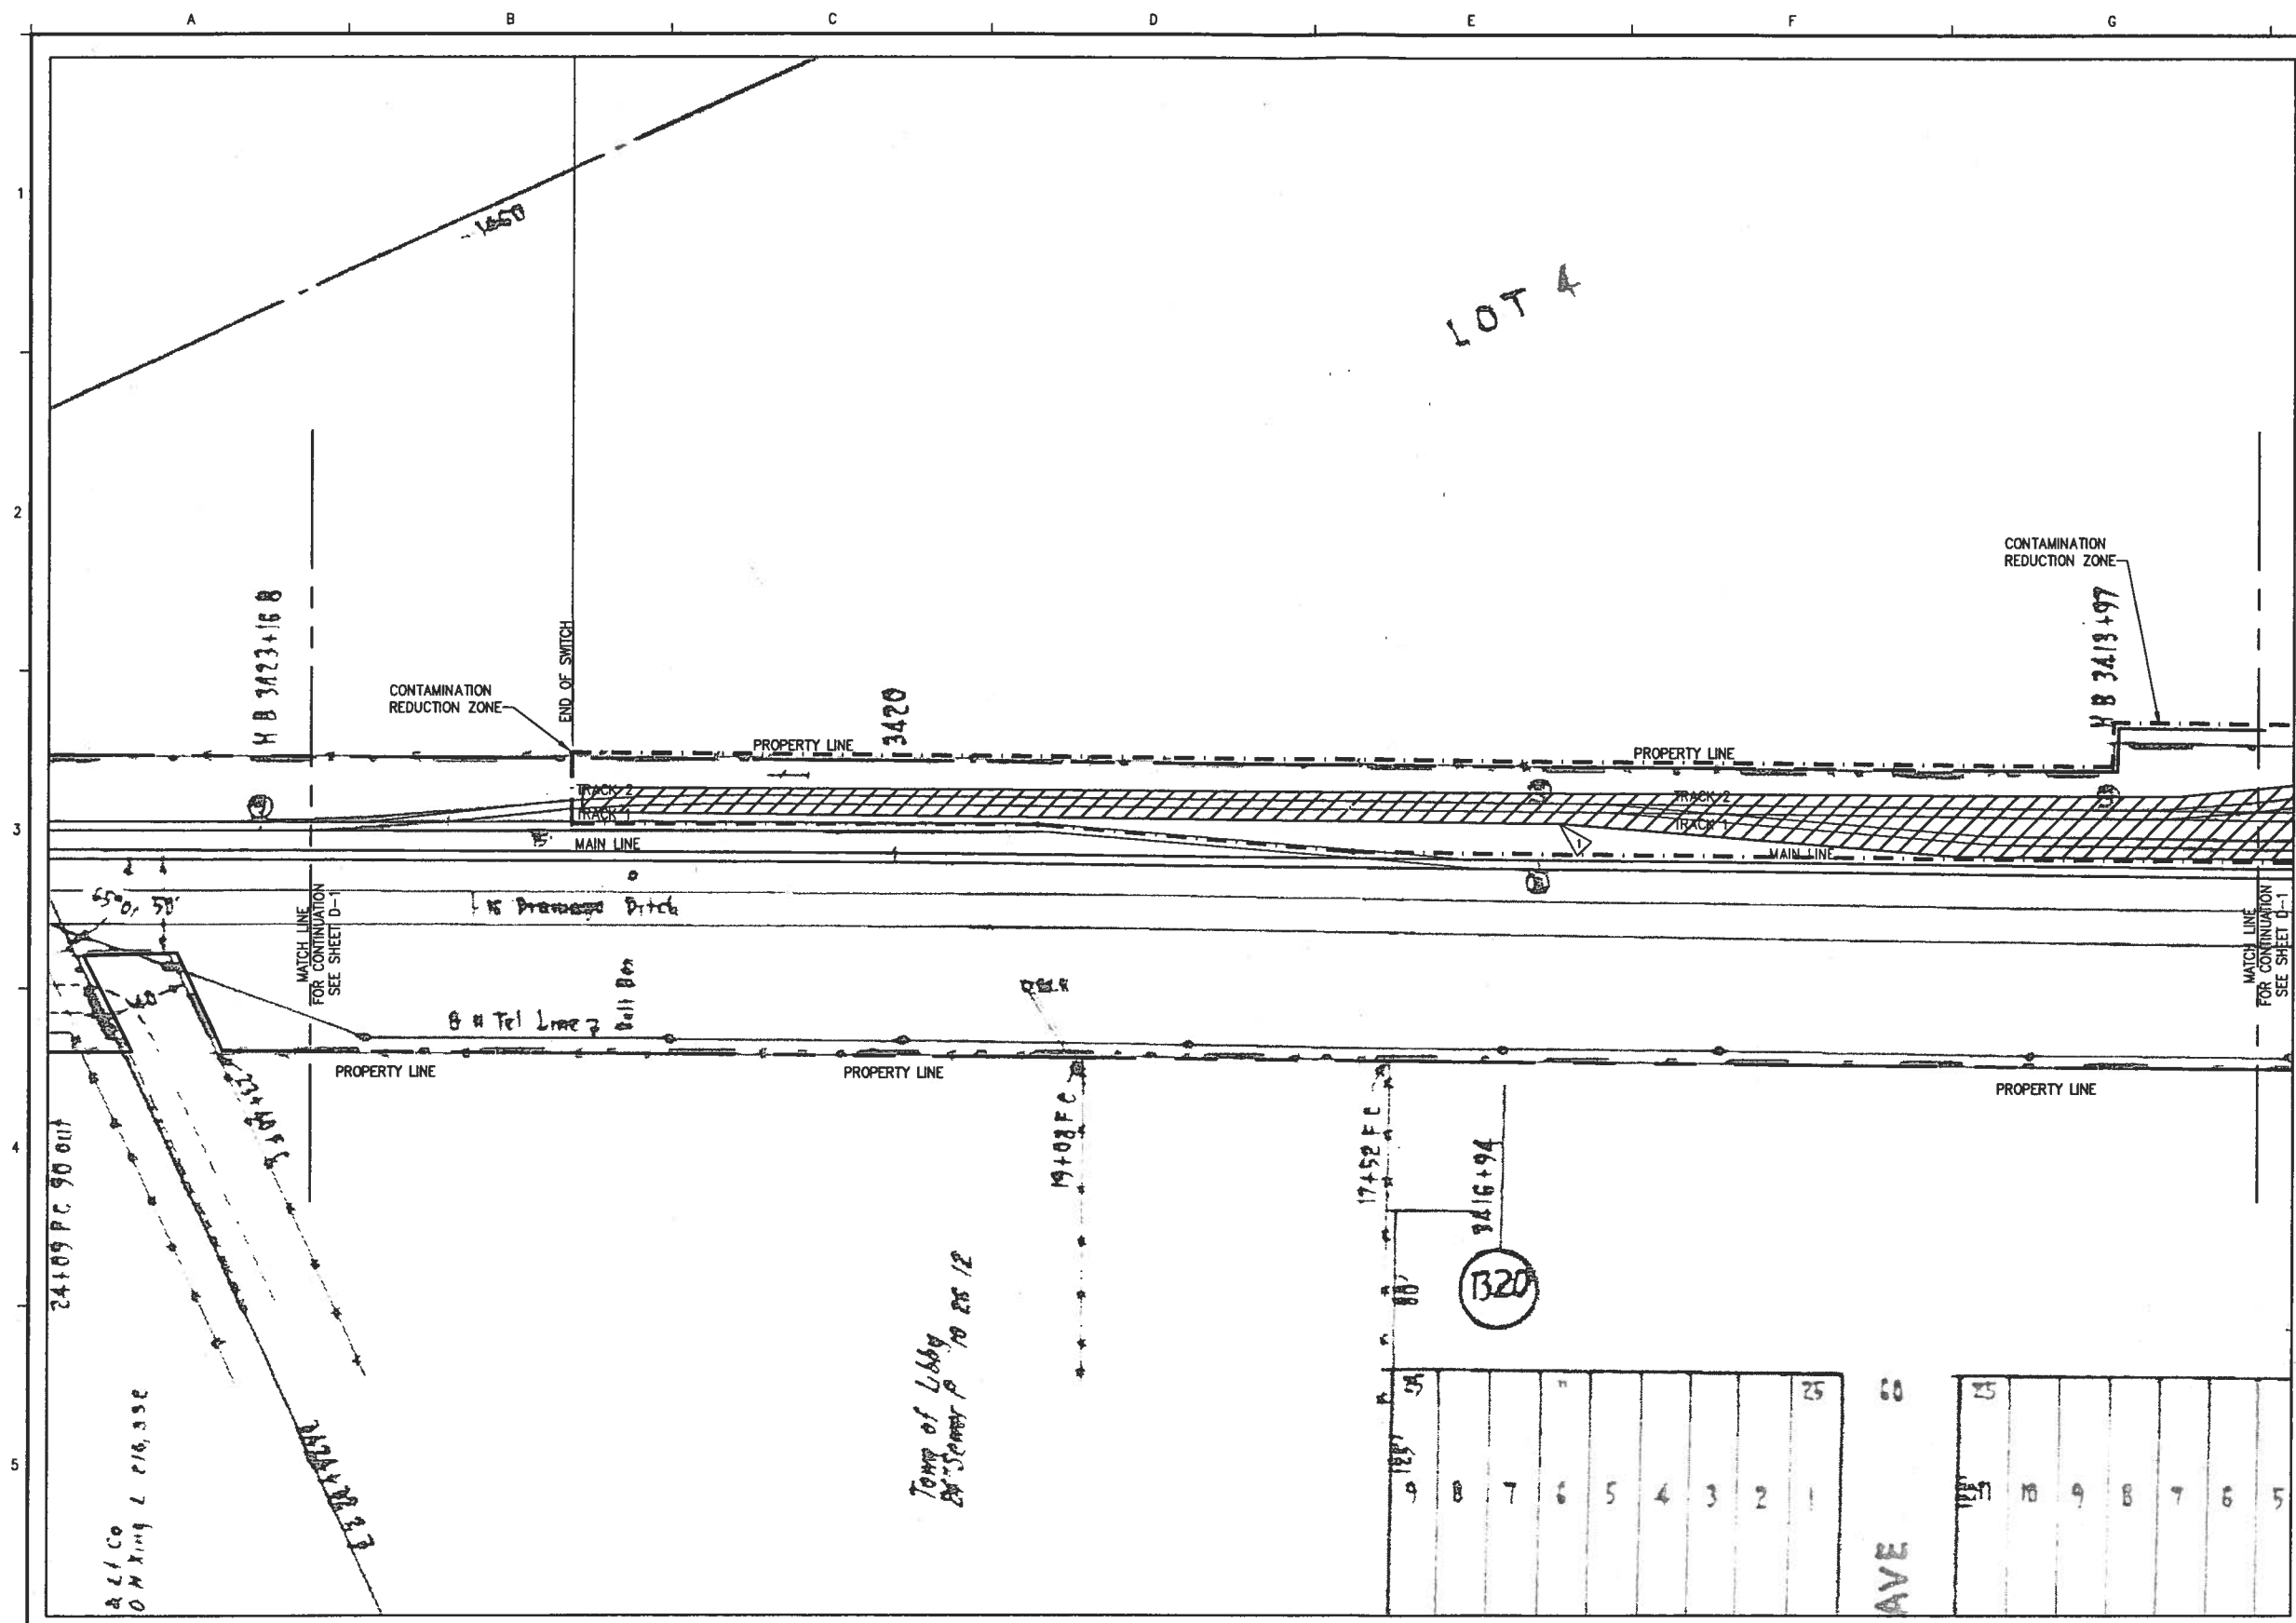
RAIL  
 DEMOLITION  
 SHEET 2

**CONSTRUCTION NOTES:**  
 [Symbol] REMOVE INDICATED TRACK. [Hatched Box Symbol]

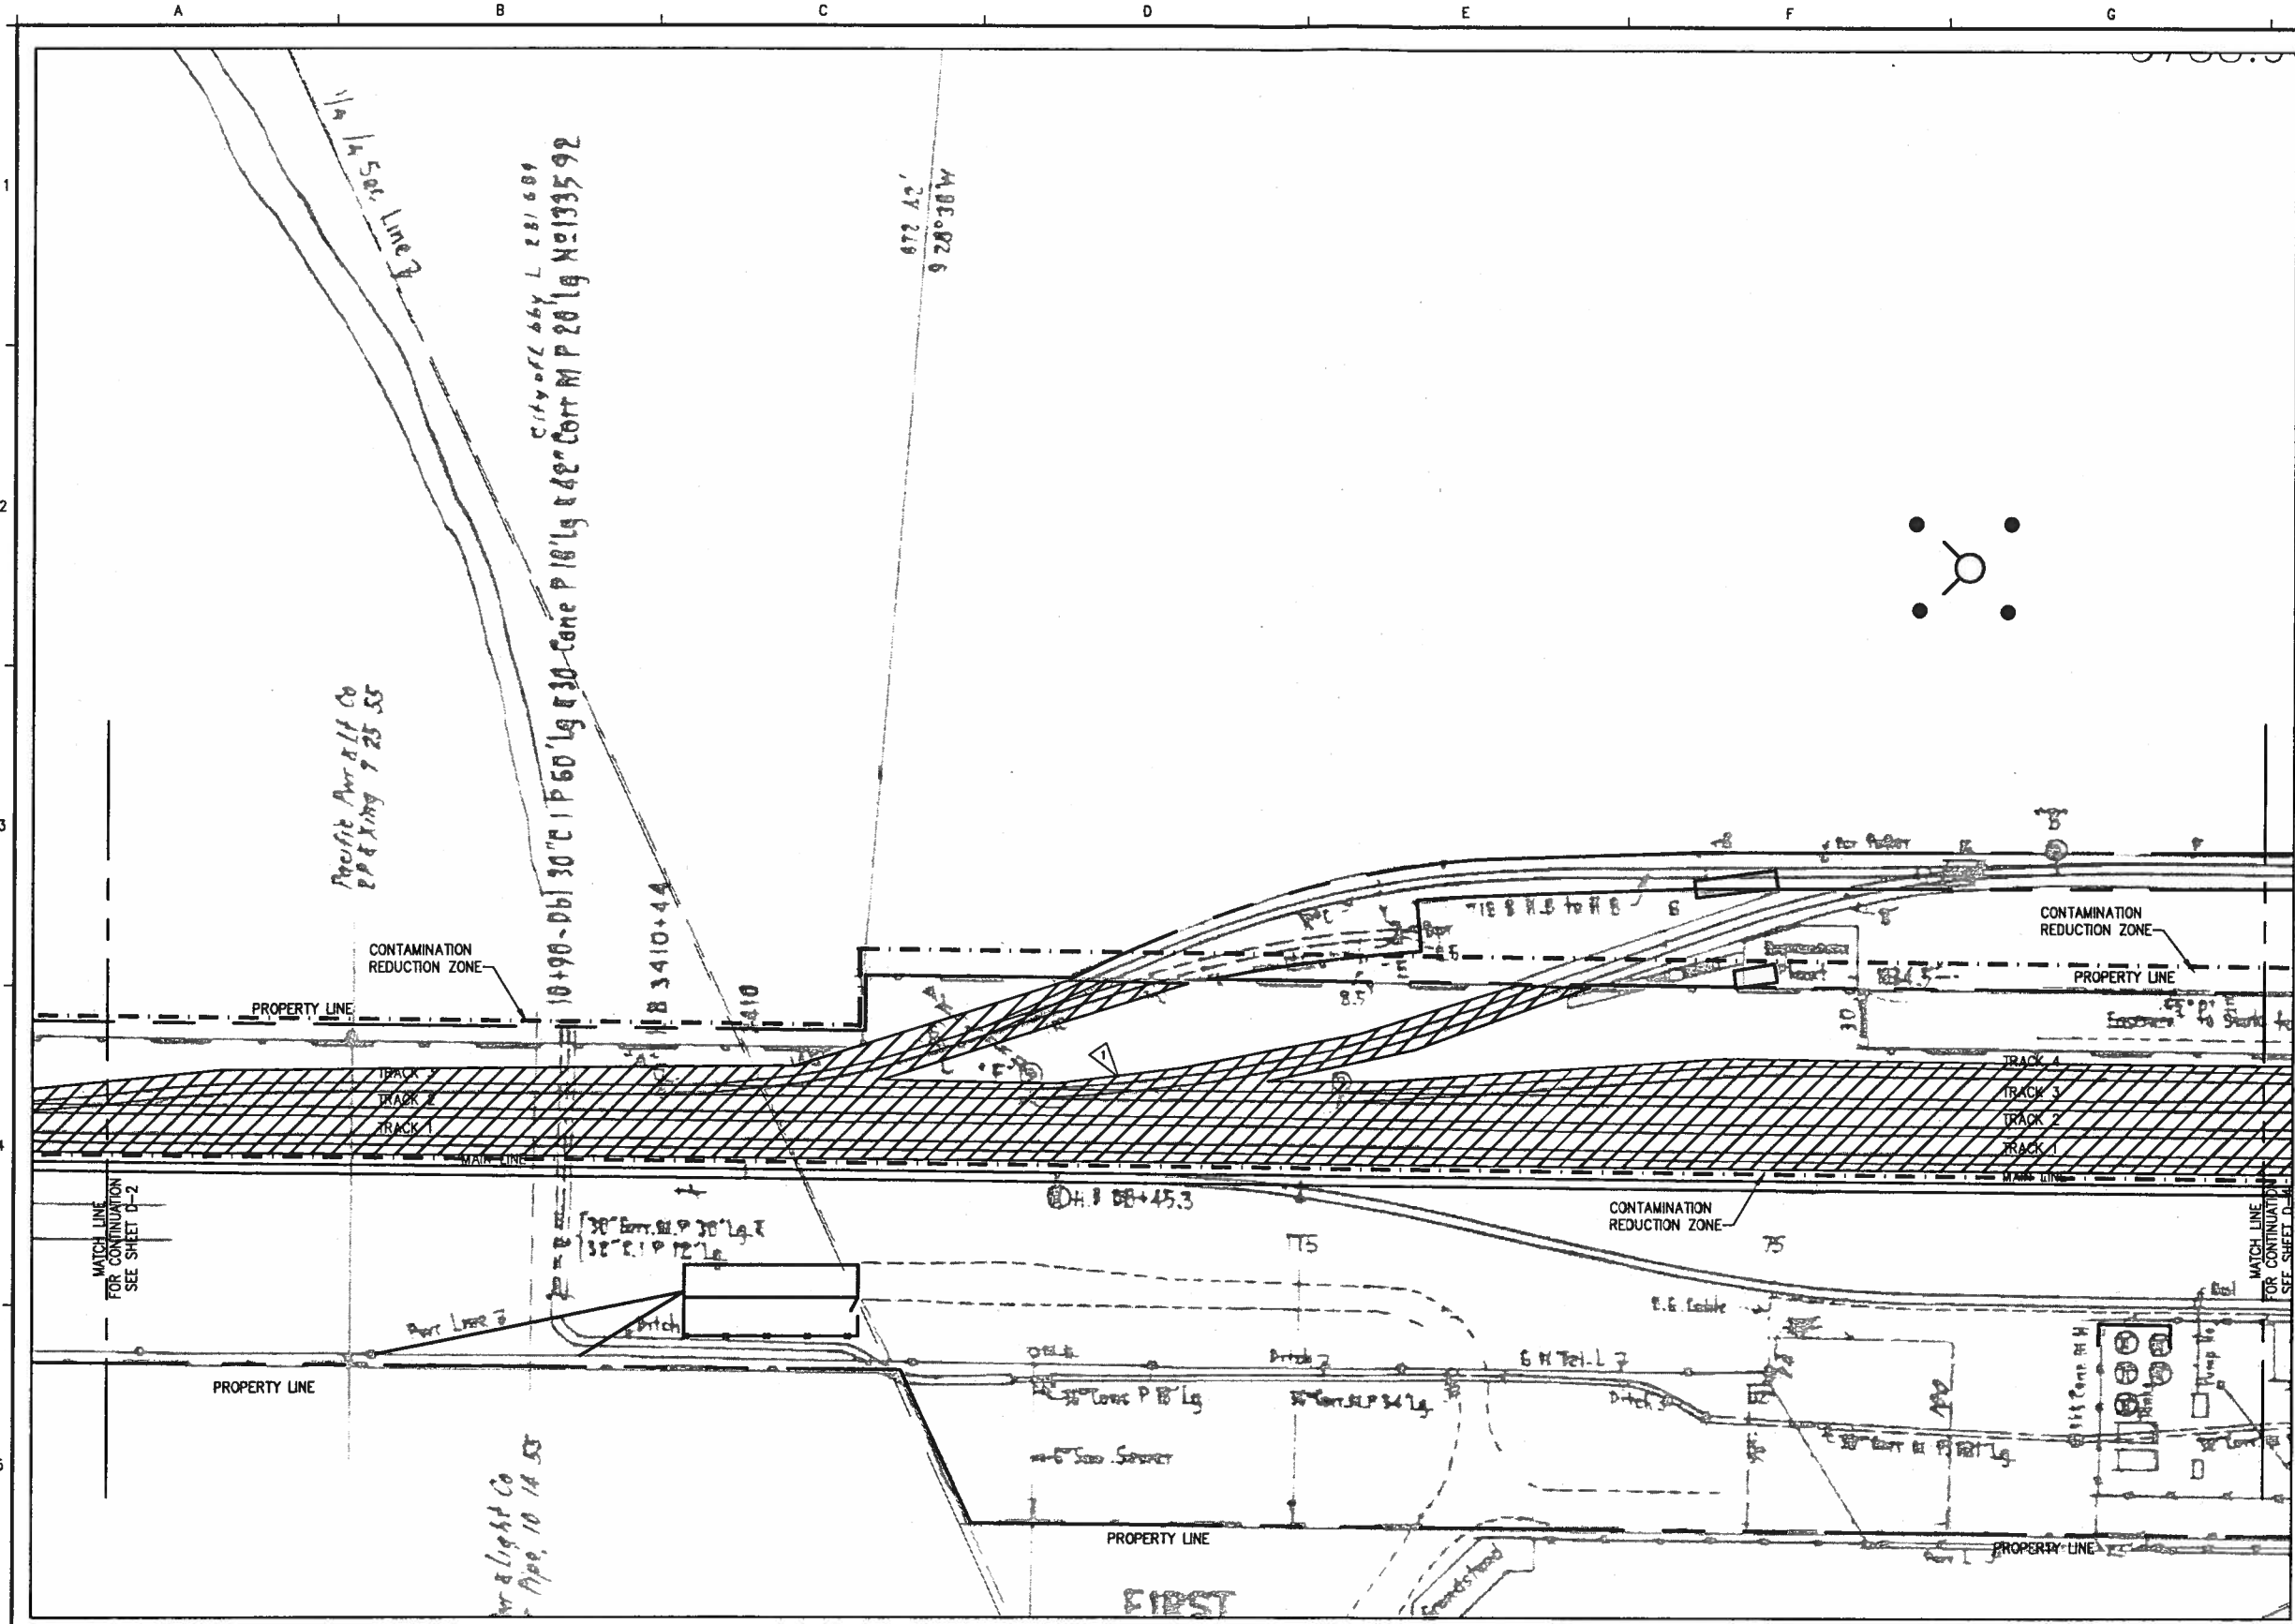
**RAIL  
 DEMOLITION  
 SHEET 3**

**CONSTRUCTION NOTES:**  
 REMOVE INDICATED TRACK.

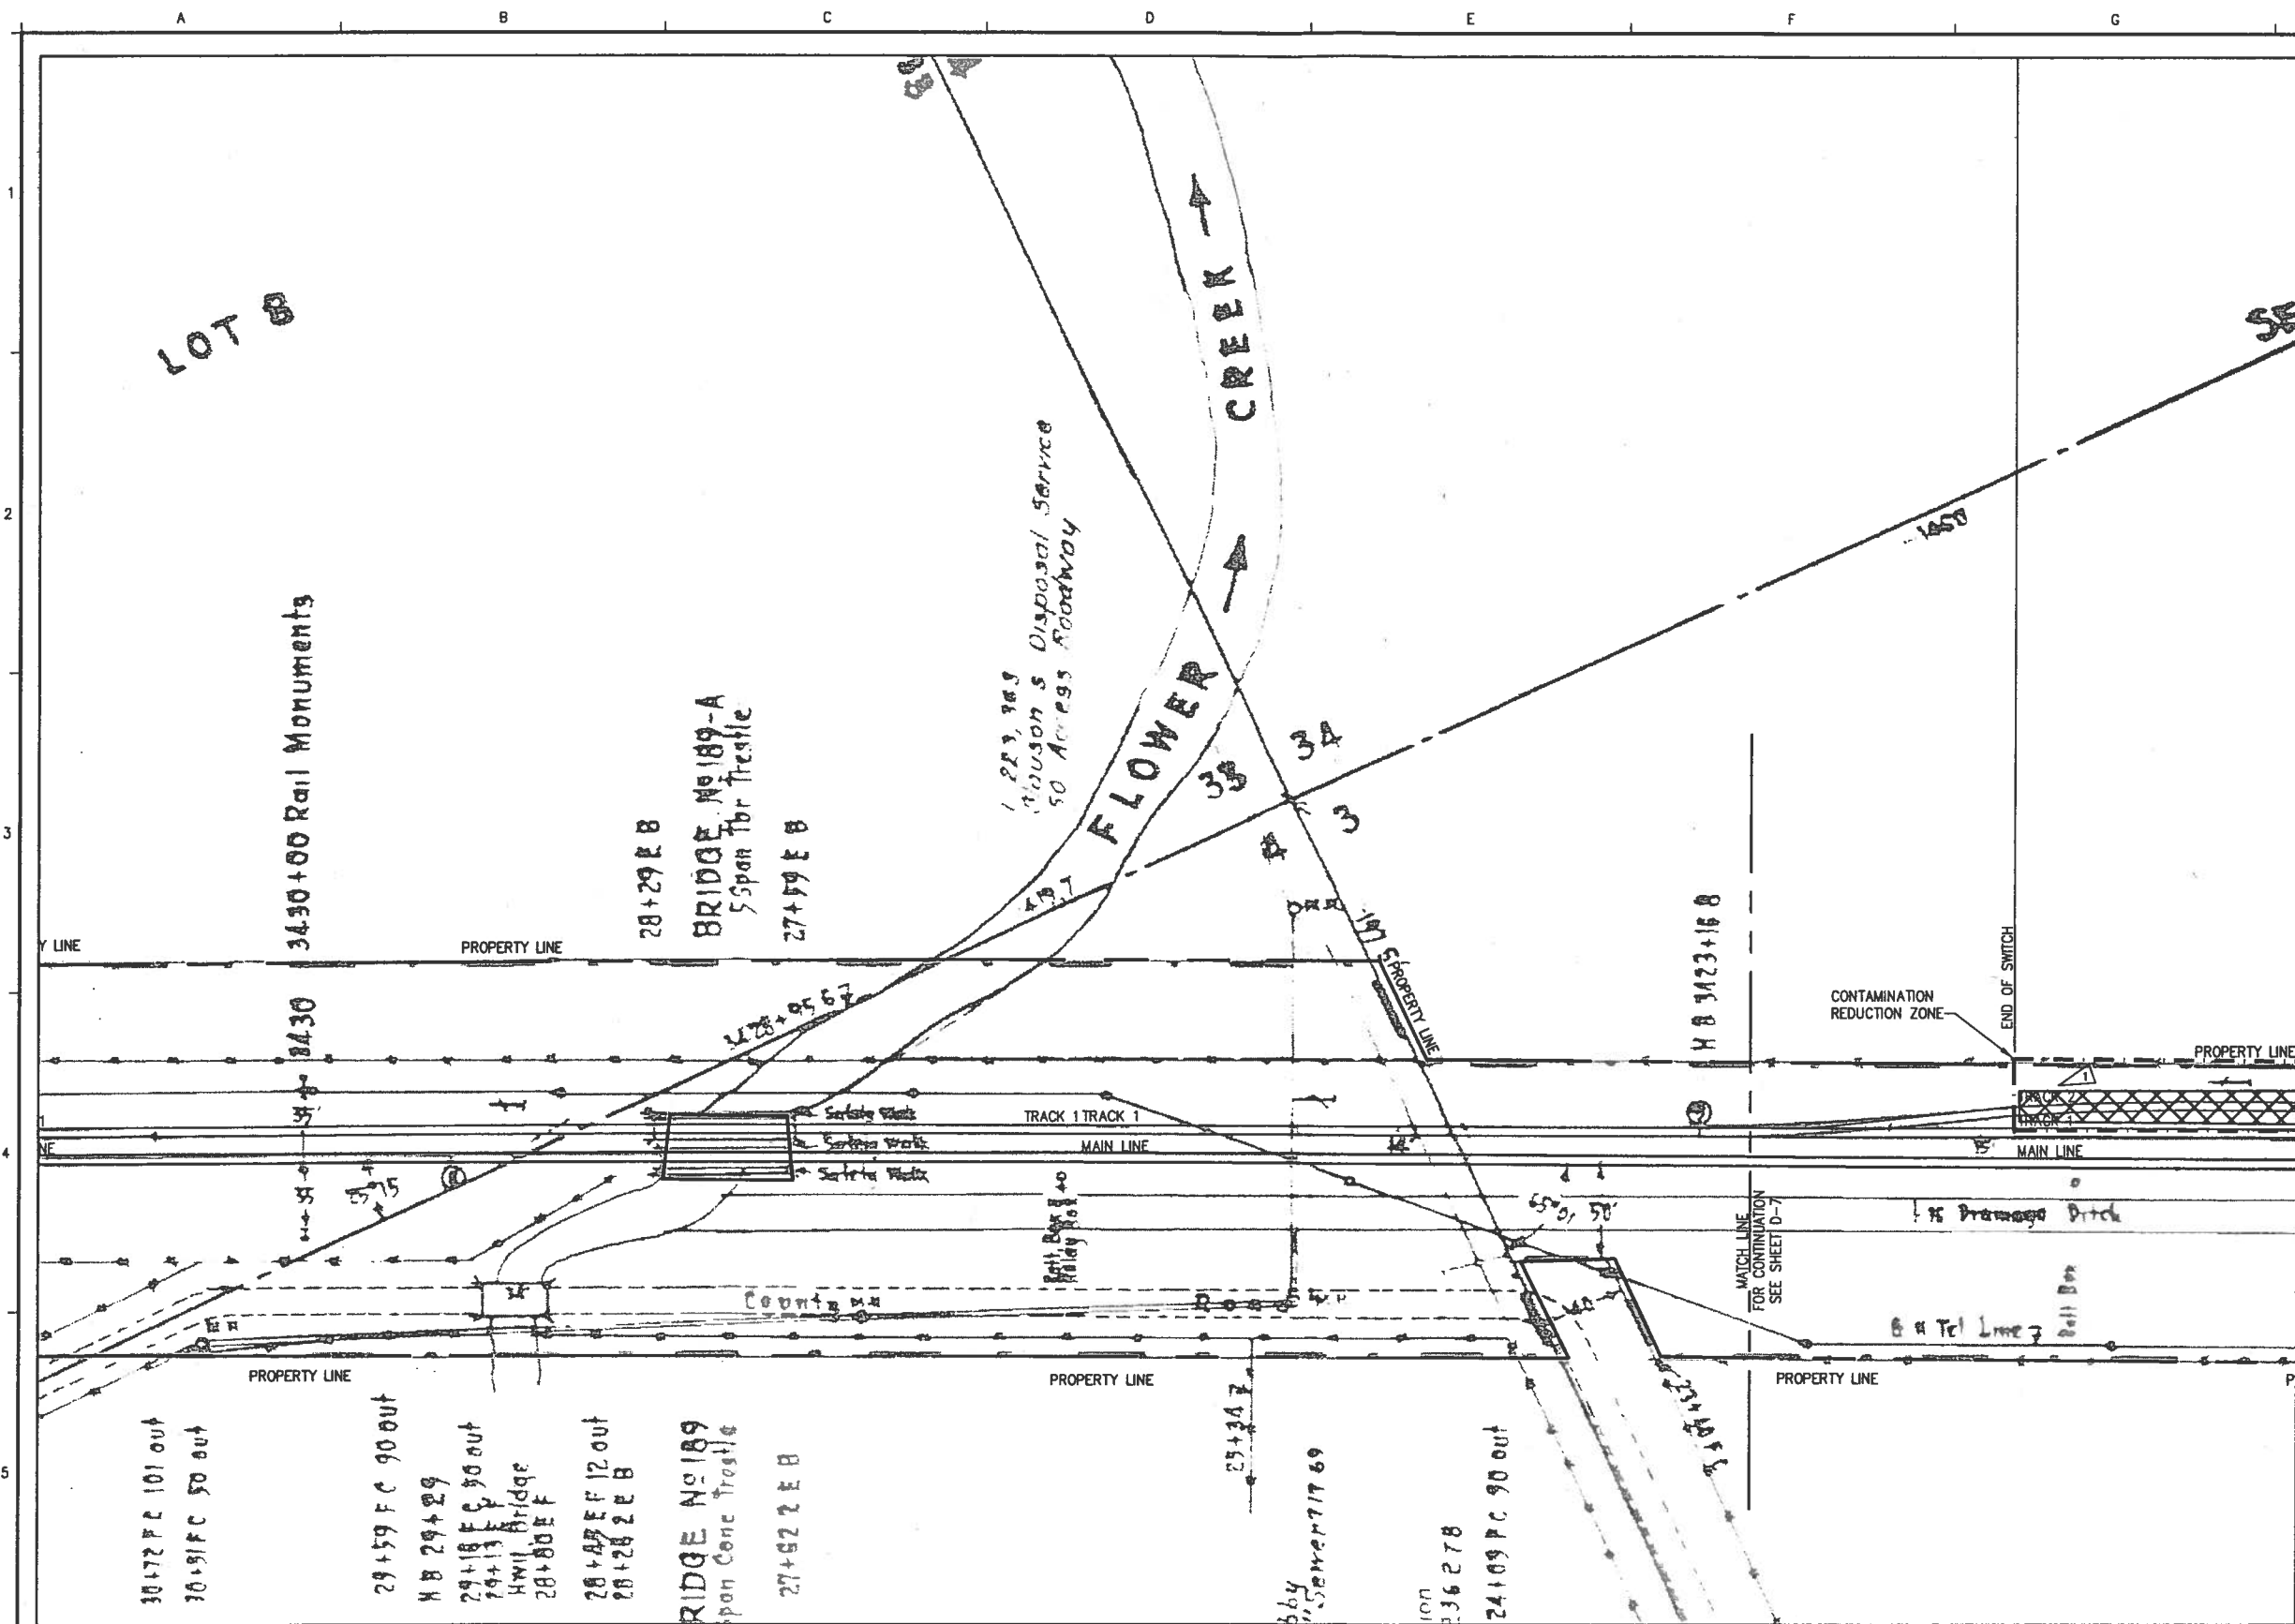
**CONSTRUCTION NOTES:**  
 REMOVE INDICATED TIES.

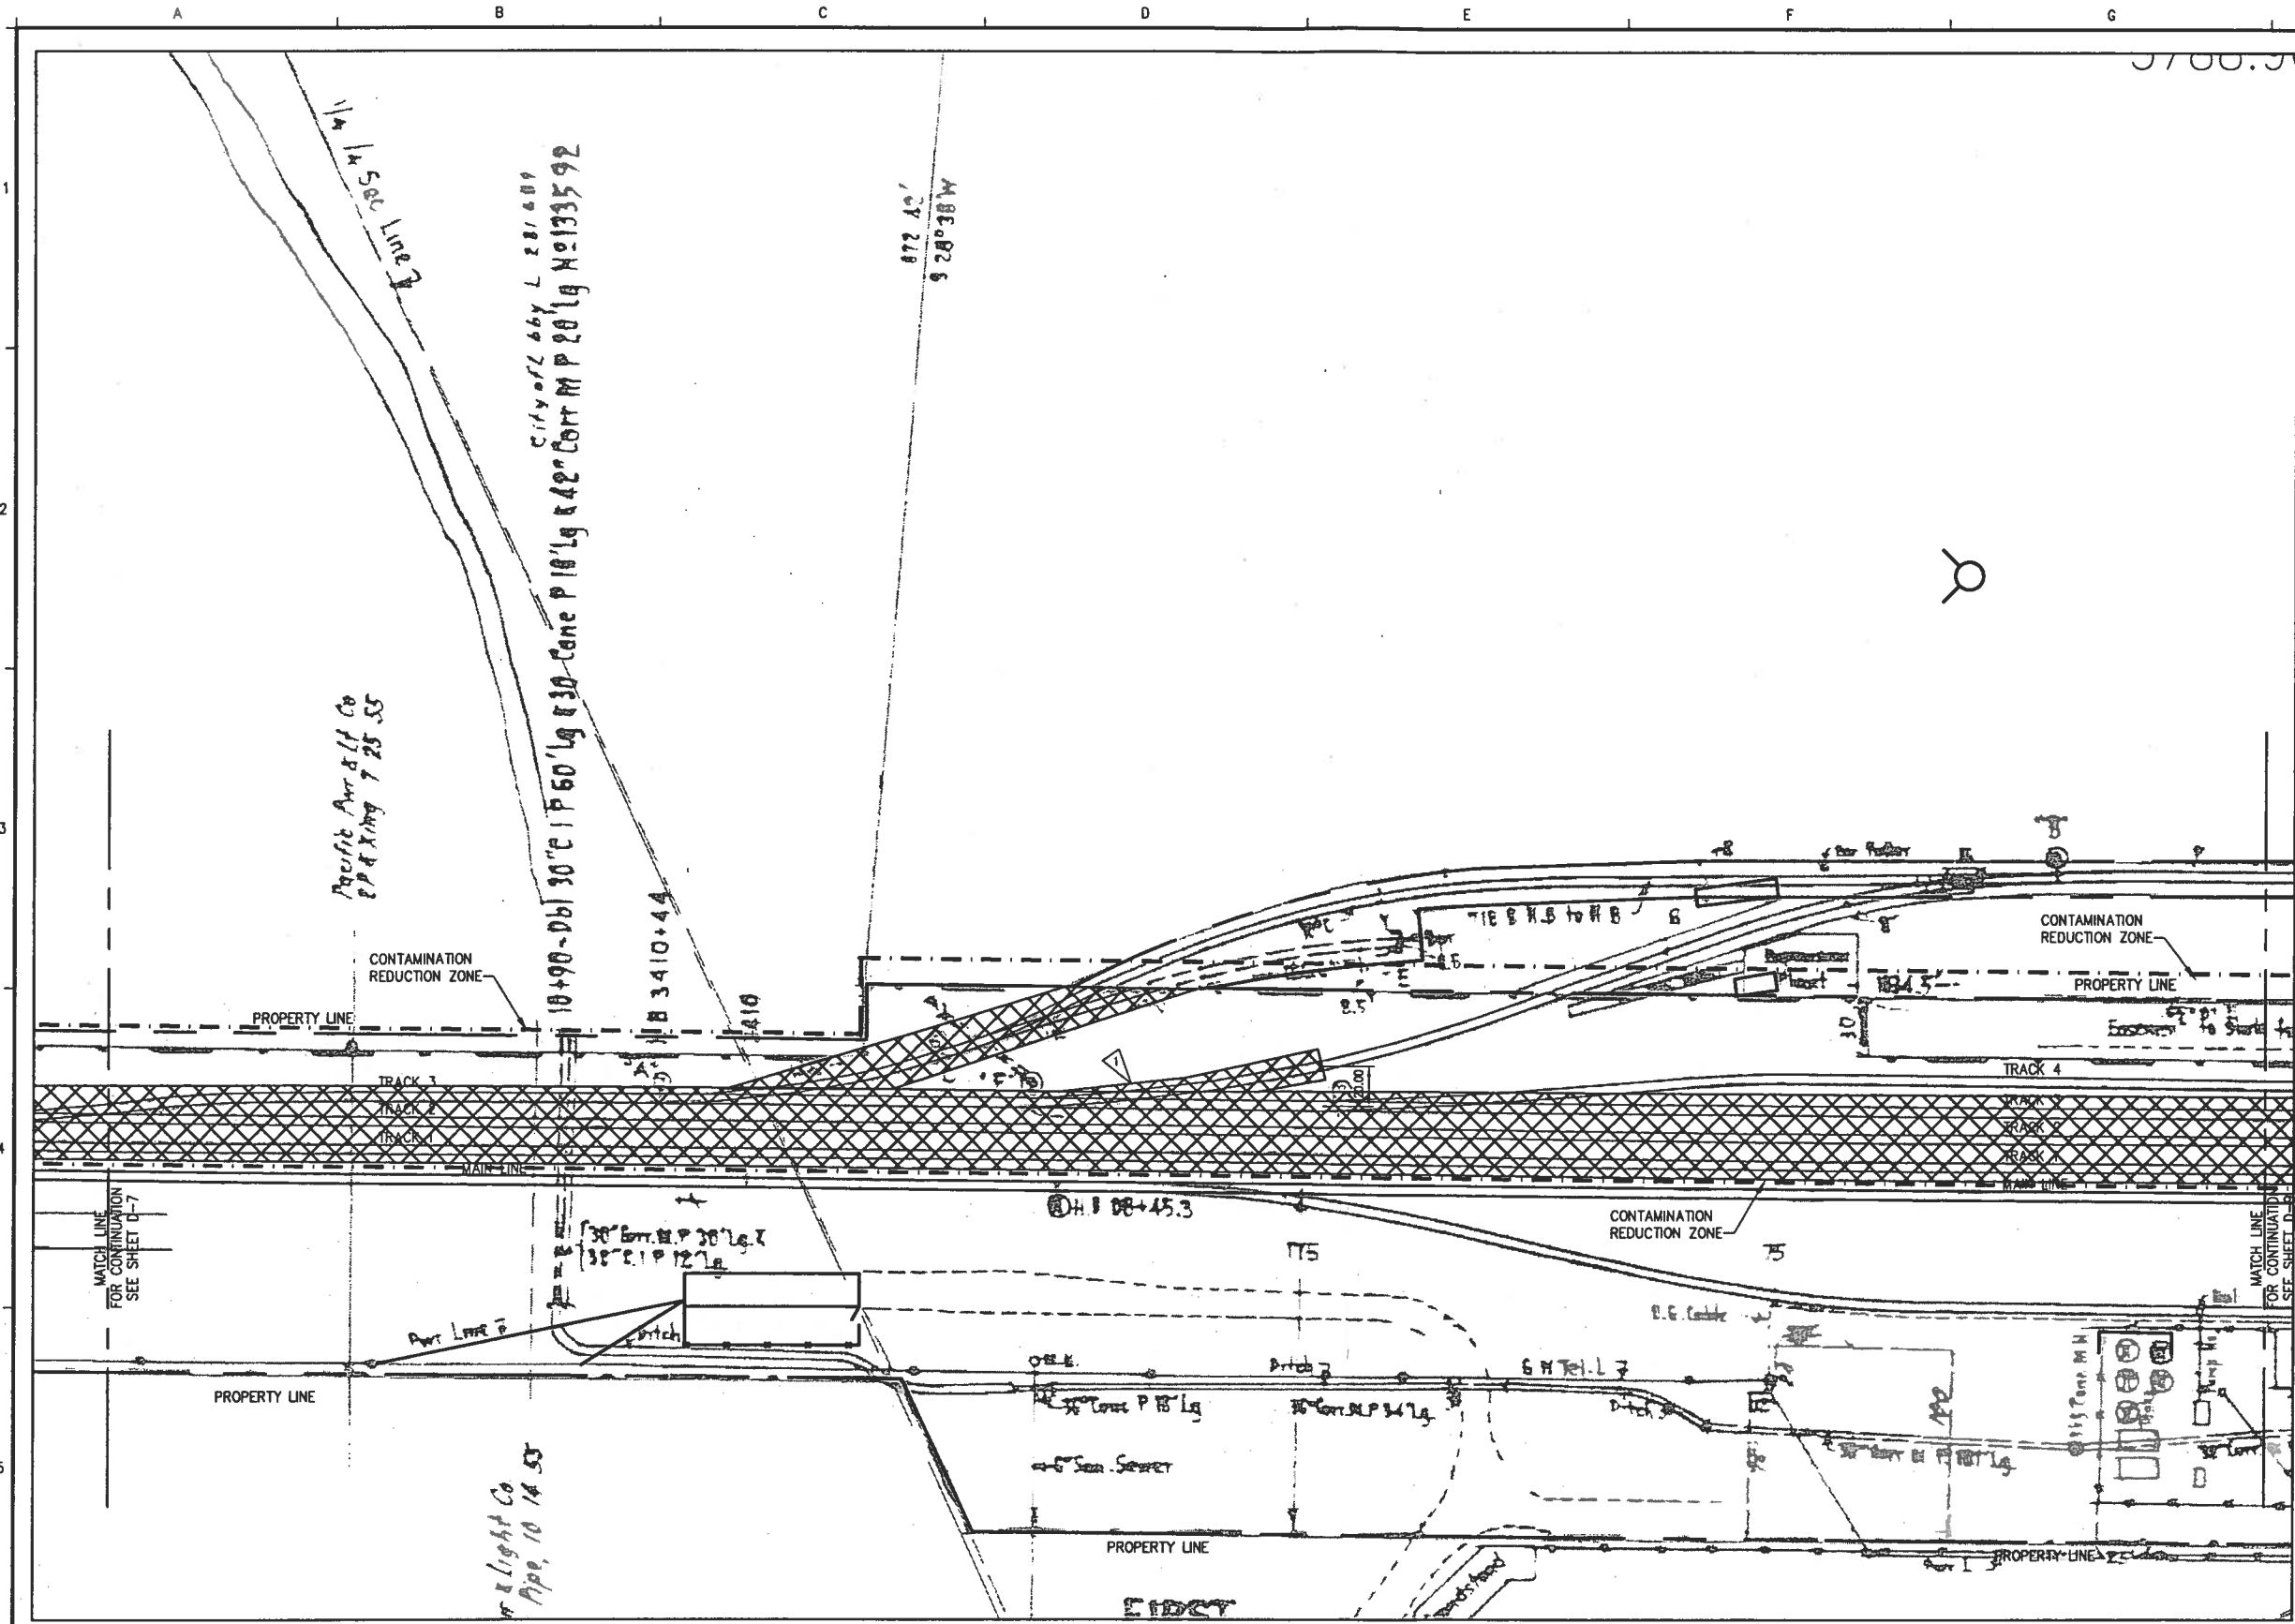
**CONSTRUCTION NOTES:**  
 REMOVE INDICATED TIES.

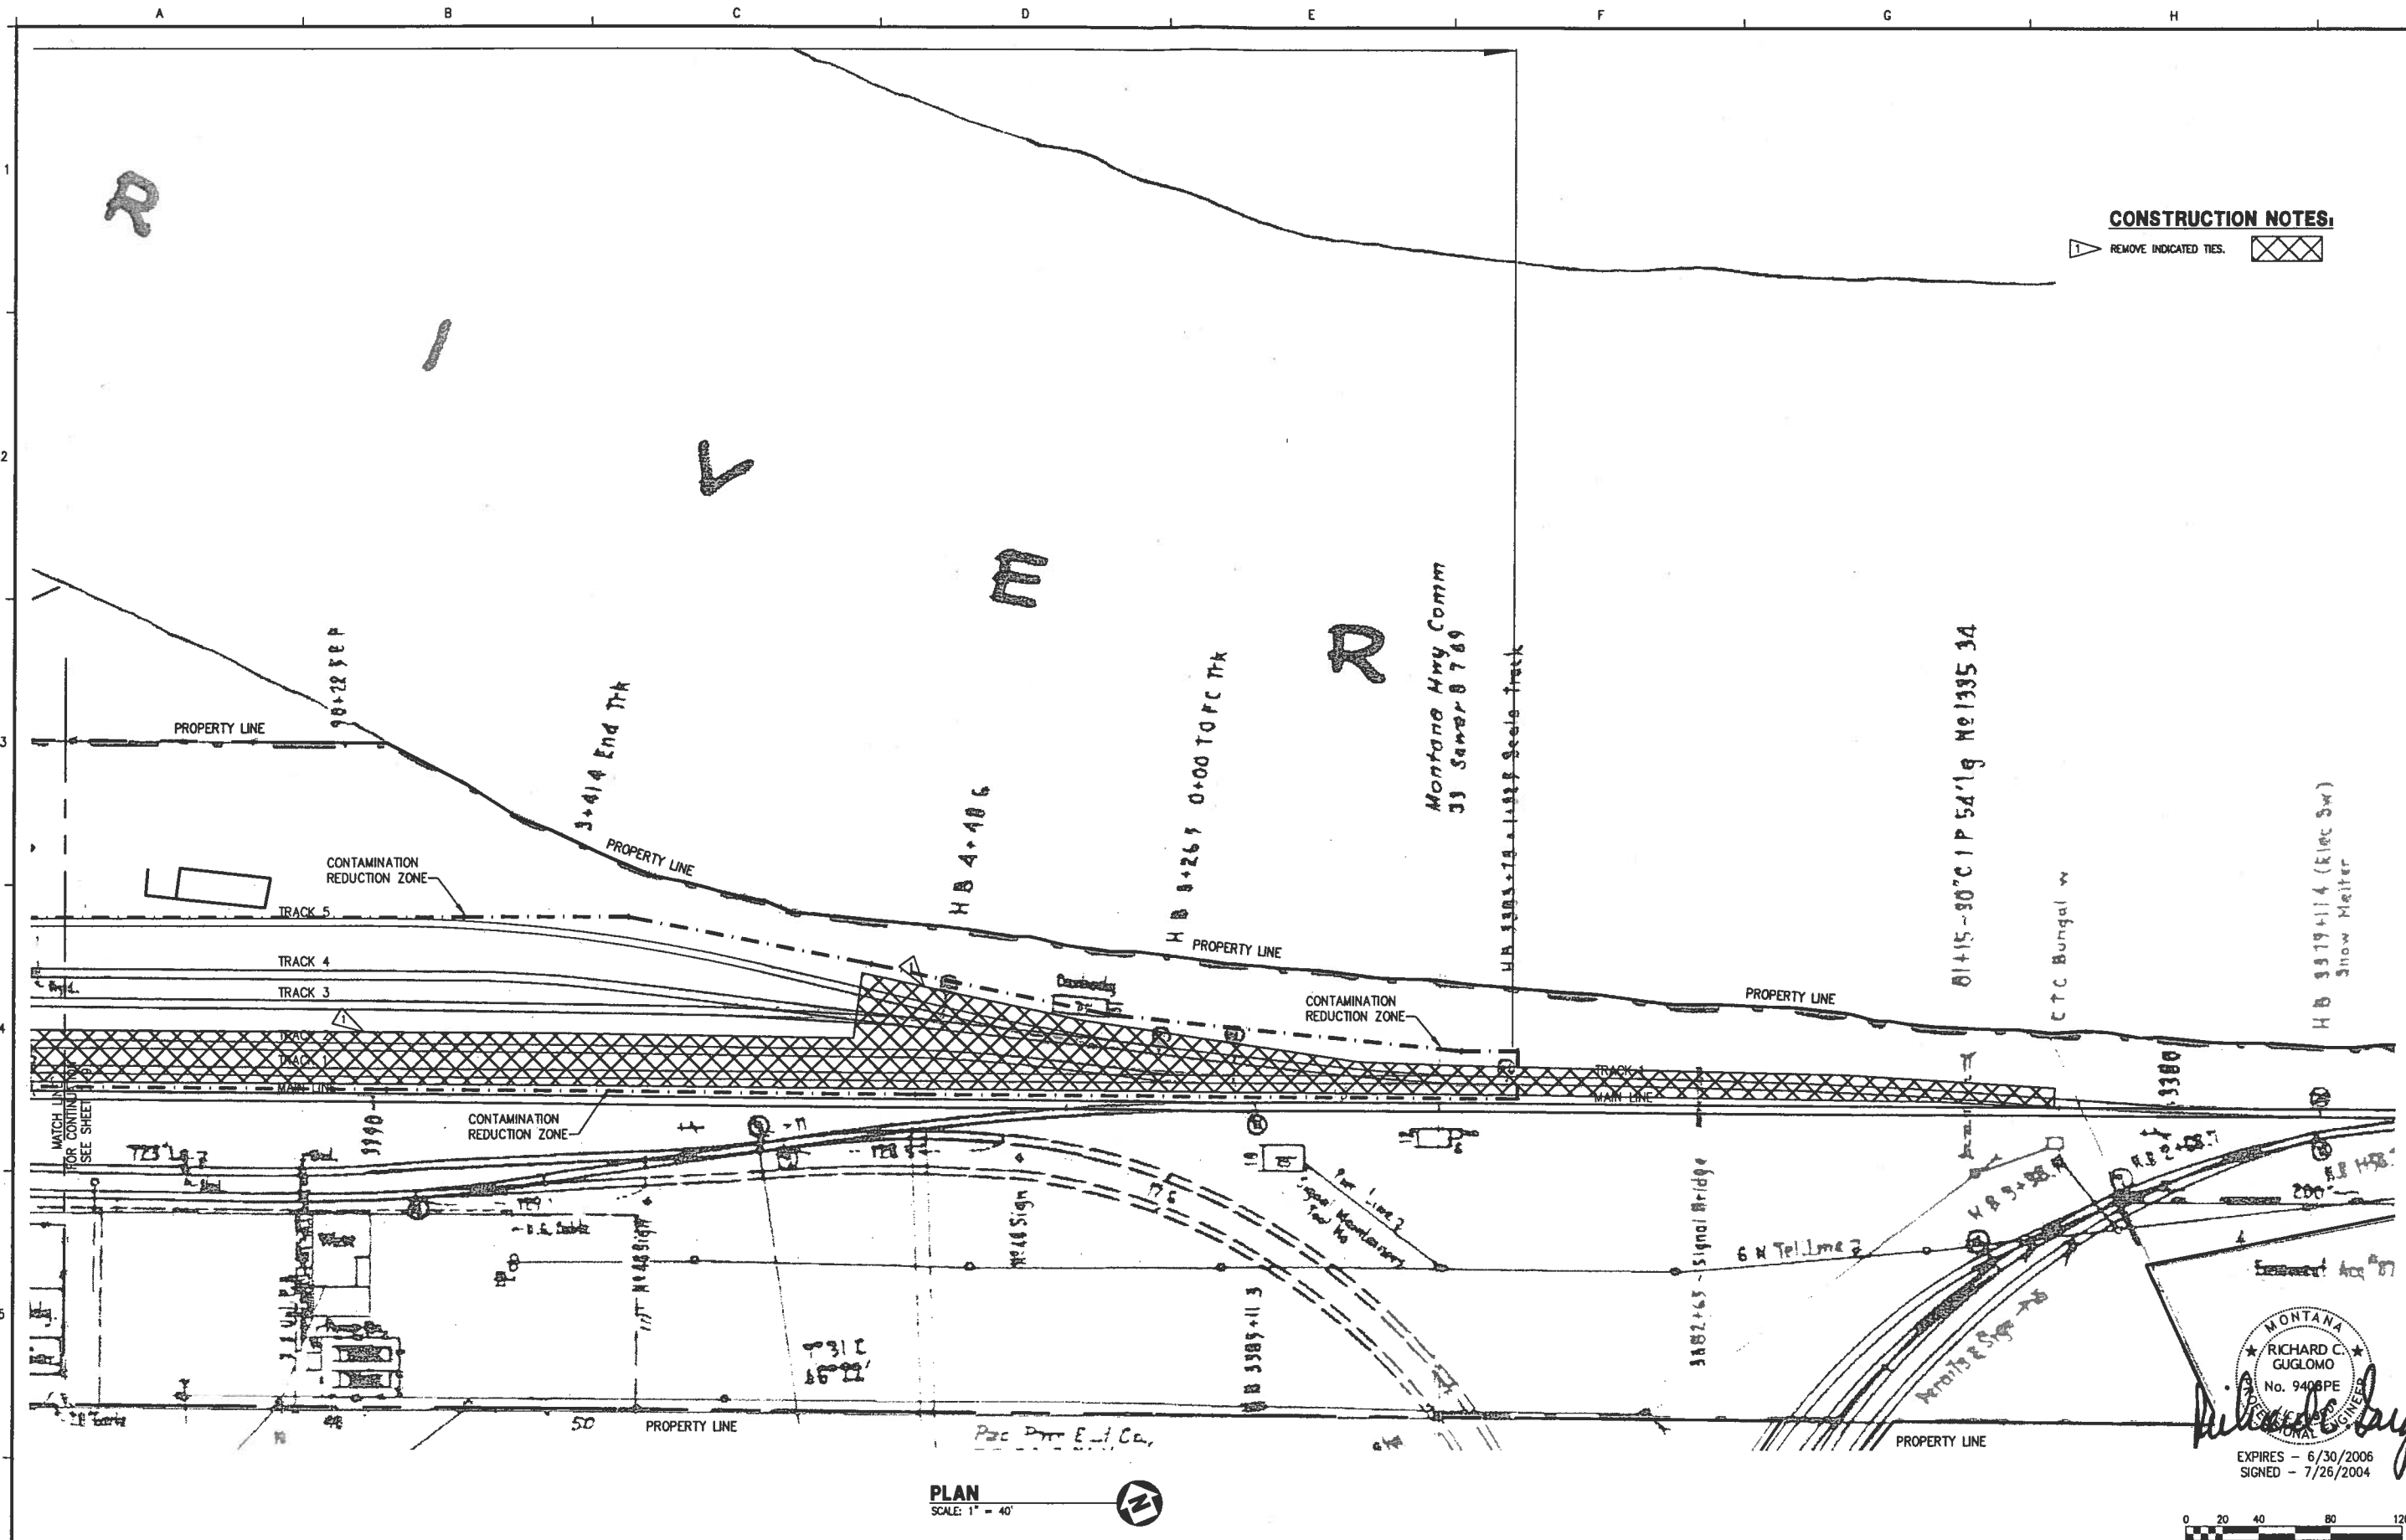
**CONSTRUCTION NOTES:**  
 REMOVE INDICATED TIES.
