# Final Remedial Investigation Report For Operable Unit 6 at the Libby Asbestos Site Libby, Montana

30 April 2014

Prepared for  
BNSF Railway Company  
800 North Last Chance Gulch, Suite 101  
Helena, Montana 59601

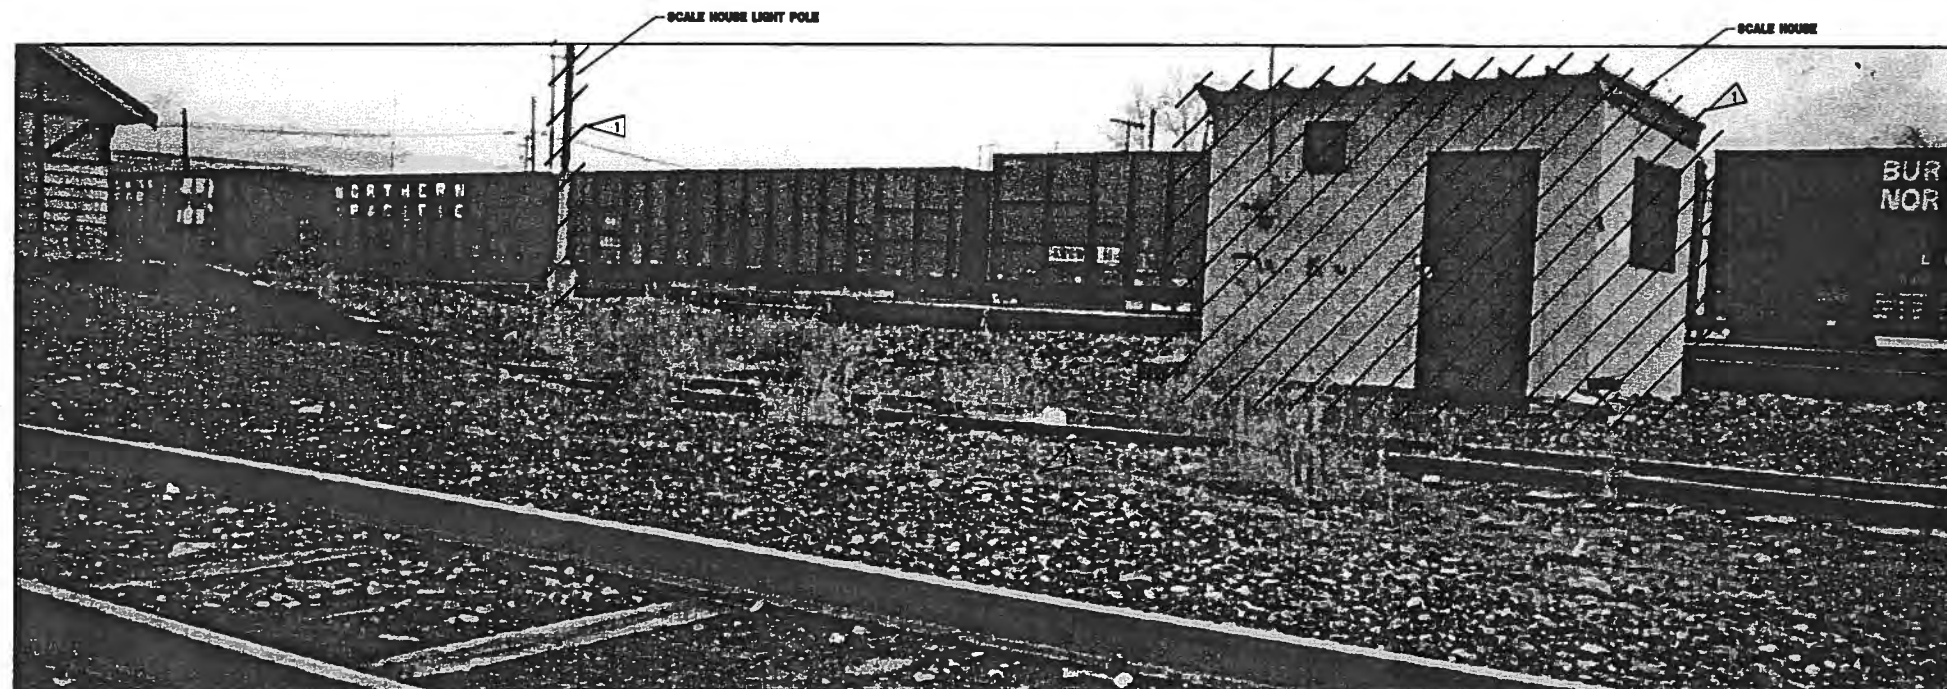
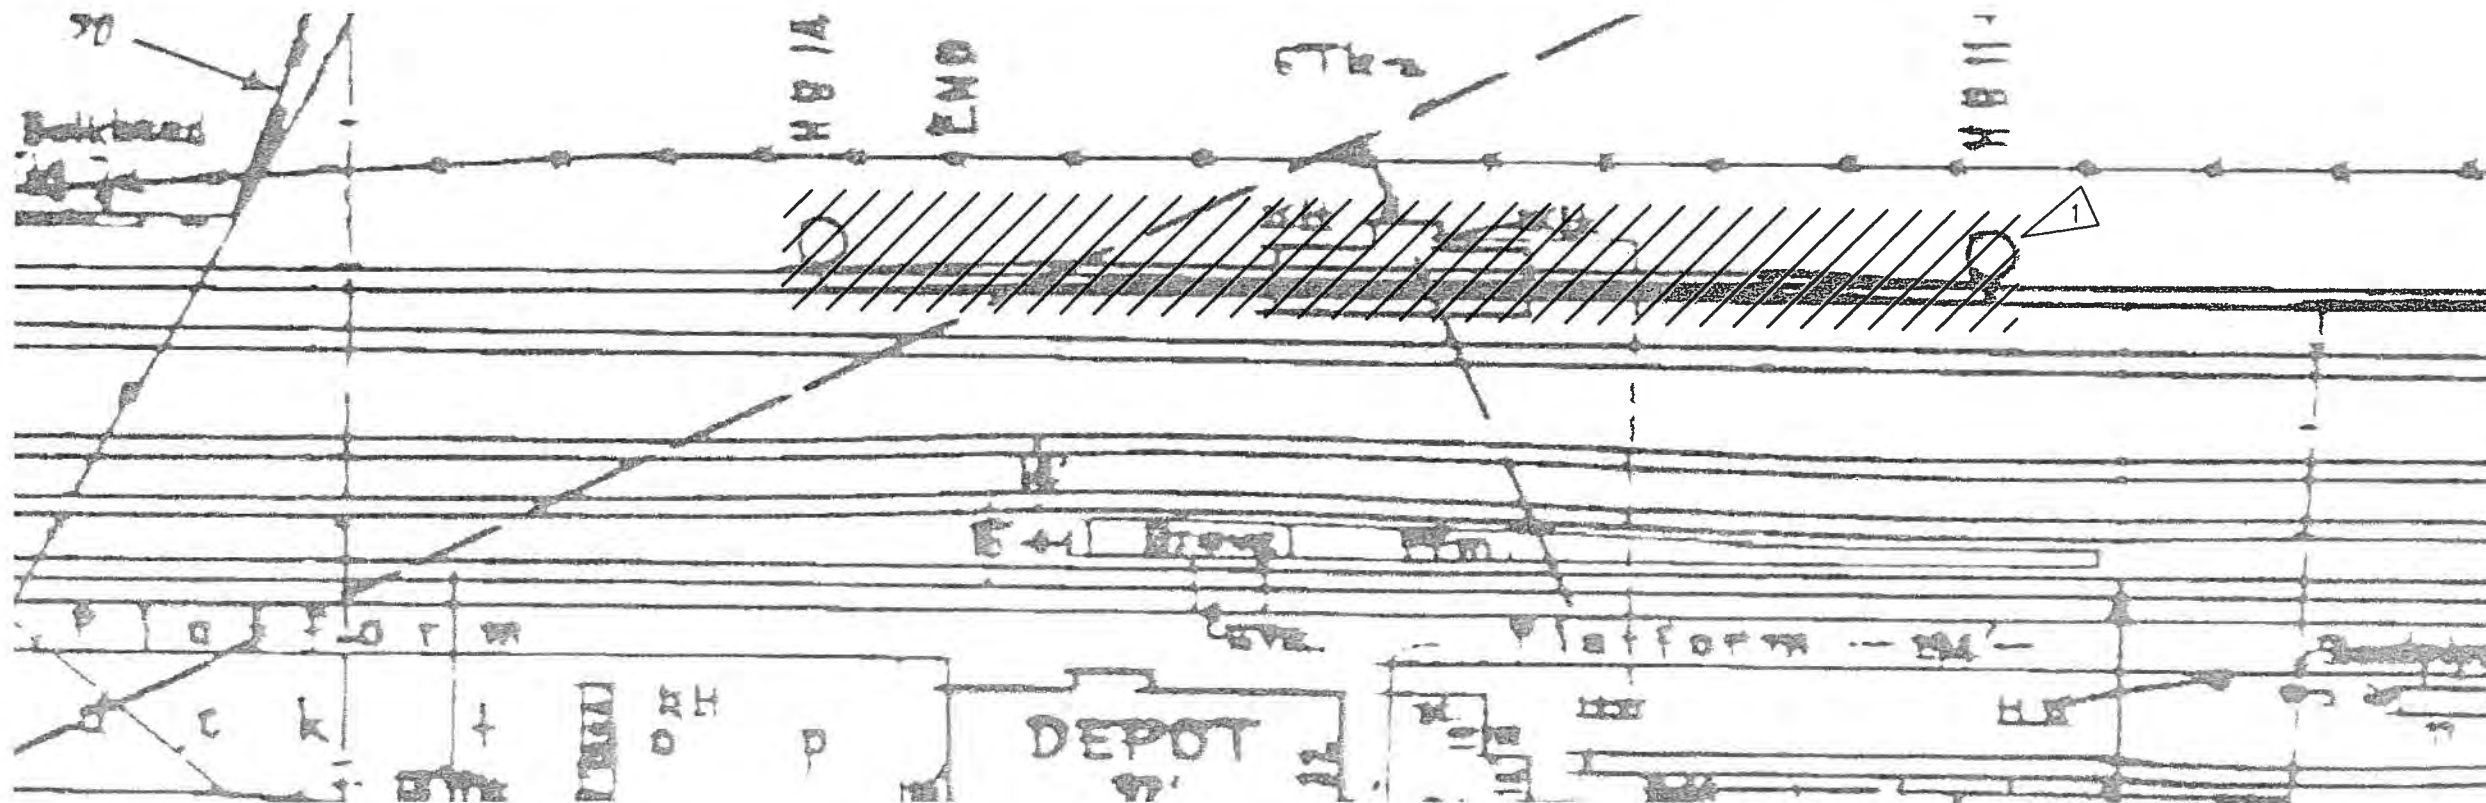
SCALE  
DEMOLITION SHEET

- 1 DEMOLISH SCALE, SCALE HOUSE, AND LIGHT POLES.
- 2 BNSF WILL DISCONNECT THE ELECTRICAL SERVICE TO THE SCALE HOUSE BUILDING. NOTIFY THE ENGINEER TO COORDINATE DISCONNECT WITH BNSF WHEN READY.

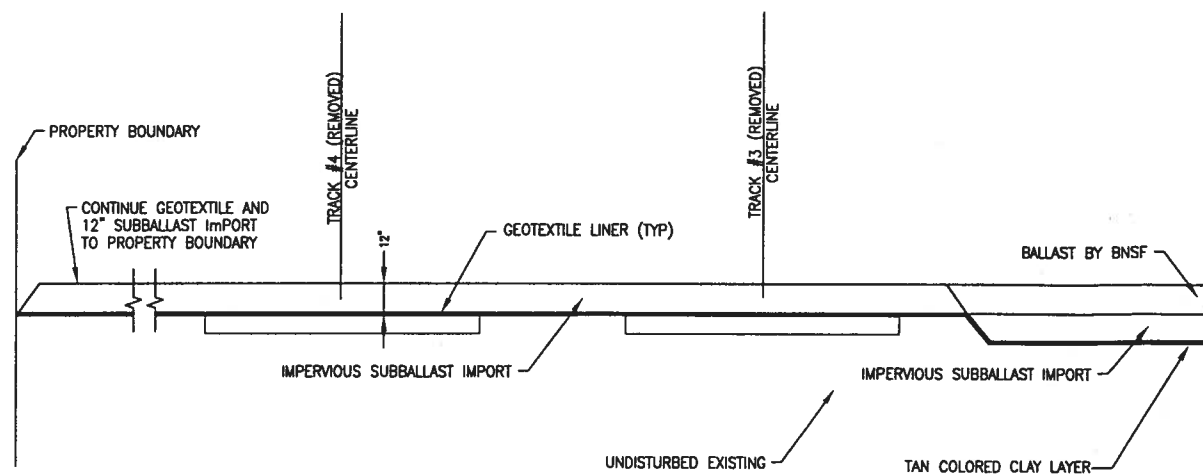
1. REMOVE CONTAMINATED MATERIAL THE LENGTH OF THE YARD TO THE TAN CLAY LAYER. MAINTAIN EXCAVATED AREA IN CLEAN CONDITION. WHEN CONTAMINATED MATERIAL HAS BEEN REMOVED AS SHOWN ON THE DRAWINGS, REMOVE ADDITIONAL CLEAN MATERIAL TO 25 INCHES BELOW THE TOP OF THE NEW TIES FOR TRACKS 1 AND 2. IF LINCOLN COUNTY LANDFILL APPROVES, CLEAN MATERIAL MAY BE DISPOSED OF AT LANDFILL. SEE SPECIFICATION SECTION 02302 FOR ADDITIONAL REQUIREMENTS.

**PARTIAL SECTION  
EAST OF BRIDGE**  
SCALE: 3/8" = 1'

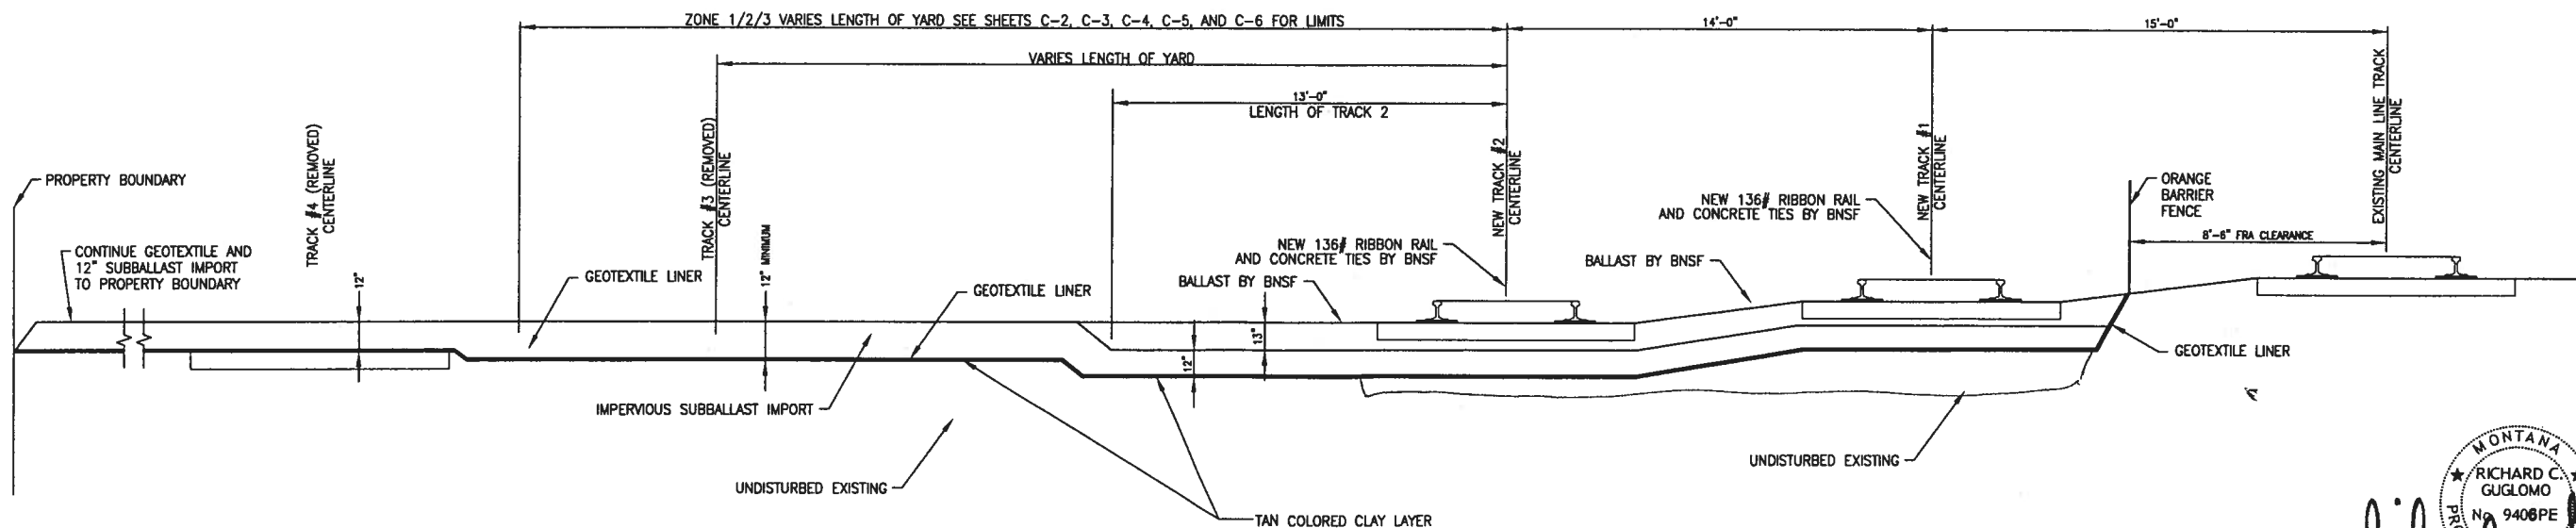
**SECTION WEST  
OF BRIDGE**  
SCALE: 3/8" = 1'

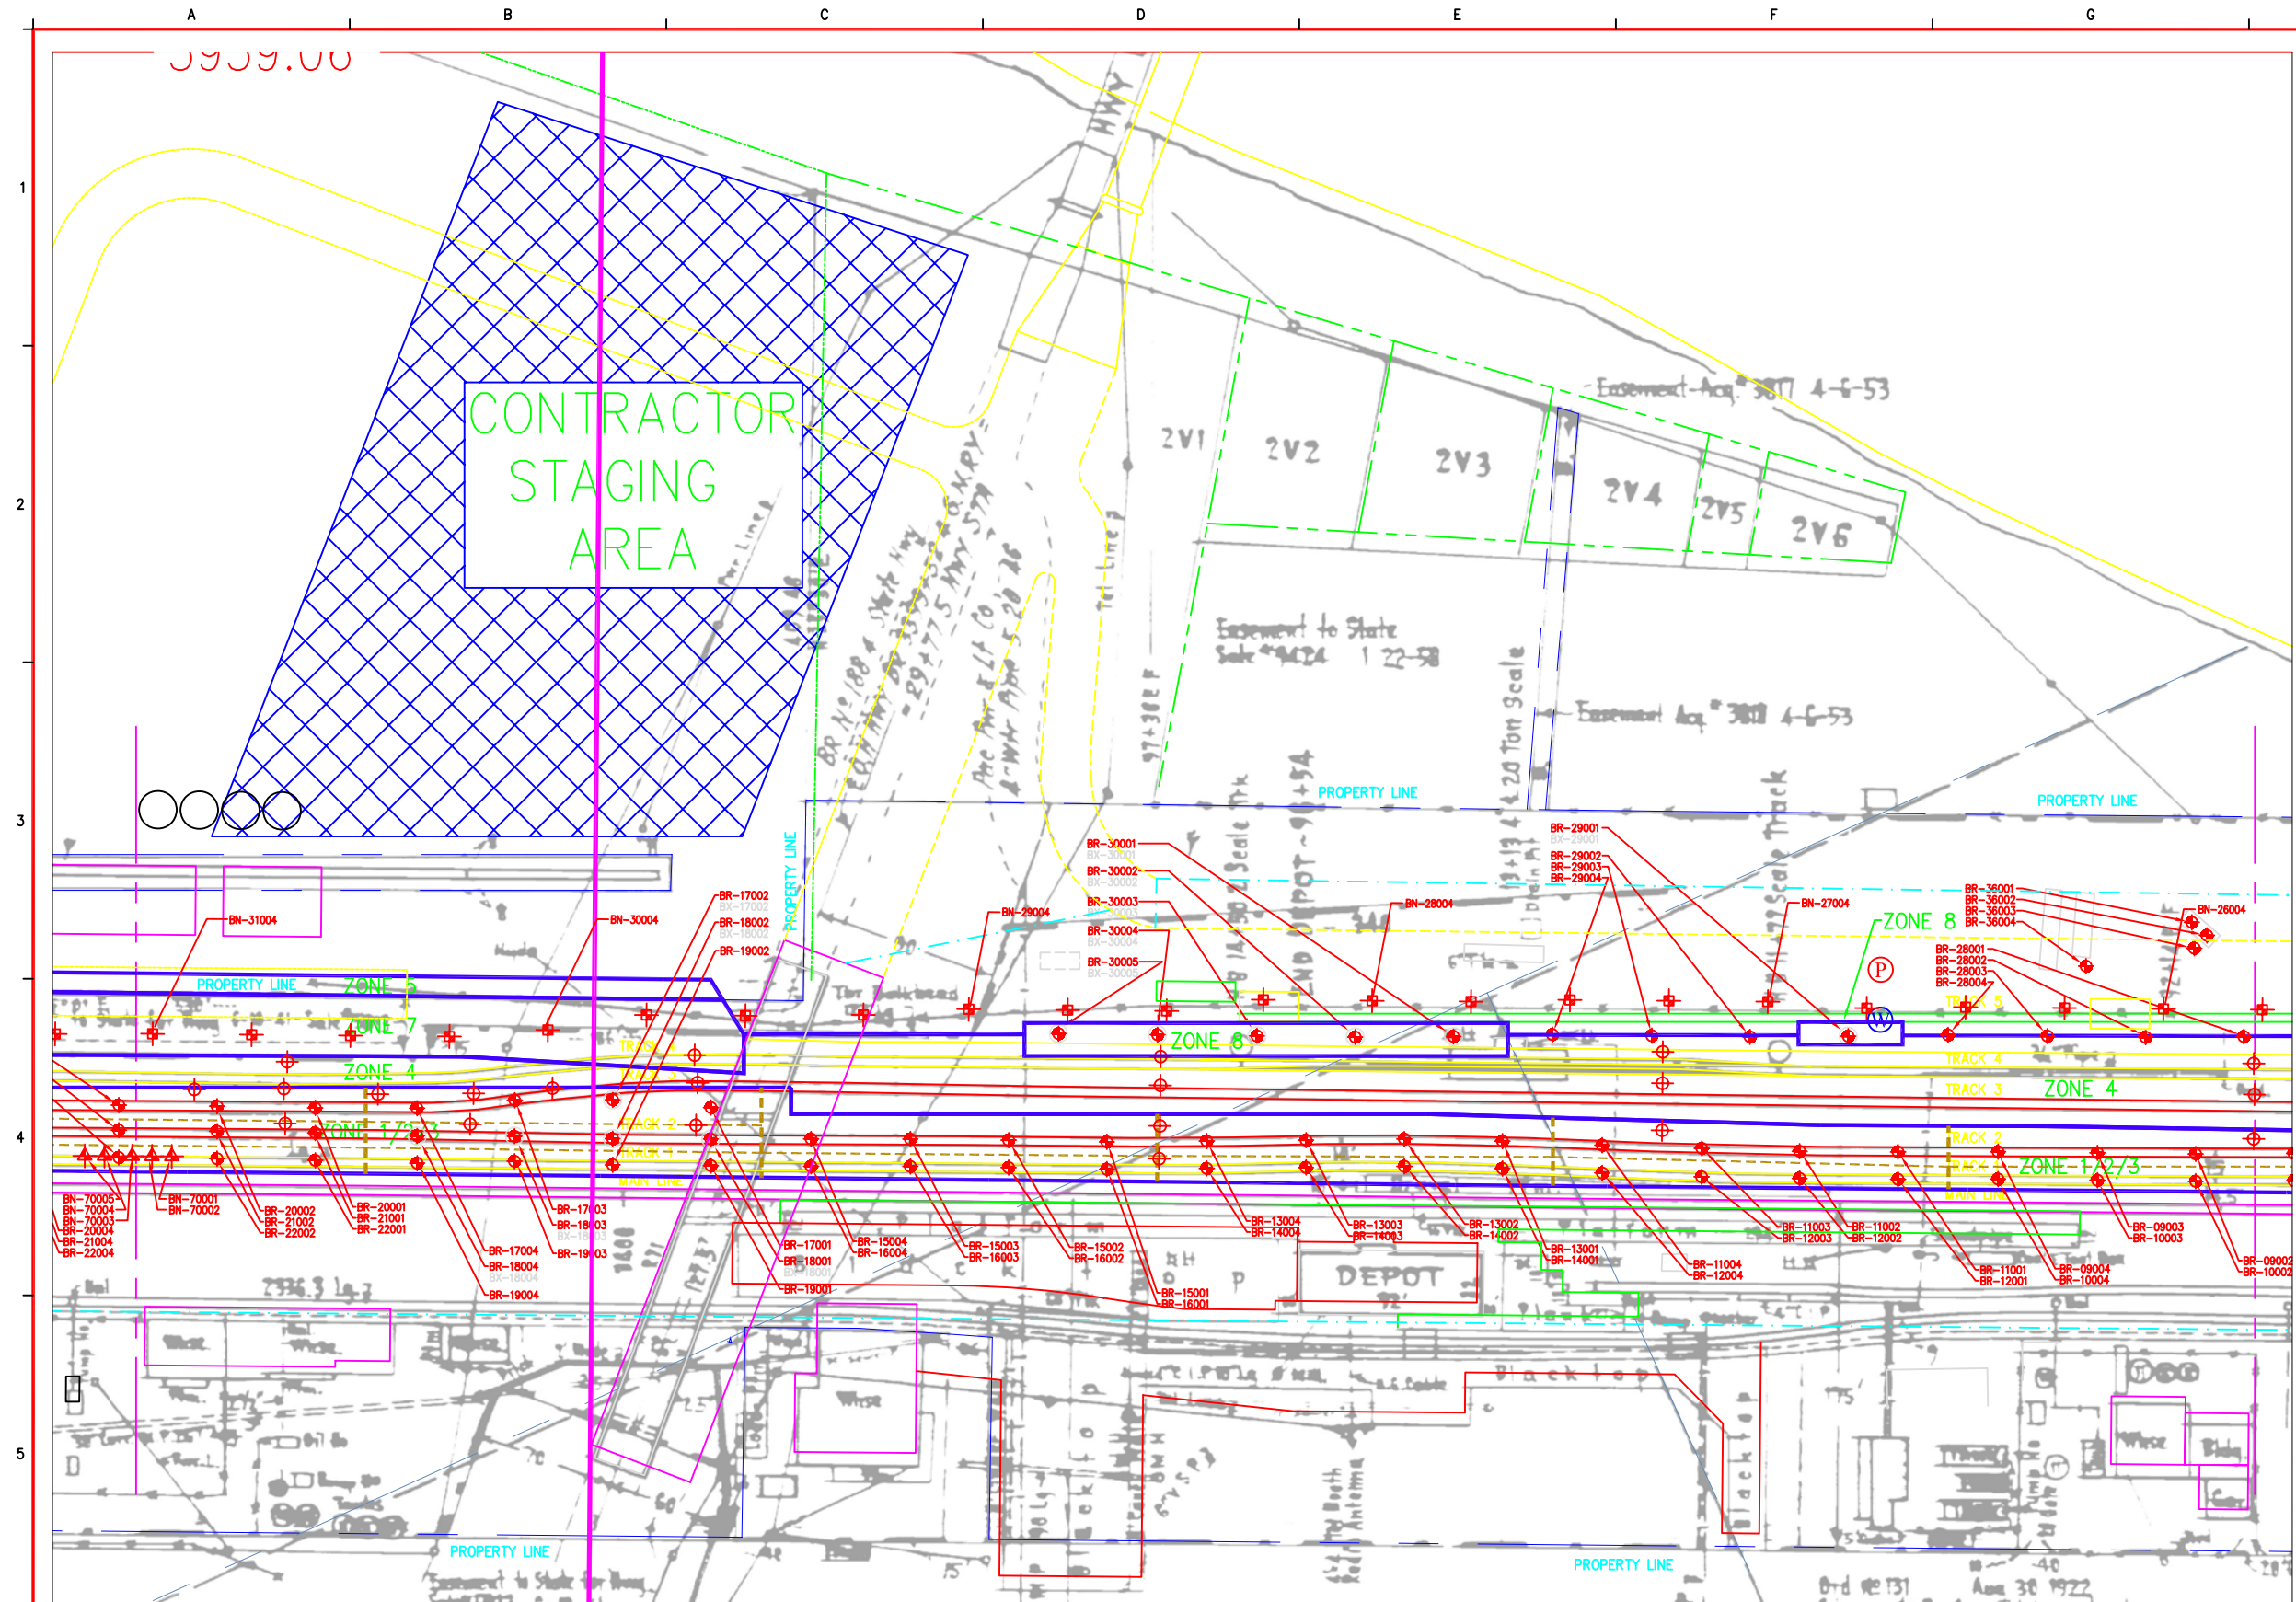
SOIL SAMPLE LOCATION MAP  
SHEET 4

- CHARACTERIZATION SAMPLES 2003 OR LATER
- CHARACTERIZATION SAMPLES 2002 OR EARLIER
- CLEARANCE SAMPLES
- DEEPER CLEARANCE SAMPLES AT APPROXIMATE LOCATIONS OF EARLIER FAILED CLEARANCE SAMPLE
- AREA EXCAVATED MORE THAN 4 FEET BELOW GROUND SURFACE, BUT DEEPEST SAMPLE CONTAINED DETECTABLE LIBBY AMPHIBOLE

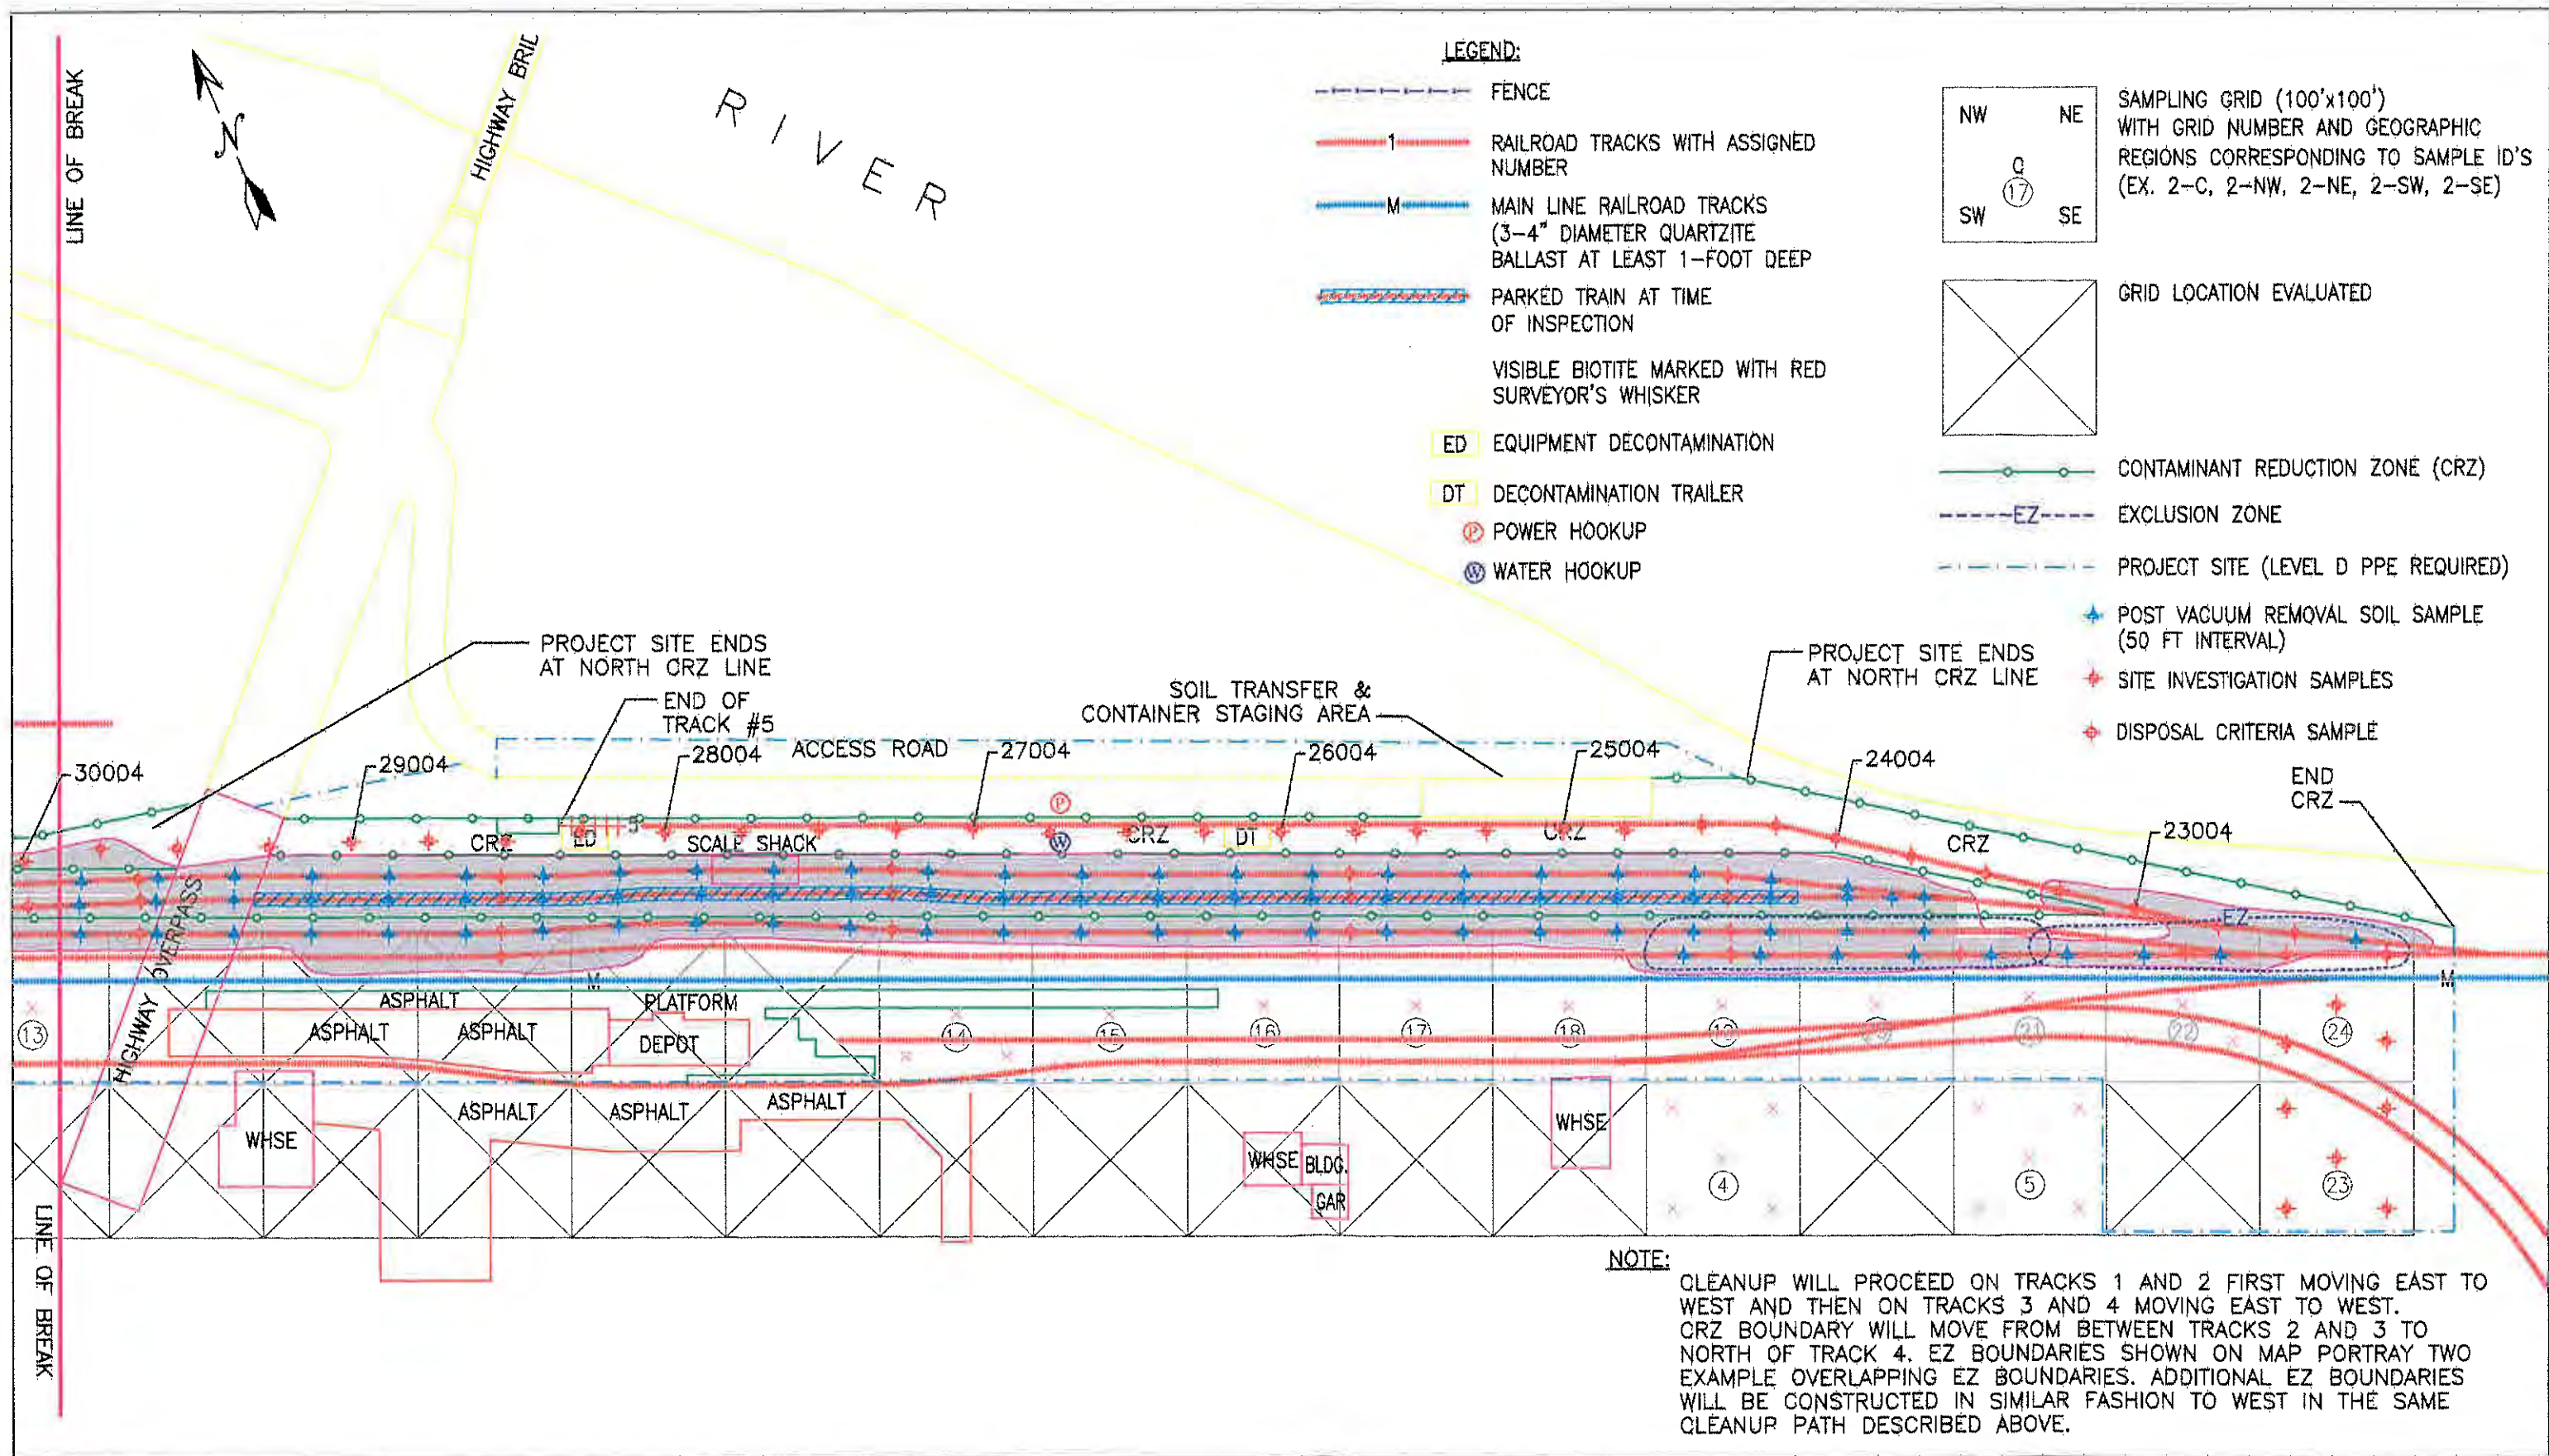
EAST AREA  
 FIELD SAMPLING PLAN/  
 MAP OF VISIBLE BIOTITE  
 BNSF RAIL YARD  
 LIBBY, MT.

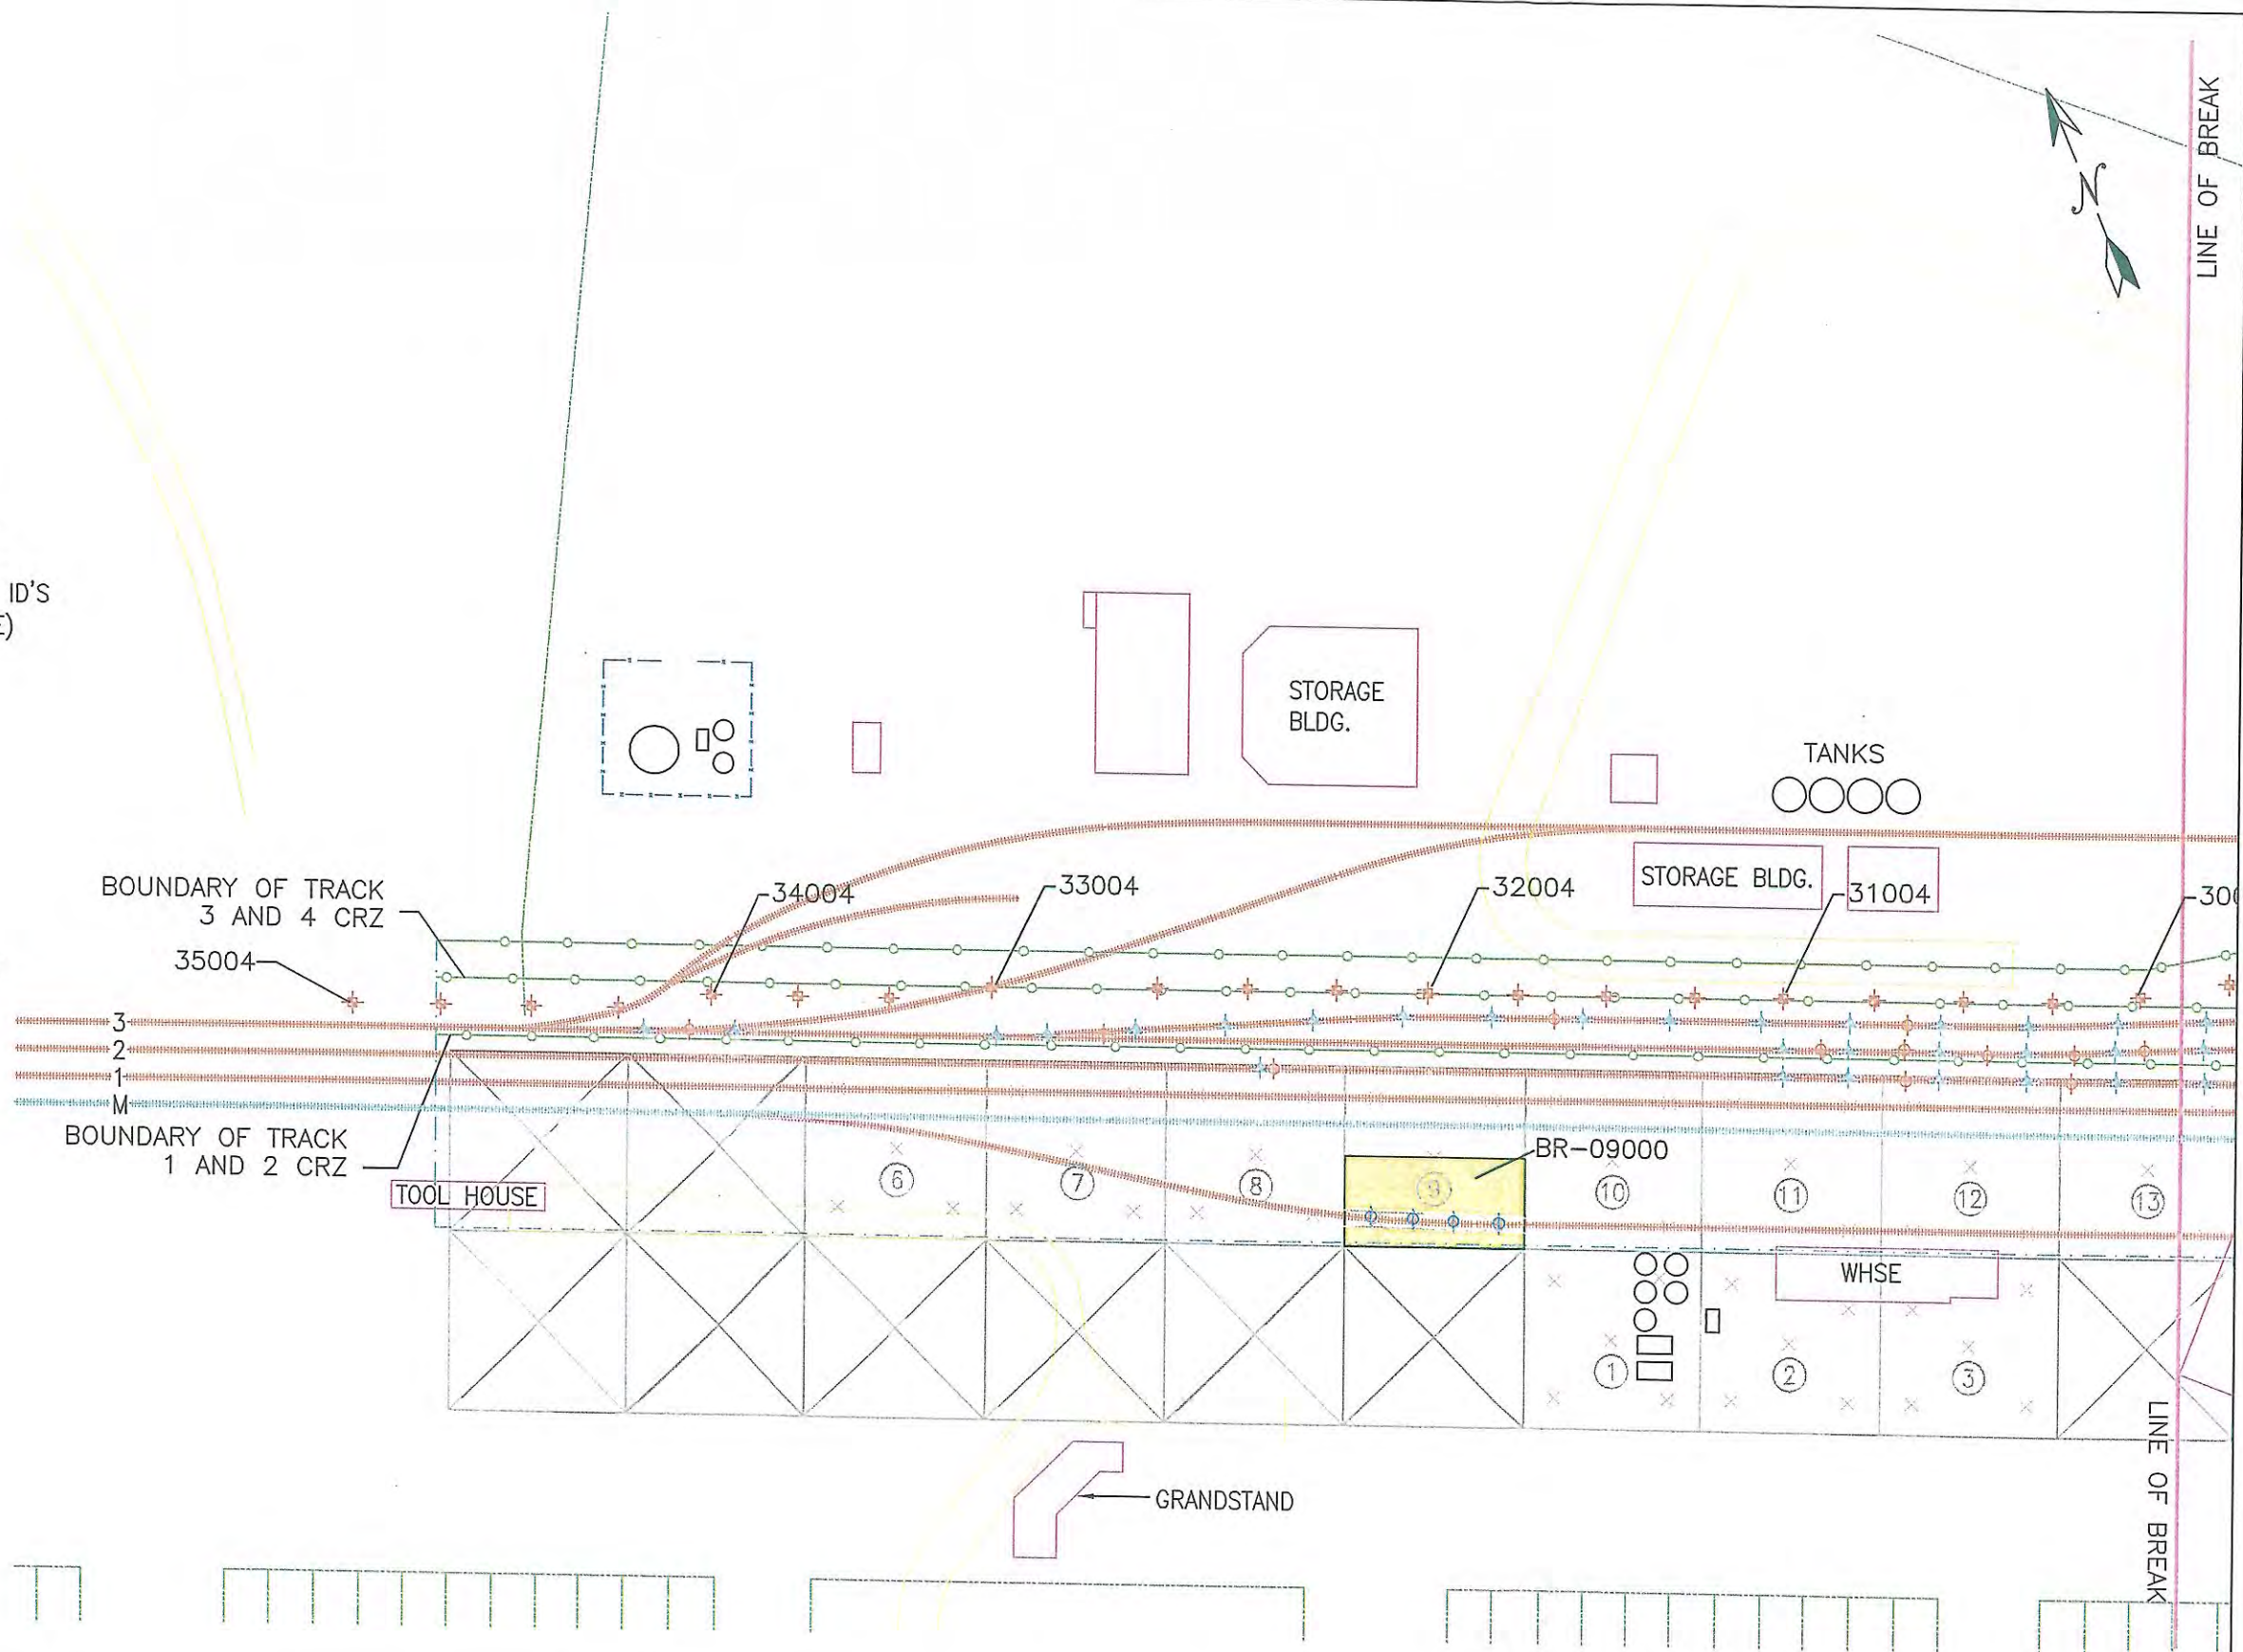
2005 REMEDIAL  
ACTION MAP  
WEST SIDE  
BNSF RAIL YARD  
LIBBY, MT.

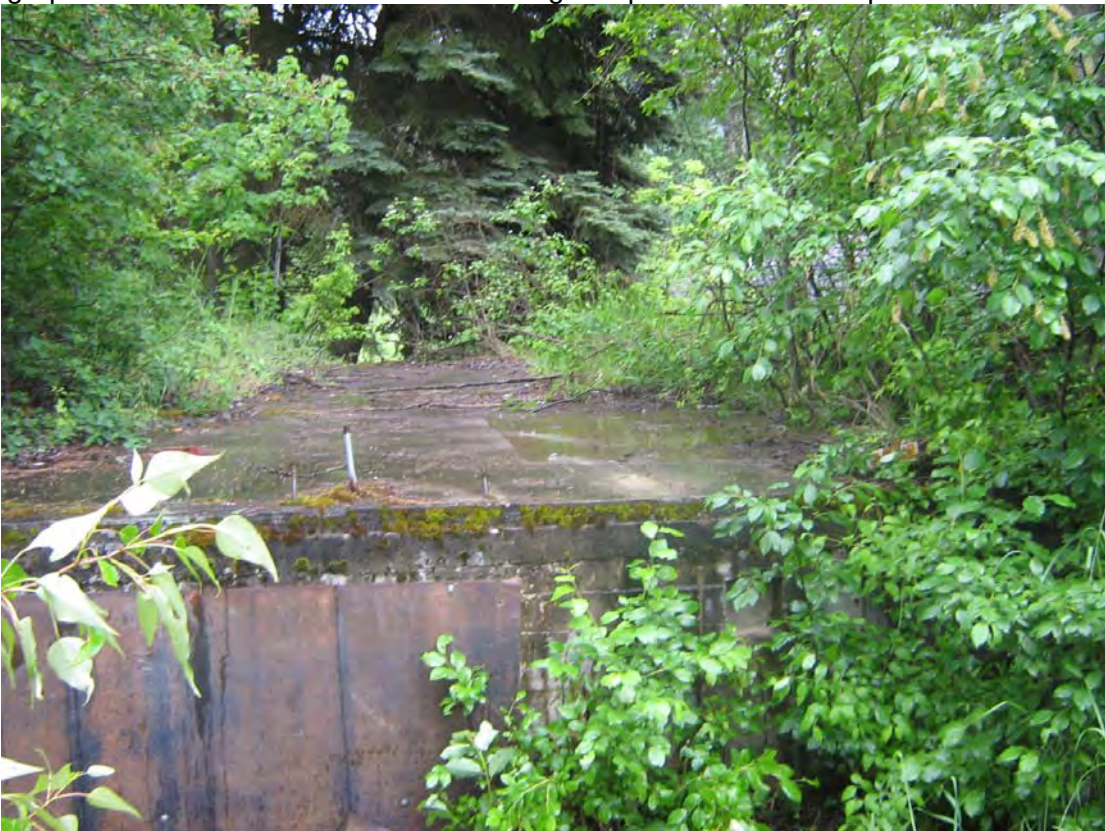
Photograph 3. View of bunker showing reattached steel plates. View to the East
