Fifth Five-Year Review Report
Anaconda Smelter Superfund Site
Anaconda-Deer Lodge County, Montana

Prepared by:
U.S. Environmental Protection Agency
Region 8
Helena, Montana

Executive Summary

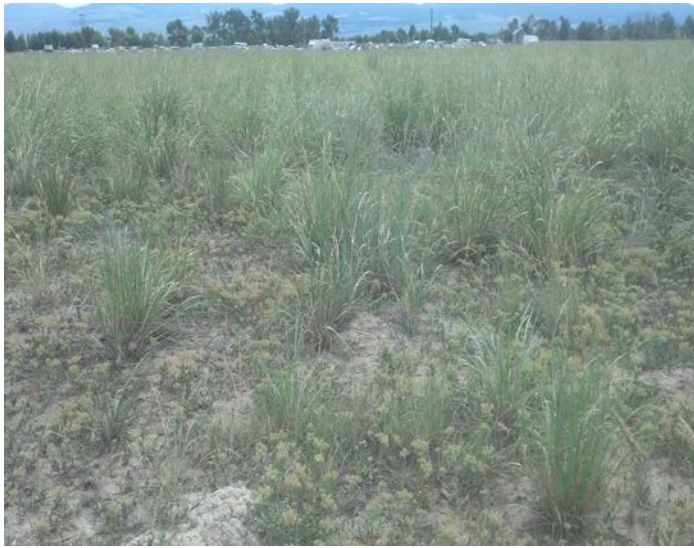
Photograph 002. Dragstrip: Subarea 6 (northern area). Shows very low perennial grass cover and prolific whitetop, which are indicative of contaminated soils. Note that this small area is surrounded by ample growth by Great Basin wildrye.

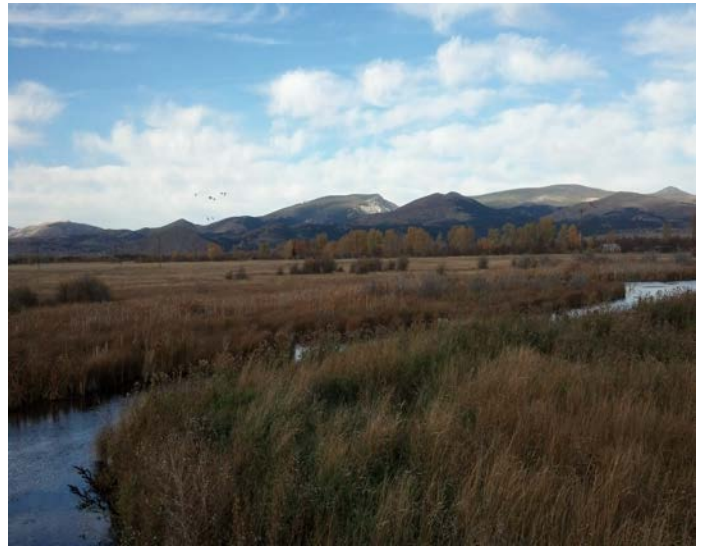
Photograph 052. Show well-established wetland vegetation and habitat in the northeast portion of the Opportunity Ponds in the reconstructed wetland habitat area.

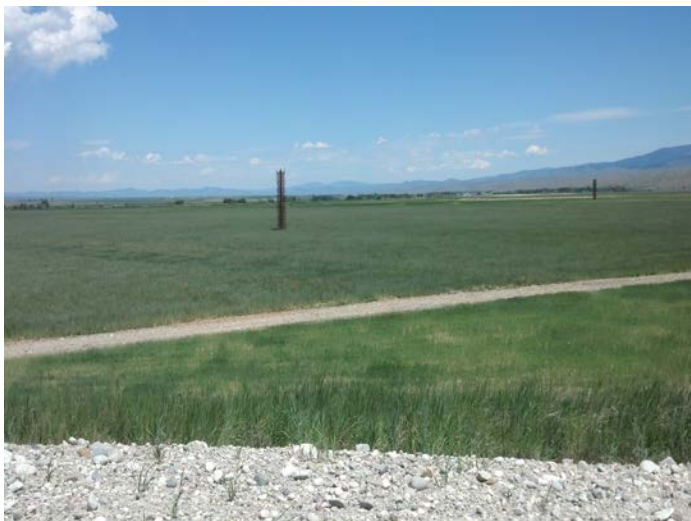
Photograph 056. RDU 8 - Opportunity Tailings Pond, D Cells. This photograph shows the excellent overall perennial plant cover in these cells.

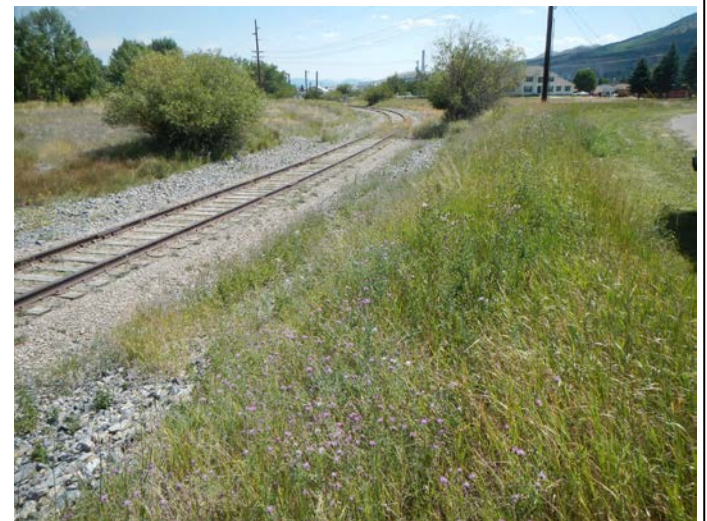
Photograph 163. RDU 5 - Anaconda Active Railroad Bed portion of the West Valley Line lying between Sycamore and Pennsylvania Streets. Shot toward the east, this shows good perennial grass cover, some weeds, and no erosion. This area is O&F.

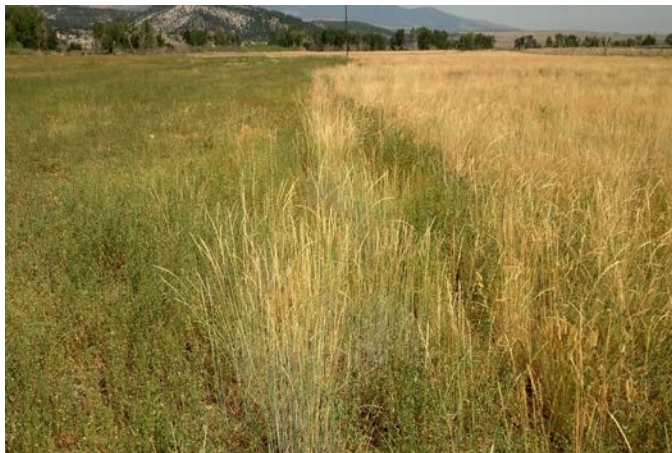
Photograph 214. West Galen, Polygons near the Lost Creek Water Treatment Ponds. Looking north, this photograph shows the vegetation contrast between OWSR 1.03 on the left (non-O&F) and OWSR 1.01 on the right (O&F). OWSR 1.03 is dominated by *Kochia scoparia* and has low cover by perennial grasses. In contrast, OWSR 1.01 has a healthy stand of perennial grasses. This indicates that it is possible to get the reclamation plant species established in OWSR 1.03, and once established they should be able to grow well and be productive in this location. EPA recommended reseeding OWSR 1.03 and limiting cattle use of this area until the grasses are well-established.

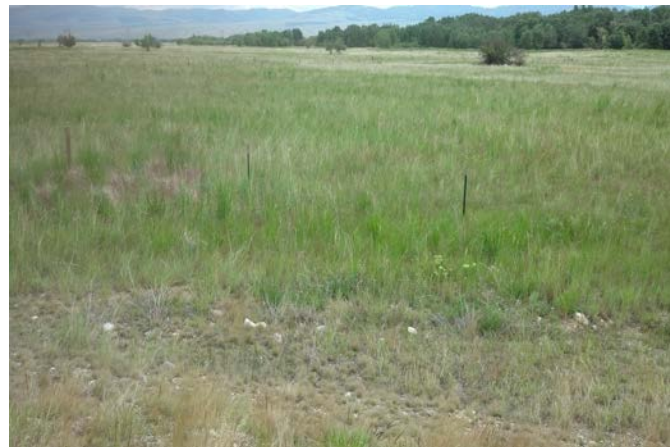
Photograph 219. RDU 7 - North Opportunity Uplands, Evaluation Area 3 and 4. Shot toward the east from the Galen road, this photograph shows generally good perennial grass cover in Evaluation Area 3 (foreground) and Evaluation Area 4 (background, on the right).

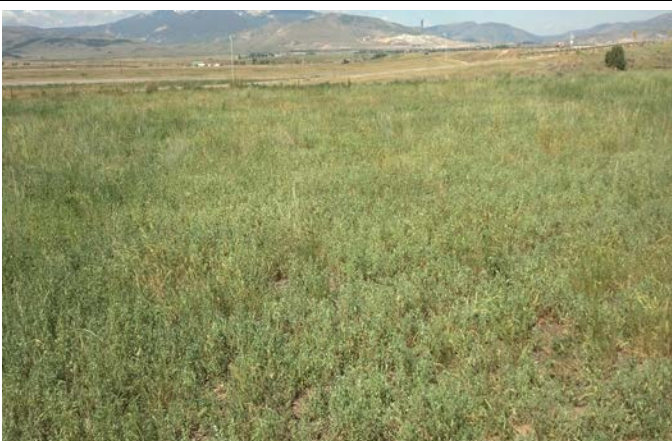
Photograph 242. RDU 9 - Fluvial Tailings. Looking west with the Washoe Smelter stack in background, this photograph shows large areas dominated by *Kochia scoparia* (summer cyprus). This portion of 9.02B was recommended for reseeding.

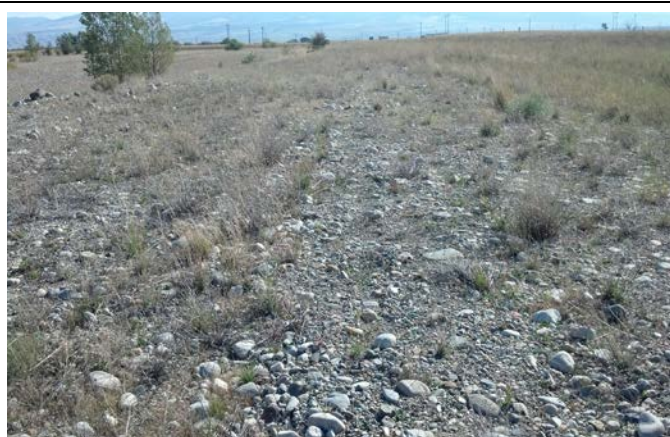
Photograph 254. Old Works Area 1, Sewage Pond Area. Looking east, this photograph shows sparse perennial grass and abundant weed cover in the non-O&F portion of this site.

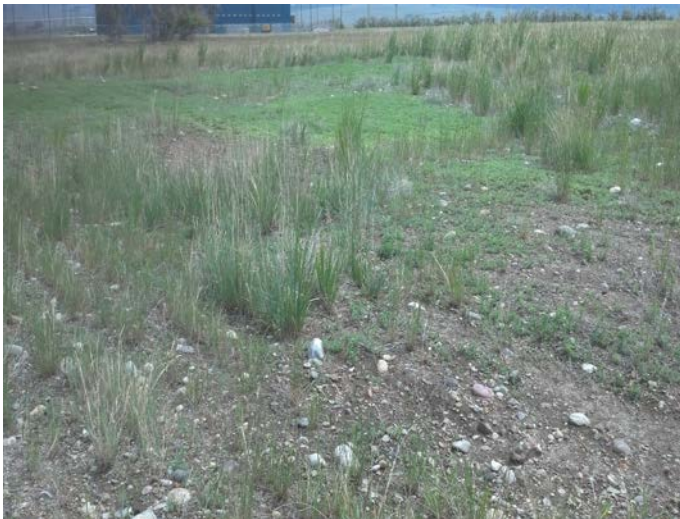
Photograph 277. RDU 7 - North Opportunity Uplands, Evaluation Area 1. Looking east toward the START building. This photograph shows a "hot spot" dominated by *Kochia scoparia* and no perennial grasses established. It appears that the surface soil in this area was not stripped deep enough or at all. This is a very small area surrounded by the generally good perennial grass cover and density within this polygon.

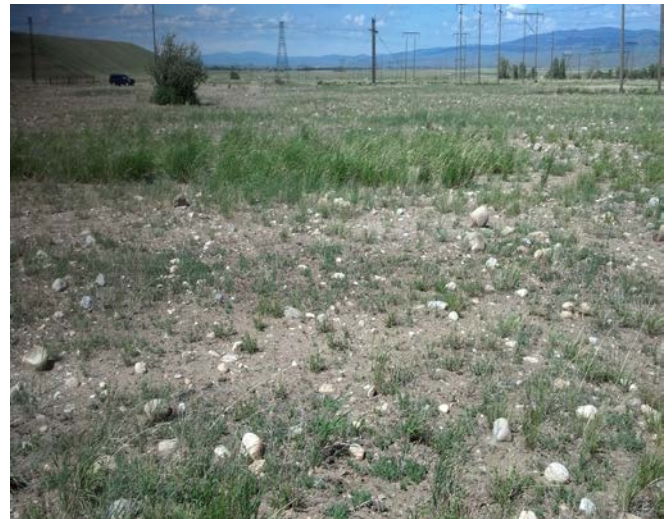
Photograph 324. RDU 6 – South Opportunity, SHOP 2.02B. Looking north, this photograph shows some establishment of perennial grass but the area is still not O&F. Most plants in this area are weeds: *Kochia scoparia* and *Iva axillaris*.

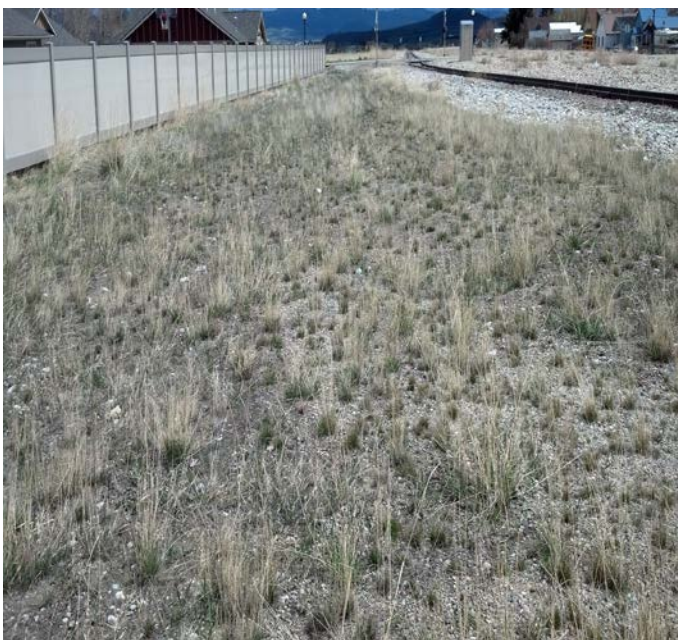
Photograph 364. Adjacent to Railroad Areas. Direction is toward the east. Photograph shows adequate but thin perennial plant cover in center of this land parcel for an area seeded in 2006. Coarse substrate could be contributing to the thin cover.

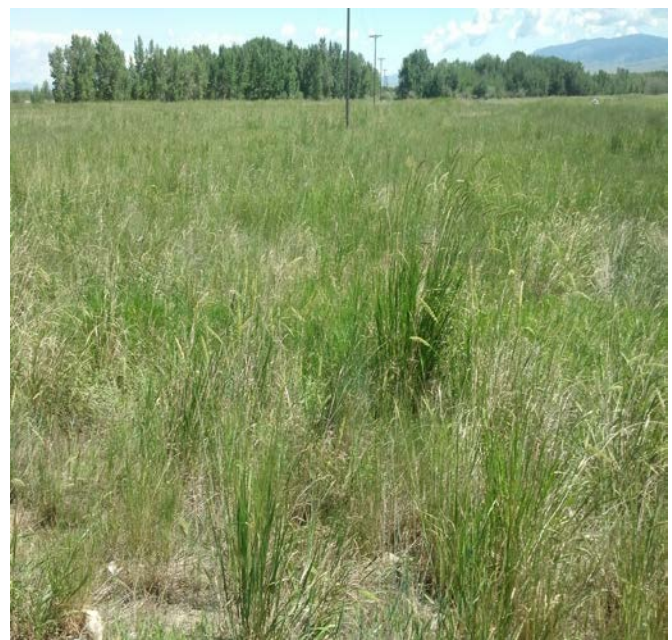
Photograph 400. RDU 8 - Opportunity North Uplands, Evaluation Area 2. Looking northwest, this photograph shows excellent perennial plant growth.

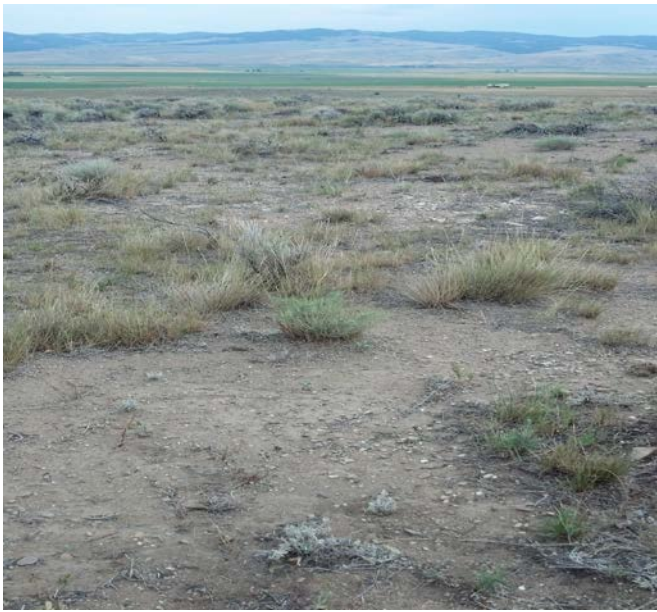
Photograph 375. West Galen, Launderville Boundary Line. Looking east from the ridgeline where the Anaconda Site outer boundary line is located. This photograph shows primarily bare soil areas where smelter impacts have been followed by many years of wind and water erosion, and livestock grazing.

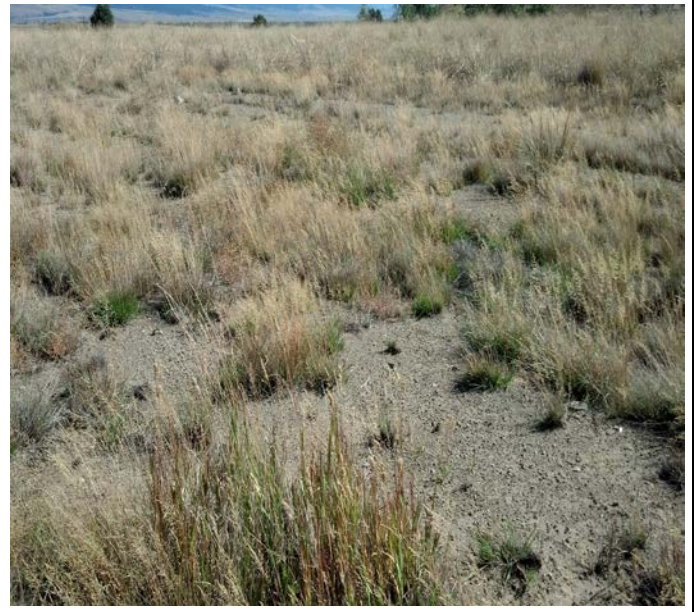
Photograph 444. Moto Cross, Evaluation Area 1
Looking southeast, this photograph shows faint plow lines indicating that it was historically reseeded in-situ. This area is to the east of the Moto Cross site access road. It is dominated today by redtop and there are frequent, small barren areas.

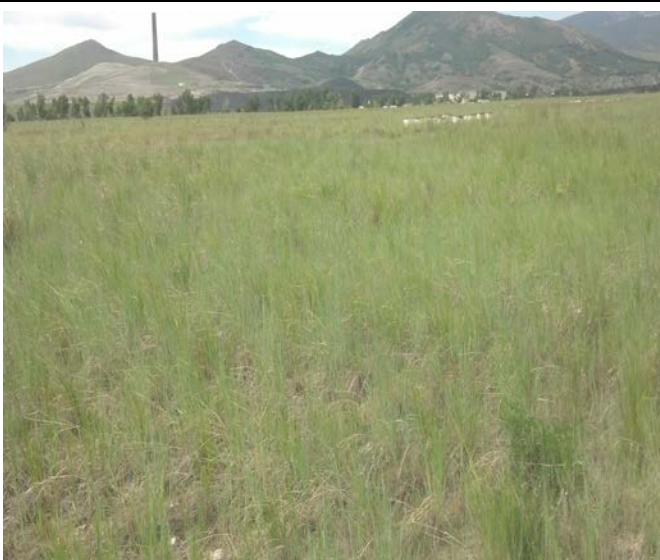
Photograph 464. Old Works, Dragstrip, Subarea 6 Type D Cap (northern area). Aspect is south toward the Washoe Smelter stack. This photograph shows high perennial grass cover, no weeds and no barren areas. The soils are erosionally stable.

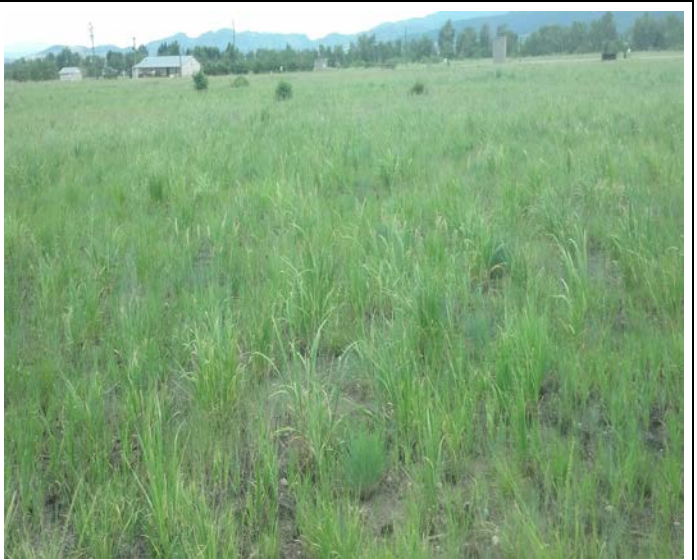
Photograph 451. RDU 8, Opportunity South Uplands, Evaluation Area 6. Looking south toward the trap shooting club, this photograph shows excellent perennial grass cover. Great Basin Wildrye dominates this plant community.

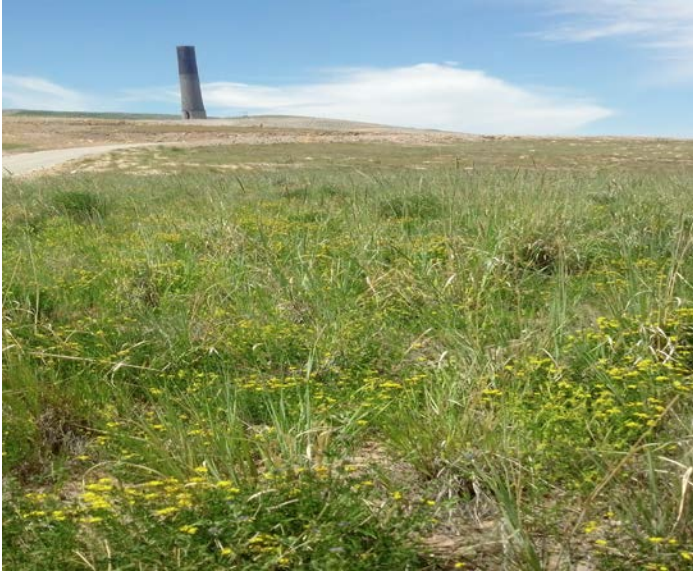
Photograph 470. RDU 14 - Smelter Hill Facilities. Excellent plant cover in Previously Reclaimed.

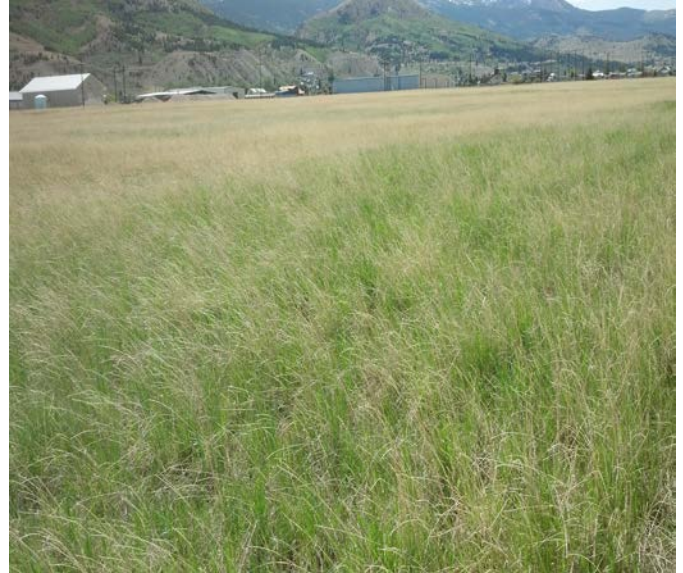
Photograph 494. Old Works, ALDC RA Areas. Looking SW across Lot C1, this photograph shows abundant perennial grass cover. There was no erosion on this level site.

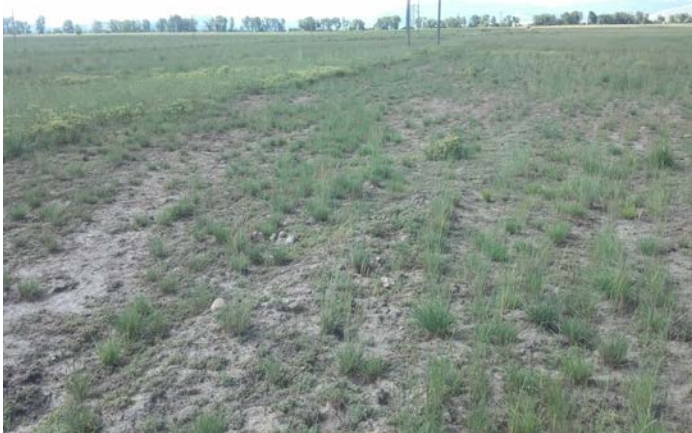
Photograph 521. West Galen Expansion Area 2, Evaluation Area 33. This photograph was shot toward the south from underneath the power line. It shows abundant whitetop on the left and what appears to be a plow line. The area in the center has relatively low perennial grass cover (20-25%), the likely result of the soil being underlined compared to the area on the left. The center area still has an abundance of summer cyprus.

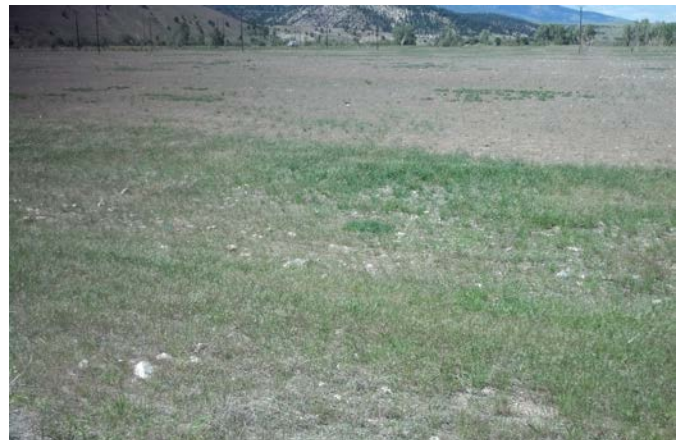
Photograph 564. West Galen Expansion Area, Polygons near the Water Treatment Ponds Adjacent to Lost Creek. Looking north, this photograph shows that the strip next to the access road has some plant establishment but poor establishment in the field. This suggests that the different reclamation techniques or time of seeding had different results and that some perennial plants can be established at the site, which has had a history of seeding failures.

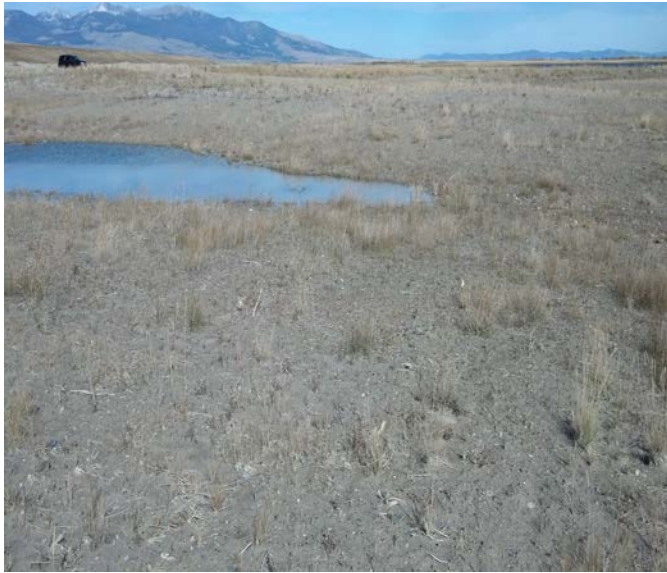
Photograph 608. Early stage of plant establishment following seeding in a wetland habitat area adjacent to the Opportunity tailings Ponds (RDU 8).

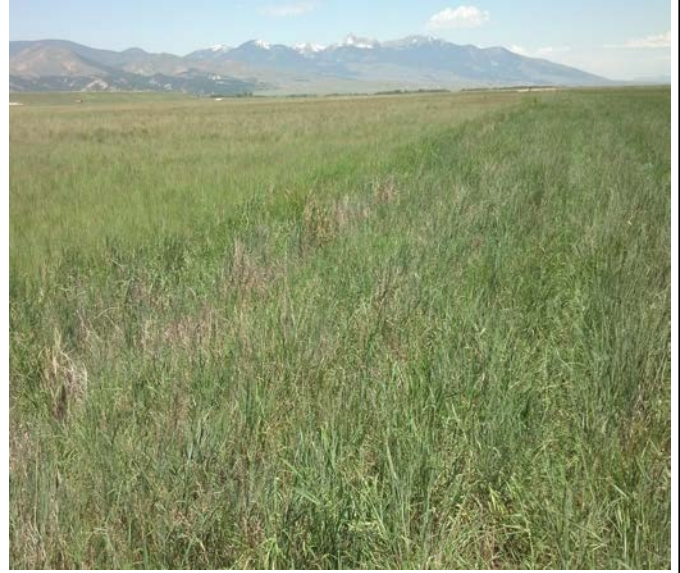
Photograph 674. RDU 8 - Opportunity Ponds, C1 Cells, Seed Mixture 4, Type 12 Cap. Shot toward the Mt Powell (northwest). Shows excellent perennial plant cover indicative of this group of cells.

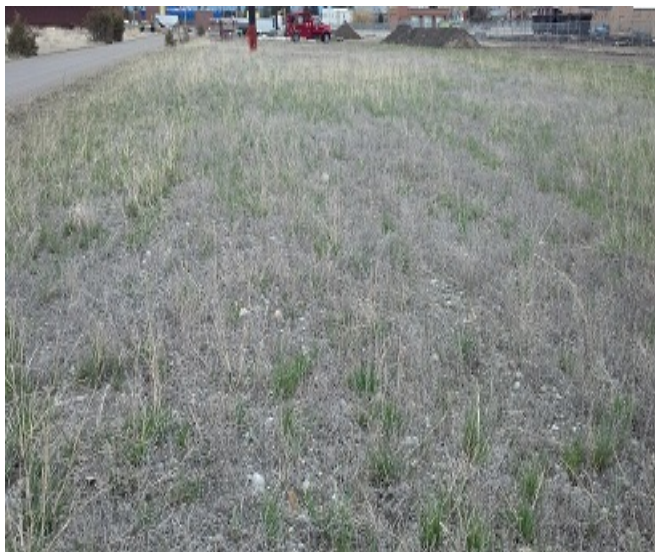
Photograph 677. Adjacent to Railroad Properties, Southern Portion of Hospital Property. This area was seeded in 2011. Shot toward the east, this photograph shows sparse perennial plant cover and old *Kochia scoparia* litter. EPA's recommendation for this area was interseeding with Seed Mixture 4.

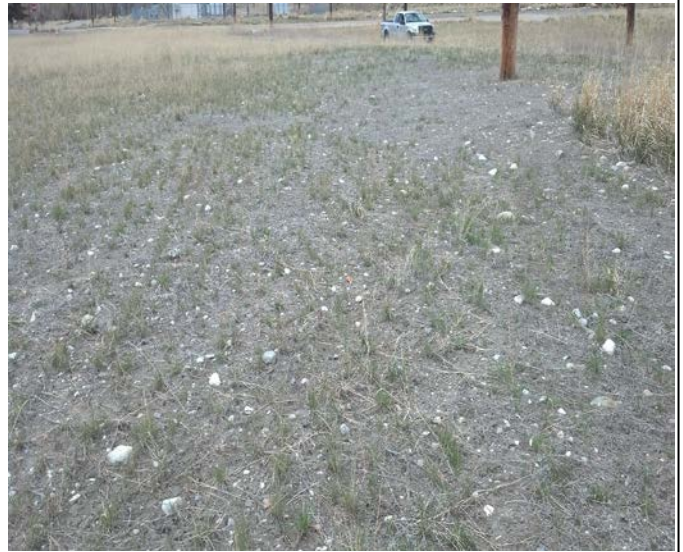
Photograph 709. Adjacent to Railroad Properties, North of Cedar Park Homes. Shot towards the west, this area has sparse perennial plant cover that does not meet O&F criteria. This area was seeded in 2011. Old (dead) *Kochia scoparia* plants are present suggesting intense competition for the perennial seedlings and that the area would benefit from being interseeded at this time.

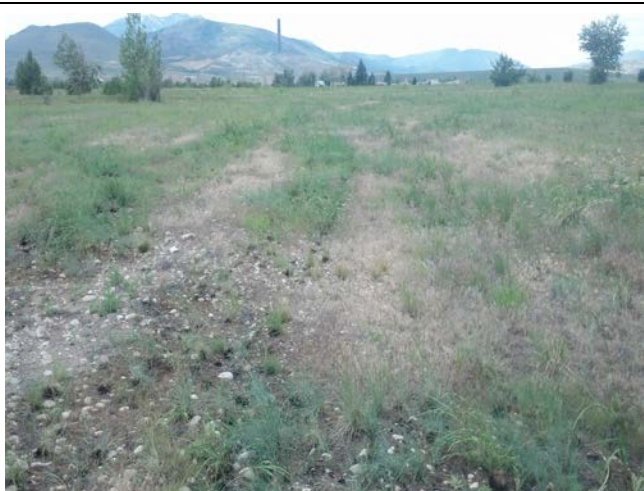
Photograph 788. RDU 8 - Opportunity South Uplands, Evaluation Area 7. Looking west with the Washoe Smelter stack in the background. Photograph shows an area that is barren of perennial plants in a 20 x 20 foot area. Low perennial grass cover, rocky, and with abundant cheatgrass brome and summer cyprus in this portion of the site; this is west of the trap shooting club.

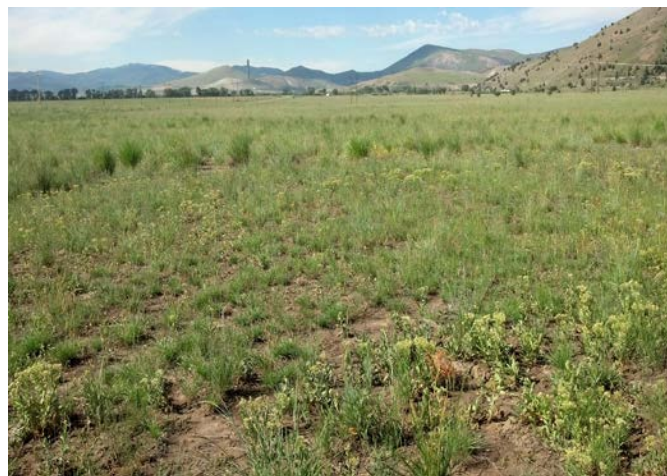
Photograph 793. West Galen Expansion Area 2, Evaluation Area 33. This photograph was taken in the northern portion of the polygon. It is shot toward the southwest and shows the generally good perennial grass cover and the Washoe Smelter stack in the background. A patch of leafy spurge can be seen in the foreground. This noxious weed is scattered throughout the polygon.

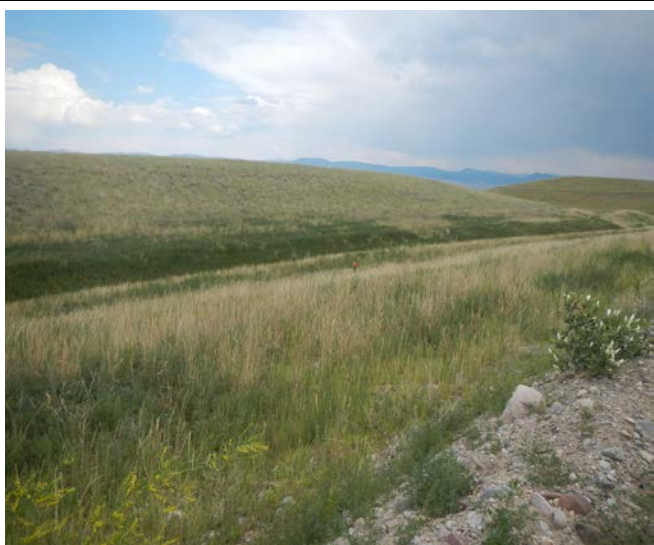
Photograph 848. Excellent plant growth on the Flue Dust Repository

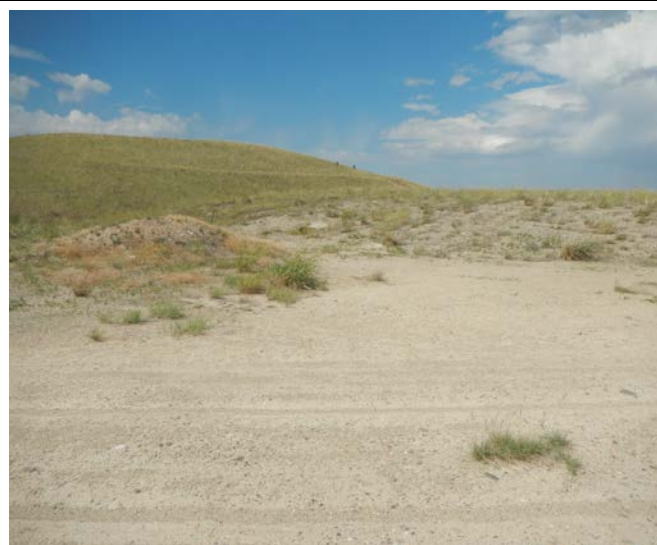
Photograph 852. South side of Arbiter Repository (upper left) shows very good perennial grass cover. In contrast, the south side of Original Beryllium Repository (center) has very sparse vegetation cover.

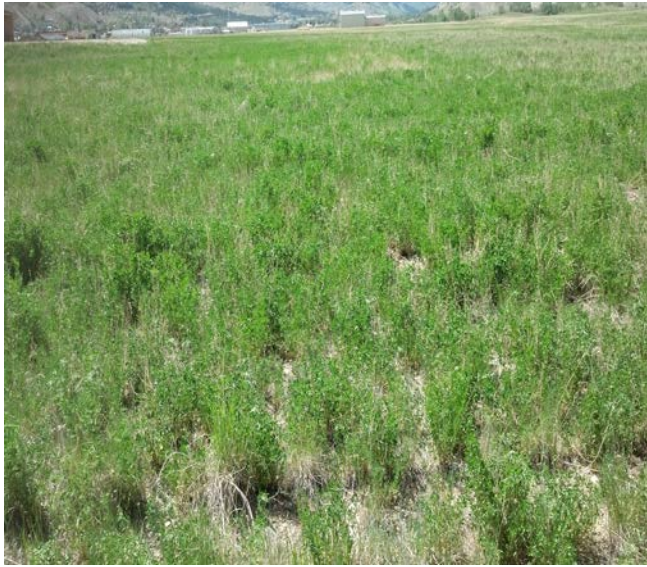
Photograph 856. Old Works, Northwoods Enterprises property. Looking west across the site, this photograph shows abundant perennial plant growth and cover. Site is dominated by alfalfa.

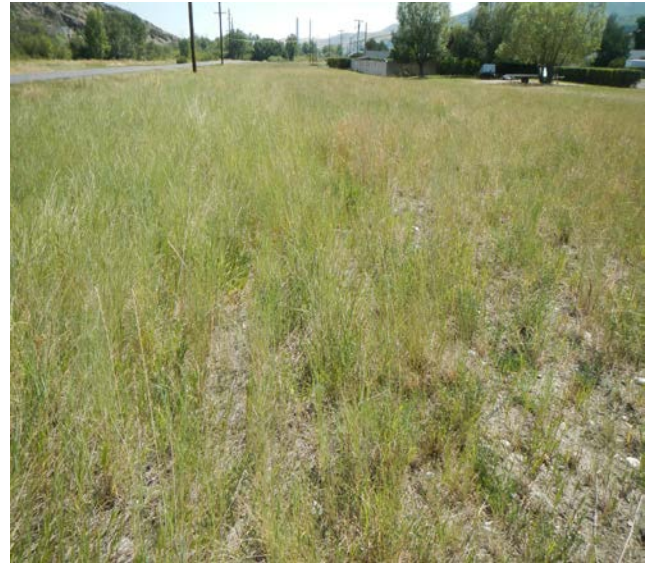
Photo 867. This is the Non-MDT Transfer portion of the West Valley Railroad line between Pennsylvania and Linden Streets. Photograph shot toward the east. Shows high cover by alfalfa and perennial grasses. No erosion. This area is O&F.

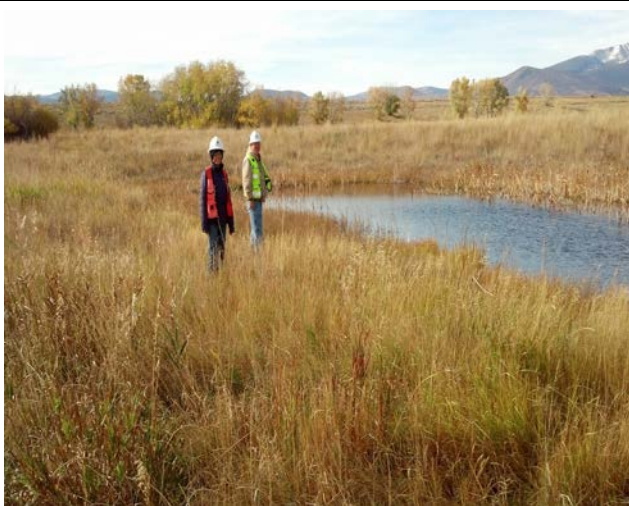
Photograph 907. Very high perennial plant cover and species diversity in the reconstructed wetland habitat area northeast of the Opportunity Tailings Ponds.

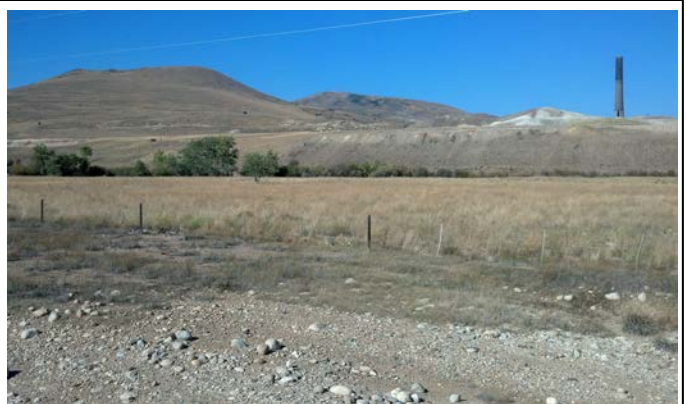
Photograph 910. Mill Creek Industrial Park. Looking southwest, this photograph shows abundant perennial grass cover; this site has virtually no soil erosion.

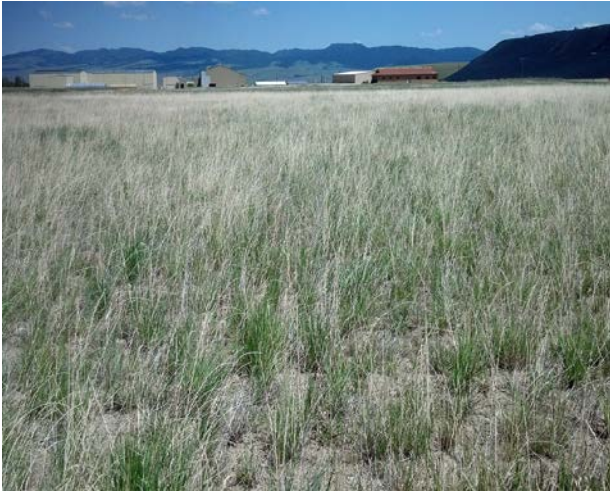
Photograph 955. Old Works, ADLC Property in Subarea 4. Looking east across the western portion of the ADLC property. This photograph shows high intermediate wheatgrass growth and cover. Some smooth brome and alfalfa are present. Level site with no erosion.

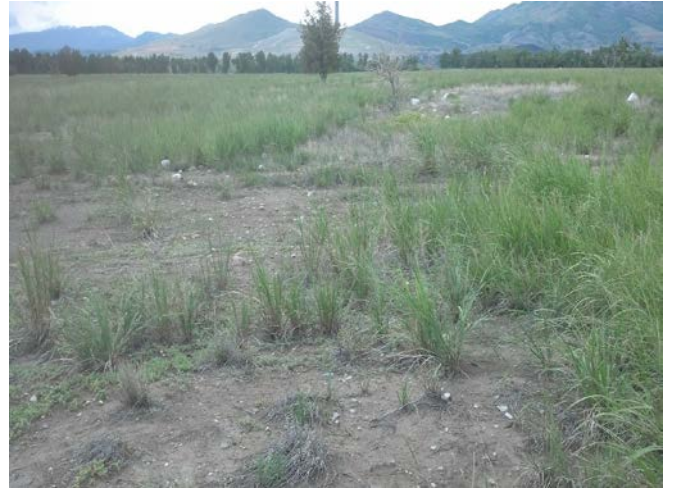
Photograph 983. RDU 7 - North Opportunity Uplands, Evaluation Area 4. Shot toward the southwest with the Washoe Stack in the background, this photograph shows a good stand of Great Basin wildrye interspersed with barren soil areas indicative of low pH or high metals. Noxious weeds such as whitetop and summer cyprus tend to occupy the sparsely vegetated and barren areas.

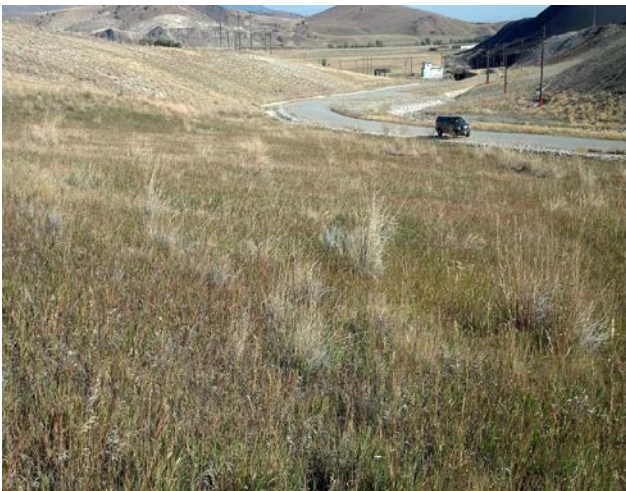
Photograph 986. Smelter Hill Facilities, Previously Reclaimed Area 9. Looking north, this photograph shows abundant perennial grass cover (approximately 80%). This site has abundant litter and virtually no soil erosion.

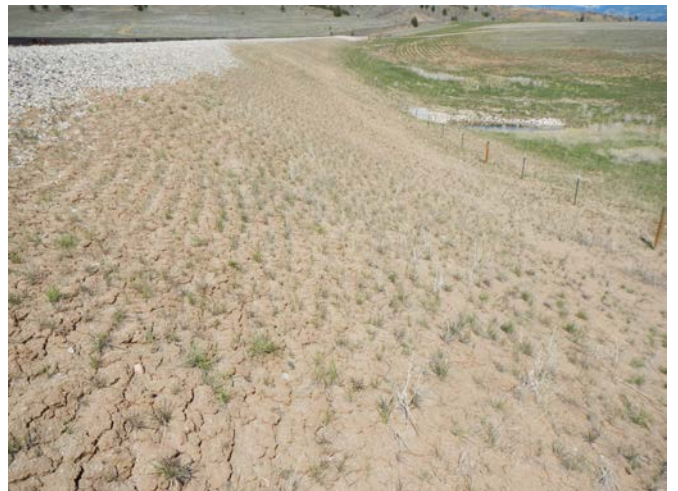
Photograph 1070. Thin but adequate perennial plant establishment on a north-facing slope at the Son of Blue Lagoon.

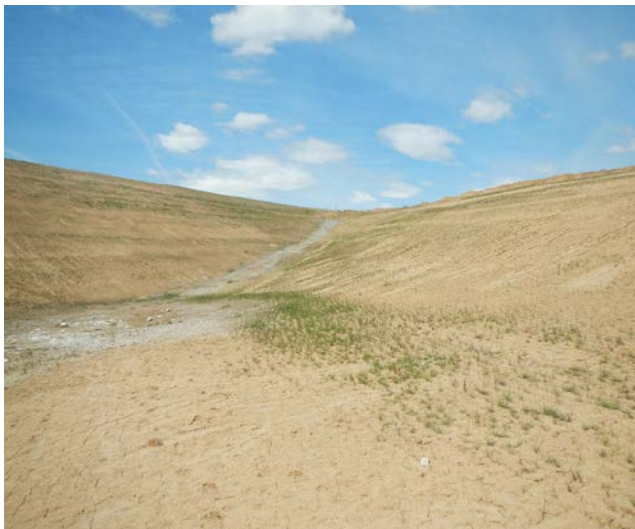
Photograph 1080. This shows a very thin and sparsely vegetated area at the Blue Lagoon. Vegetation on this site failed to full-in during the 2014 growing season.

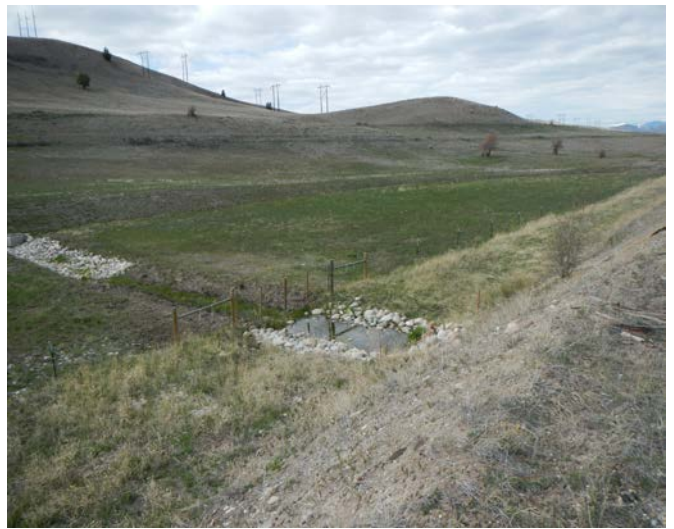
Photograph 1089. This photograph shows the very good establishment of vegetation at the Mill Creek Flood Irrigation site.

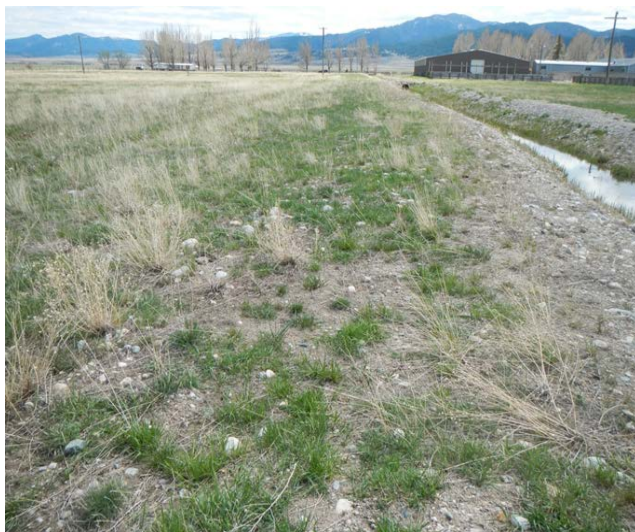
Photograph 1093. This photograph shows a section of Yellow Ditch in the spring of 2014; banks are stable and vegetation is emerging.

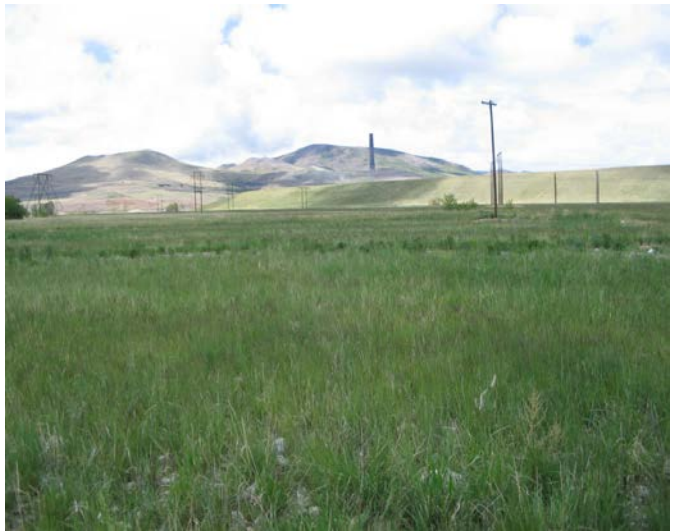
Photograph 5775. Stripped and in-situ treated area with abundant perennial plant growth. RDU 6 – South Opportunity.

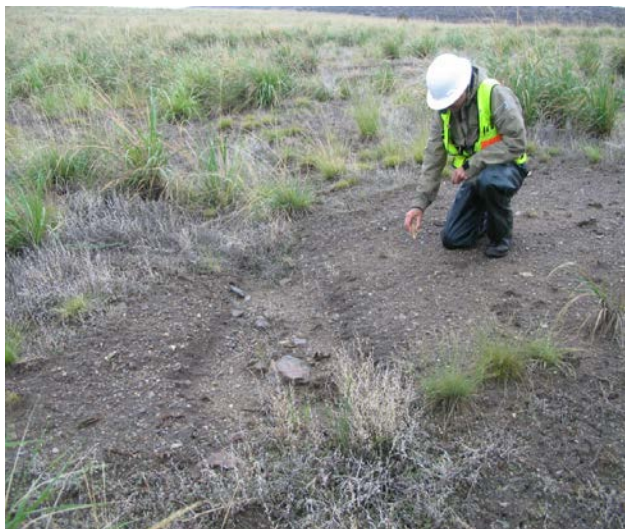
Photograph 5814. Sparsely vegetated and barren areas on Stucky Ridge (RDU 1) in the RFC No 3 2005/2006 Reclaimed Areas.
