# SANDIA REPORT

SAND2000-2427

## Alternative Landfill Cover Demonstration, FY2000 Annual Data Report

Stephen F. Dwyer, Bruce Reavis, and Gretchen Newman

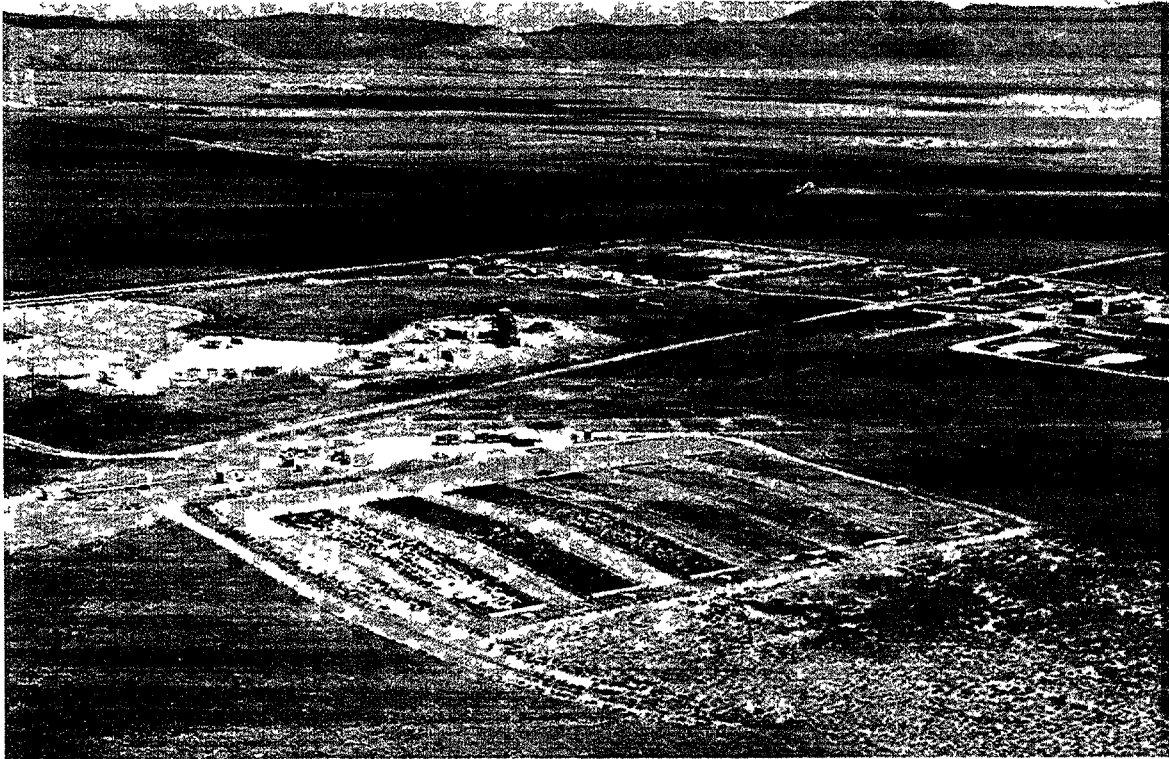
**Figure 1. Aerial View of Alternative Landfill Cover Demonstration**

The Alternative Landfill Cover Demonstration (ALCD) is a large-scale field test at Sandia National Laboratories located on Kirtland Air Force Base in Albuquerque, New Mexico (Figure 1). The project's intent is to compare and document the performance of alternative landfill cover technologies of various costs and complexities for interim stabilization and/or final closure of landfills in arid and semi-arid environments. The test covers are constructed side-by-side for comparison based on their performance, cost, and ease of construction. The ALCD is not intended to showcase any one particular cover system. The focus of this project is to provide the necessary tools; i.e., cost, construction and performance data, to the public and regulatory agencies so that design engineers can have less expensive, regulatory acceptable alternatives to the conventional cover designs.

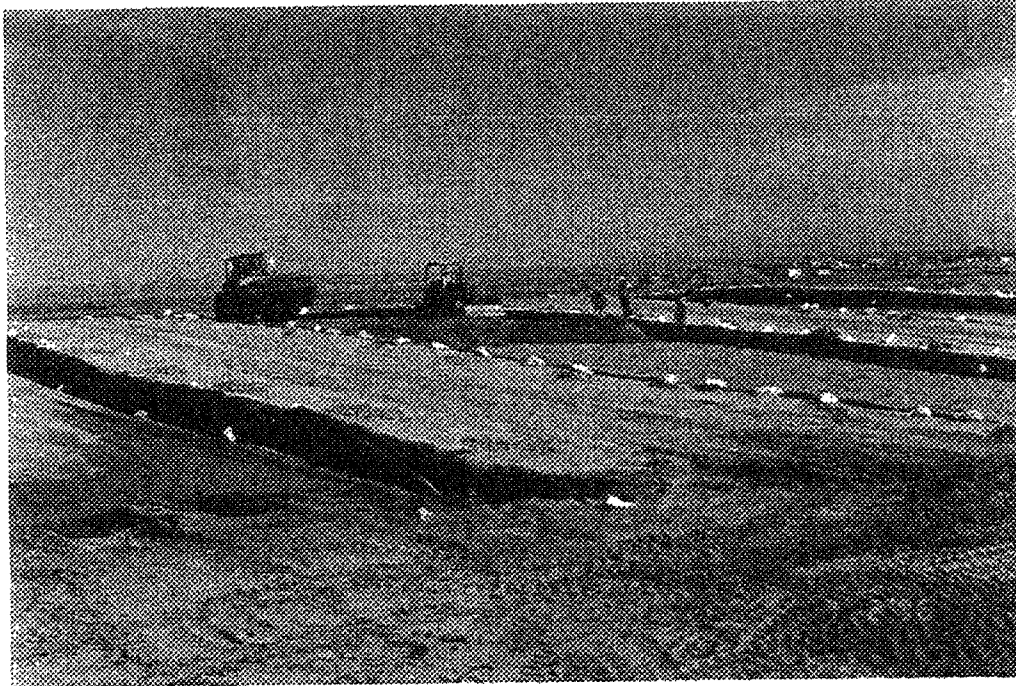
**Figure 9. Capillary Barrier Installation**

The 45 cm barrier soil layer was installed directly on the sand (Figure 9). The upper drainage layers were placed over the barrier soil layer. This upper drainage layer consists of two materials containing 22 cm of clean pea gravel and 15 cm of washed concrete sand. Finally, a 30 cm thick layer of topsoil was placed on the sand.

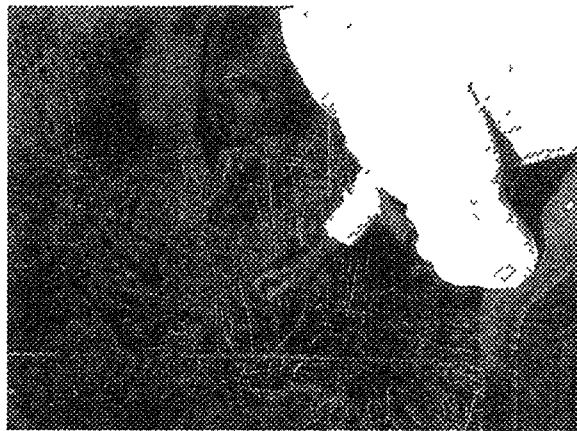
**Figure 17b. Vegetation Species Count**

*Vegetation:* Attributes of the vegetation on each landfill cover (Wolters et al. 2000) are measured yearly to relate vegetation characteristics to potential changes in erosion and evapotranspiration. Several point frames are used to evaluate total cover, species count and vegetation biomass (Figure 17 a and b). Biomass production is determined by clipping and weighing oven-dried

samples collected from subplots within each landfill cover. Species composition is measured using line transects staked within each landfill subplot.

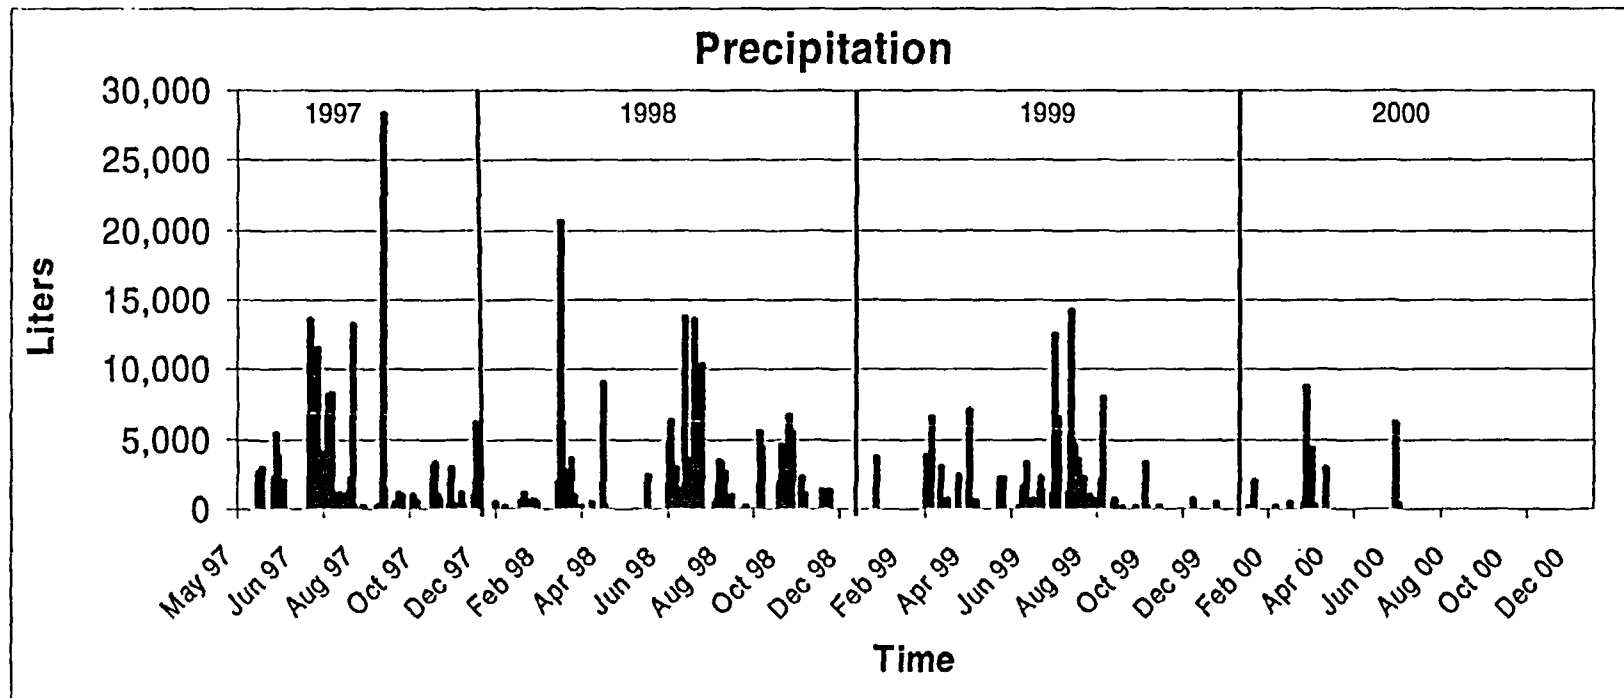
Figure A-2. Precipitation at ALCD Site

The measured percolation and precipitation data collected to date is presented below in tabular format. The first year of monitoring (1997) was a relatively wet year. The precipitation values listed in Table 2 include the periods May through Dec of 1997 and January through June of 2000 as well as all of 1998 and 1999. The last two years (1999 and 2000) have been extremely dry years. The precipitation values are also presented in graphical format in Appendix A.

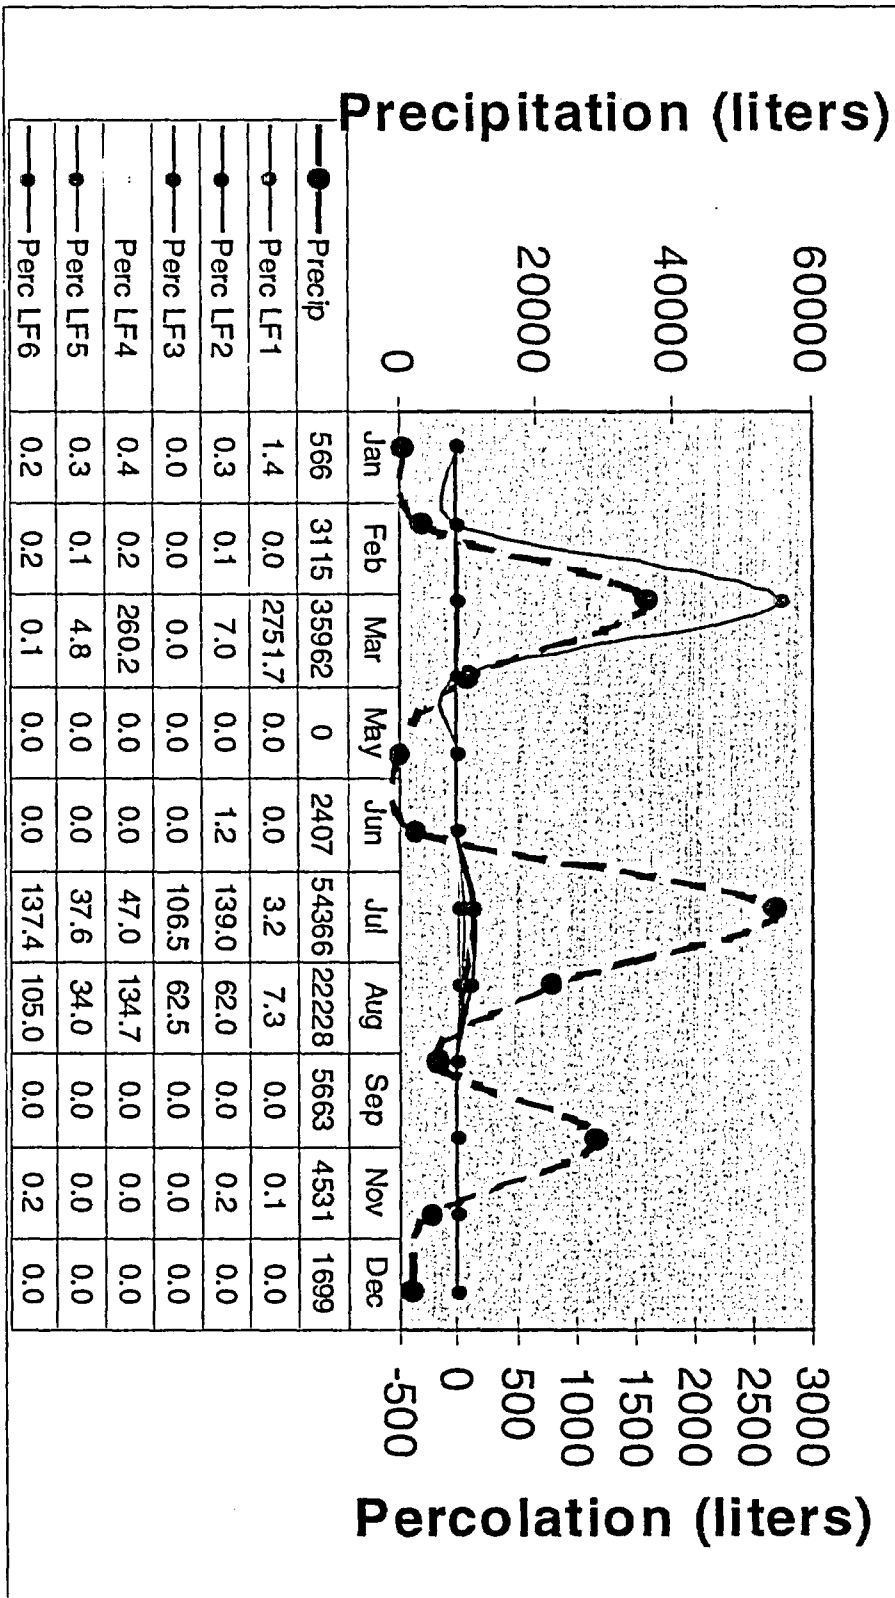
Figure B-2. 1998 Precipitation Versus Percolation

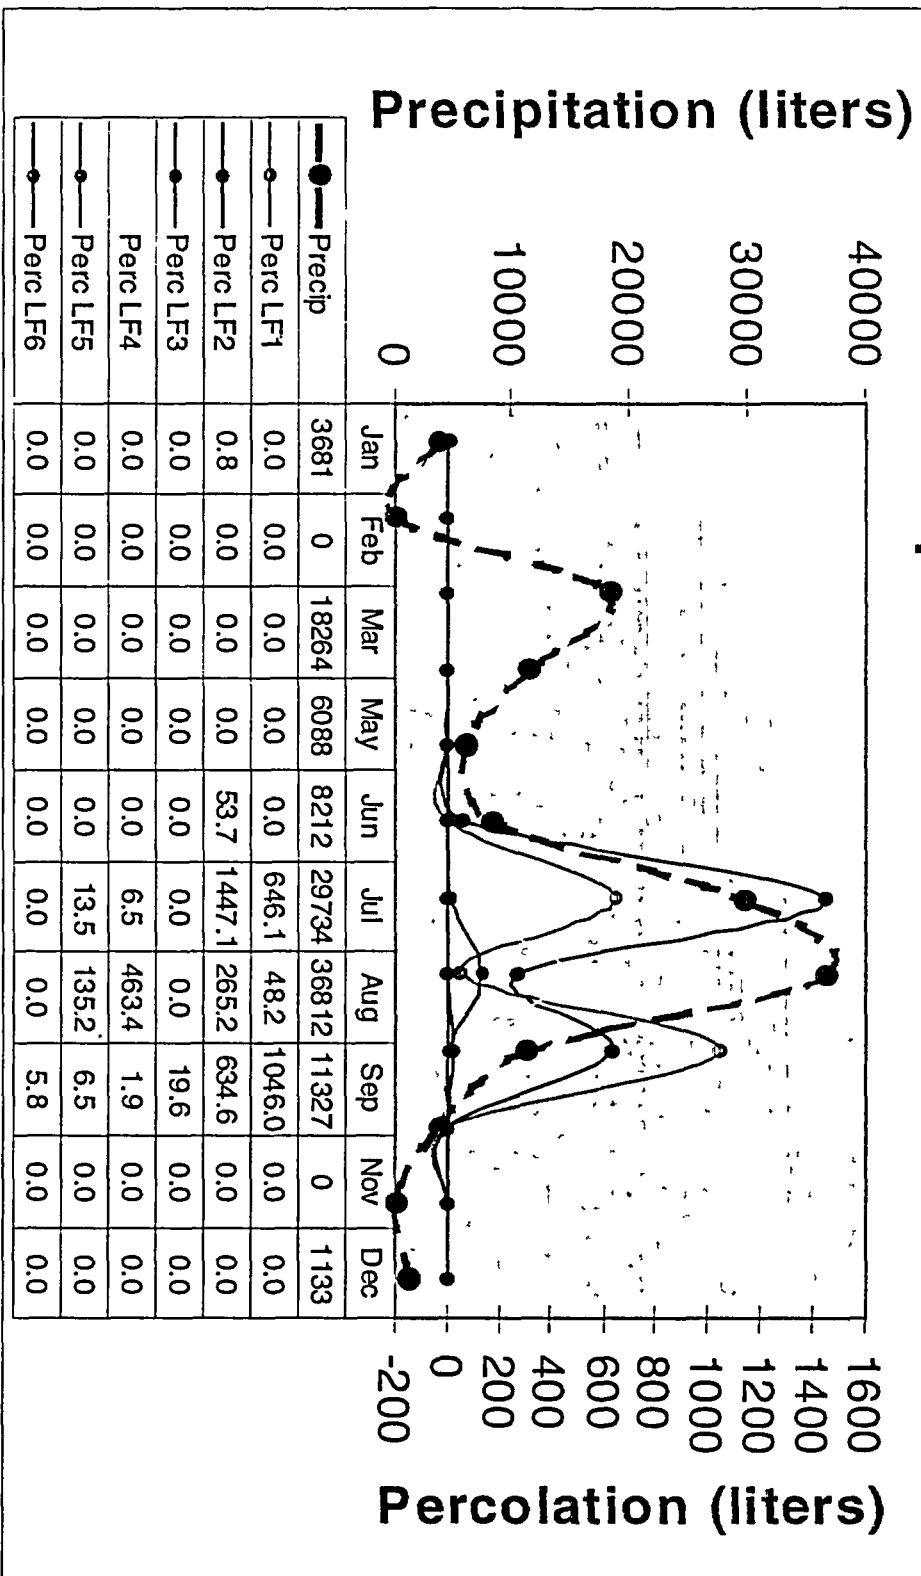
Figure B-3. 1999 Precipitation Versus Percolation

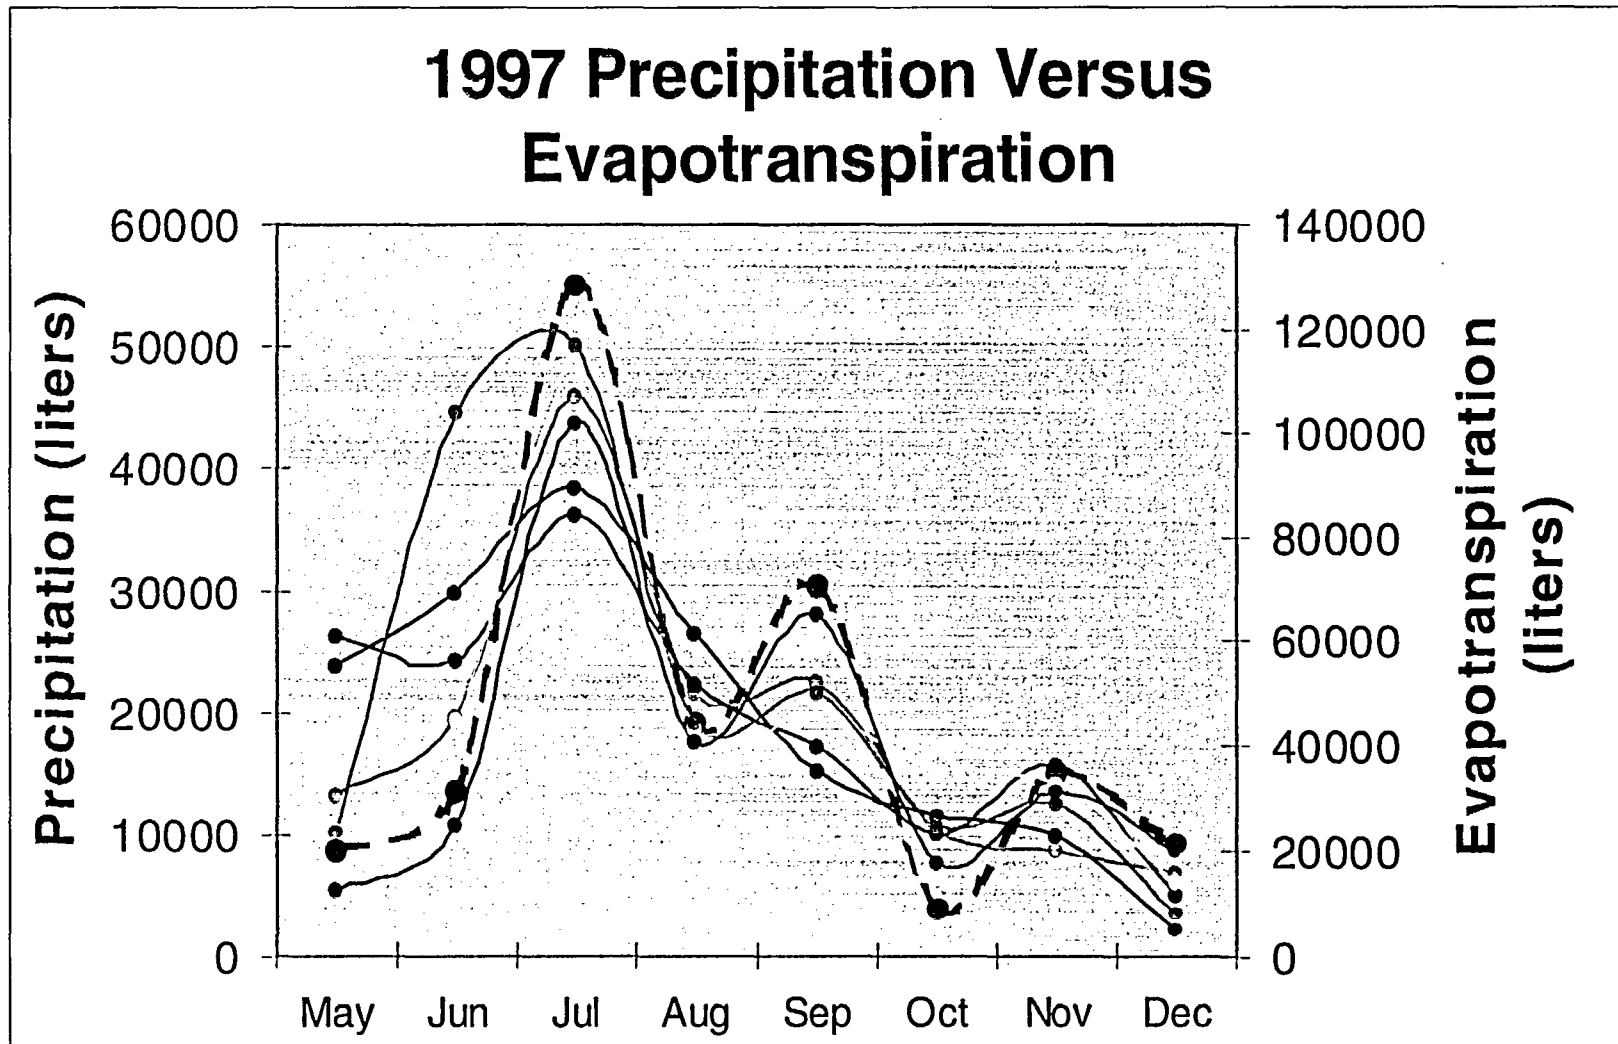
Figure E-1. 1997 Precipitation Versus Evapotranspiration

The presentation of past data from the ALCD has generally centered on the test covers measured percolation. A stakeholder has specifically requested that all water balance data measured with respect to the ET Cover be presented in this report. This request has been granted. Consequently, all water balance data measured on the ET Cover, as well as similar data on all covers, is included. Water balance data collected on the ET Cover include percolation, surface runoff, and soil moisture. There is no drainage layer in the ET Cover therefore the lateral drainage parameter does not exist for this cover. Bear in mind that the vegetation on the covers built during Phase I was established one year earlier than the vegetation on the covers built during Phase II. Slight variations in surface runoff and soil moisture can be noticed due to the differences in vegetation growth on the covers pertaining to the two phases, as well as the different surface treatments associated with these covers. In general, however, the data collected to date is good and clearly reveals the differences in water balance activity within the six landfill covers. Surface runoff versus precipitation is graphically presented in Appendix C. Soil Moisture versus precipitation is graphically presented in Appendix D. Finally, ET versus precipitation for the six covers is graphically presented in Appendix E.
