**2018 Deposition and Erosion Areas Compared to FS  
RM 1.9 to 8.0**

Portland Harbor Superfund Site  
Pre-Remedial Design Footprint Report

2018 Deposition and Erosion Areas Compared to FS  
RM 8.0 to 11.8

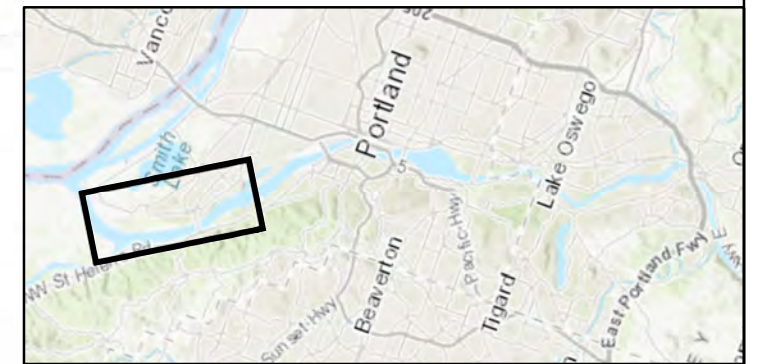
**3.4a**

PDI Sediment Deposition Rates (2009 through 2018)

FS Sediment Deposition Rates (2002 through 2009)

Note:  
1. FS Sediment Deposition Rates for 2002 to 2009, taken from FS Figure 3.4-20

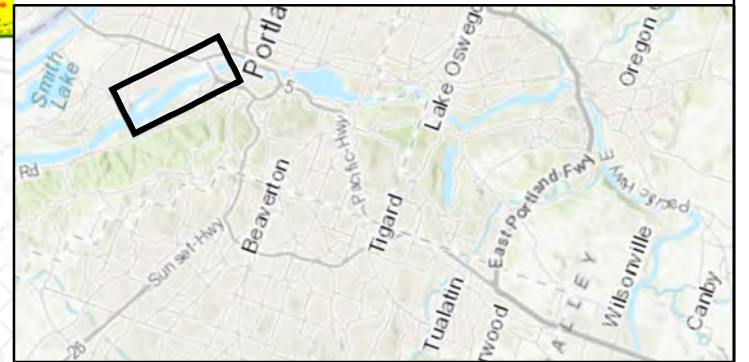
Figure  
3.4b

PDI Sediment Deposition Rates (2009 through 2018)

FS Sediment Deposition Rates (2002 through 2009)

Note:  
1. FS sediment Deposition Rates for 2002 to 2009, taken from FS Figure 3.4-20
