**FIFTH FIVE-YEAR REVIEW REPORT
FOR
UMATILLA CHEMICAL DEPOT SUPERFUND SITE
EPA ID: OR6213820917
MORROW AND UMATILLA COUNTIES,
HERMISTON, OREGON**

April 2023

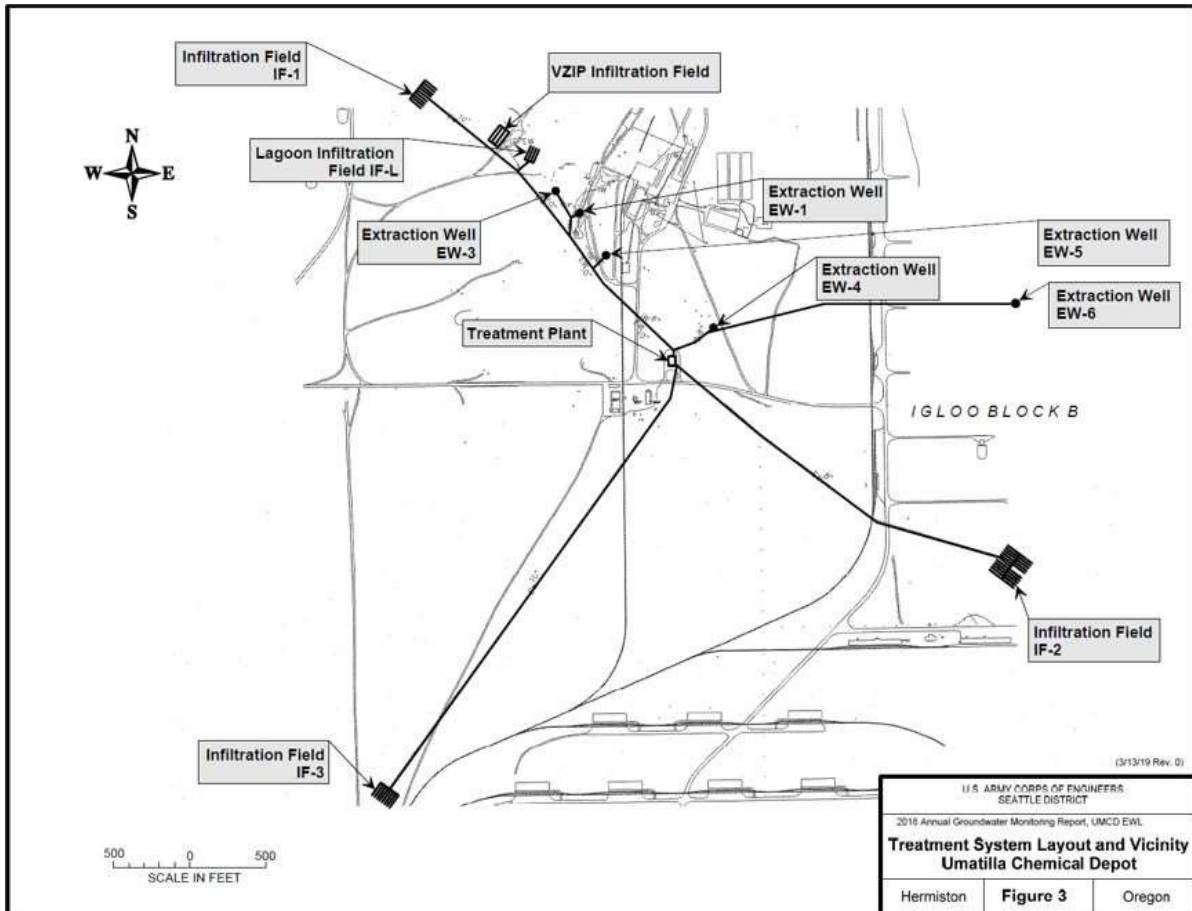
Figure 7
Treatment System Layout

Beginning in 1995, the extraction and treatment system was constructed consisting of three extraction wells with a combined flow of 1,300 gpm, a treatment plant with four 20,000-pound GAC filters, three infiltration fields in addition to the original EWL and ancillary piping. Initial start-up of the system occurred in 1996 and full-time operation began in January 1997. Initially, all treated groundwater was absorbed onto the unsaturated soil underlying the EWL. The soil flushing component of the remedy was completed in 2000. Since that time, all treated groundwater has been discharged to two active down-gradient infiltration fields (IF-2 and IF-3) that reintroduce the treated water back into the aquifer. Spent GAC has been periodically sent off-site for thermal regeneration once it has reached its absorptive capacity.

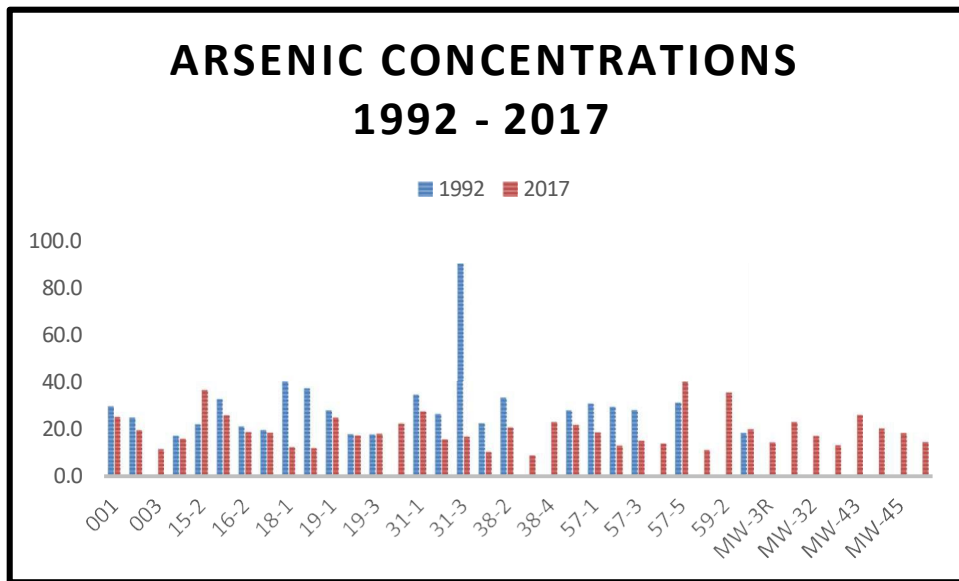
Arsenic groundwater concentrations in the ADA OU were reported in the 1992 RI and were again sampled as part of the Bay West contract in 2017. The 2017 well sampling results showed arsenic in groundwater ranged from 8.67 µg/L to 40.2 µg/L (Bay West, 2017). The current MCL for arsenic 10 ug/L. The ADA OU does not have a cleanup value for groundwater and while most are above the MCL, there is a general decrease since 1992 see Table 14 and Figure 13). Of the 38 wells only 23 were sampled in 1992. The average concentration for those wells was from 29.5 ug/L to 20.1 ug/L. The only well that was below the MCL was 38-3 with a concentration of 8.67, therefore LUC are required for the ADA groundwater. LUCs restricting groundwater usage is documented in the Order and Agreement between the ODEQ and OMD. The Guard has an Order and Agreement for the Maintenance of Institutional Controls between ODEQ and the OMD, signed April 2021. It provides ODEQ enforcement action for the institutional controls on the Guard property. The Army property manages institutional controls through the LUCIP. For property leaving Army control, LUCs will be in the EES and through deed restrictions.

Figure 13
Arsenic Levels in Groundwater 1992 – 2017 (µg/L)

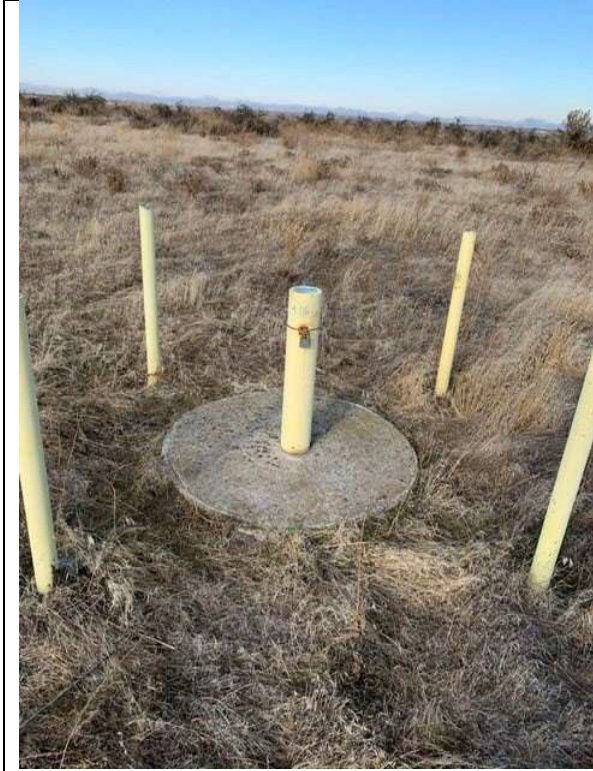
Typical well condition on site (pictured: 4-116)

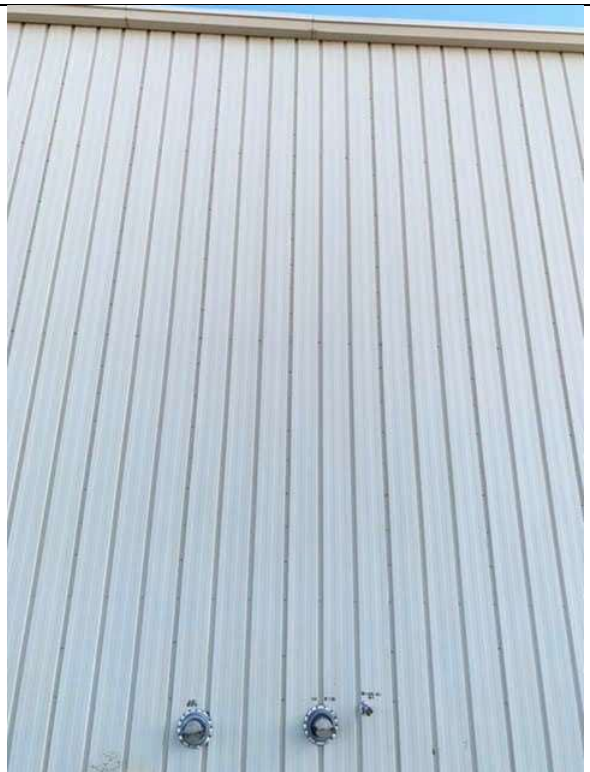
The site inspection of the EWL Groundwater OU treatment system and associated infiltration area did not yield any notable observations. Both the infiltration field and the washout lagoons appeared to be dry. Wells that were included in the inspection appeared to be in acceptable condition. The GETS building, located adjacent to the EWL area was also visited during the inspection. The building appeared to be in good condition, though an exterior gutter leak was noted to be dripping directly onto a valve associated with the GAC treatment system.

Leaking gutter with location of leak and drip path

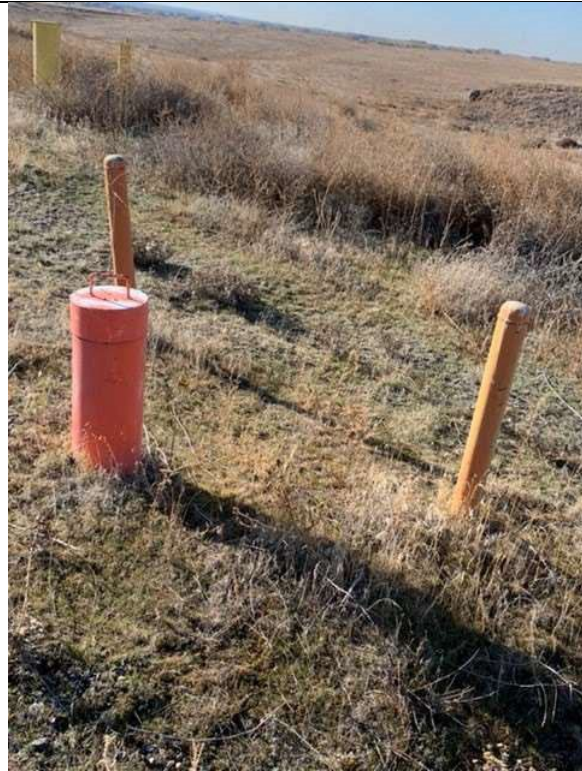
Well near washout lagoons with only two bollards

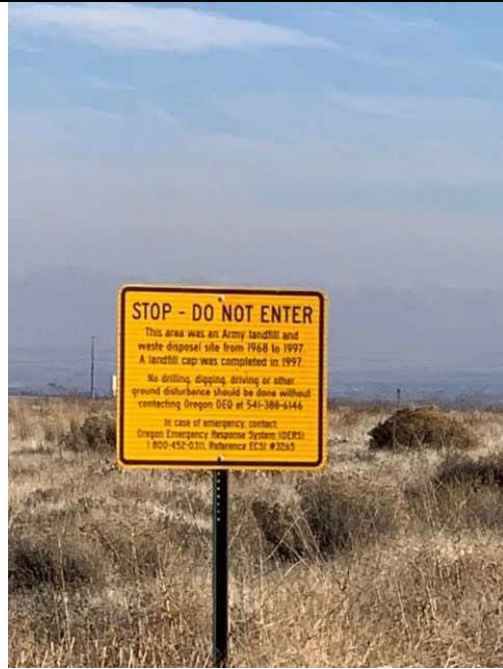
During the site inspection, it was noted that a sign on the southern portion of the landfill had fallen. Animal burrows and distressed, black vegetation were observed in the cap. Photos of the active landfill area are included in the full site inspection report.

Landfill sign

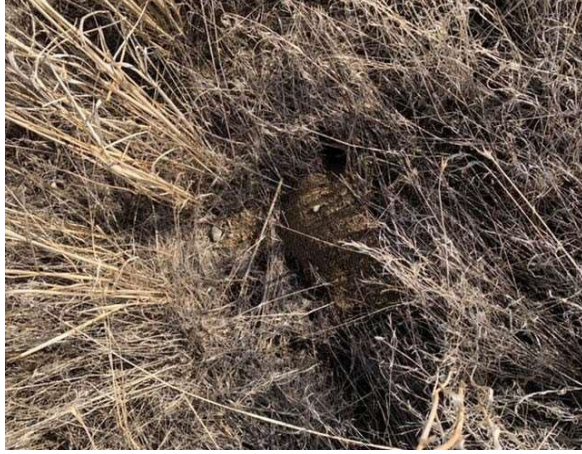
Animal burrows in landfill cap

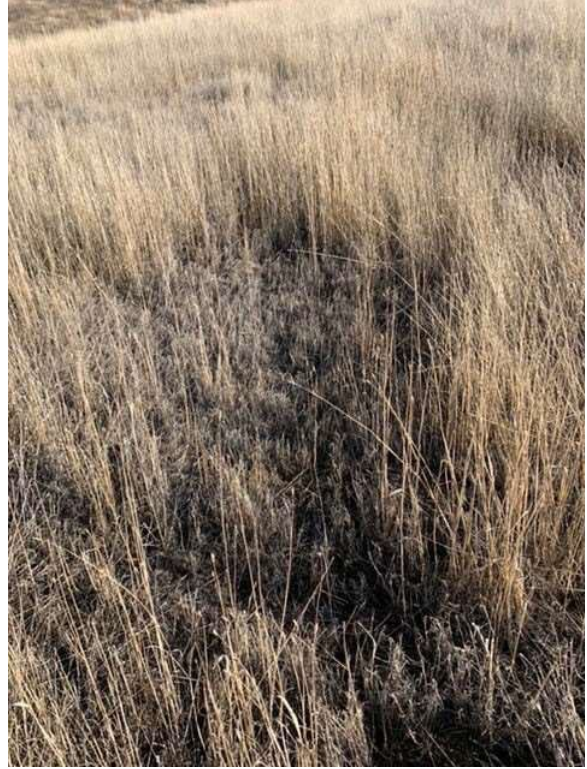
Flattened and dark vegetation on landfill cap

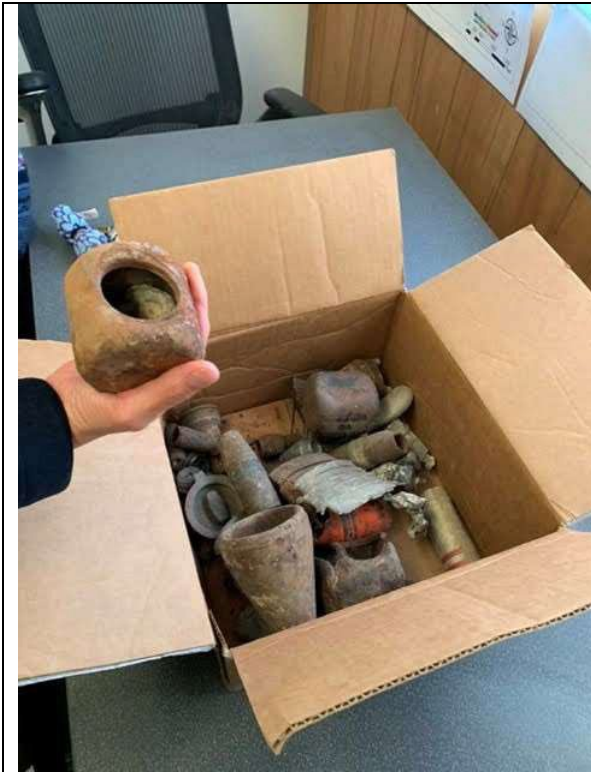
Examples of munitions debris recovered from the ADA
