**First Five-Year Review Report**  
**for**  
**Pemaco Superfund Site**  
**Maywood, California**

**September 2010**

**U.S. Environmental Protection Agency, Region 9**  
**San Francisco, California**

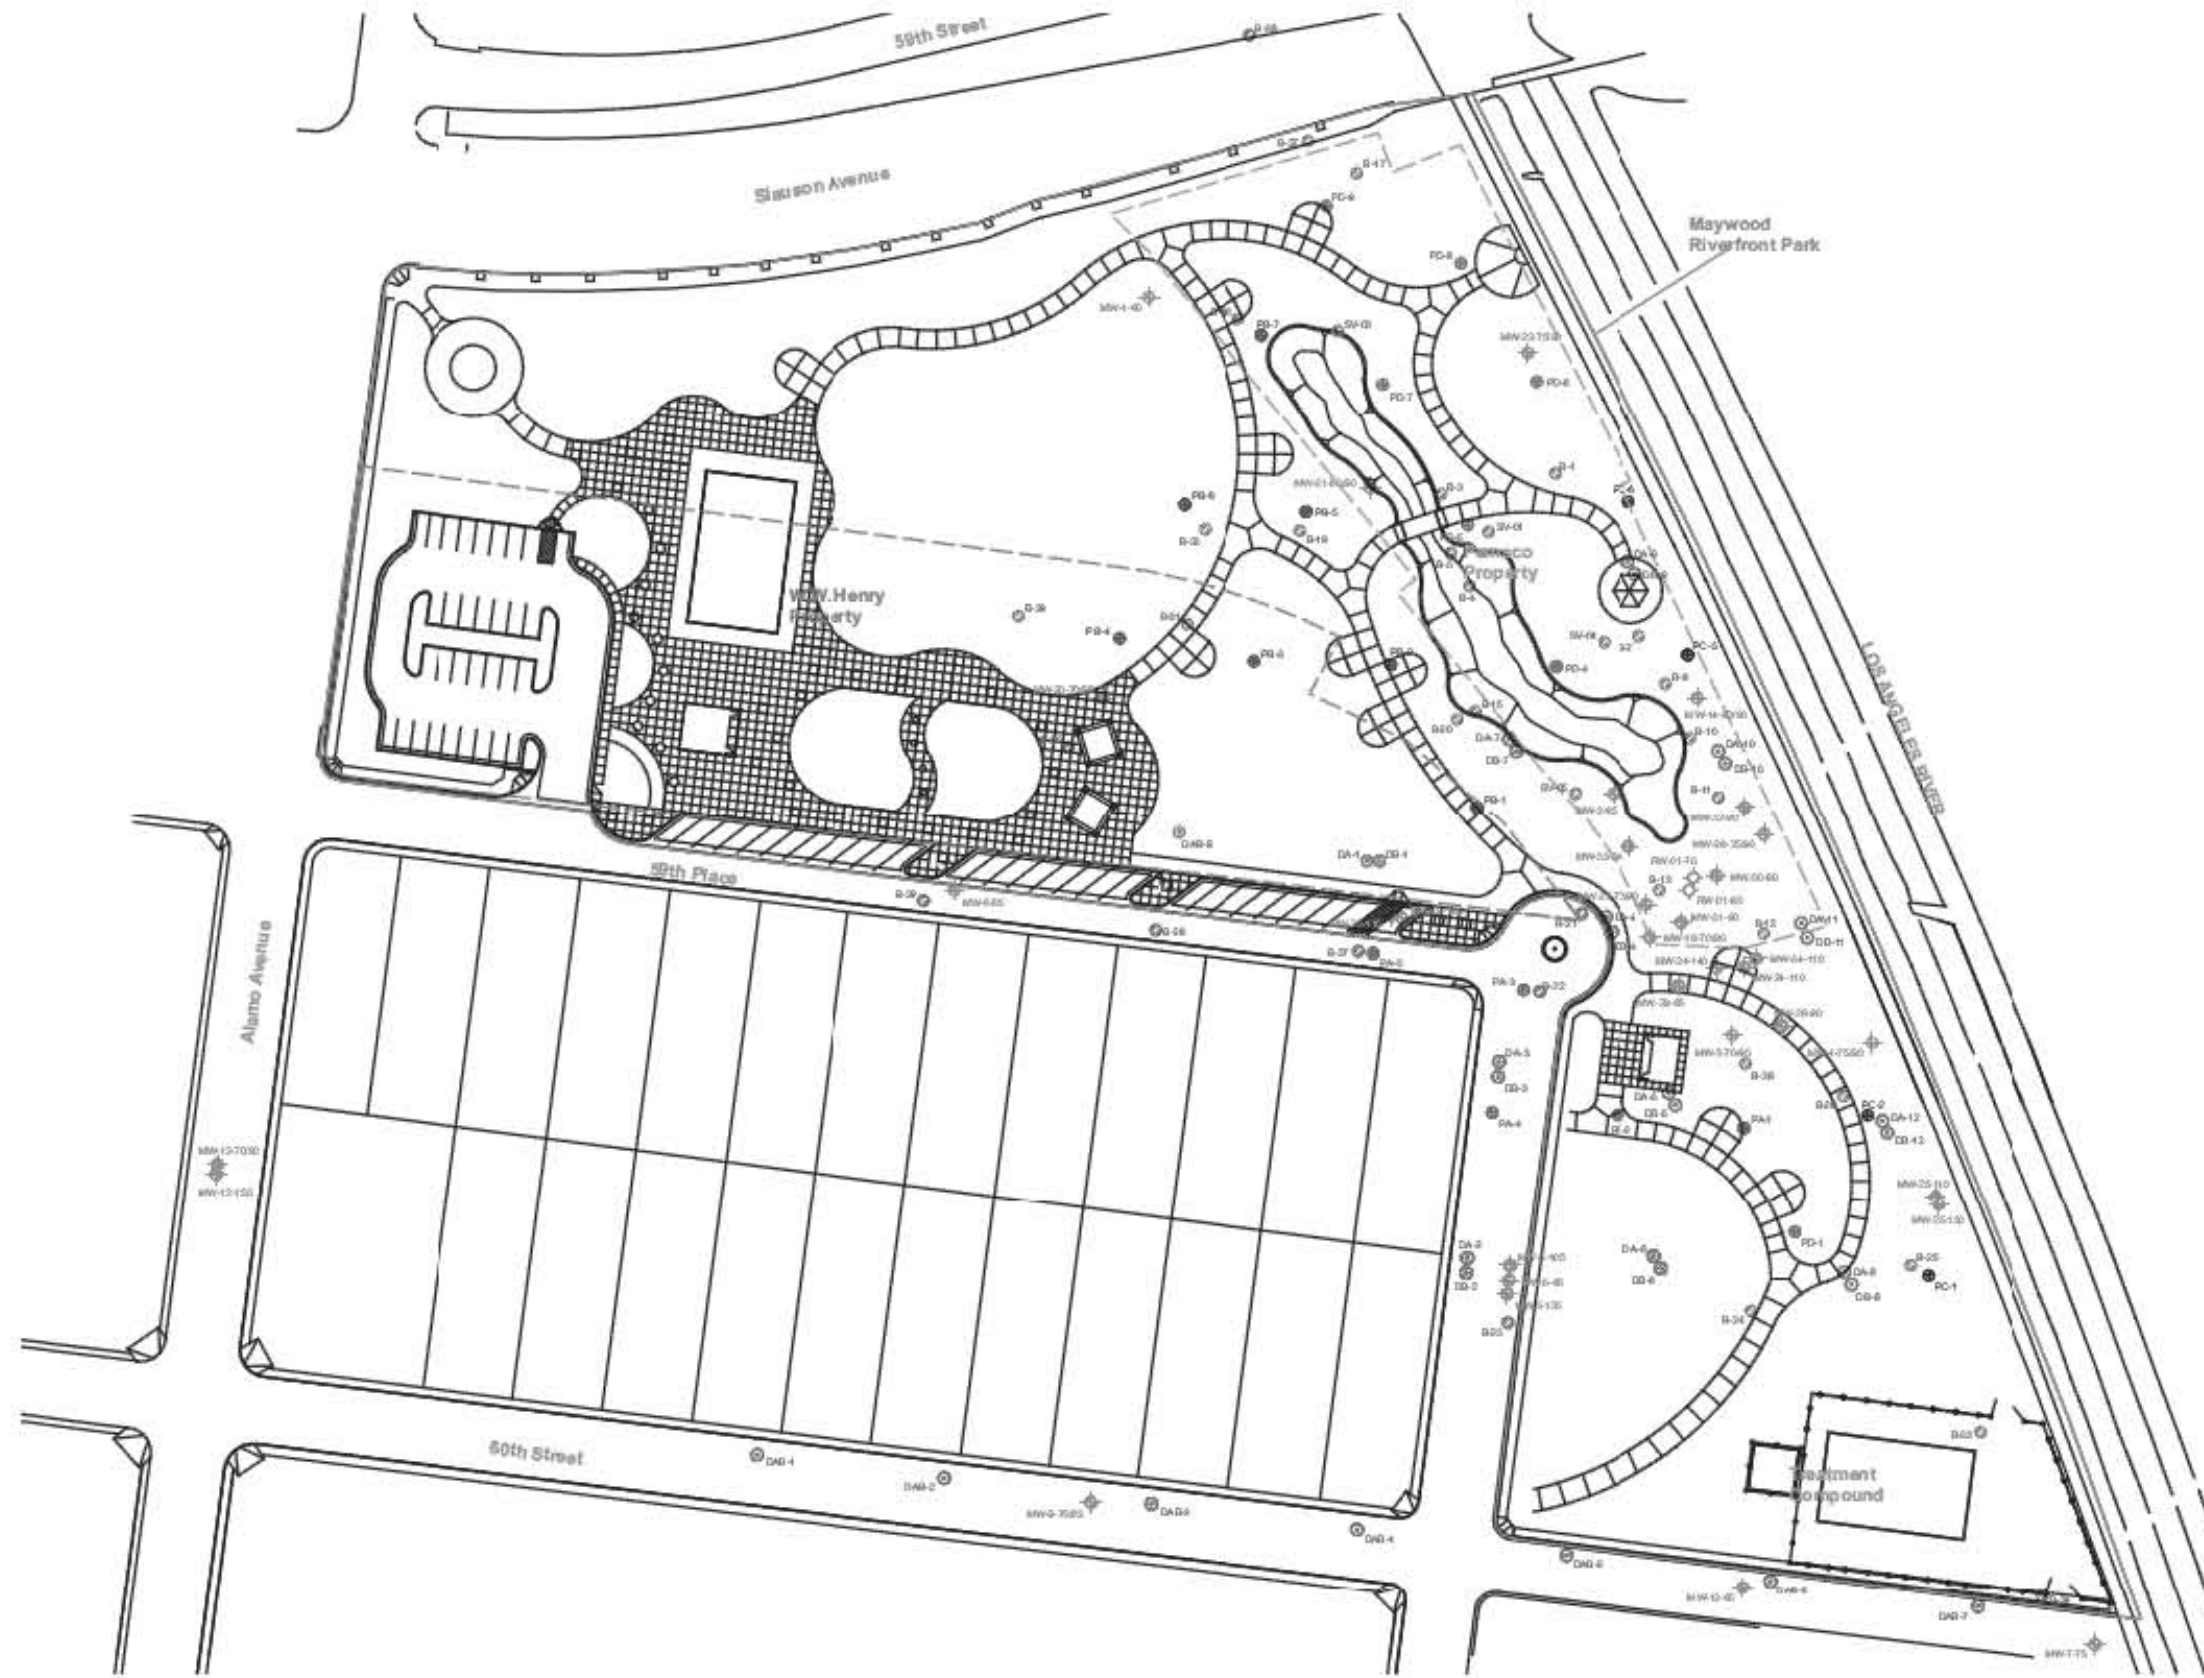
Figure 4-2: Site Plan with All Monitoring and Extraction Wells

Site-wide groundwater, vapor, and effluent monitoring is conducted to monitor conditions and evaluate the effectiveness of the remedial actions conducted at the site. The monitoring network includes a mix of 128 active groundwater extraction and monitoring wells to monitor groundwater quality; 29 vapor recovery wells, 21 soil-vapor monitoring probes; 30 multi-level temperature monitoring probes in the ERH Area; and groundwater and vapor sampling ports at various locations in the treatment plant to aid in performance analysis of the treatment system. The vapor and groundwater monitoring network is shown on [Figure 4-2](#).

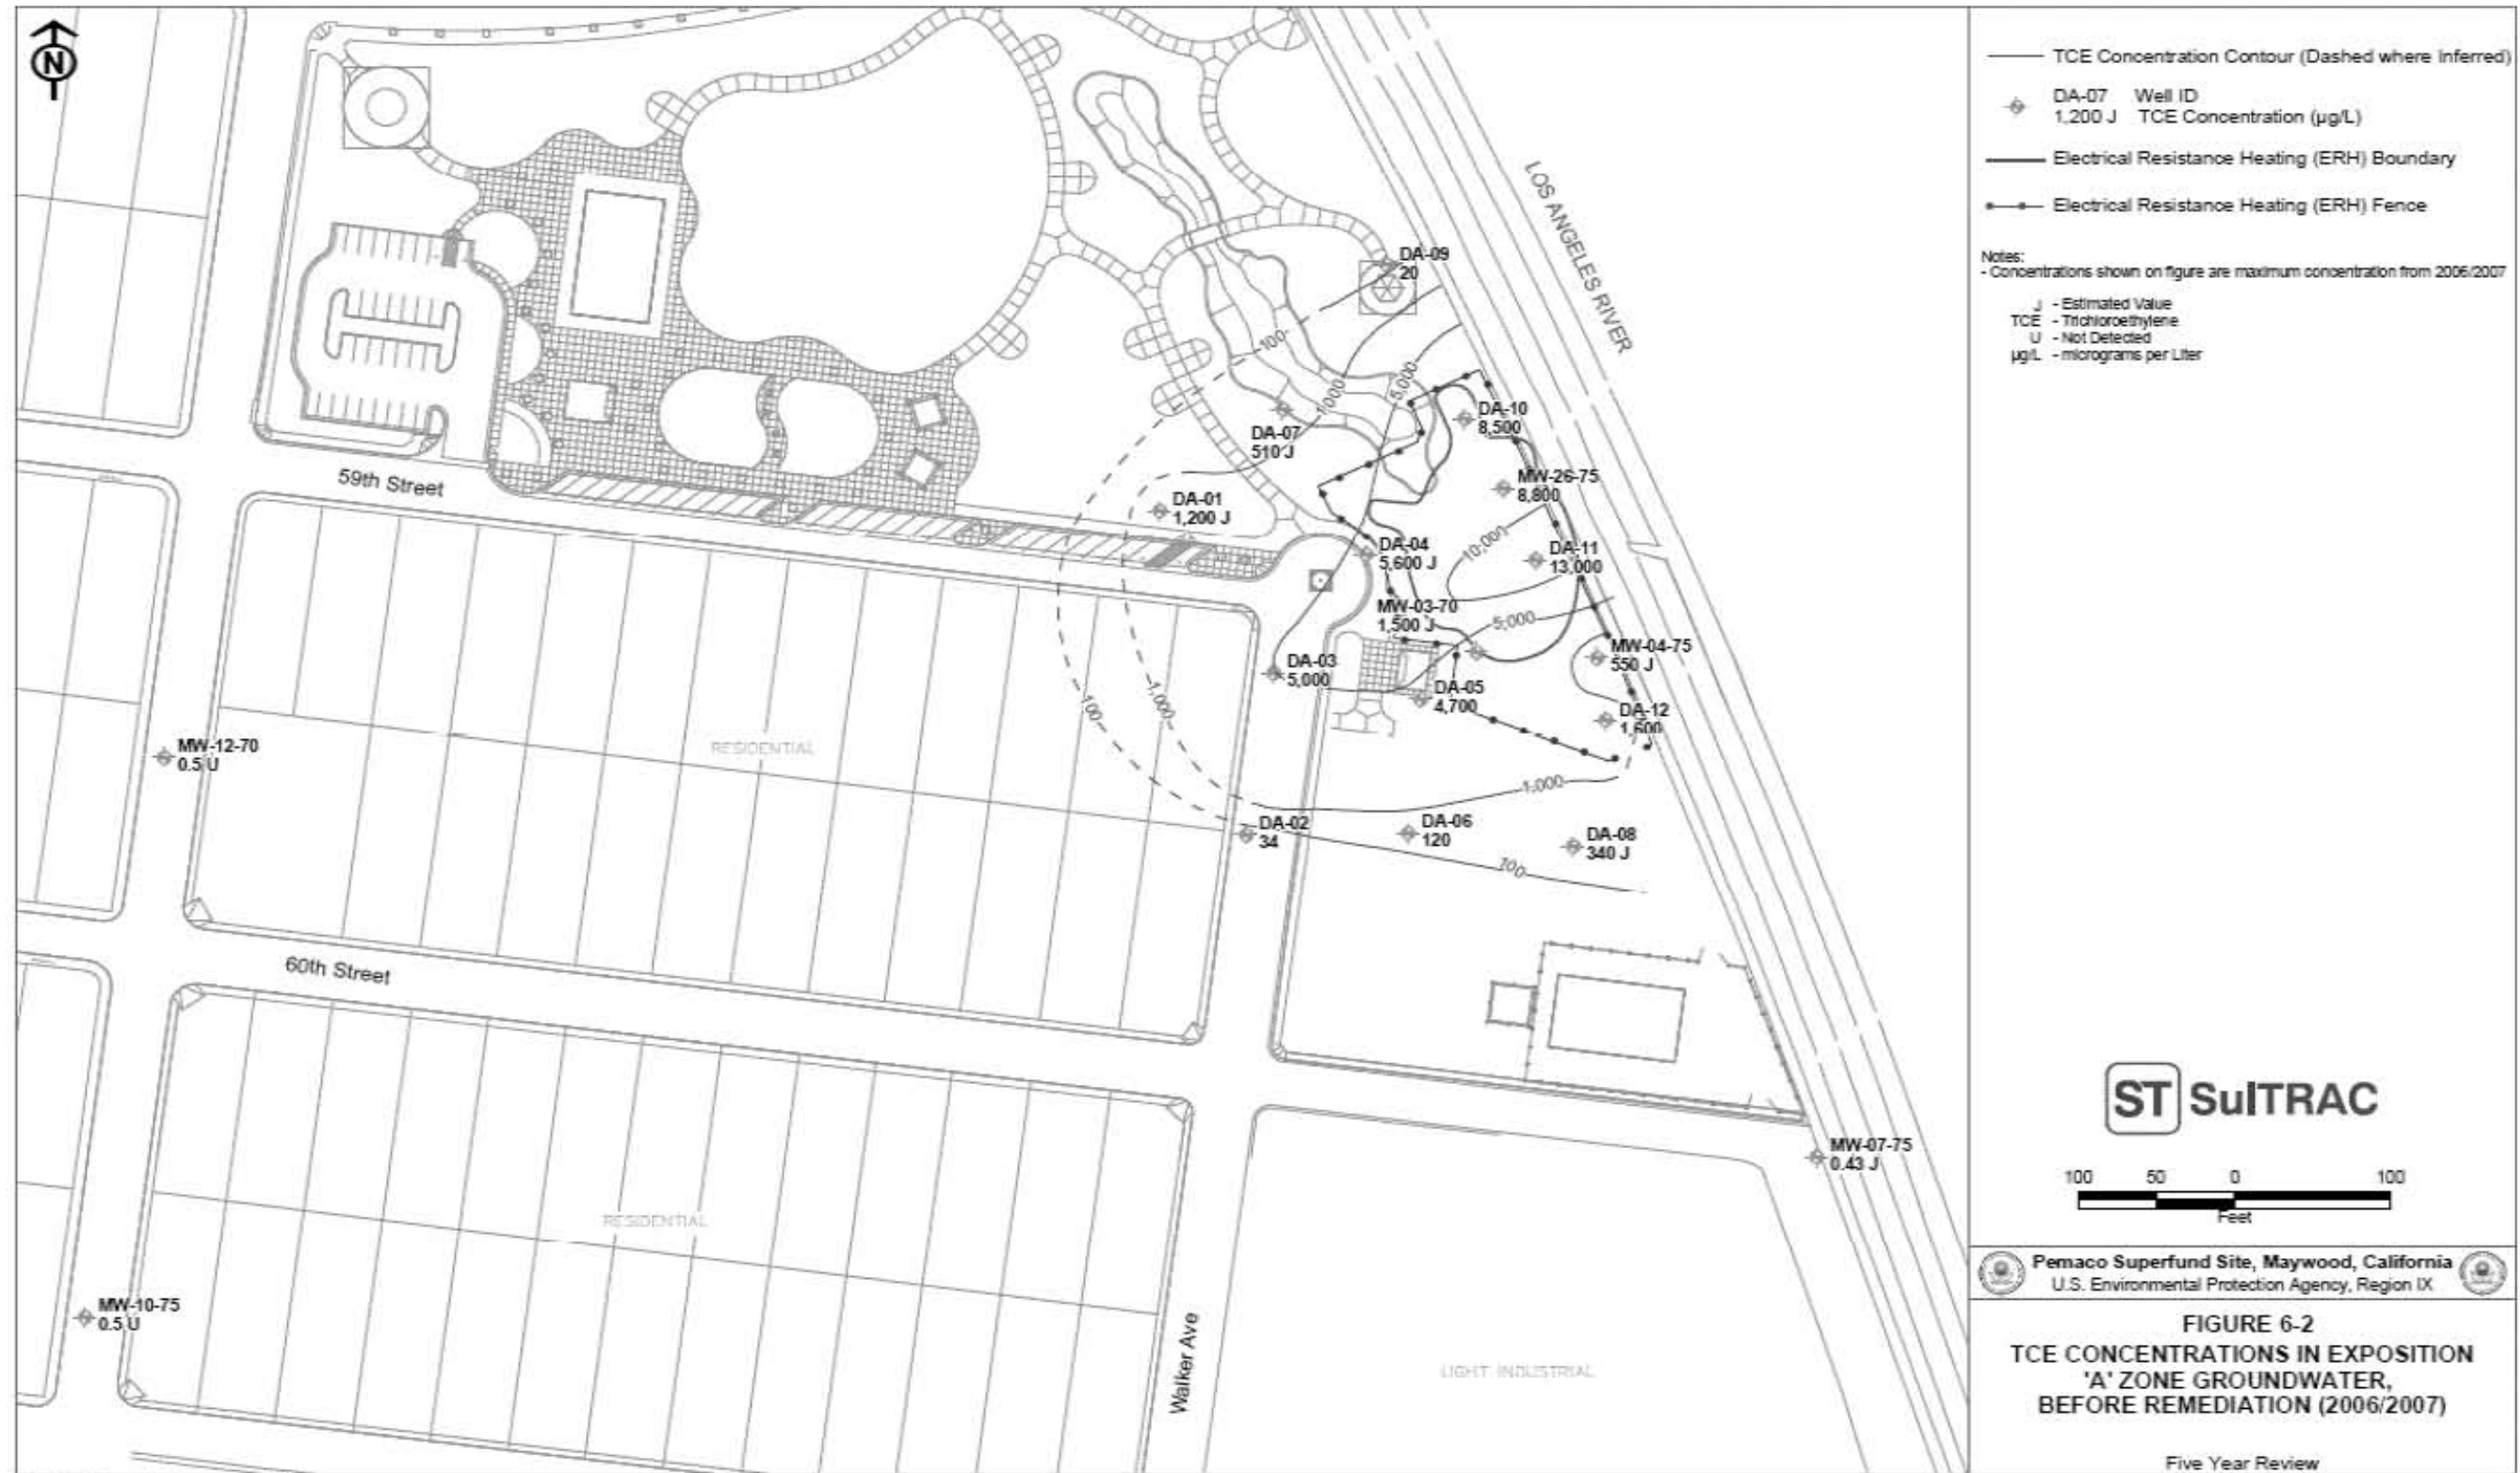
Figure 6-2 Pre-HVDPE Maximum Concentrations of TCE in Exposition 'A' Zone Groundwater, Pemaco Superfund Site, Maywood CA

The most common contaminants found in the 'A' Zone are TCE, PCE, cis-1,2-DCE, trans-1,2-DCE, 1,1-DCE, VC, and benzene. COC concentrations, especially those of TCE and cis-1,2-DCE, have decreased significantly since the ERH remedy and groundwater pump-and-treat system were implemented. Figure 6-2 shows the maximum TCE concentrations in 'A' Zone groundwater between the signing of the ROD in January 2005 and the implementation of the HVDPE system in May 2007. Figure 6-3 shows the maximum concentration of TCE in 'A' Zone groundwater in 2009. Within the ERH Area, groundwater samples from 'A' Zone wells have not exceeded SSRLs since 2008, except for one detection of TCE at 39 µg/L in MW03-70 (5/20/09). EPA conducted bio-treatment in an area of TCE contaminated groundwater located adjacent to the ERH Area prior to the start of heating. Extraction wells DA-01, DA-03, and DA-05 now contain TCE concentrations of approximately 100 µg/L in October 2009. EPA may follow-up with additional bio-remediation treatment sometime in the future.

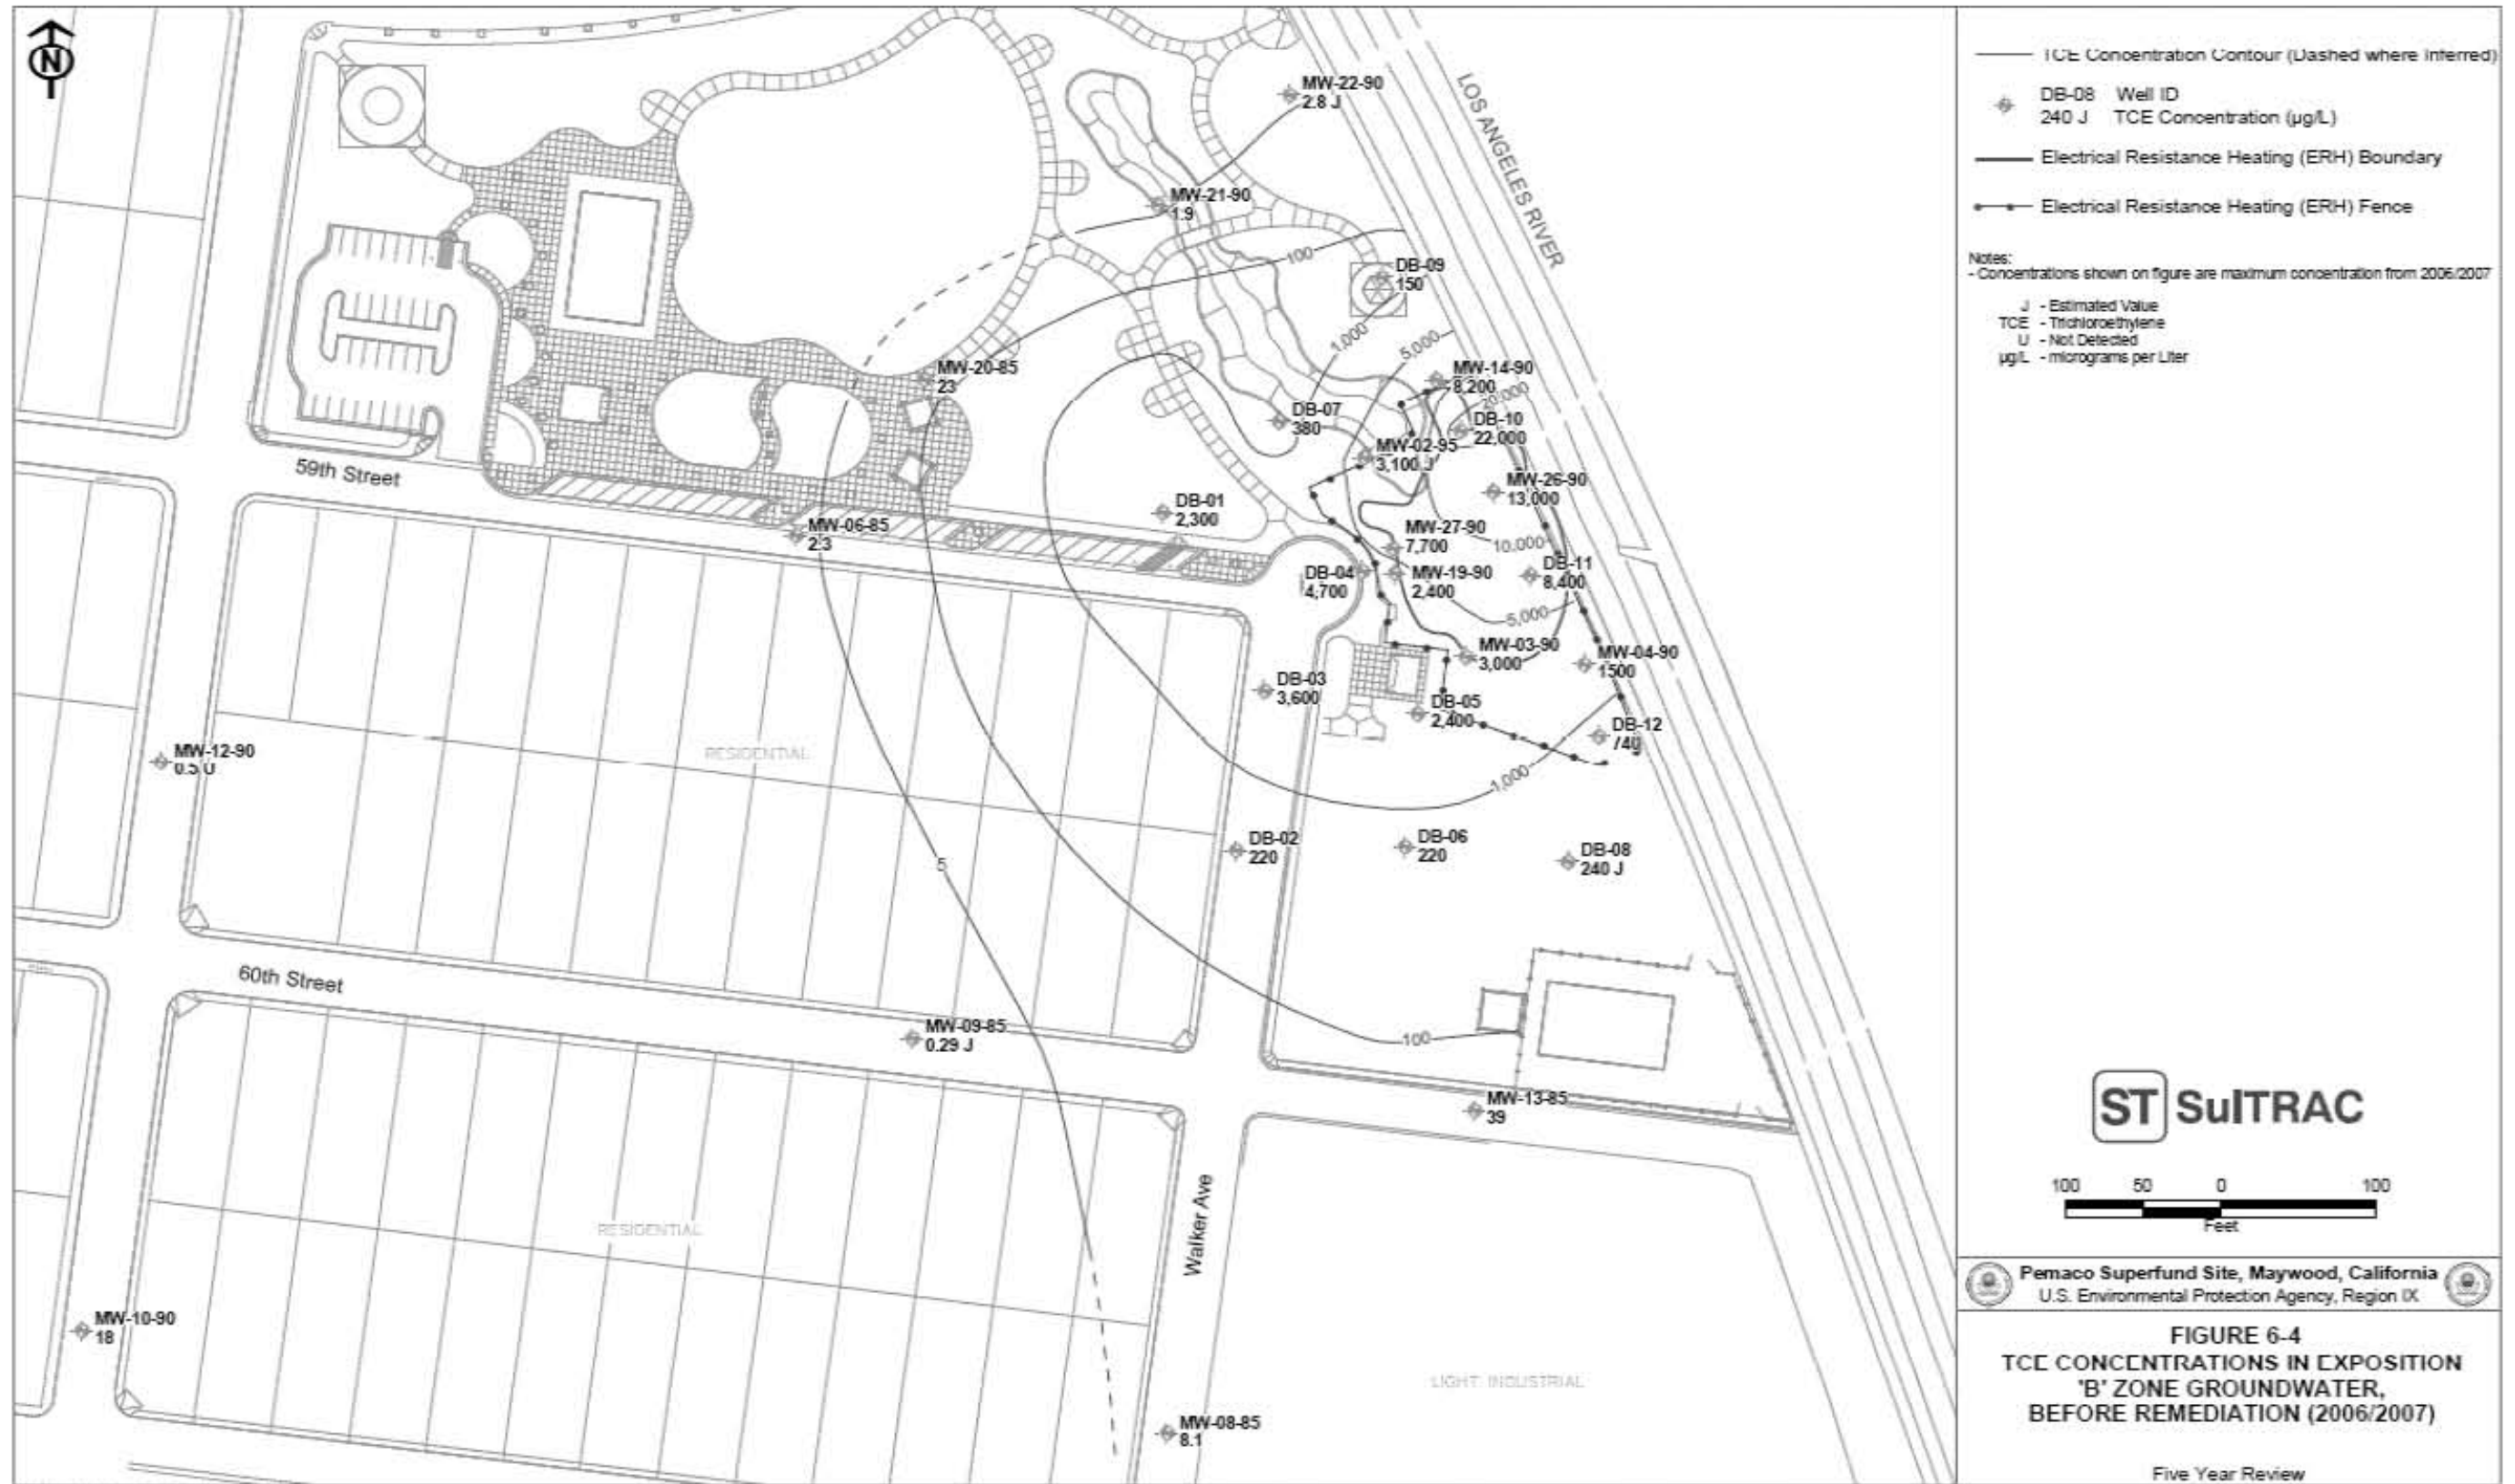
Figure 6-4 Pre-HVDPE Maximum Concentrations of TCE in Exposition 'B' Zone Groundwater, Pemaco Superfund Site, Maywood CA

The most common contaminants in the 'B' Zone are benzene and the chlorinated solvents TCE, PCE, cis-1,2-DCE, trans-1,2-DCE, 1,1-DCE, and VC. TCE is the primary contaminant in the 'B' Zone. TCE concentrations decreased significantly after the ERH remedy and the groundwater extraction system were implemented. Figure 6-4 shows the maximum TCE concentrations in 'B' Zone groundwater between the signing of the ROD in January 2005 and the implementation of the HVDPE system in May 2007. Figure 6-5 shows the maximum concentration of TCE in 'B' Zone groundwater in 2009. The surface area of the plume was 4.56 acres in December 2007. Post-ERH sampling in October 2009 showed that TCE concentrations exceeded the SSRL in an area of 2.66 acres, a 42% decrease. TCE and cis-1,2-DCE continue to be detected in 'B' Zone extraction wells and select monitoring wells above their respective SSRLs. In 2009, TCE concentrations in the 'B' Zone ranged from 0.56 µg/L (MW30-90, 10/12/09) to 720 µg/L (DB-08, 5/19/09), and cis-1,2-DCE concentrations ranged from 0.28J µg/L (MW28-90, 7/22/09) to 130 µg/L (MW02-95, 3/17/09). In the ERH Area and immediate surroundings, TCE concentrations in 'B' Zone wells have decreased 97%. Wells that recently had detections of TCE and cis-1,2-DCE above 25 µg/L are depicted in Figure 6-1. The maximum concentrations of select COCs in 'B' Zone groundwater before HVDPE began in April 2007 and post-ERH remedy in 2009 are presented in Table 6-3.

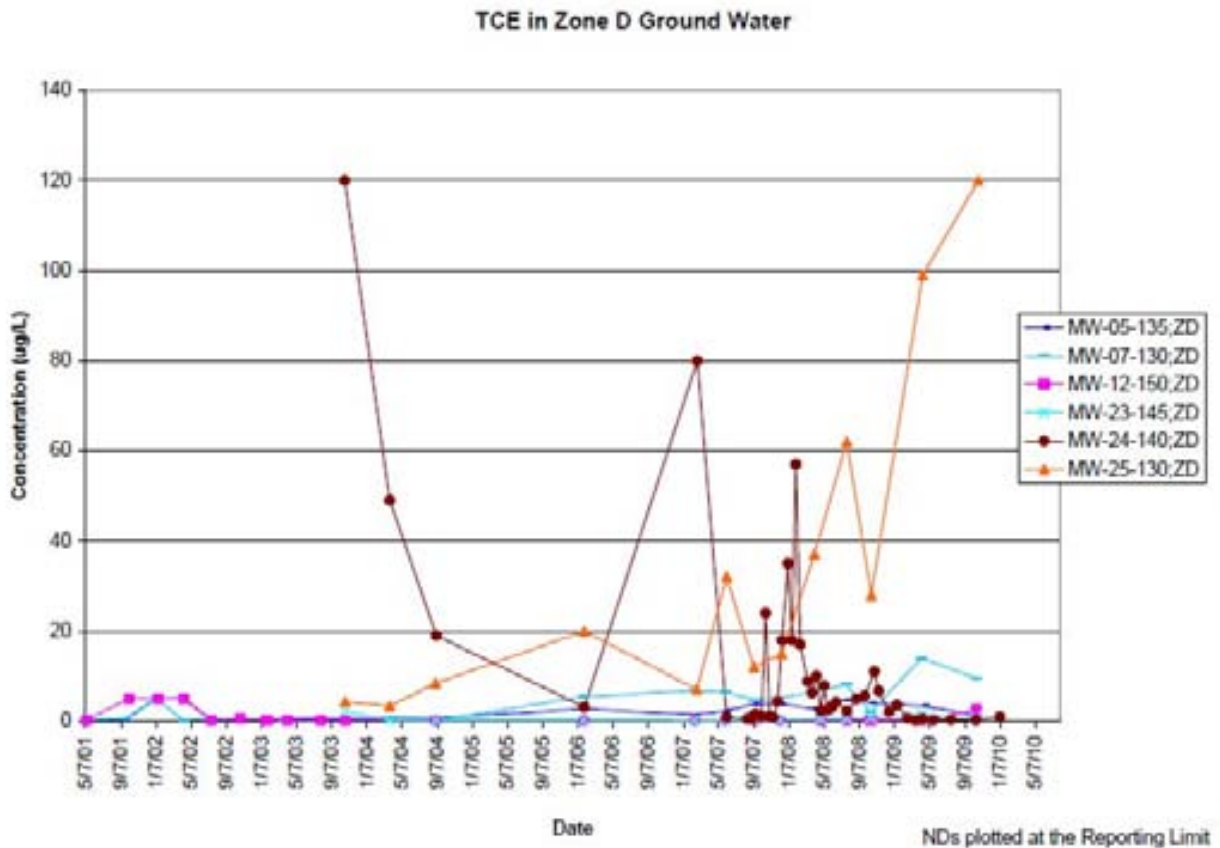
Figure 6-9: TCE in Exposition 'D' Zone Groundwater

TCE concentrations have steadily increased in well MW25-130, which is just south of MW24-140 and the ERH Area (from 4.3J µg/L in 2003 to 120 µg/L in October 2009). In January 2006, MW07-130, which is further downgradient from MW25-130, had detections of TCE in groundwater slightly above the SSRL at 5.4 µg/L, and had increased to 9.5 µg/L by October 2009. The graph below shows the trend of TCE concentrations in 'D' Zone monitoring wells, MW-07-130, , MW24-140 and MW25-130.

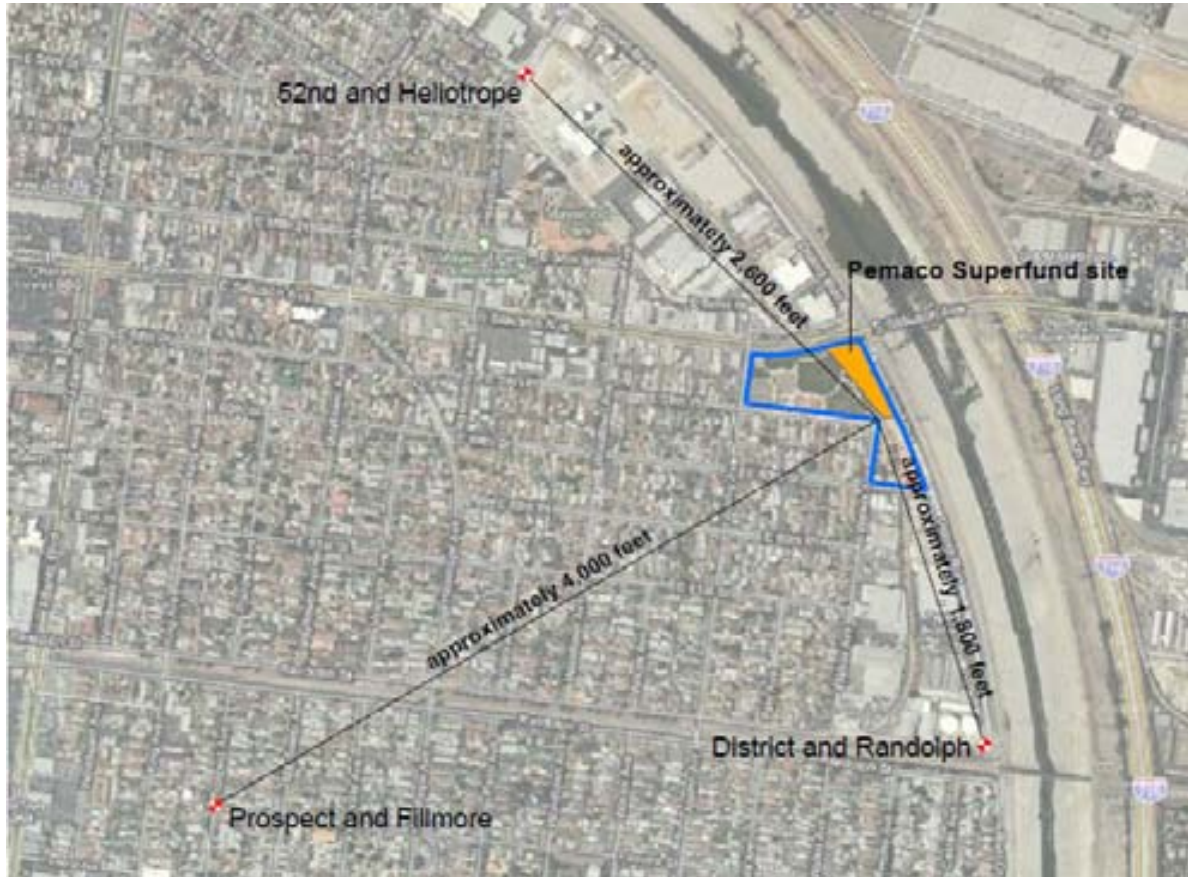
**Figure 7-1: City of Maywood Municipal Wells**

The groundwater plume does not appear to pose a threat to off-site receptors. The City of Maywood public water supply wells are located a minimum of 1,800 feet from the boundaries of the site (see Figure 7-1 below). Bob Roth, City of Maywood Municipal Water District 3 engineer, stated that all three of the city wells withdraw water from 350 to 600 ft bgs, and thus are not likely to be affected by relatively low-level contamination in shallower lithologic zones. Any contamination that does migrate toward the municipal wells is expected to be attenuated by natural processes such as diffusion, dispersion, and adsorption to organic materials in the aquifer. This is based on the relatively large lateral distances between the site boundaries and the municipal wells, the vertical differences between the stratigraphic intervals that are contaminated ('A,' 'B,' 'C' and 'D' Zones, which extend to about 145 ft bg, and the zones that produce water for the municipal wells (350 to 600 ft bgs).

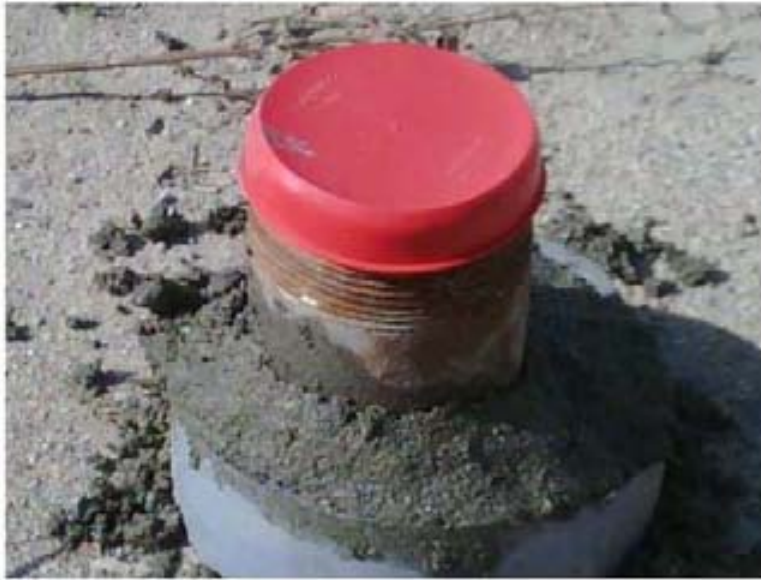
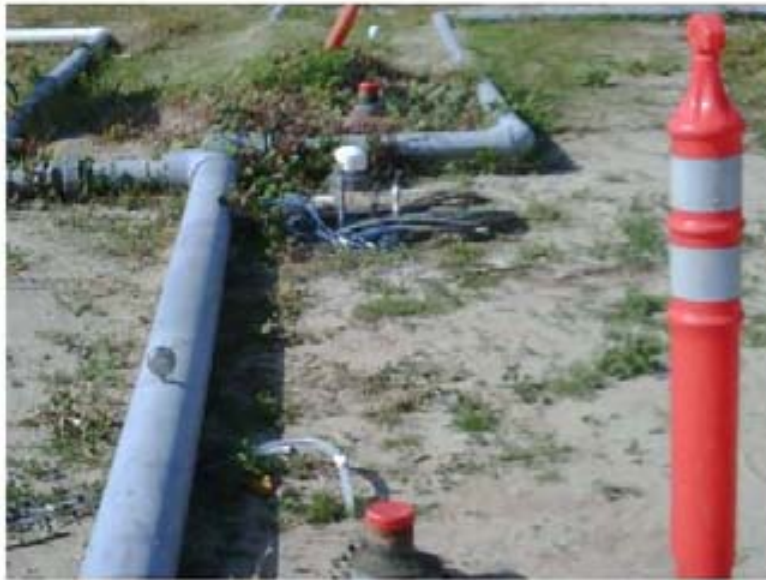
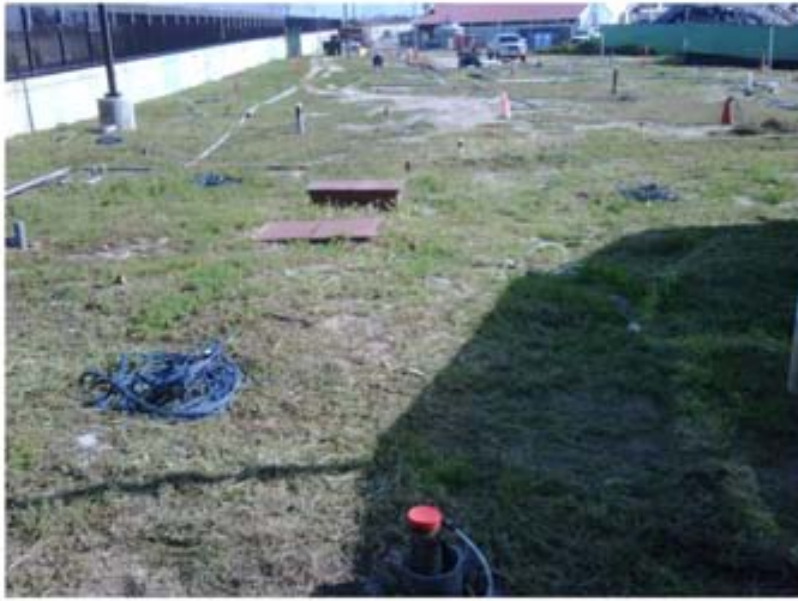
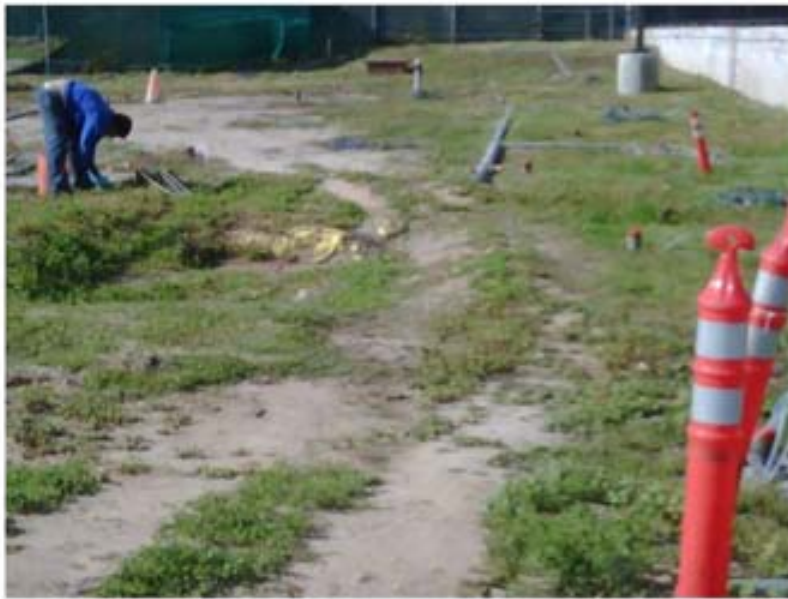
- The outer casing was removed from the ERH electrodes during the week of January 8, 2010, leaving open casings at the surface. The open ends of the electrode casings were covered with caps and the annular space at the ground surface was grouted to prevent infiltration of rainwater on March 10, 2010.

Caps and grout on electrode pipe taken March 10, 2010

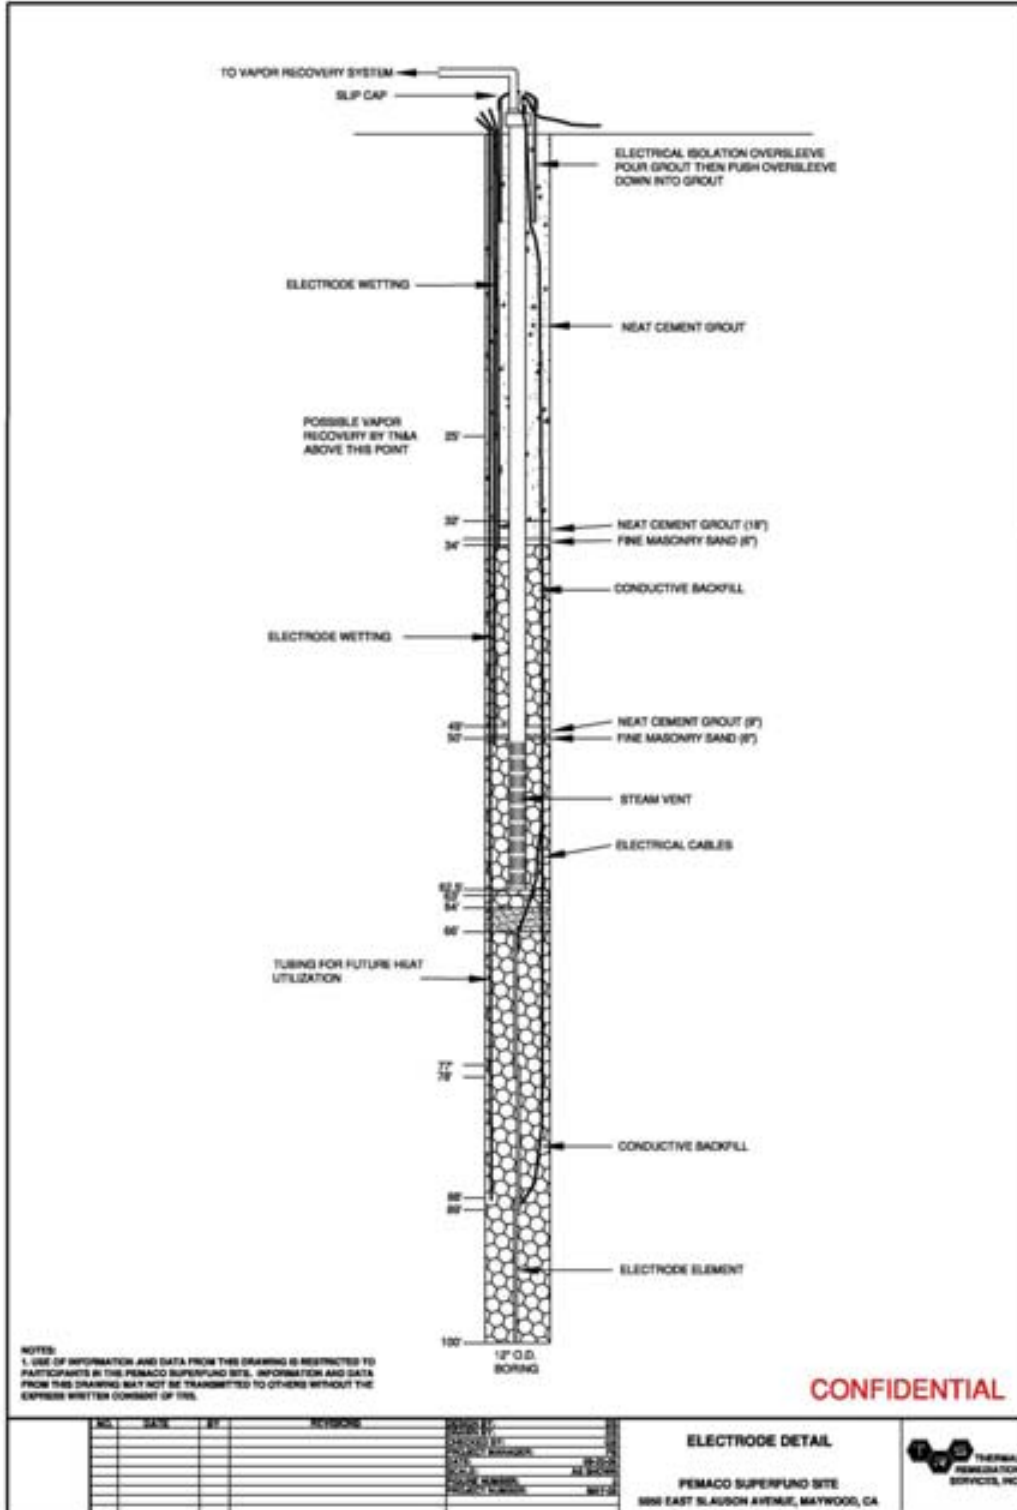
ERH electrode schematic

Includes a schematic illustration of ERH electrodes

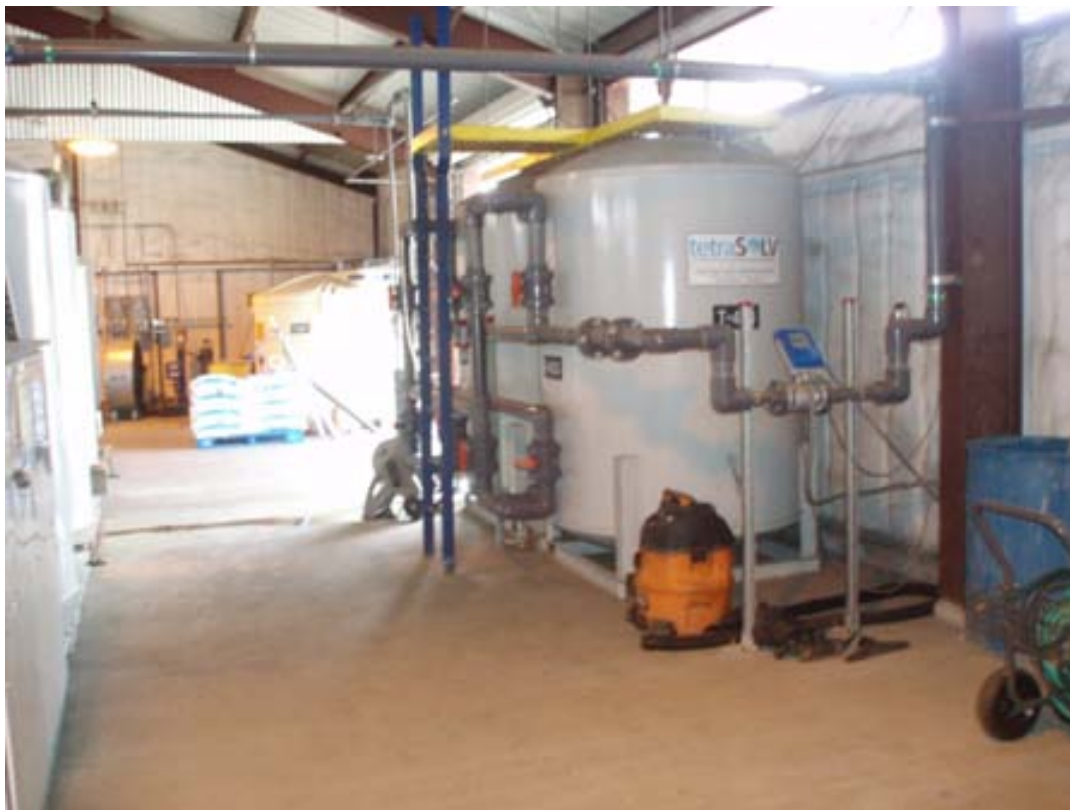
Photo 4: SP-204 and clean filter bag ready to be inserted into filter bag housing. May 27, 2010.

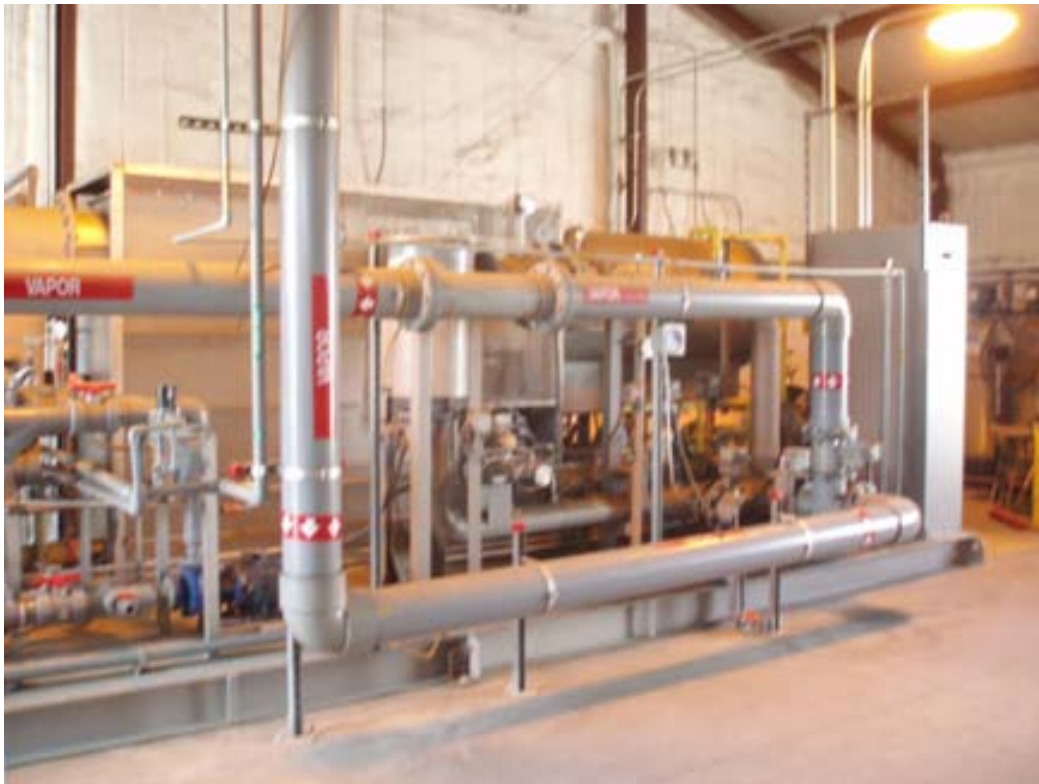
Photo 7: Flame Thermal Oxidizer at East end of plant. May 27, 2010.

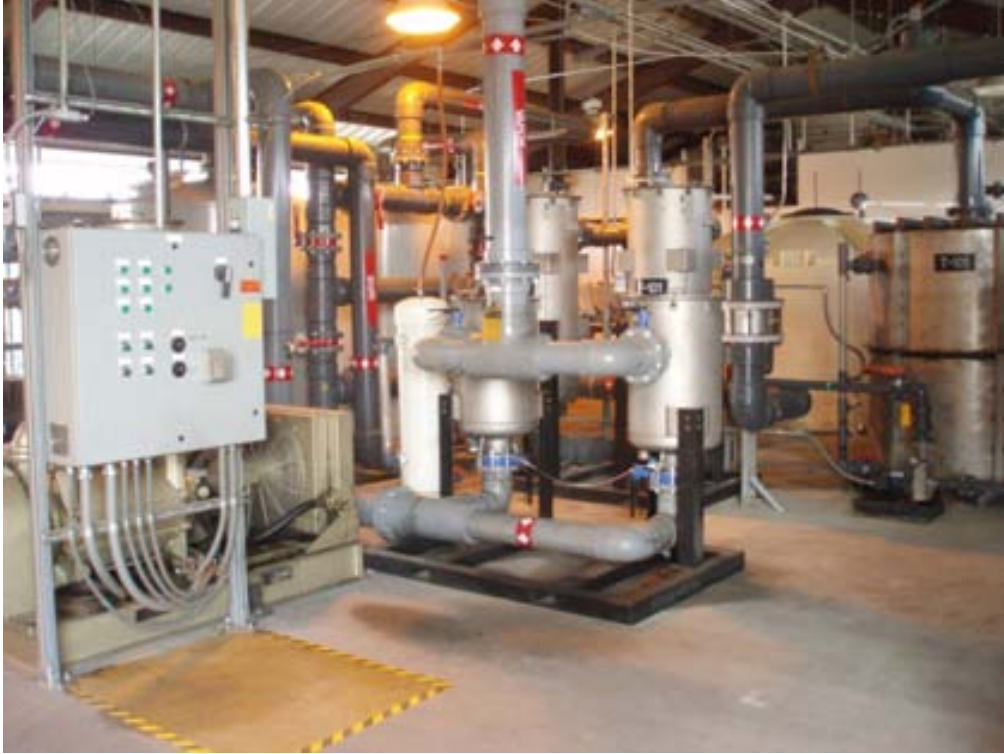
Photo 8: Flame Thermal Oxidizer view 2. May, 27 2010

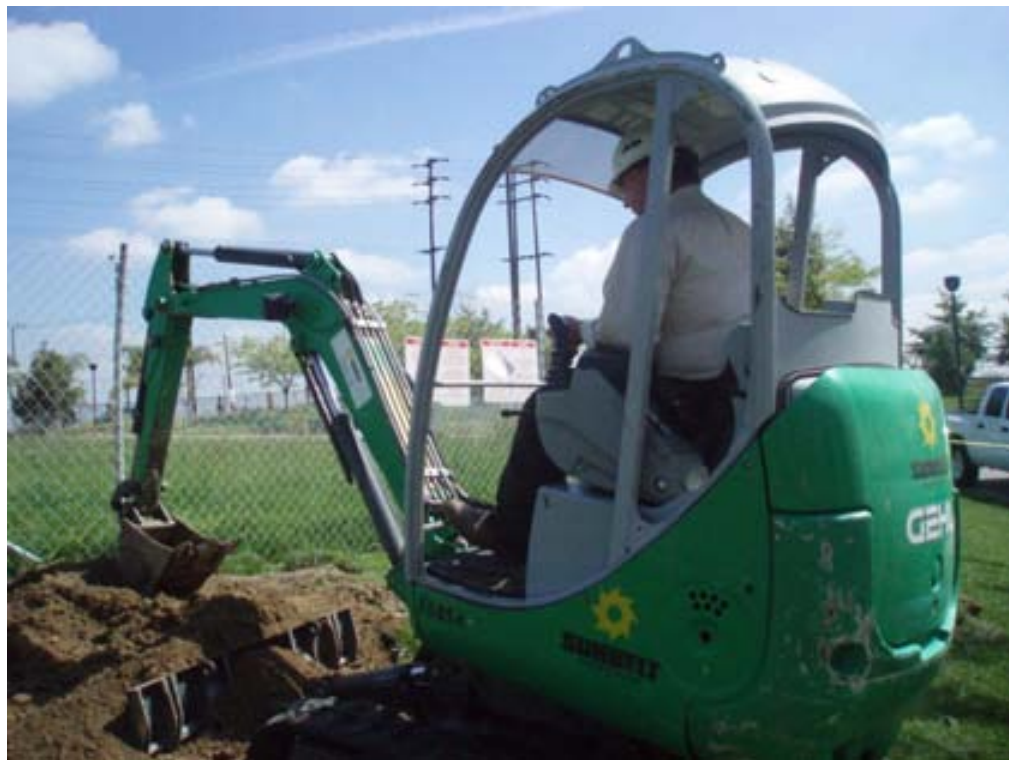
Photo 13: View of ERH area fencing and MW-2-95 and SV-05. May 27, 2010.
