SUBJECT: Midway Landfill 2010 Five Year Review Addendum

Second Five-Year Review Report

**MIDWAY LANDFILL
Superfund Site**

Kent, Washington

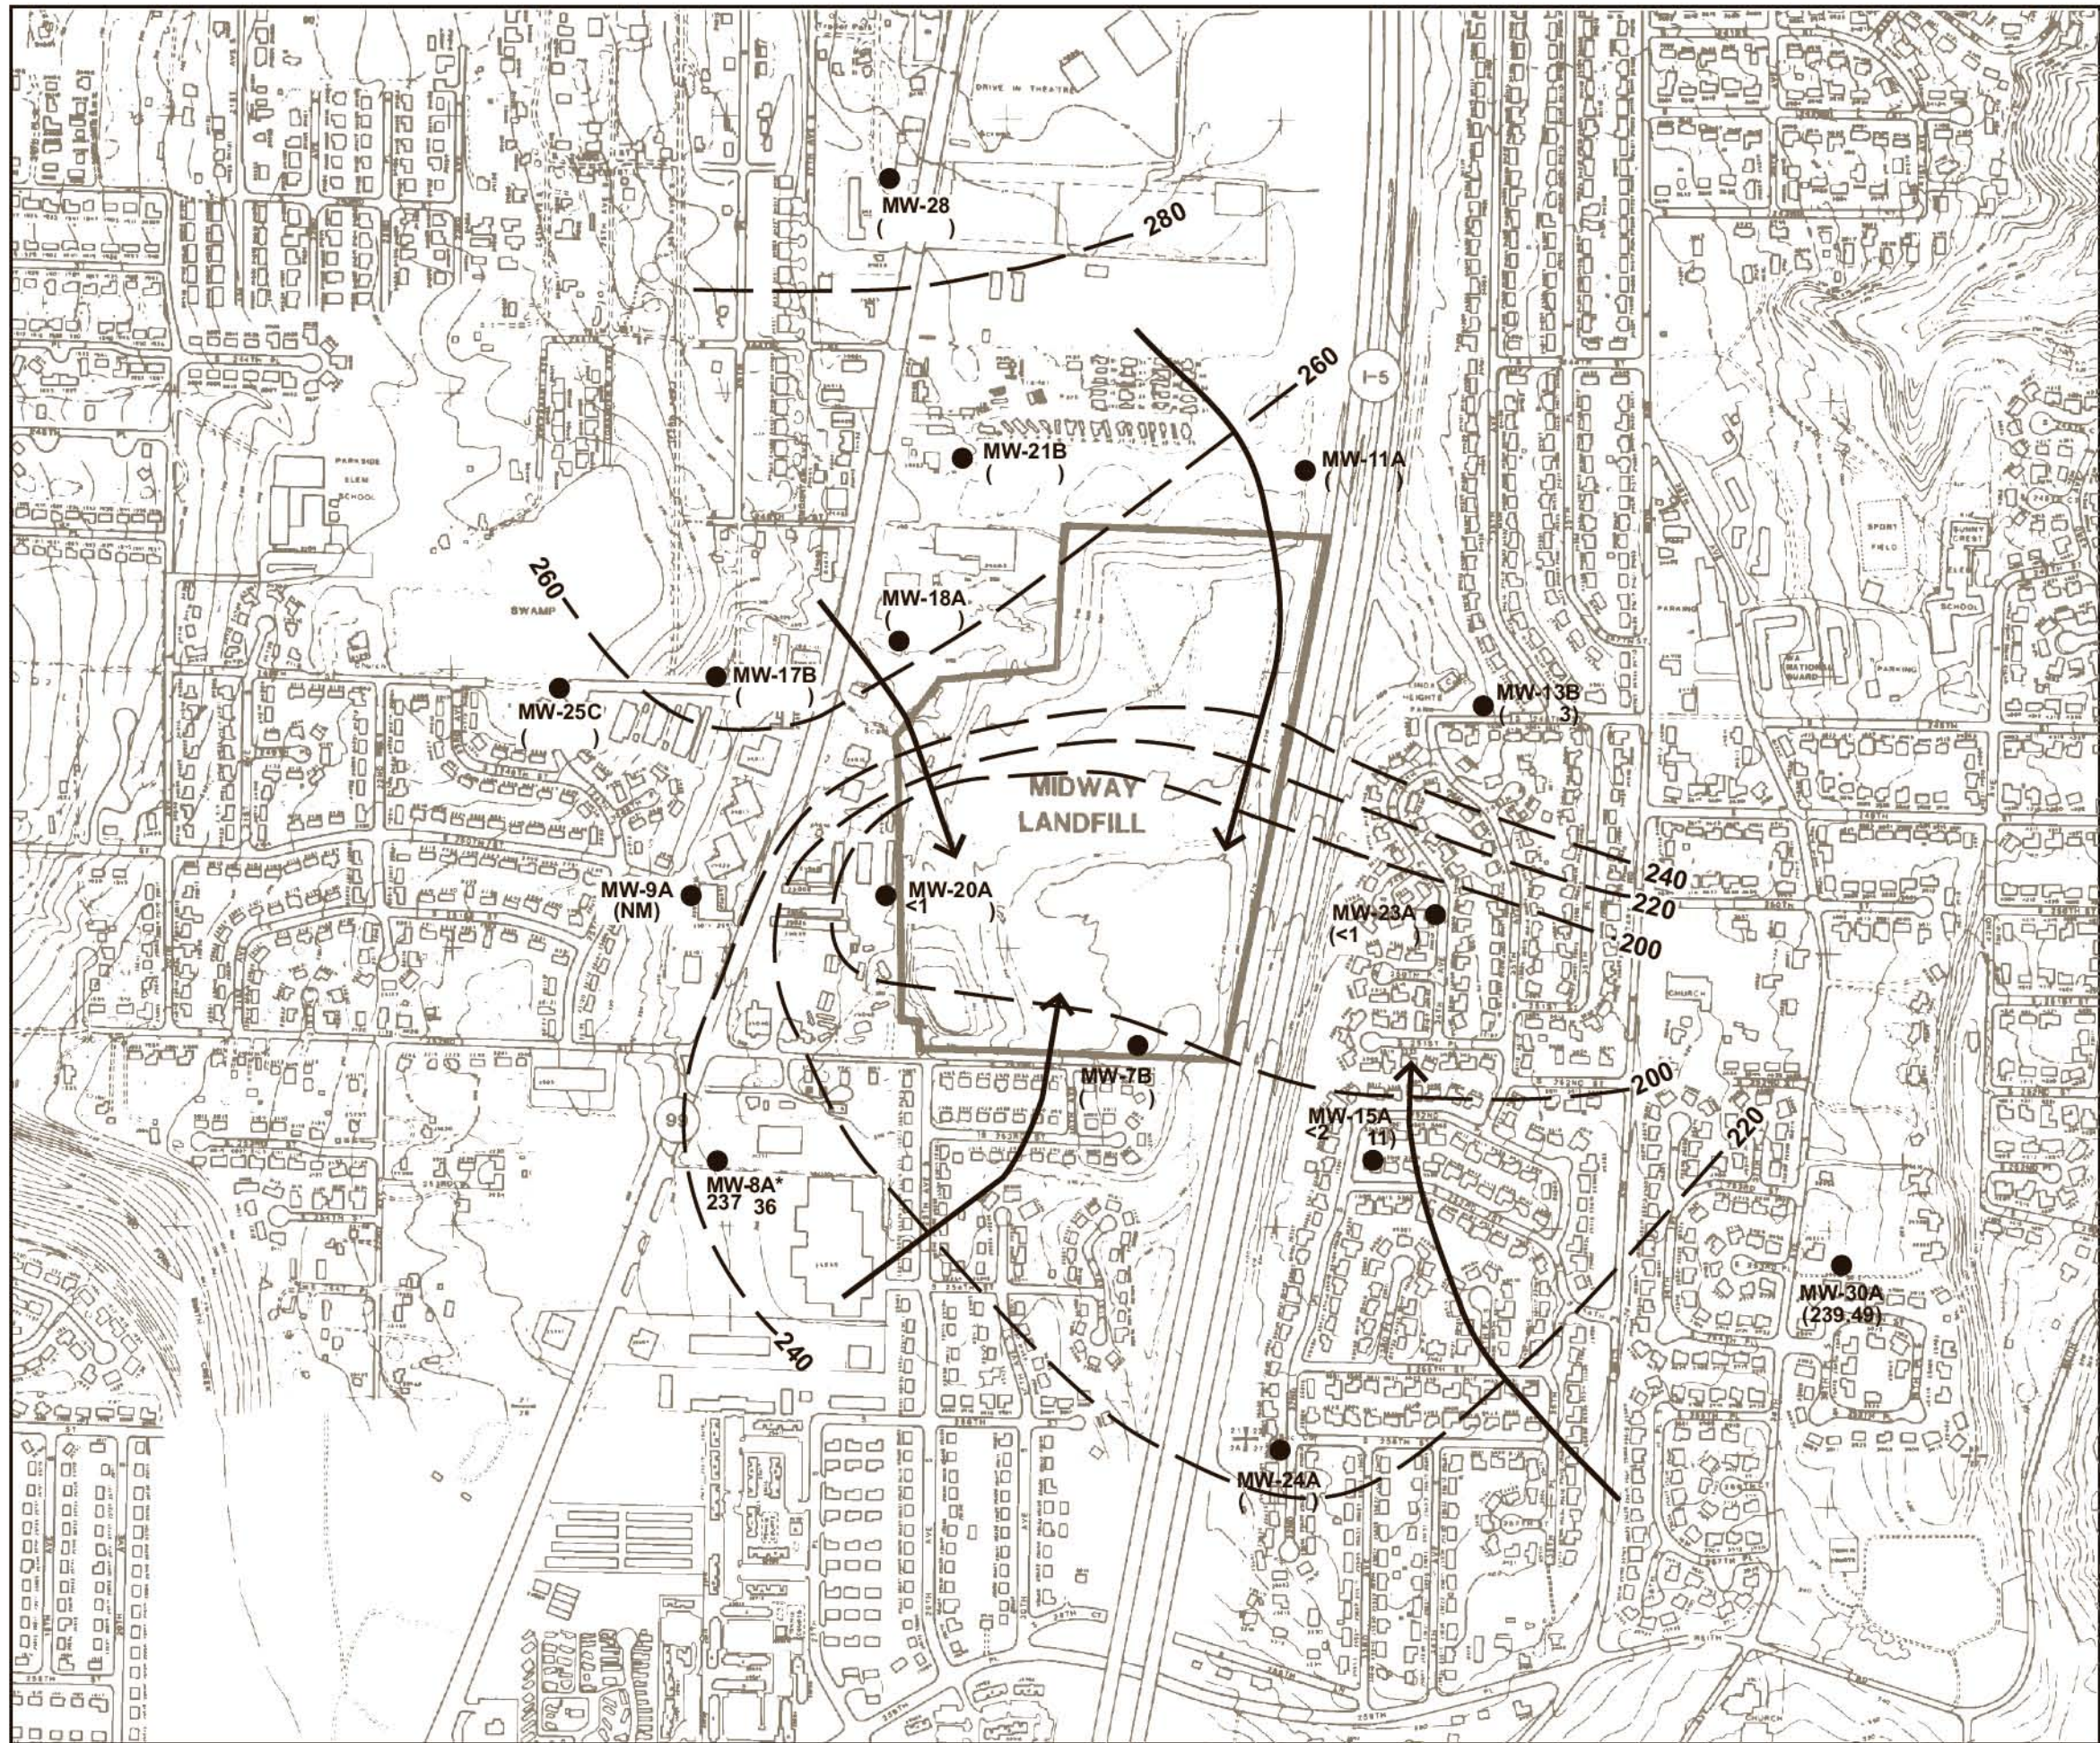
Figure 2
Generalized Upper Gravel Aquifer
Potentiometric Surface Map, October 2008
Midway Landfill
Kent, Washington

- MW-7A** Upper Gravel Aquifer Monitoring Well Number and Approximate Location
- 250—** Approximate Potentiometric Surface Contour (in feet)
- (275.25)** Measured Groundwater Elevation in Feet October 27, 2008
- ←** General Direction of Groundwater Flow
- (<215.23)** Well was Dry, Elevation is Elevation of Bottom of Well
- [Shaded Area]** Inferred Extent of Upper Gravel Aquifer

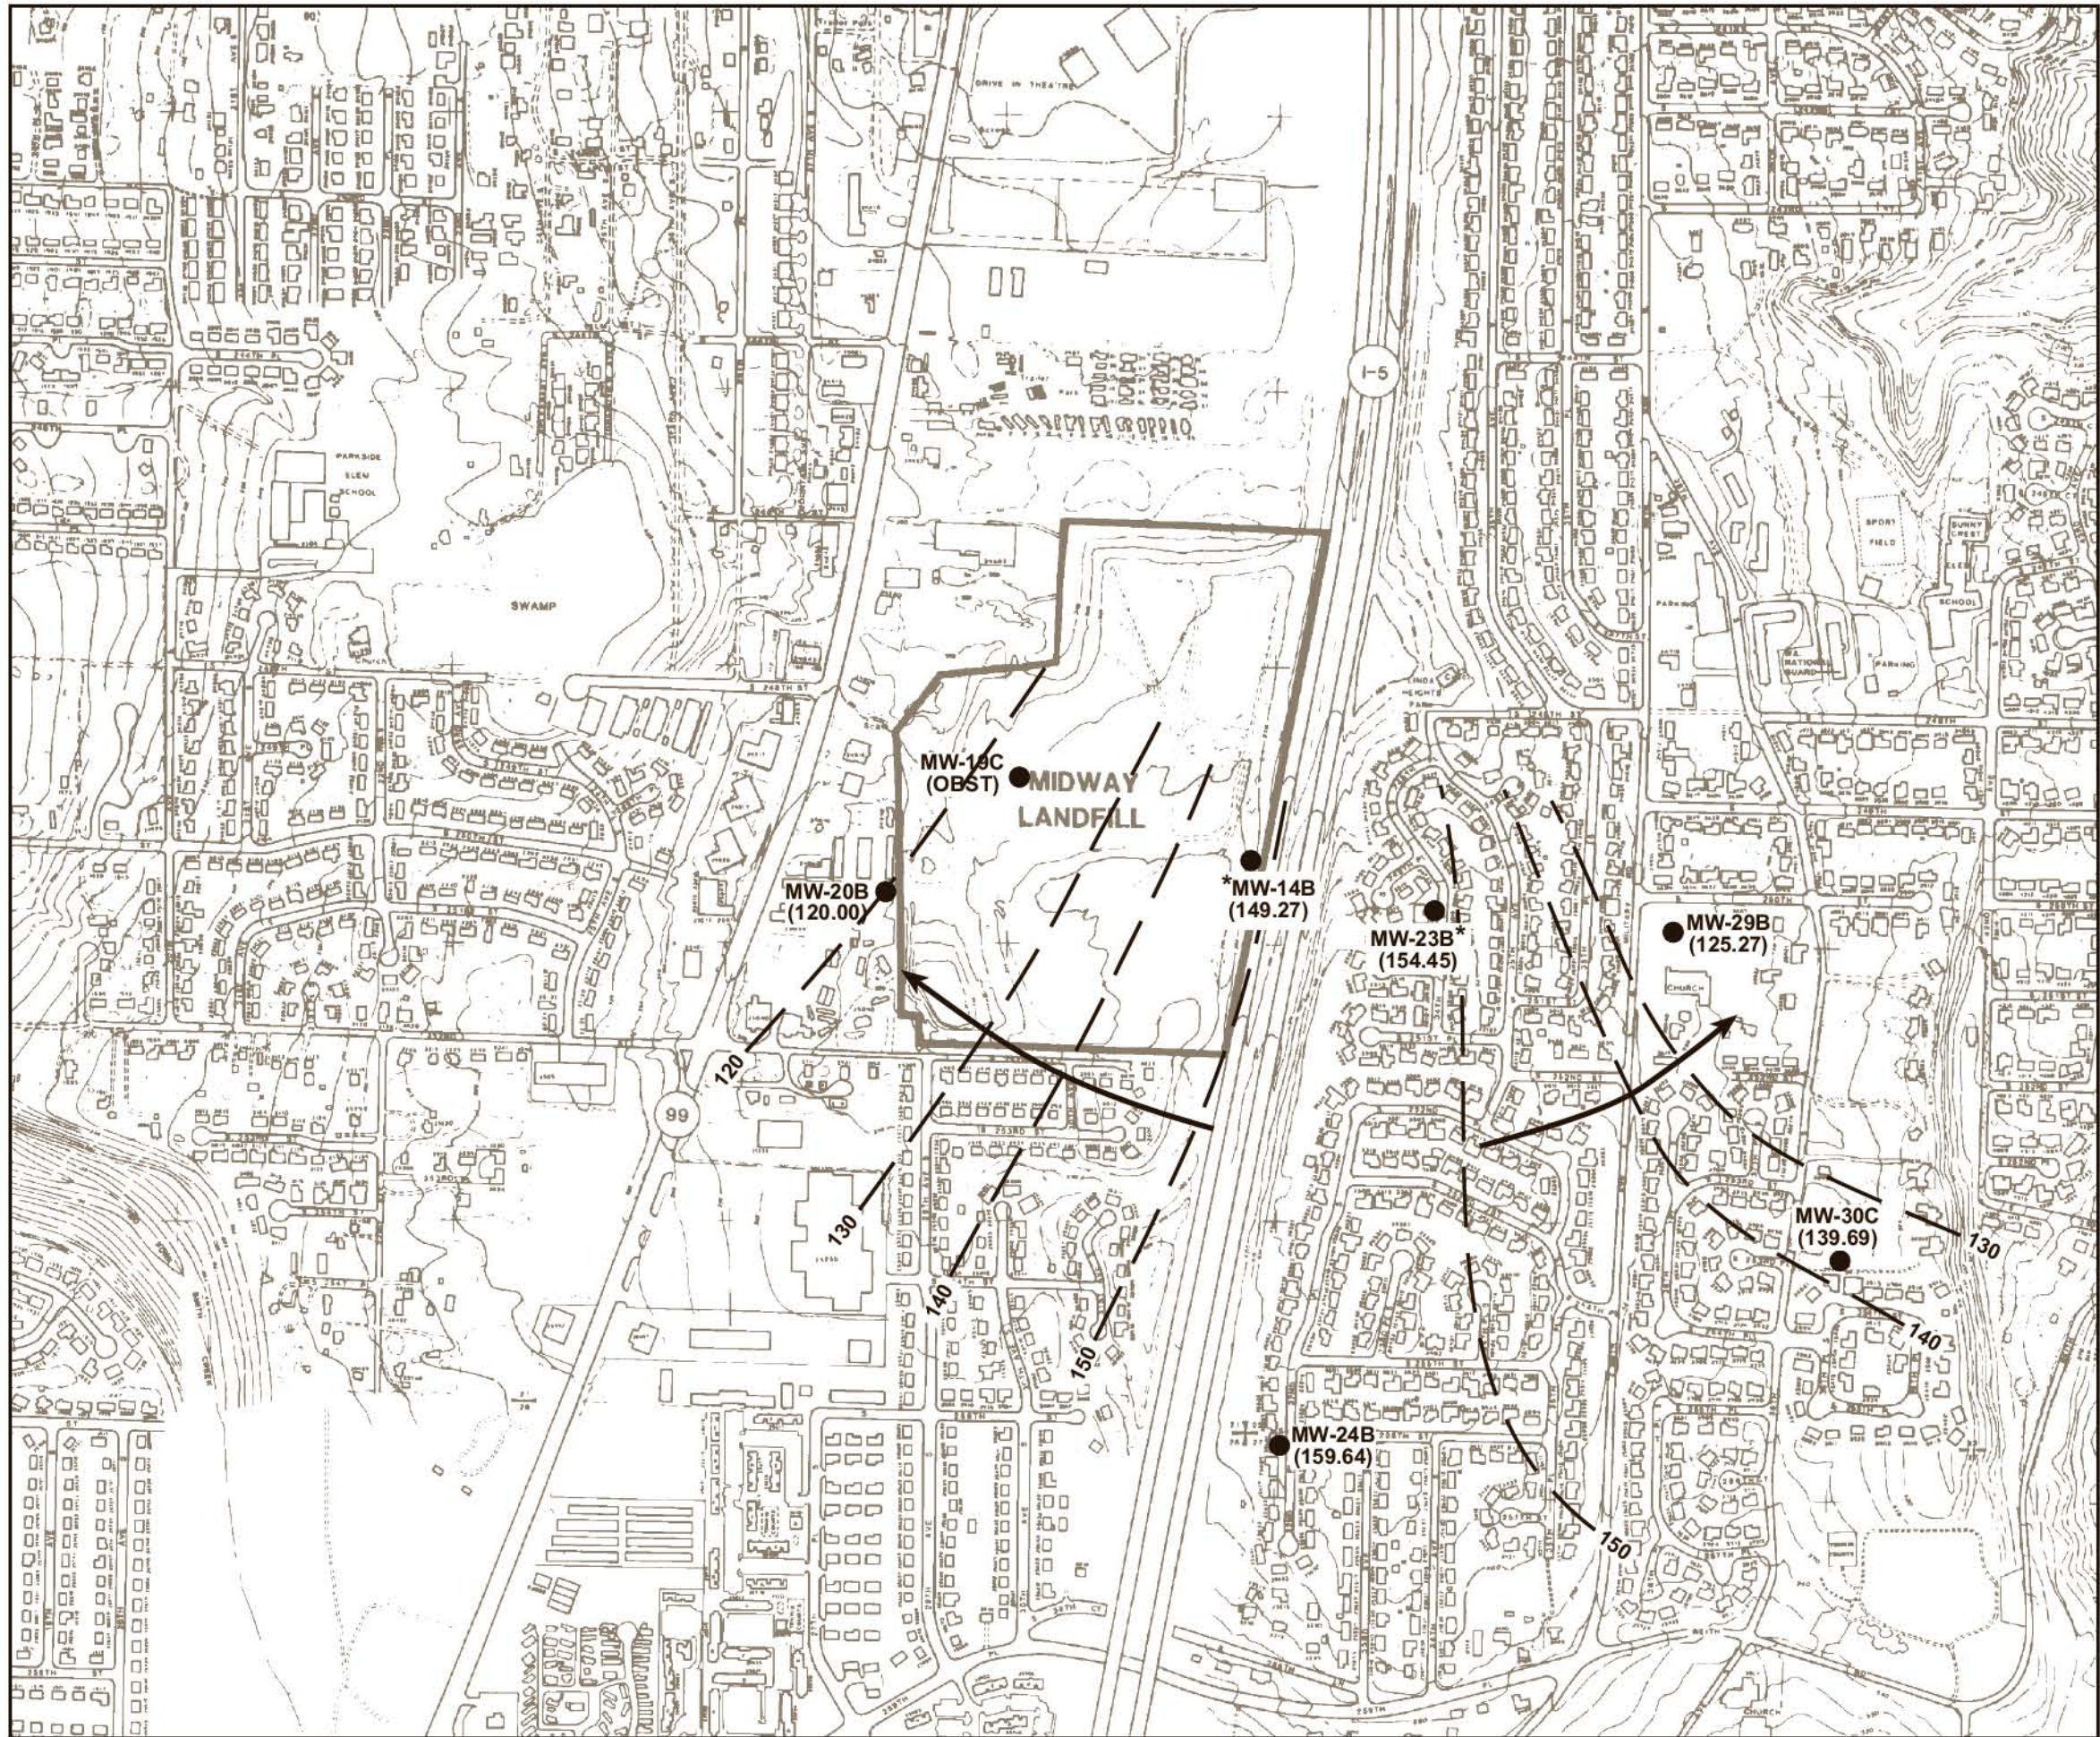
Figure 3
Generalized Sand Aquifer
Potentiometric Surface Map, October 2008
Midway Landfill
Kent, Washington

- MW-11A** Sand Aquifer Monitoring Well Number and Approximate Location
- 220—** Approximate Potentiometric Surface Contour (in feet)
- (279.09)** Measured Groundwater Elevation in Feet October 27, 2008
- ←** General Direction of Groundwater Flow
- (<184.84)** Well was Dry, Elevation is Elevation of Bottom of Well
- NM** Not Measured
- *** Although MW-8A is Used for Groundwater Chemistry Monitoring in the UGA, Water Elevations in this Well are Considered Representative of the SA

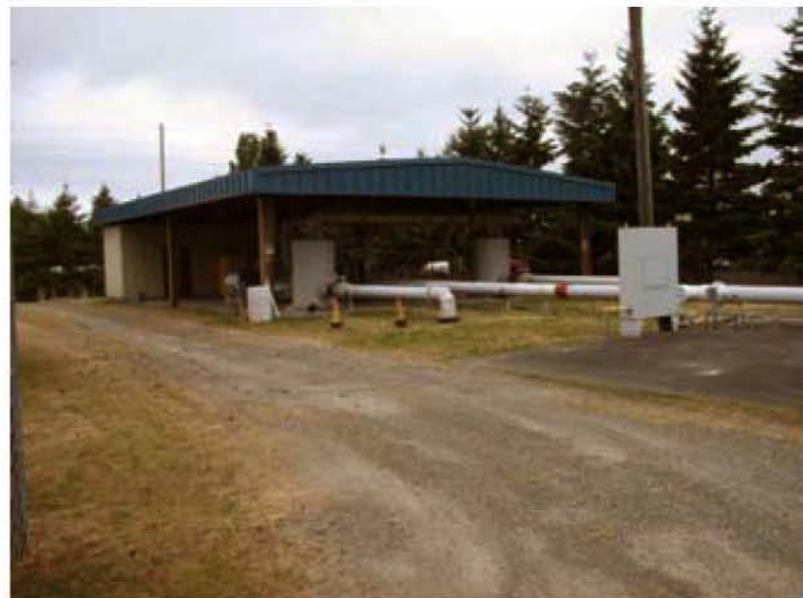
Linda Heights Park storm water diversion mechanical room.

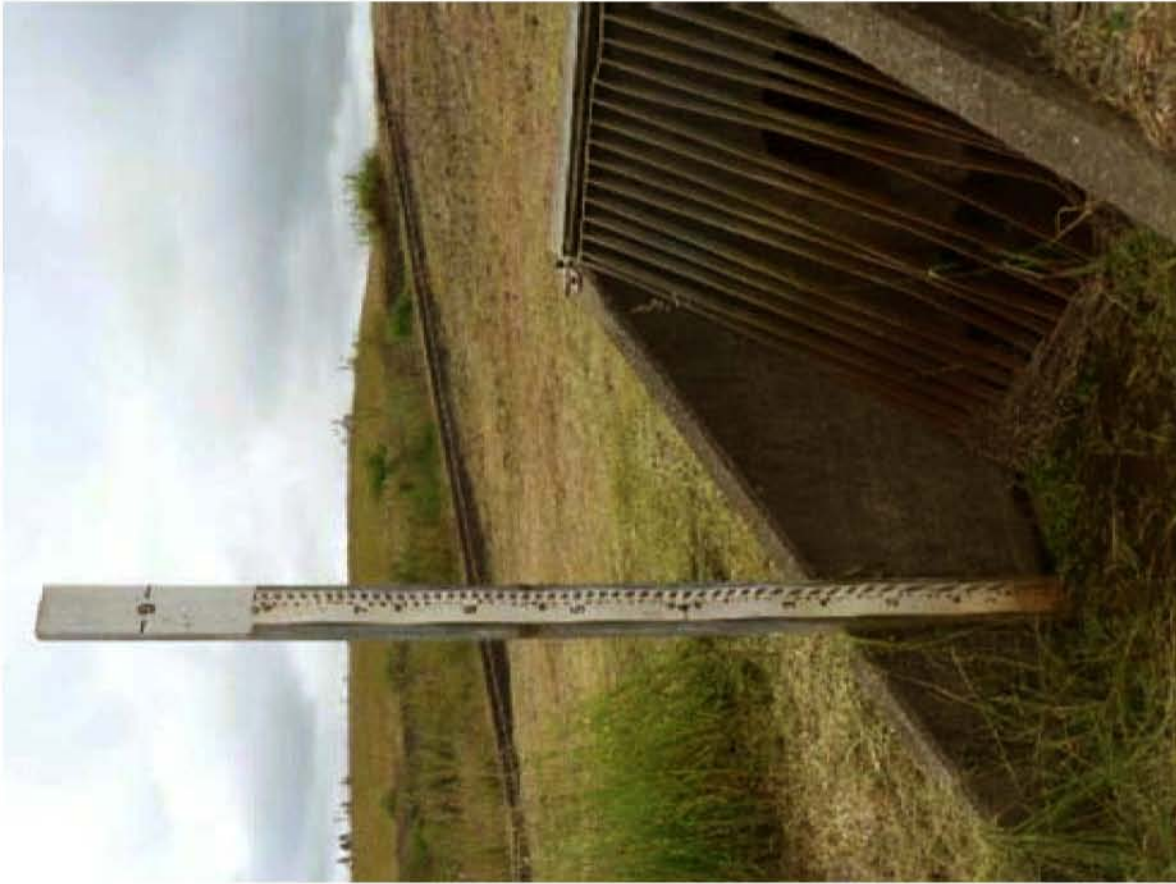
Retention pond.

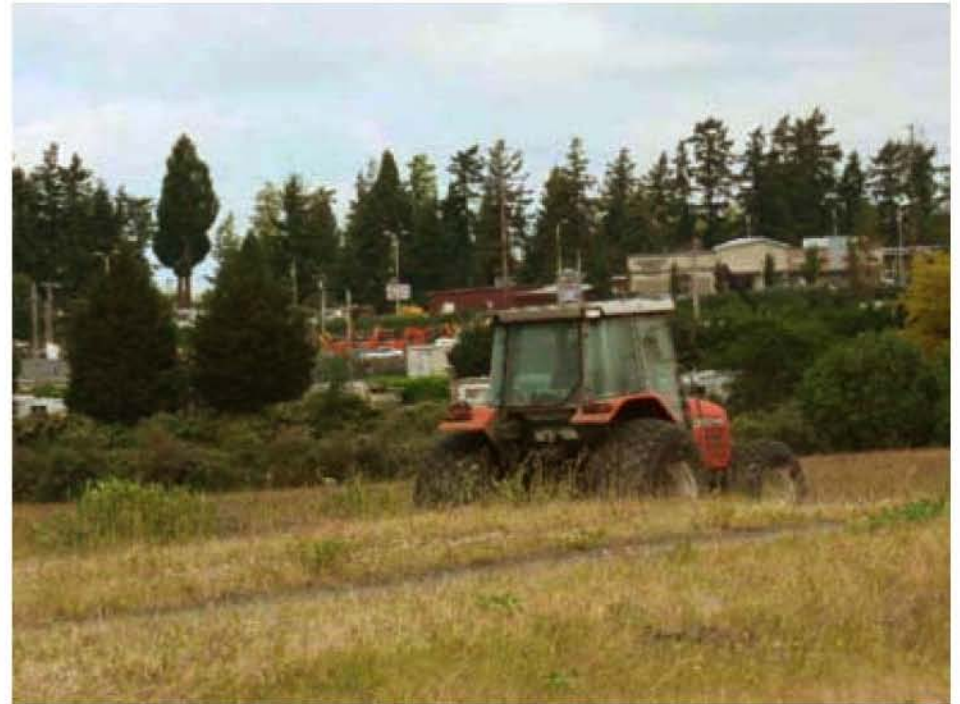
Maintenance at the landfill cap and gas collection system was evaluated during the site visit. At the time of the site visit, the vegetative cap was being mowed. Cap settlement or damaged areas were not observed. According to the City of Seattle, the cap is mowed 2-3 times per year and cap inspections are completed during landfill gas sampling events.

Landfill cover.
