**Fourth Five-Year Review Report
for
Hollingsworth Solderless Terminal Company
Ft. Lauderdale
Broward County, Florida**

September 2011

United States Environmental Protection Agency
Region 4
Atlanta, Georgia

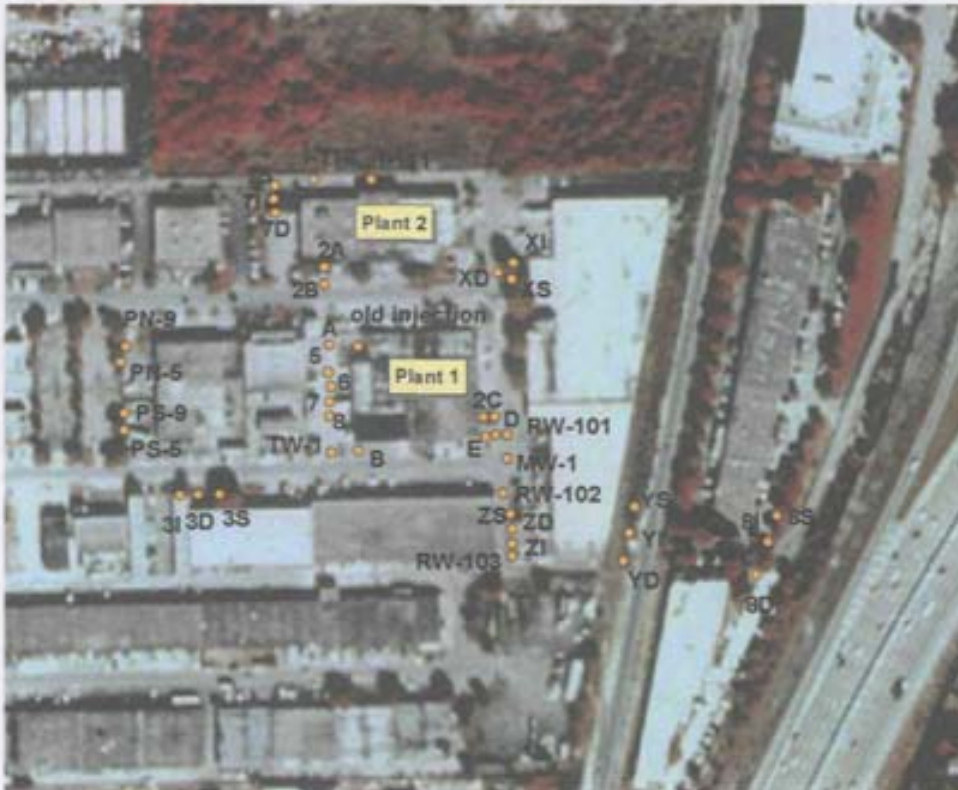
Figure 2: HSTC Historic Groundwater Monitoring

Groundwater monitoring locations approximate. Locations derived through inspection of Site Layout Map found in First Five-Year Review report.

Injection Well location approximate and not found during Second or Third Five-Year Review.

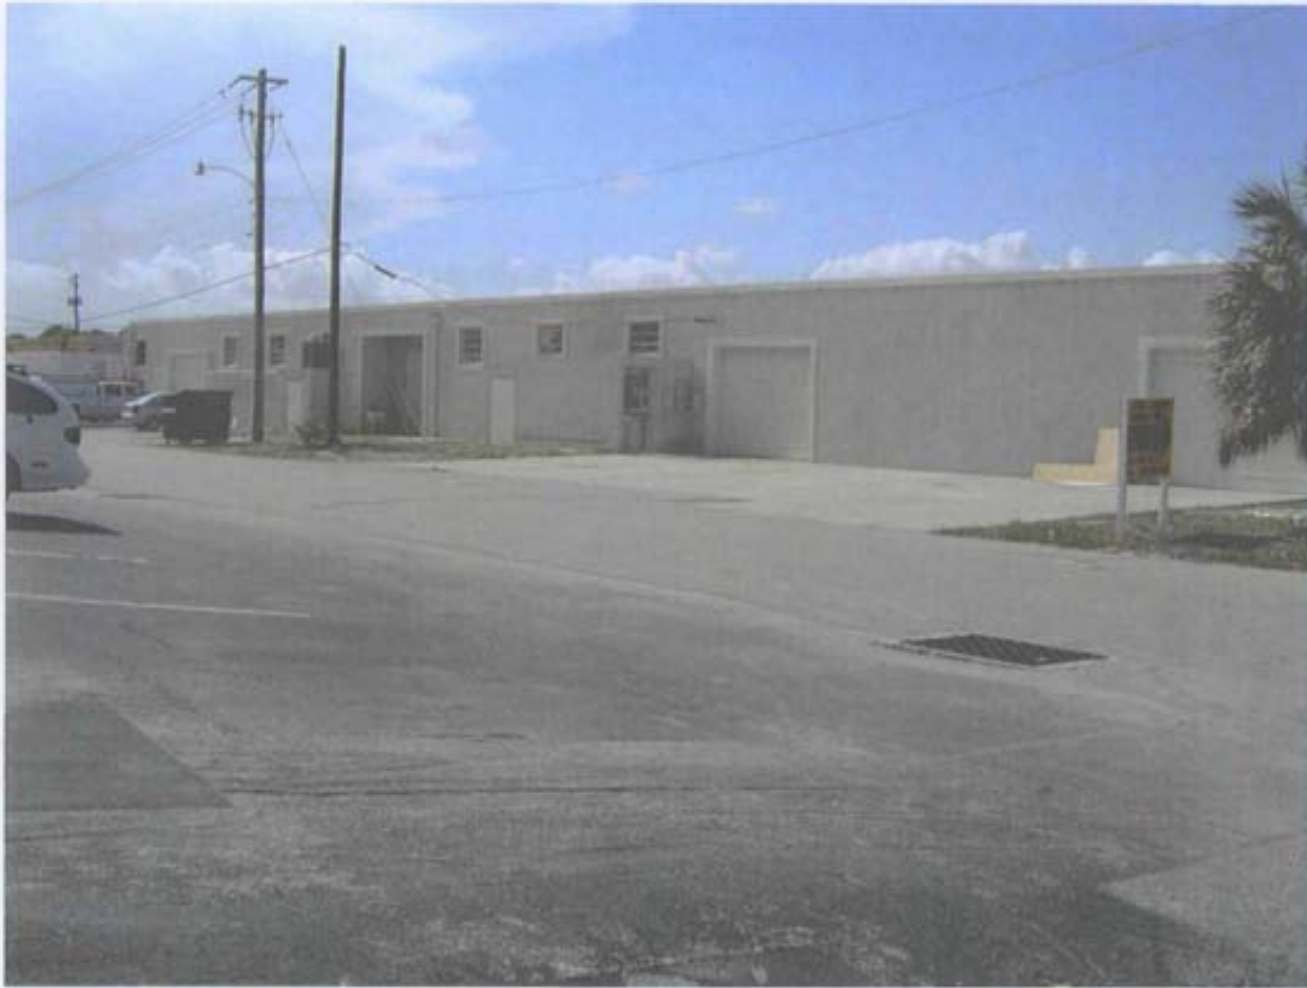
FIGURE 3

Plant #1: April 2011

The SVE system was removed from the Site in March 1992. The groundwater remediation system was removed in November 1994. The bioremediation system beginning to be in April 2005, two months after the previous Site inspection took place. The constructed re-circulation system has since been removed, after operating for months. During the current Site inspection, there was little to inspect, except for the existing monitoring wells. All of the monitoring wells appeared functional. Caps and locks were observed on all the monitoring wells. Some cover plates on flush mounted wellheads were not bolted down. Monitoring wells at the HSTC Site were not clearly marked and labeled. The periphery of the Plant #1 was paved with asphalt or concrete, except for a grass area on the north side of the building. The north side of Plant #1 can be seen on Figure 3.
