RE: Auburn Road Landfill, Administrative Order,
Docket Number I-90-1092, Londonderry, New Hampshire

**2013 SOURCE CONTROL
OPERATION & MAINTENANCE REPORT
AUBURN ROAD LANDFILL**

**FOR
TOWN OF LONDONDERRY, NEW HAMPSHIRE**

FEBRUARY 2014

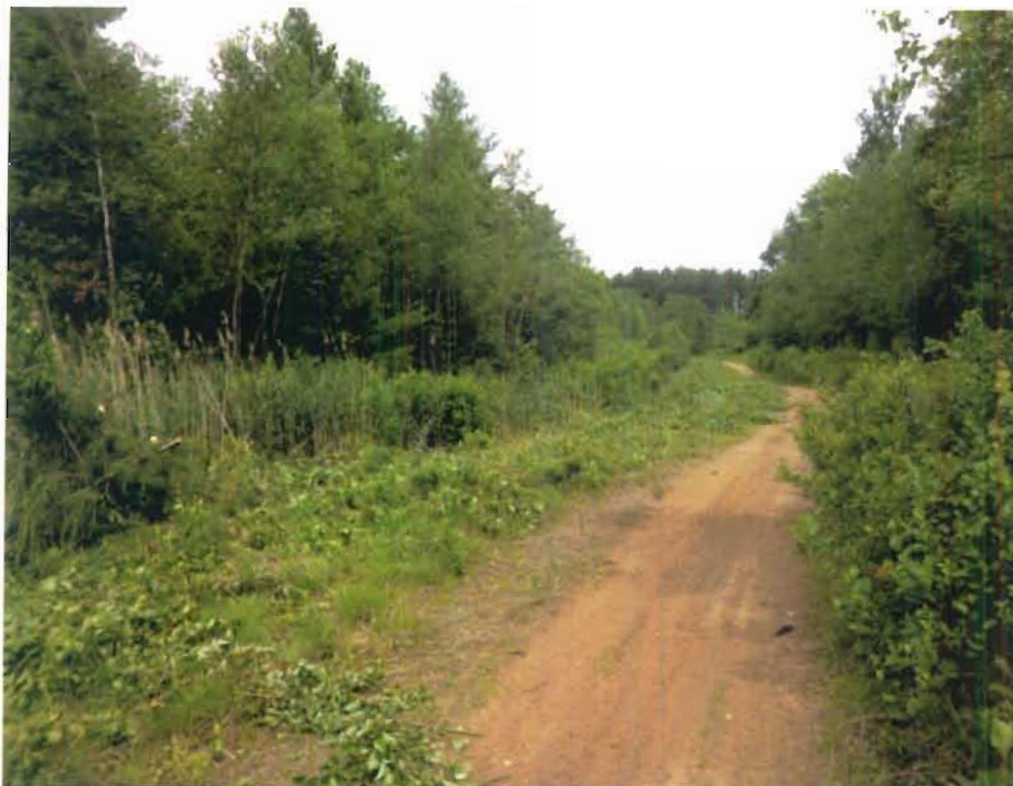
Photo No. 1: Swale E

(e.) Swale E (Tire Dump)	The swale is not operating as designed due to two new beaver dams. The beavers should be trapping and relocated and the dam removed.	√	
(f.) Swale F	In general the swale appears to be operating as designed. In the invert of Swale F near the confluence of Swale E and H, a pocket of sediment and grass build up was found. No standing water was observed, however this area could pose as a restriction to flow from swale H. Sediment build up in this area should be monitored and removed if ponded water is observed in Swale H. A fallen tree was observed approximate 150 feet from the access road on the western bank that should be removed. Town crews were on-site during inspection and they may have removed this after the inspection concluded.	√	
(g.) Swale H	The swale is functioning as designed. Sediment build up in the swale should be monitored and removed if ponded water is observed.		√

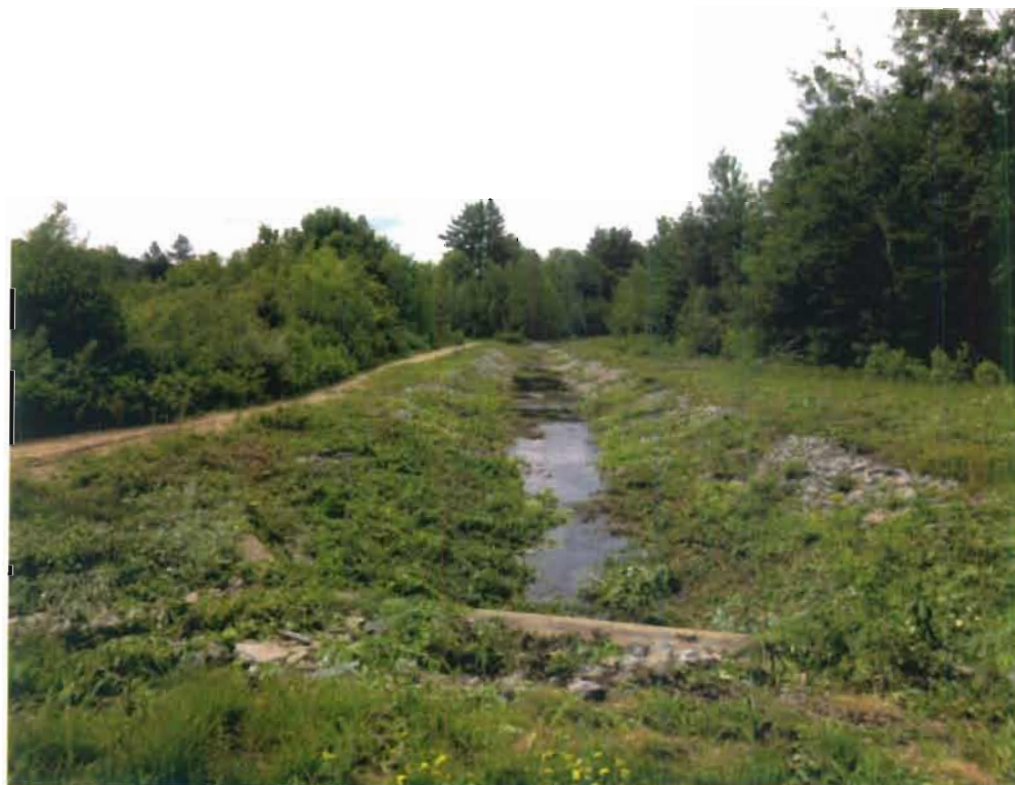
Photo No. 4: Swale F

All swales and culverts were observed to be operating as designed. Vegetation and sediment deposits have been observed in the invert of Swale F at the confluence of Swales E and H. If ponded water is observed, the Town should remove the sediment. Currently, the deposits do not prevent the swale from passing stormwater runoff.

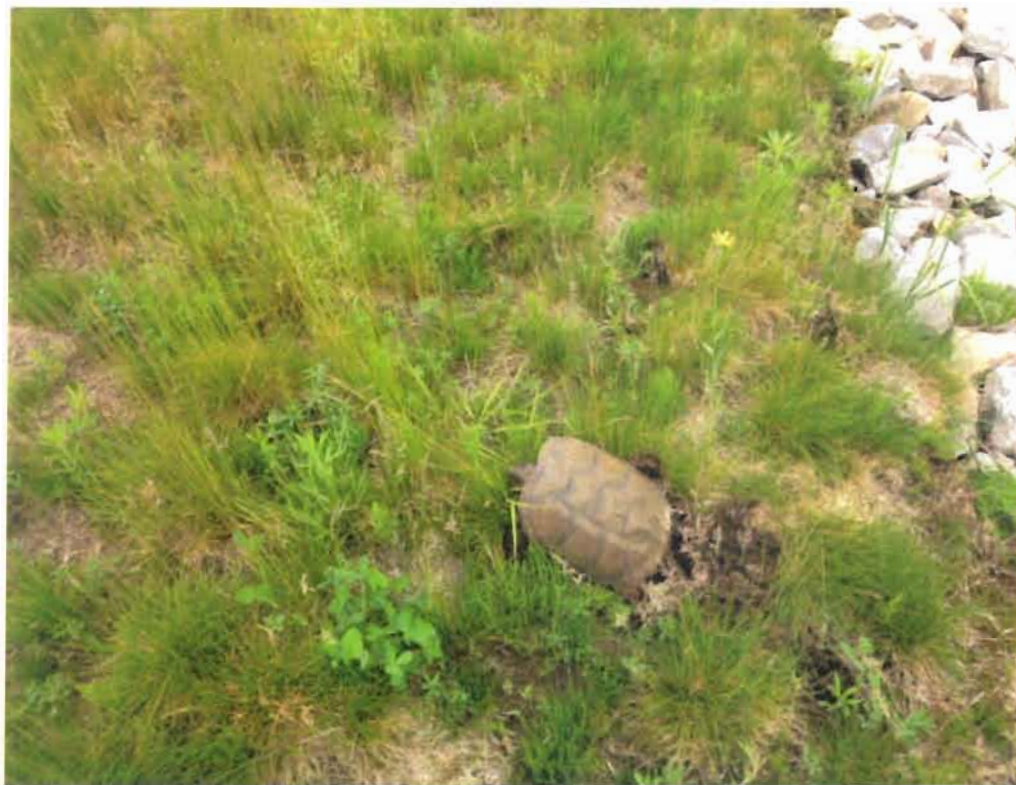
Photo No. 40: Tire Dump – Eastern Toe-of-Slope & Snapping Turtle

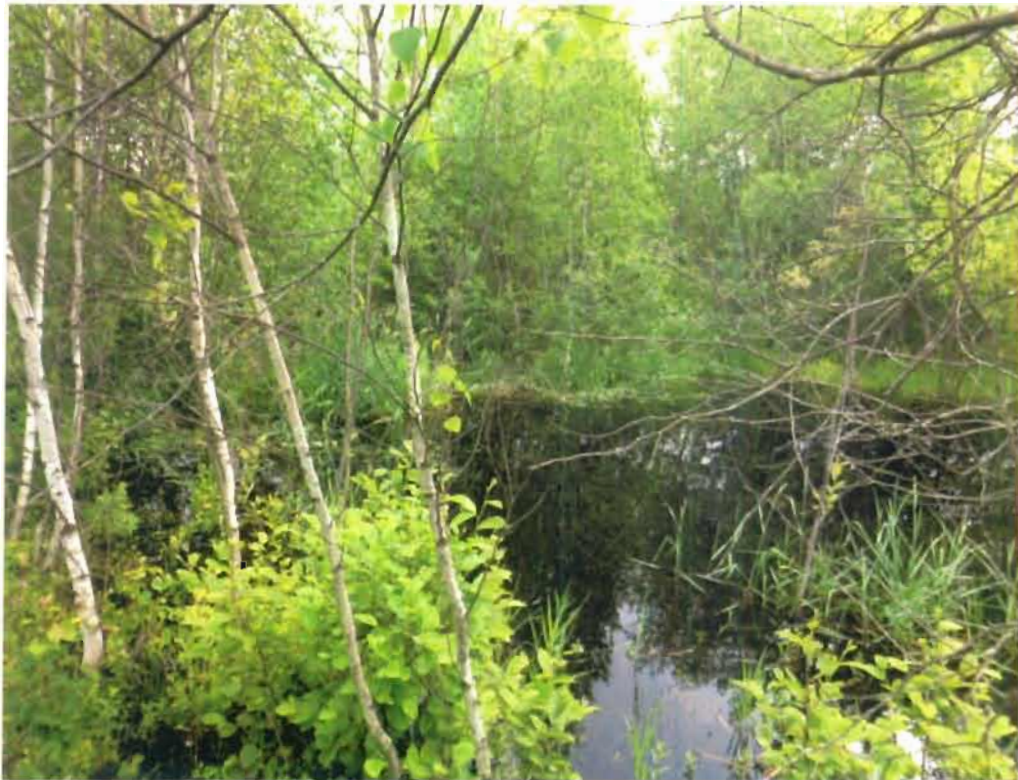
Photo No. 46: Swale D Ponded Area (South)

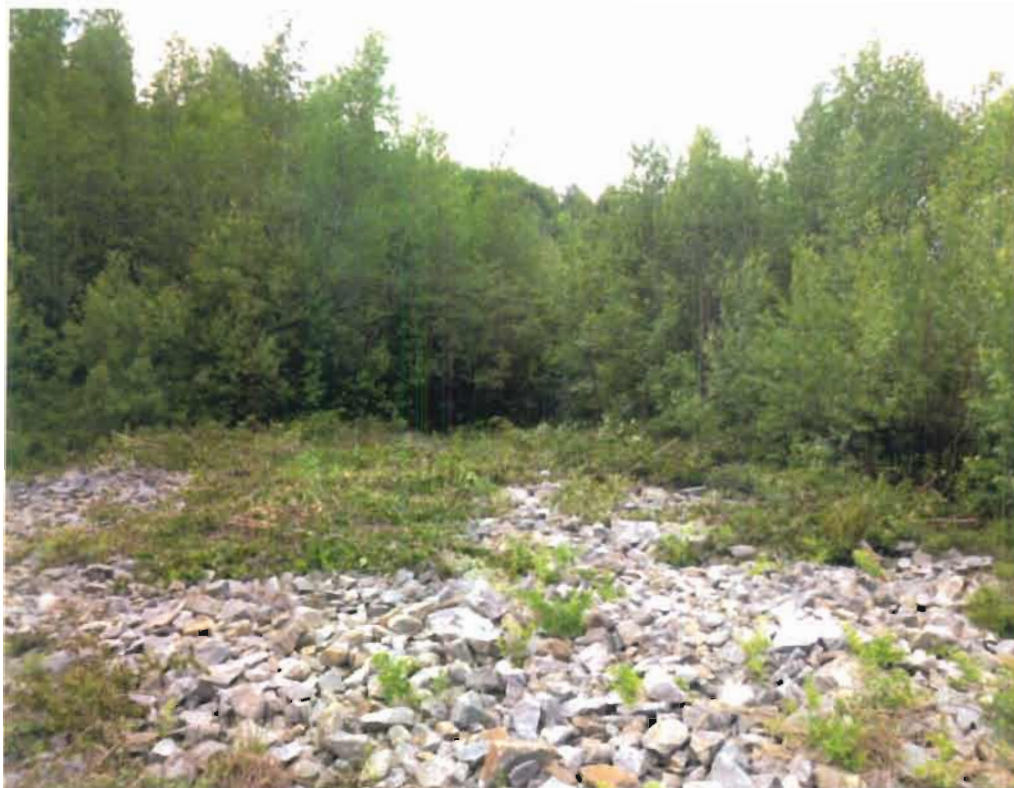
Photo No. 47: Swale D – Rip-Rap Area (South)

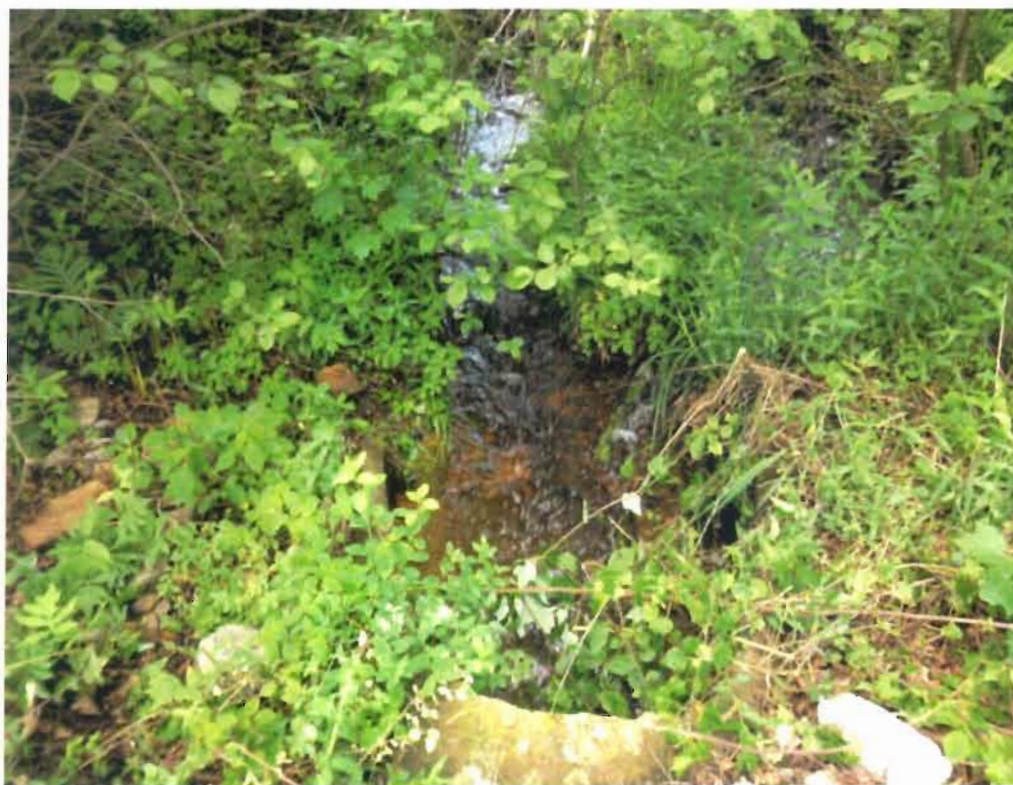
Photo No. 48: Swale D – Inlet Culvert (South)

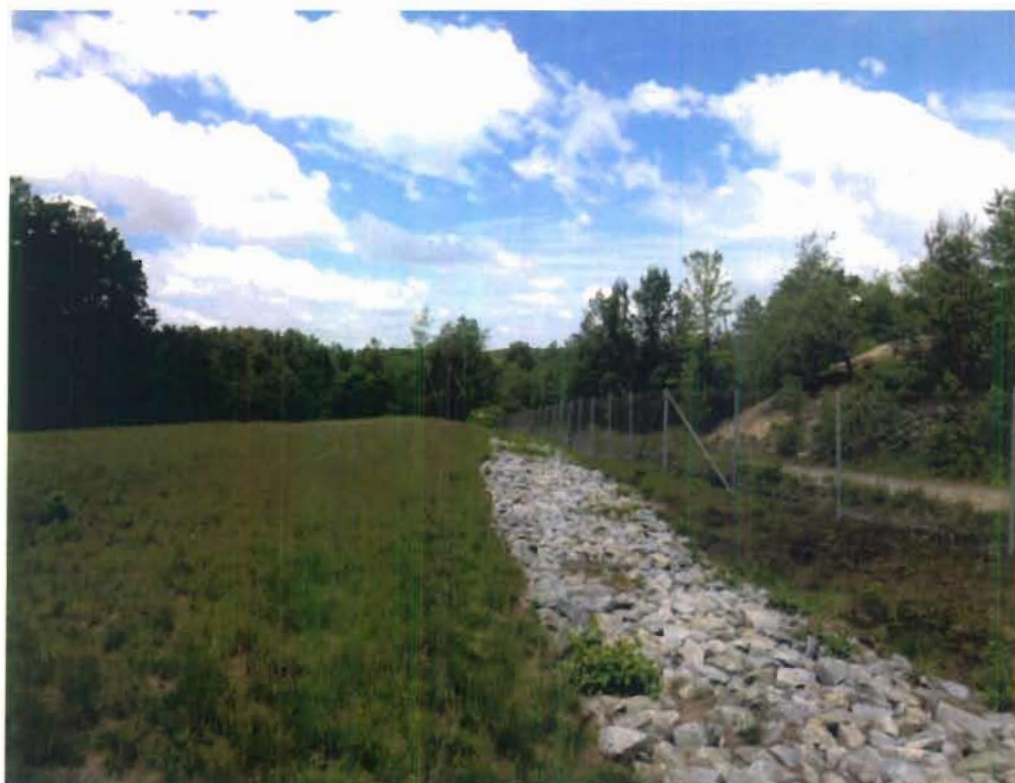
Photo No. 52: SWLF – Northern Toe-of-Slope & Fence

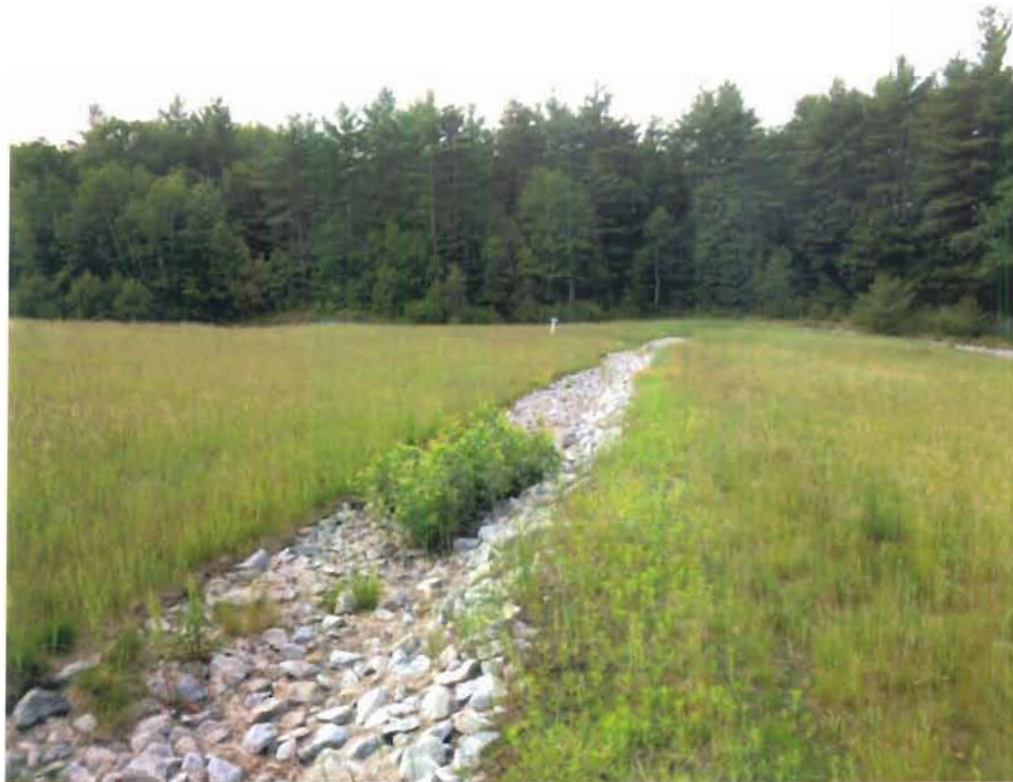
Photo No. 54: SWLF – Mid-Slope Swale

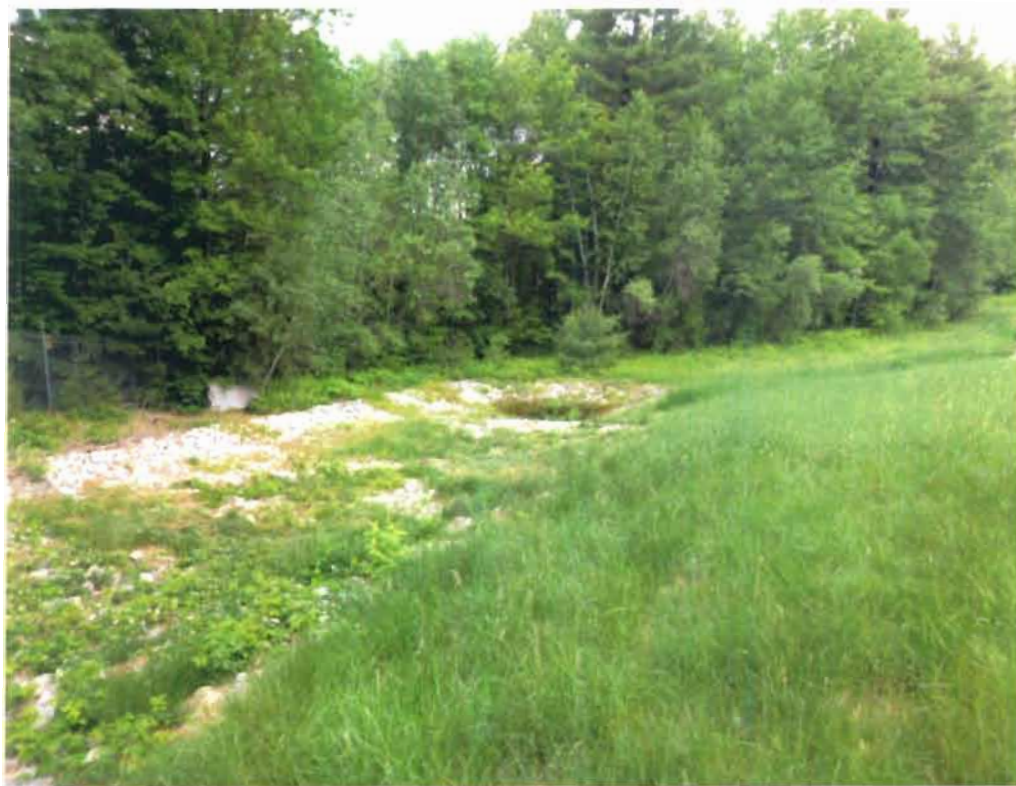
Photo No. 56: SWLF – Western Stormwater Basin

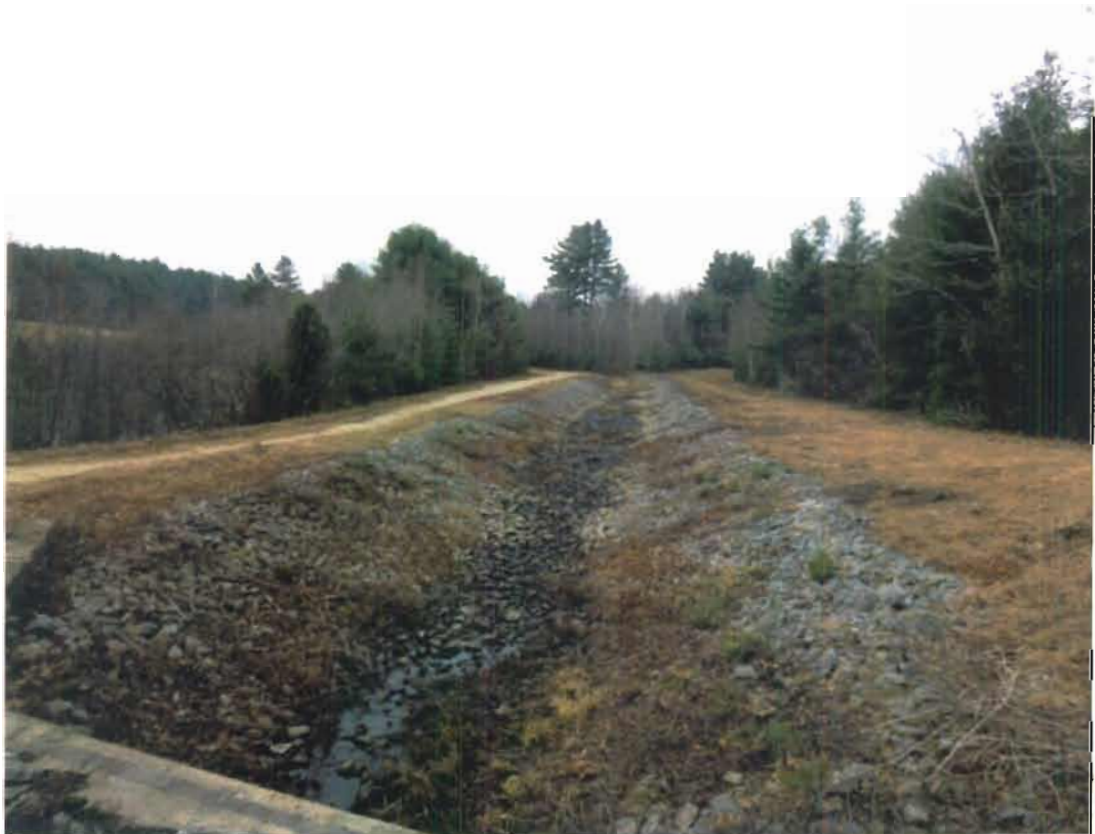
(e.) Swale E (Tire Dump)	The Town has removed the beaver dam. The swale appears to be operating as designed. No standing water was observed during this site visit.		√
(f.) Swale F	In general the swale appears to be operating as designed. In the invert of Swale F near the confluence of Swale E and H, a pocket of sediment and grass build up was found. No standing water was observed, however this area could pose as a restriction to flow from swale H. Sediment build up in this area should be monitored and removed if ponded water is observed in Swale H. The fallen tree reported in the previous report has been removed.		√
(g.) Swale H	The swale is functioning as designed. Sediment build up in the swale should be monitored and removed if ponded water is observed.		√
(h.) Concrete Culverts	The concrete culverts were observed to be in good condition.		√

Photo No. 4: Swale F

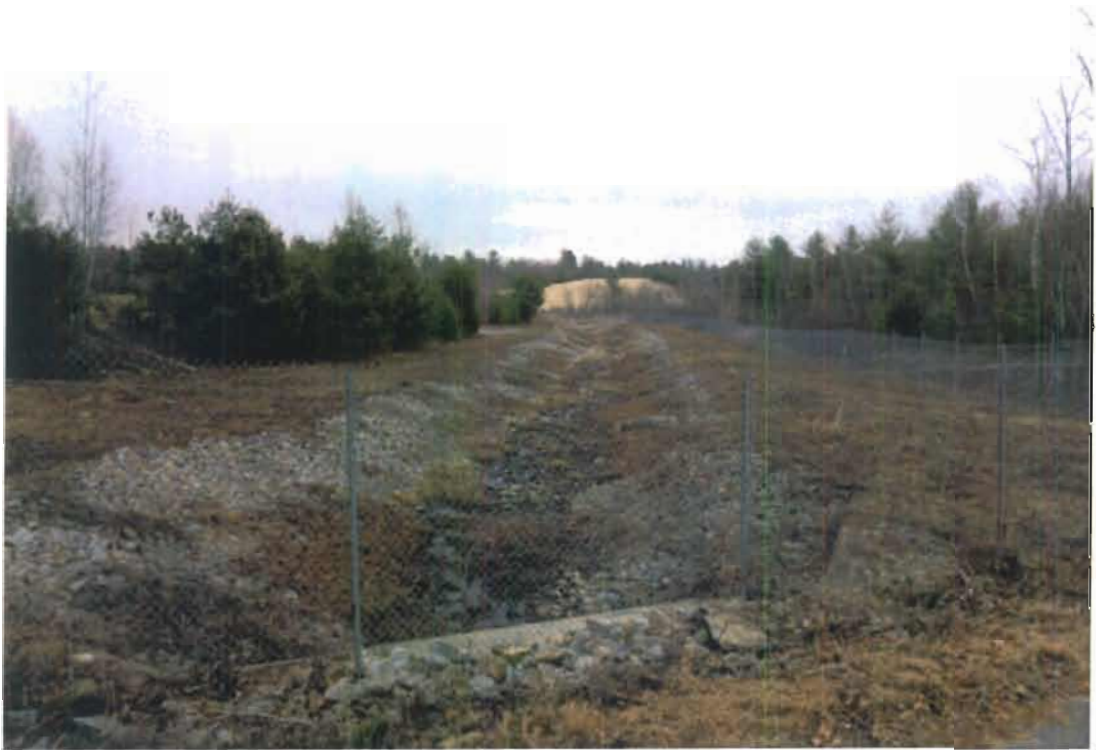
(6.) LRDIRA	Comments on the LRDIRA are provided in items (6a) through (6h).		
(a.) Swale A (Town Dump)	This swale appears to be operating as designed.		√
(b.) Swale B (Town Dump)	This swale is operating as designed. Brush has been cut back within the swale and on the banks. Town crews on-site during inspection.		√
(c.) Swale C (Town Dump)	This swale is operating as designed. Brush has been cut back within the swale and on the banks. Town crews on-site during inspection.		√
(d.) Swale D (Tire Dump)	Two (2) beaver dams were observed; one on the southern side of the access road and one on the northern side of the access road. Both dams have been breached to permit stream flow. Continue to trap and remove the beaver(s) from the area and then breach the beaver dams as necessary. The southern beaver dam has been breached; alleviating ponded water. The northern beaver dam has not been breached but water levels were low.		√

Photo No. 5: Swale B

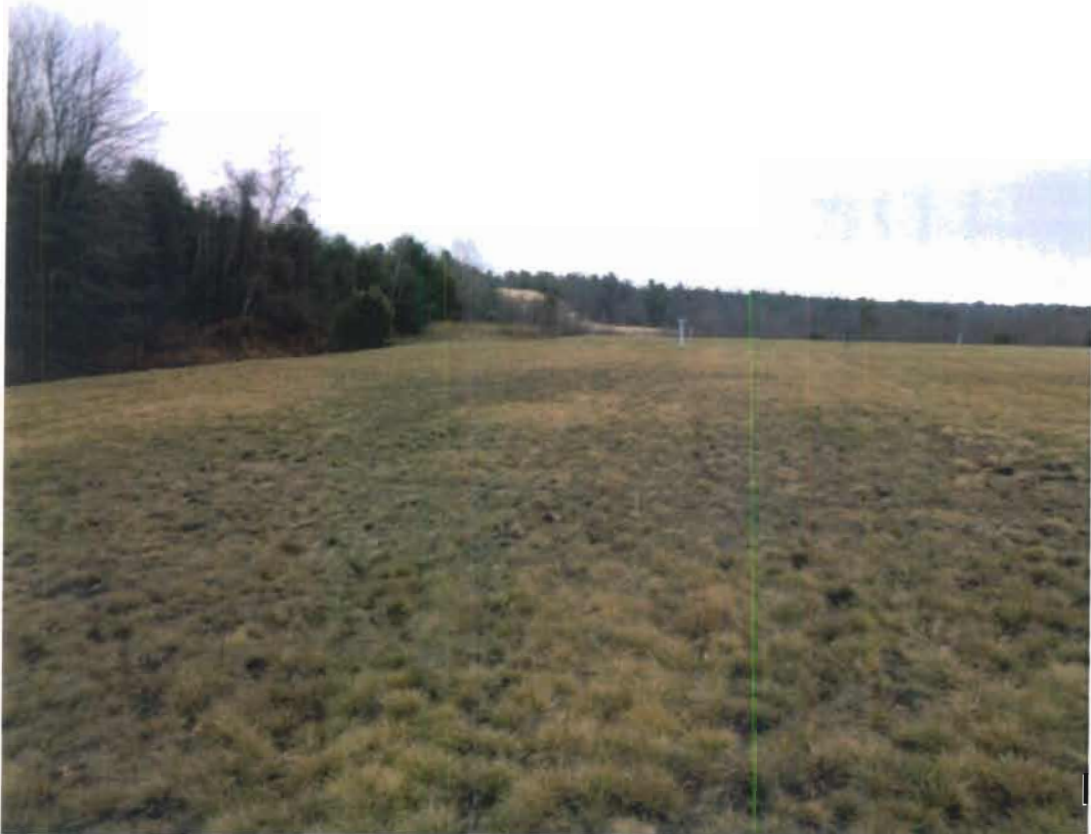
Photo No. 16: Town Dump – Gas Vent GV-4

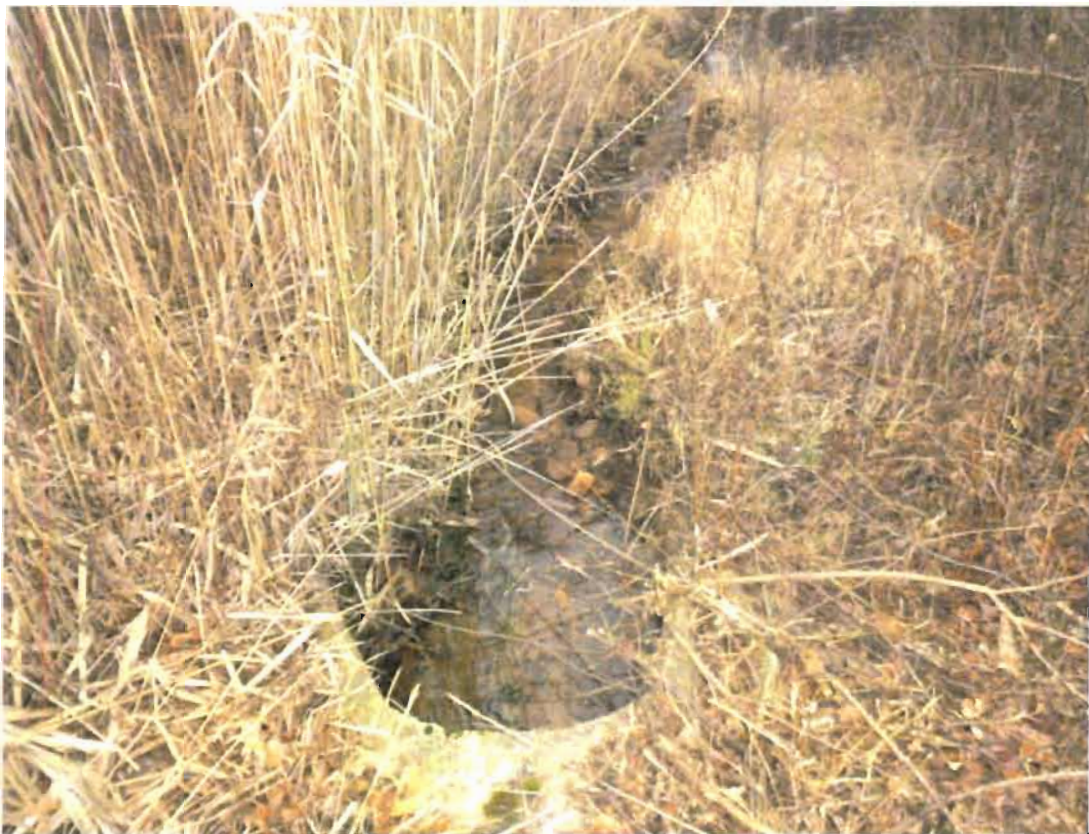
Photo No. 51: Swale D – Breached Beaver Dam (South)

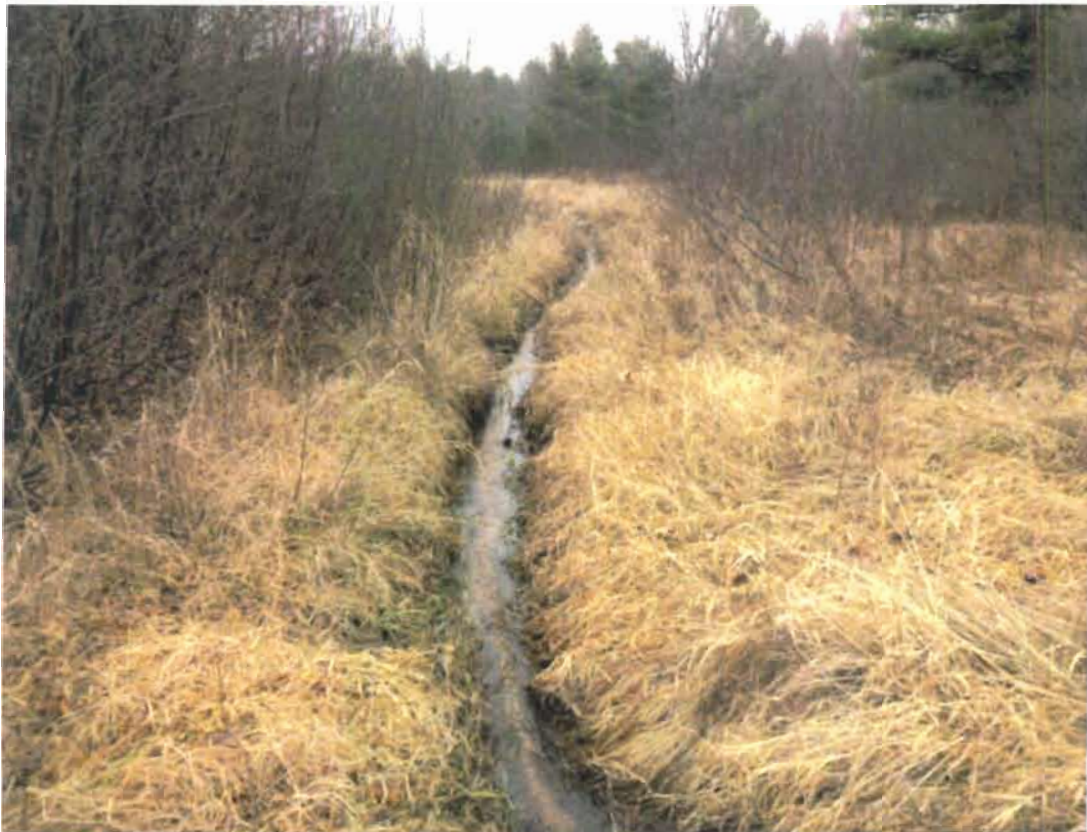
Photo No. 55: Swale D – Beaver Dam (North)

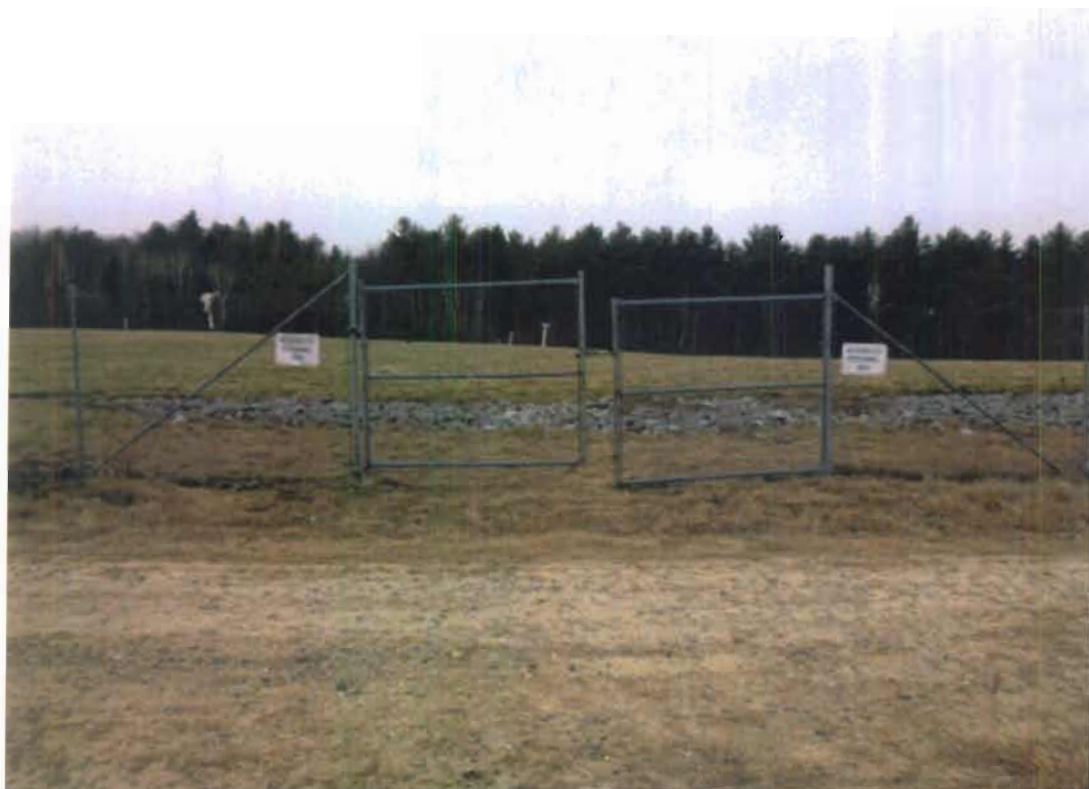
Photo No. 56: Swale D (North)

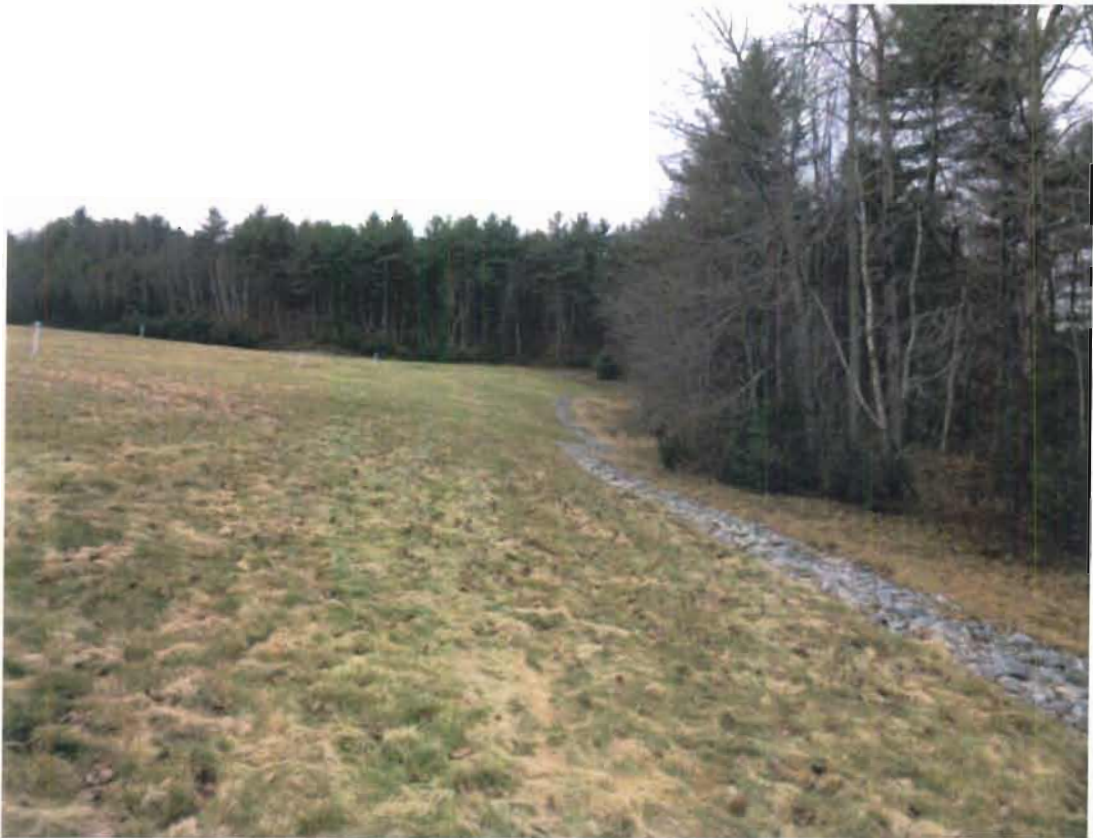
Photo No. 58: SWLF – Northern Toe-of-Slope

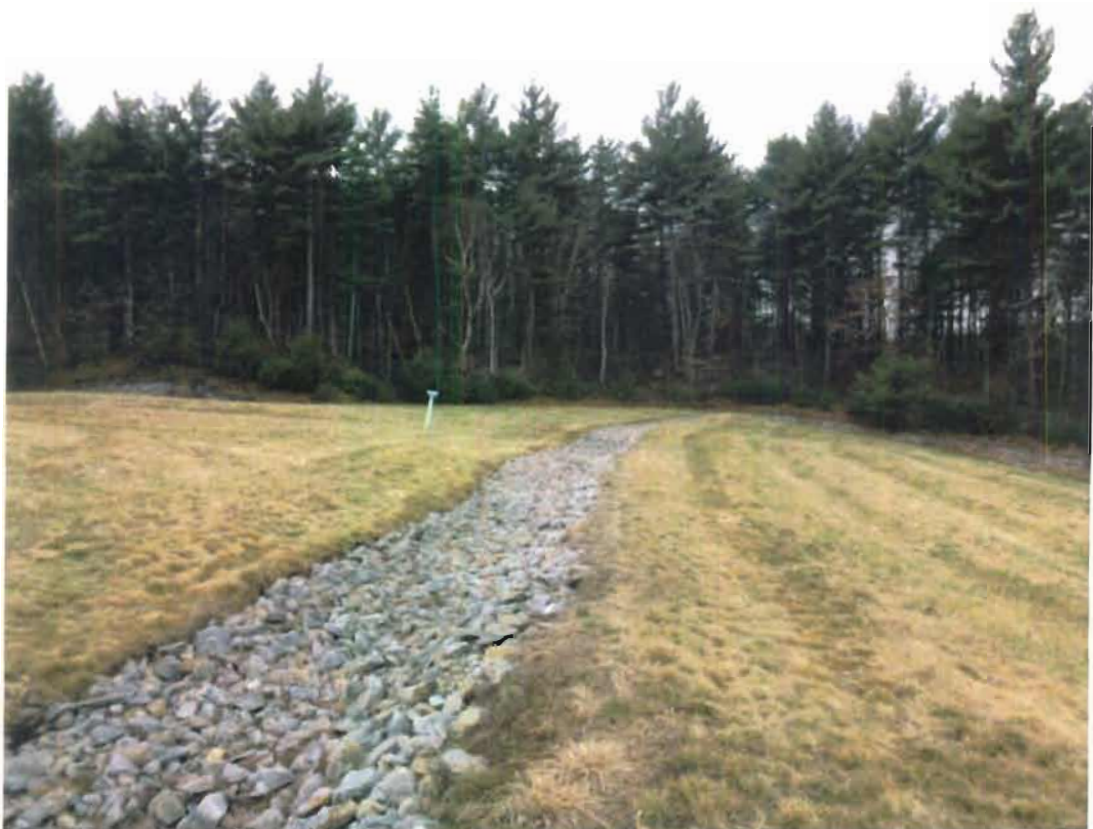
Photo No. 59: SWLF – Western Surface & Toe-of-Slope

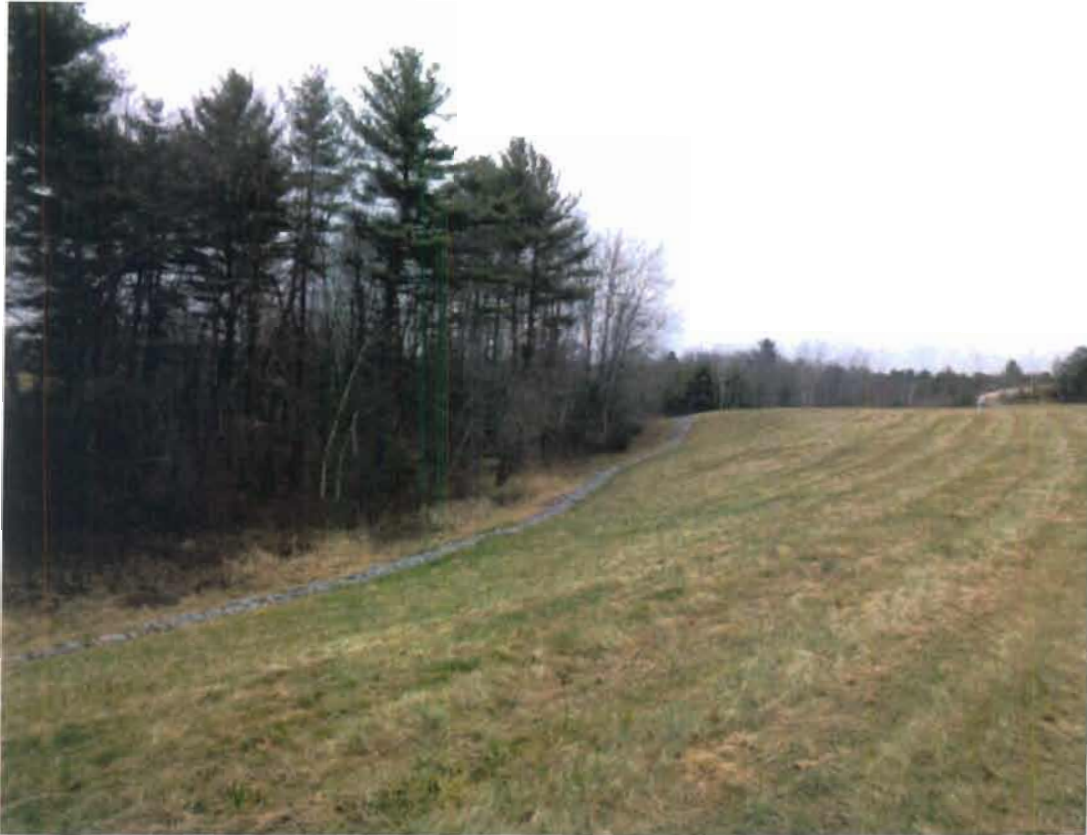
Photo No. 60: SWLF – Mid-Slope Swale

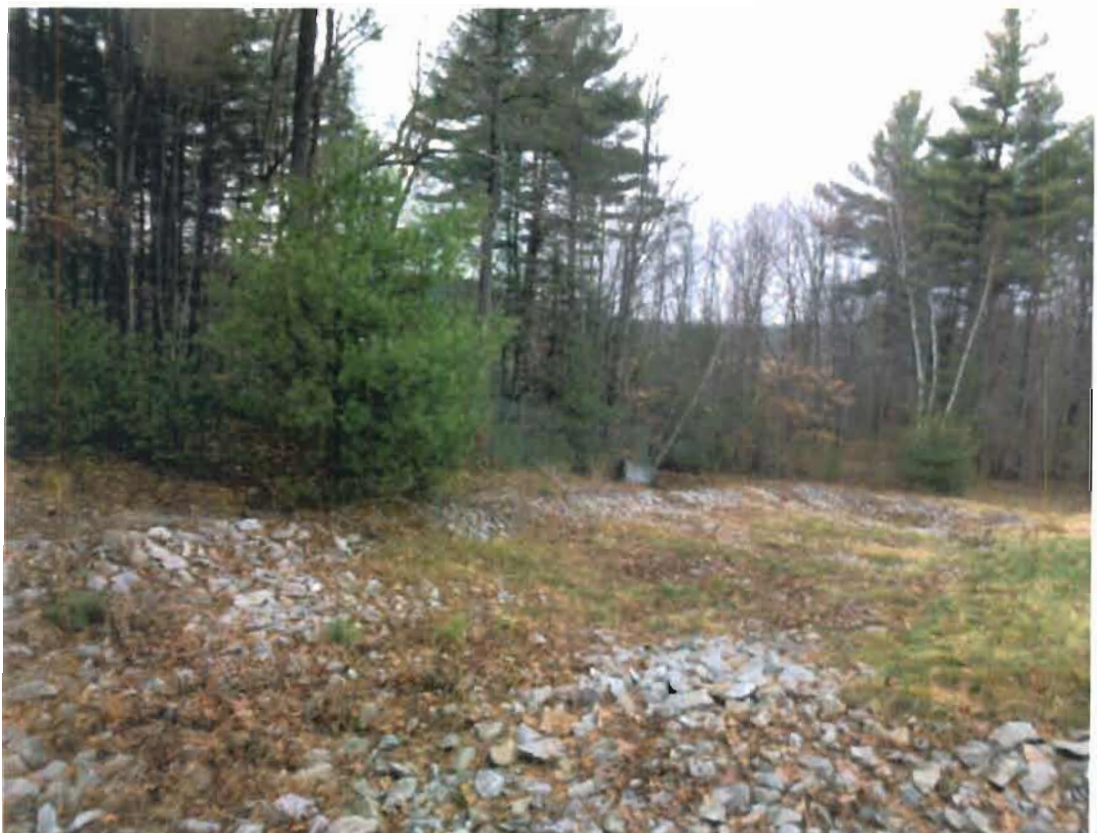
Photo No. 61: SWLF – Western Surface

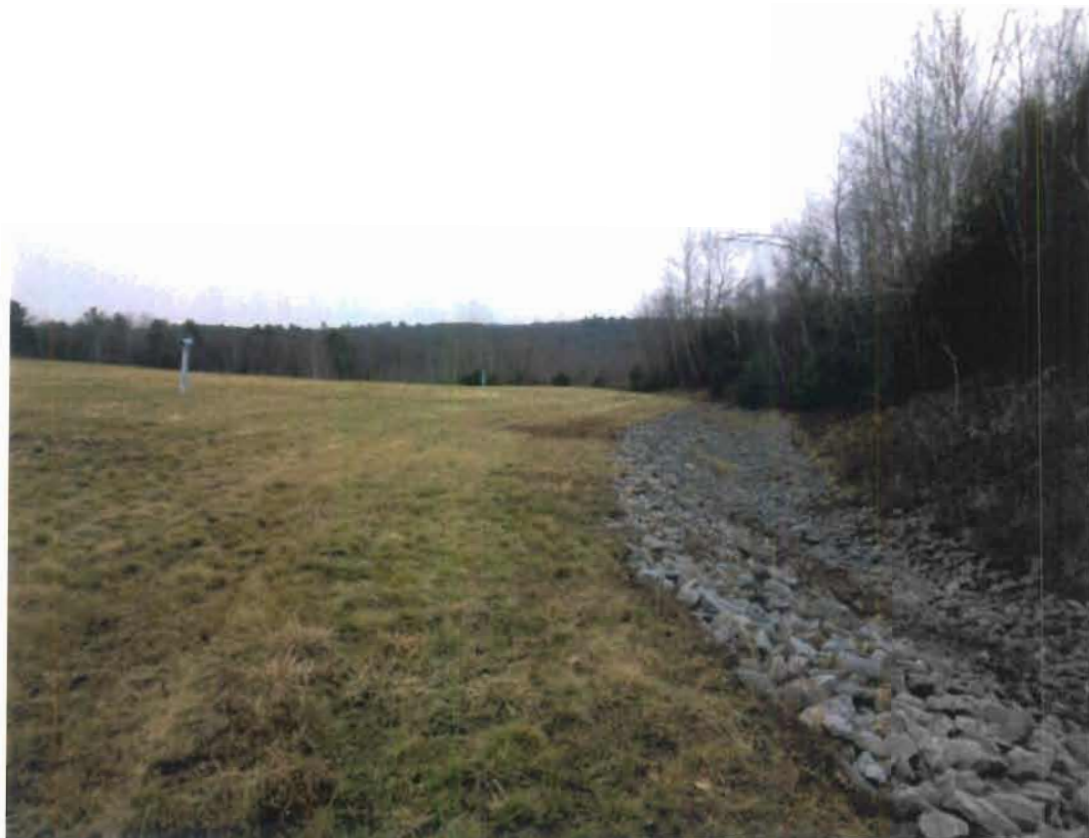
Photo No. 62: SWLF – Western Stormwater Basin

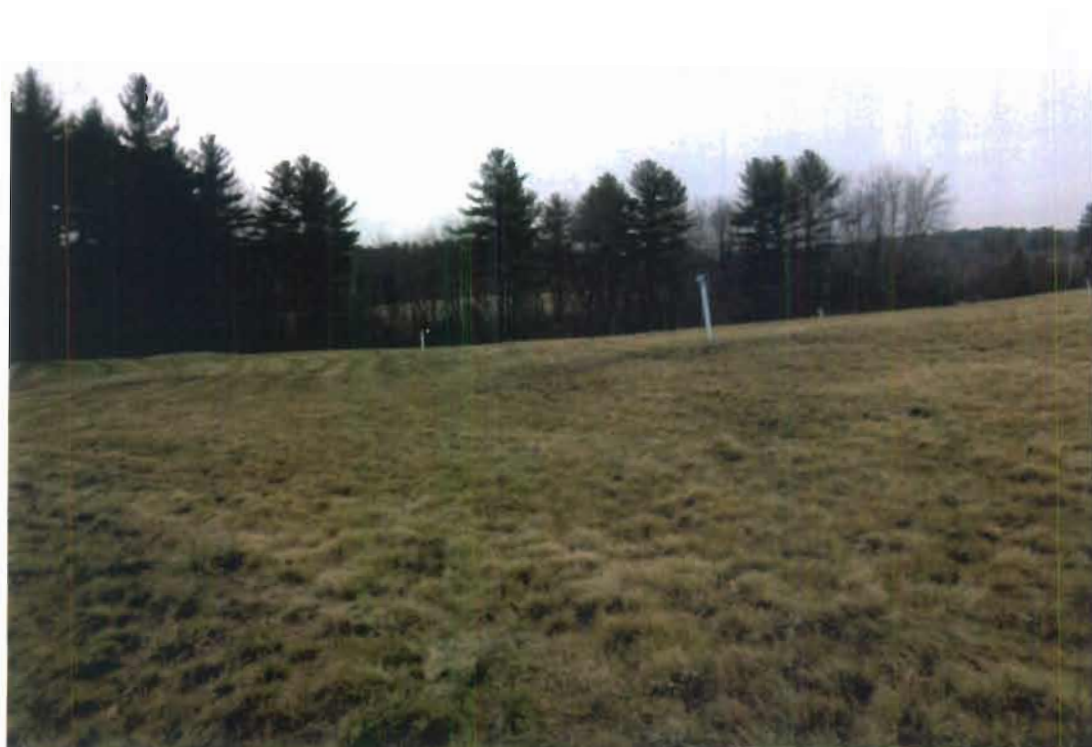
Photo No. 63: SWLF – Southern Toe-of-Slope & Surface

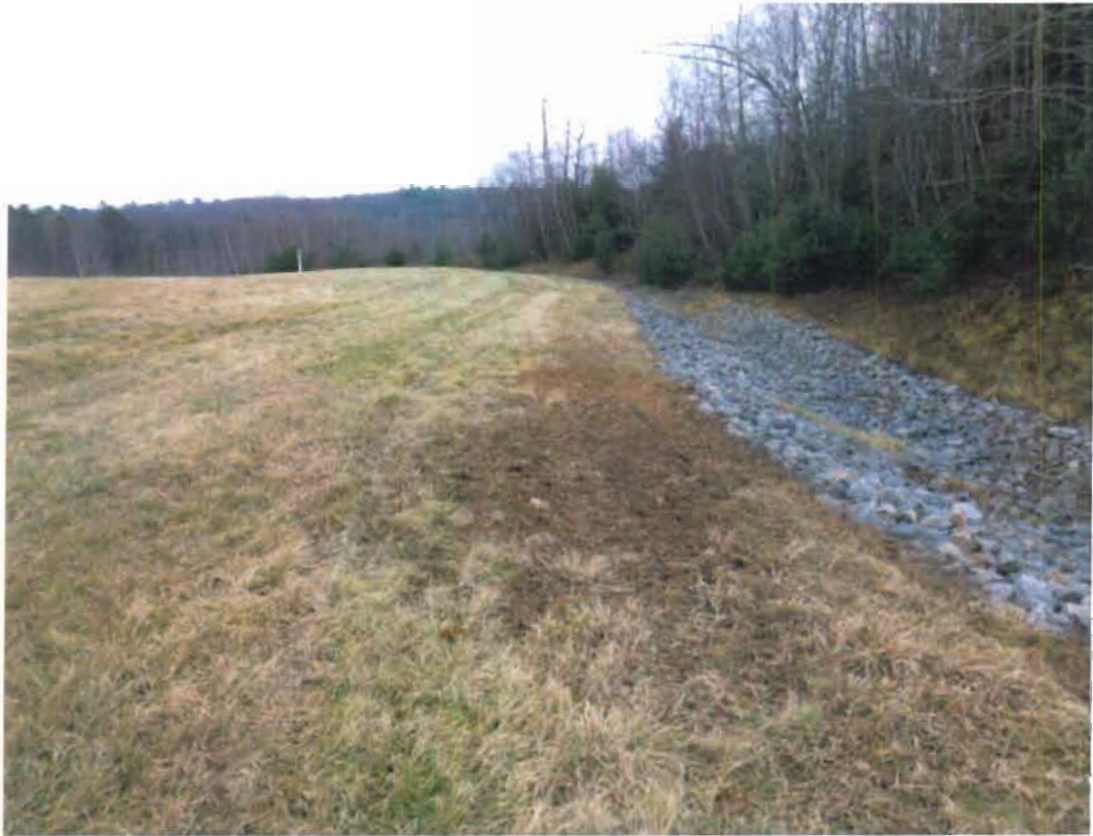
Photo No. 64: SWLF – Southern Surface

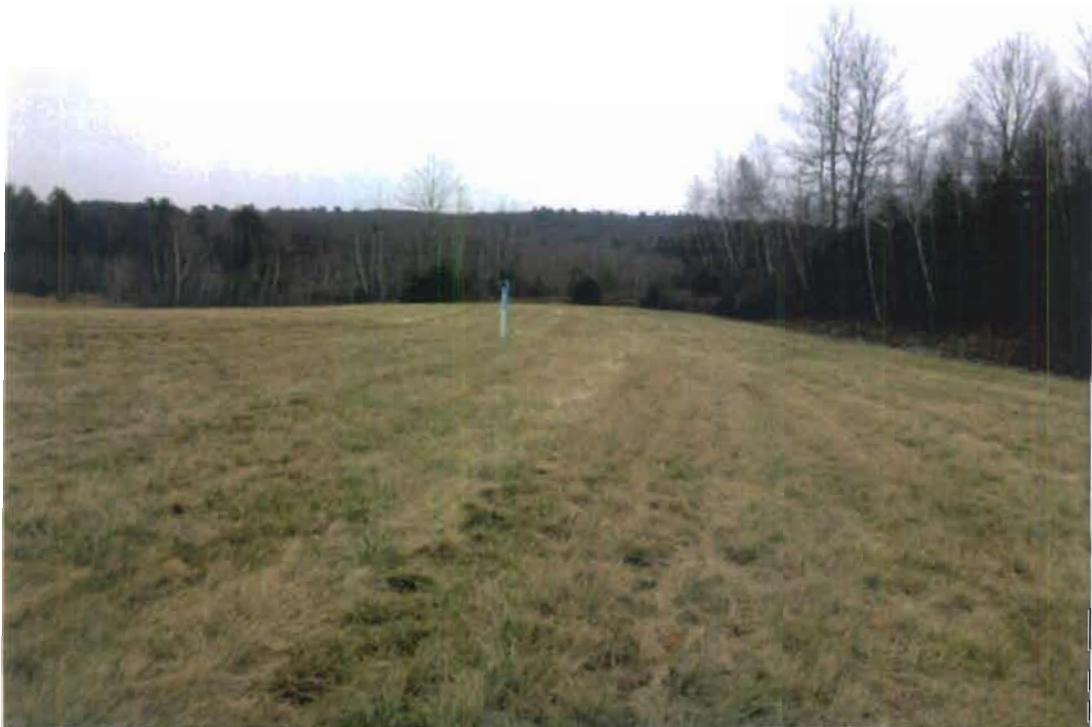
Photo No. 65: SWLF - Southern Toe-of-Slope & Surface

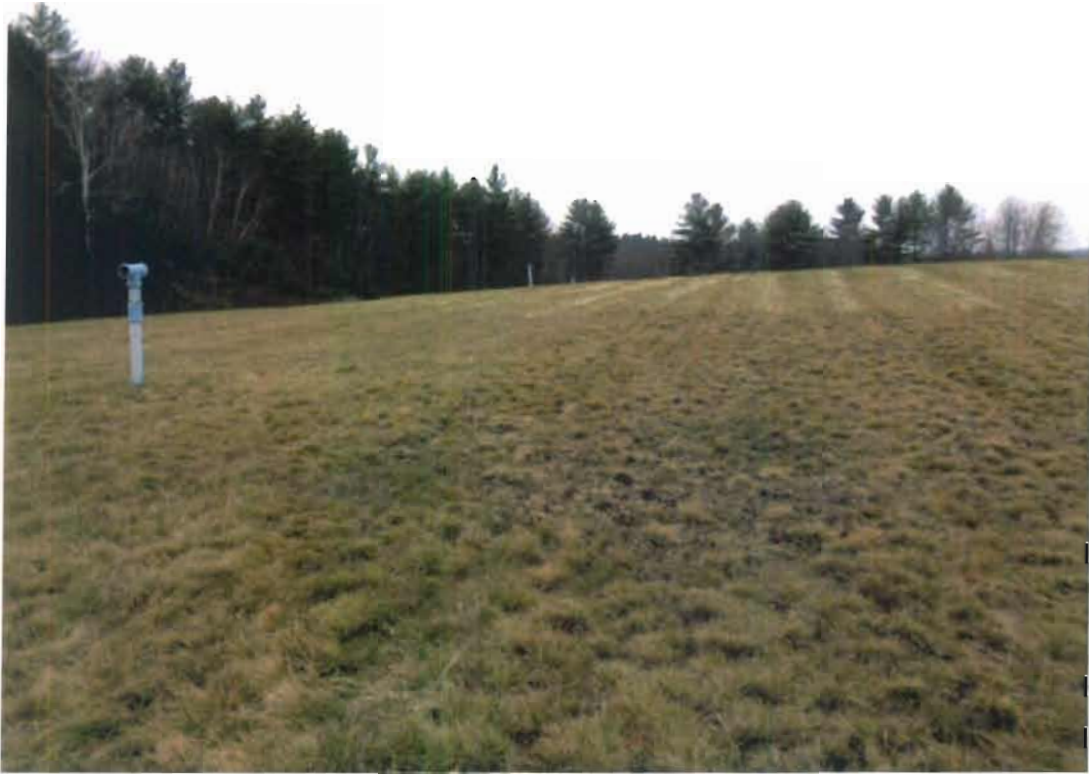
Photo No. 66: SWLF – Southeastern Surface

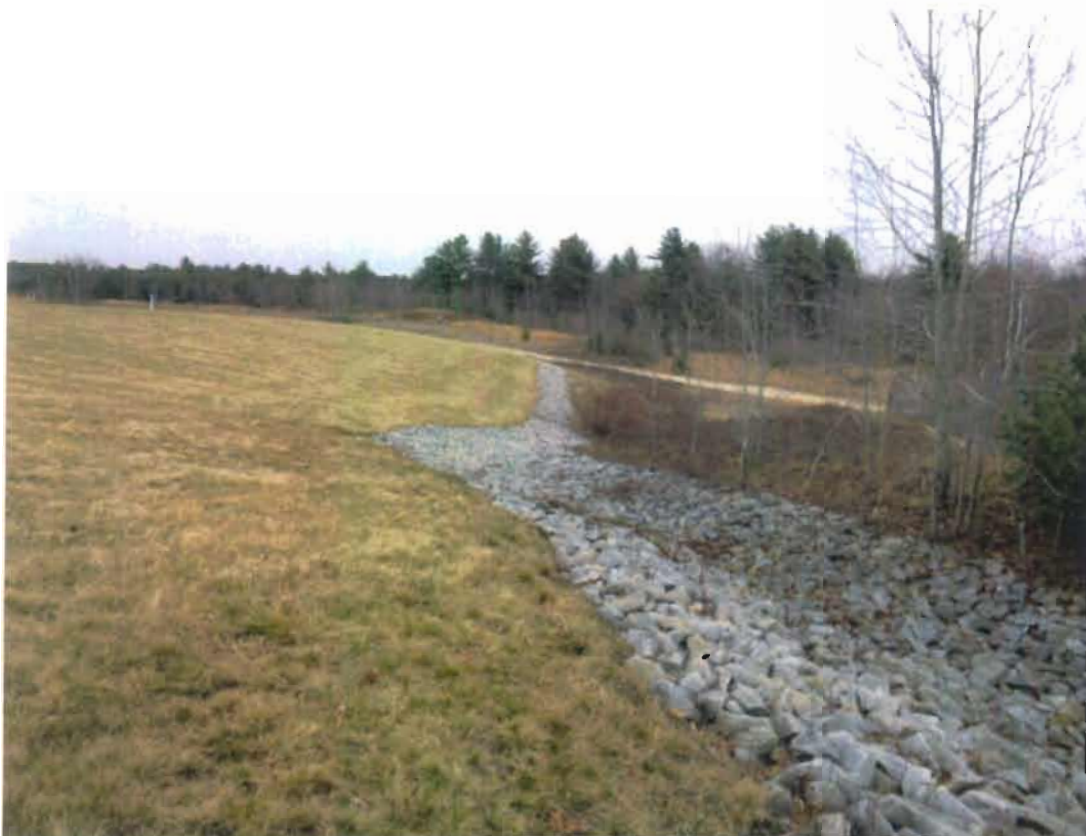
Photo No. 67: SWLF – Southeastern Surface
