RE: Auburn Road Landfill, Administrative Order,
Docket Number I-90-1092, Londonderry, New Hampshire

**2013 SOURCE CONTROL
OPERATION & MAINTENANCE REPORT
AUBURN ROAD LANDFILL**

**FOR
TOWN OF LONDONDERRY, NEW HAMPSHIRE**

FEBRUARY 2014

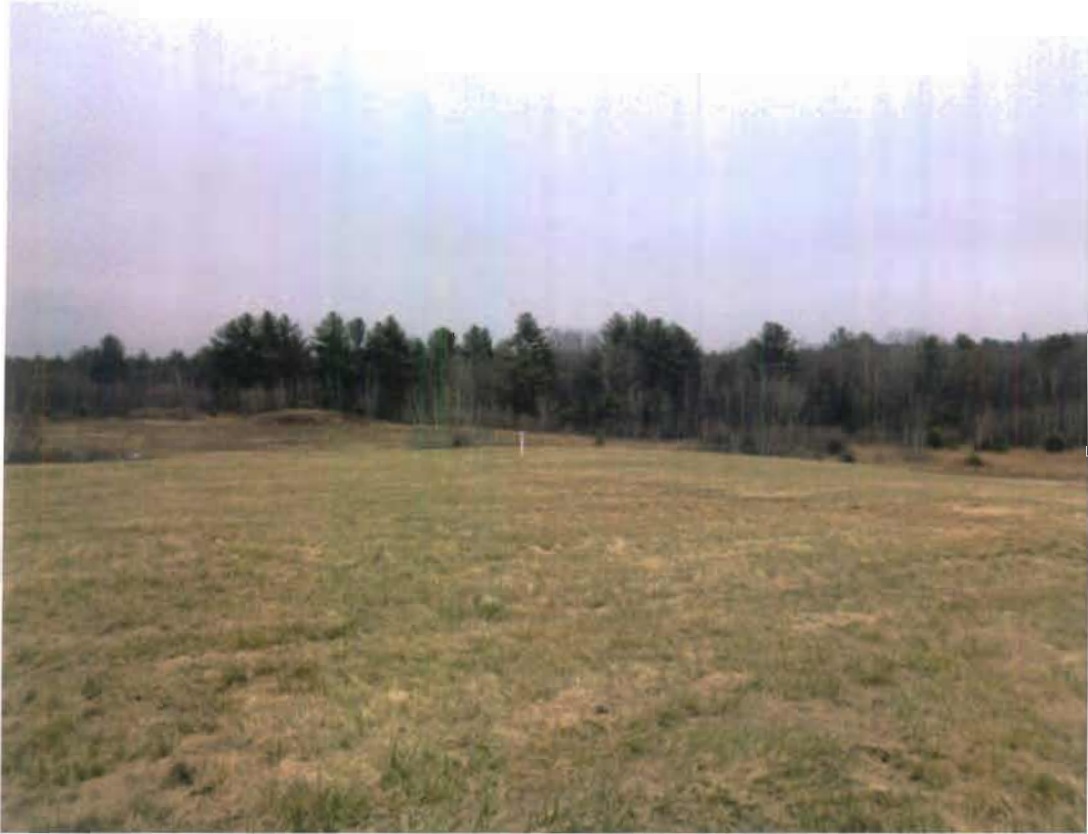
Photo No. 68: SWLF – Eastern Toe-of-Slope

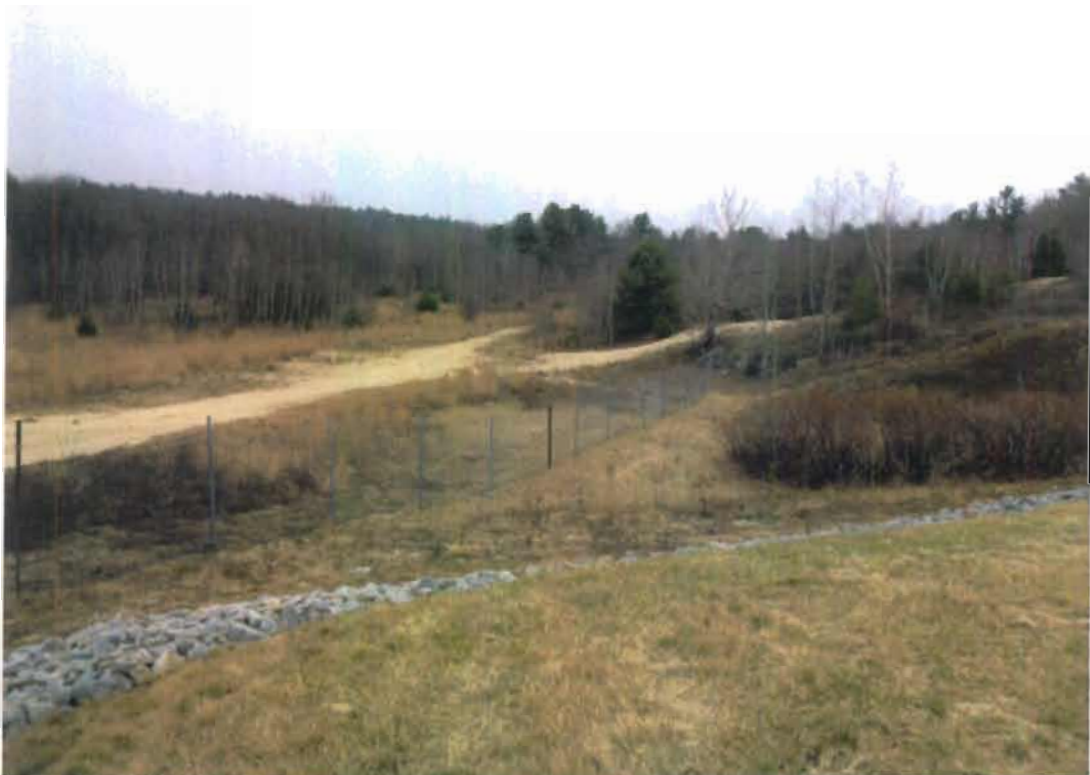
Photo No. 69: SWLF - Top Northeastern Surface

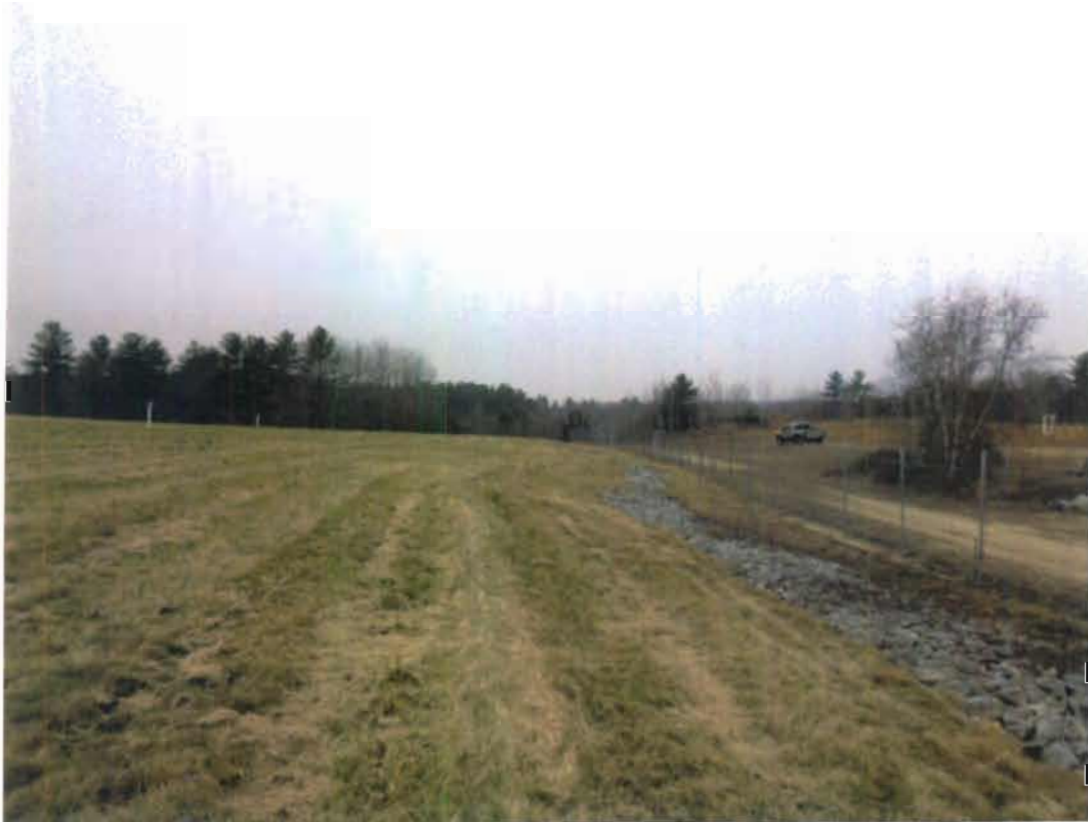
Photo No. 70: SWLF - Northeastern Toe-of-Slope

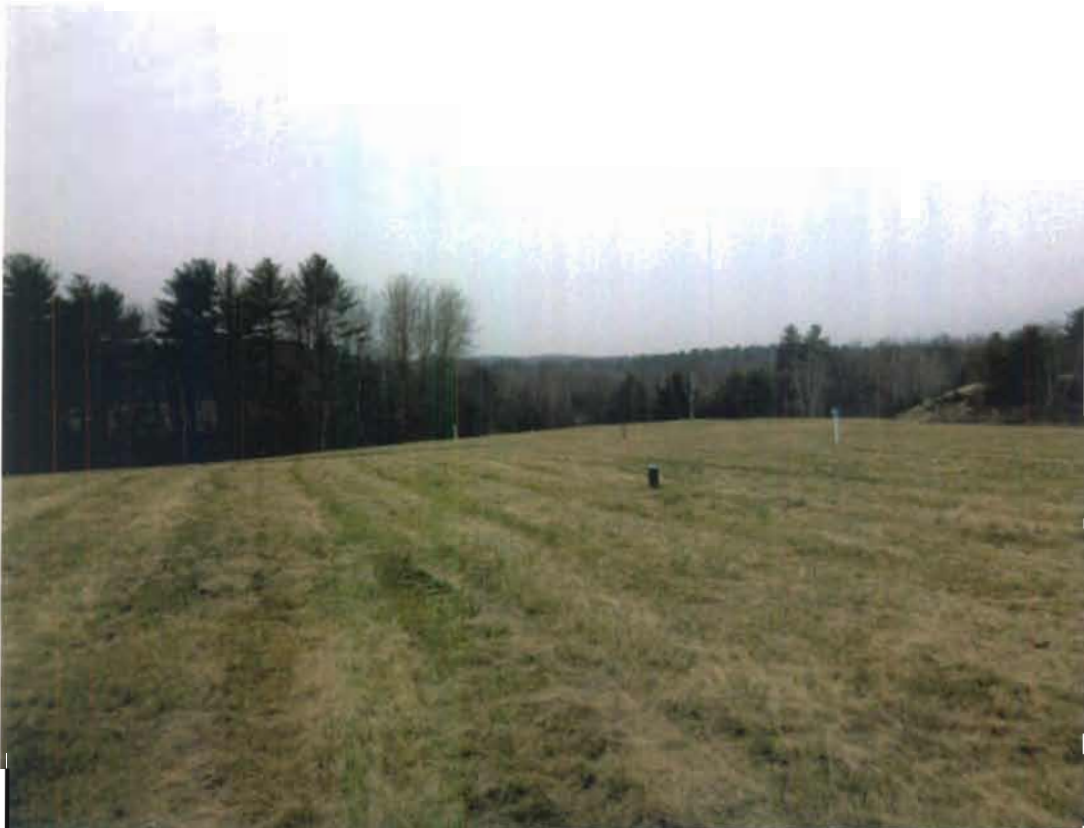
Photo No. 71: SWLF – Northern Toe-of-Slope
