**FOCUS FEASIBILITY STUDY DATA EVALUATION
BLUE SPRUCE INTERNATIONAL, INC.
BOUND BROOK, NEW JERSEY**

**TECHNICAL DIRECTIVE DOCUMENT NO. 02-8502-02B
CONTRACT NO. 68-01-6699**

**ENVIRONMENTAL SERVICES DIVISION
U.S. ENVIRONMENTAL PROTECTION AGENCY**

NOVEMBER 4, 1985

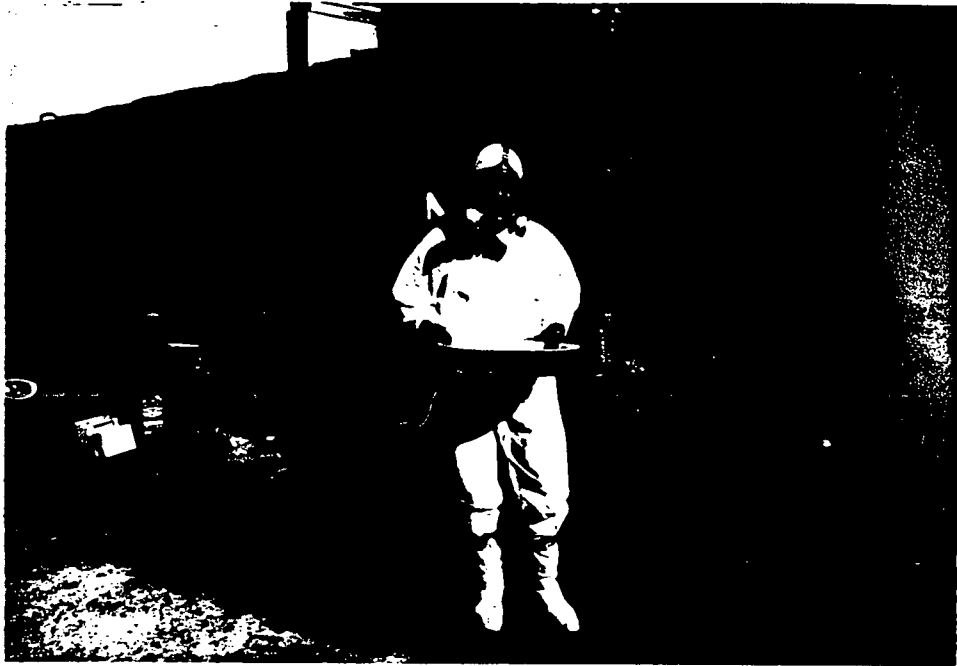
34. June 25, 1985 1710
Sample NJP3-13.

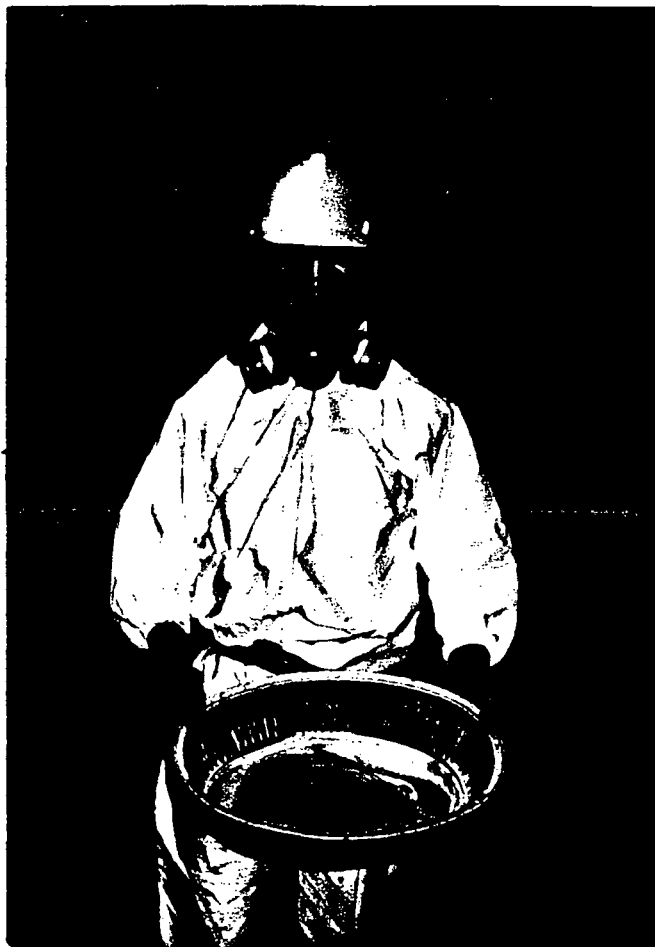
36. June 26, 1985 1045
Sample NJP3-14.

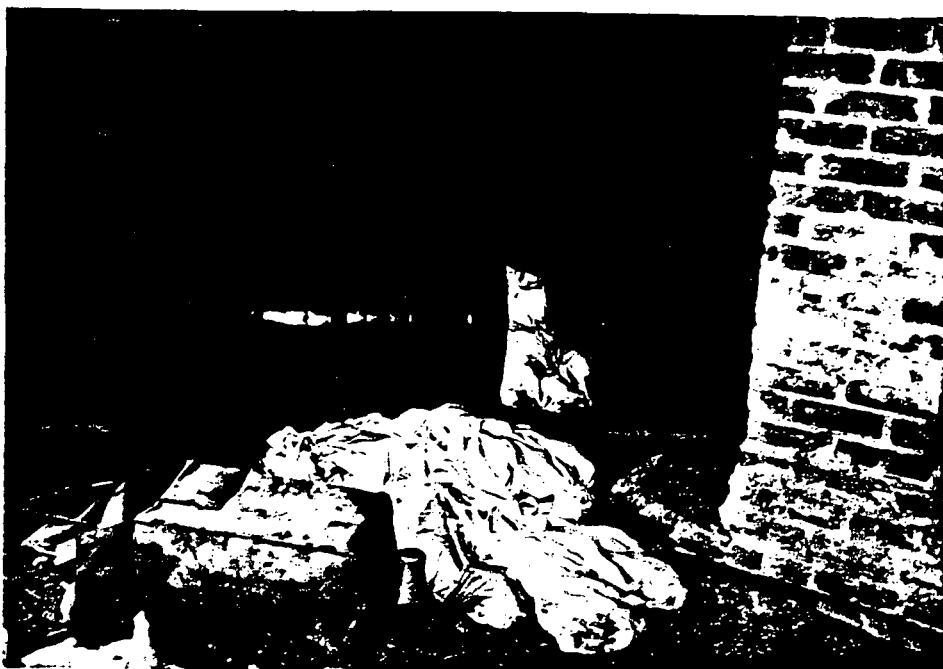
37. June 26, 1985 1050
Sampling waste used by NJDEP.

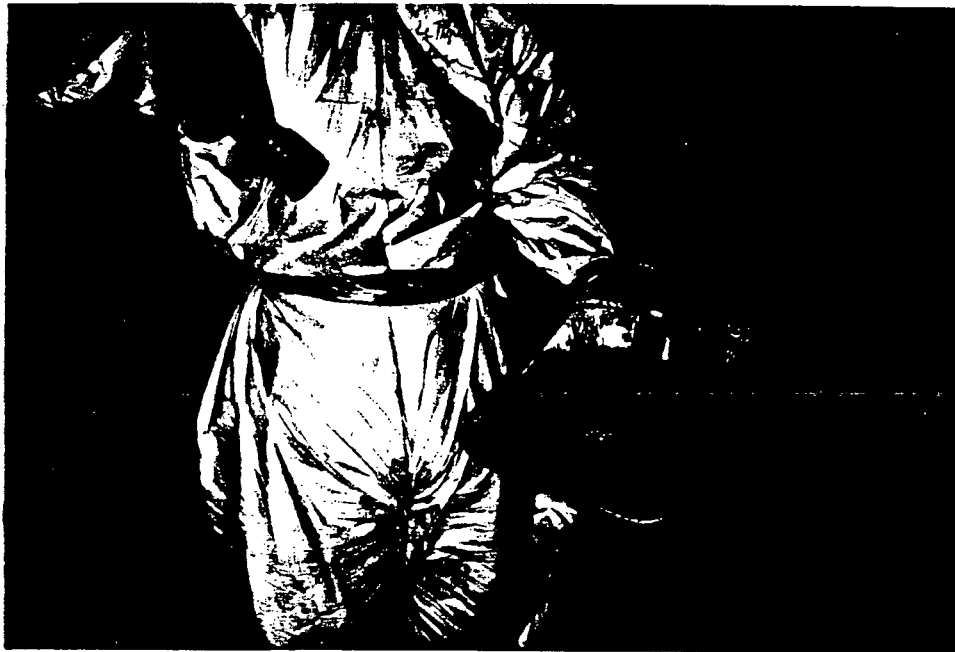
60. June 26, 1985 1510
Sample NJP3-24.

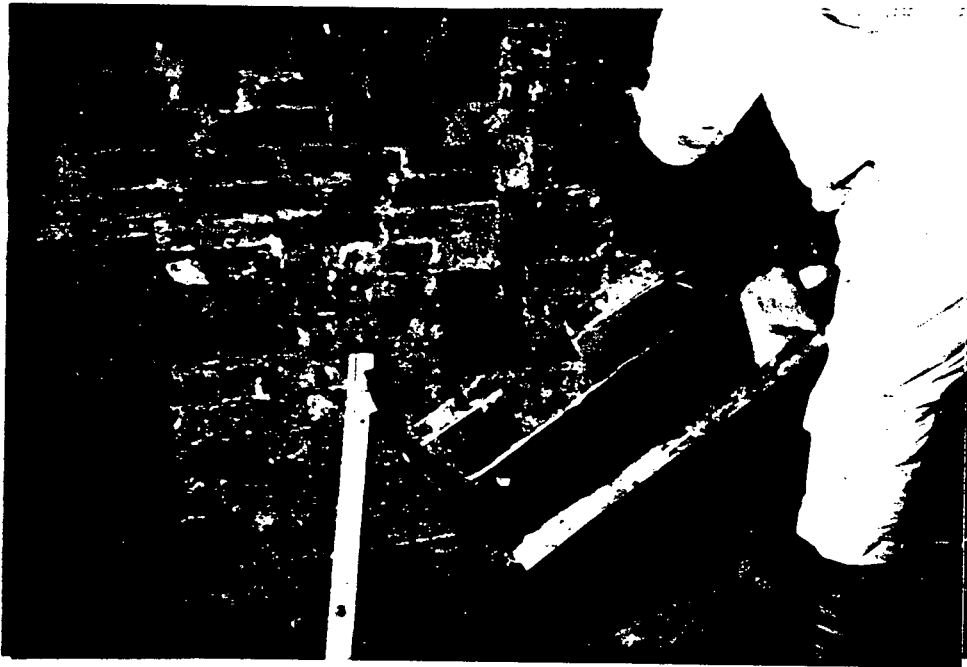
The highest concentration of 2,3,7,8-TCDD in the building, 99.5 ppb, was found in the brick subfloor in Room 2, sample NJP3-47. Three other samples in Room 2 contained detectable levels of 2,3,7,8-TCDD. The three wall samples collected from Room 2 had herbicide concentrations between 1.49 and 15.9 ppm. The wood subflooring sample collected from Room 2, NJP3-43 did not pass EPA QA requirements.

77. June 27, 1985 1450
Sample NJP3-47.
