FINAL FOURTH FIVE-YEAR REVIEW

NAVAL WEAPONS STATION EARLE COLTS NECK, NEW JERSEY

March 2018

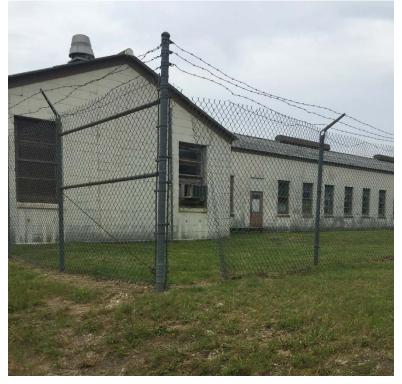
View facing south of hole in corner of Site 26 fence.

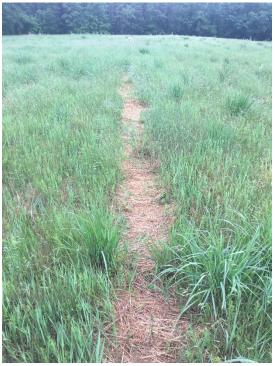
Strip of dead vegetation on the west side of the Site 3 landfill cover

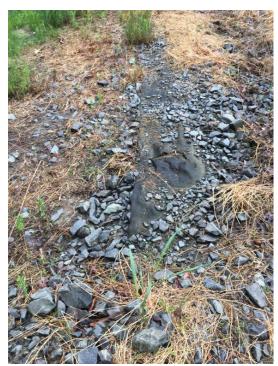
Area of dead vegetation on the southern portion of the rip rap

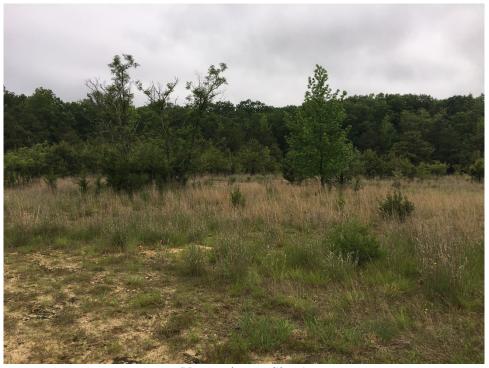
Vegetation at Site 1
