**FIFTH FIVE-YEAR REVIEW REPORT FOR
PMC GROUNDWATER SUPERFUND SITE
EMMET COUNTY, MICHIGAN**

**U.S. Environmental Protection Agency
Region 5
CHICAGO, ILLINOIS**

3/5/2025

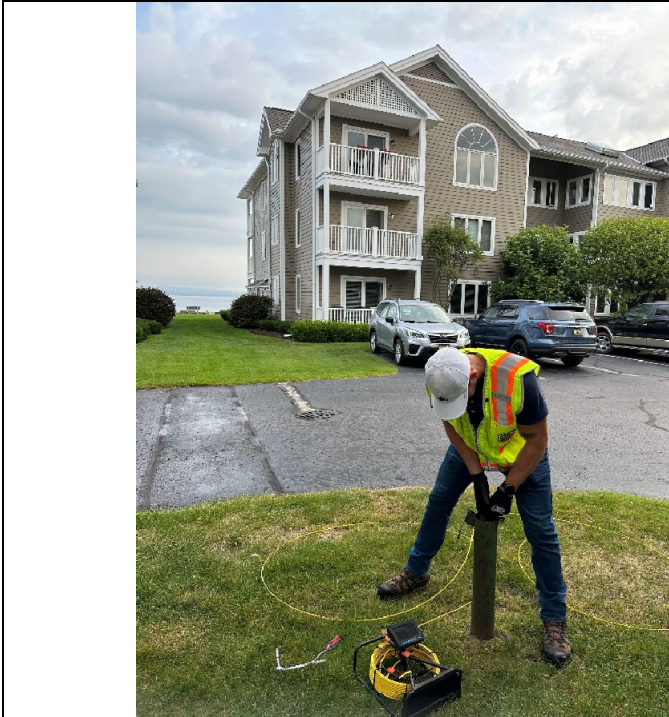
Photograph #: 3
File Name: IMG_2135.jpg
Date: 7/31/2024
Photographer: Cheryl Kondreck
Location: PS-10A
Subject: One of three stick-up wells at the Site

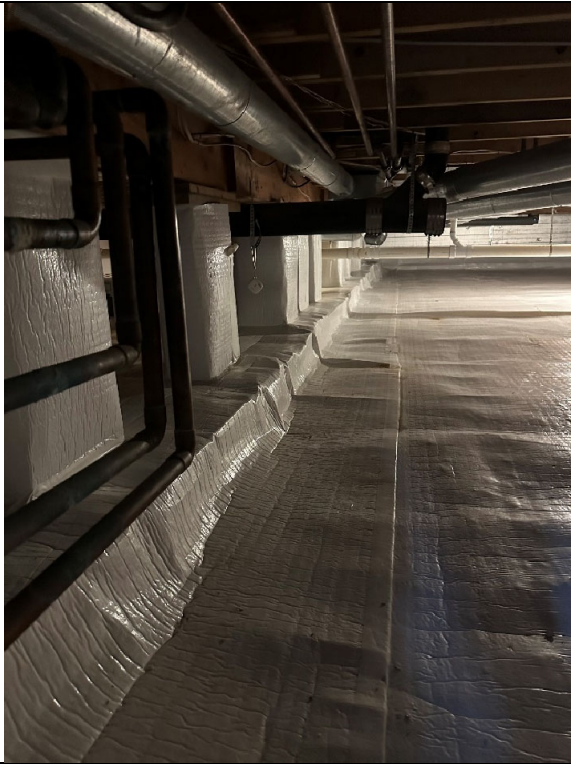
<p>Photograph #: 10 File Name: IMG_2169.jpg Date: 8/1/2024 Photographer: Cheryl Kondreck Location: Sunset Shores Condominiums Subject: Crawl space sealed by the Condominium association</p>

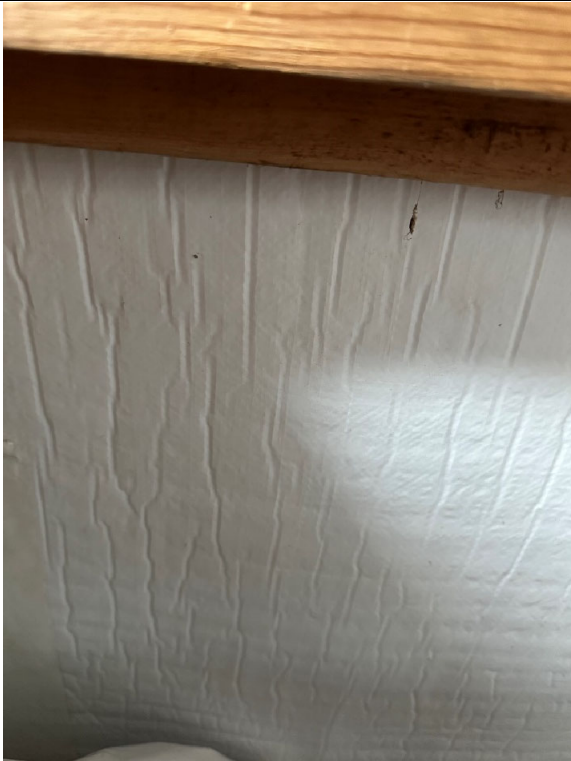
<p>Photograph #: 11 File Name: IMG_2174.jpg Date: 8/1/2024 Photographer: Cheryl Kondreck Location: Sunset Shores Condominiums Subject: Up close view of plastic sheeting material used.</p>

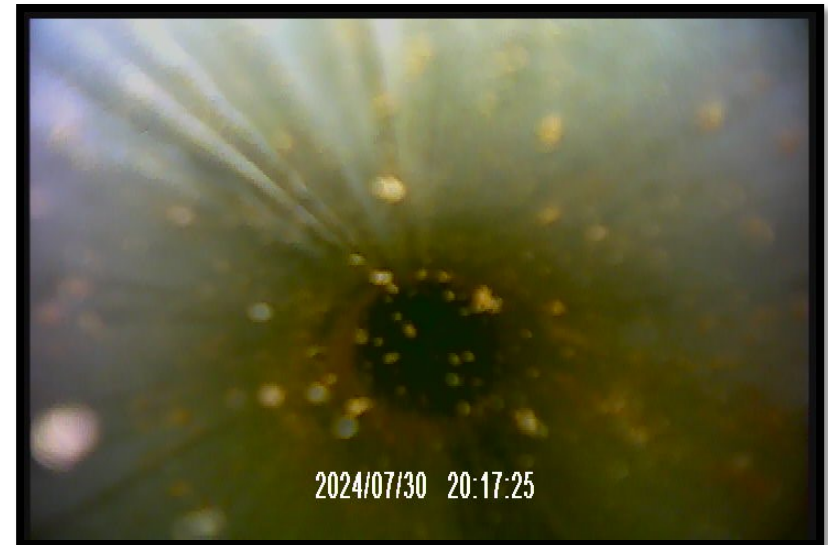
MW401D – Suspended sediment, reduced clarity

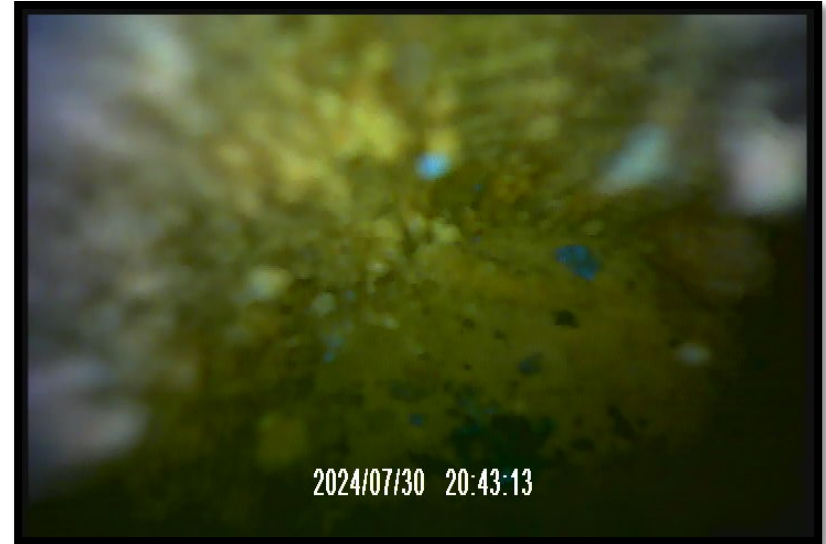
MW401S – well bottom, turbid water

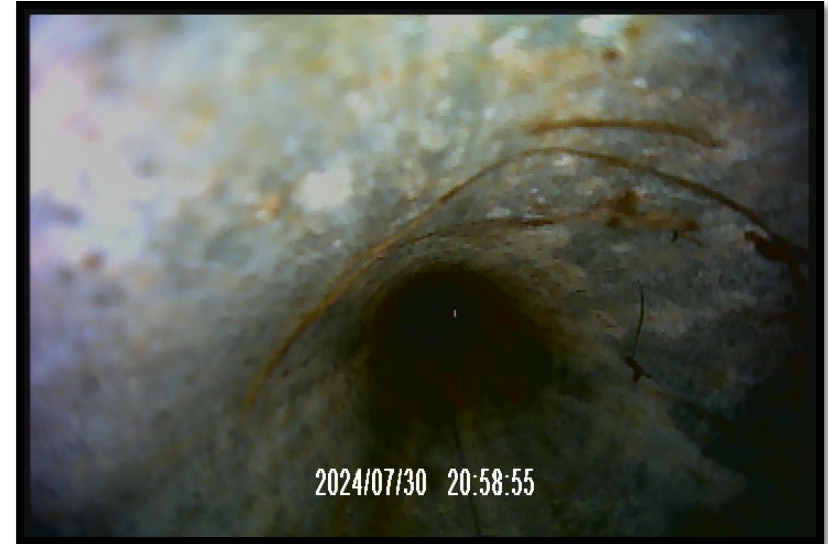
COP1 – minor indentation in casing

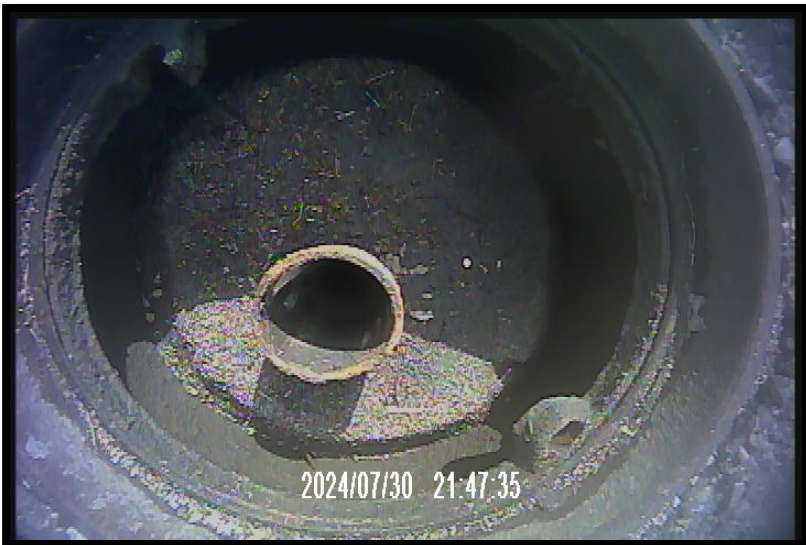
PSCD – Well within flush mount

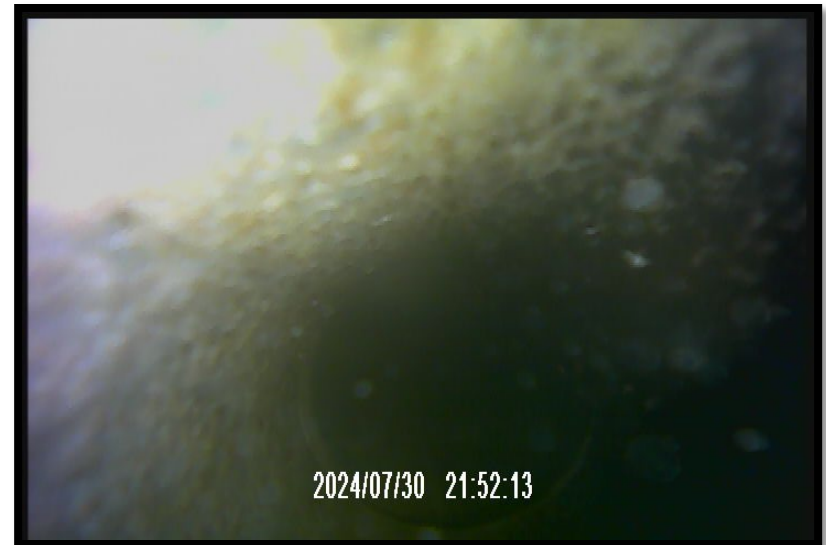
PSCD – reduced clarity, joint

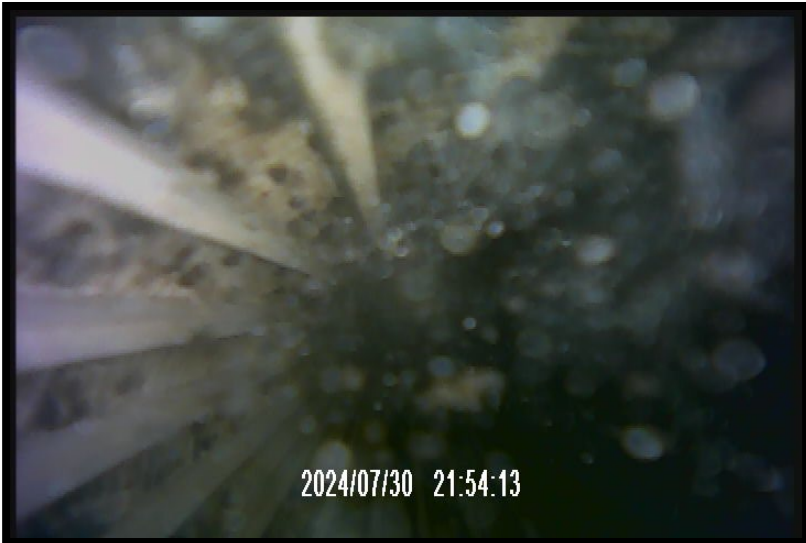
PSCD – screen has buildup near top

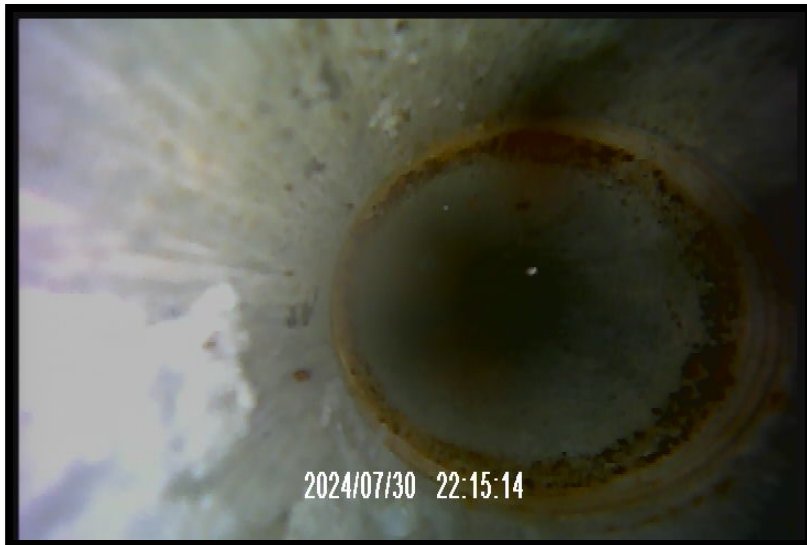
51

PS105S - joint

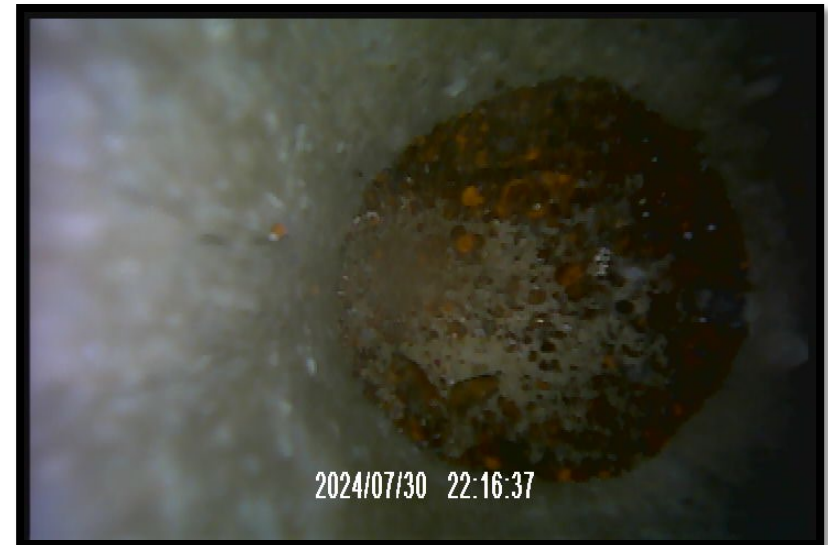
52

PS105S – bottom, no obvious screen

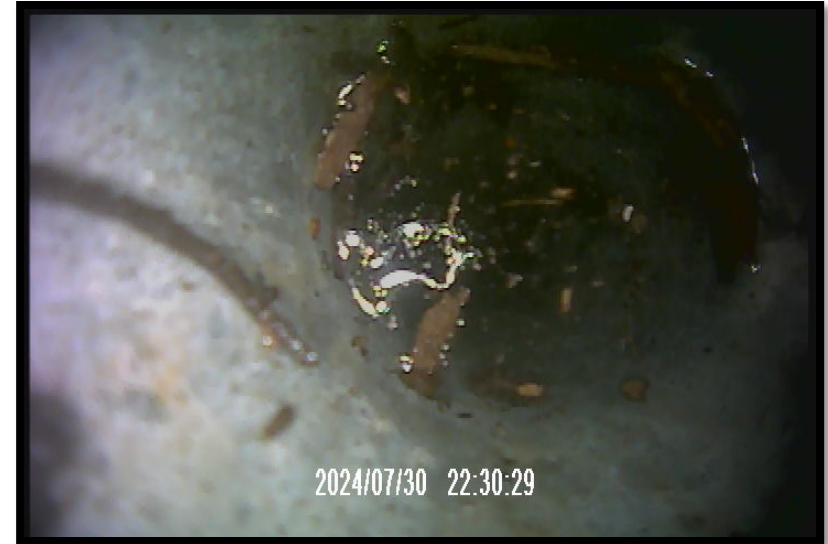
54

PS105D – water table, some debris on top

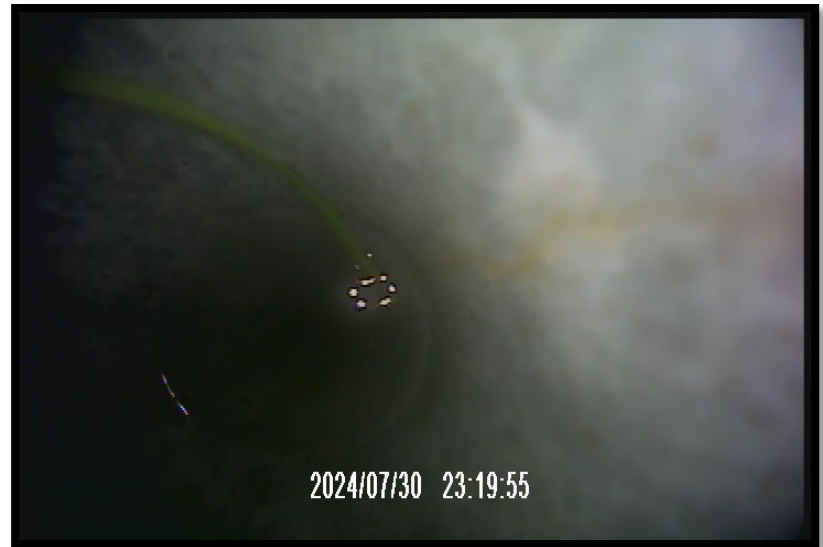
60

PS106 – water table, off center

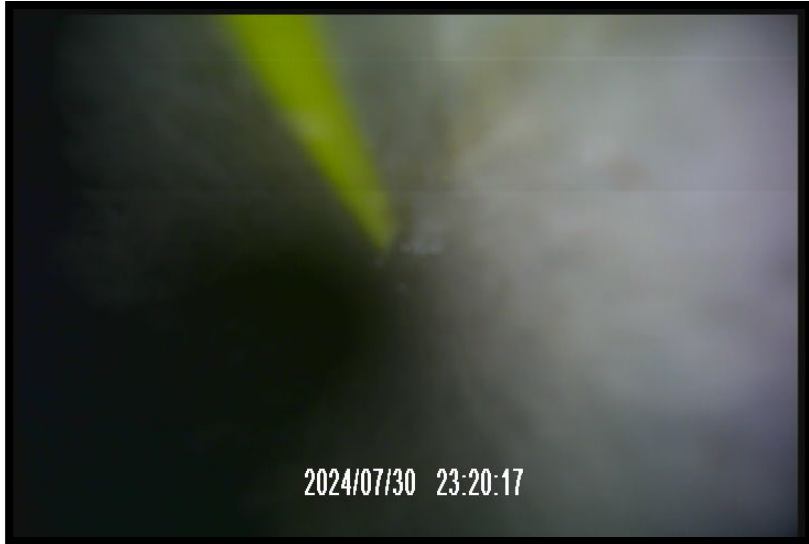
61

PS106 – piece of grass in well

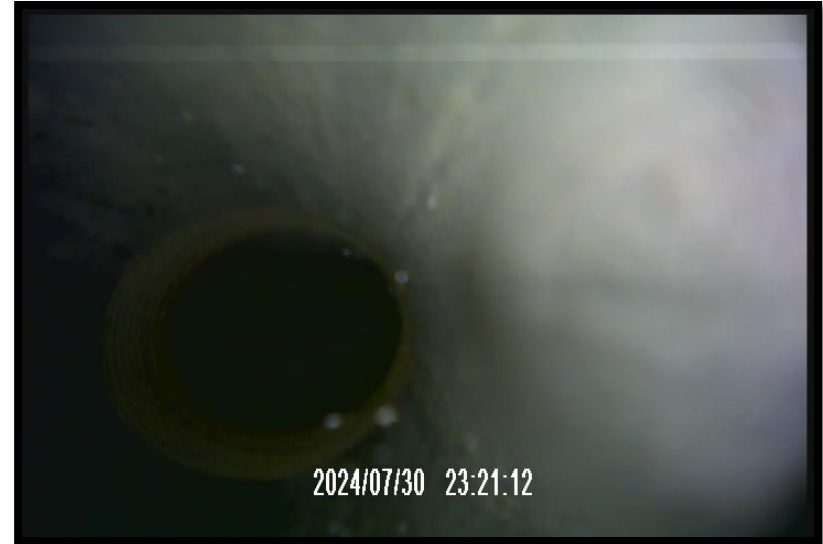
62

PS106 – reduced clarity, joint, top of screent

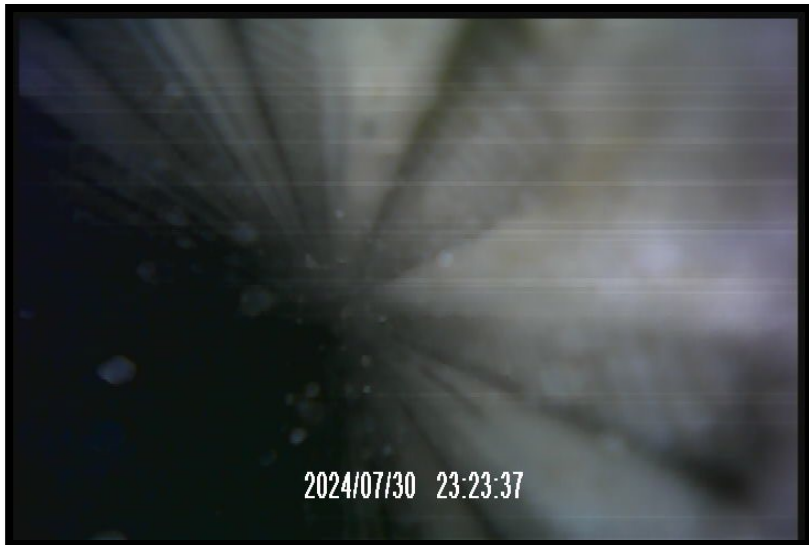
63

PS106 – reduced clarity, screen

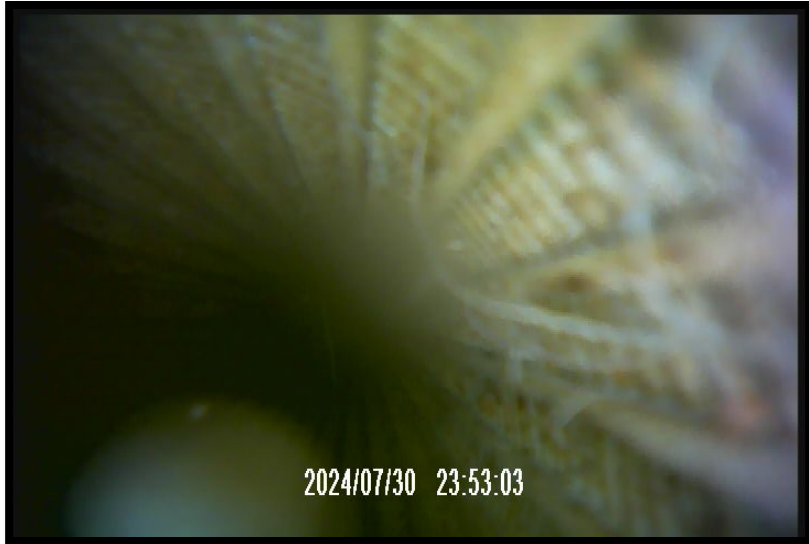
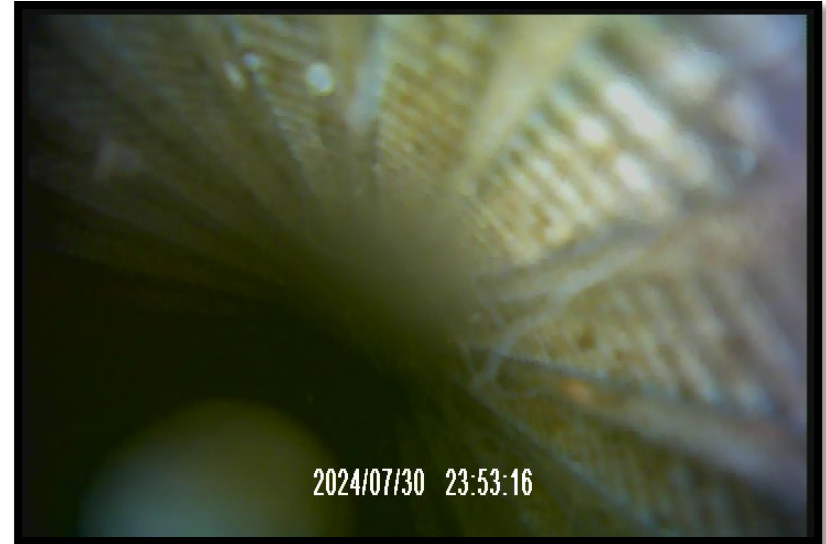
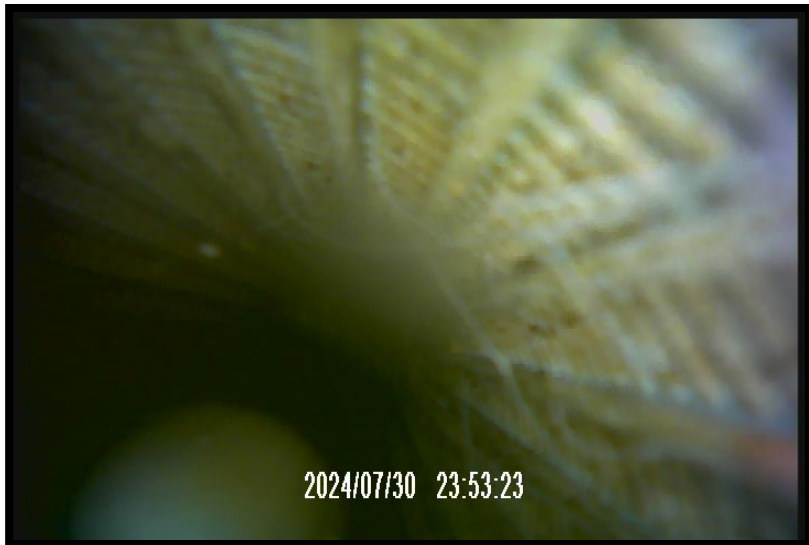
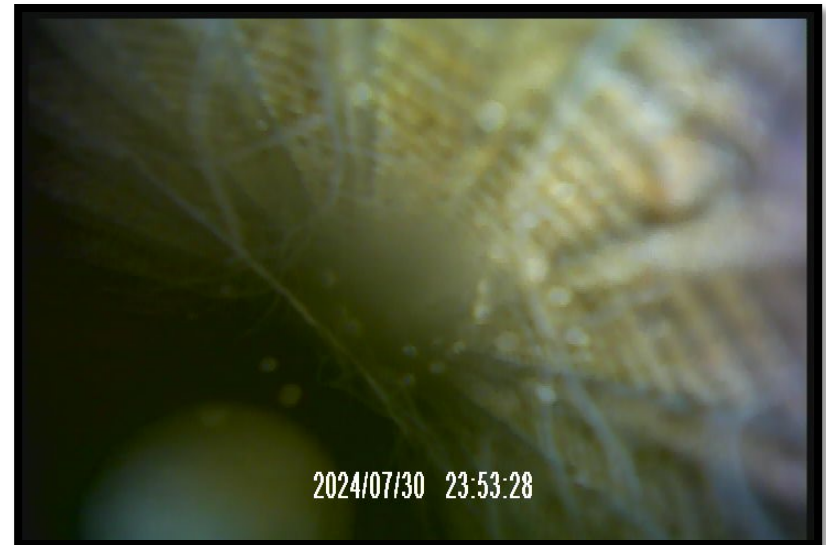
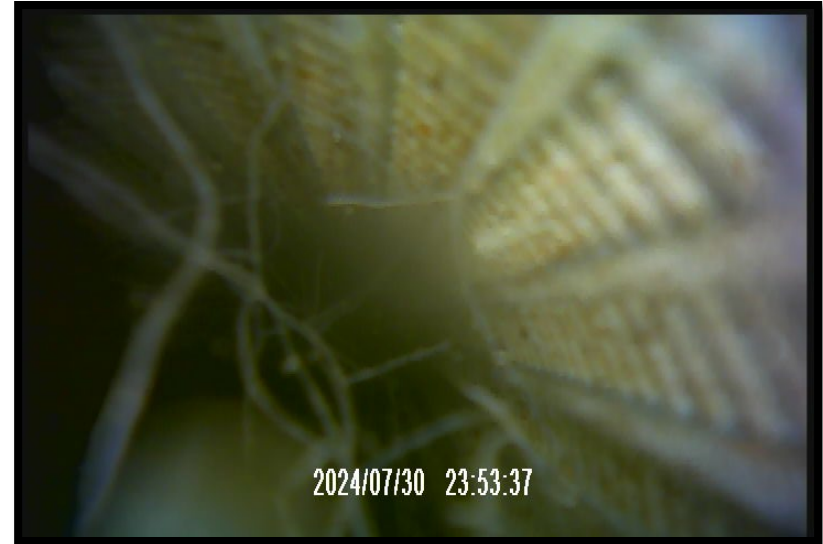
COP3 – additional roots

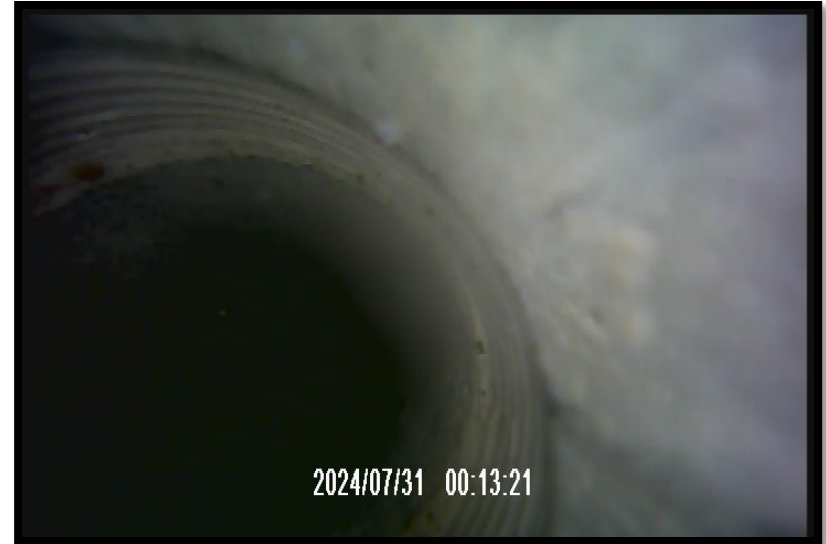
86

PS11 – camera off center, joint

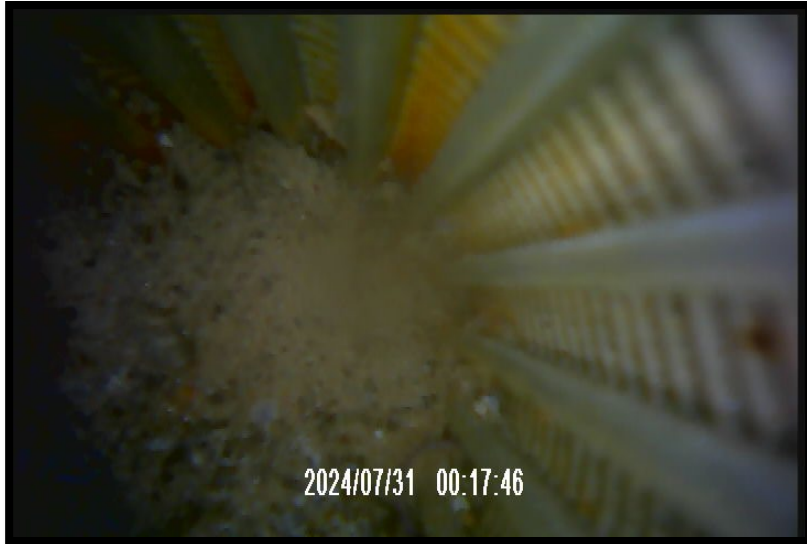
89

PS11 – sand bottom after only a couple of feet

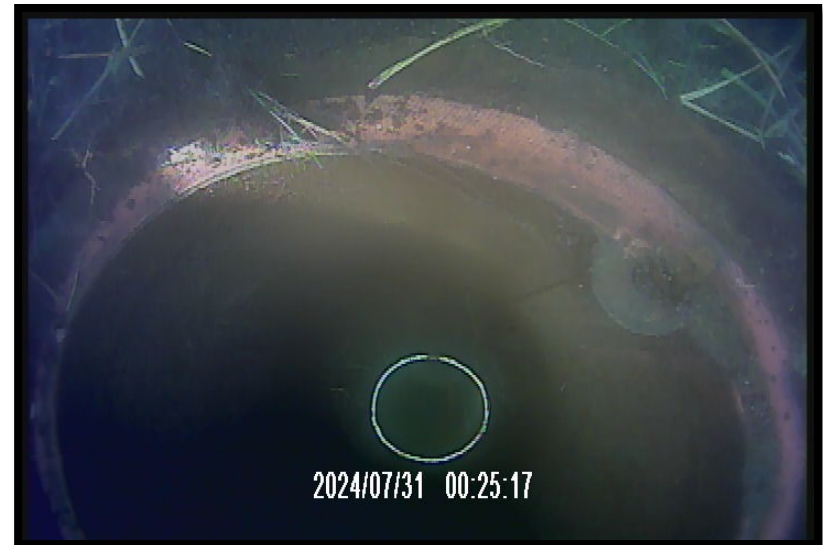
93

MW205DR – reflection off water table, reduced clarity

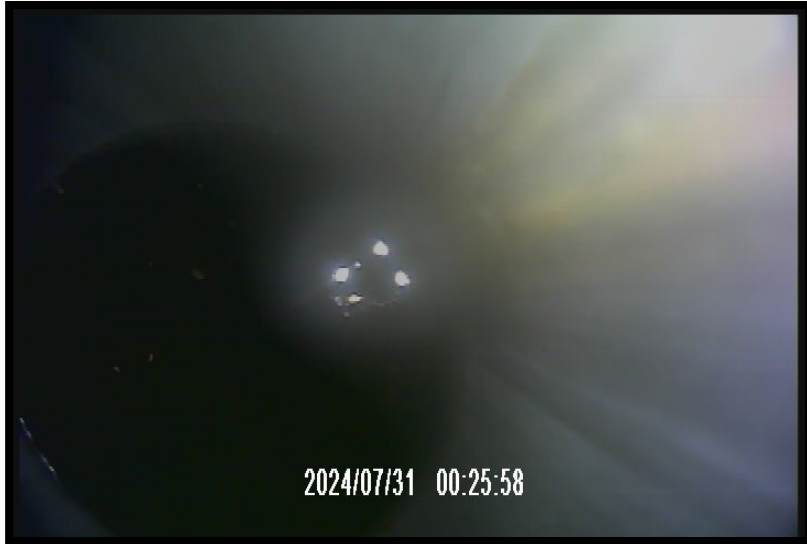
94

MW205DR – off center, joint below water table

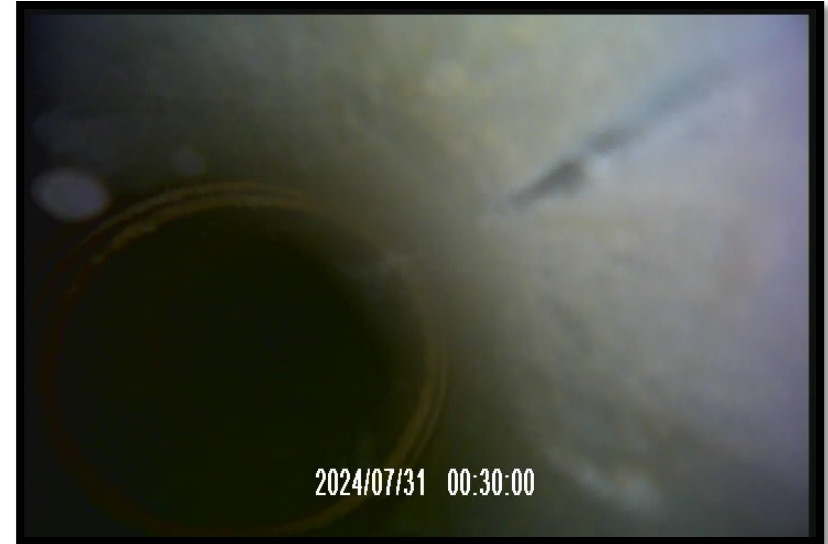
98

MW205DR - joint

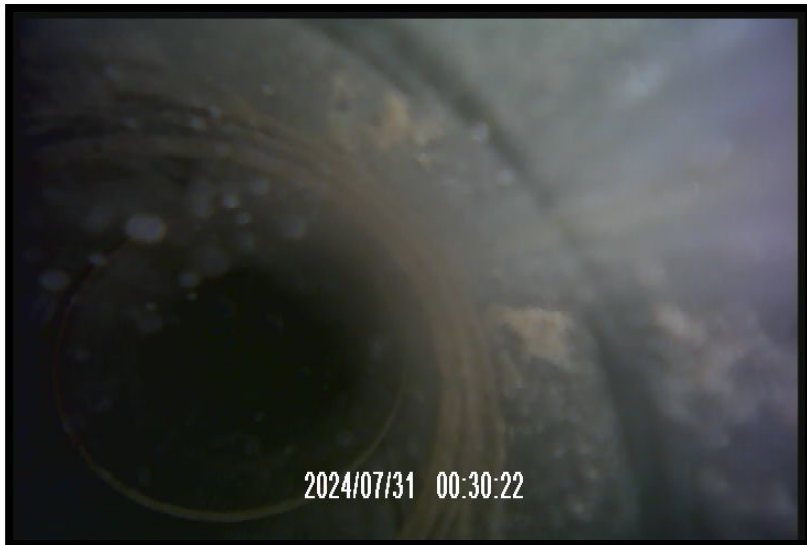
99

MW205DR – joint above screen

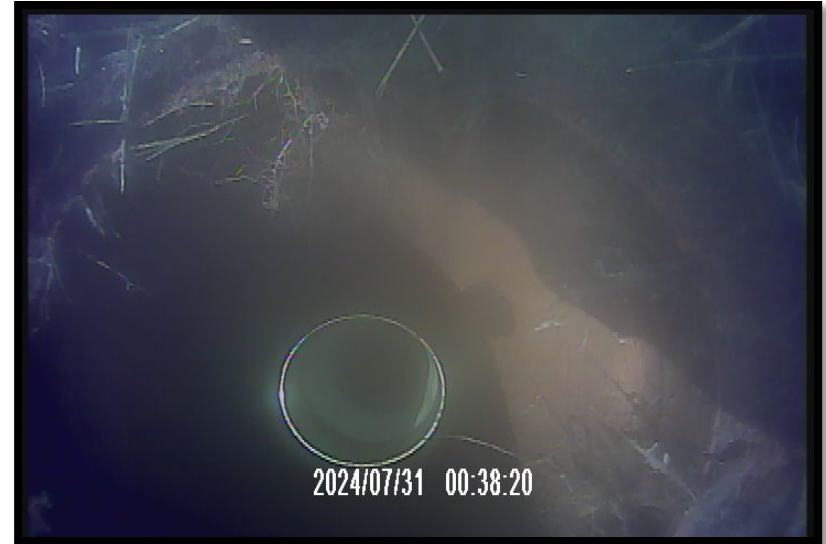
102

MW205SR – well within flush mount

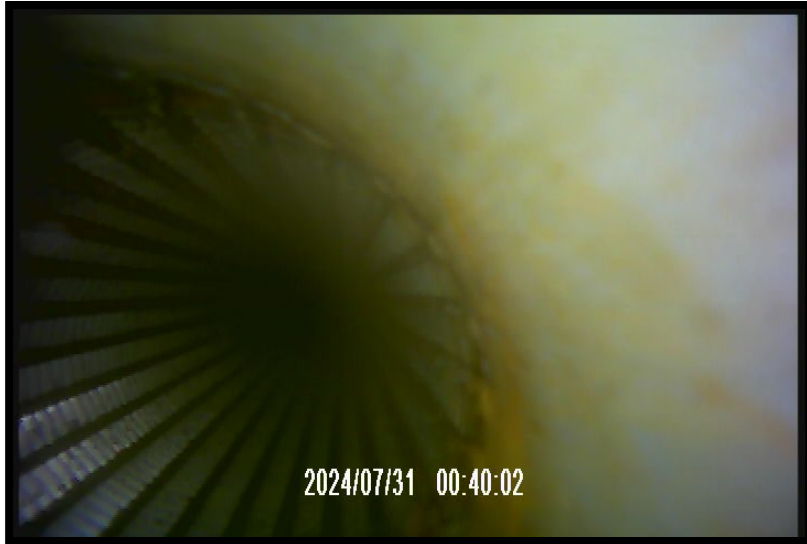
105

MW205SR – off center, top of screen in good condition

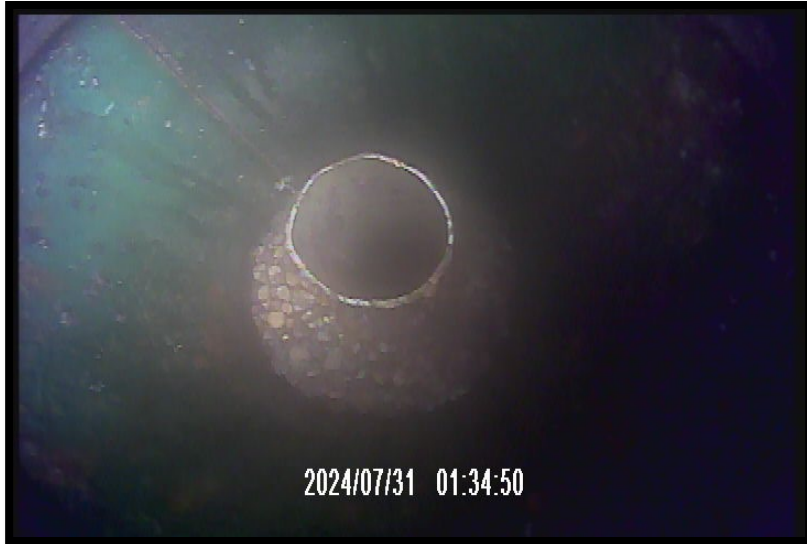
109

MW402S – well within flush mount

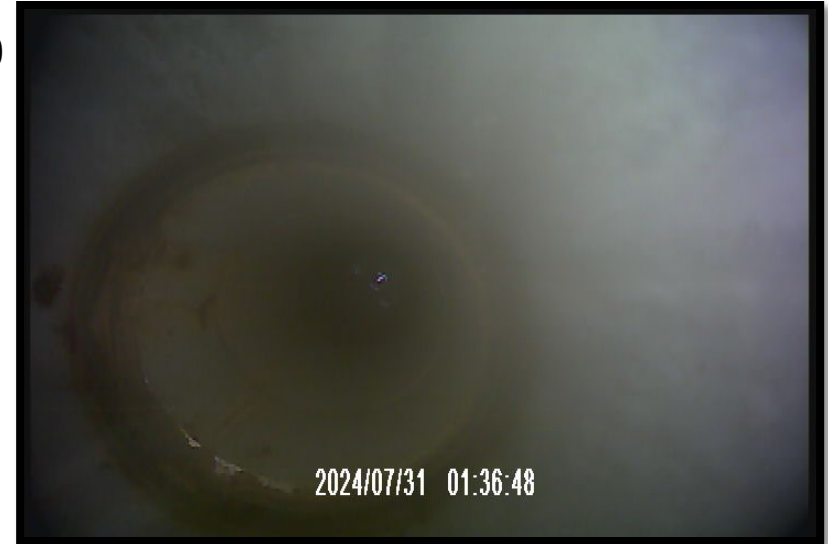
110

MW402S – poor clarity, joint

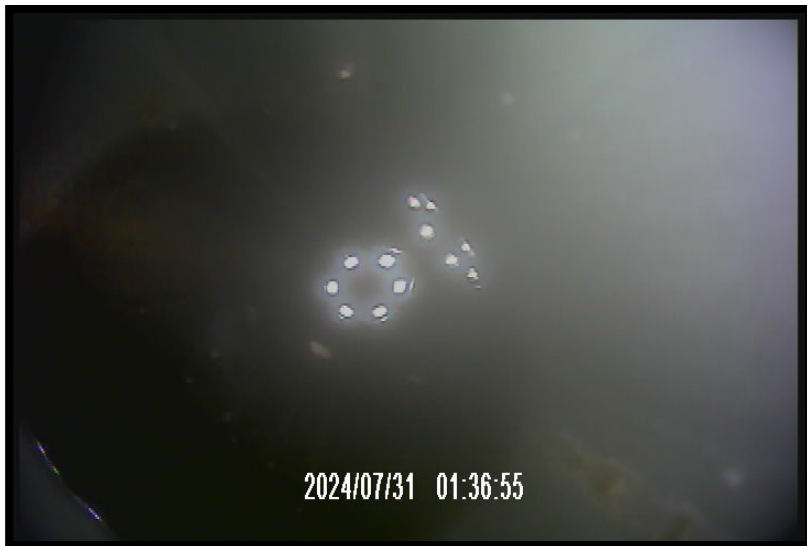
111

MW402S – reflection off water table

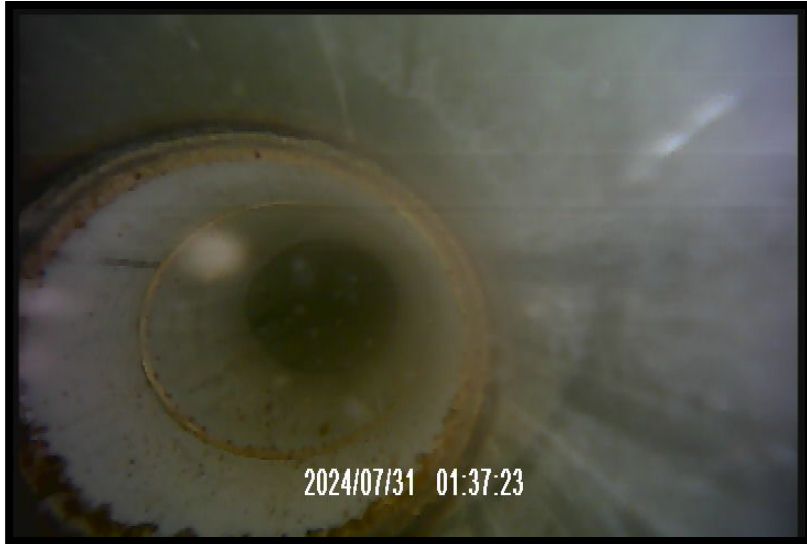
113

MW402S - joint

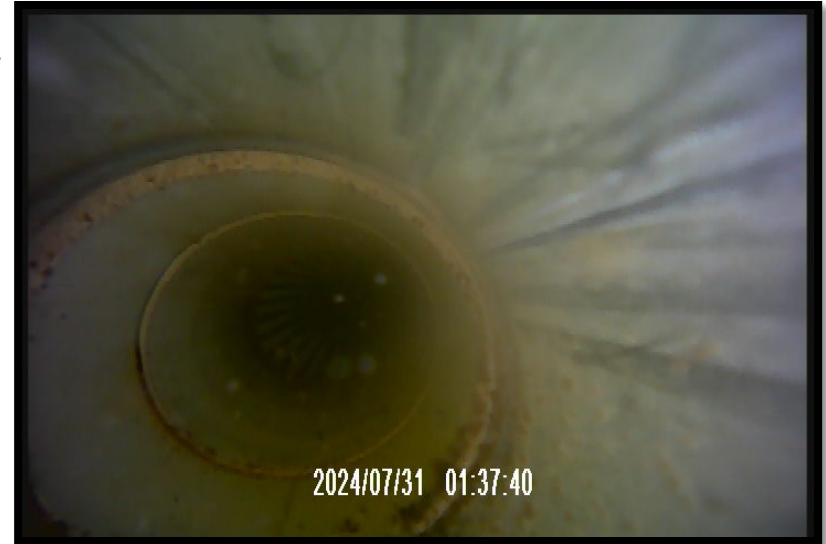
114

MW402S - joint

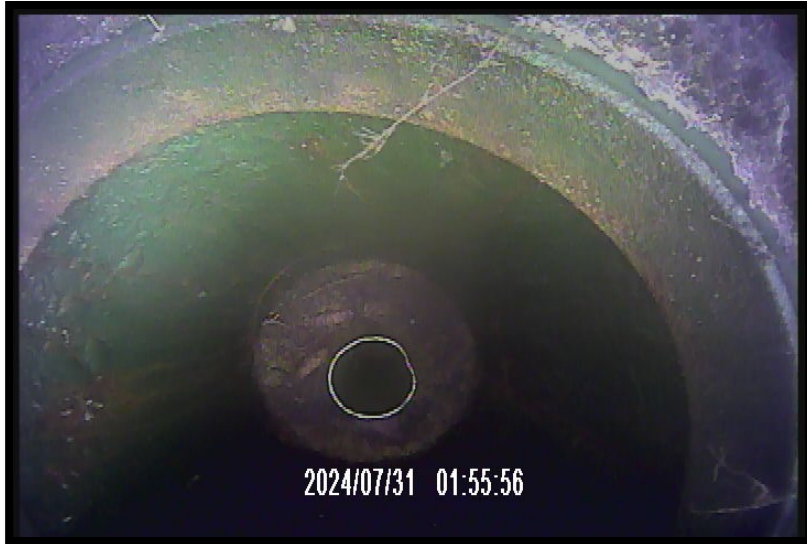
117

MW402D – well within flush mount

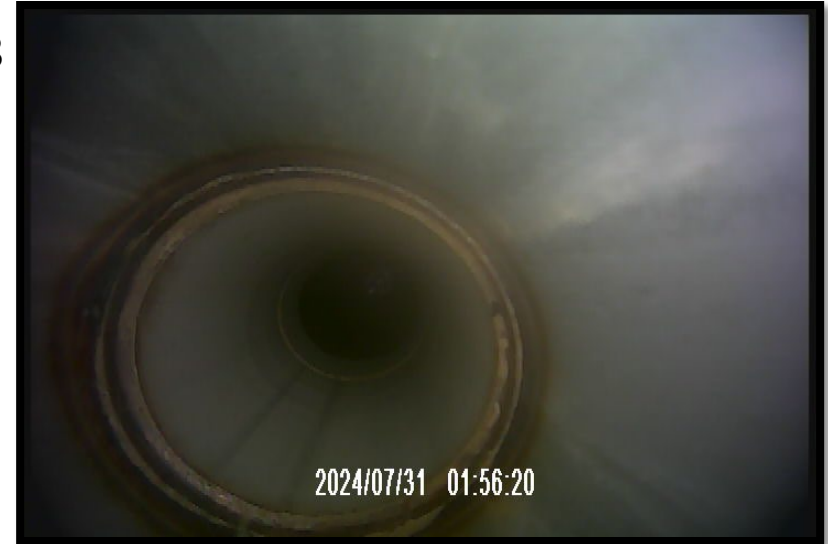
118

MW402D – joint in good condition

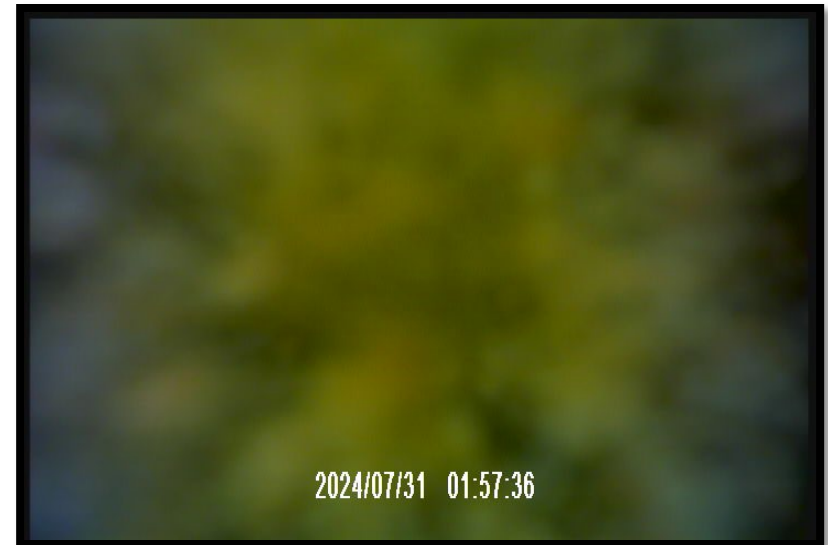
120

MW-402D	117-123	Extremely high turbidity, suggest purging and re-examining
PS-6	124-130	No visible screen, no well cap, suggest abandonment
PS-BD	131-134	Good enough condition to try cleaning and re-development
PS-BS	135-139	Good enough condition to try cleaning and re-development
PS-104	140-145	Good enough condition to try cleaning and re-development
PS-4	146-152	Bent screen, suggest abandonment
PS-CS	153-159	Good enough condition to try cleaning and re-development
PS-10A	160-166	Good enough condition to try cleaning and re-development

MW402D – extremely high turbidity, low to no visibility

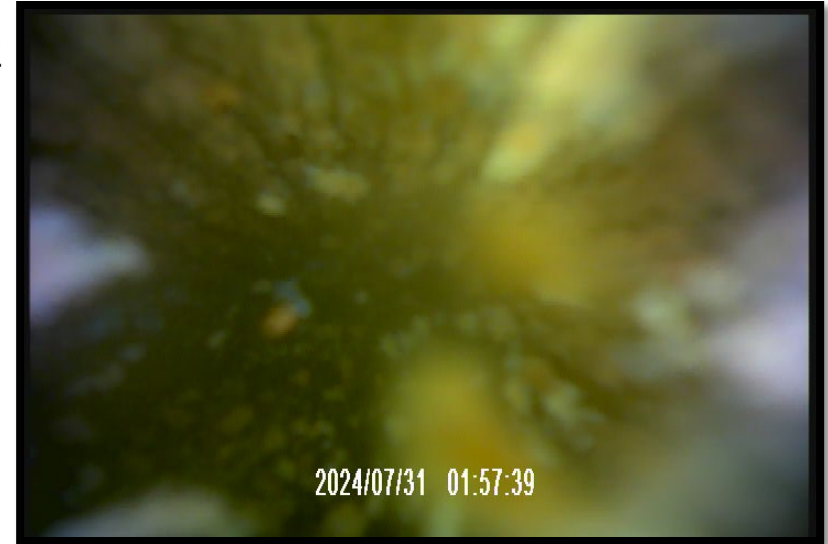
122

MW402D – low to no visibility

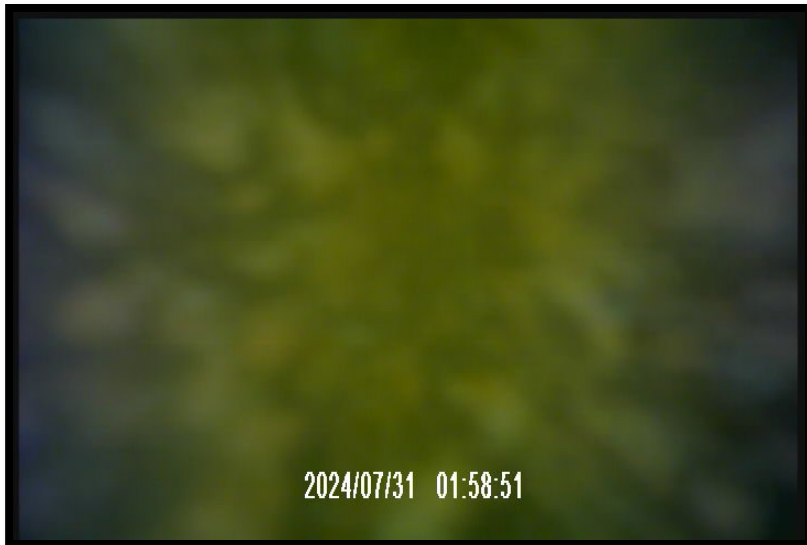
123

MW402D – low to no visibility

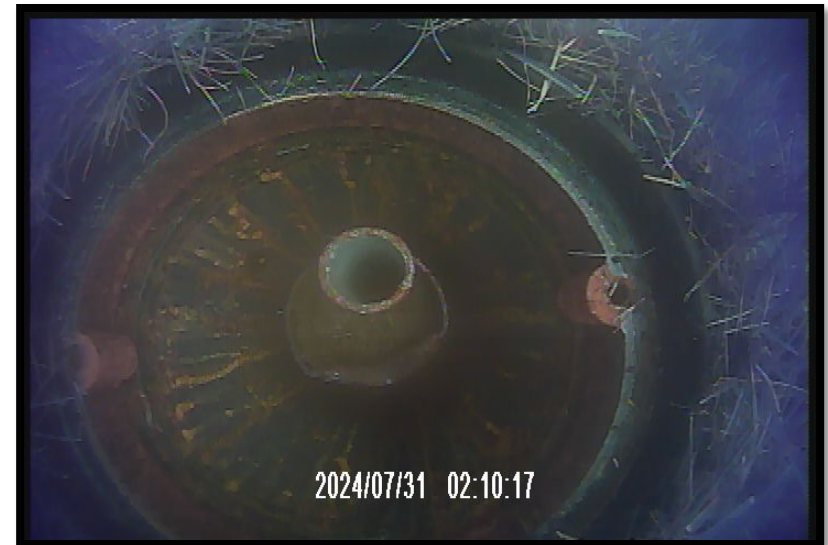
124

PS6 – well within flush mount, no cap when opened

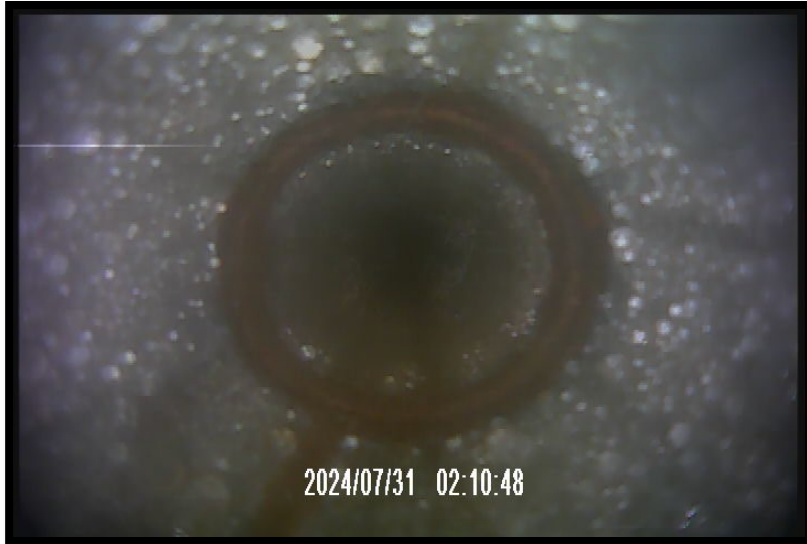
125

PS6 - joint

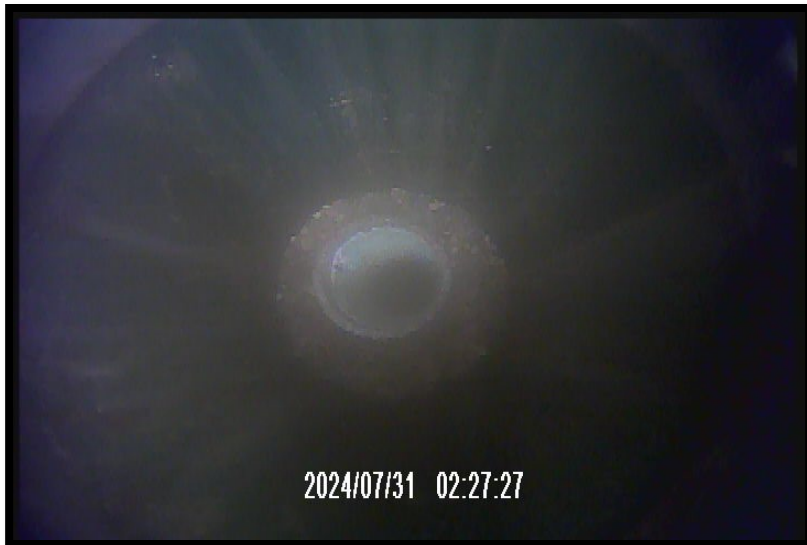
131

PSBD - well

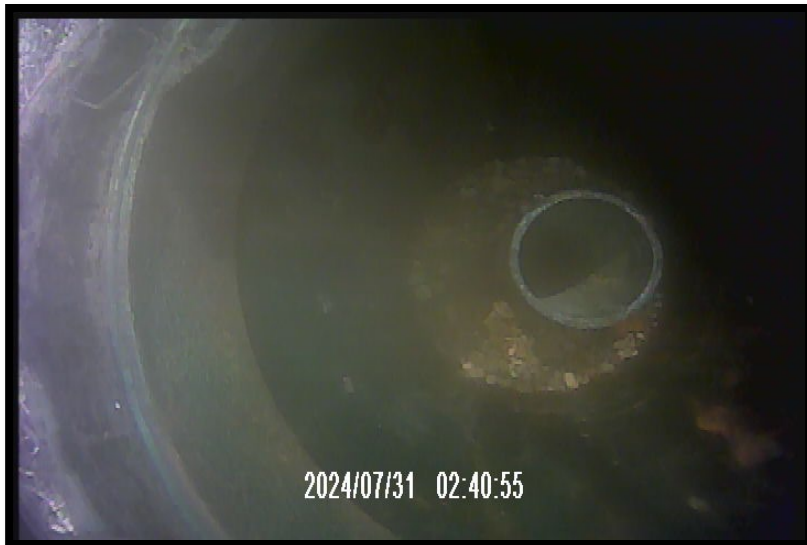
135

PSBS – well within flush mount

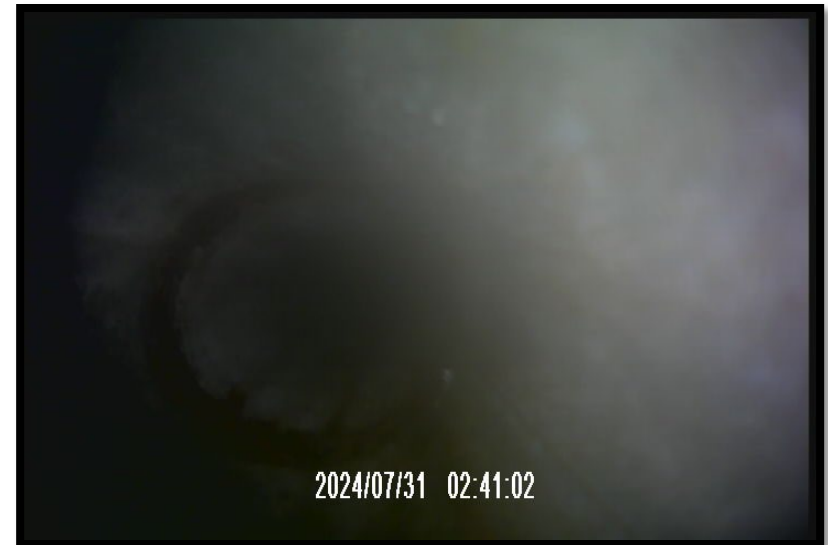
136

PSBS – low visibility joint

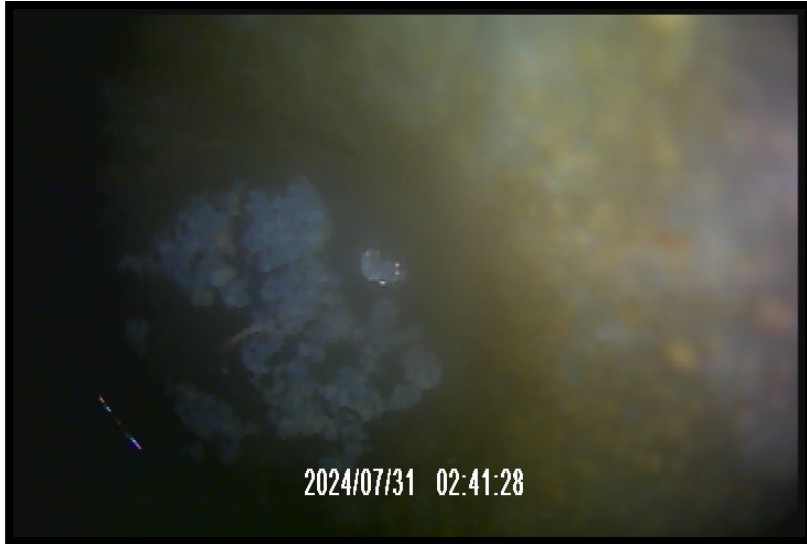
137

PSBS – “film” on top of water table

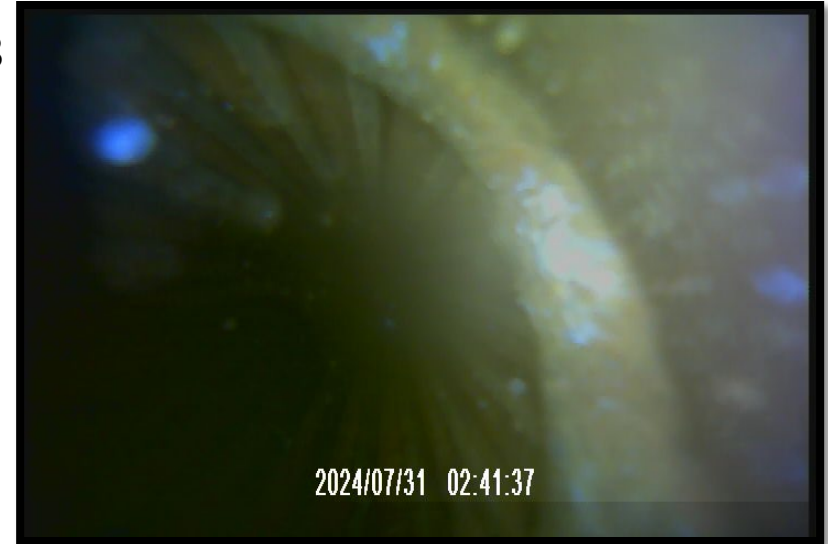
138

PSBS – top of screen, off center

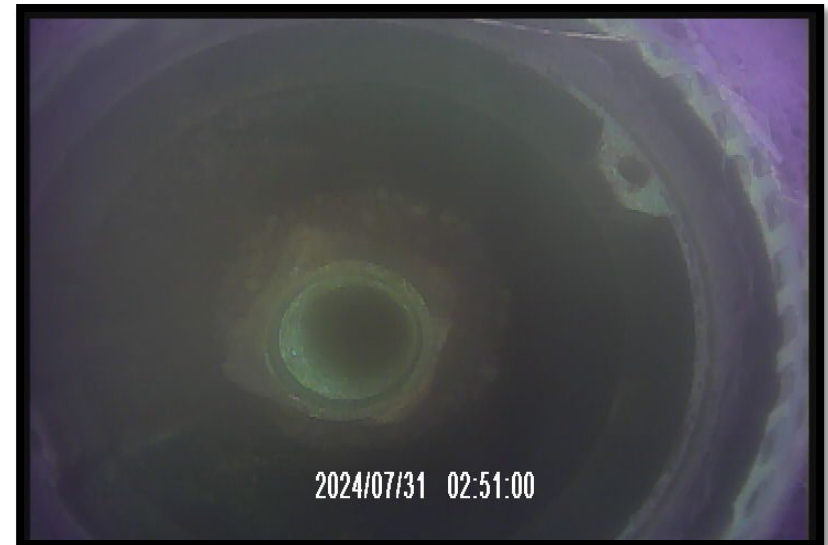
140

PS104 – well within flush mount

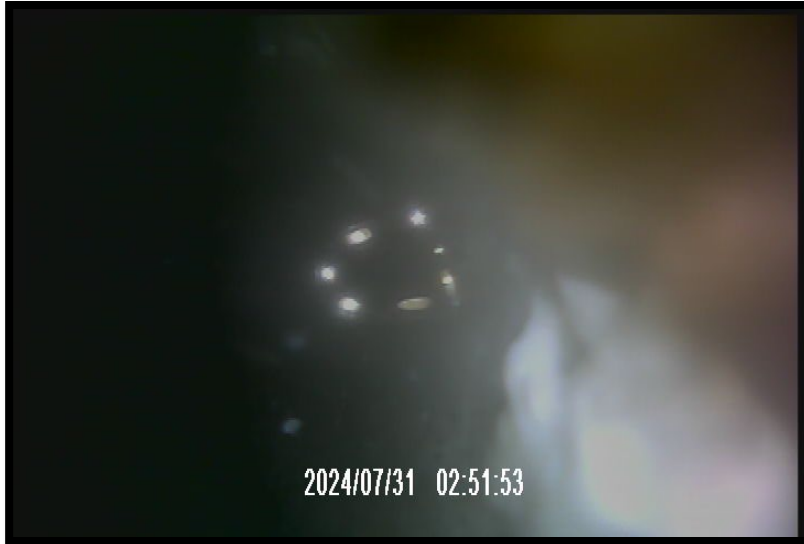
141

PS104 – reflection off water table

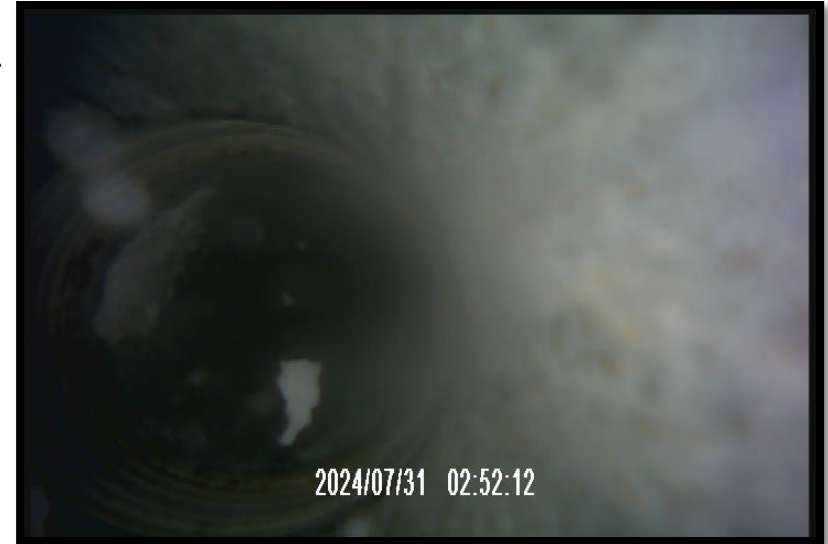
142

PS104 – low clarity joint

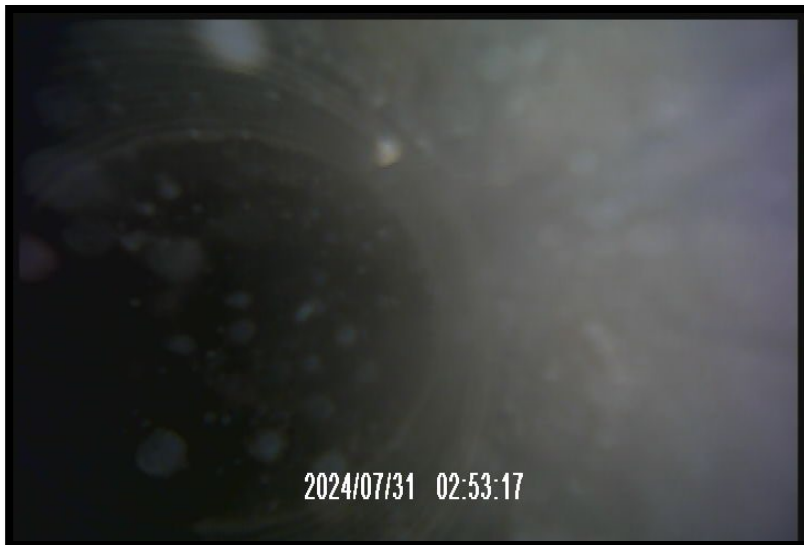
143

PS104 – low clarity joint
