**FIFTH FIVE-YEAR REVIEW REPORT FOR
PMC GROUNDWATER SUPERFUND SITE
EMMET COUNTY, MICHIGAN**

**U.S. Environmental Protection Agency
Region 5
CHICAGO, ILLINOIS**

3/5/2025

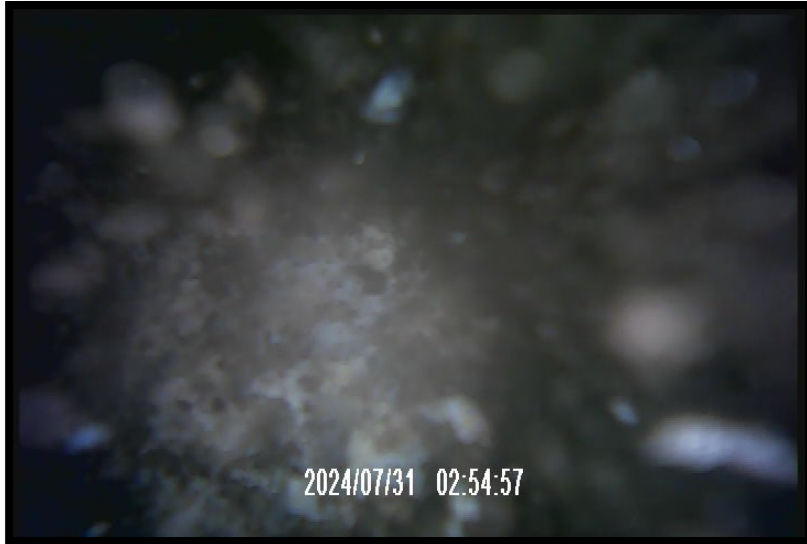
145

PS104 – bottom of well, high turbidity

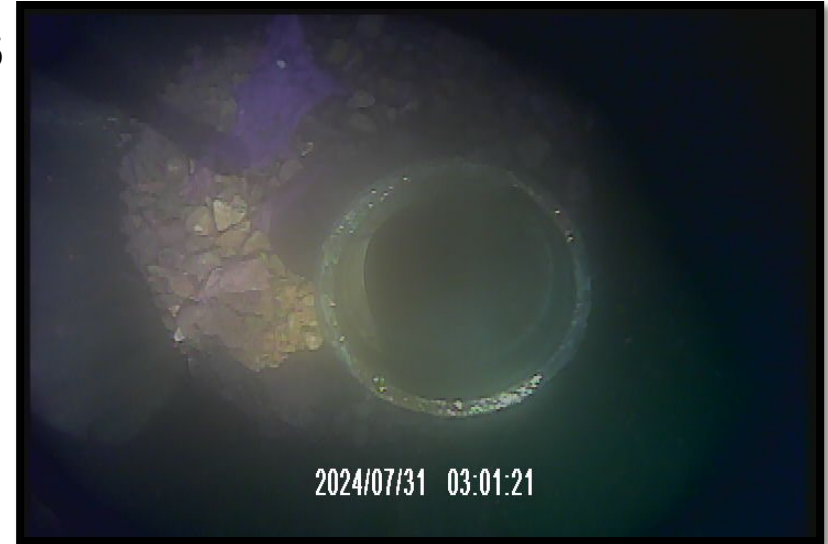
146

PS4 – well within flush mount

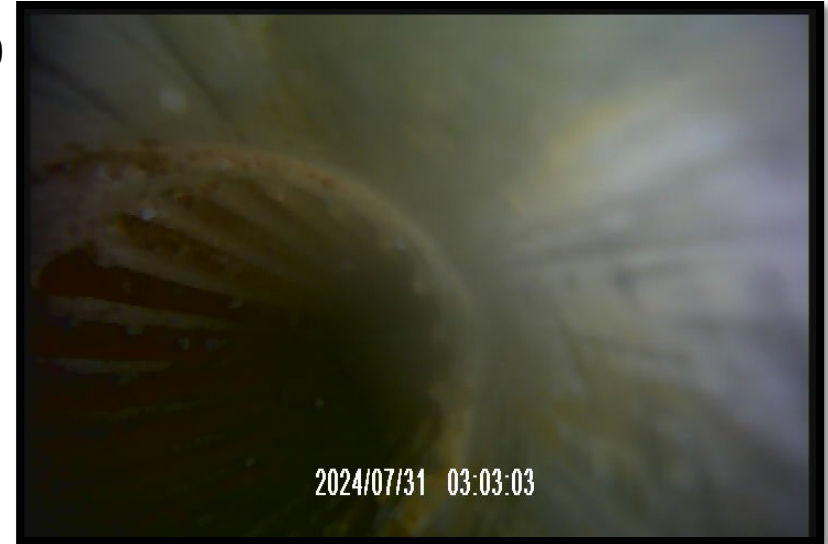
150

PS4 – top of screen

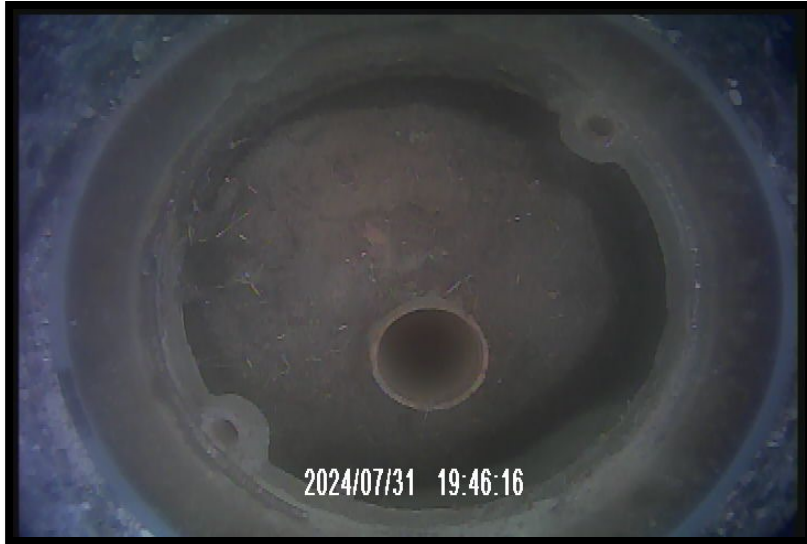
153

PS4 – bend in screen and build up along left side

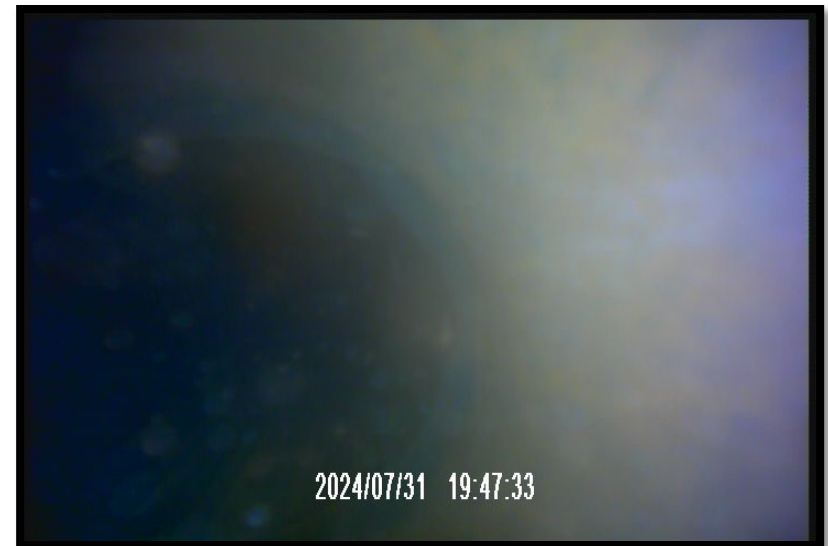
156

PSCS – top of water table

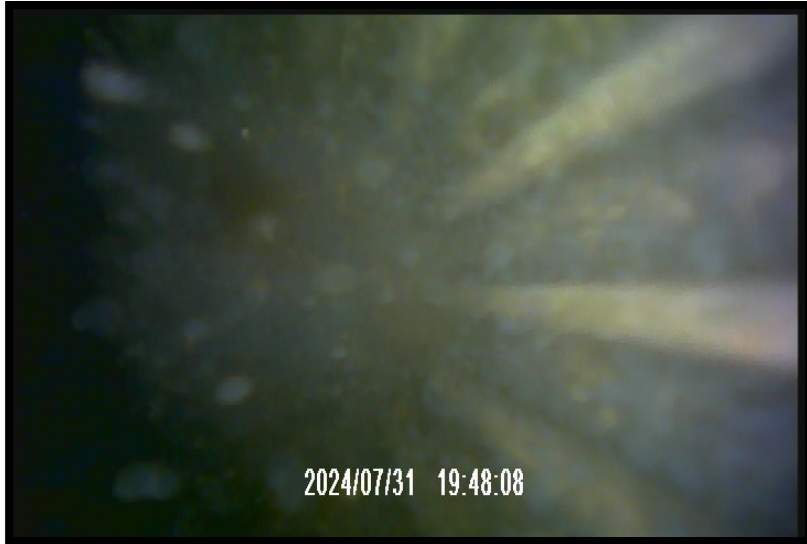
157

PSCS – very poor visibility, joint

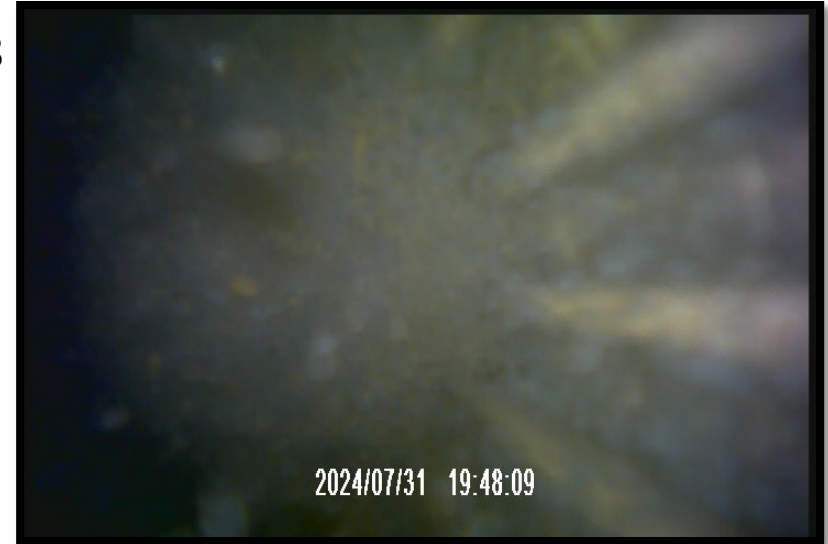
158

PSCS – high turbidity within screened interval

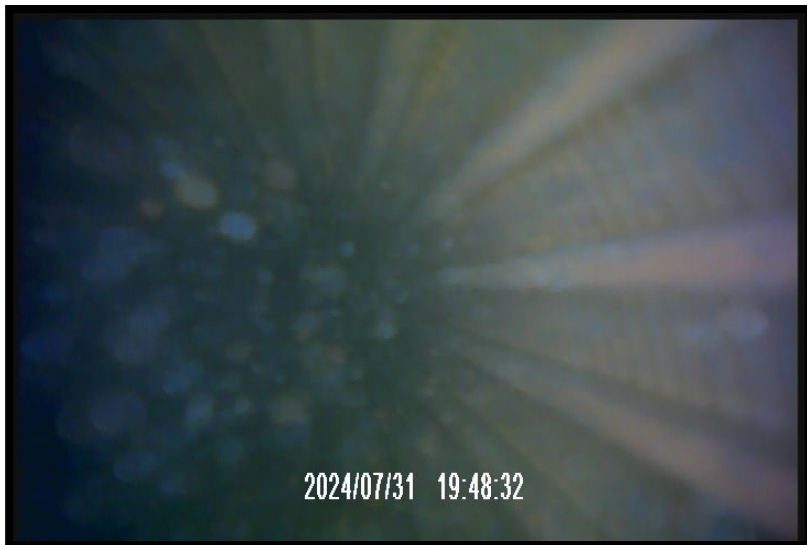
159

PSCS – high turbidity

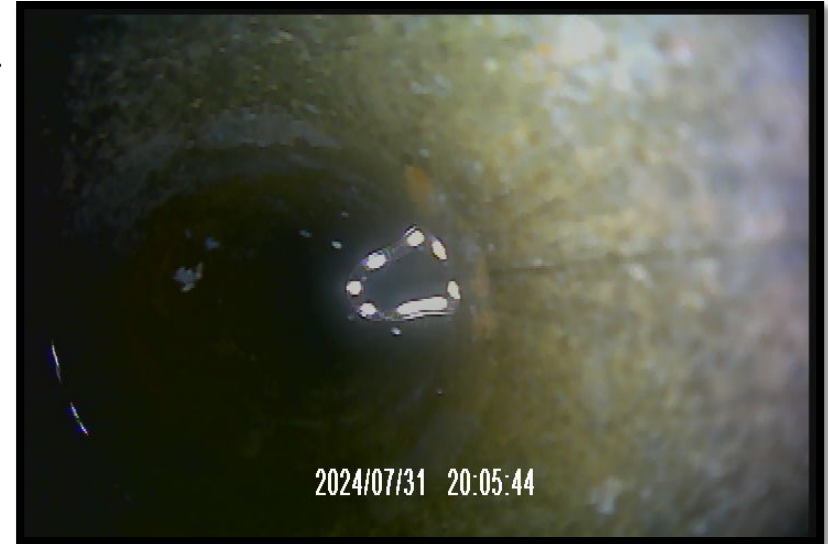
162

PS10A – rusty joint
