Memorandum

August 13, 2019

**Re: Northwest Slope Enhancement Completion Report
San Jacinto River Waste Pits Time Critical Removal Action**

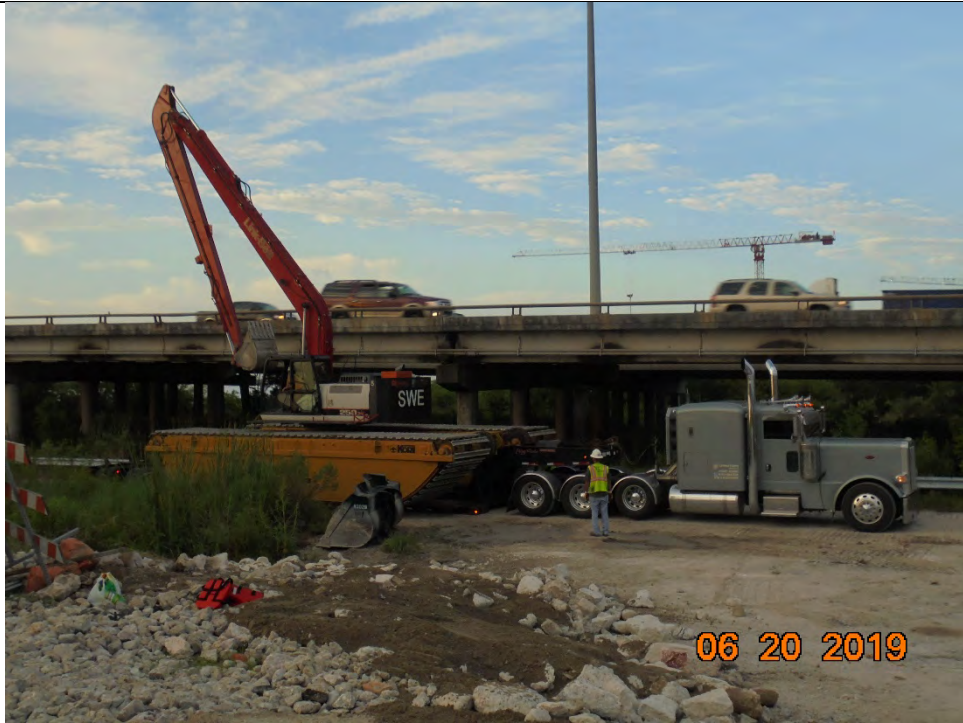
Photo 1 – Demobilization of SWE's marsh buggy
