**FINAL  
FIRST FIVE-YEAR REVIEW  
FOR THE  
ROCKWOOL INDUSTRIES, INC. SUPERFUND SITE  
BELTON, BELL COUNTY, TEXAS**

September 2012

### FIVE-YEAR REVIEW Rockwool Industries, Inc. Superfund Site EPA ID# TXD06637964

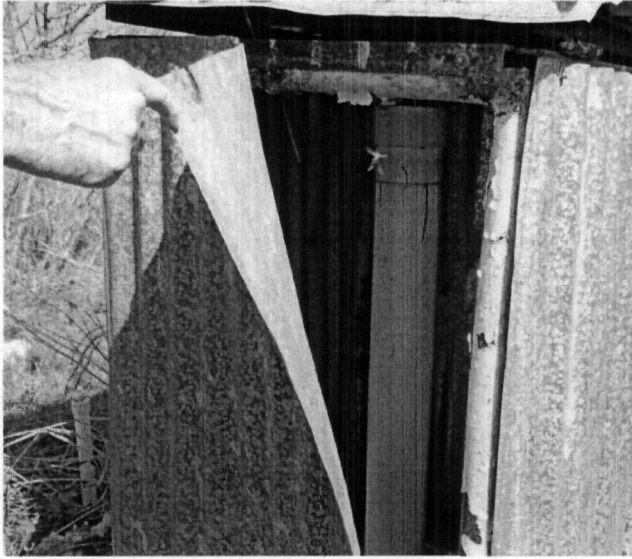
Photo 1. MW-07, no identification marker, enclosed in a corrugated metal housing.

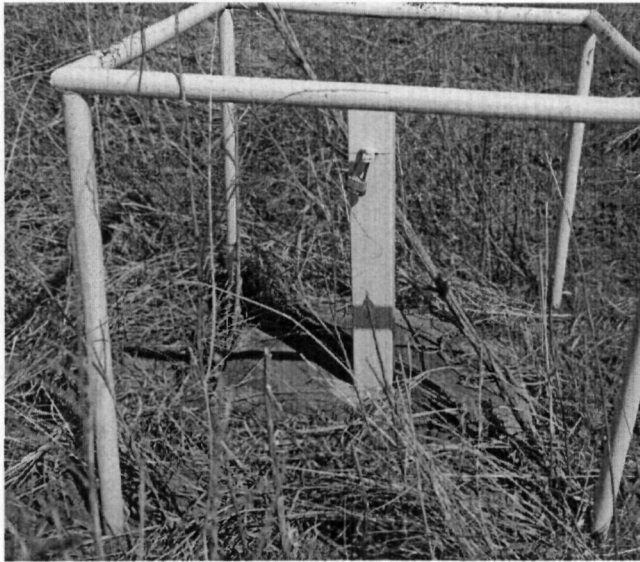
Photo 5. MW-14, has no identification marker

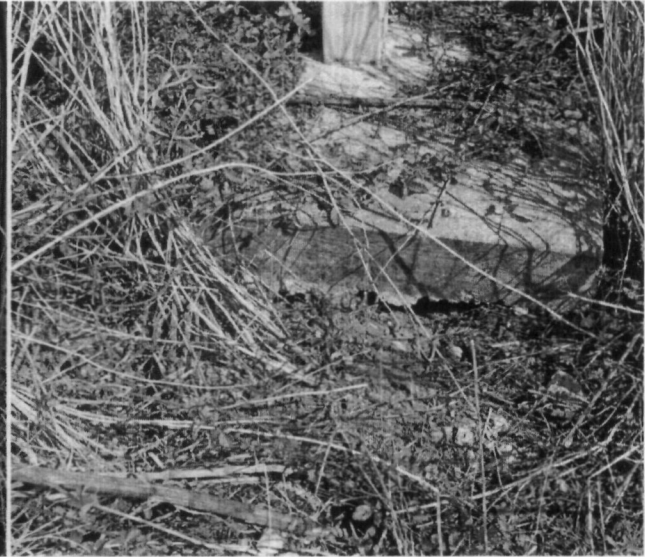
Photo 18. MW-28-90, soil has eroded out beneath the well pad.

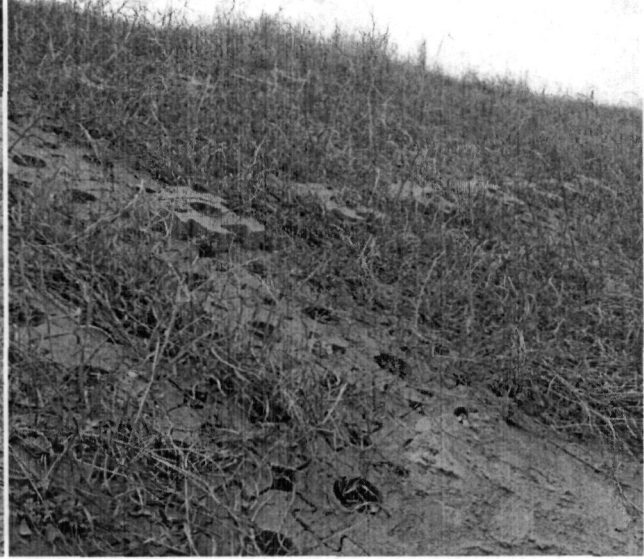
Photo 28. Looking west at ACB from the eastern edge.  
Note the raised concrete blocks.

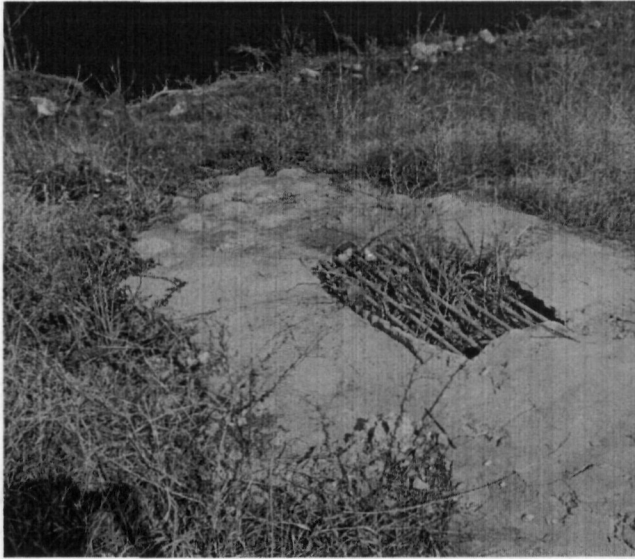
Photo 31. Clogged CMP outfall in stabilized Leon River bank.

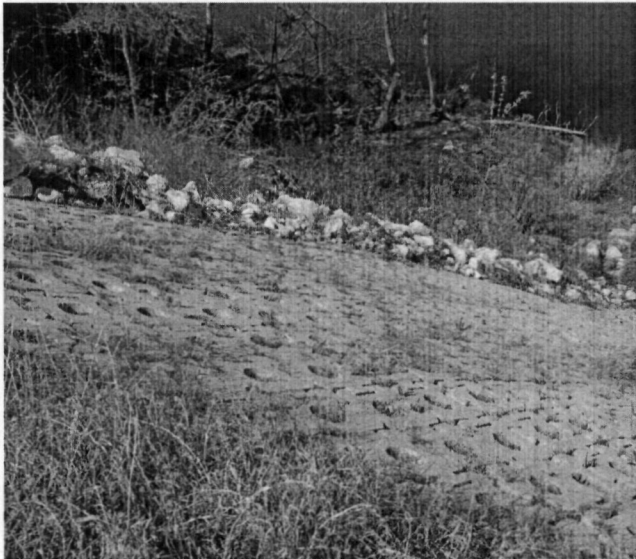
Photo 35. Western edge of the stabilized Leon River bank.

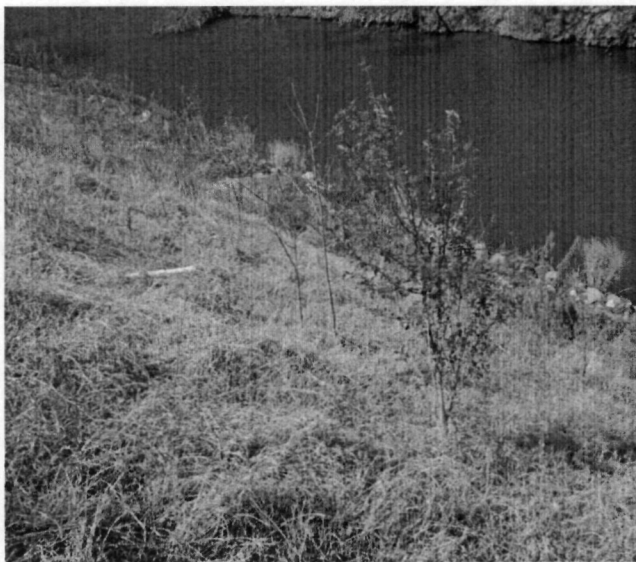
Photo 37. Small trees growing out of the ACB.

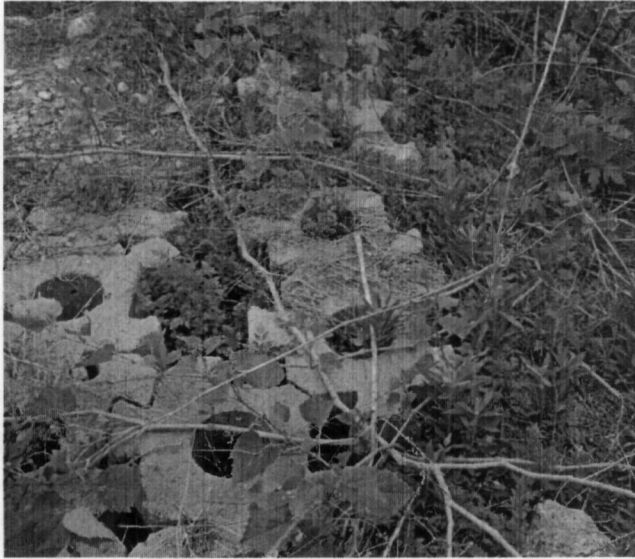
Photo 39. Instability and loss of continuity in the ACB at the toe of the LRB.

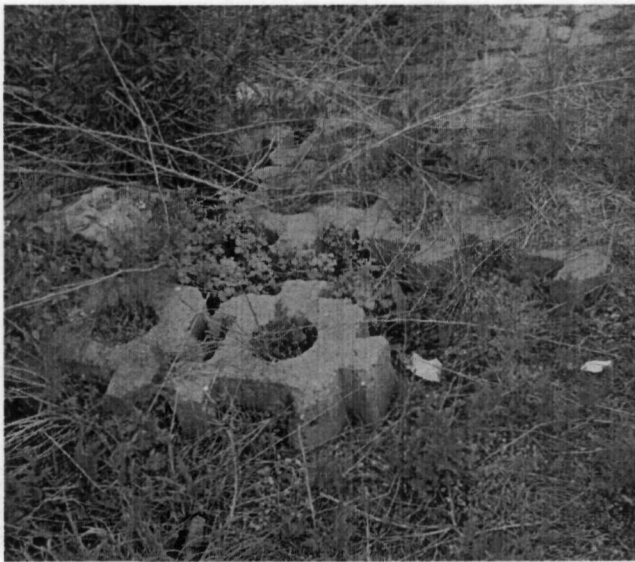
Photo 41. Instability and loss of continuity in the ACB at the toe of the LRB.

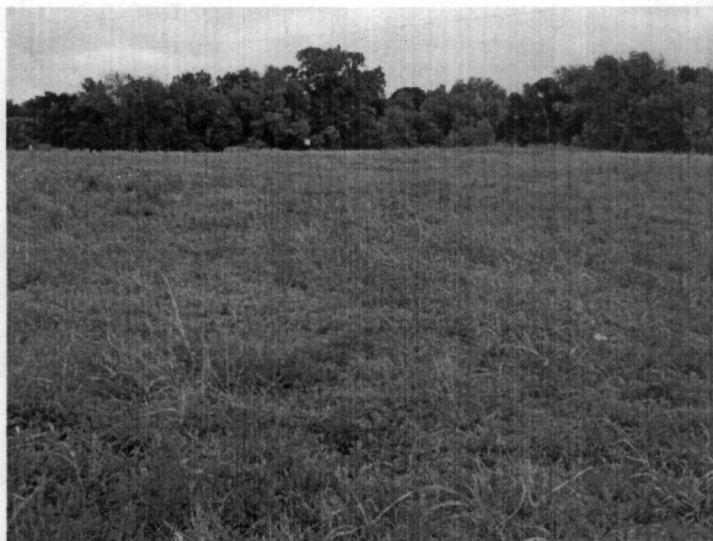
Photo 49. Good grass cover over EVL cap.

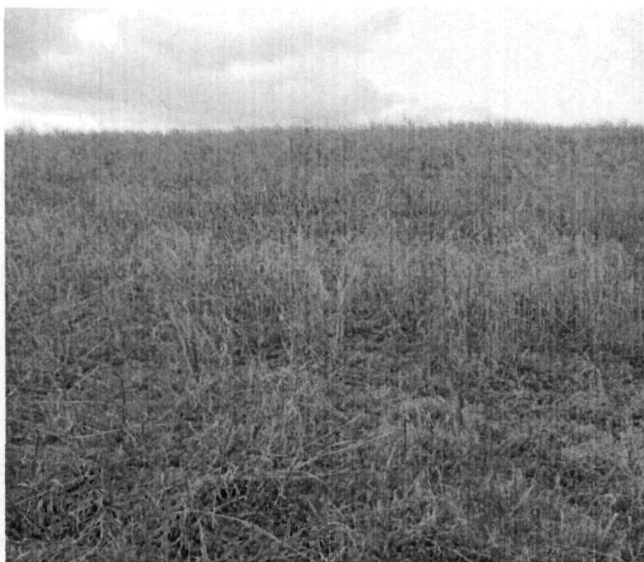
Photo 50. Northern slope of the NSP.

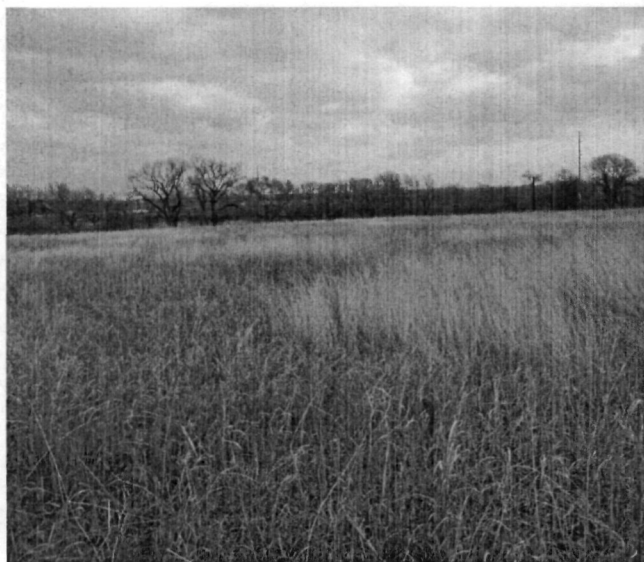
Photo 52. Grass cover on the top of the NSP.

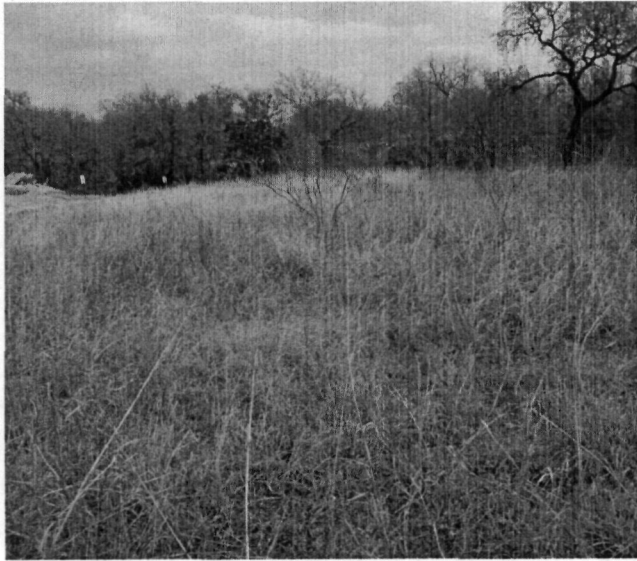
Photo 53. Grass cover on the top of the CSP.

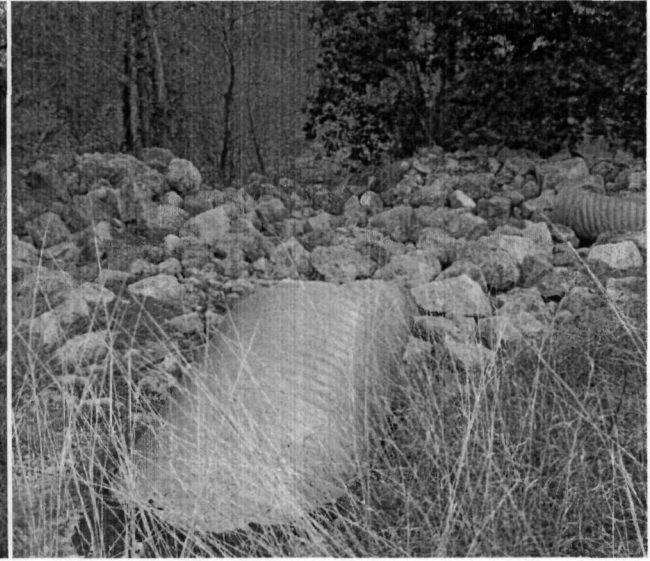
Photo 54. CMP outfalls at the northern edge of the CSP.

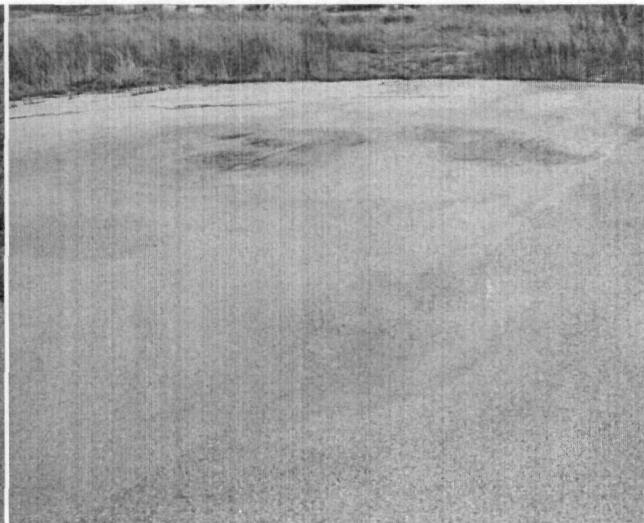
Photo 61. Area where water stands near the edge.

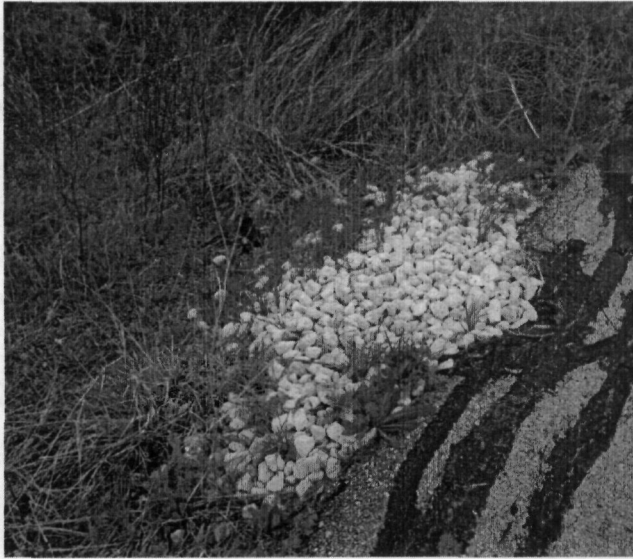
Photo 62. Rip rap along the southern edge of the CC.

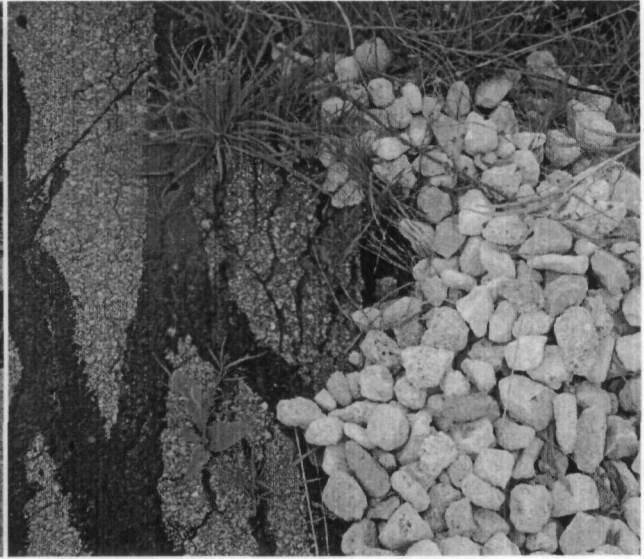
Photo 63. Rip rap along the southern edge of the CC. The hole in the rip rap indicates that erosion may still be occurring.

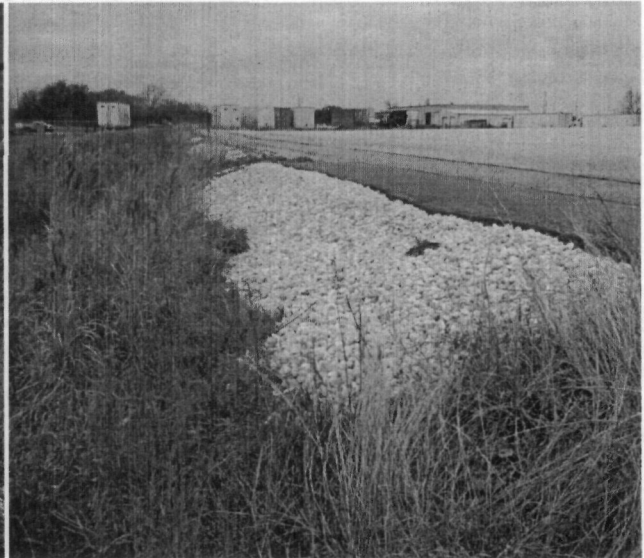
Photo 65. Rip rap and repaired cap along the southern edge of the CC.

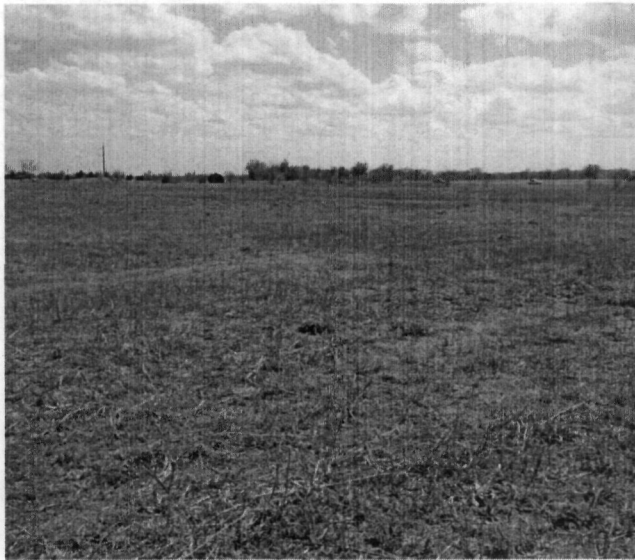
Photo 70. SSP waste capped in place.

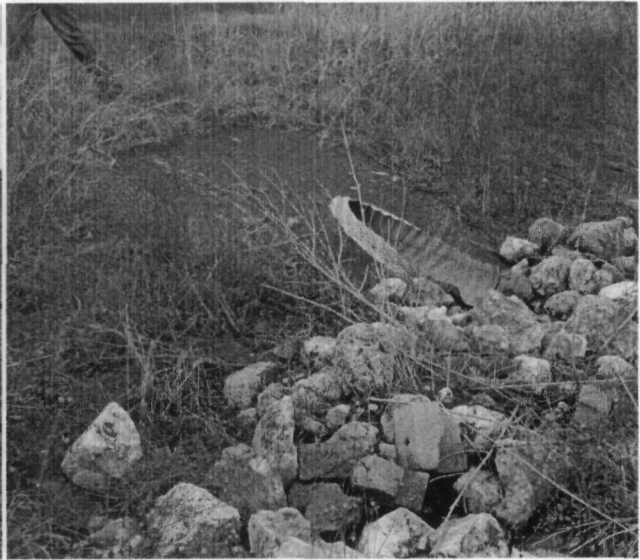
Photo 71. Detention basin outlet pipe.

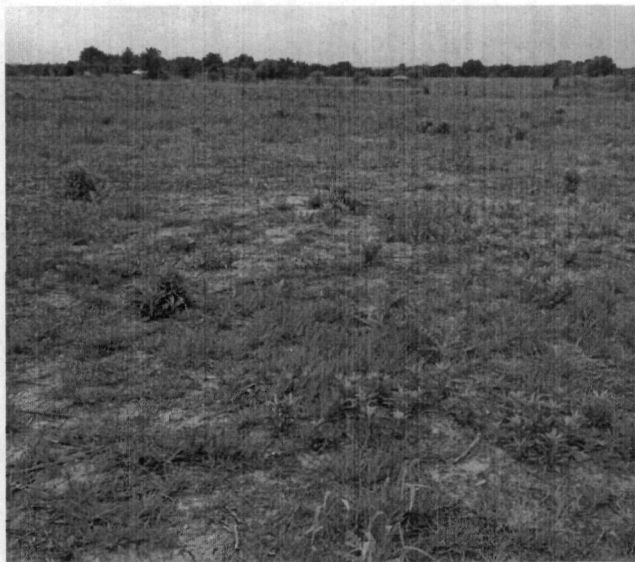
Photo 72. Sparse vegetation cover over SSP waste capped in place.
