RE: 2013 Five-Year Review Report
Naval Air Station (NAS) Patuxent River
Patuxent River, Maryland

Five-Year Review Report

Figure 1-2
Locations of ER Sites
2013 Five-Year Review Report
NAS Patuxent River
St. Mary's County, Maryland

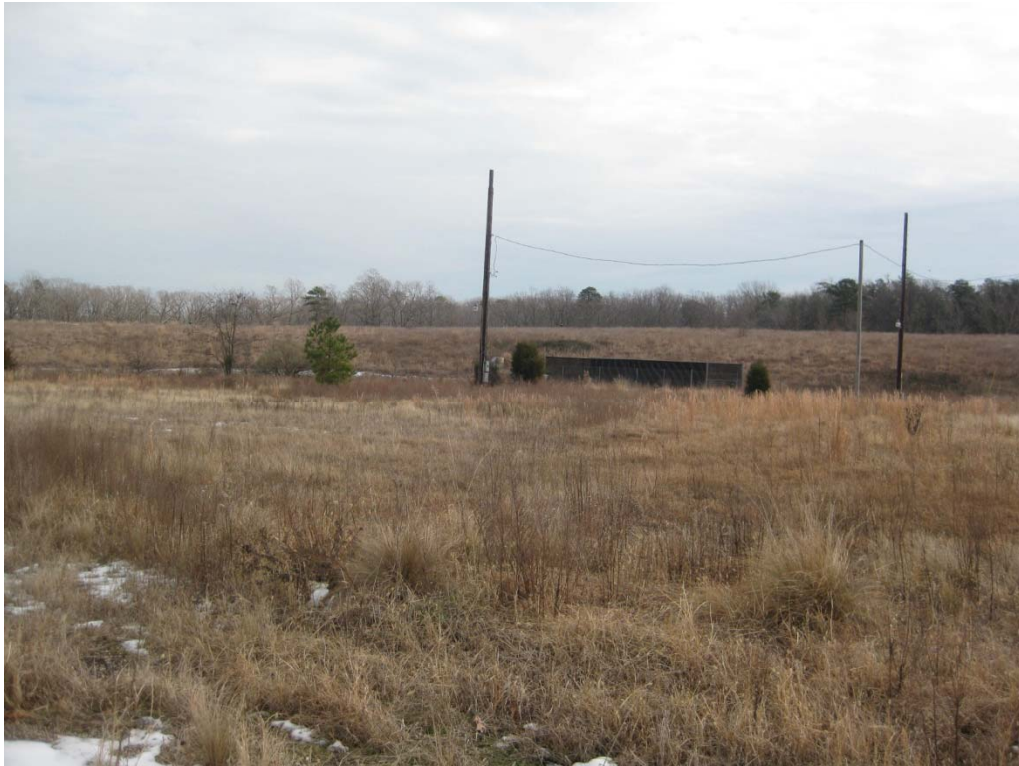
December 22, 2010 Site 11 Inspection

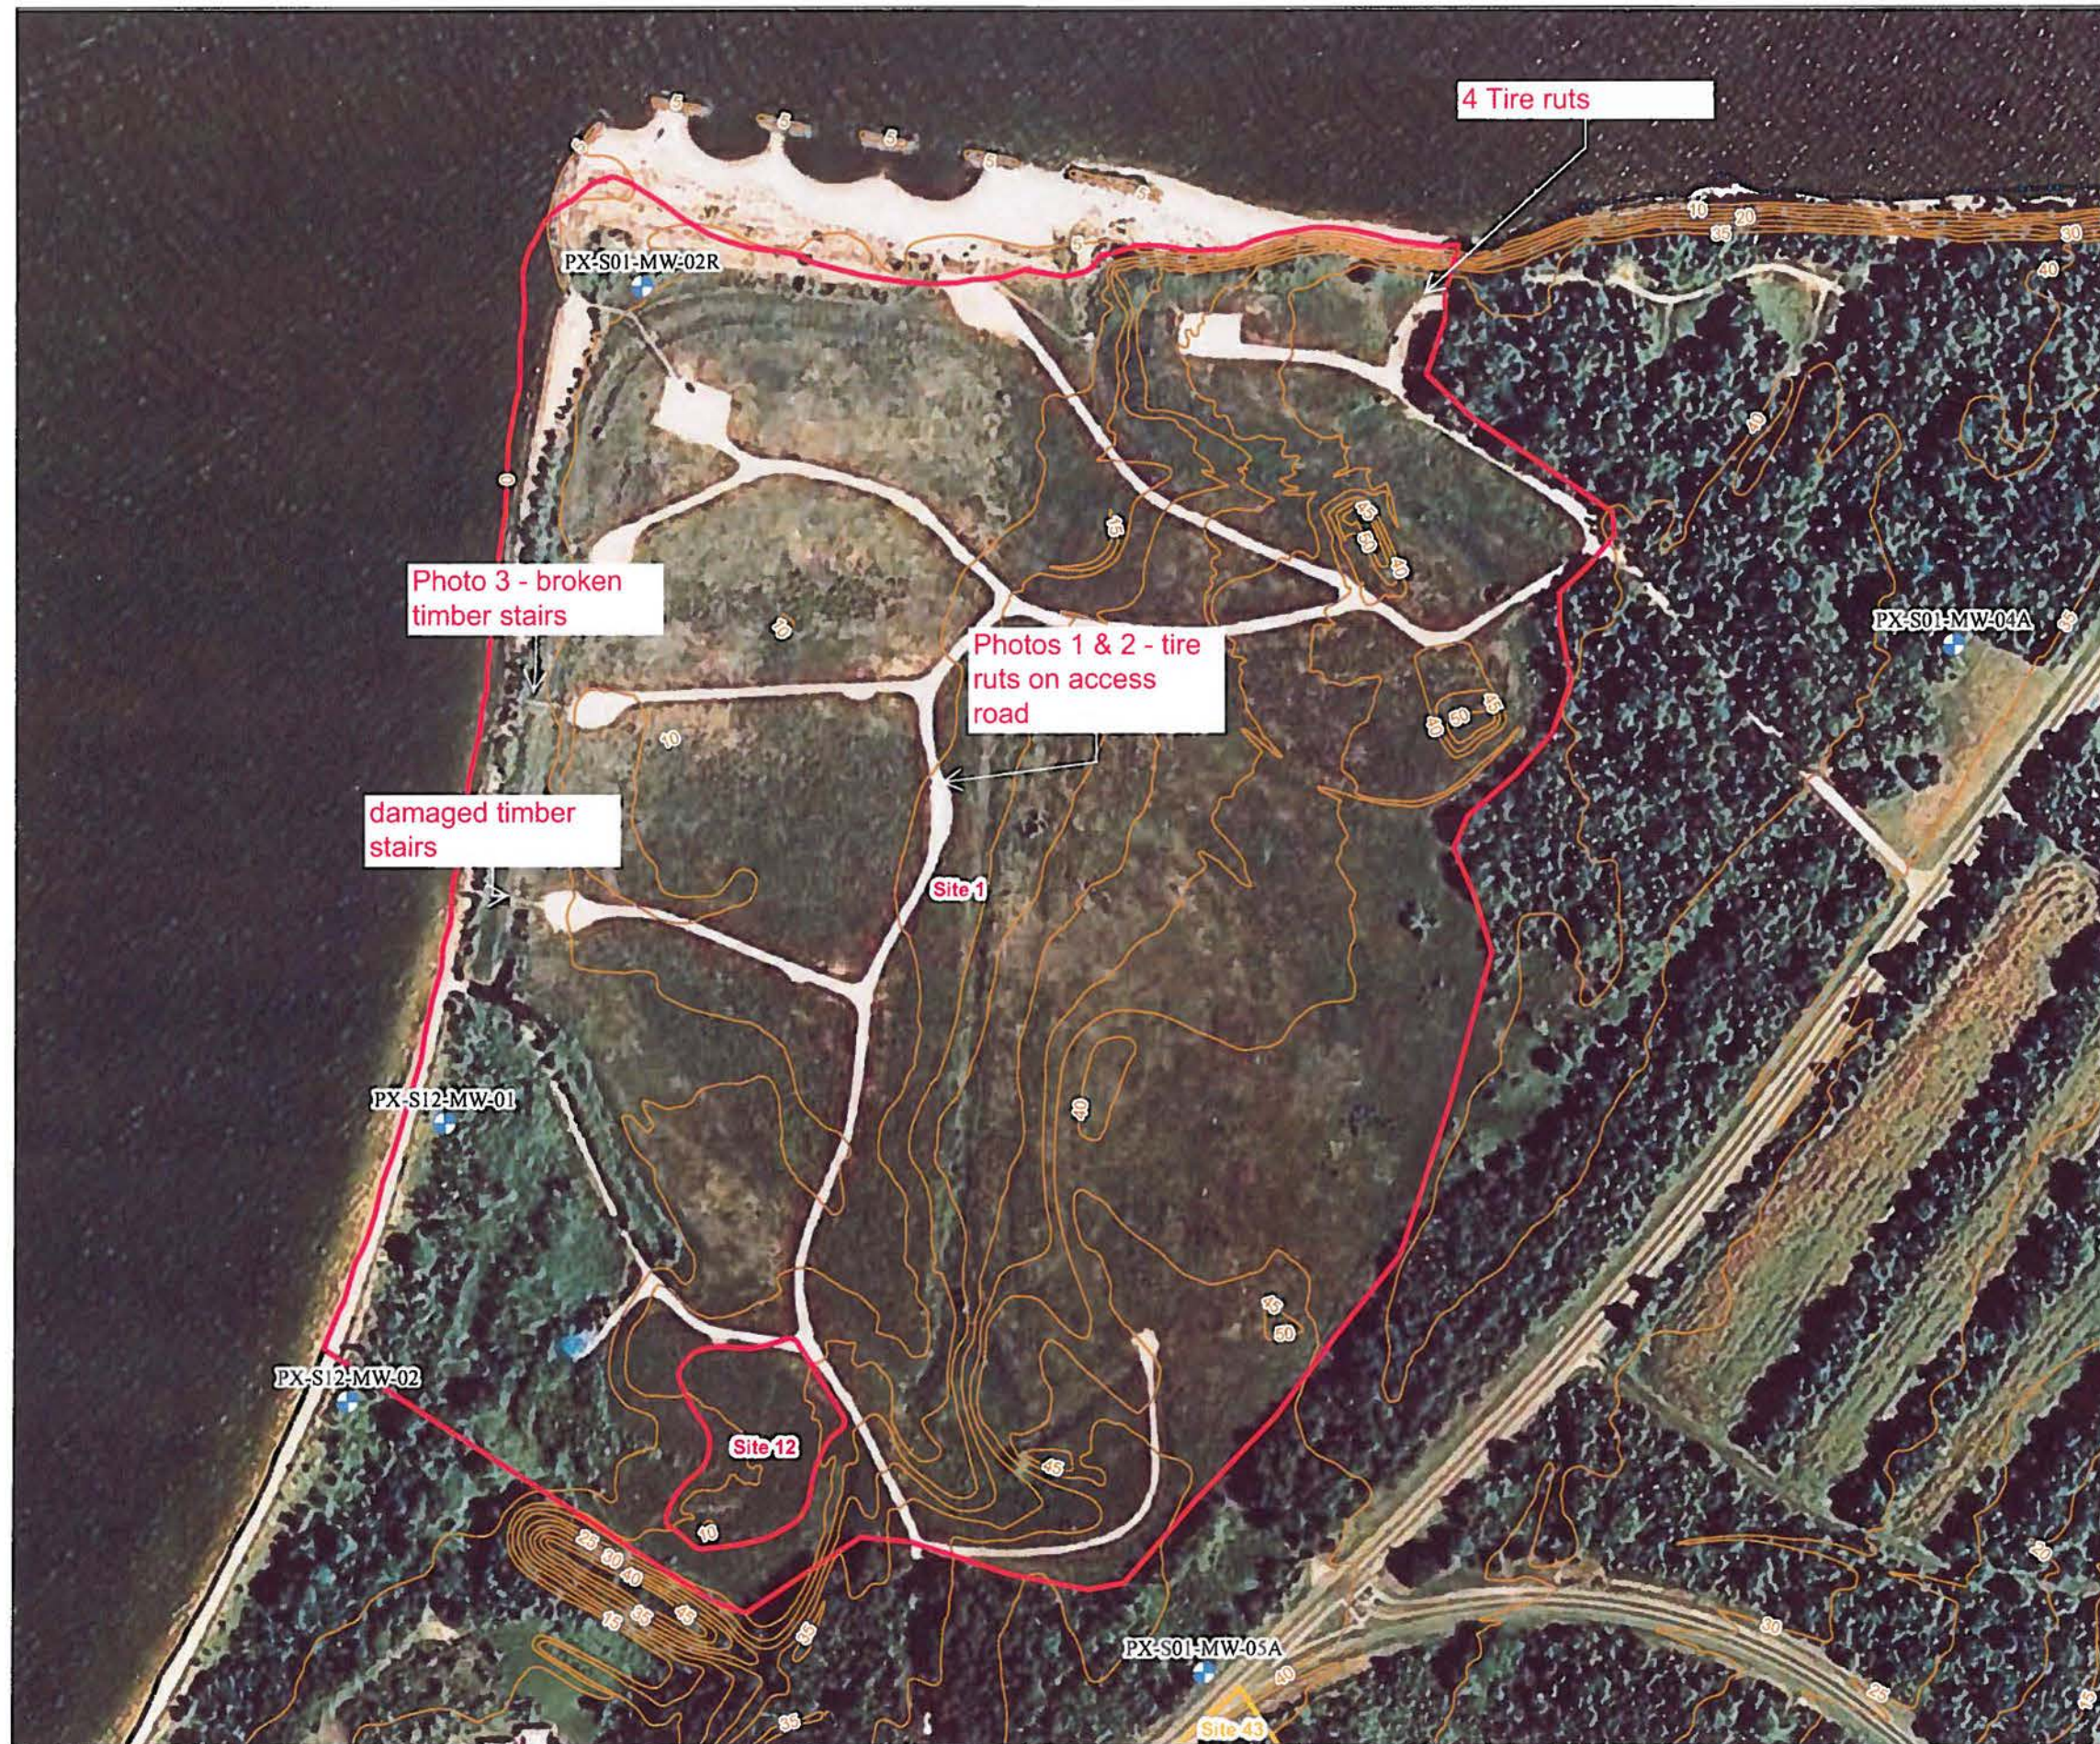
Observations w/photo #
from June 2, 2011
Semiannual Landfill Cap
Inspections

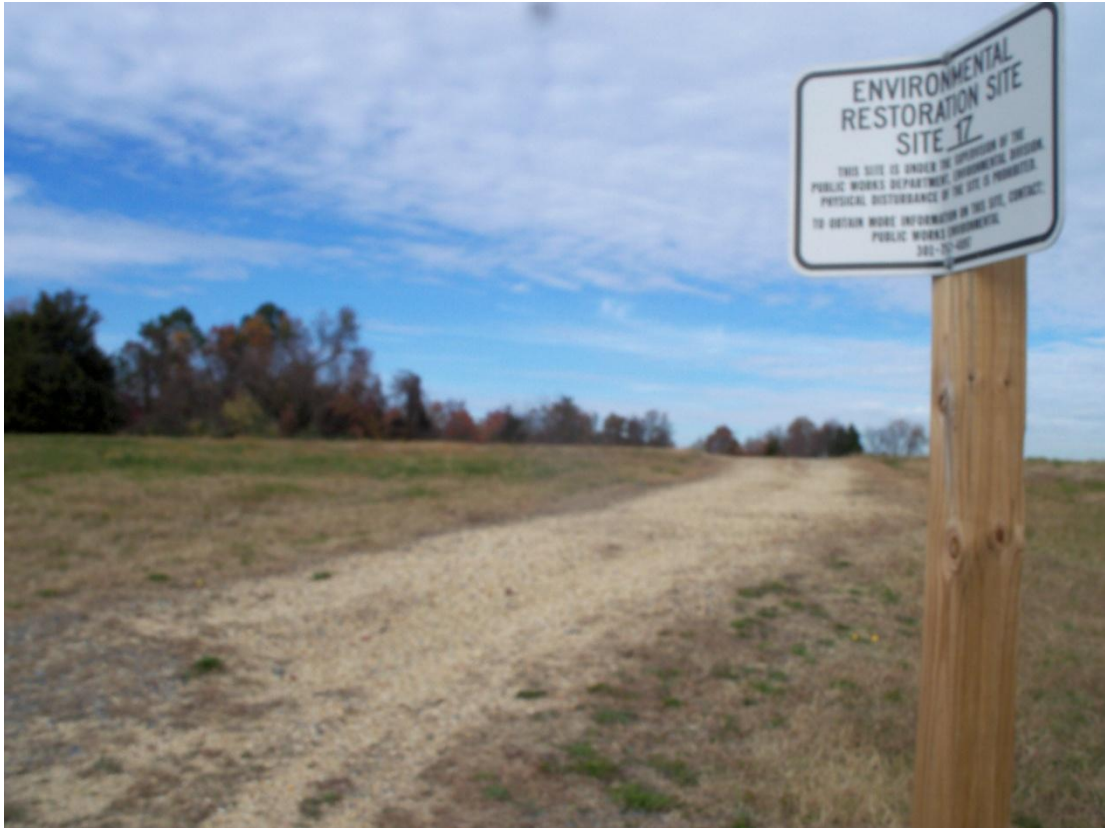
View of gravel road and entrance sign at Site 17.
