Memorandum

Re: San Jacinto River Channel Slope Maintenance Completion Report

Re: Revised Plan for Armor Rock Placement Adjacent to the Time Critical Removal Action
Armored Cap, San Jacinto River Waste Pits Superfund Site, Channelview, Texas

July 2016 Quarterly Inspection Report

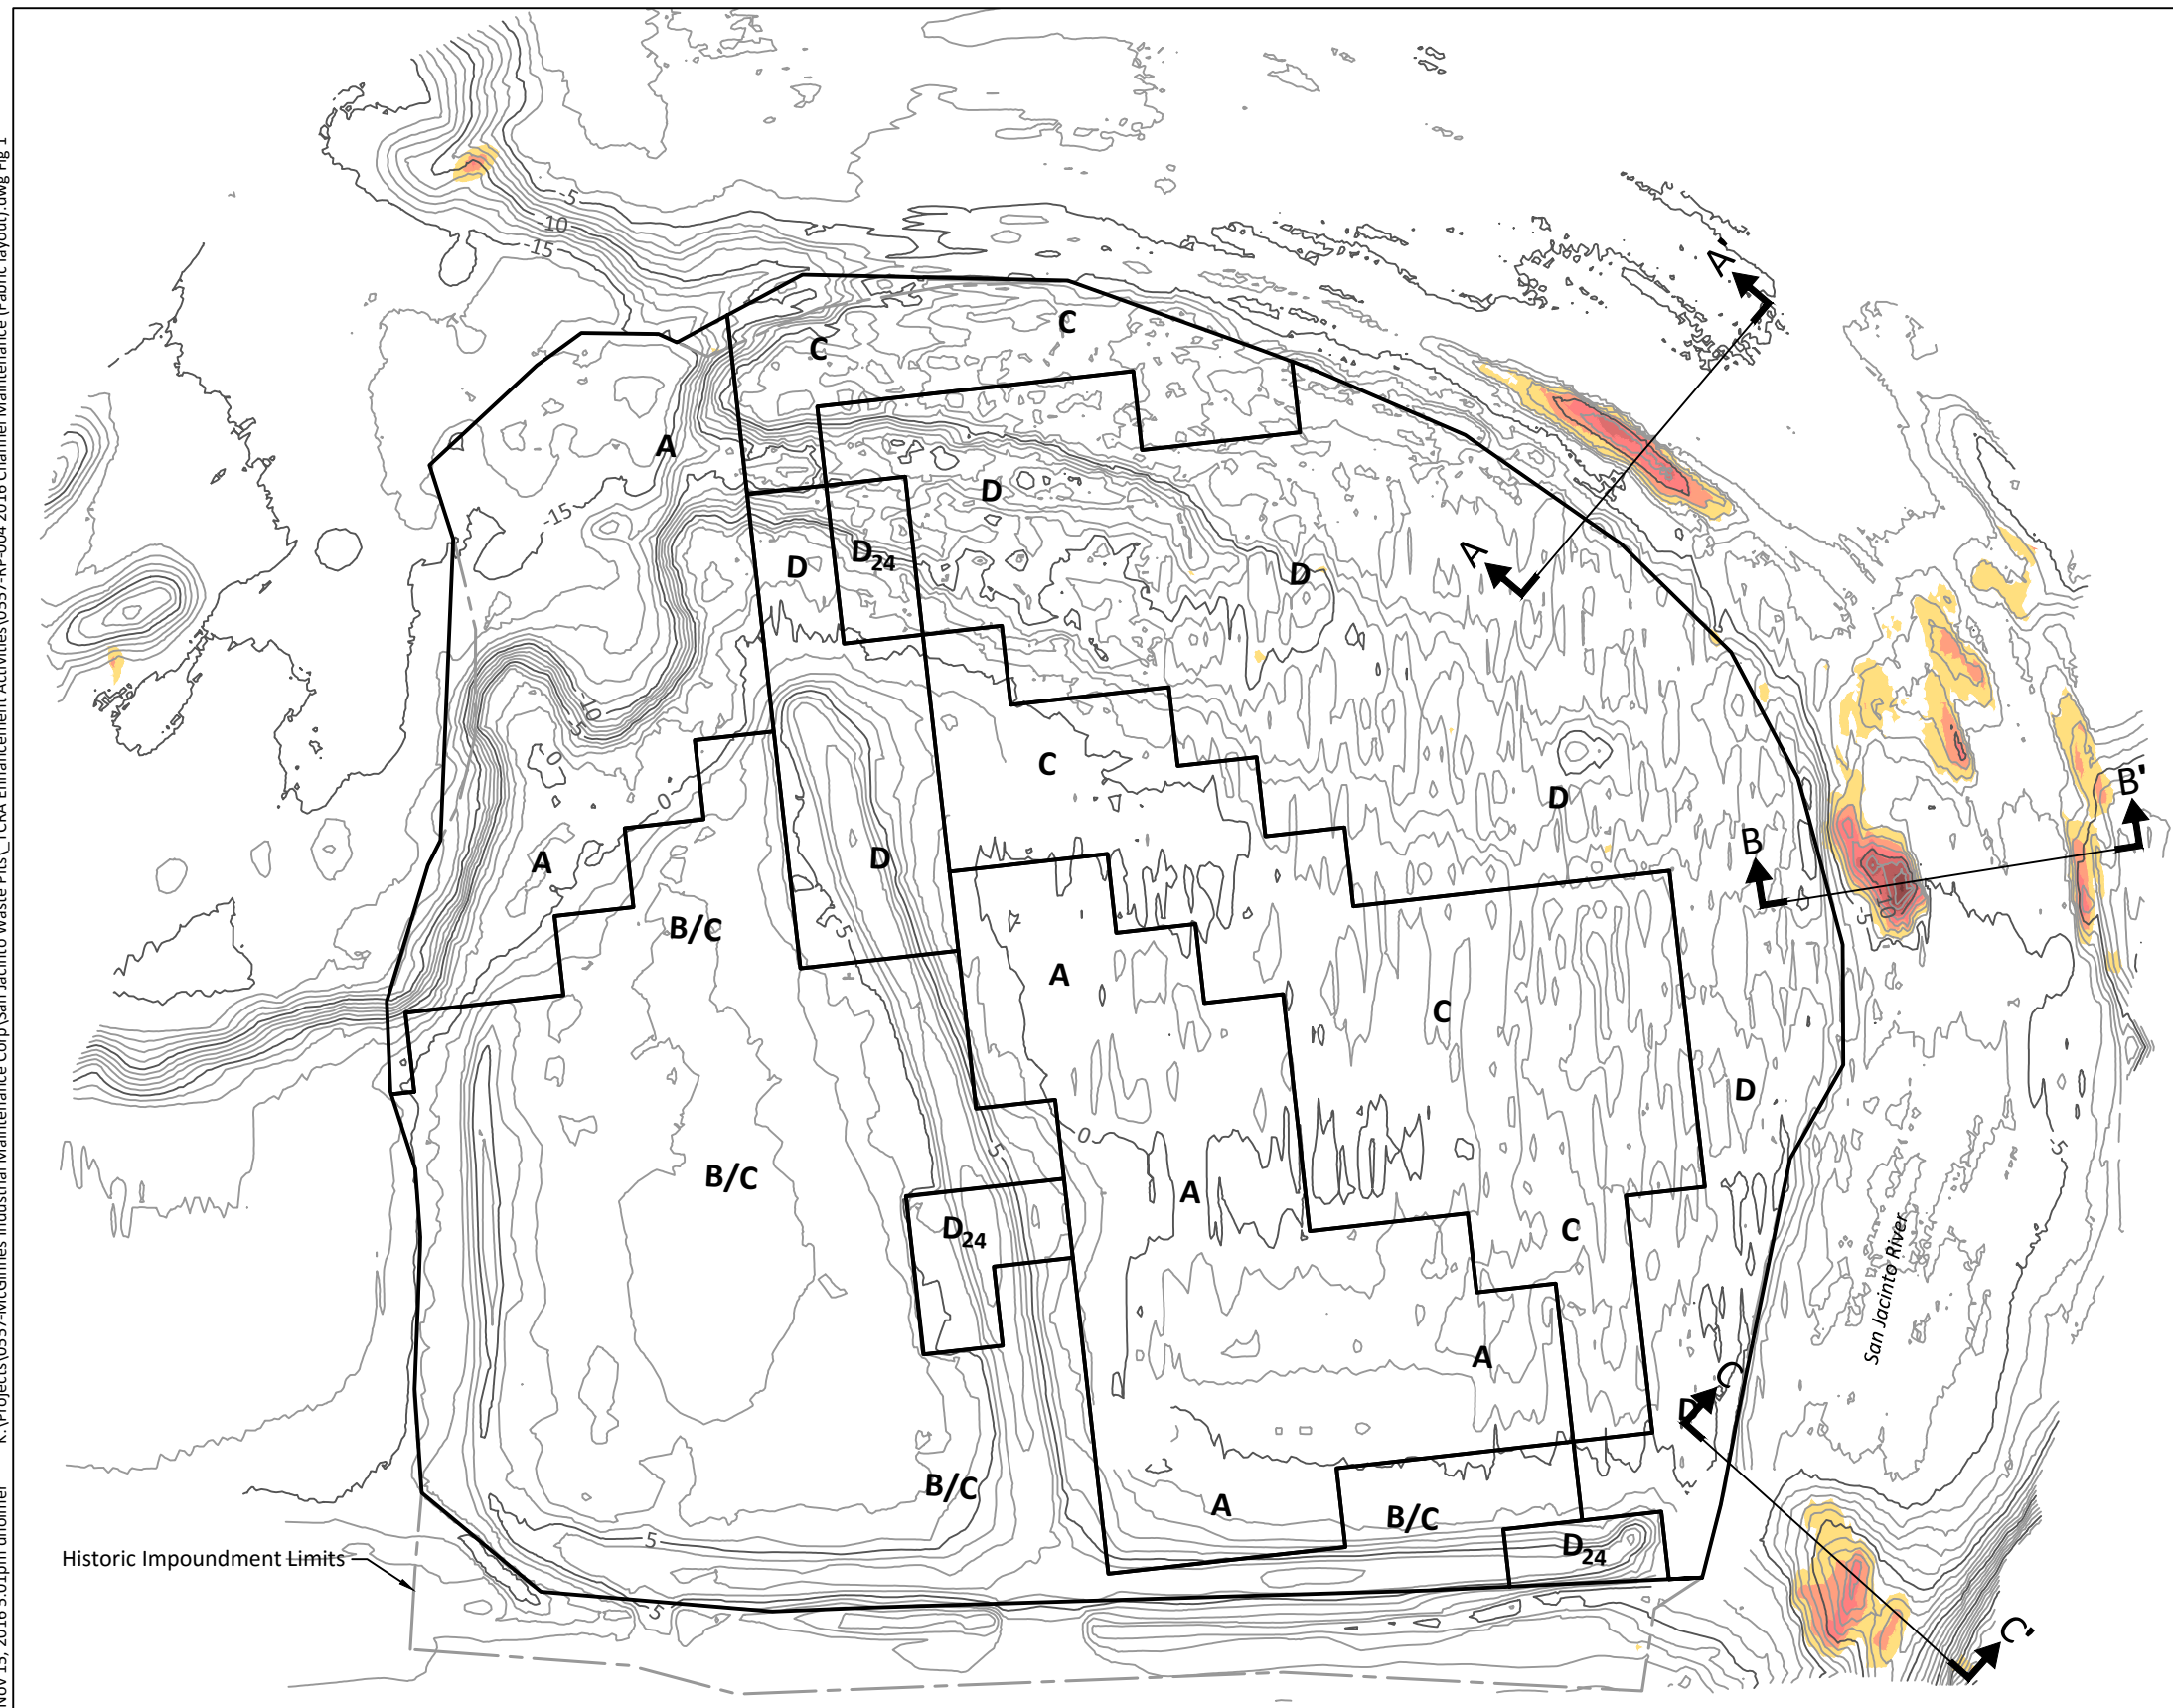
K:\Projects\0557-McGinnes Industrial Maintenance Corp San Jacinto Waste Pits\TCRA Enhancement Activities\0557-RP-004 2016 Channel Maintenance (Fabric layout).dwg Fig 1

the TCRA Operations, Monitoring, and Maintenance Plan (Anchor QEA 2011).¹ The deeper areas are likely the result of high flows during large storm events that occurred between April and June 2016. One storm, in May 2016, was between a 20- and a 50-year return interval storm based on river stage elevations measured at US-90. The Armored Cap was not damaged by this flood; however, this plan proposes to fortify the area shown in Cross Section B of Figure 2.

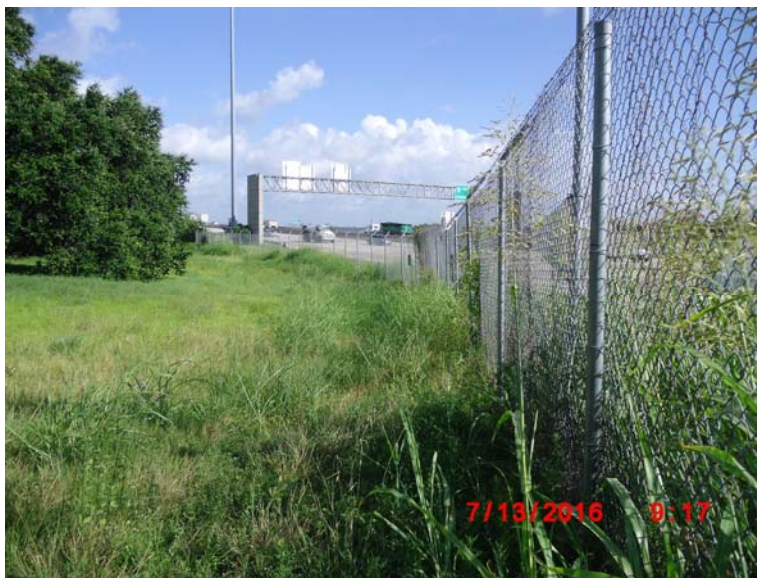
The perimeter fencing (Figure 2) on the west and east banks of the San Jacinto River was visually inspected for breaches or other signs of damage on July 13, 2016. The fencing on the west bank on the south side of I-10 was observed to be detached at the bottom and pushed away about 1 foot from the fence posts. Based on the debris build up on the ground, the damage was likely caused by high river levels during recent flood events in June 2016. Repairs of the fencing began on July 27, 2016 and were completed on July 29, 2016. The repairs to the fencing included pulling the fence back into place, replacement of the lower tension wires, and replacement of the couplings holding the fabric to the fence in the affected area. Photographs 17 and 20 in Appendix A show the damaged and repaired fence. No other breaches or signs of fence damage were observed during the inspection of the perimeter fencing on either the east bank south of I-10 or west bank north of I-10. For examples, see Photographs 14 through 16 in Appendix A.

Photograph 15: Perimeter fence located south of I-10 on east bank (view northwest)

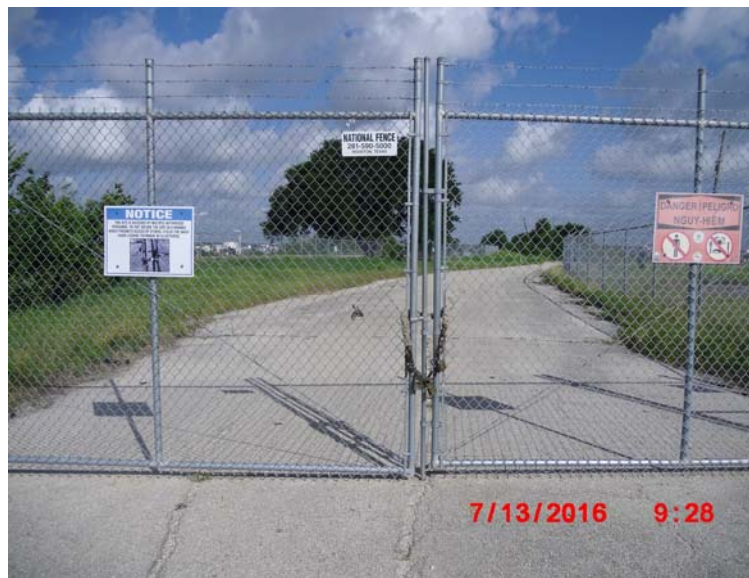
Signage on all locked gates reminds entrants to “daisy chain” the locks properly prior to leaving the TCRA Site, as seen in Photograph 16. These signs were observed to be in place and undamaged. Table 1 summarizes the condition of the TCRA Site signage described in this section.

Photograph 16: Signage and access gate located south of I-10 on east bank (view west)

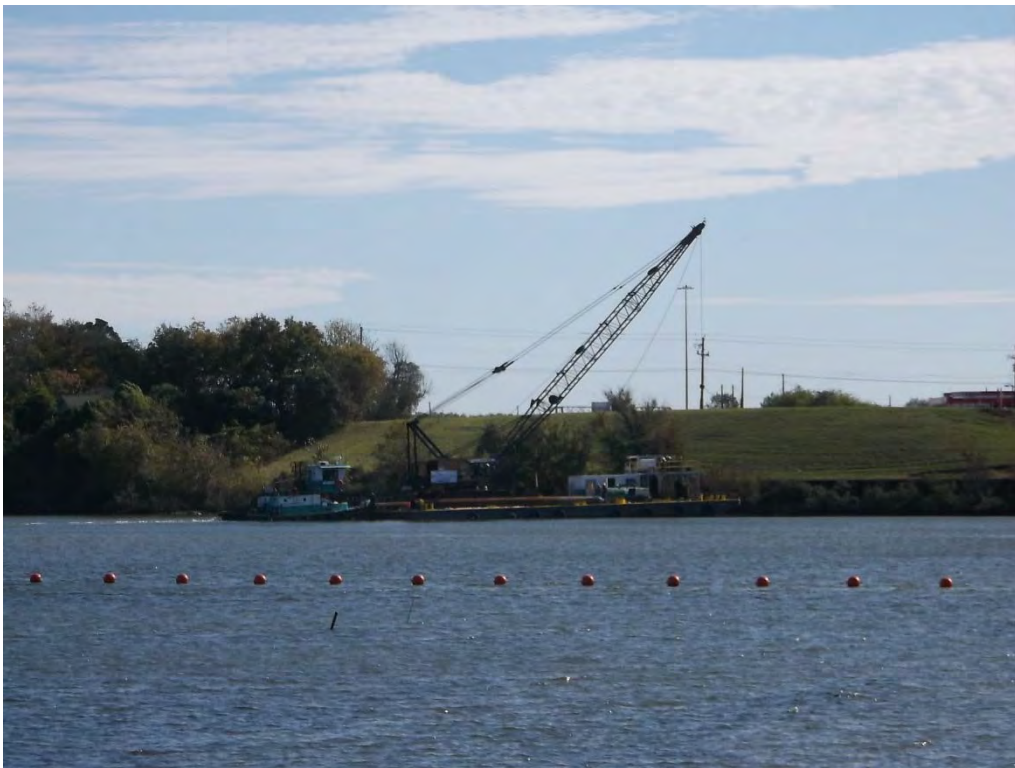
Photograph 3: Commencement of geotextile placement

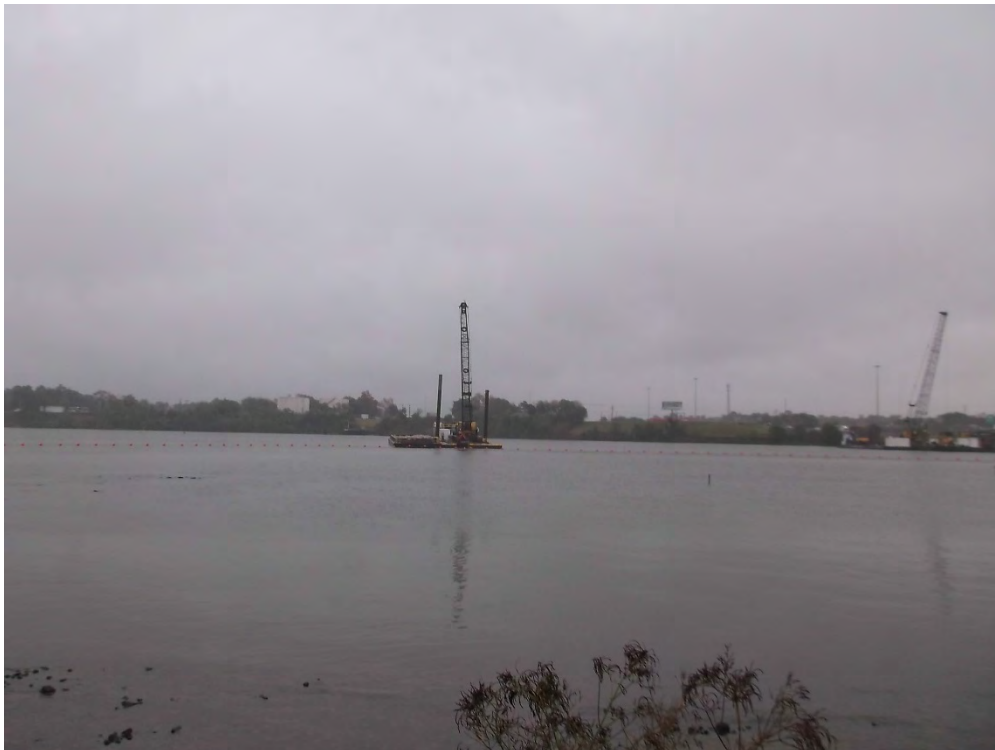
Photograph 3: Orion placing rock on panels 2 and 3 for the day (panels 5 and 6 for the job)

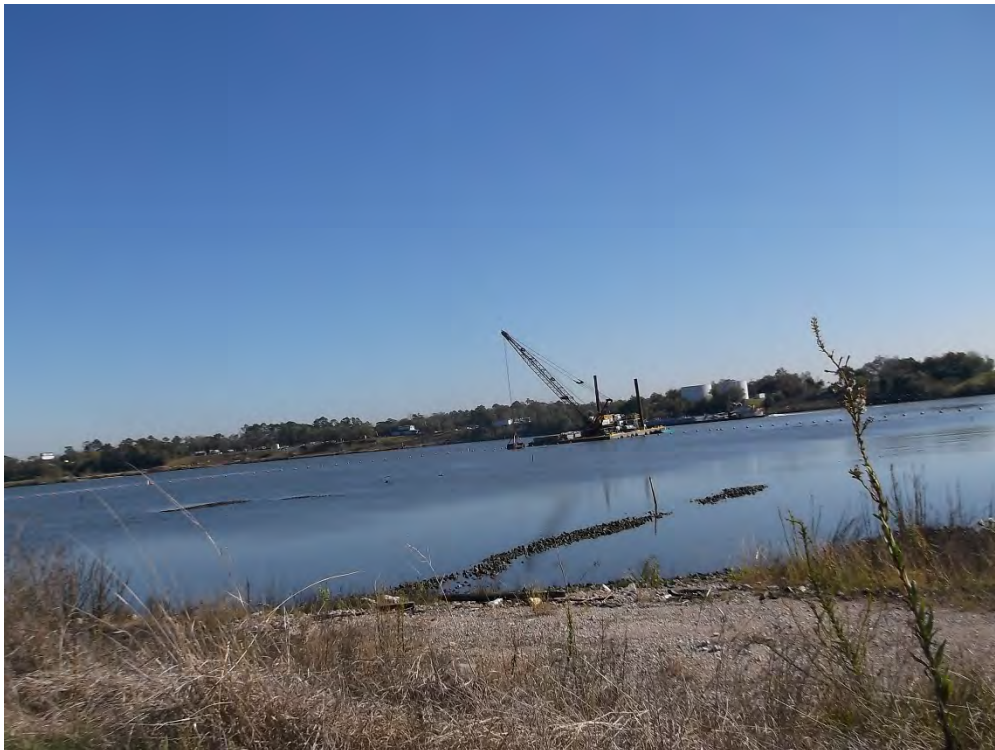
Photograph 3: Orion placing rock on panels 1 and 2 for the day (panels 7 and 8 for the job)

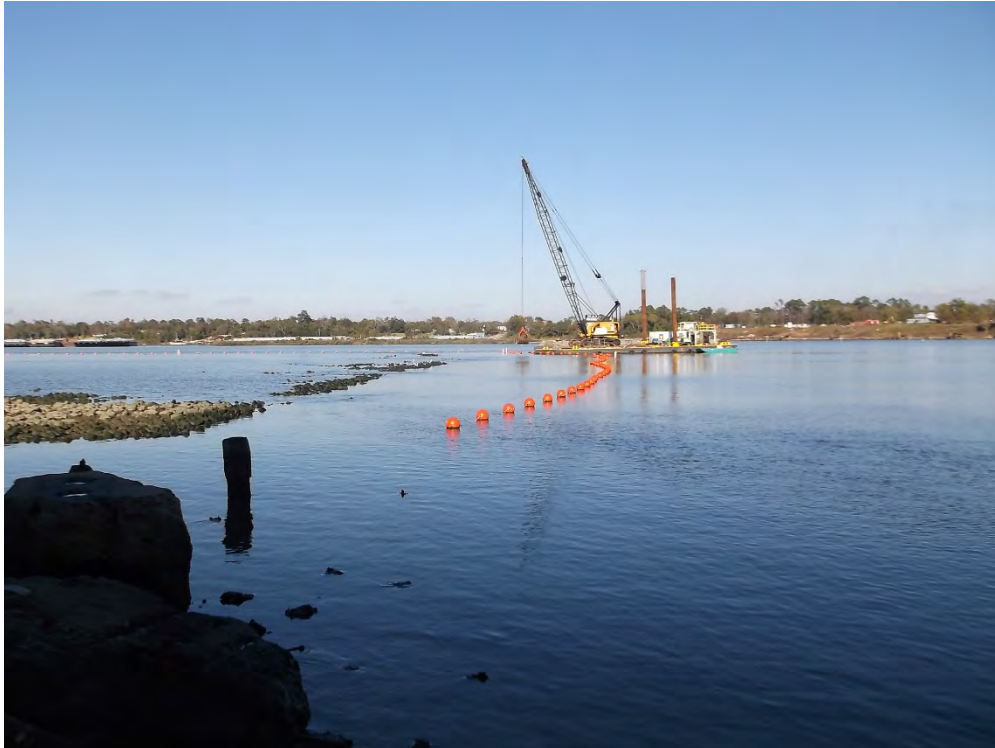
Photograph 4: Orion placing rock on panels 1, 2 and 3 for the day (panels 7 to 9 for the job)

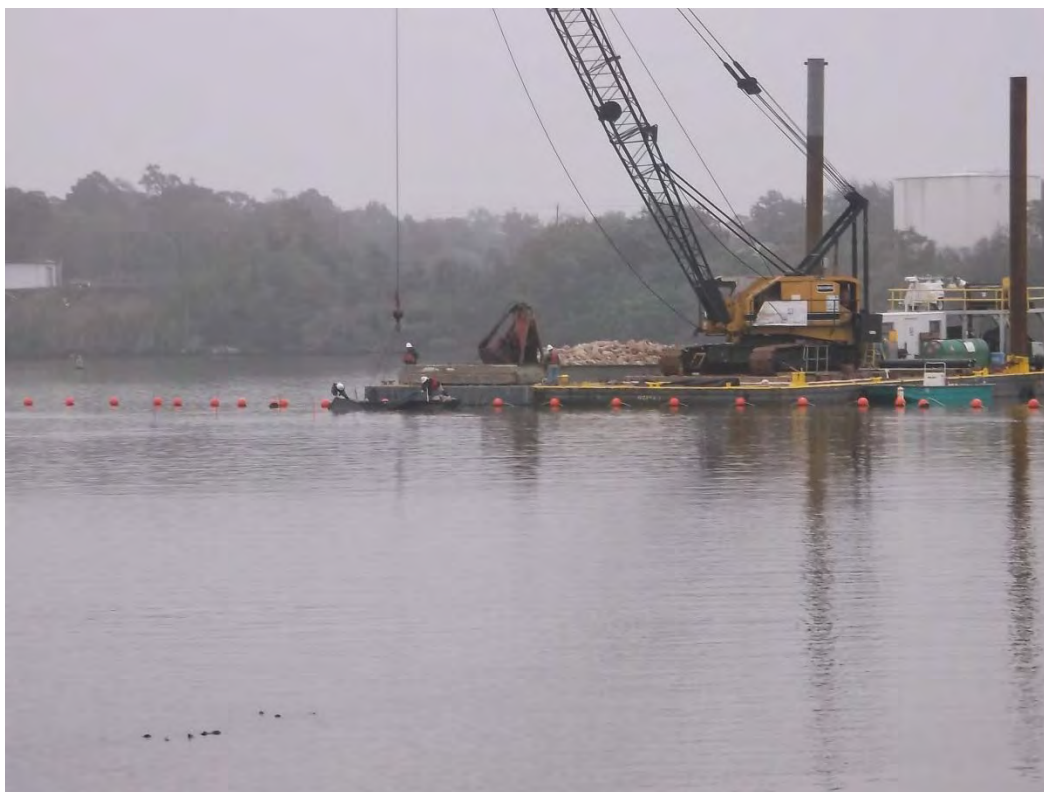
Photograph 1: Orion starts un-furling two panels after rock barge arrives

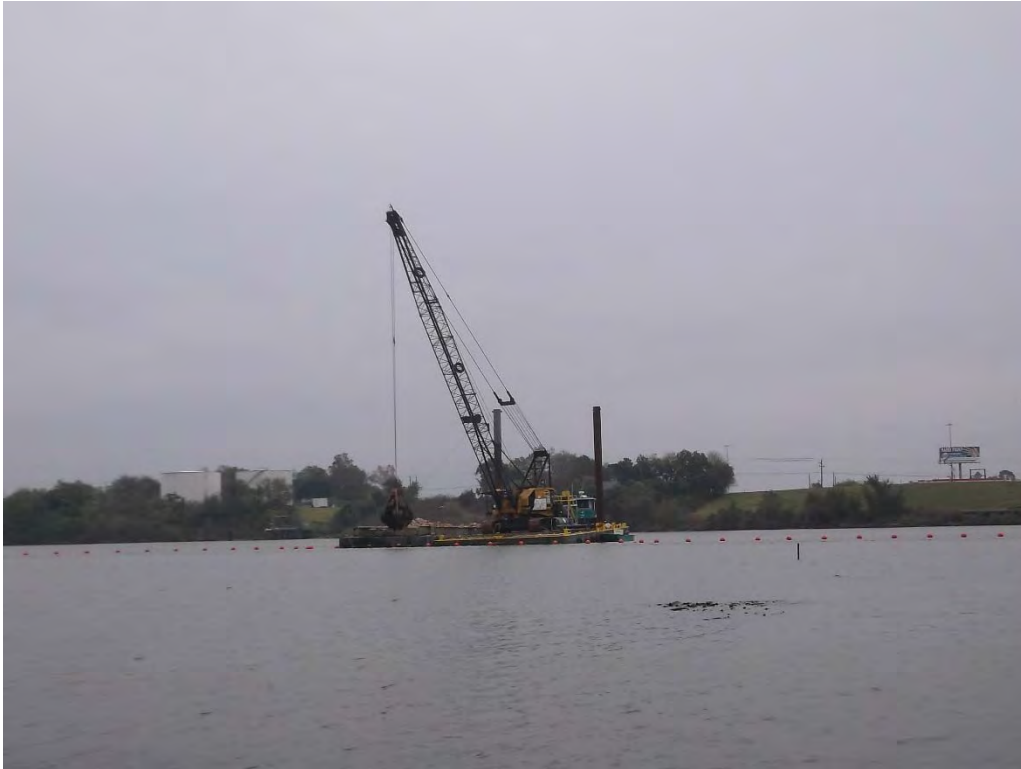
Photograph 2: Orion work barge placing stone with new bucket. Increased production

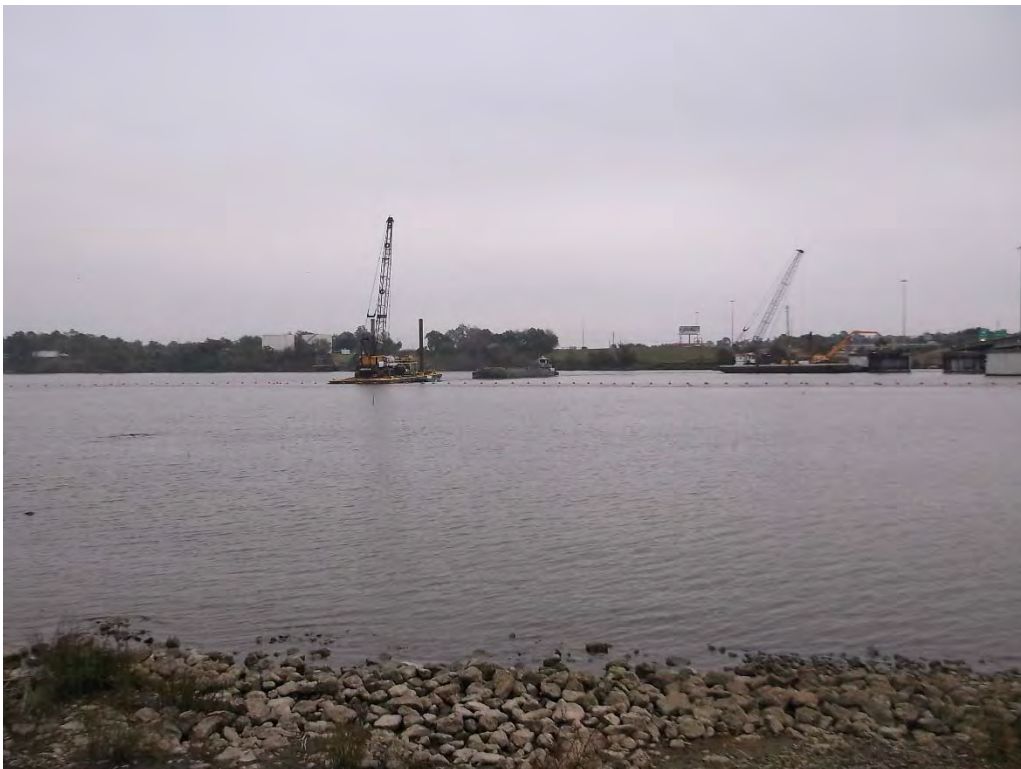
Photograph 3: Orion rock barge returning for refill near end of day.

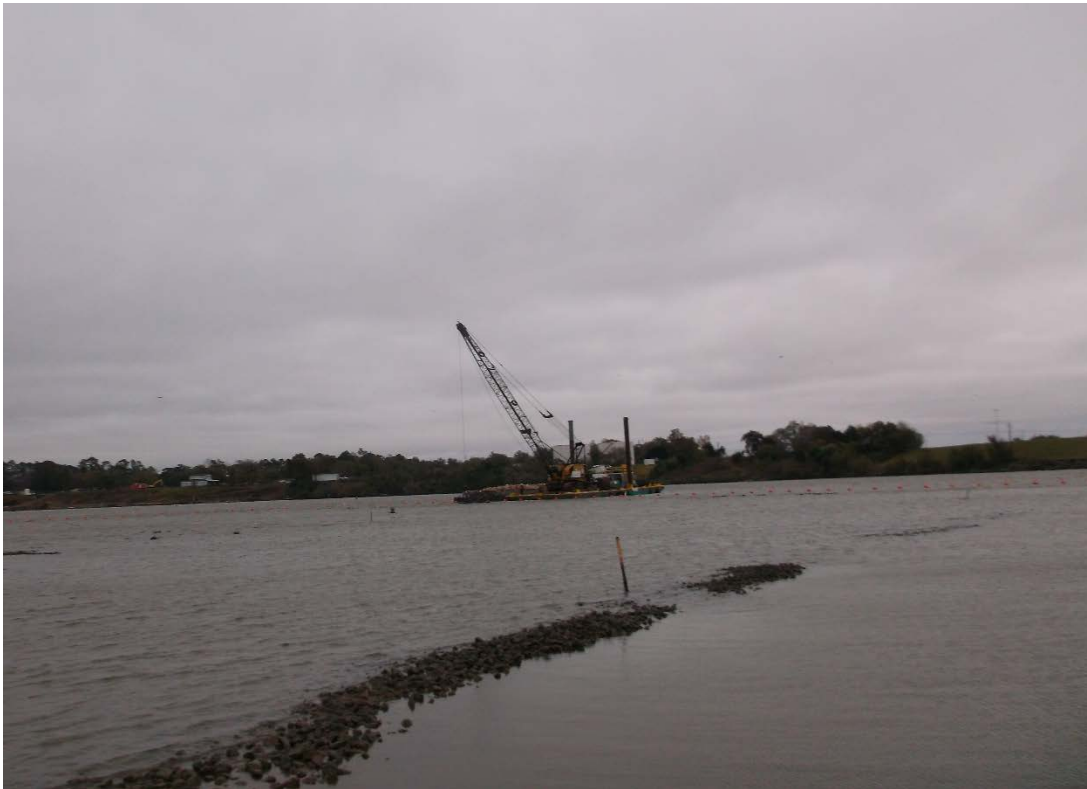
Photograph 1: Orion starts un-furling two panels after rock barge arrives

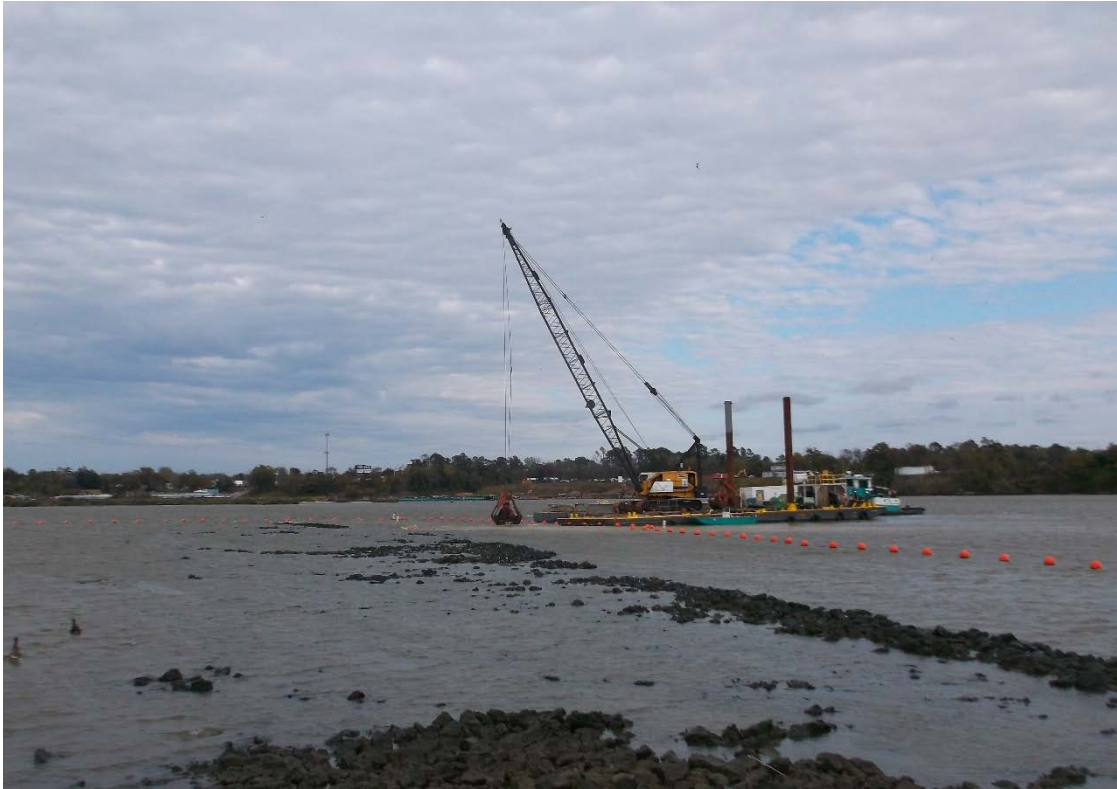
Photograph 2: Orion work barge placing stone near south end of maintenance area

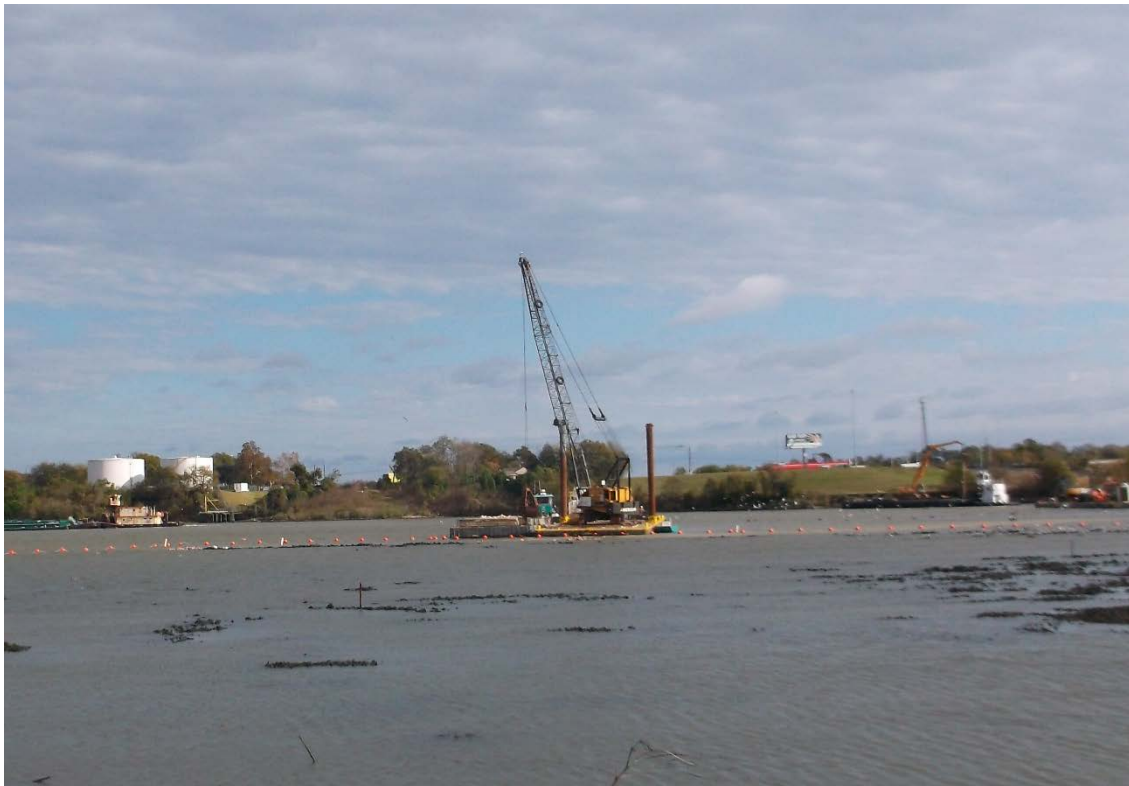
Photograph 3: Orion placing rock thickness during low tide

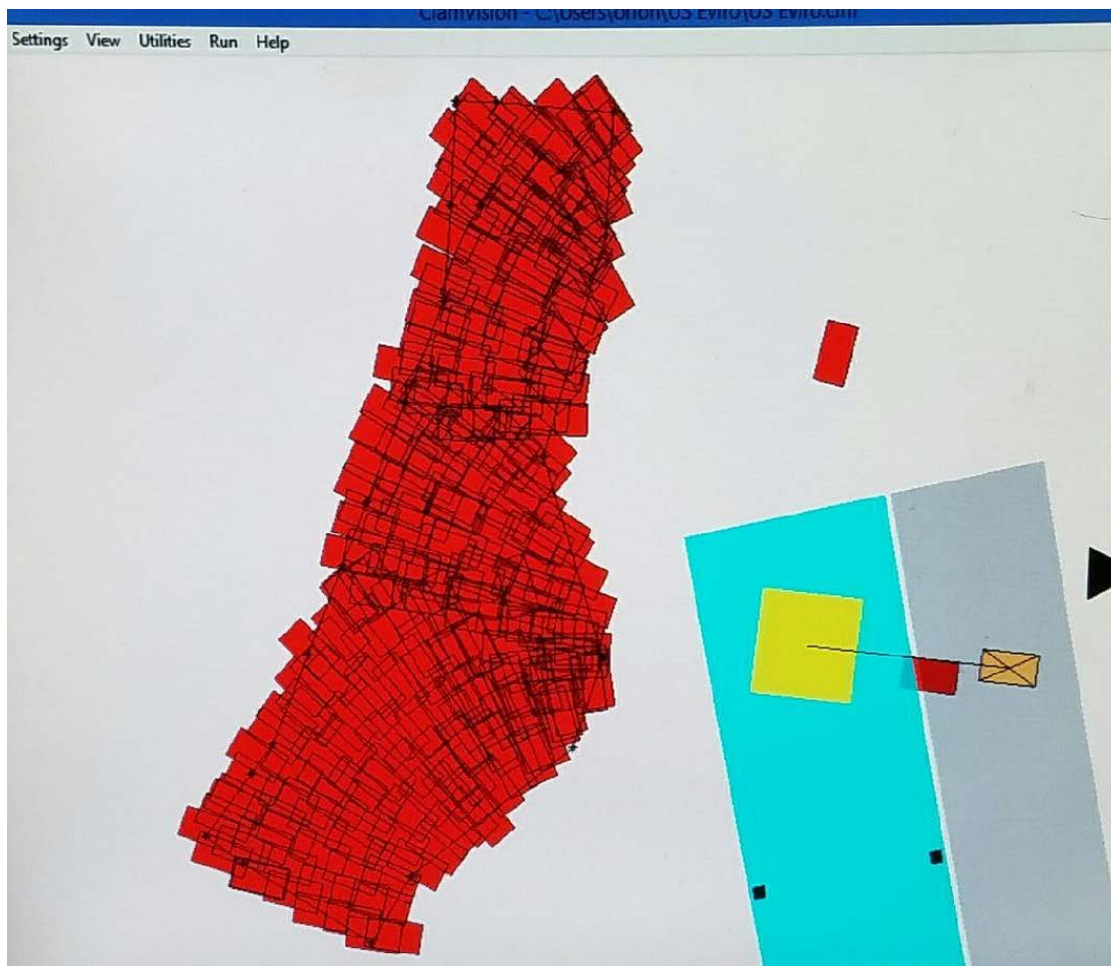
Photograph 4: Crane Tip GPS system. Shows total bucket coverage with first rock pass

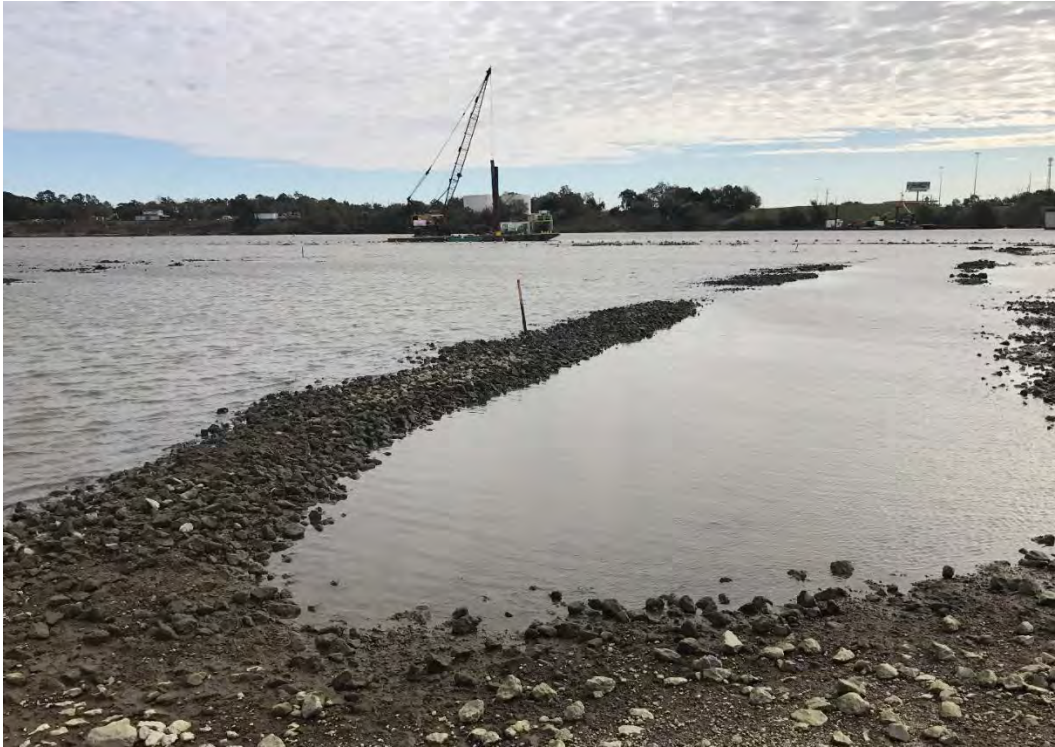
Photograph 1: Orion work barge placing stone near south end of maintenance area

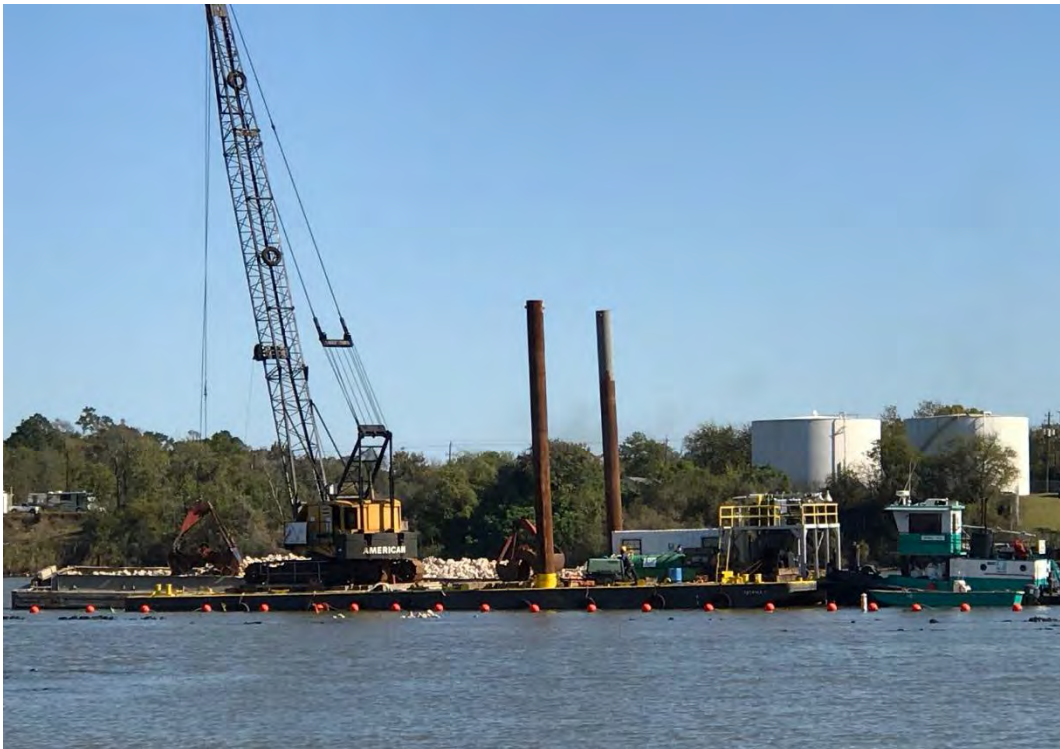
Photograph 2: Orion placing rock

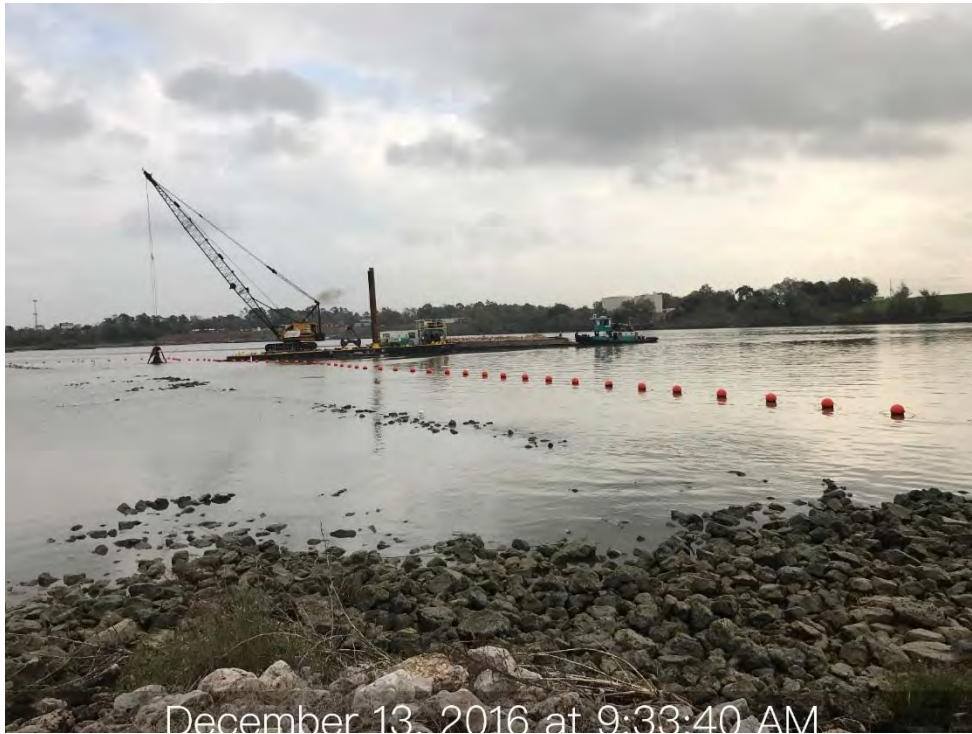
Photograph 1: Orion work barge placing stone near south end of maintenance area

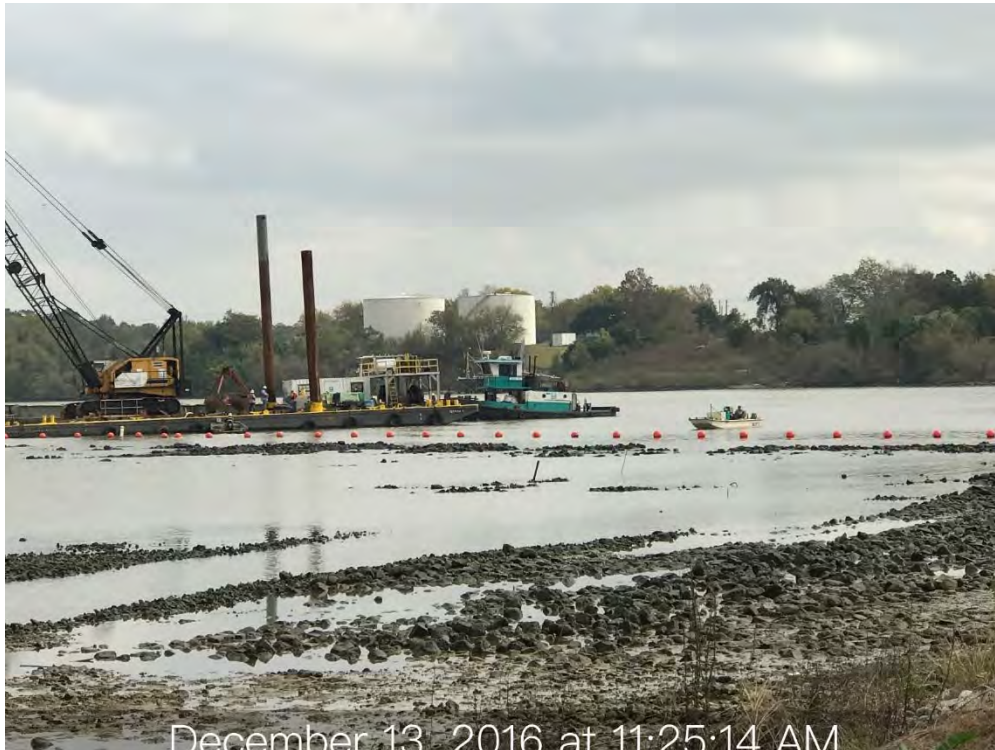
December 13, 2016 at 11:25:14 AM
Photograph 3: HCL surveying.

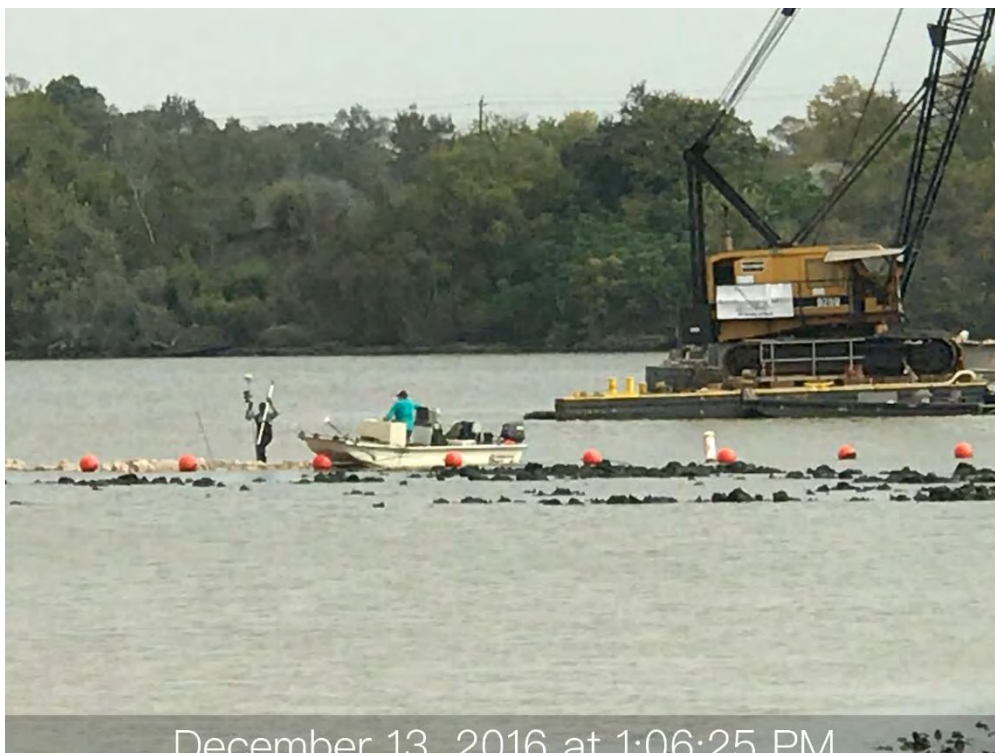
December 13, 2016 at 1:06:25 PM
Photograph 4: HCL surveying northern limits.

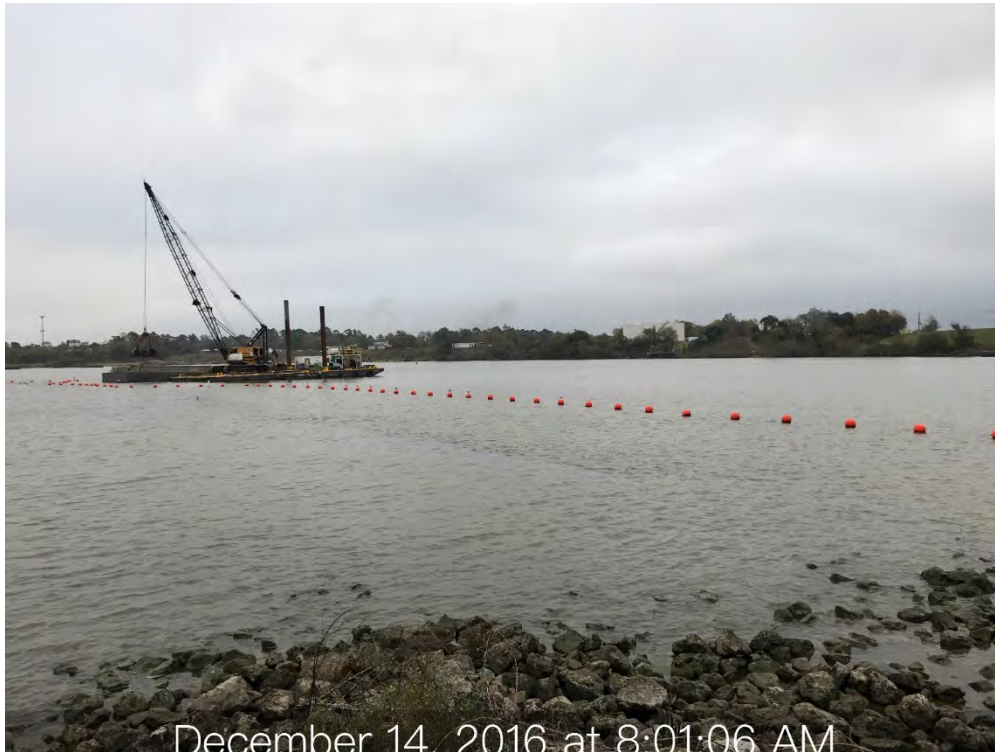
Photograph 1: Orion work barge placing stone near south end of maintenance area

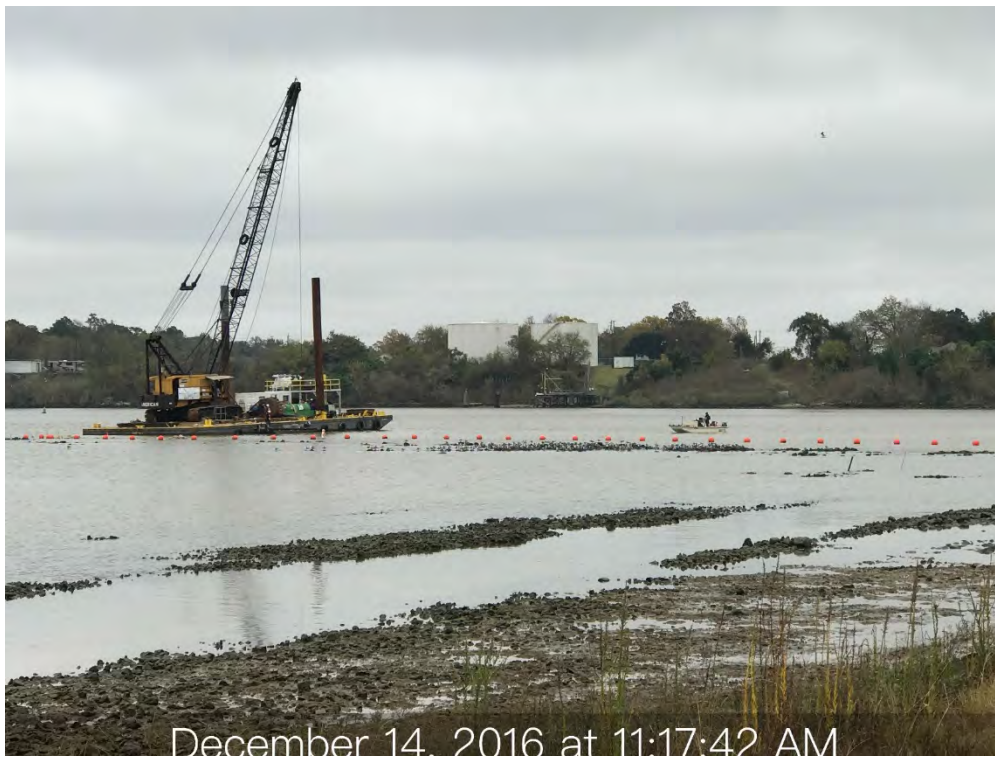
Photograph 2: HCL surveying.

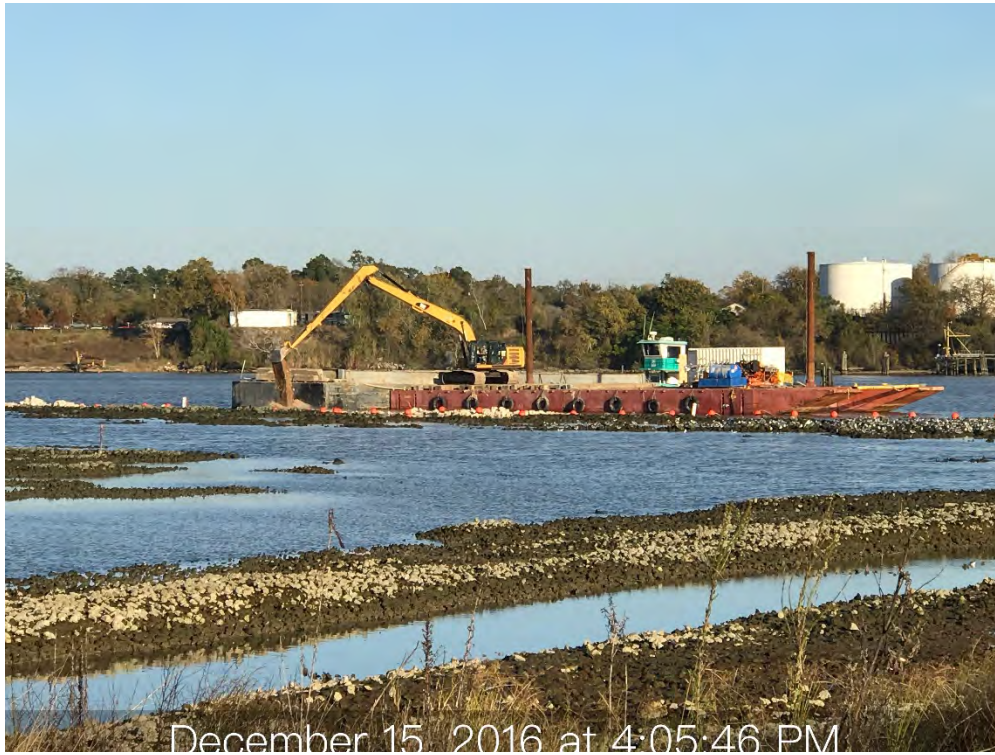
Photograph 2: Orion work barge placing stone near south end of maintenance area

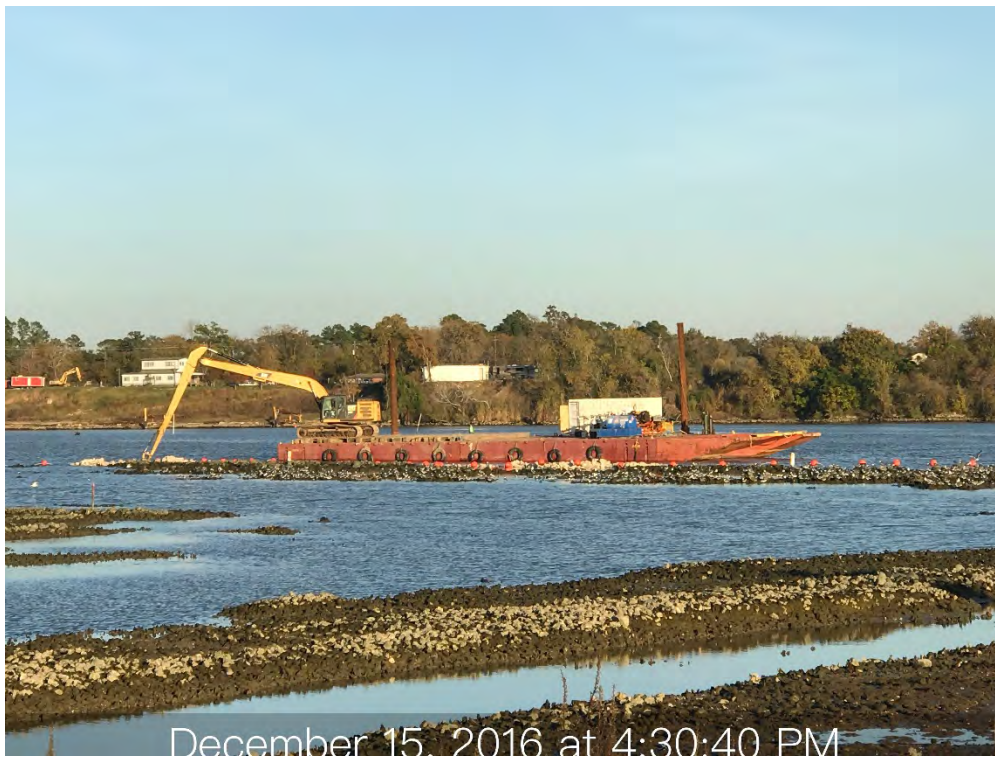
Photograph 3: Excavator shaping rock areas.

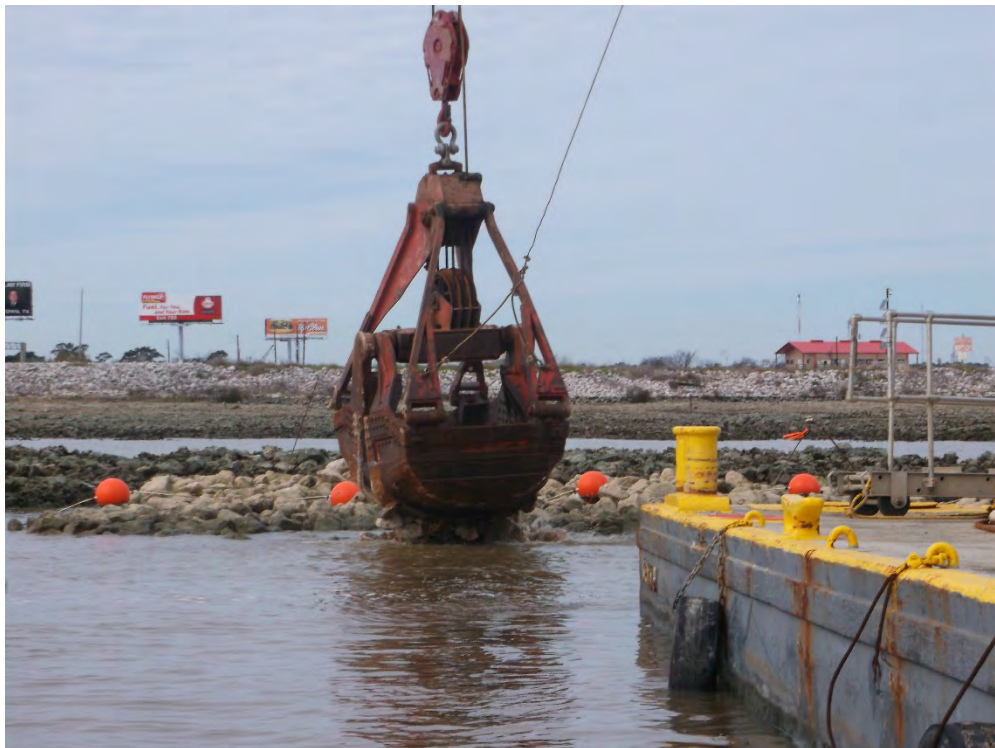
Photograph 1: Orion work barge placing stone near south end of placement area

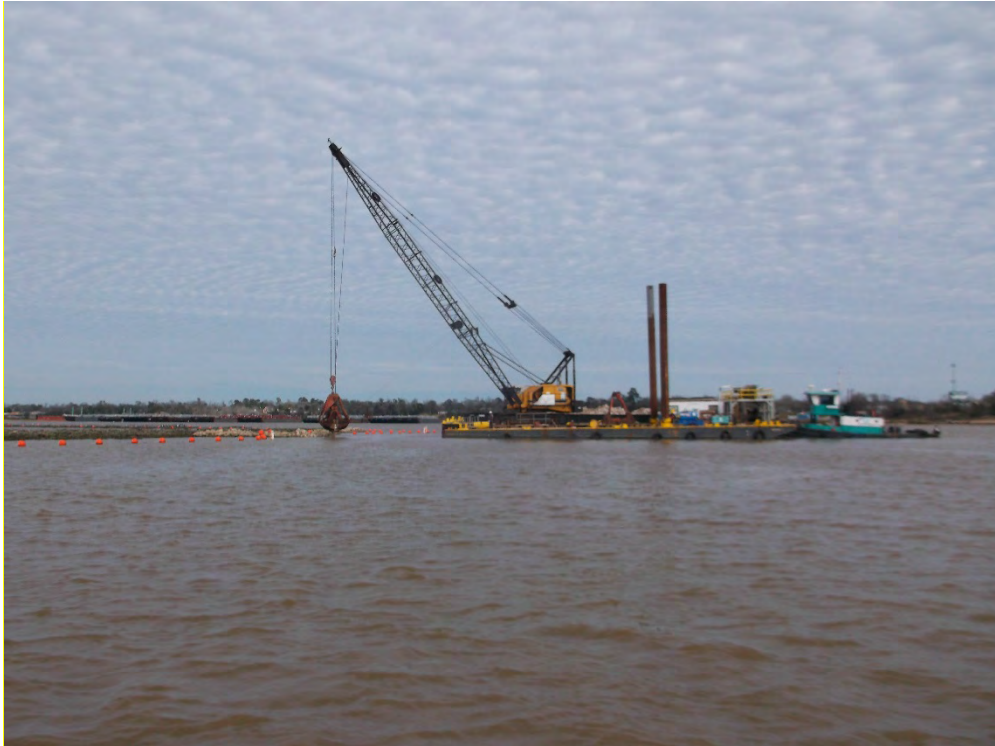
Photograph 2: Orion work barge placing stone near south end of placement area
